US007603890B2

(54) **METHOD OF INSPECTING A METAL ALLOY PART FOR INCIPIENT MELTING**

A method of inspecting a repaired metal alloy part to analyze a microstructure of the metal part includes placing a replicating material on a surface of the metal part to create an inverted replica of the microstructure. The replicating material is then removed from the surface. An image of the inverted replica on the replicating material is magnified in order to evaluate the microstructure for incipient melting and areas of boride concentration. This inspection method facilitates that evaluation without causing any destruction to the metal part.

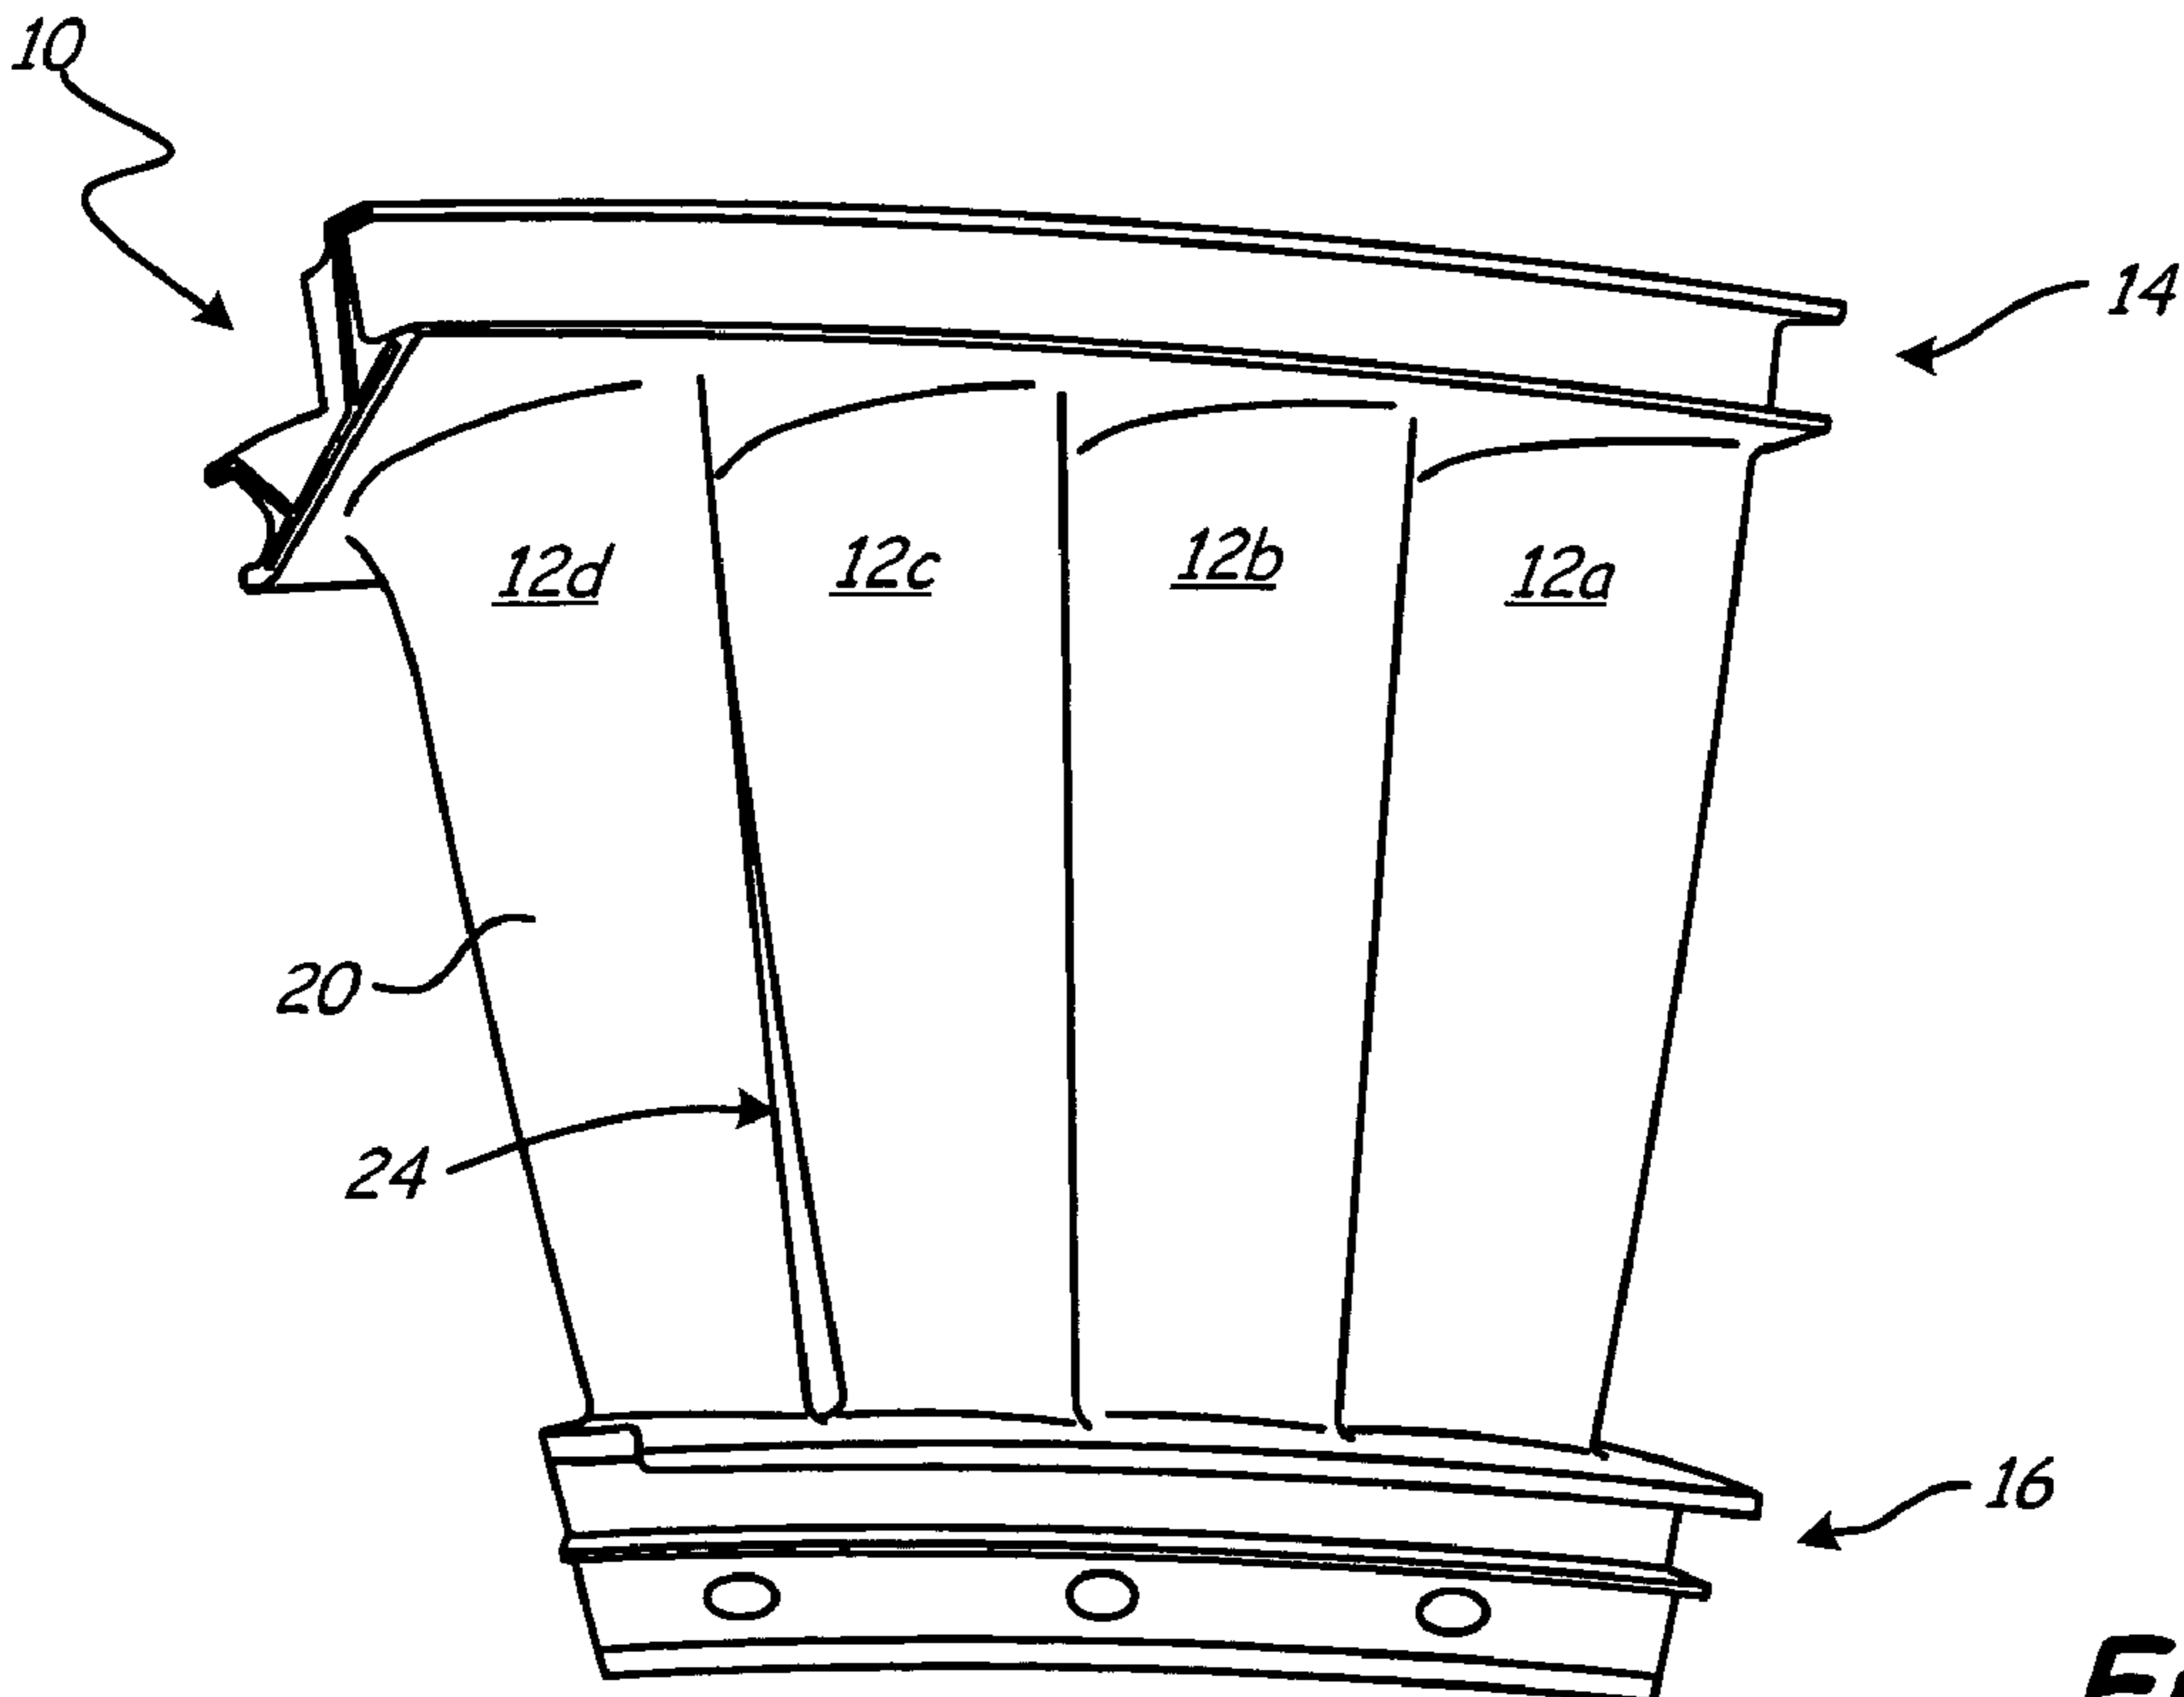
**Fig. 1B**

FIG. 1B is a perspective view of the vane assembly of FIG. 1A rotated approximately 180 degrees.

FIGS. 1A and 1B are perspective views of vane assembly 10, which may be part of a low pressure turbine or a high pressure turbine, both of a gas turbine engine. Vane assembly 10 may also be referred to as a nozzle segment, and may be formed by casting of a metal alloy, such as, for example, a nickel alloy. Vane assembly 10 includes vanes 12 (also known as airfoils), shroud 14 and platform 16. In the embodiment of FIGS. 1A and 1B, vane assembly 10 includes four vanes 12a, 12b, 12c and 12d. Each of vanes 12 includes pressure side 18, suction side 20, leading edge 22 and trailing edge 24.

In the embodiment shown in FIGS. 1A and 1B, vane assembly 10 includes four airfoils or vanes 12. It is recognized that the inspection method described herein may be used on a vane assembly or nozzle segment having more or less than four airfoils. Moreover, the inspection method may also be used for other gas turbine engine parts that may be repaired with the TURBOFIX® process or similar repair processes.
