(54) **METHOD OF INSPECTING A METAL ALLOY PART FOR INCIPIENT MELTING**

A method of inspecting a repaired metal alloy part to analyze a microstructure of the metal part includes placing a replicating material on a surface of the metal part to create an inverted replica of the microstructure. The replicating material is then removed from the surface. An image of the inverted replica on the replicating material is magnified in order to evaluate the microstructure for incipient melting and areas of boride concentration. This inspection method facilitates that evaluation without causing any destruction to the metal part.

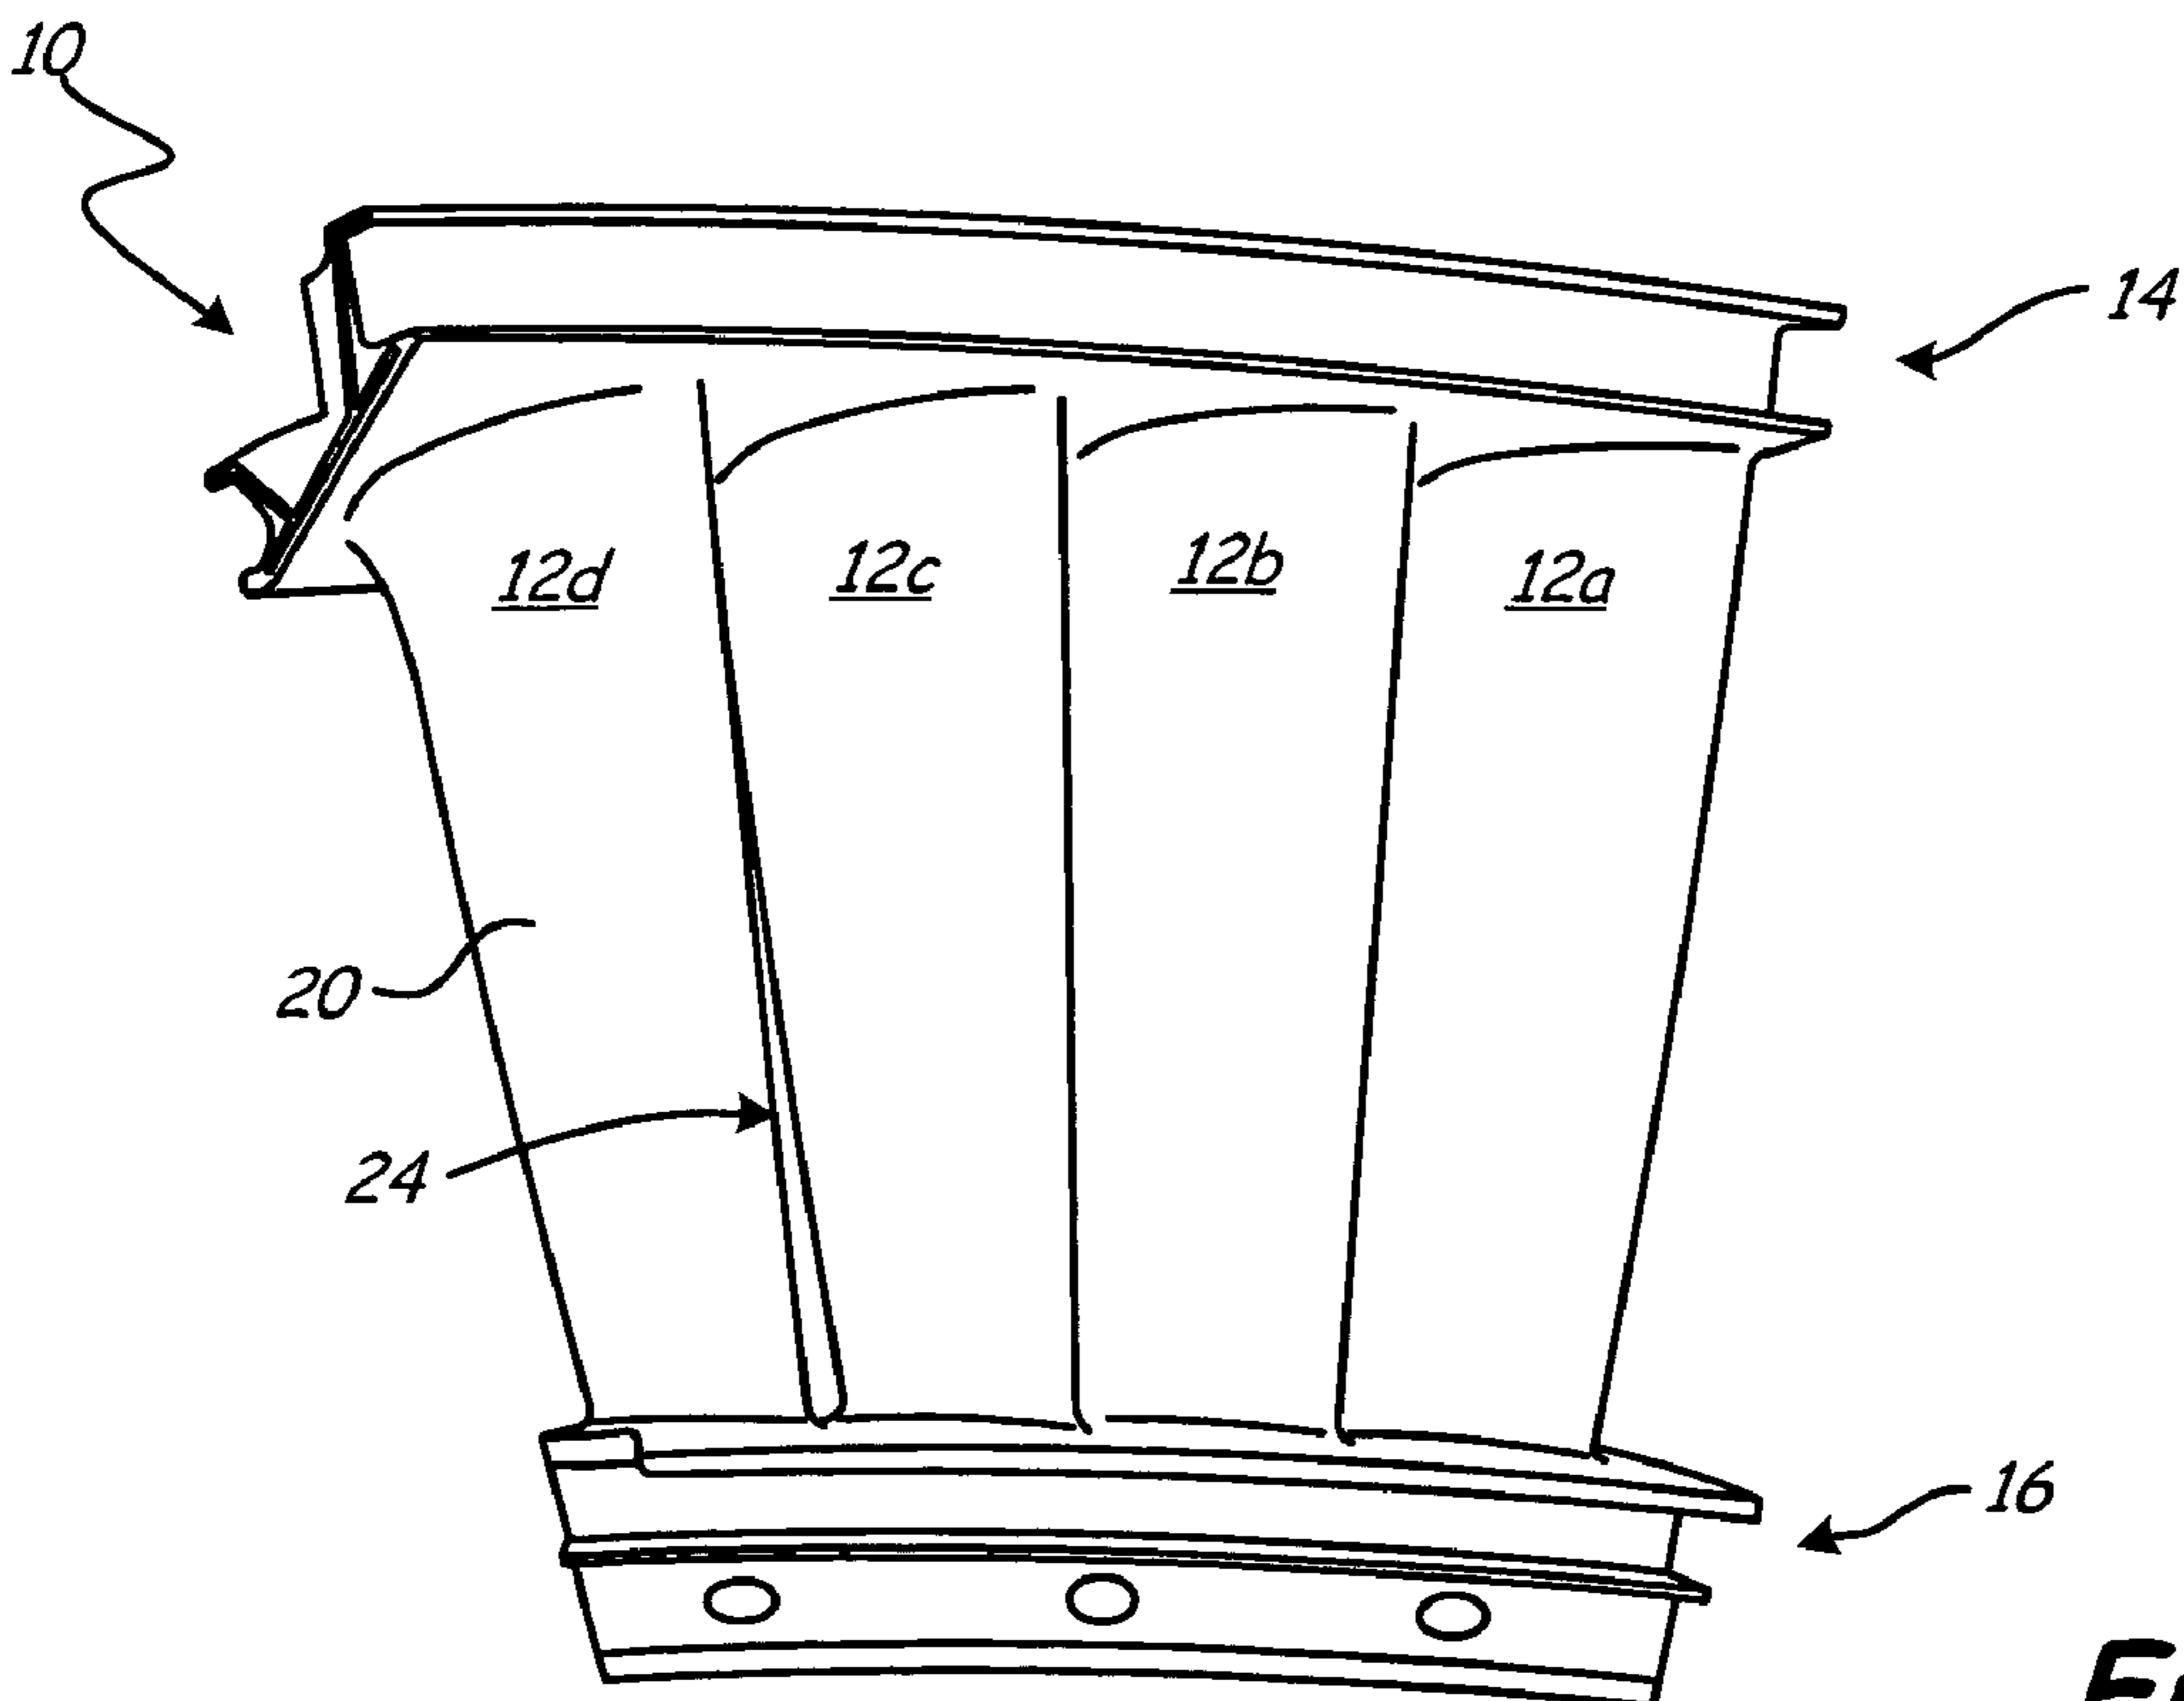
**Fig. 1B**

FIG. 1B is a perspective view of the vane assembly of FIG. 1A rotated approximately 180 degrees.

FIGS. 1A and 1B are perspective views of vane assembly 10, which may be part of a low pressure turbine or a high pressure turbine, both of a gas turbine engine. Vane assembly 10 may also be referred to as a nozzle segment, and may be formed by casting of a metal alloy, such as, for example, a nickel alloy. Vane assembly 10 includes vanes 12 (also known as airfoils), shroud 14 and platform 16. In the embodiment of FIGS. 1A and 1B, vane assembly 10 includes four vanes 12a, 12b, 12c and 12d. Each of vanes 12 includes pressure side 18, suction side 20, leading edge 22 and trailing edge 24.

num and boron. A significant portion of the blend may be made up of the base metal in the alloy used to form vane assembly 10. In the exemplary embodiment of FIGS. 1A and 1B, the base metal is nickel. The braze repair may be applied as a powder, viscous paste, paint, transfer tape, controlled density tape, and plate produced from powder.

In the embodiment shown in FIGS. 1A and 1B, vane assembly 10 includes four airfoils or vanes 12. It is recognized that the inspection method described herein may be used on a vane assembly or nozzle segment having more or less than four airfoils. Moreover, the inspection method may also be used for other gas turbine engine parts that may be repaired with the TURBOFIX® process or similar repair processes.

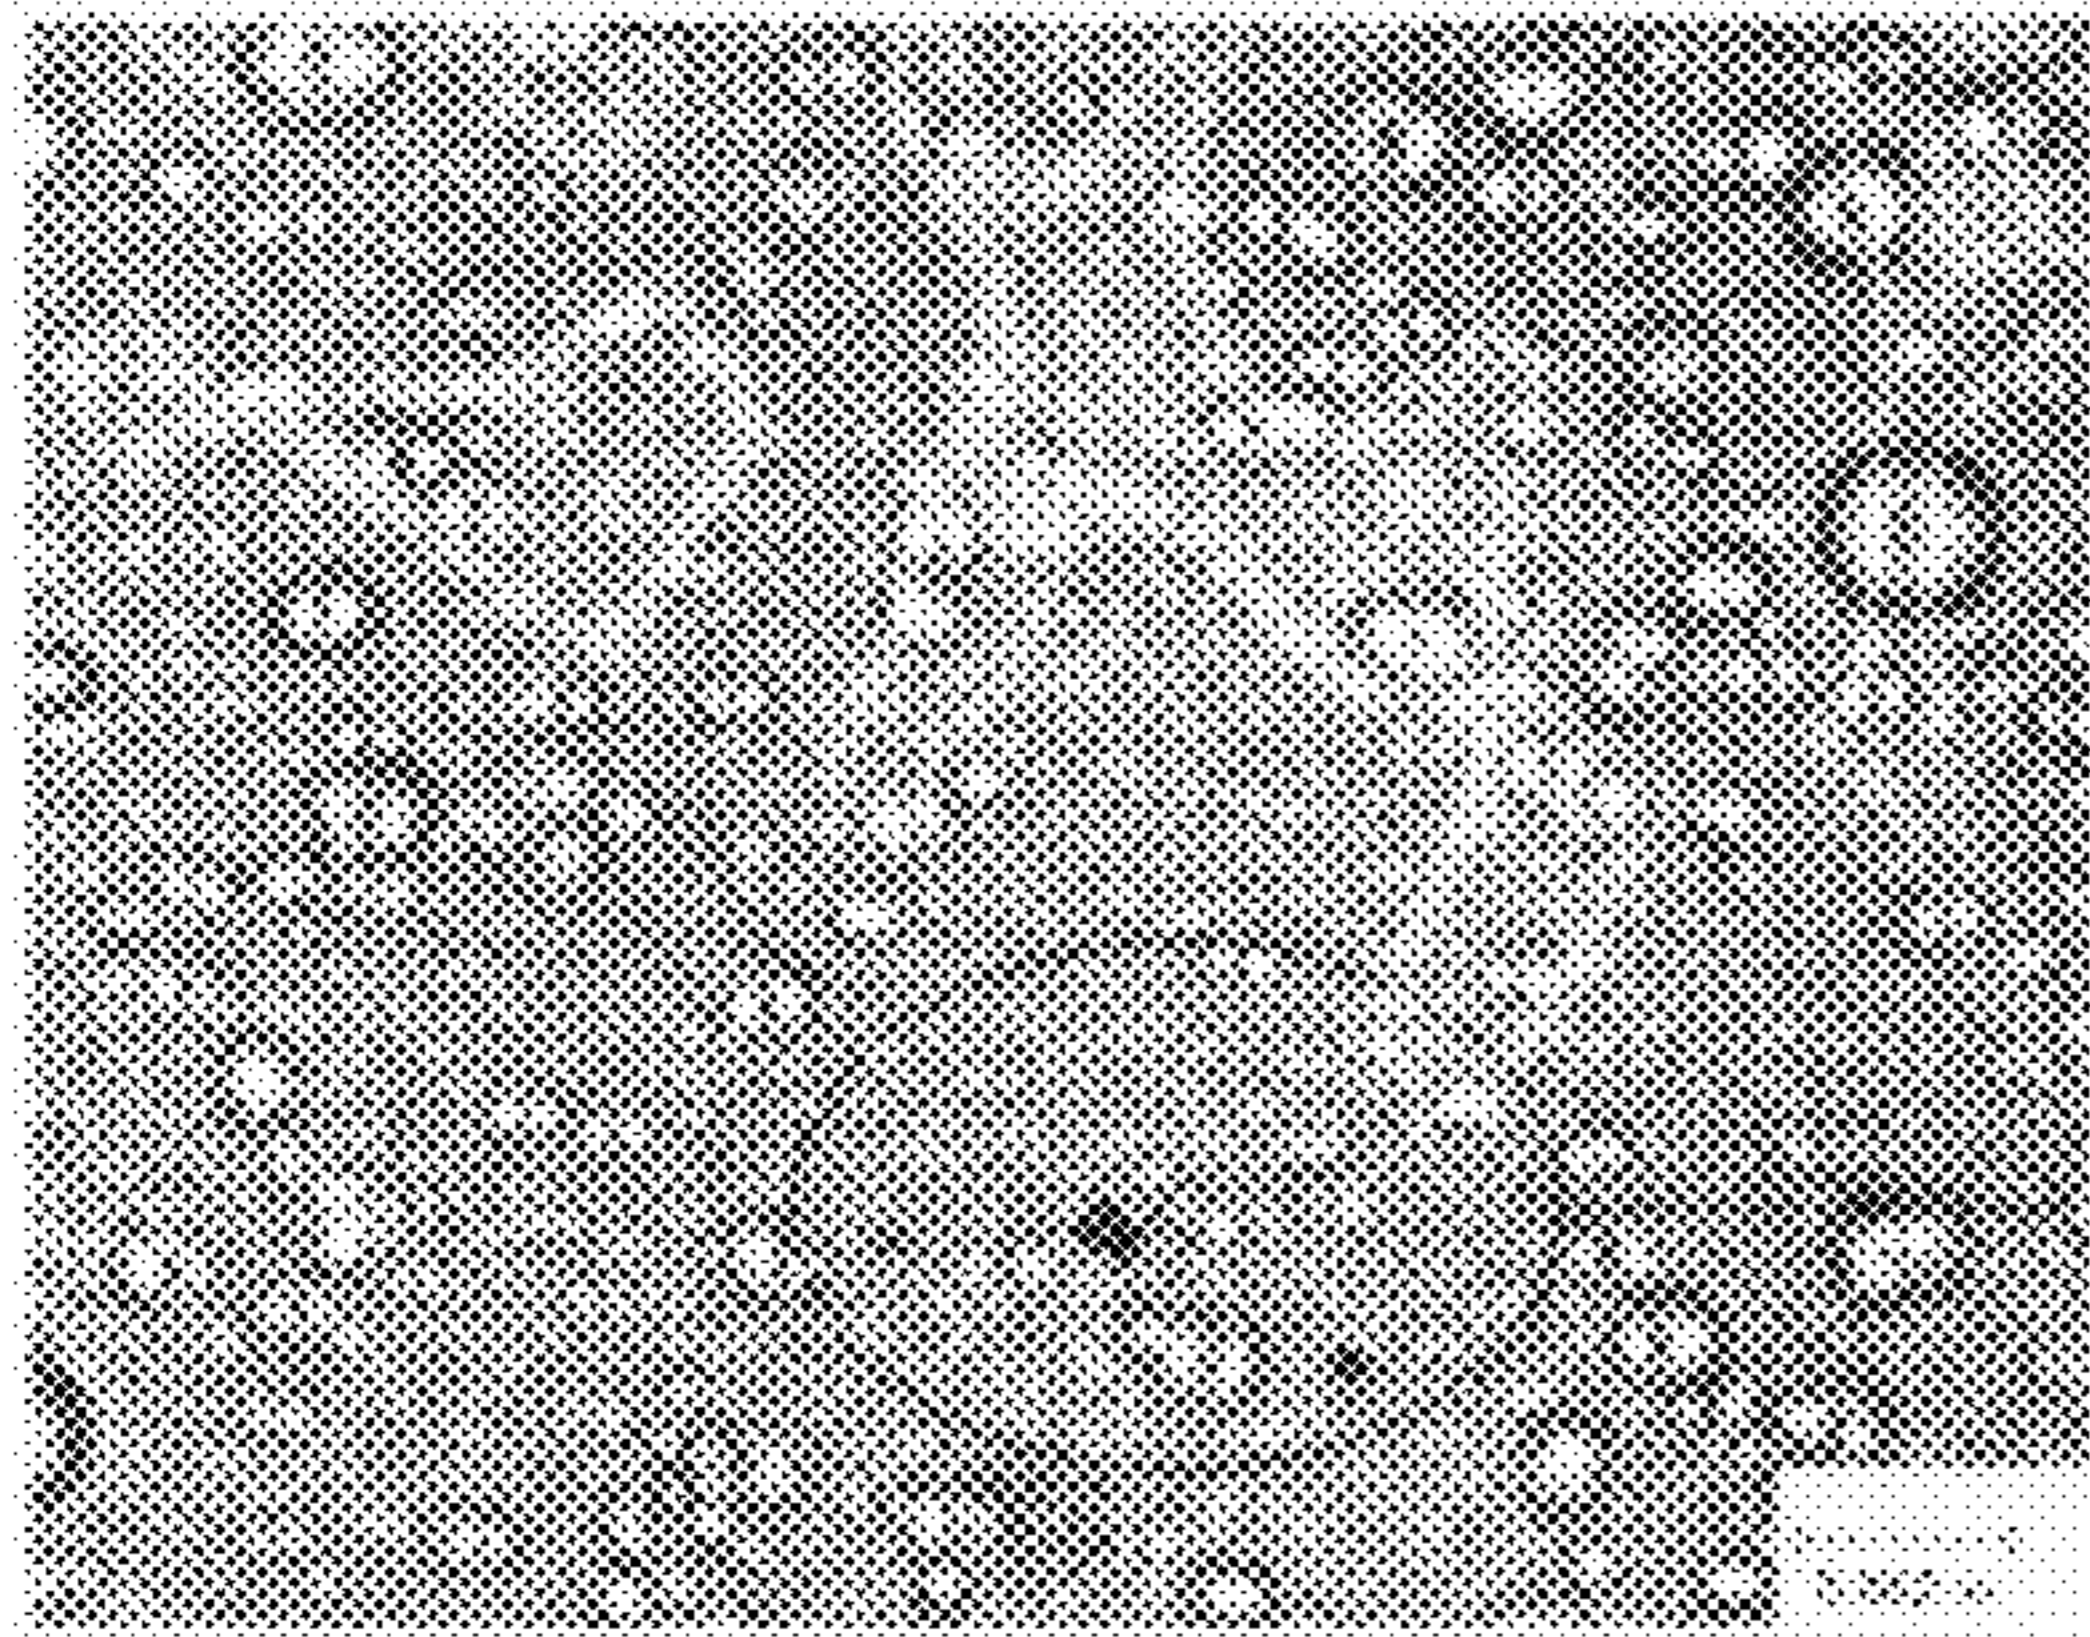
*Fig. 3A*

FIGS. 3A and 3B are magnified photographs of a replicated image of a microstructure of a metal alloy part.

FIGS. 3A and 3B are photographs of the replica from the test study. FIGS. 4A and 4B are photographs of the actual metal sample (i.e. the micro) that was destructively removed from a leading edge of the LPT blade. FIGS. 3A and 4A are magnified 200 times; FIGS. 3B and 4B are magnified 500 times.

In both FIGS. 3A and 4A, a circle contains an area where incipient melting occurred. The circled area is further magnified in FIGS. 3B and 4B to better illustrate incipient melting in the nickel based superalloy. The dark spot in the images represents a void in the metal, which is caused by melting. Note that the replication process results in an inverted image compared to images taken from an actual metal sample. Bubbles that formed in the replicating film are visible in the replicated images of FIGS. 3A and 3B, particularly in FIG. 3A.

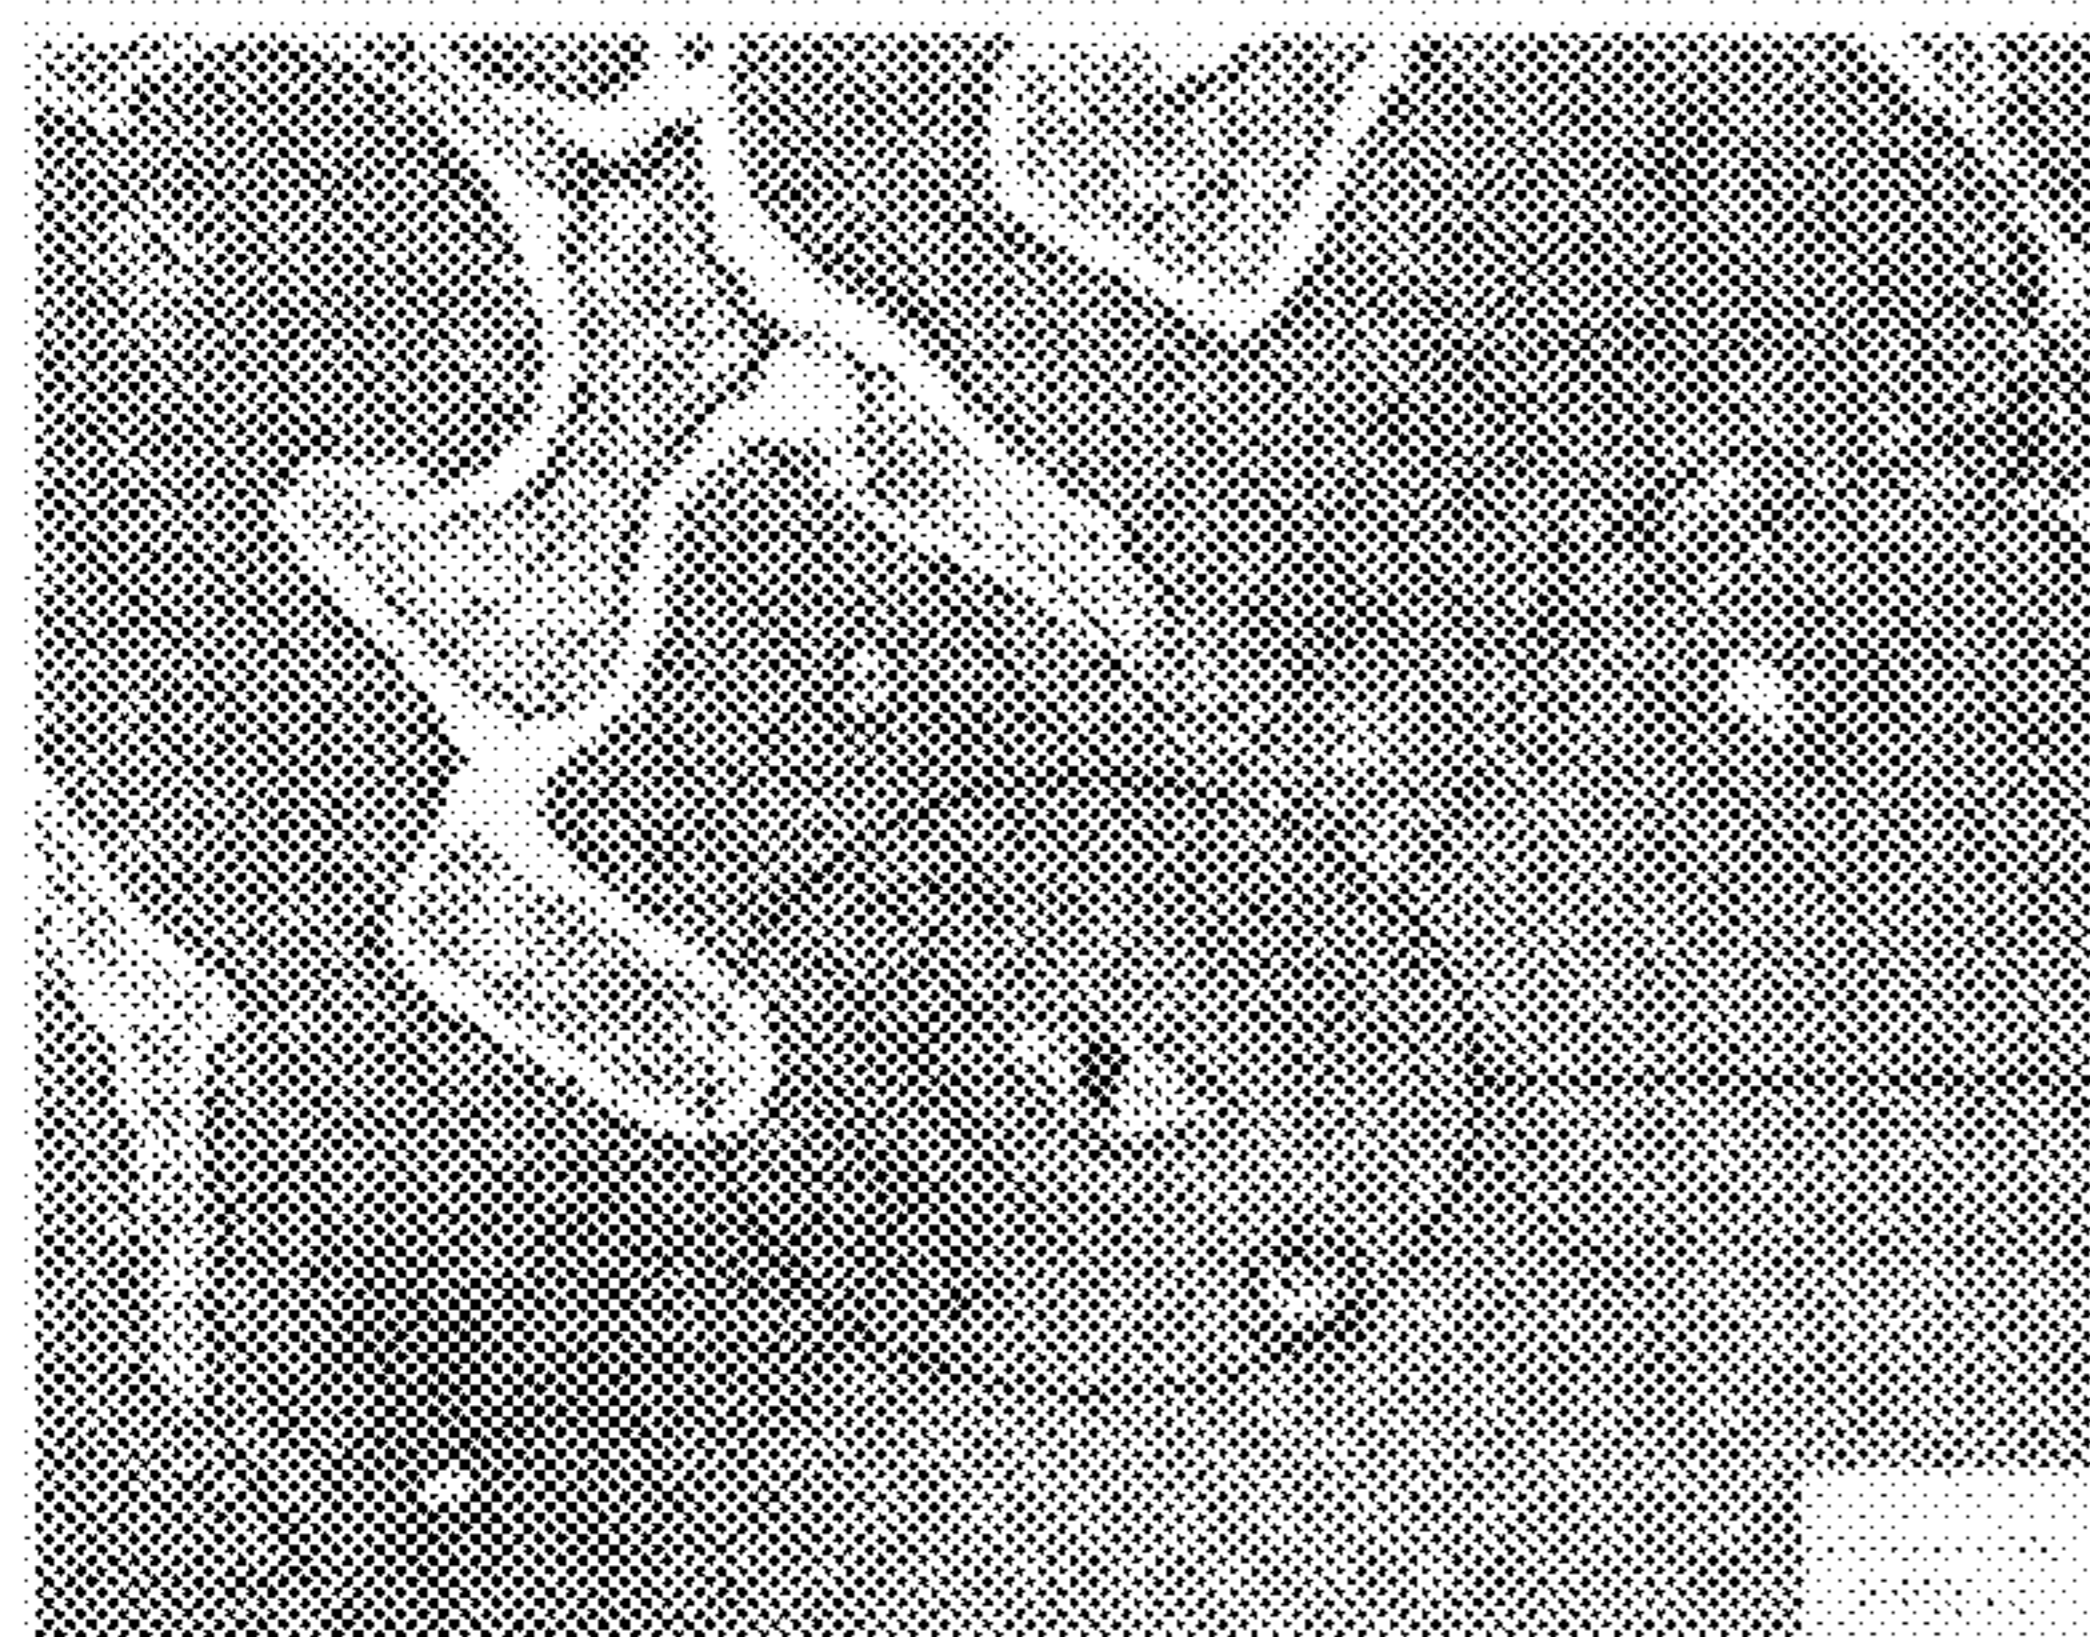
*Fig. 4A*

FIGS. 4A and 4B are magnified photographs of a micro or sample that was removed from a metal alloy part.

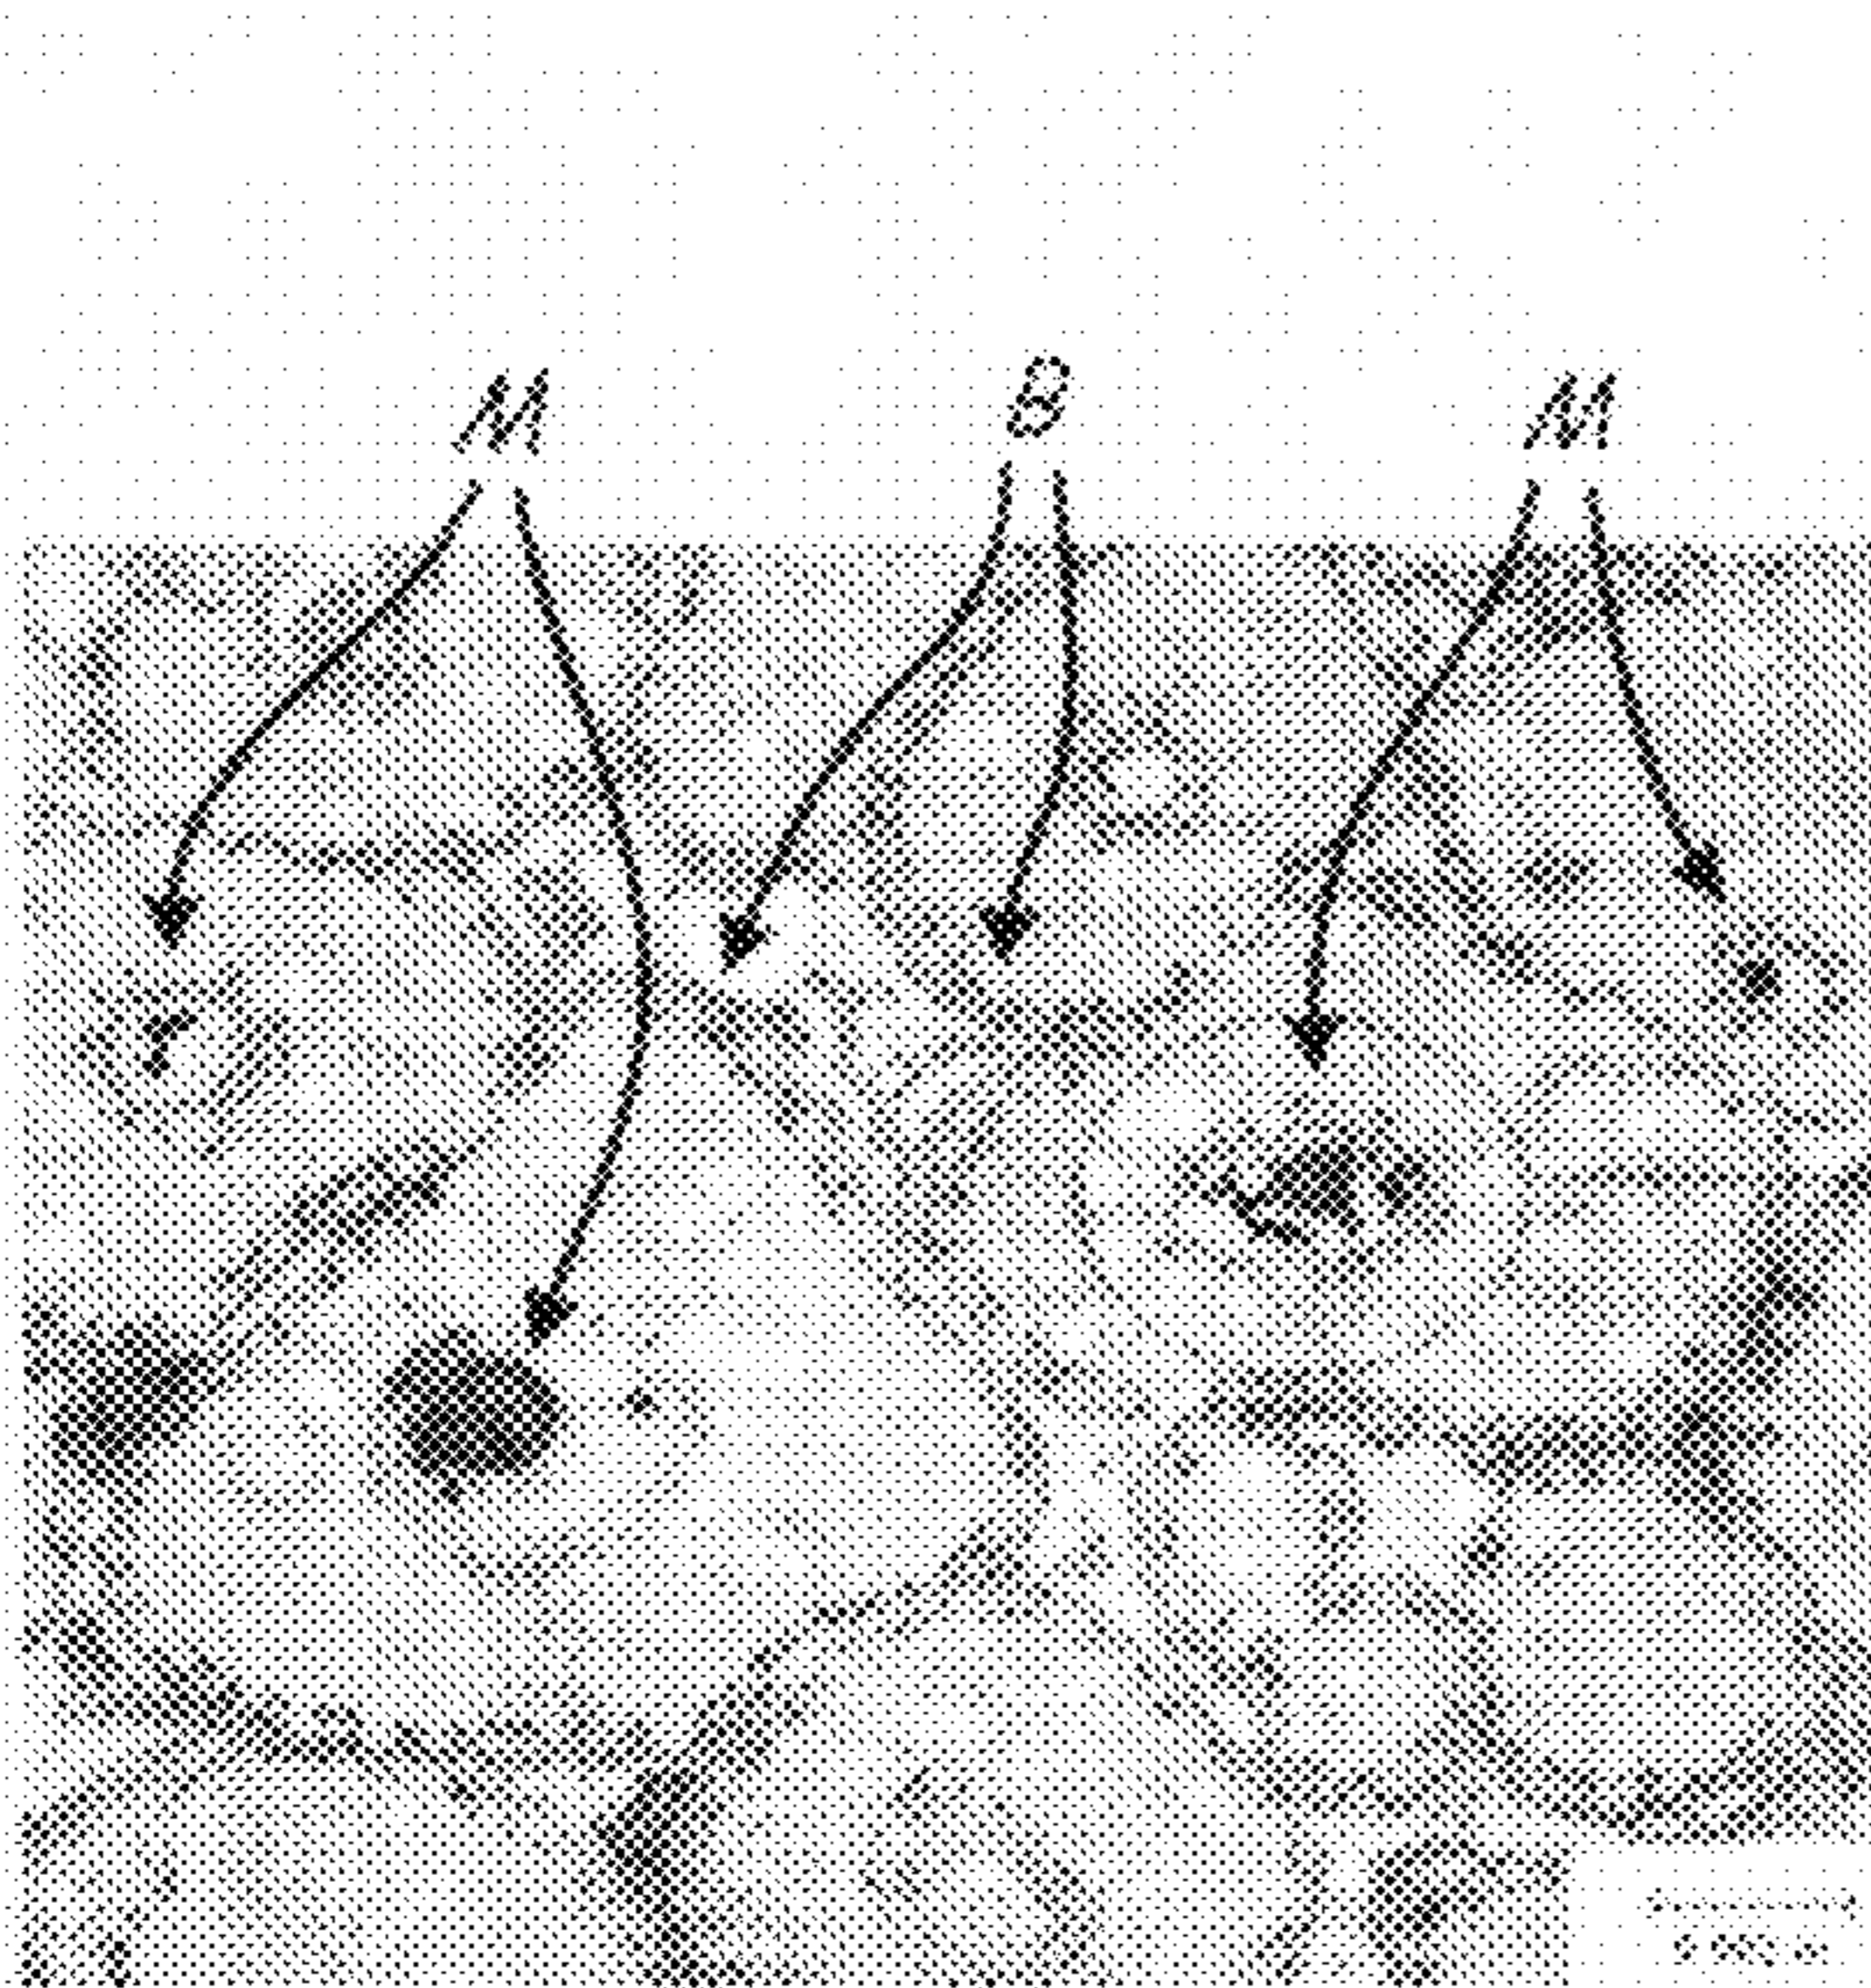
*Fig. 5A*

FIGS. 5A and 5B are magnified photographs of a replicated image of a microstructure of a second metal alloy part.
