(54) **FABRIC BUSHING INSTALLATION TO REPAIR A HOLE**

A method and system for repairing a damaged hole includes a deformable rod and a fabric wrapped around a middle portion of the rod. A first portion of the rod is inserted into the damaged hole. The rod is stretched to align the middle portion of the rod and the fabric with an inside circumference of the hole. The rod is then relaxed to compress the fabric against the inside circumference of the hole.

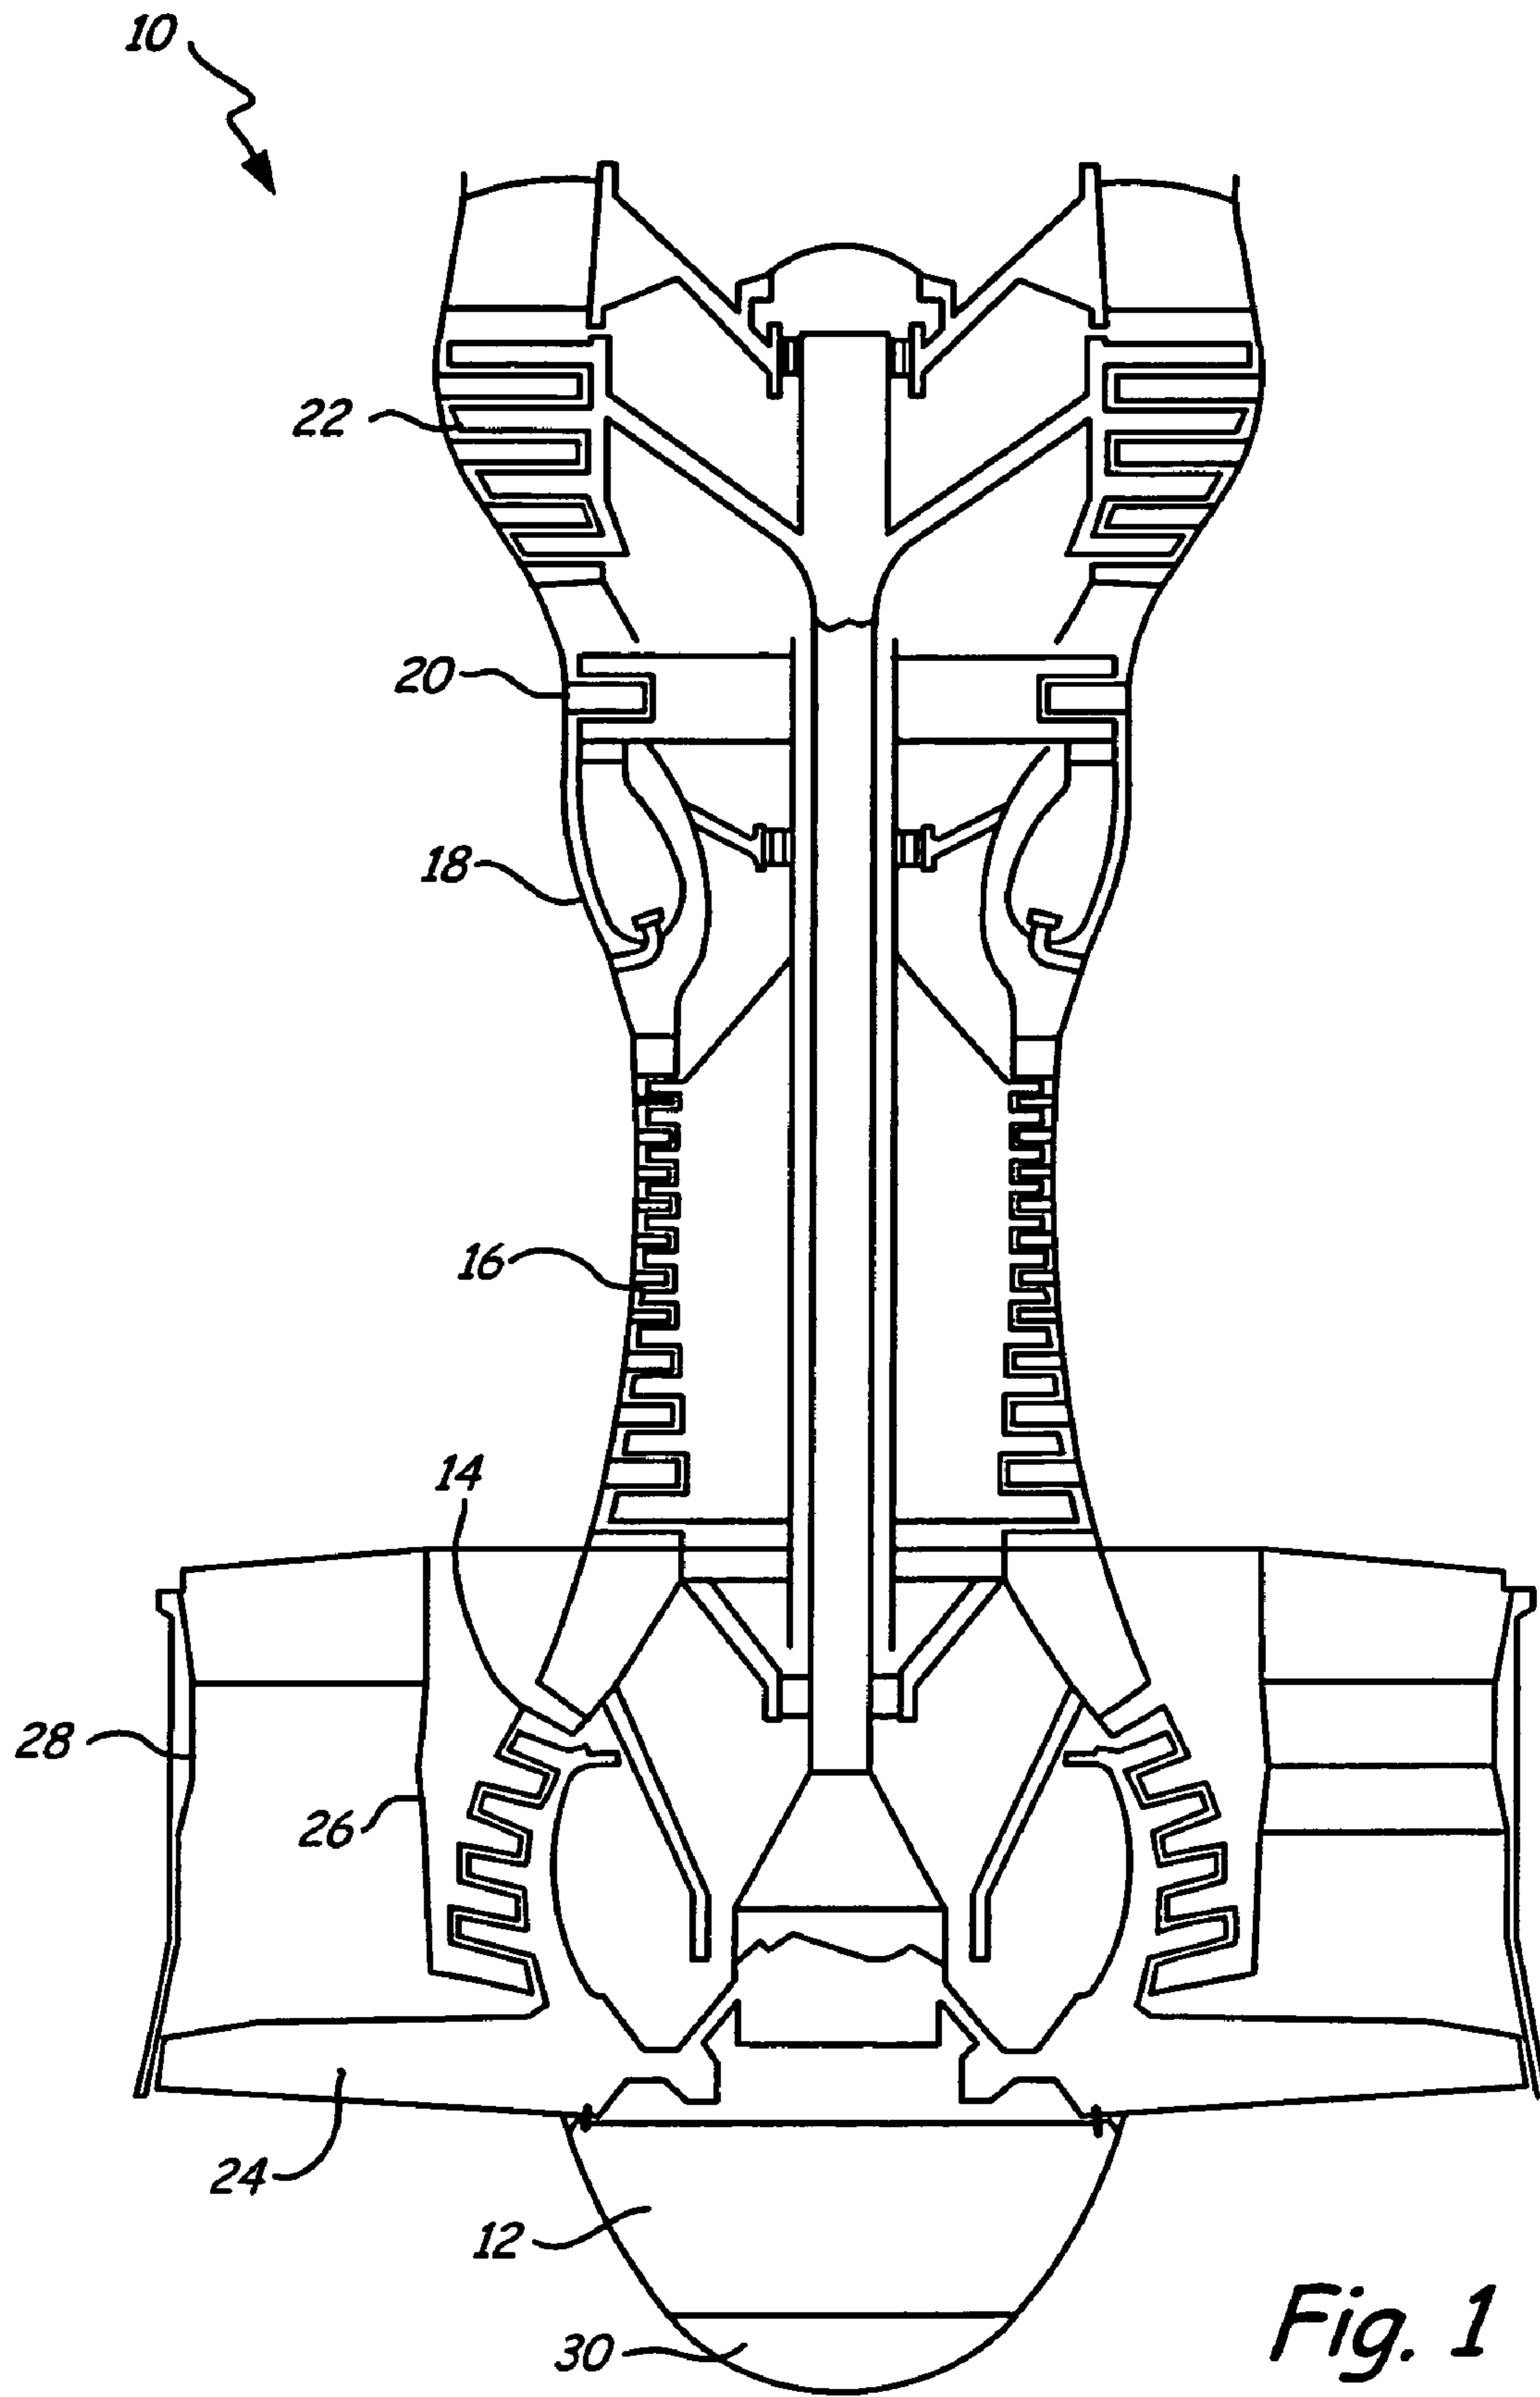
Fig. 1

FIG. 1 is a cross-sectional view of a turbofan engine.

FIG. 1 is a cross-sectional view of turbofan gas turbine engine 10, which includes inlet nose cone 12, low pressure compressor 14, high pressure compressor 16, combustor 18, high pressure turbine 20, and low pressure turbine 22.

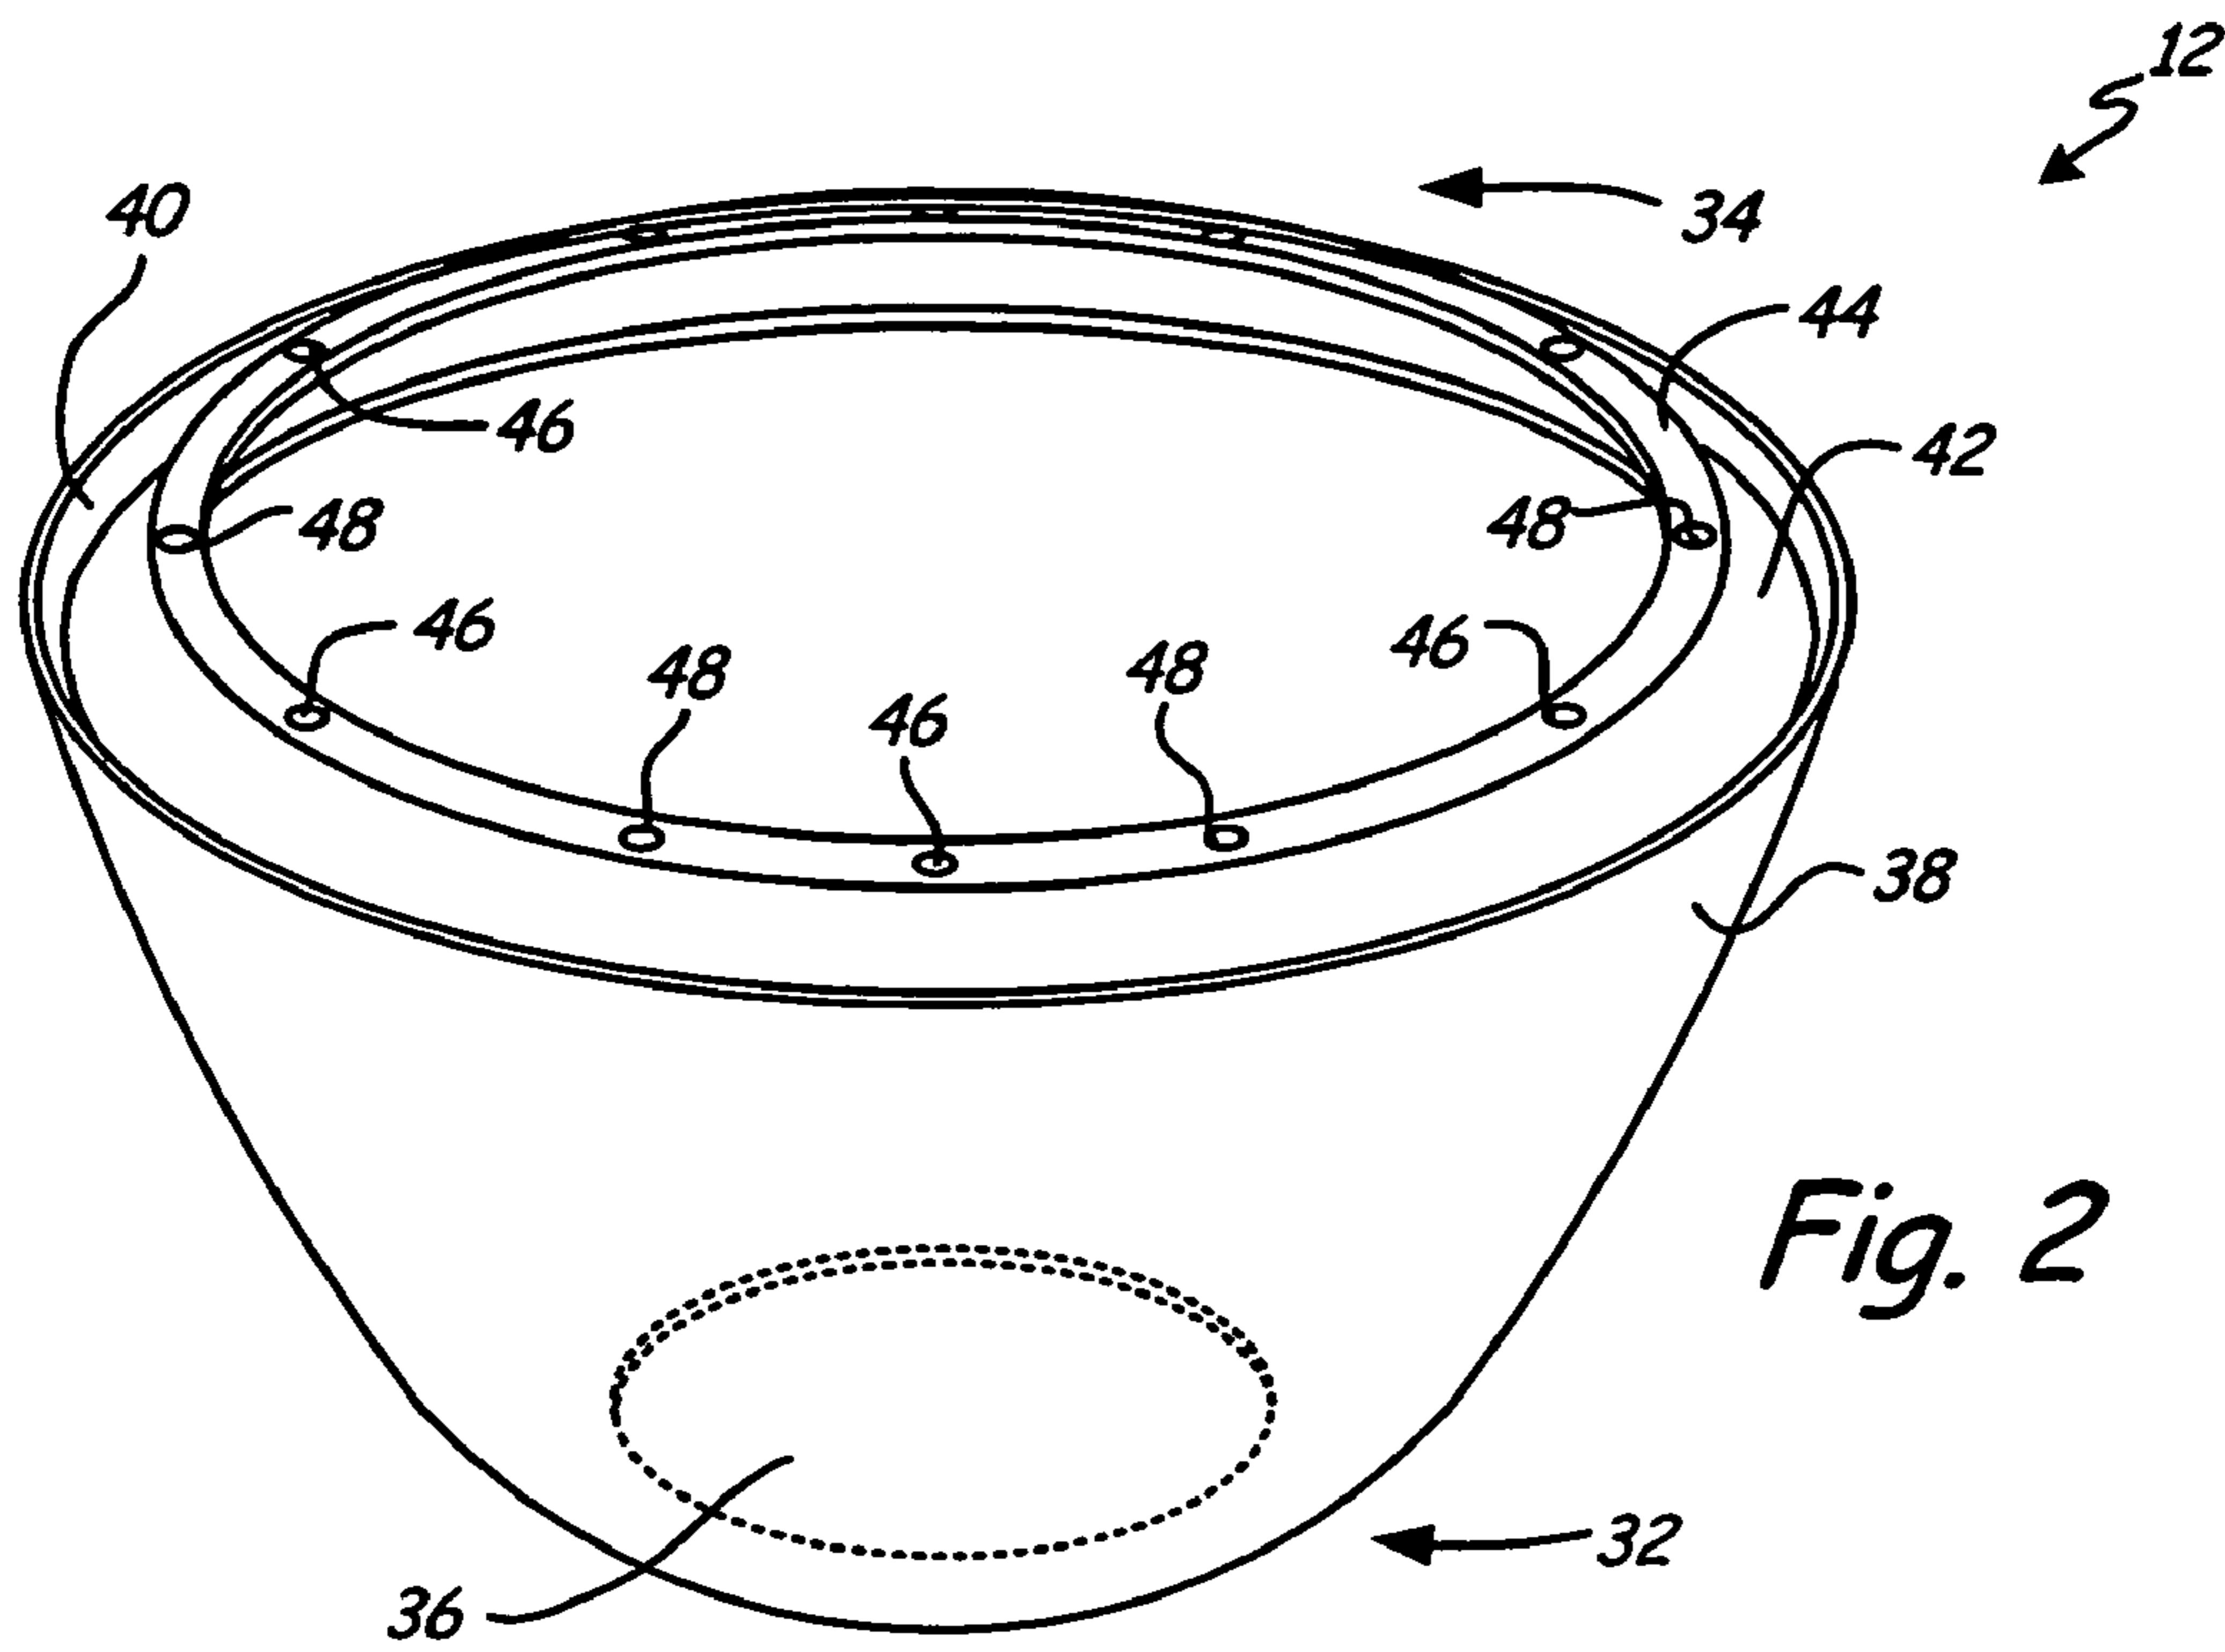
Fig. 2

FIG. 2 is a perspective view of an inlet nose cone of the turbofan engine of FIG. 1.

FIG. 2 is a perspective side view of inlet nose cone 12 having forward (front) end 32 and aft (rear) end 34. Inlet nose cone 12 includes opening 36, body portion 38, aft fairing 40, ramp 42 and flange 44. Opening 36 is located at forward end 32 of nose cone 12 and is configured to receive access cap 30. Aft fairing 40 extends from body portion 38 at aft end 34 of nose cone 12. Ramp 42 also extends from body portion 38 at aft end 34 of nose cone 12. Body portion 38, aft fairing 40 and ramp 42 are configured such that they form a Y-joint at their junction. Flange 44 extends from ramp 42. Flange 44 includes a plurality of balance weight holes 46 and a plurality of attachment holes 48 in an alternating sequence around flange 44.

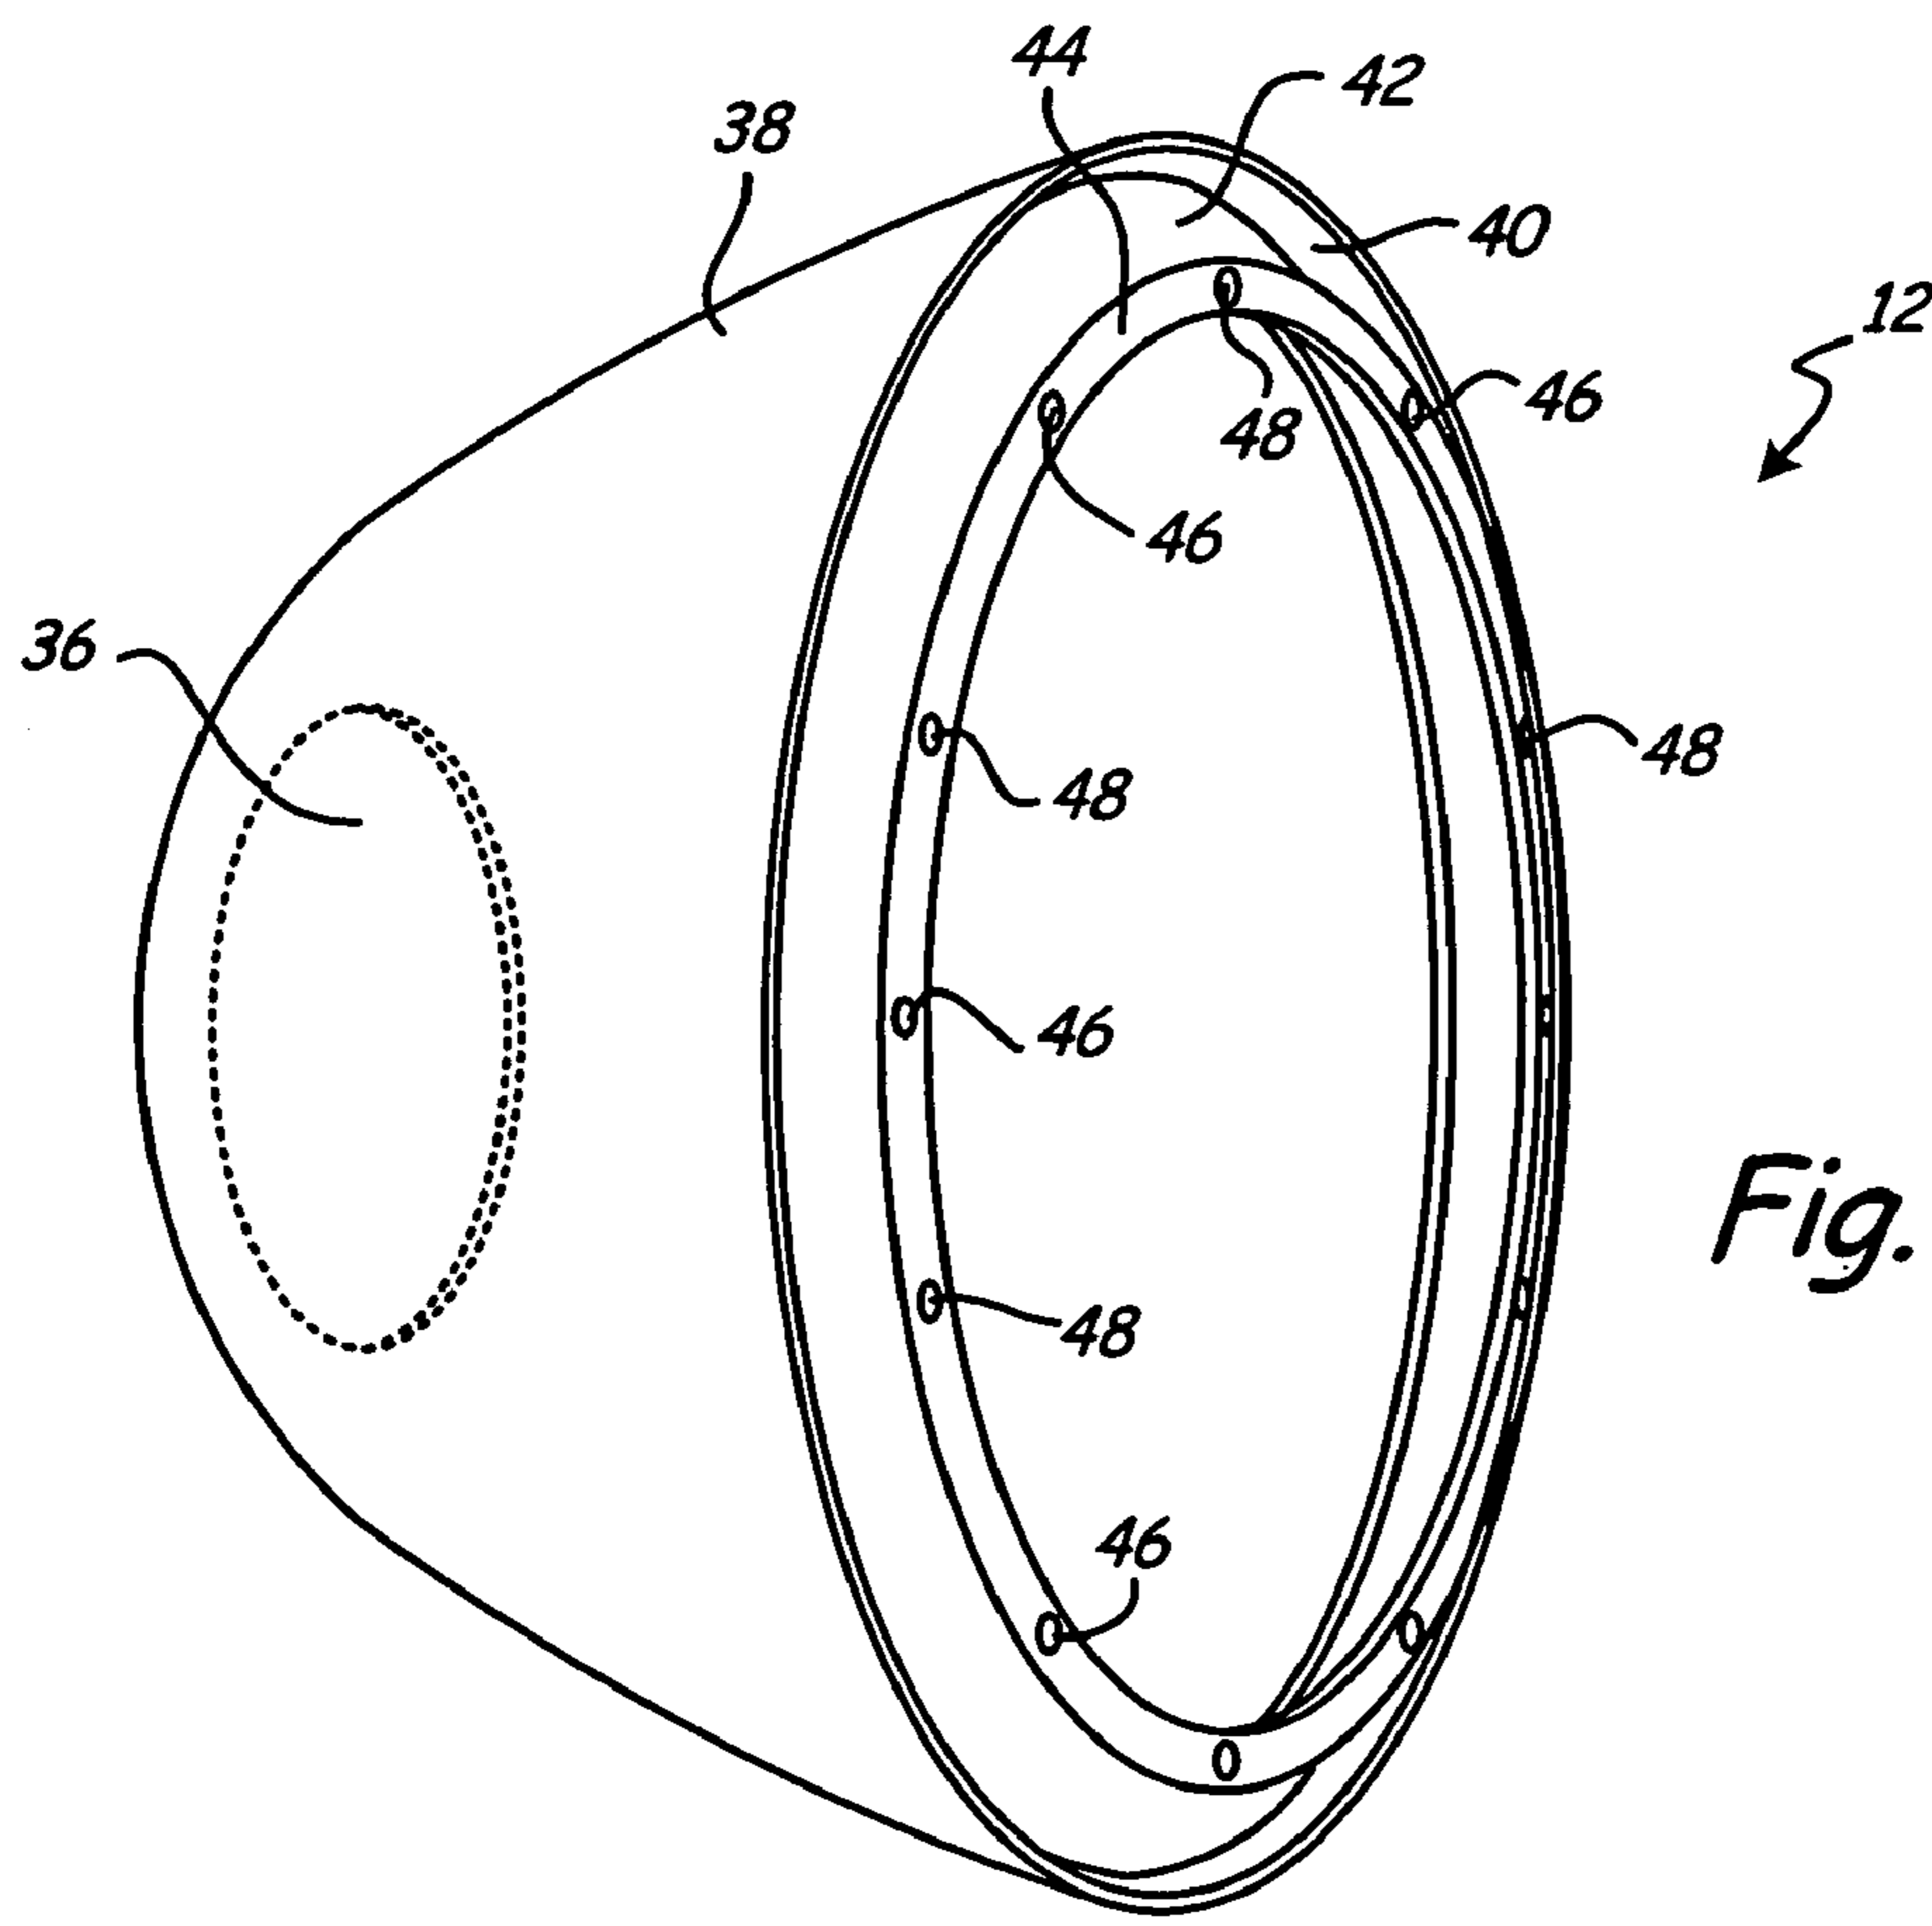
Fig. 3

FIG. 3 is a perspective view of the inlet nose cone of FIG. 2 rotated 90 degrees clock-wise.

FIG. 3 is another perspective view of inlet nose cone 12 of FIG. 2.

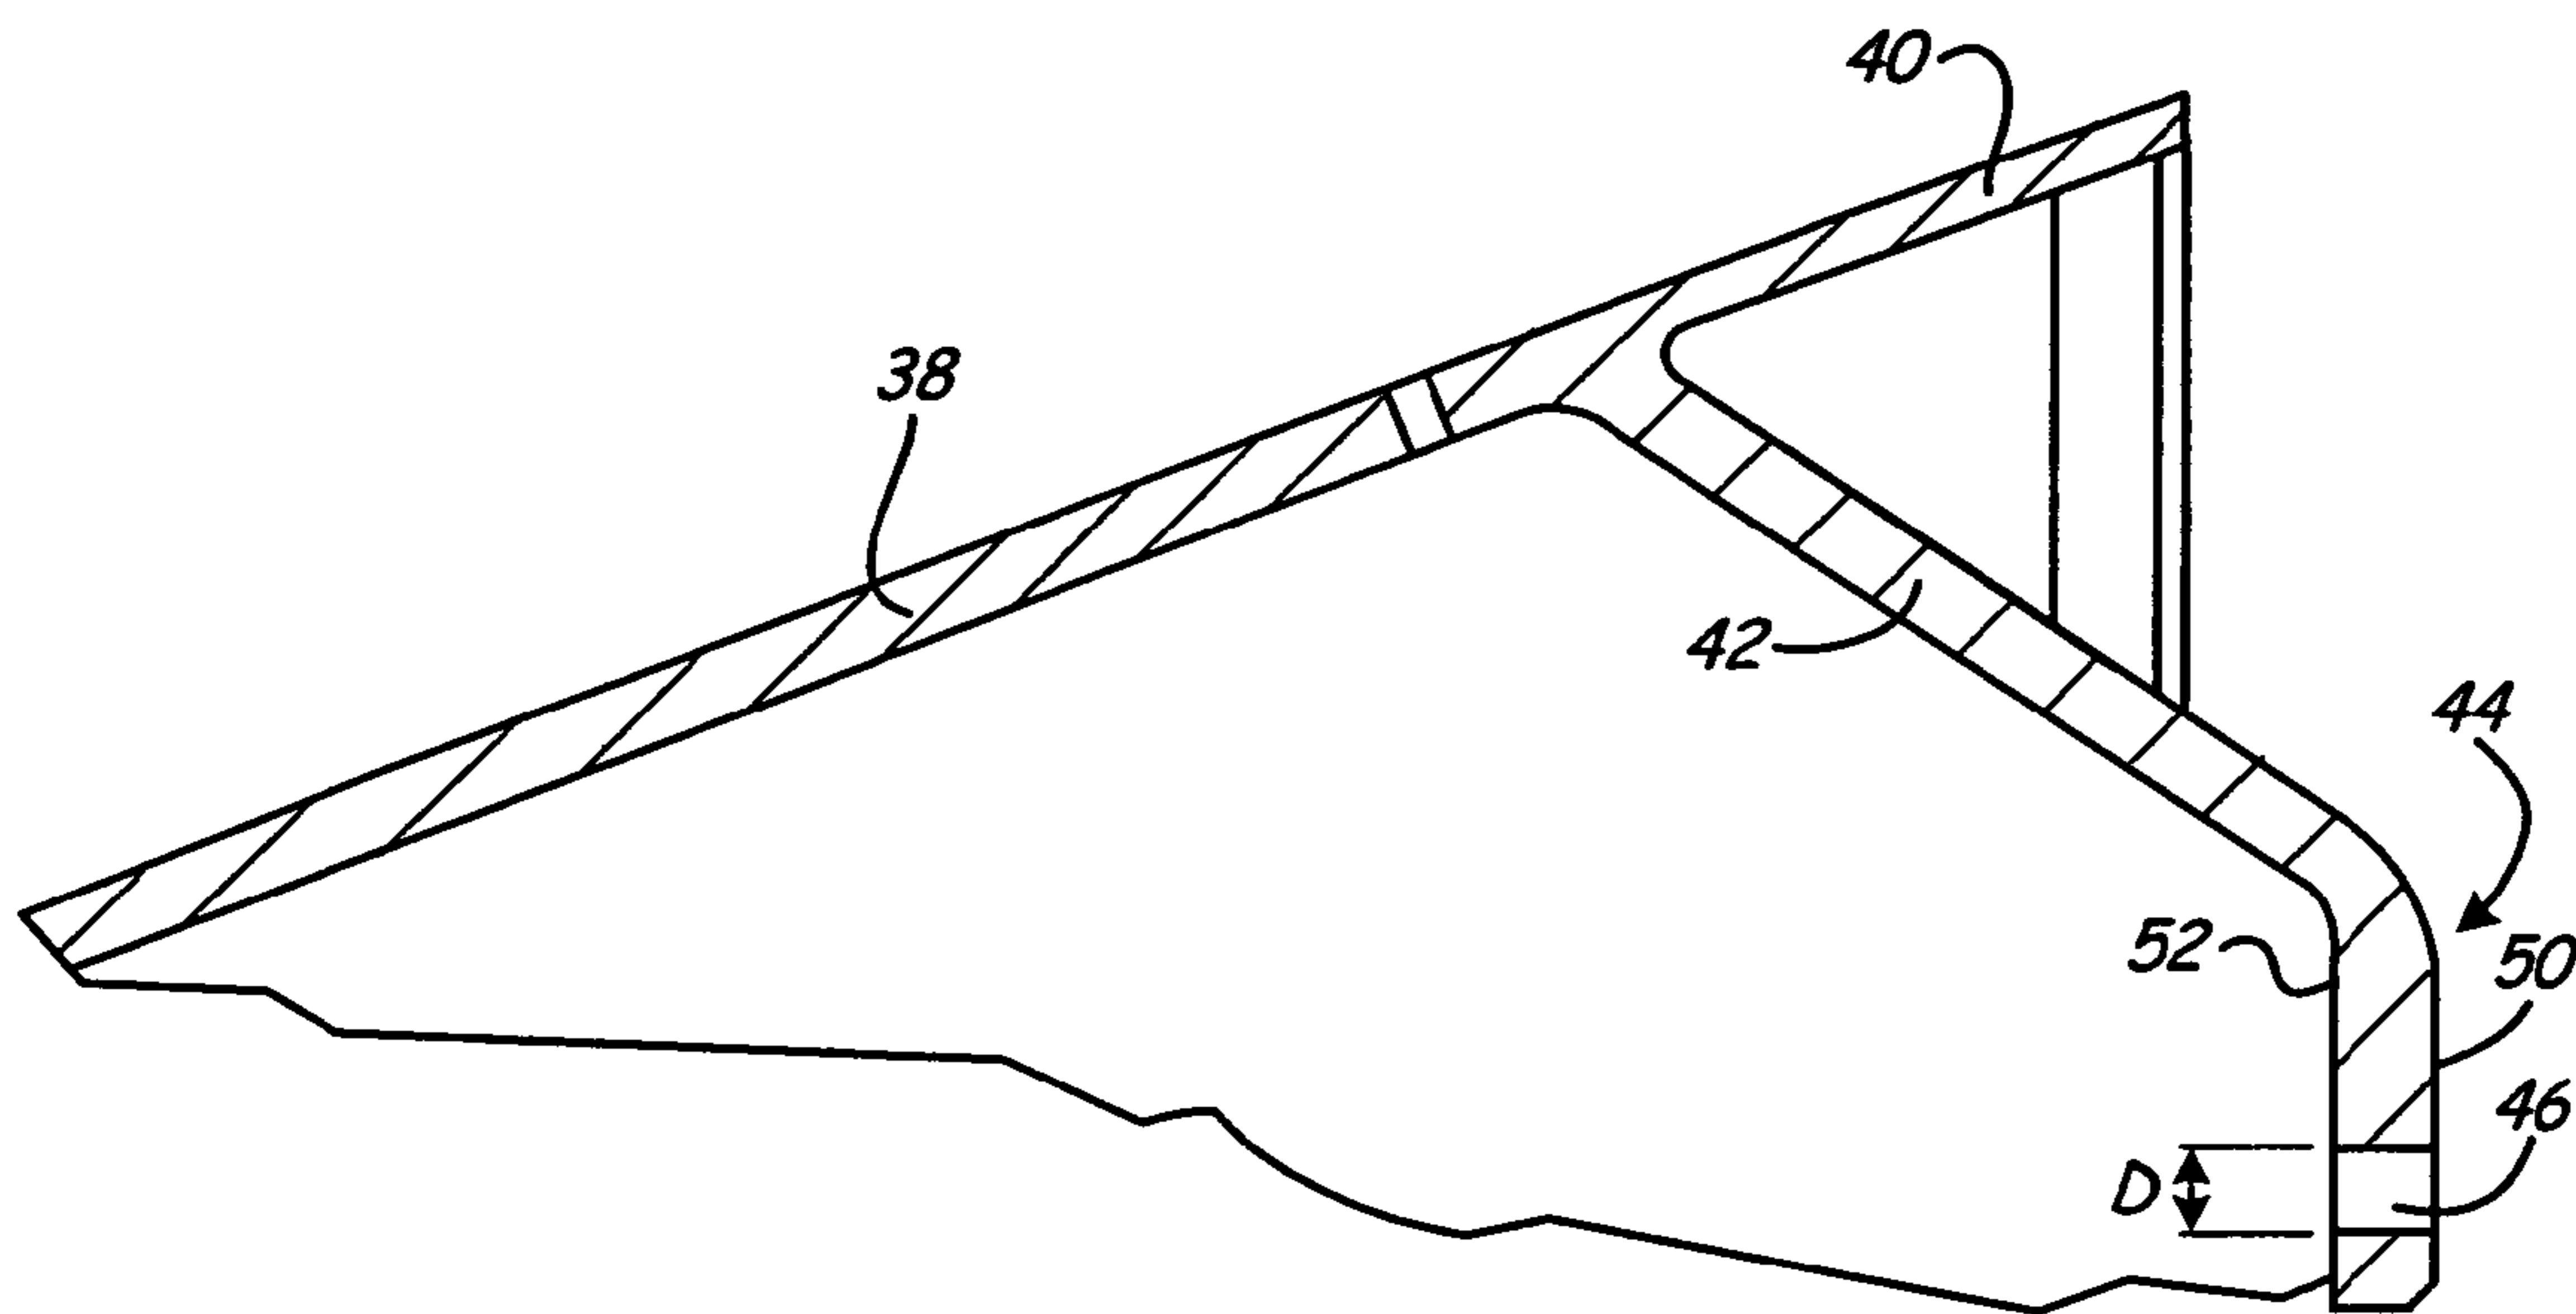
Fig. 4

FIG. 4 is a cross-sectional view of a portion of the nose cone of FIG. 3, including an enlarged bolt hole needing repair.

FIG. 4 is a cross-sectional view of a portion of inlet nose cone 12 of FIG. 3. As shown in FIG. 4, nose cone 12 includes body portion 38, aft fairing 40, ramp 42 and flange 44 including a balance weight hole 46. Flange 44 also includes outer surface 50 and inner surface 52.

Although not shown in FIG. 4, attachment holes 48 on flange 44 may also increase in diameter over time. As such, attachment holes 48 may similarly need to be repaired to reduce the size of the enlarged holes.

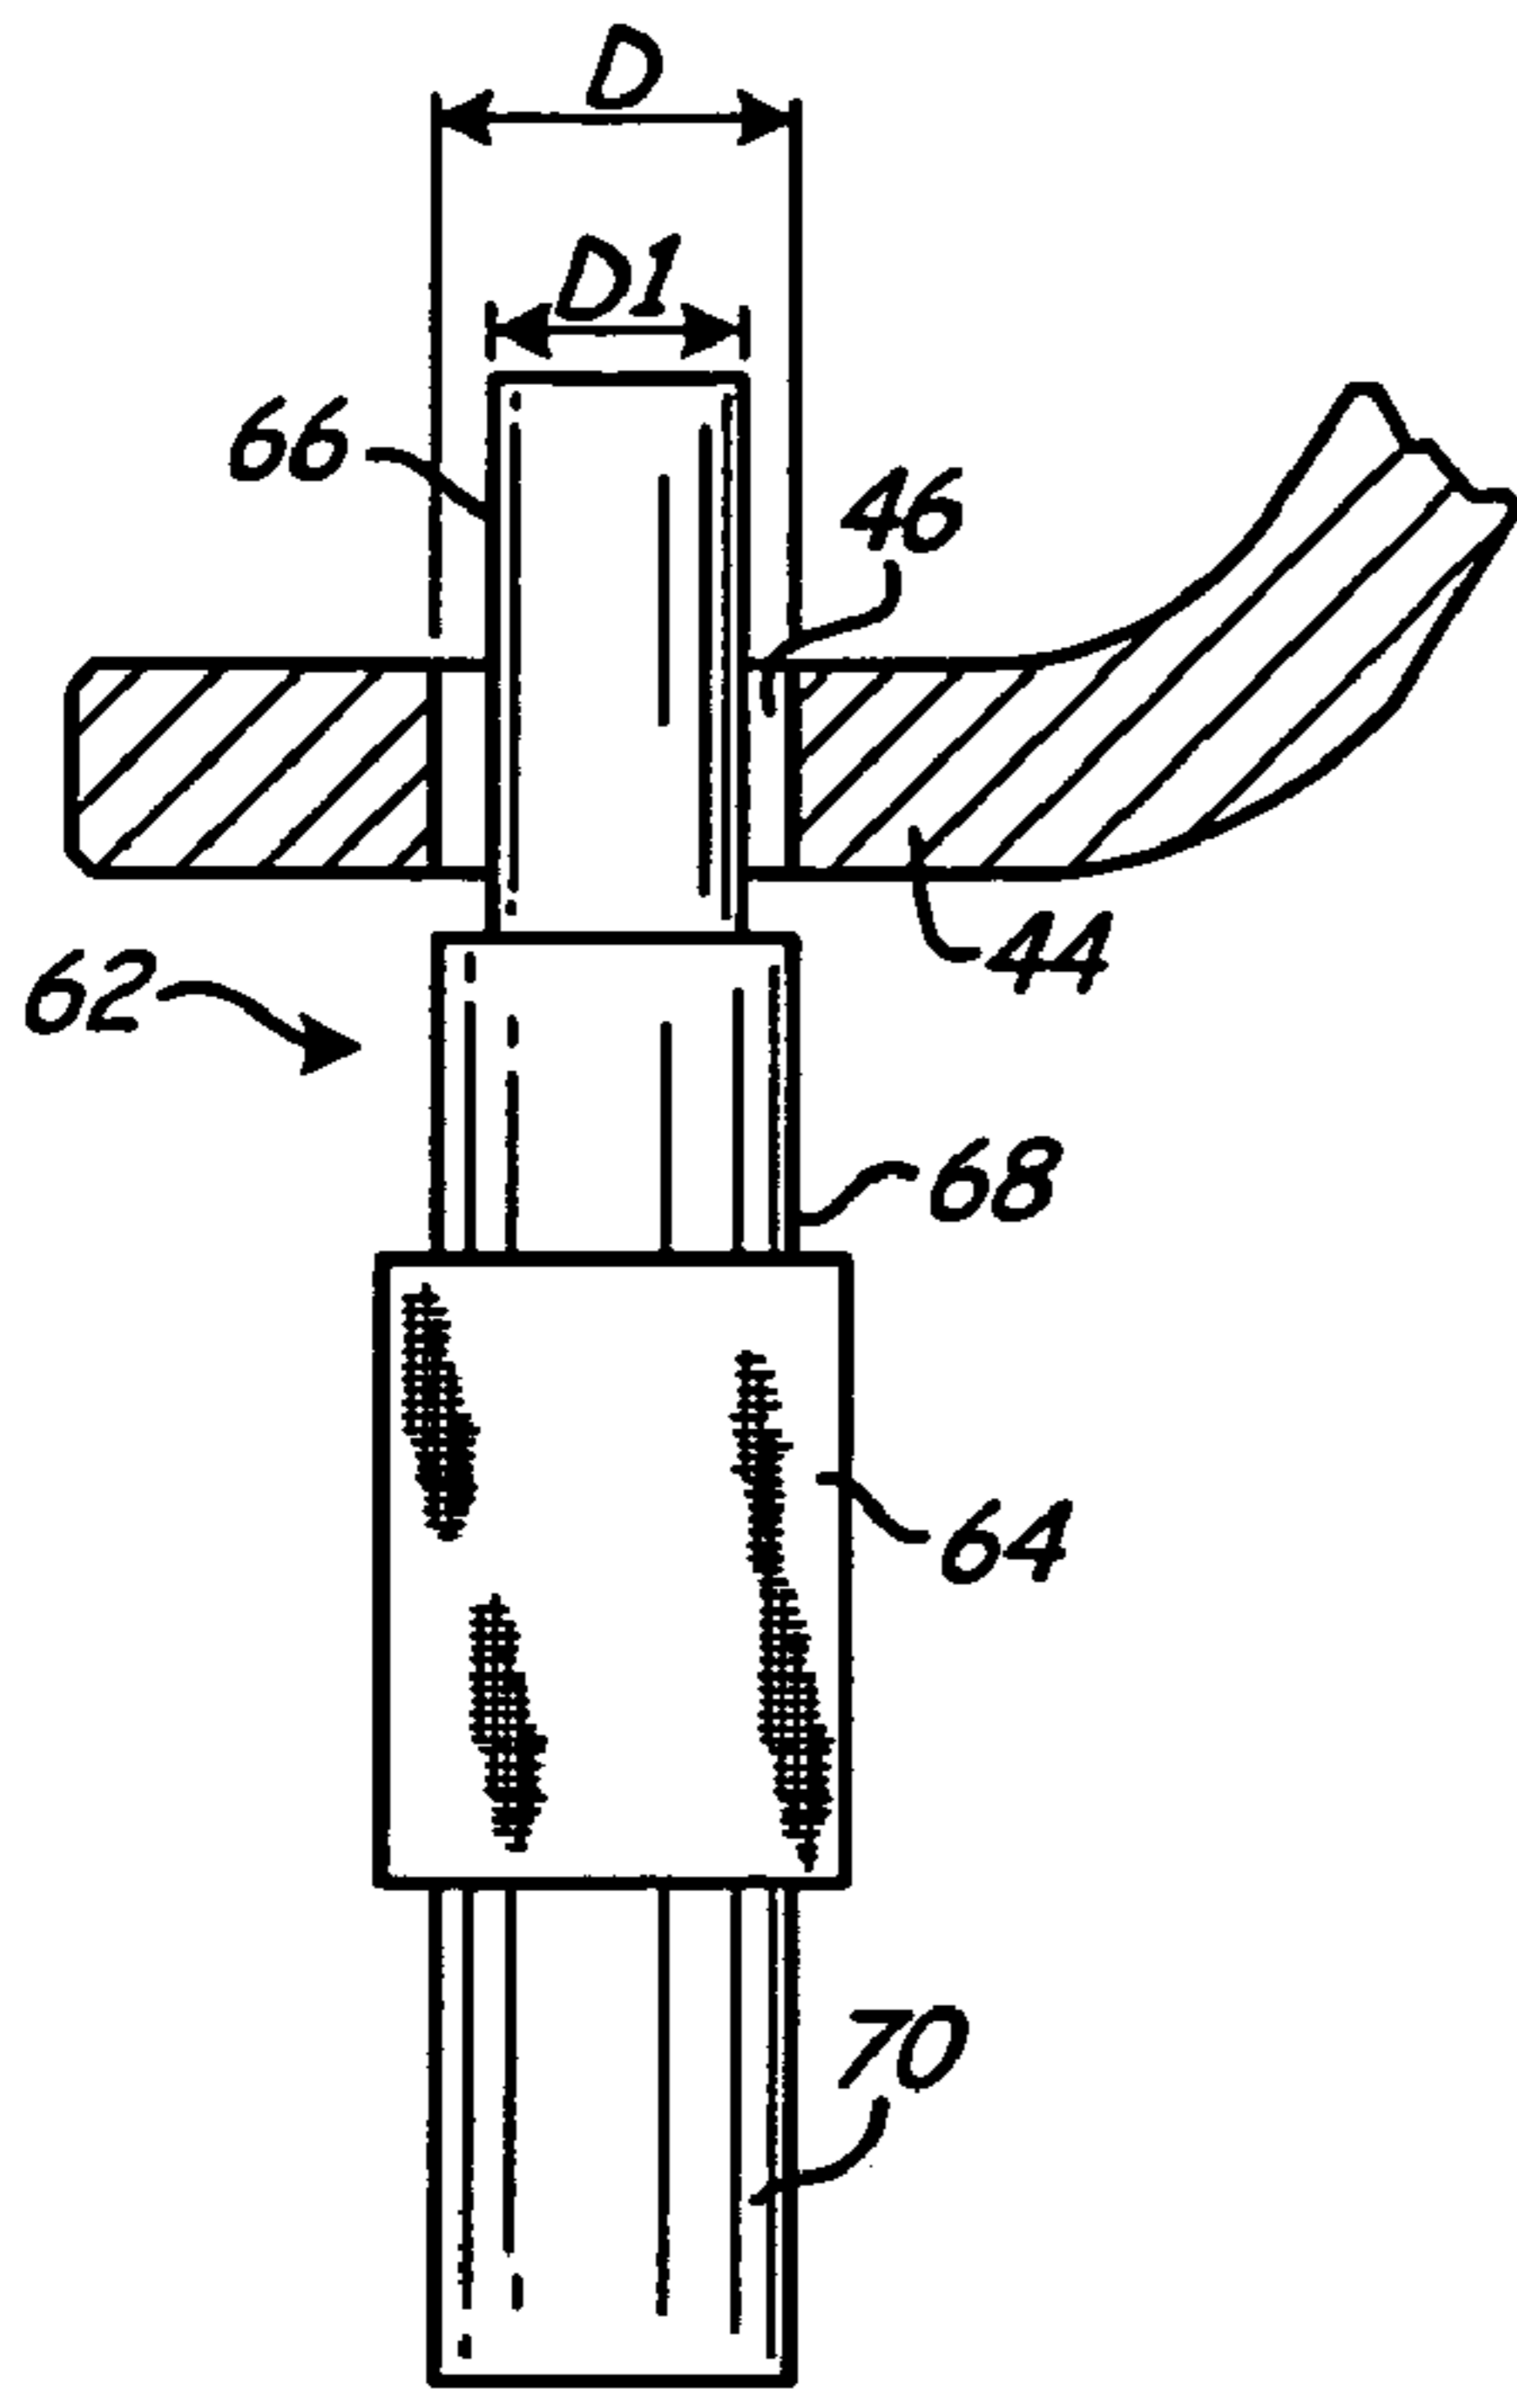
Fig. 8

FIGS. 8-15 show general steps for using system 60 to repair an enlarged bolt hole. FIG. 8 shows system 60 including rod 62 wrapped with fabric 64, and flange 44 (shown in section) including balance weight hole 46 and a portion of ramp 42, both on nose cone 12 as shown in FIG. 4. In FIG. 8, nose cone 12 has been rotated approximately 90 degrees clockwise relative to its position in FIG. 4.

FIG. 8 shows first end region 66 of rod 62 being inserted through hole 46. Because first diameter D1 of first end region 66 is less than enlarged diameter D of hole 46, first end region 66 is easily able to pass through hole 46. Once first end region 66 is through hole 46, first end region 66 and second end region 70 may each be grasped and pulled to elongate rod 62 to the stretched state.

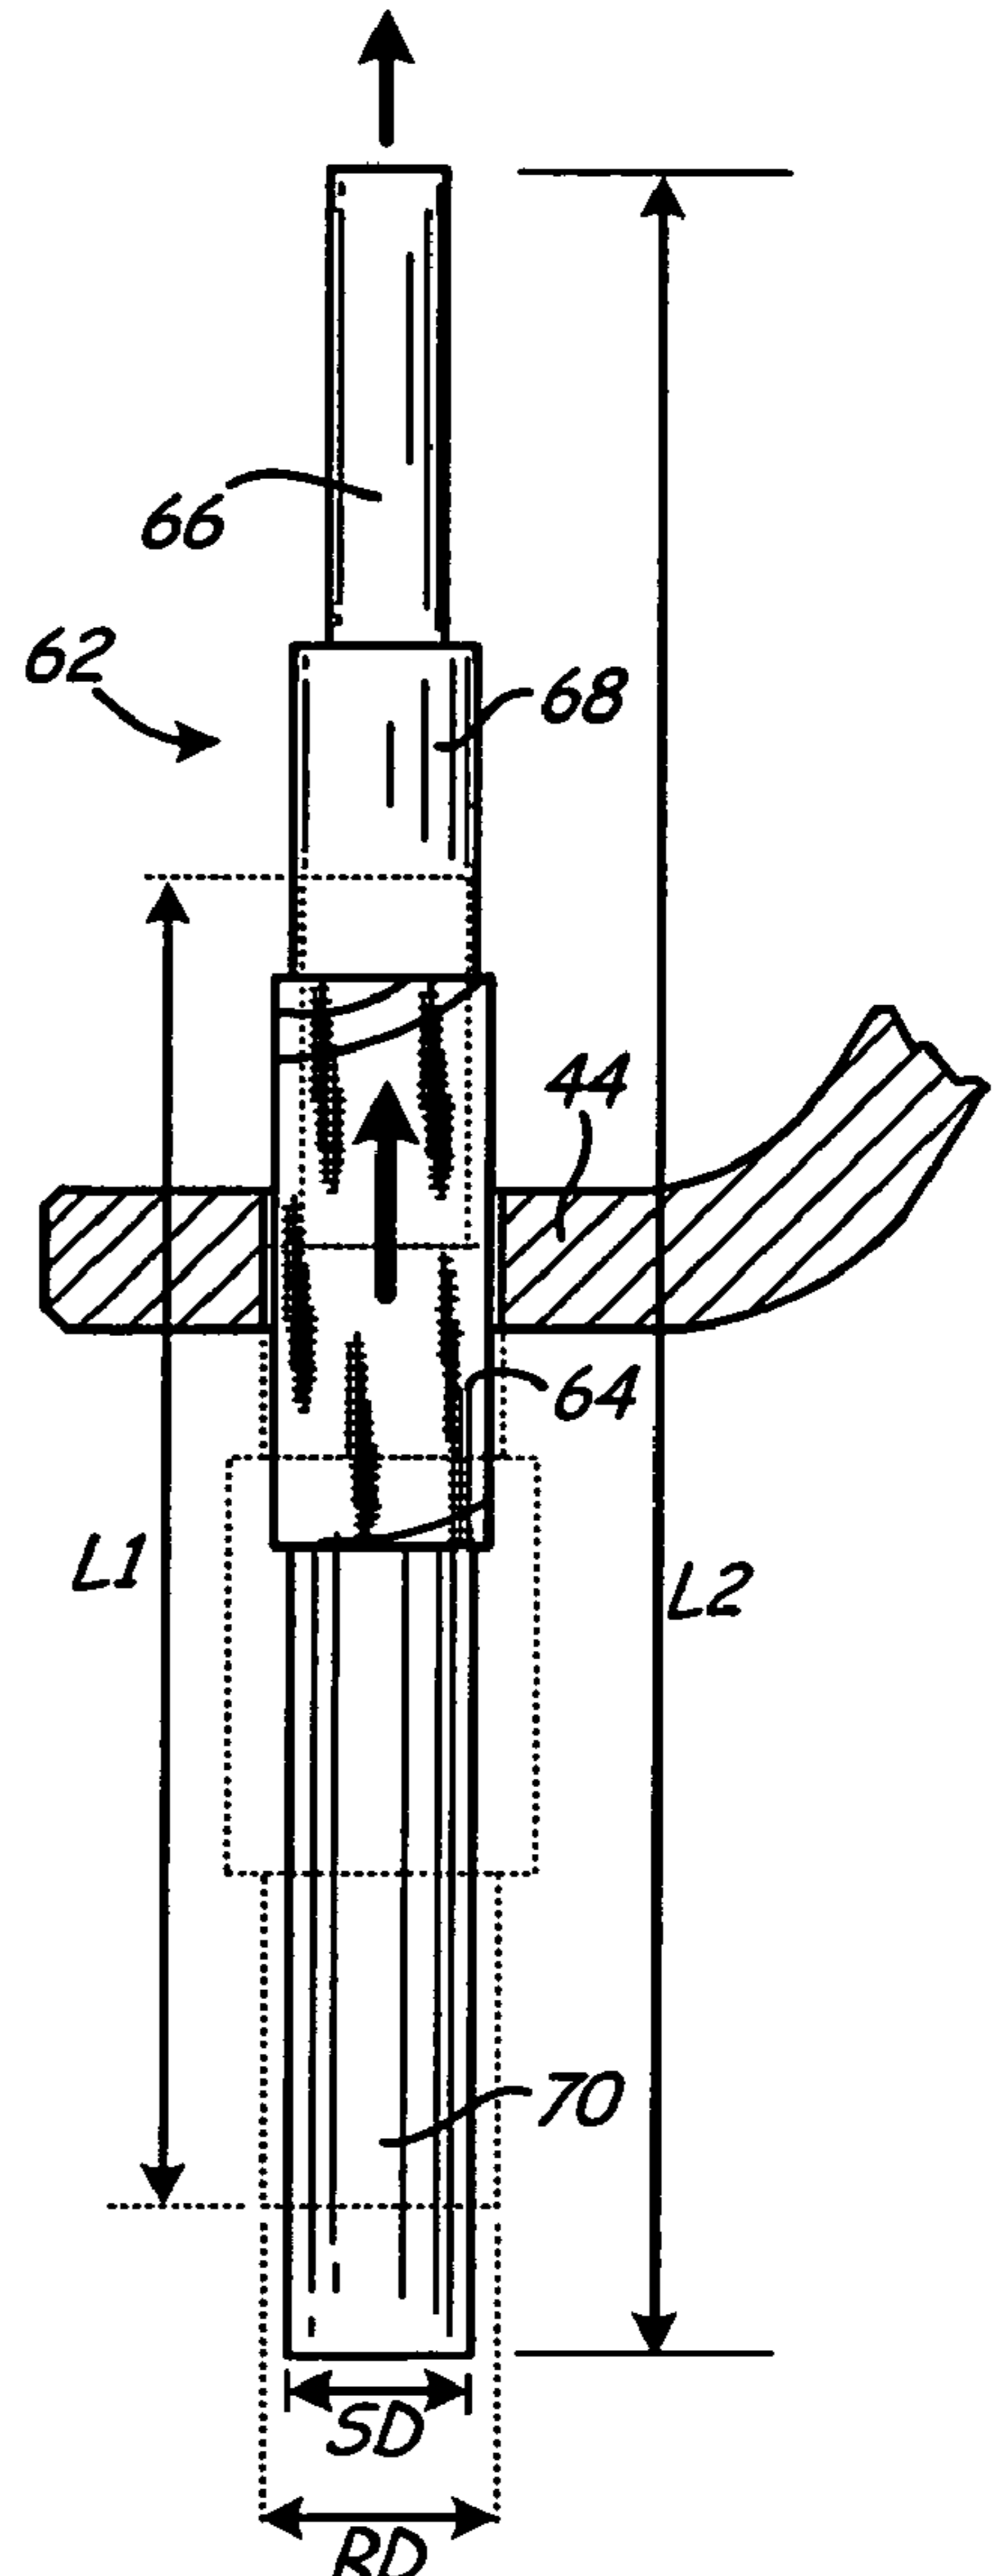
Fig. 9

FIG. 9 shows rod 62 in the stretched state, as compared to its relaxed state as shown in FIG. 8. In the stretched state, rod 62 has second length L2 which is substantially greater than length L1 of the relaxed state, and middle region 68 of rod 62 has stretched diameter SD which is substantially less than diameter RD of the relaxed state.
