(54) **FABRIC BUSHING INSTALLATION TO REPAIR A HOLE**

A method and system for repairing a damaged hole includes a deformable rod and a fabric wrapped around a middle portion of the rod. A first portion of the rod is inserted into the damaged hole. The rod is stretched to align the middle portion of the rod and the fabric with an inside circumference of the hole. The rod is then relaxed to compress the fabric against the inside circumference of the hole.

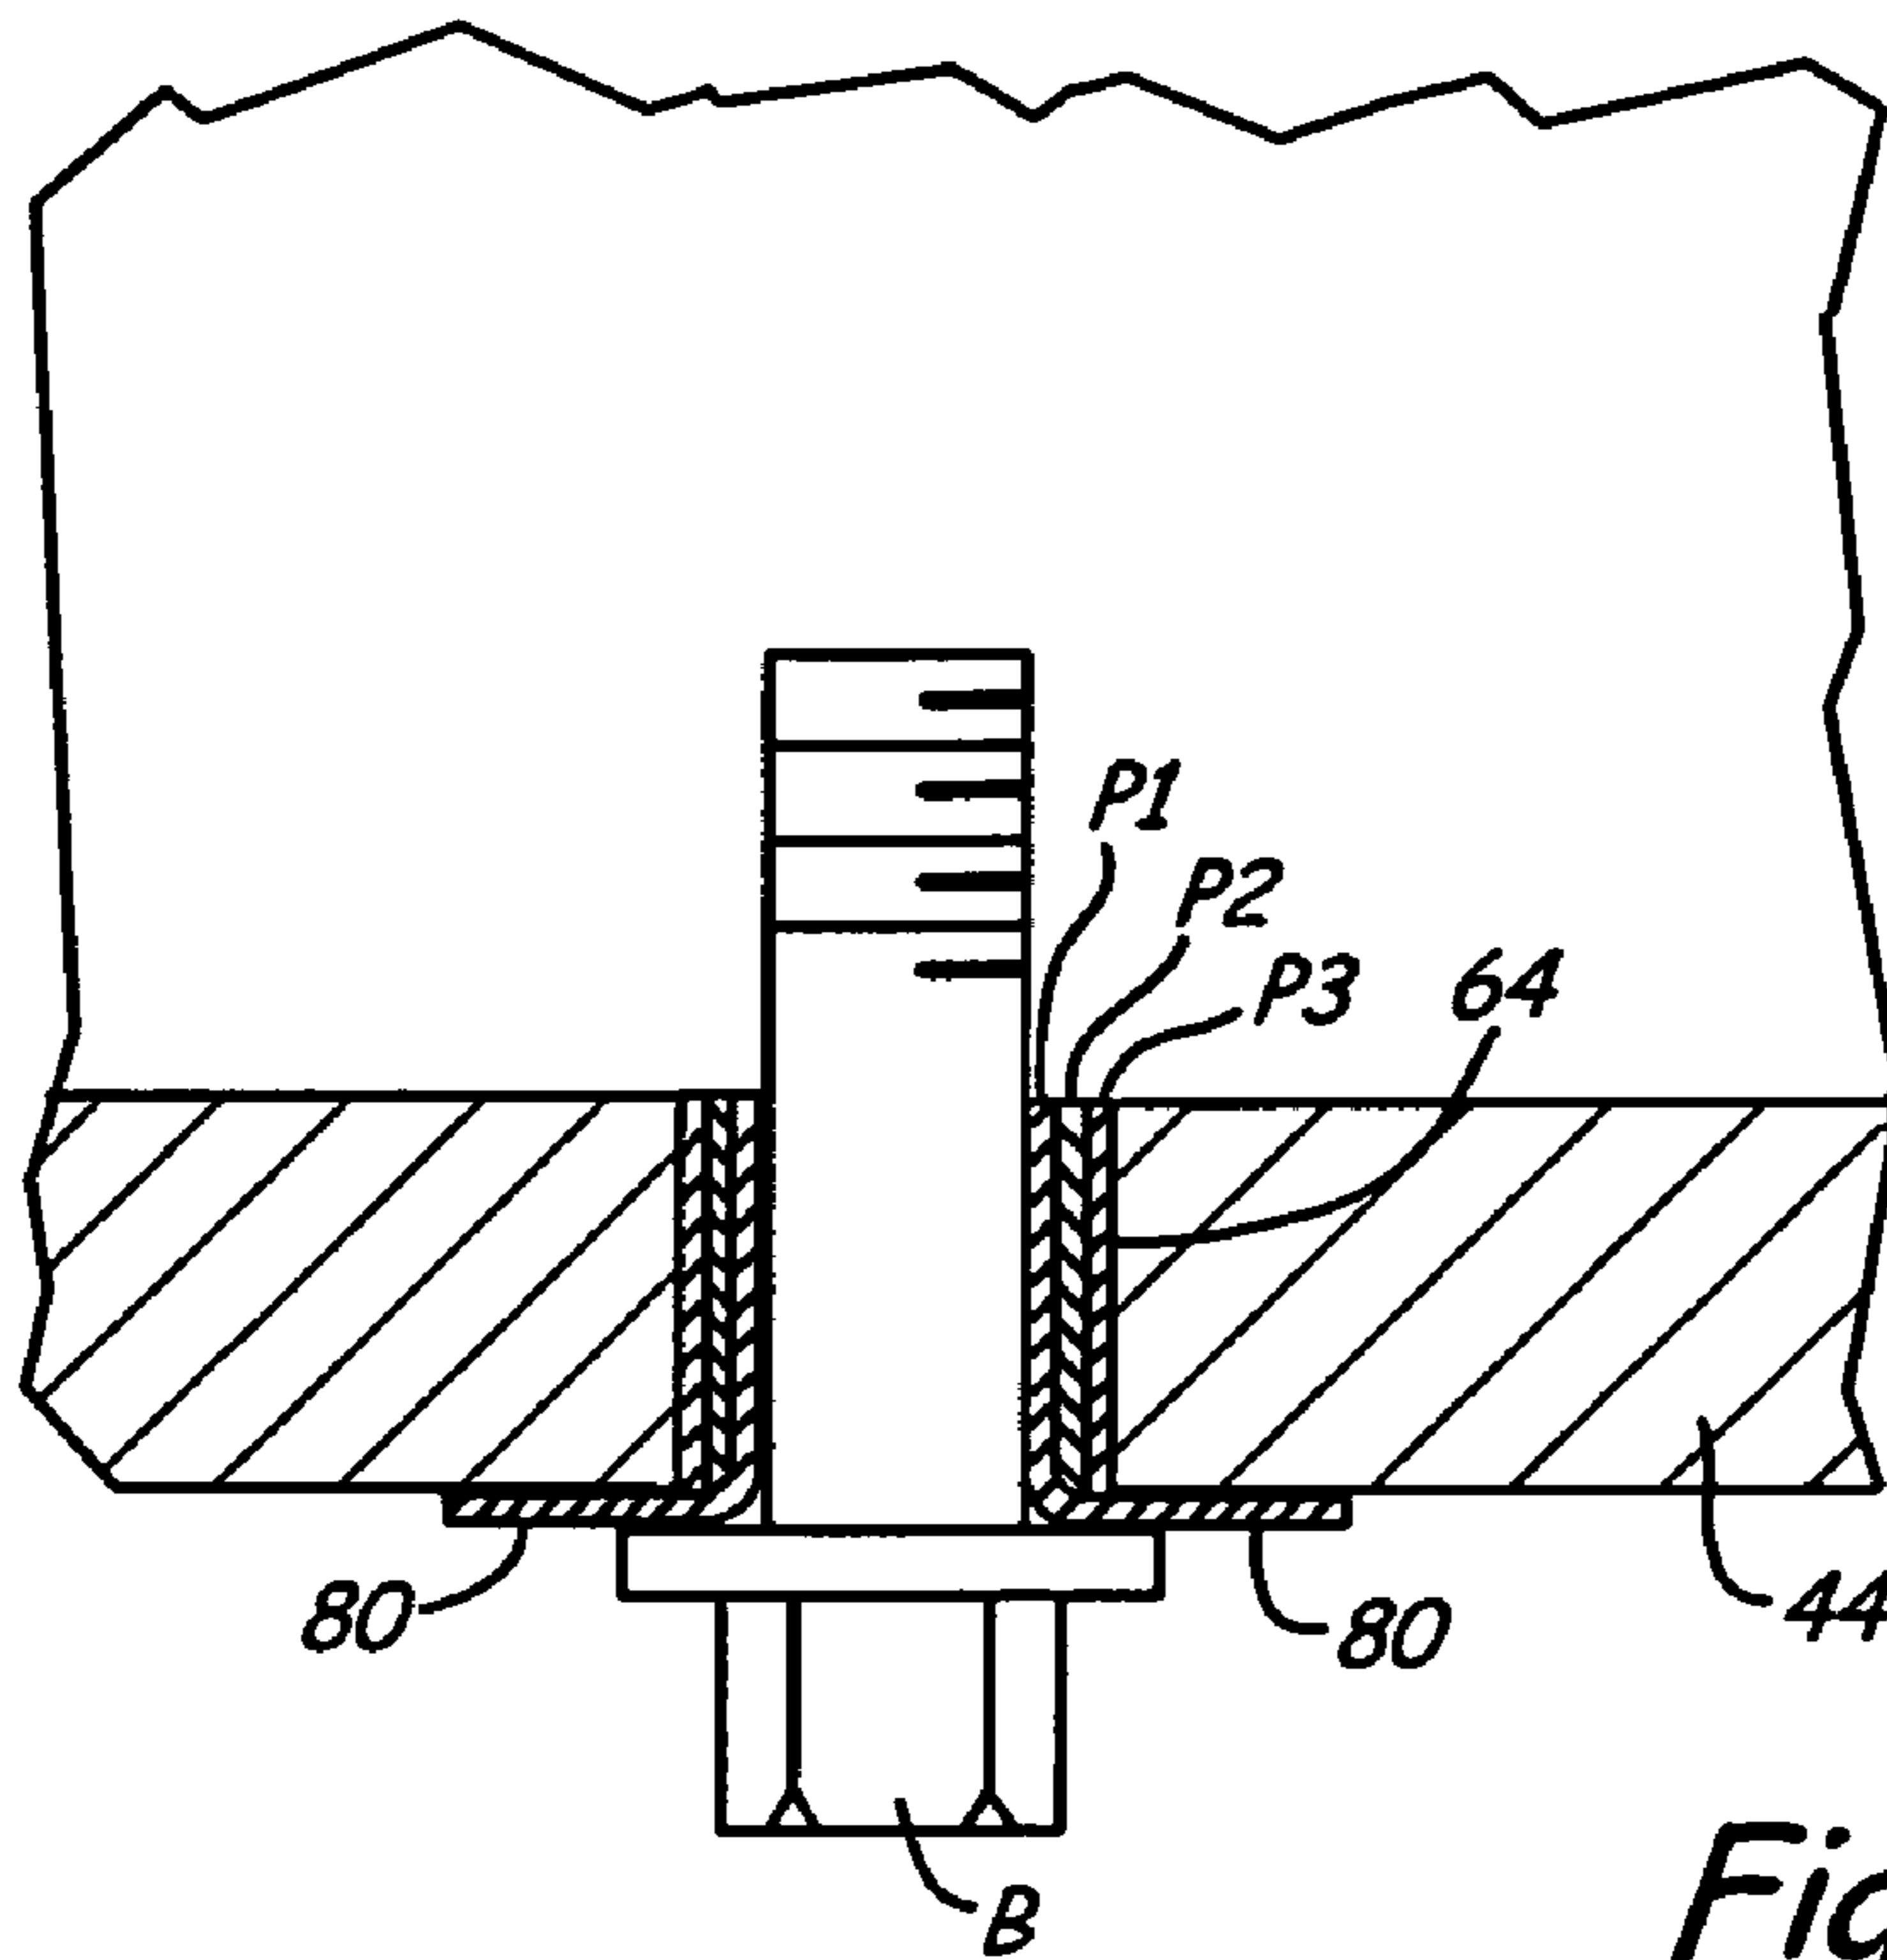
Fig. 16

FIG. 16 is a cross-sectional view of the portion of the nose cone of FIG. 4 with the repaired hole and a bolt secured within the repaired hole.

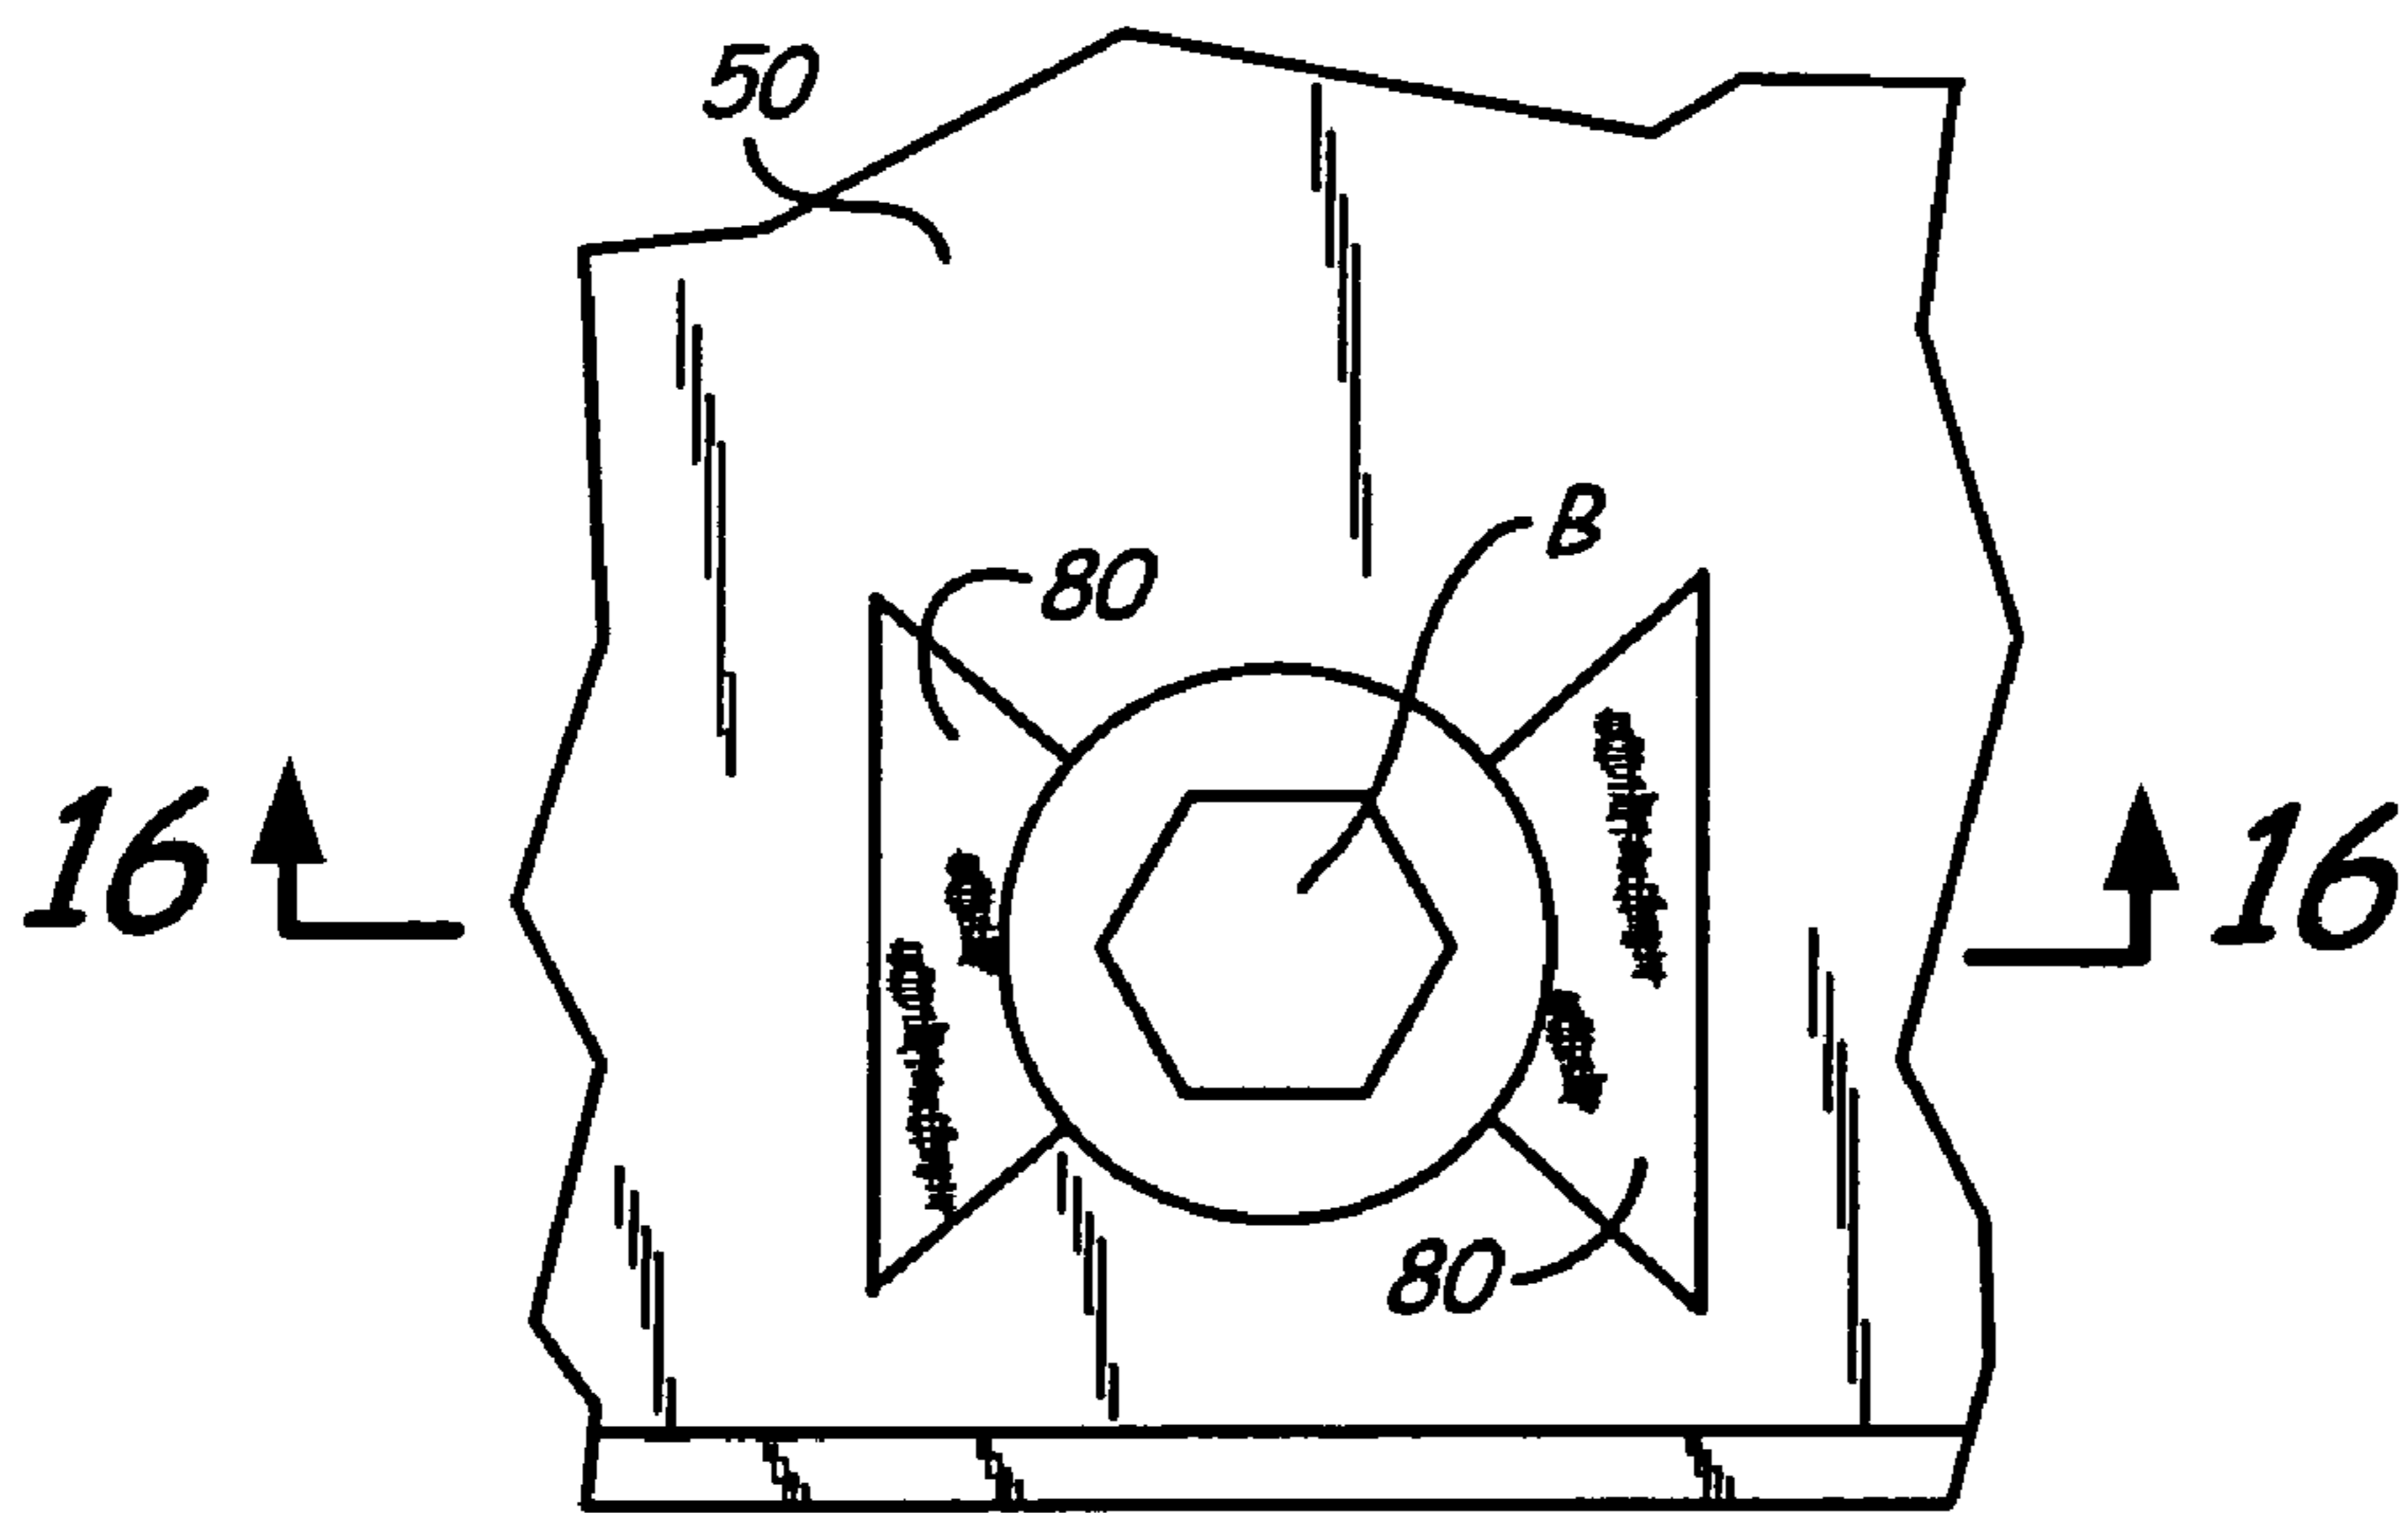
Fig. 17

FIG. 17 is a top view of the portion of the nose cone of FIG. 16 rotated 90 degrees.
