(10) **Patent No.:** **US 7,695,585 B2**  
(45) **Date of Patent:** **Apr. 13, 2010**

(54) **REBONDING A METALLIZED FABRIC TO AN UNDERLYING LAYER**

(57) **ABSTRACT**

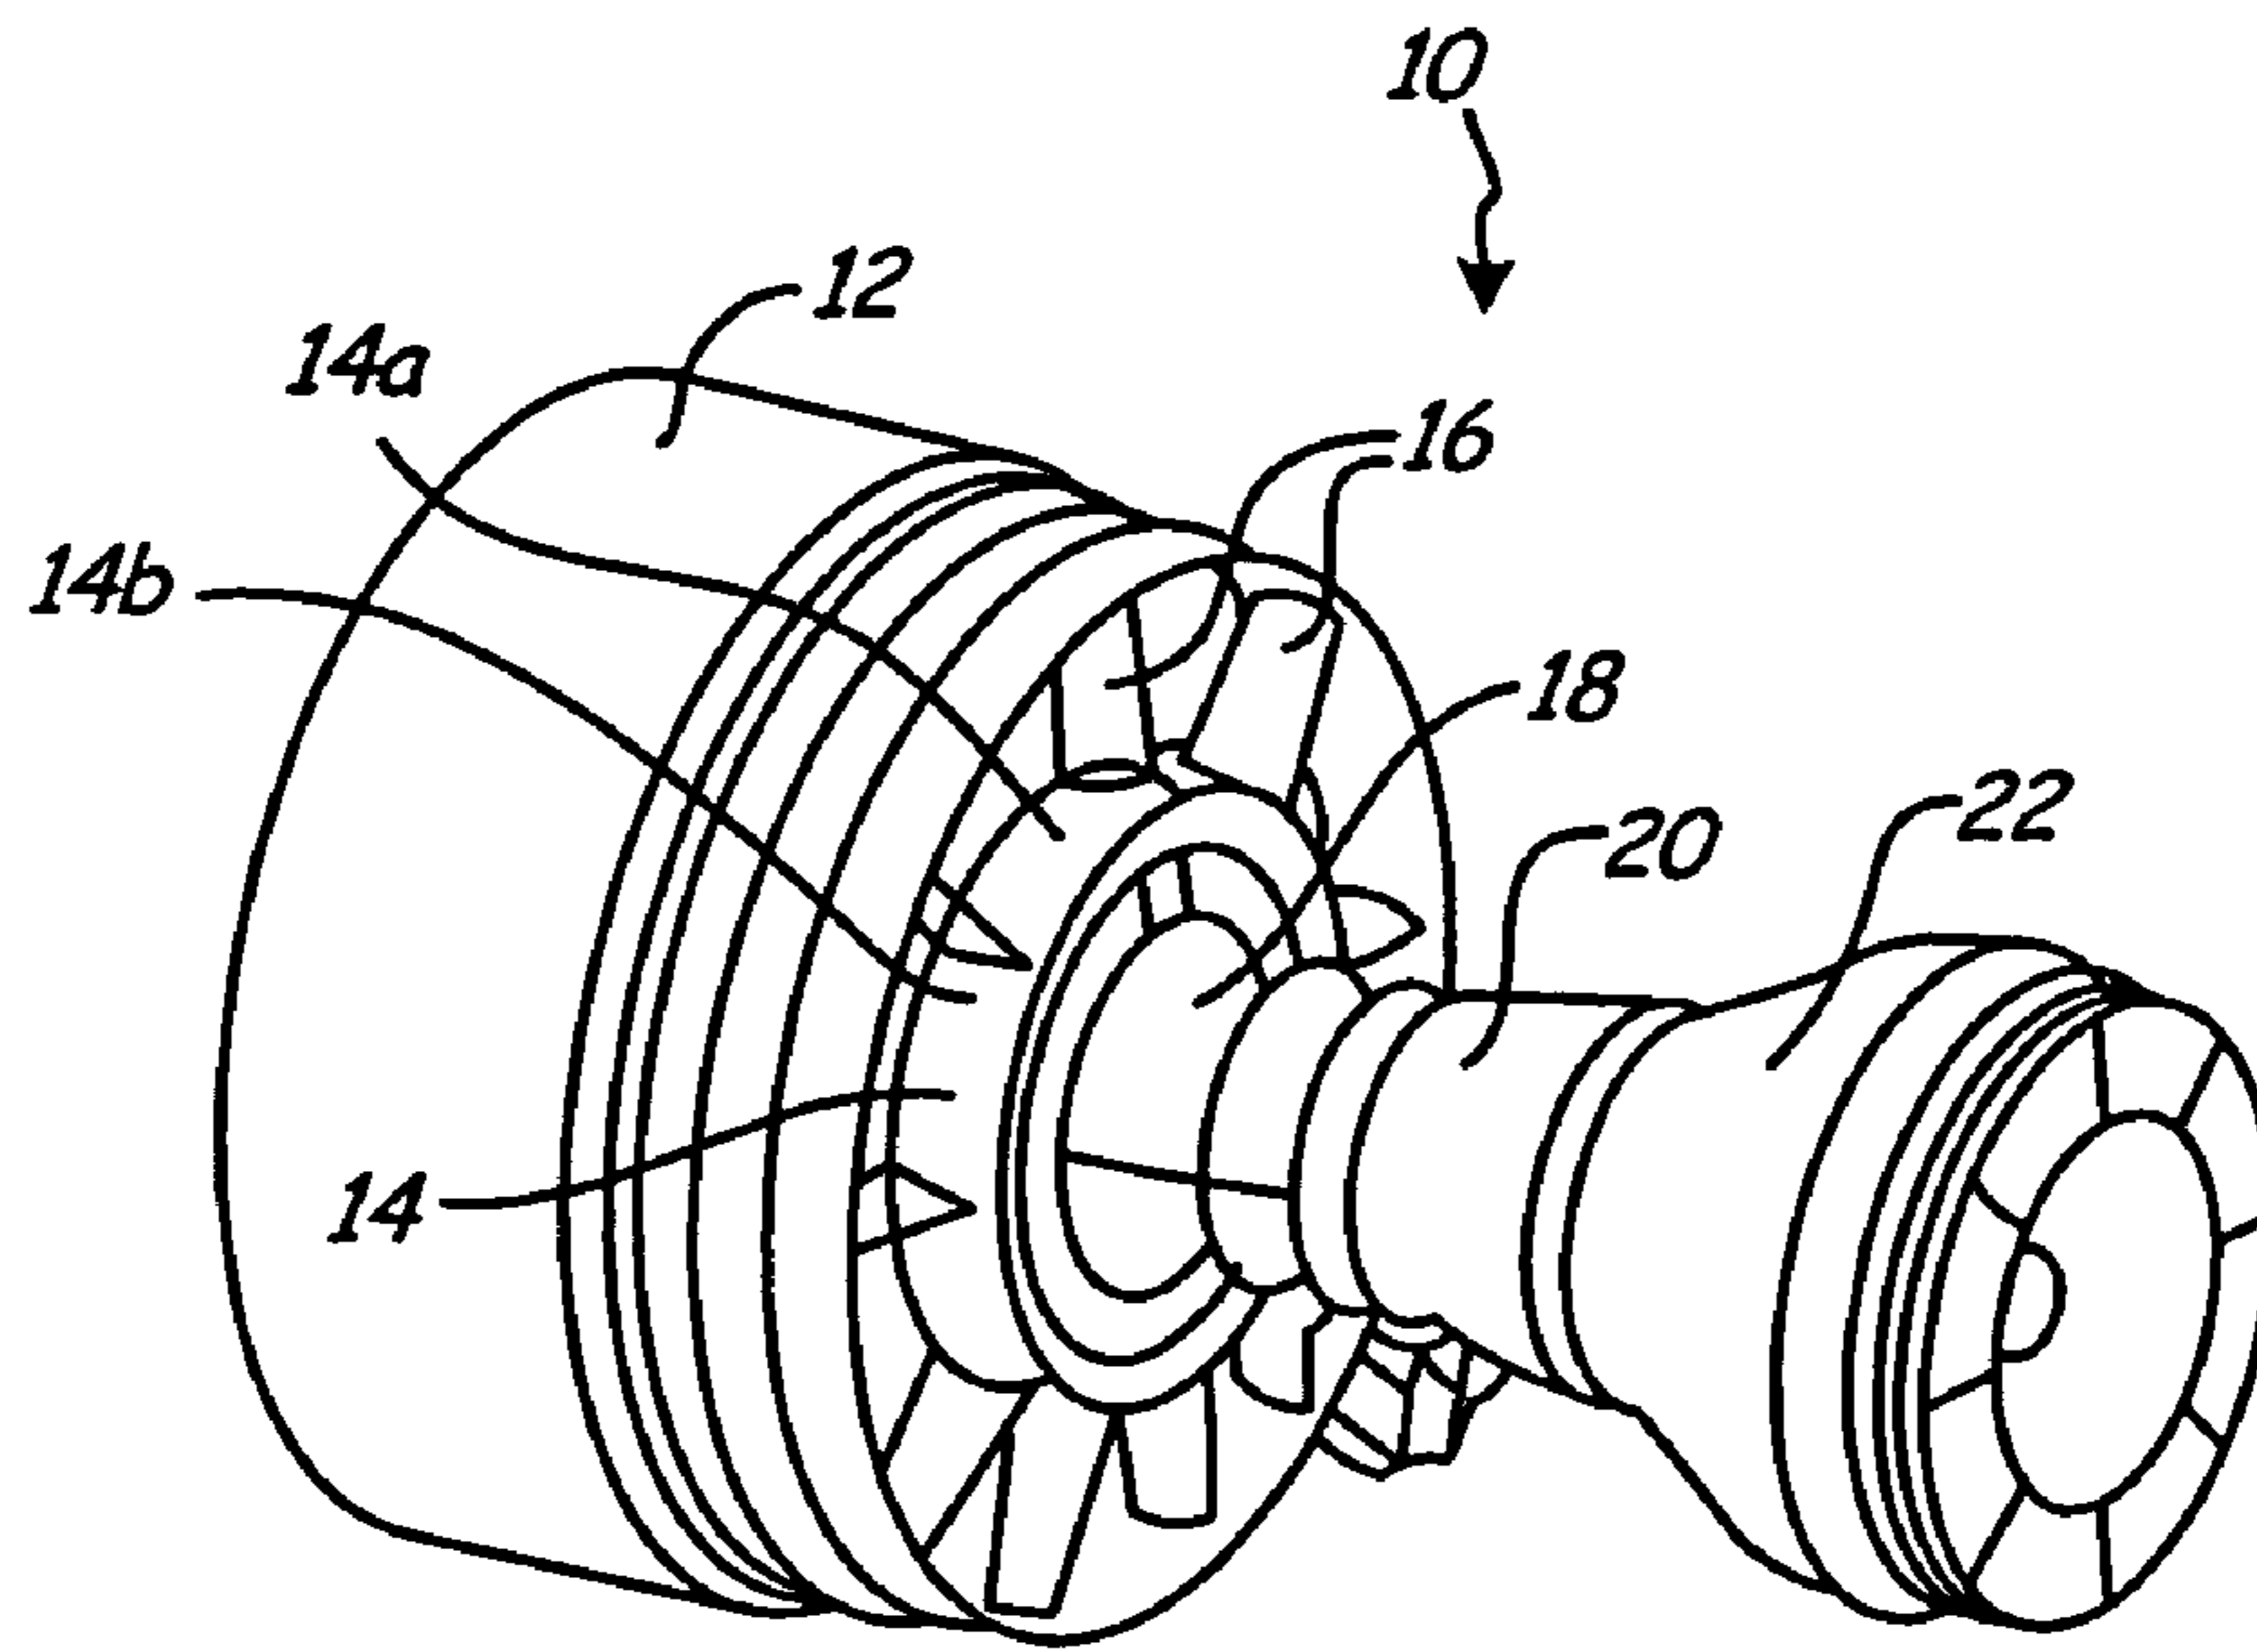
**Fig. 1**

FIG. 1 is a perspective view of a gas turbine engine, including a plurality of fan exit liner segments supported by struts on an intermediate case of the engine.

FIG. 1 is a perspective view of a high bypass gas turbine engine assembly 10, including intermediate case 12, fan exit liner segments 14, struts 16, high pressure compressor (HPC) 18, high pressure turbine 20, and low pressure turbine 22.

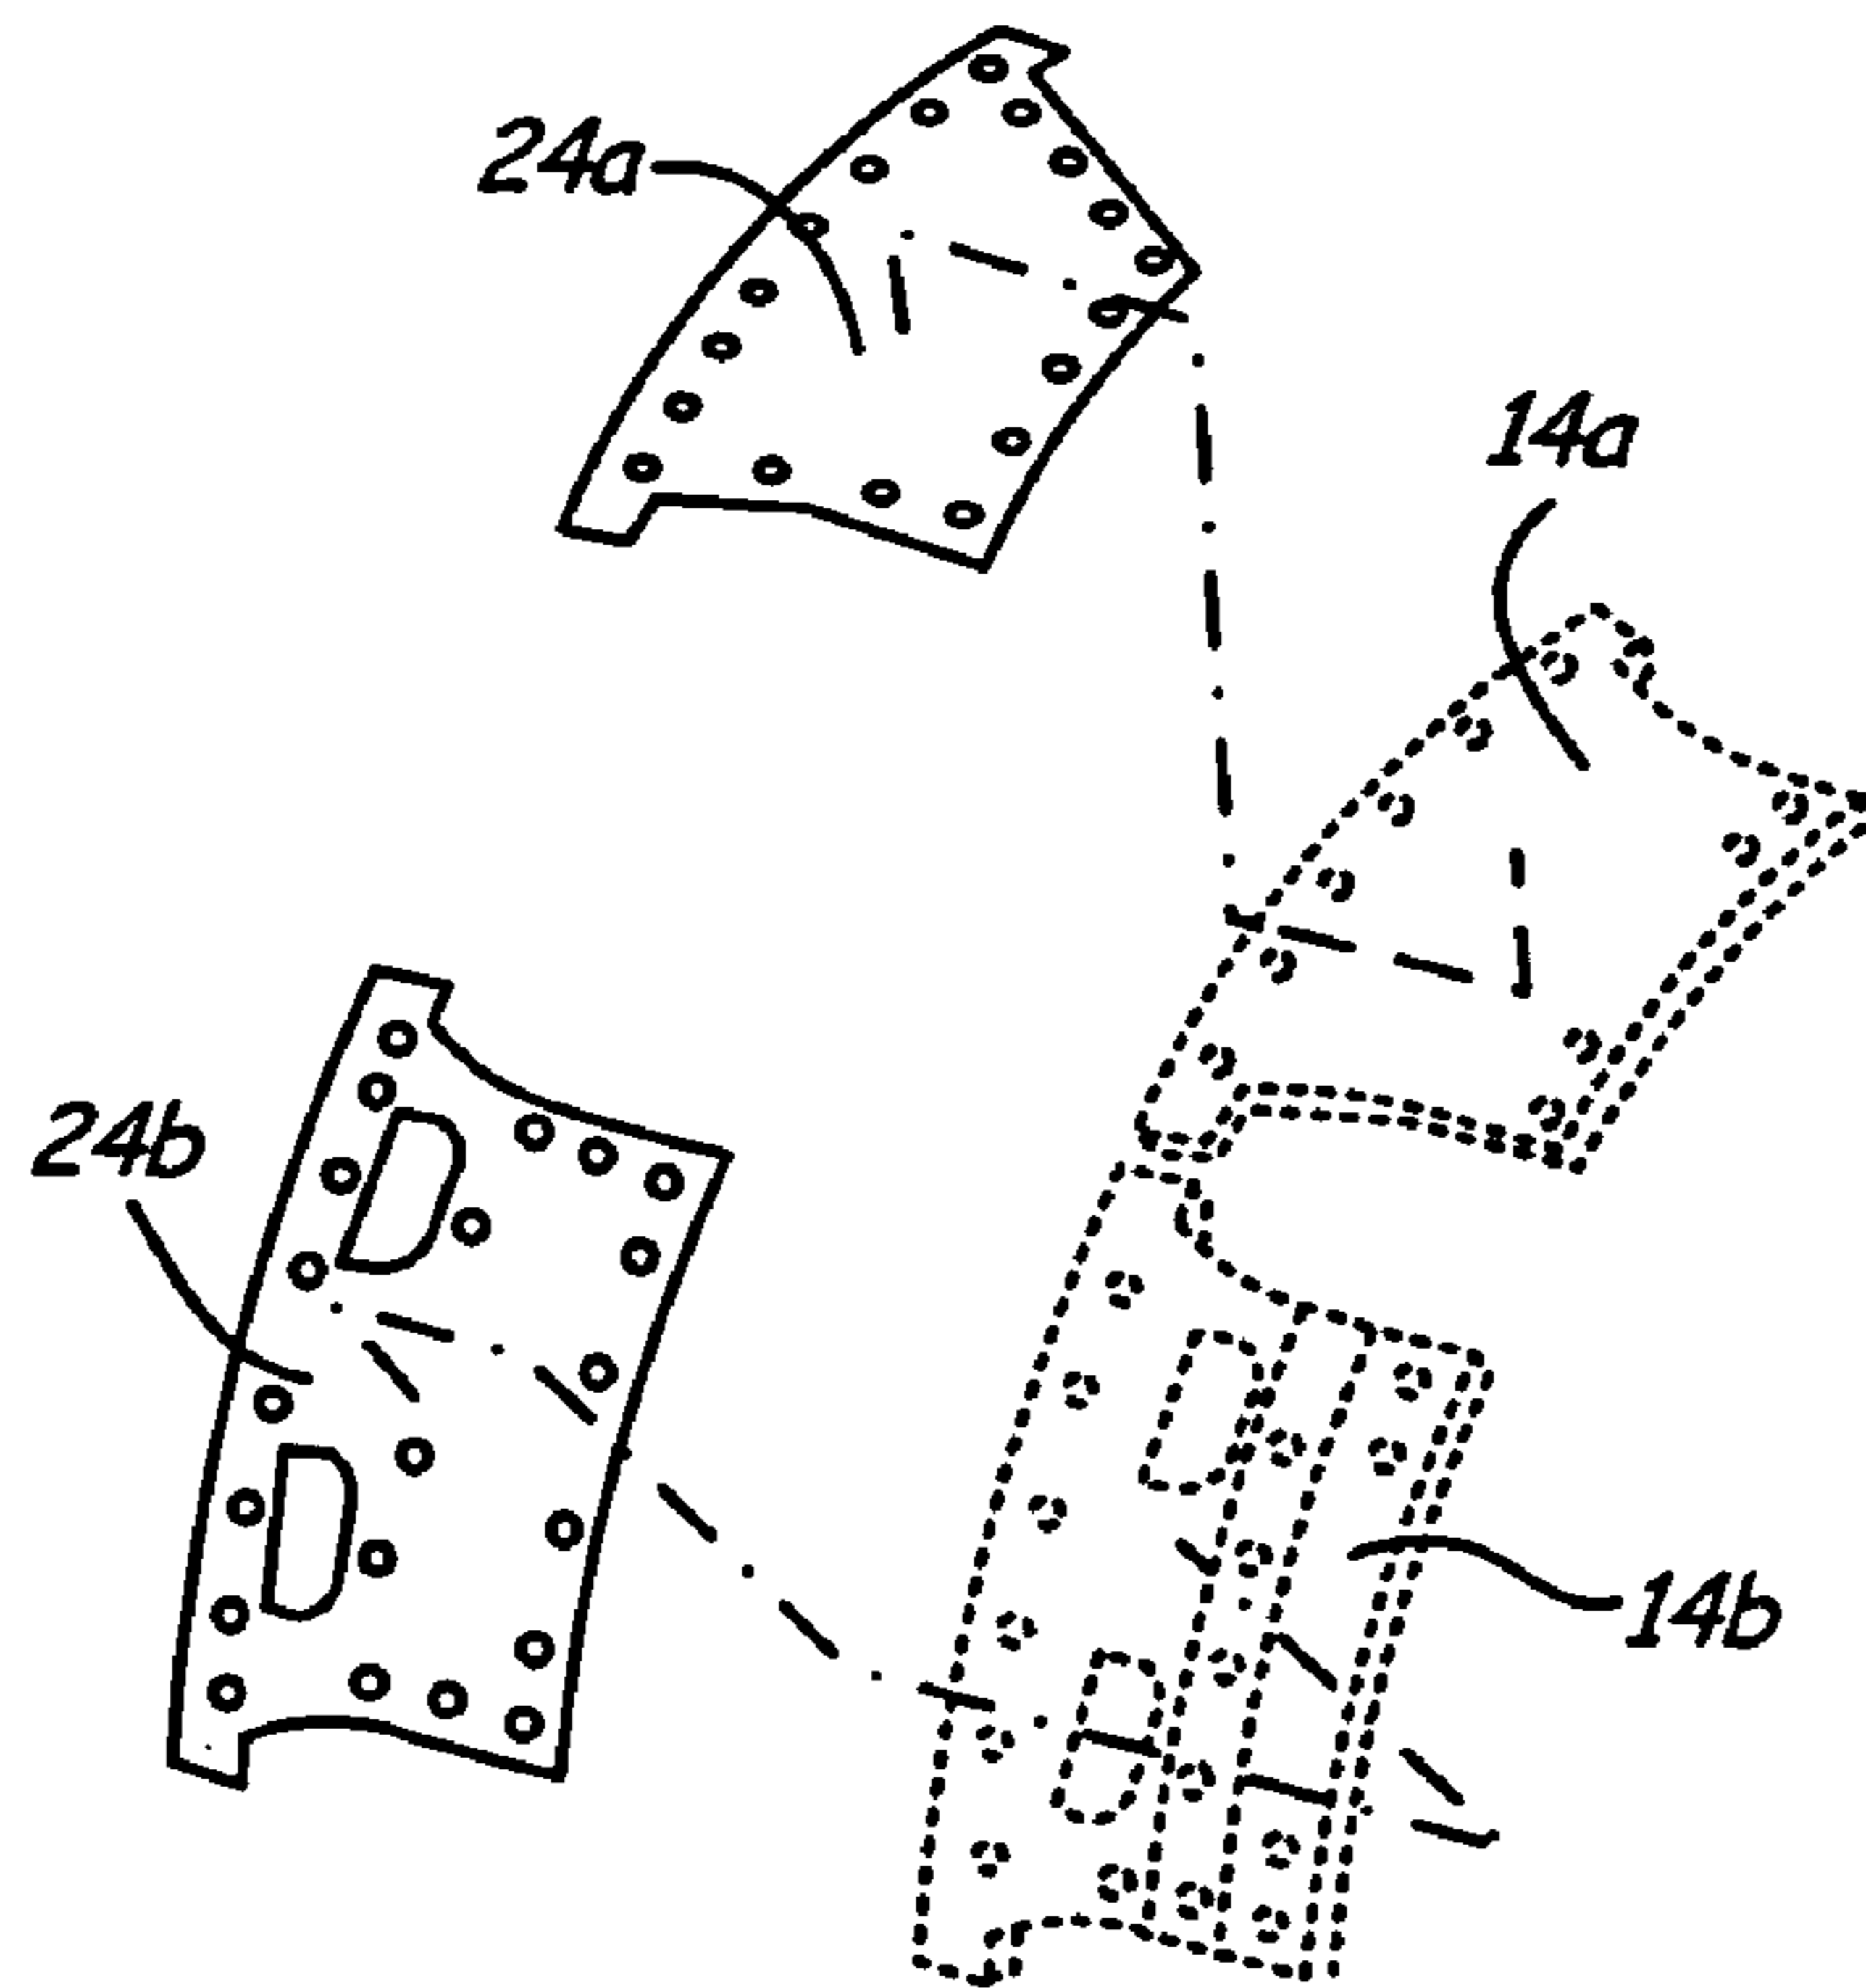
**Fig. 2**

FIG. 2 is an enlarged view of first and second liner segments of FIG. 1, including insulation blankets that are attached to an inner surface of the liner segments.

FIG. 2 is an enlarged view of first and second liner segments 14a and 14b of FIG. 1. As also shown in FIG. 2, insulation blankets 24a and 24b are configured to attach to an inner surface of liner segments 14a and 14b. Insulation blankets 24a and 24b are designed to protect inner liner segments 14 from high temperatures in and around HPC 18, and also to provide fire containment. If a fire were generated in HPC 18, insulation blankets 24a and 24b may contain or resist a spread of fire in engine assembly 10. Additional insulation blankets not shown in FIG. 2 are similarly attached to seven additional liner segments (also not shown in FIG. 2) that are similar to first and second segments 14a and 14b.

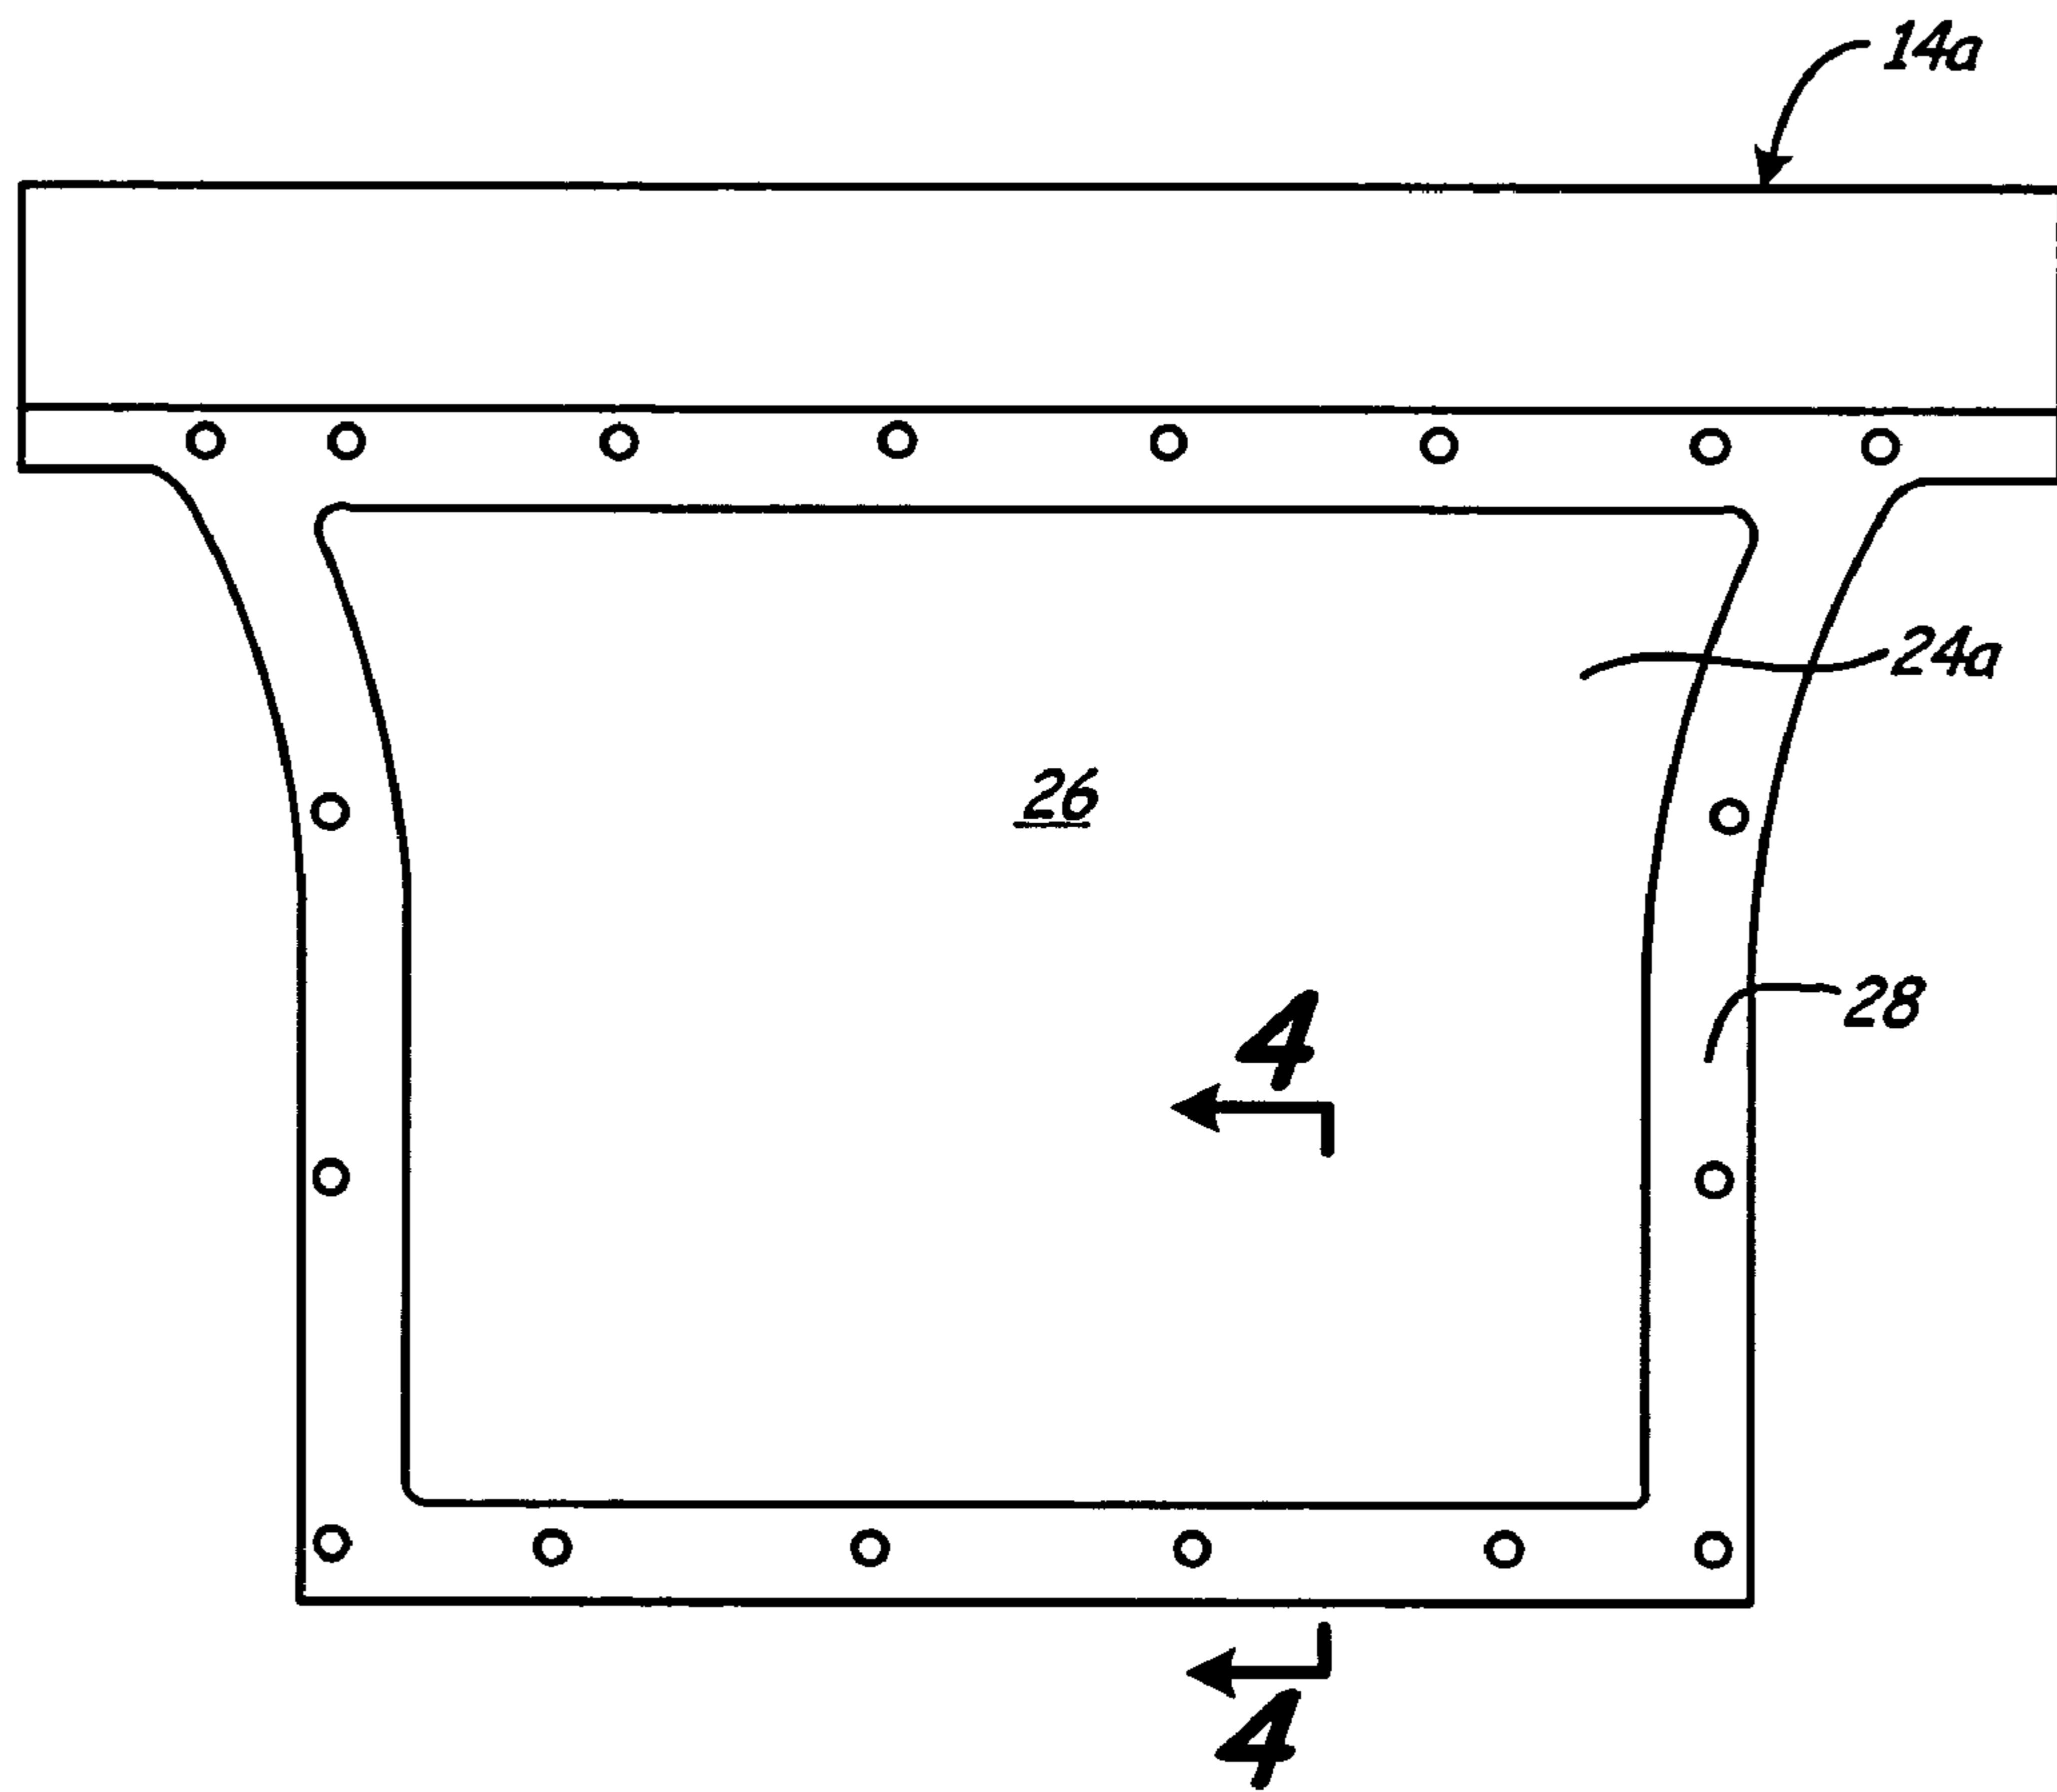
**Fig. 3**

FIG. 3 is a perspective view of an inner surface of the first liner segment of FIG. 2, including the insulation blanket.

FIG. 3 is a perspective view of an inner surface of liner segment 14a of FIG. 2, including insulation blanket 24a having outer layer 26, and backing 28. Outer layer 26 of insulation blanket 24a may be formed of a metallized fabric; more specifically, layer 26 may be a woven fabric made from glass or ceramic, in which individual fibers have been coated with a metal, such as aluminum. As shown in FIG. 3, backing 28 is used to frame insulation blanket 24a, and provide additional retention of blanket 24a around a perimeter of liner segment 14a.

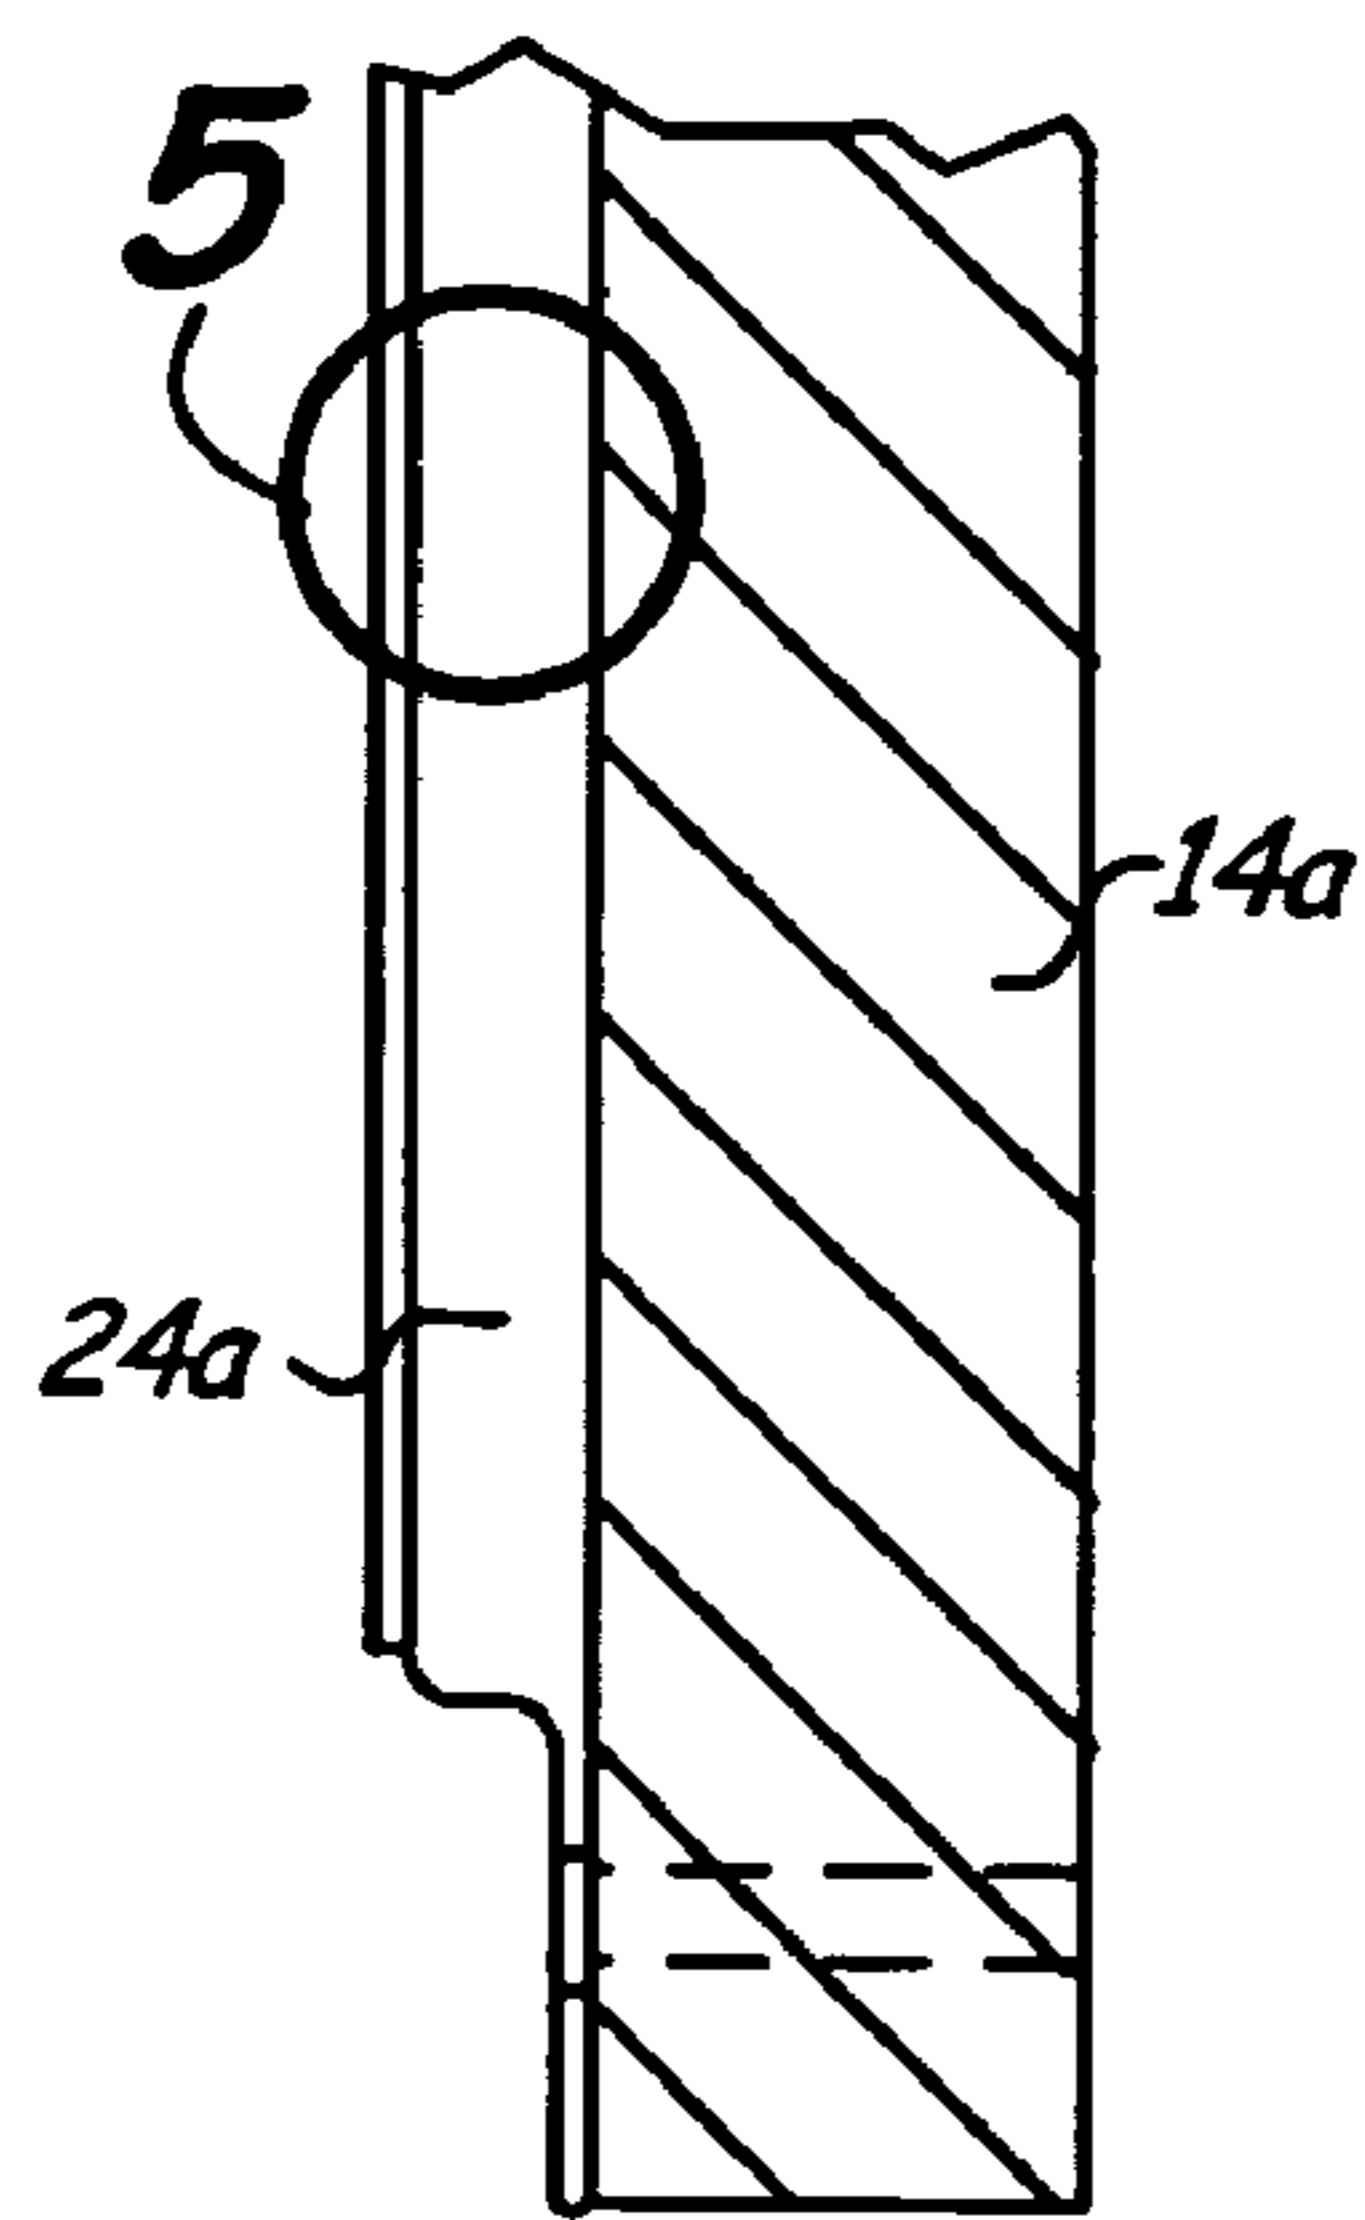
**Fig. 4**

FIG. 4 is a cross-sectional view of a portion of the first liner segment and insulation blanket of FIG. 3.

FIG. 4 is a cross-sectional view of a portion of liner segment 14a of FIG. 3 showing insulation blanket 24a attached to liner segment 14a.

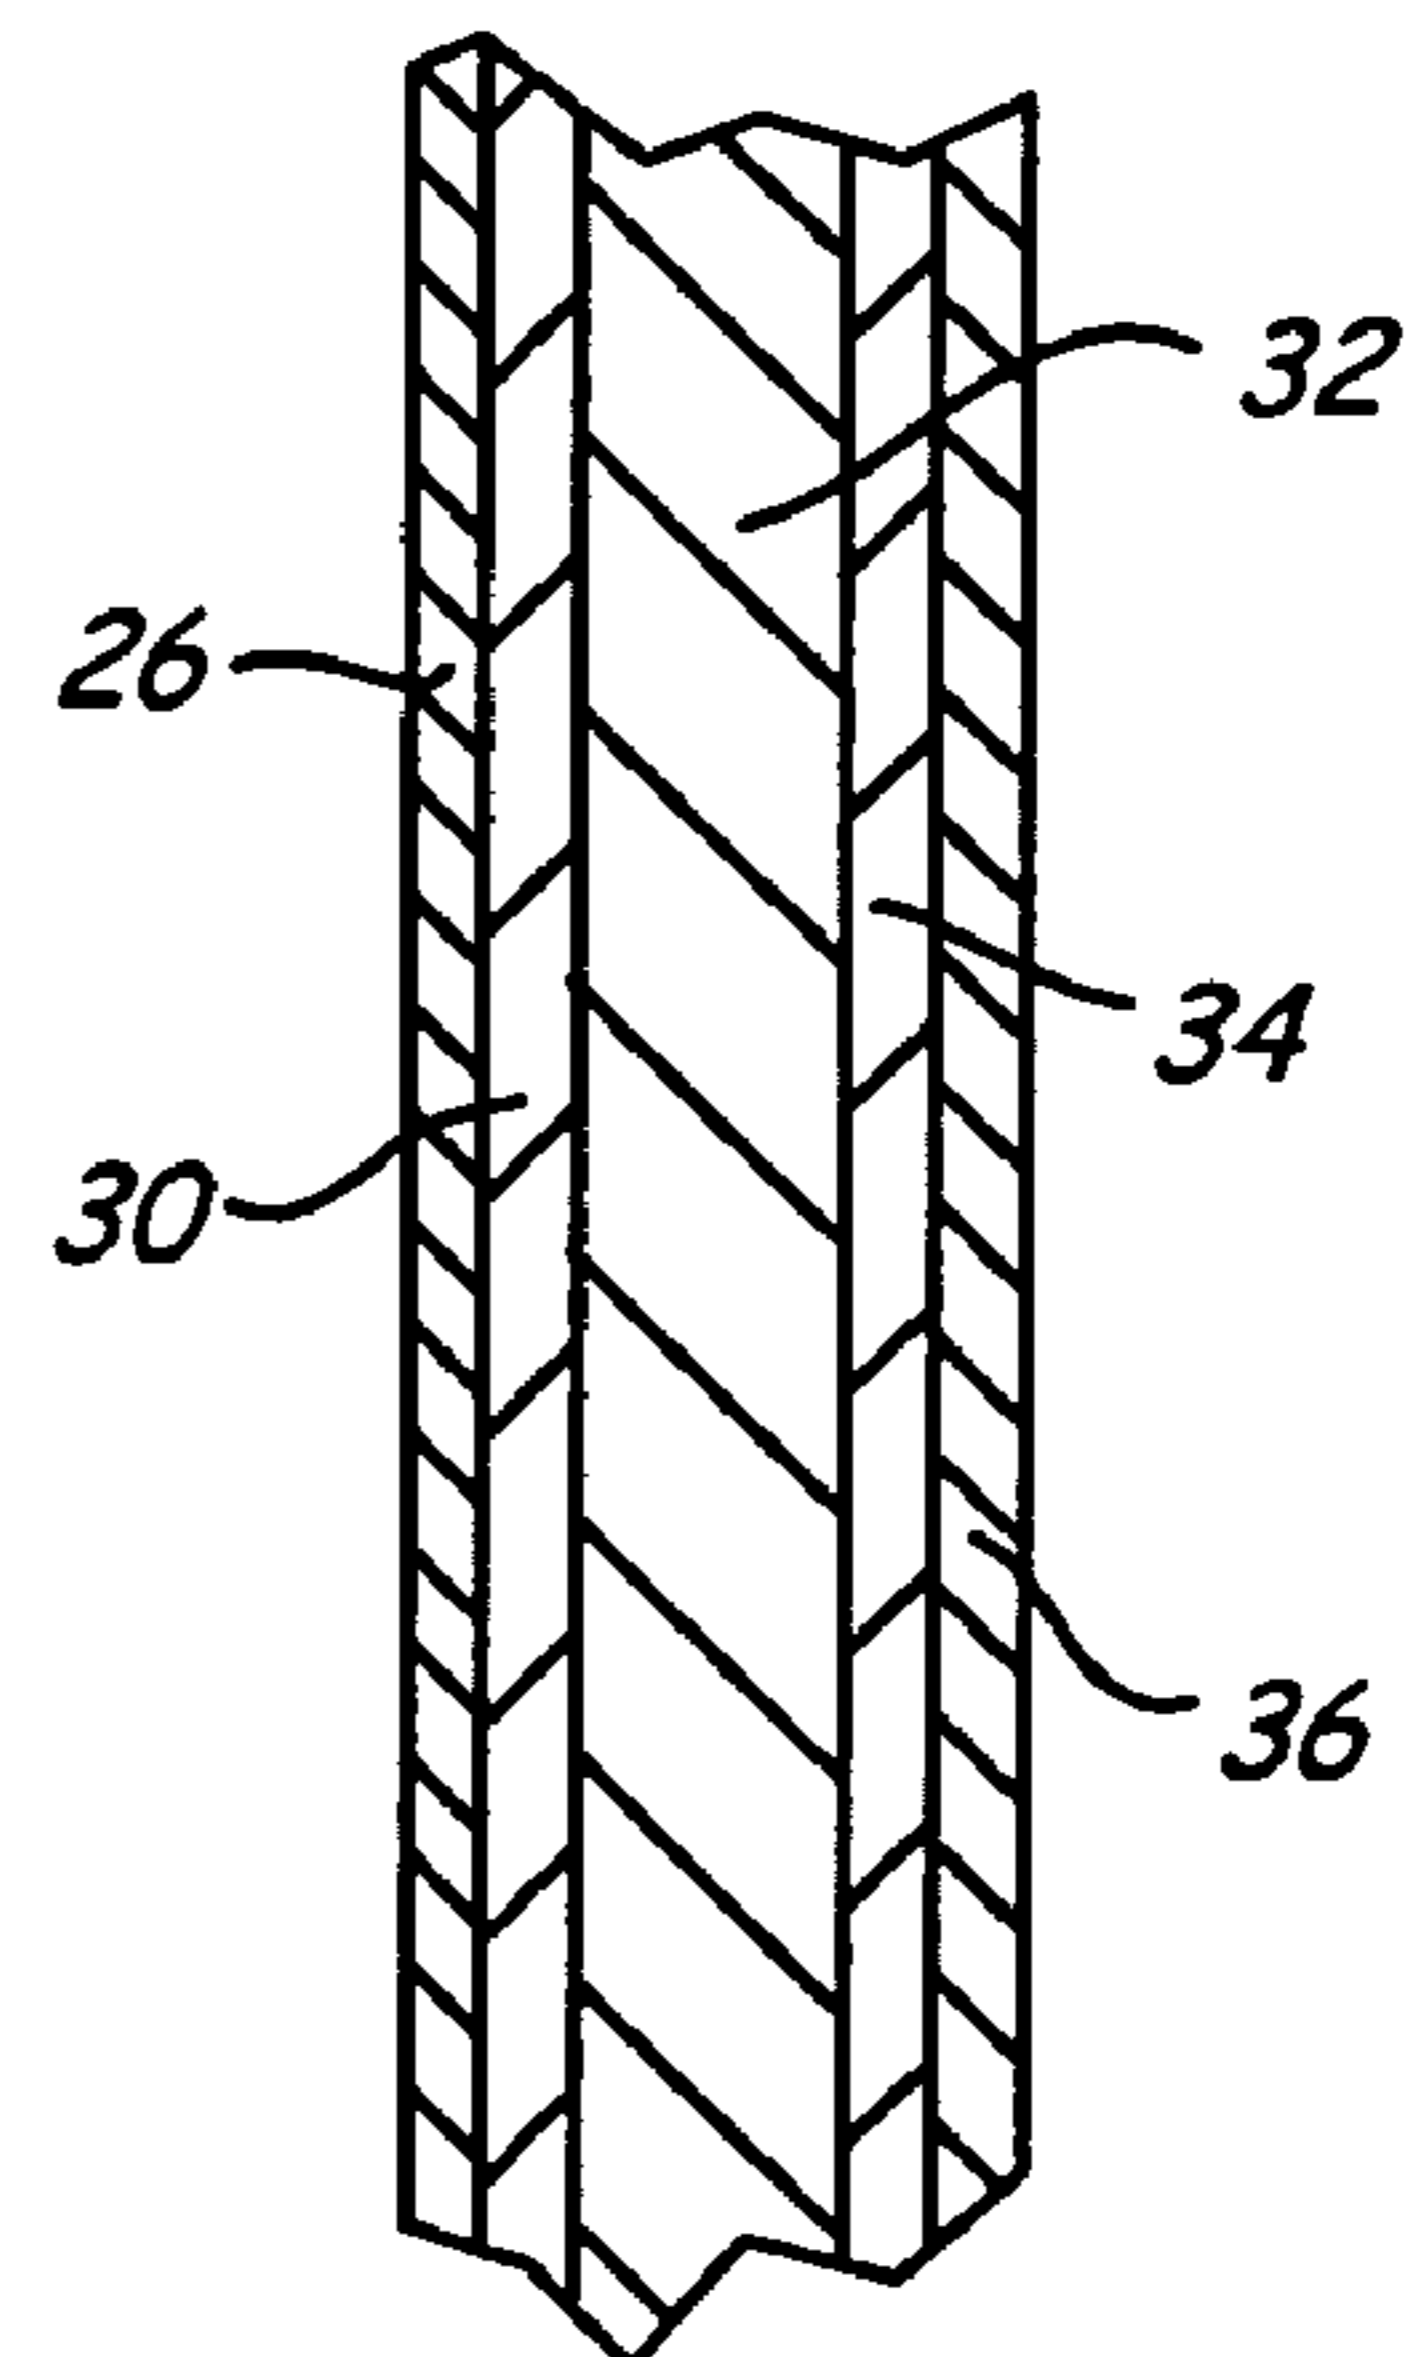
**Fig. 5**

FIG. 5 is a cross-sectional view of a portion of the insulation blanket in FIG. 4.

FIG. 5 is a cross-sectional view of an enlarged portion of insulation blanket 24a of FIG. 4, which includes outer layer 26, ceramic layer 30, insulation 32, second ceramic layer 34, and glass cover 36. As stated above, outer layer 26 may be a metallized fabric, such as an aluminized fabric, and is bonded to underlying ceramic layer 30 by a thin layer of adhesive, such as, but not limited to, silicone rubber. Ceramic layers 30

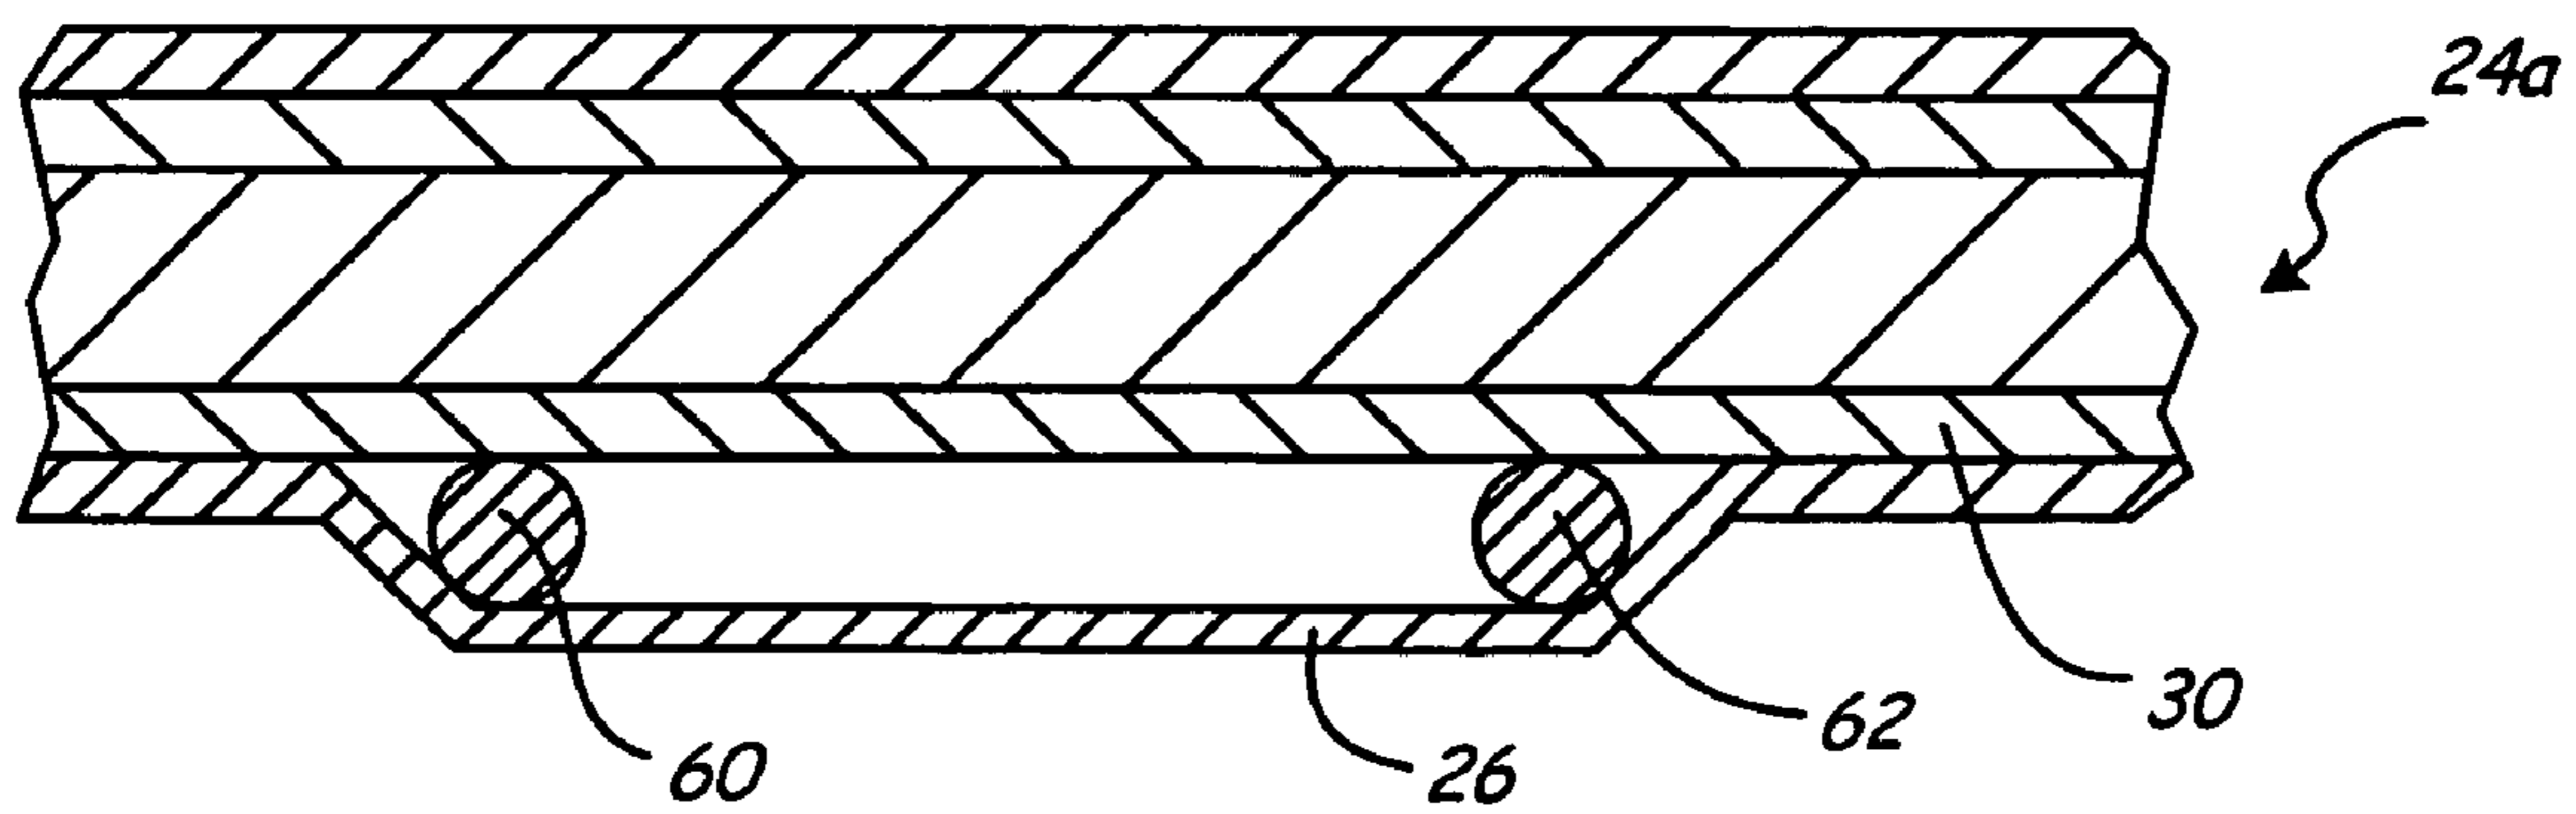
**Fig. 9**

FIG. 9 is a cross-sectional view of the insulation blanket in FIG. 8, including optional spacers between two layers of the insulation blanket.
