(54) **METHOD FOR CHECKING SURFACE  
CONDITION AFTER CLEANING**

(73) Assignee: **United Technologies Corporation**,  
Hartford, CT (US)

**METHOD FOR CHECKING SURFACE  
CONDITION AFTER CLEANING**

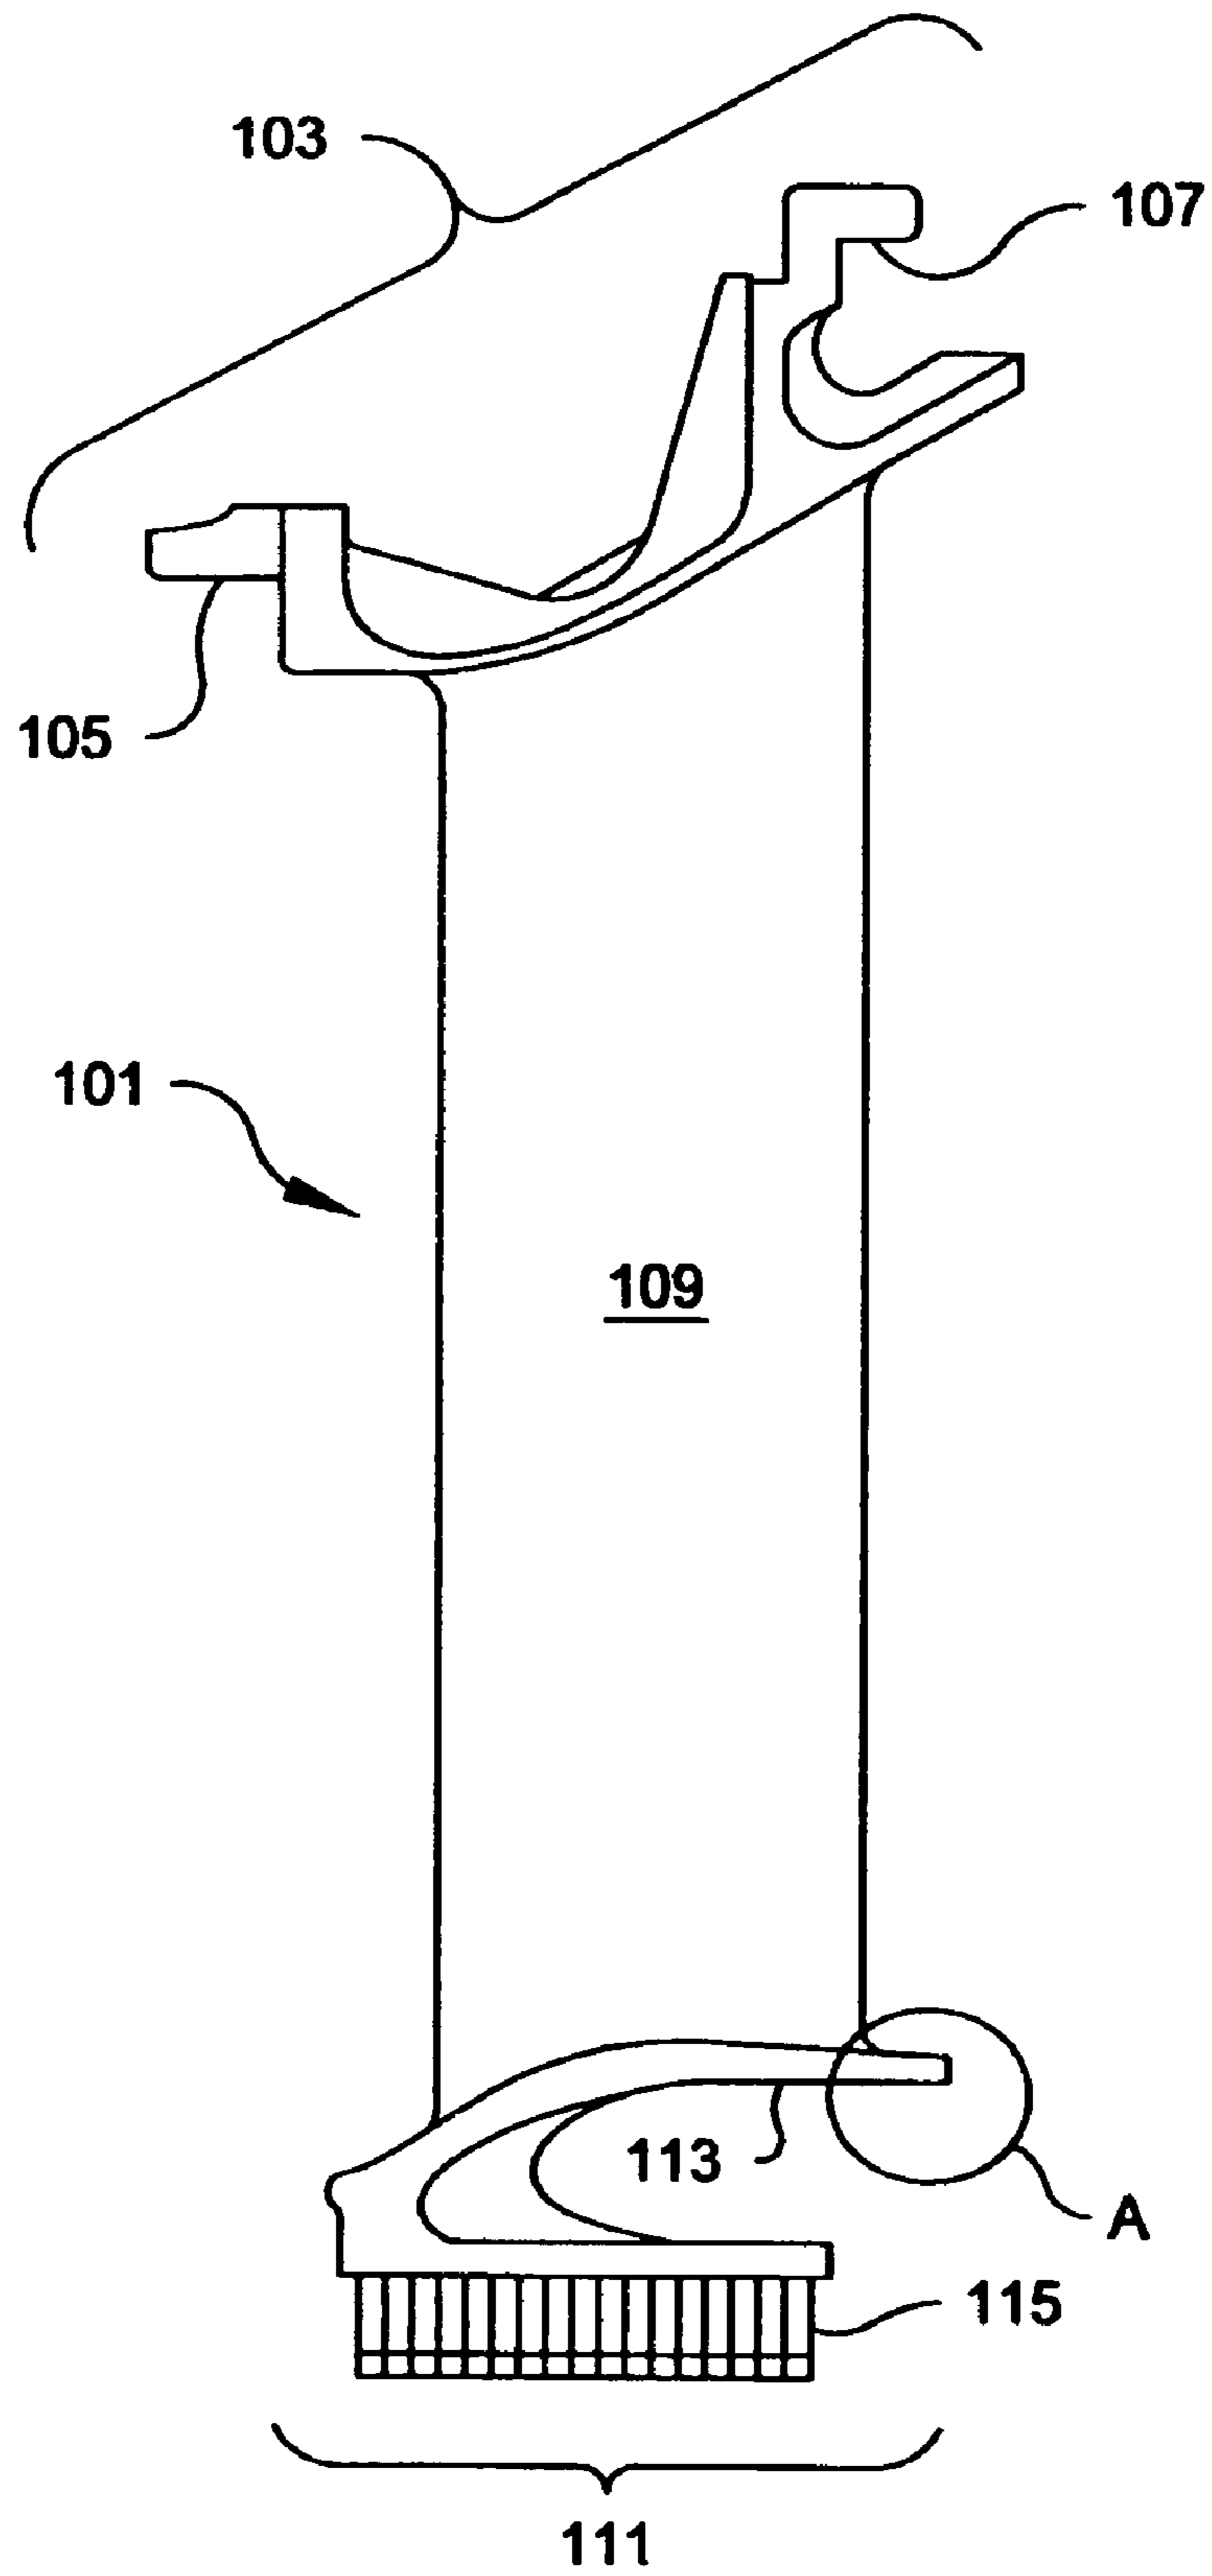
***Fig. 1***

FIG. 1 is an exemplary gas turbine vane showing a post cleaning inspection point.

Shown in FIG. 1 is an illustration of a turbine vane **101** that has undergone HF cleaning. Areas of the turbine vane **101** include an outer platform **103** that includes front **105** and rear **107** hook attachments, an airfoil section **109**, and an inner platform **111** that includes a rear inner platform edge **113** and a honeycomb seal **115**. Shown in FIG. 3 is an exemplary, non-limiting method of the invention. The method examines an area that is typically the most vulnerable and susceptible to IGA. An area, A, determined to be susceptible may be chosen for inspection (step **305**). In embodiments, the exemplary area, A, of the rear inner platform edge **113** is chosen due to its gas path and non-gas path exposure, accessibility, and ease of repair after performing the inspection method. The surface chosen for examination may be a marginally loaded edge, or surface, such that performing the method does not impact the structural integrity of the component part. The part **101** may be put in a fixture for positioning and to provide an examination surface reference (step **310**).

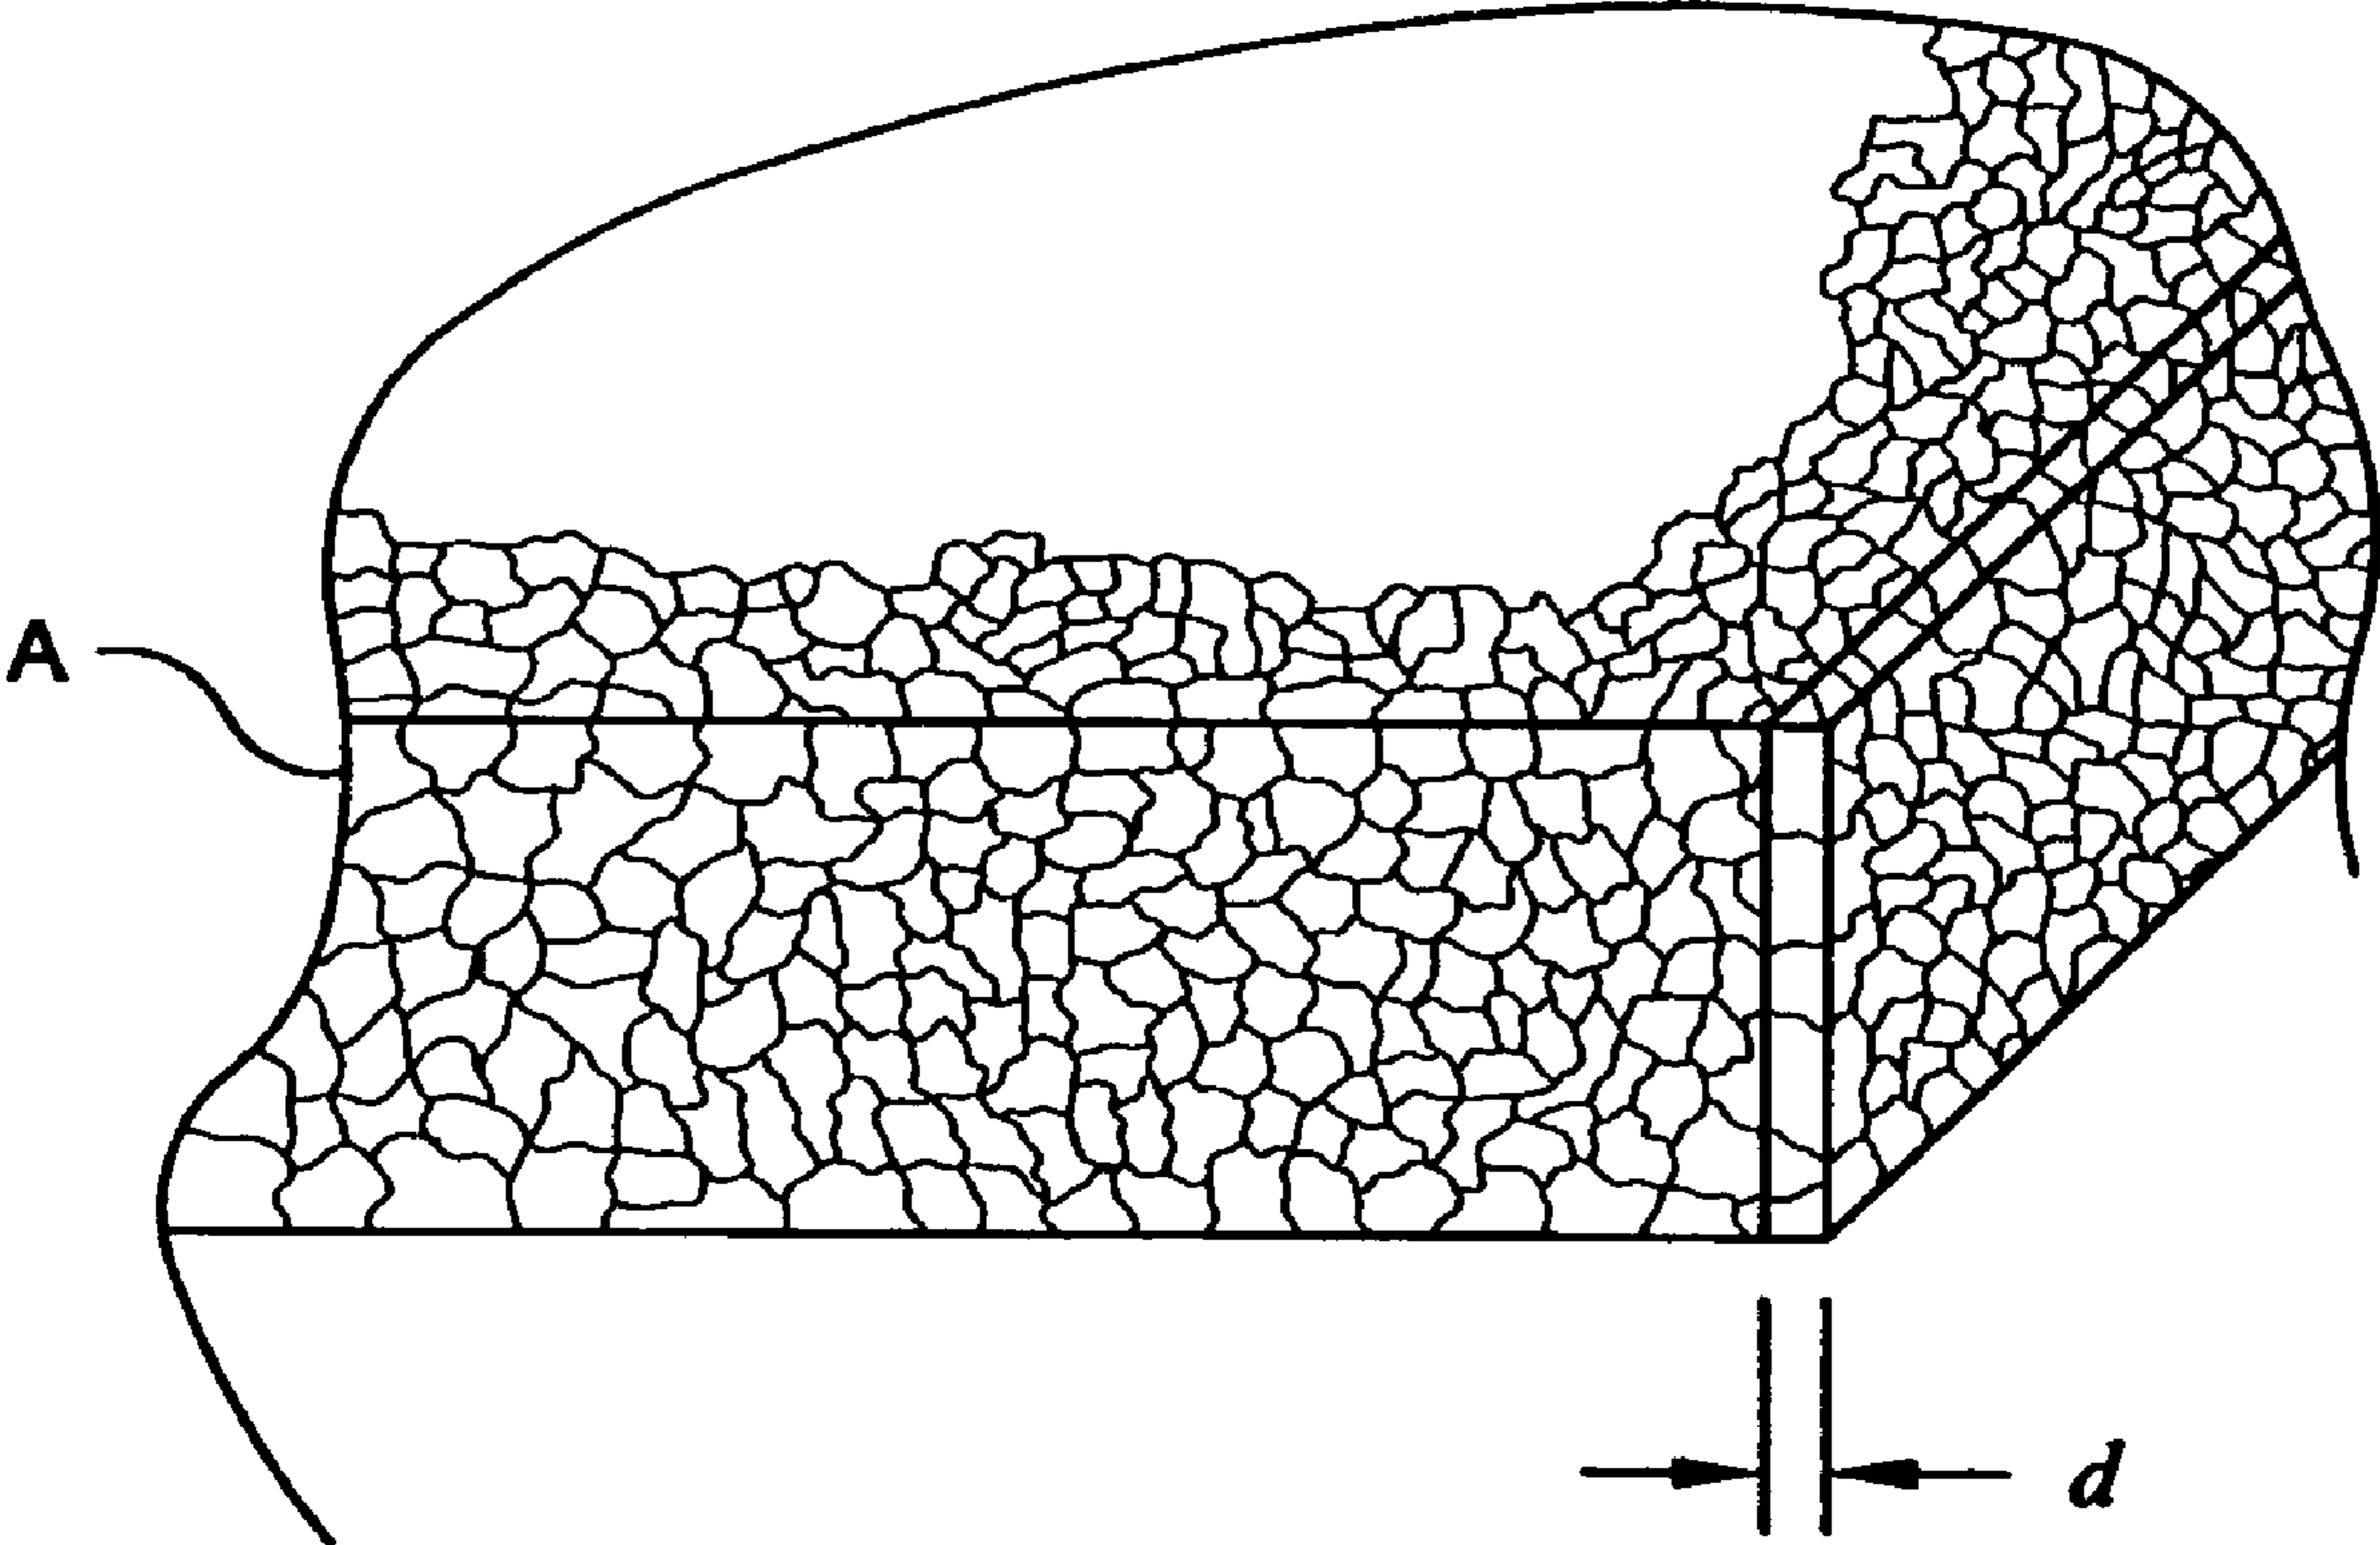
***Fig. 2***

FIG. 2 is the inspection point from FIG. 1 showing intergranular attack affecting all cleaned surfaces.

Material may then be removed from the surface of the chosen area (step **315**) to a predetermined depth *d* as shown in FIG. 2 (in embodiments, about 0.010 to 0.020 inch deep) using a series of abrasive papers that may be comprised of SiC, aluminum oxide, or others. Coarse to fine mesh abrasives may also be used in series to achieve a final polished surface finish.

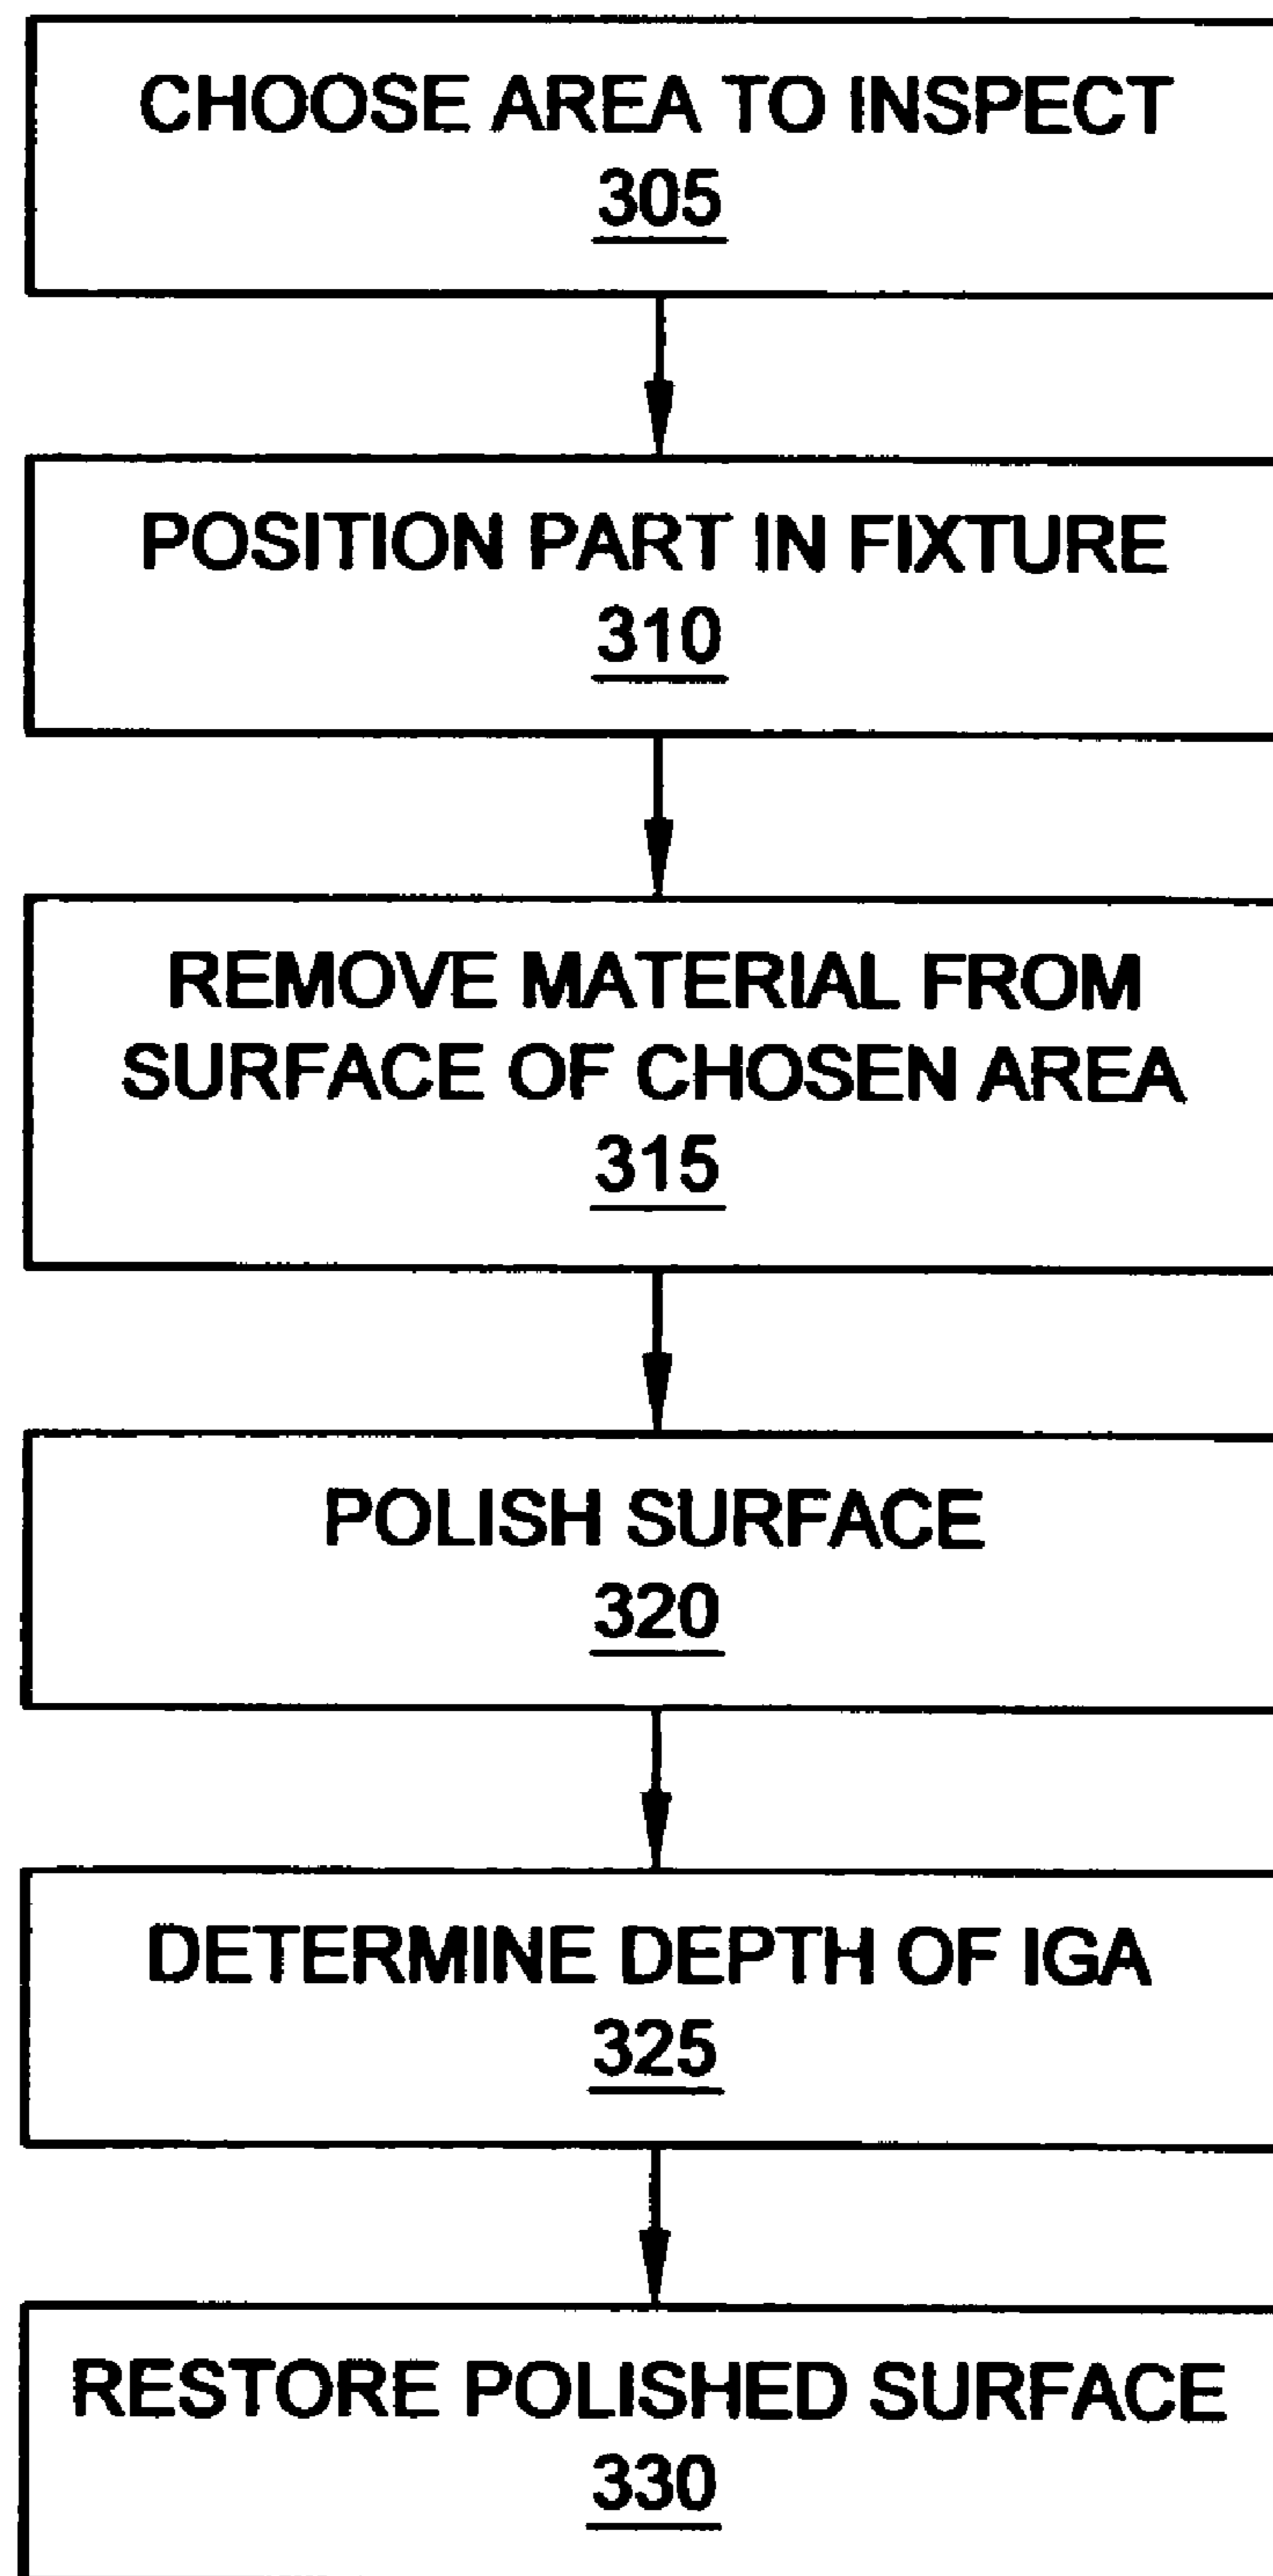
*Fig. 3*

FIG. 3 is a block diagram of an exemplary inspection method according to the invention.
