(54) **METHOD FOR CHECKING SURFACE
CONDITION AFTER CLEANING**

Methods for inspecting gas turbine component parts for possible distress after hydrogen fluoride cleaning are disclosed. The methods selectively remove a small amount of material for IGA inspection and restore the material using the same procedures as when the parts were manufactured.

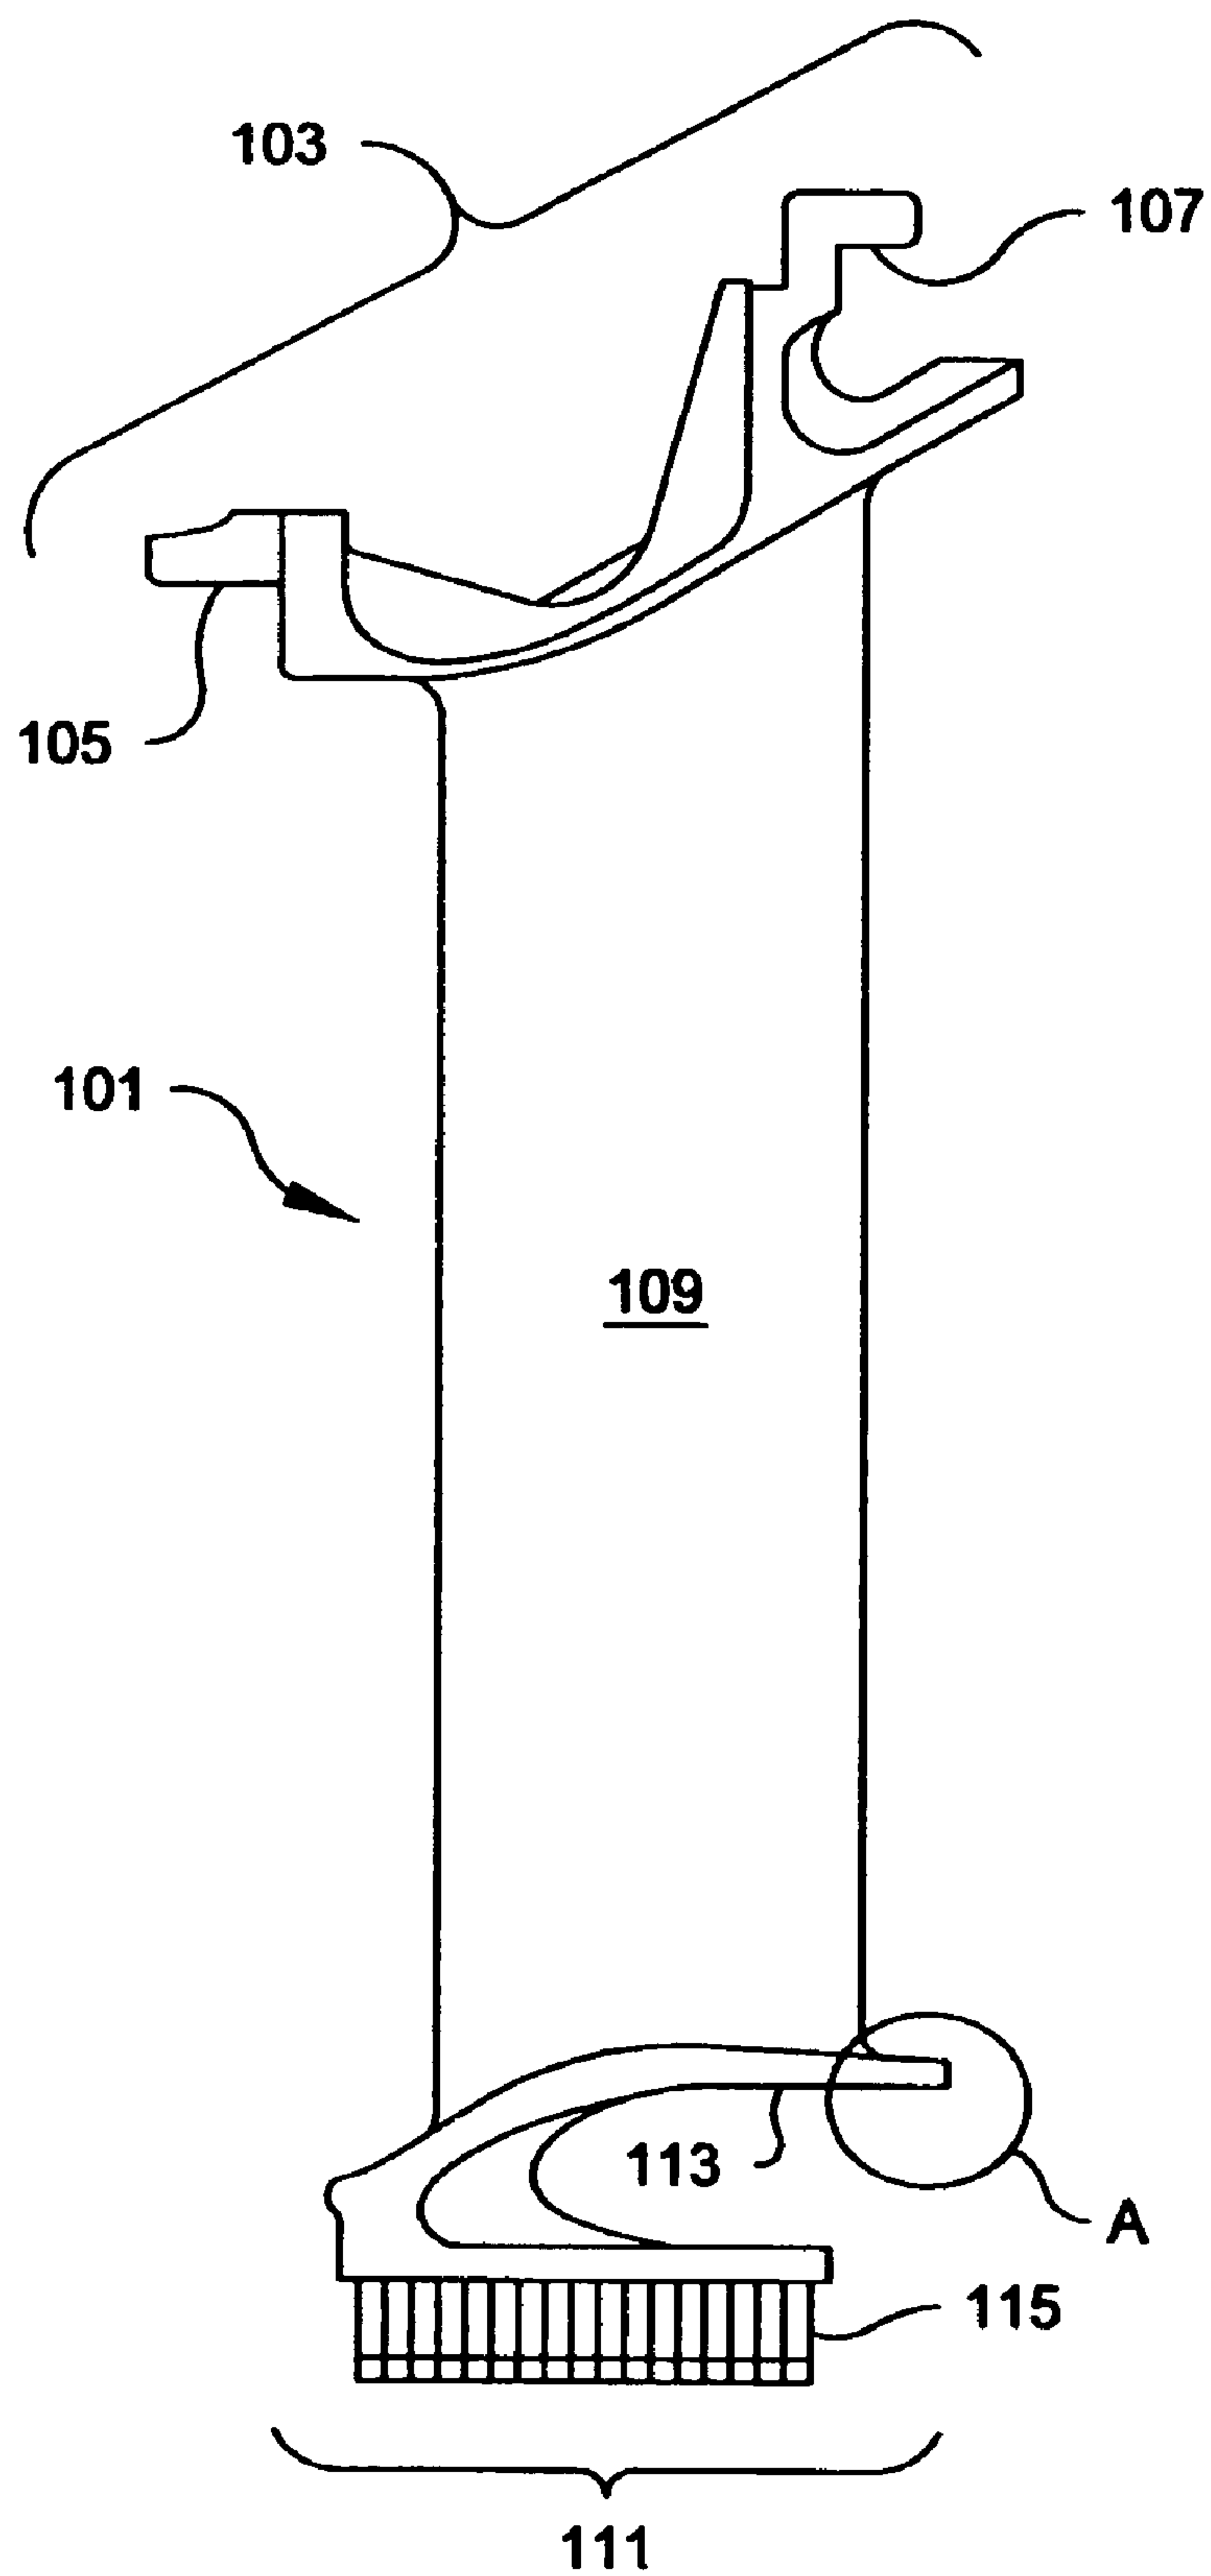
Fig. 1

FIG. 1 is an exemplary gas turbine vane showing a post cleaning inspection point.

Shown in FIG. 1 is an illustration of a turbine vane **101** that has undergone HF cleaning. Areas of the turbine vane **101** include an outer platform **103** that includes front **105** and rear **107** hook attachments, an airfoil section **109**, and an inner platform **111** that includes a rear inner platform edge **113** and a honeycomb seal **115**. Shown in FIG. 3 is an exemplary, non-limiting method of the invention. The method examines an area that is typically the most vulnerable and susceptible to IGA. An area, A, determined to be susceptible may be chosen for inspection (step **305**). In embodiments, the exemplary area, A, of the rear inner platform edge **113** is chosen due to its gas path and non-gas path exposure, accessibility, and ease of repair after performing the inspection method. The surface chosen for examination may be a marginally loaded edge, or surface, such that performing the method does not impact the structural integrity of the component part. The part **101** may be put in a fixture for positioning and to provide an examination surface reference (step **310**).

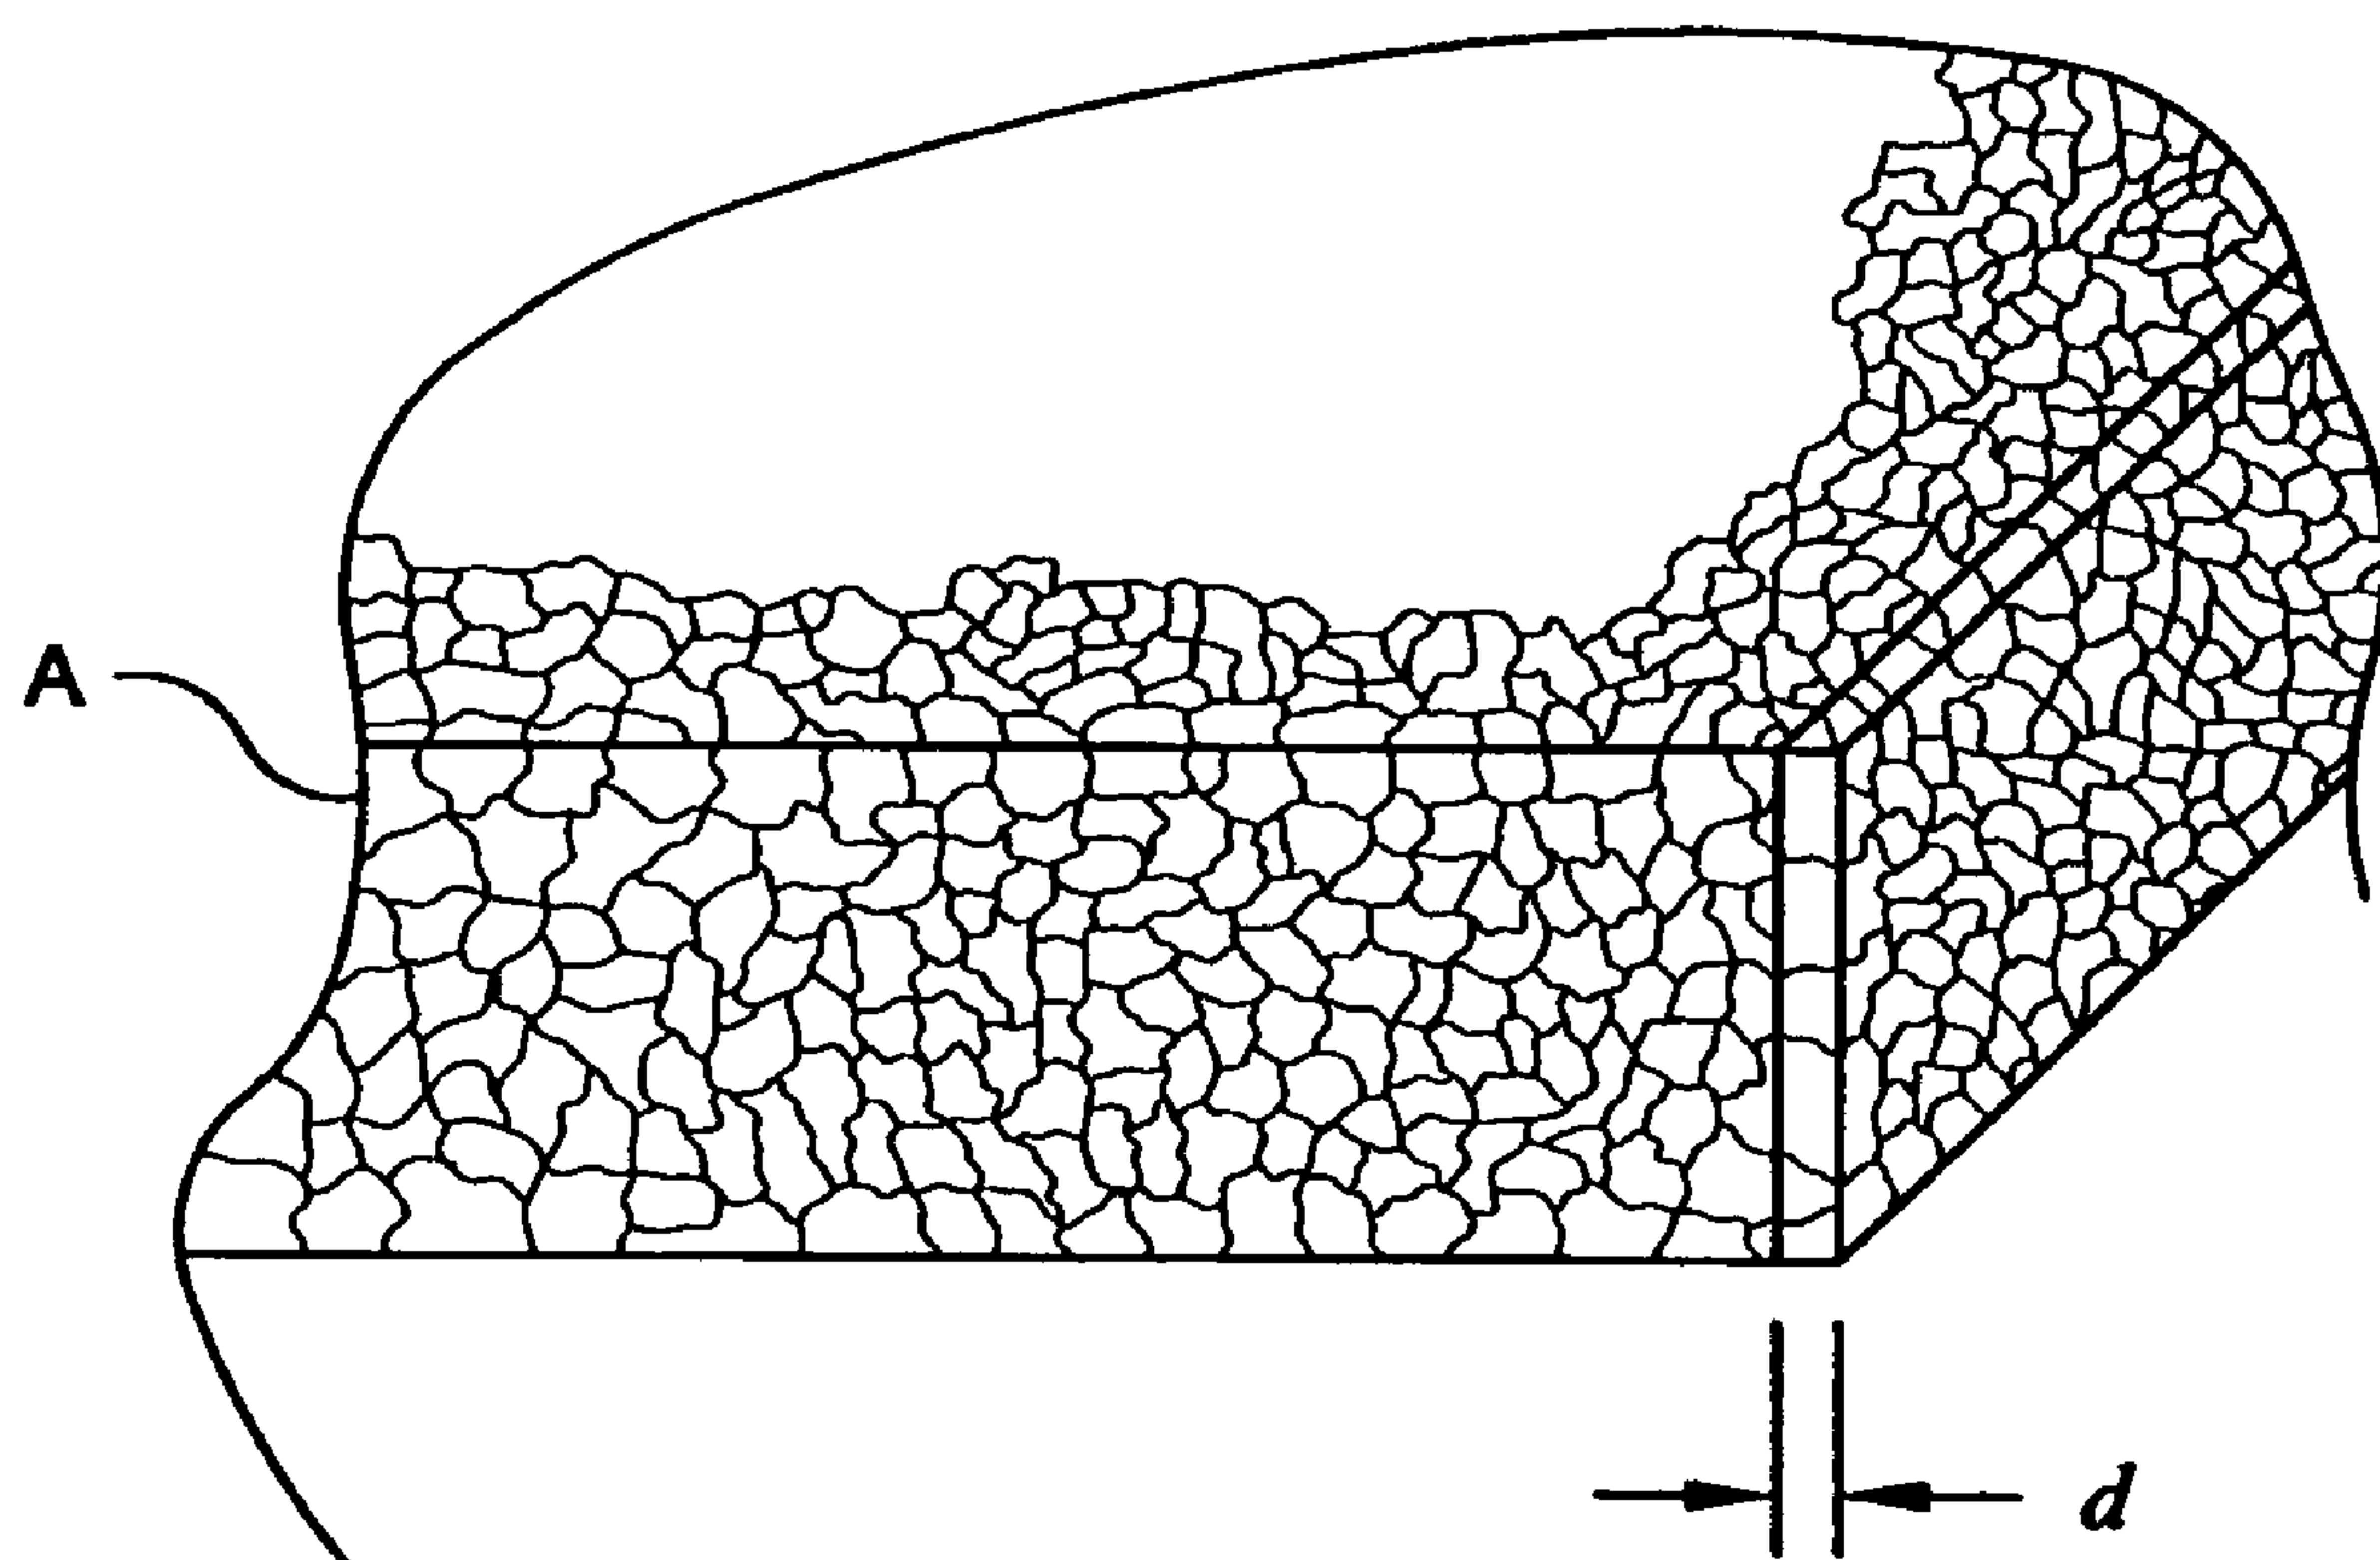
Fig. 2

FIG. 2 is the inspection point from FIG. 1 showing intergranular attack affecting all cleaned surfaces.

Material may then be removed from the surface of the chosen area (step **315**) to a predetermined depth *d* as shown in FIG. 2 (in embodiments, about 0.010 to 0.020 inch deep) using a series of abrasive papers that may be comprised of SiC, aluminum oxide, or others. Coarse to fine mesh abrasives may also be used in series to achieve a final polished surface finish.

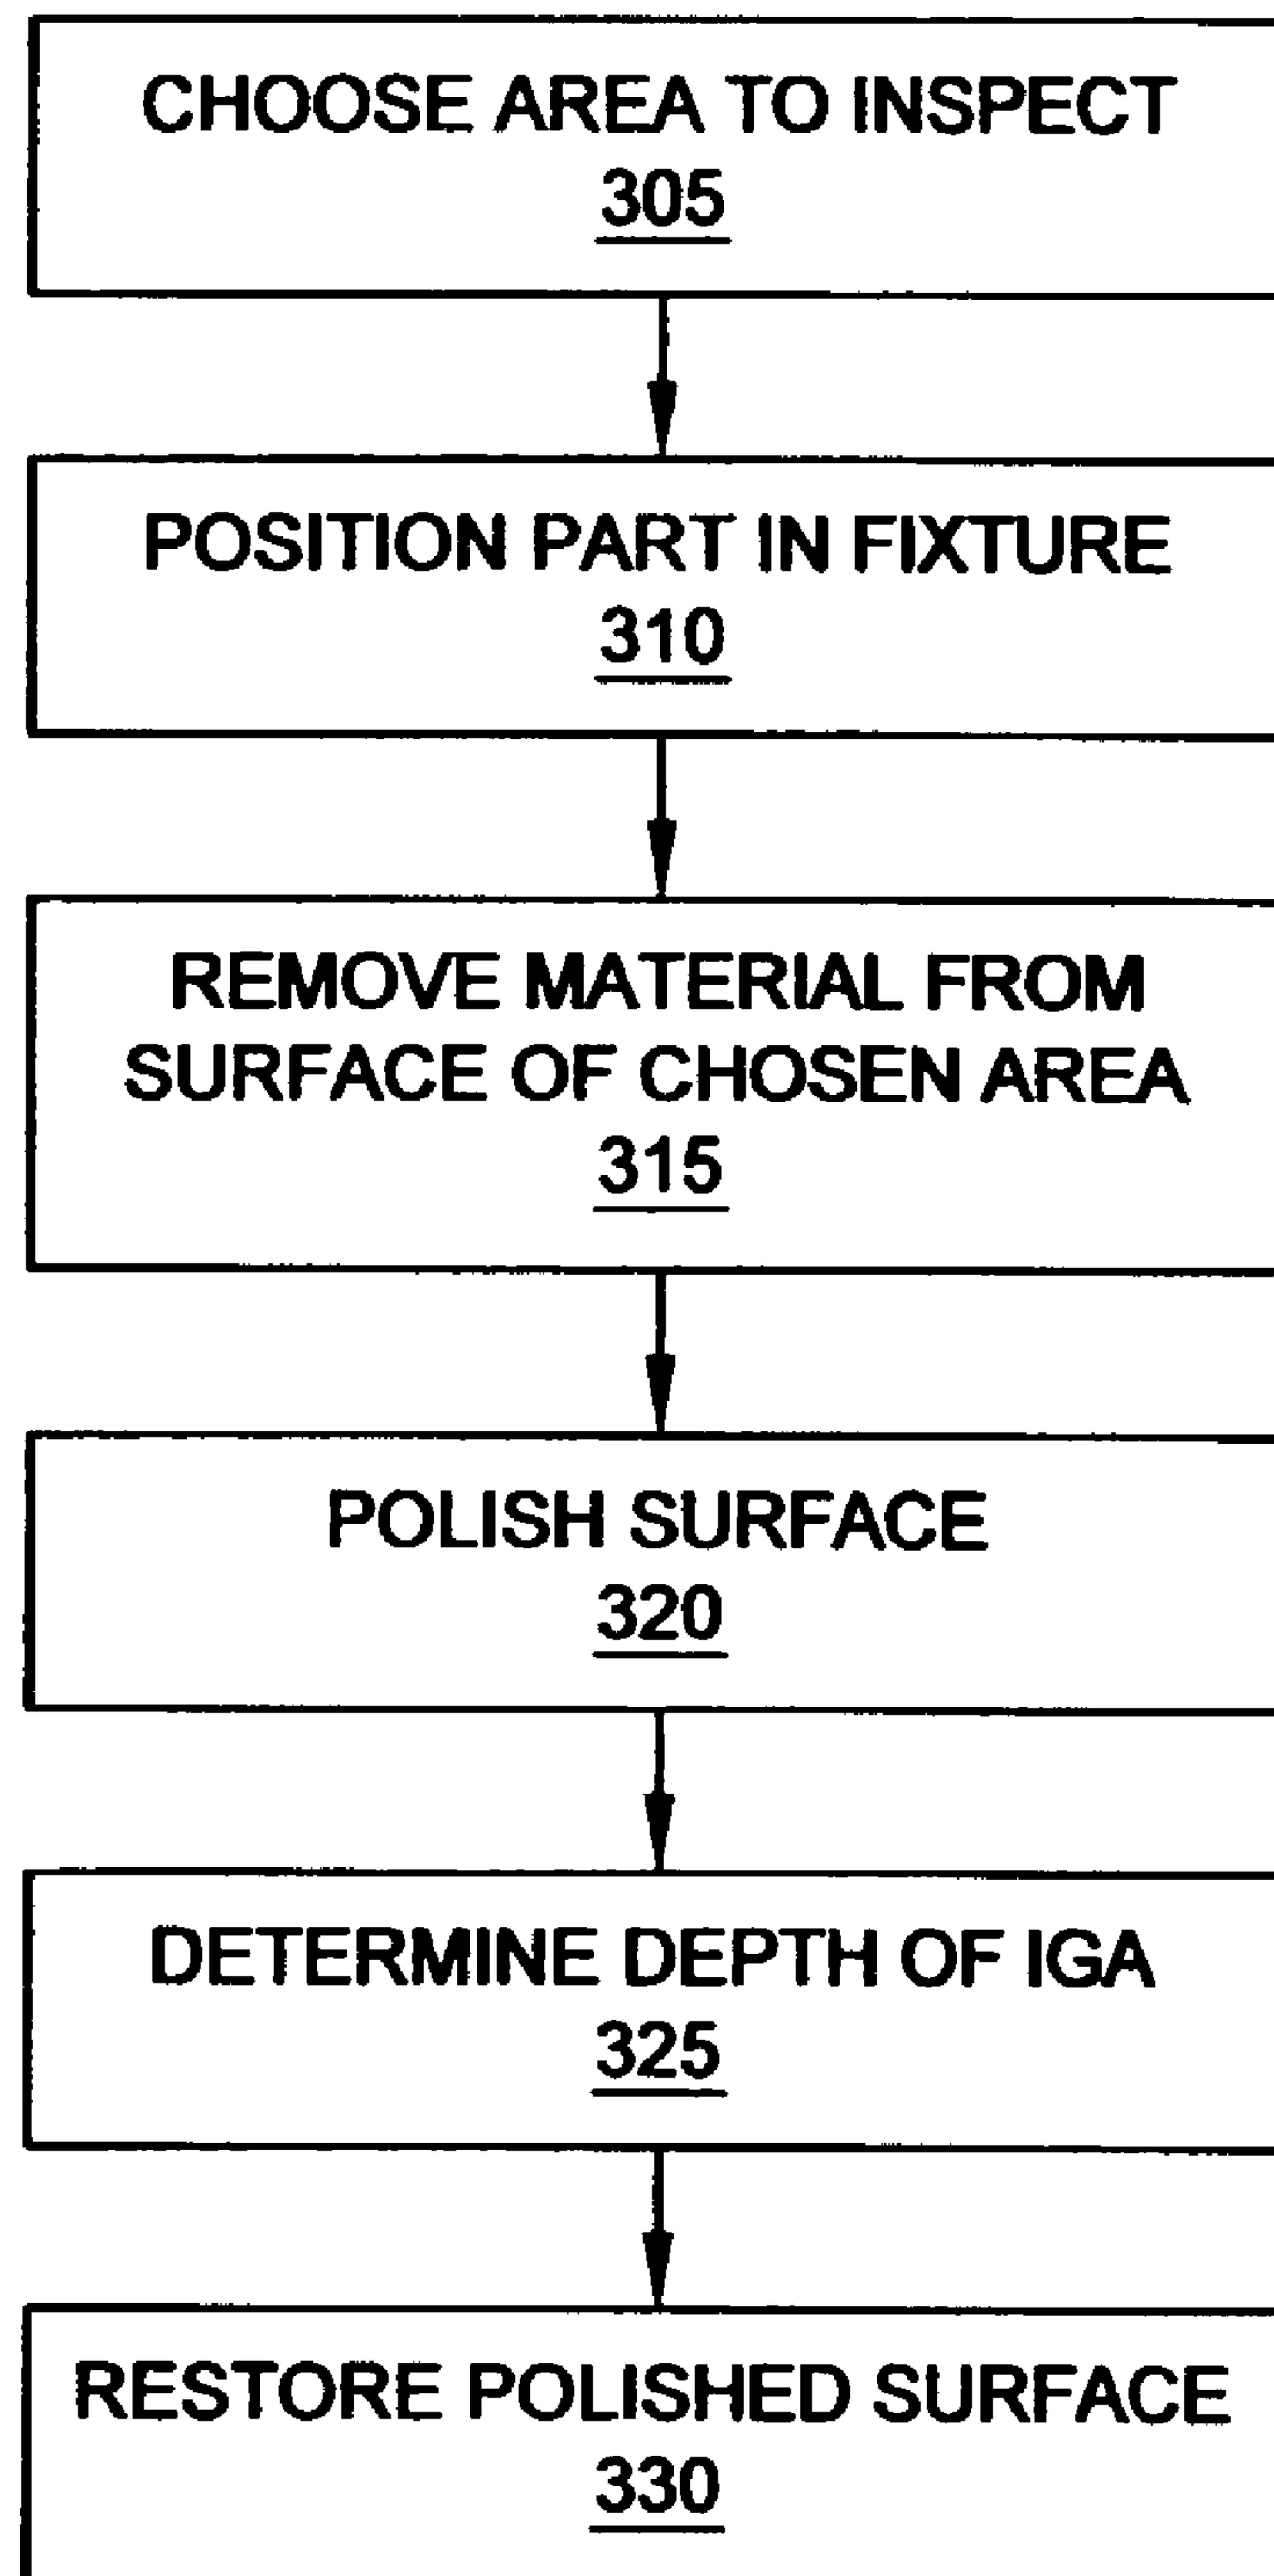
Fig. 3

FIG. 3 is a block diagram of an exemplary inspection method according to the invention.
