(54) **METHOD OF INSPECTING CANOPY STRUCTURES**

A method of inspecting canopy structures is provided to determine the structural integrity of the roof support system. The method includes steps designed to uncover hidden deficiencies in the roof support system through nondestructive testing and discovery. Timely use of the method of inspection not only minimizes the risk of canopy collapse but also produces information needed for making repair or replacement of the roof support system.

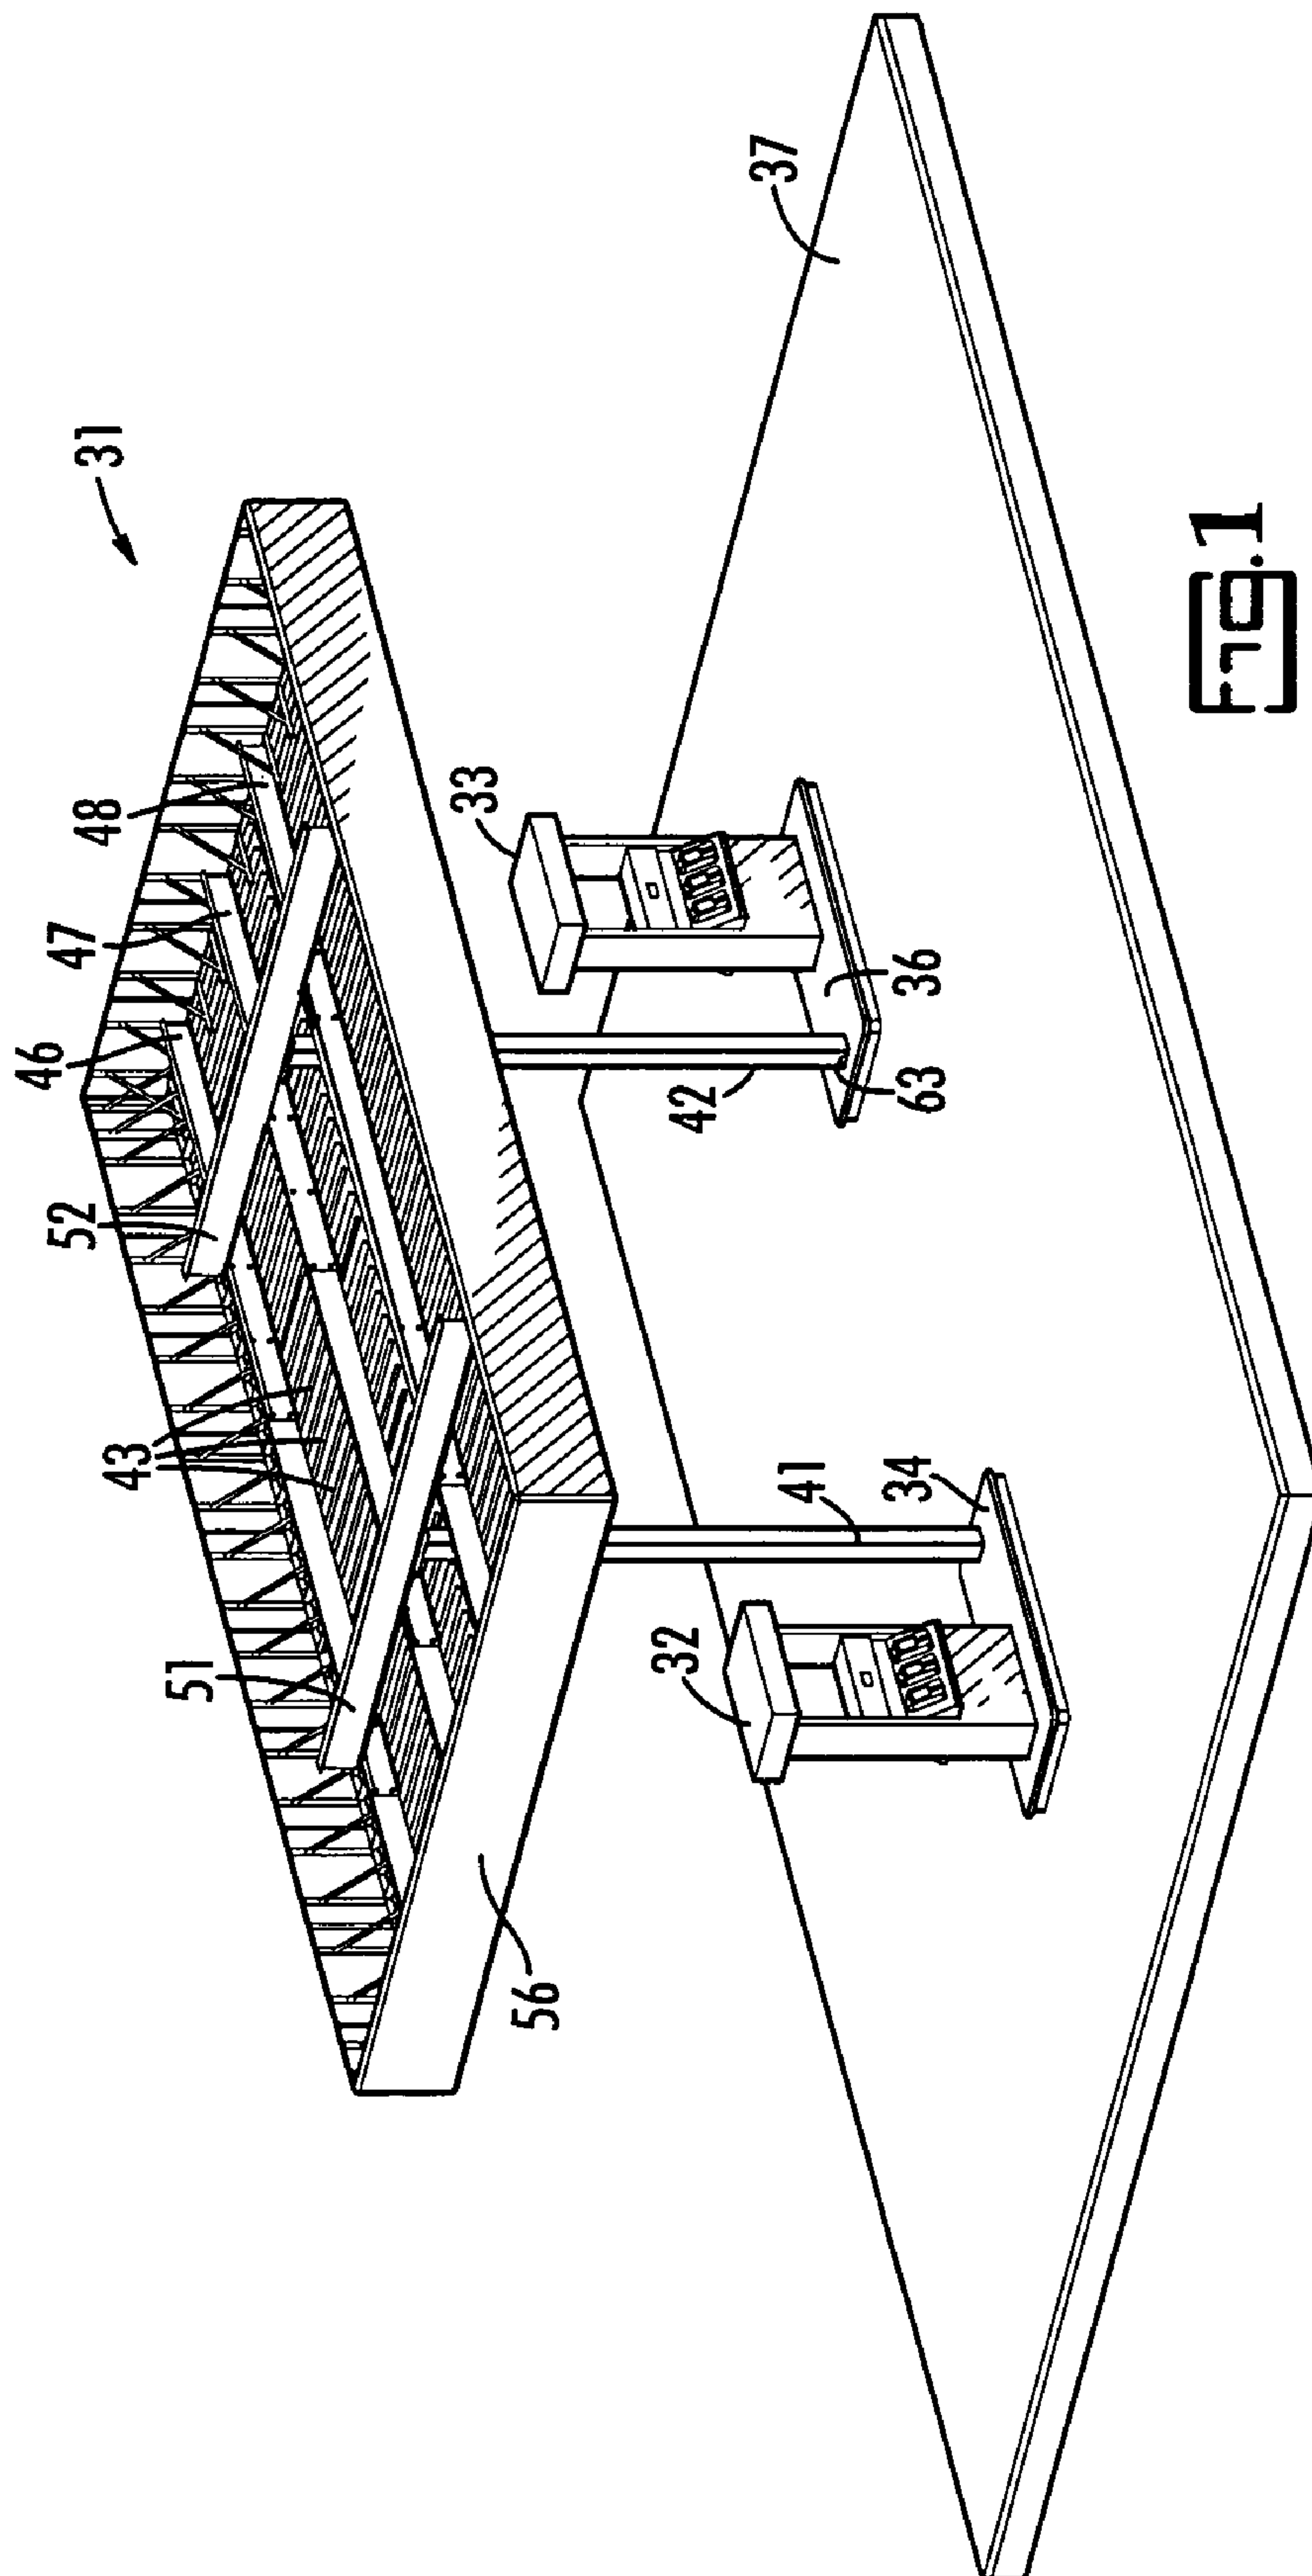
FIG. 1 is a perspective view of a first vehicle fuel servicing station canopy having a roof with a single central longitudinal gutter and two support columns which serve as drainage conduits;

FIGS. 1 through 12 illustrate several types of vehicle fuel service station canopies to which the herein described methods of inspection can be beneficially applied. FIGS. 1, 2, 3, 4 and 5 show one type of canopy for a vehicle fuel service station to which the herein disclosed method of inspection is advantageously applied. The service station includes a pair of fuel dispensing unit or modules 32, 33 mounted on concrete service islands 34, 36, respectively, which in turn are mounted on a concrete floor 37. The canopy 31 includes an elongated roof 38 supported on a pair of upright or vertical hollow steel columns 41, 42 of square or quadrilateral cross section the lower ends of which are embedded in and supported by the islands 34, 36 respectively. The roof 38 includes interconnected roof panels 43 secured to the underside of longitudinally extending horizontal steel roof stringers or channels 46, 47, 48, 49. The vertical support columns 41, 42 support a pair of steel I beams 51, 52 which in turn support the roof stringers 46, 47, 48, 49. The I beams 51, 52 rest on horizontal steel plates 53, 54 which seal off the top of the columns 41, 42. A façade 56 rims the roof 38. Water on the roof 38 drains into a central gutter 61 which in turn drains into the support columns 41, 42 through openings. One such opening 62 is shown in FIG. 3, their opposite sides facing the gutter 61. Water is discharged from the columns 41, 42 through openings 63 at their bottoms, only one of which is shown.

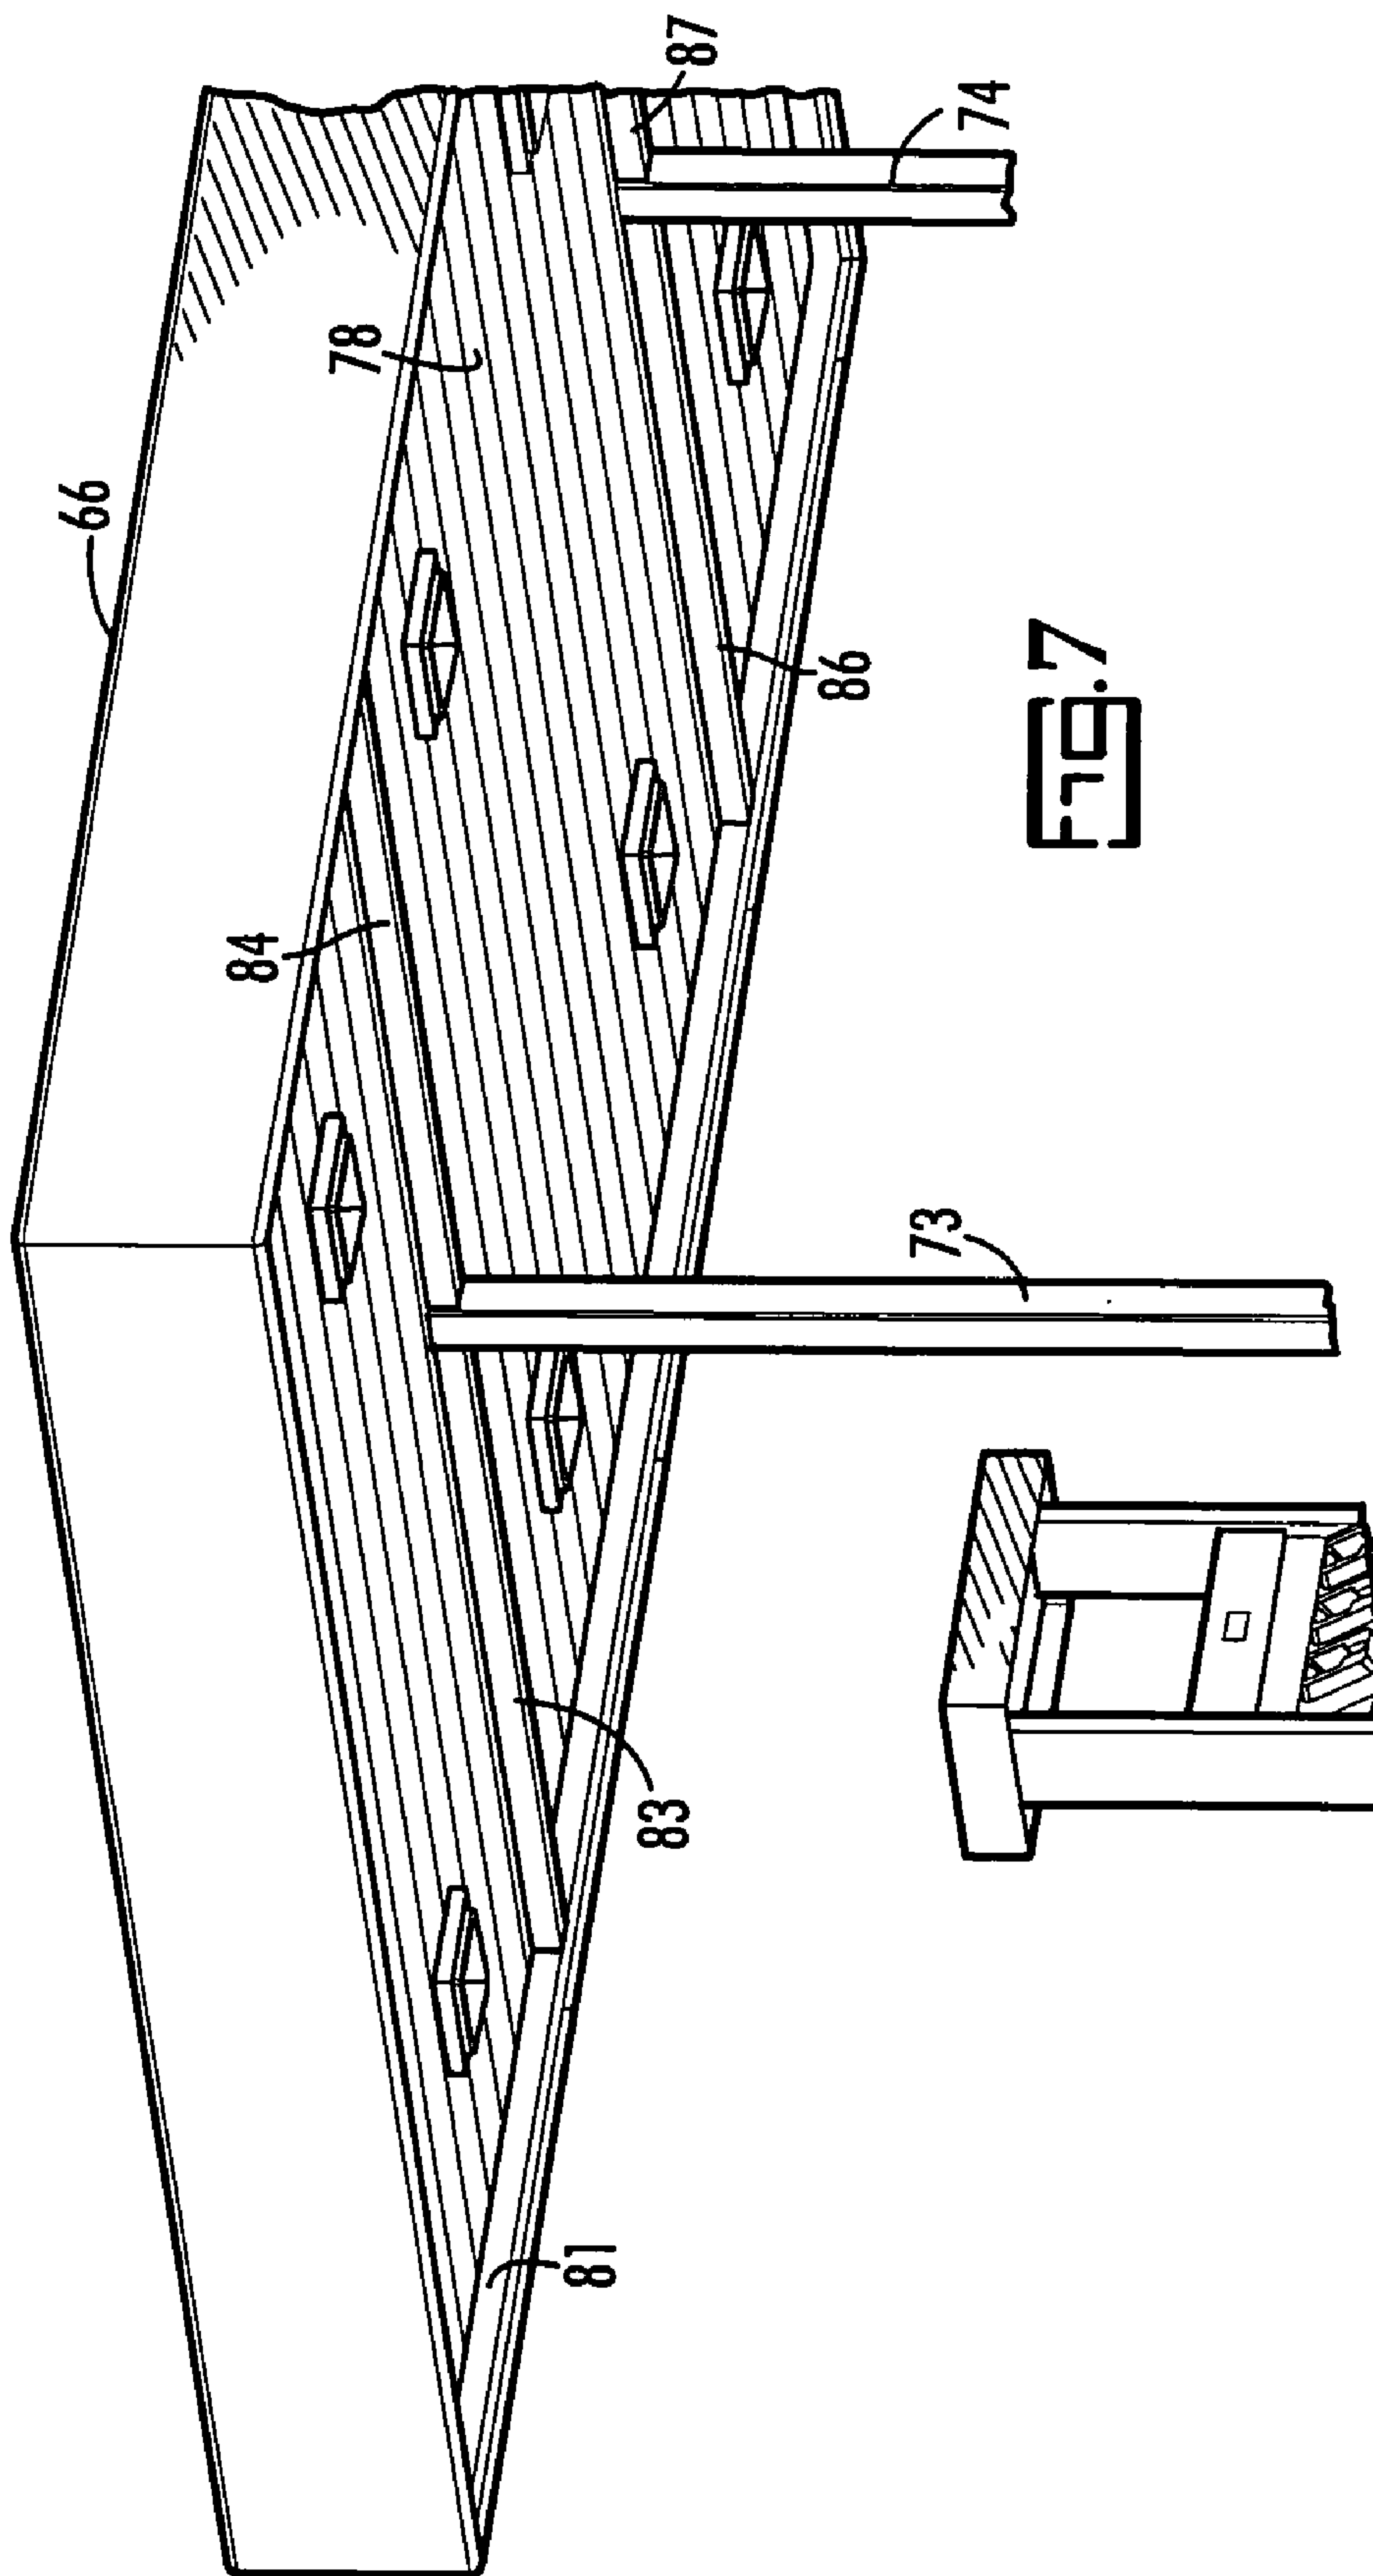
FIG. 7 is a perspective view of the canopy of FIG. 6 showing part of the underside of the roof, the gutters and the support columns;

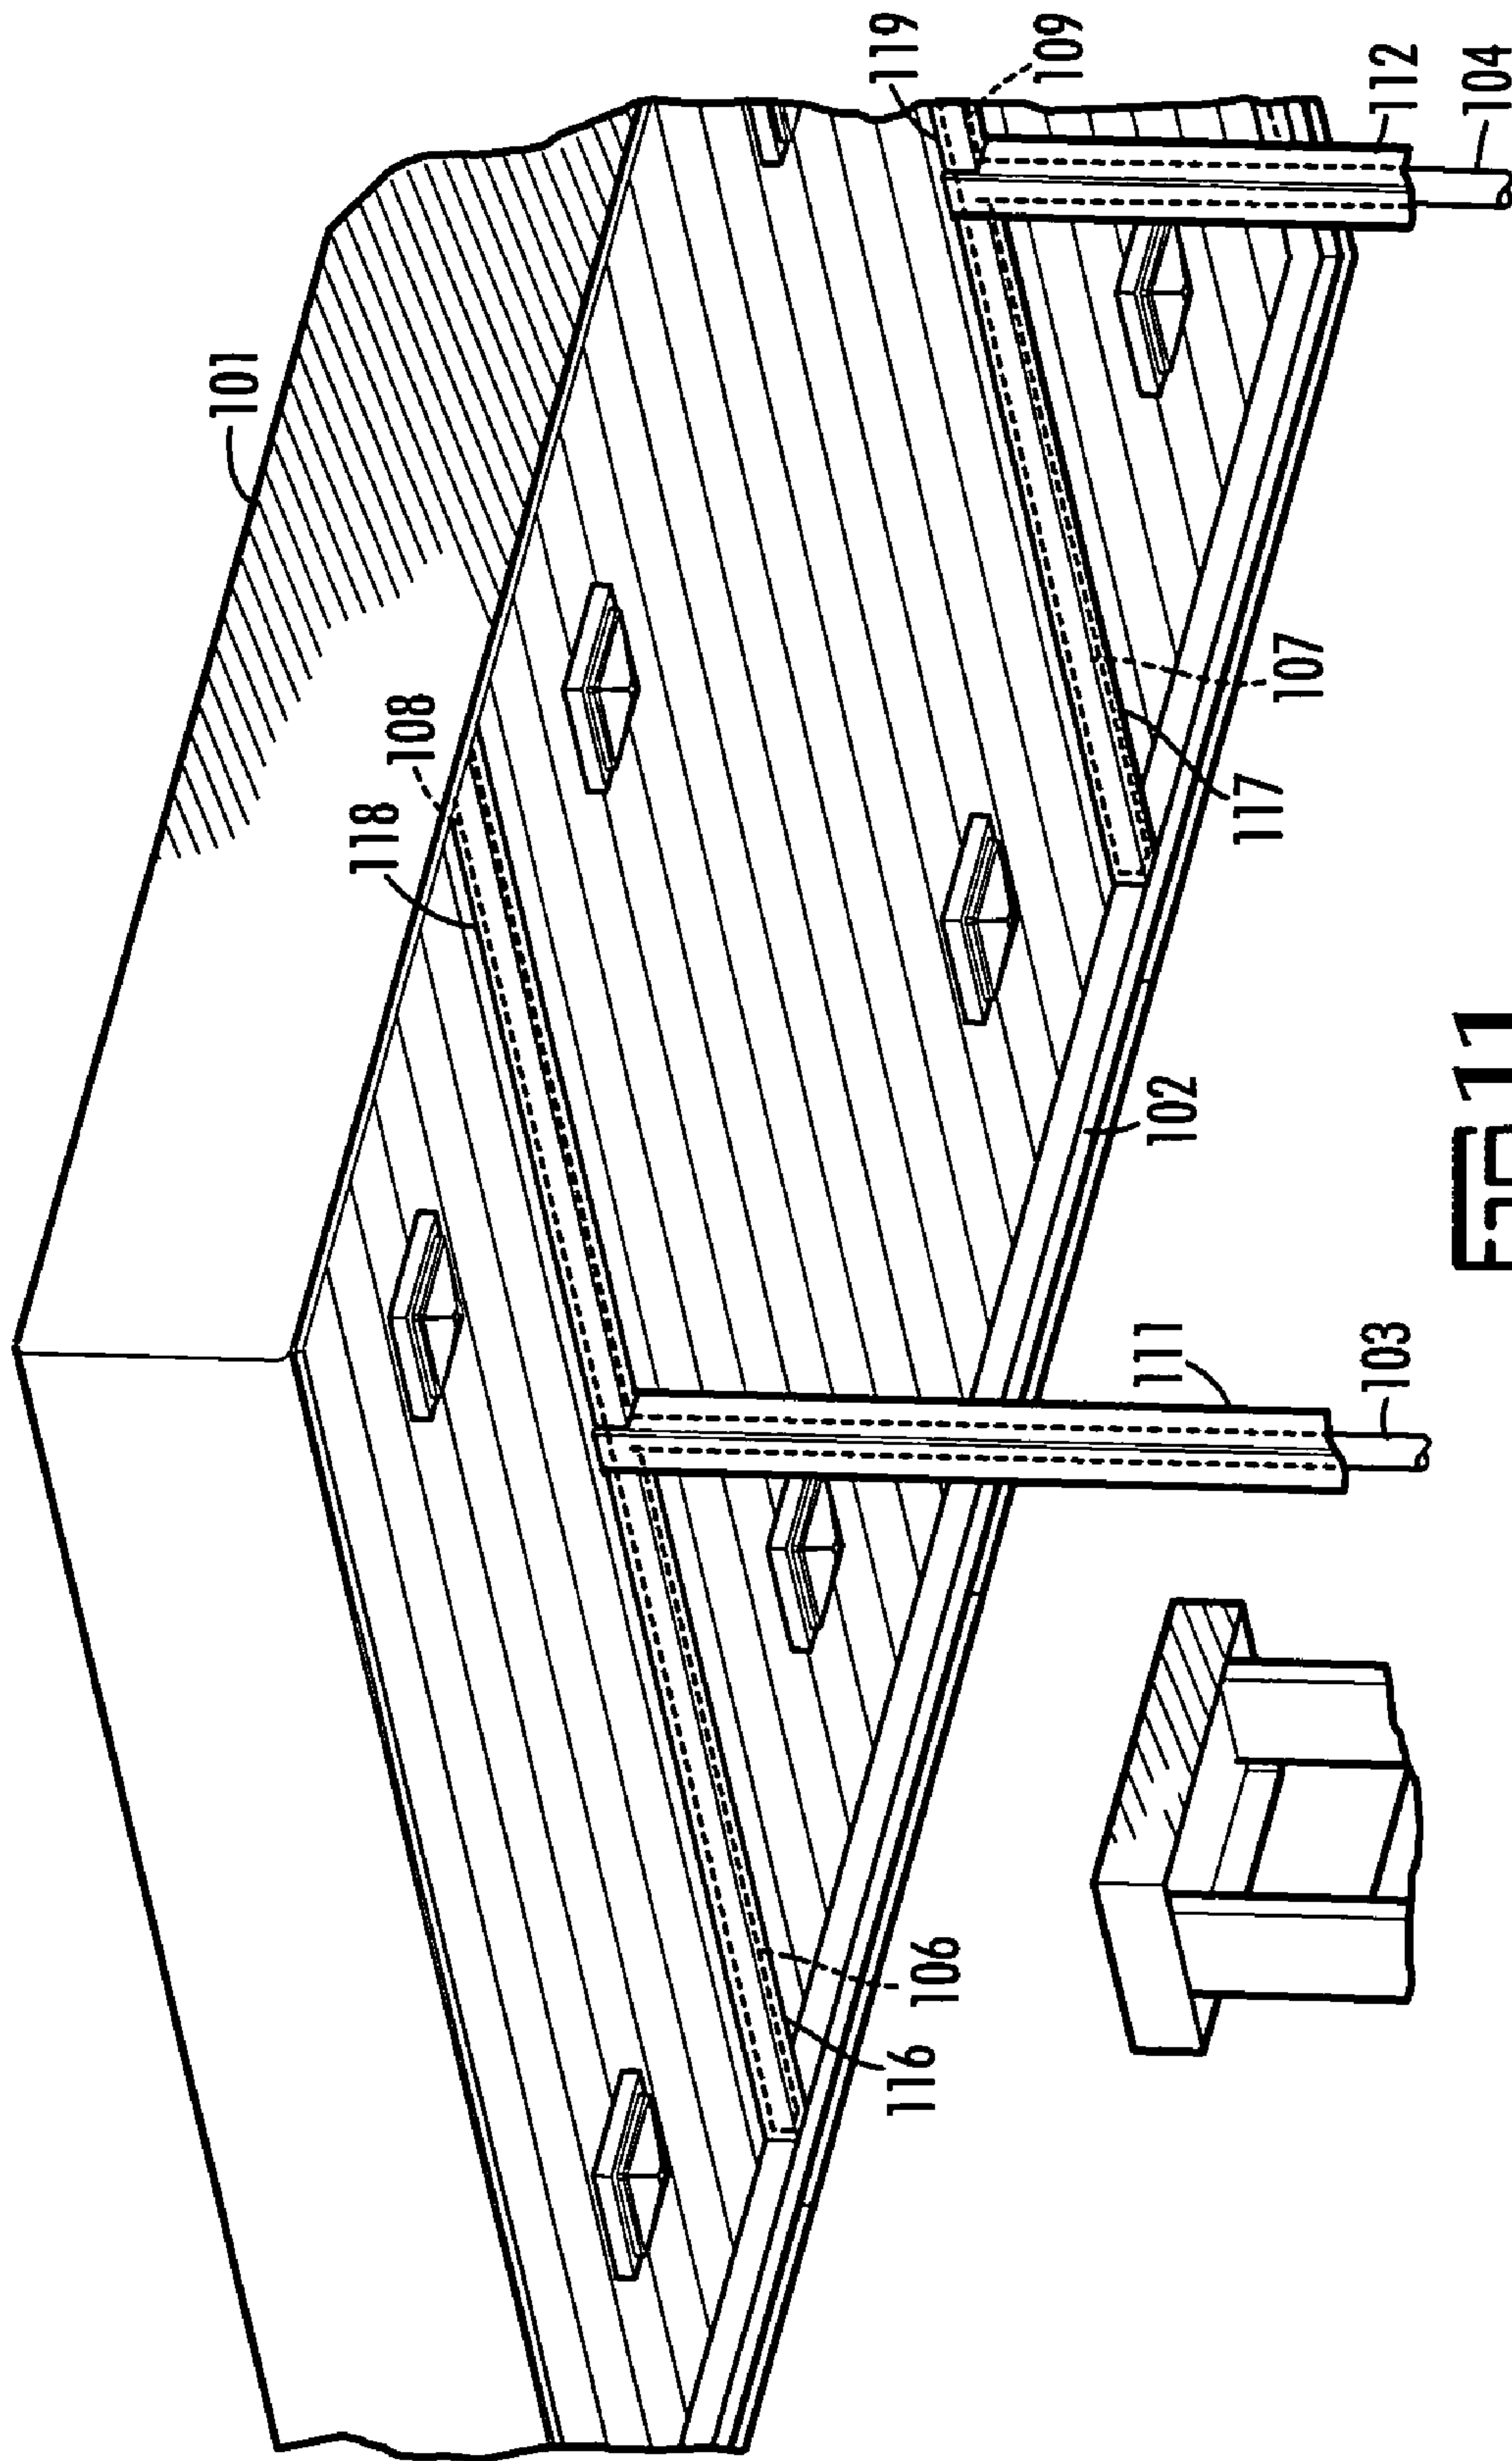
FIG. 11 is a perspective view similar to FIG. 10 showing the piping between the laterally opposite gutters and the support columns boxed in for decorative purposes;

FIG. 10 illustrates a canopy 101 having gutters at laterally opposite sides, only gutter 102 of which is shown, which are interconnected to vertically disposed PVC pipes 103, 104 by laterally extending PVC pipes 106, 107, 108, 109. The pipes 106, 107 extend downwardly through the support columns 111, 112 and, as shown in FIG. 12, water is discharged from the lower end of the columns, in FIG. 12 shows a discharge elbow 113 at the lower end of the conduit 104. An opening not shown is provided in the support column 112 to allow discharge of water from the elbow 113. In a similar manner, water is discharged from the conduit 103 through an opening at the lower end of the support column 111. FIG. 11 shows a construction similar to that of FIG. 10; however, the lateral pipes 106, 107, 108, and 109 are boxed in with trough shaped members 116, 117, 118, 119 to improve the ceiling décor.

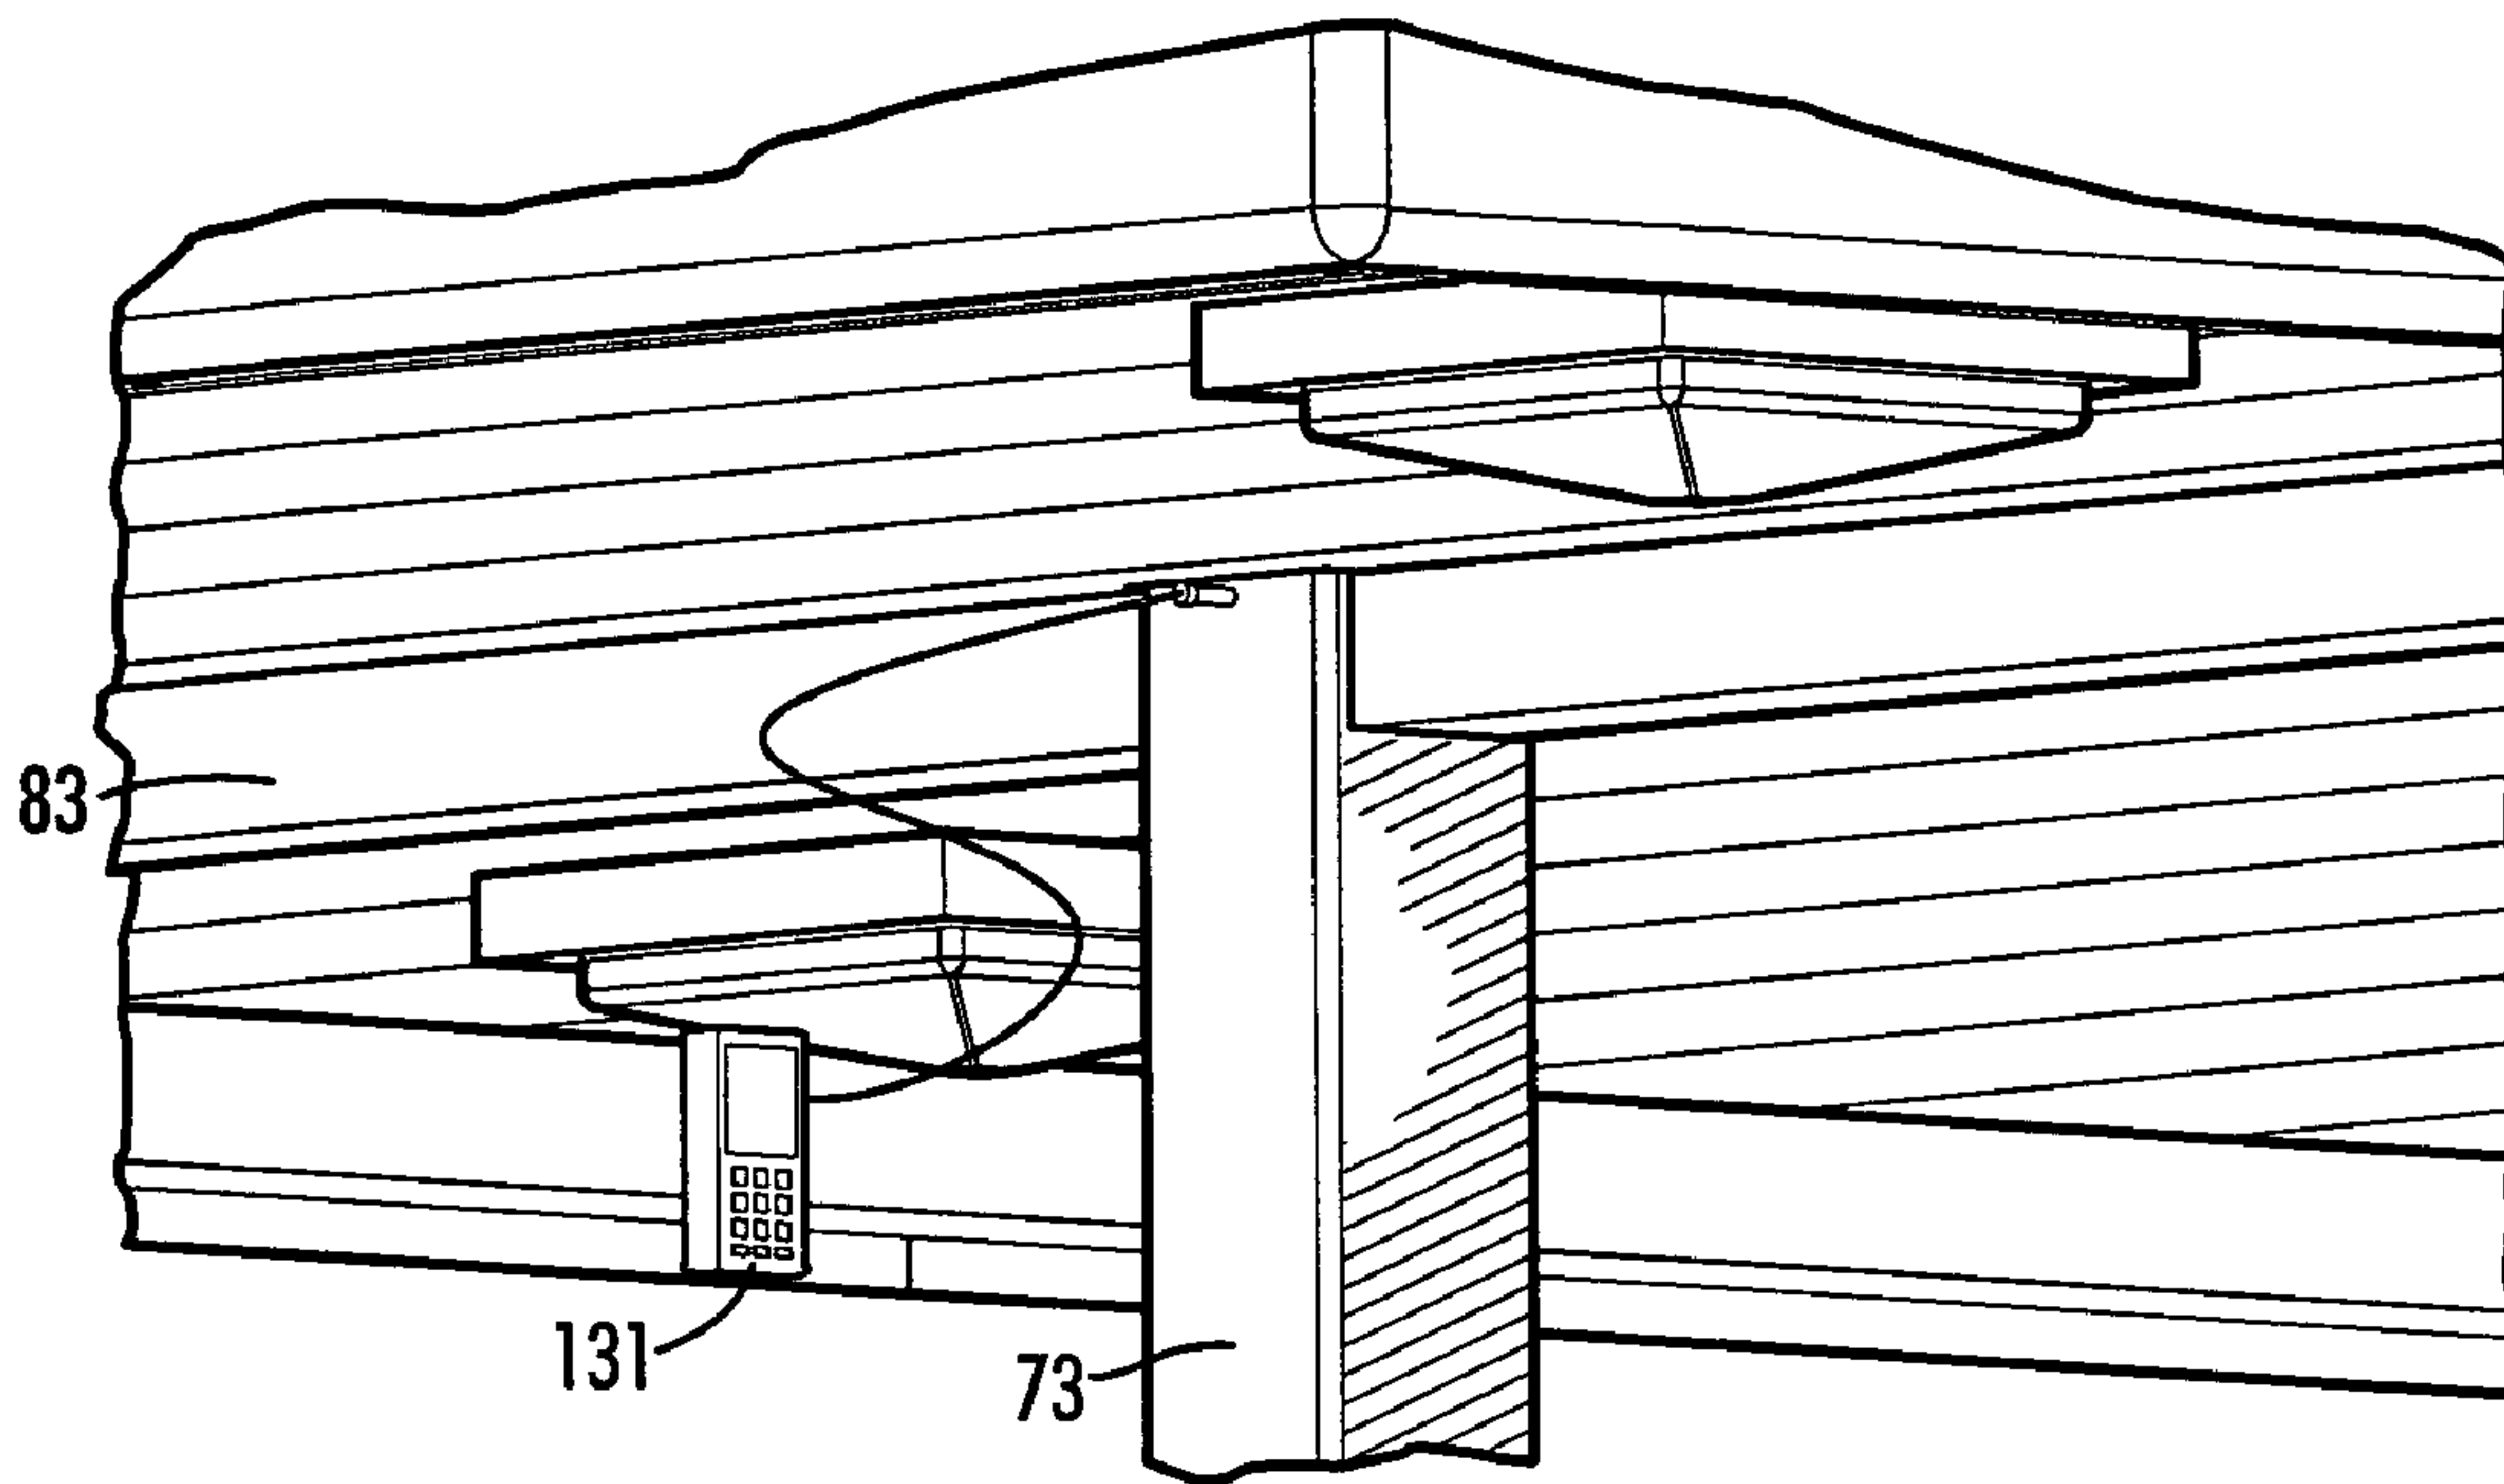
FIG. 14 shows measurement of the support column wall thickness at the underside of the roof with an ultrasonic thickness gauge;

It is preferred that the support columns be tested for wall thickness with ultrasonic testing equipment, after calibrating the thickness gauge of the ultrasound testing equipment. The column thickness readings at all four sides at the base of each column are recorded. If a thickness reading is not obtained near the bottom, the sensor is moved vertically up the column until a reading is obtained and the height at which the reading is obtained and its value are recorded. The last mentioned column thickness test procedure is preferably performed on all four sides of the column at its top. It is also desirable that a recorded top to bottom scan of all four sides of each column be made producing graphs showing deviations in wall thickness. This is done using the scan mode of the thickness gauge of the ultrasonic testing equipment. The graph on the thickness gauge display is recorded by an image recording device or photographed and referenced as to location on the support column. This definitive examination is essential for an engineering analysis in evaluating the risk of a canopy collapse. FIG. 13 shows an ultrasonic thickness gauge 131 being used measuring the thickness of the column wall at one side of the support column 73 near its bottom. FIG. 14 shows an ultrasonic thickness gauge 131 being used to measure the thickness of the wall of the column 73 near its upper end and FIG. 15 shows the ultrasonic thickness gauge being used to measure the adjacent wall of the support column 73 just below the junction of the gutter 83 with the support column 73.

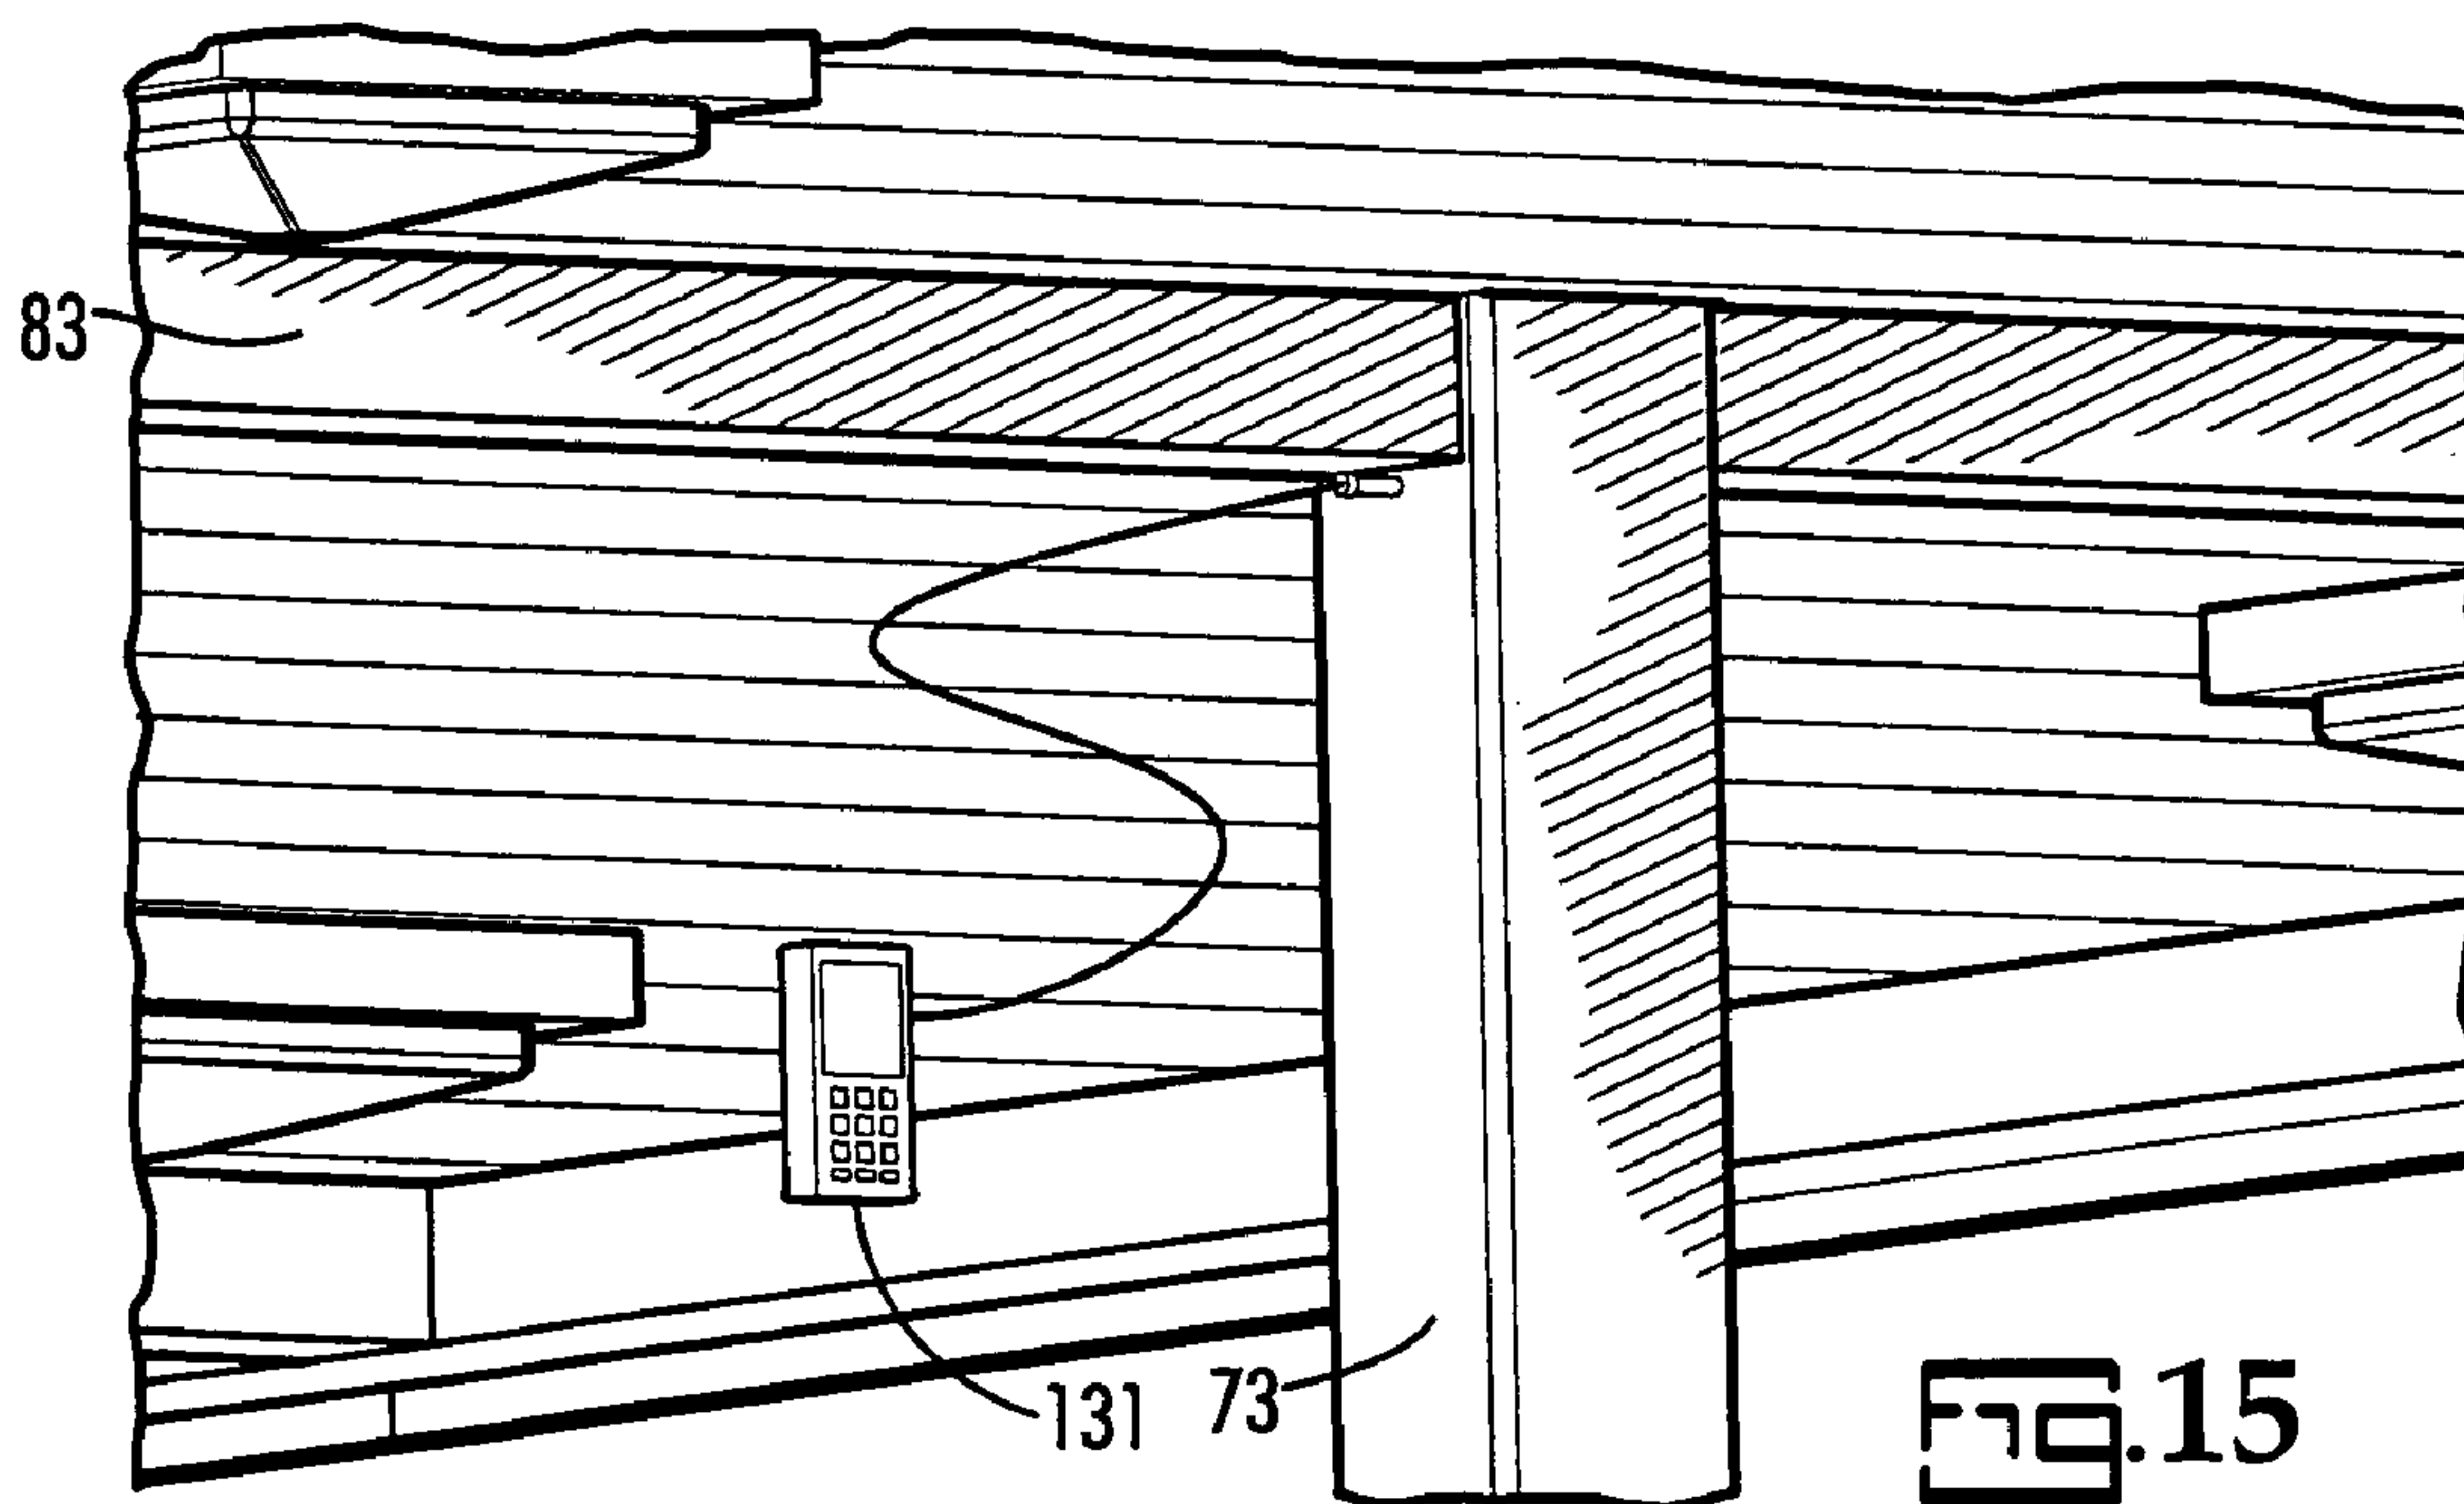
FIG. 15 shows measurement of the support column wall thickness at its junction with a laterally extending gutter;
