(54) **METHOD OF INSPECTING CANOPY STRUCTURES**

A method of inspecting canopy structures is provided to determine the structural integrity of the roof support system. The method includes steps designed to uncover hidden deficiencies in the roof support system through nondestructive testing and discovery. Timely use of the method of inspection not only minimizes the risk of canopy collapse but also produces information needed for making repair or replacement of the roof support system.

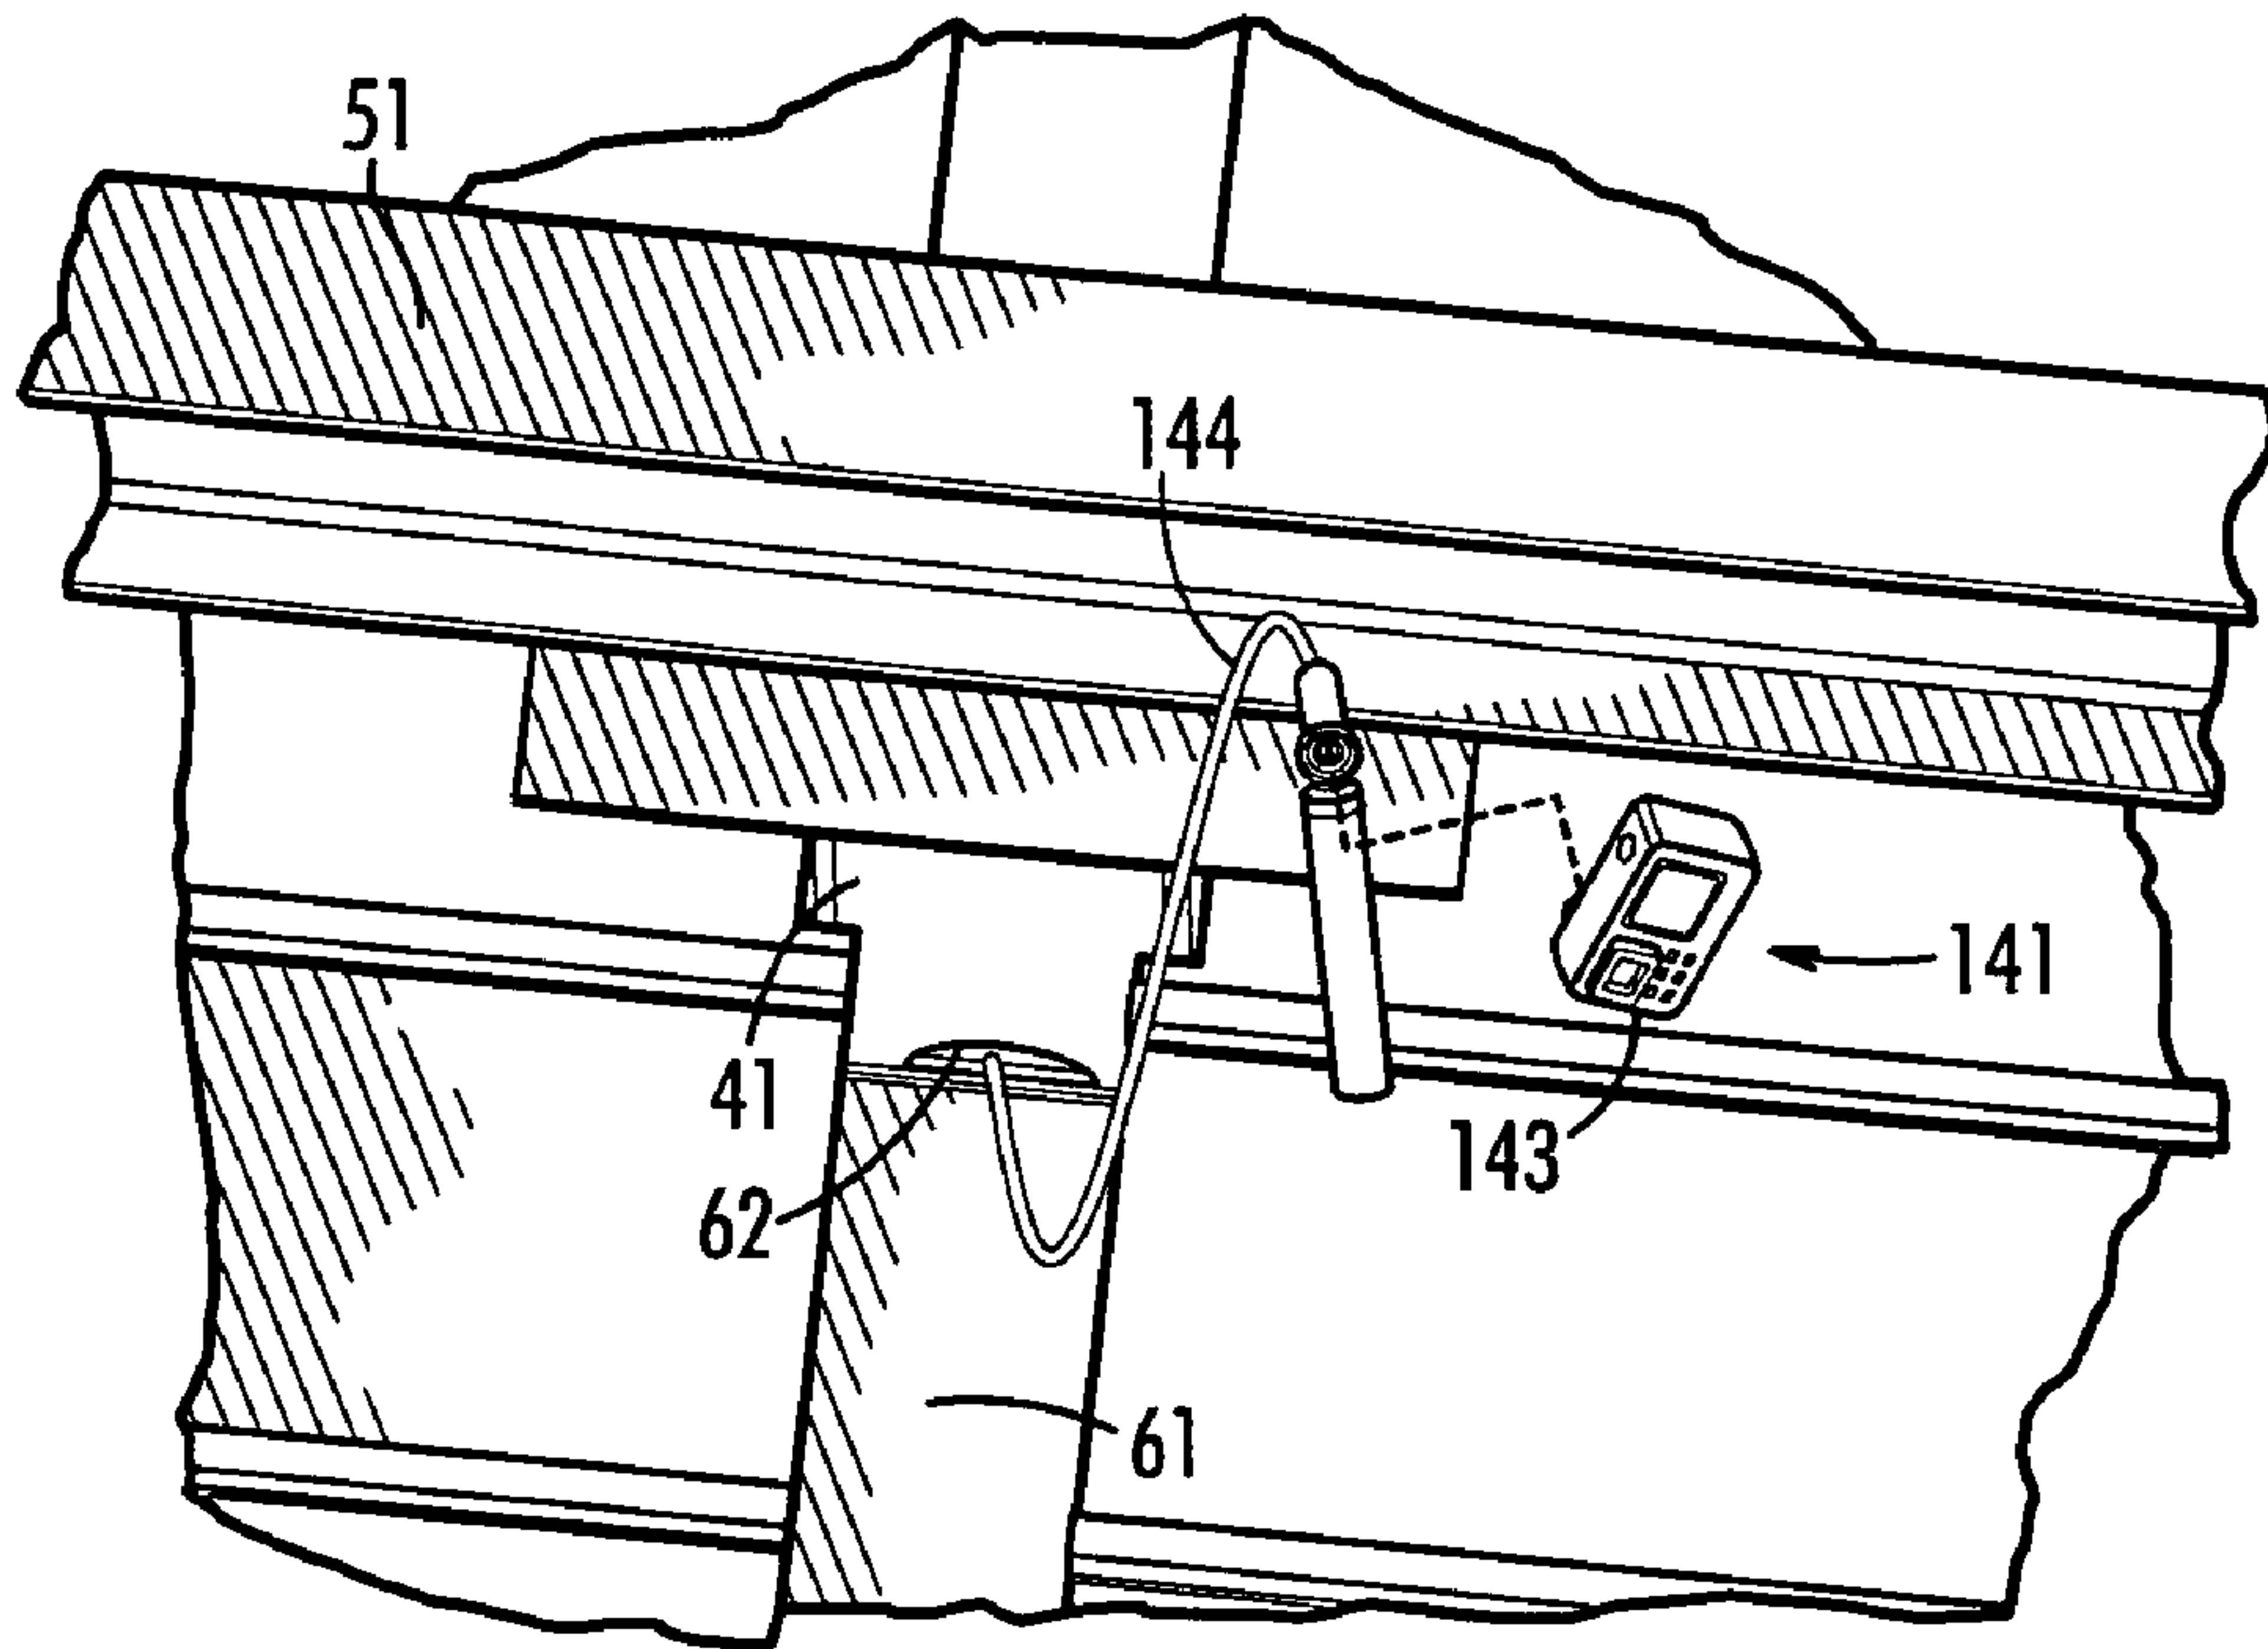
FIG. 16 shows a fiber scope with an attached digital camera taking pictures of the interior of the upper end of a canopy support column;

As shown in FIG. 16 a fiberscope testing device or equipment 141 is being used to observe, through opening 62, the interior of the upper end of the hollow support column 61 and, as shown in FIG. 17, the fiberscope testing equipment 141 is used to view the inside of the column drain 93 passing through the island 76. This allows the people performing the inspection to observe and record the nature of any clogged condition of the inspected components of the canopy drainage system. The fiberscope testing equipment includes a camera or image recording device 143 for recording images or pictures which are included in the written report of the inspection. It may be desirable to drill small diameter holes in the support columns in order to insert the fiber bungle or probe 144 into the interior of the vertical support columns, thereby permitting the inspector to view and record images of selected areas of the interior of the columns.

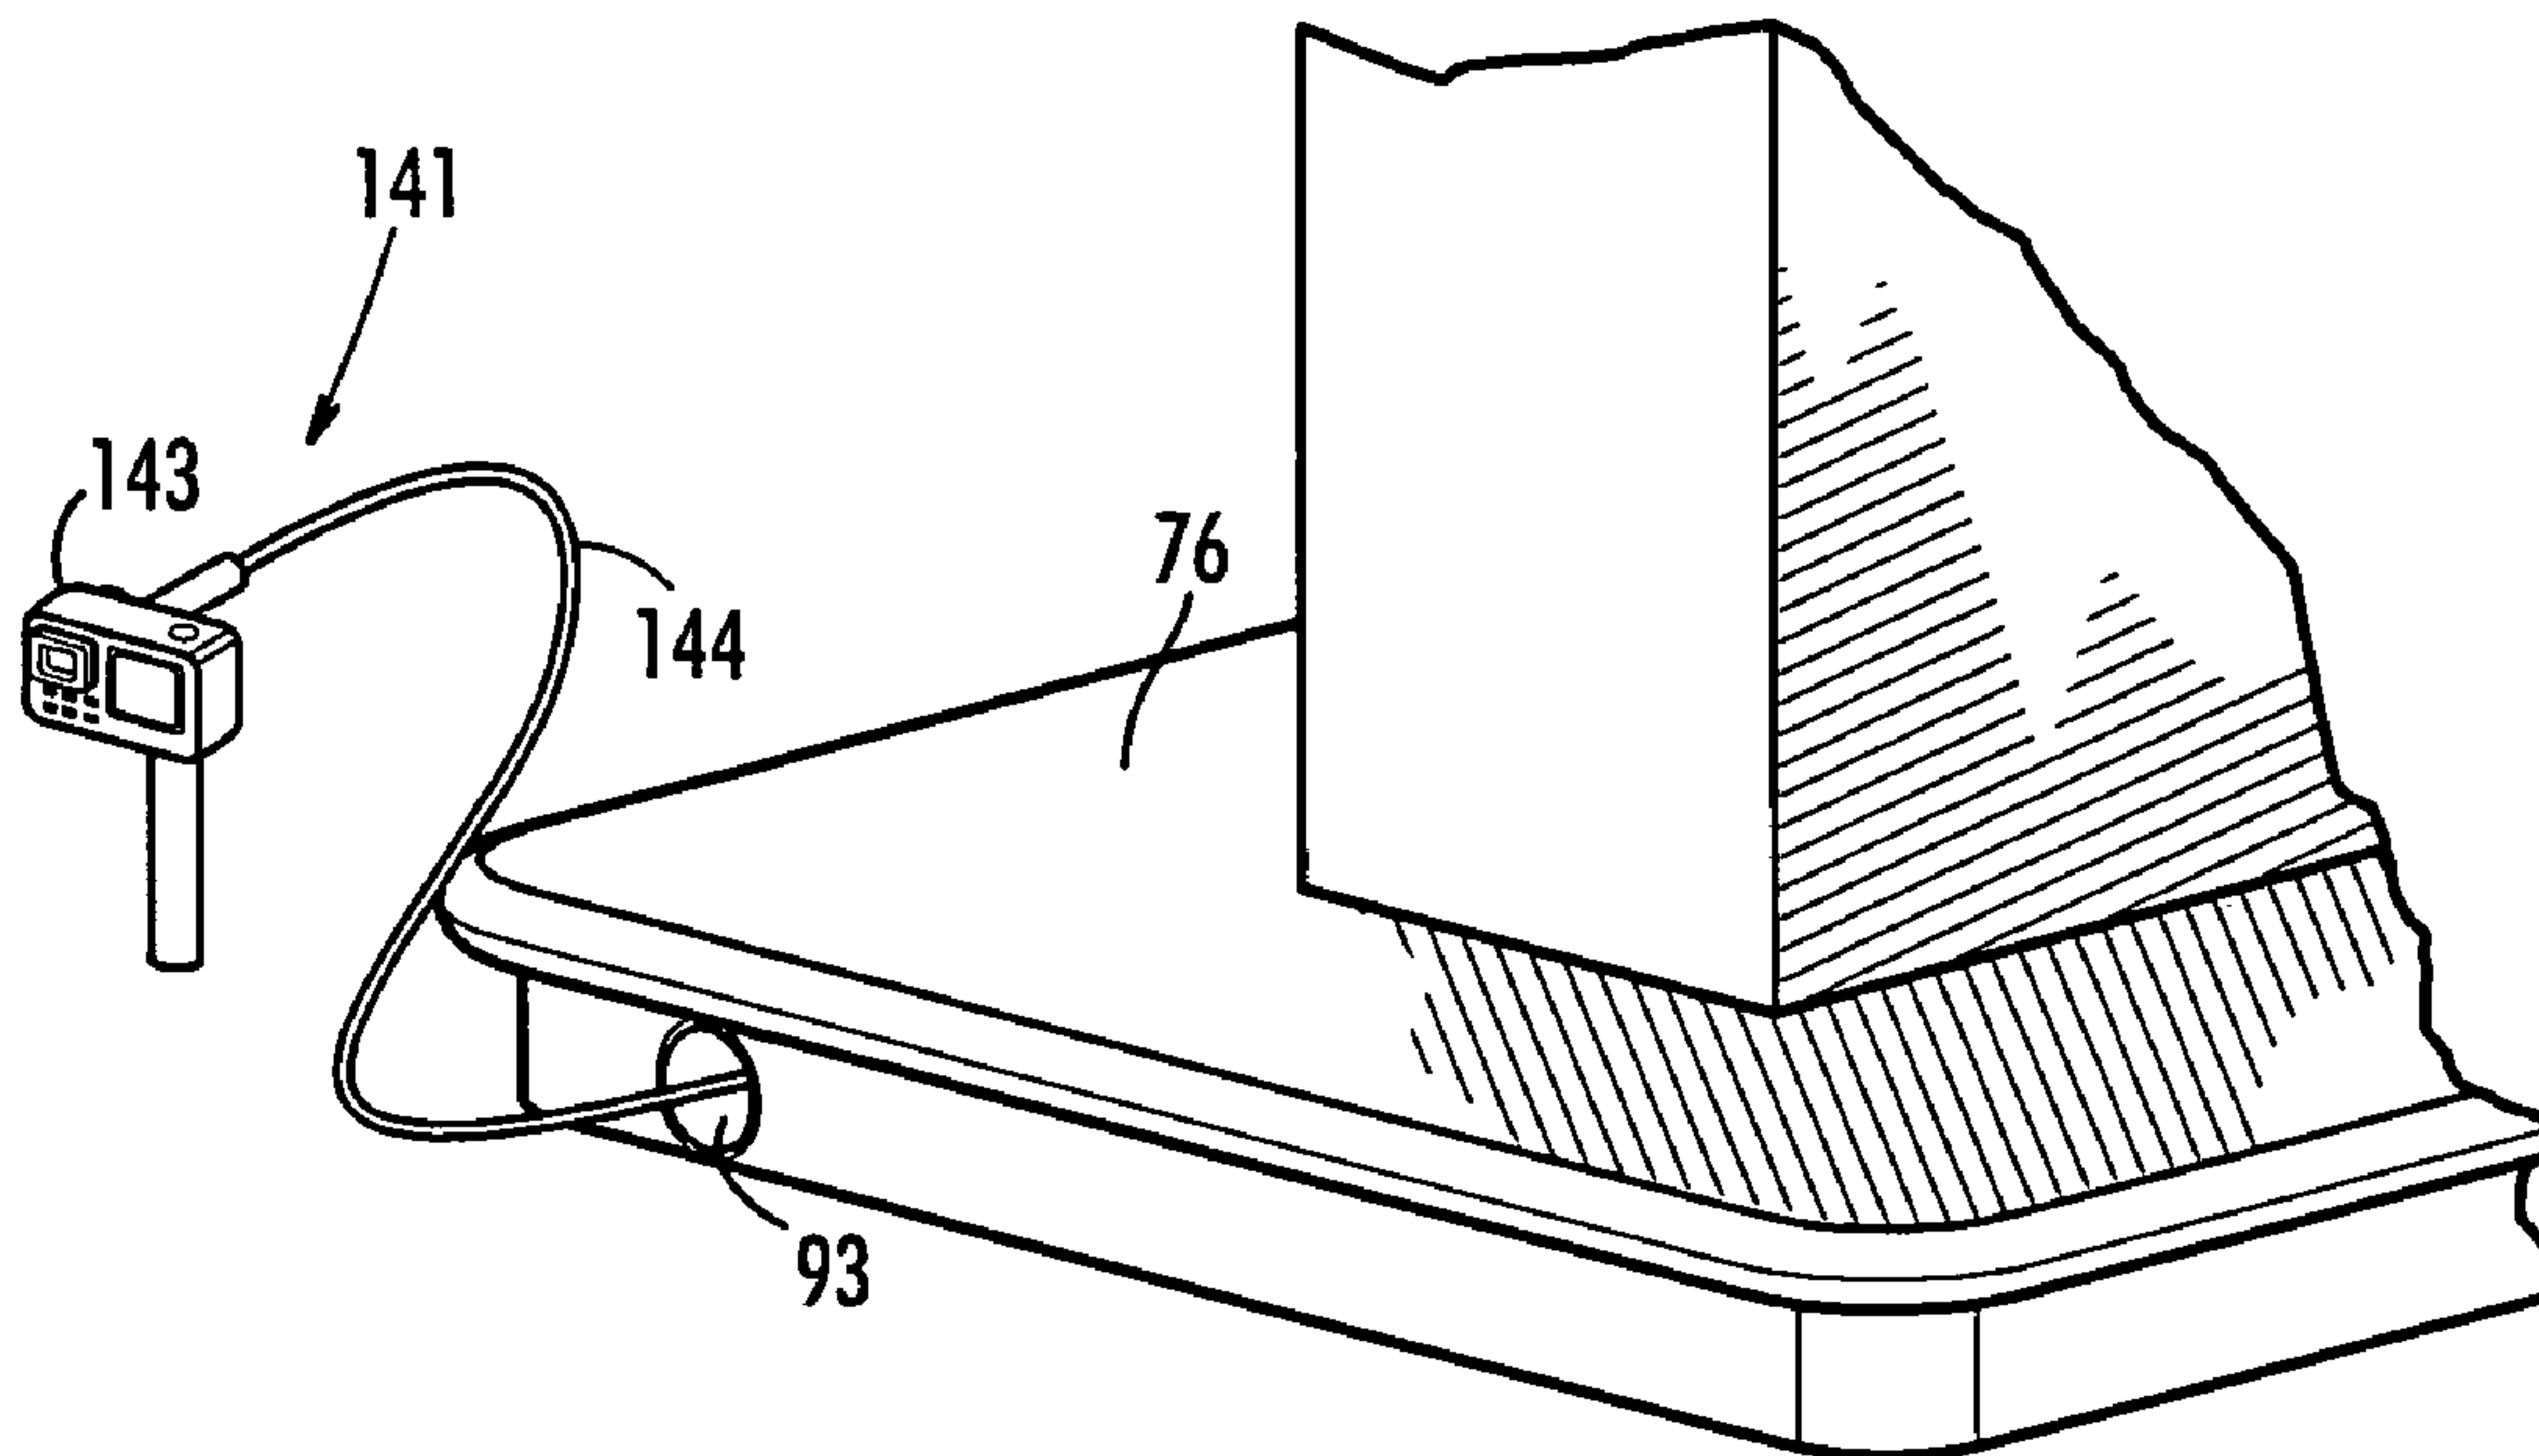
FIG. 17 shows a fiber optic scope with digital camera taking pictures of the interior of a drain in fuel dispensing island, and
