(54) **METHOD OF INSPECTING CANOPY STRUCTURES**

A method of inspecting canopy structures is provided to determine the structural integrity of the roof support system. The method includes steps designed to uncover hidden deficiencies in the roof support system through nondestructive testing and discovery. Timely use of the method of inspection not only minimizes the risk of canopy collapse but also produces information needed for making repair or replacement of the roof support system.

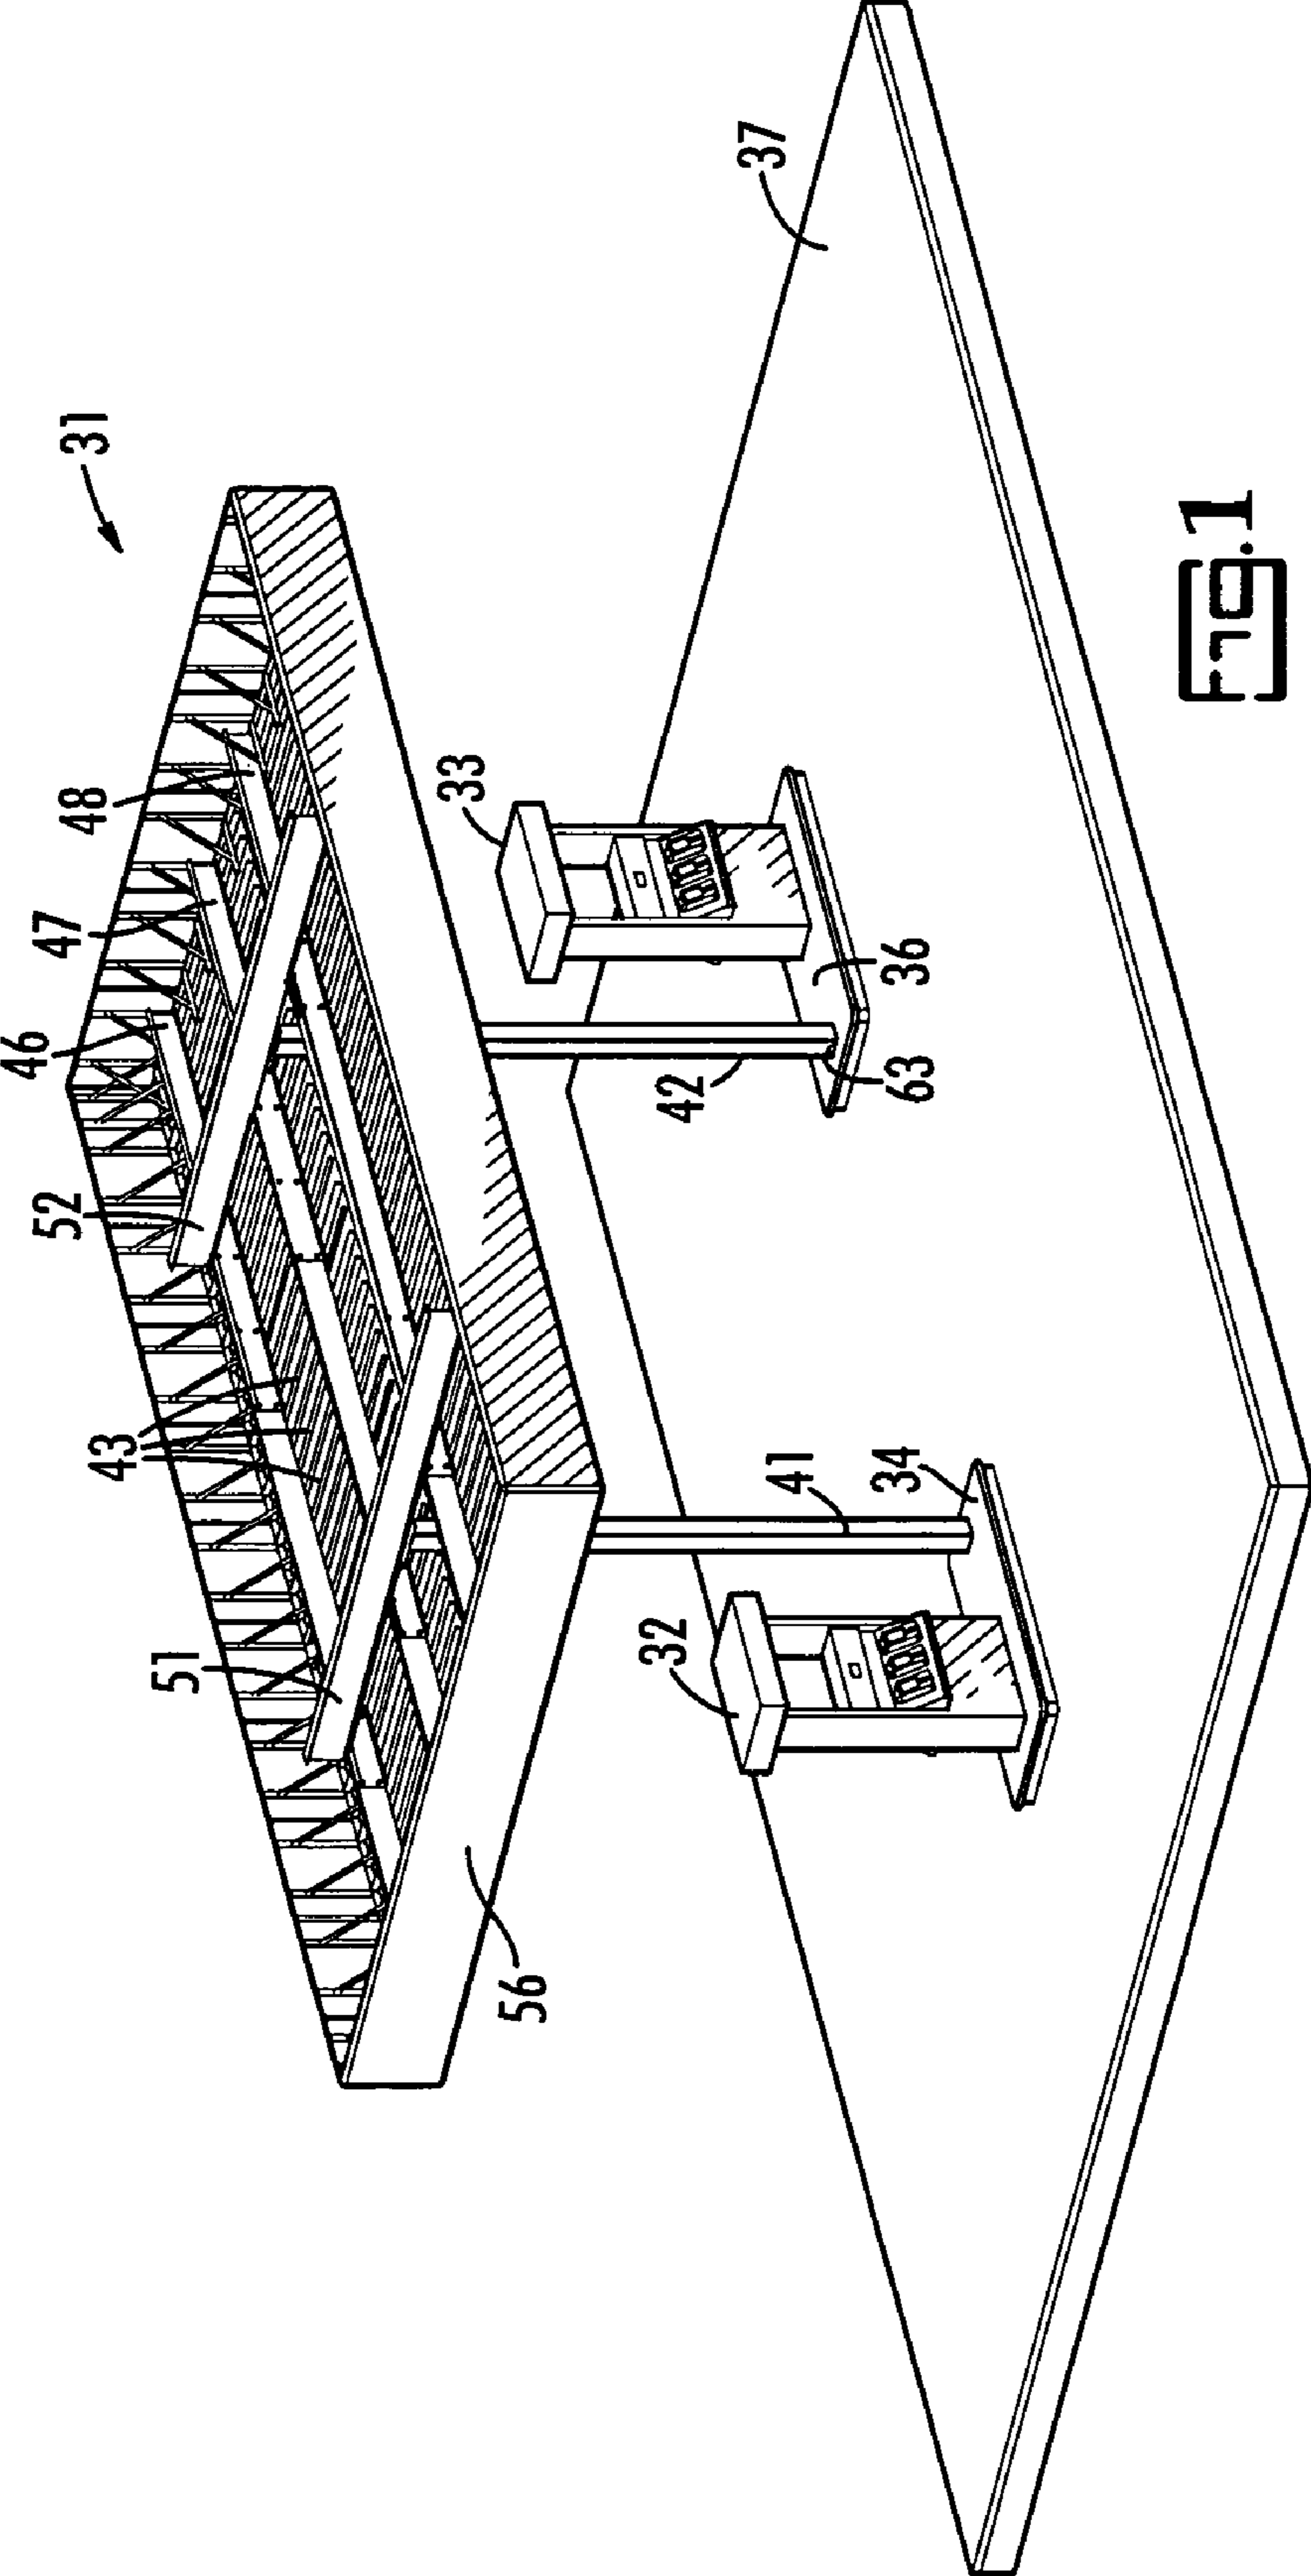
FIG. 1 is a perspective view of a first vehicle fuel servicing station canopy having a roof with a single central longitudinal gutter and two support columns which serve as drainage conduits;

FIGS. 1 through 12 illustrate several types of vehicle fuel service station canopies to which the herein described methods of inspection can be beneficially applied. FIGS. 1, 2, 3, 4 and 5 show one type of canopy for a vehicle fuel service station to which the herein disclosed method of inspection is advantageously applied. The service station includes a pair of fuel dispensing unit or modules 32, 33 mounted on concrete service islands 34, 36, respectively, which in turn are mounted on a concrete floor 37. The canopy 31 includes an elongated roof 38 supported on a pair of upright or vertical hollow steel columns 41, 42 of square or quadrilateral cross section the lower ends of which are embedded in and supported by the islands 34, 36 respectively. The roof 38 includes interconnected roof panels 43 secured to the underside of longitudinally extending horizontal steel roof stringers or channels 46, 47, 48, 49. The vertical support columns 41, 42 support a pair of steel I beams 51, 52 which in turn support the roof stringers 46, 47, 48, 49. The I beams 51, 52 rest on horizontal steel plates 53, 54 which seal off the top of the columns 41, 42. A façade 56 rims the roof 38. Water on the roof 38 drains into a central gutter 61 which in turn drains into the support columns 41, 42 through openings. One such opening 62 is shown in FIG. 3, their opposite sides facing the gutter 61. Water is discharged from the columns 41, 42 through openings 63 at their bottoms, only one of which is shown.

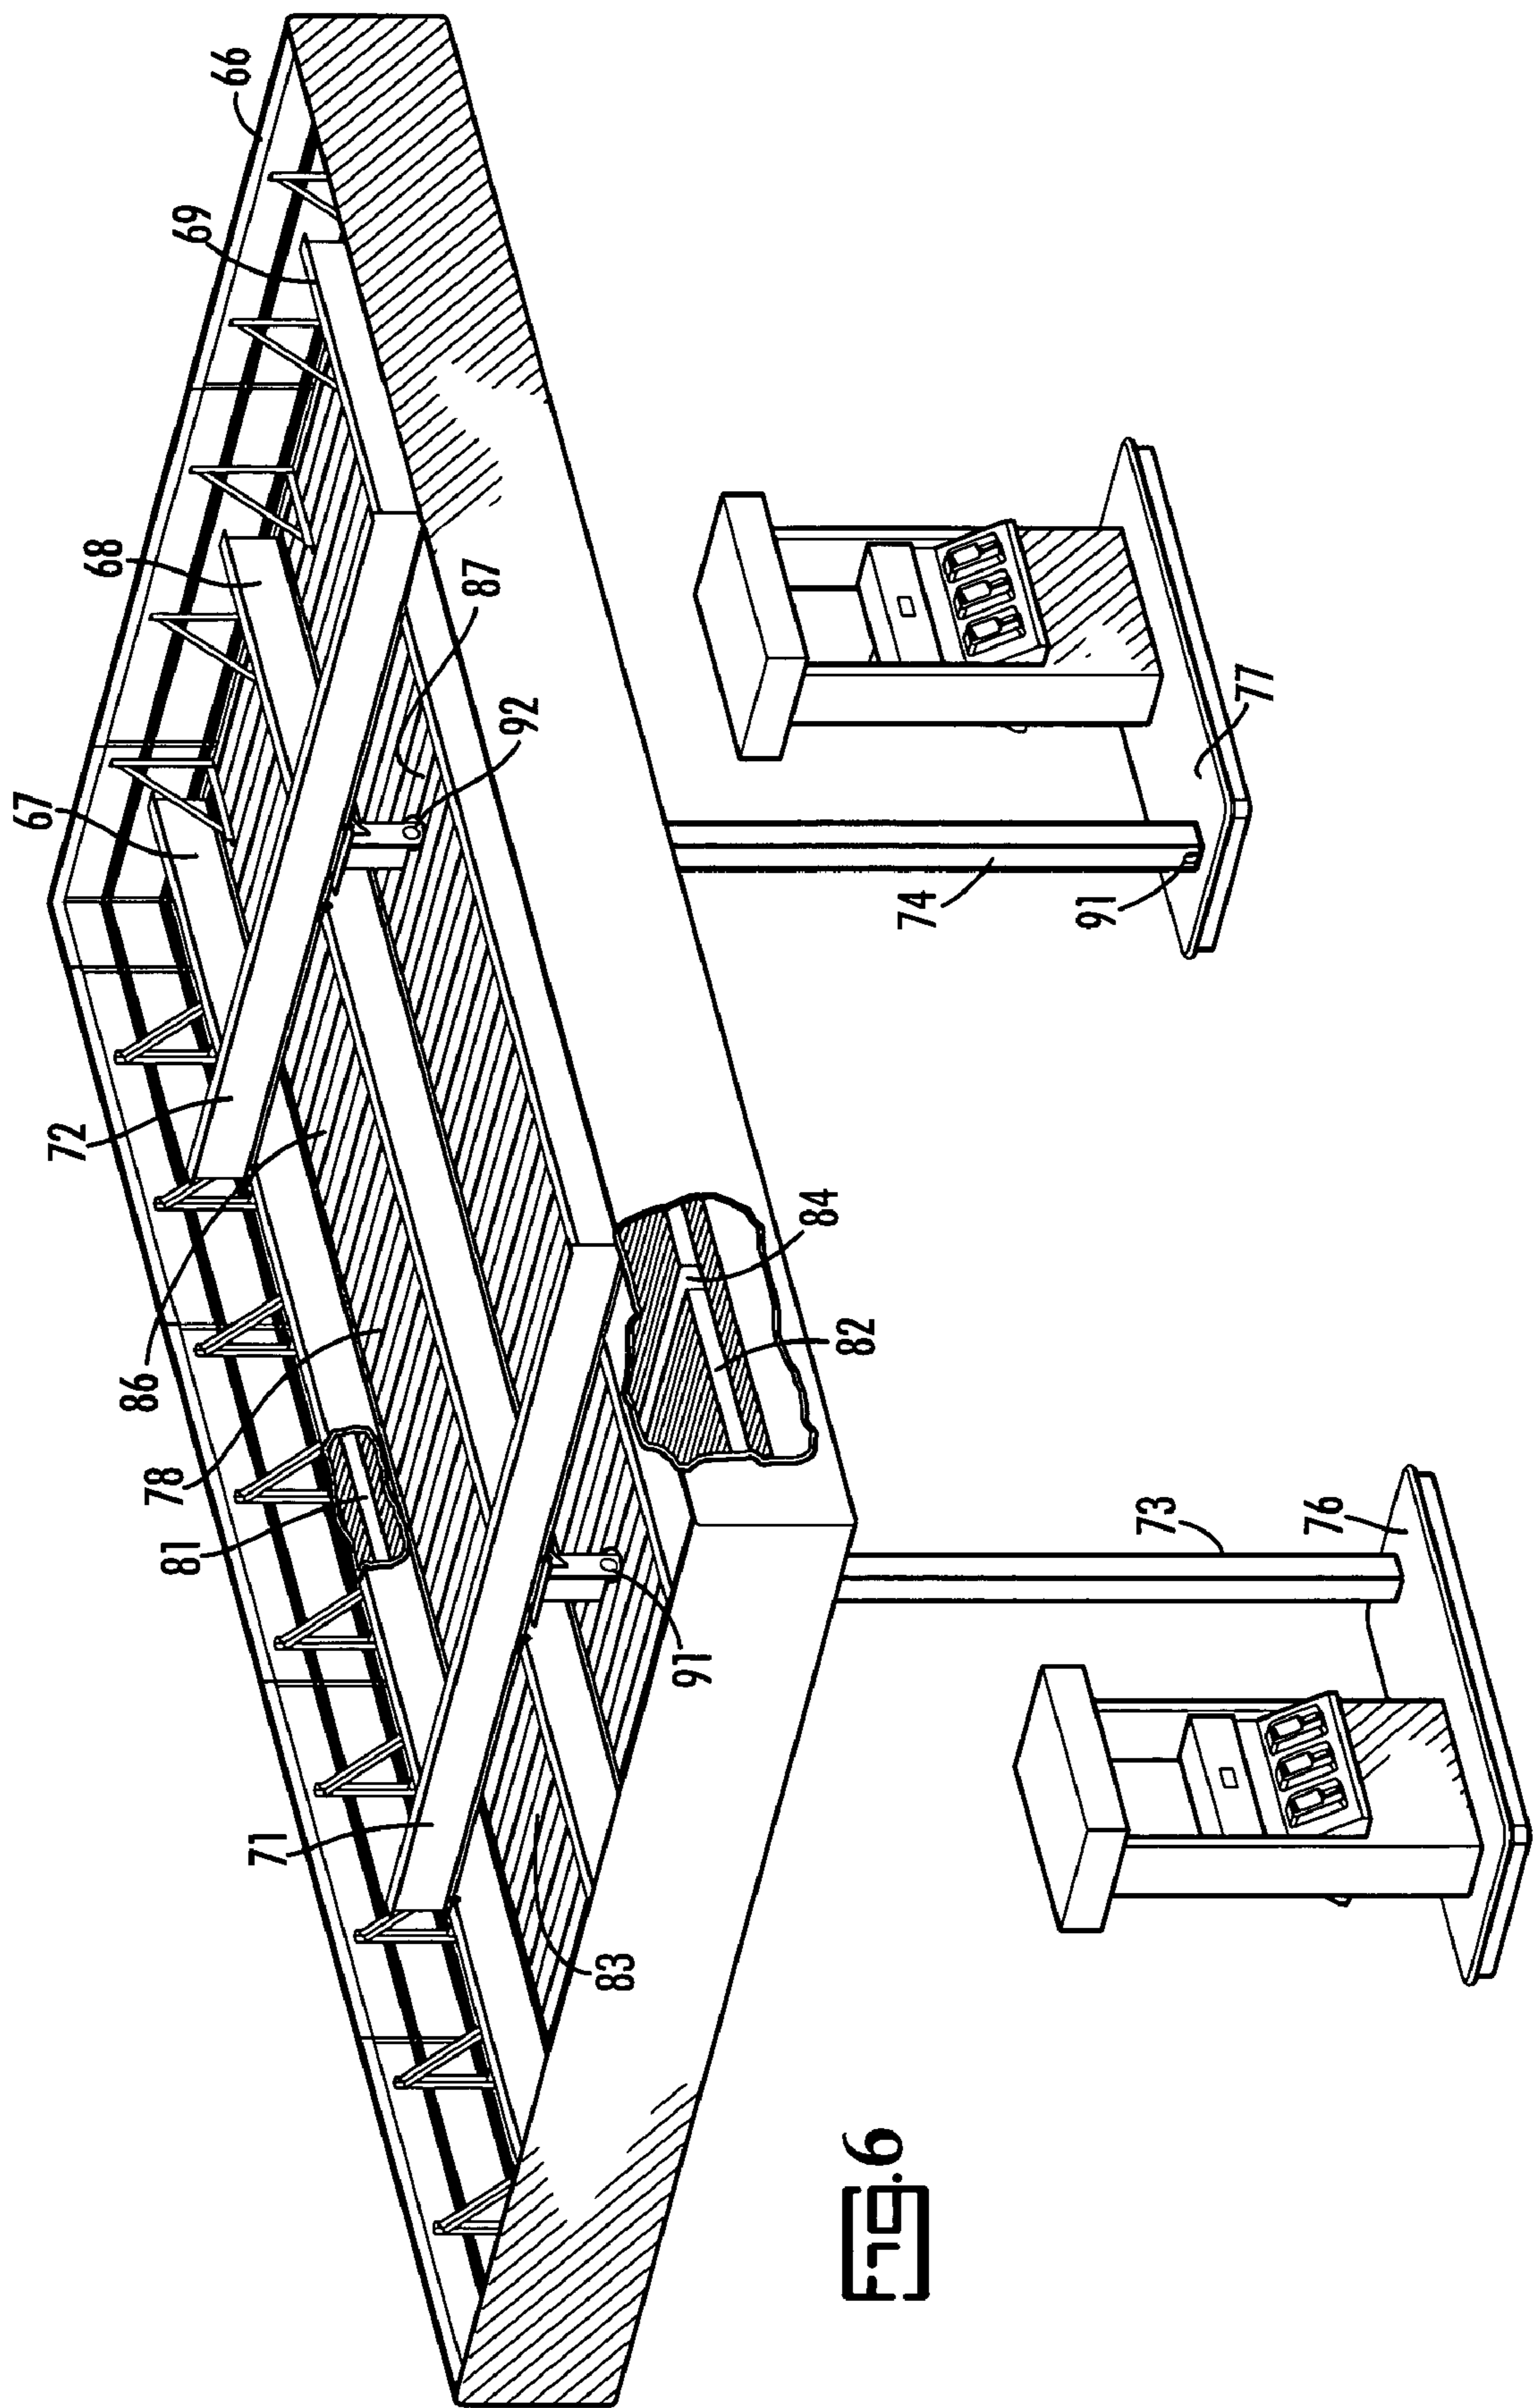
FIG. 6 is a top perspective view of a second vehicle fuel service station canopy having gutters at laterally opposite sides of the roof which drain to two support column through lateral gutters;

A second type vehicle fuel service station canopy 66 is illustrated in FIGS. 6 and 7. The canopy 66 includes three longitudinal roof stringers 67, 68, 69 supported by two transverse I beams 71, 72. The I beams 71, 72 are supported on hollow vertical steel columns 73, 74 mounted on fuel dispensing islands 76, 77. The roof 78 of the canopy 66 includes a pair of longitudinally extending gutters 81, 82 at its laterally opposite sides which drain to the support columns 73, 74 by way of laterally extending connecting gutters 83, 84, 86, 87. Openings 91, 92 are formed in opposite sides of the support columns 73, 74, respectively, for draining the water from the roof 78 via the connecting gutters 83, 84, 86, 87. An opening 91 at the bottom of column 74 allows discharge of water from its interior. A similar opening, not shown is provided in column 73.

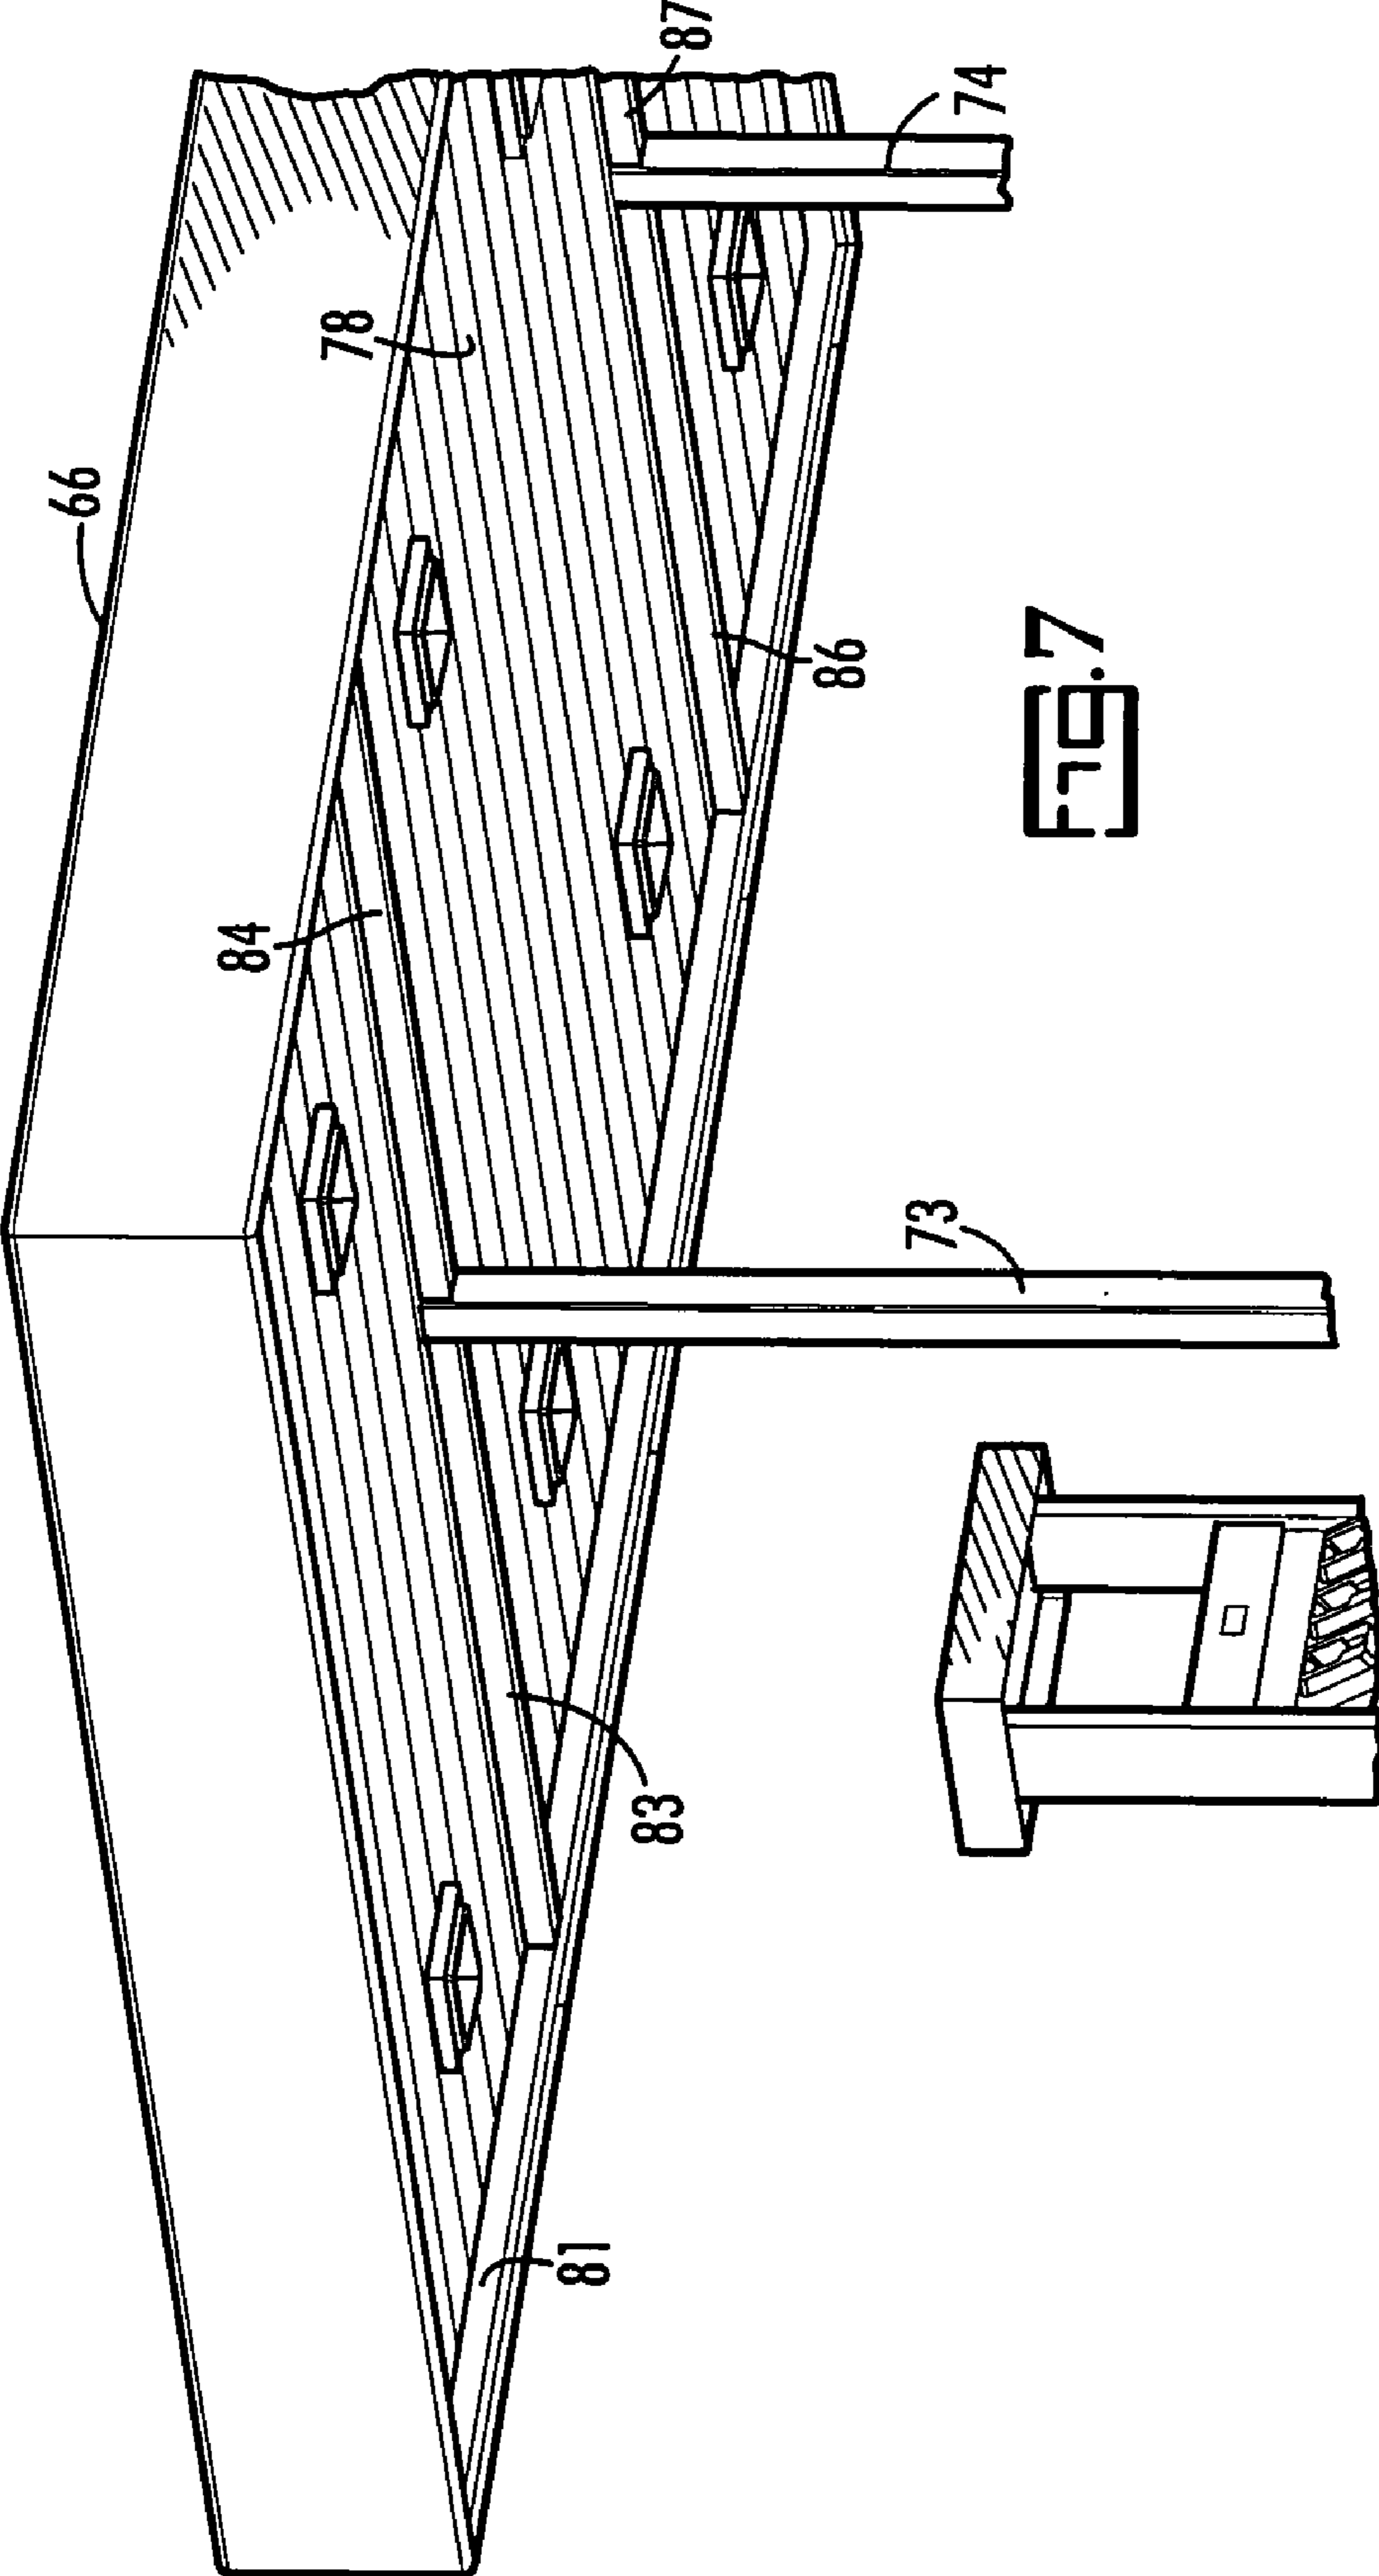
FIG. 7 is a perspective view of the canopy of FIG. 6 showing part of the underside of the roof, the gutters and the support columns;

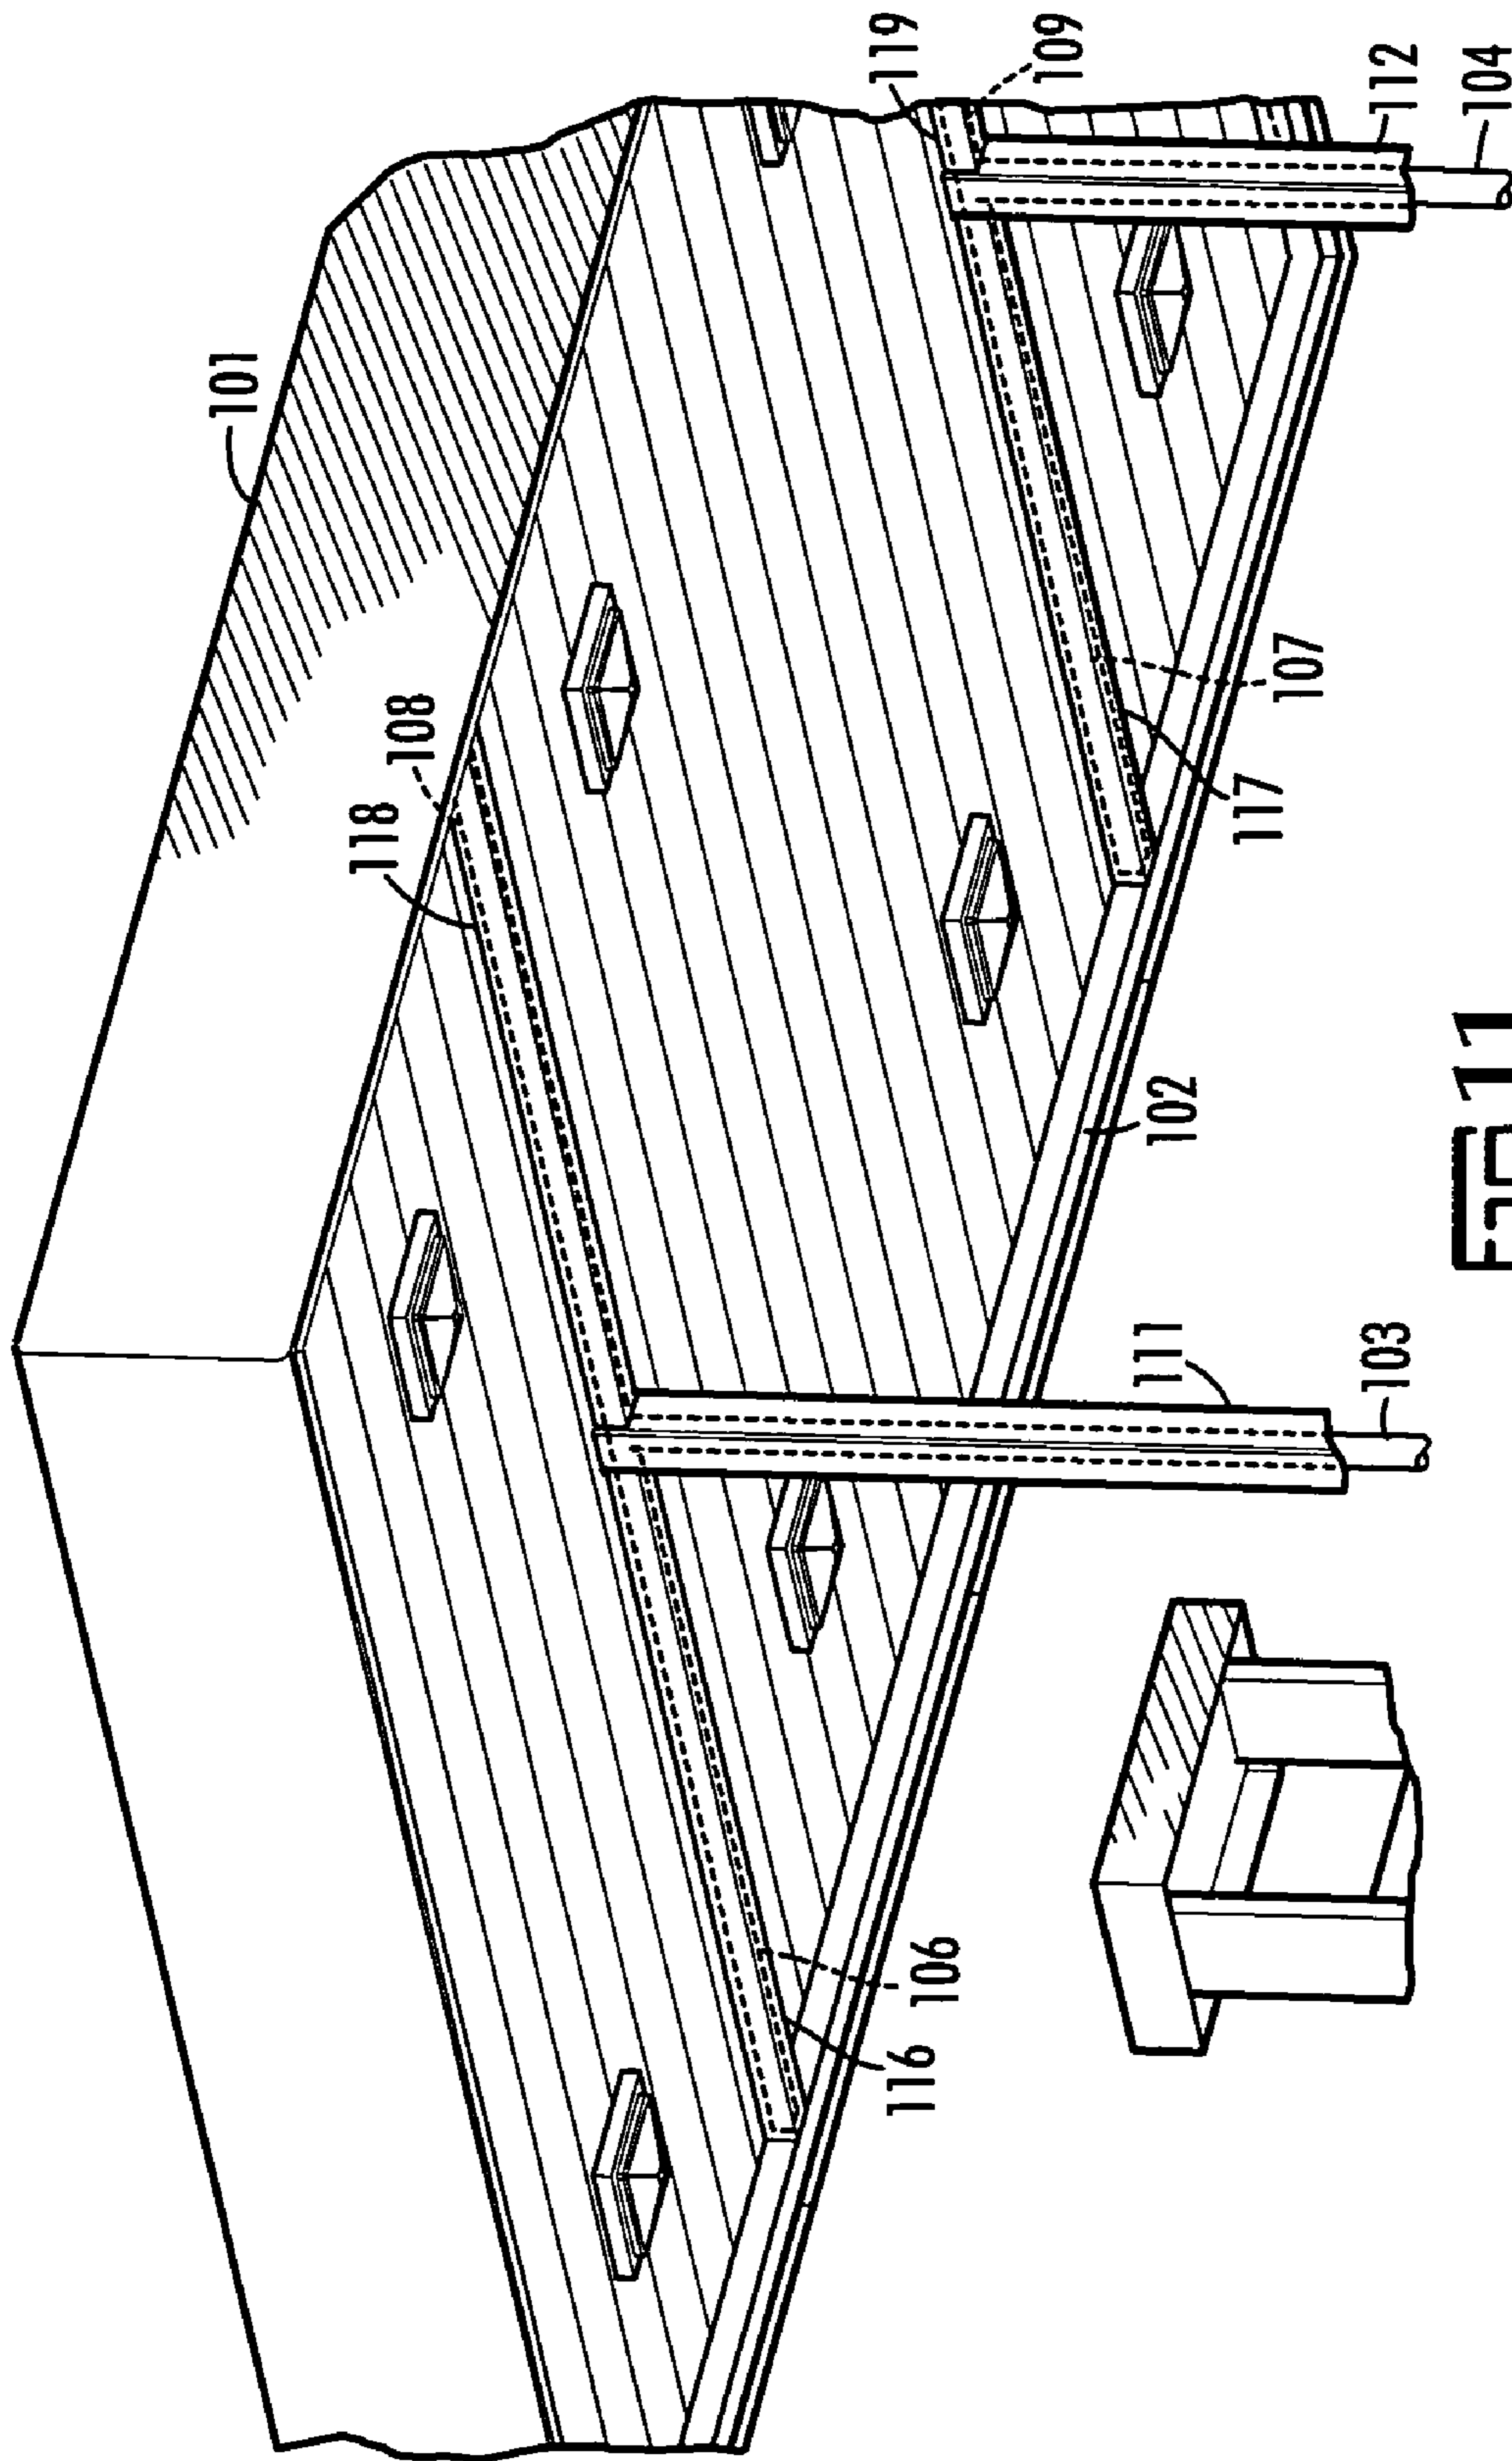
FIG. 11 is a perspective view similar to FIG. 10 showing the piping between the laterally opposite gutters and the support columns boxed in for decorative purposes;

FIG. 10 illustrates a canopy 101 having gutters at laterally opposite sides, only gutter 102 of which is shown, which are interconnected to vertically disposed PVC pipes 103, 104 by laterally extending PVC pipes 106, 107, 108, 109. The pipes 106, 107 extend downwardly through the support columns 111, 112 and, as shown in FIG. 12, water is discharged from the lower end of the columns, in FIG. 12 shows a discharge elbow 113 at the lower end of the conduit 104. An opening not shown is provided in the support column 112 to allow discharge of water from the elbow 113. In a similar manner, water is discharged from the conduit 103 through an opening at the lower end of the support column 111. FIG. 11 shows a construction similar to that of FIG. 10; however, the lateral pipes 106, 107, 108, and 109 are boxed in with trough shaped members 116, 117, 118, 119 to improve the ceiling décor.

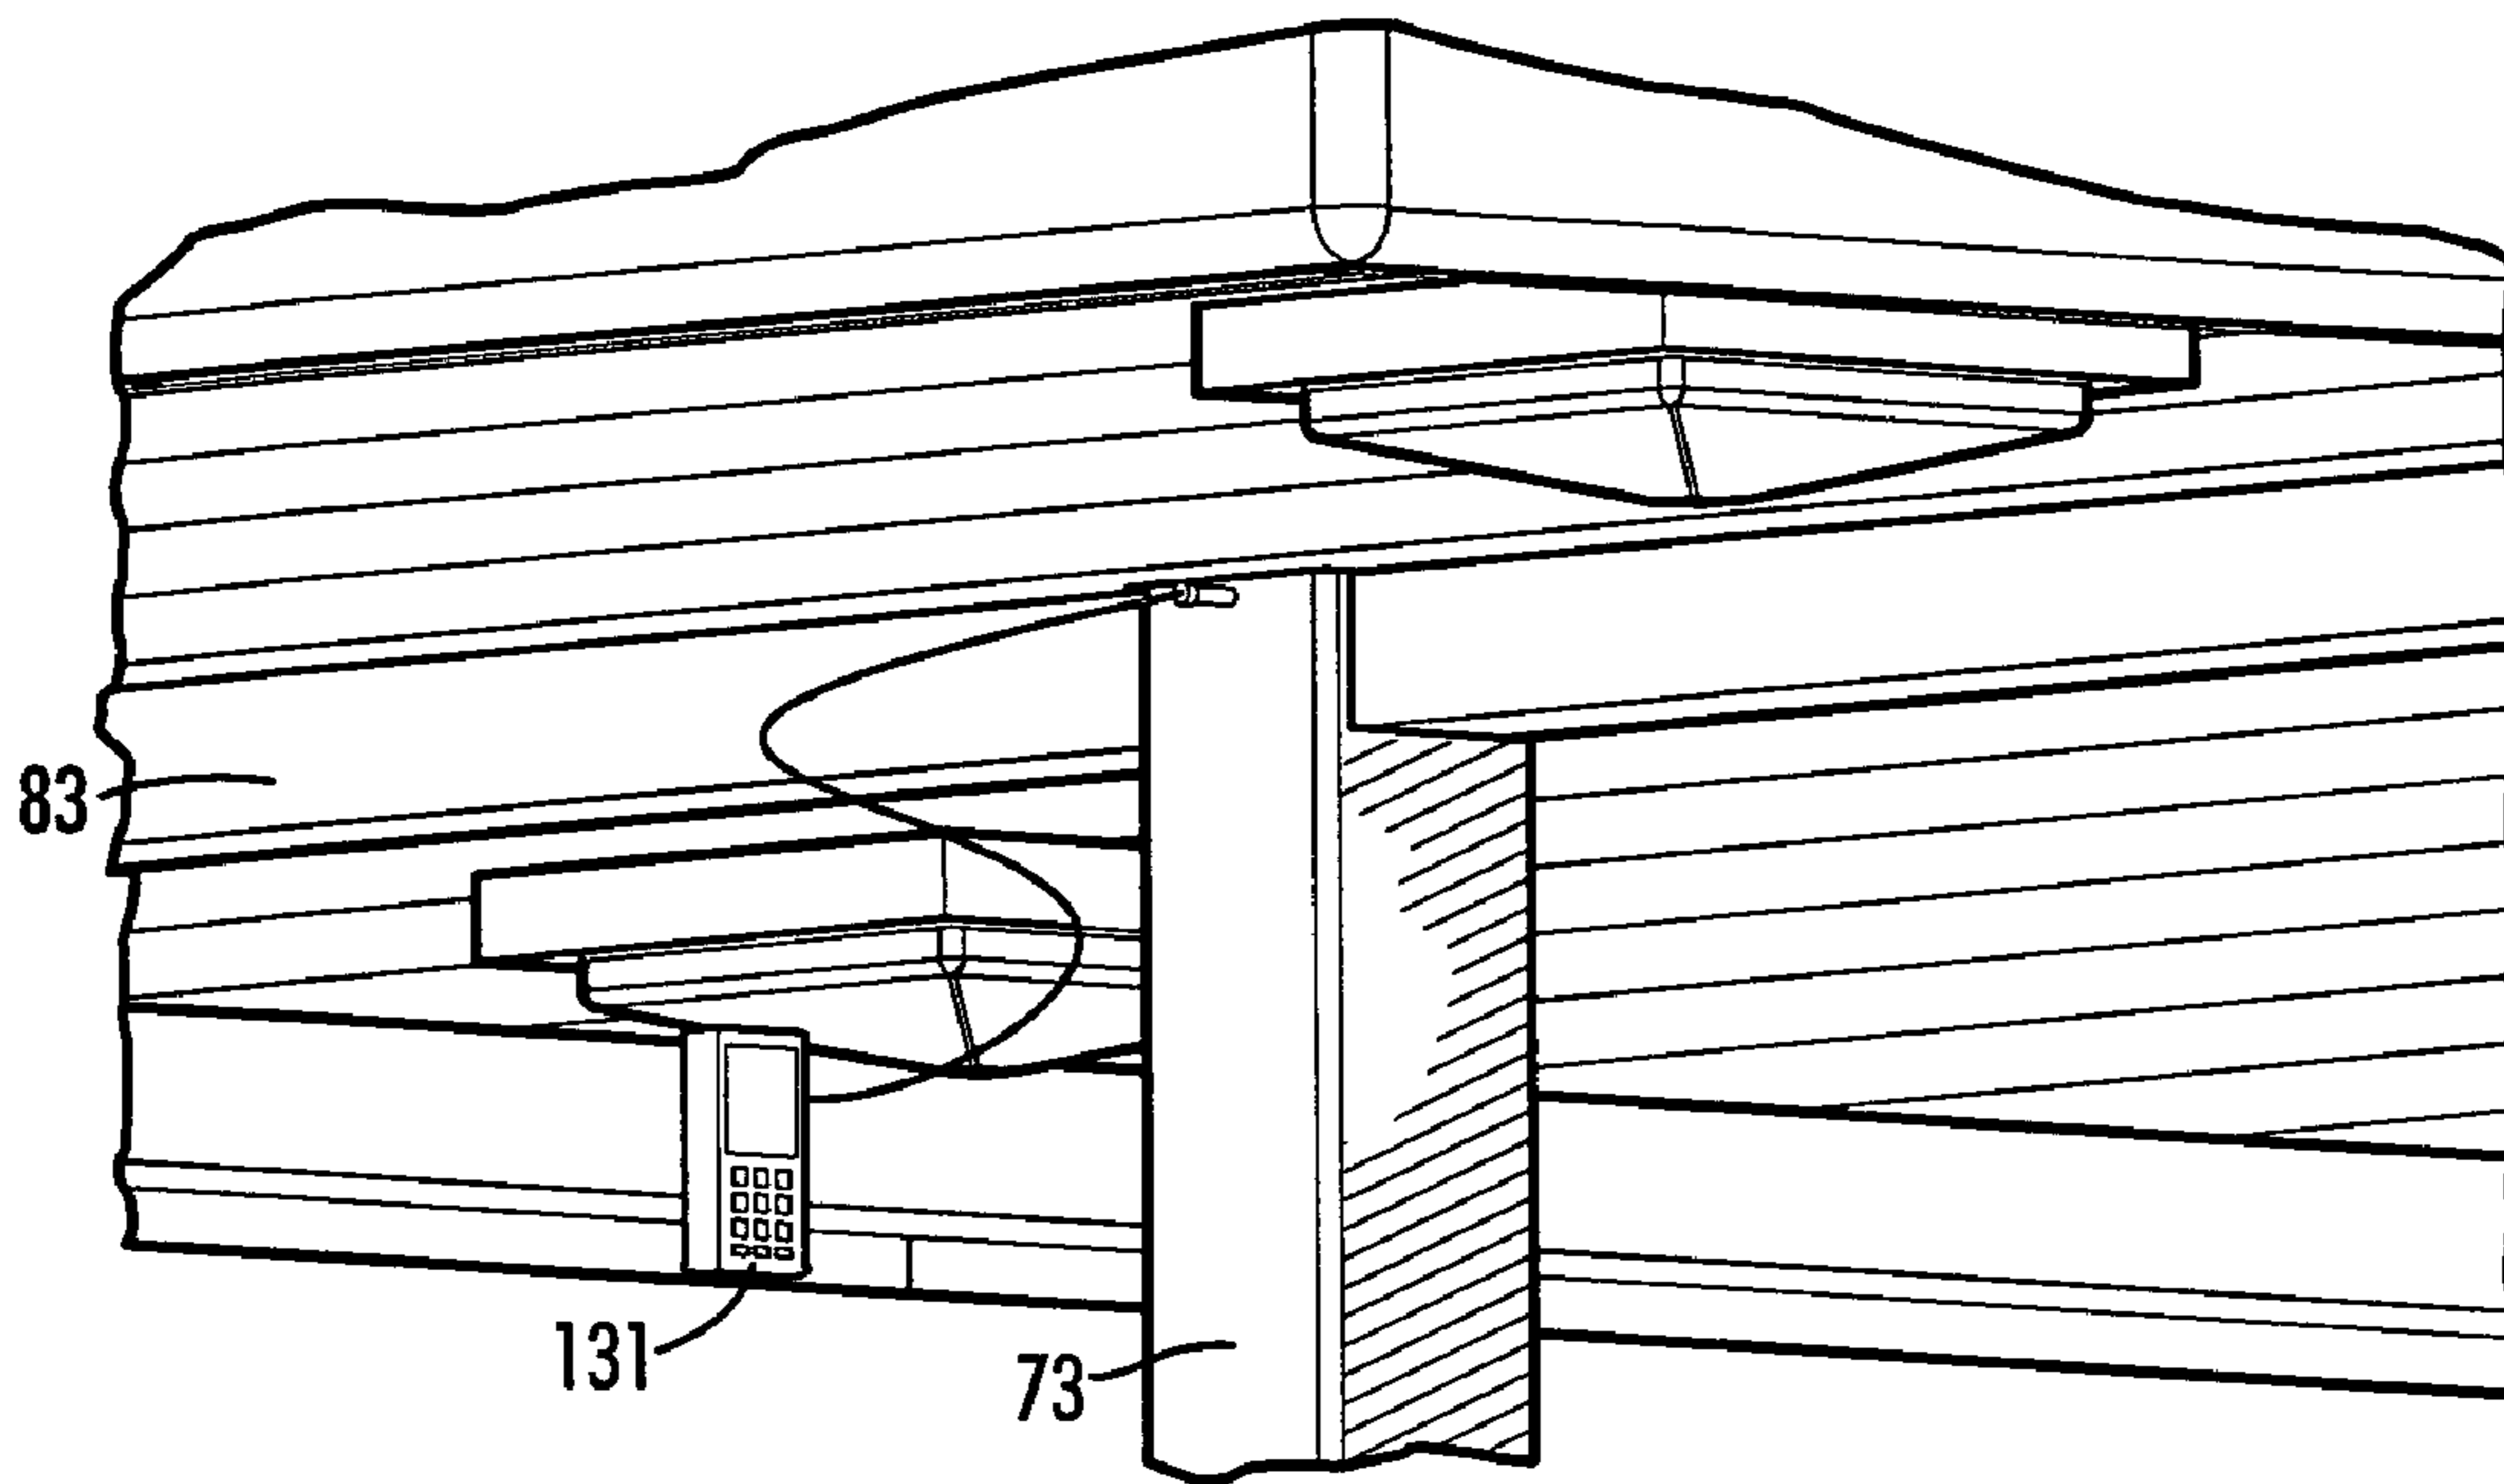
FIG. 14 shows measurement of the support column wall thickness at the underside of the roof with an ultrasonic thickness gauge;

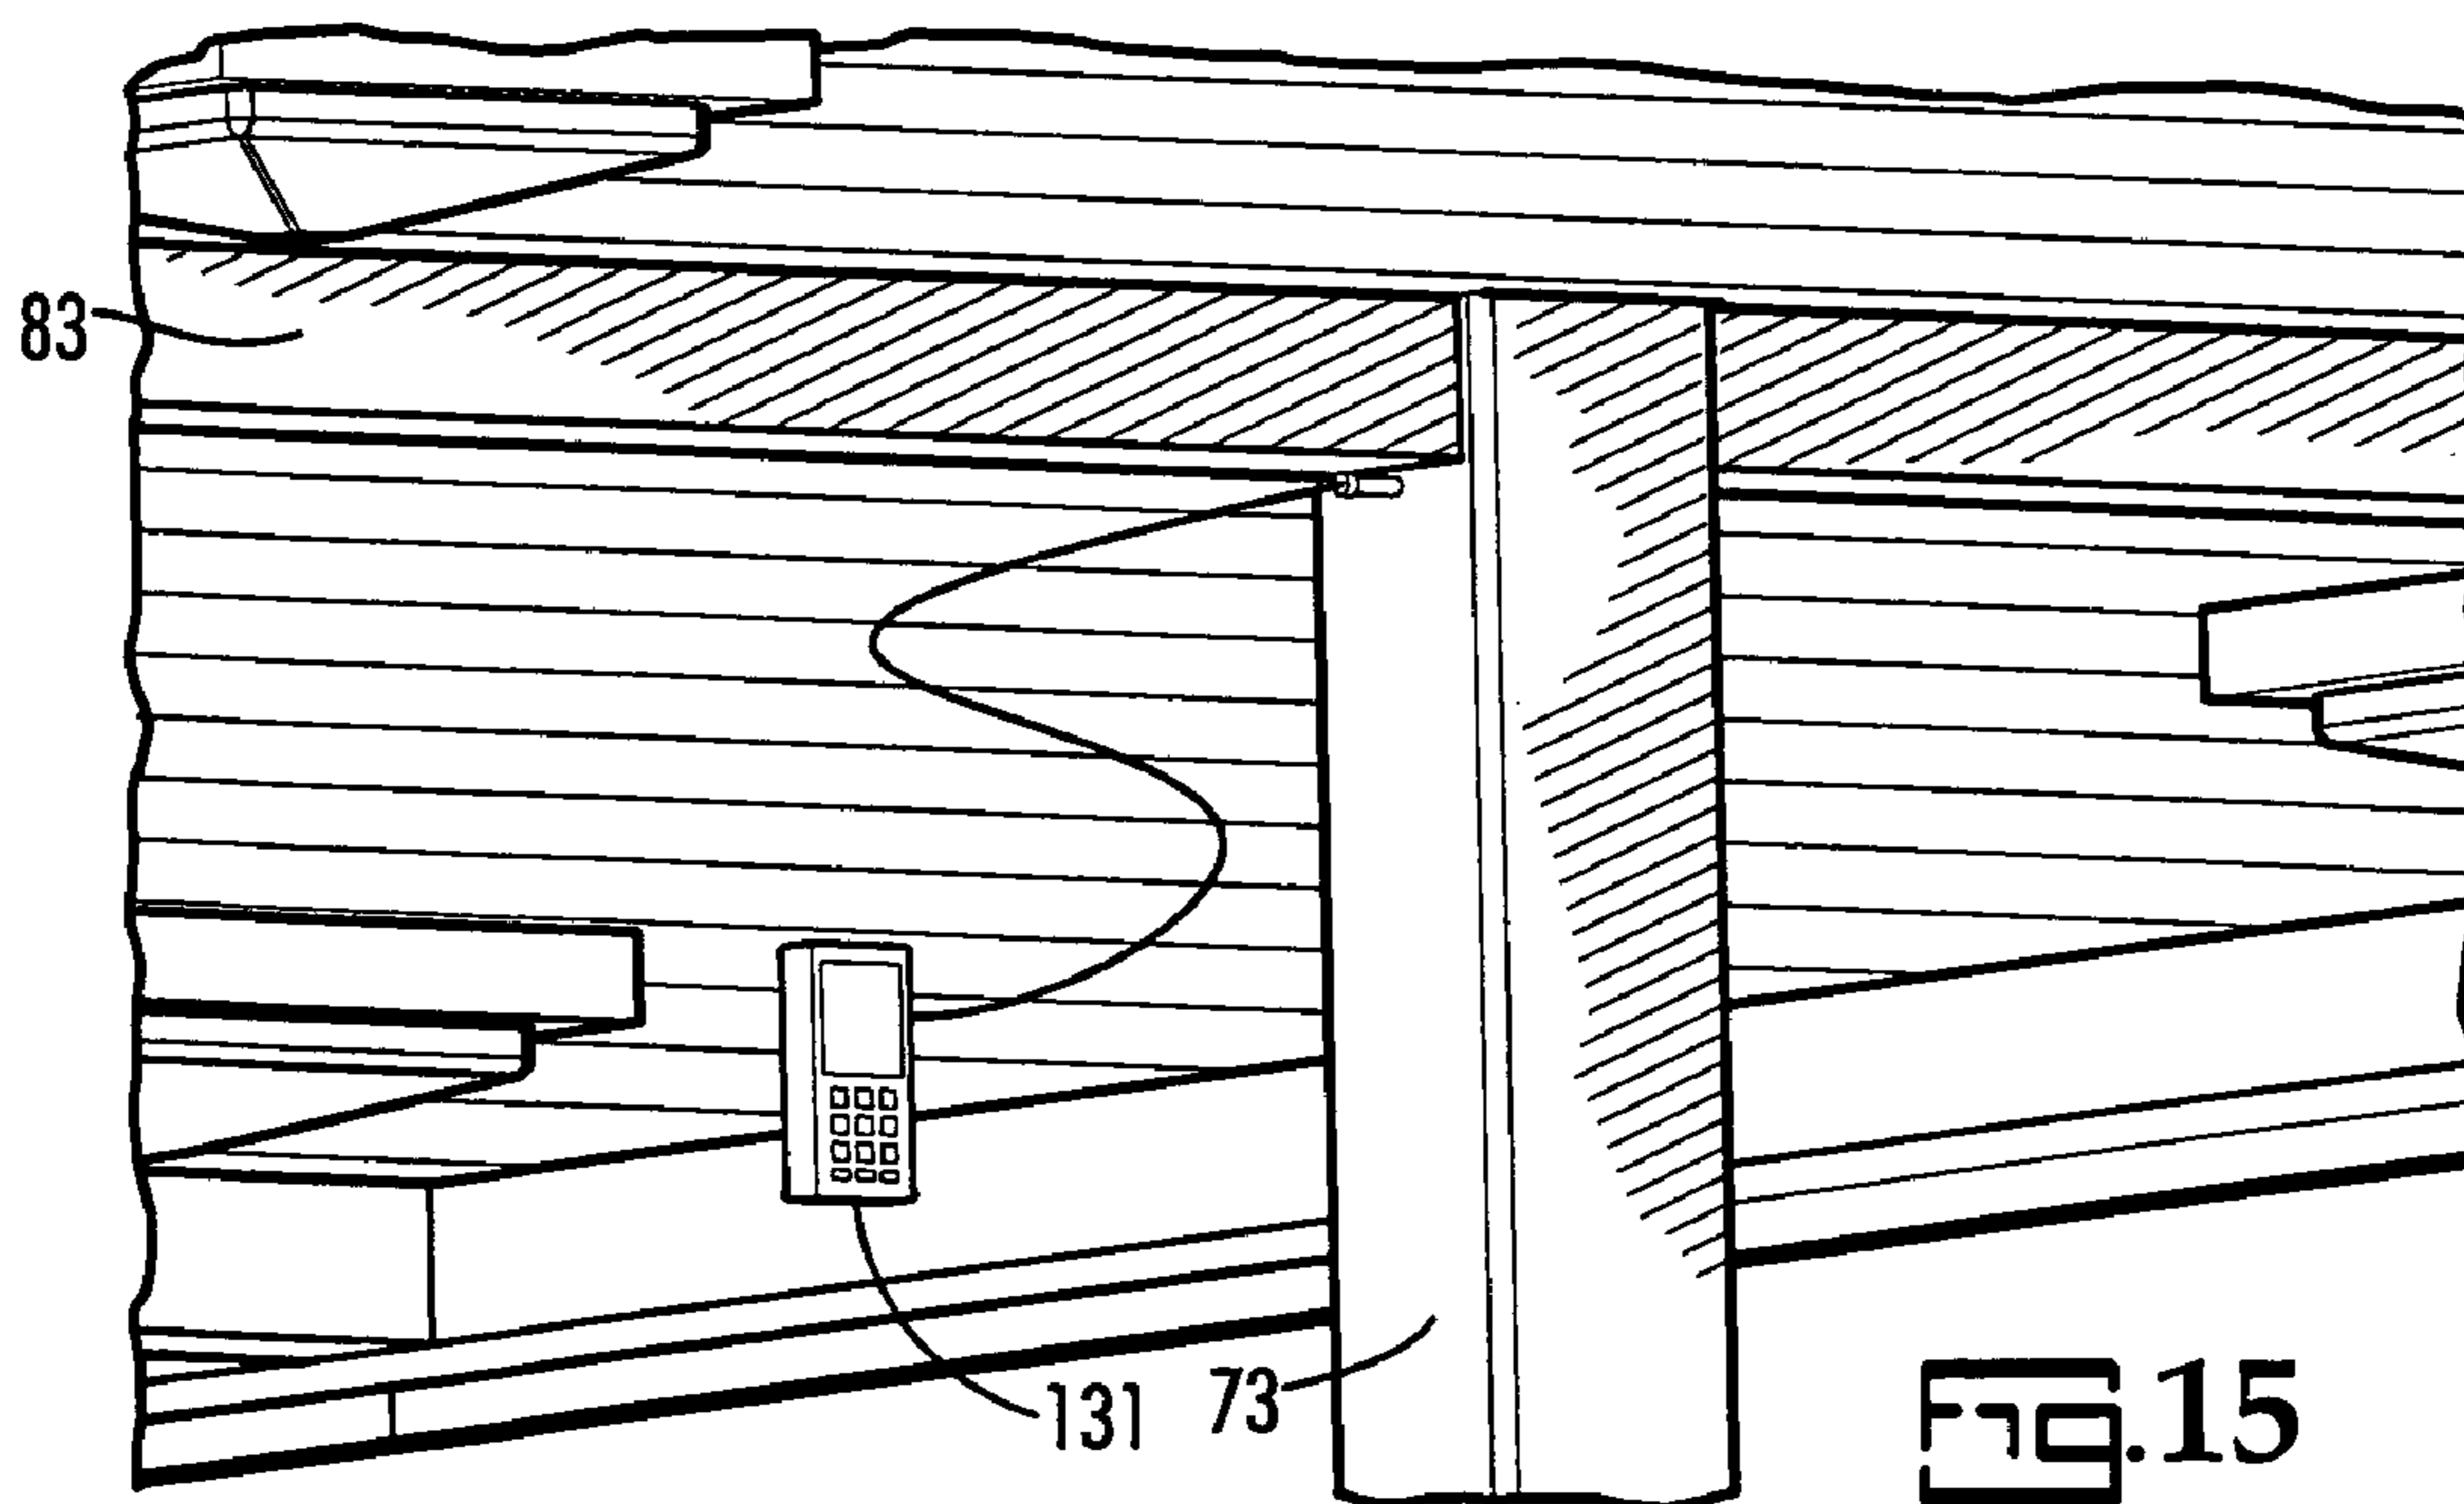
FIG. 15 shows measurement of the support column wall thickness at its junction with a laterally extending gutter;
