(54) **METHOD OF INSPECTING CANOPY STRUCTURES**

A method of inspecting canopy structures is provided to determine the structural integrity of the roof support system. The method includes steps designed to uncover hidden deficiencies in the roof support system through nondestructive testing and discovery. Timely use of the method of inspection not only minimizes the risk of canopy collapse but also produces information needed for making repair or replacement of the roof support system.

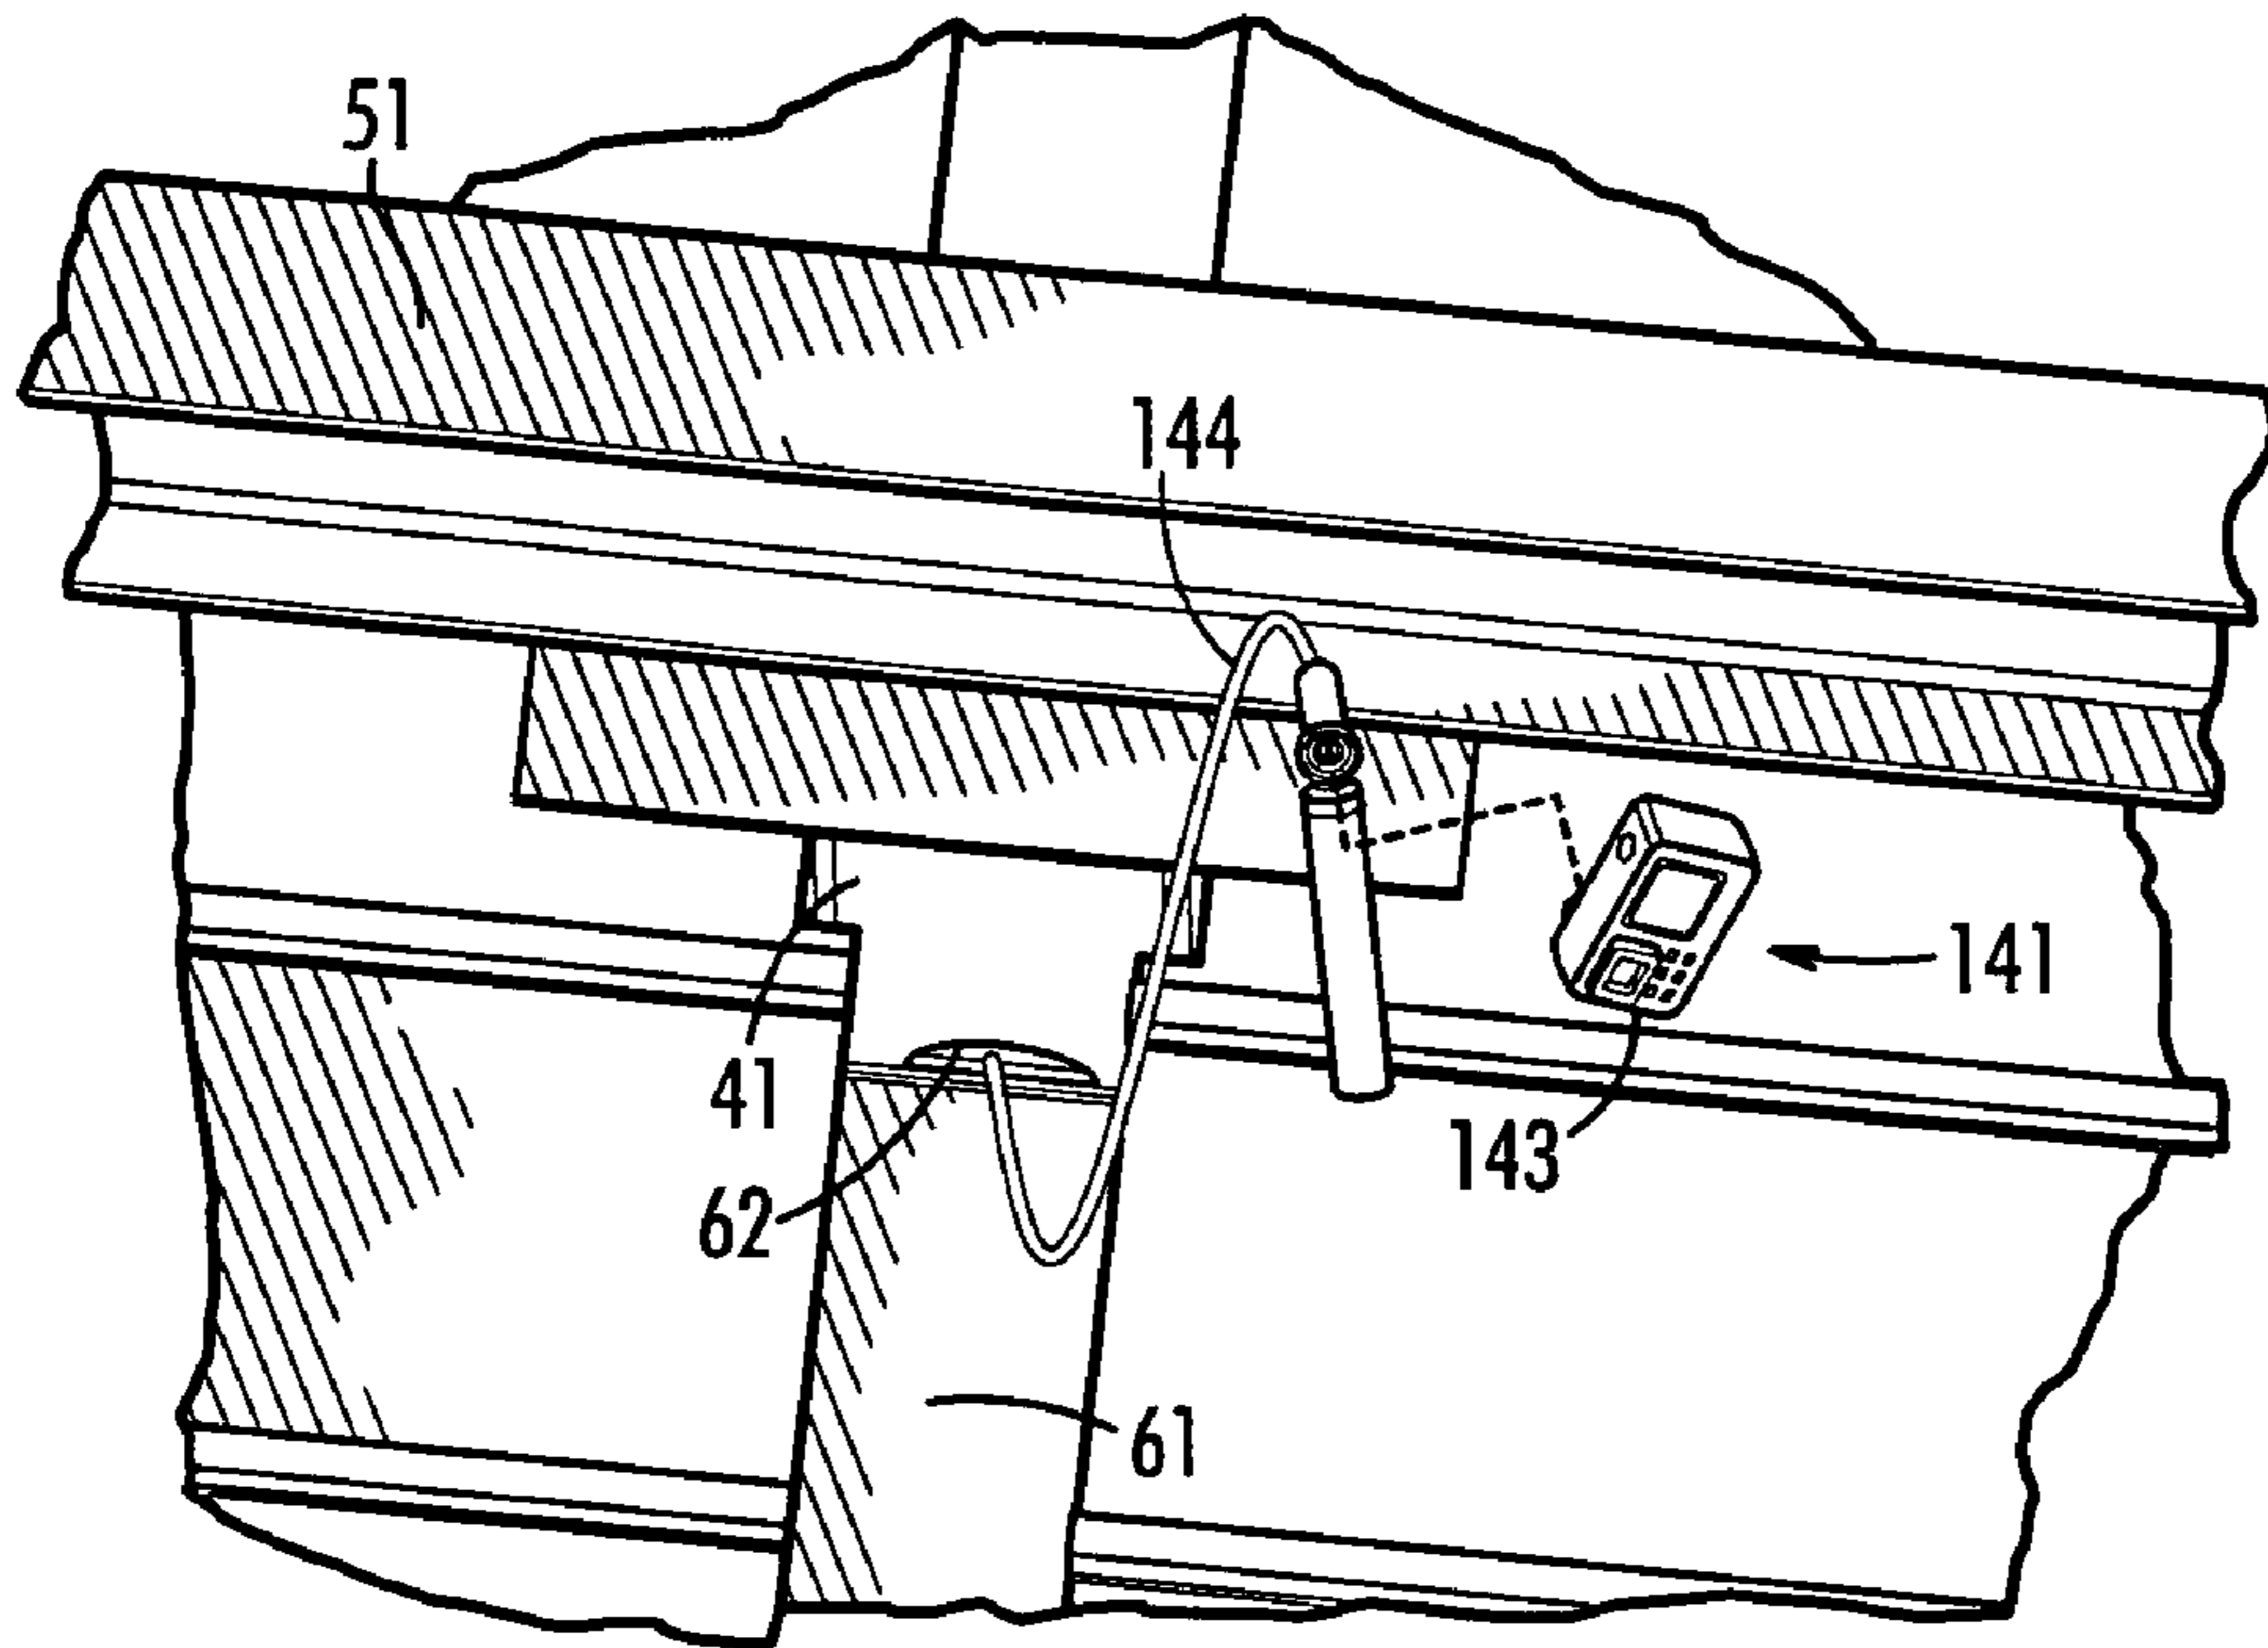
FIG. 16 shows a fiber scope with an attached digital camera taking pictures of the interior of the upper end of a canopy support column;

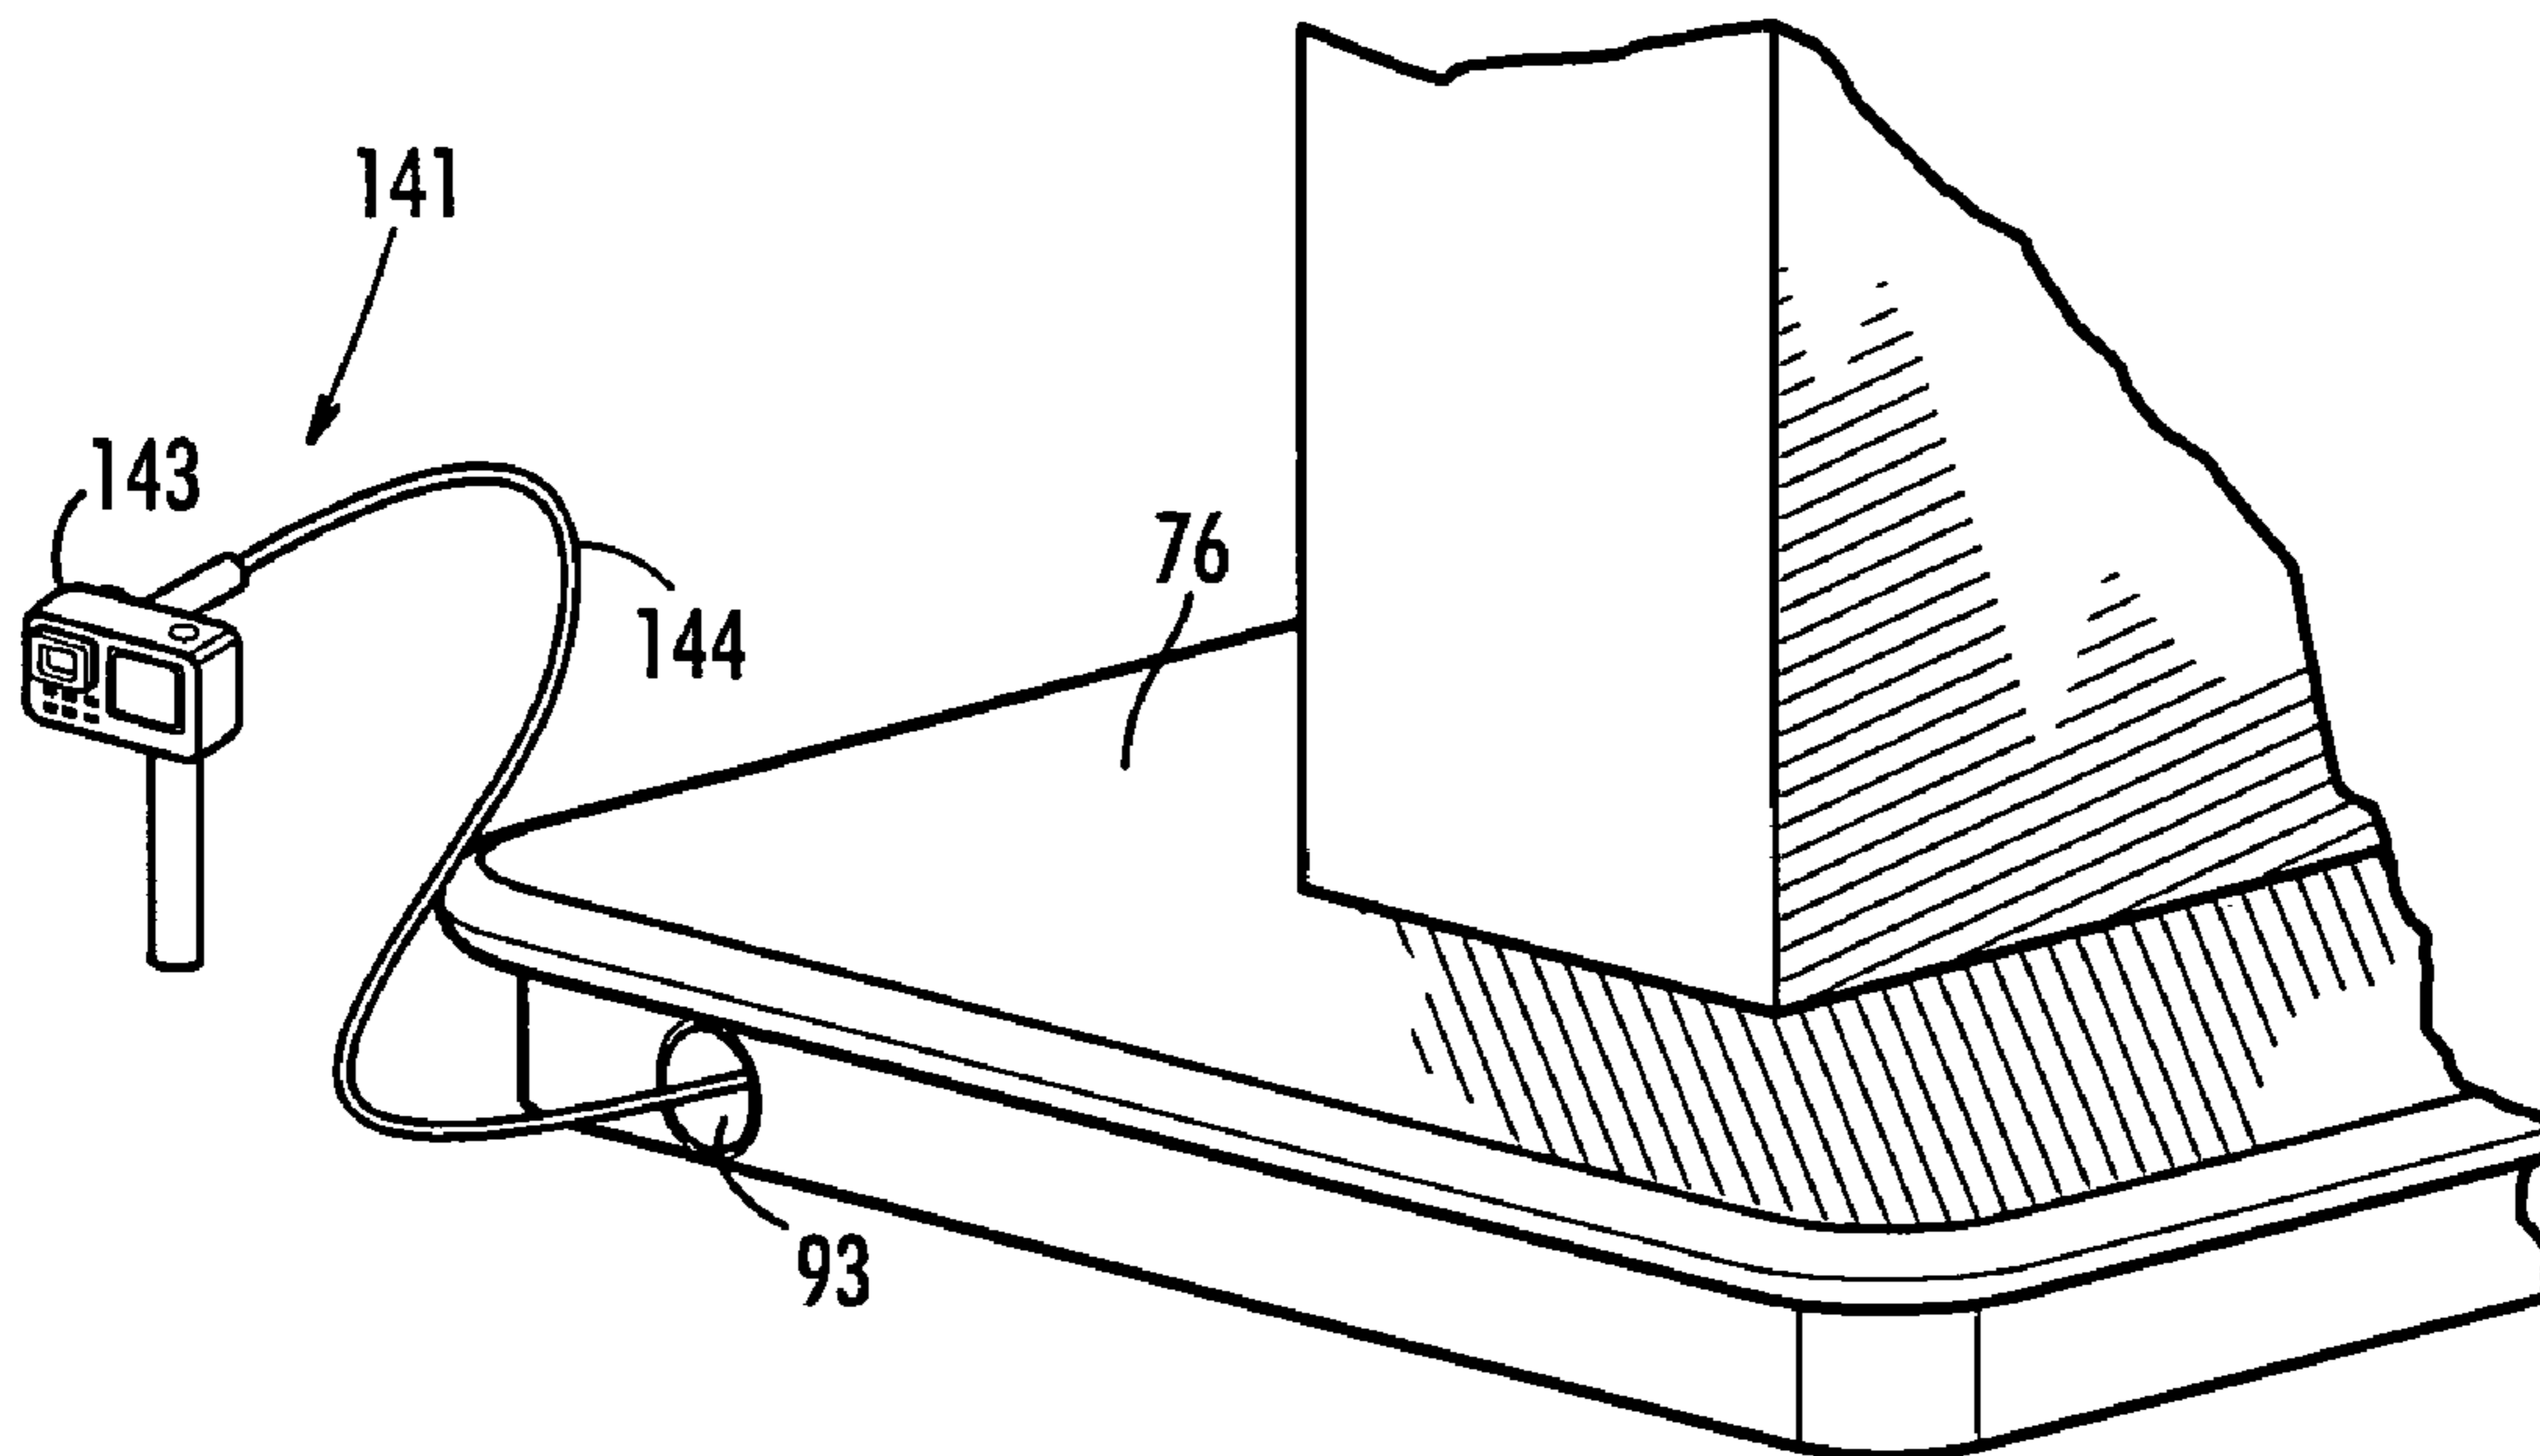
FIG. 17 shows a fiber optic scope with digital camera taking pictures of the interior of a drain in fuel dispensing island, and

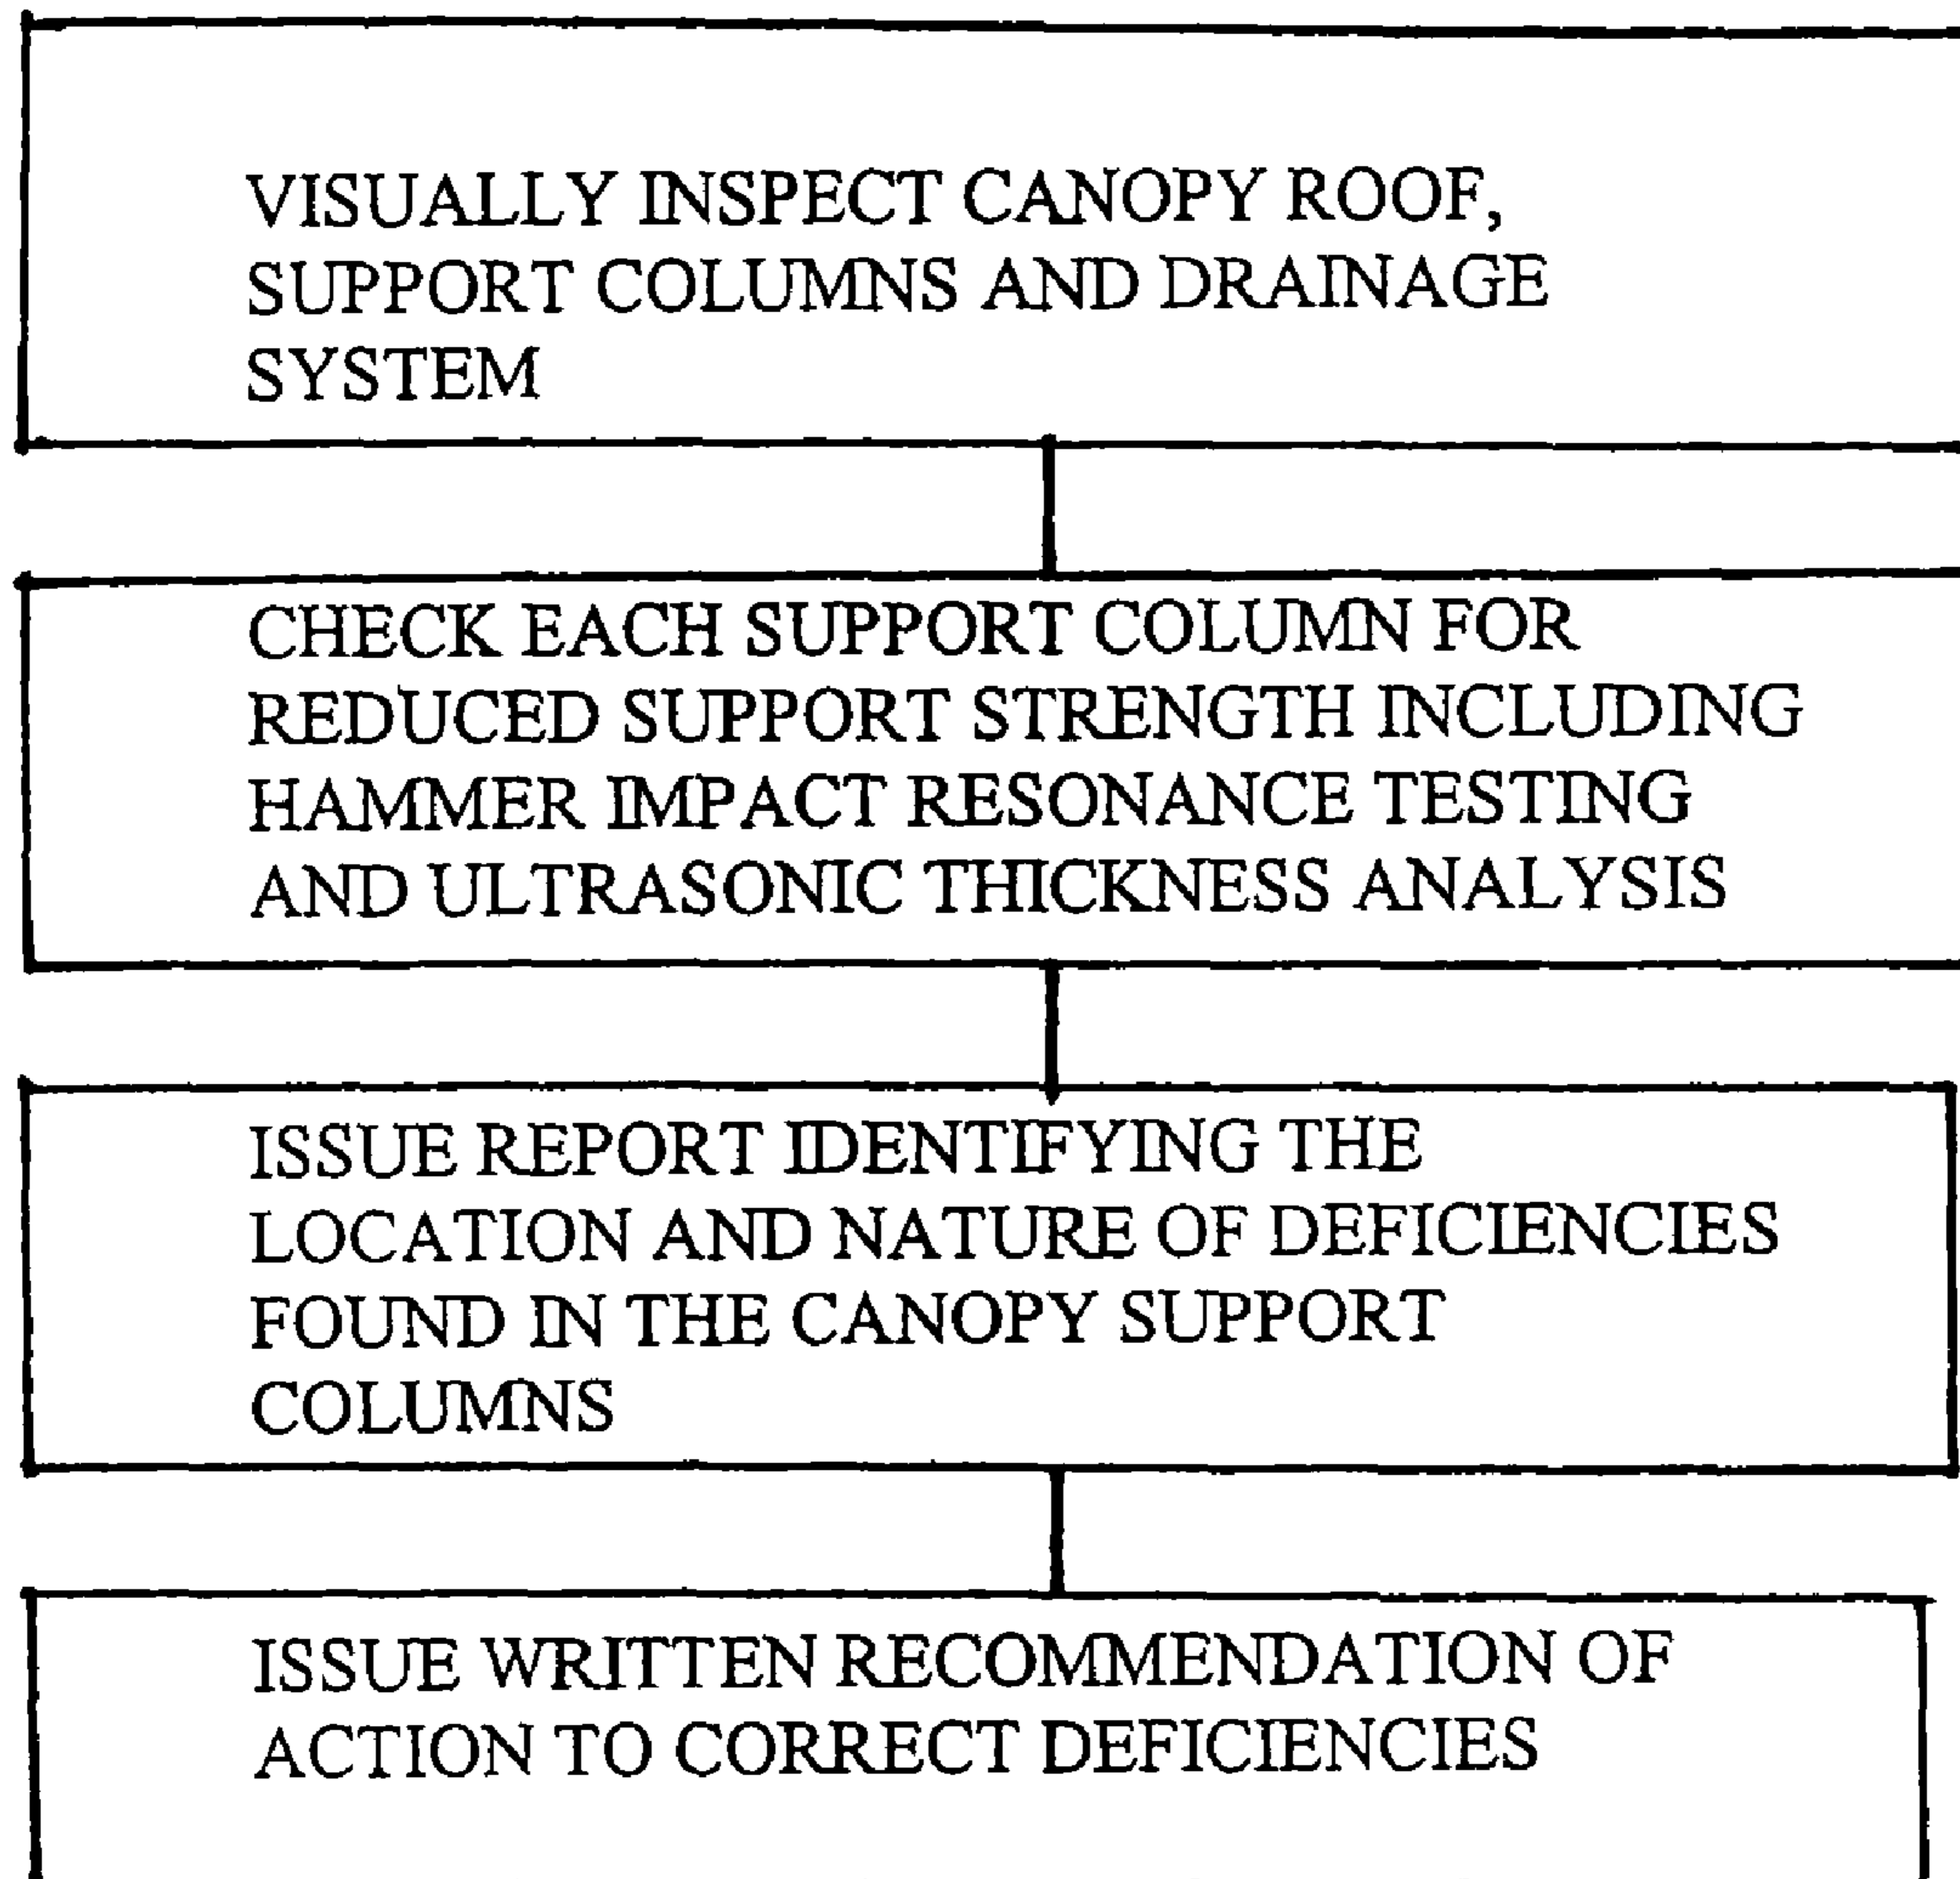
**FIG. 18**

FIG. 18 through 22 illustrate some of the herein disclosed methods of inspection.
