(54) **REFURBISHED CAMSHAFT AND METHOD**

(73) Assignee: **Caterpillar Inc.**, Peoria, IL (US)

A method of refurbishing a camshaft (100) having at least one defective portion (202, 206) includes removing material from the at least one defective portion (202, 206) to create a neck region (302). An alignment feature (402) is introduced in the neck region (302) according to a previous orientation of the defective portion (202, 206). A blank (508) is installed around the neck region (302) and oriented with the alignment feature (402).

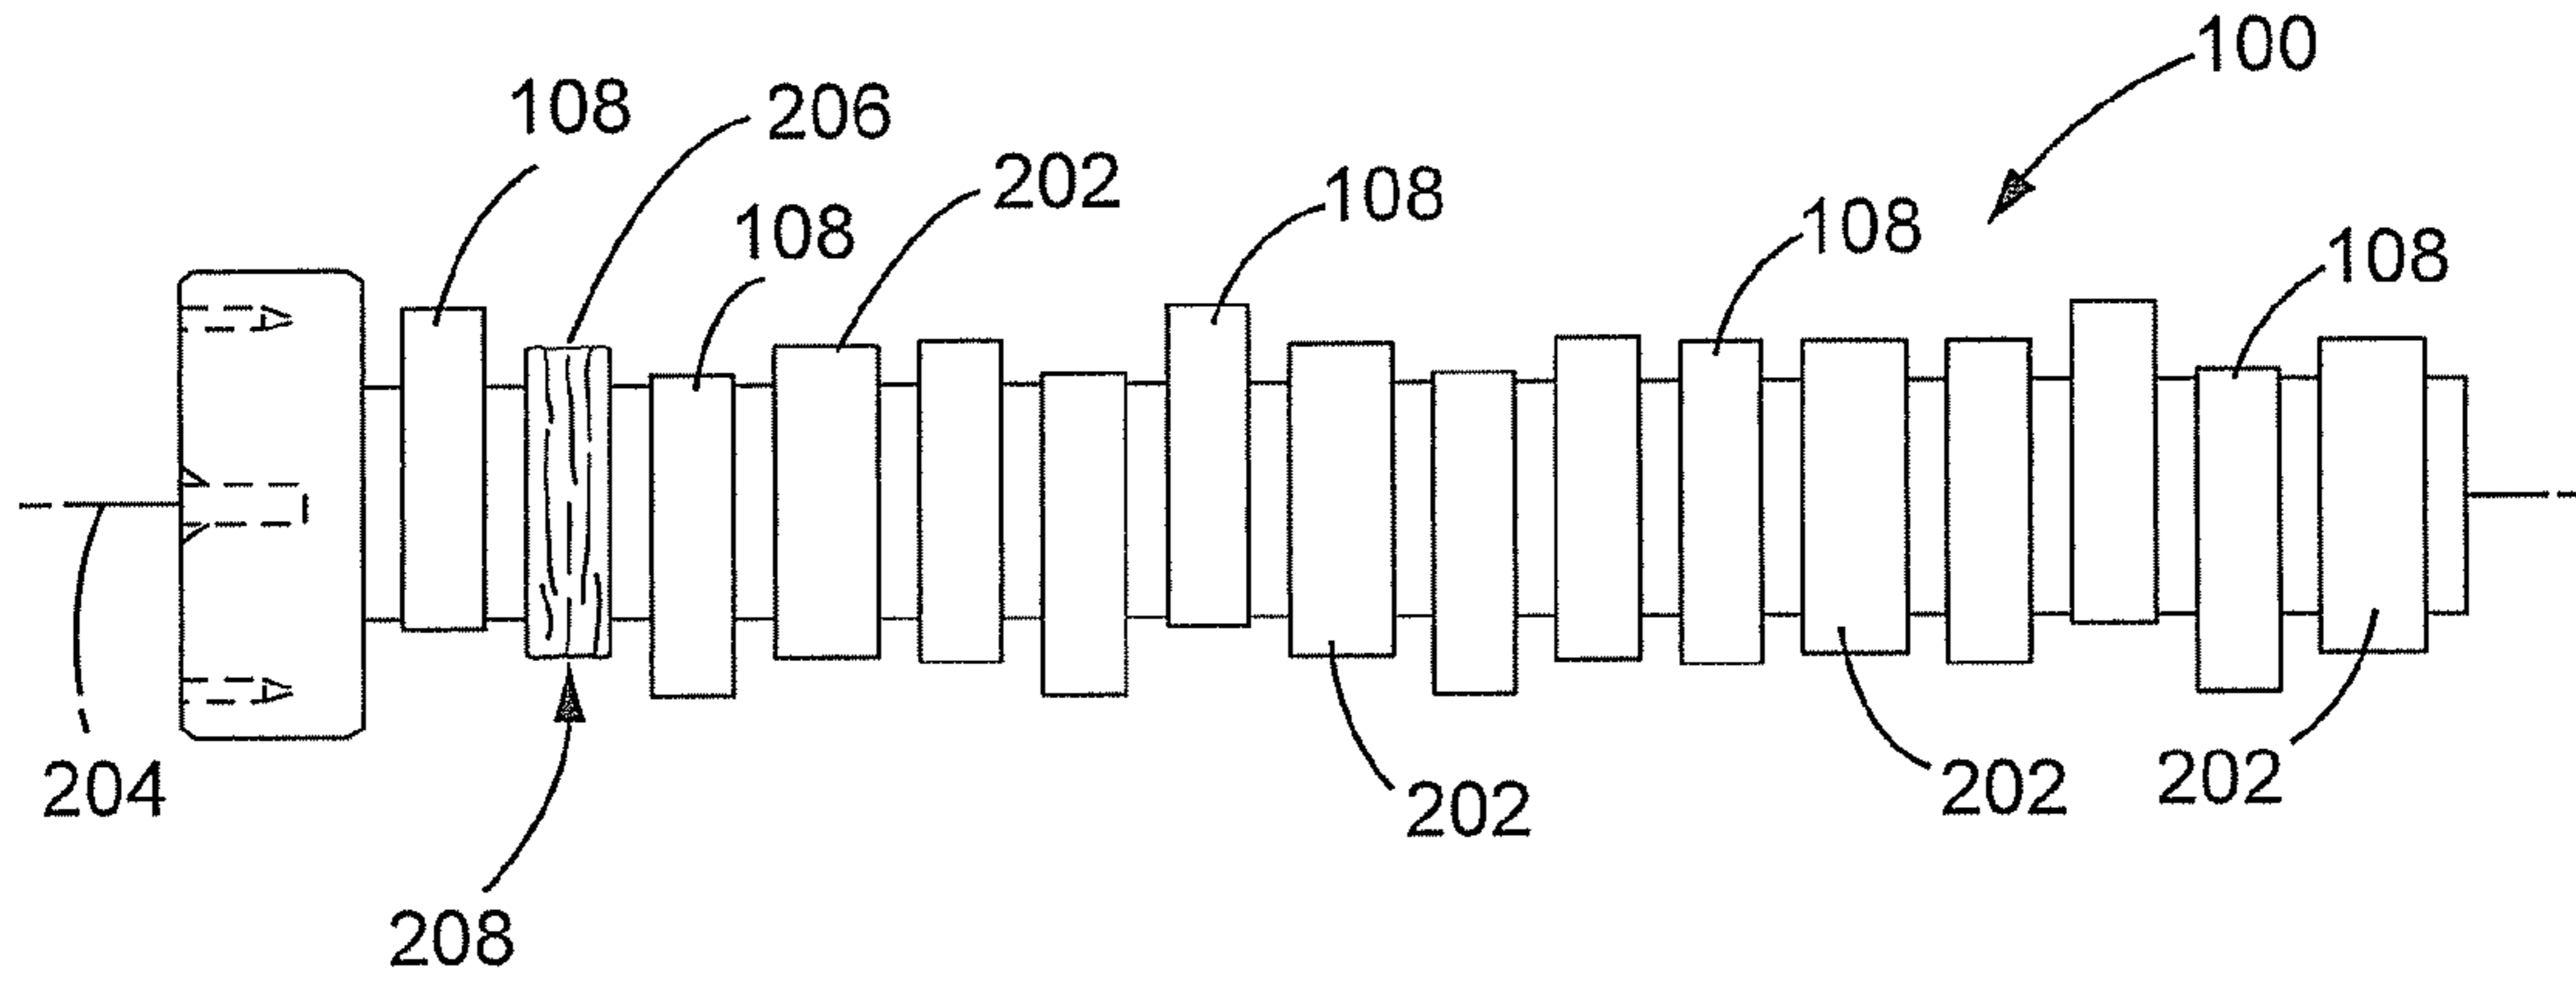
FIG. 3 is a partial outline view of a camshaft having a neck region resulting from the removal of a damaged lobe in accordance with the disclosure.

The rebuilding process may begin with a grinding or machining operation to remove the defective lobe 206. As shown in the partial view of FIG. 3, the defective lobe 206 is ground down at least partially or, in this case entirely, leaving a neck region 302 in its place. The neck region 302 may be formed, for example, by turning the camshaft 100 on a lathe or subjecting the camshaft 100 to a single or multi axial machining process. When a lathe is used, the neck region 302 may have a cylindrical shape and be concentric with the centerline 204 of the camshaft 100. As can be appreciated, more than one defective lobe 206 may be ground at the same time. Optionally, the neck region 302 may be ground to have an outer diameter that is smaller than a diameter of the camshaft core 106 of the camshaft 100 to create a shoulder 304 on either side of the neck region 302 along the centerline 204. If a shoulder 304 is not deemed necessary, the neck region 302 may be formed with either a larger or smaller diameter than the diameter of the camshaft core 106.

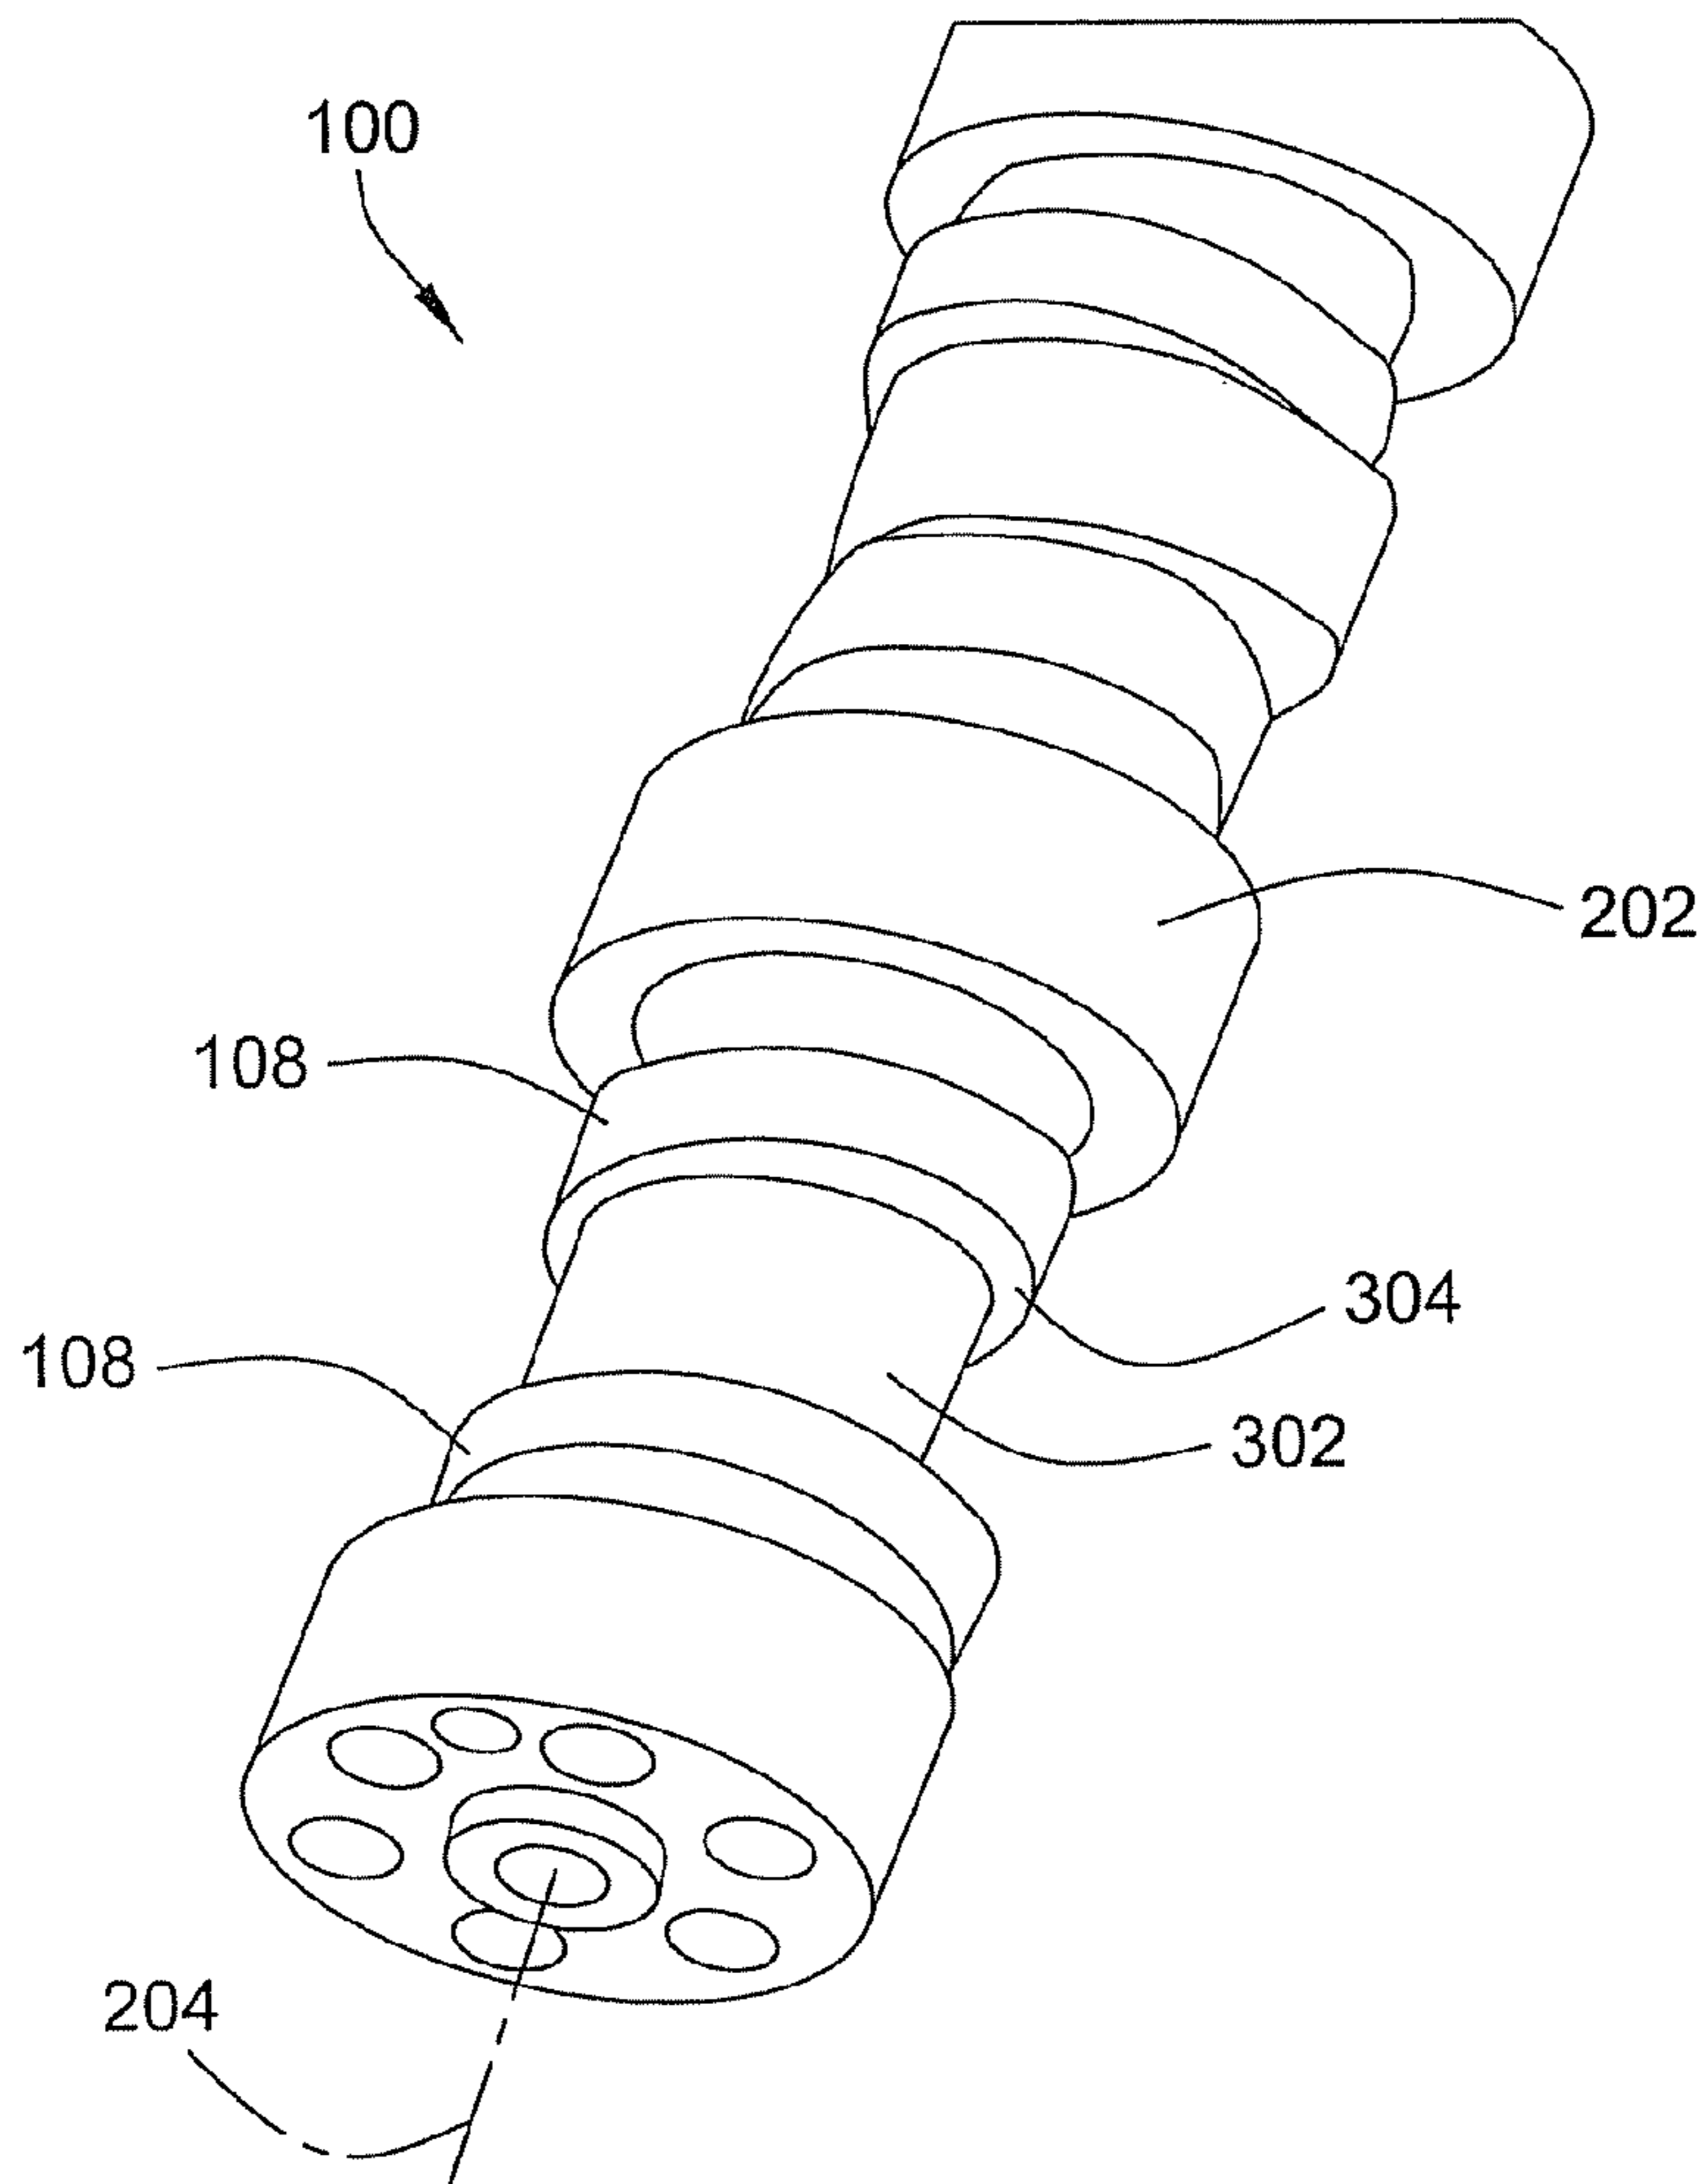
FIG. 4 is a partial outline view of an alignment feature formed in the neck region of a camshaft in accordance with the disclosure.

The camshaft 100 in the state shown in FIG. 4 is ready to receive a replacement lobe or bearing portion blank. As shown, the camshaft 100 is adapted to receive a lobe blank, but the processes and methods disclosed herein are equally adaptable for replacement of a bearing portion. Two embodiments are disclosed herein for connecting a replacement lobe to the camshaft 100 having the neck region 302 and flat portion 404 formed thereon. The description will be focused on replacement of a lobe, which requires a more precise alignment to the camshaft 100, but the methods can easily be adapted for a bearing blank. In the first embodiment, the camshaft 100 is cut along a surface 500 as shown in FIG. 5. The cut, which can be performed after an alignment feature has been formed in the neck region 302, separates the camshaft 100 into a first and second portions 502 and 504 at a cut location 506 along the centerline 204. Each of the first and second portions 502 and 504 advantageously retains at least a portion of the alignment feature or flat portion 404 thereon to aid in proper re-assembly of the camshaft 100. The surface 500 shown in FIG. 5 is planar and intersects the centerline 204 perpendicularly. Of course, the surface 500 may be non planar, or may even intersect the centerline 204 at a different angle to facilitate alignment during re-assembly of the first and second portions 502 and 504. Moreover, dowel holes or other alignment features may be formed in the neck region or surface 500 to facilitate re-assembly of the camshaft 100.
