(10) **Patent No.:** **US 7,927,077 B2**  
(45) **Date of Patent:** **Apr. 19, 2011**

(54) **WIND BLADE SPAR CAP LAMINATE REPAIR**

A wind blade spar cap laminate repair for wind turbine rotor blades, a repair kit to repair spar cap laminate damage, and a method of repairing damage on wind turbine rotor blades is provided. The wind blade spar cap laminate repair includes a prepared surface, an adhesive region disposed on the prepared surface, and a repair disposed on the adhesive region, wherein the adhesive region sufficiently bonds the repair to the prepared surface to substantially match the mechanical properties of the bulk of the wind turbine rotor blade.

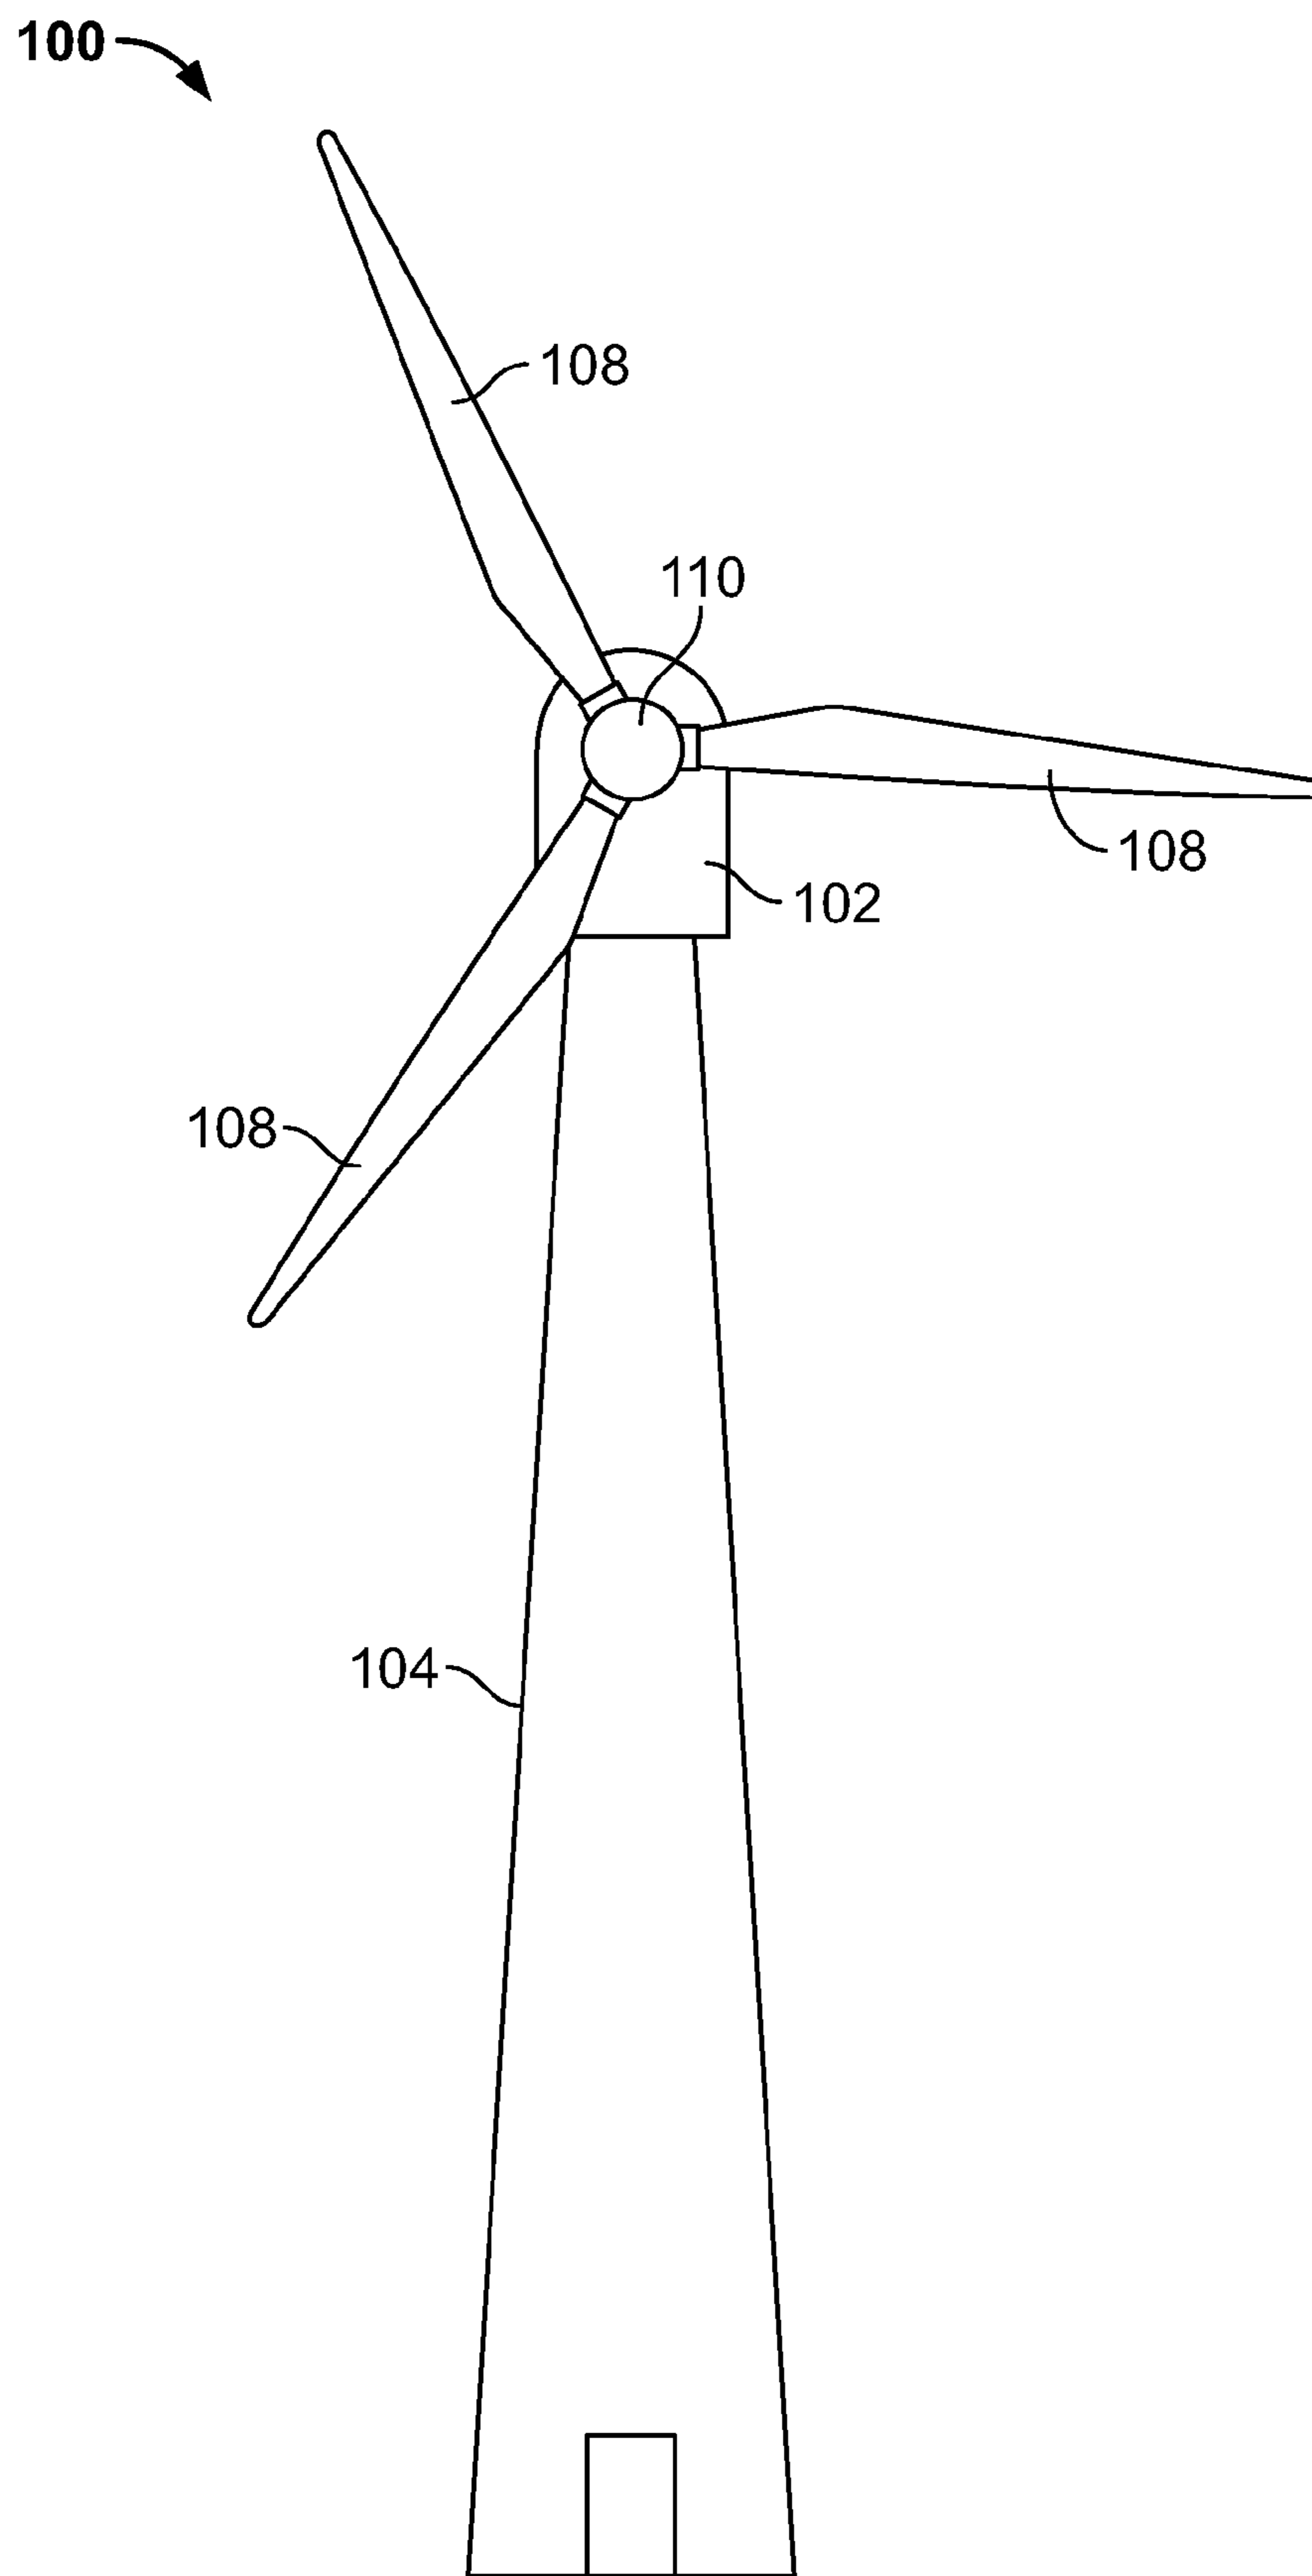
FIG. 1 is a front view of a wind turbine according to an embodiment of the present disclosure.

As shown in FIG. 1, a wind turbine **100** generally comprises a nacelle **102** housing a generator (not shown). Nacelle **102** is a housing mounted atop a tower **104**. The wind turbine **100** may be installed on any terrain providing access to areas having desirable wind conditions. The terrain may vary greatly and may include, but is not limited to, mountainous terrain or off-shore locations. Wind turbine **100** also com-

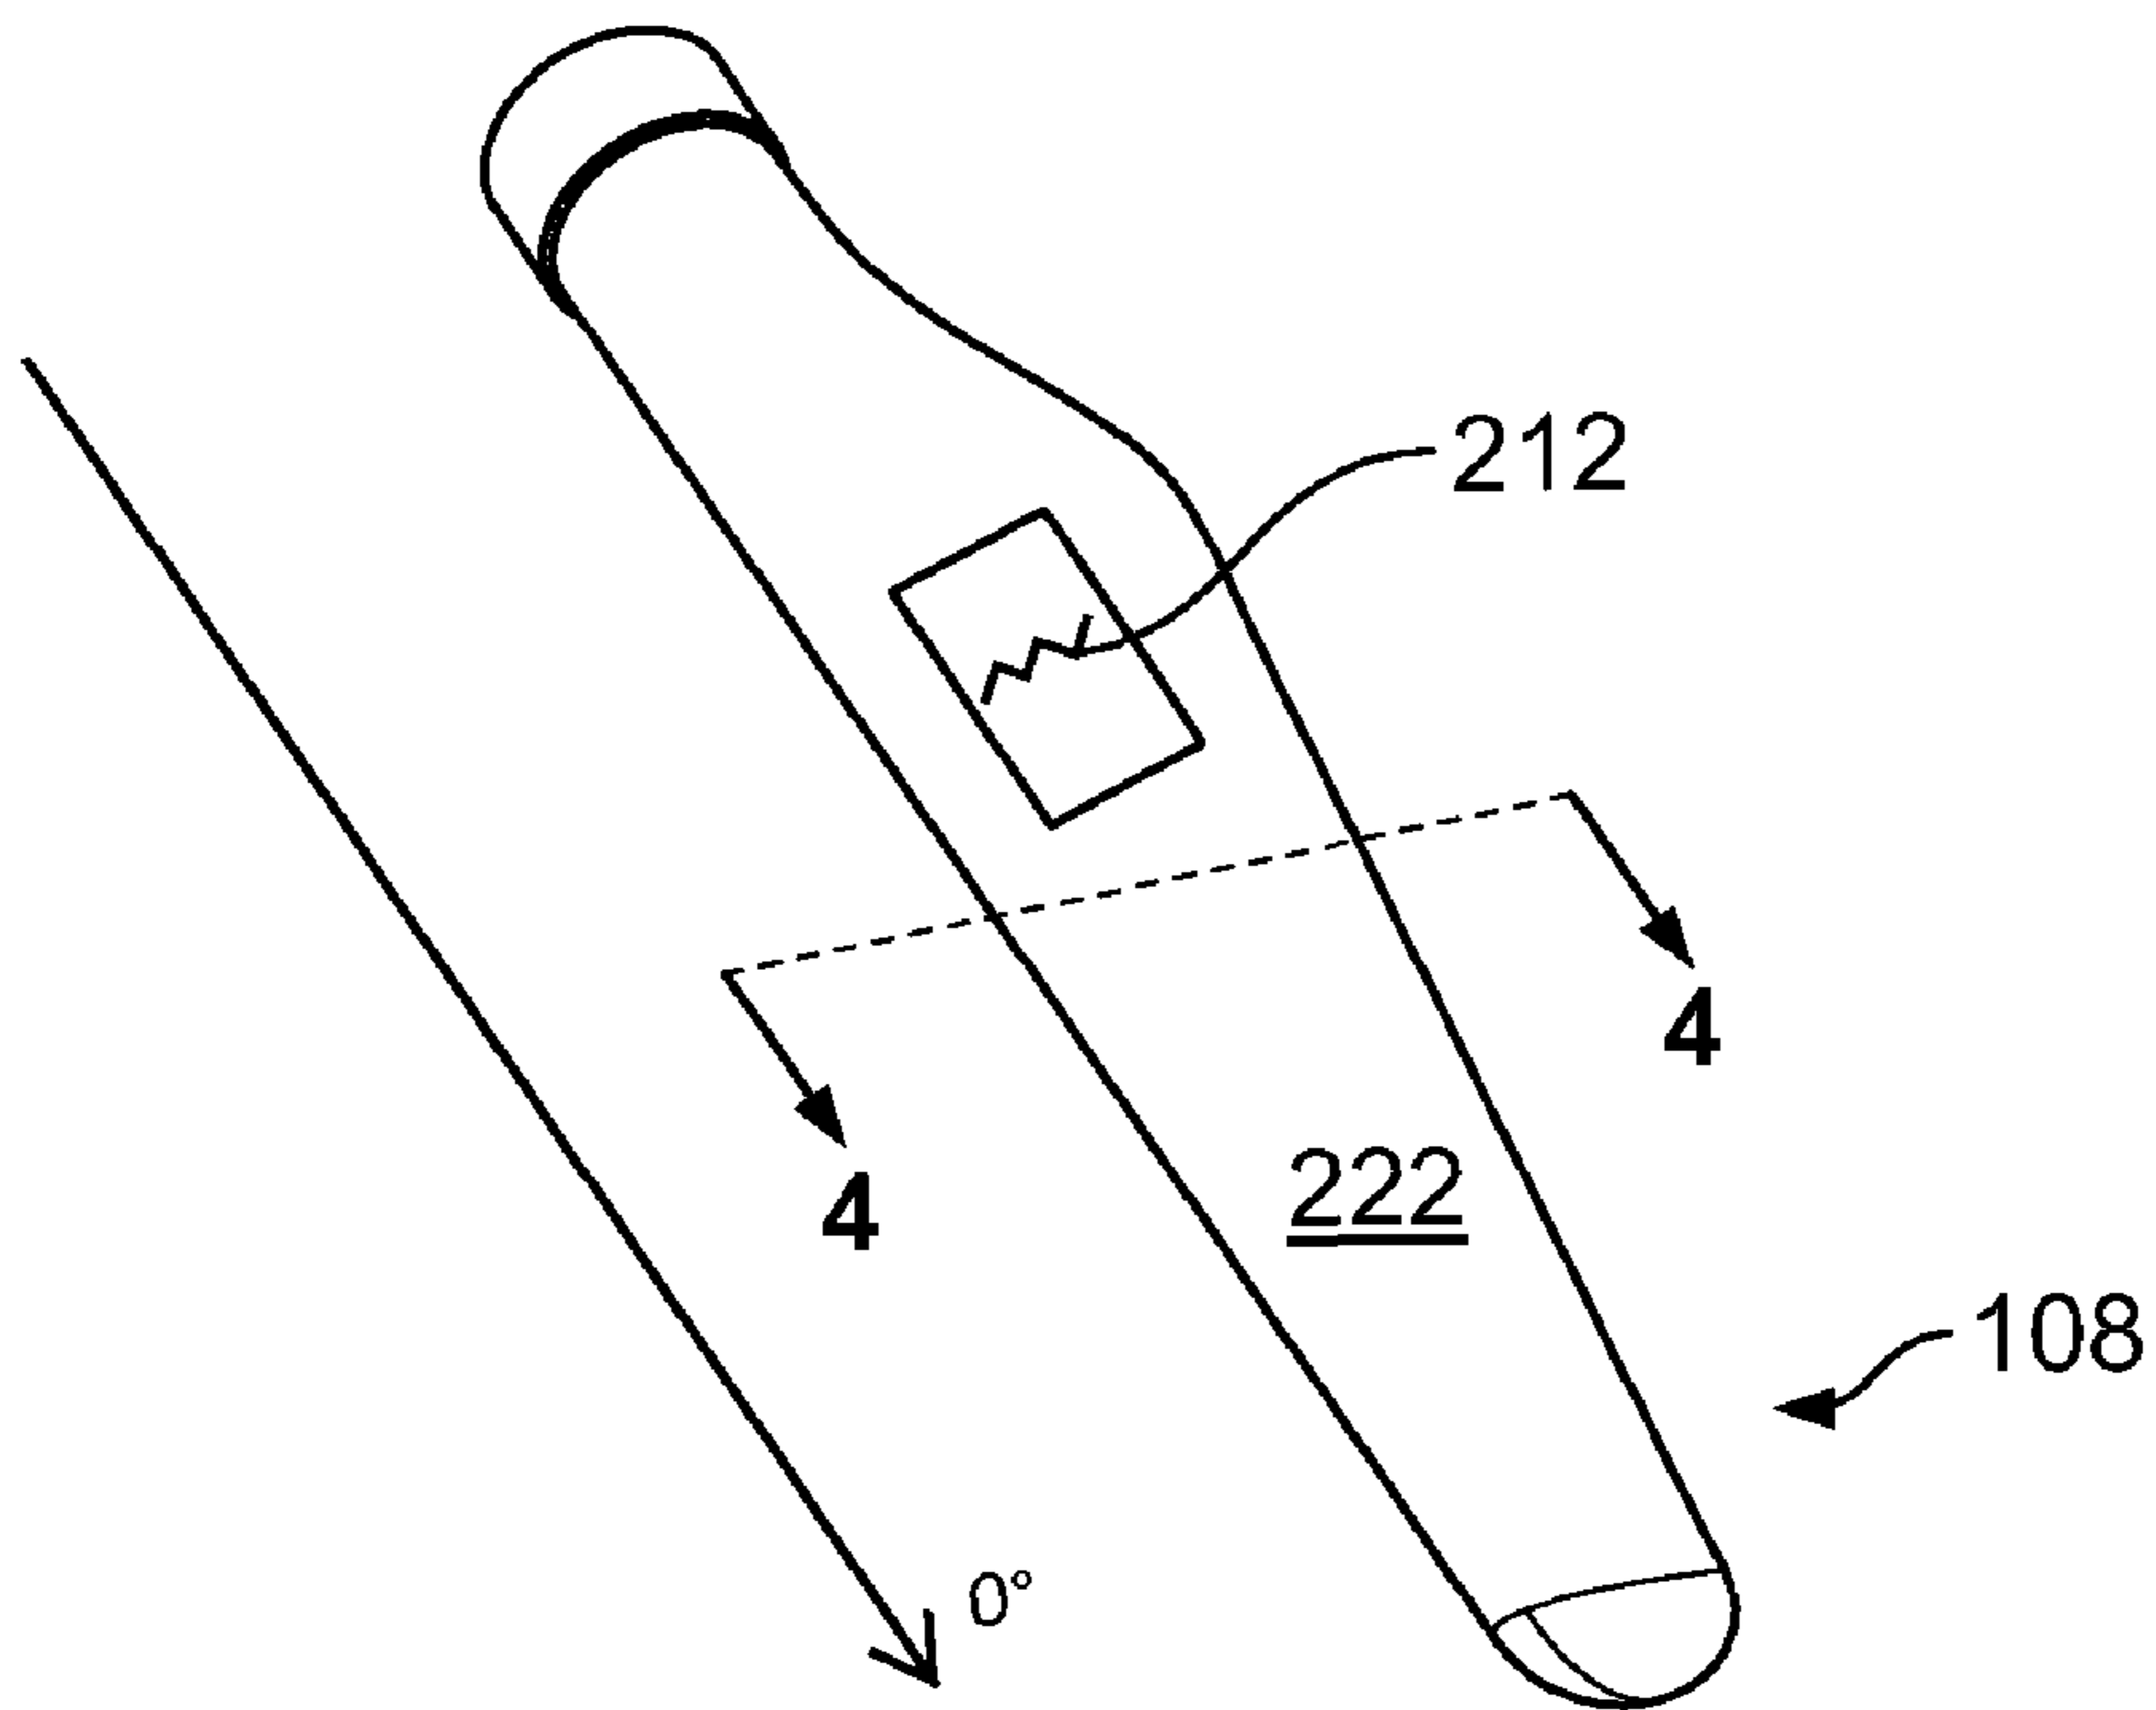
FIG. 2 is a perspective view of a wind turbine rotor blade having spar cap damage.

FIG. 2 shows damage **212** to a spar cap laminate **222** of wind turbine rotor blade **108**. Spar cap laminate **222** further includes a plurality plies of composite fabric fibers laid up and cured in a matrix to form the composite part. Damage **212** may include imperfections or defects from any number of typical composite failures, for example, such as, cracking, waves, and delamination. Currently, when wind damage **212** is discovered to spar cap laminate **222**, wind turbine rotor blade **108** cannot be repaired. As such, if a wind turbine rotor blade **108** is damaged it must be replaced with a new turbine blade, usually at a great cost and well before the end of the twenty-year service life period.

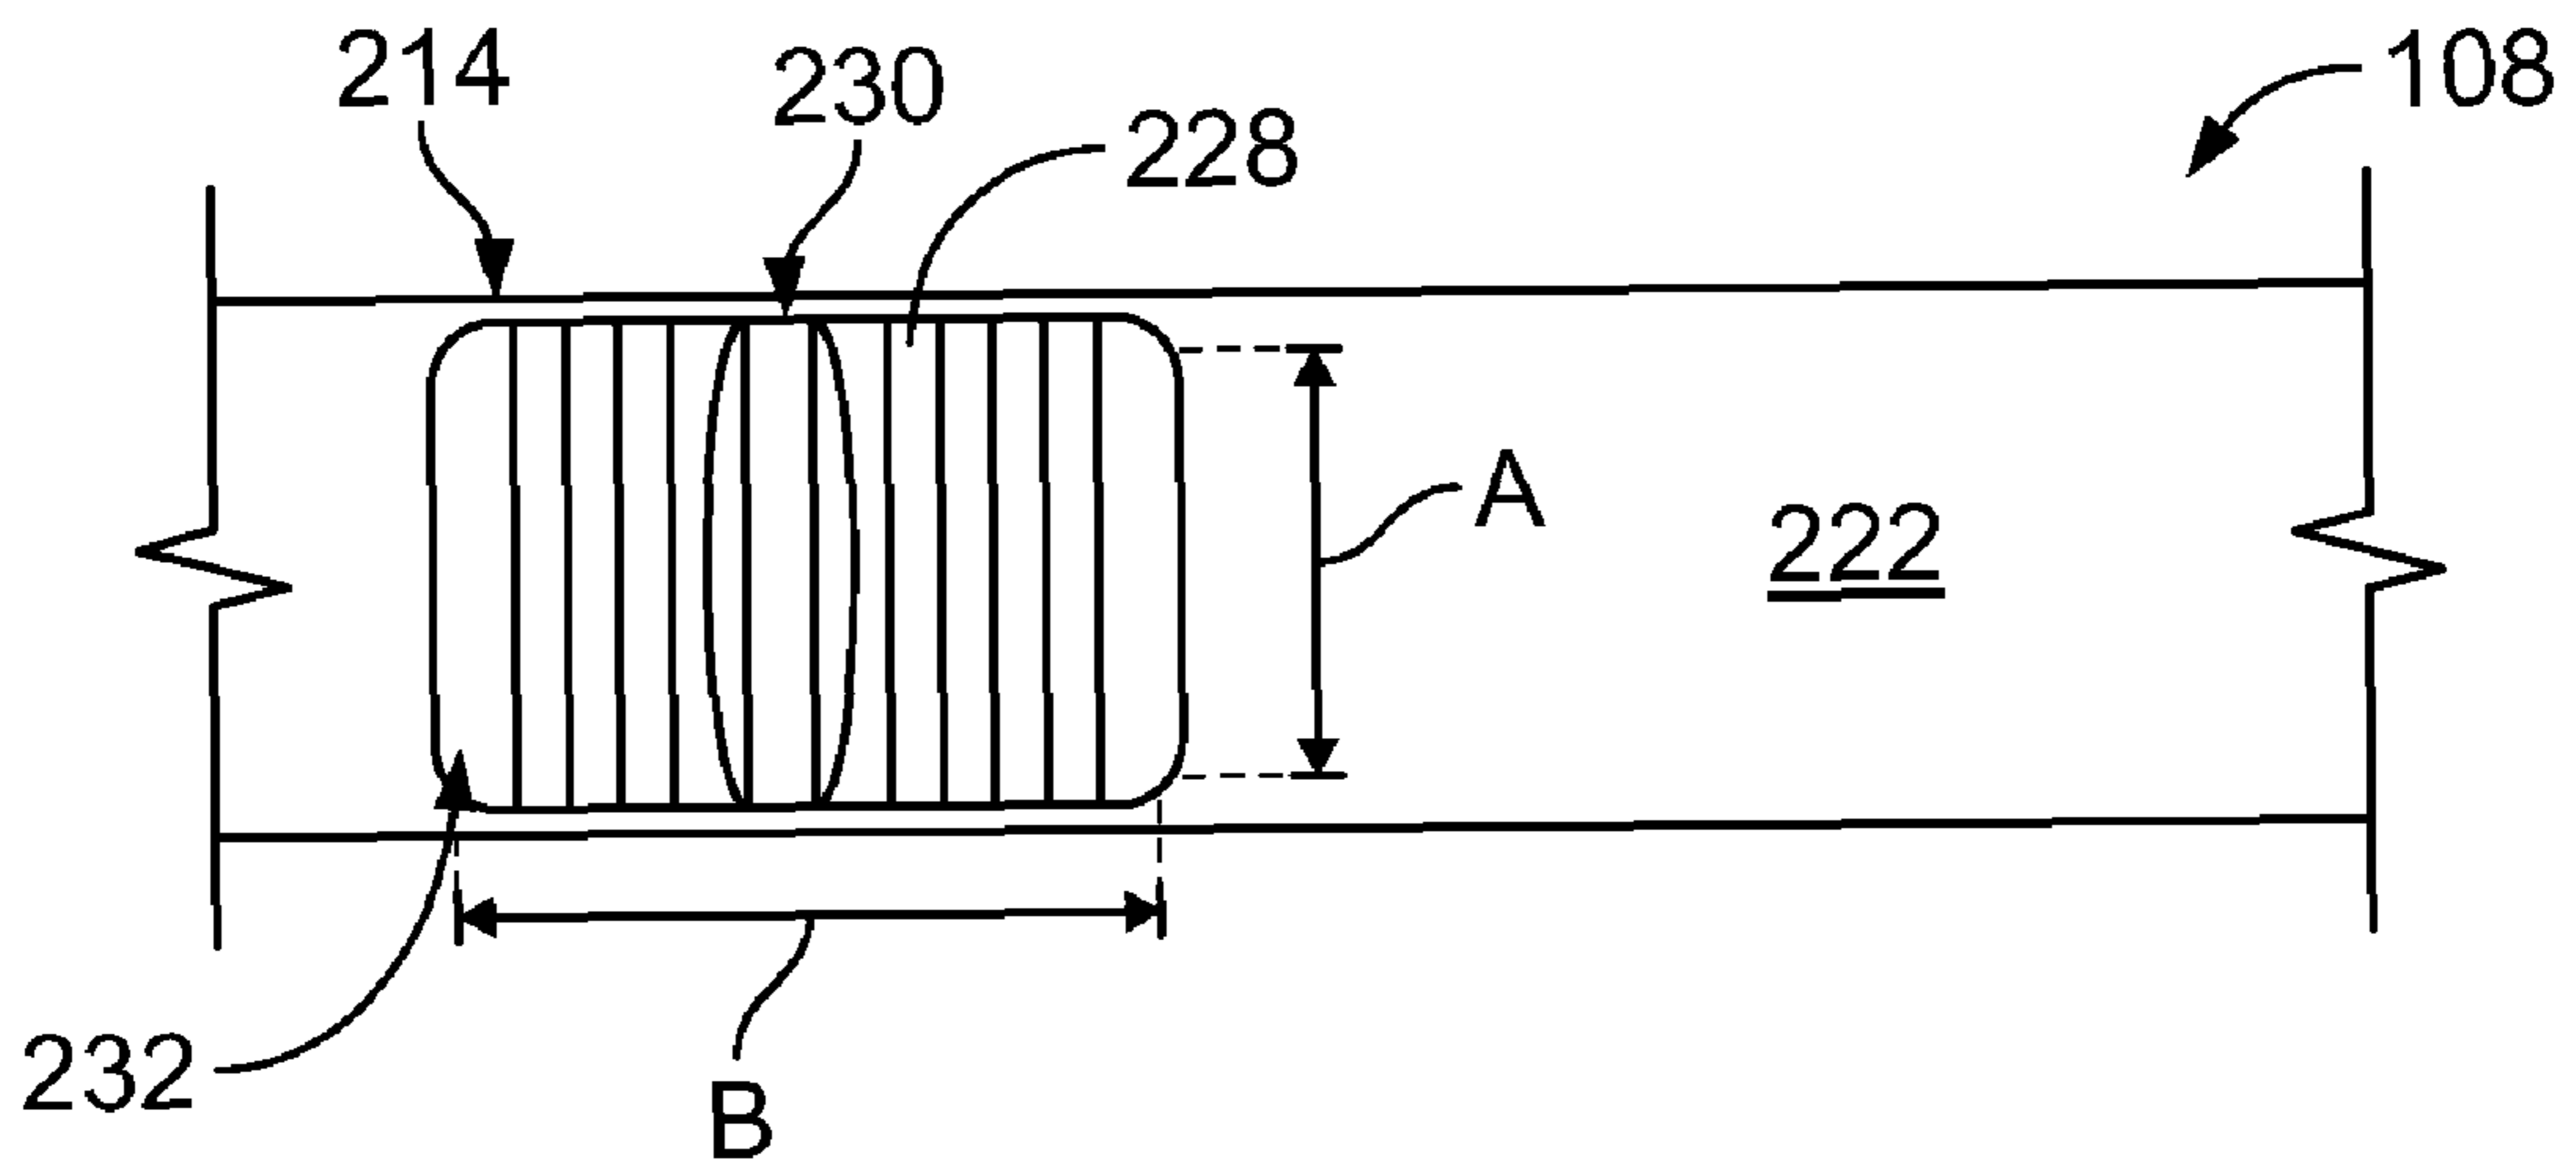
FIG. 3 is a top view of the wind turbine rotor blade depicting the prepared surface to receive a patch according to an embodiment of the present disclosure.

FIG. 3 is a top view of wind turbine rotor blade **108** showing prepared surface **214** of spar cap **222**. Prepared surface **214** further comprises a repair area **232** and an area **230** scarfed to receive a repair patch **210**. Repair area **232**, as utilized herein, is the total area that covered by repair **216**. Scarf area **230**, as utilized herein, is the area that is removed or scarfed from the original spar cap laminate **222**. Scarfing, as utilized herein, is defined as taper sanding or any other process in which composite material surfaces may be selectively removed. Any number of methods can be used to scarf the area to be repaired, for example, such as grit wheels, sand paper, or grinding. In one embodiment, repair area **232** is scarfed with a grit wheel to grind out each ply of spar cap laminate **222**. This grinding is done from the center out and down to the first ply of spar cap laminate **222**. Alternatively, the grinding can be through the first ply, so that a small cut-out or hole is formed in spar cap laminate **222**. Next, using the proper tooling, a preselected distance on each side of the first layer of spar cap laminate **222** is stepped out from the center of the first ply of spar cap laminate **222**. The stepping distance **228** will depend on the thickness and number of plies in spar cap laminate **222**. While not so limited, stepping distance **228** on each side may be from about 25 millimeters to about 50 millimeters. Next, the grit wheel is used to grind up to or step out to the second ply of spar cap laminate **222** at a preselected distance from the center of the repair area **232** of first ply of spar cap laminate **222**. The process of stepping out and grinding for each ply is repeated until all of the plies in spar cap laminate **222** are indentified, and a small area of each ply is ground out of spar cap laminate **222**. After the steps **228** have been made in spar cap laminate **222**, scarf area **230** and repair area **232** may be sanded with sandpaper to produce prepared surface **214**. In one embodiment, 180-grit to 220-grit sandpaper is on scarf area **230** and repair area **232** to produce prepared surface **214**. Scarf area **230** is shown as the width measurement A and the length measurement B (FIG. 3). Scarf area **230** is prepared using a predetermined scarf ratio or scarf joint. Scarf ratio or scarf joint, as utilized herein, is defined such that for every inch of laminate thickness of the original spar cap there are a number of inches of prepared surface **214** on each side from the center of the scarf area **230** for a total number of inches (shown in FIG. 3 as length (B)) per inch of thickness of the original spar cap laminate. In one embodiment, a scarf ratio of approximately 20:1 to approximately 70:1 may be used to provide prepared surface **214**, alternatively a ratio of 40:1 to approximately 60:1 may be used to provide prepared surface **214**, or a ratio 45:1 to 55:1 may be used to provide prepared surface **214**. Scarf angle, as utilized herein, is defined as the angle ( $\theta$ ) that results from the use of a particular scarf ratio. According to an embodiment of this disclosure, a scarf angle ( $\theta$ ) of approximately  $1.0^\circ$  to approximately  $3.5^\circ$  may result, alternatively a scarf angle ( $\theta$ ) of approximately  $1.0^\circ$  to approximately  $2.0^\circ$  may result, or a

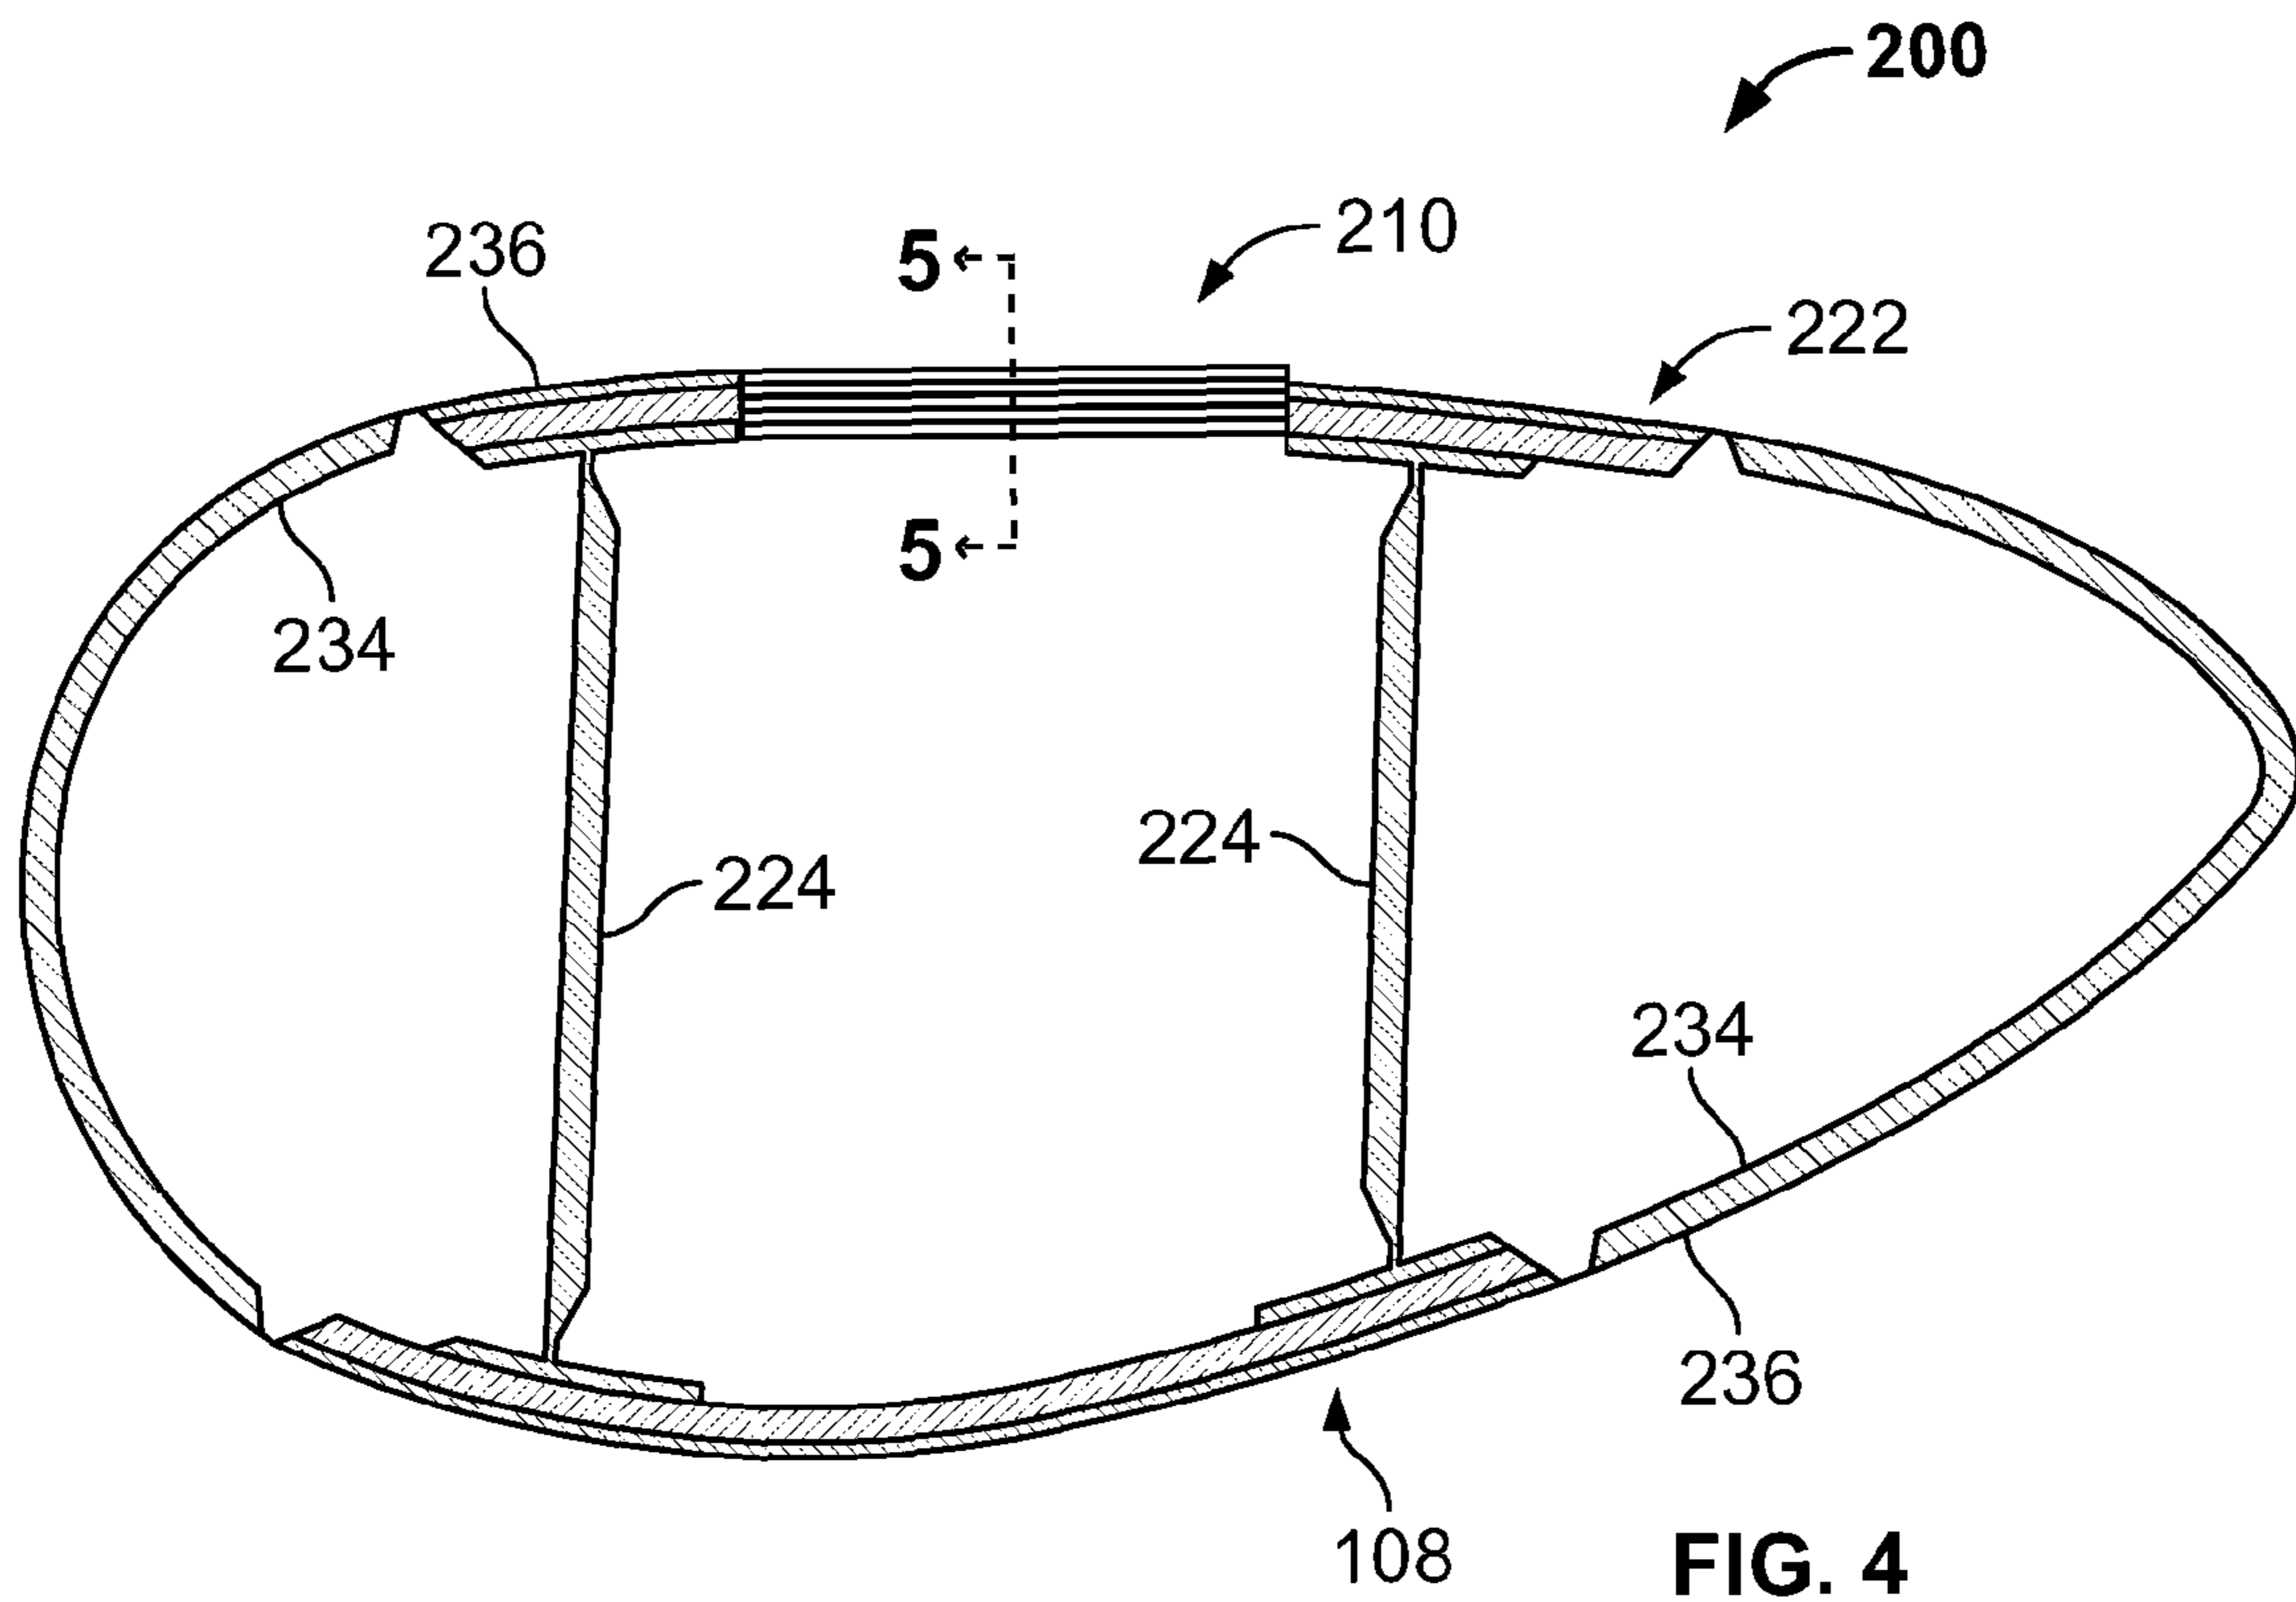
FIG. 4 is a sectional view of the spar cap of a wind blade of FIG. 2 taken in direction 4-4 showing a patch according to an embodiment of the present disclosure.

FIG. 4 is a sectional view in the 4-4 direction of FIG. 2. Wind turbine rotor blade **108** comprises spar cap laminate **222** and shear webs **224**. Spar cap **222** comprises an interior surface **234** and an exterior surface **236**. As shown in the figure, exterior surface **236** contains repair patch **210**.

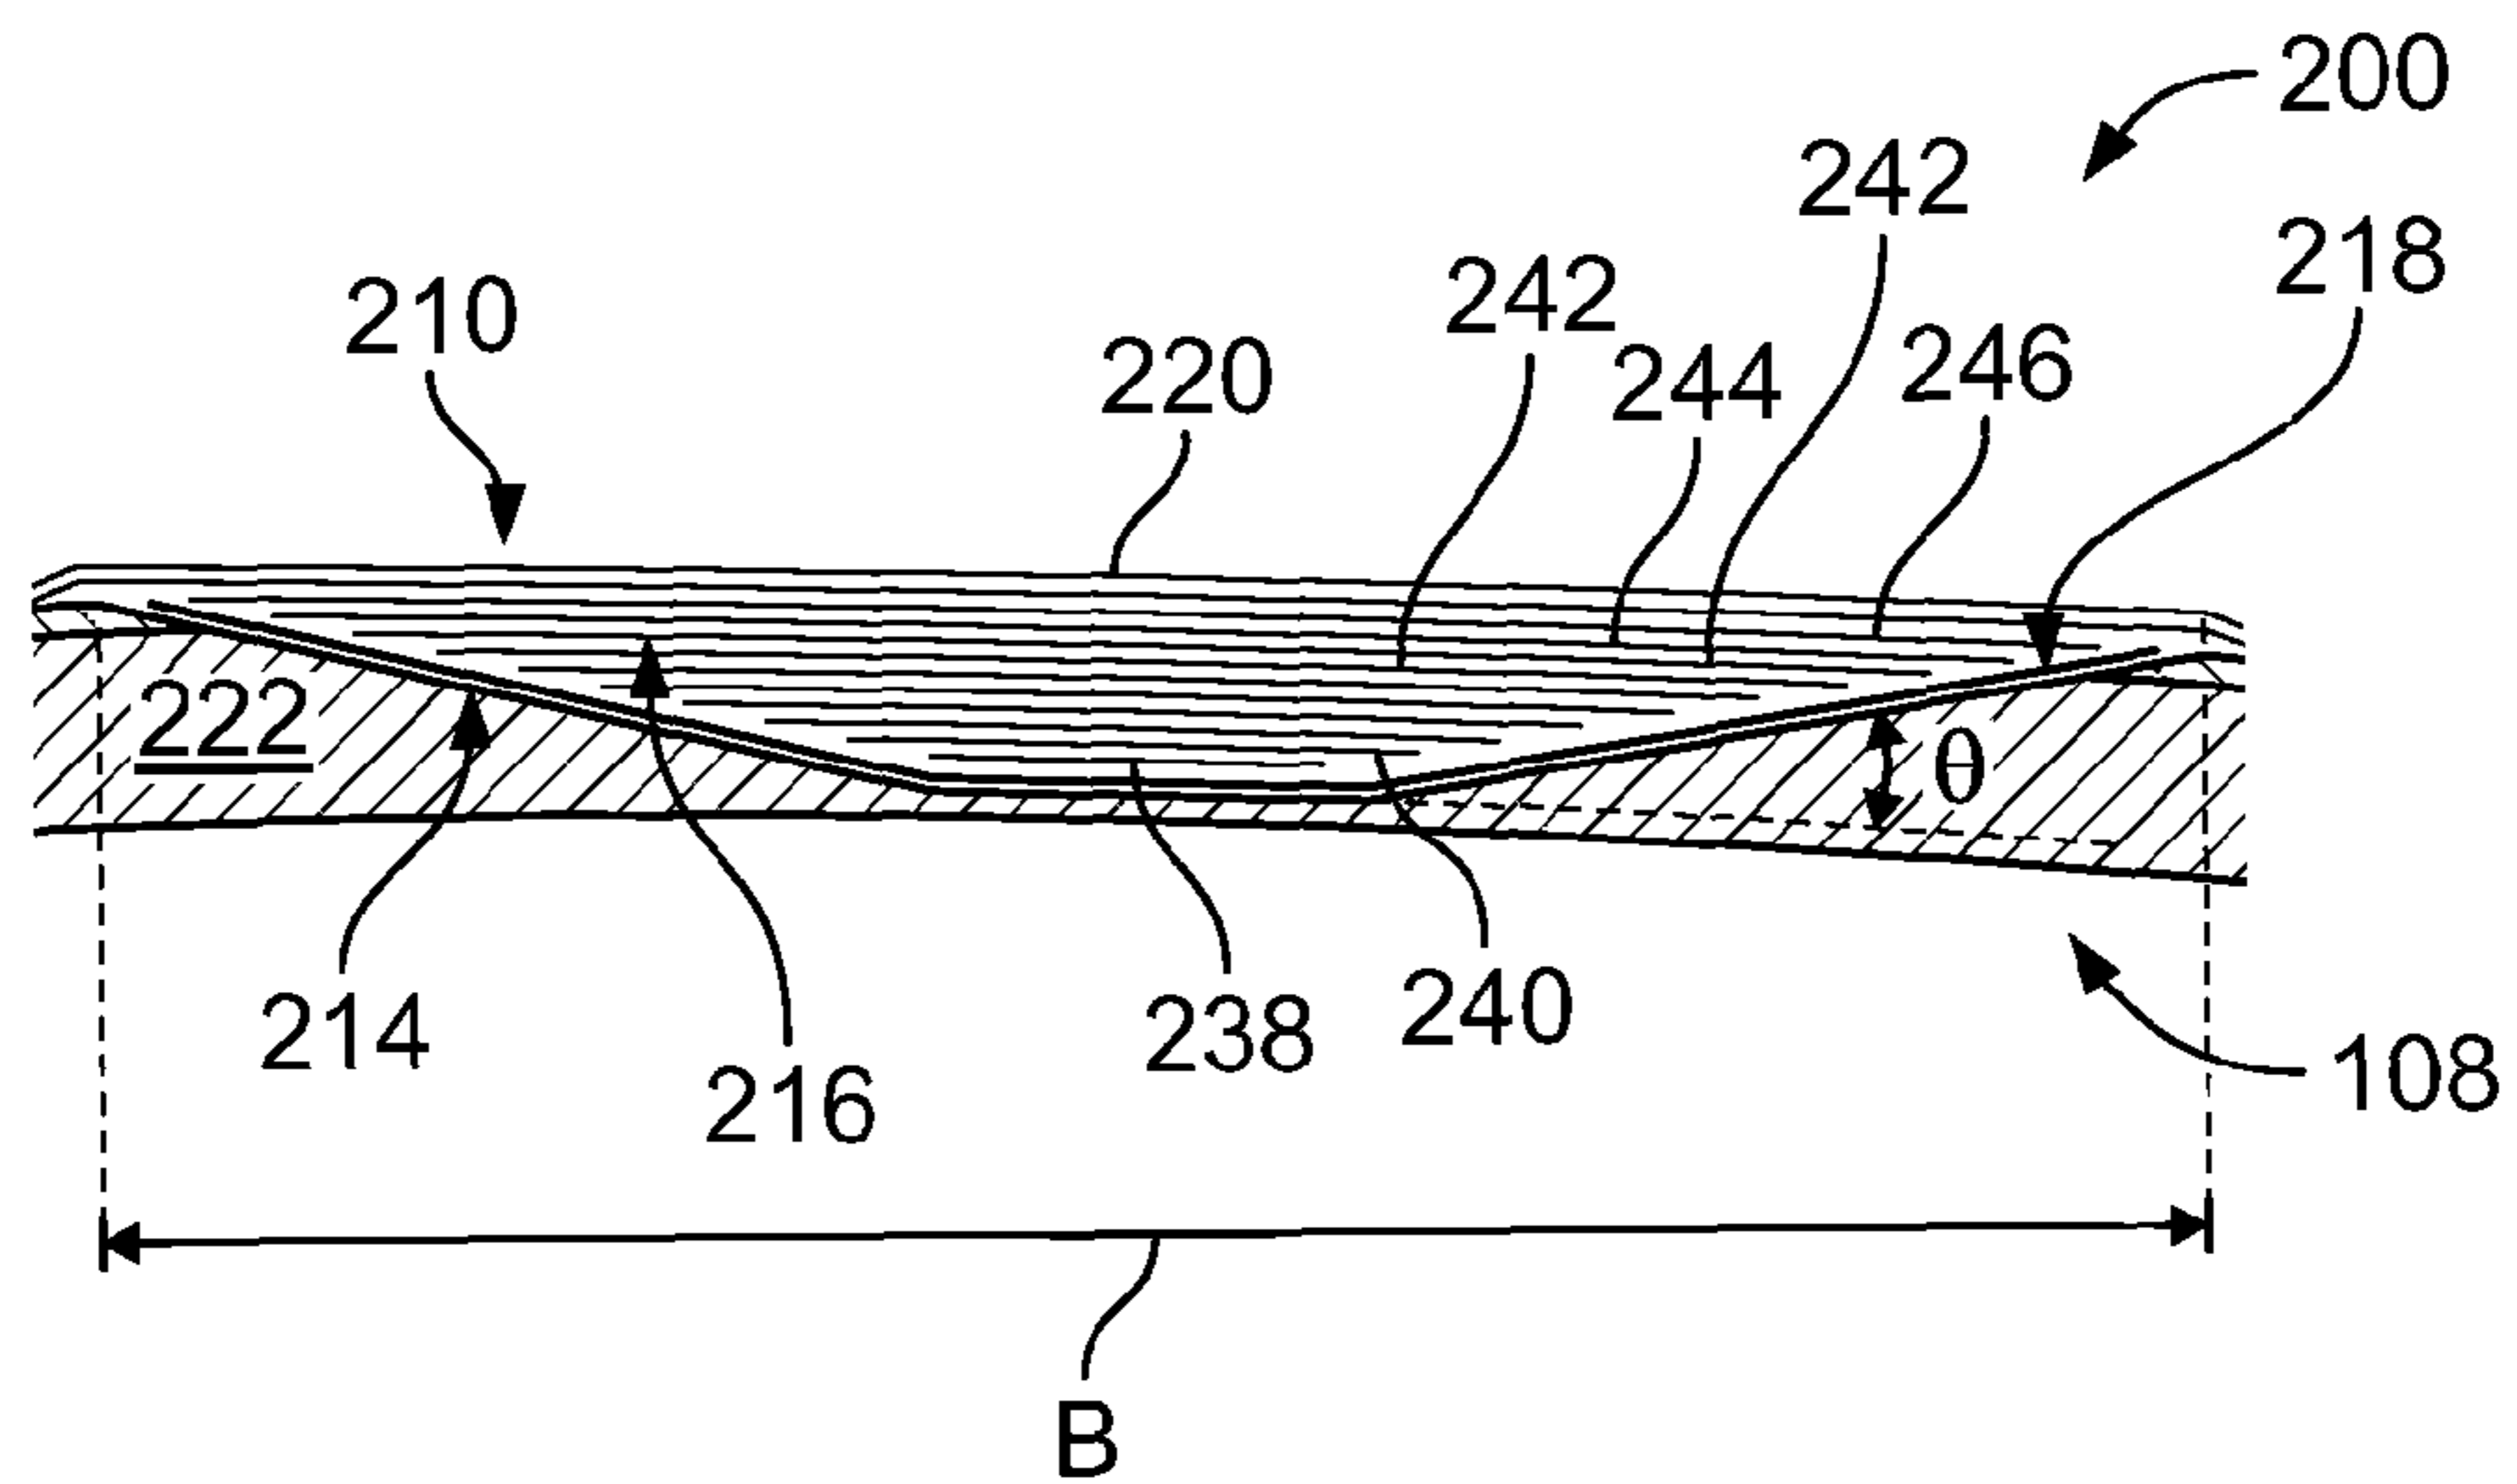
FIG. 5 is a sectional view in the 5-5 direction of the patched wind turbine rotor blade of FIG. 4 of the present disclosure.

FIG. 5 is a sectional view in the 5-5 direction of patched wind turbine rotor blade **200** of FIG. 4. Repair patch **210** is applied to spar cap laminate **222** of wind turbine rotor blade **108**, and further includes prepared surface **214**, an adhesive region **218** disposed on or adjacent to prepared surface **214**, and a repair **216** disposed on or adjacent to adhesive region **218**. Adhesive region **218** sufficiently bonds repair **216** to the prepared surface **214** to substantially match the mechanical properties of the bulk of the turbine blade **108**. Repair patch **210** can further include a backing plate (not shown) of fiberglass, cardboard or sheet metal on the interior of the spar cap to assist in lay-up of adhesive region **218** on prepared surface **214**. The backing plate is removed after installation of repair patch **210**.
