(10) **Patent No.:** **US 7,934,315 B2**
(45) **Date of Patent:** **May 3, 2011**

(54) **METHOD OF REPAIRING SHROUDED TURBINE BLADES WITH CRACKS IN THE VICINITY OF THE OUTER SHROUD NOTCH**

(57) **ABSTRACT**

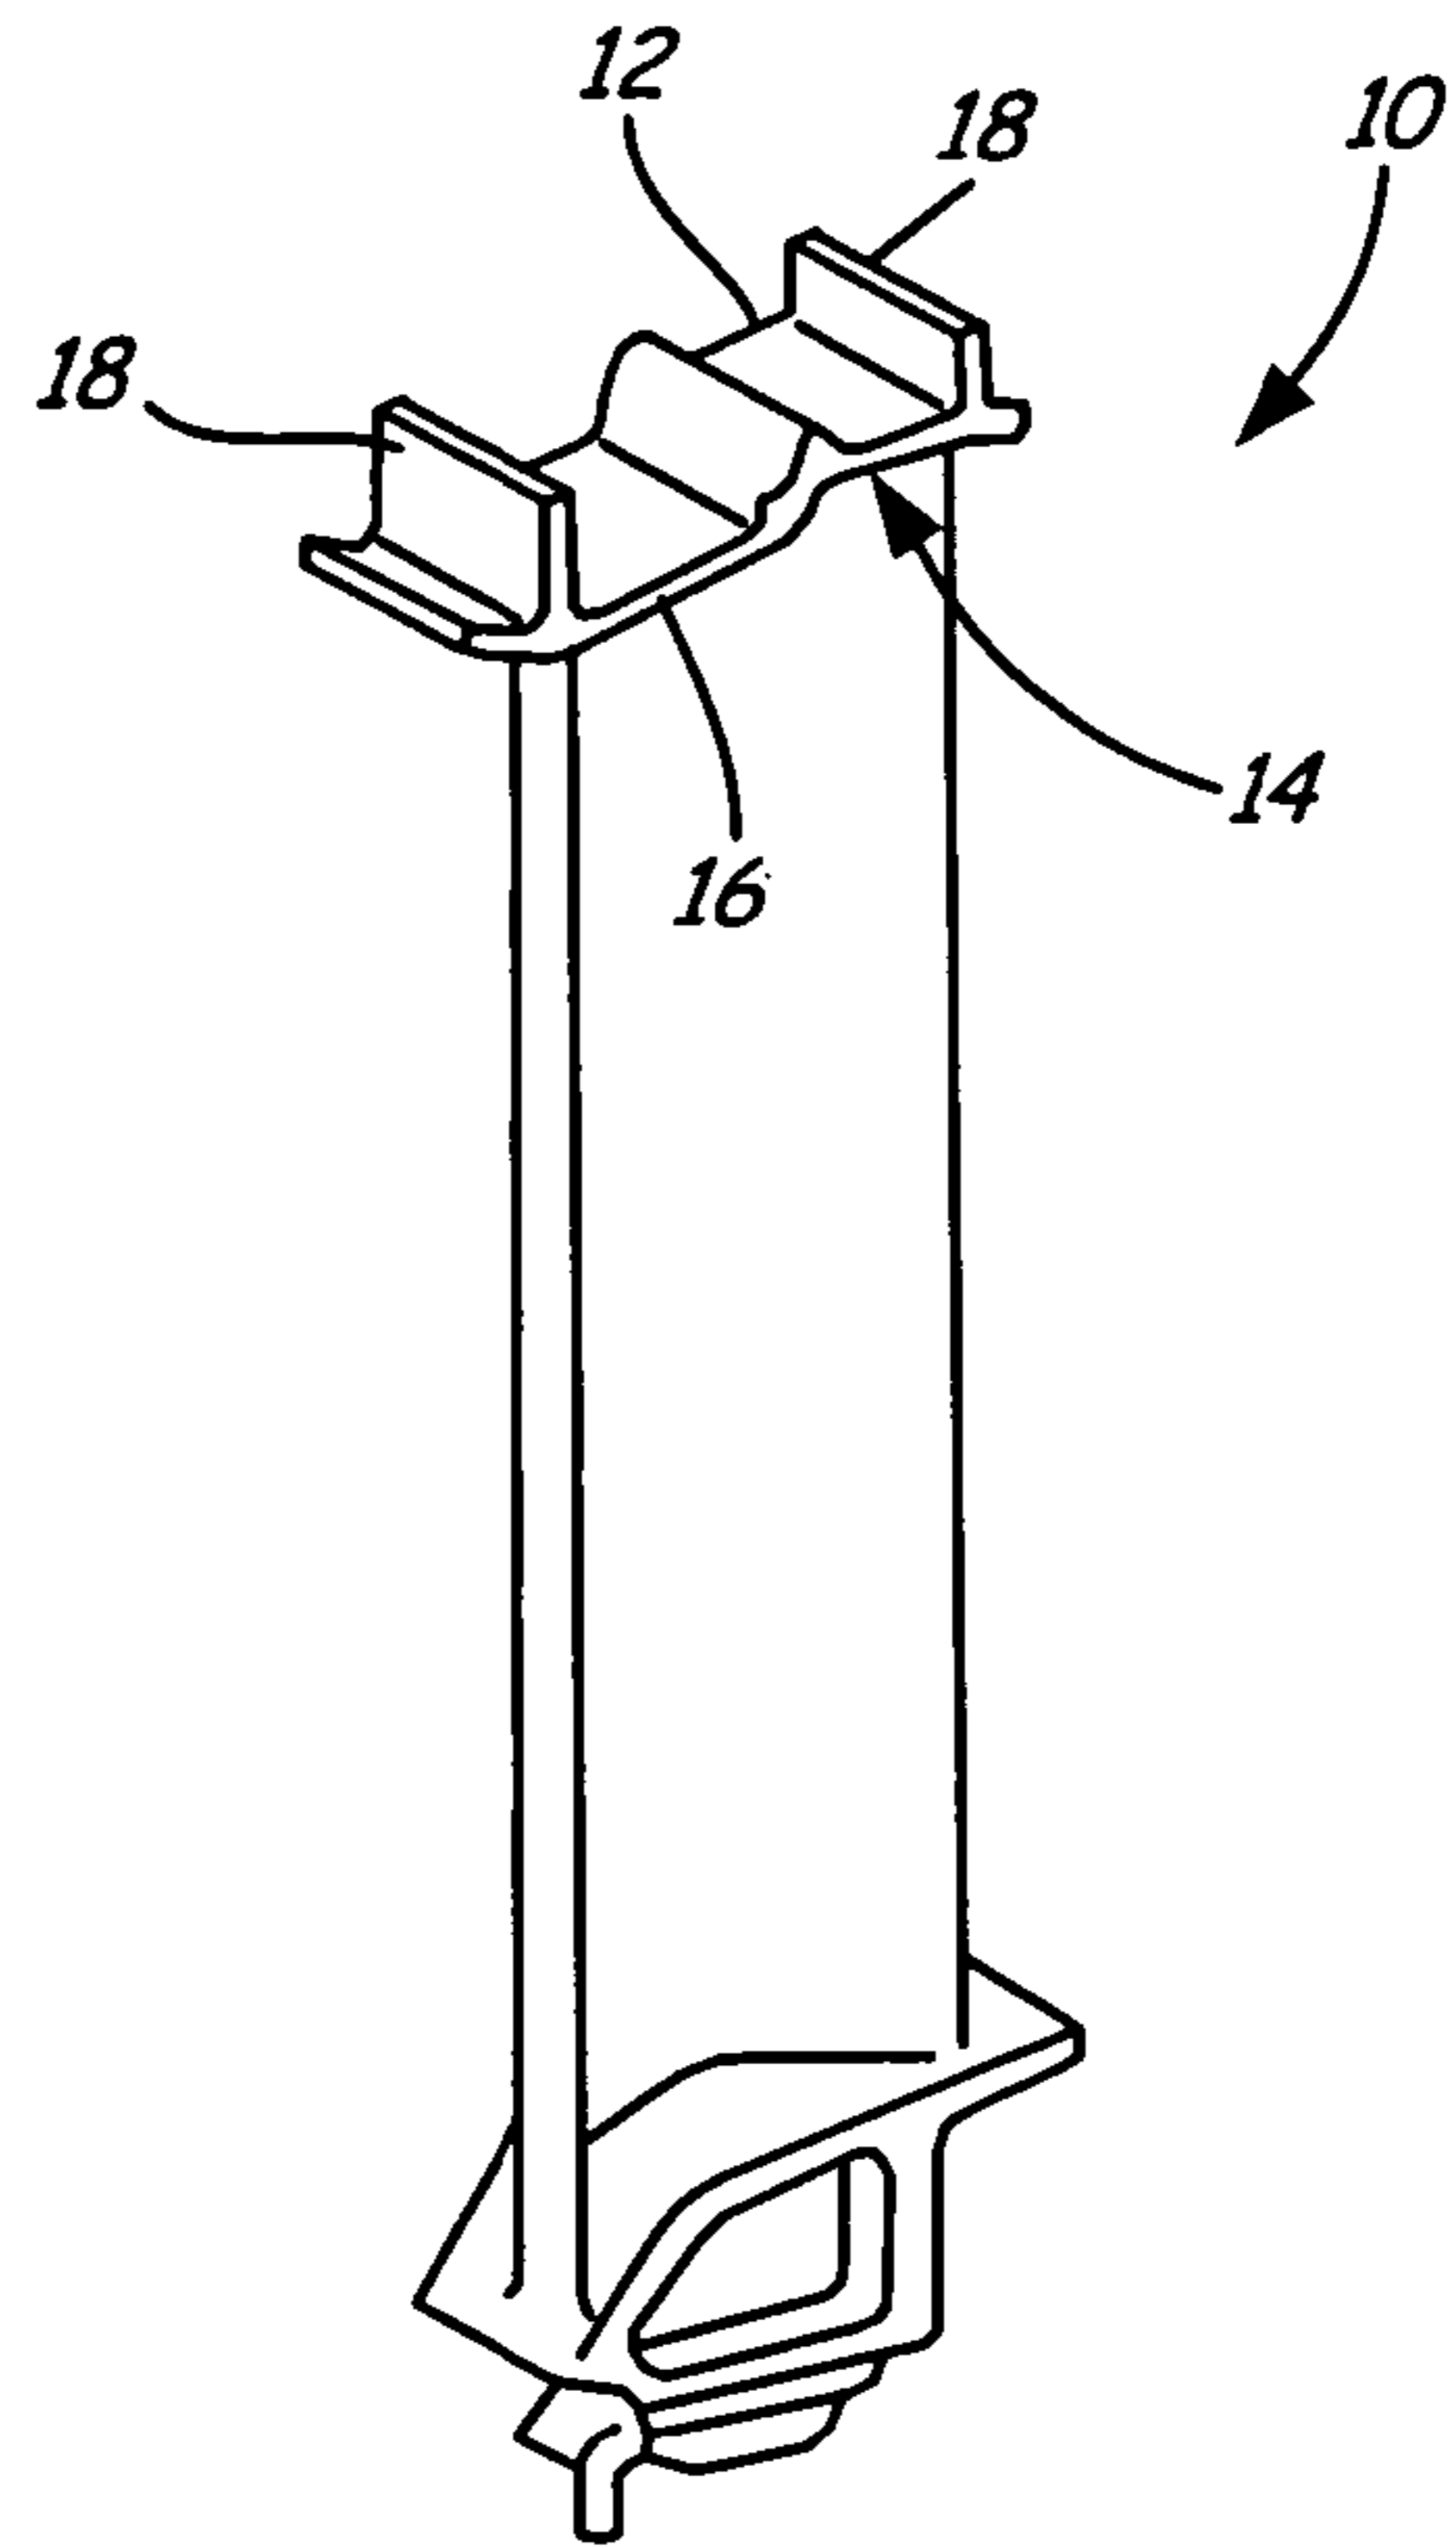
FIG. 1 is a perspective view of a turbine blade.

FIGS. 1 and 2 show a perspective view of turbine blade 10 and a top view of shroud 12 of turbine blade 10, respectively, and will be discussed in conjunction with one another. Turbine blade 10 generally includes shroud 12 positioned at a top end 14 of turbine blade 10. Shroud 12 has an original edge 16 and generally includes air seals 18, notch fillet radius 20, and hardface structures 22. Notch fillet radius 20 is formed at original edge 16 of shroud 12. Hardface structure 22 is welded to original edge 16 adjacent notch fillet radius 20 and functions to dissipate the vibration energy when hardface structure 22 rubs against adjacent blade hardfaces. In operation, the shrouds of adjacent turbine blades are positioned next to each other such that each notch fillet radius 20 of shroud 12 abuts a hardface structure of an adjacent shroud on either side of shroud 12. Turbine blade 10 is exposed to high temperatures and vibratory stresses present in jet turbine engines with loads constantly exerted on original edge 16 of shroud 12, and particularly notch fillet radius 20. Thus, notch fillet radius 20 and the area proximate notch fillet radius 20 can crack, with the crack typically radiating inward. Whereas current repair techniques only allow cracks of up to approximately 0.03 inches deep to be repaired, the new methods of repairing cracks described herein allow cracks up to approximately 0.1 inches deep to be repaired. This allows many parts to be repaired instead of being scrapped.

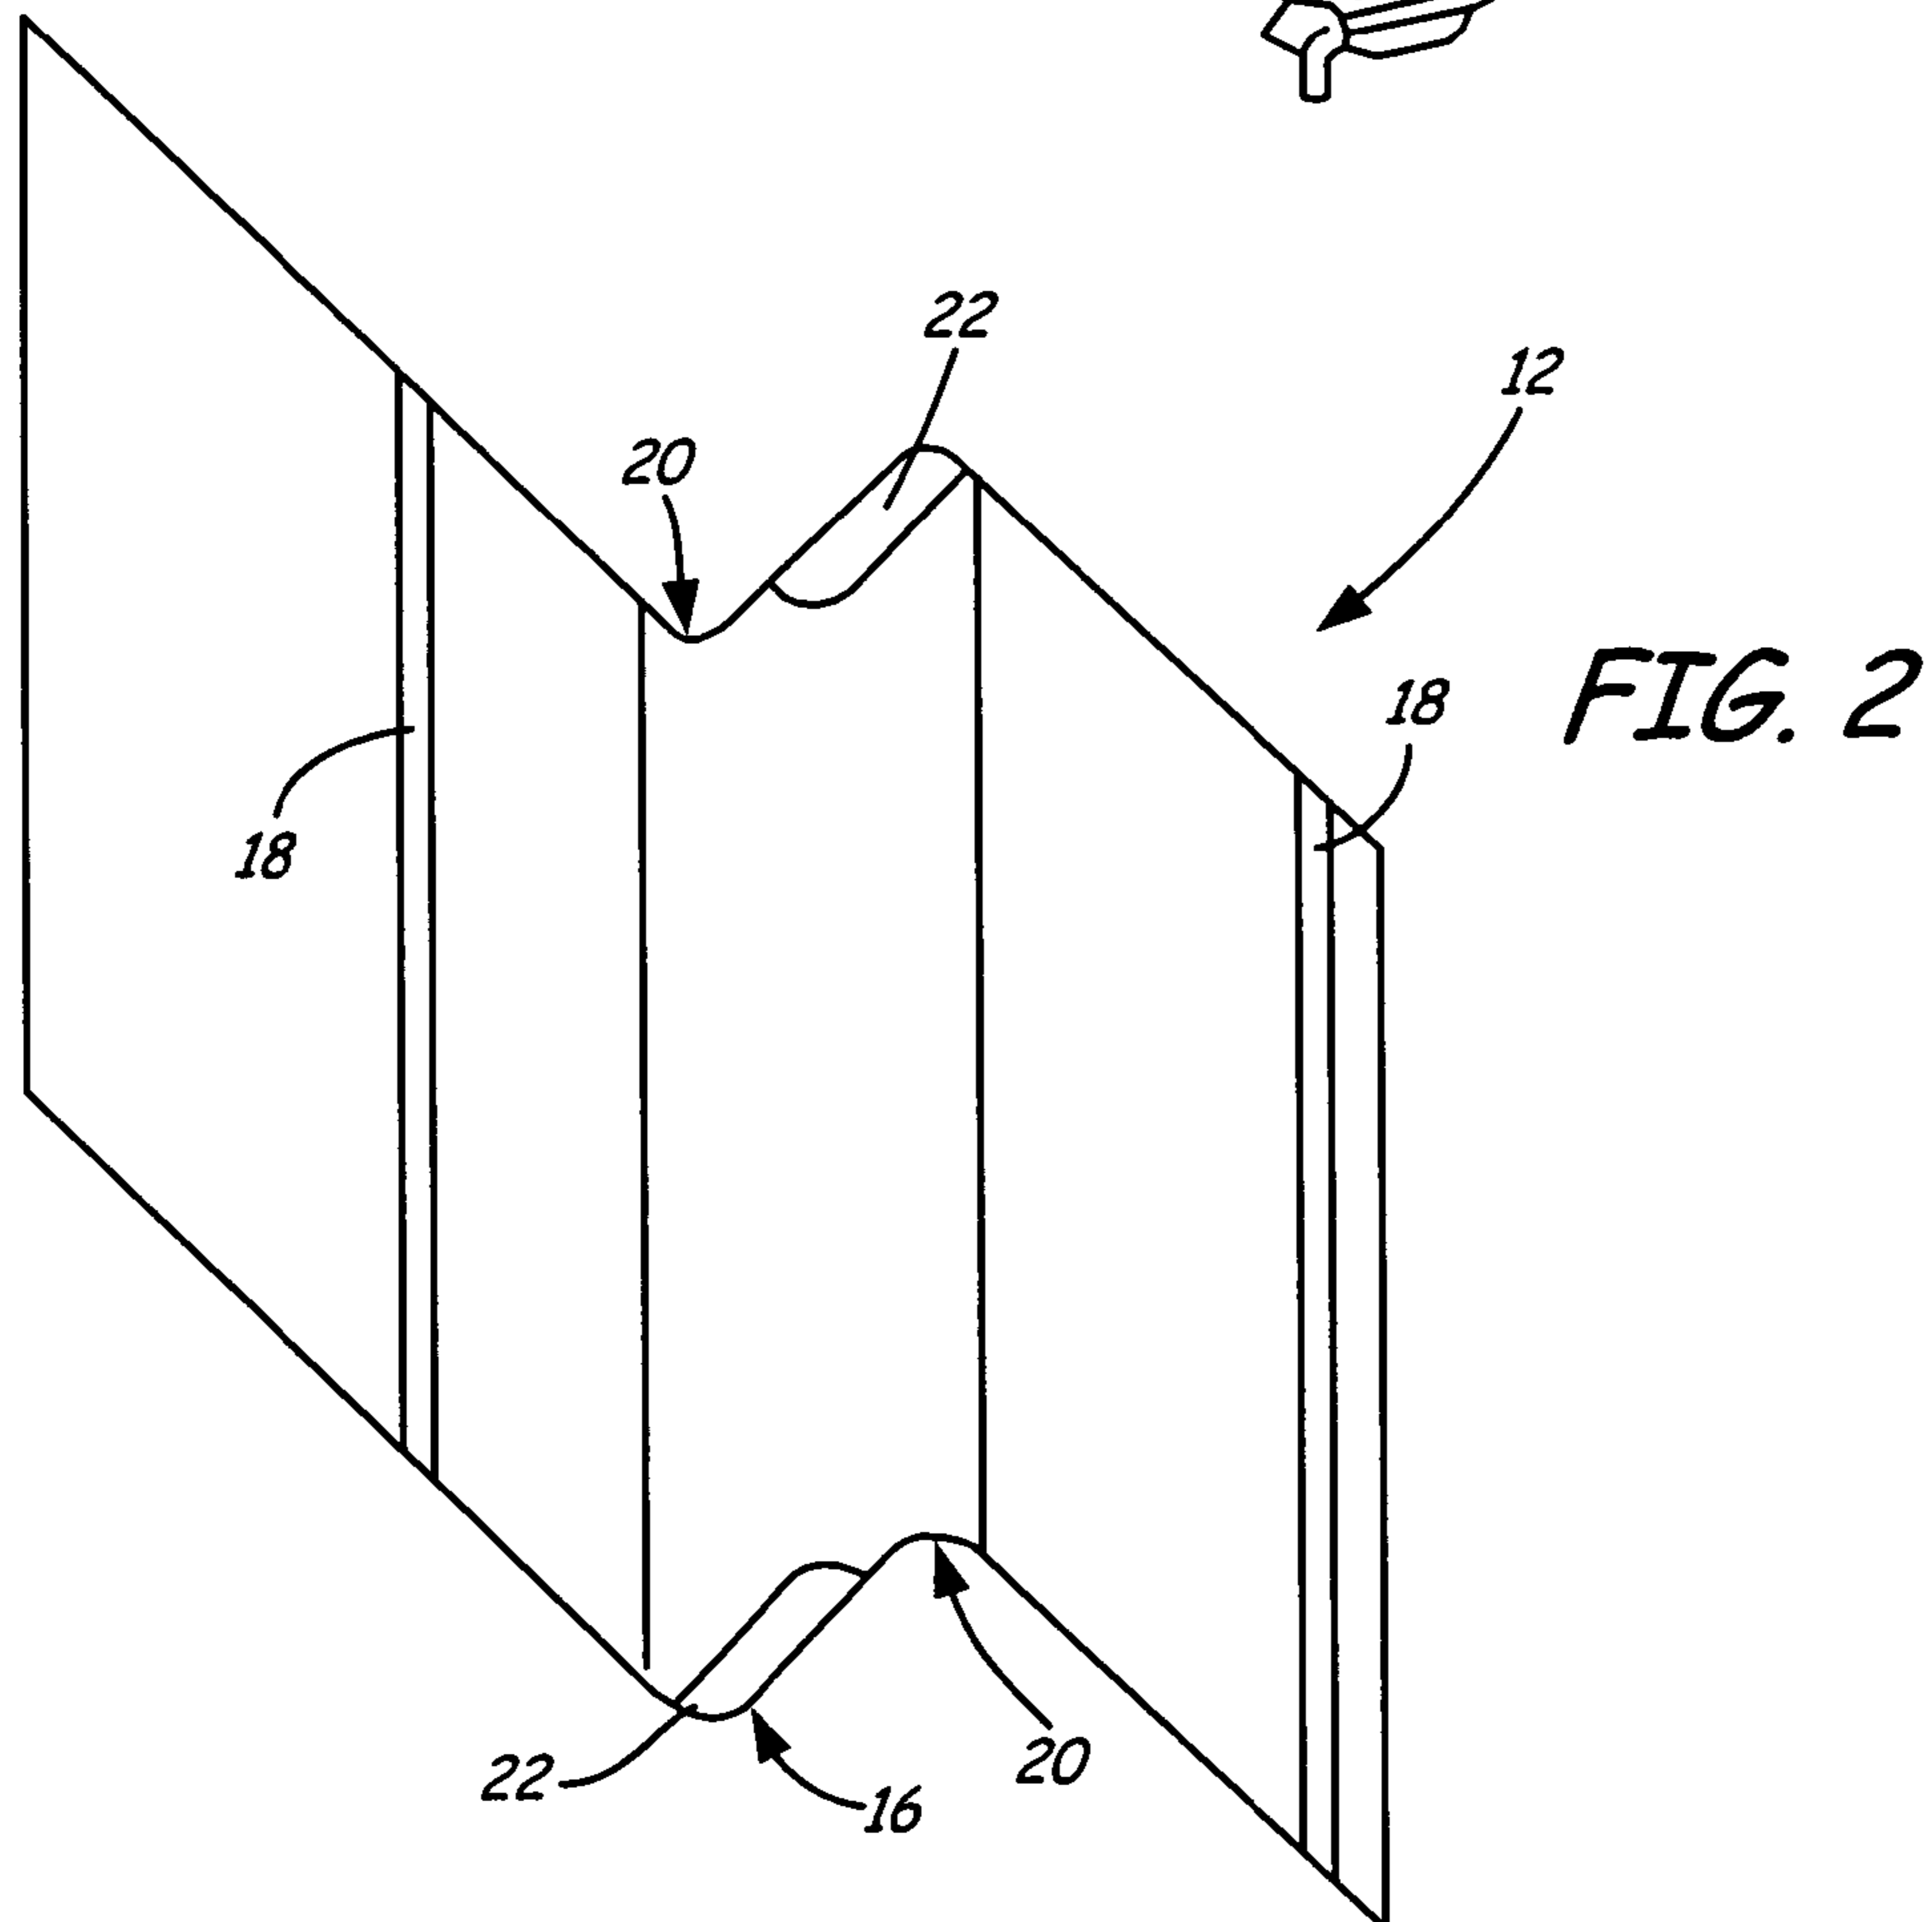
FIG. 2 is an enlarged top view of a shroud of the turbine blade.

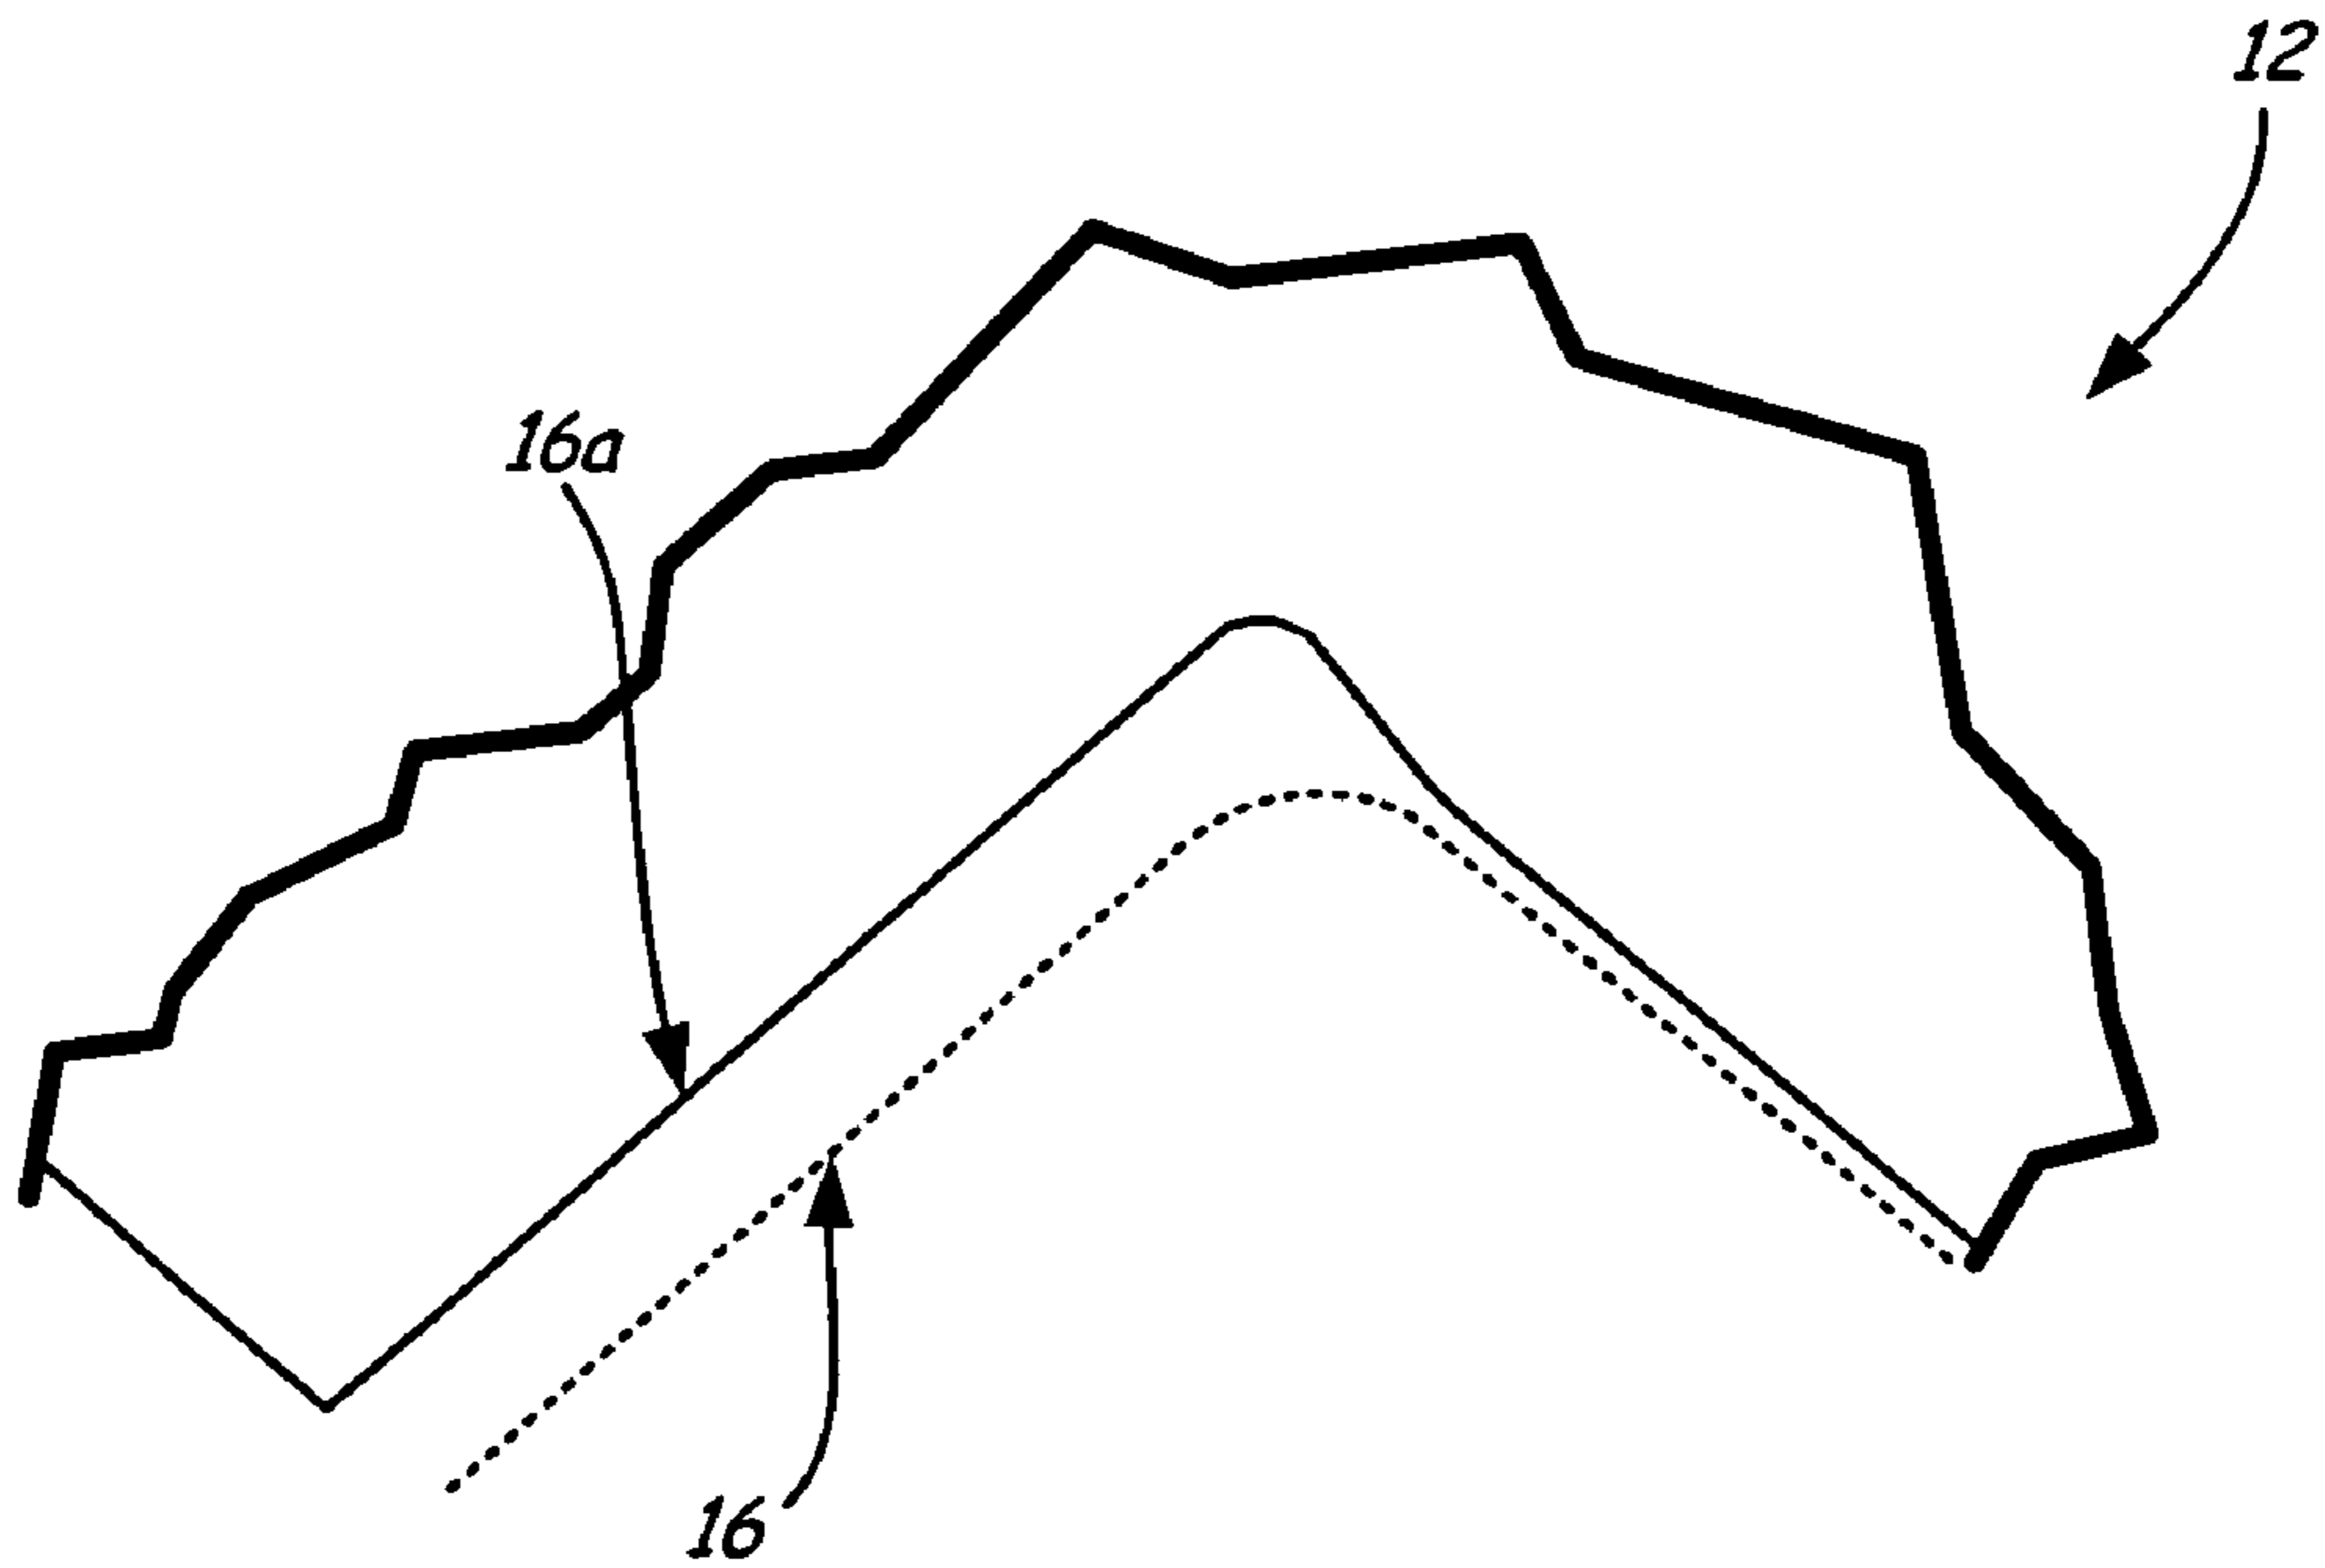
FIG. 5 is an enlarged view of the notch fillet radius with a hardface structure of the turbine blade removed.

FIG. 5 shows an enlarged view of new edge 16a after notch fillet radius 20 and hardface structure 22 have been removed from shroud 12. After crack 24 (shown in FIG. 3) and the area proximate crack 24 have been blended out from shroud 12, hardface structure 22 (shown in FIG. 4) is also removed from shroud 12. Hardface structure 22 may be removed in any suitable manner, such as by machining or grinding hardface structure 22 from shroud 22. Removal of crack 24, the area proximate crack 24, and hardface structure 22 essentially eliminates original edge 16 (shown in FIG. 3) and forms new edge 16a as the new perimeter of shroud 12.

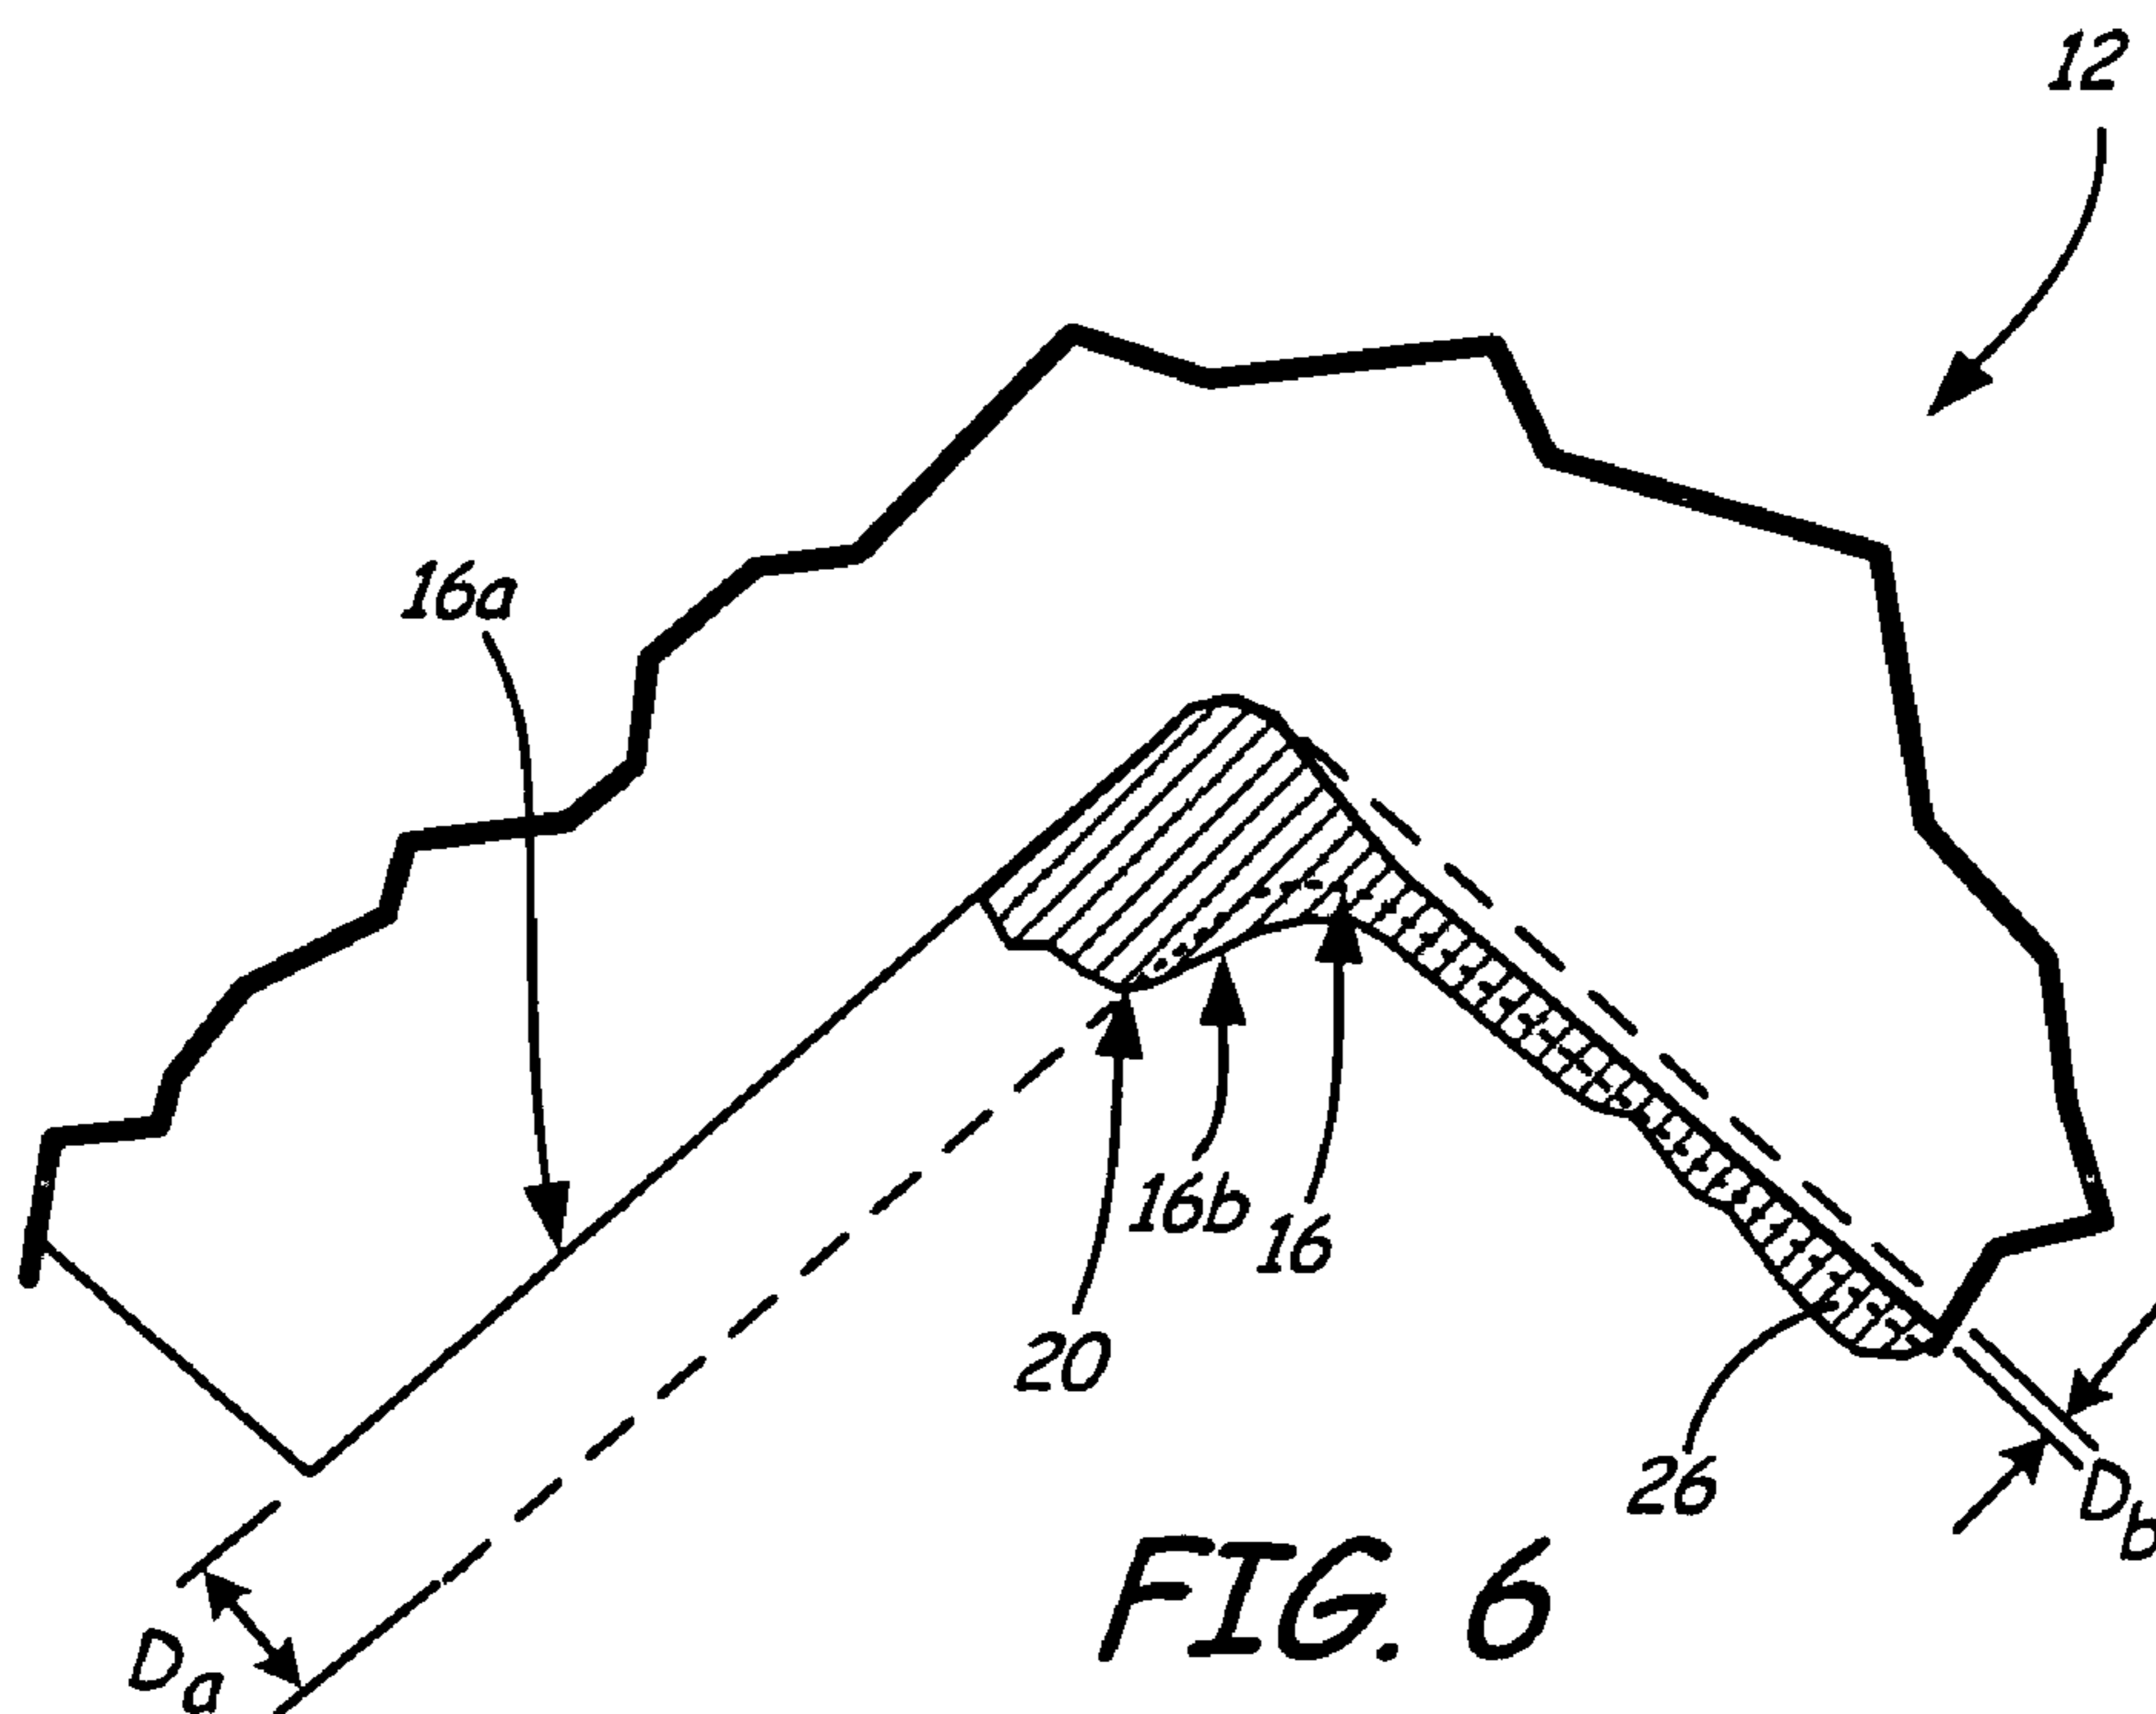
FIG. 6 is an enlarged view of the notch fillet radius with a replacement weld.

FIG. 6 shows an enlarged view of new edge 16a and notch fillet radius 20 with replacement weld 26. Once crack 24 and hardface structure 22 (shown in FIG. 3) have been removed from shroud 12, replacement weld 26 is formed with a weld filler along a portion of new edge 16a. Replacement weld 26 is formed to fill in the notch fillet radius removed by blending out crack 24 and has a height of at least depth D_a and a width of at least depth D_b . Replacement weld 26 thus takes the shape of notch fillet radius 20 that was previously removed and extends new replacement weld edge 16b back to at least original edge 16 at notch fillet radius 20. While any suitable weld filler material may be used, in one embodiment, a suitable weld filler is a nickel-based alloy known as Inconel 625, available from International Nickel, Inc., Saddle Brook, N.J.

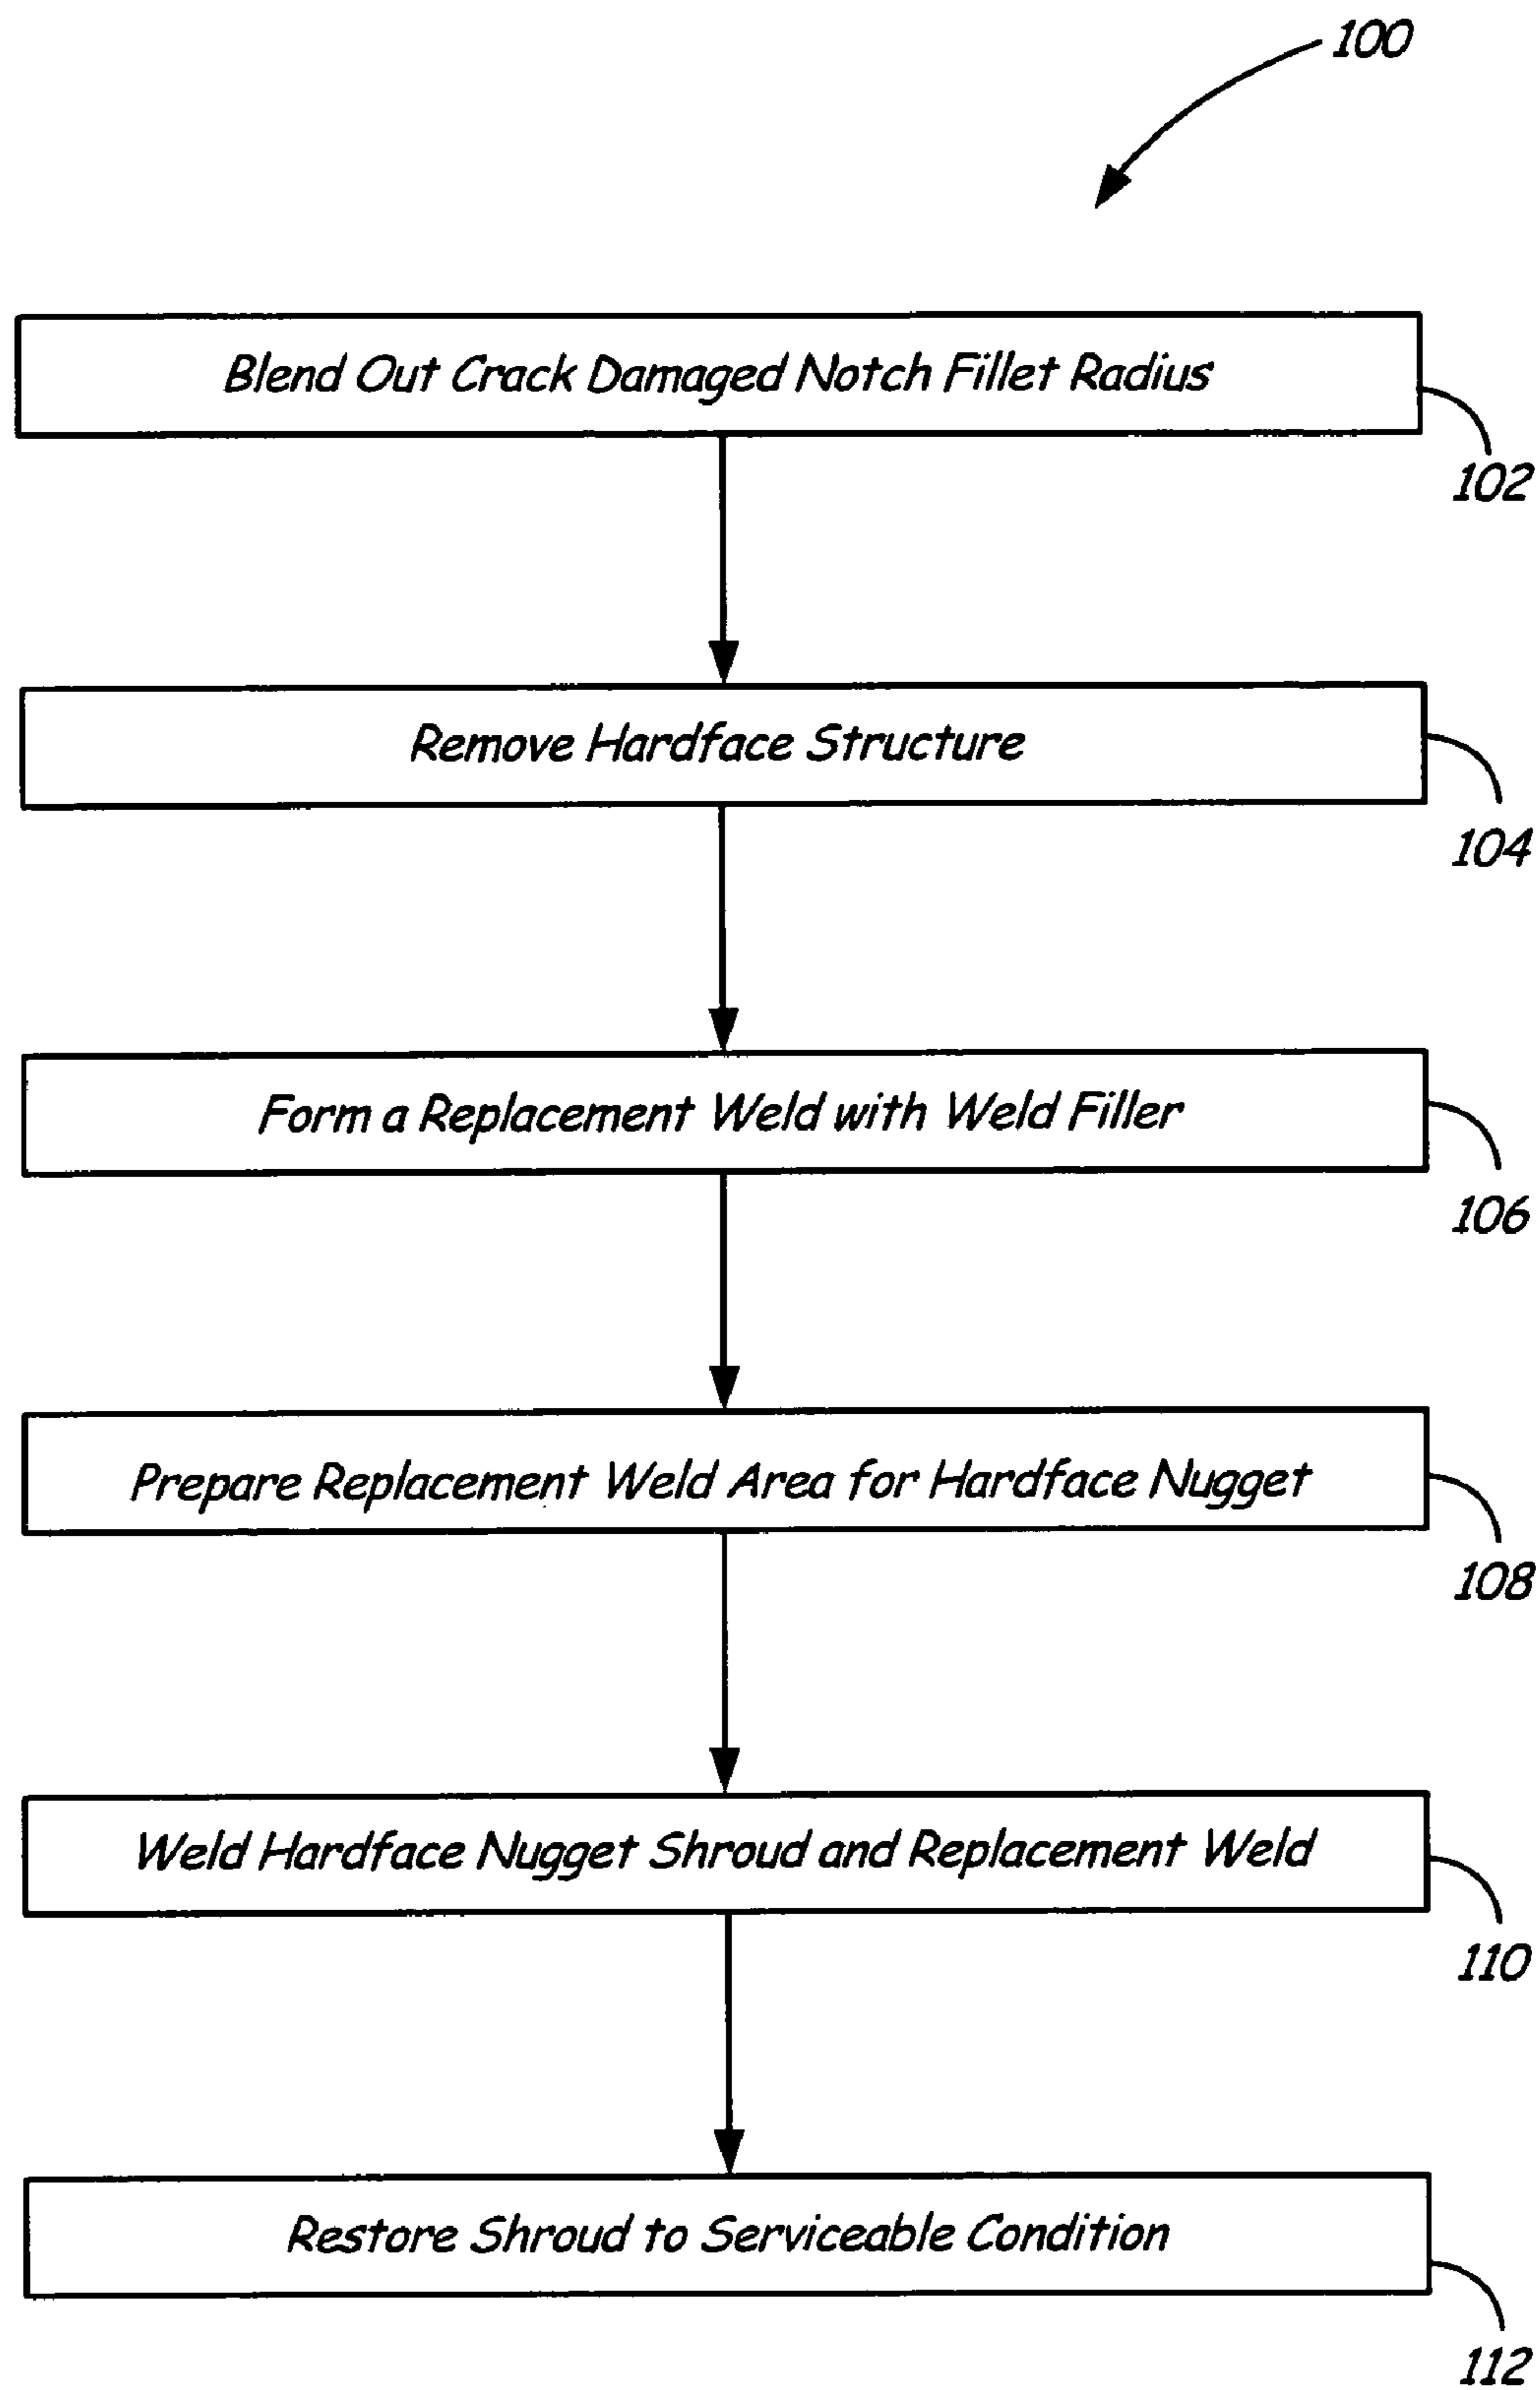
FIG. 9 is a block diagram of a method of repairing a damage site of a notch fillet radius of a turbine blade.

FIG. 9 shows a block diagram of an exemplary, non-limiting method 100 of repairing shroud 12 with crack 24 located at notch fillet radius 20. Conventional blending techniques can repair cracks only up to a depth of approximately 0.03 inches. Method 100 allows the repair of cracks having a depth of up to approximately 0.1 inches. Conventional blending techniques can repair cracks only up to a depth of approximately 0.03 inches. As shown in Box 102, crack 24 and the surrounding damaged area of notch fillet radius 20 are blended out locally. Hardface structure 22 is then either machined or ground off of shroud 12, as represented by Box 104. As described in Box 106, replacement weld 26 is formed at new edge 16a and notch fillet radius 20 with a weld filler to fill in the area previously removed in Box 102. After replacement weld 26 has been formed on shroud 12, shroud 12 is prepared to accept hardface nugget 30 by machining edge portion 28 of replacement weld 26, as represented by Box 108. Hardface nugget 30 is welded to shroud 12 and replacement weld 26 at the same location that hardface structure 22 was located, as represented by Box 110. As depicted in Box 112, after hardface nugget 30 has been welded onto shroud 12, shroud 12 is restored to serviceable condition using conventional notch repair procedures, which can include, for example: grinding, degreasing, stress-relieving, shot peening, and the like.
