(54) **REPAIR APPARATUS AND METHOD FOR PIPE AND FITTINGS**

Disclosed herein is a repair apparatus and method for pipe and fittings. In one form, the method relates to utilizing fabric-like material which is intermixed with an adhesive. In one form, the adhesive is a two-part adhesive which hardens to a semi-rigid state to avoid stress fractures through repeated expansion and contraction due to physical movement or temperature variation in the pipe and/or fittings. In one form the method and apparatus are particularly useful in thermoplastic pipes. In other forms, the method is particularly useful in metal pipes and fittings, or in non-pipe structures.

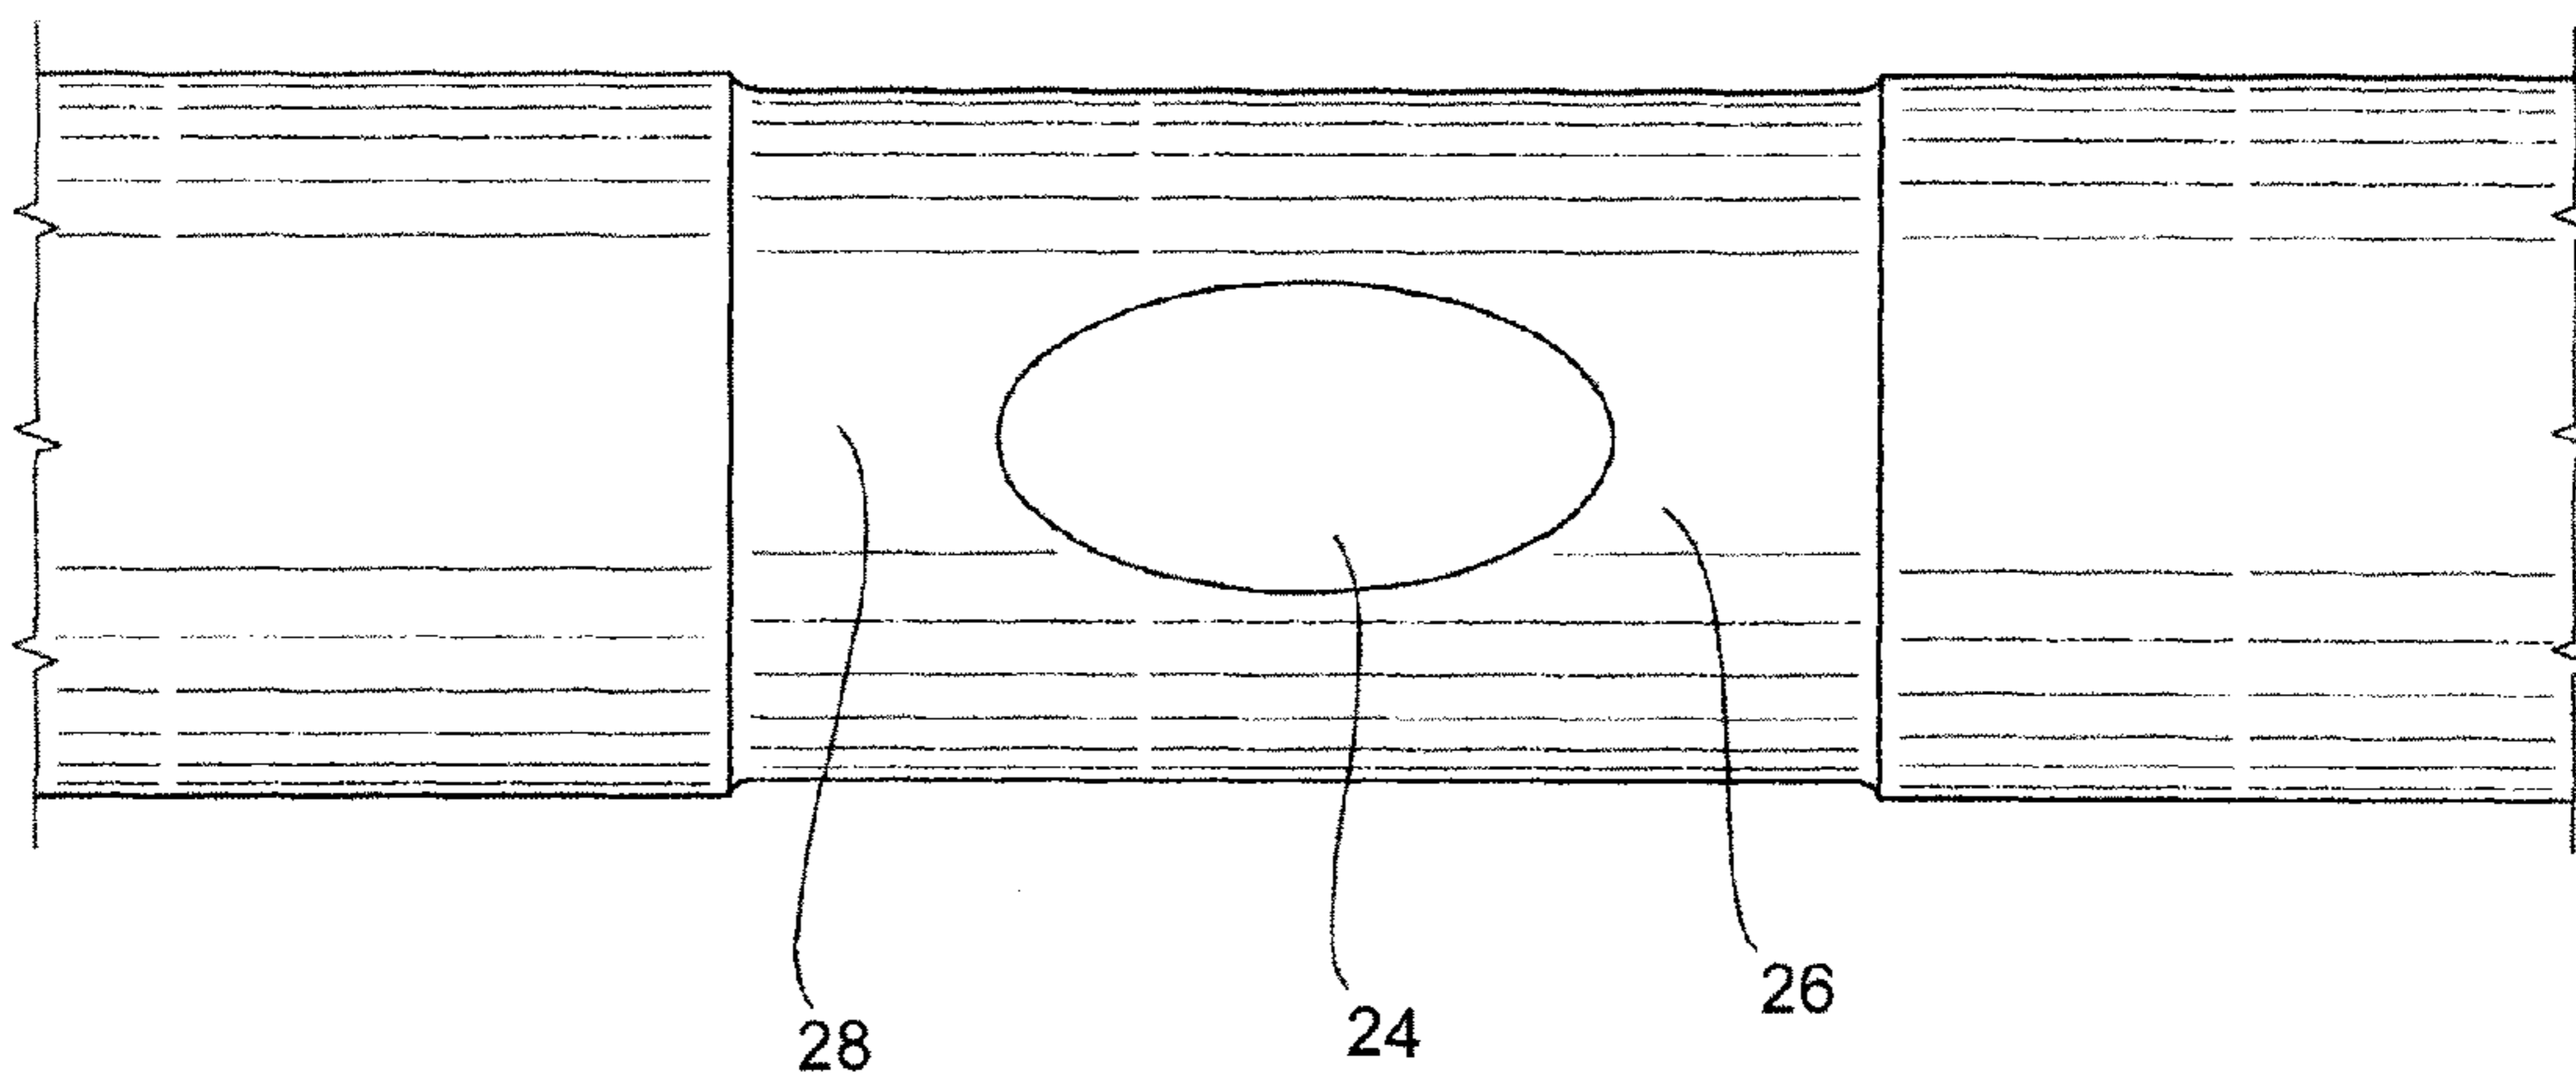
FIG. 4

outer surface **30** of the pipe **22** as shown in FIG. 4. Once again, contaminants left over from the abrasion process should be removed prior to continuing.

Looking to FIG. 4, once the compromised portion **24** and overlap portion **28** are sufficiently abraded, the pipe adjacent to the compromised portion **24** may be heated such as by a propane or acetylene torch or heat gun. The pipe could be heated up to 100°, 180° or more as long as the melting point of the pipe **22** is not reached.

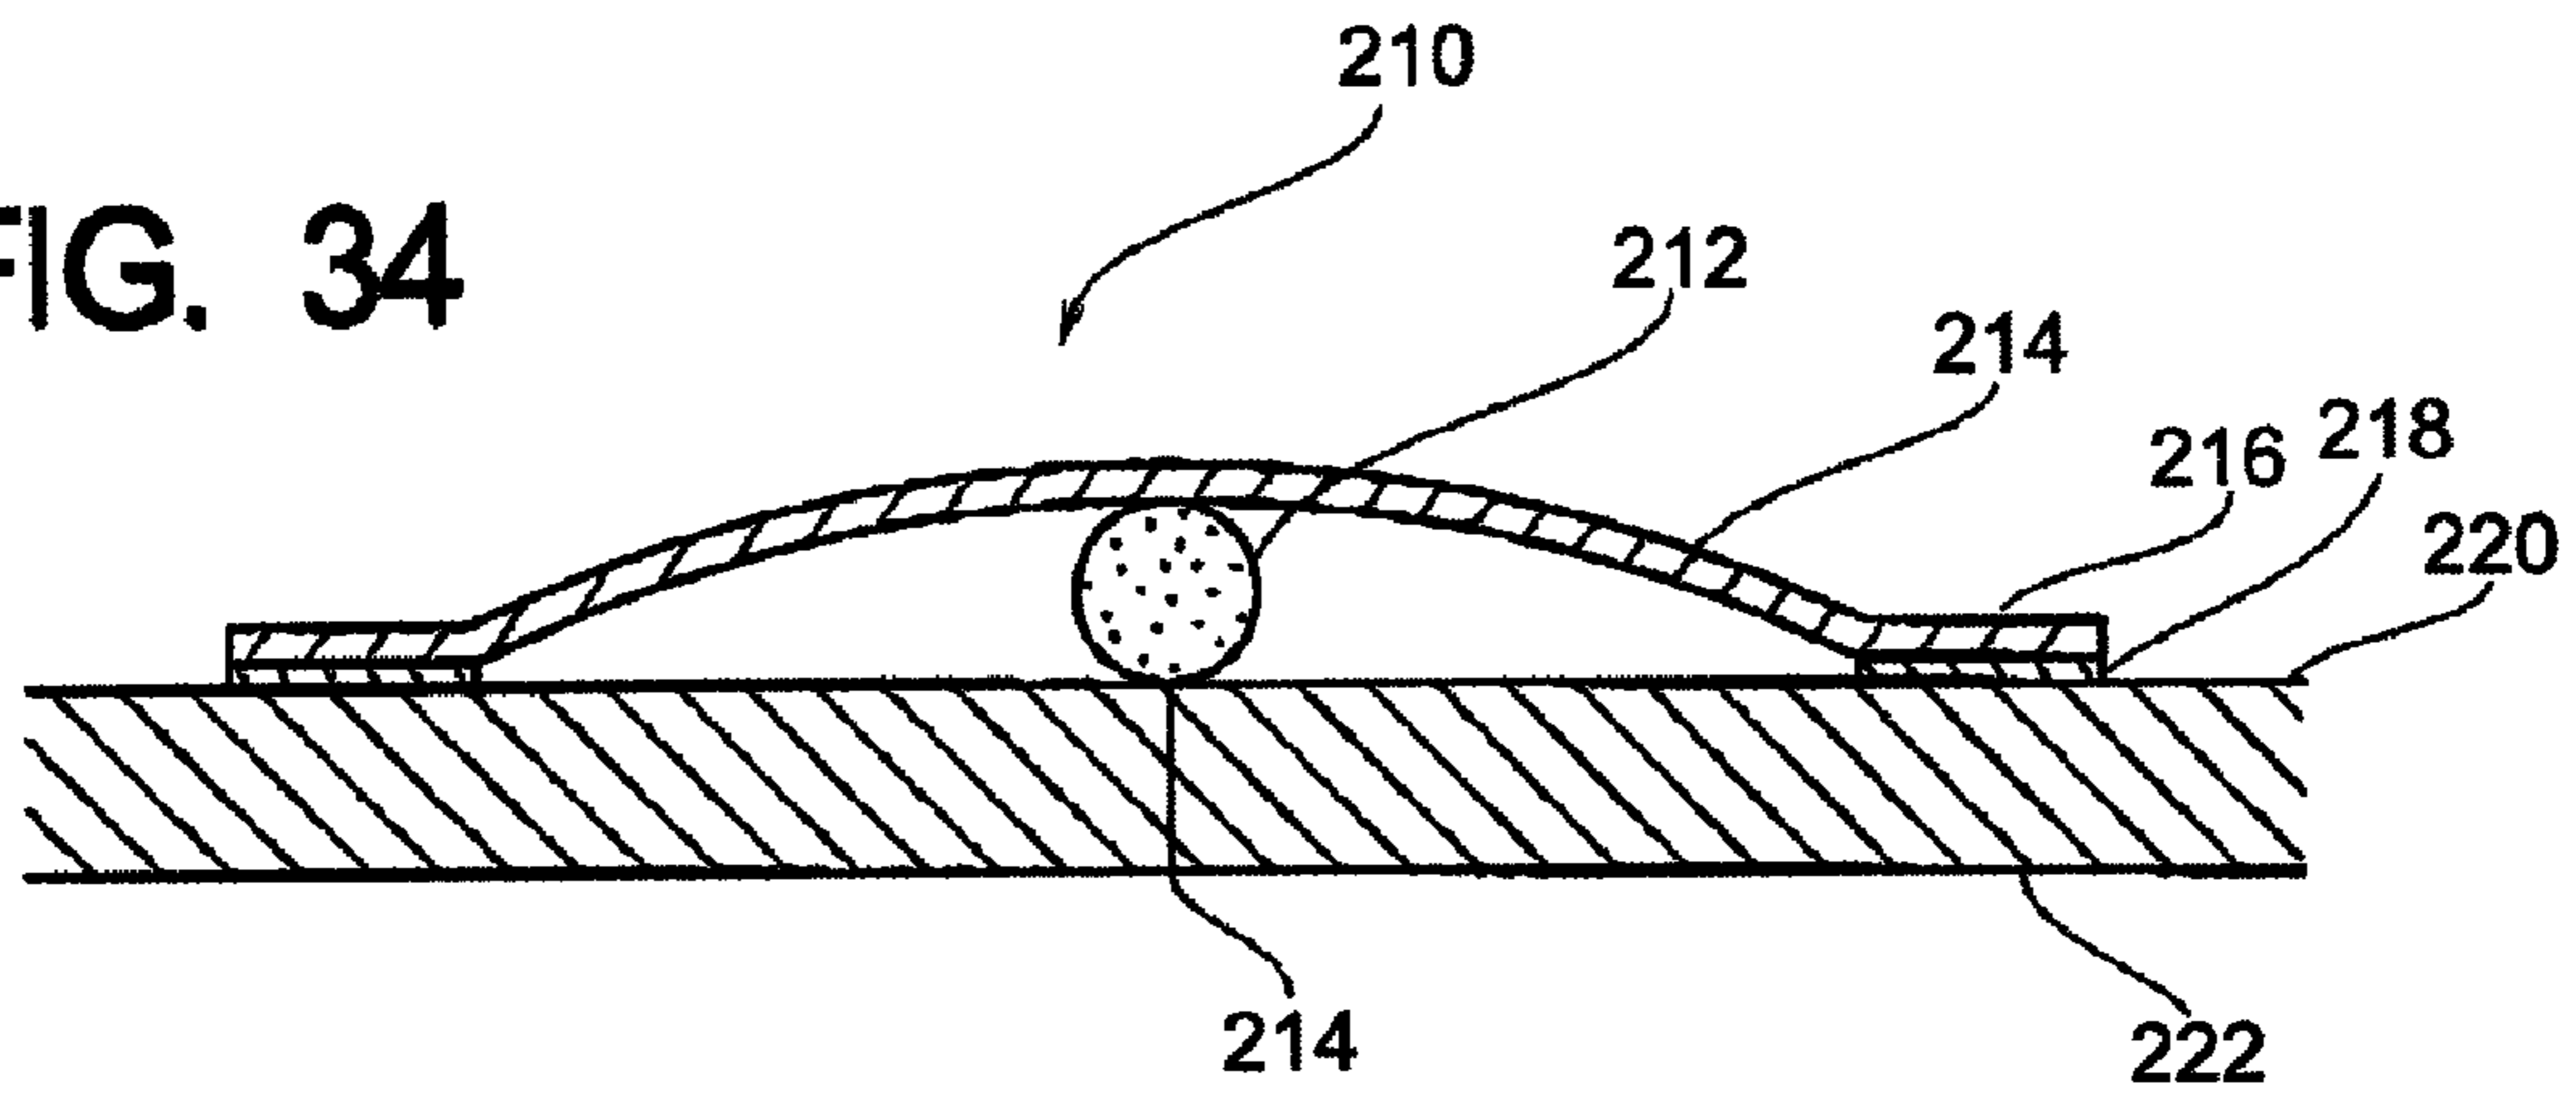
FIG. 35

FIG. 34 is a side cutaway view of a stop leak patch repair using the disclosed method in one form.

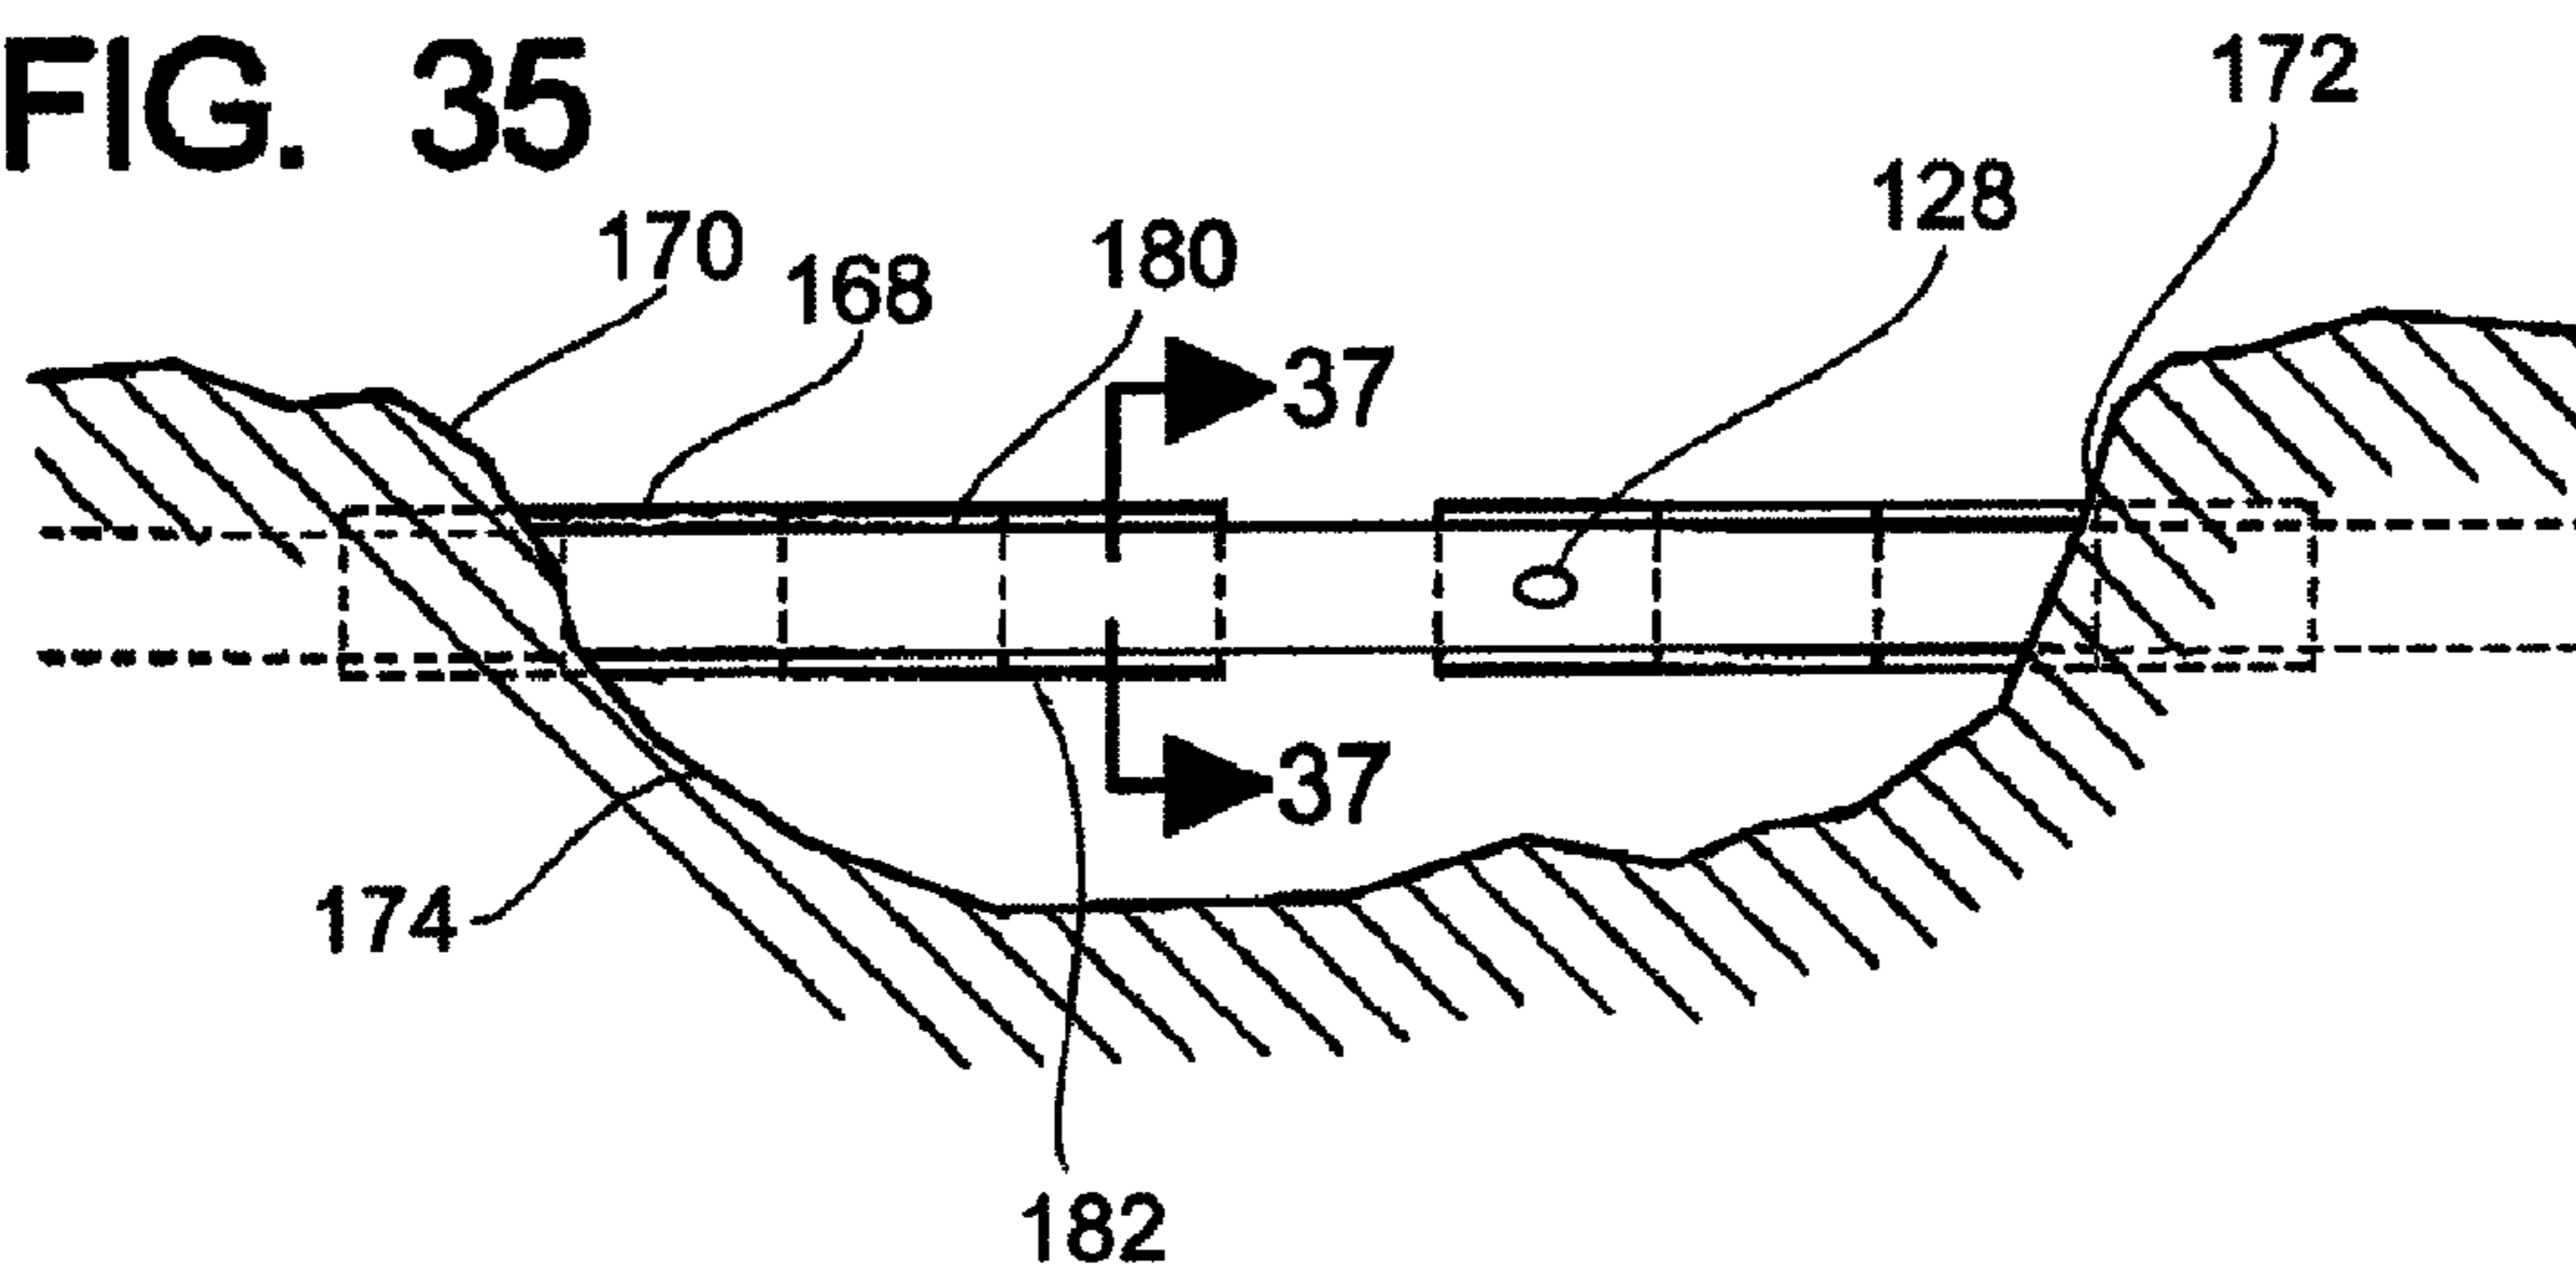
FIG. 36

FIG. 35 is a side environmental (hidden line) view of a repair using the disclosed method in one form.

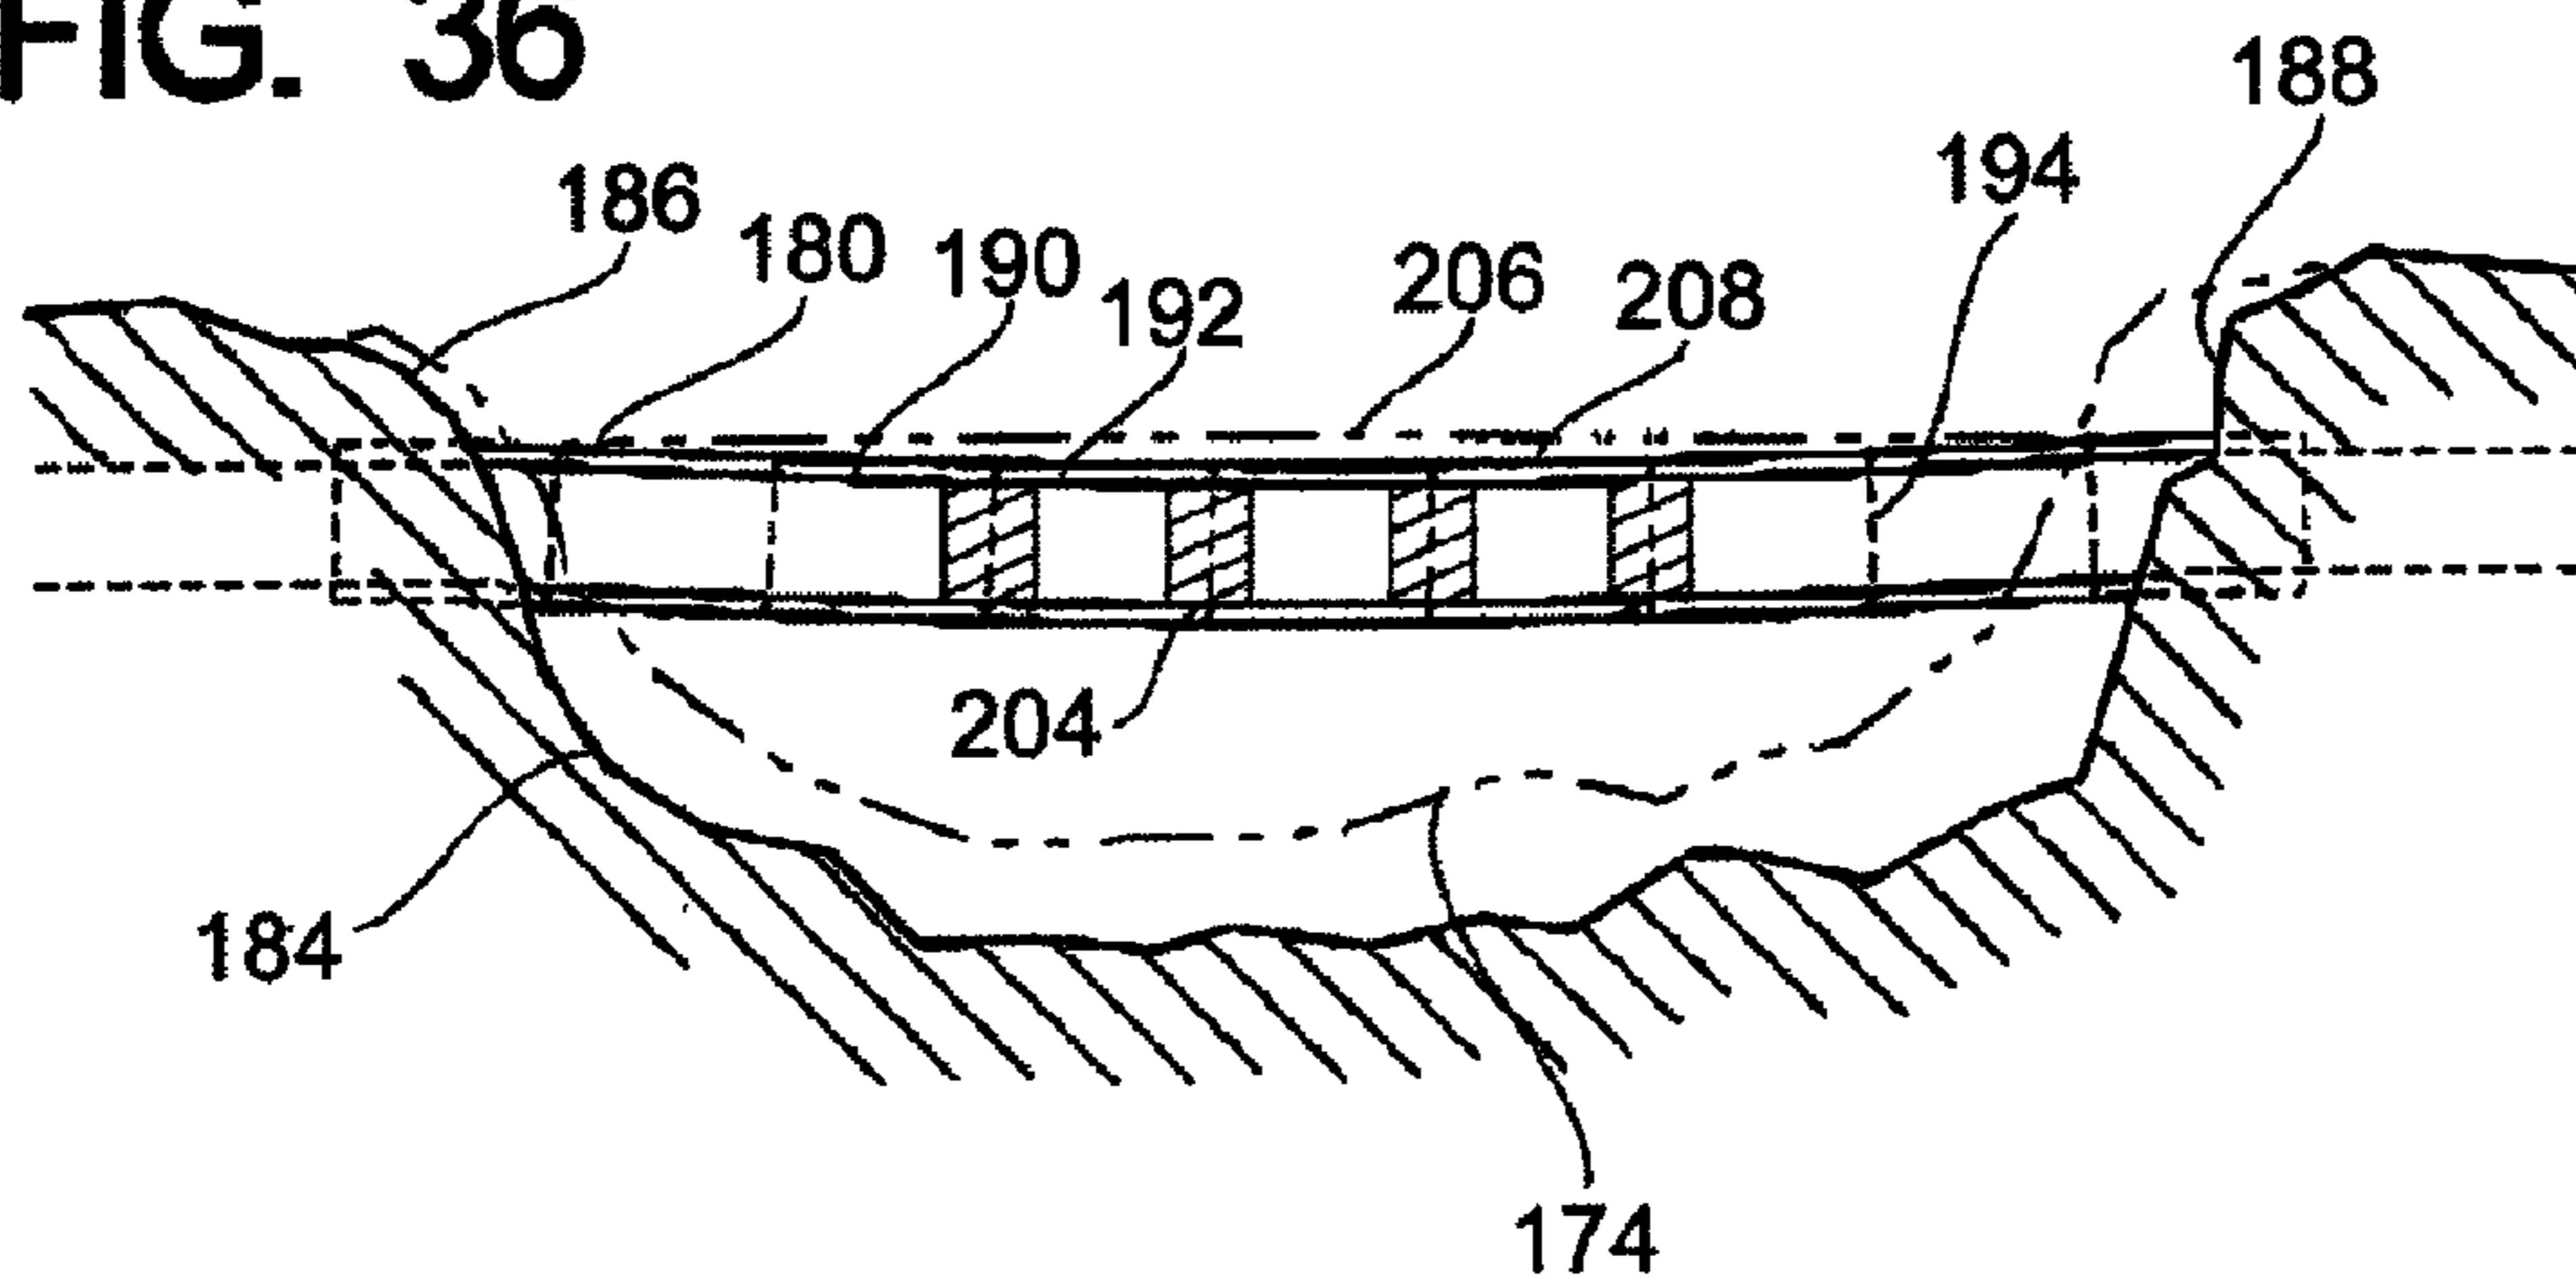
# FIG. 37

FIG. 36 is a side environmental (hidden line) view of a strengthening system using the disclosed method in one form.

As shown in FIG. 36, the pipe 180 has sagged from its original position 206 to a lower position 208. Thus it may be

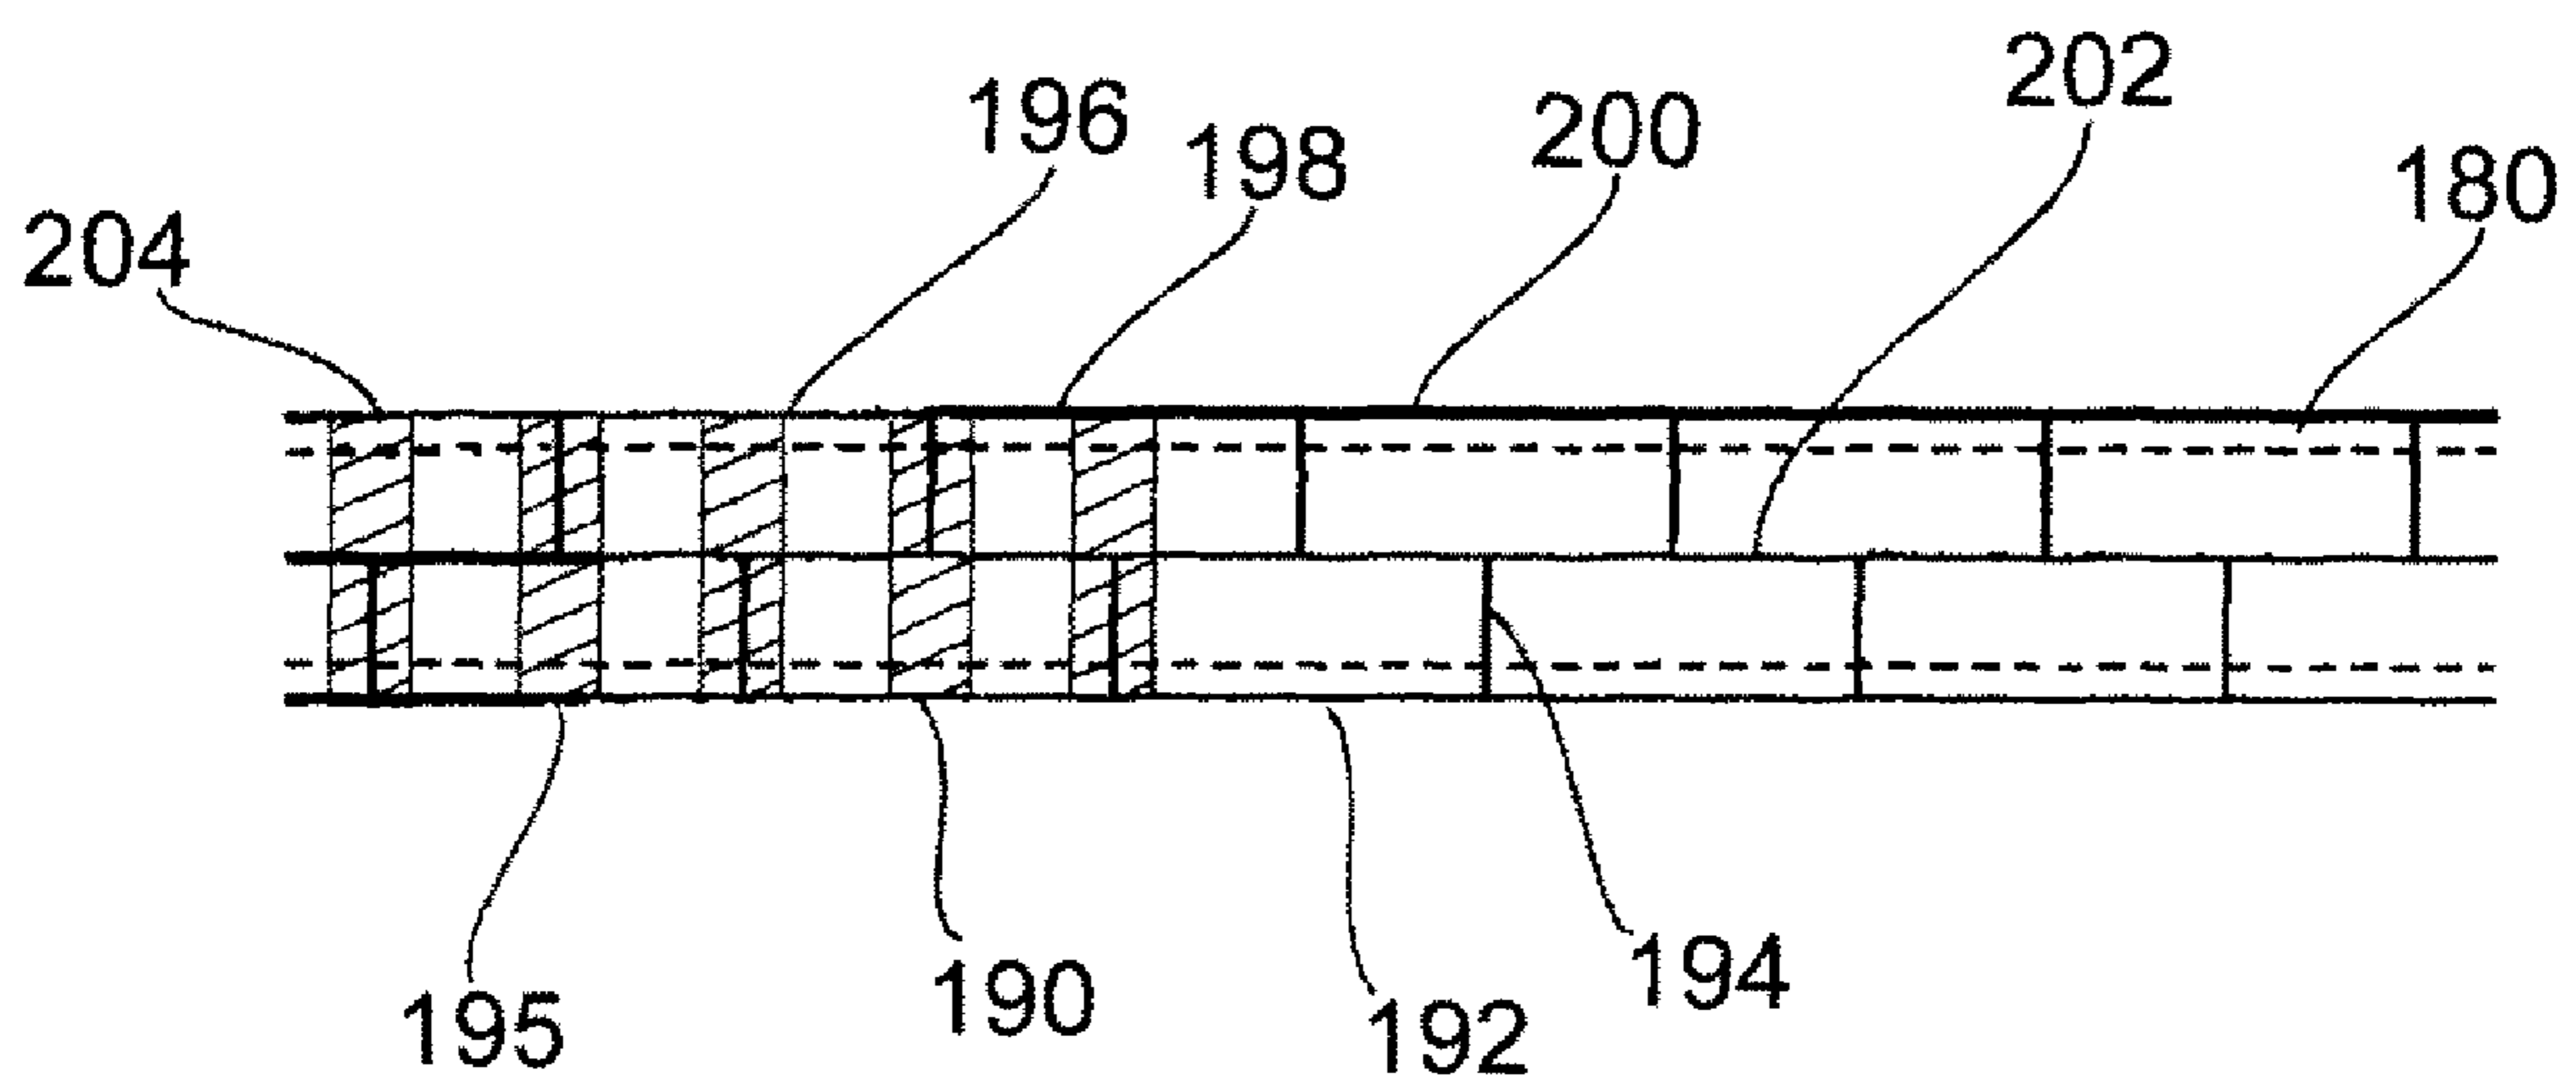
FIG. 38 is a side hidden line view of a repair using the disclosed method in one form.
