(12) **United States Patent**
Brooks et al.

(54) **REPAIR APPARATUS AND METHOD FOR
PIPE AND FITTINGS**

Disclosed herein is a repair apparatus and method for pipe and fittings. In one form, the method relates to utilizing fabric-like material which is intermixed with an adhesive. In one form, the adhesive is a two-part adhesive which hardens to a semi-rigid state to avoid stress fractures through repeated expansion and contraction due to physical movement or temperature variation in the pipe and/or fittings. In one form the method and apparatus are particularly useful in thermoplastic pipes. In other forms, the method is particularly useful in metal pipes and fittings, or in non-pipe structures.

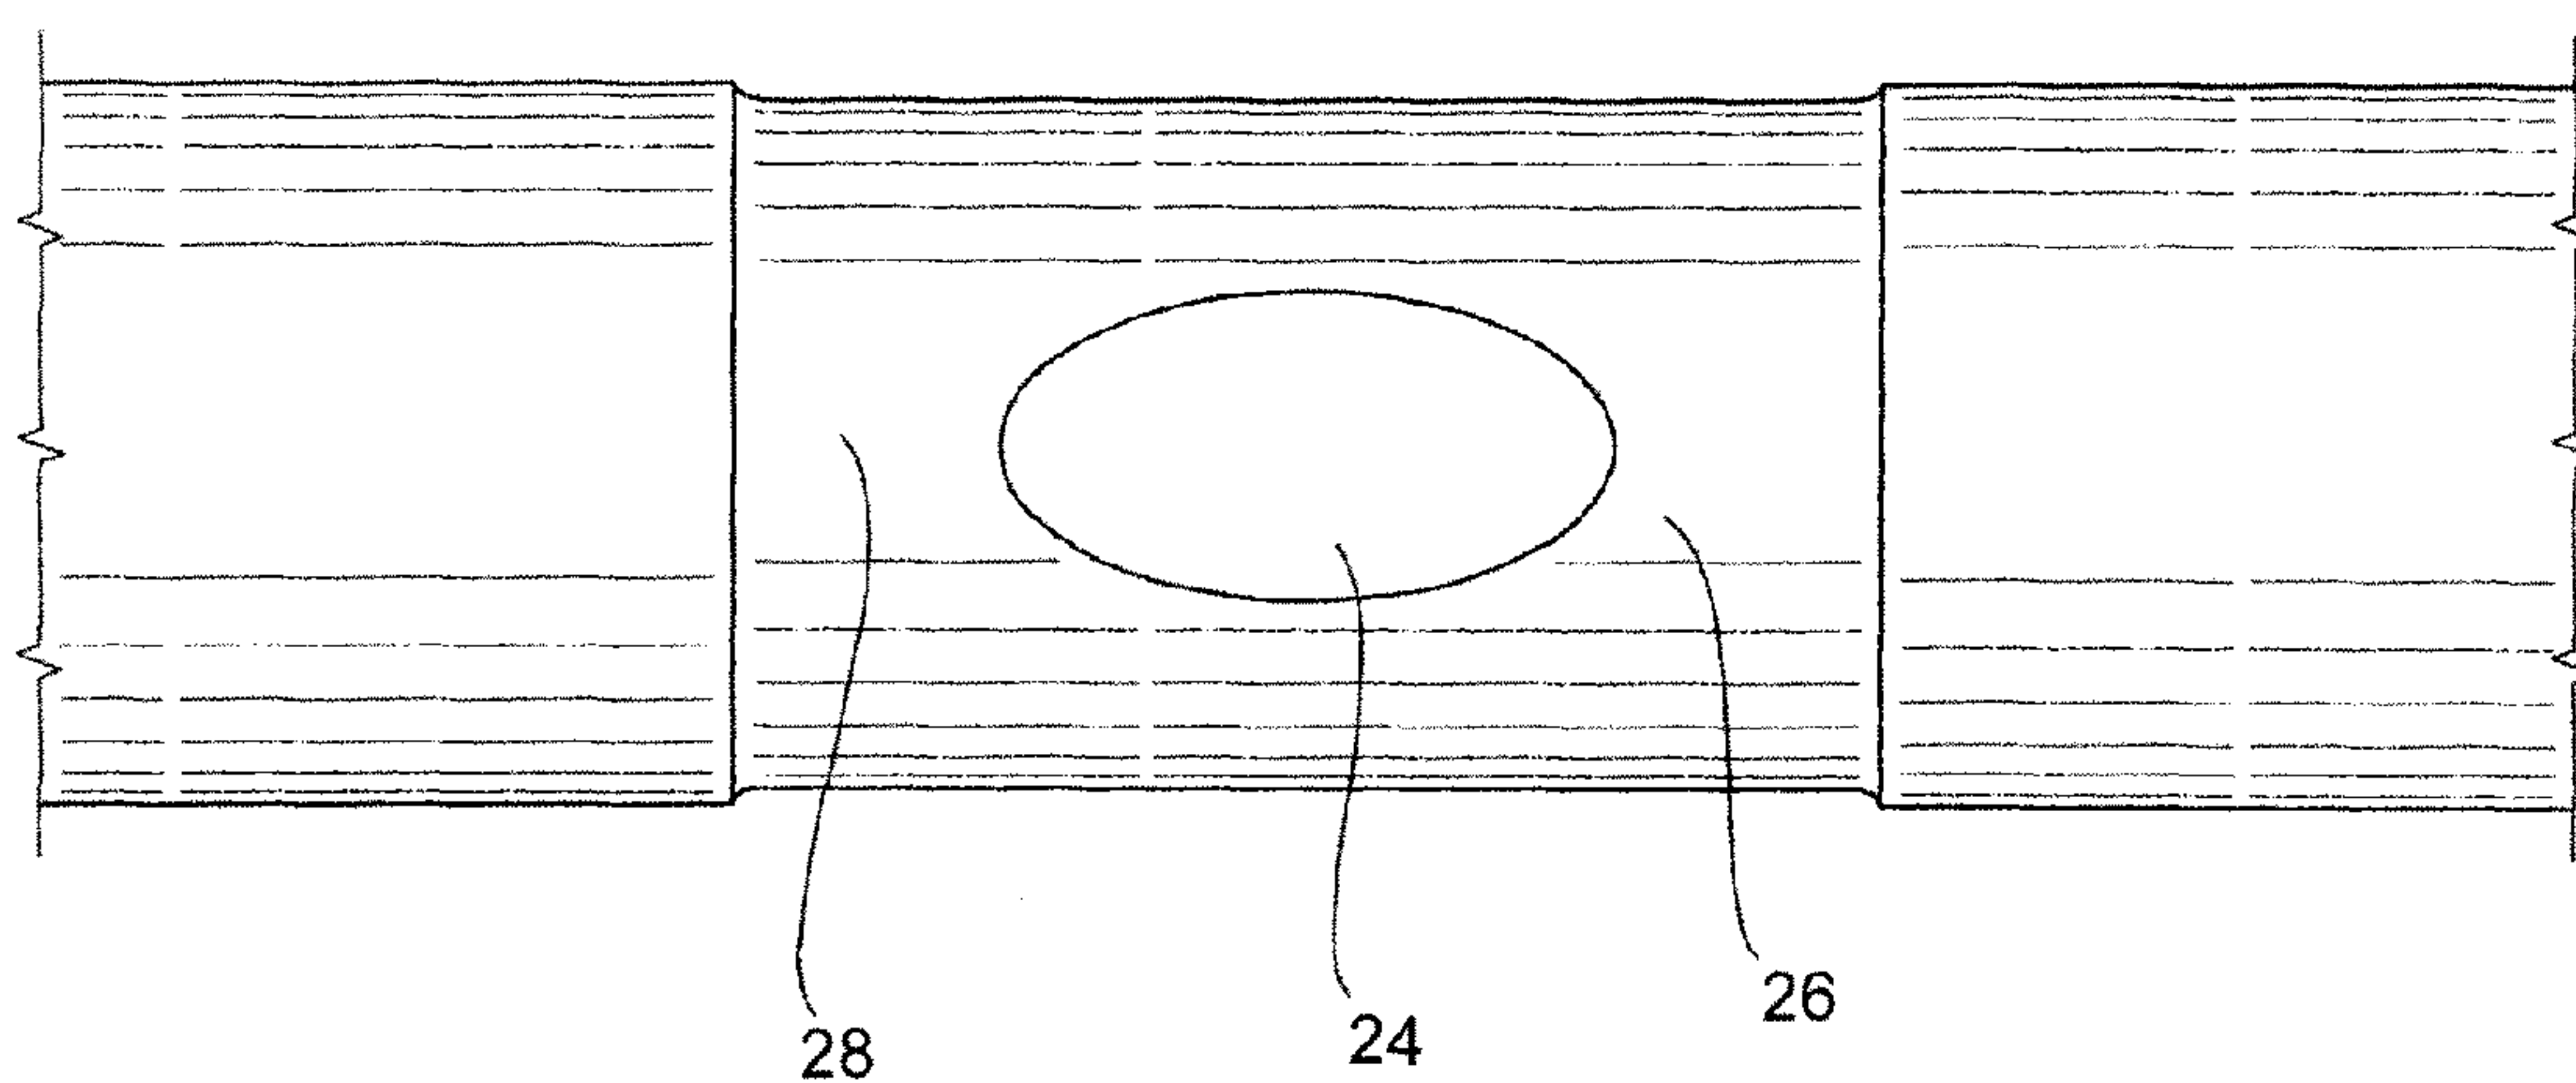
FIG. 3 is a plan view of a section of pipe in the process of being repaired using the disclosed method in one form.

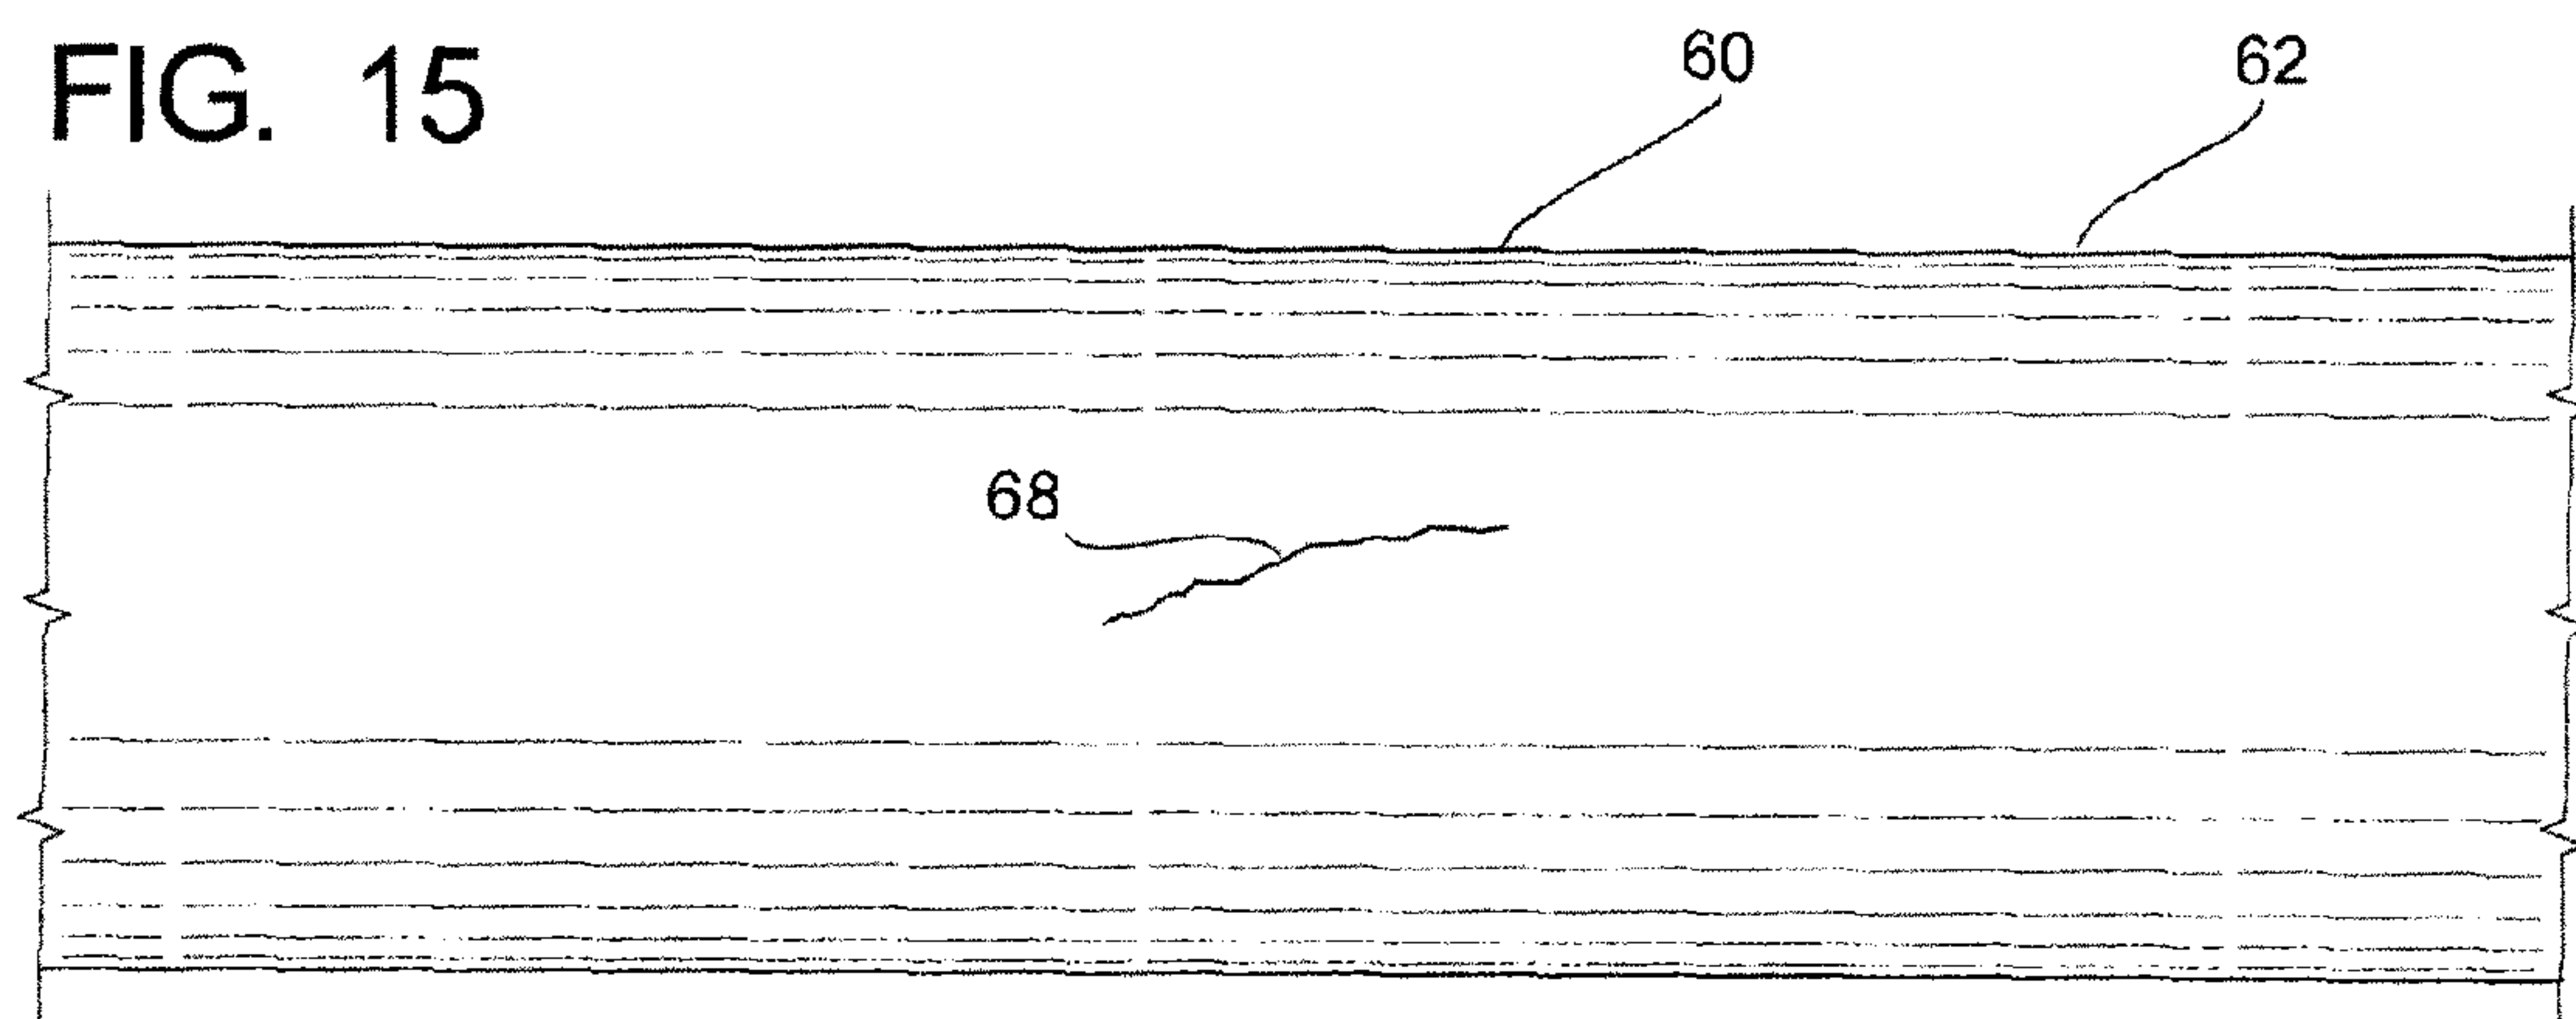
FIG. 15 is a plan view of a structure having a compromised portion in the form of a crack.

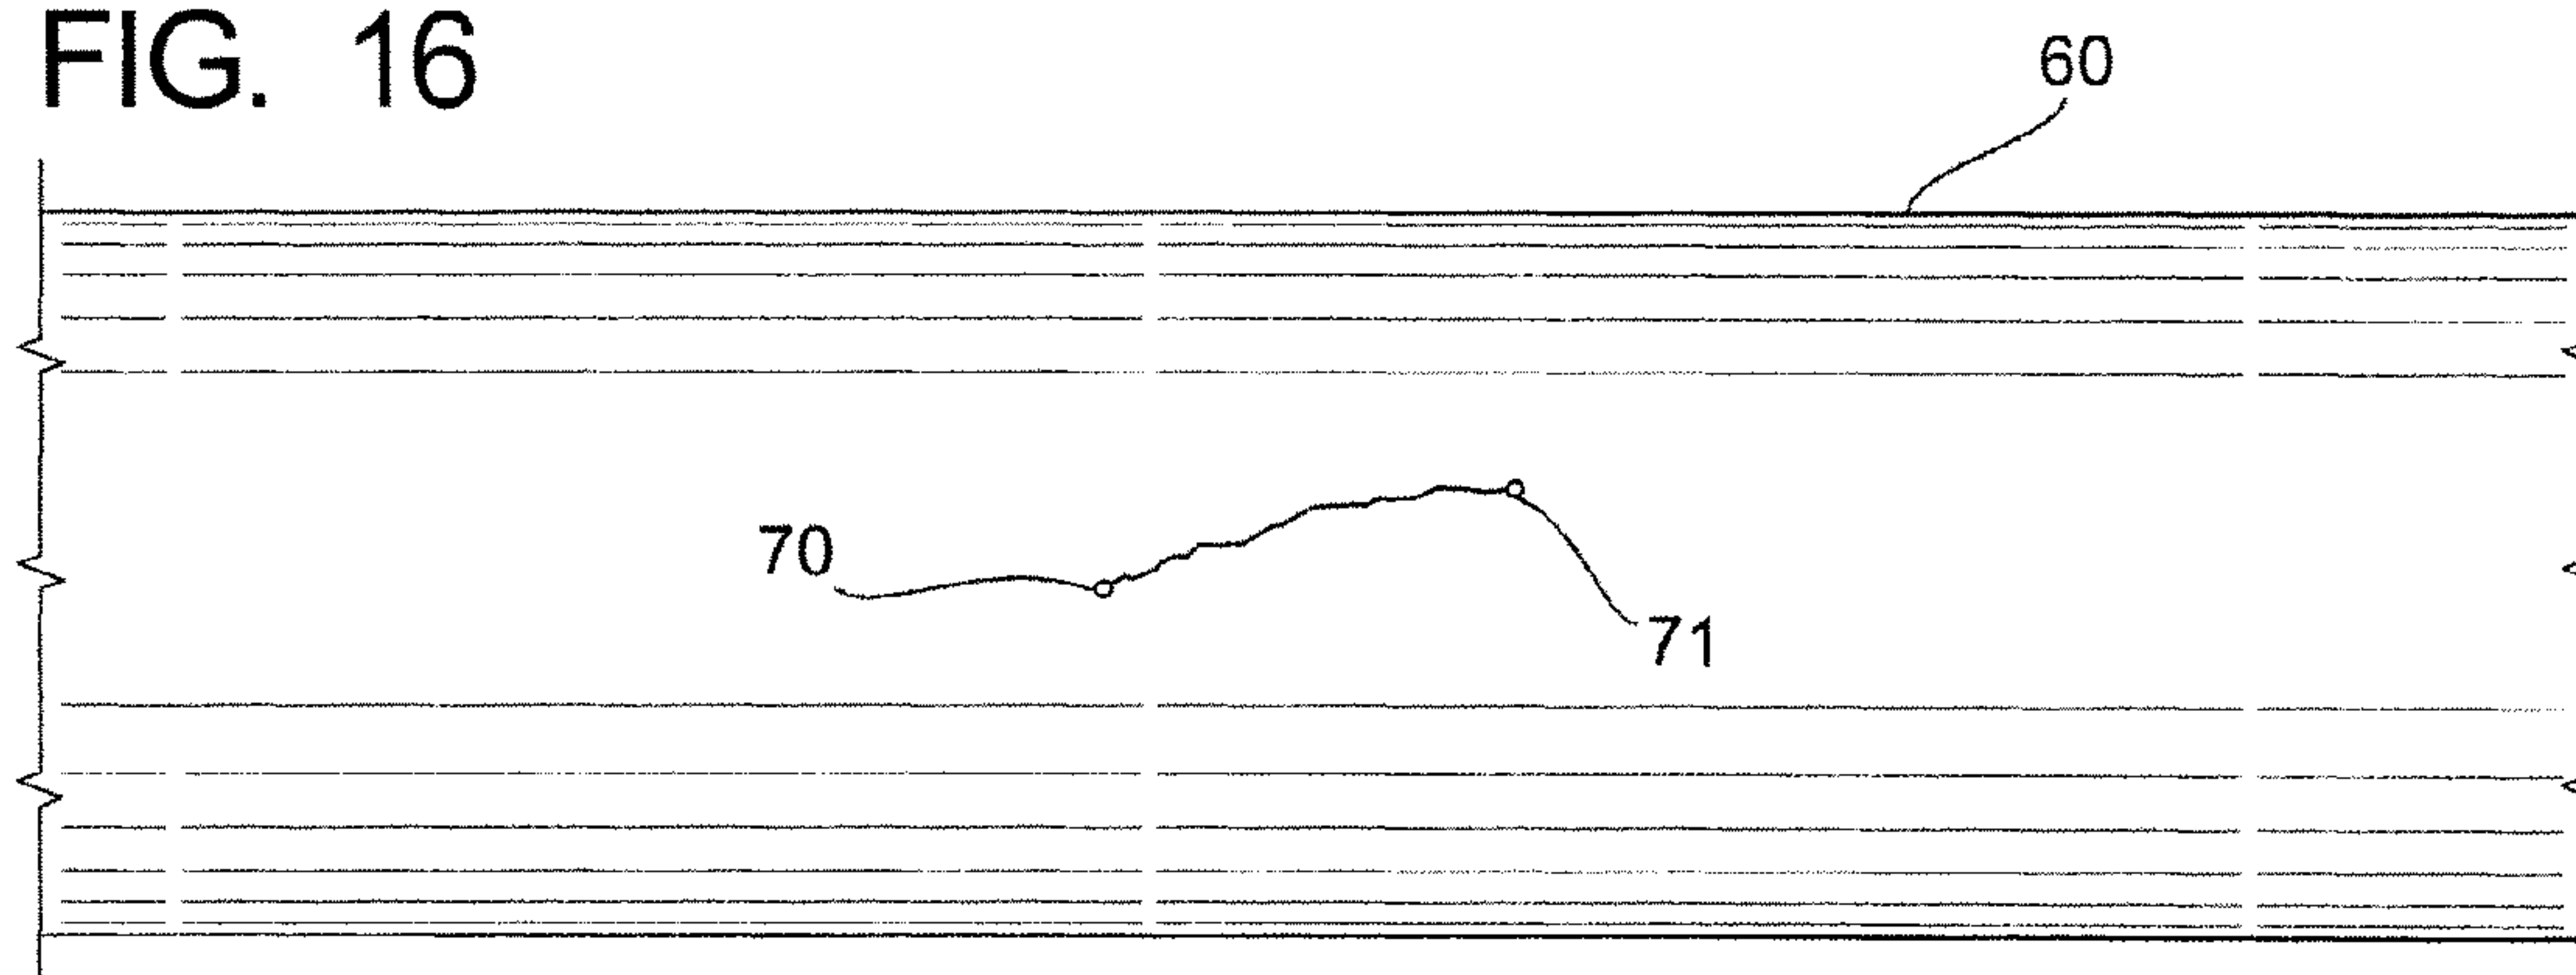
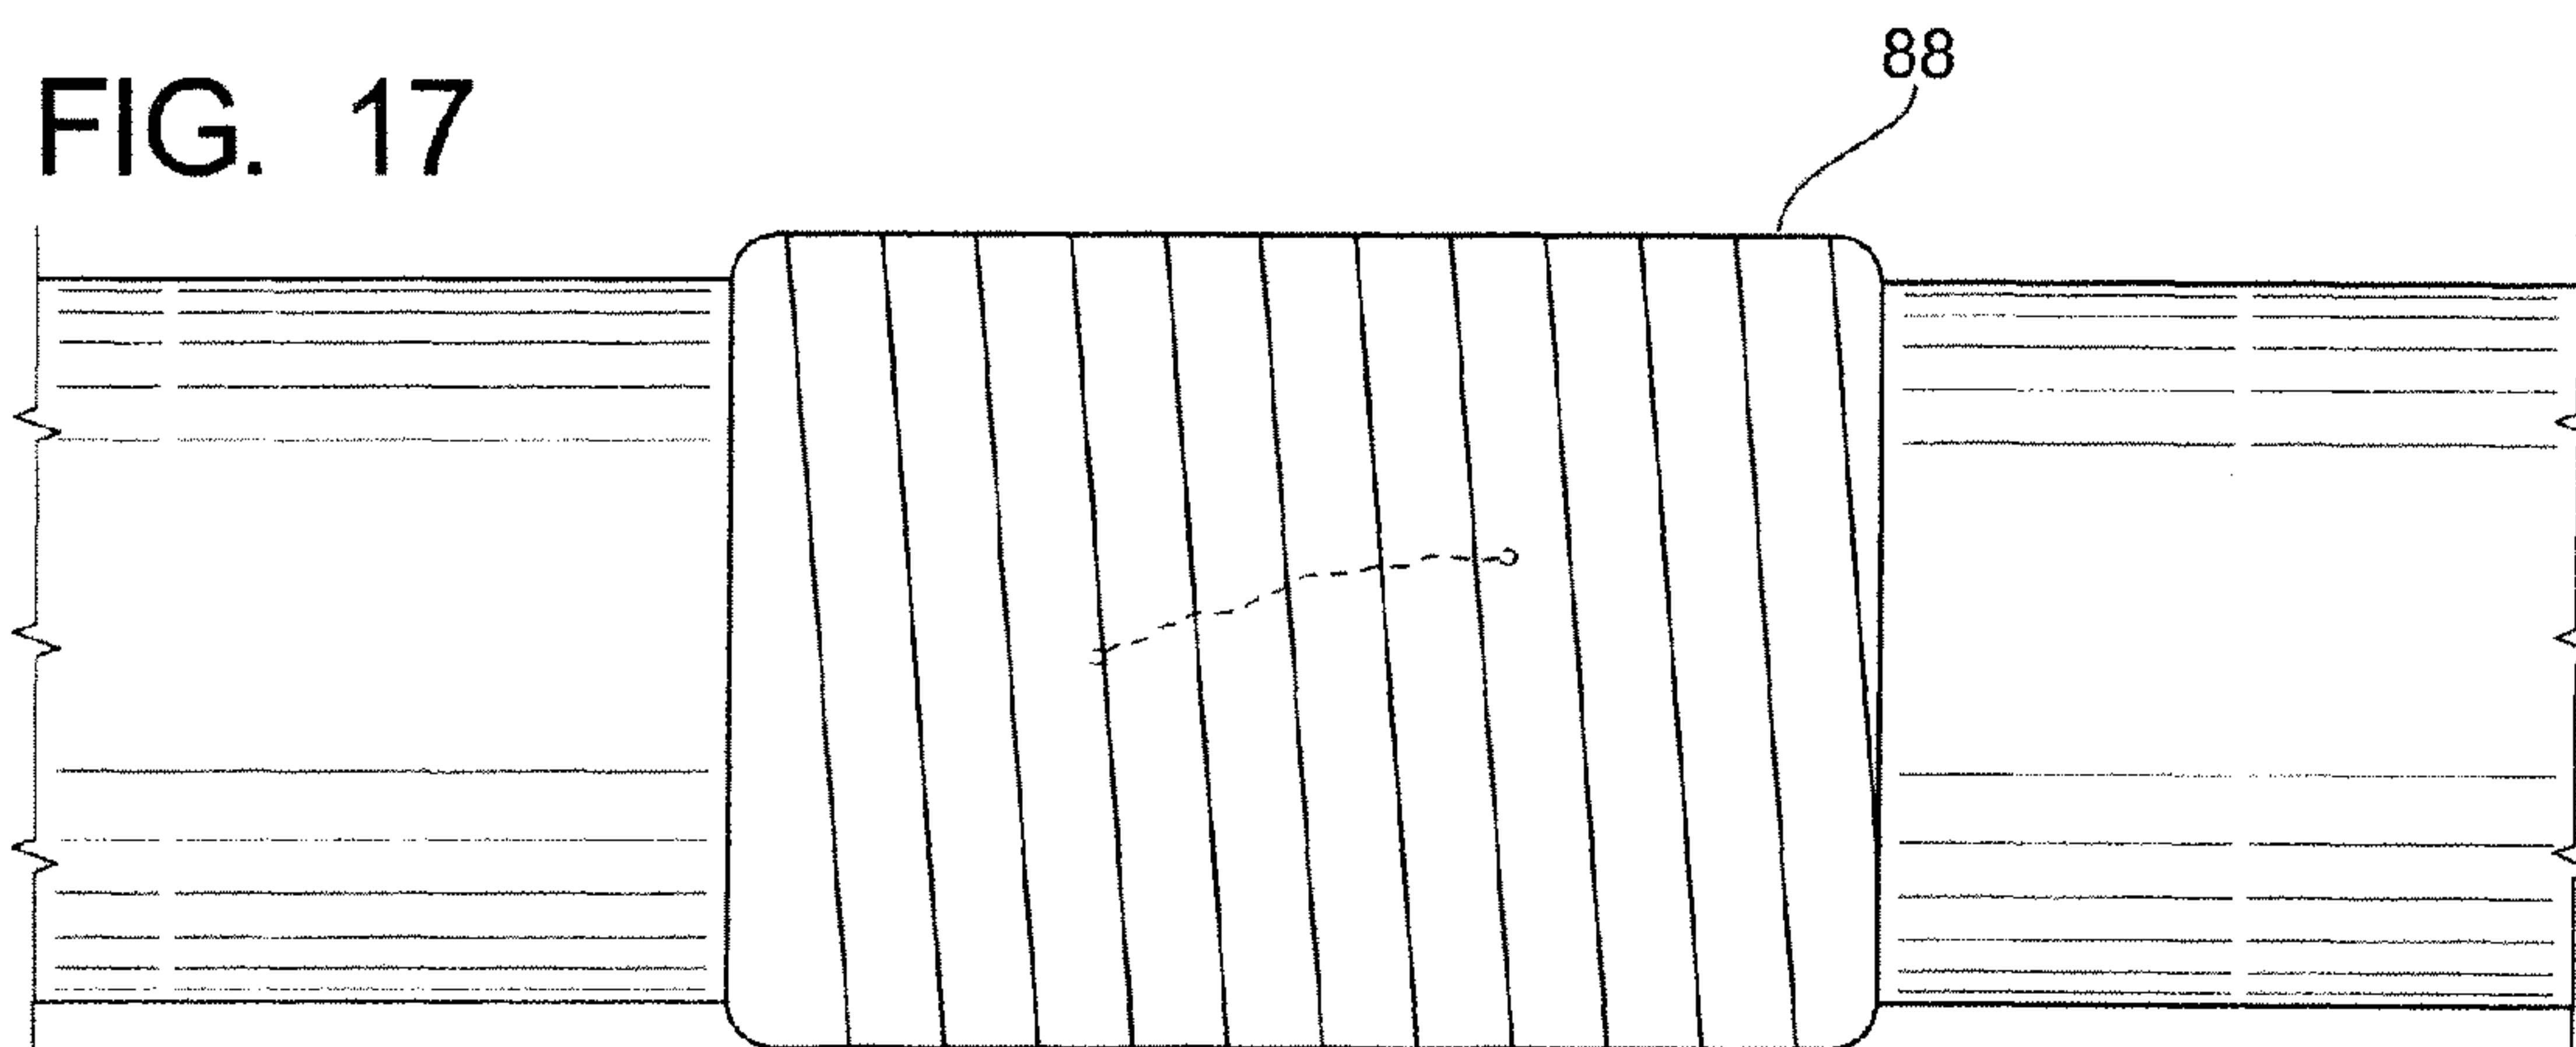
FIGS. 16 and 17 are plan views of a compromised structure in the process of being repaired using the disclosed method in one form.

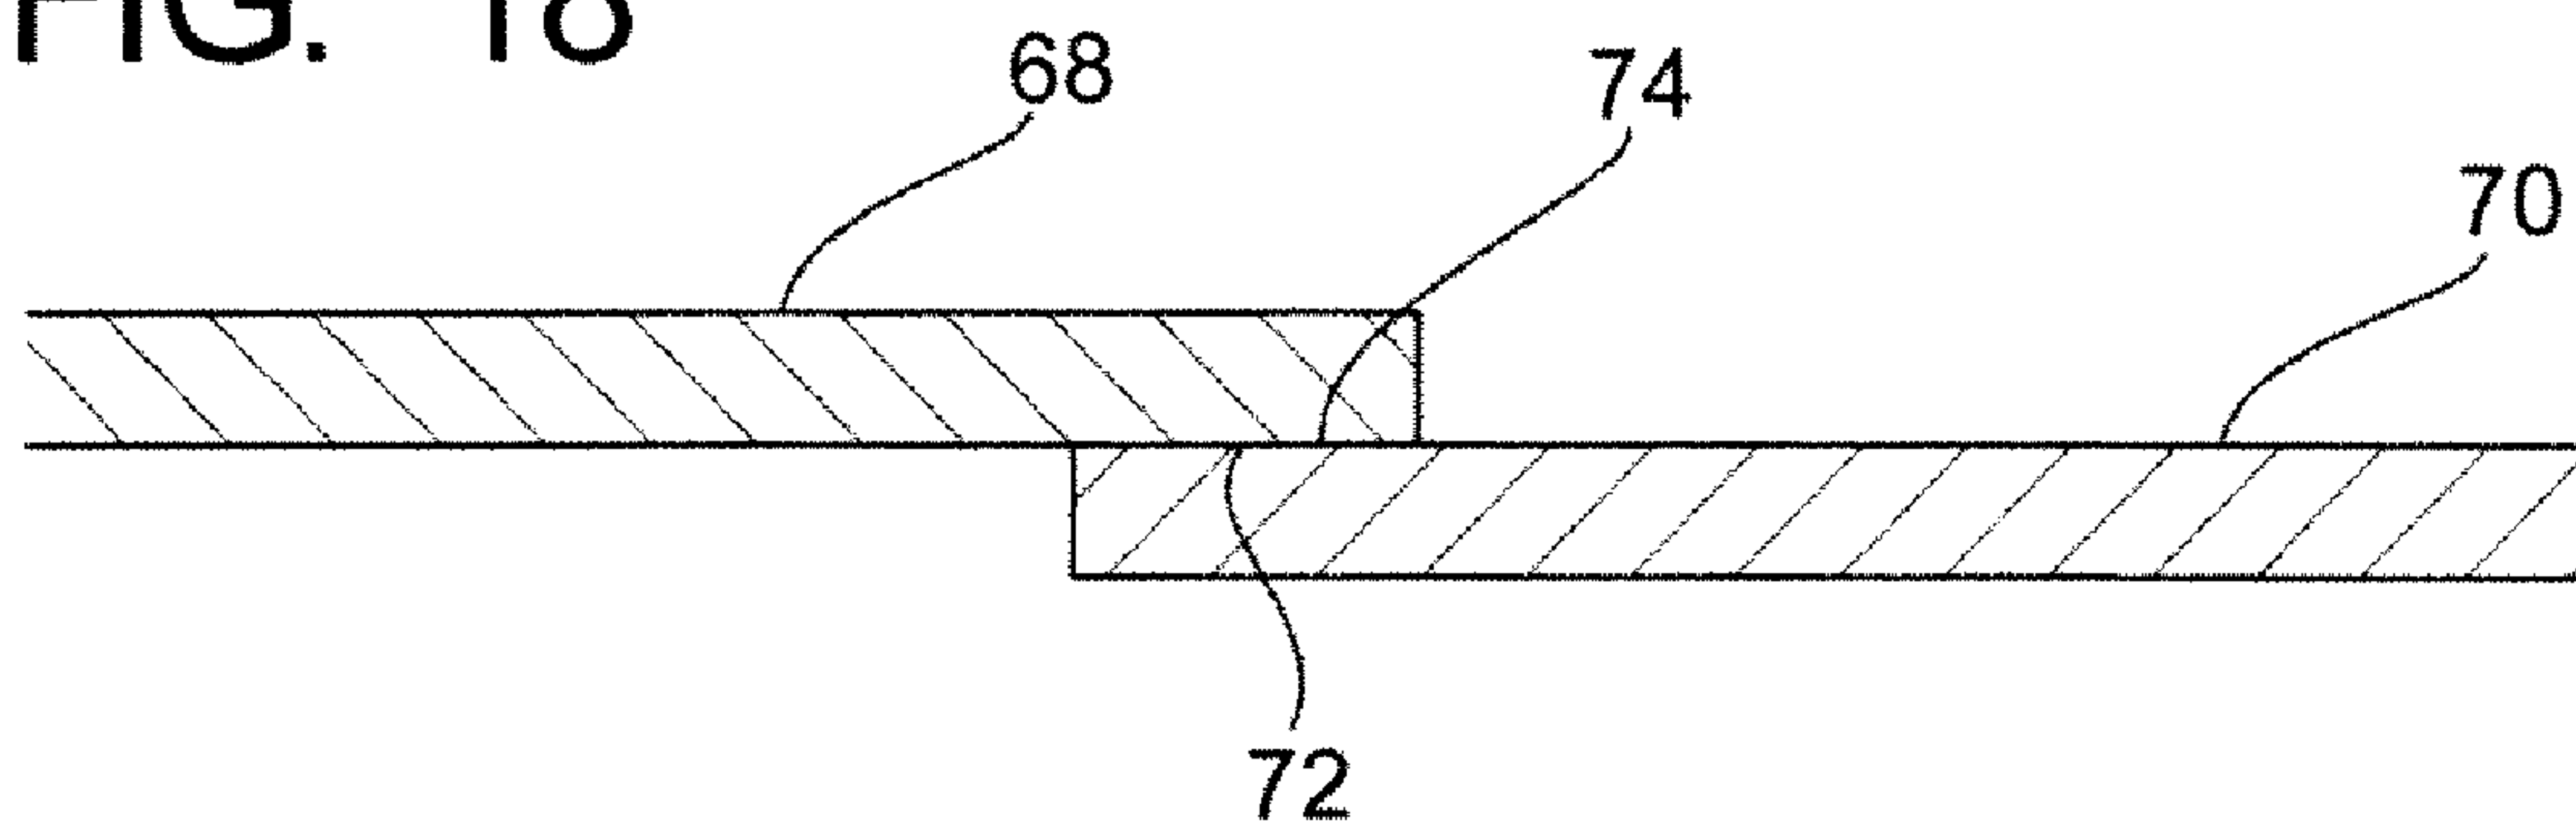
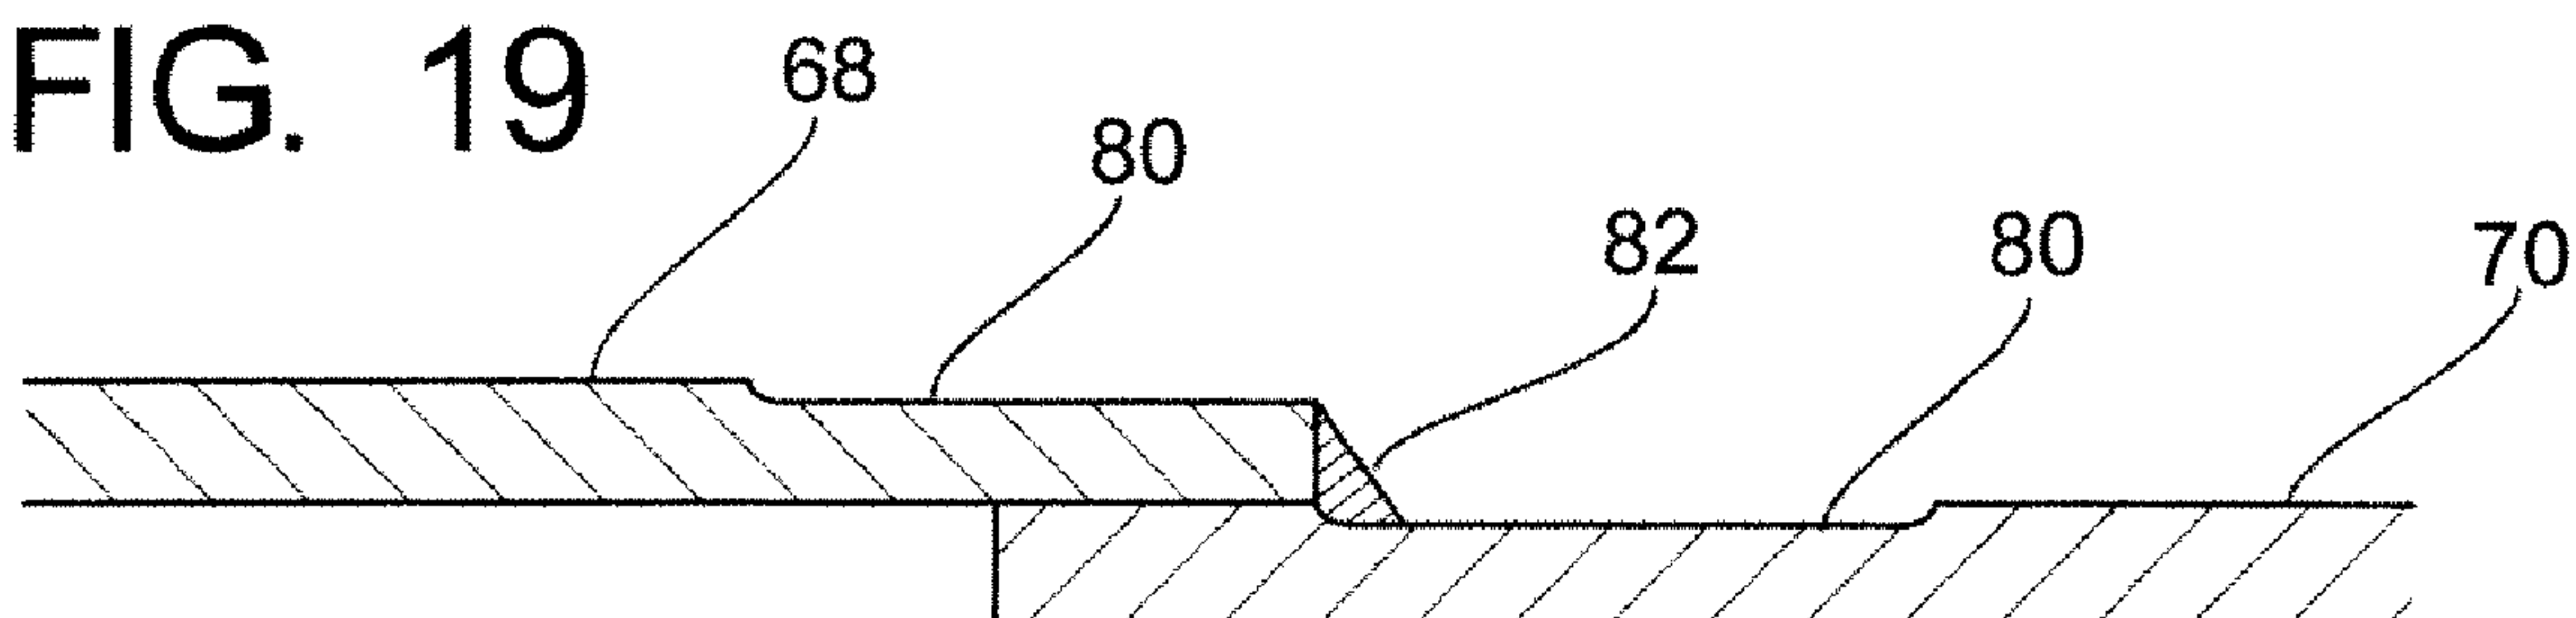
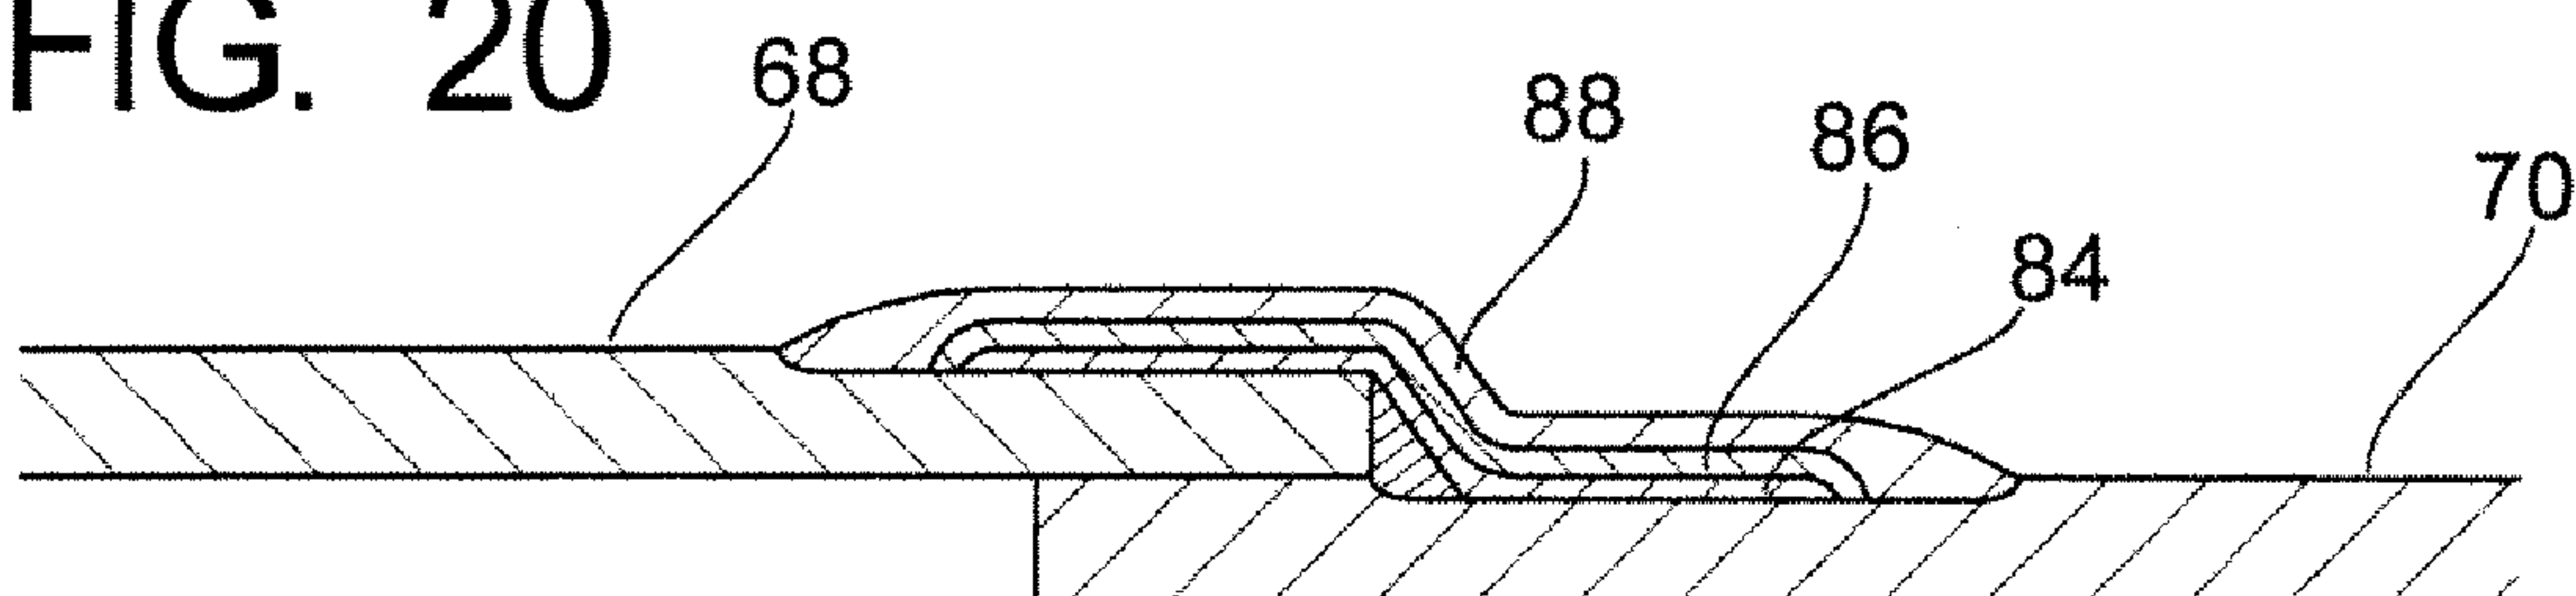
FIGS. 18 through 20 are side cutaway views of a structure in the process of being repaired using the disclosed method in one form.

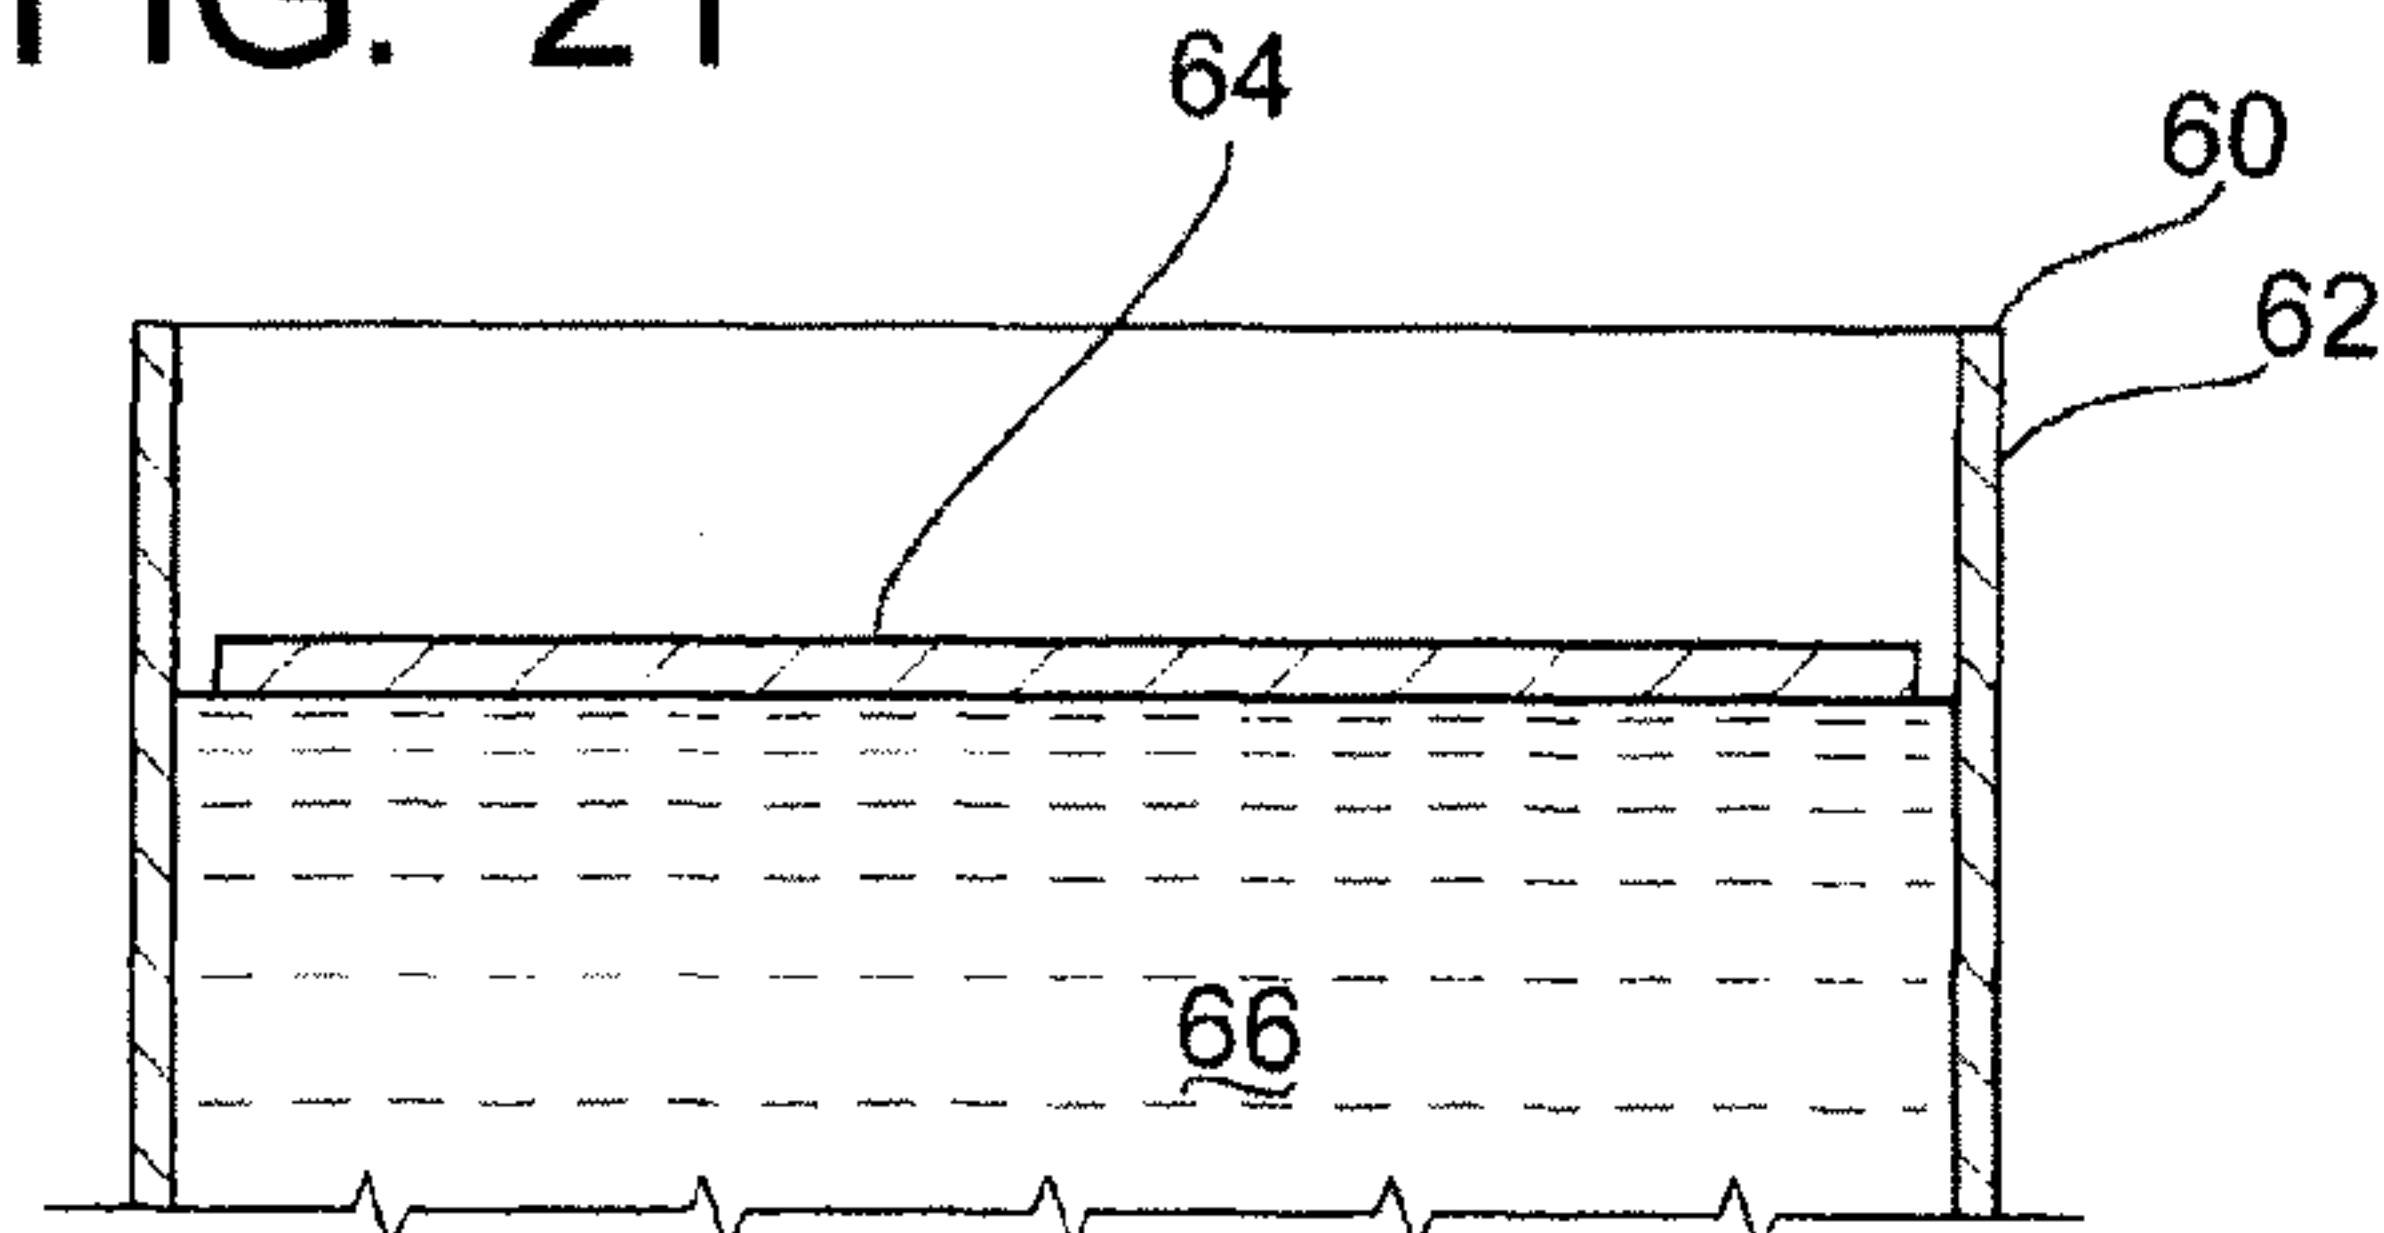
FIG. 21 is a side cutaway view of a storage tank having a floating cover portion.

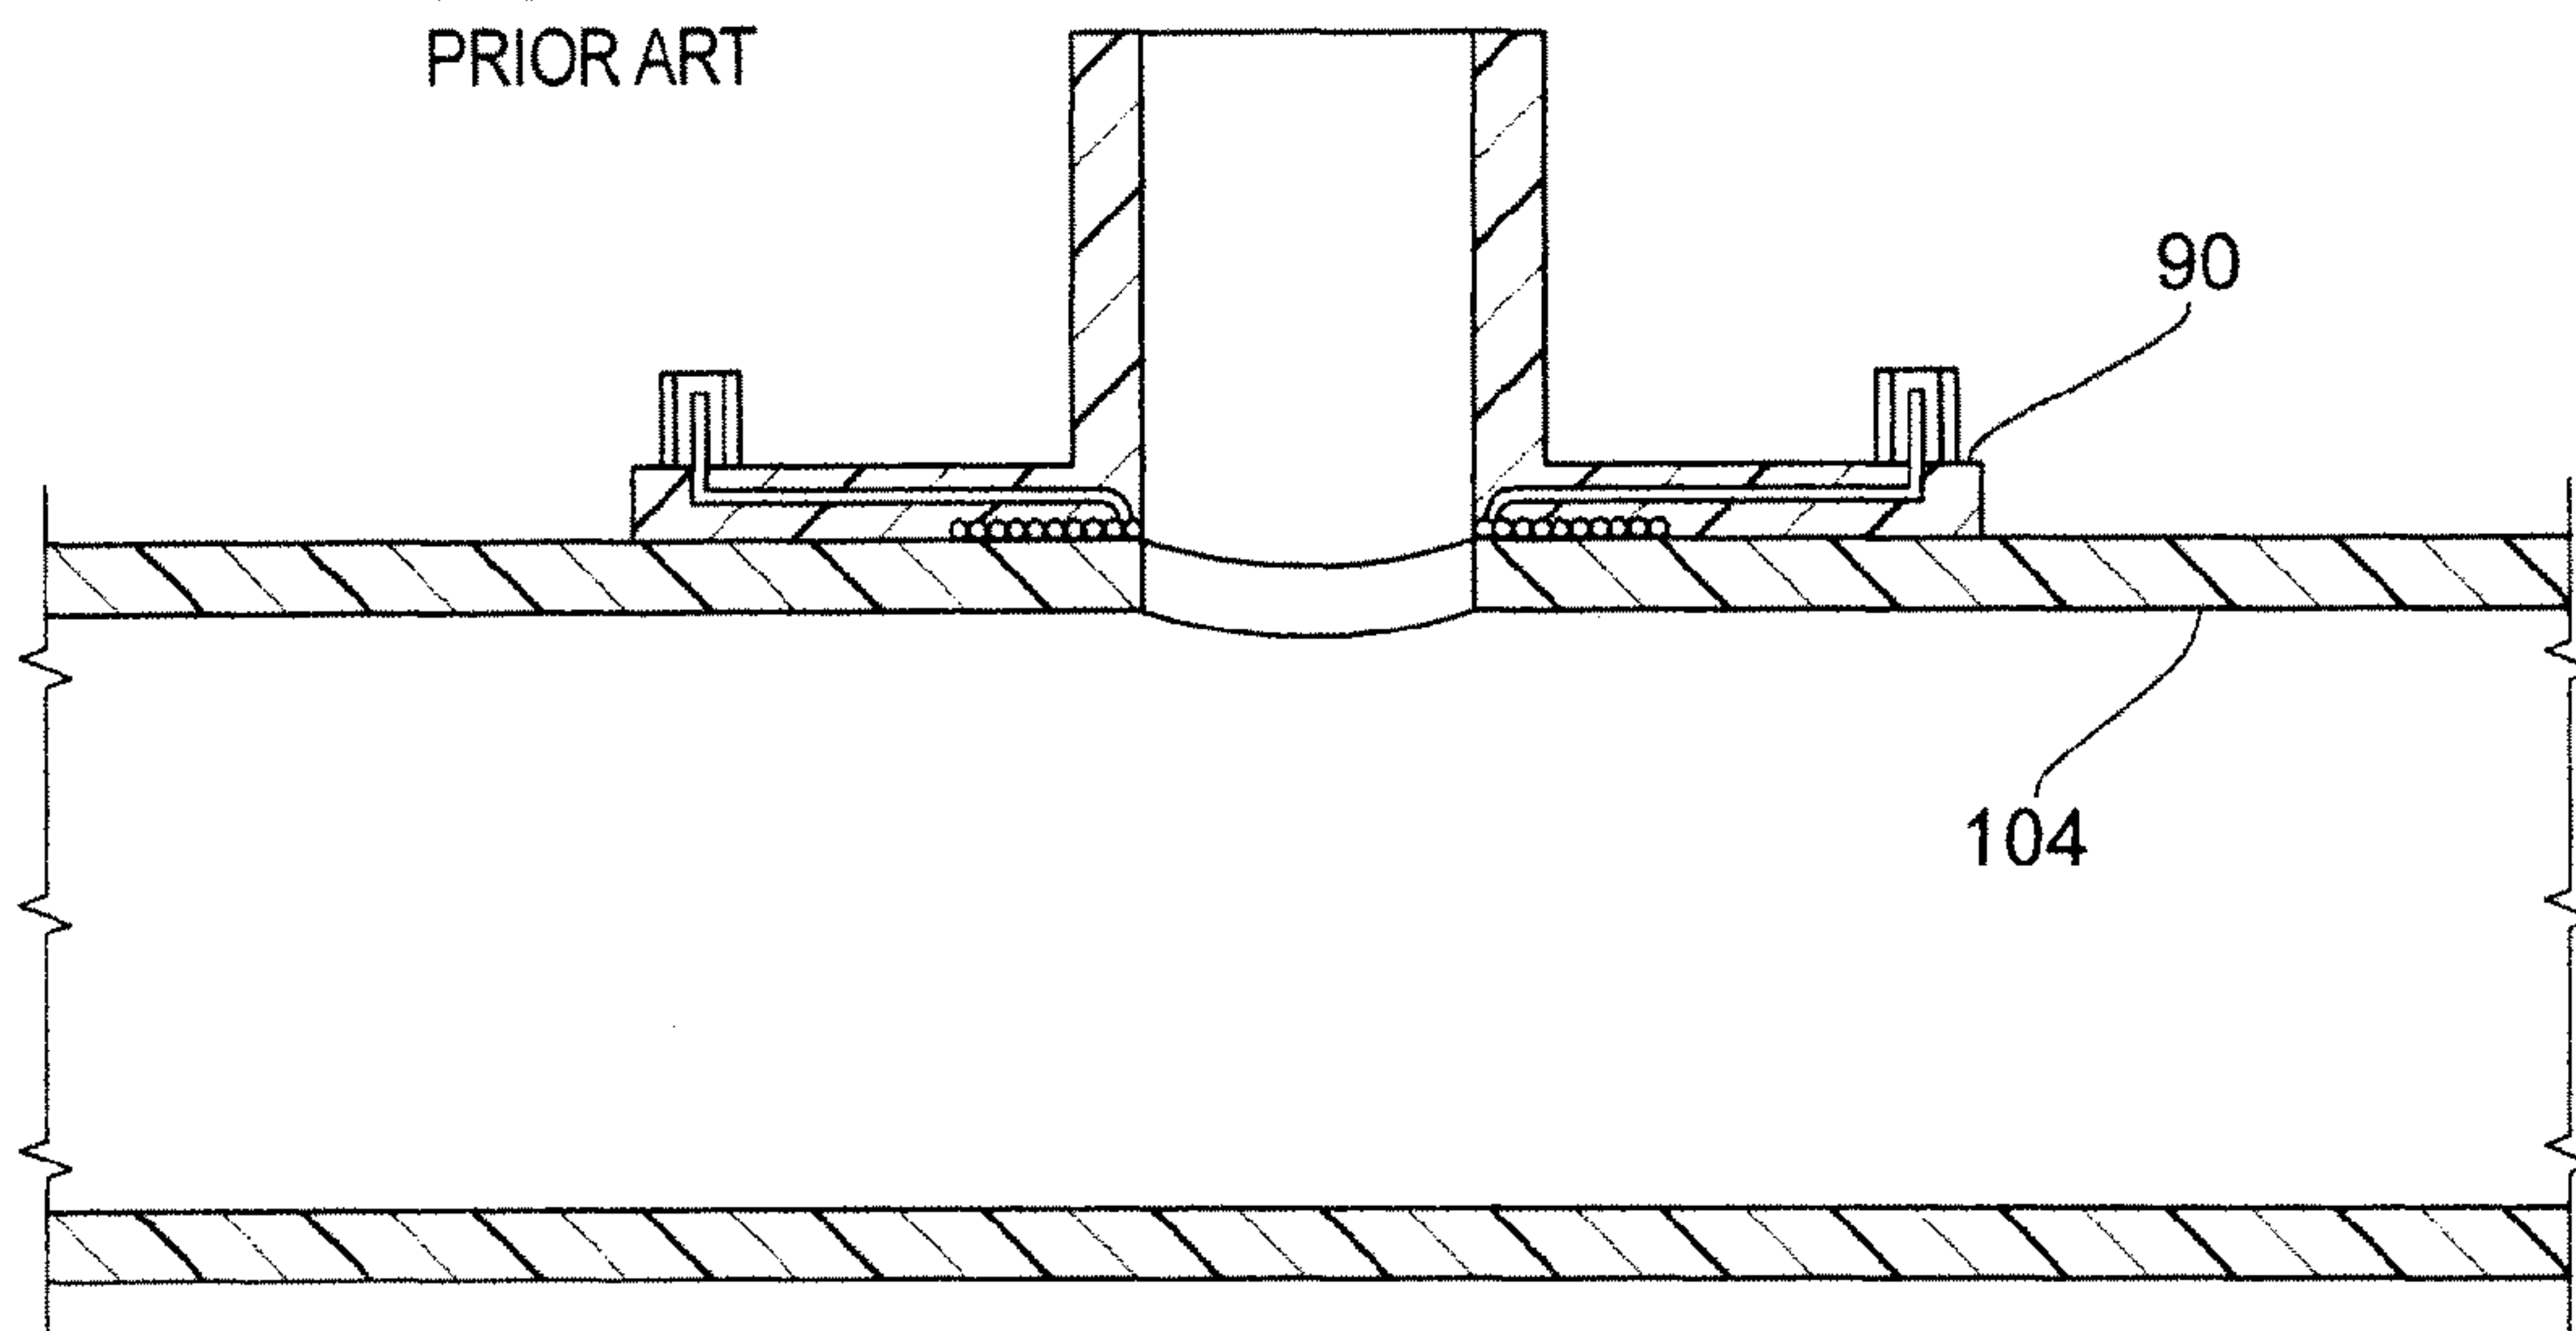
FIG. 25
PRIOR ART

FIG. 25 is a side cutaway view of a prior art thermocouple saddle fitting positioned upon a pipe structure.
