(12) **United States Patent**
Brooks et al.

(54) **REPAIR APPARATUS AND METHOD FOR
PIPE AND FITTINGS**

Disclosed herein is a repair apparatus and method for pipe and fittings. In one form, the method relates to utilizing fabric-like material which is intermixed with an adhesive. In one form, the adhesive is a two-part adhesive which hardens to a semi-rigid state to avoid stress fractures through repeated expansion and contraction due to physical movement or temperature variation in the pipe and/or fittings. In one form the method and apparatus are particularly useful in thermoplastic pipes. In other forms, the method is particularly useful in metal pipes and fittings, or in non-pipe structures.

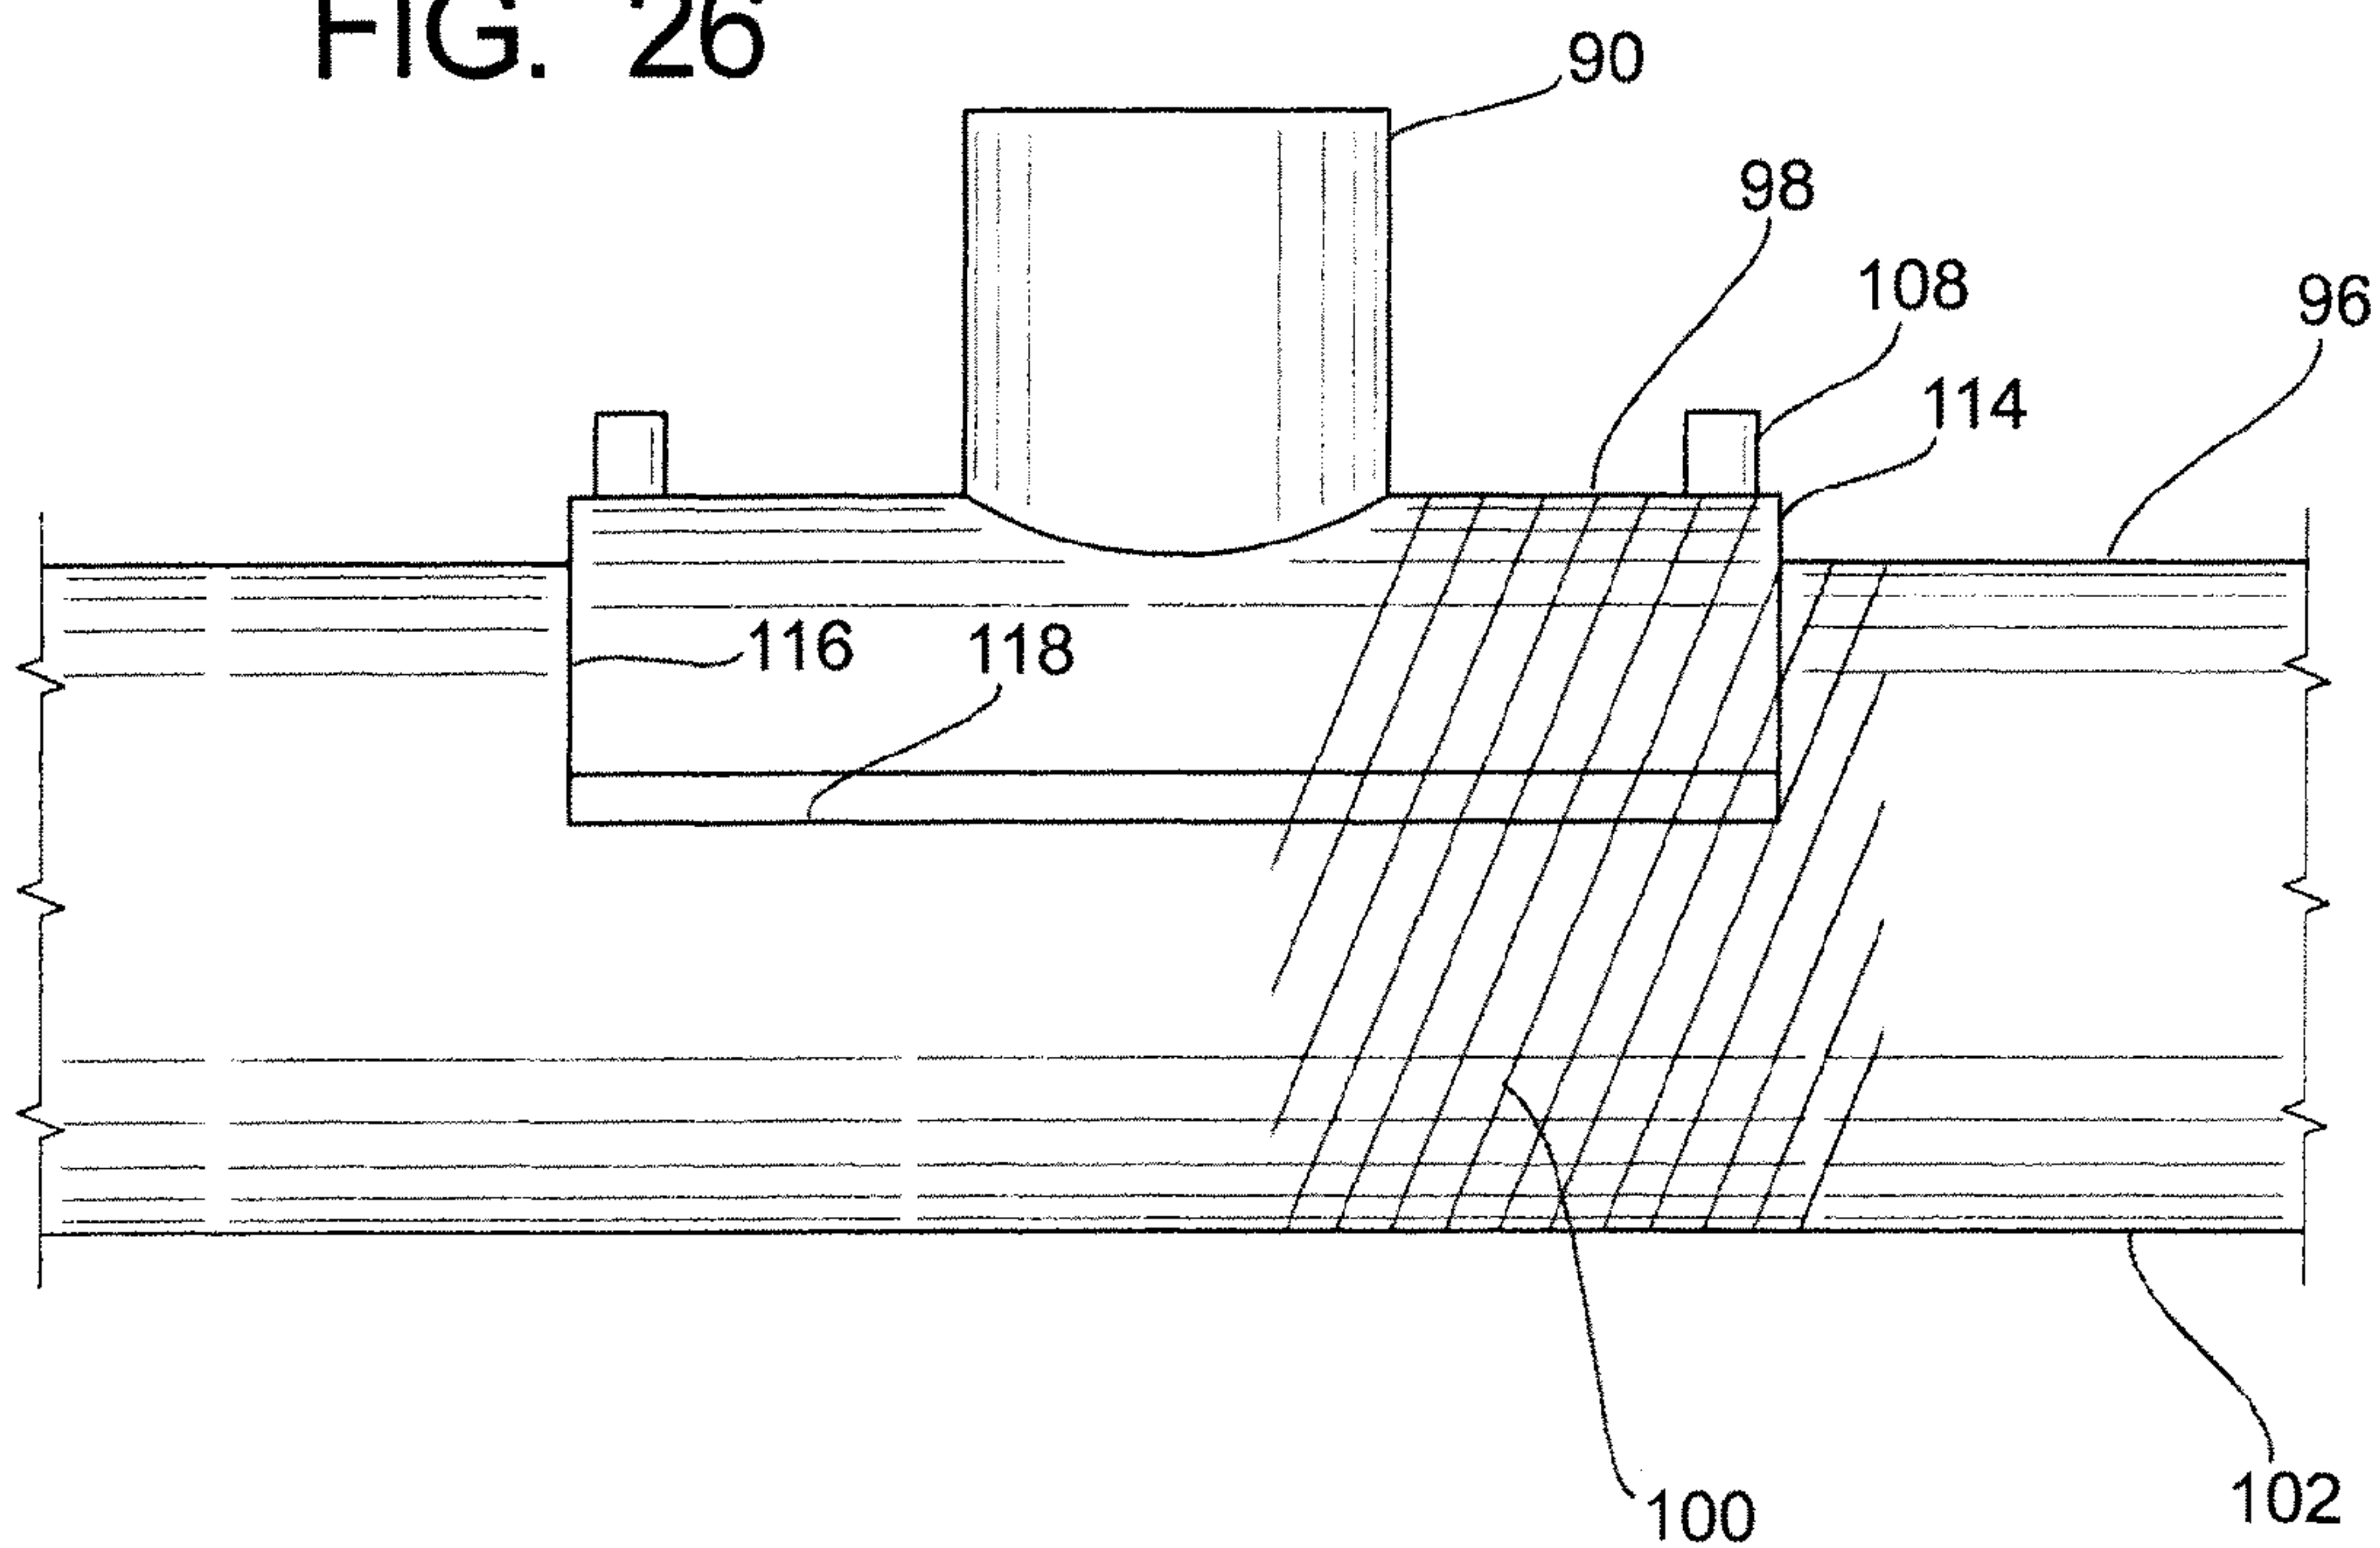
FIG. 26 is a side view of a thermocouple saddle fitting positioned upon a pipe structure.

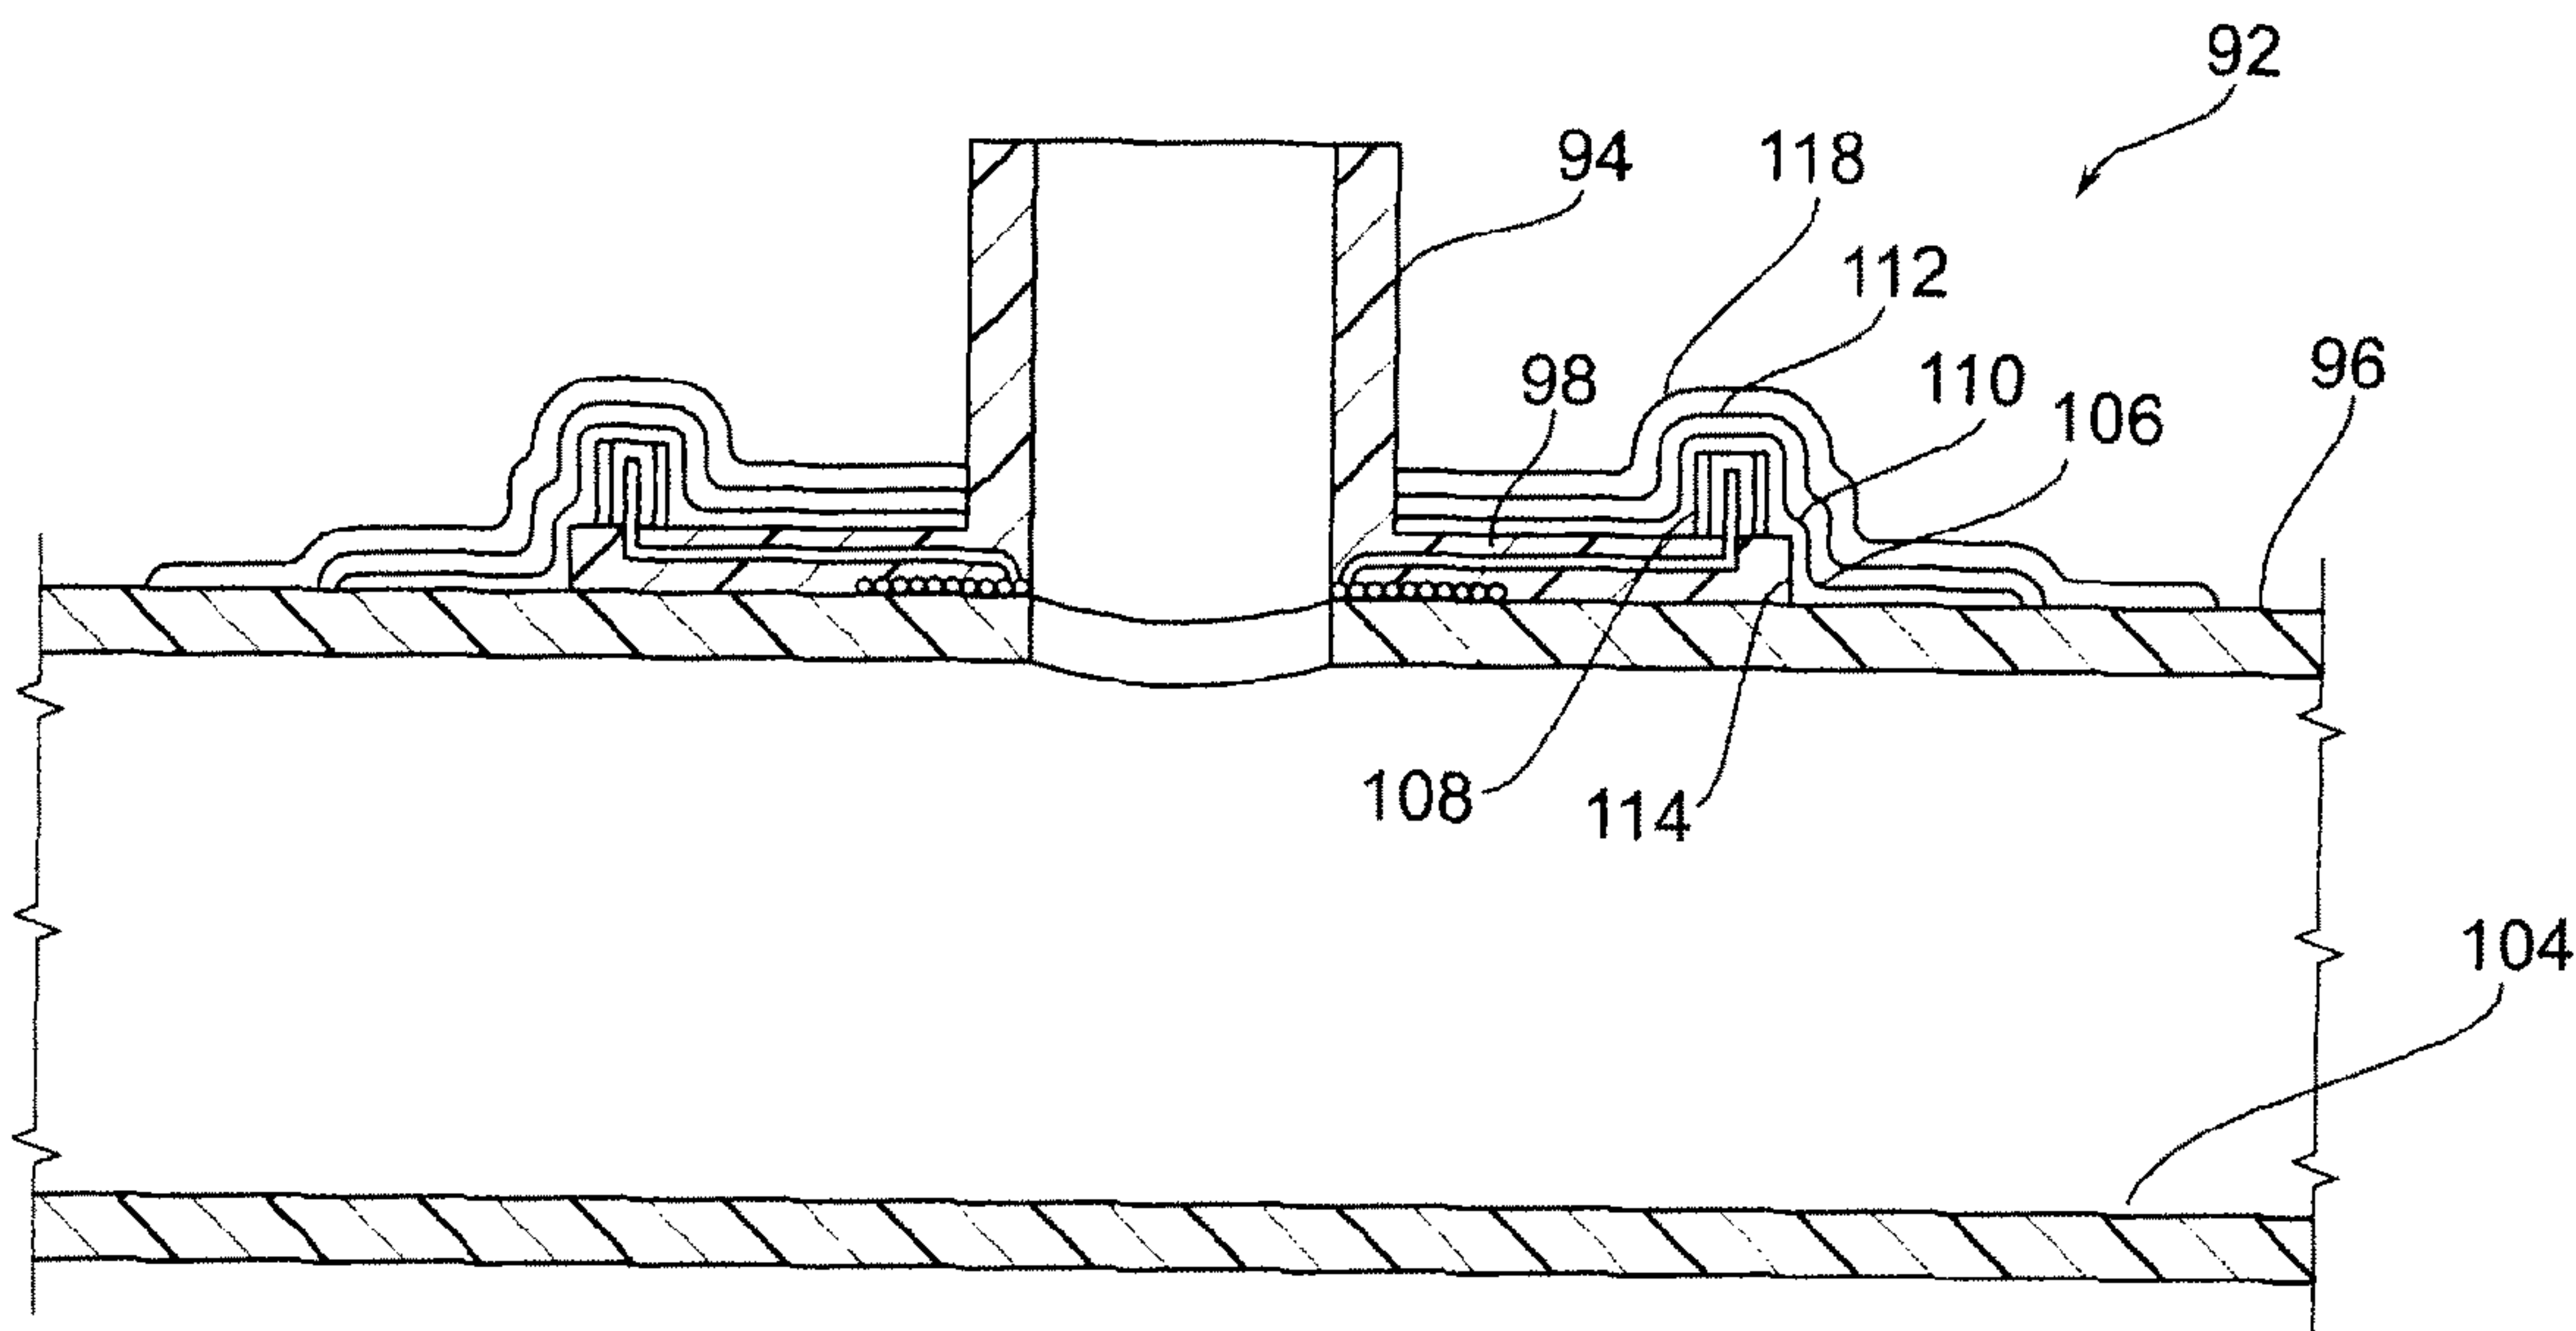
FIG. 27 is a side cutaway view of a section of pipe and a fitting in the process of being repaired using the disclosed method in one form.

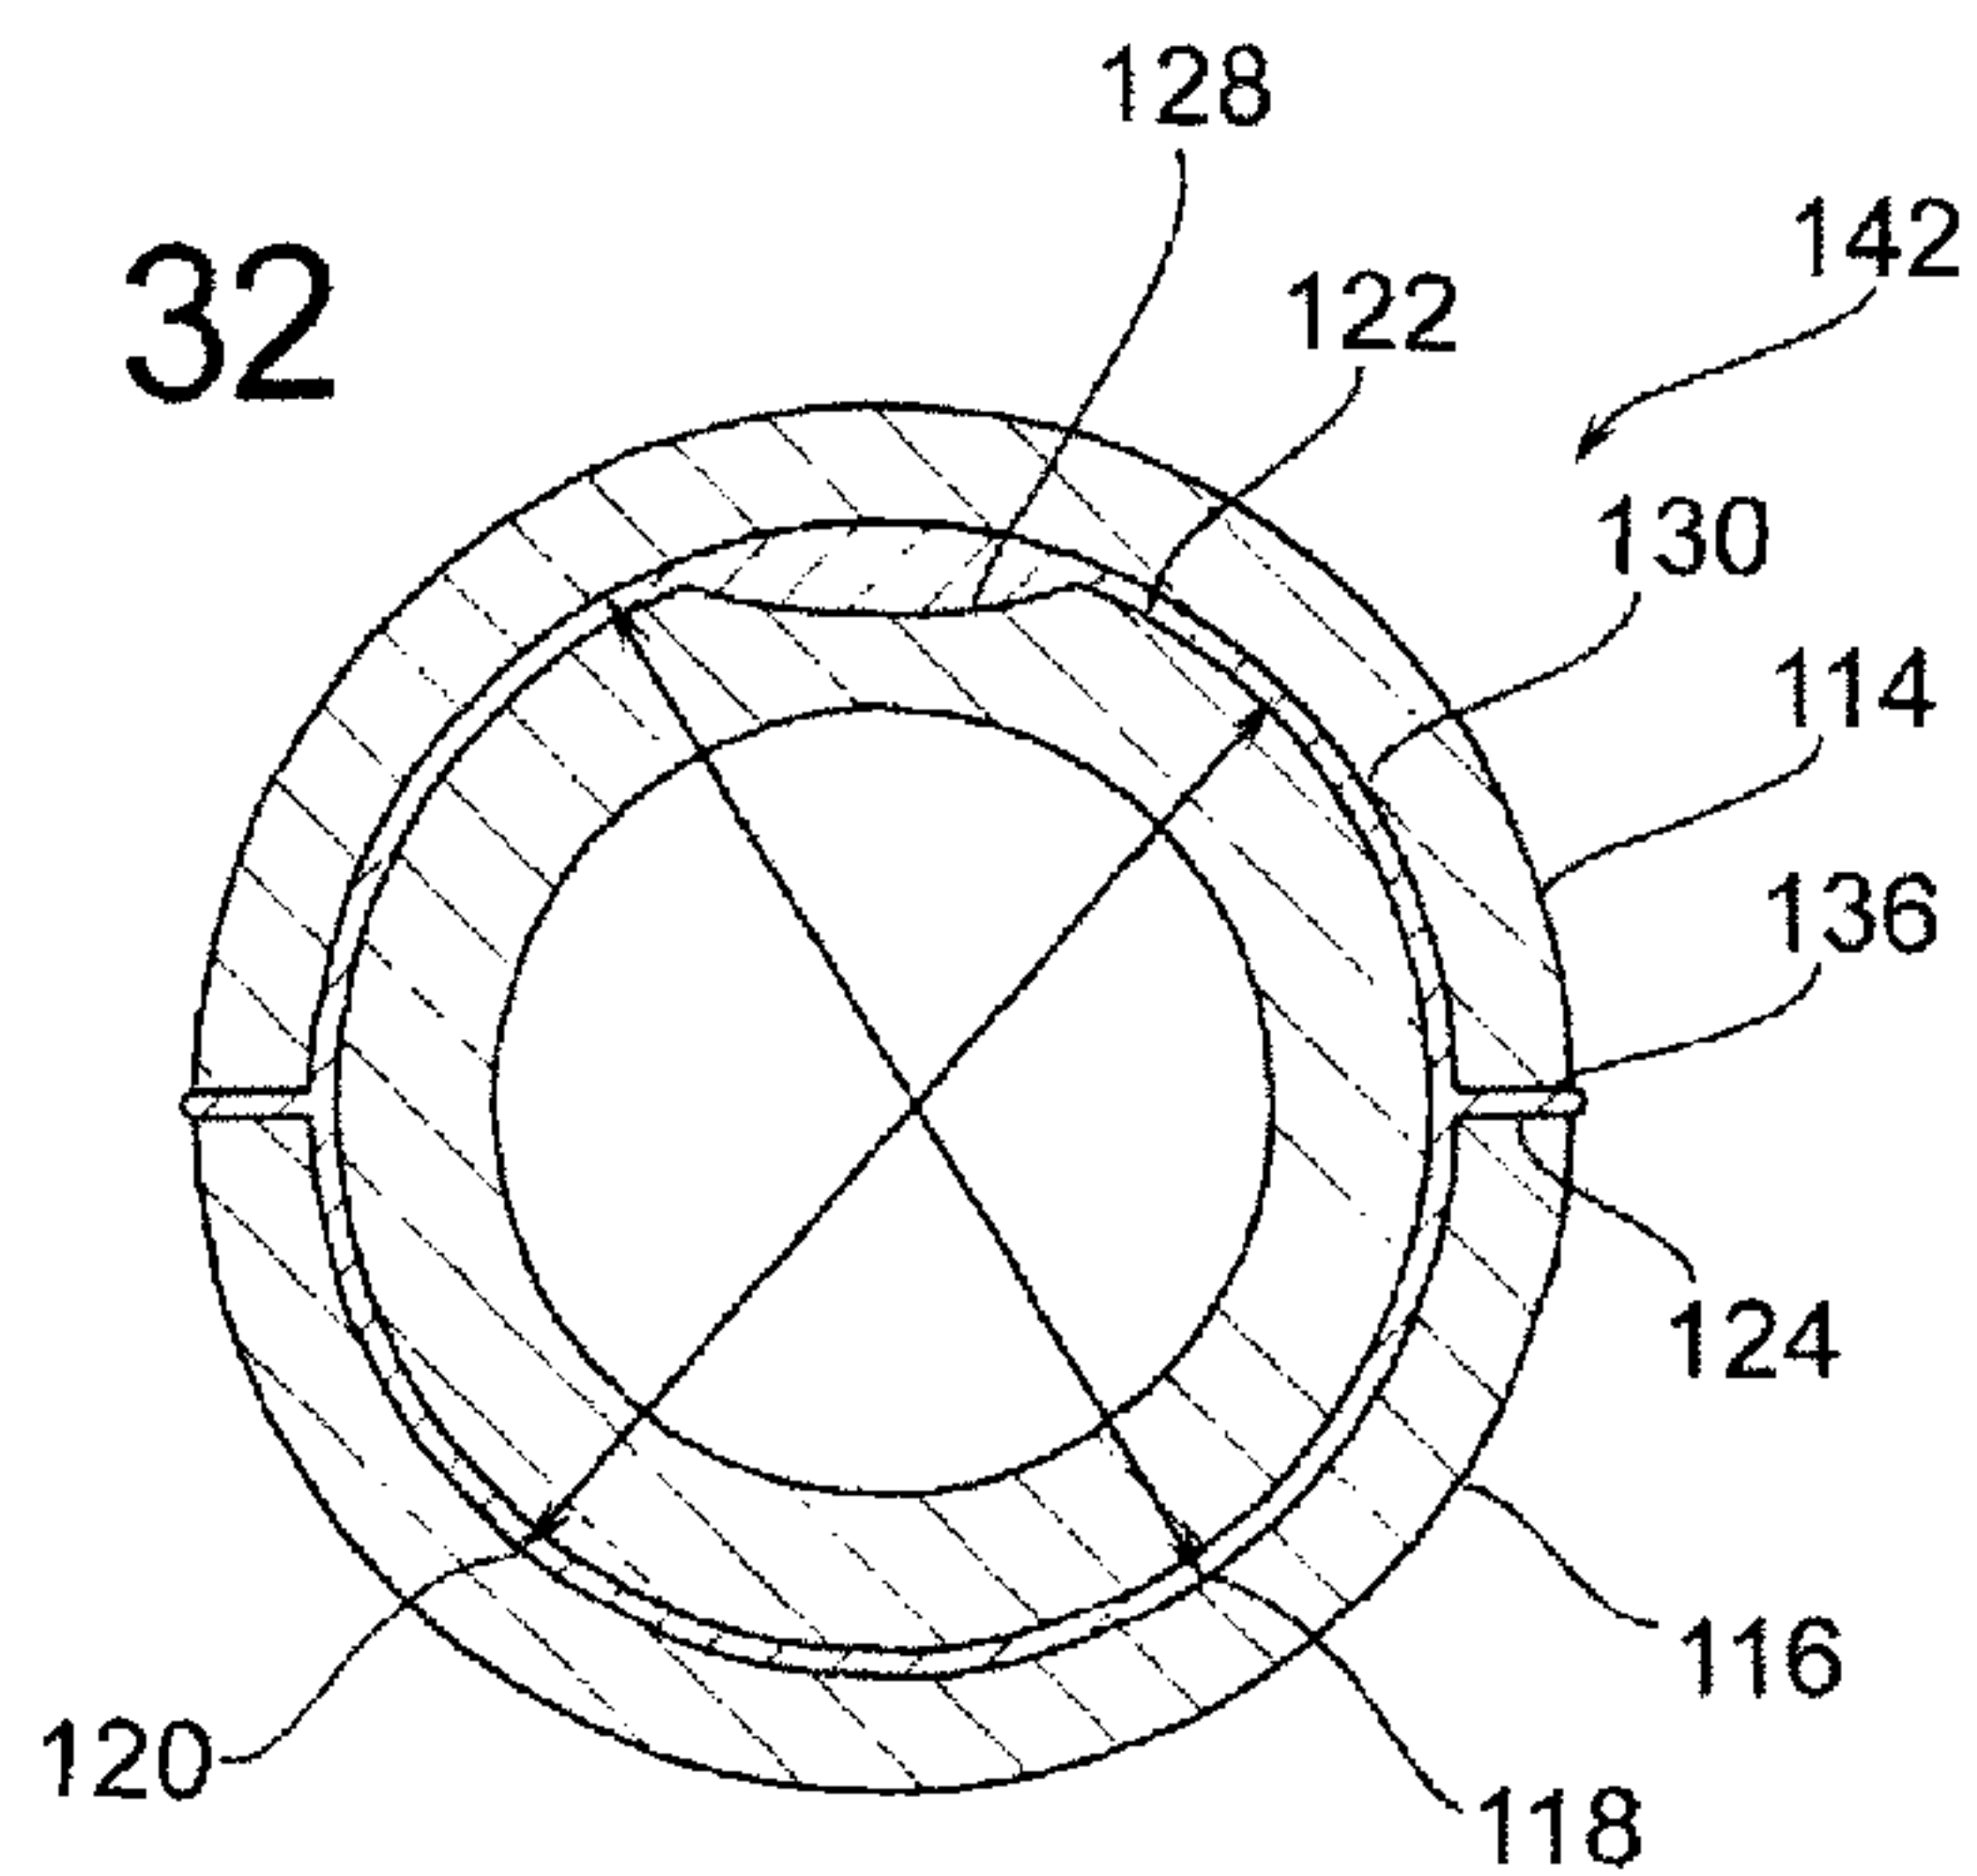
FIG. 32 is an end cutaway view of a compromised pipe section in the process of being repaired using a clamshell sleeve in one form.

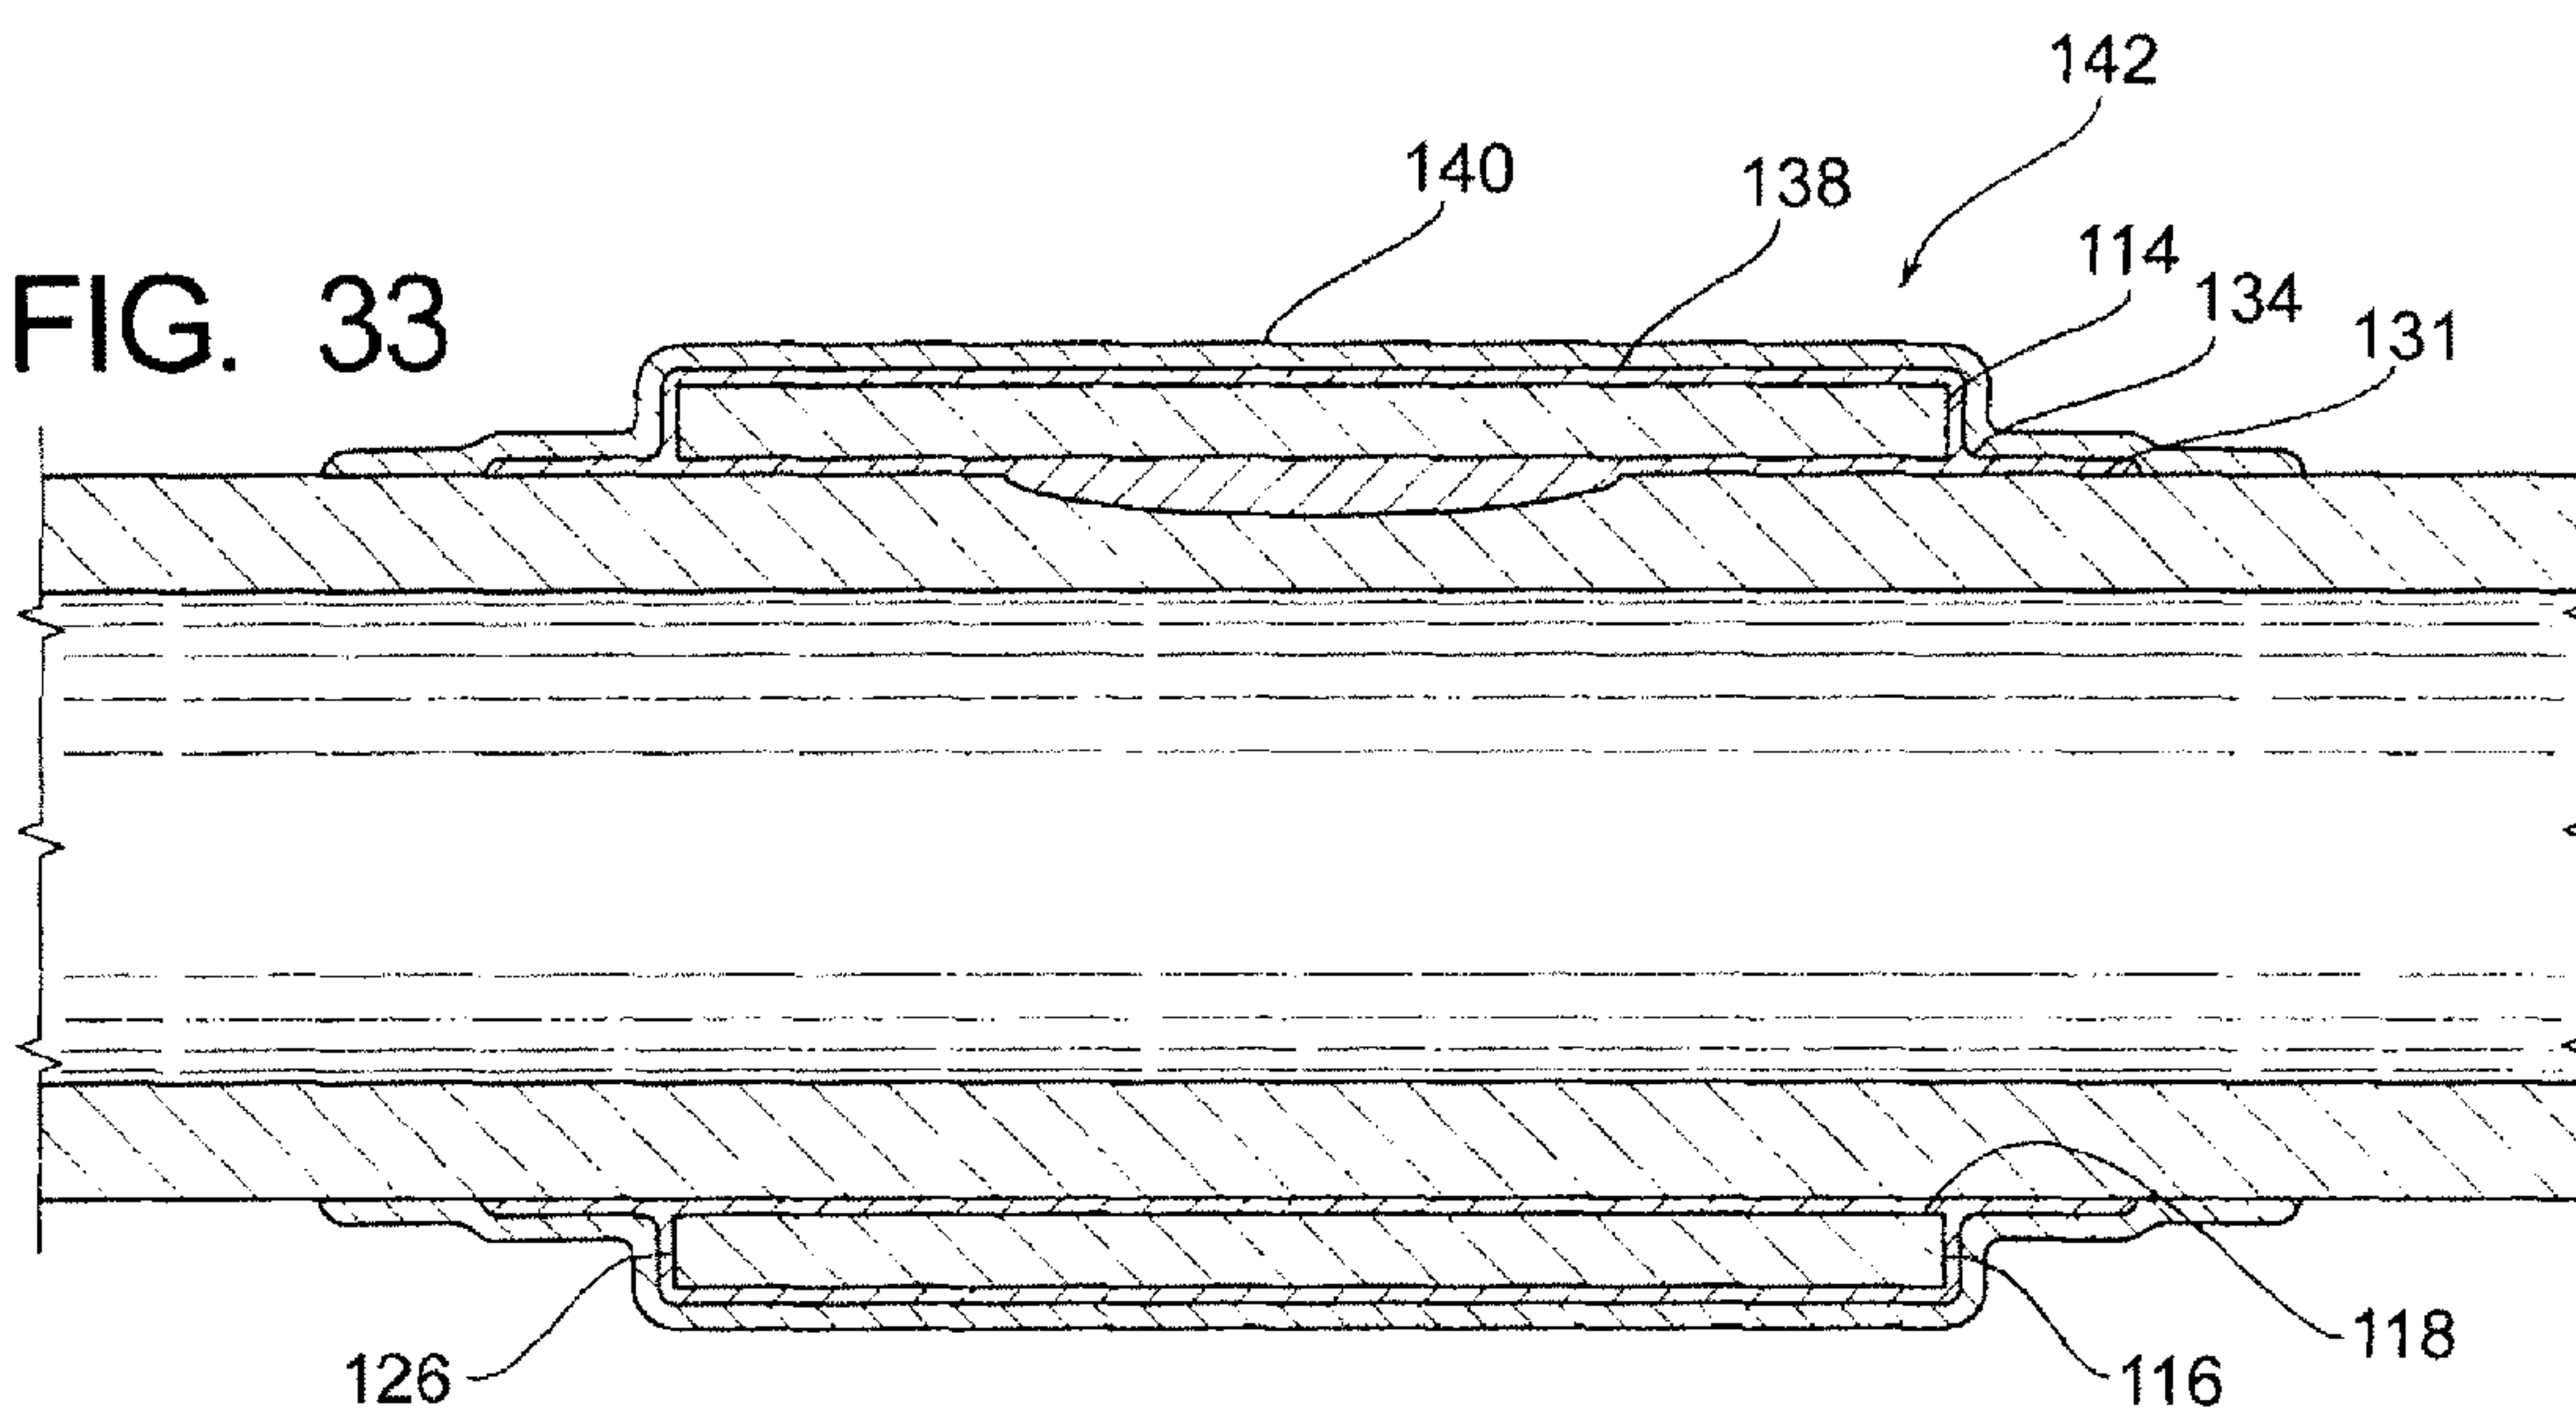
FIG. 33 is a side cutaway view of a compromised pipe section with a substantially completed repair using the disclosed method in one form.

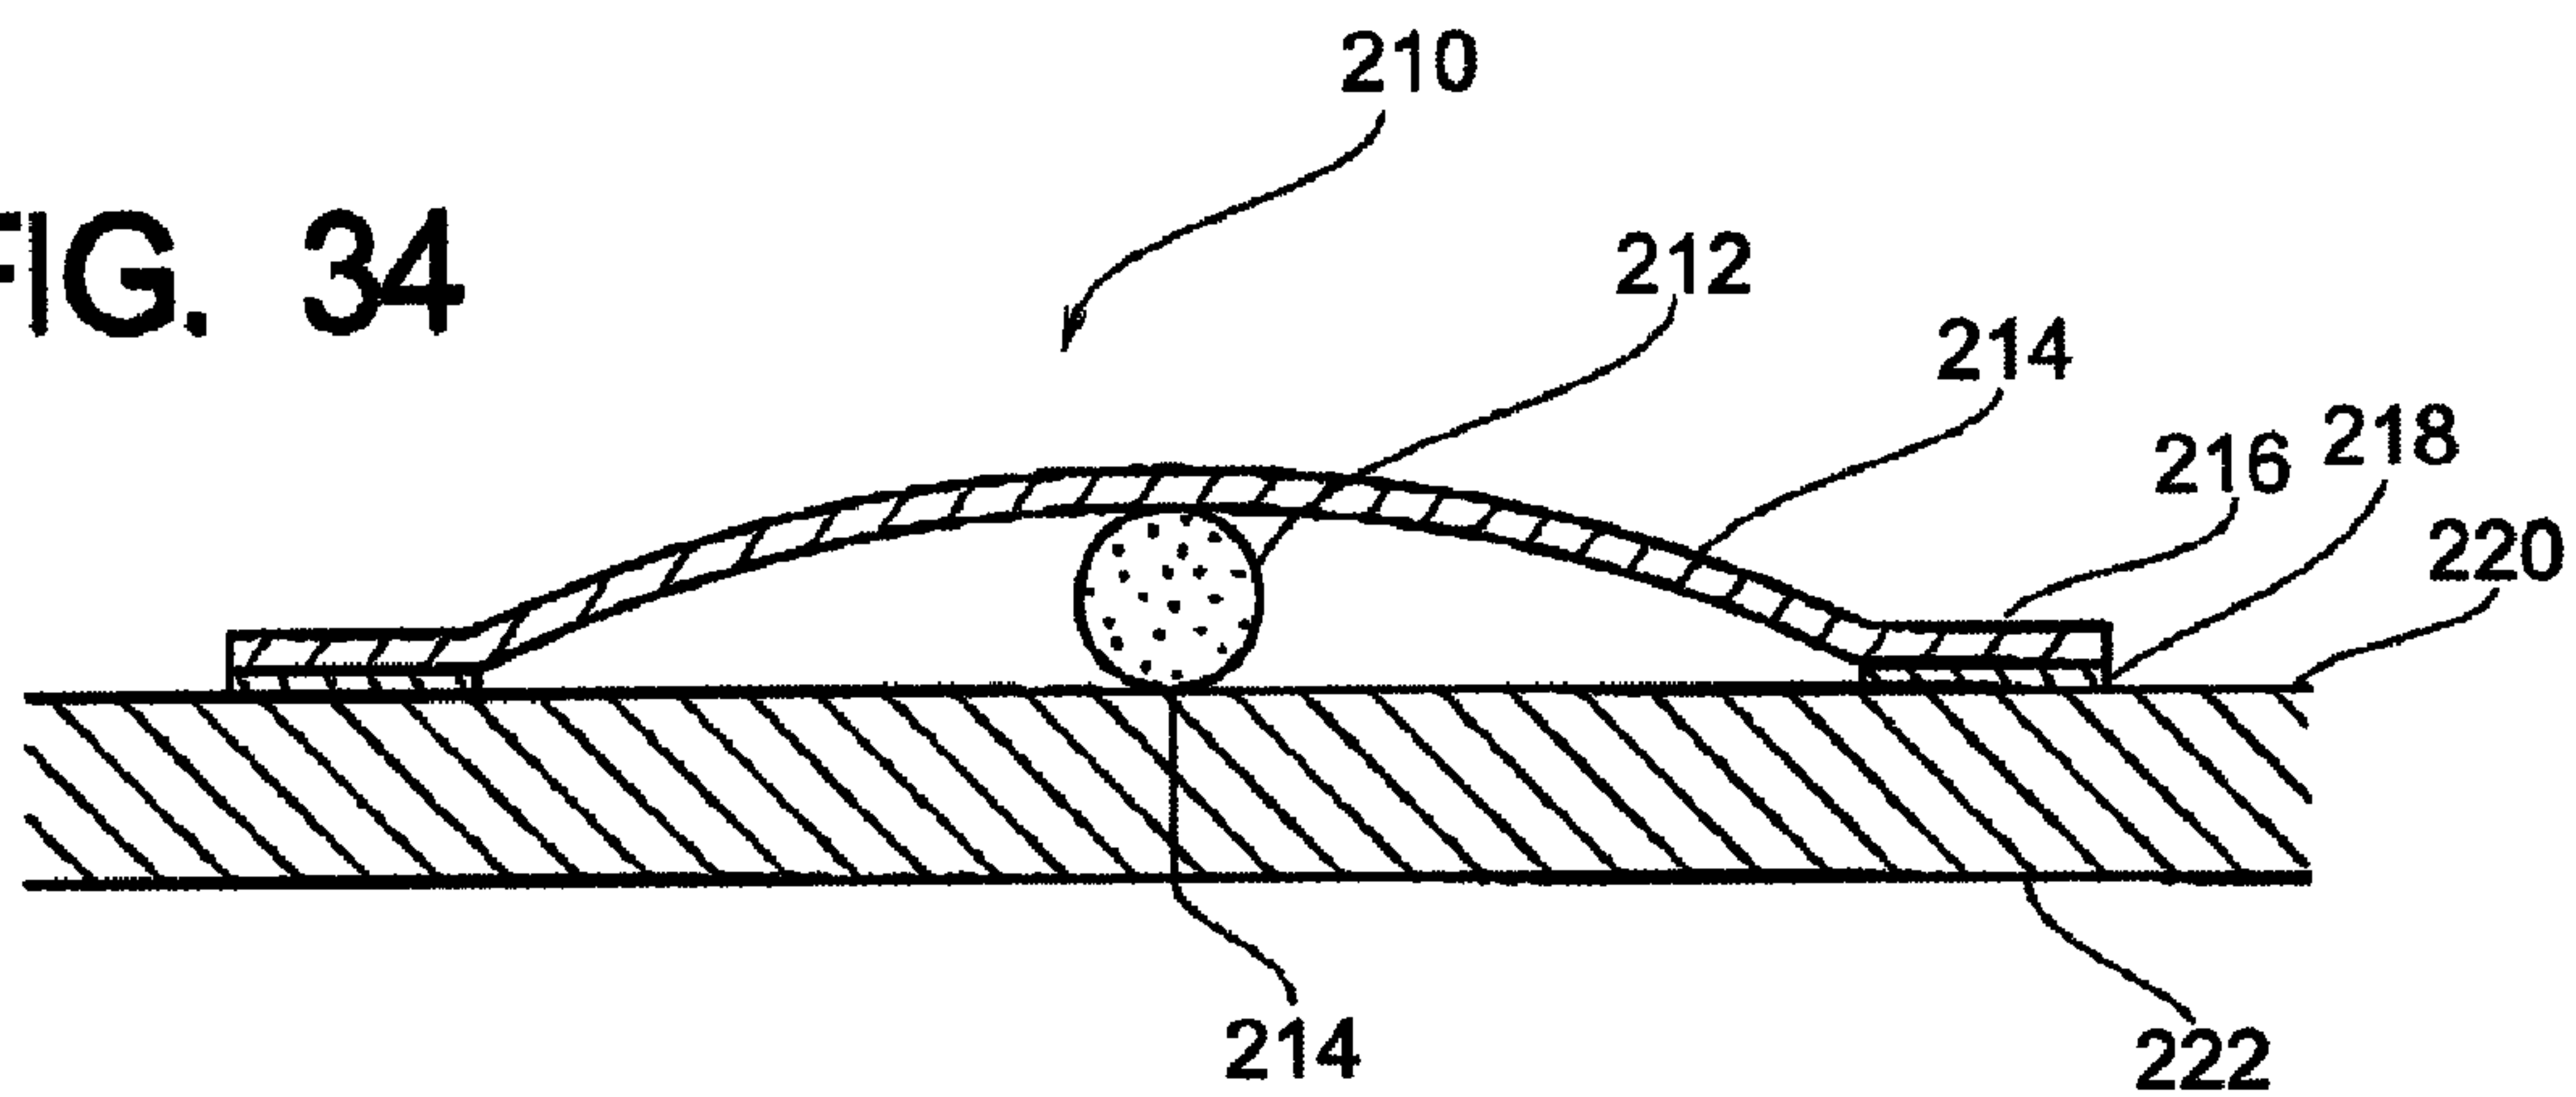
FIG. 34 is a side cutaway view of a stop leak patch repair using the disclosed method in one form.

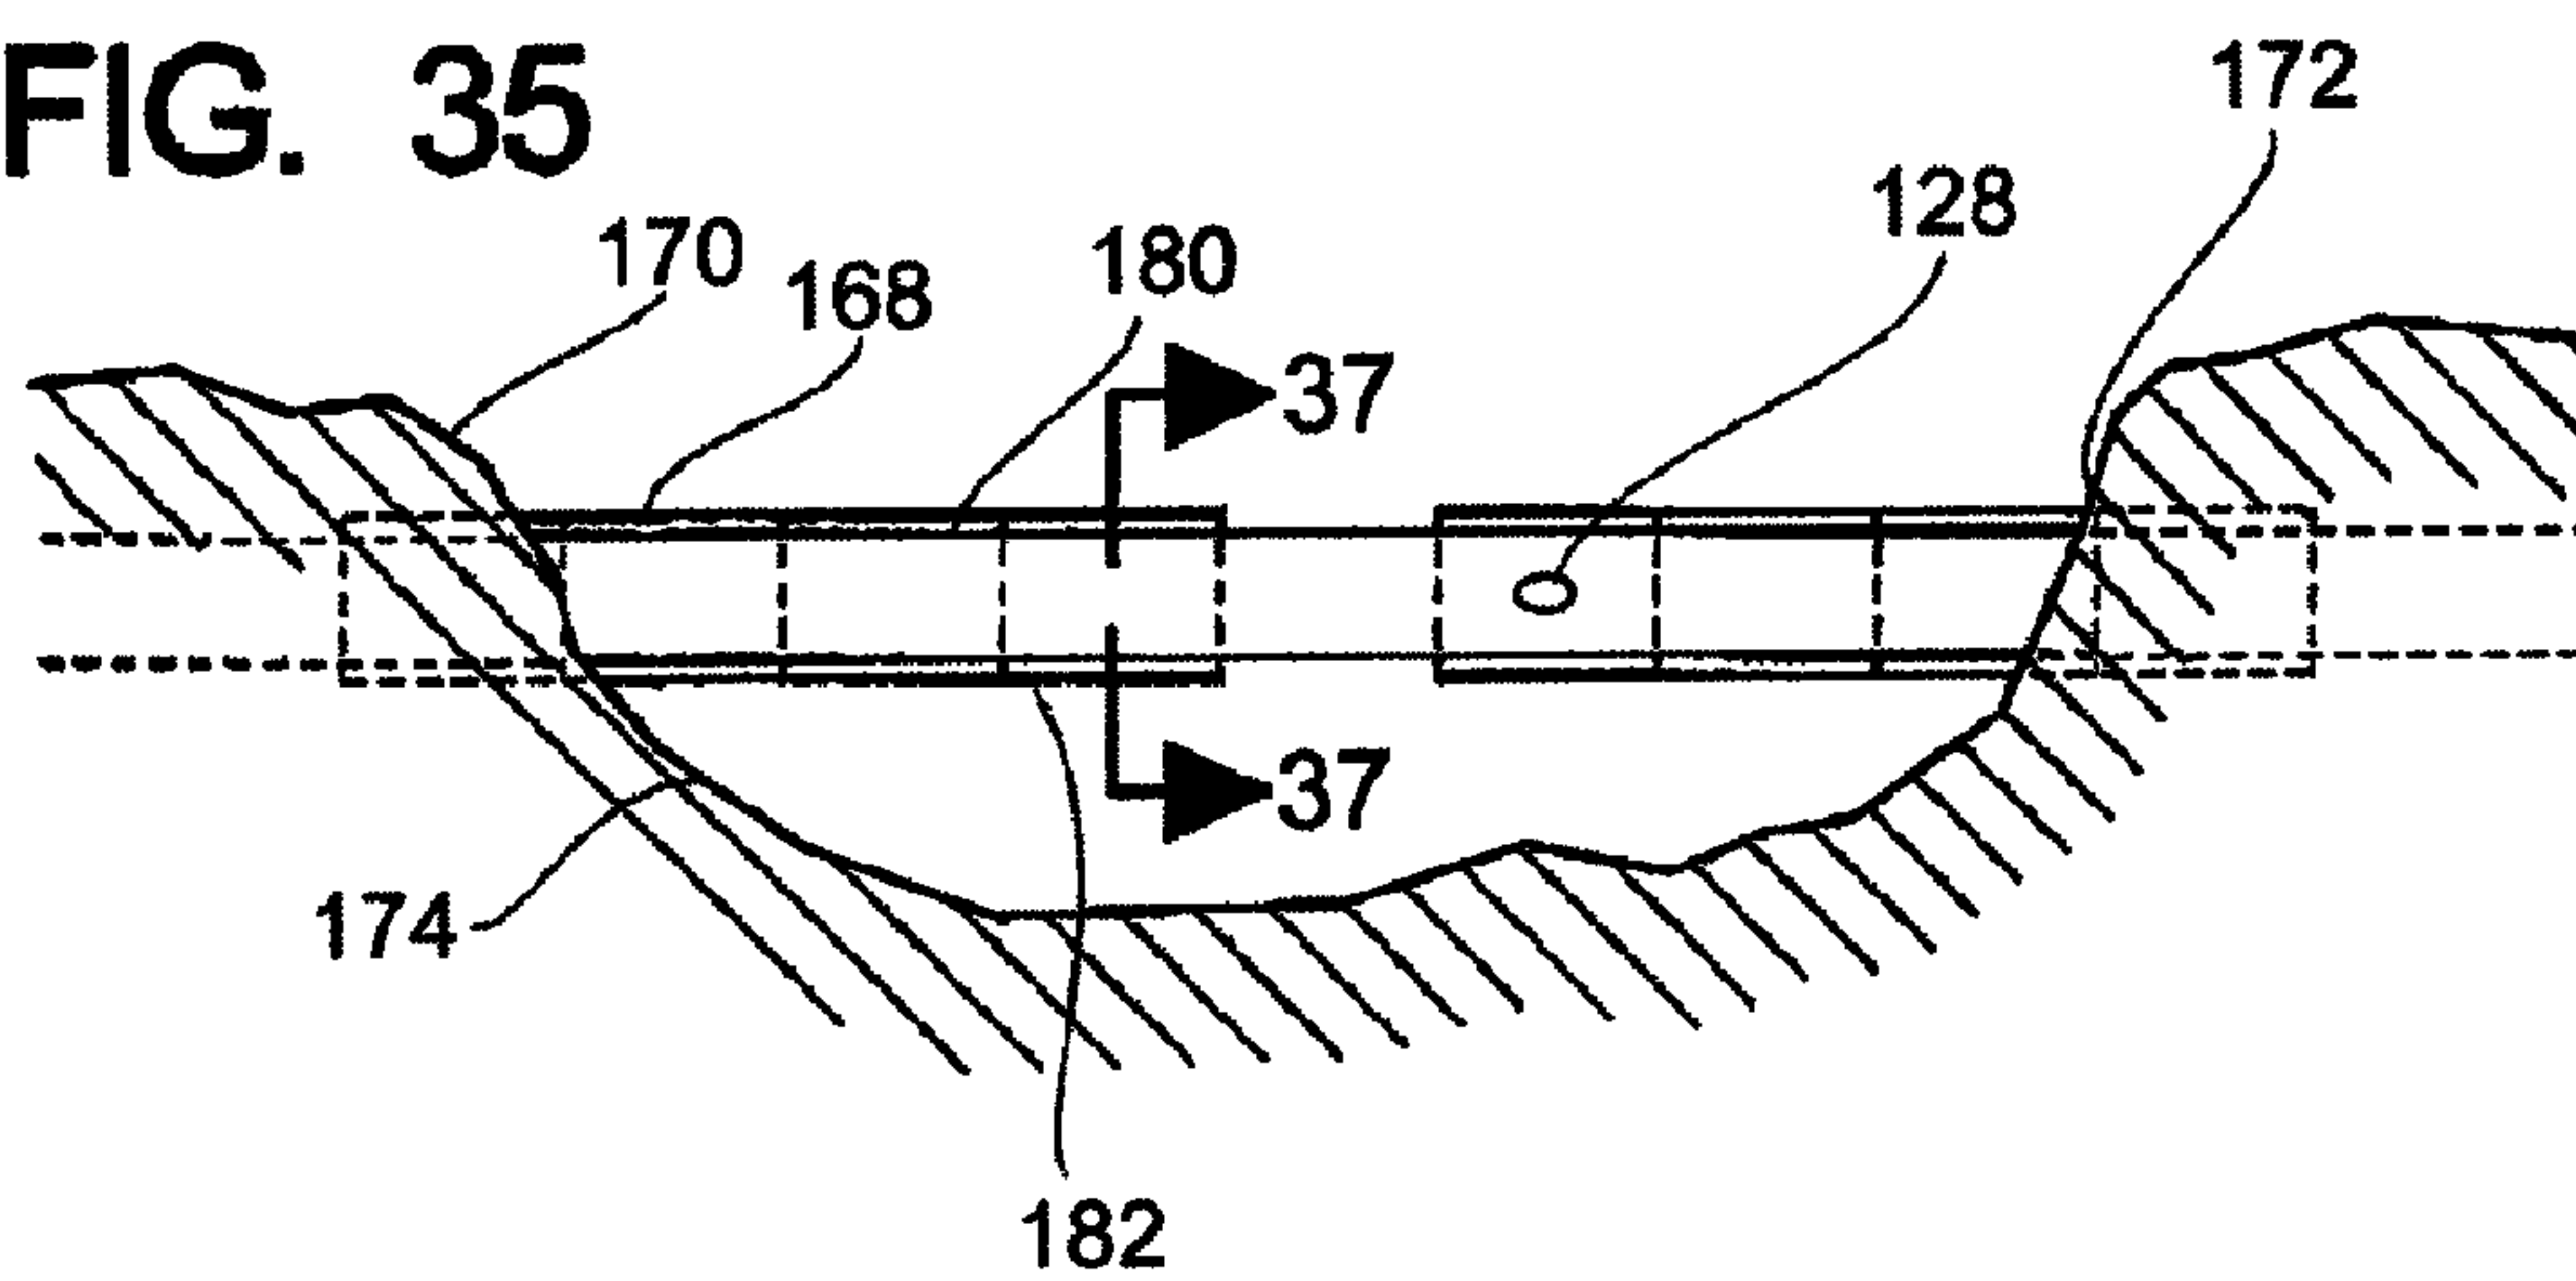
FIG. 35 is a side environmental (hidden line) view of a repair using the disclosed method in one form.
