(12) **United States Patent**
Brooks et al.

(54) **REPAIR APPARATUS AND METHOD FOR
PIPE AND FITTINGS**

Disclosed herein is a repair apparatus and method for pipe and fittings. In one form, the method relates to utilizing fabric-like material which is intermixed with an adhesive. In one form, the adhesive is a two-part adhesive which hardens to a semi-rigid state to avoid stress fractures through repeated expansion and contraction due to physical movement or temperature variation in the pipe and/or fittings. In one form the method and apparatus are particularly useful in thermoplastic pipes. In other forms, the method is particularly useful in metal pipes and fittings, or in non-pipe structures.

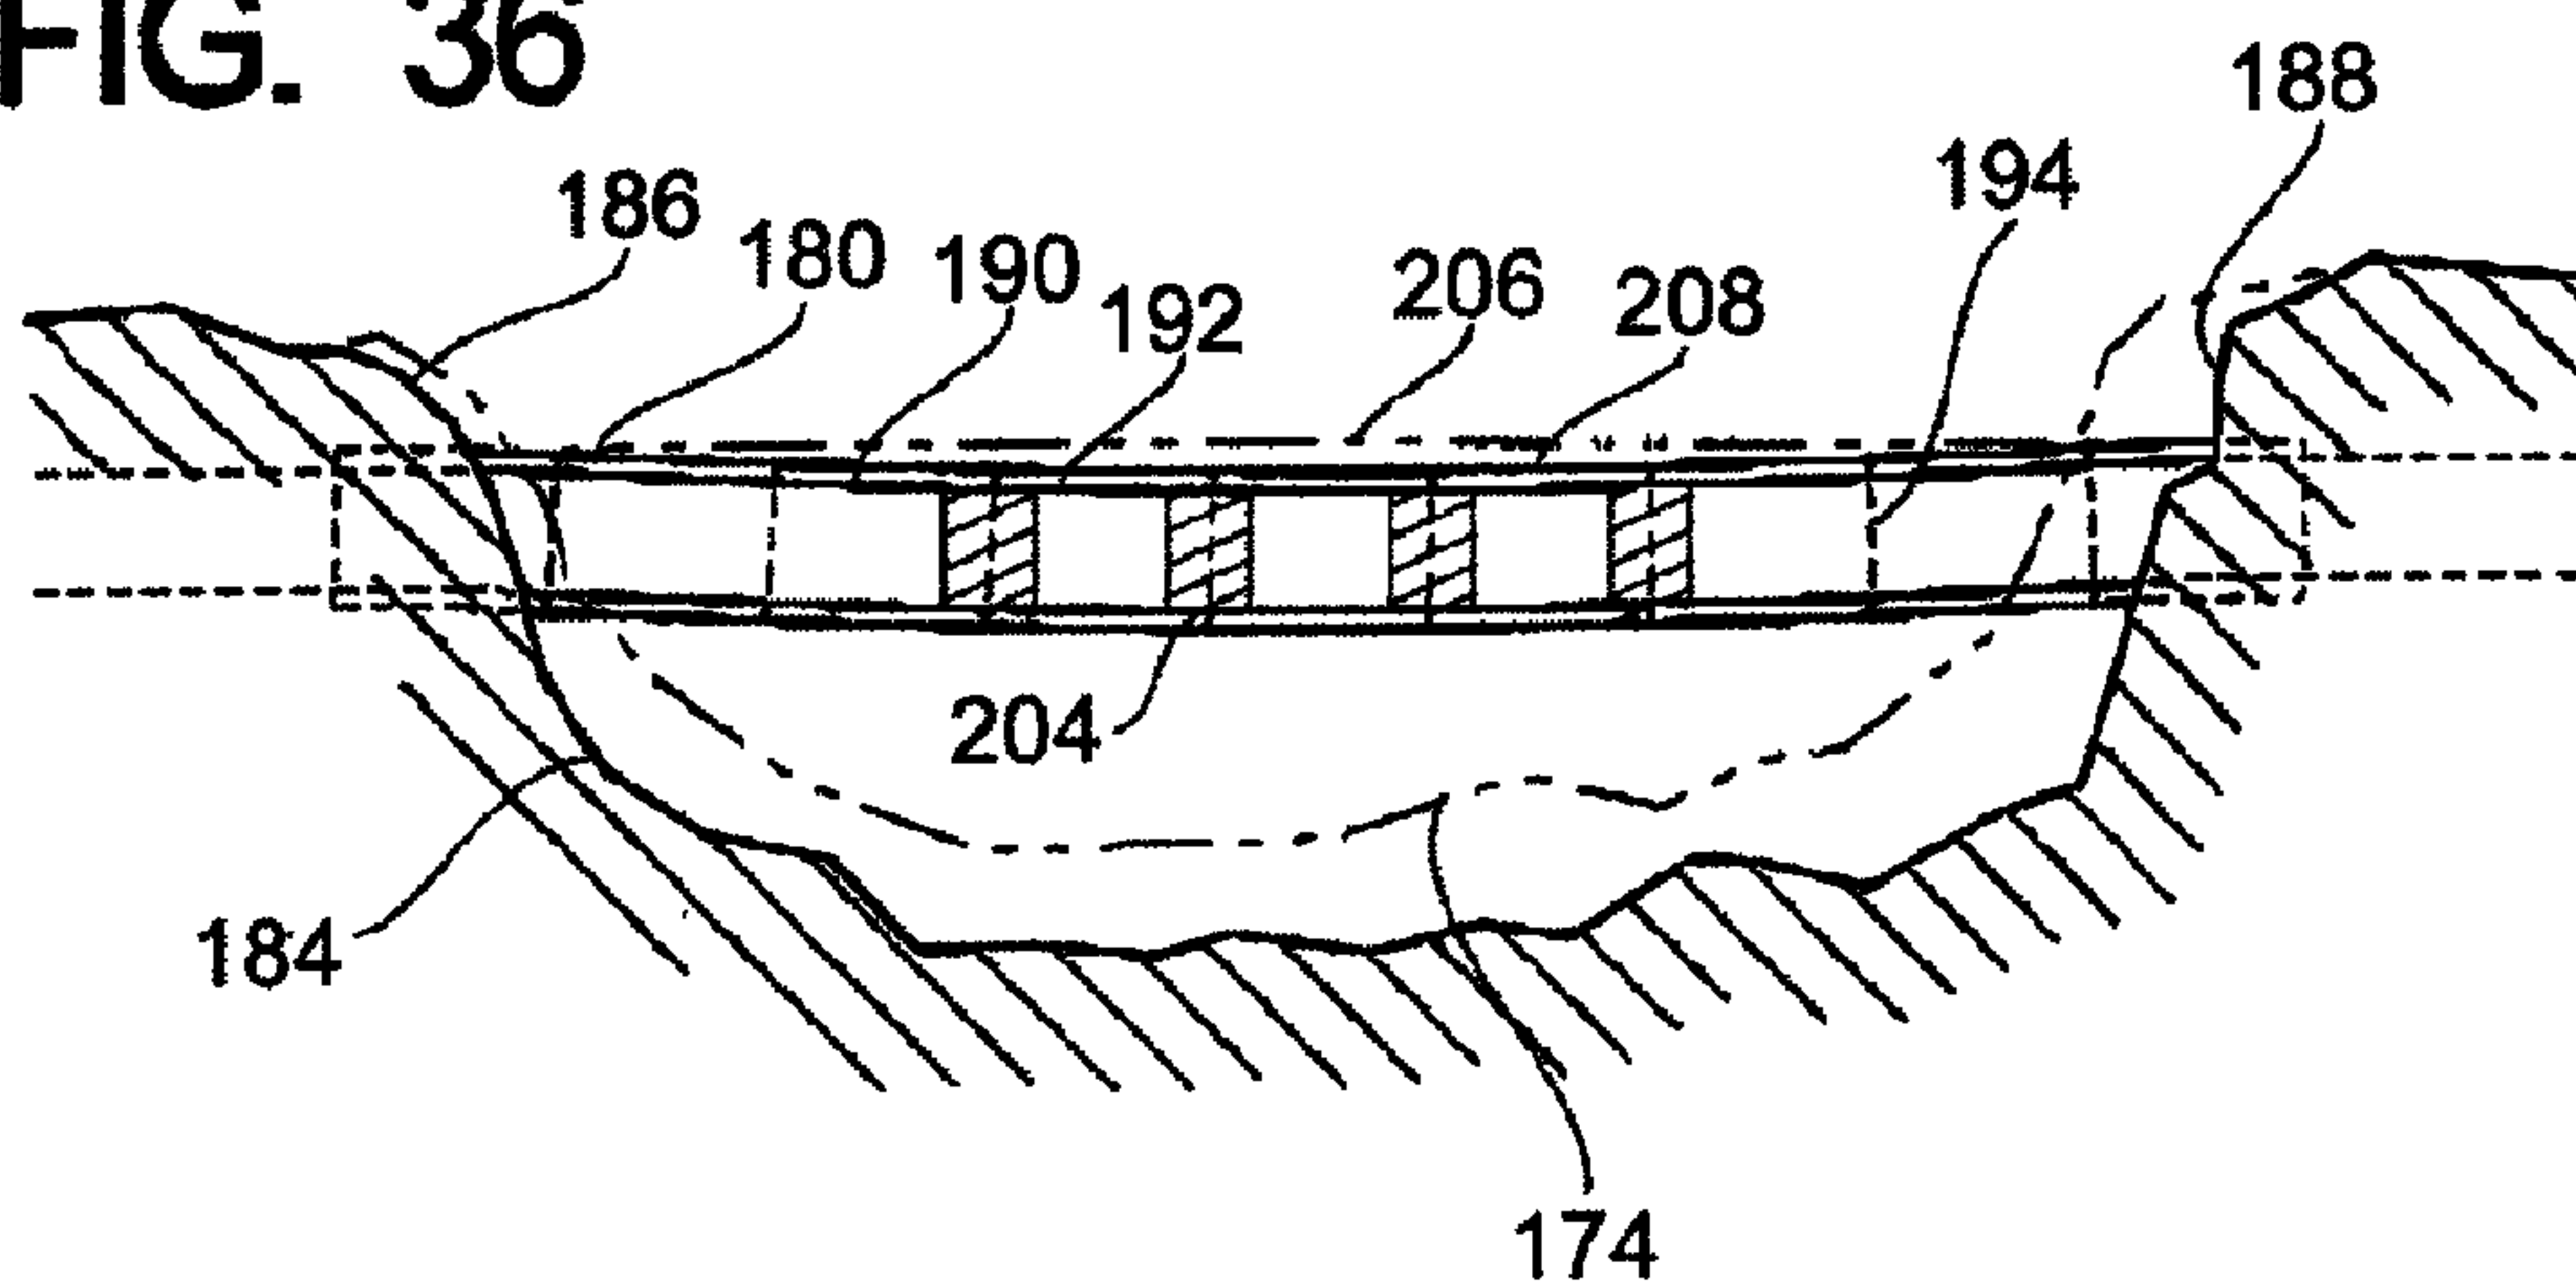
FIG. 36 is a side environmental (hidden line) view of a strengthening system using the disclosed method in one form.

As shown in FIG. 36, the pipe 180 has sagged from its original position 206 to a lower position 208. Thus it may be

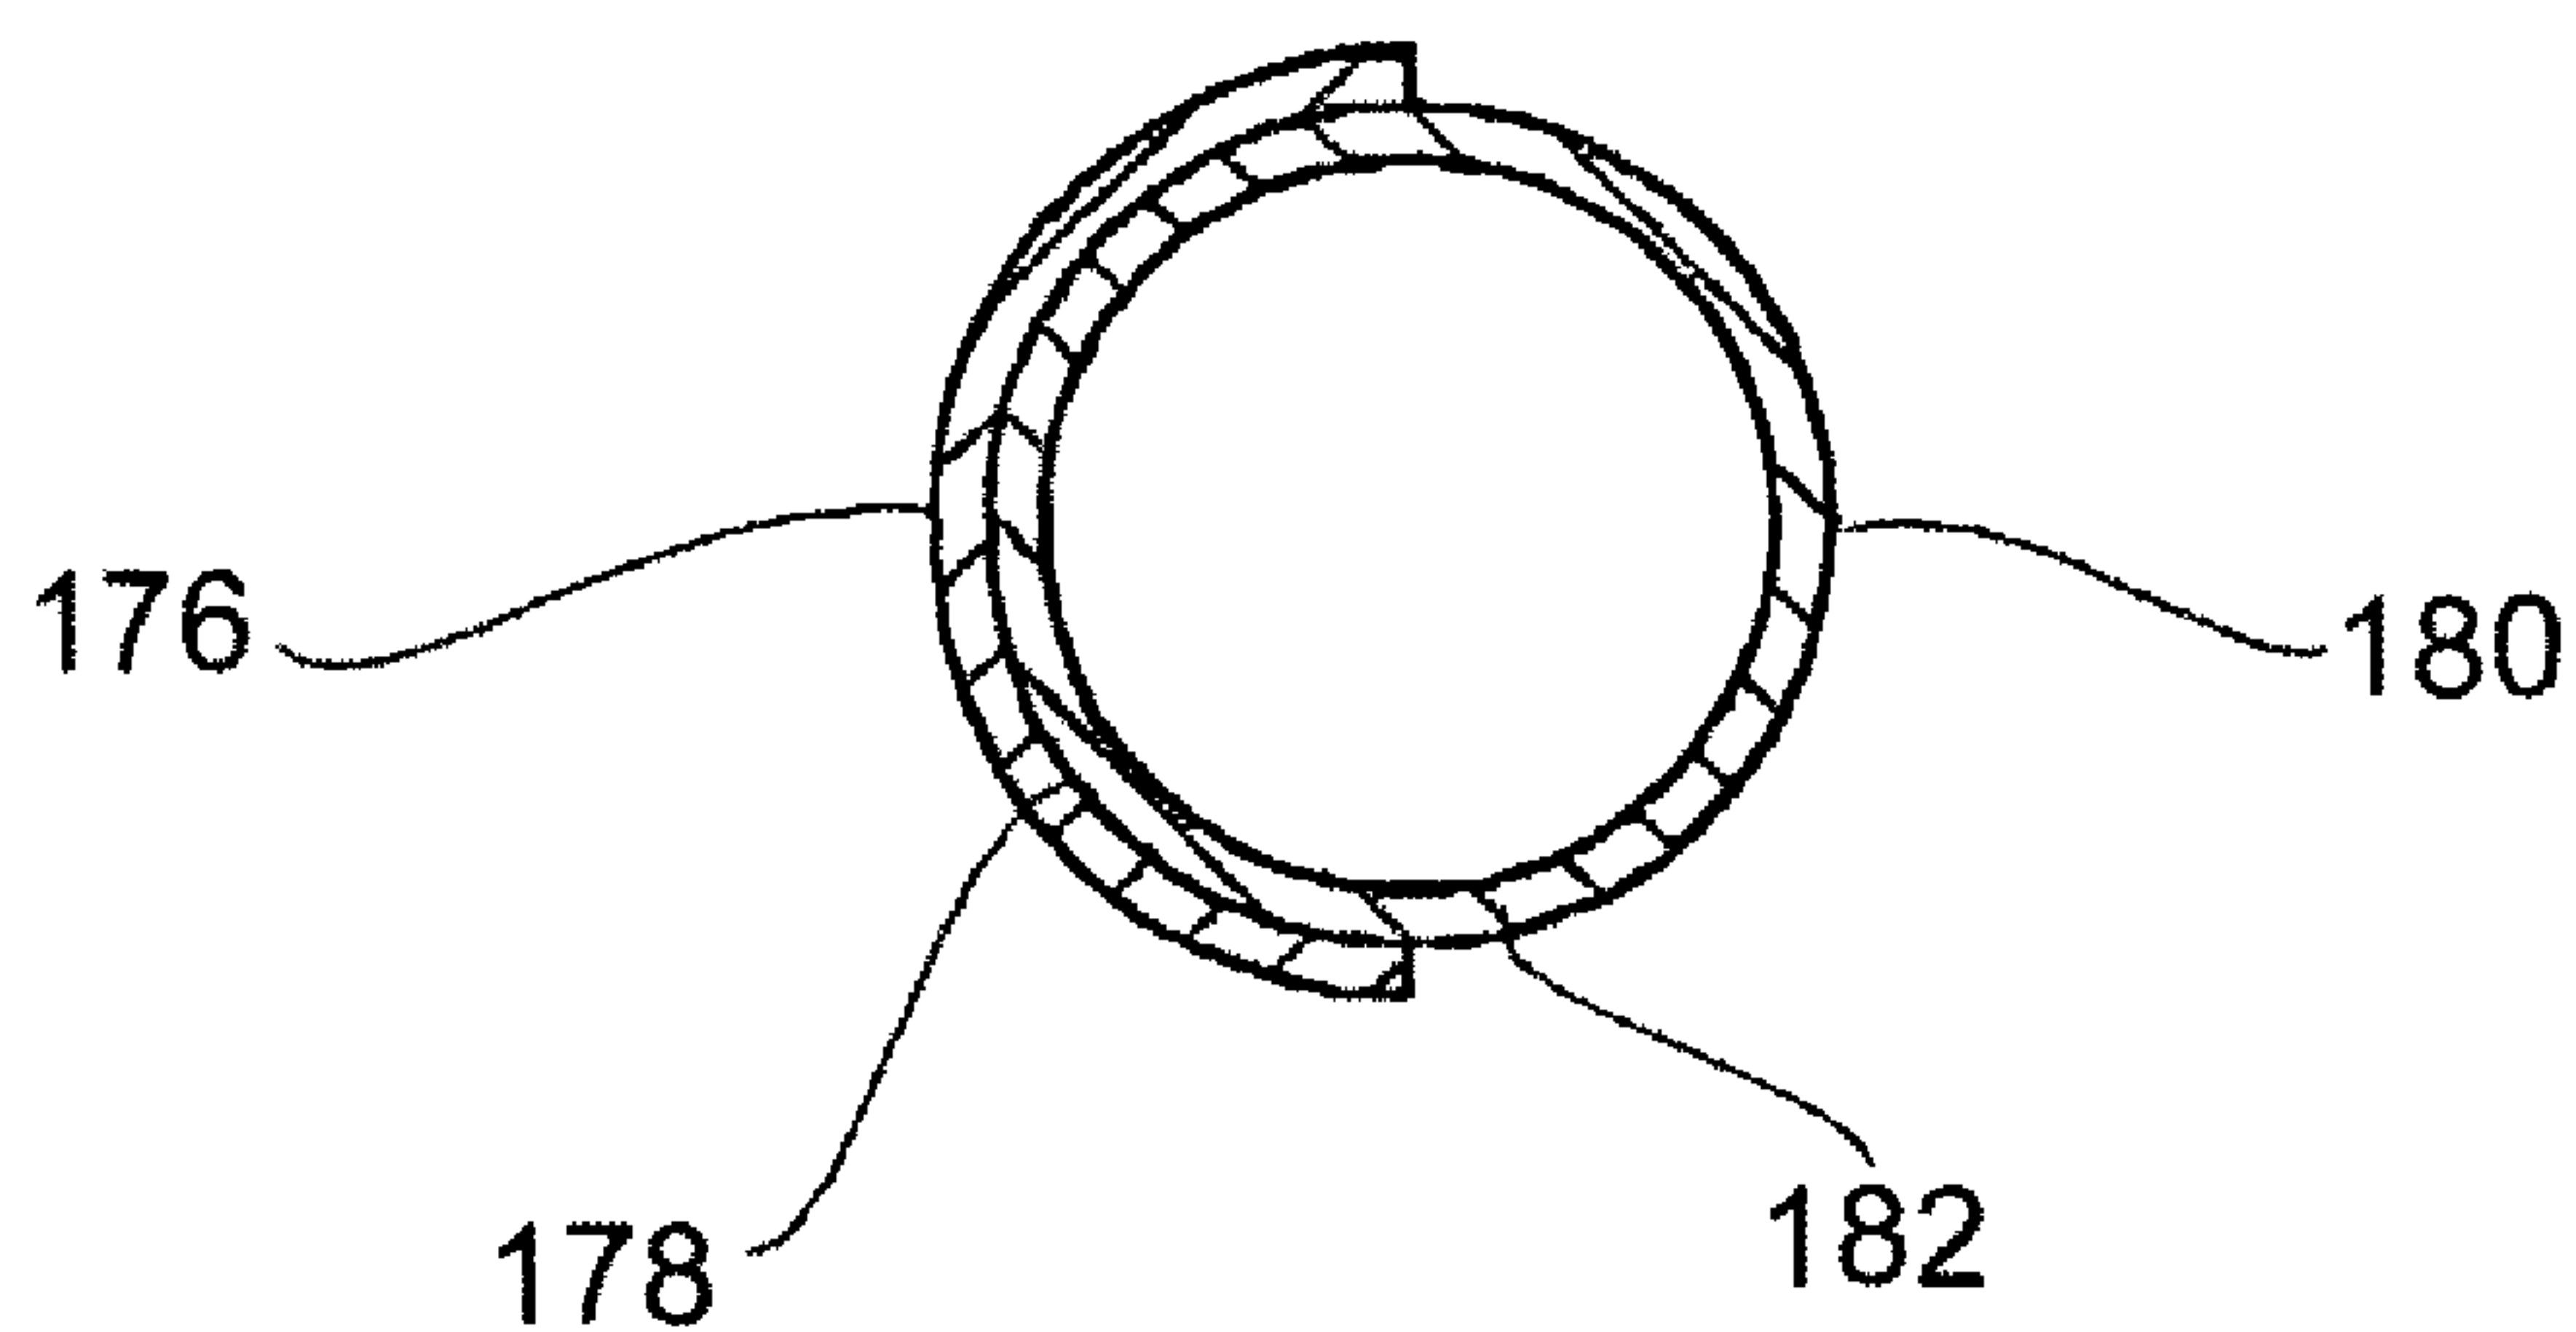
FIG. 37 is an end cutaway view of a repair using the disclosed method in one form.

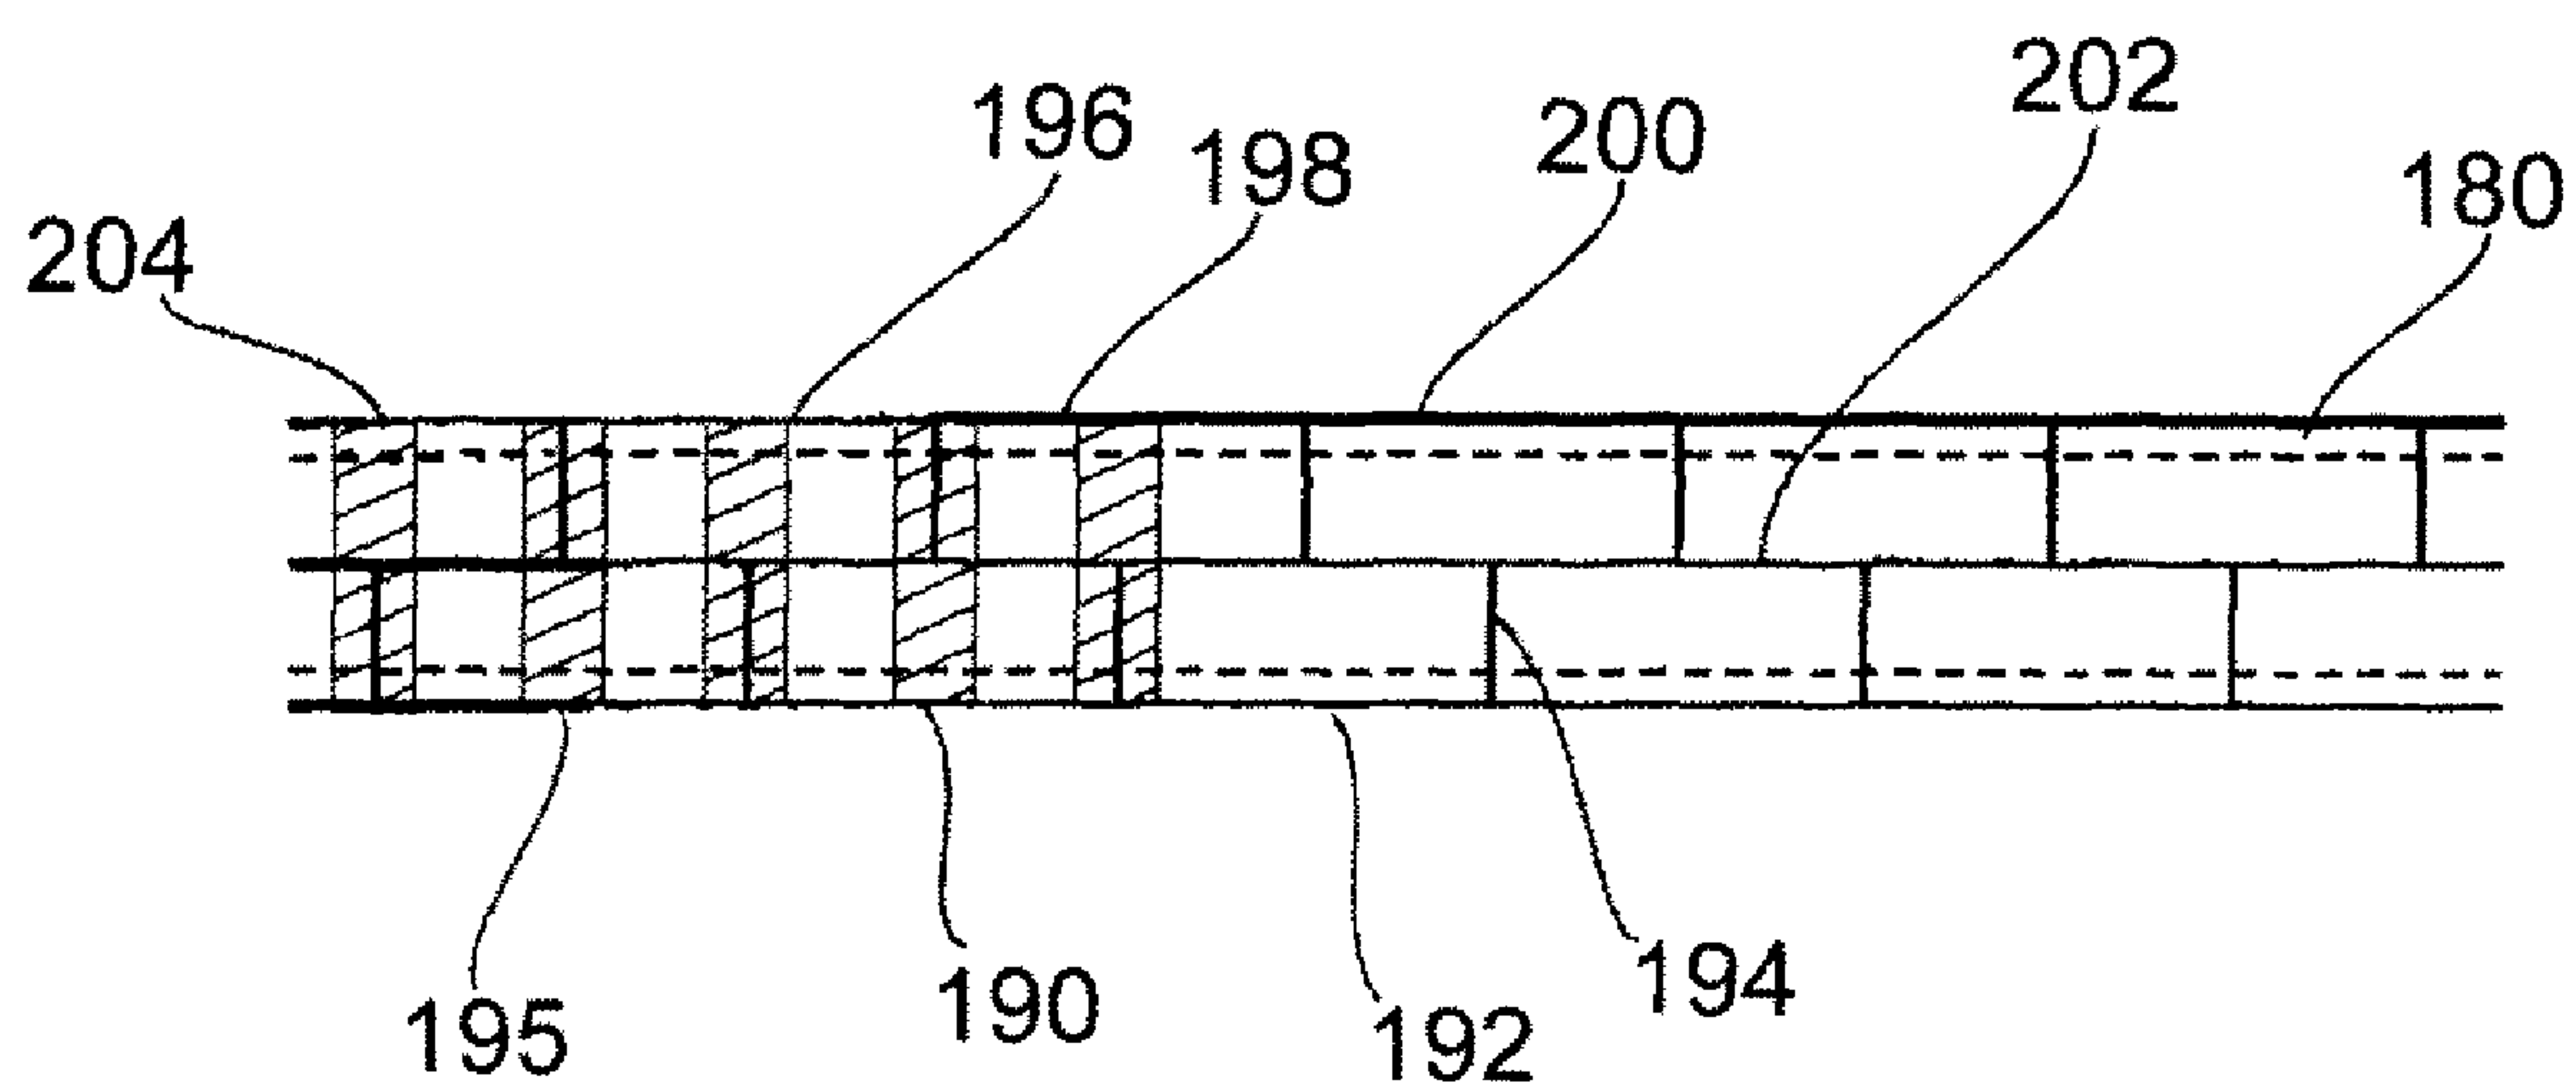
FIG. 38 is a side hidden line view of a repair using the disclosed method in one form.
