(10) **Patent No.:** **US 7,981,519 B2**
(45) **Date of Patent:** **Jul. 19, 2011**

(54) **METALLIC DOUBLER FOR REPAIR OF A
GAS TURBINE ENGINE PART**

A method and system of repairing an engine part having a cracked metal skin bonded to a honeycomb core includes removing a portion of the honeycomb that corresponds to a cracked portion of the metal skin. A crack in the metal skin originates from an edge of the engine part. A portion of the honeycomb is removed to form a slot in the honeycomb beginning at the edge of the part. A doubler is inserted into the slot in the honeycomb and is attached to an underside of the metal skin to form a lap joint between the doubler and the metal skin. In one embodiment, the portion of the metal skin that includes the crack remains. In an alternative embodiment, the cracked portion of the metal skin is removed and a metal patch is attached to the doubler such that the patch replaces the removed metal skin.

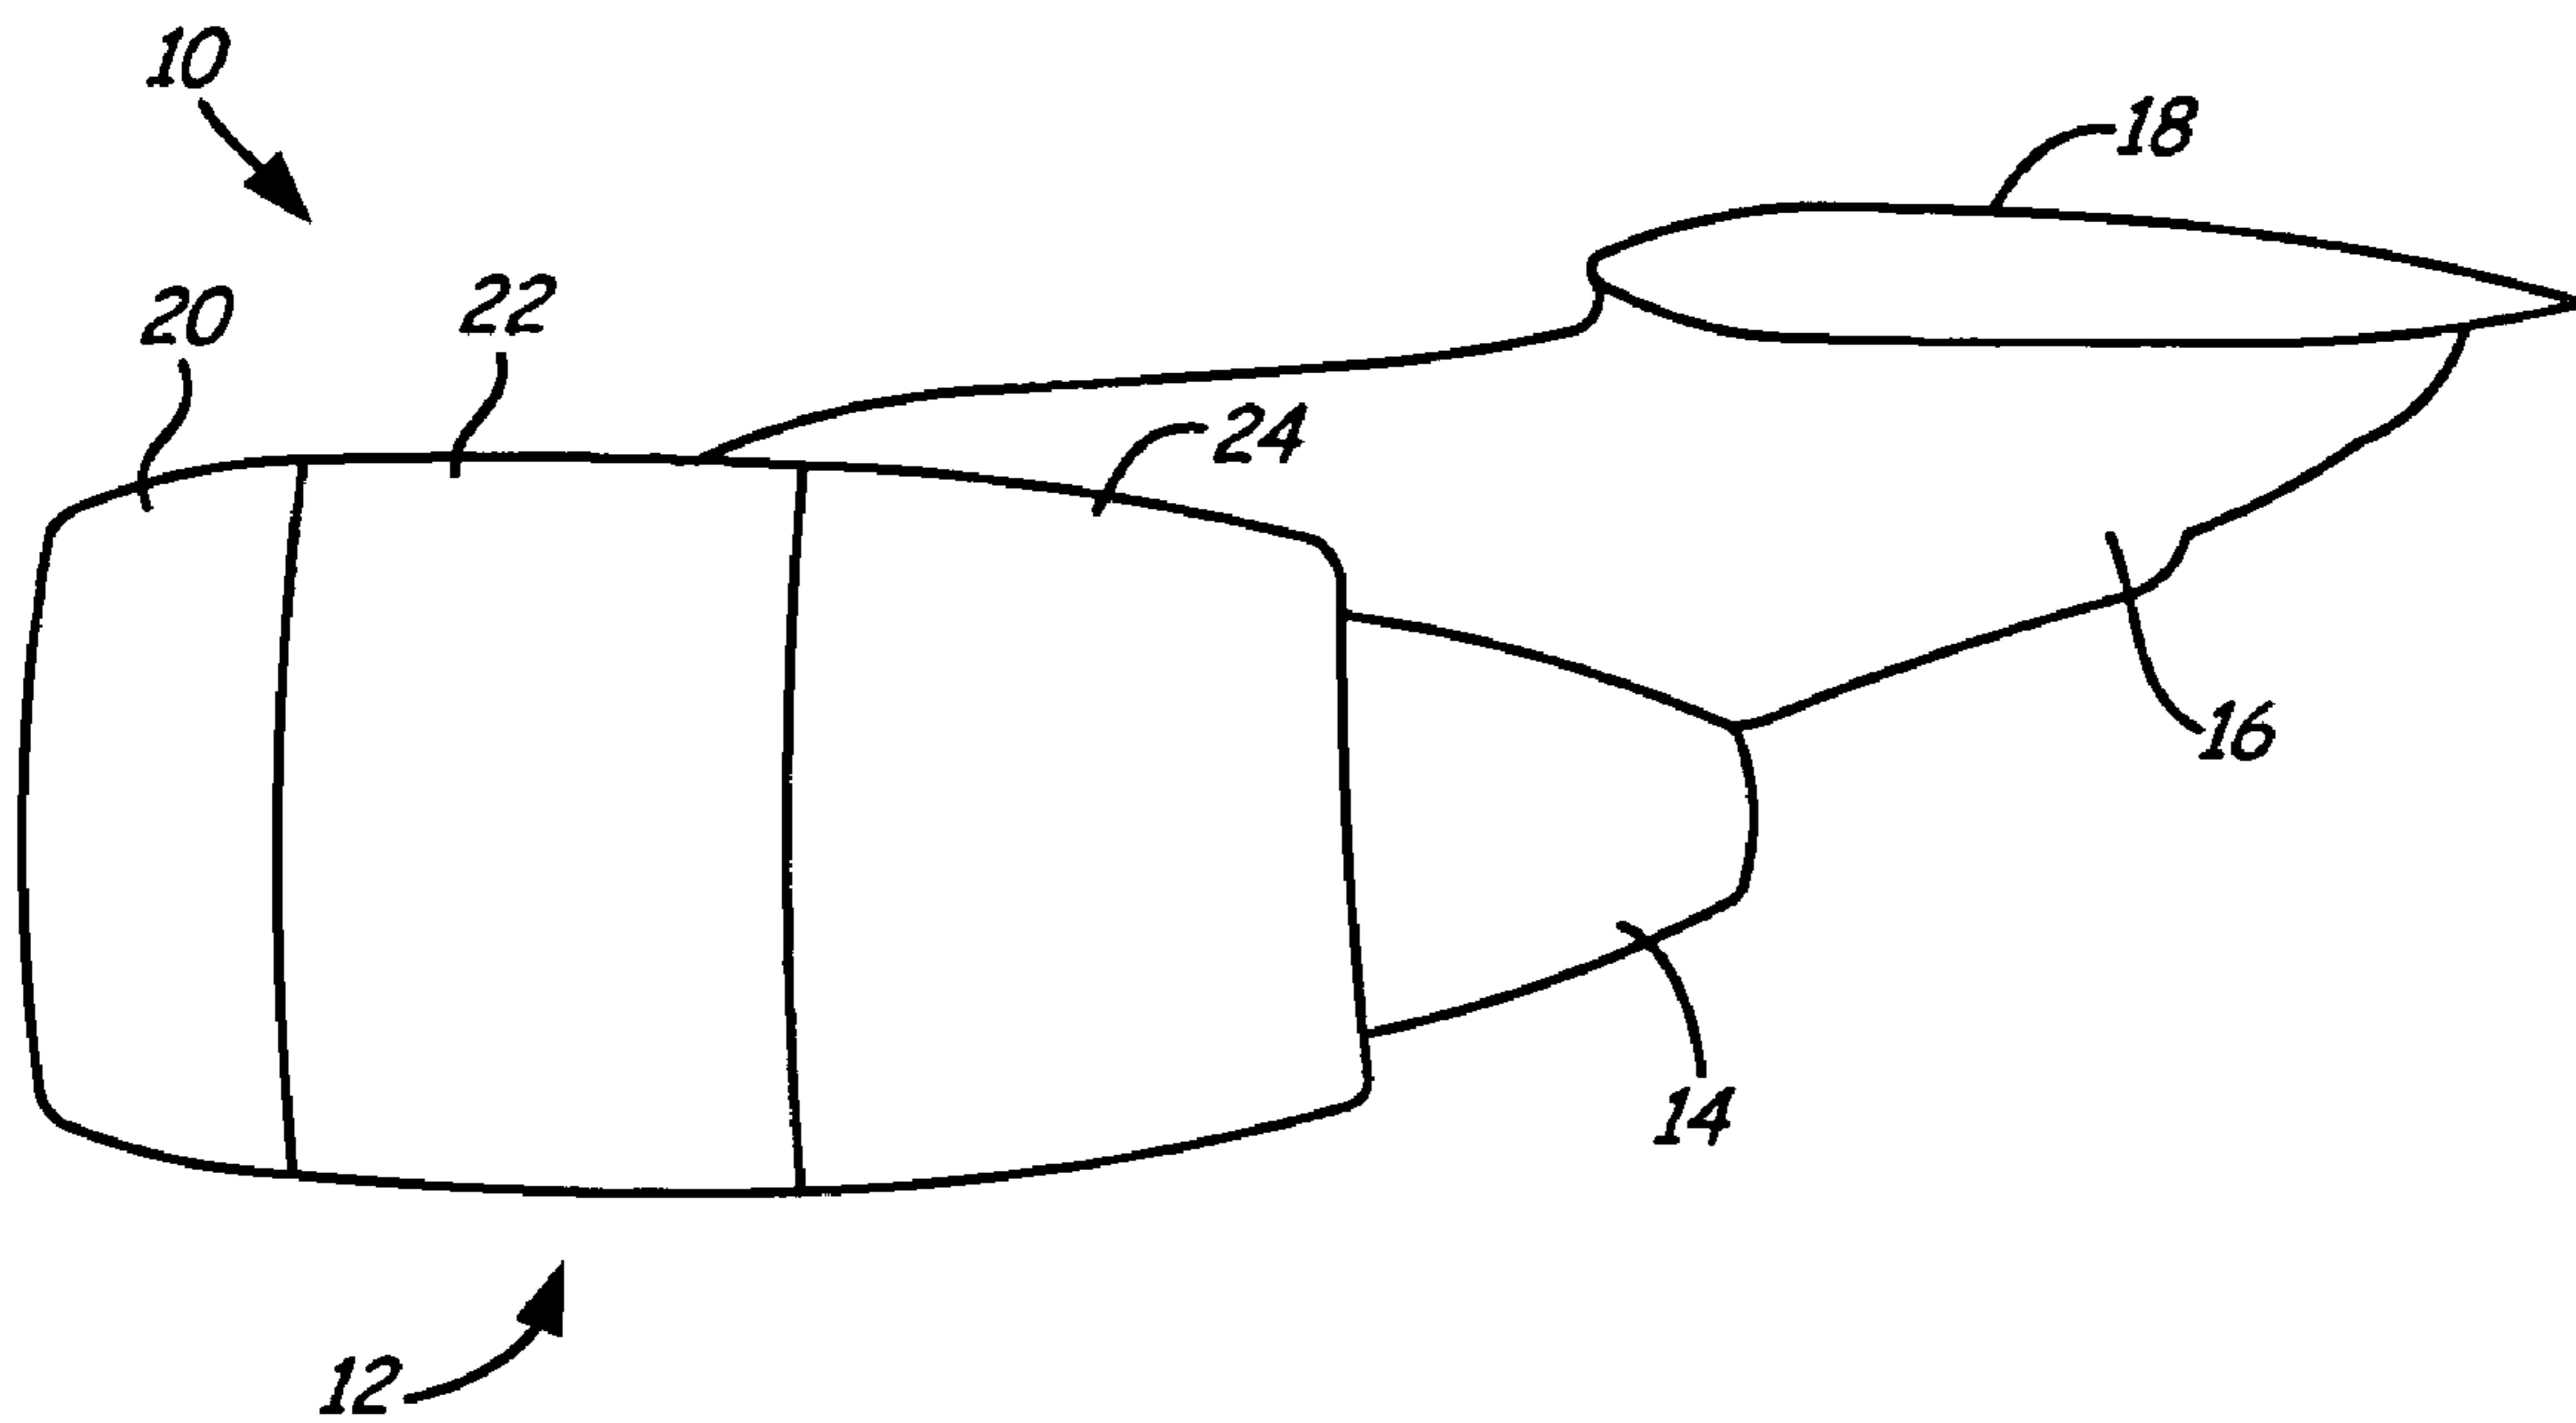
FIG. 1 is a schematic of a nacelle of a gas turbine engine attached to a pylon of an aircraft and including a thrust reverser.

FIG. 1 is a schematic of aircraft 10 including nacelle 12, exhaust nozzle 14, pylon 16 and wing 18. Nacelle 12 functions as an outer casing for a gas turbine engine (not shown), and includes inlet cowl 20, fan cowl 22, and thrust reverser 24. Nacelle 12 is also configured for mounting the gas turbine engine to pylon 16.

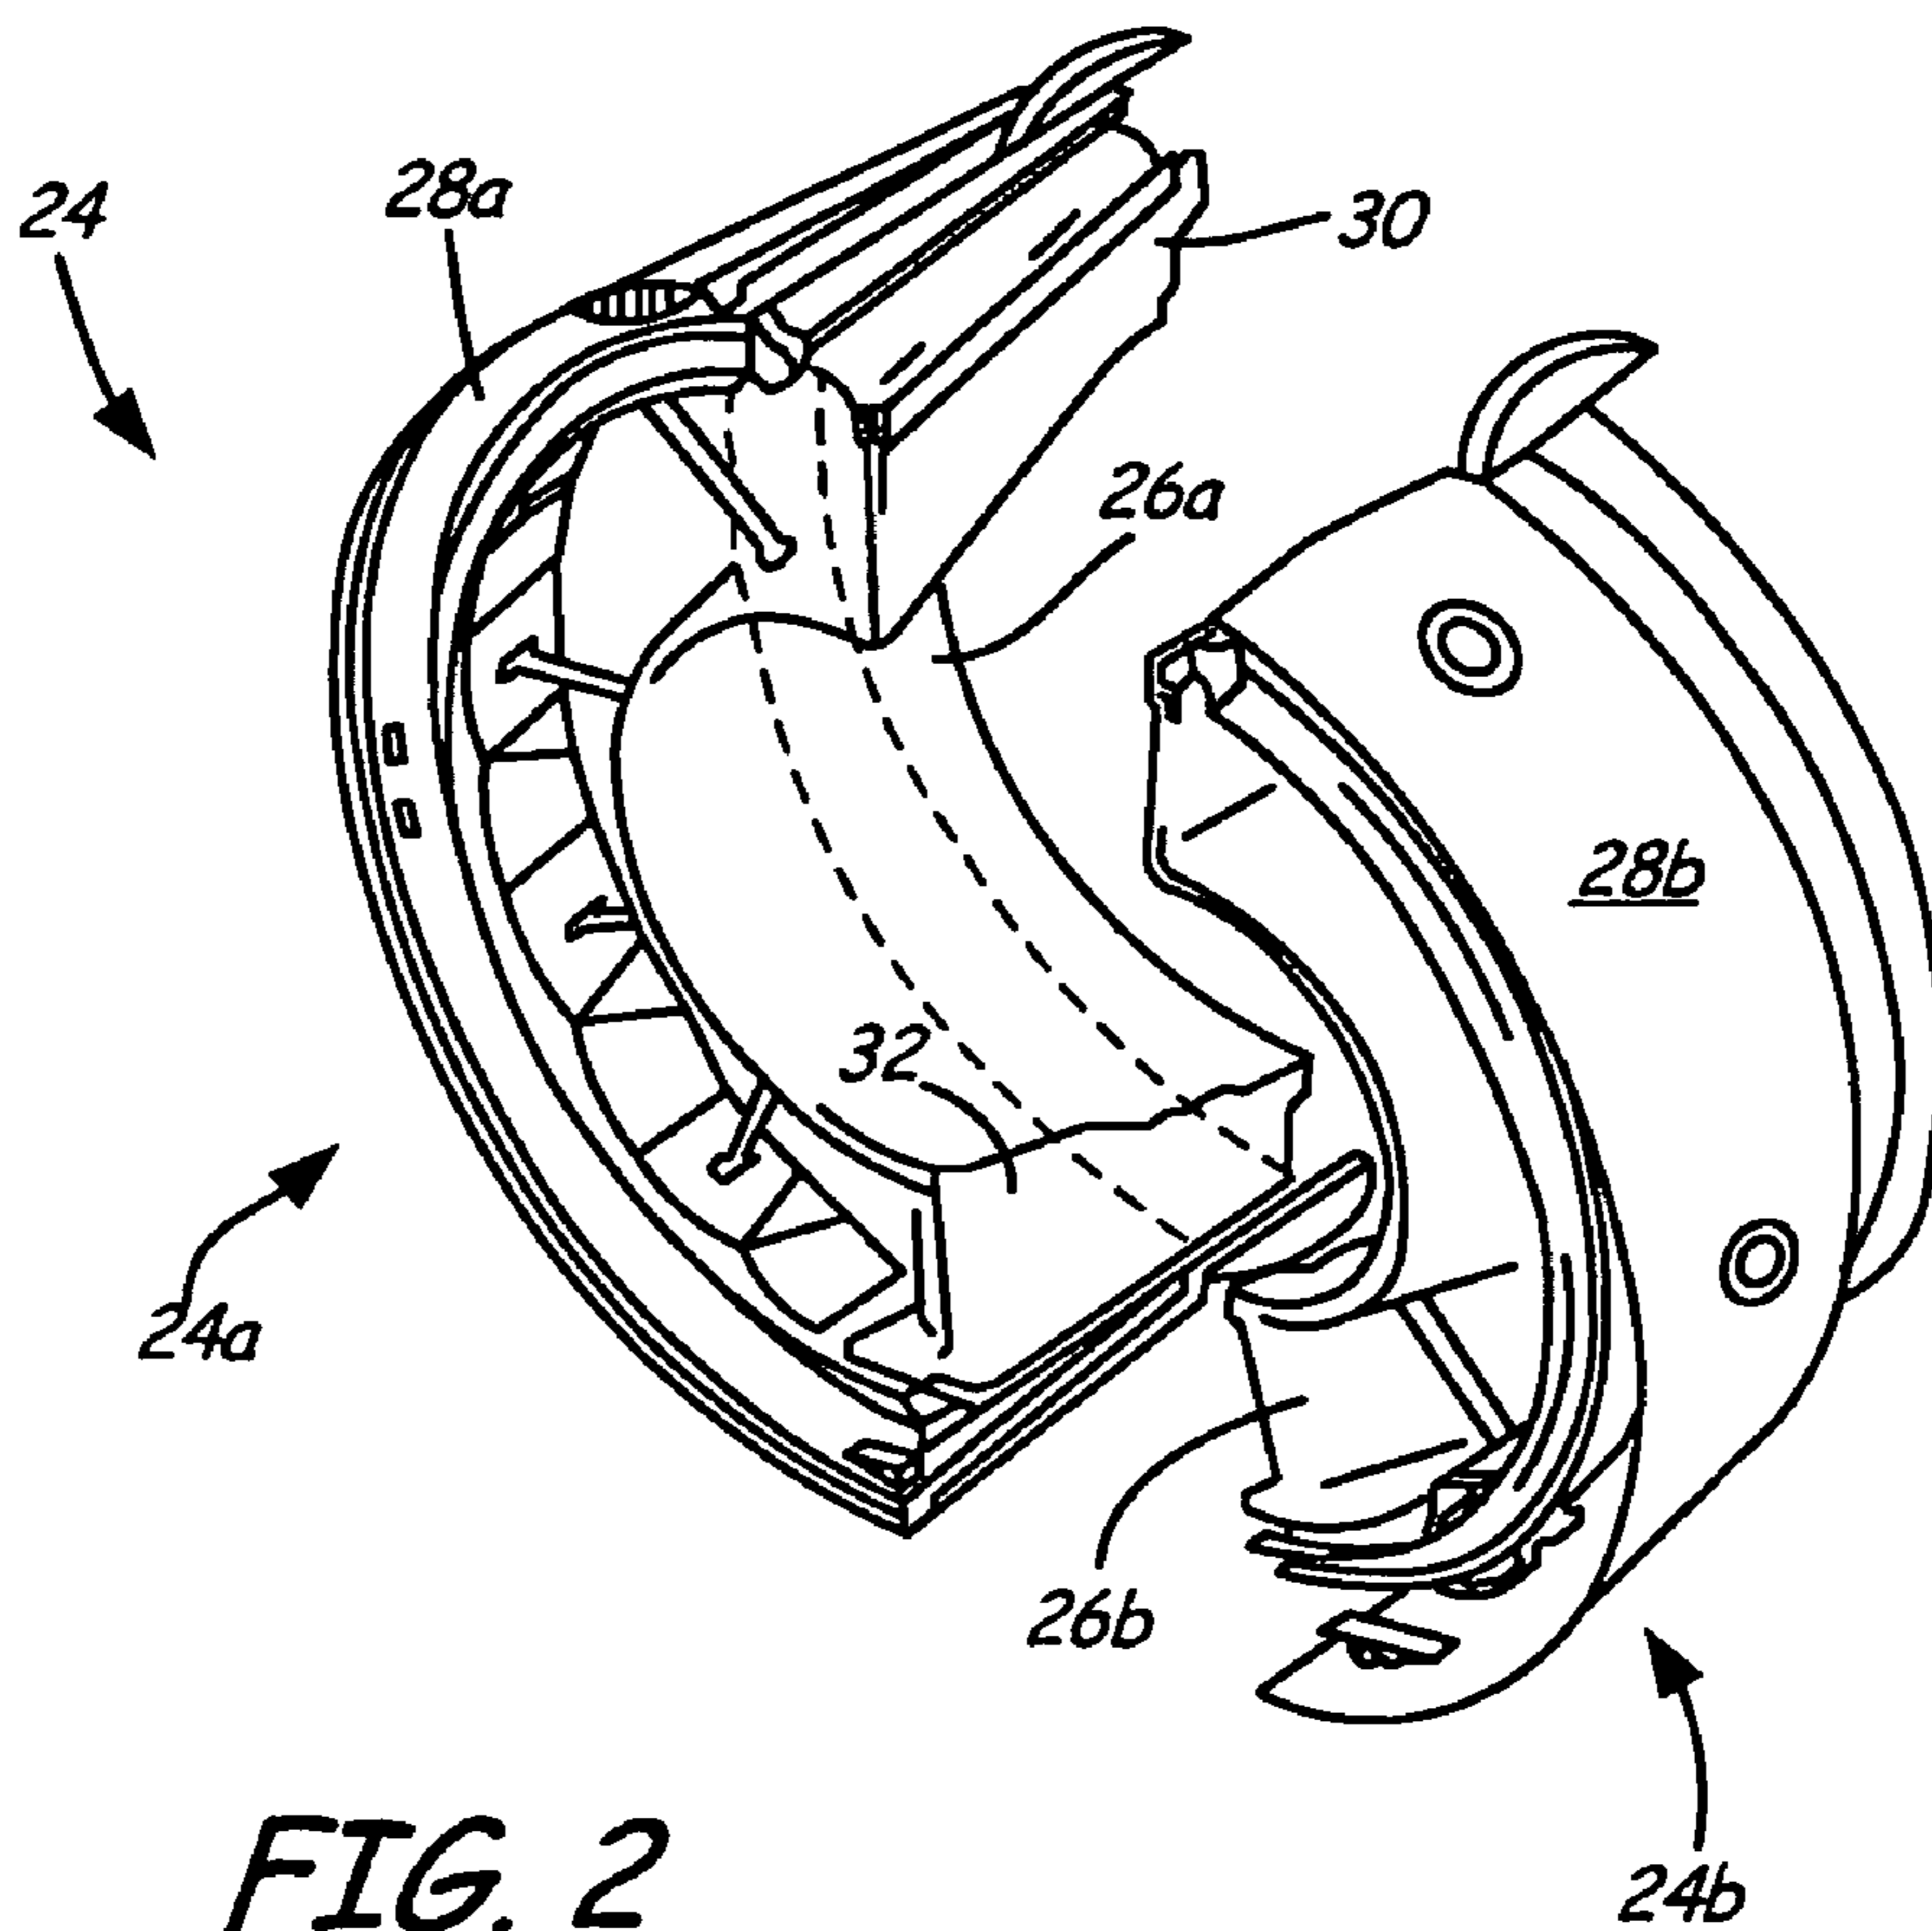
FIG. 2 is a perspective view of the thrust reverser of FIG. 1 in two halves.

FIG. 2 is an expanded perspective view of thrust reverser 24 of FIG. 1 having first half 24a and second half 24b, which are attached to one another to surround the gas turbine engine (not shown). Each half 24a and 24b includes inner cowl 26a and 26b (also known as the core cowl) and outer cowl 28a and 28b. Thrust reverser 24 is configured such that outer cowl 28 slides in an aft direction, and air flowing through thrust reverser 24 is directed forwardly to aid in deceleration during landing of aircraft 10. Inner cowl 26a and outer cowl 28a are attached to one another, in part, by bifurcation panels 30 and 32. Although not visible in FIG. 2, second half 24b also includes two bifurcation panels.

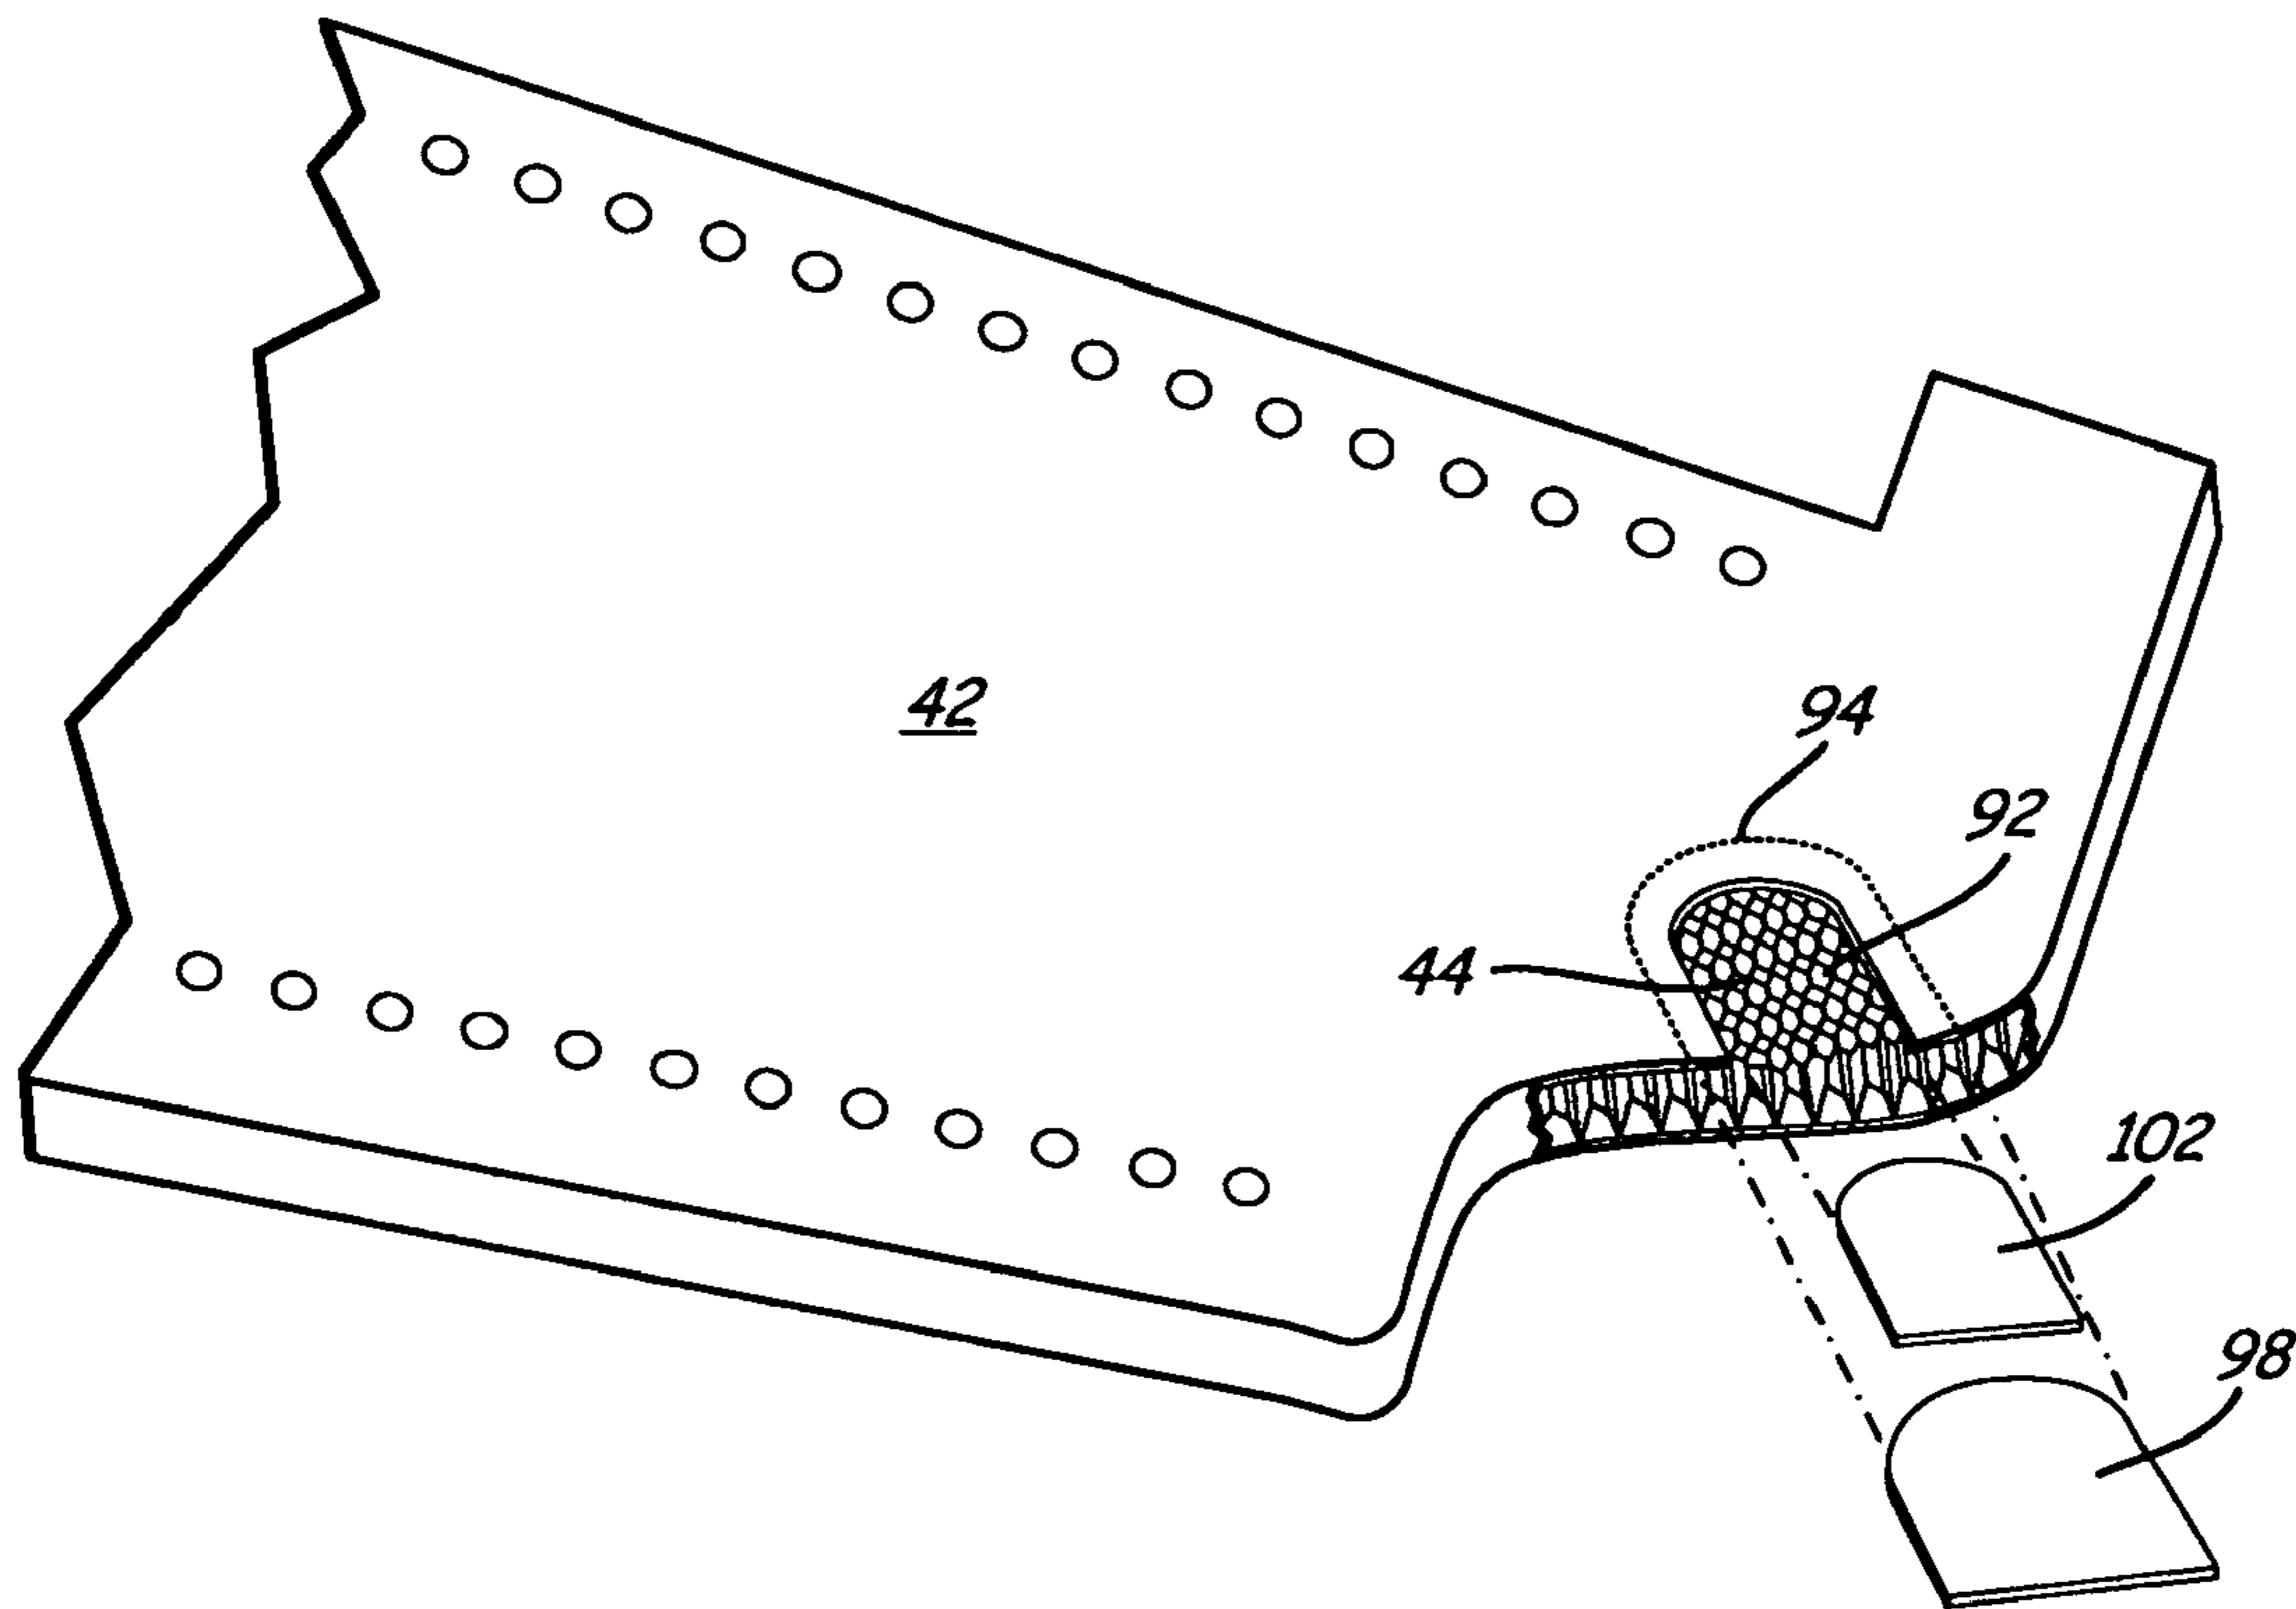
FIG. 6 is a perspective view of the panel of FIG. 4 illustrating the method of repairing the crack in the back skin.

A next step in method 50 depends on the analysis of the crack in step 52. Step 54 is to remove a portion of the back skin that includes the crack by cutting out a portion of the back skin. FIG. 6 shows an example of how much of the back skin is removed relative to the crack. Alternatively, in step 56, the back skin remains as part of the repair and the crack is stop drilled using, for example, a 1/4" drill bit. (See FIG. 11.) This is done to reduce stress concentration at the end of the crack. In step 56, caution should be used so that the underlying

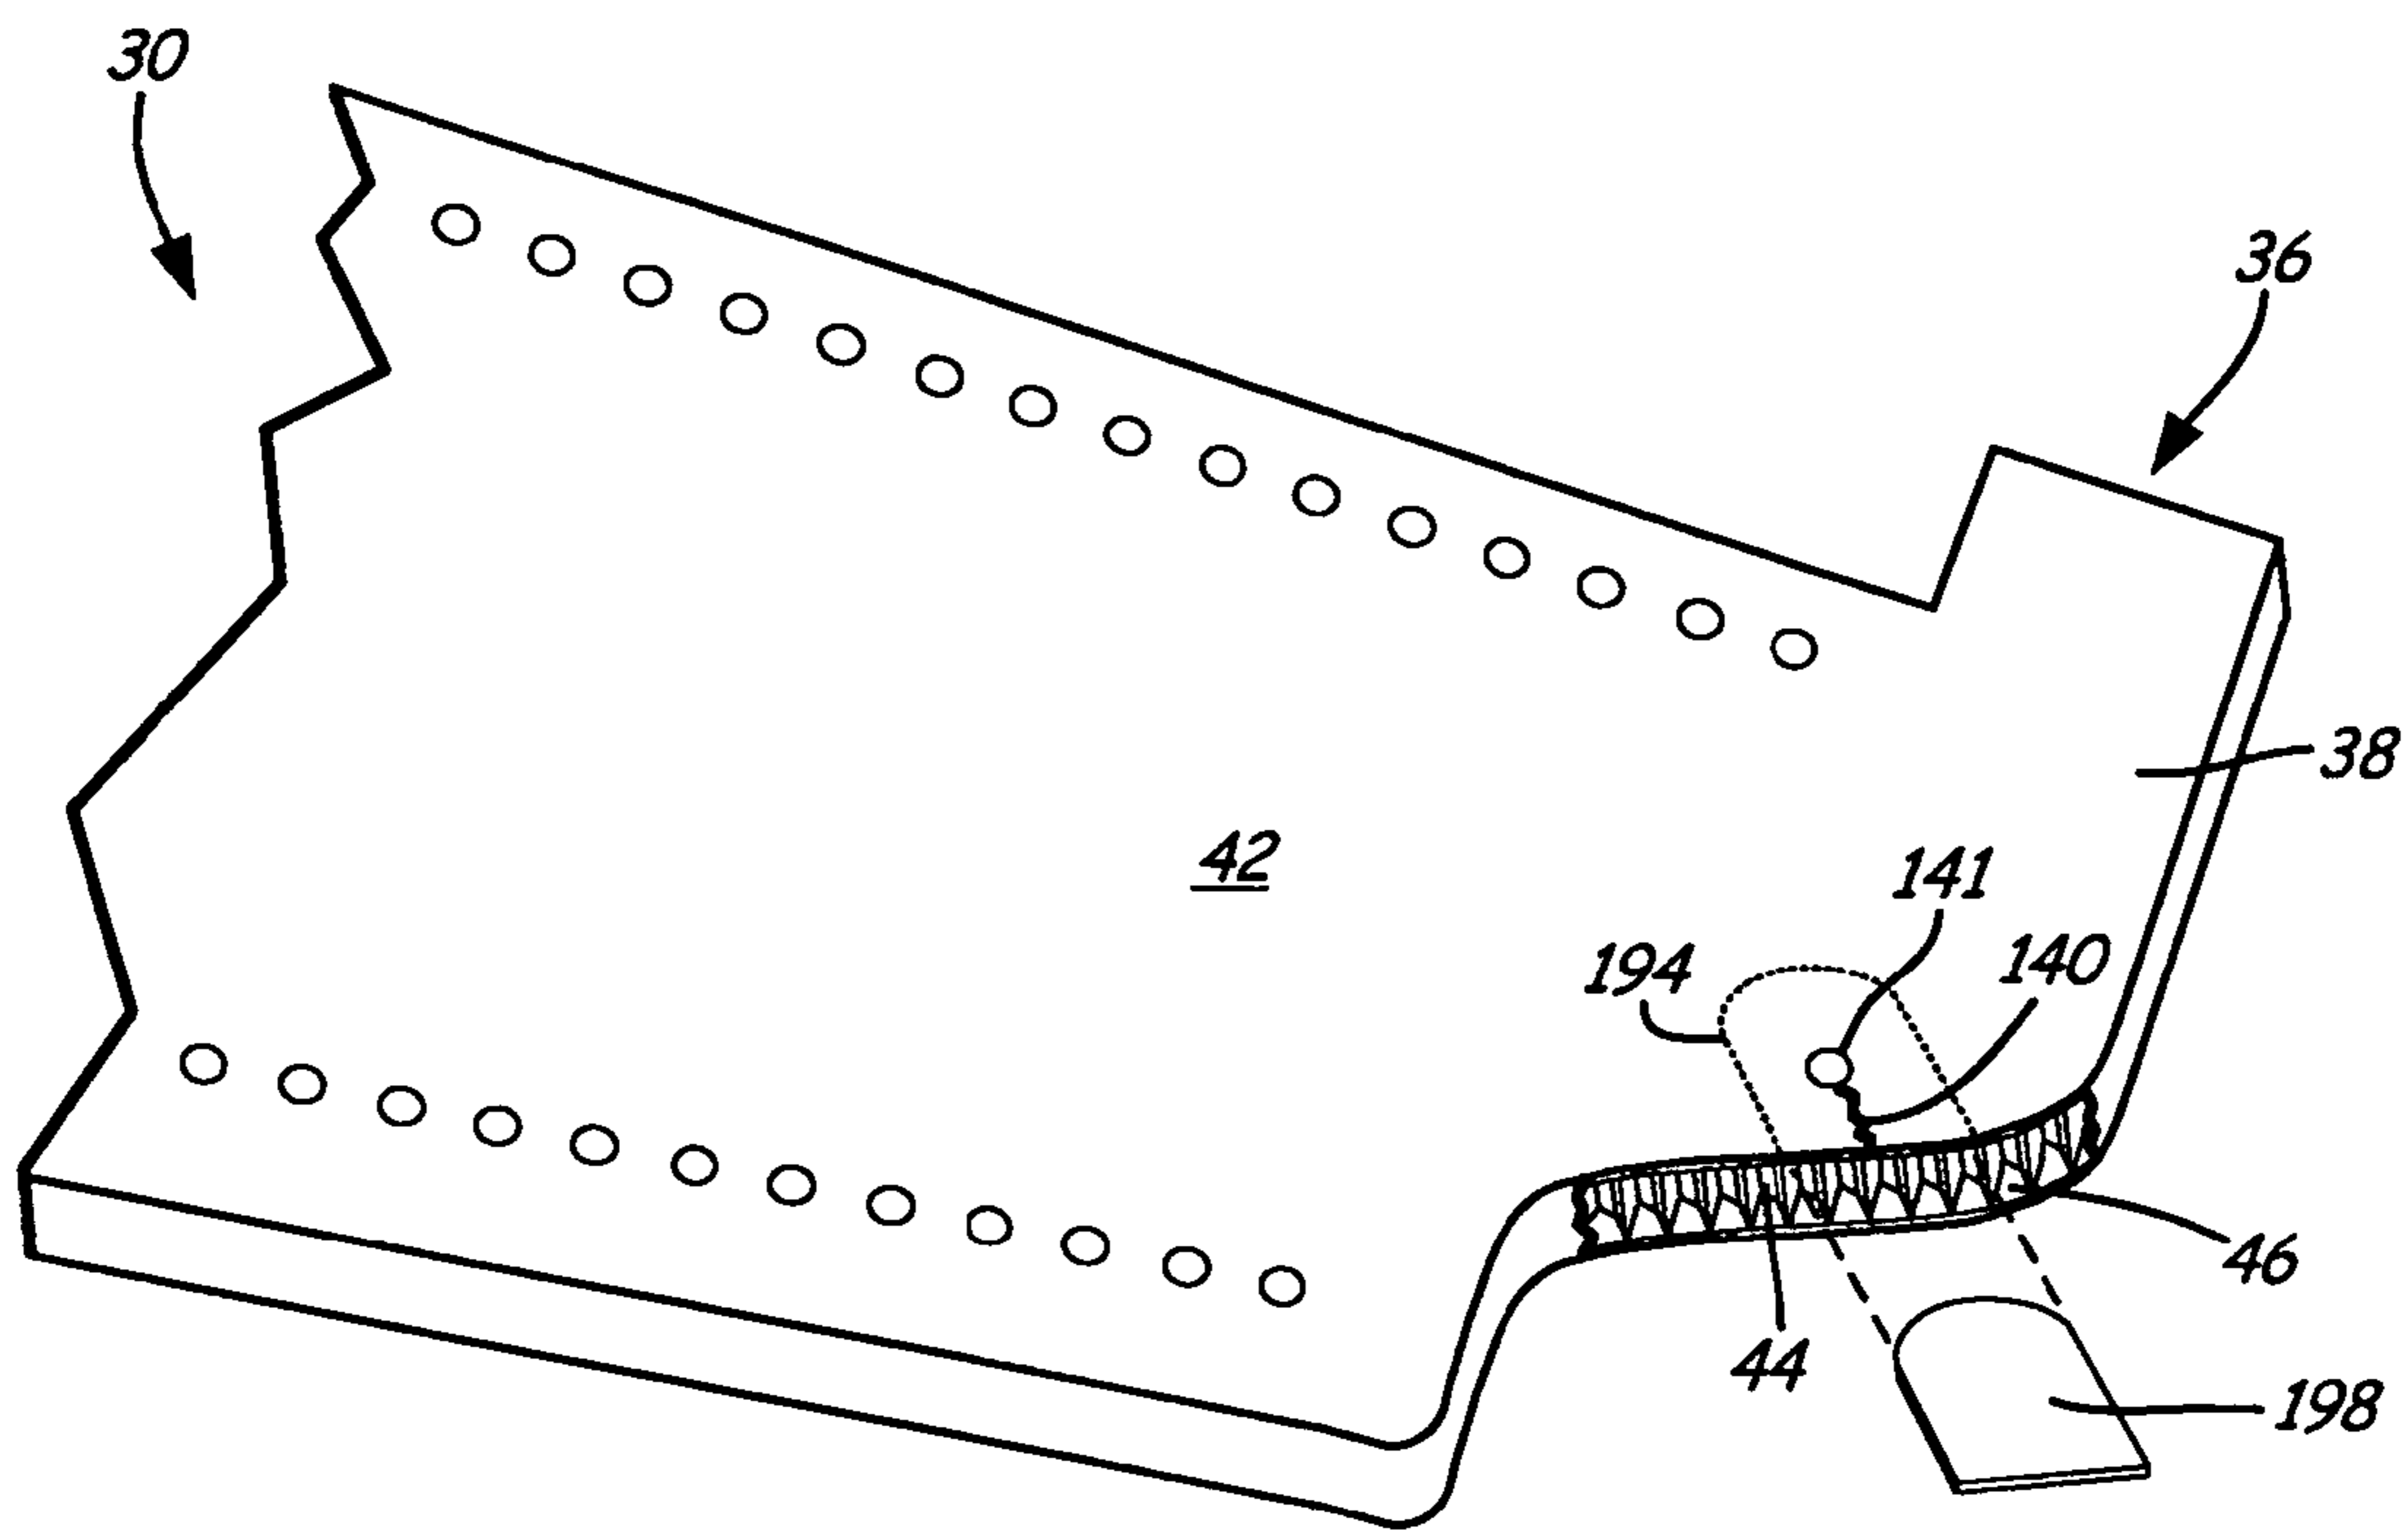
FIG. 11 is a perspective view of the panel of FIG. 4 illustrating an alternative embodiment for repairing a crack in the back skin.

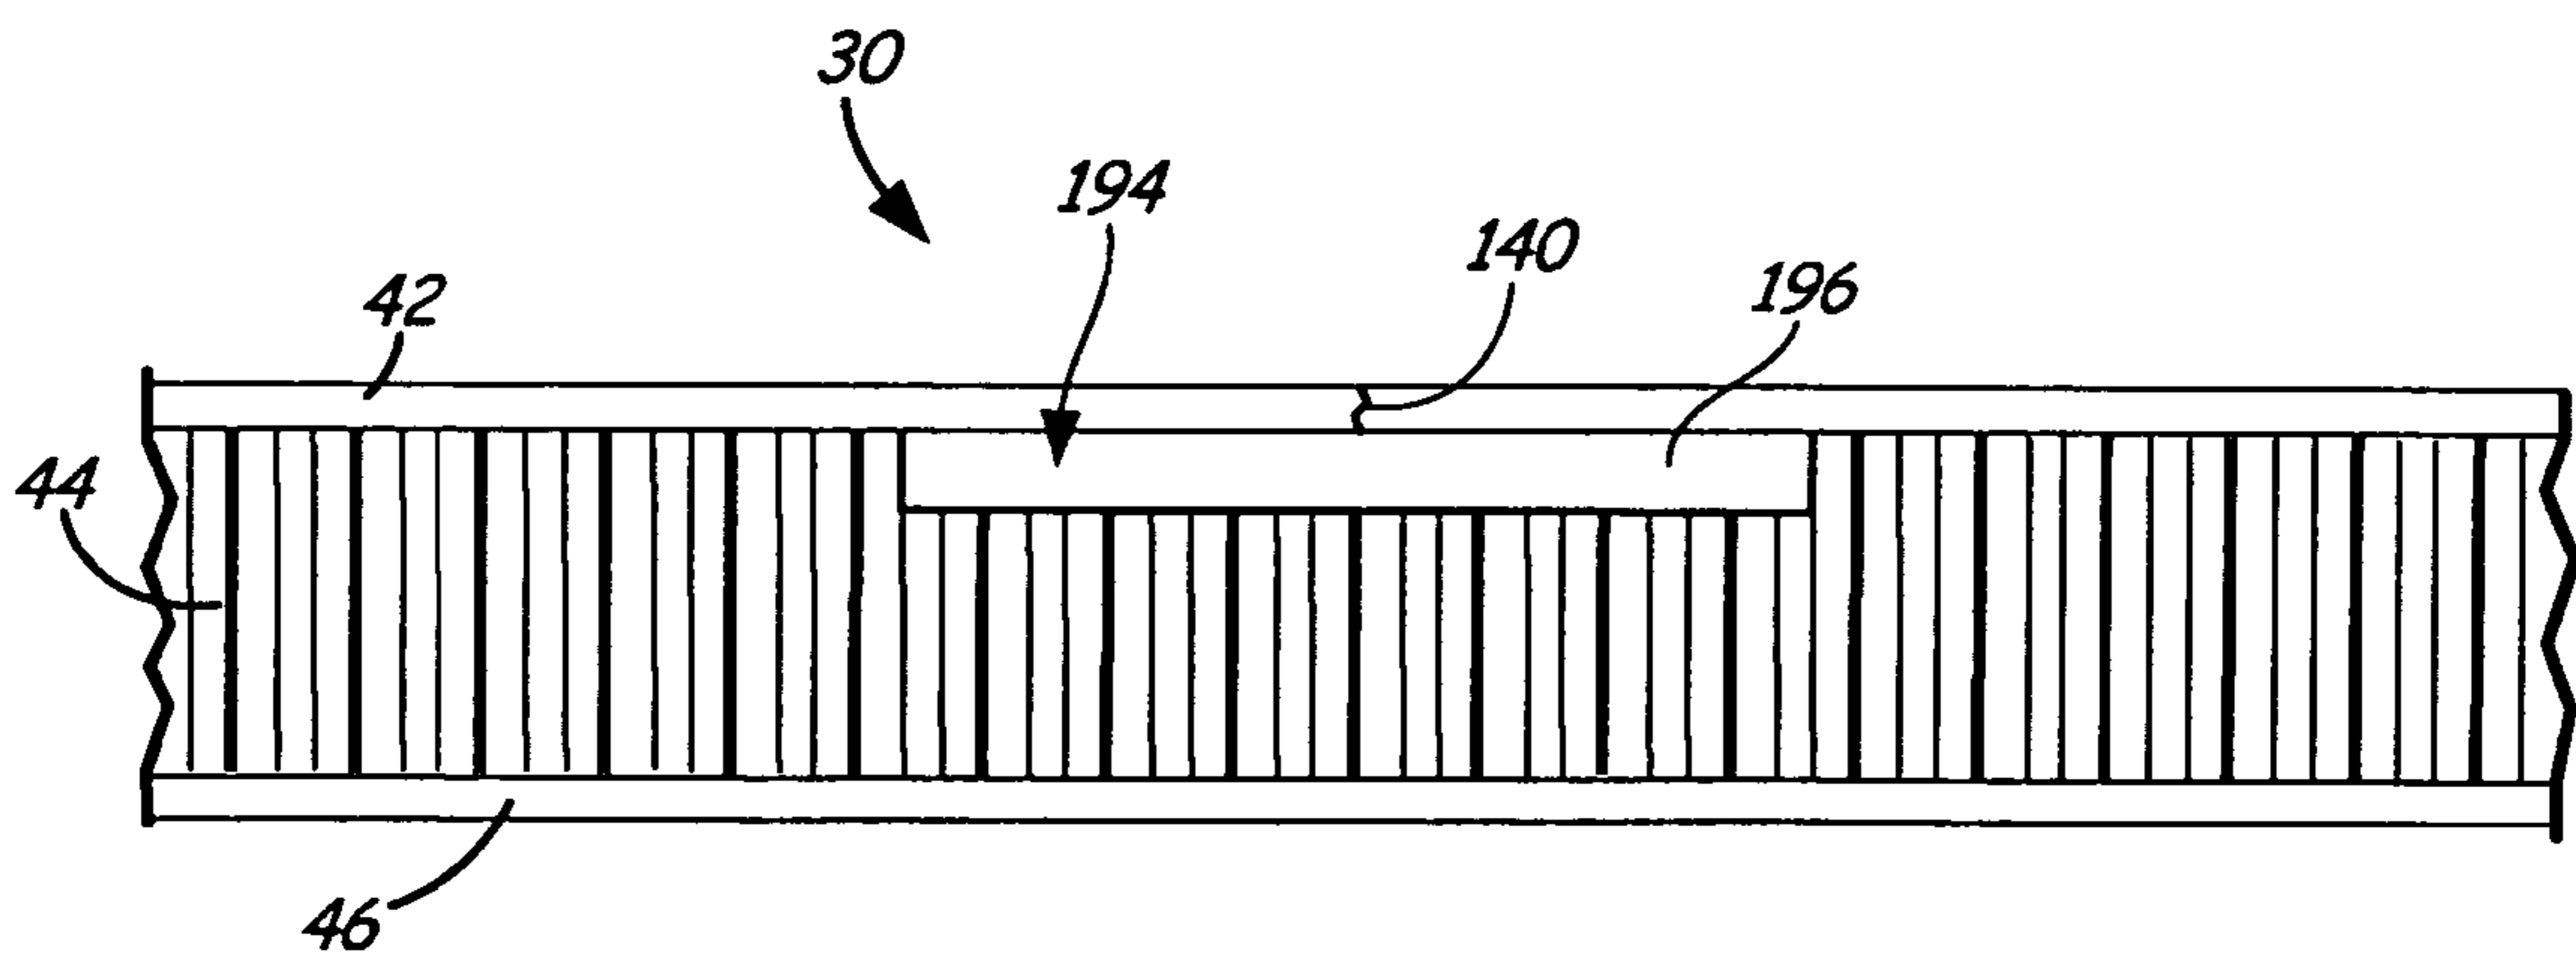
FIG. 12 is a cross-sectional view of the panel from FIG. 11 showing a slot formed in the honeycomb core as part of the repair.
