US007981519B2

(54) **METALLIC DOUBLER FOR REPAIR OF A GAS TURBINE ENGINE PART**

A method and system of repairing an engine part having a cracked metal skin bonded to a honeycomb core includes removing a portion of the honeycomb that corresponds to a cracked portion of the metal skin. A crack in the metal skin originates from an edge of the engine part. A portion of the honeycomb is removed to form a slot in the honeycomb beginning at the edge of the part. A doubler is inserted into the slot in the honeycomb and is attached to an underside of the metal skin to form a lap joint between the doubler and the metal skin. In one embodiment, the portion of the metal skin that includes the crack remains. In an alternative embodiment, the cracked portion of the metal skin is removed and a metal patch is attached to the doubler such that the patch replaces the removed metal skin.

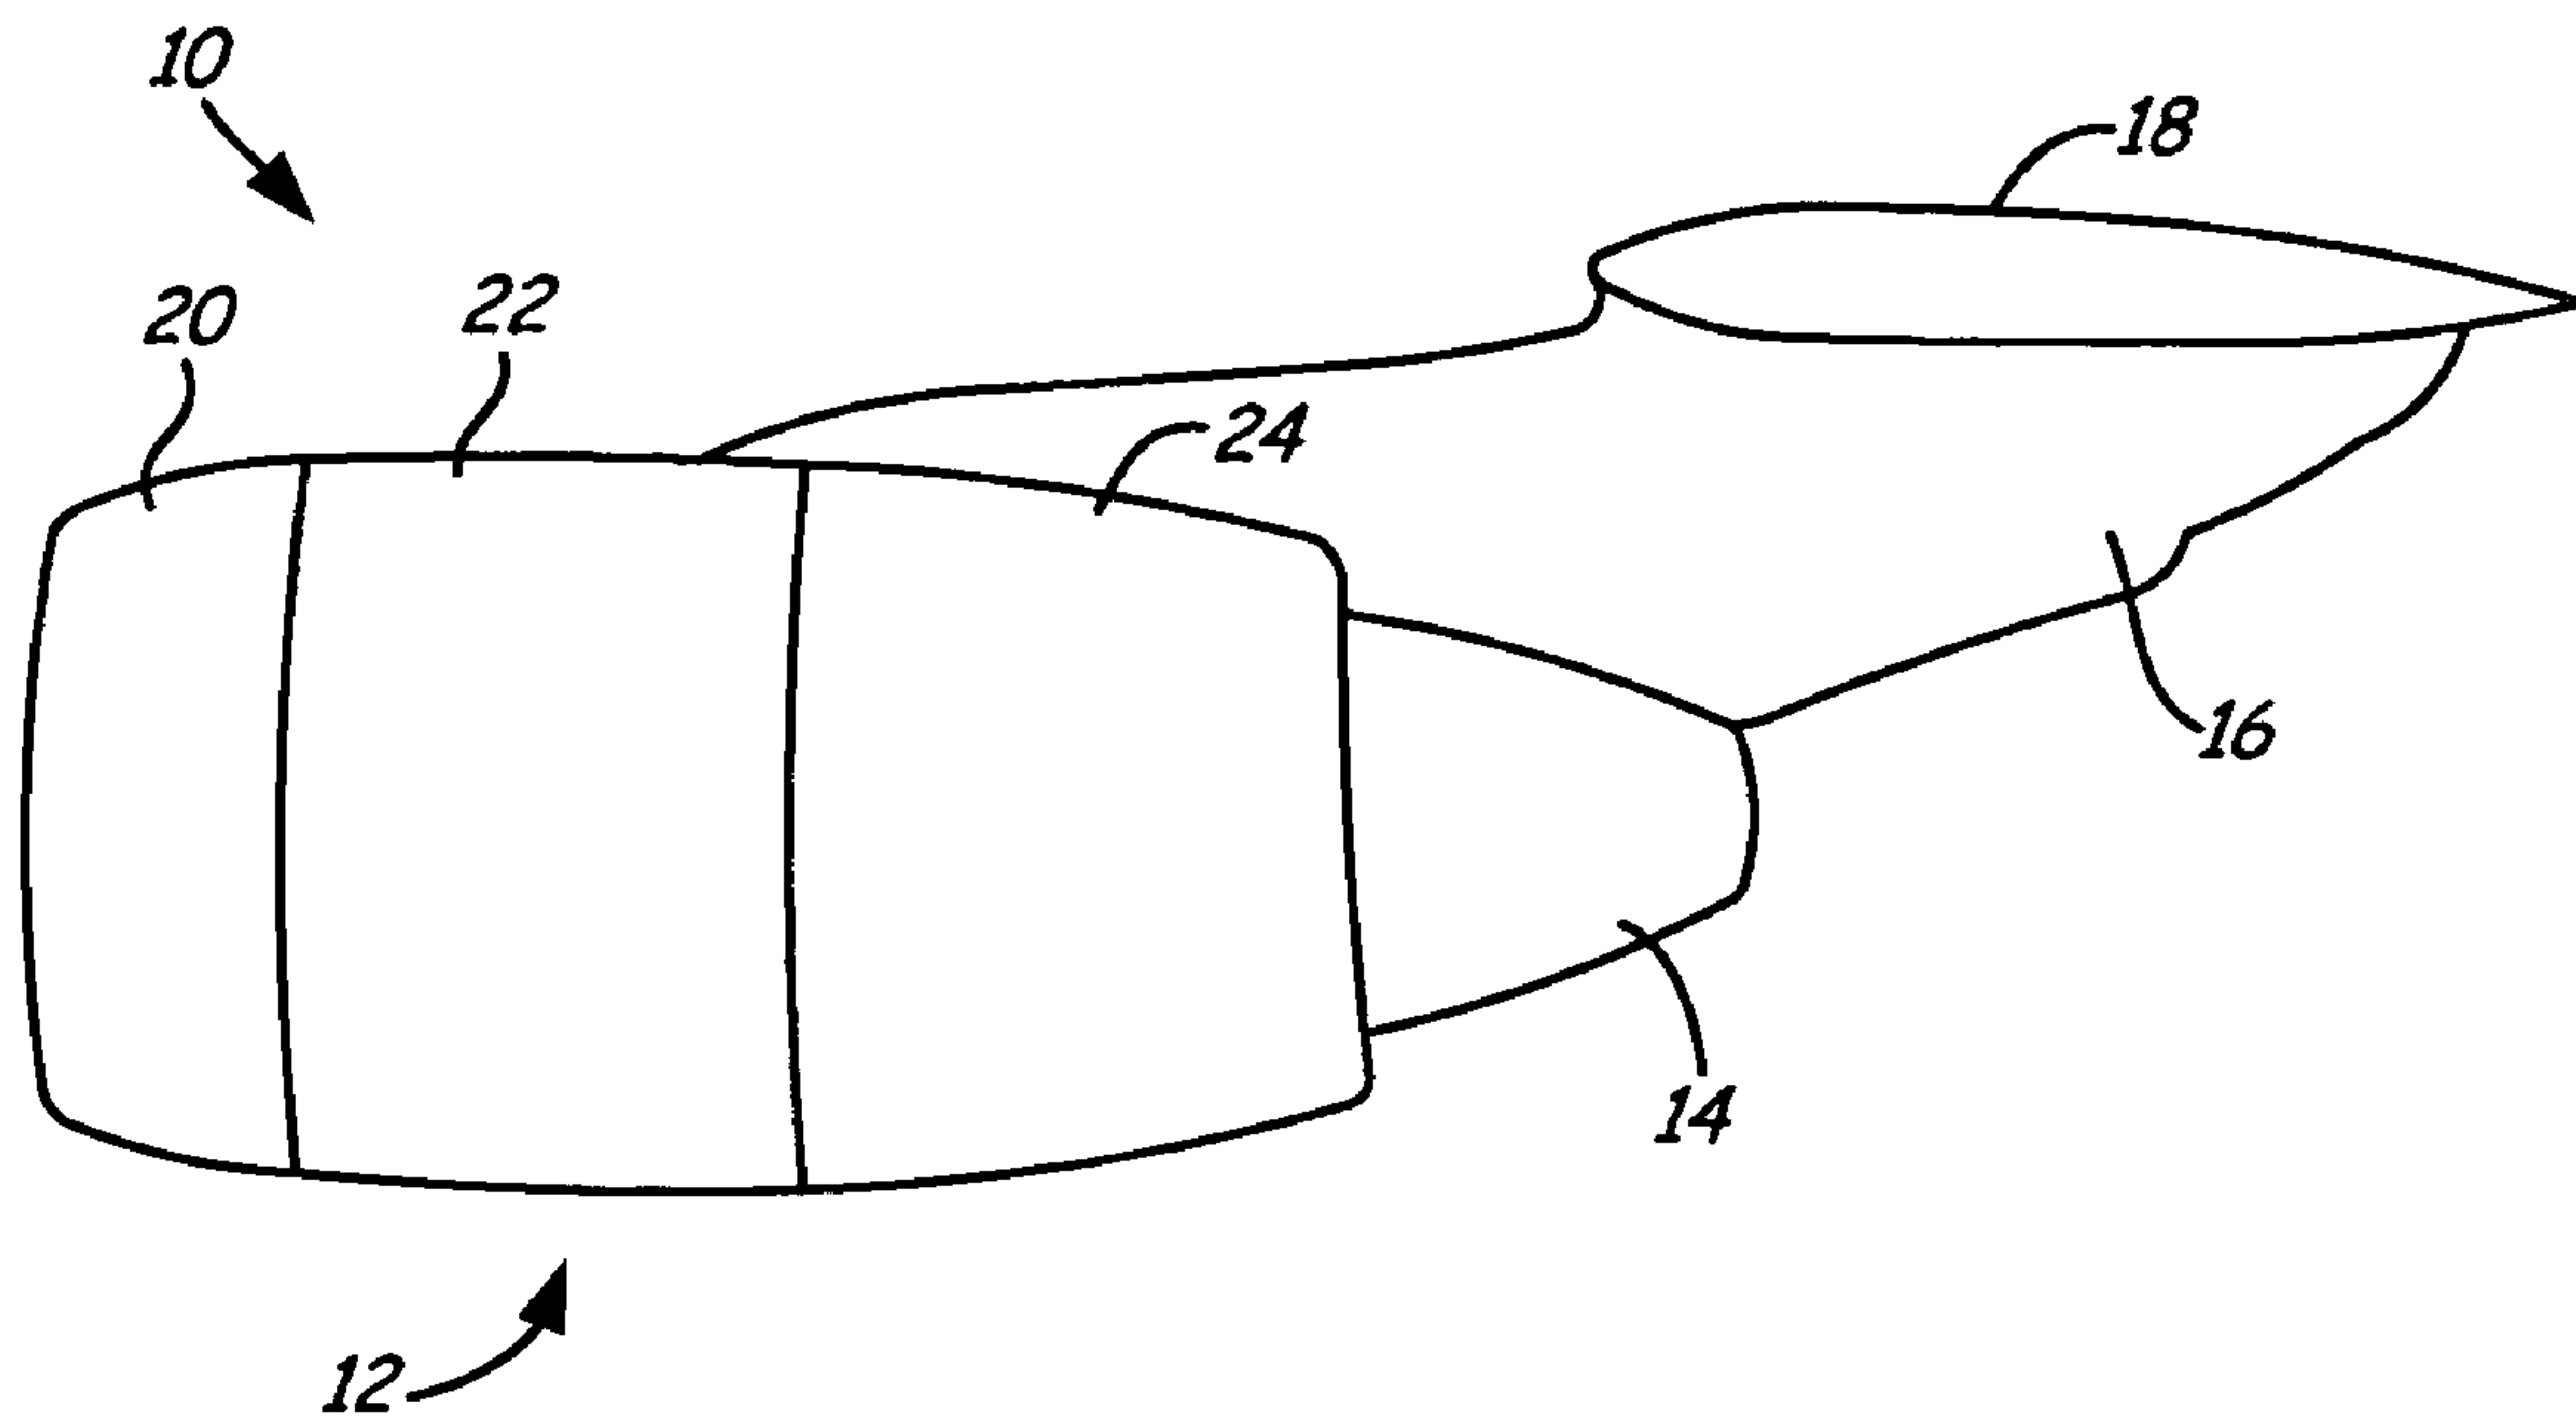
FIG. 1 is a schematic of a nacelle of a gas turbine engine attached to a pylon of an aircraft and including a thrust reverser.

FIG. 1 is a schematic of aircraft 10 including nacelle 12, exhaust nozzle 14, pylon 16 and wing 18. Nacelle 12 functions as an outer casing for a gas turbine engine (not shown), and includes inlet cowl 20, fan cowl 22, and thrust reverser 24. Nacelle 12 is also configured for mounting the gas turbine engine to pylon 16.

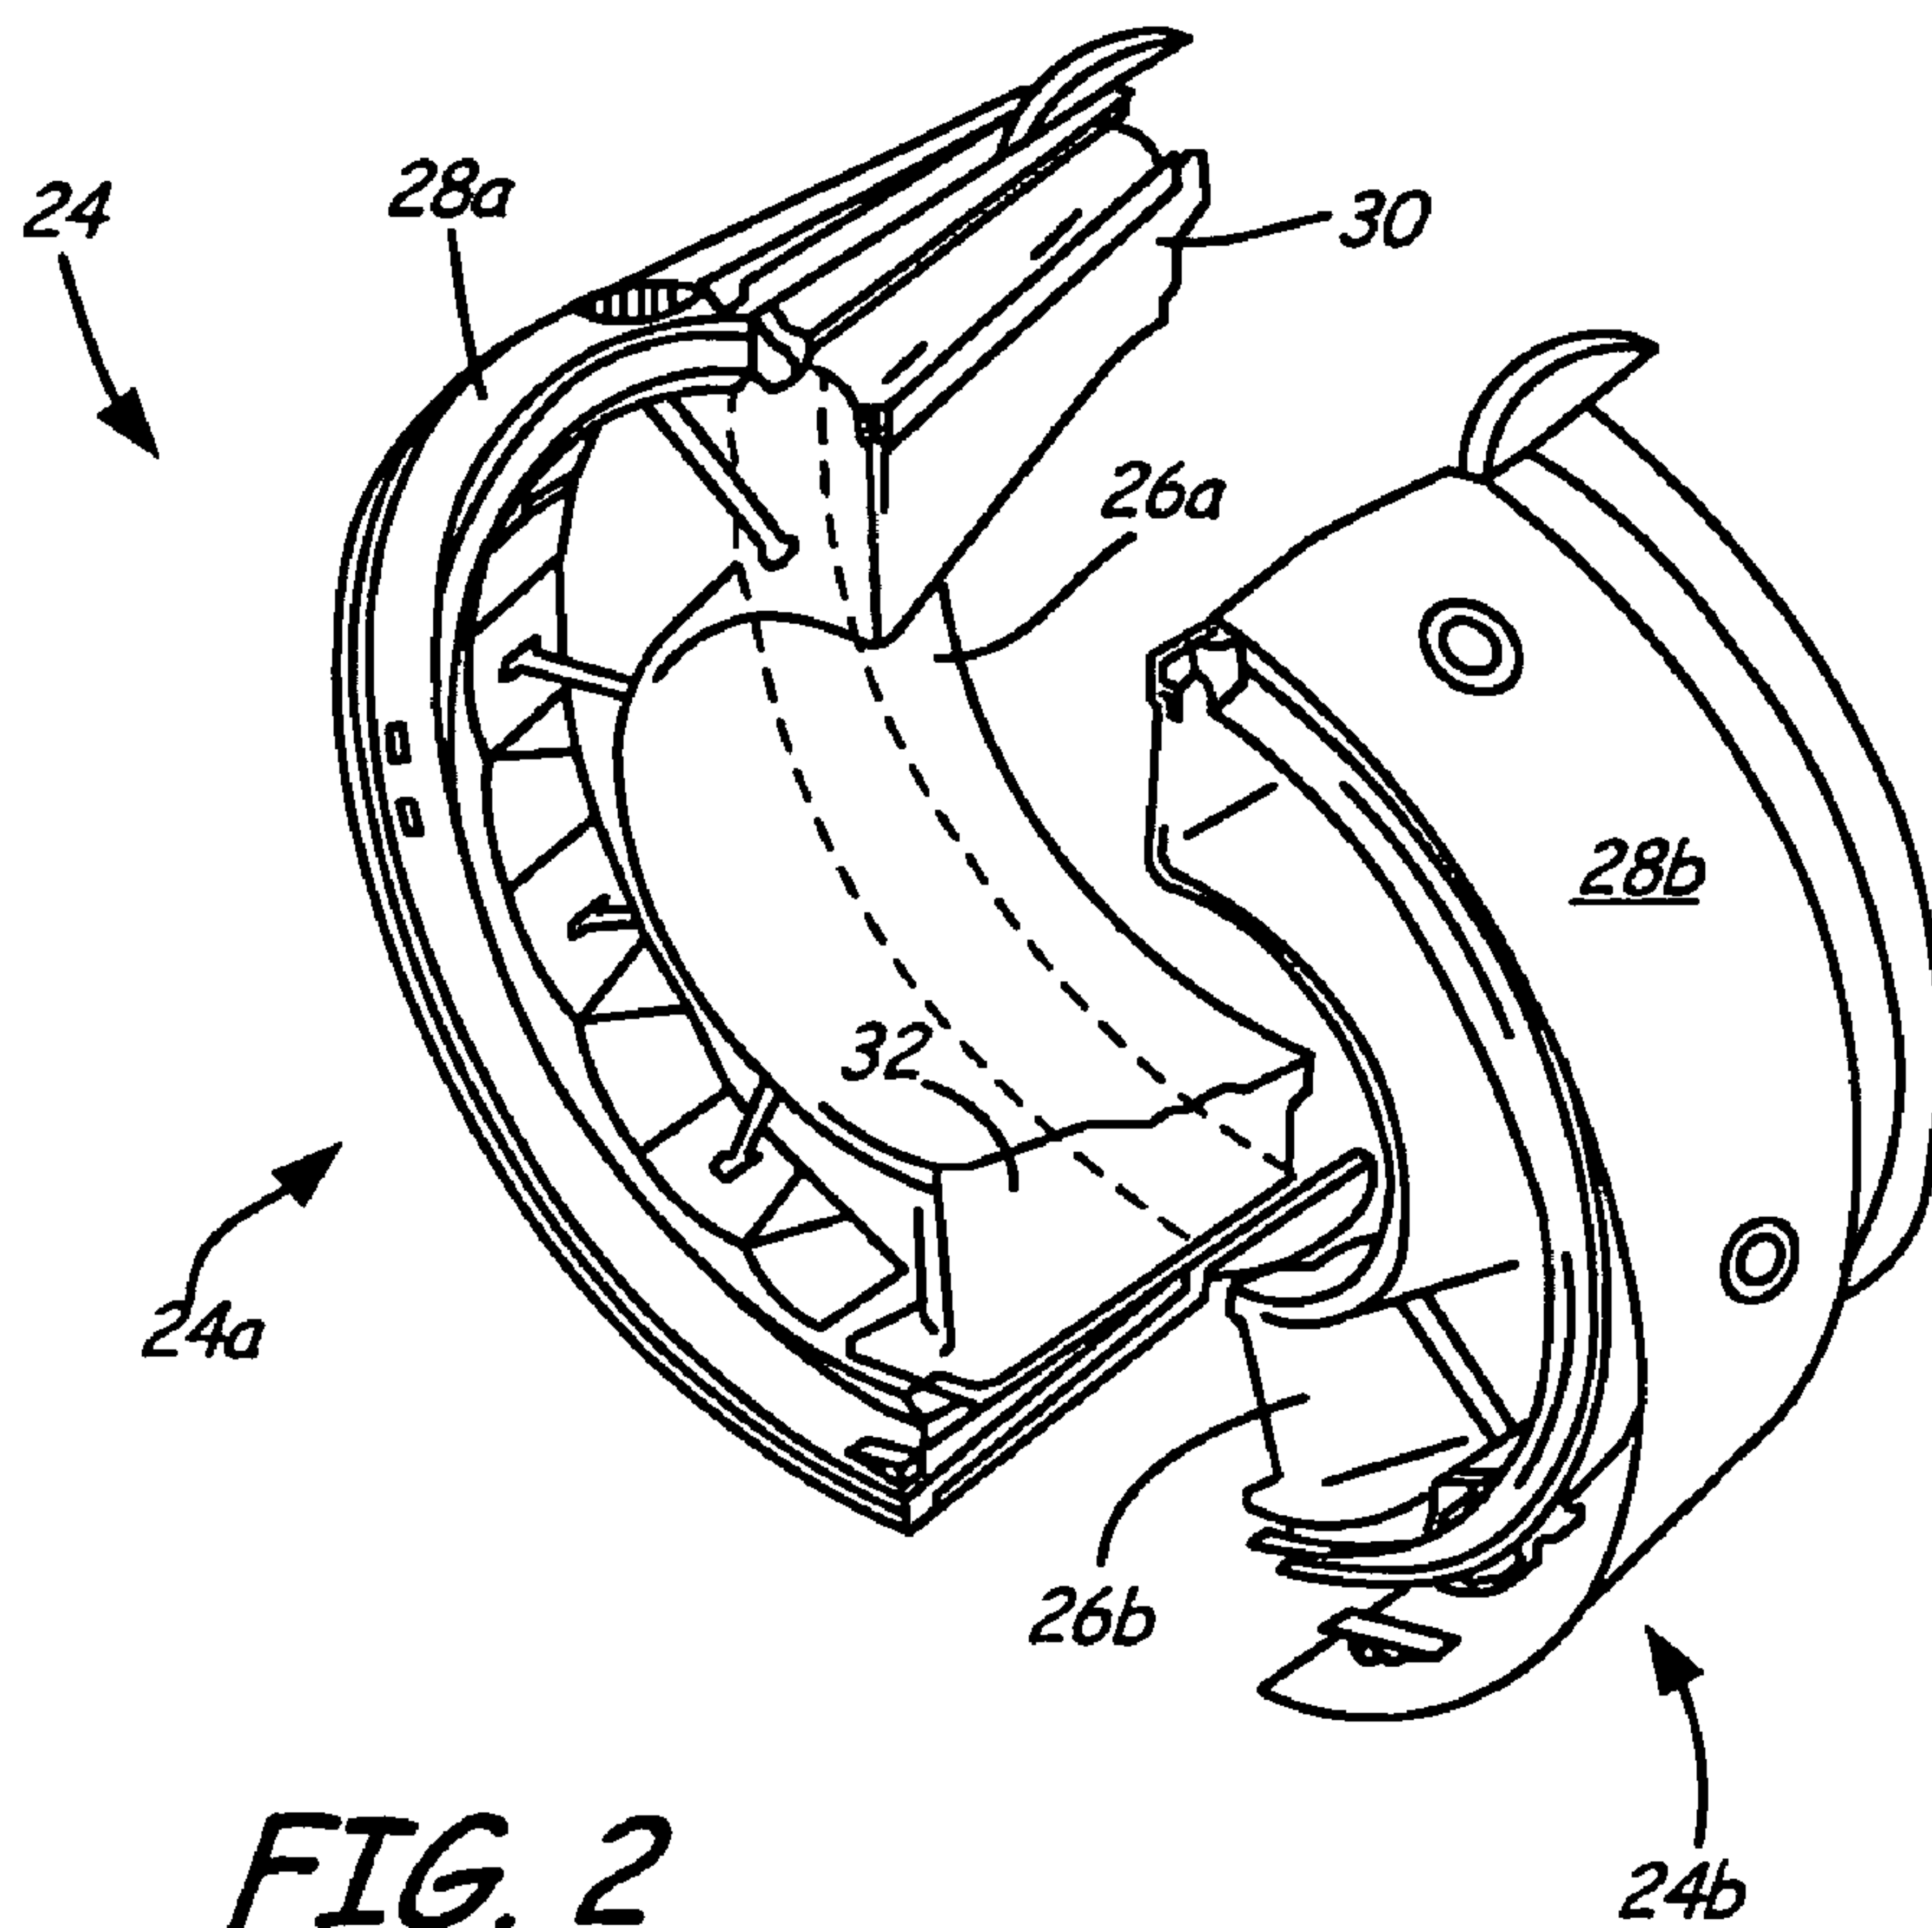
FIG. 2 is a perspective view of the thrust reverser of FIG. 1 in two halves.

FIG. 2 is an expanded perspective view of thrust reverser 24 of FIG. 1 having first half 24a and second half 24b, which are attached to one another to surround the gas turbine engine (not shown). Each half 24a and 24b includes inner cowl 26a and 26b (also known as the core cowl) and outer cowl 28a and 28b. Thrust reverser 24 is configured such that outer cowl 28 slides in an aft direction, and air flowing through thrust reverser 24 is directed forwardly to aid in deceleration during landing of aircraft 10. Inner cowl 26a and outer cowl 28a are attached to one another, in part, by bifurcation panels 30 and 32. Although not visible in FIG. 2, second half 24b also includes two bifurcation panels.

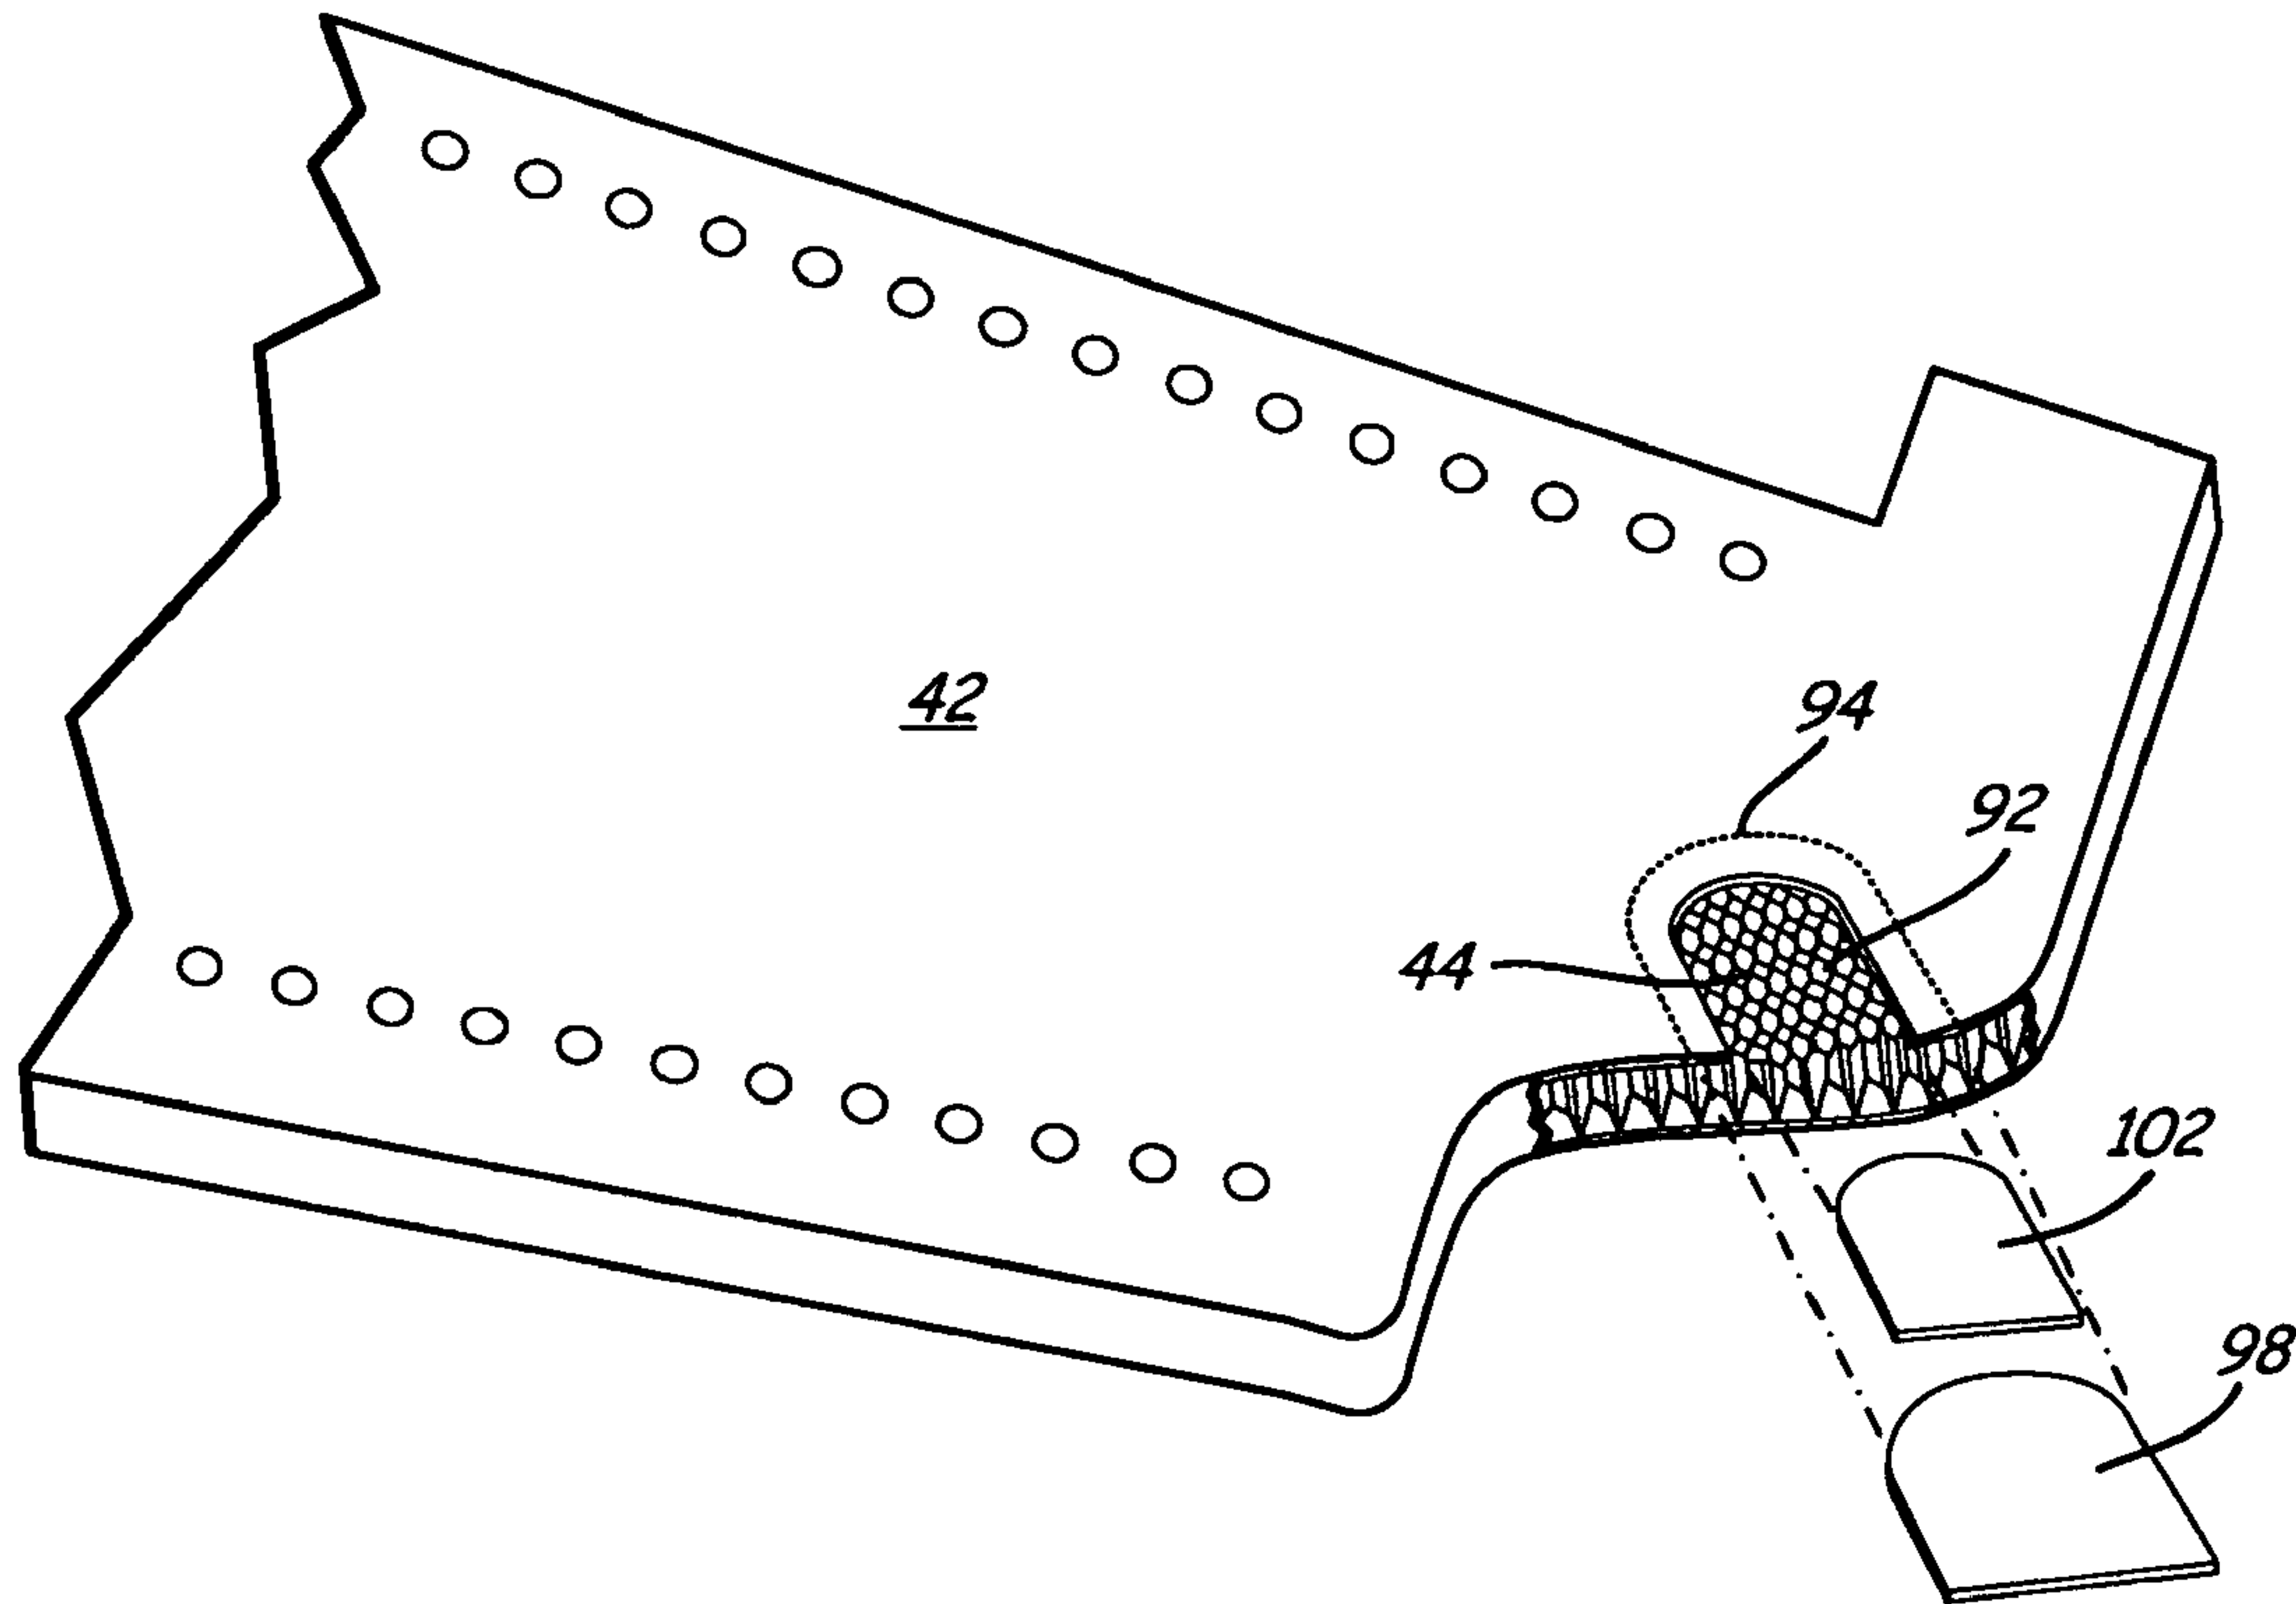
FIG. 6 is a perspective view of the panel of FIG. 4 illustrating the method of repairing the crack in the back skin.

A next step in method 50 depends on the analysis of the crack in step 52. Step 54 is to remove a portion of the back skin that includes the crack by cutting out a portion of the back skin. FIG. 6 shows an example of how much of the back skin is removed relative to the crack. Alternatively, in step 56, the back skin remains as part of the repair and the crack is stop drilled using, for example, a 1/4" drill bit. (See FIG. 11.) This is done to reduce stress concentration at the end of the crack. In step 56, caution should be used so that the underlying

FIG. 7) for receiving doubler 98. The removed area of honeycomb 44 is designated by dashed line 94. Doubler 98 has a shape generally similar to the area represented by dashed line 94. As shown in FIG. 6, the removed area of honeycomb 44 is larger than the removed area 92 of back skin 42.

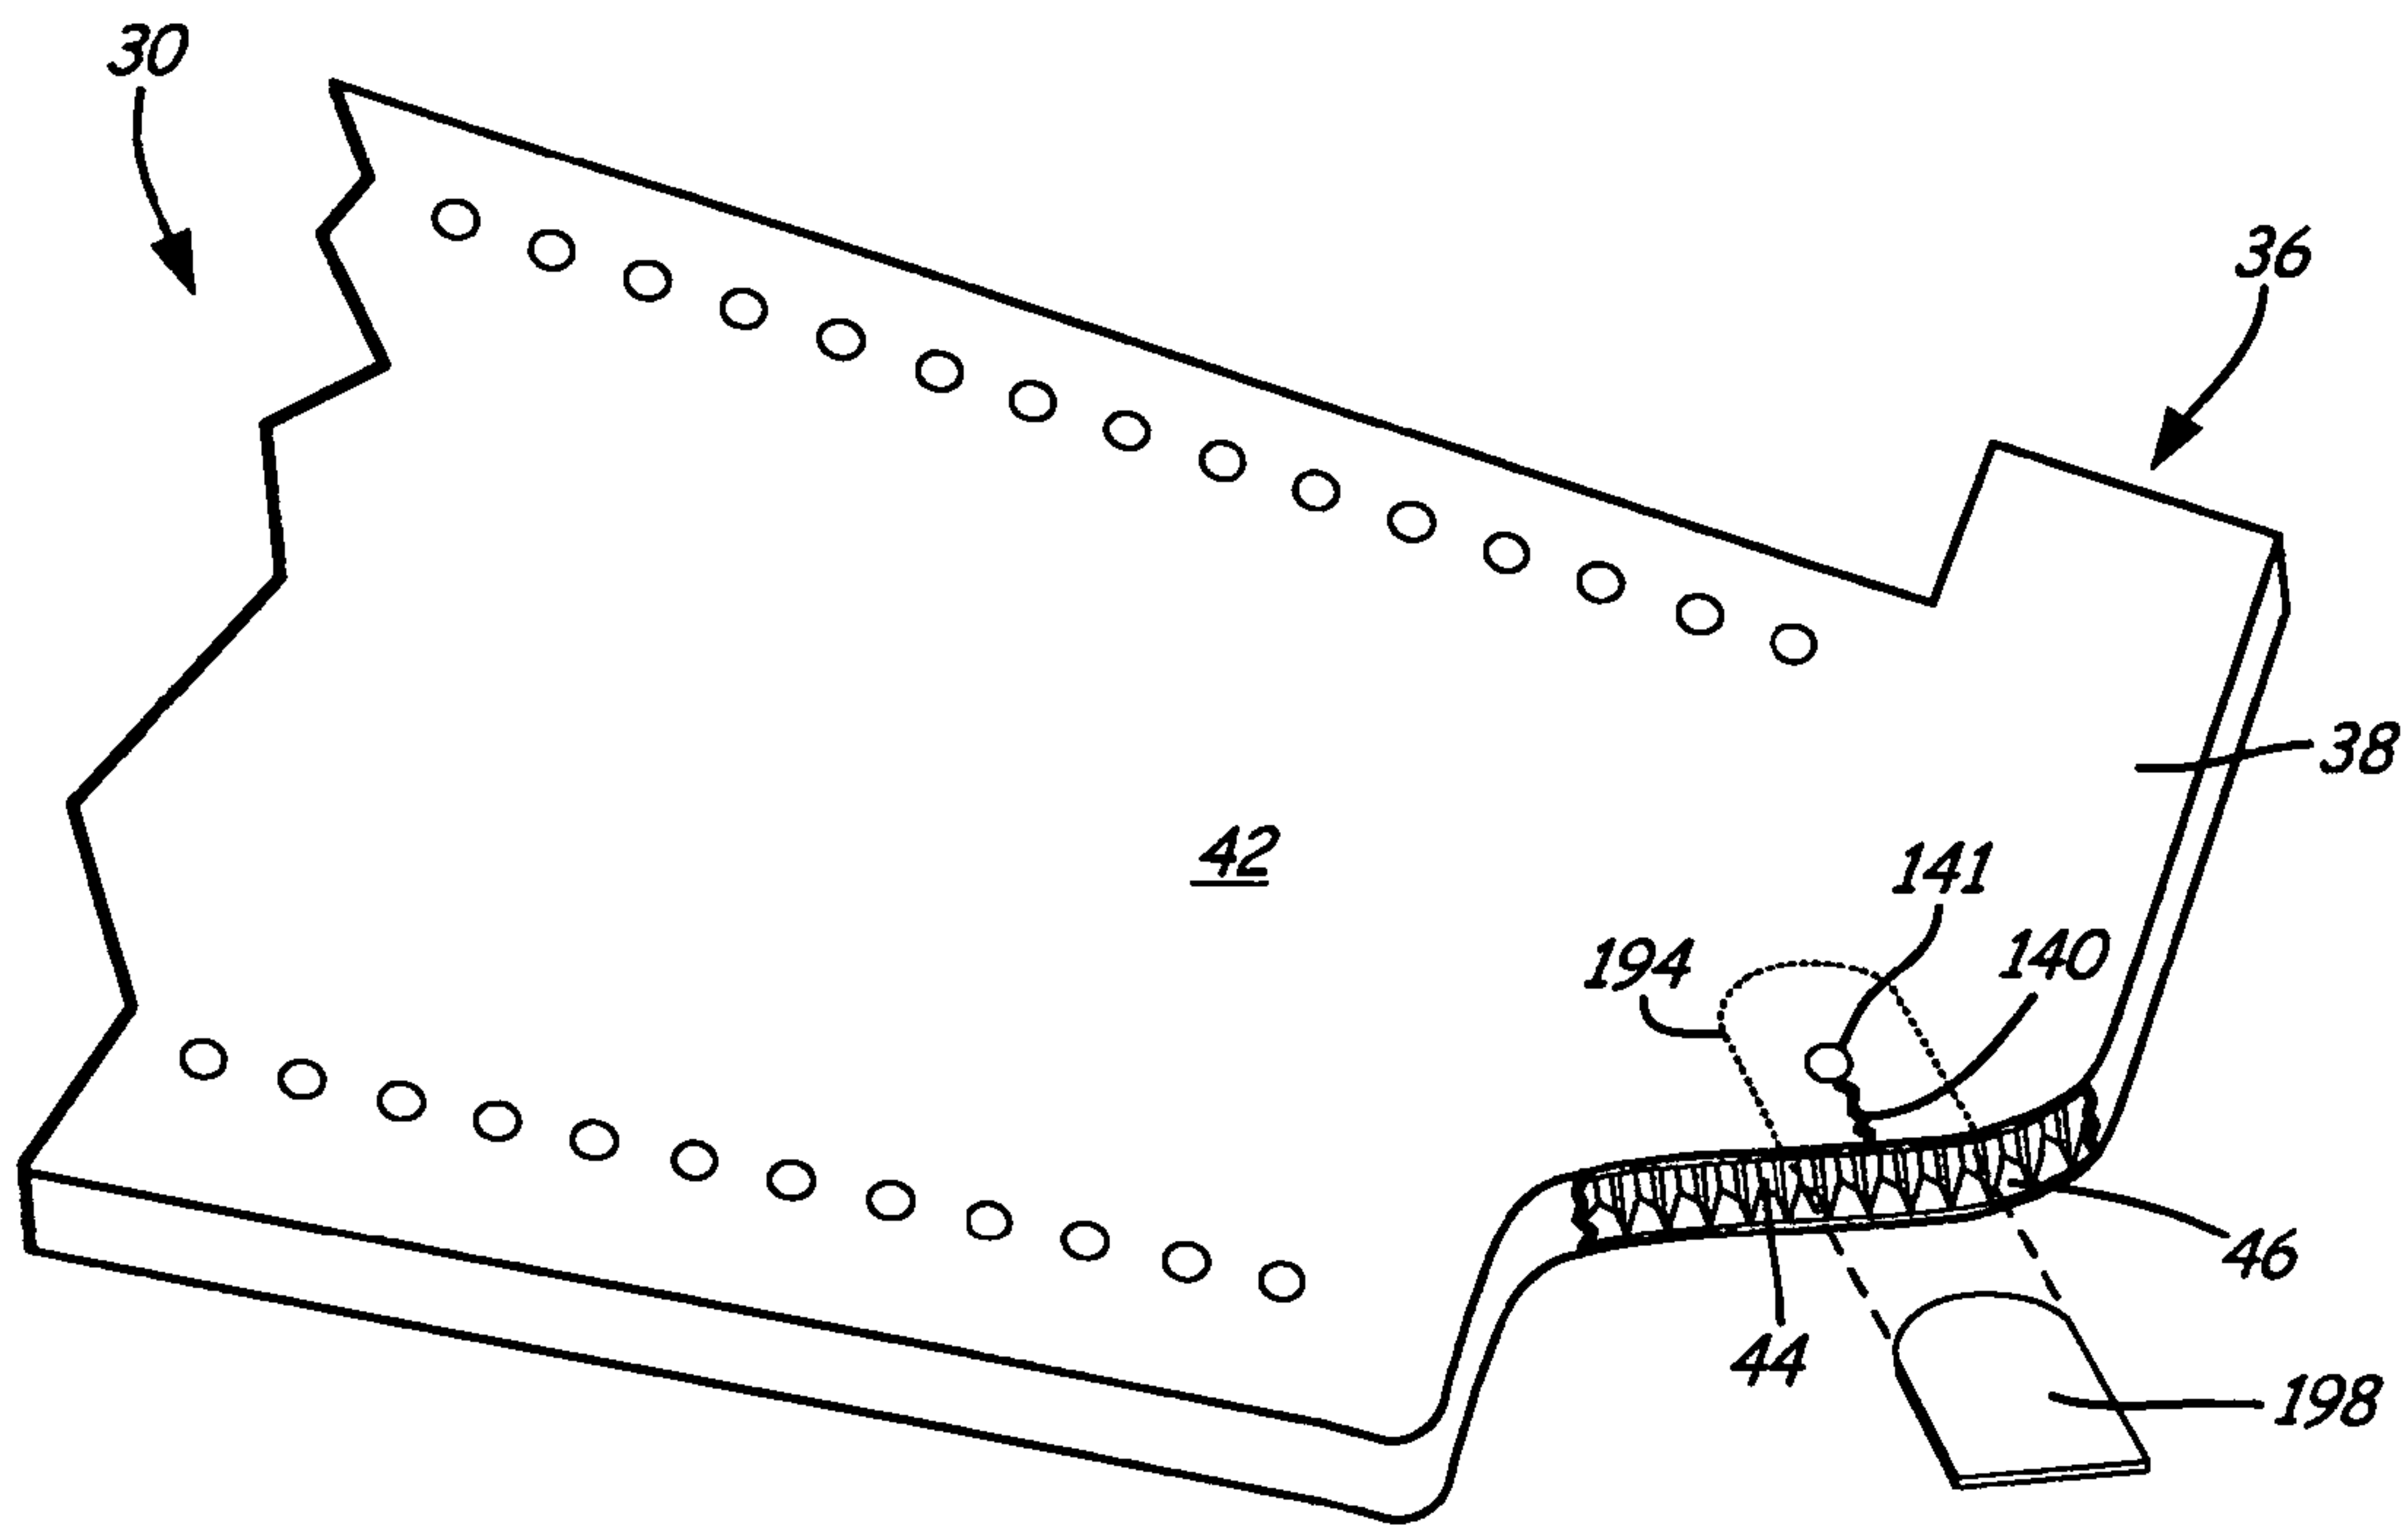
FIG. 11 is a perspective view of the panel of FIG. 4 illustrating an alternative embodiment for repairing a crack in the back skin.

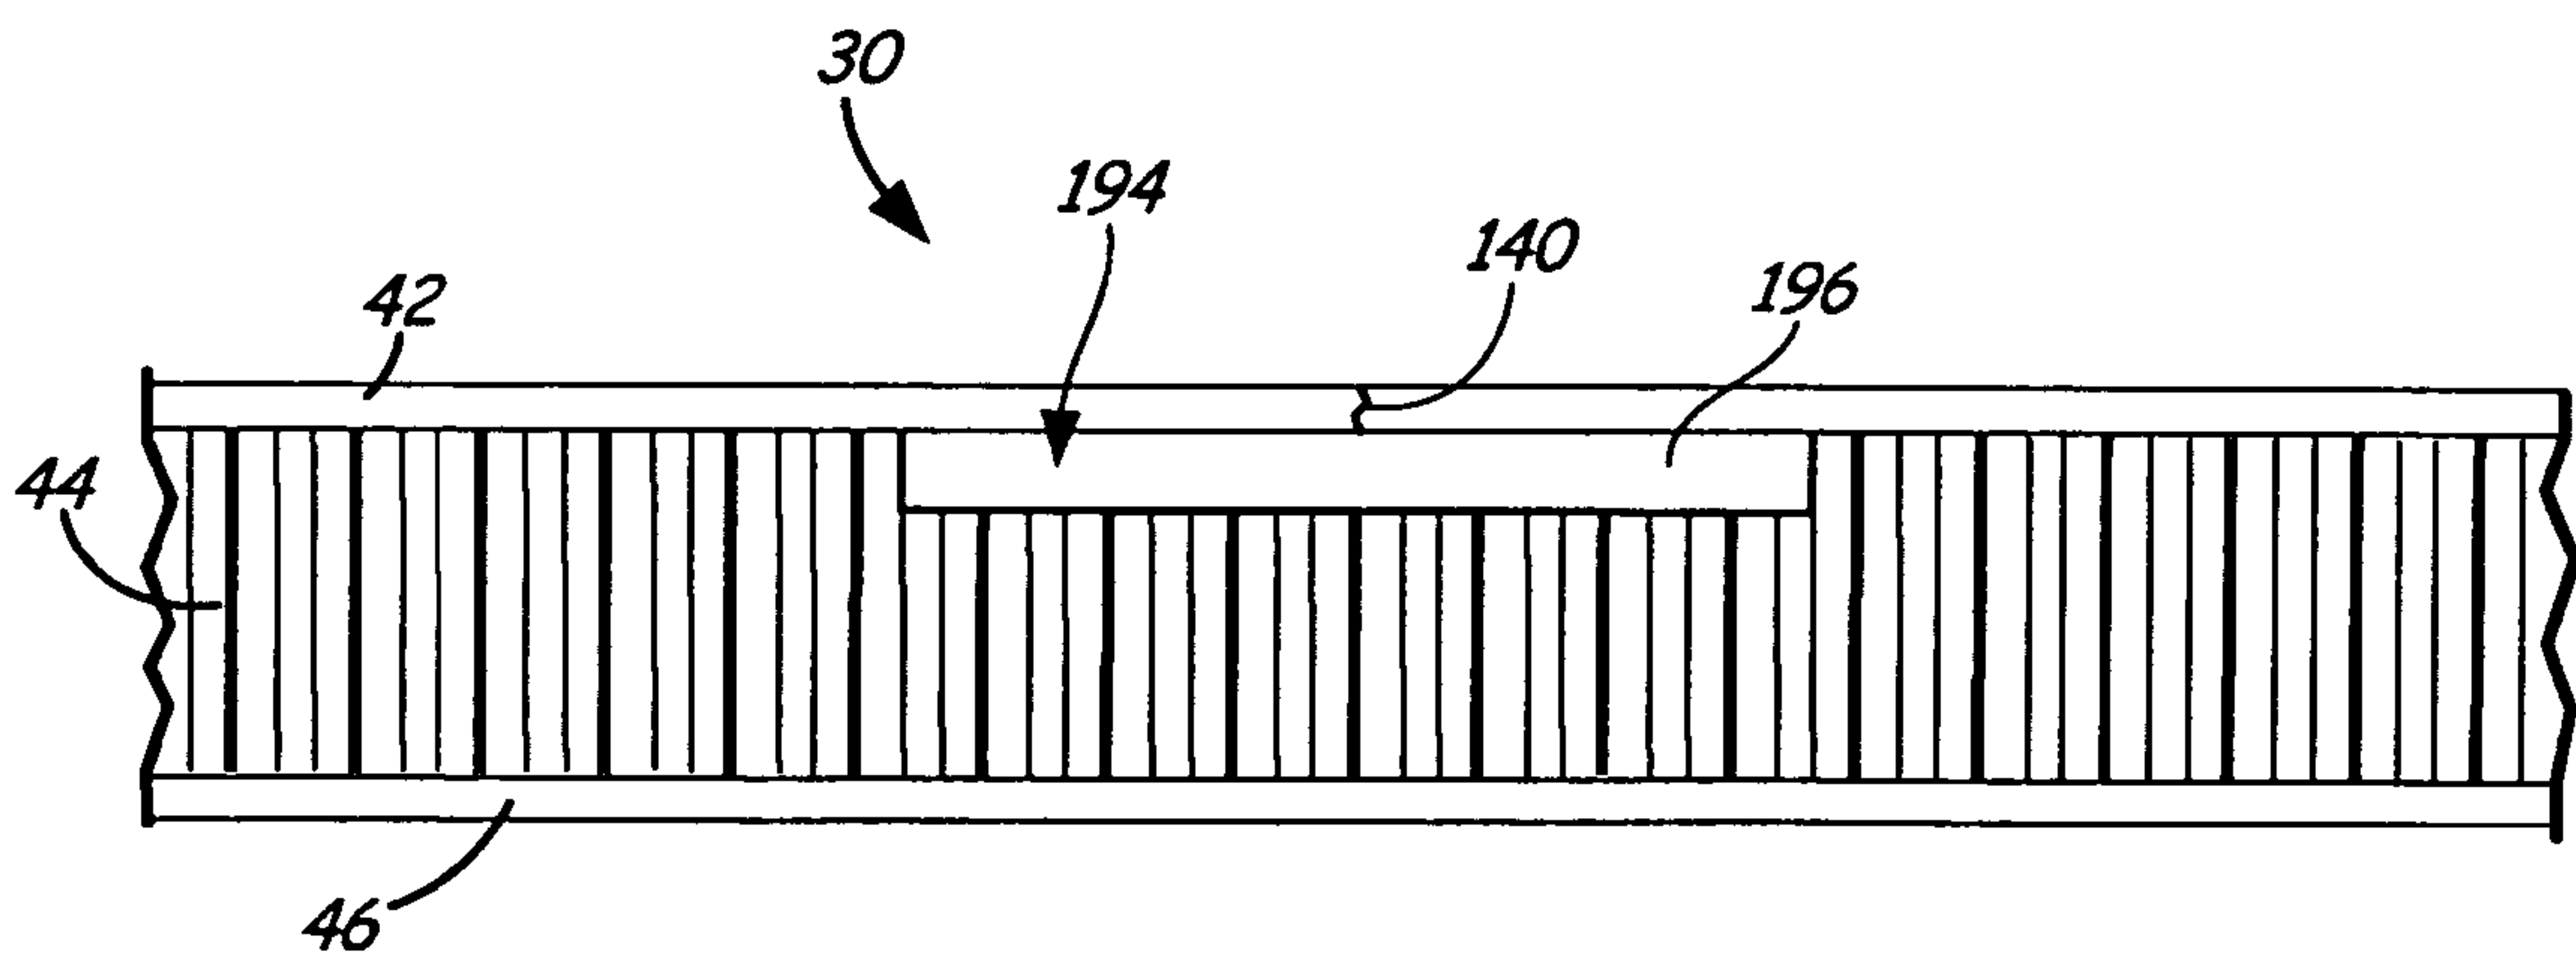
FIG. 12 is a cross-sectional view of the panel from FIG. 11 showing a slot formed in the honeycomb core as part of the repair.
