(54) **REPAIRED TURBINE EXHAUST STRUT  
HEAT SHIELD VANES AND REPAIR  
METHODS**

A method of repairing a turbine exhaust case strut heat shield vane includes removing a damaged portion of the vane, solution heat treating the vane, attaching a replacement section to the vane, and relieving local stresses in an attachment area between the replacement section and the vane.

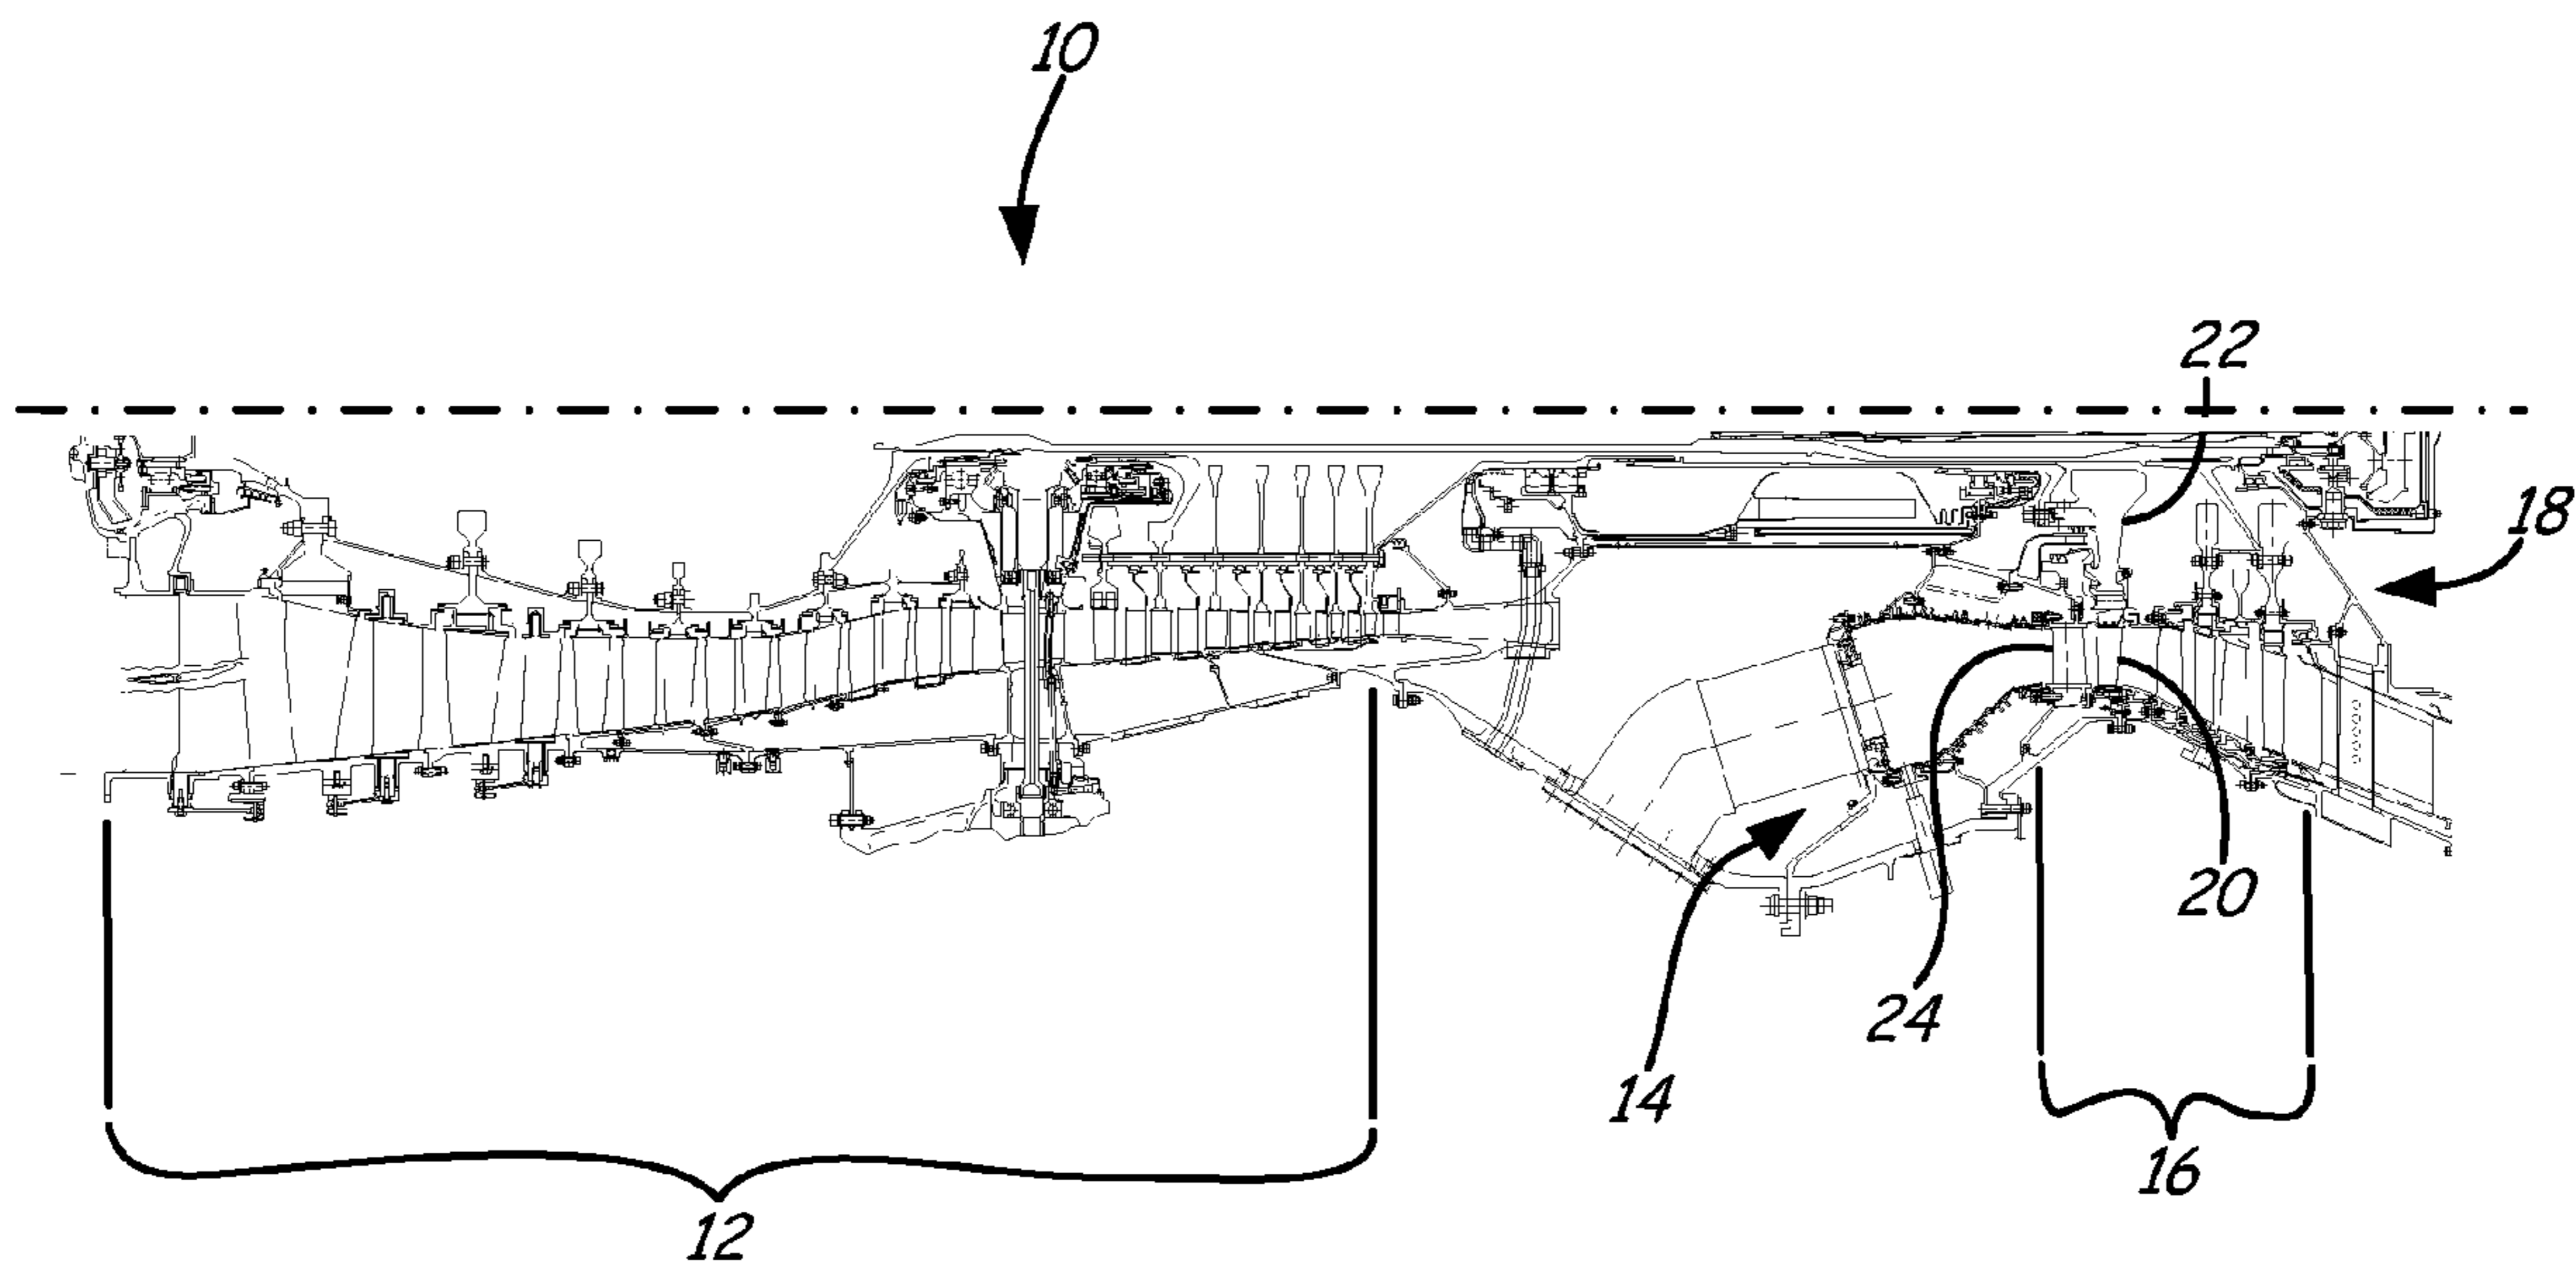
FIG. 1 is an axial section view of an industrial gas turbine including a turbine exhaust case.

FIG. 1 is a partial axial section view of industrial gas turbine 10 including compressor 12, combustor 14, turbine section 16, and exhaust case 18. Although the section view of FIG. 1 shows only one combustor 14, turbine 10 will generally include multiple combustors 14 circumferentially distributed around a turbine main shaft (not shown). Turbine section 16 includes a plurality of rotating blades 20 secured to a rotatable rotor disk 22. A plurality of stationary vanes 24 are each alternately positioned upstream of each of the rotating blades 20. The vanes 24 are dimensioned and configured to guide the working gas over the blades 20.

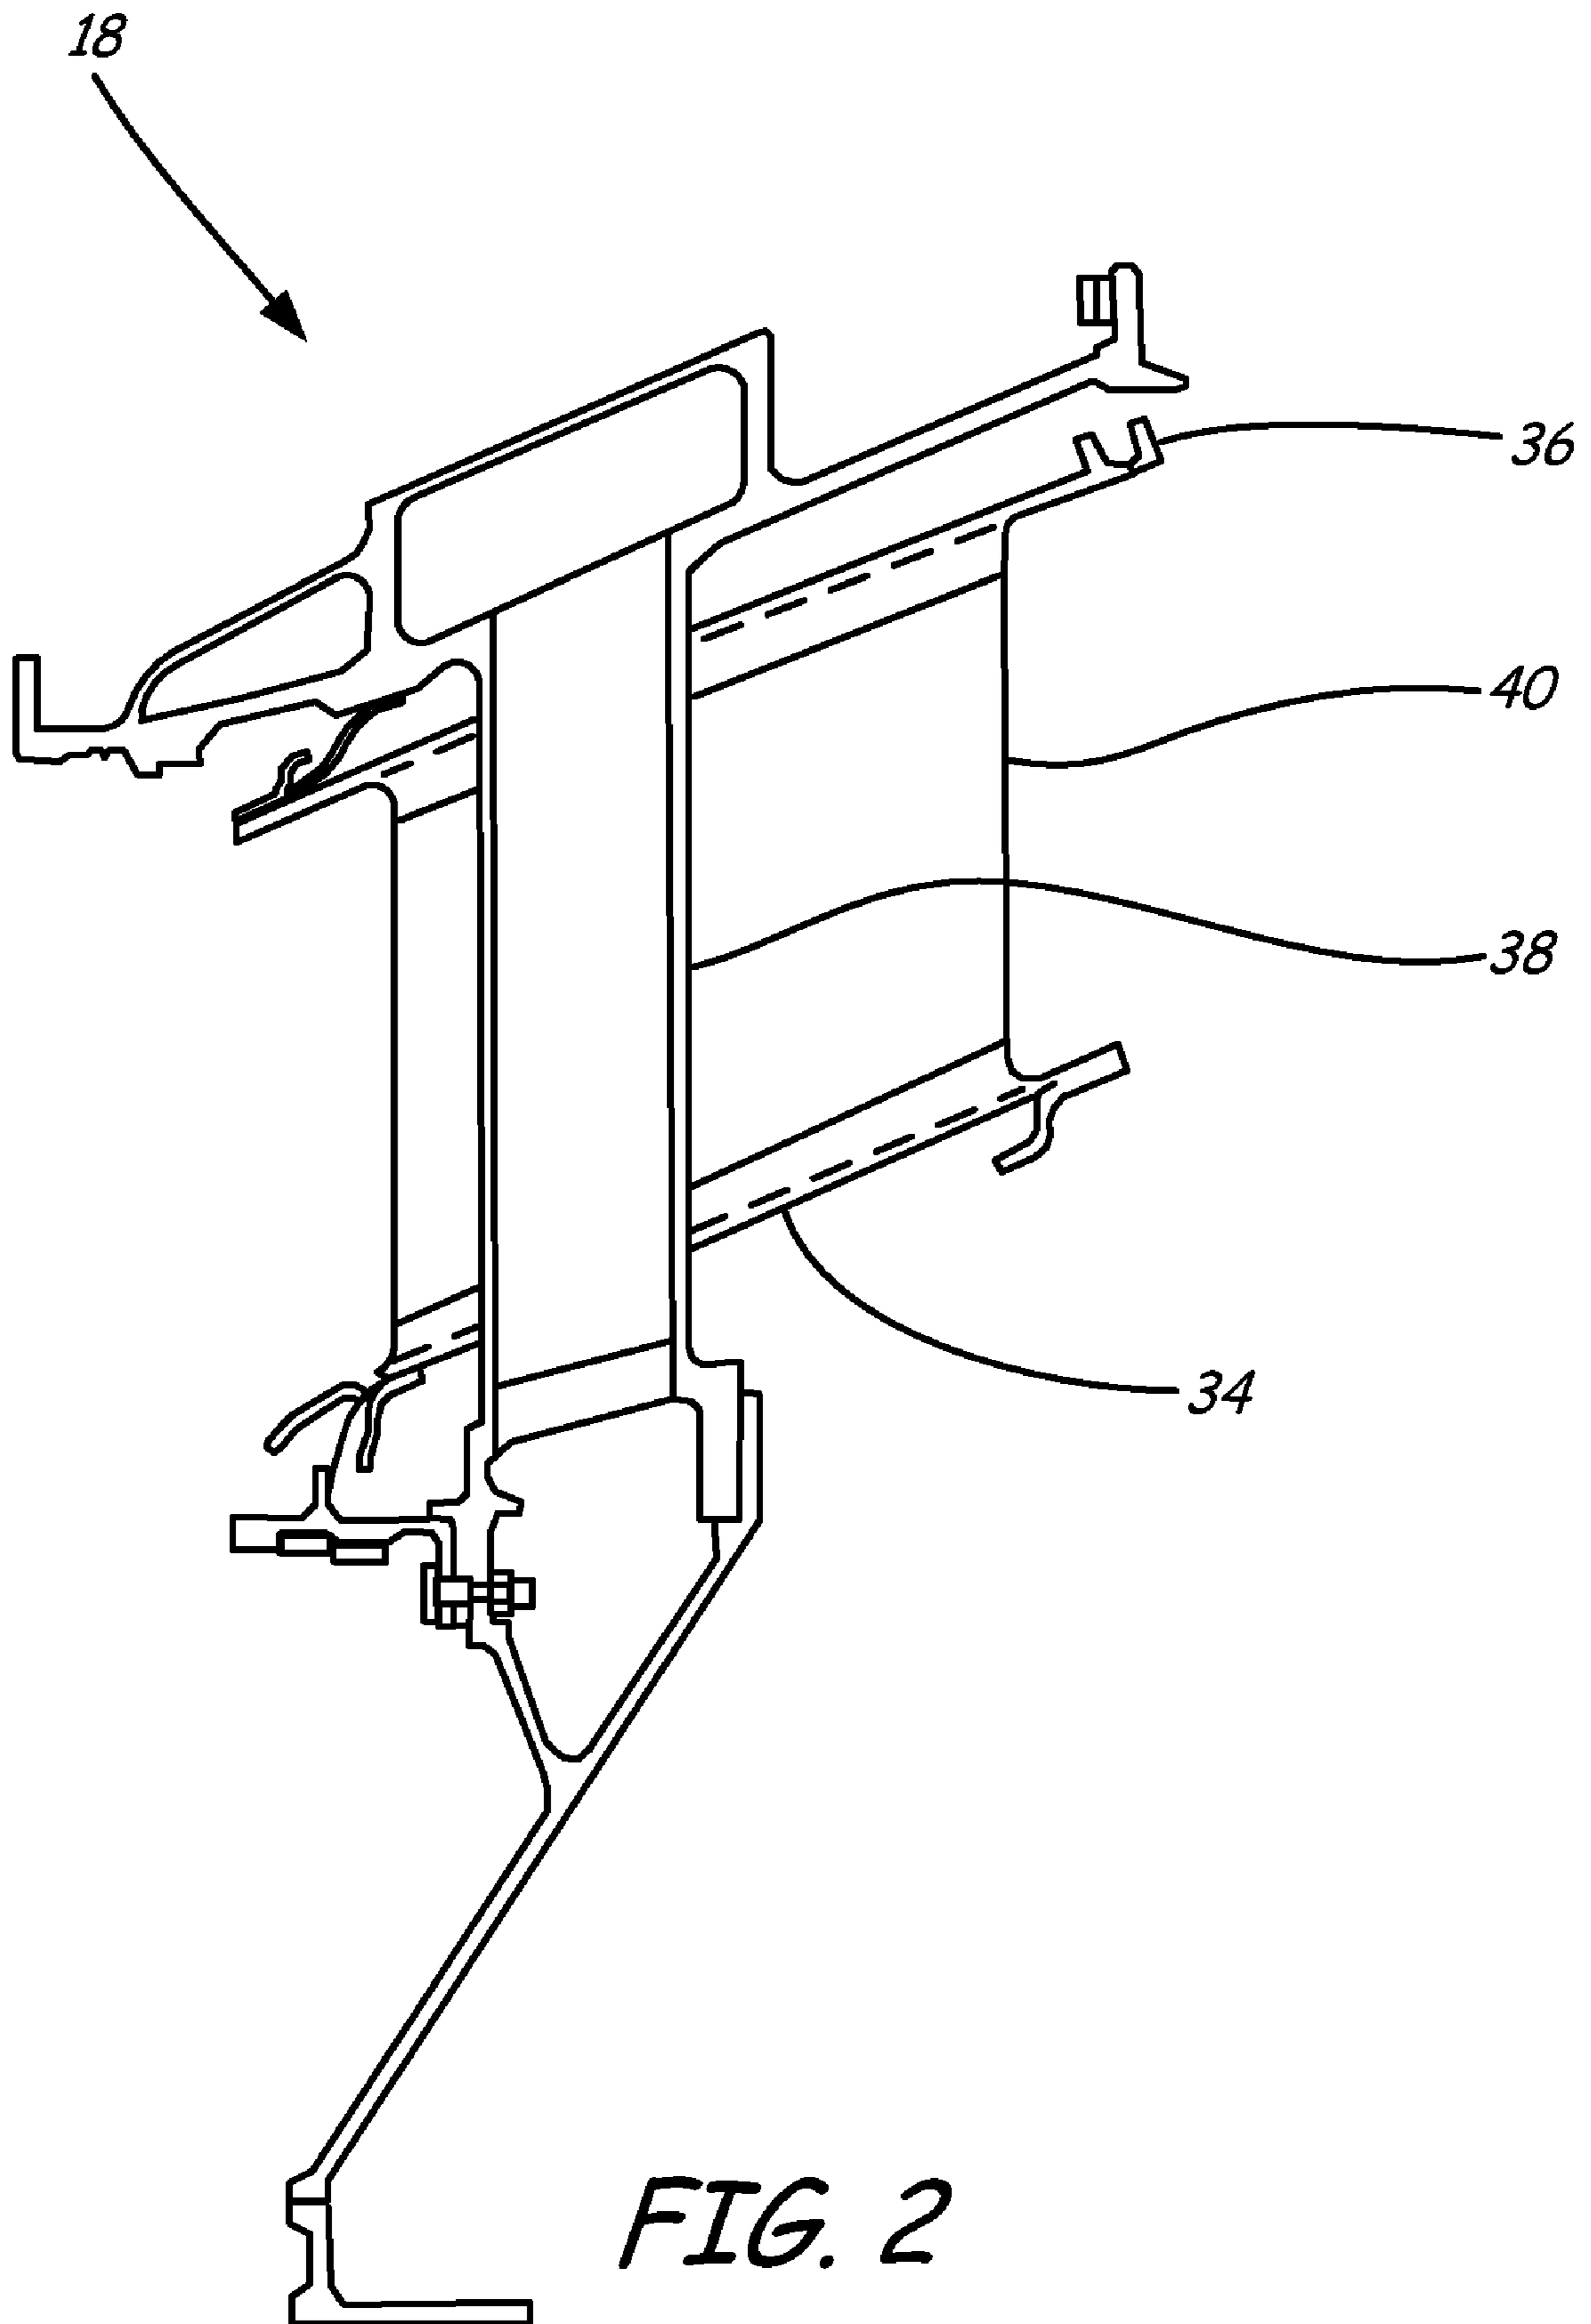
FIG. 2 is a detail view of the turbine exhaust case including a strut heat shield vane from the turbine of FIG. 1.

Exhaust case 18 is positioned downstream of the last row of turbine blades 20 shown in FIG. 1. FIG. 2 is a detail view of exhaust case 18 including a pair of annular rings, such as diffusers 34 and 36, struts 38, and heat shield vanes 40. Diffuser 34 forms the inner wall of the working gas path and diffuser 36 forms the outer wall of the working gas path. Radially extending struts 38 are circumferentially distributed about the engine axis and span the gas path between diffusers 34, 36. Each radially extending strut 38 is surrounded by vane 40. Vanes 40 act both to direct working gas flow through exhaust case 18 and to shield load bearing struts 38 from heat.

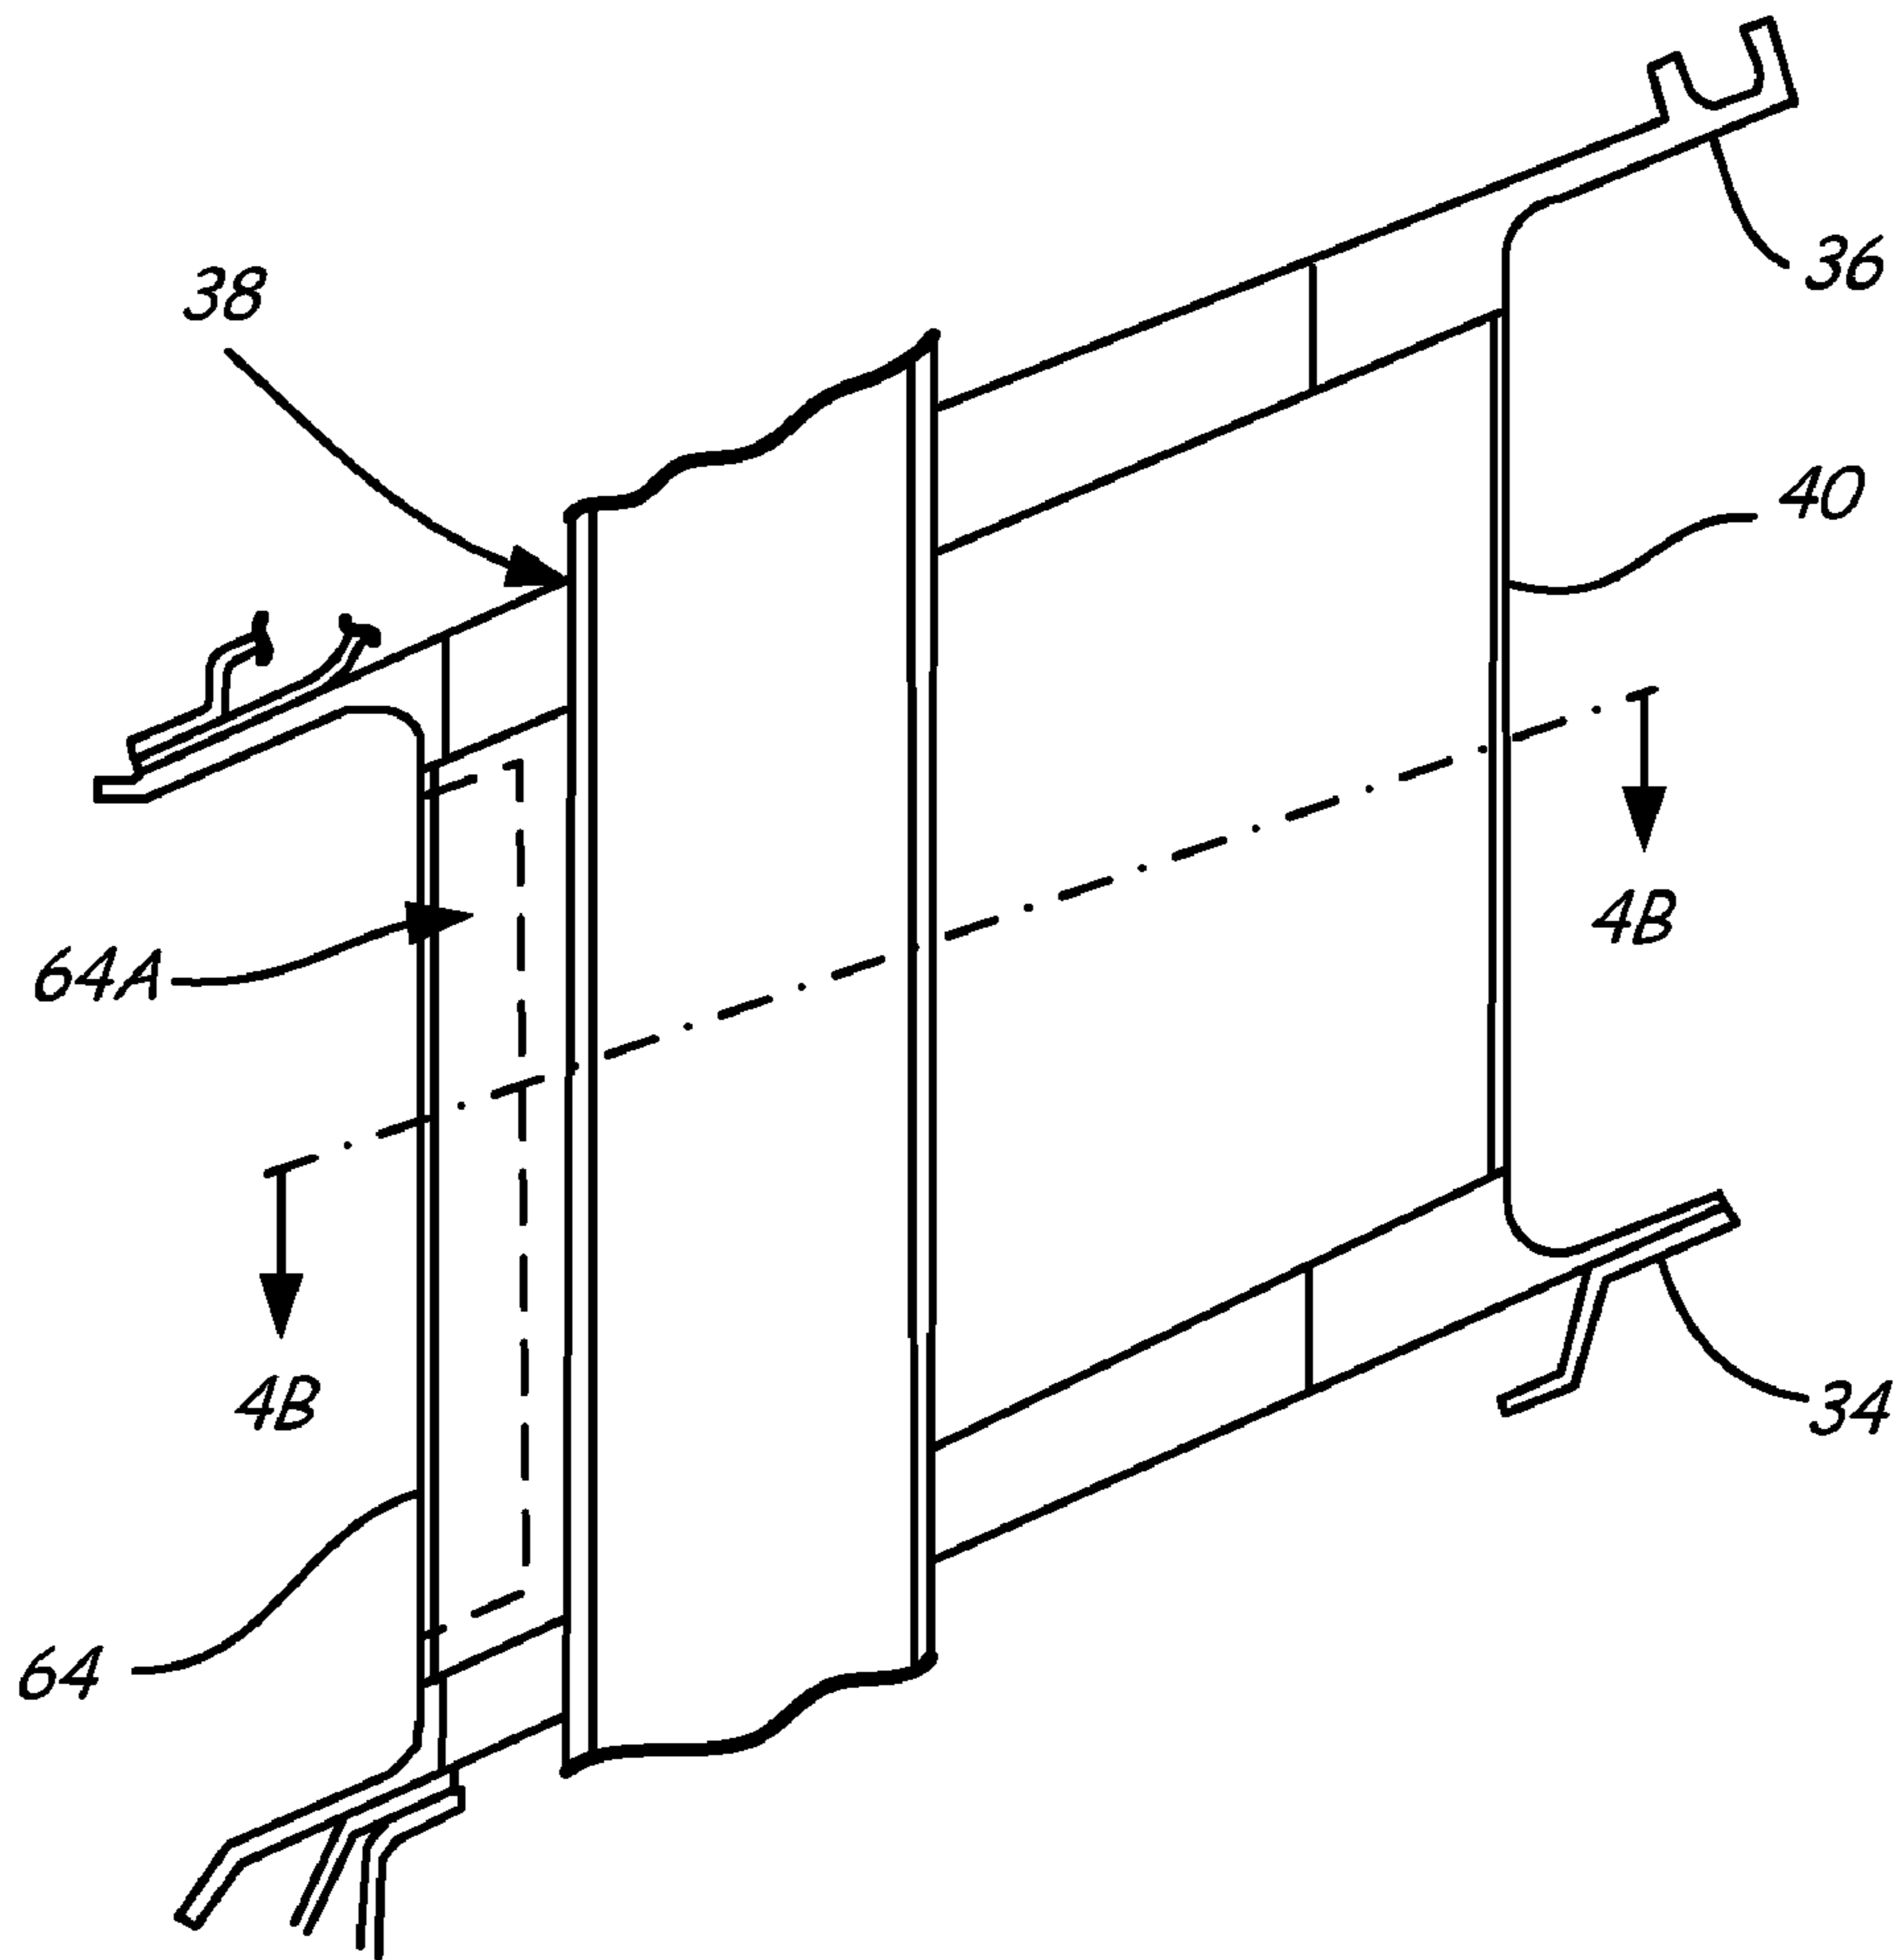
FIG. 4A

FIGS. 4A and 4B are detail views of a strut heat shield vane repaired by the exemplary method of FIG. 3.

FIGS. 4A and 4B are detail views of strut heat shield vane 40 repaired by method 50 illustrated in FIG. 3. Heat shield vane 40 surrounds strut 38 between diffusers 34 and 36. Vane 40 includes leading edge 64 and replacement section 64a. In the repaired heat shield vane 40 of FIGS. 4A and 4B, leading edge 64 may have experienced a loss of material due to a combination of abrasion, oxidation and some mode of metallurgical attack during engine operation. The damaged portion of vane 40 has therefore been removed in the region of leading edge 64. Replacement section 64a has then been attached to vane 40 by, for example, welding replacement section 64a to vane 40.
