(10) **Patent No.:** **US 8,091,229 B2**
(45) **Date of Patent:** **Jan. 10, 2012**

(54) **METHOD OF REPAIRING A SUBSURFACE VOID OR DAMAGE FOR A WIND TURBINE BLADE**

(73) Assignee: **General Electric Company**, Schenectady, NY (US)

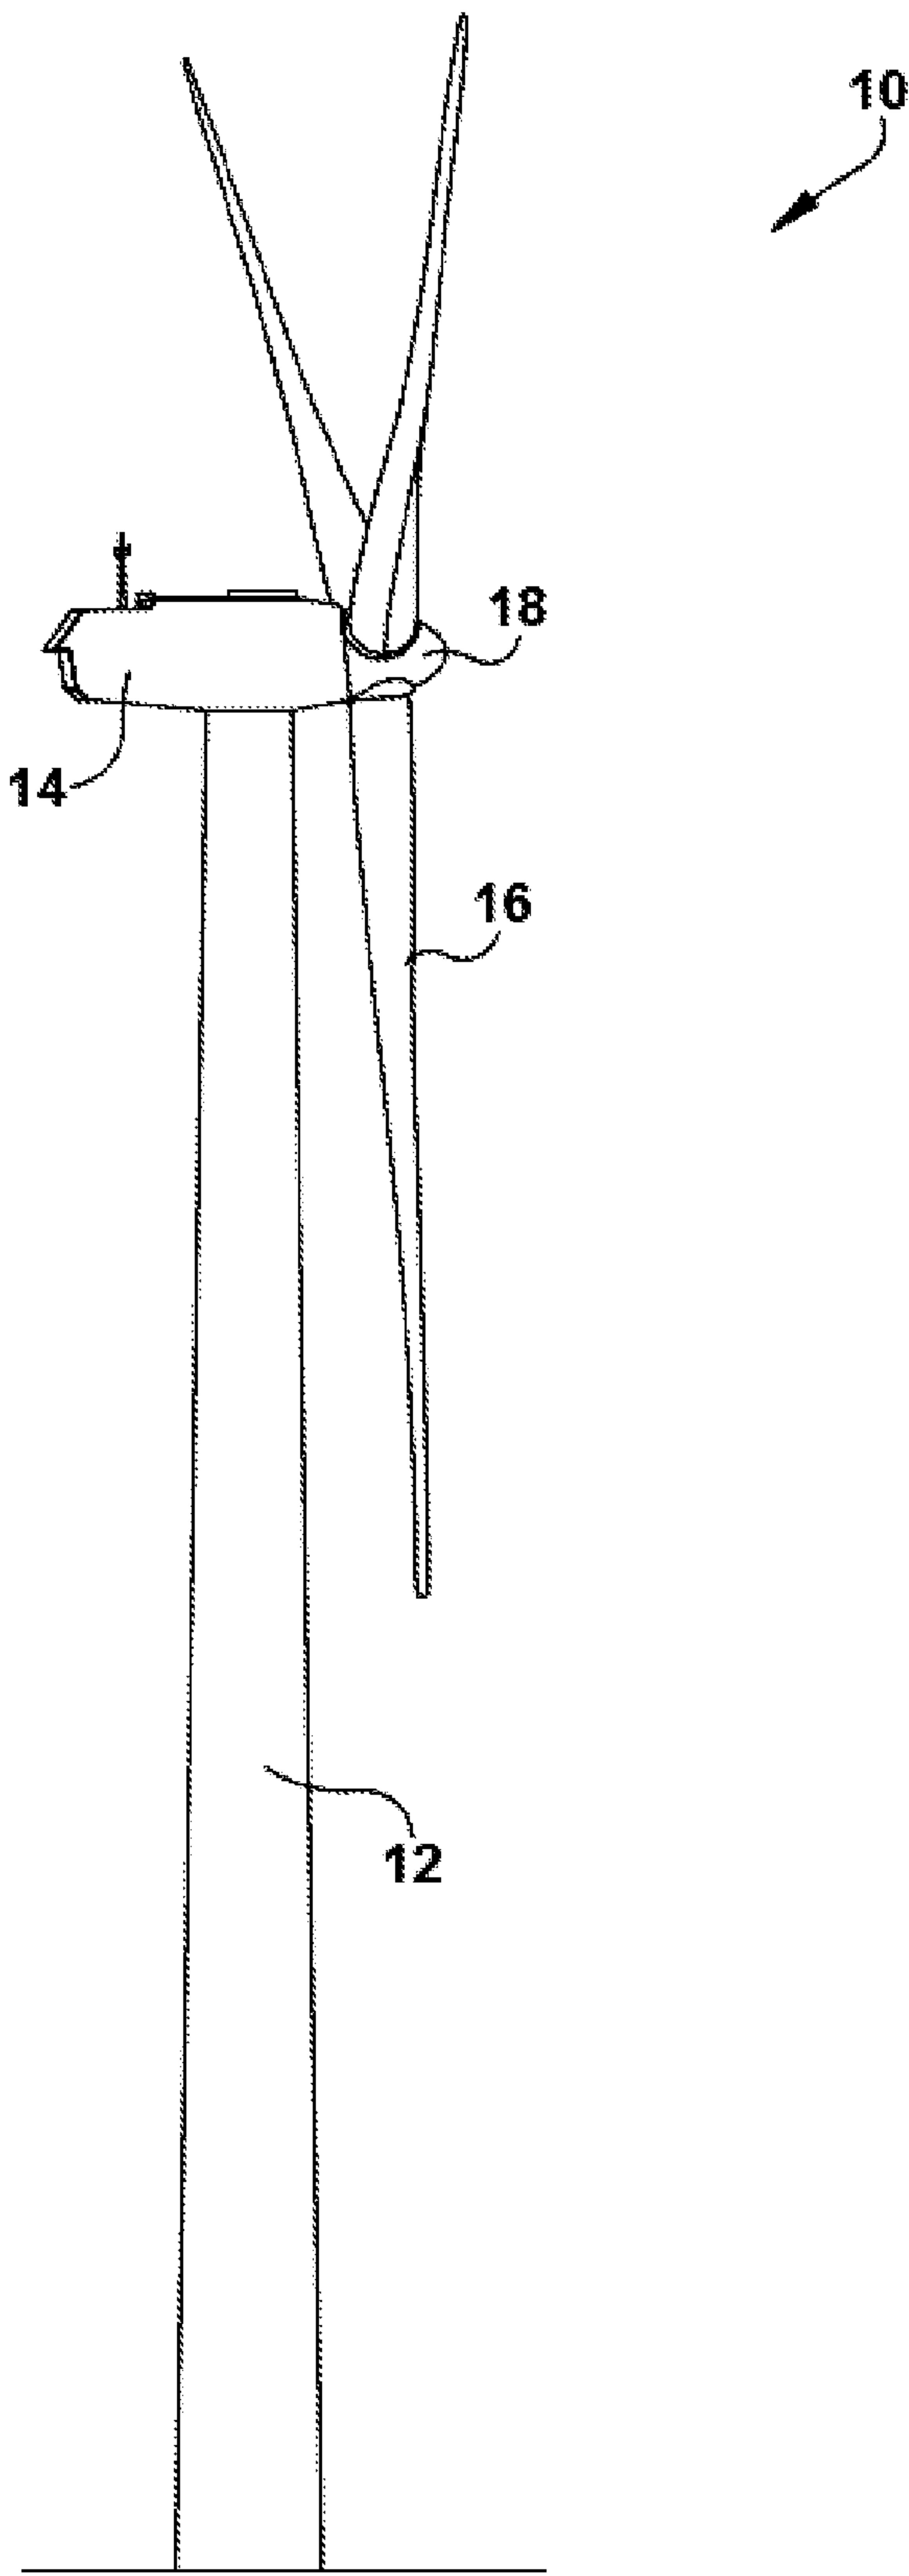
Fig. -1-

FIG. 1 is a perspective view of a conventional wind turbine;

FIG. 1 illustrates a wind turbine 10 of conventional construction. The wind turbine 10 includes a tower 12 with a nacelle 14 mounted thereon. A plurality of turbine blades 16 are mounted to a rotor hub 18, which is in turn connected to a main flange that turns a main rotor shaft. The wind turbine power generation and control components are housed within the nacelle 14. The view of FIG. 1 is provided for illustrative purposes only to place the present invention in an exemplary field of use. It should be appreciated that the invention is not limited to any particular type of wind turbine configuration.

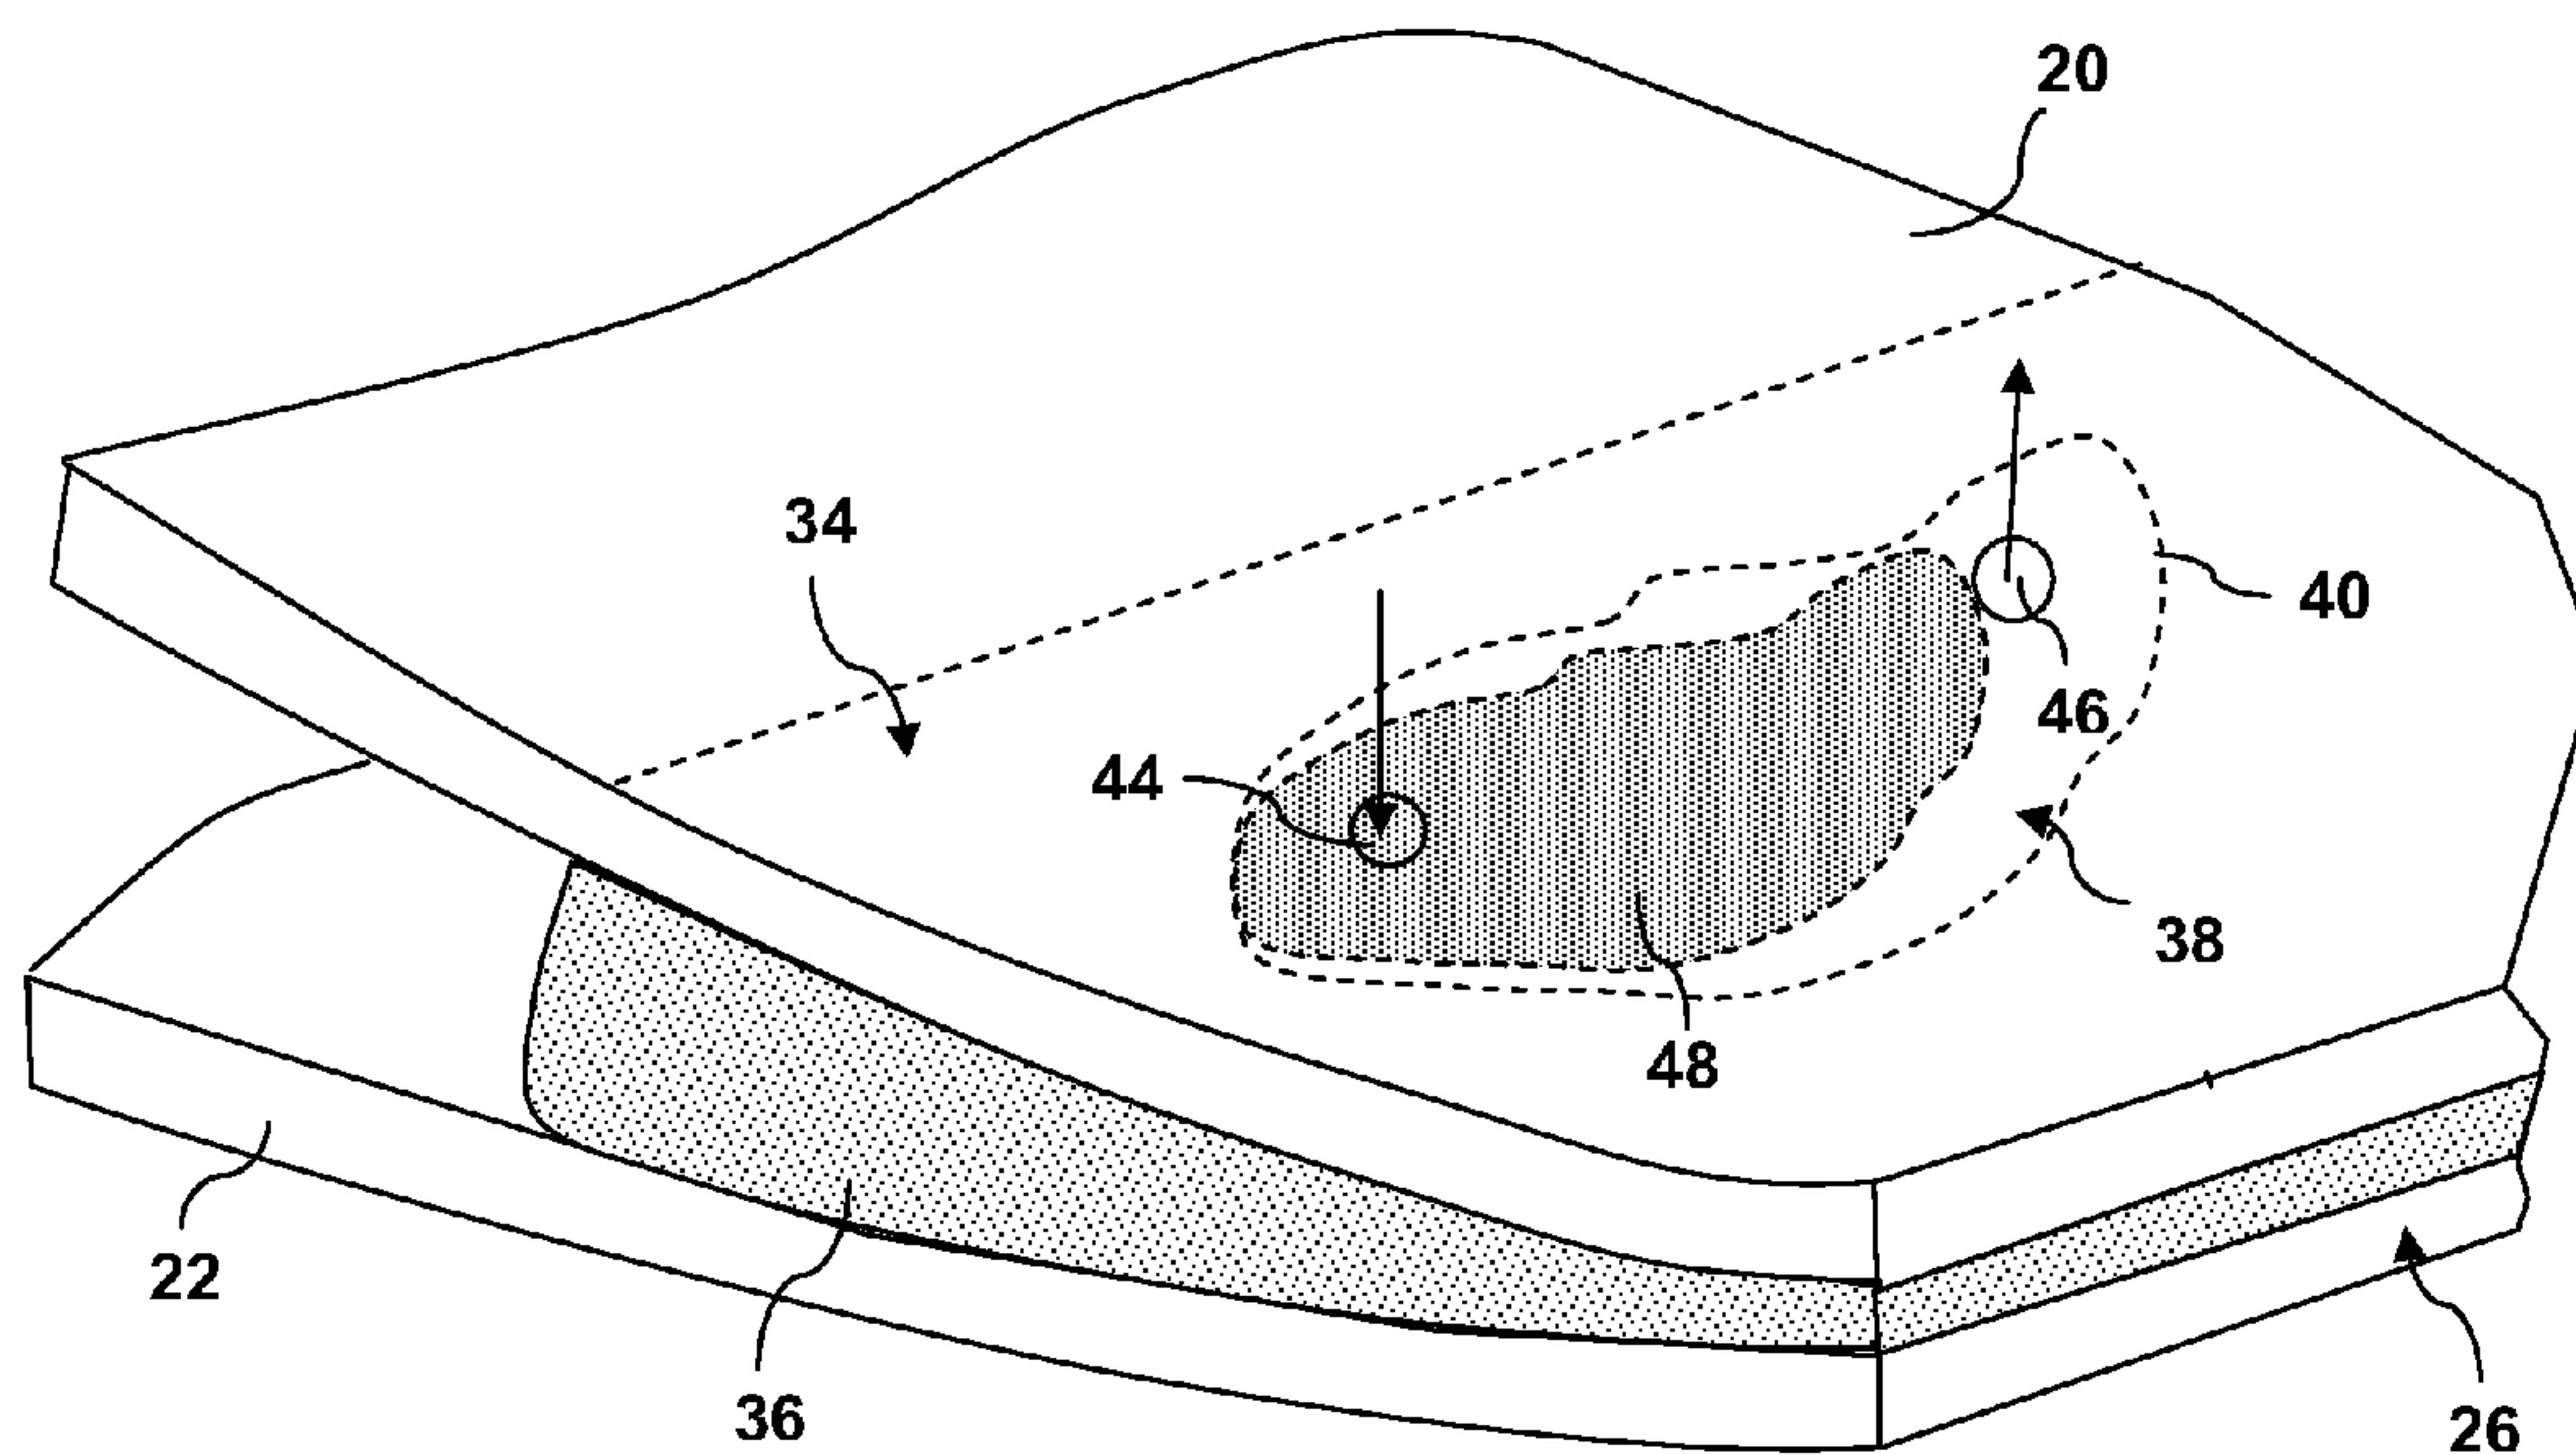
Fig. -4-

FIG. 4 is a cross-sectional perspective view of the trailing edge of a wind turbine blade with a fill hole and a vent hole defined therein in accordance with aspects of the repair procedure of the invention;

Referring to FIG. 4, once the location and boundary 40 of the defect 38 has been determined, a fill hole 44 is drilled into the defect 38 from an external surface of the laminate, as indicated by the arrow in FIG. 4. The hole 44 is drilled proximate to the boundary 40 of the defect, as compared to a more central location. Still referring to FIG. 4, a vent hole 46 is also defined from the external surface of the shell member 20 into the defect 38 proximate to the opposite boundary relative to the fill hole 44. This pattern of the drill hole 44 and vent hole 46 helps to ensure that a flowable bonding material 48 that is injected into the defect 38 through the fill hole 44 completely (or nearly completely) fills the entire void of the defect 38. As the bonding material 44 flows into the defect 38, air is forced out through the vent hole 46. By disposing the vent hole 46 generally opposite from the fill hole 44 proximate to the opposite boundary 40, a more complete fill of the void with the bonding material 48 is achieved.

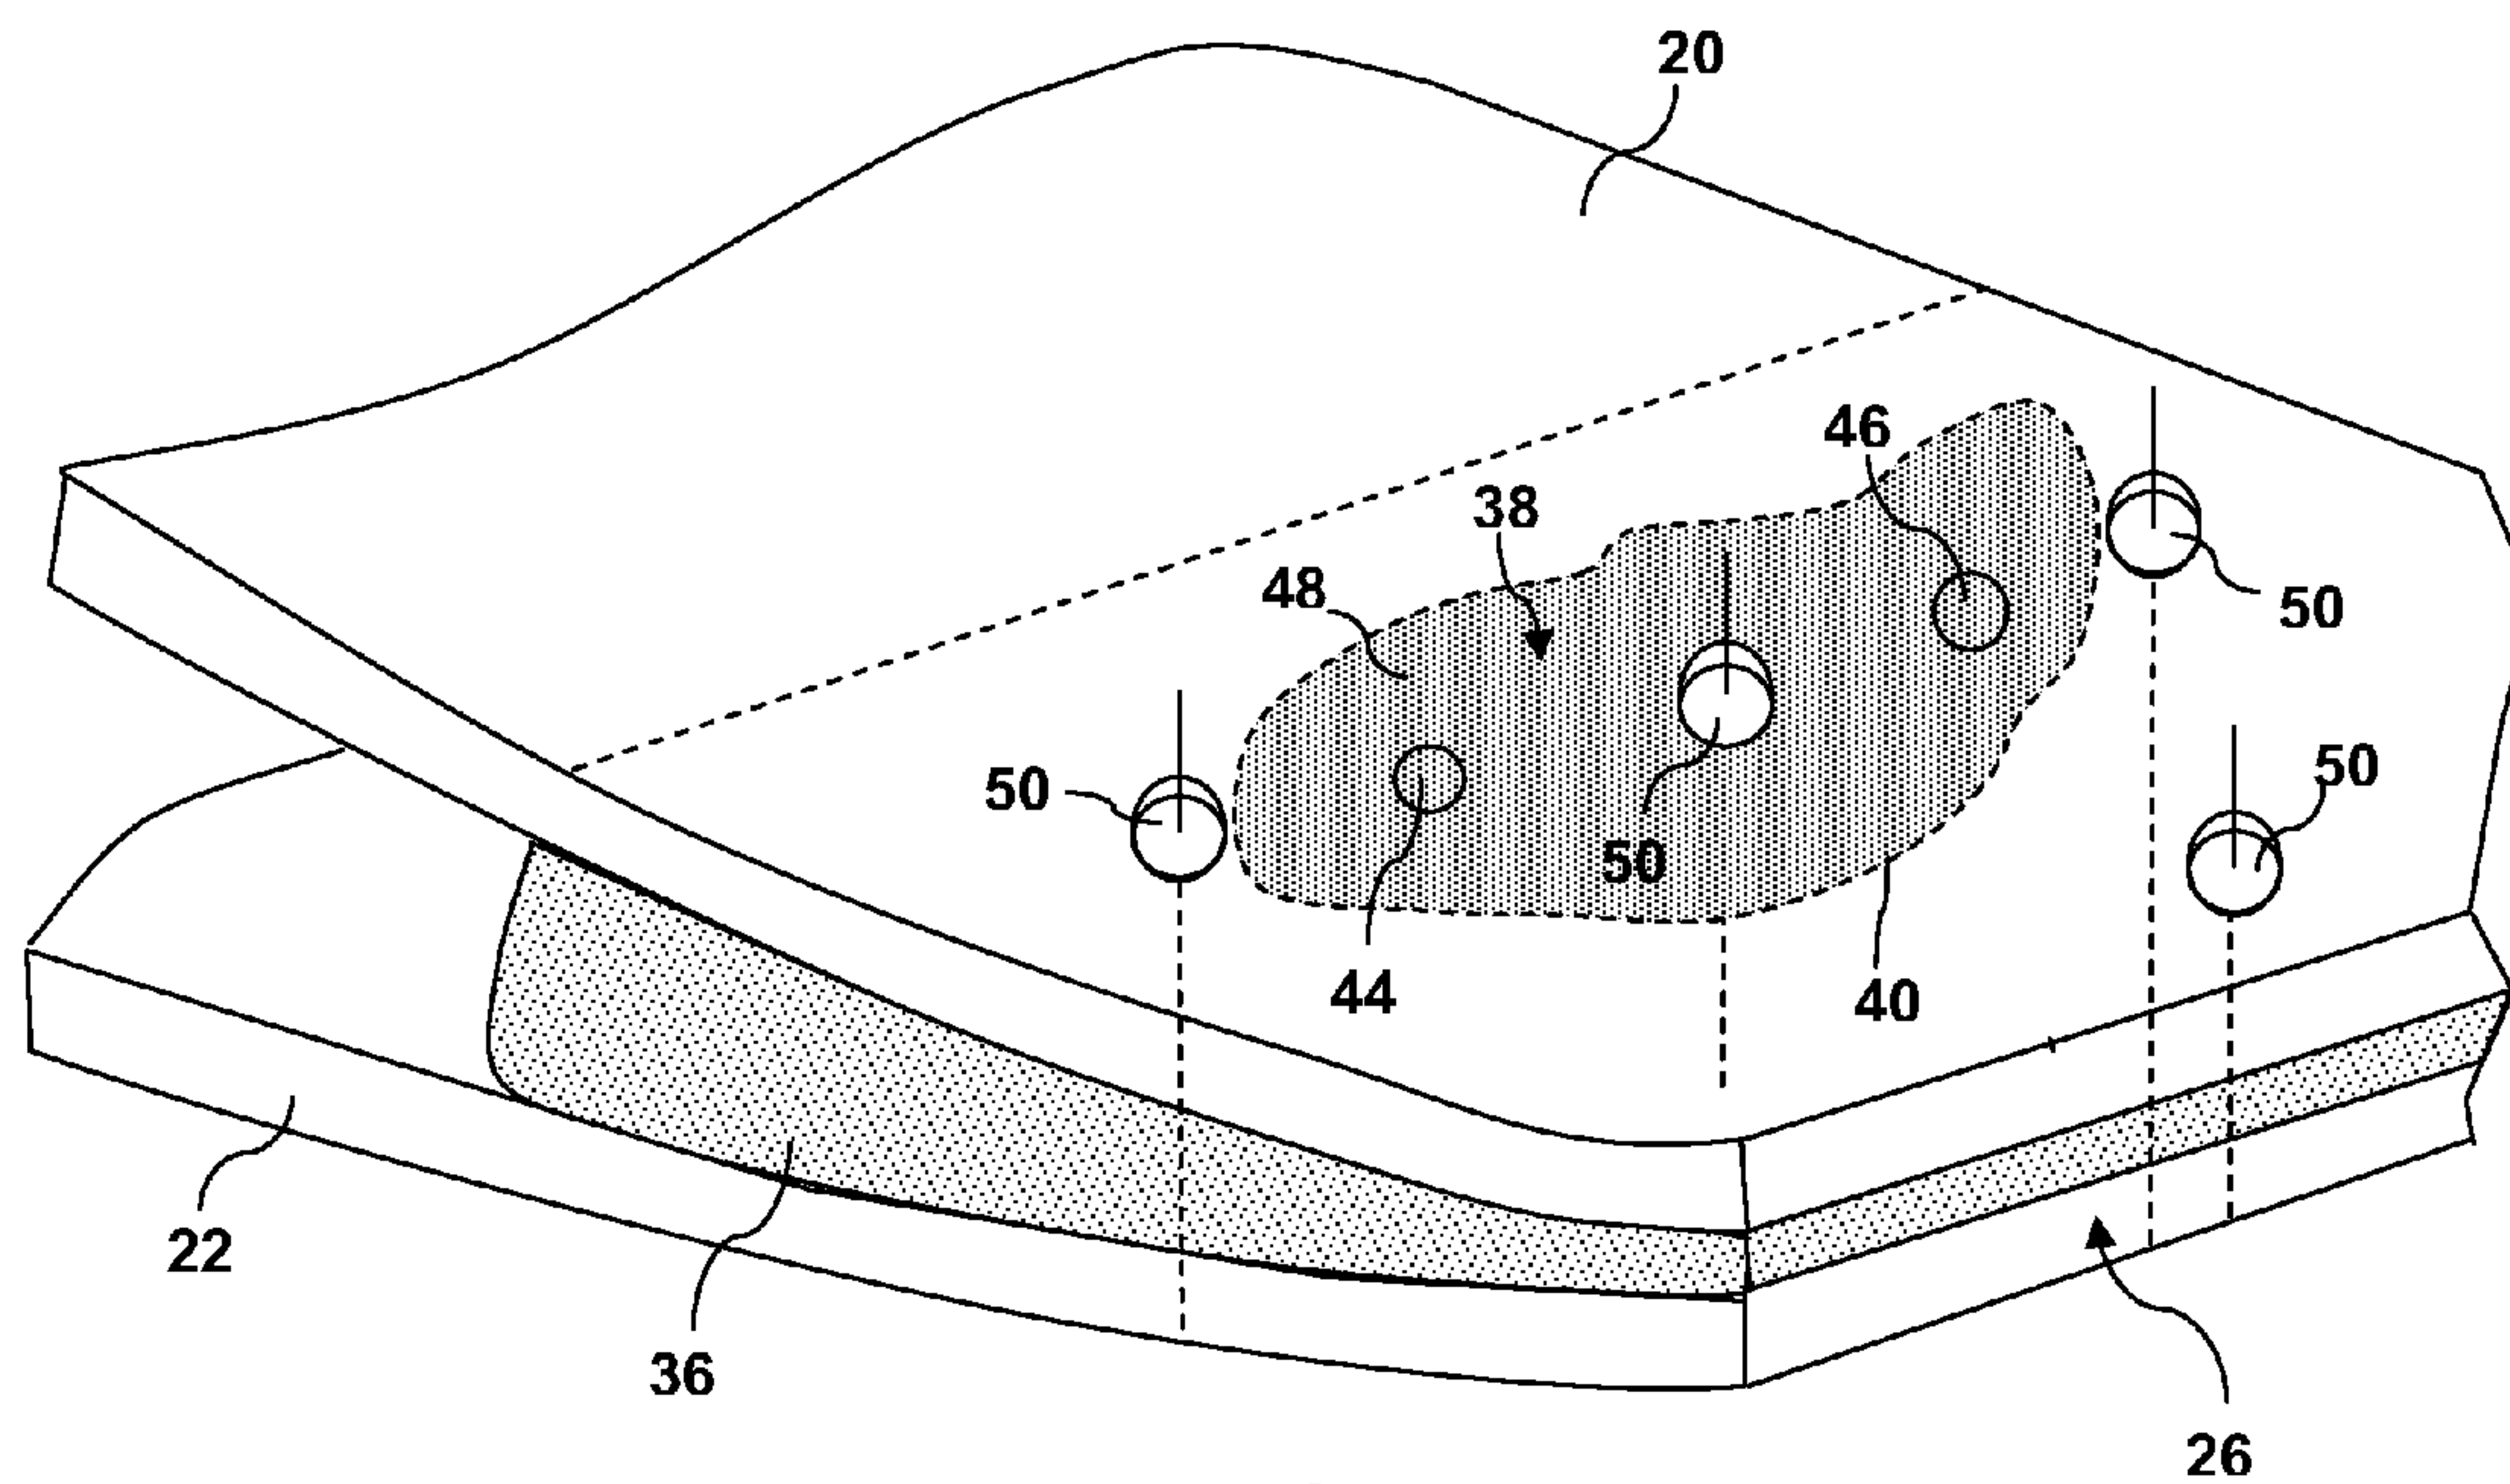
Fig. -5-

FIG. 5 is a view of a trailing edge section of FIG. 4 with holes defined therein for receipt of mechanical fasteners;

Referring to FIG. 5, the repair zone is reinforced with any number and configuration of mechanical fasteners 52 that generate a clamping load force on the laminate material in and around the repair zone as the bonding material 48 cures. A plurality of fastener holes 50 are defined through the laminate for receipt of the mechanical fasteners 52 (FIG. 6). These holes 50 may be spaced around the periphery of the defect boundary 40, as well as within the boundary 40. The number and pattern of the holes 50 and mechanical fasteners 52 will vary depending on the size, location, and other characteristics of the defect 38. In the embodiment depicted in FIGS. 5 and 6, three holes 50 are spaced around the boundary 40 and an additional hole 50 is defined through the defect 38 for the purpose of generating the clamping load on the repair zone around and within the defect 38. Referring to FIG. 6, in a desirable embodiment, the holes 50 include countersunk heads 60 defined in the shell members 20 and 22 for receipt of correspondingly shaped heads on the mechanical fasteners 52.

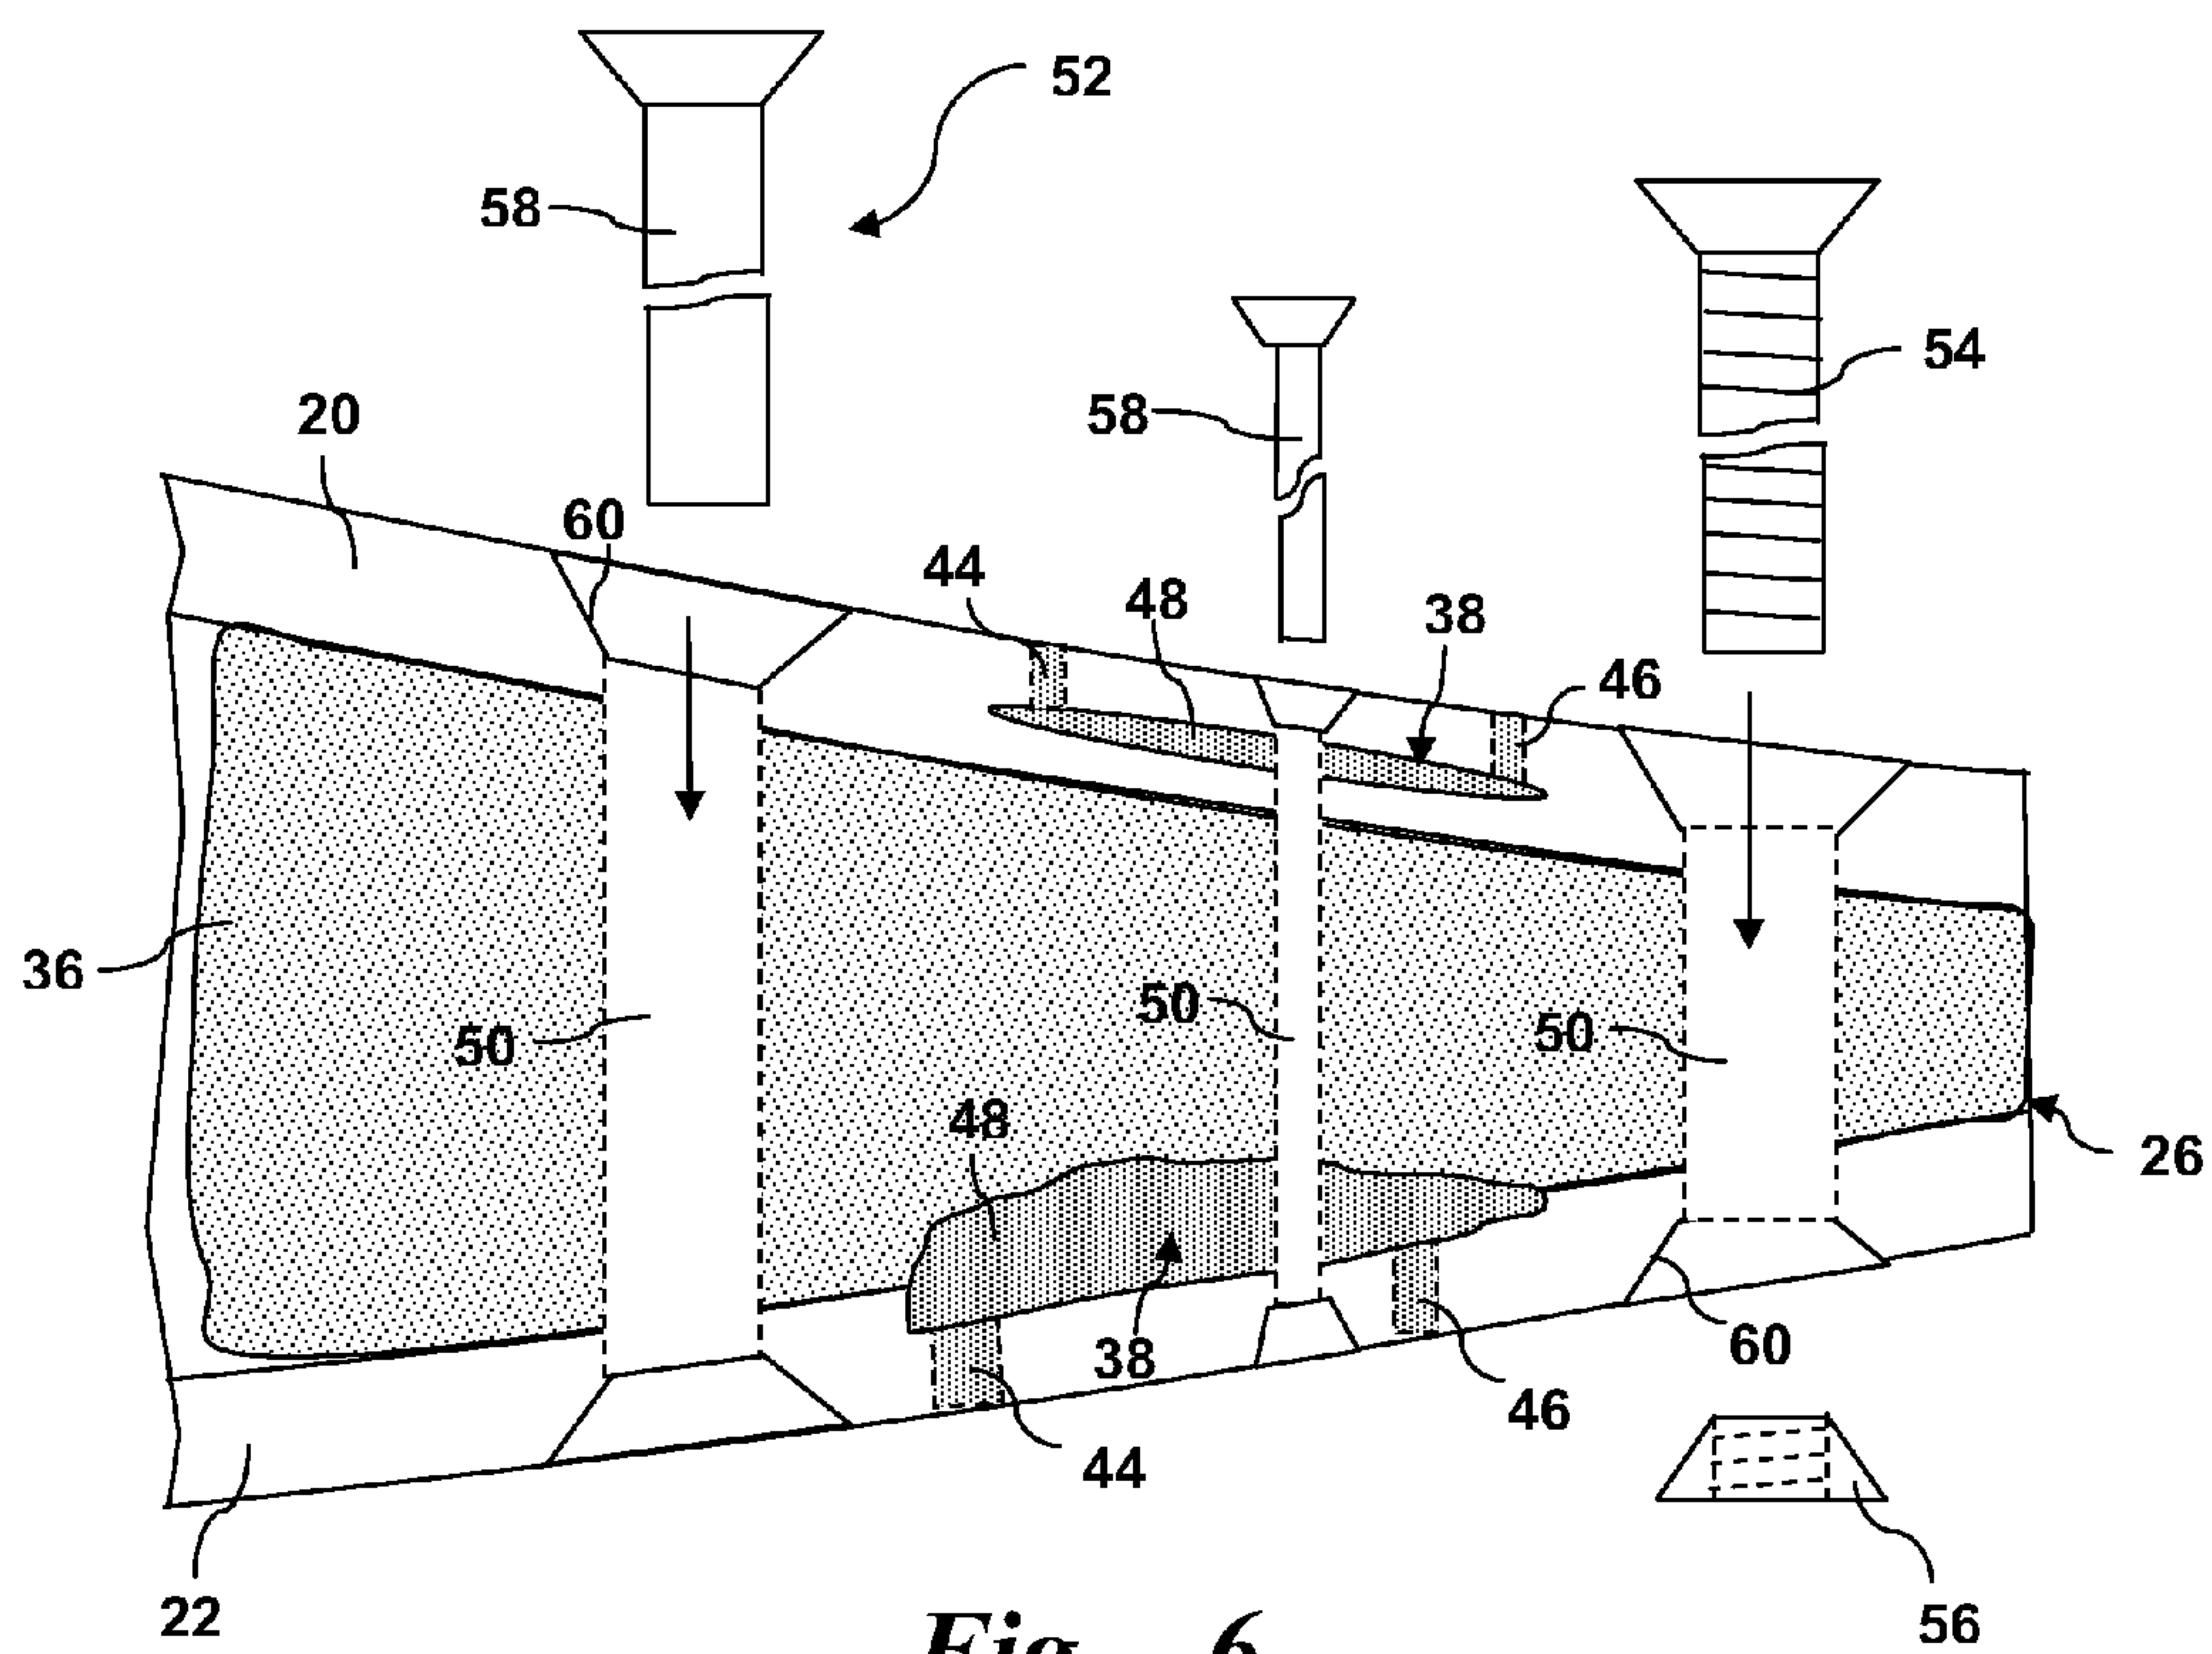
Fig. -6-

FIG. 6 is a cross-sectional view of a trailing edge particularly illustrating receipt of the mechanical fasteners in and around the repair zone; and,

de-lamination or void in the layers 42 that does not extend to the bond paste 36, as depicted by the defect 38 in the shell member 20 of FIG. 6. In still other instances, the defect 38 may be a void or de-lamination in the shell member that extends into the bond paste 36, as depicted by the defect 38 in the shell member 22 of FIG. 6. It should be appreciated that the present invention is not limited to repair of any particular type of defect in the blade materials.

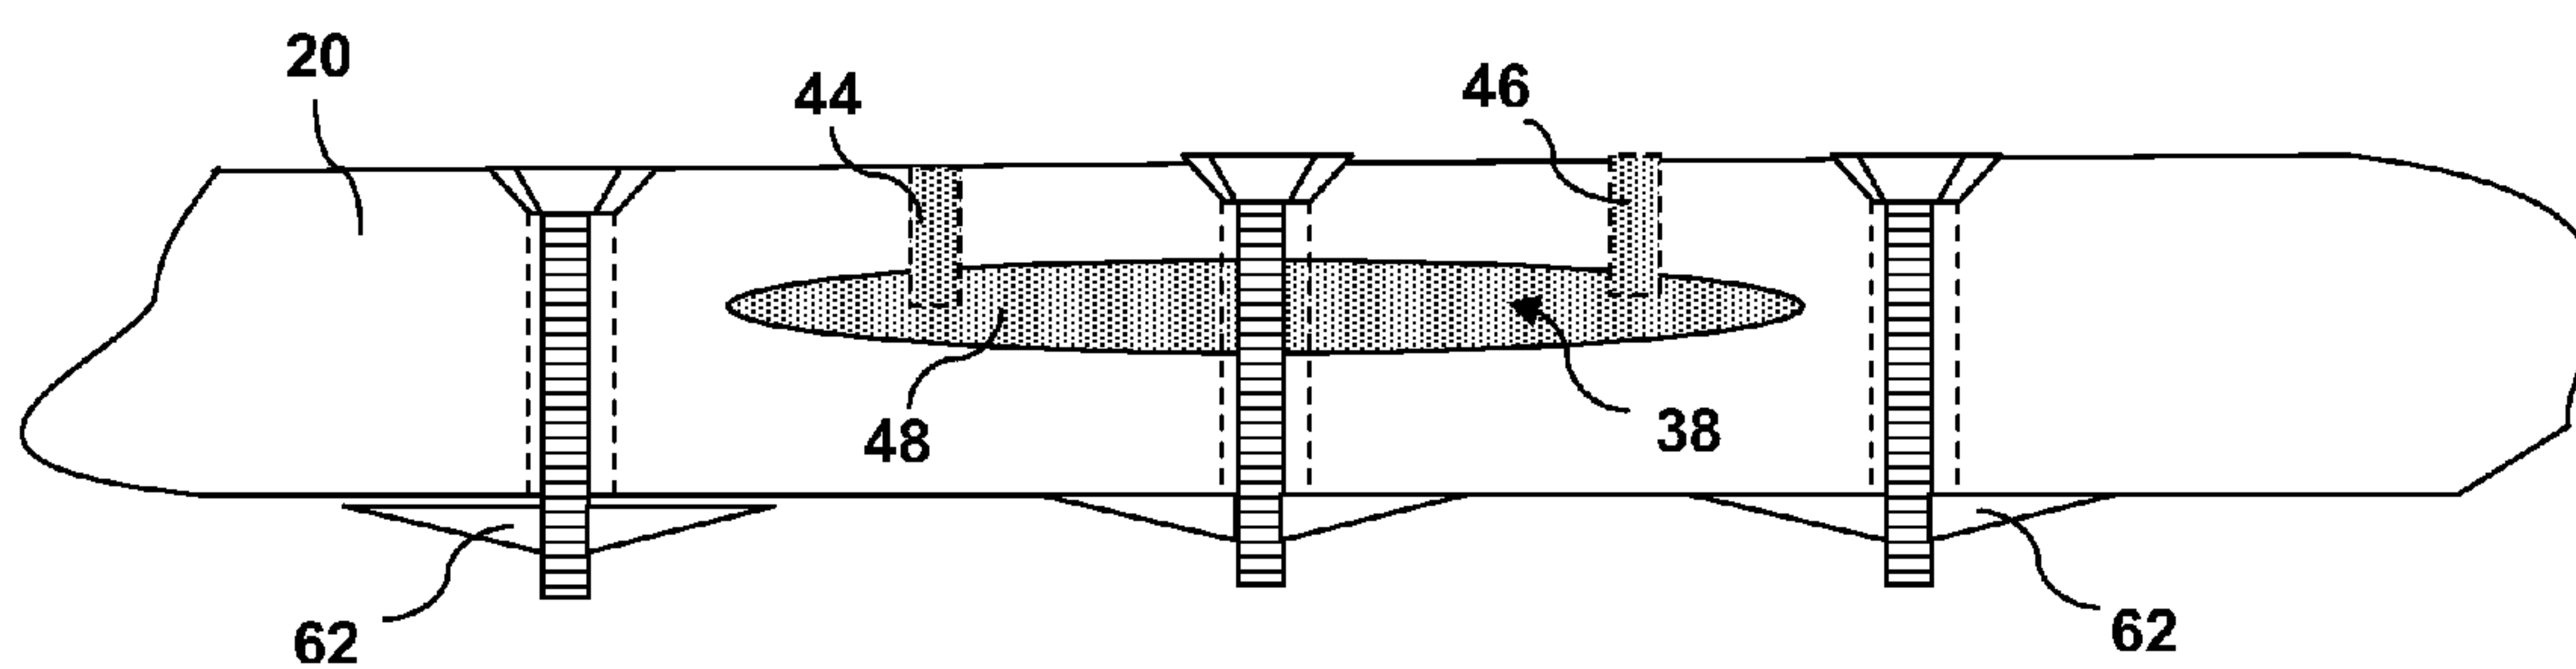
Fig. -7-

FIG. 7 is a cross-sectional view of a repair area where access to the opposite side is not readily available.
