(12) **United States Patent**
Deak et al.

(10) **Patent No.:** **US 8,091,229 B2**
(45) **Date of Patent:** **Jan. 10, 2012**

(54) **METHOD OF REPAIRING A SUBSURFACE VOID OR DAMAGE FOR A WIND TURBINE BLADE**

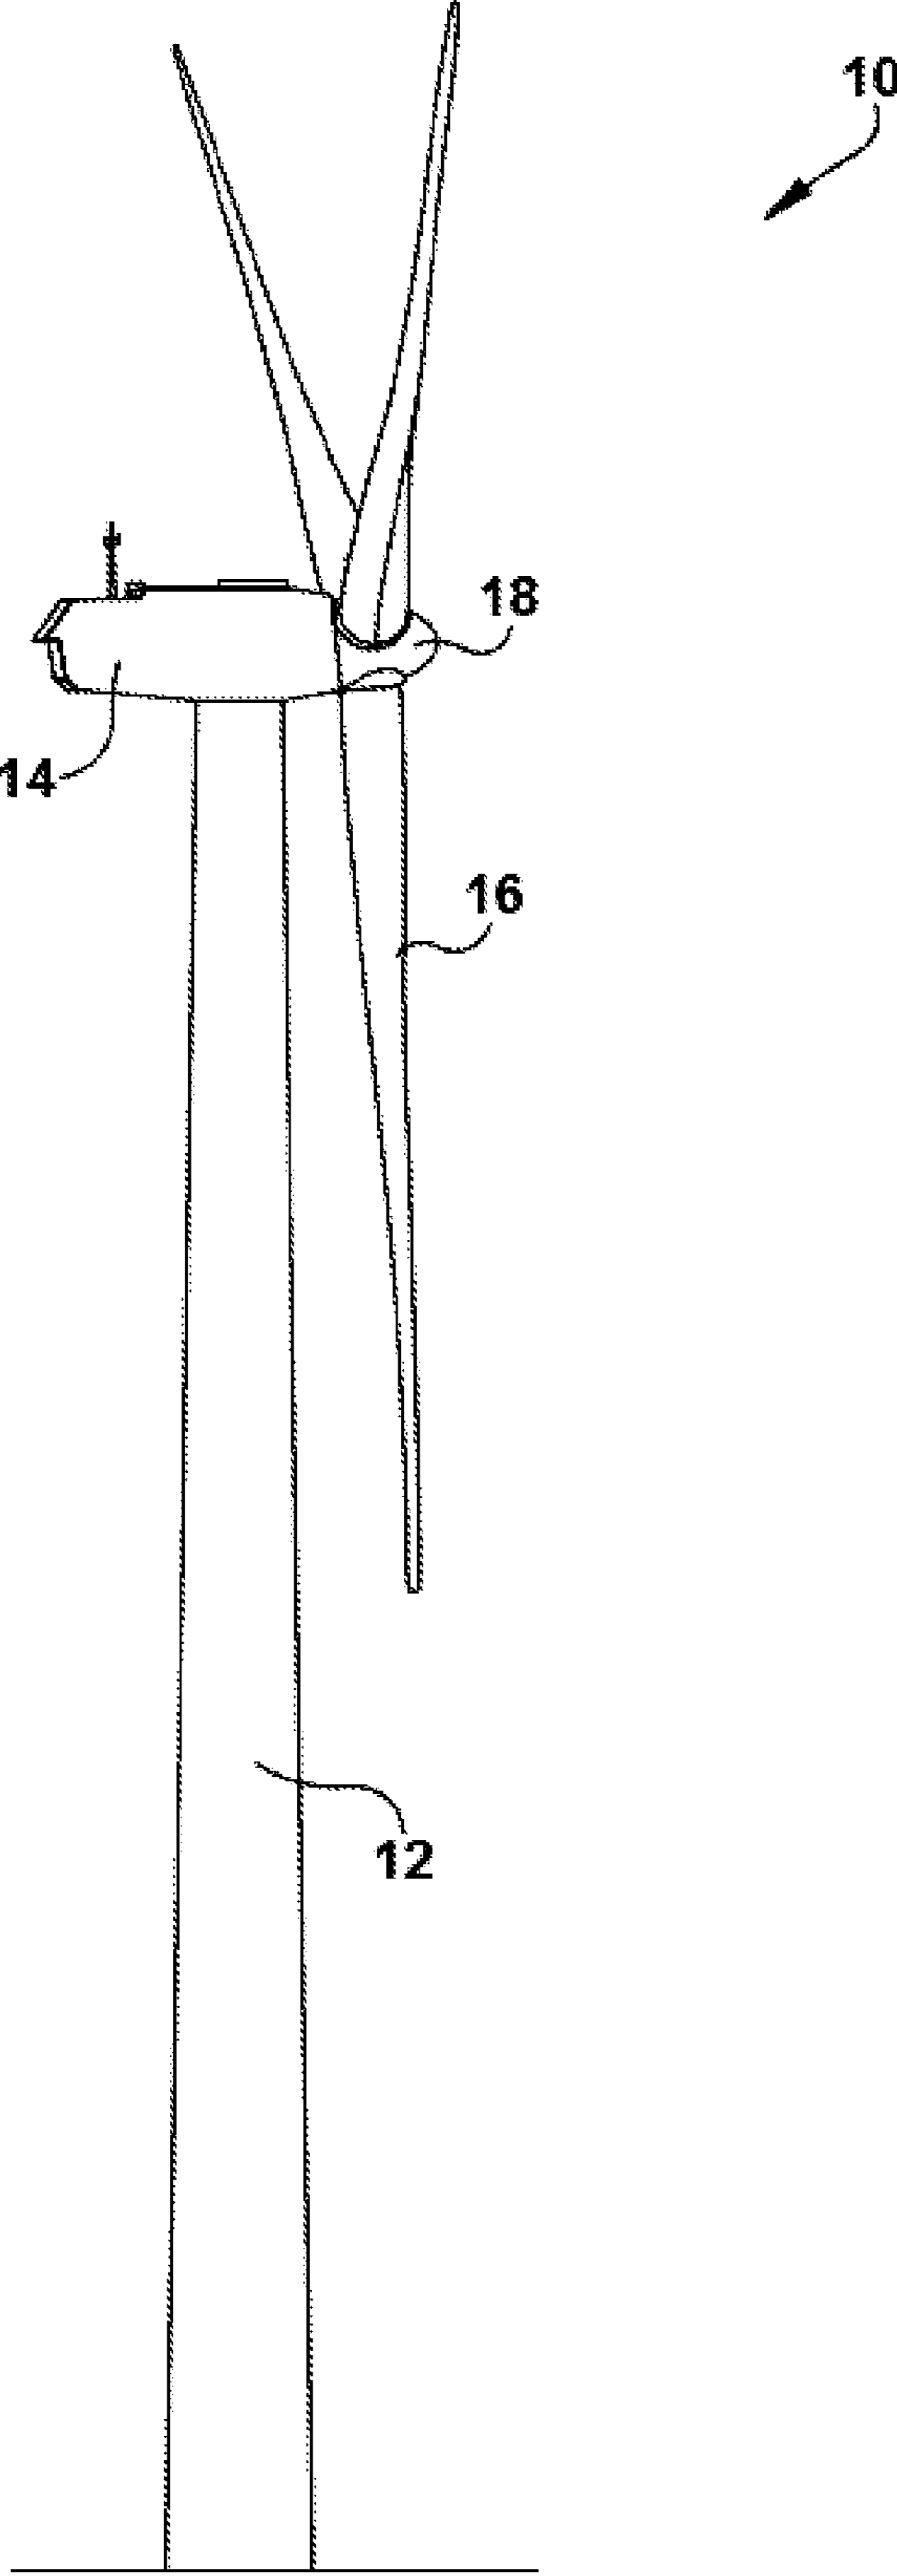
Fig. -1-

FIG. 1 is a perspective view of a conventional wind turbine;

FIG. 1 illustrates a wind turbine 10 of conventional construction. The wind turbine 10 includes a tower 12 with a nacelle 14 mounted thereon. A plurality of turbine blades 16 are mounted to a rotor hub 18, which is in turn connected to a main flange that turns a main rotor shaft. The wind turbine power generation and control components are housed within the nacelle 14. The view of FIG. 1 is provided for illustrative purposes only to place the present invention in an exemplary field of use. It should be appreciated that the invention is not limited to any particular type of wind turbine configuration.

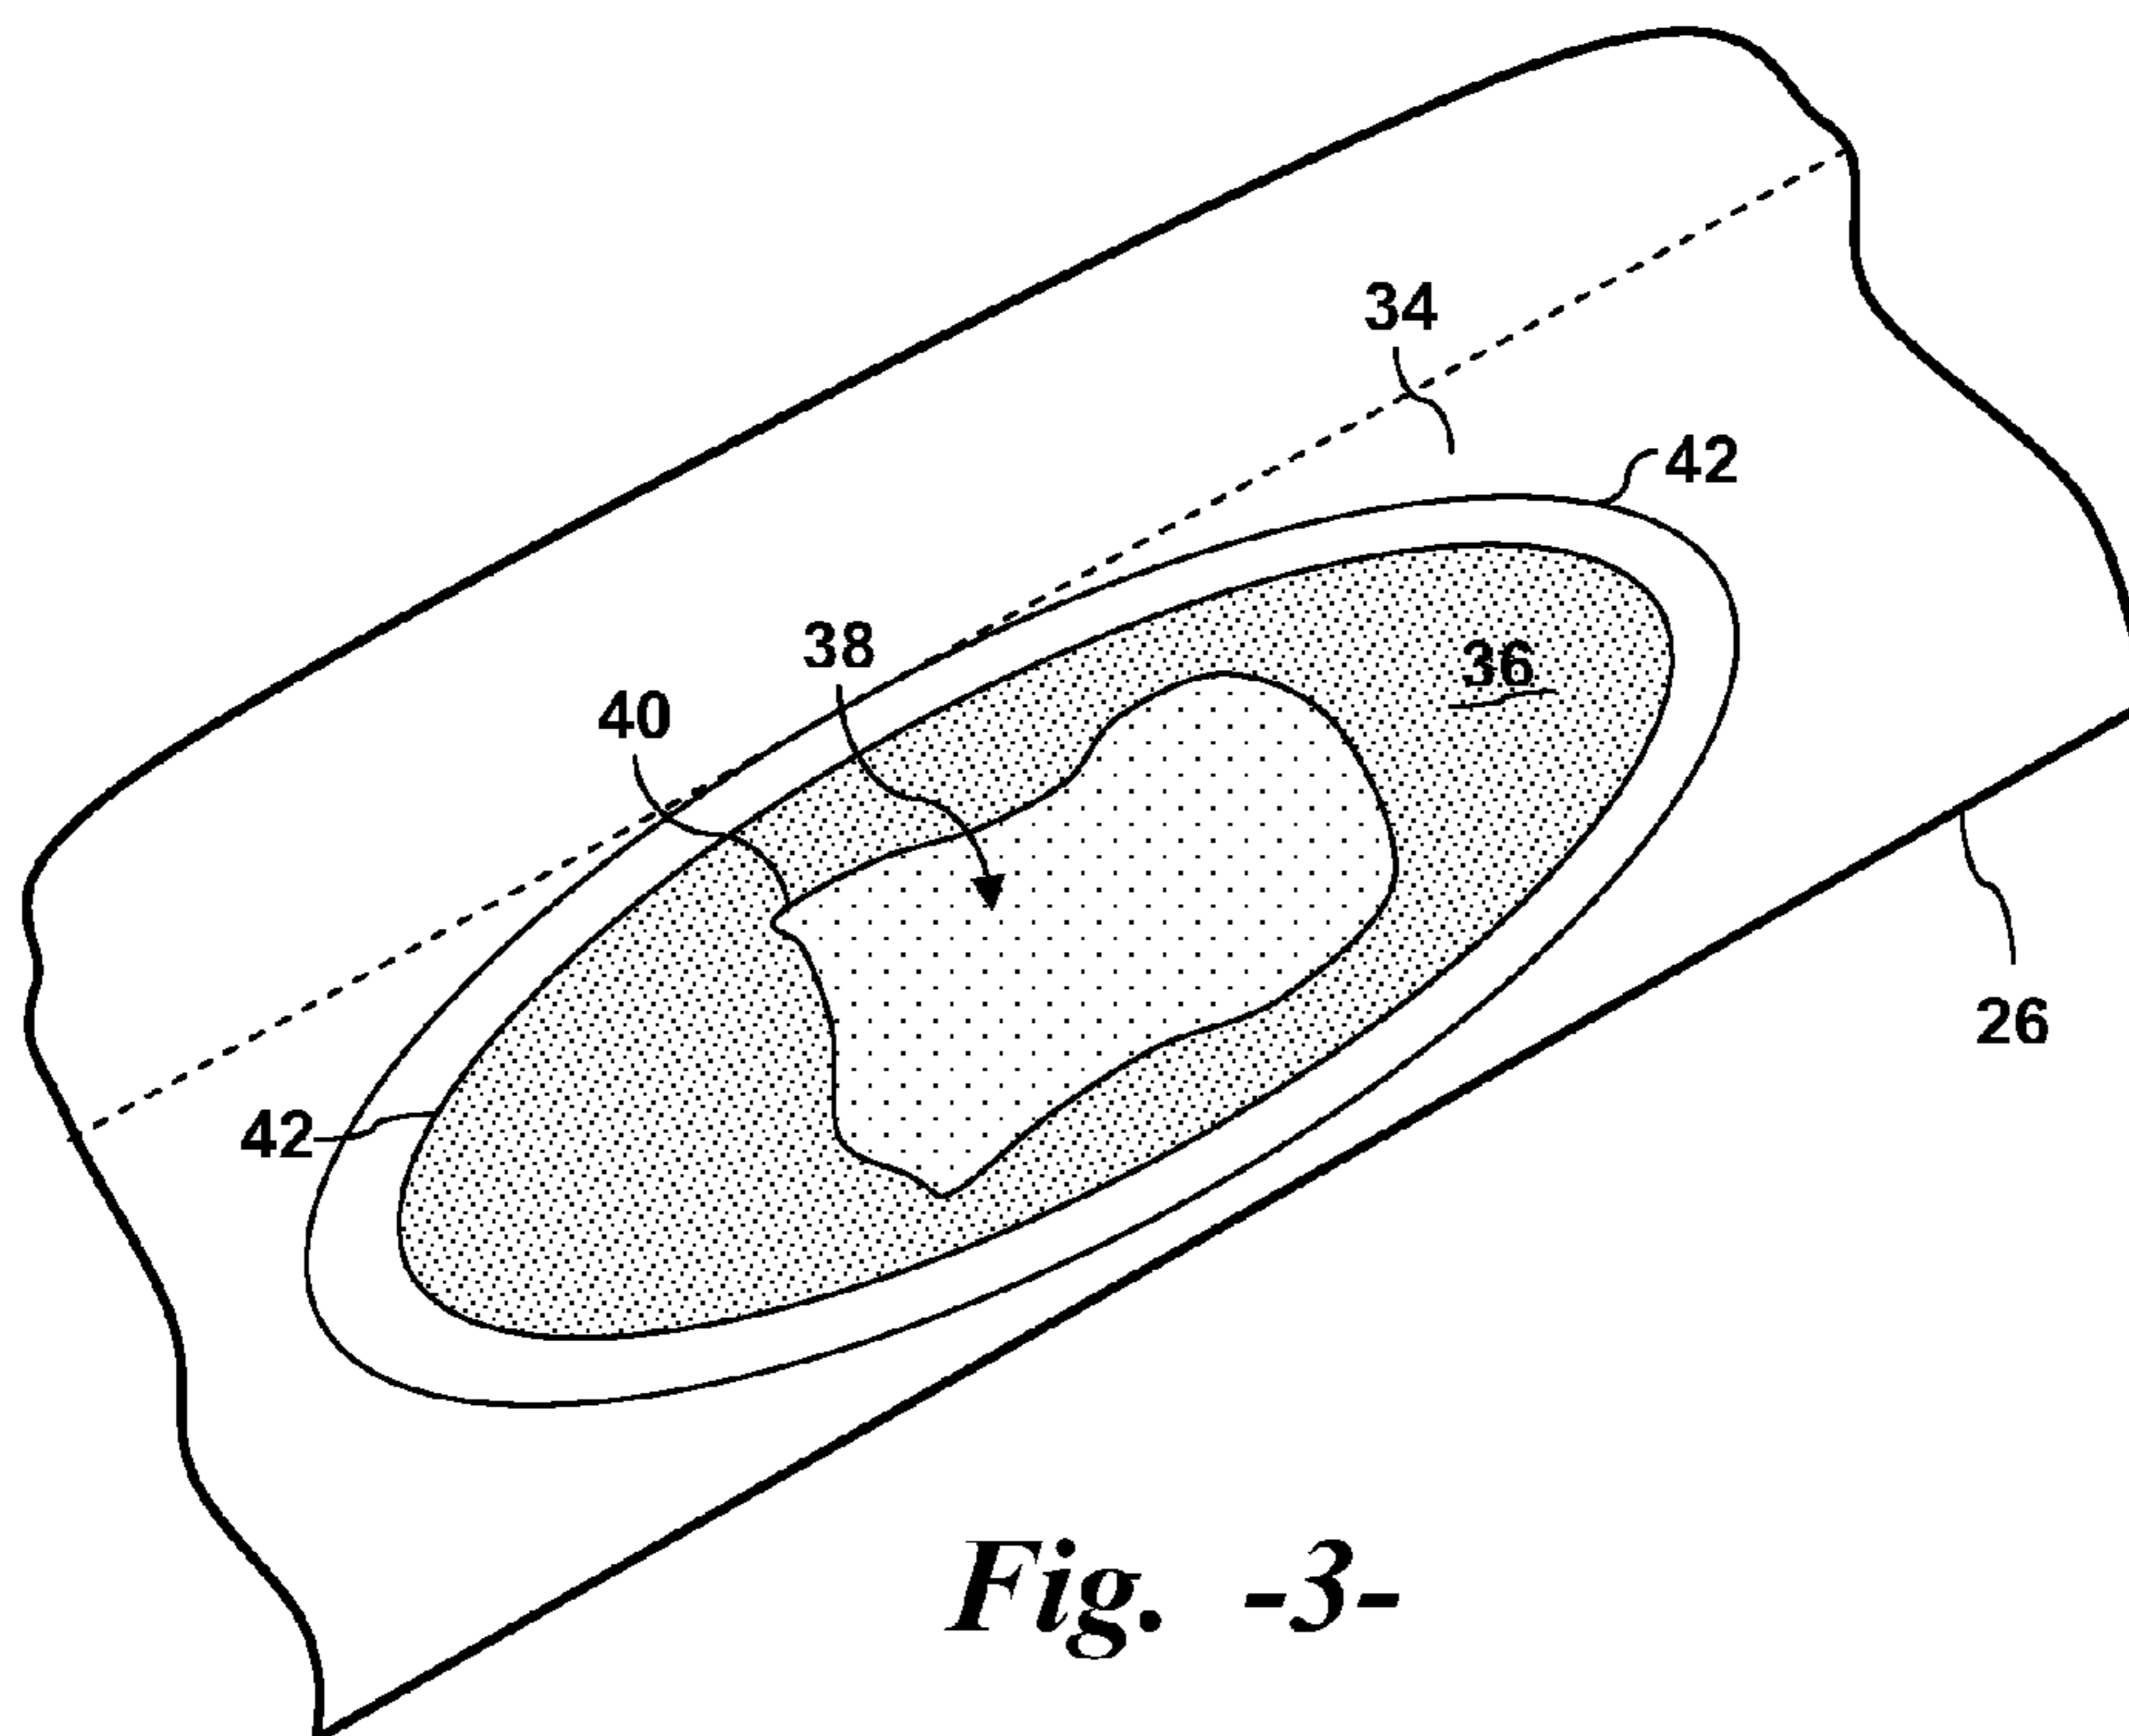
Fig. -3-

FIG. 3 is a view of a section of a trailing edge of a wind turbine blade with laminate layers removed to reveal a subsurface defect;

FIG. 3 is an enlarged view of a section of the trailing edge 26 that encompasses one of the defects 38. Layers 42 of the upper shell member 20 have been removed in the illustration in order to depict the subsurface defect 38 having a boundary 40. The defect 38 may be a void in the bond paste 36, which may extend completely through the laminate to the opposite shell member 22. In other instances the defect 38 may be a

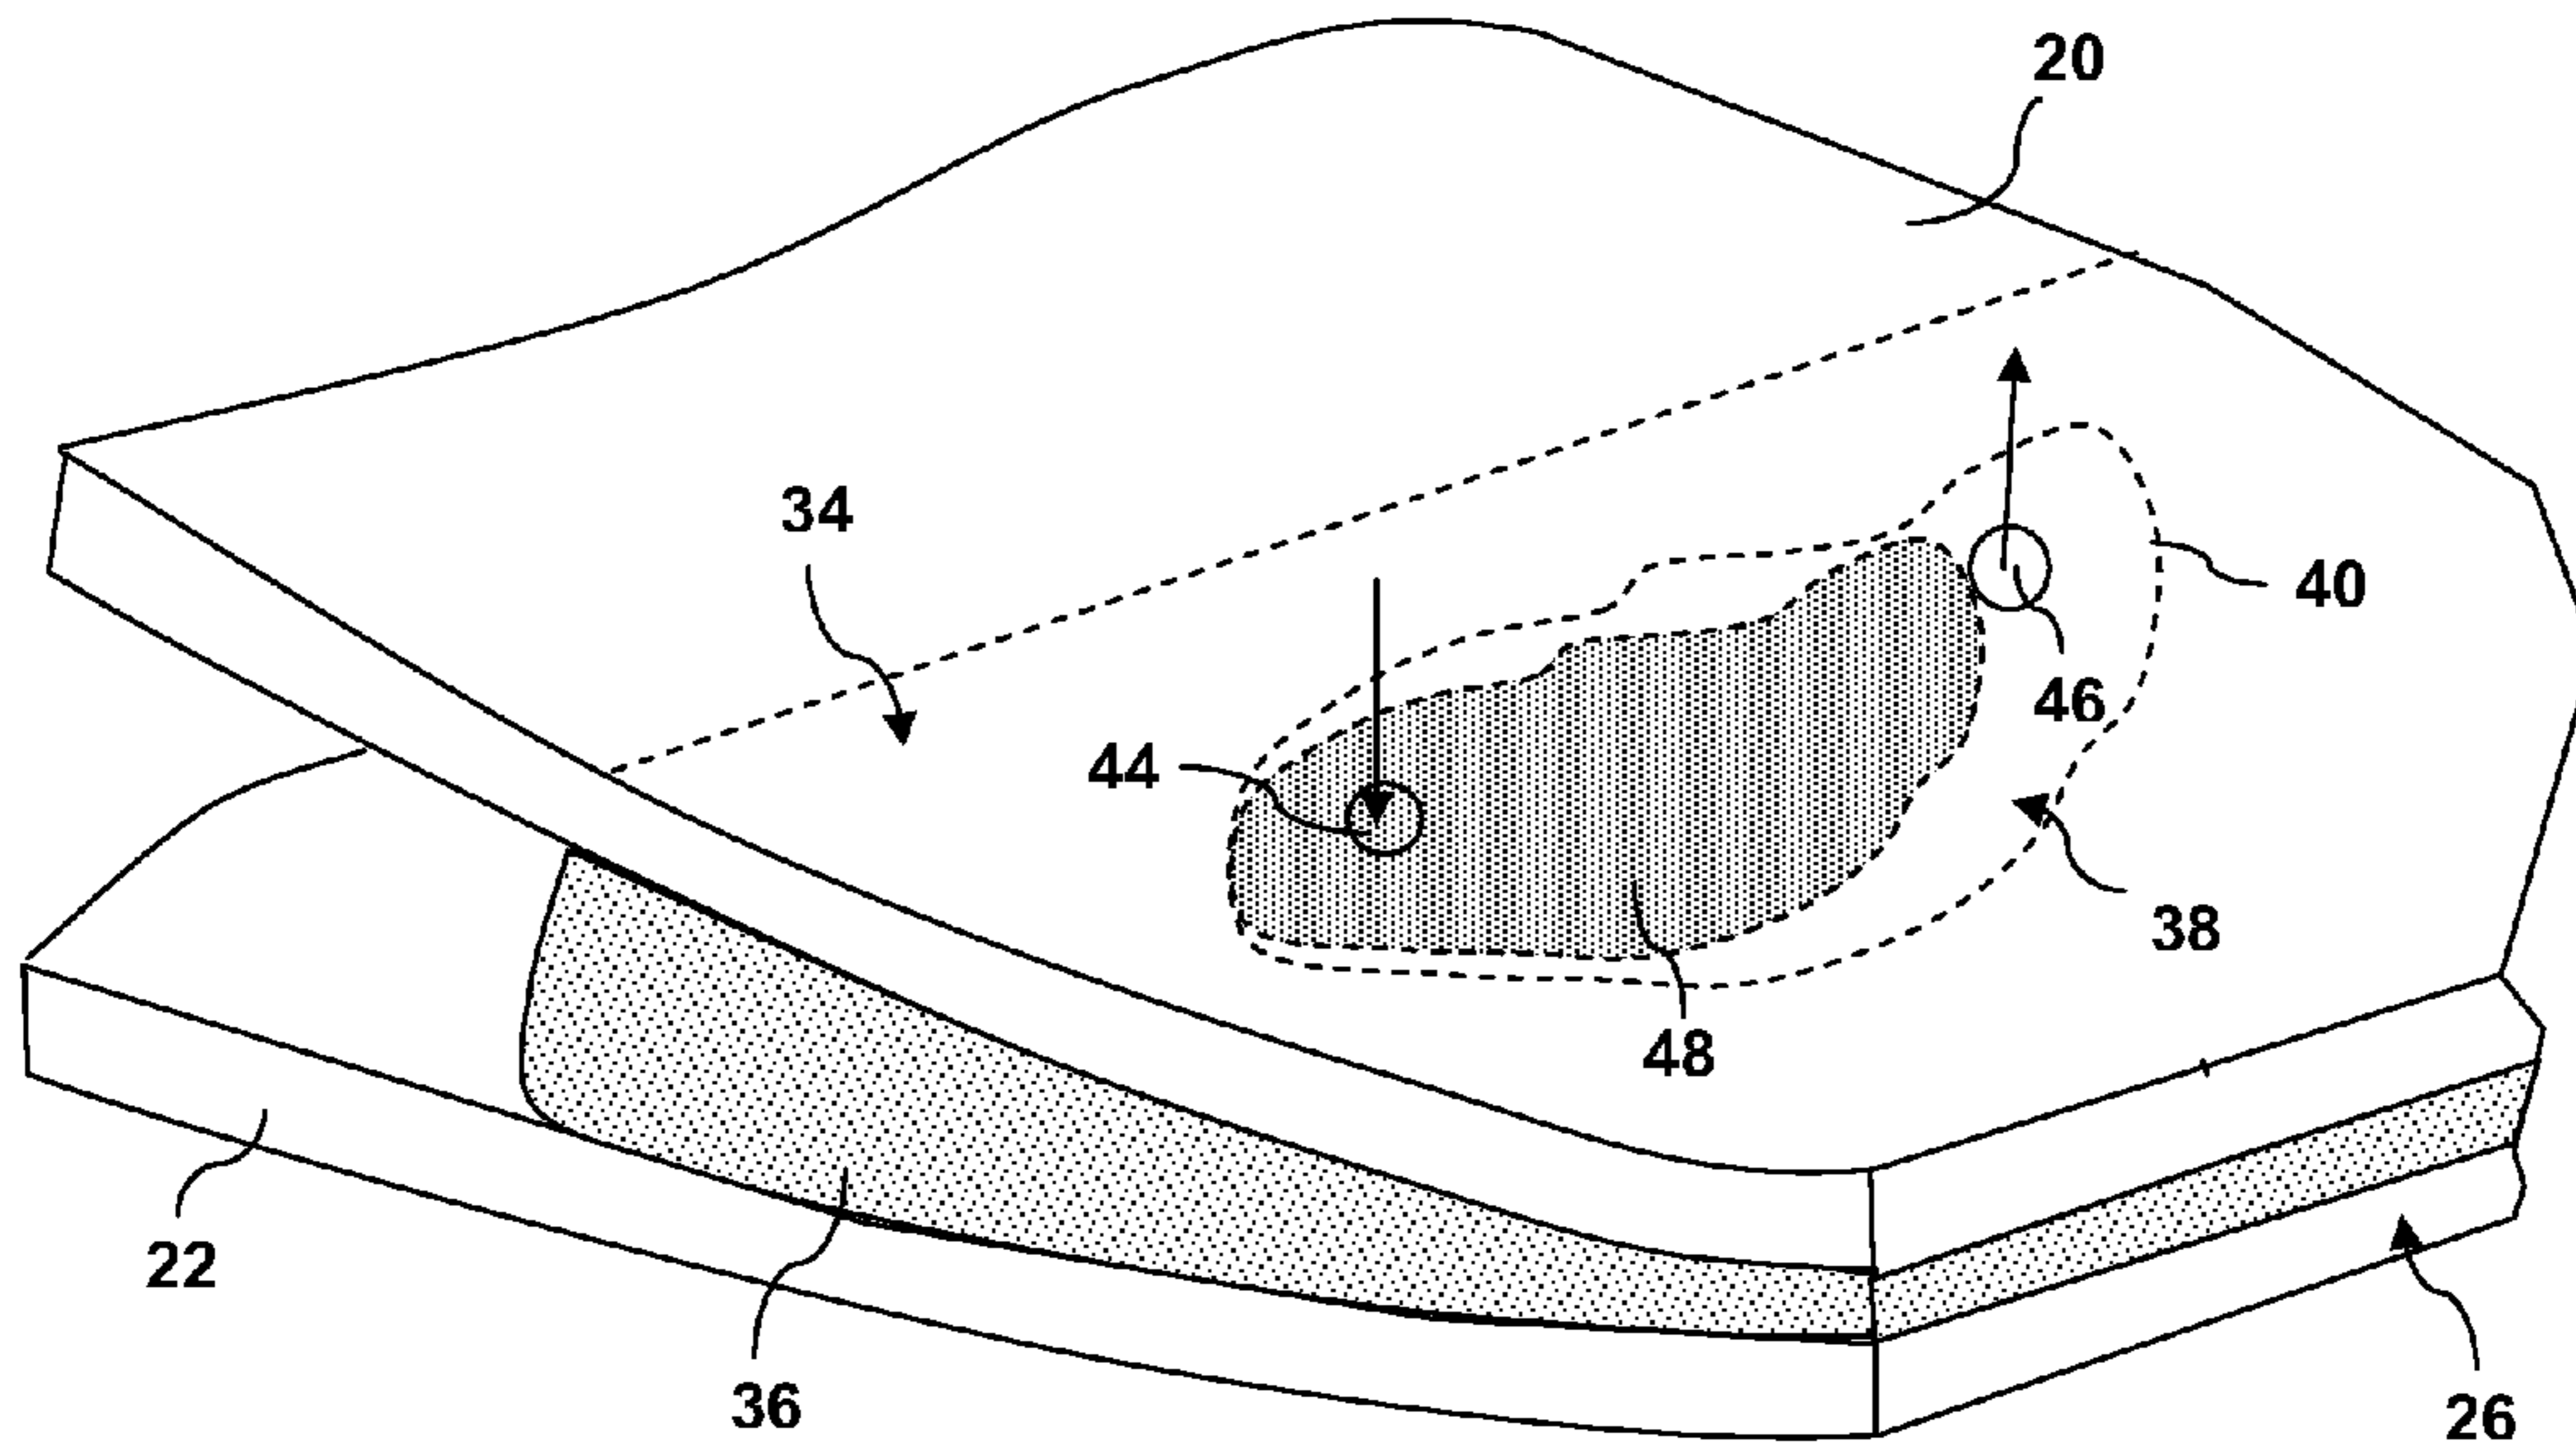
Fig. -4-

FIG. 4 is a cross-sectional perspective view of the trailing edge of a wind turbine blade with a fill hole and a vent hole defined therein in accordance with aspects of the repair procedure of the invention;

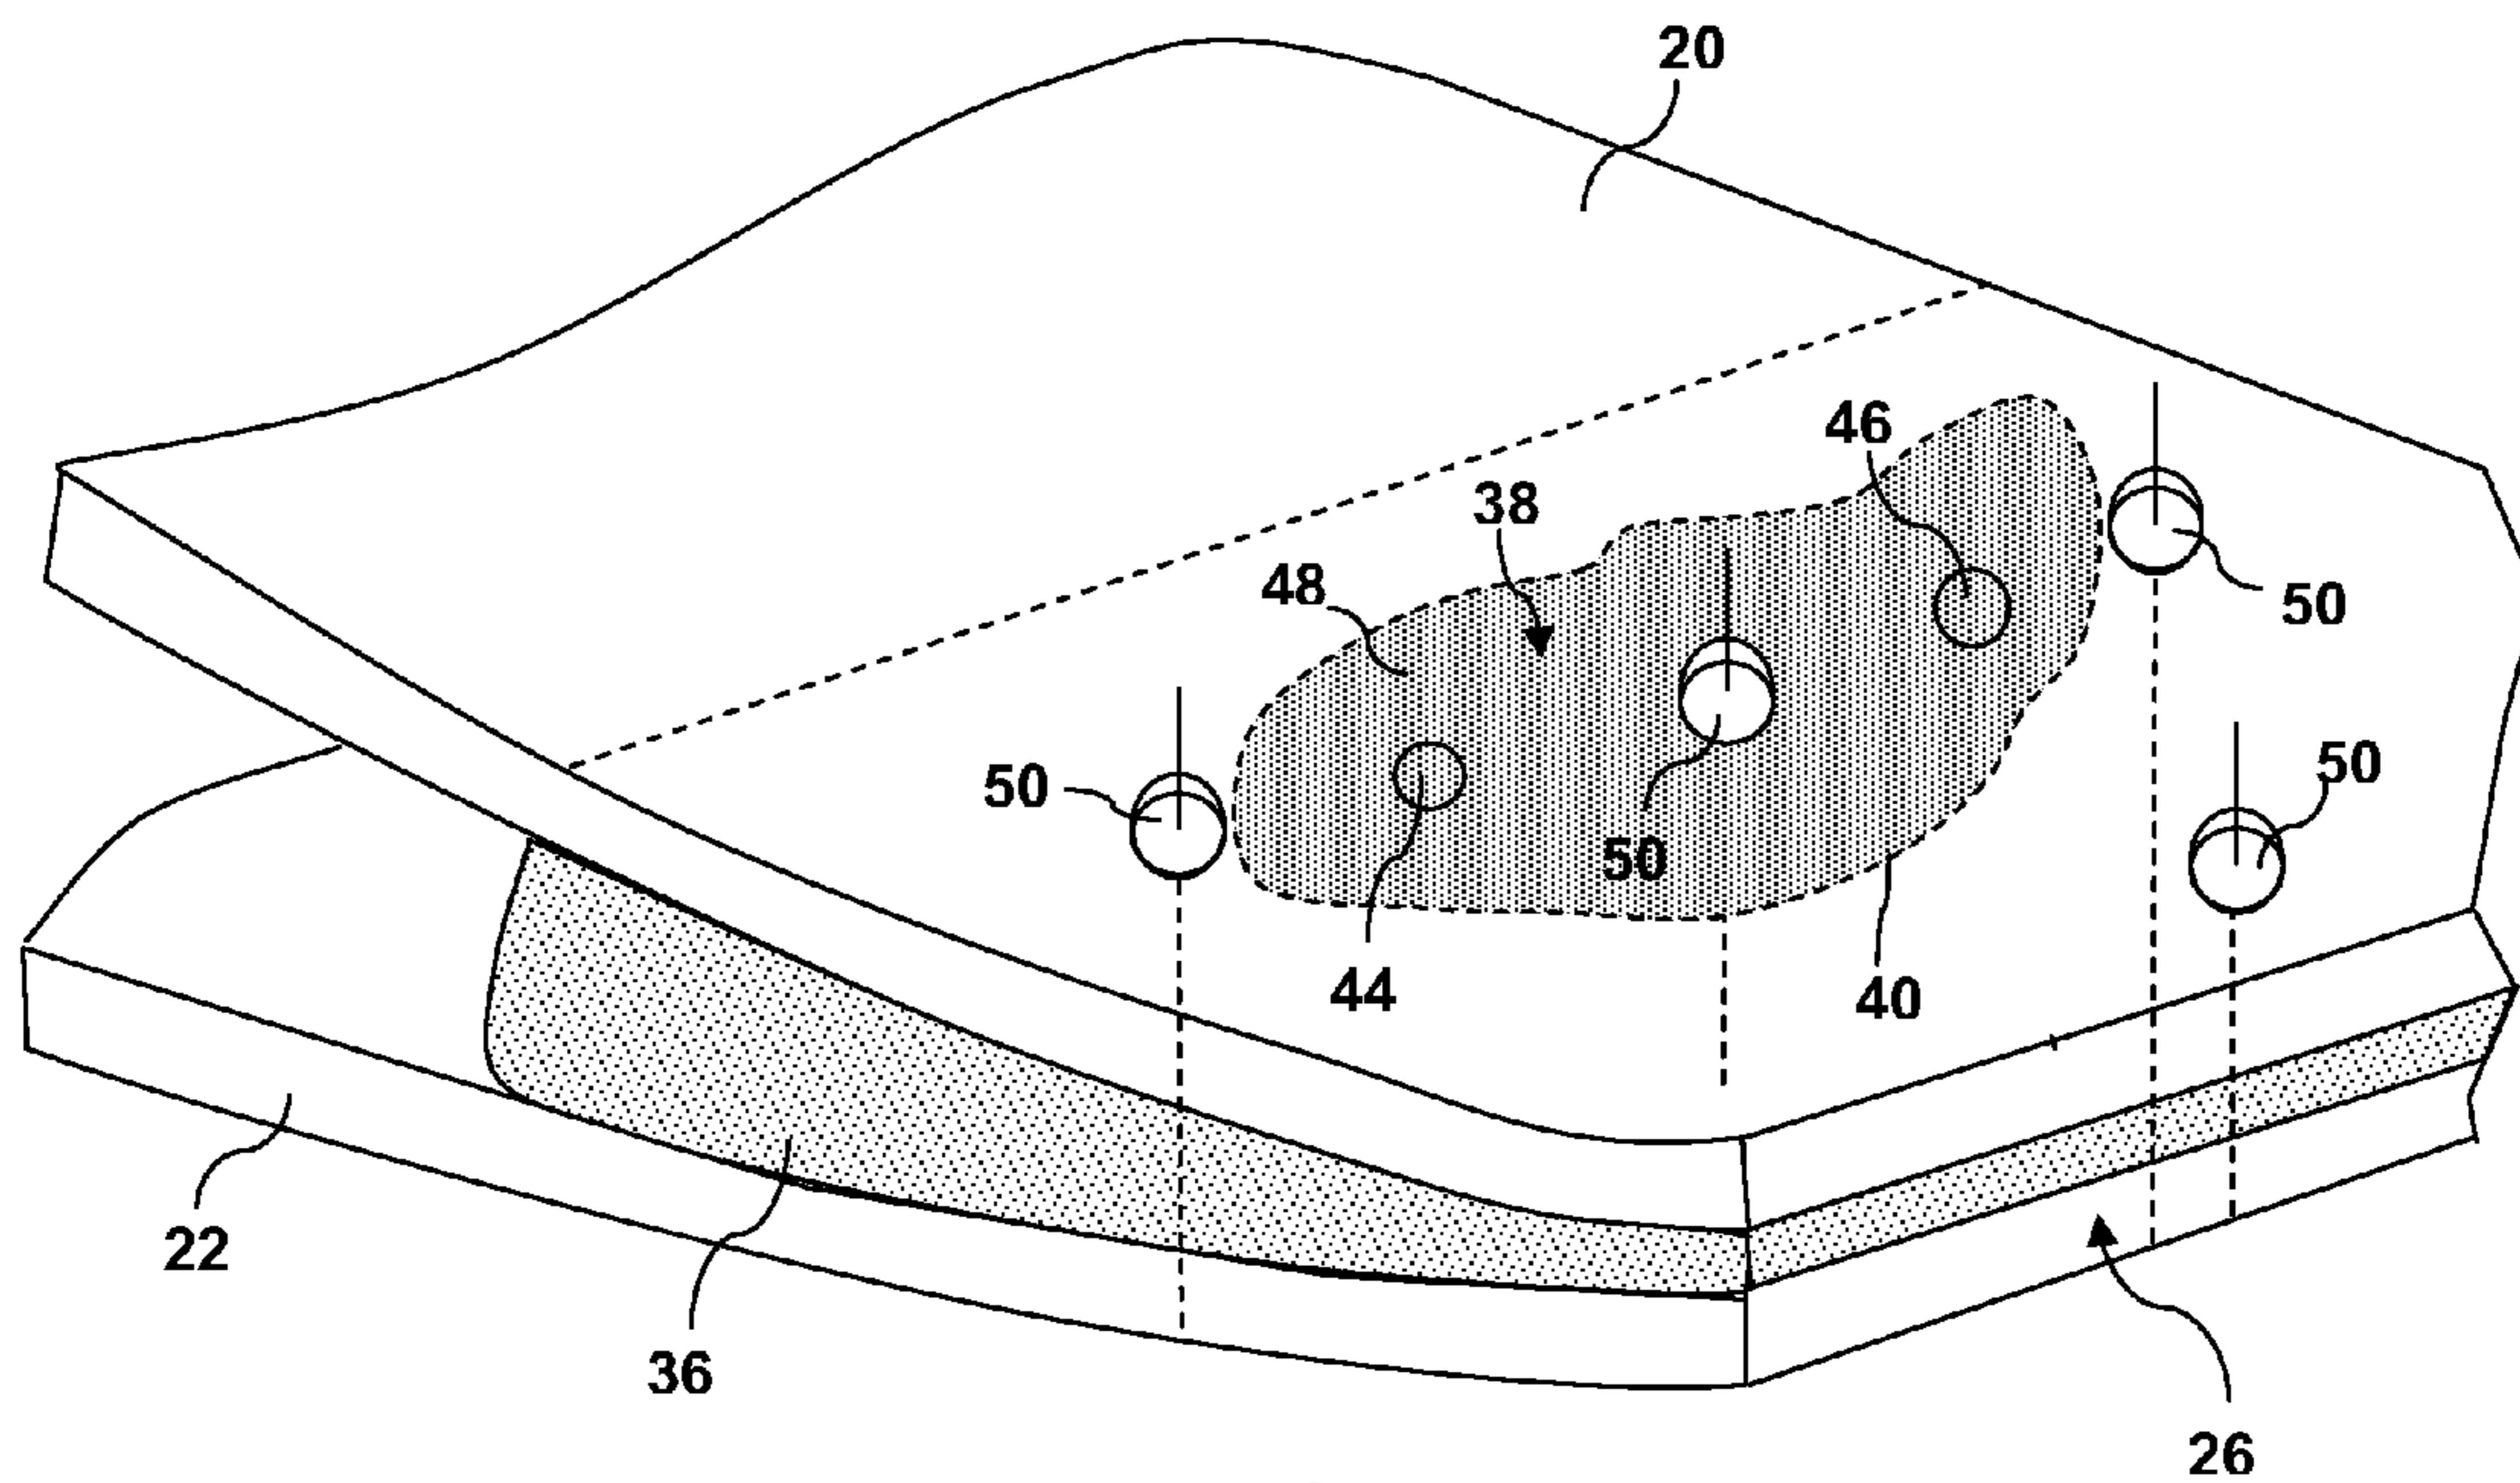
Fig. -5-

FIG. 5 is a view of a trailing edge section of FIG. 4 with holes defined therein for receipt of mechanical fasteners;

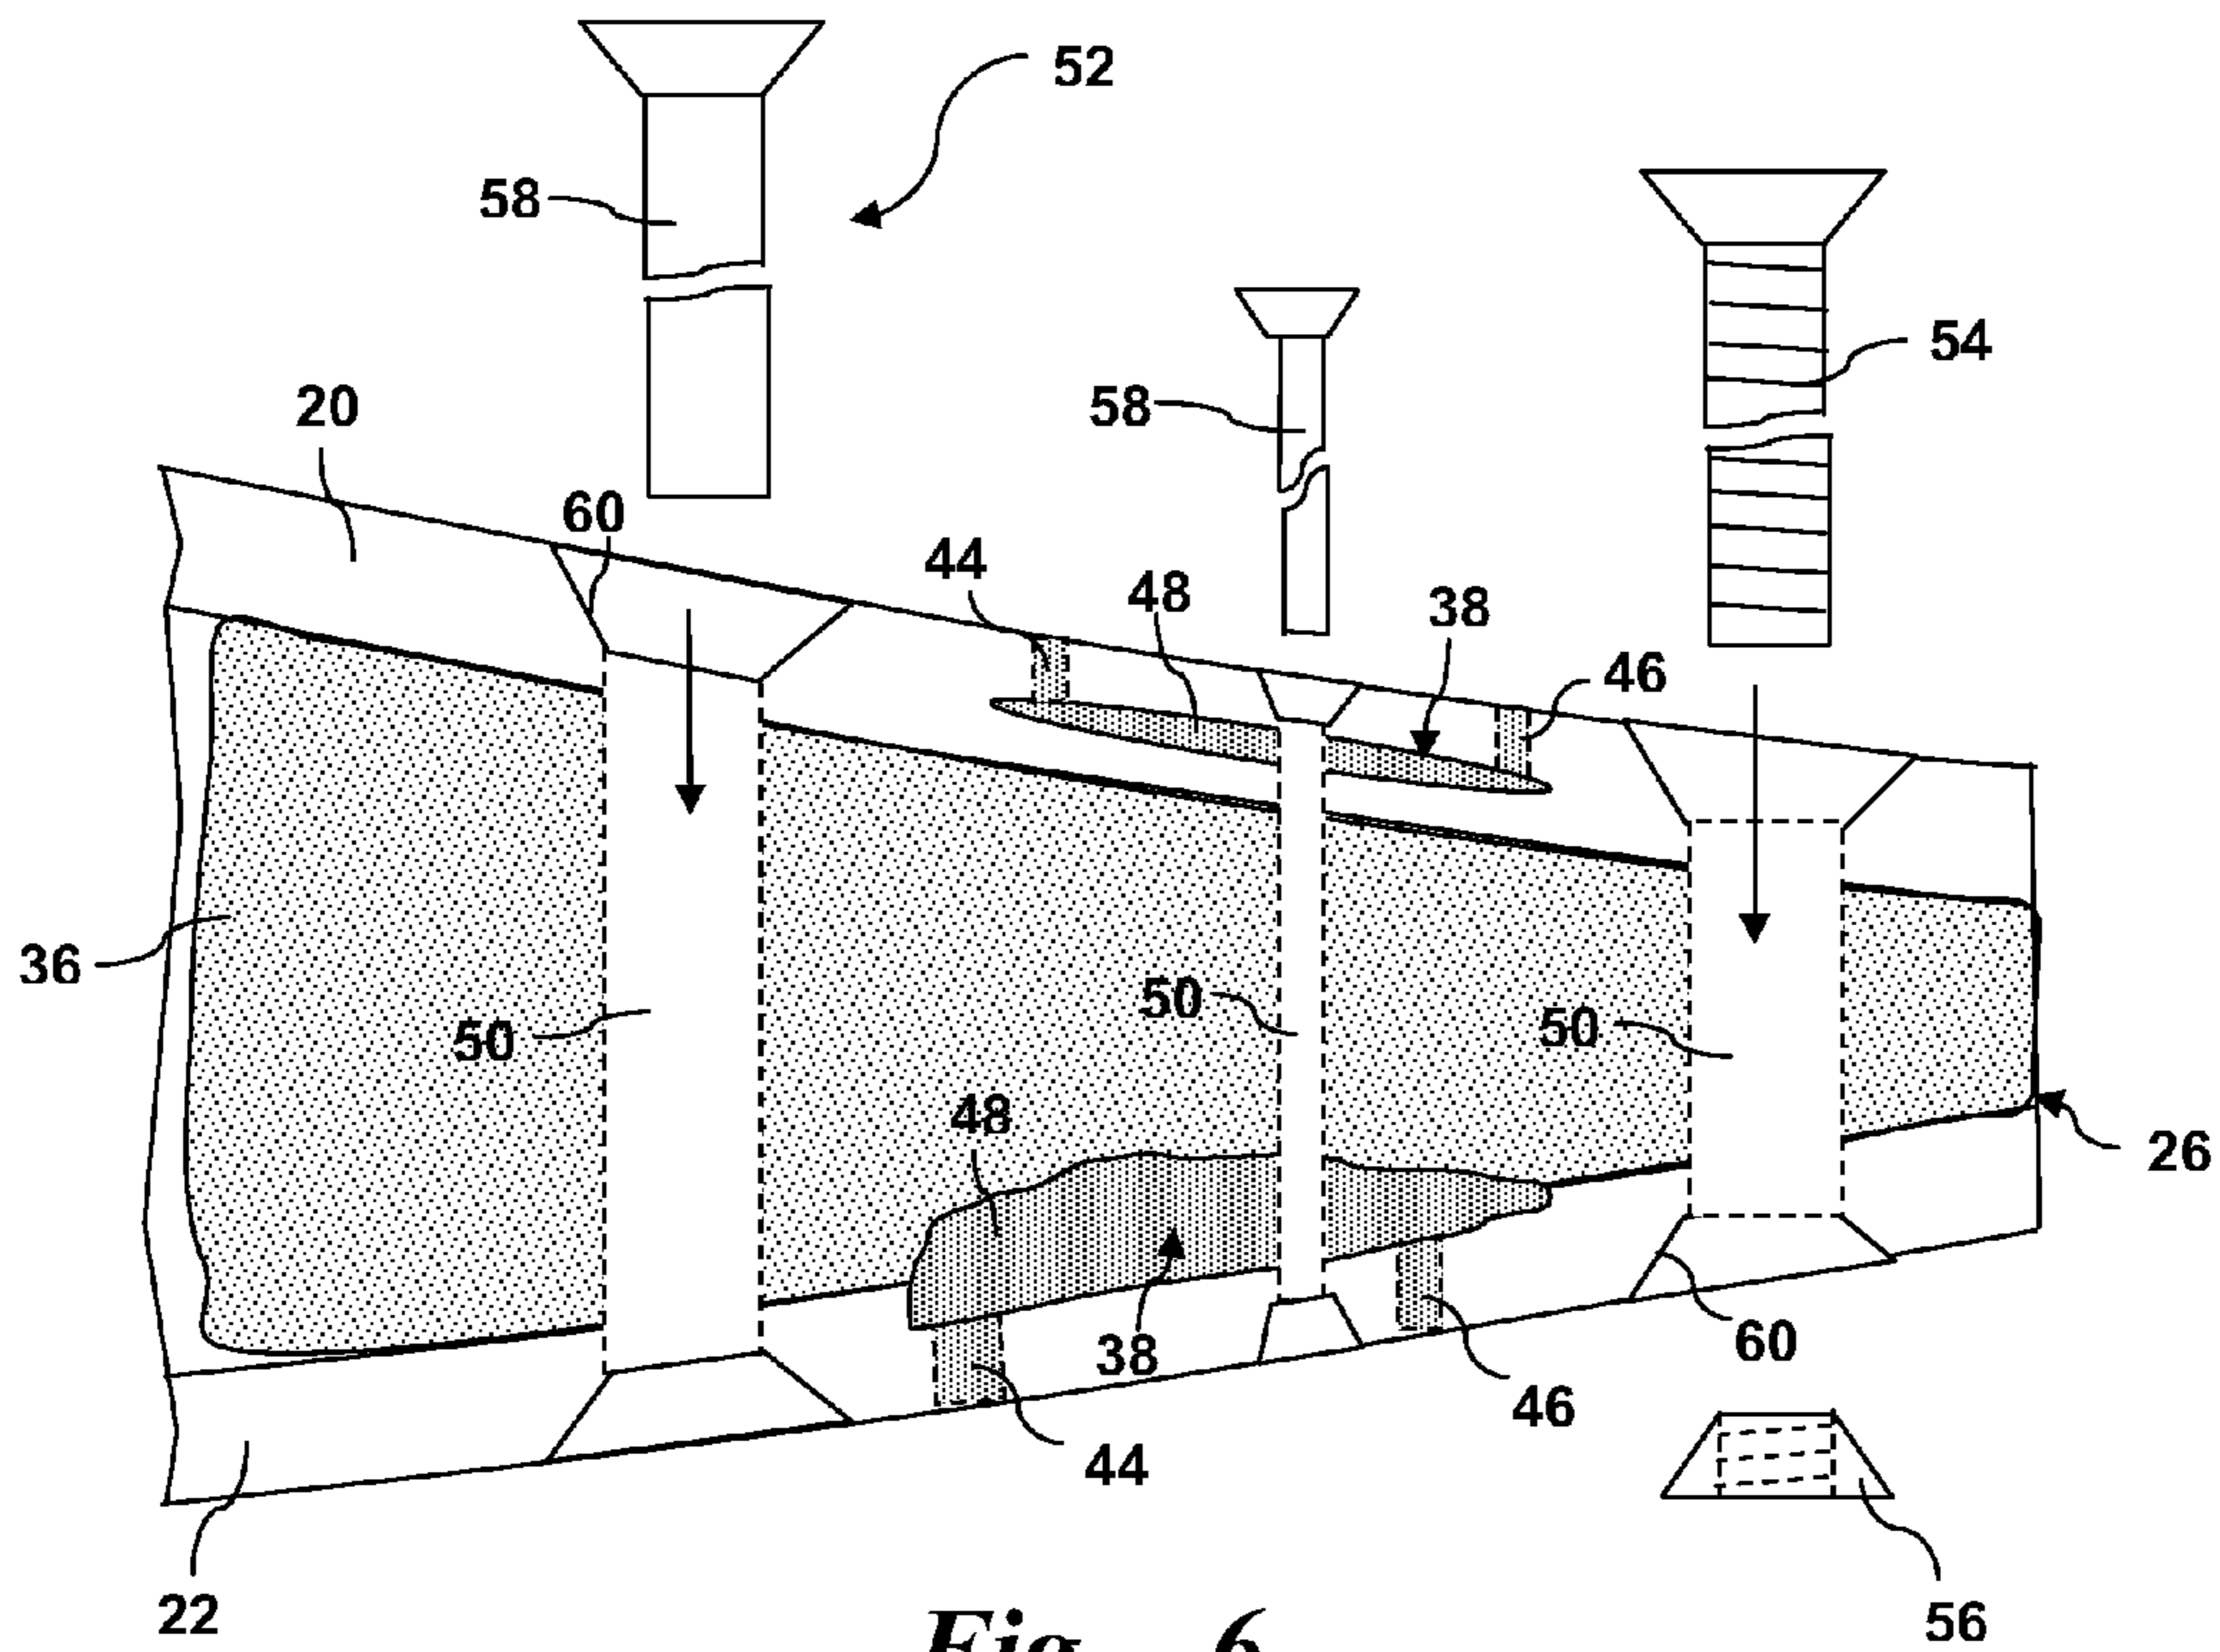
Fig. -6-

FIG. 6 is a cross-sectional view of a trailing edge particularly illustrating receipt of the mechanical fasteners in and around the repair zone; and,

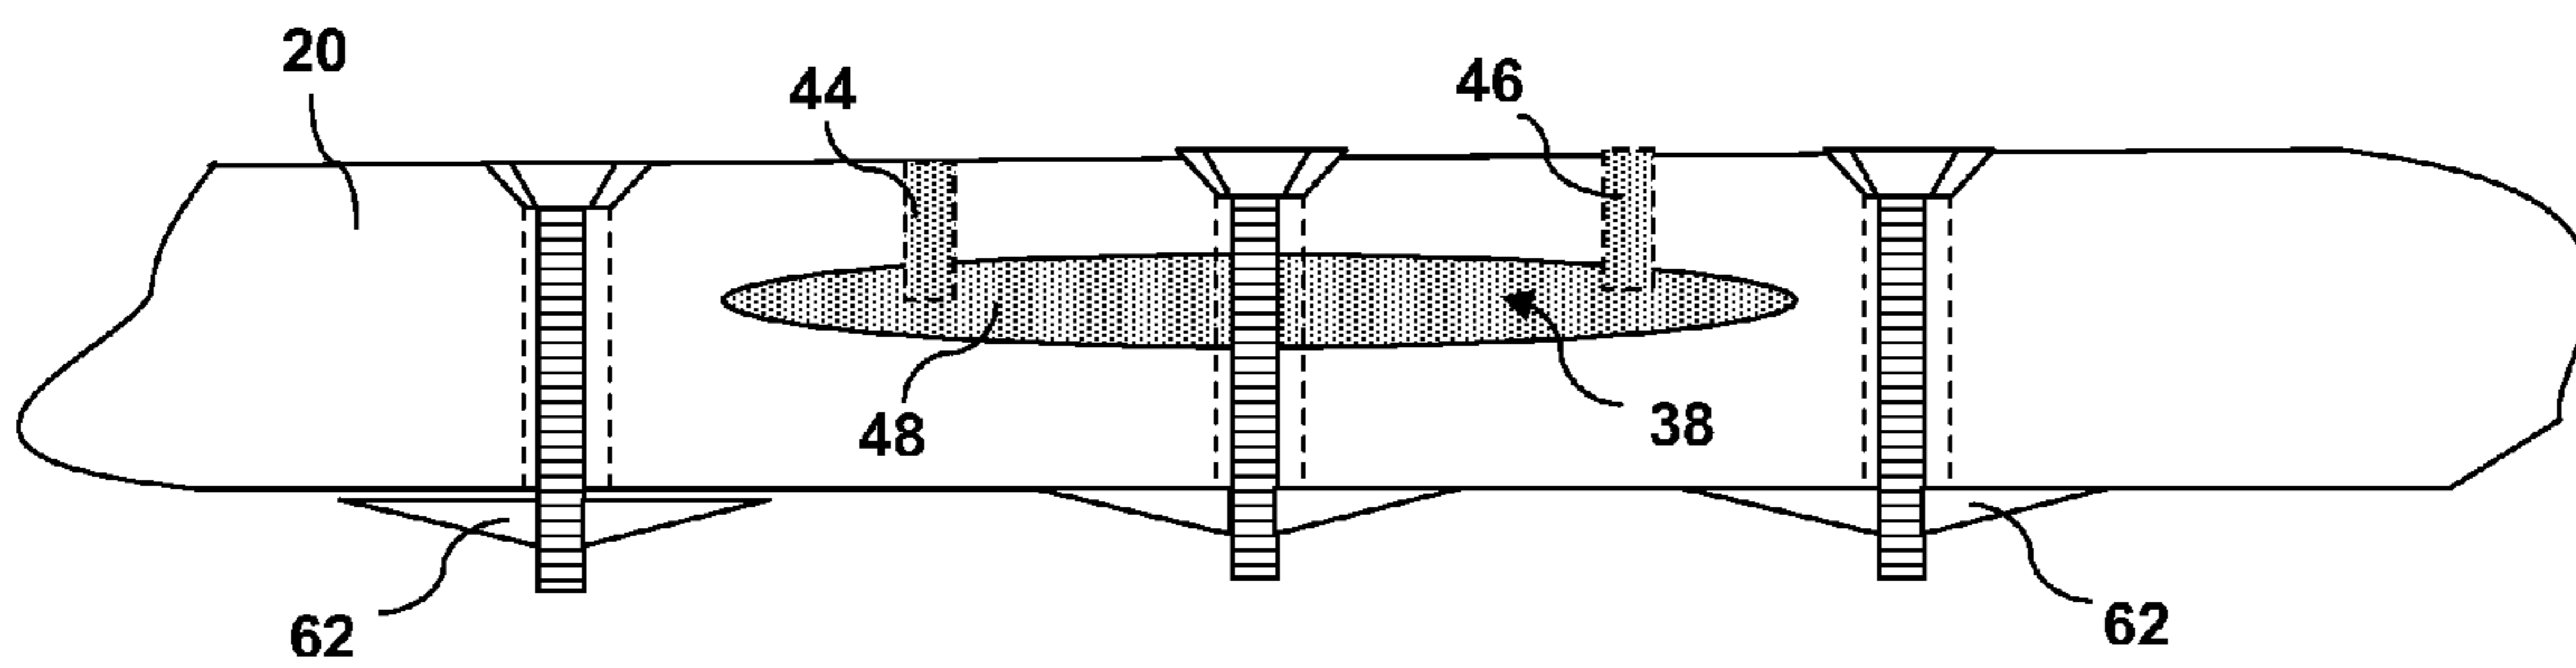
Fig. -7-

FIG. 7 is a cross-sectional view of a repair area where access to the opposite side is not readily available.
