(12) **United States Patent**
Deak et al.

(54) **METHOD OF REPAIRING A SUBSURFACE VOID OR DAMAGE FOR A WIND TURBINE BLADE**

(73) Assignee: **General Electric Company**, Schenectady, NY (US)

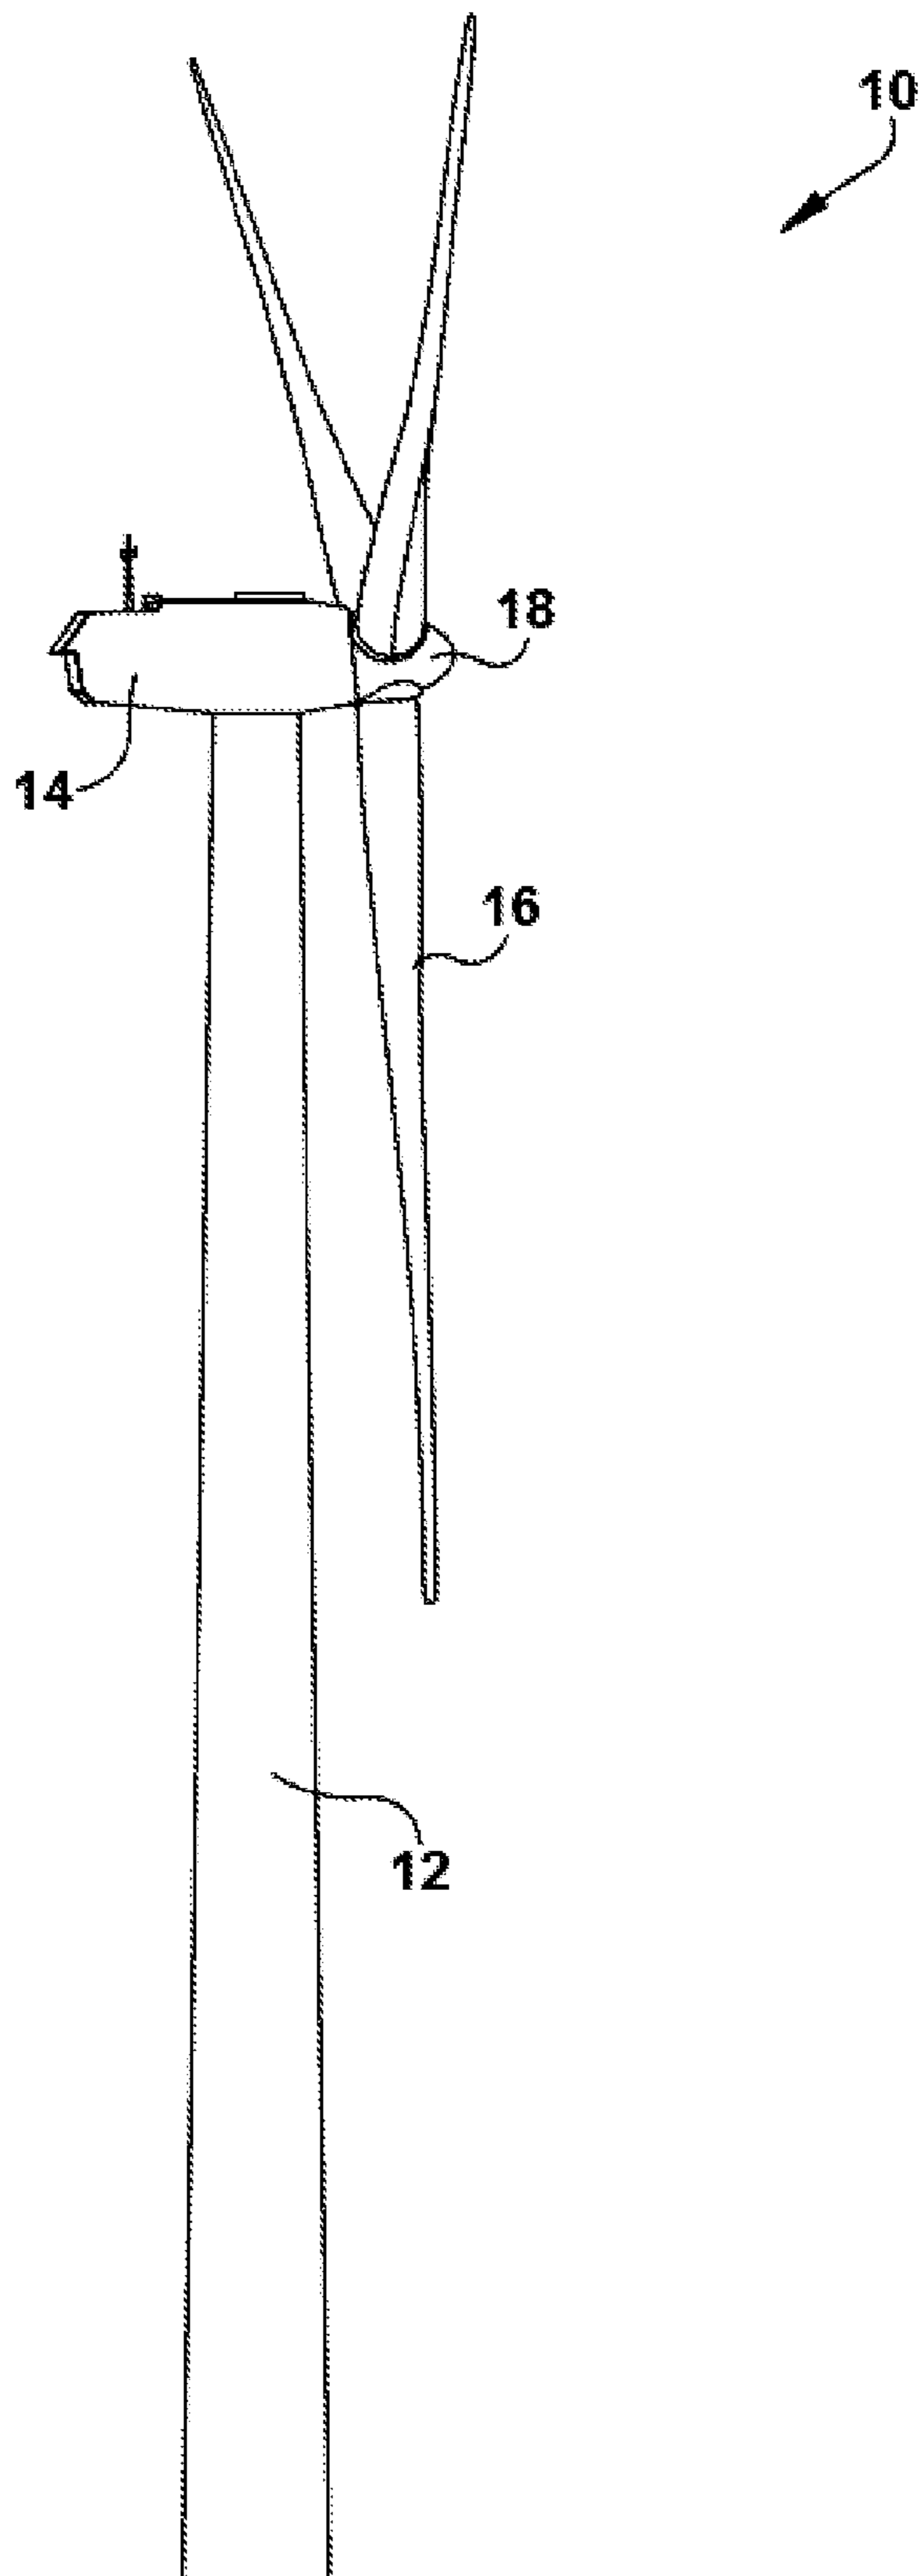
Fig. -1-

FIG. 1 is a perspective view of a conventional wind turbine;

FIG. 1 illustrates a wind turbine 10 of conventional construction. The wind turbine 10 includes a tower 12 with a nacelle 14 mounted thereon. A plurality of turbine blades 16 are mounted to a rotor hub 18, which is in turn connected to a main flange that turns a main rotor shaft. The wind turbine power generation and control components are housed within the nacelle 14. The view of FIG. 1 is provided for illustrative purposes only to place the present invention in an exemplary field of use. It should be appreciated that the invention is not limited to any particular type of wind turbine configuration.

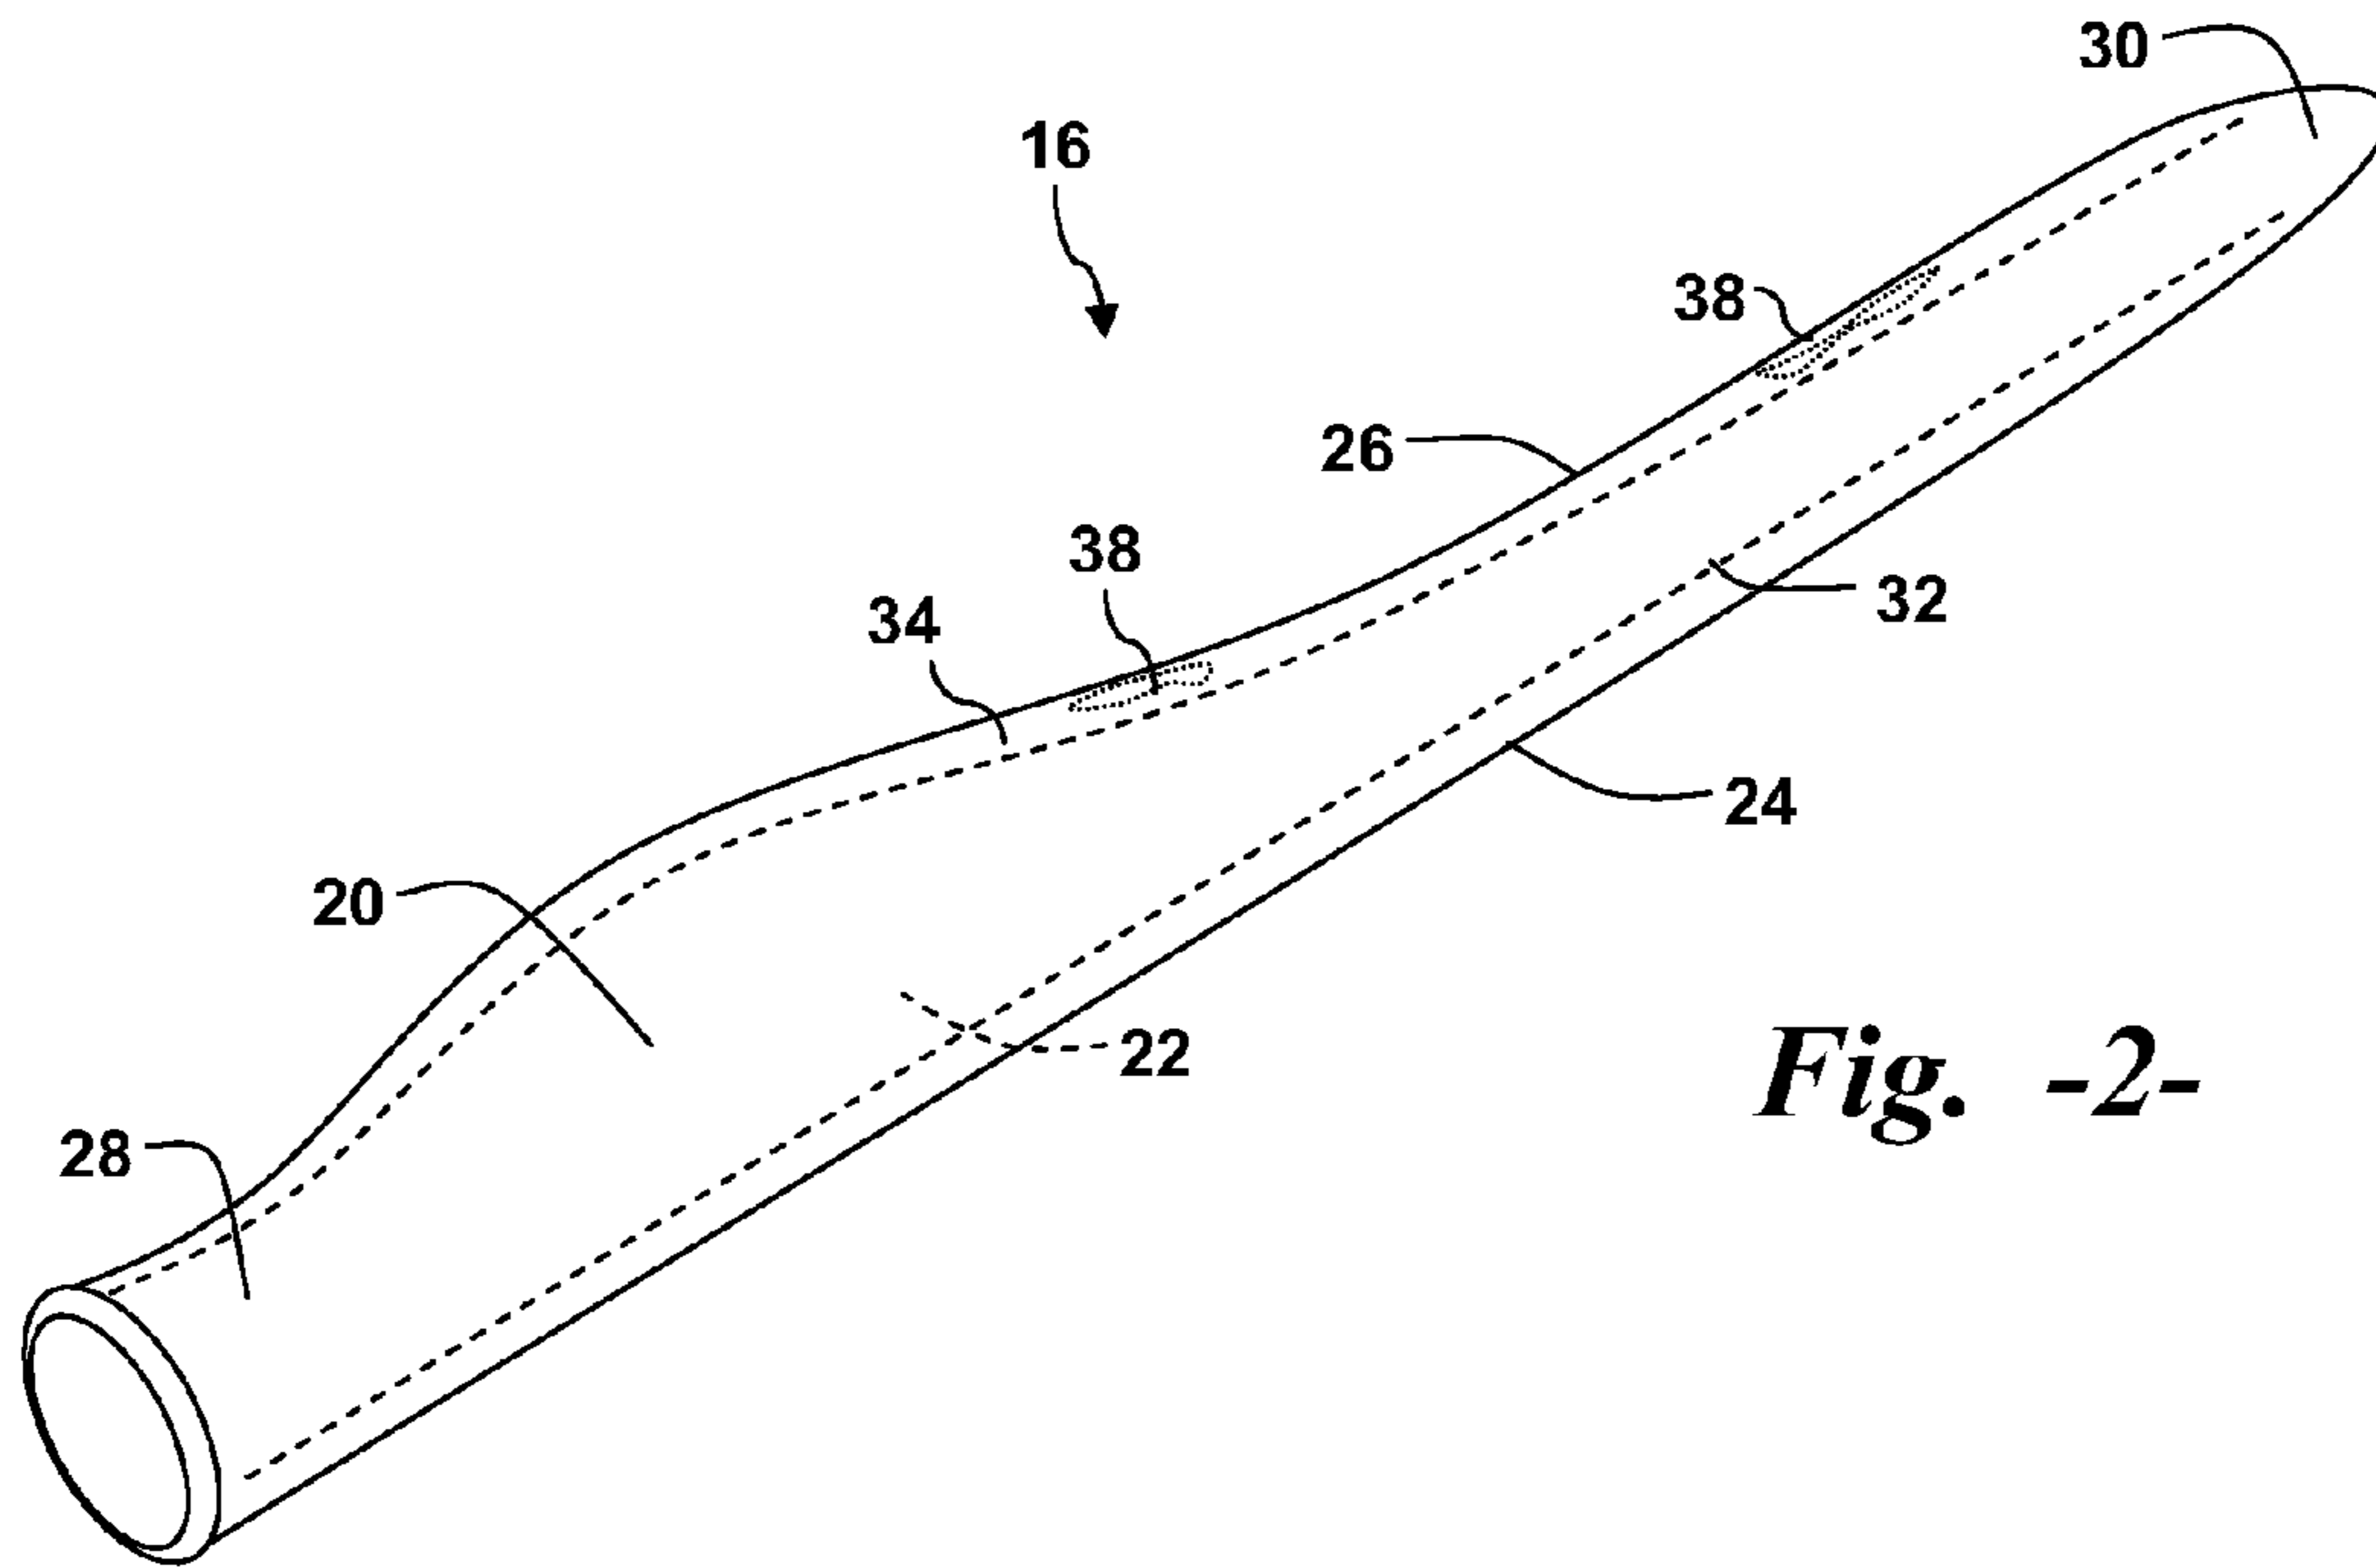
Fig. -2-

FIG. 2 is a perspective view of a wind turbine blade;

FIG. 2 is a more detailed view of a wind turbine blade 16. The blade 16 includes an upper shell member 20 and a lower shell member 22. The upper shell member 20 may be configured as the suction side surface of the blade 16, while the lower shell member 20 may be configured as the pressure side surface of the blade. The blade 16 includes a leading edge 24 and a trailing edge 26, as well as a root portion 28, and a tip portion 30. As is well known in the art, the upper shell member 20, and lower shell member 22 are joined together at a leading edge bond line 32 and a trailing edge bond line 34. In formation of these bond lines 32, 34, a bond paste 36 in flowable viscous form is applied between the mating surfaces of the shell members 20, 22 along the length of the bond lines 32, 34. The bond paste 36 is typically applied in a sufficient quantity and pattern so as to establish a designed width of the bond lines 32, 34 that ensures a minimum bonded surface area between the components. It should be appreciated that the term "bond paste" is used herein in a generic sense to encompass any type of adhesive or bonding material that is applied in an initially flowable state, such any suitable type of epoxy, compound, or other material.

FIG. 2 illustrates multiple subsurface defects 38 formed in the laminate material of either of the shell members 20, 22 along the trailing edge bond line 34. The depiction of the defects 38 in this region of the blade is presented for illustrative purposes only. It should be appreciated that the present procedure for repairing subsurface defects in a wind turbine blade may be utilized for defects 38 located at any location in the laminate materials of the blade.

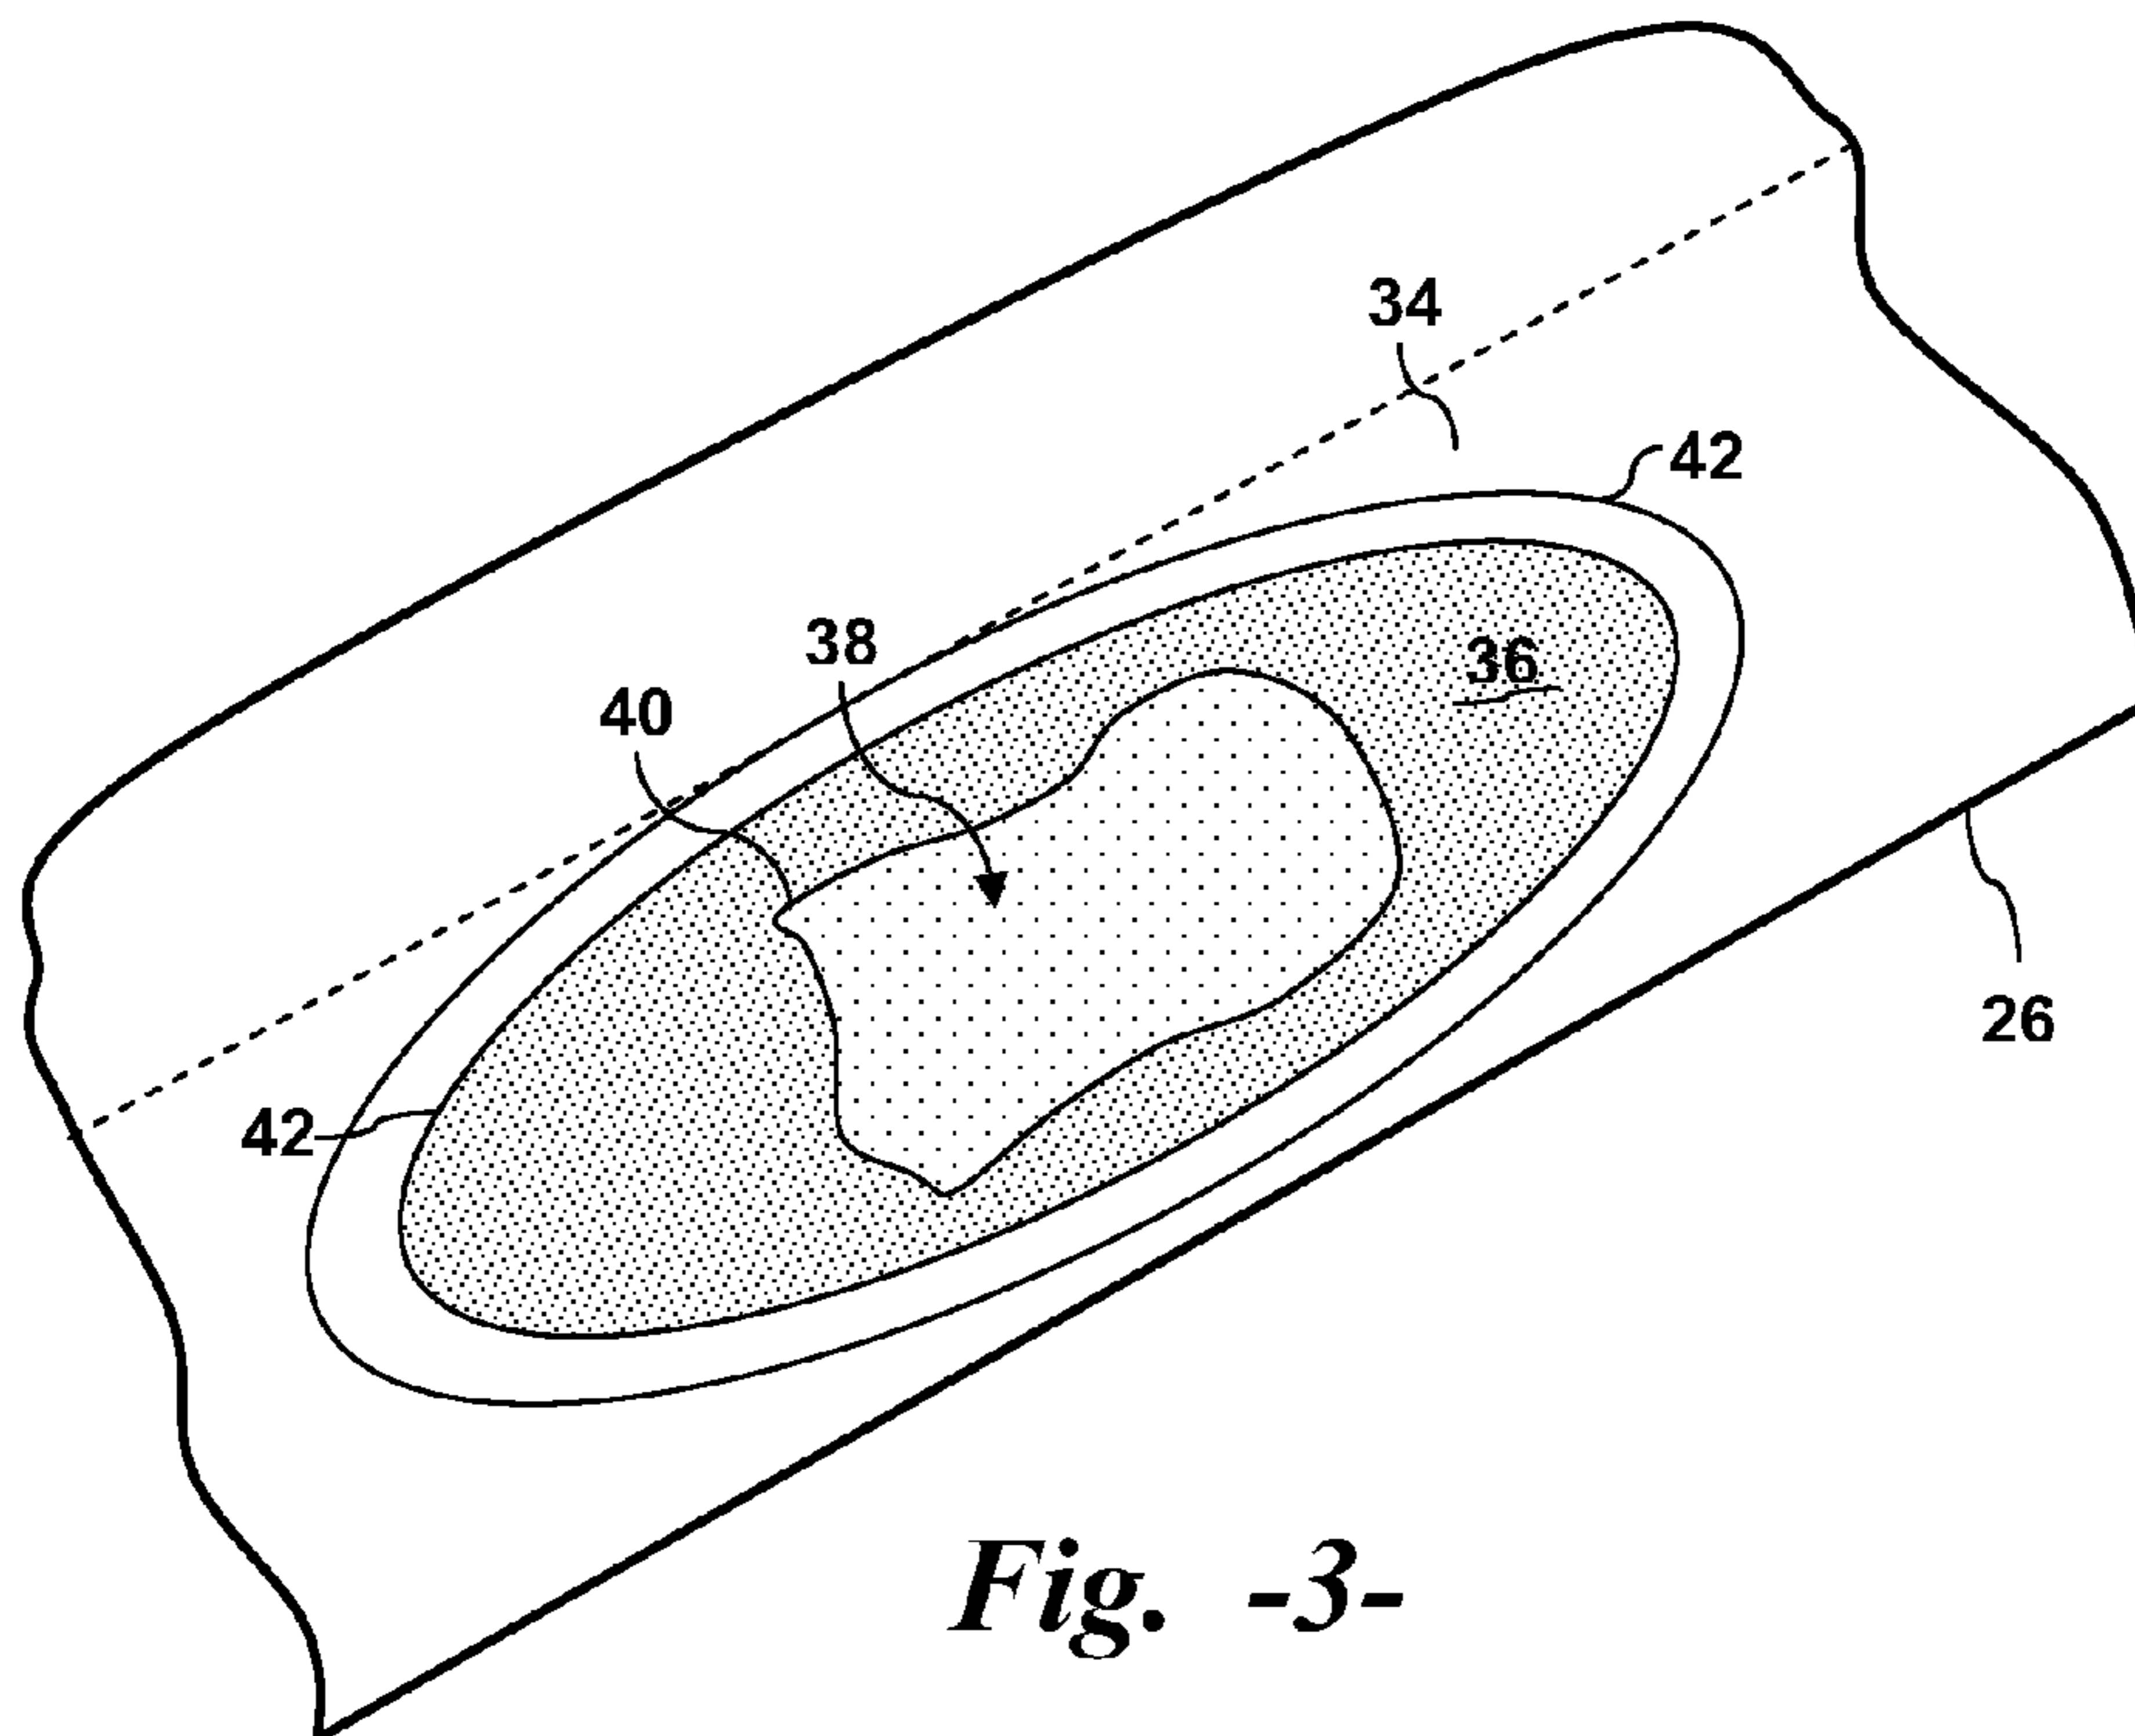
Fig. -3-

FIG. 3 is a view of a section of a trailing edge of a wind turbine blade with laminate layers removed to reveal a subsurface defect;

FIG. 3 is an enlarged view of a section of the trailing edge 26 that encompasses one of the defects 38. Layers 42 of the upper shell member 20 have been removed in the illustration in order to depict the subsurface defect 38 having a boundary 40. The defect 38 may be a void in the bond paste 36, which may extend completely through the laminate to the opposite shell member 22. In other instances the defect 38 may be a

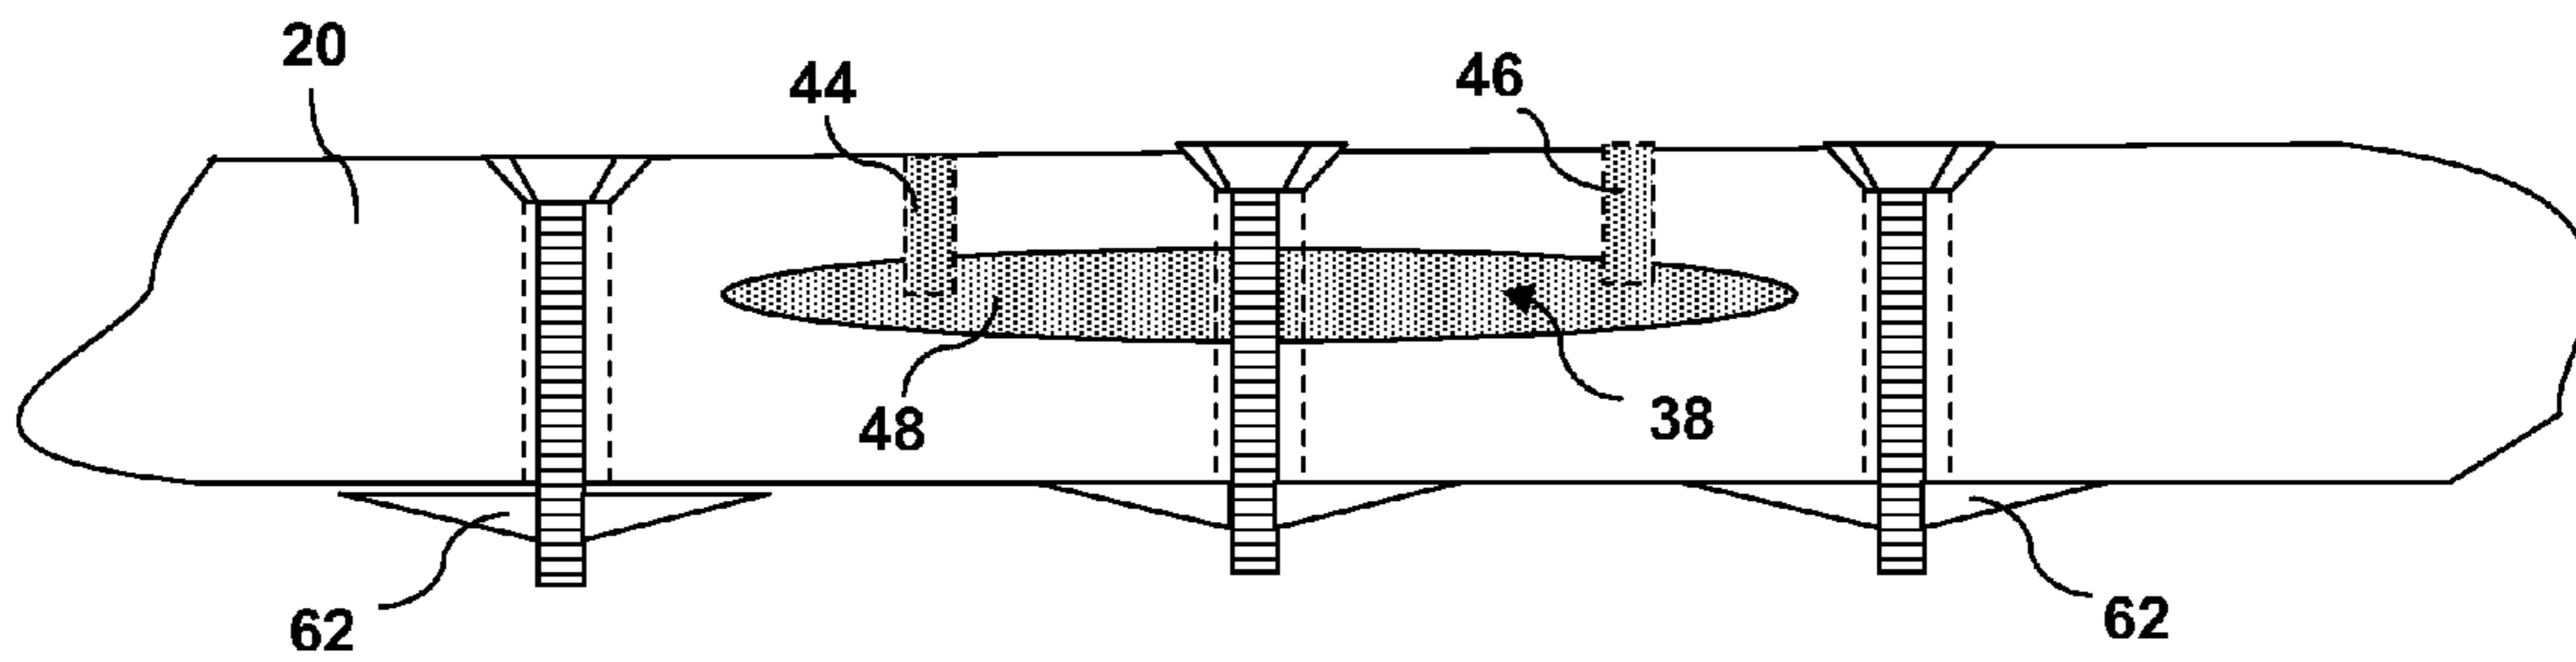
Fig. -7-

FIG. 7 is a cross-sectional view of a repair area where access to the opposite side is not readily available.
