(54) **USING A STIFFENER TO REPAIR A PART FOR AN AIRCRAFT ENGINE**

A method of repairing a part, which has a first side, a second side opposite of the first side, and an aperture that makes the part susceptible to cracking, includes the steps of forming a slot in the first side of the part near the aperture, inserting a stiffener into the slot, and attaching at least one repair ply onto the first side of the part to cover the stiffener.

## USING A STIFFENER TO REPAIR A PART FOR AN AIRCRAFT ENGINE

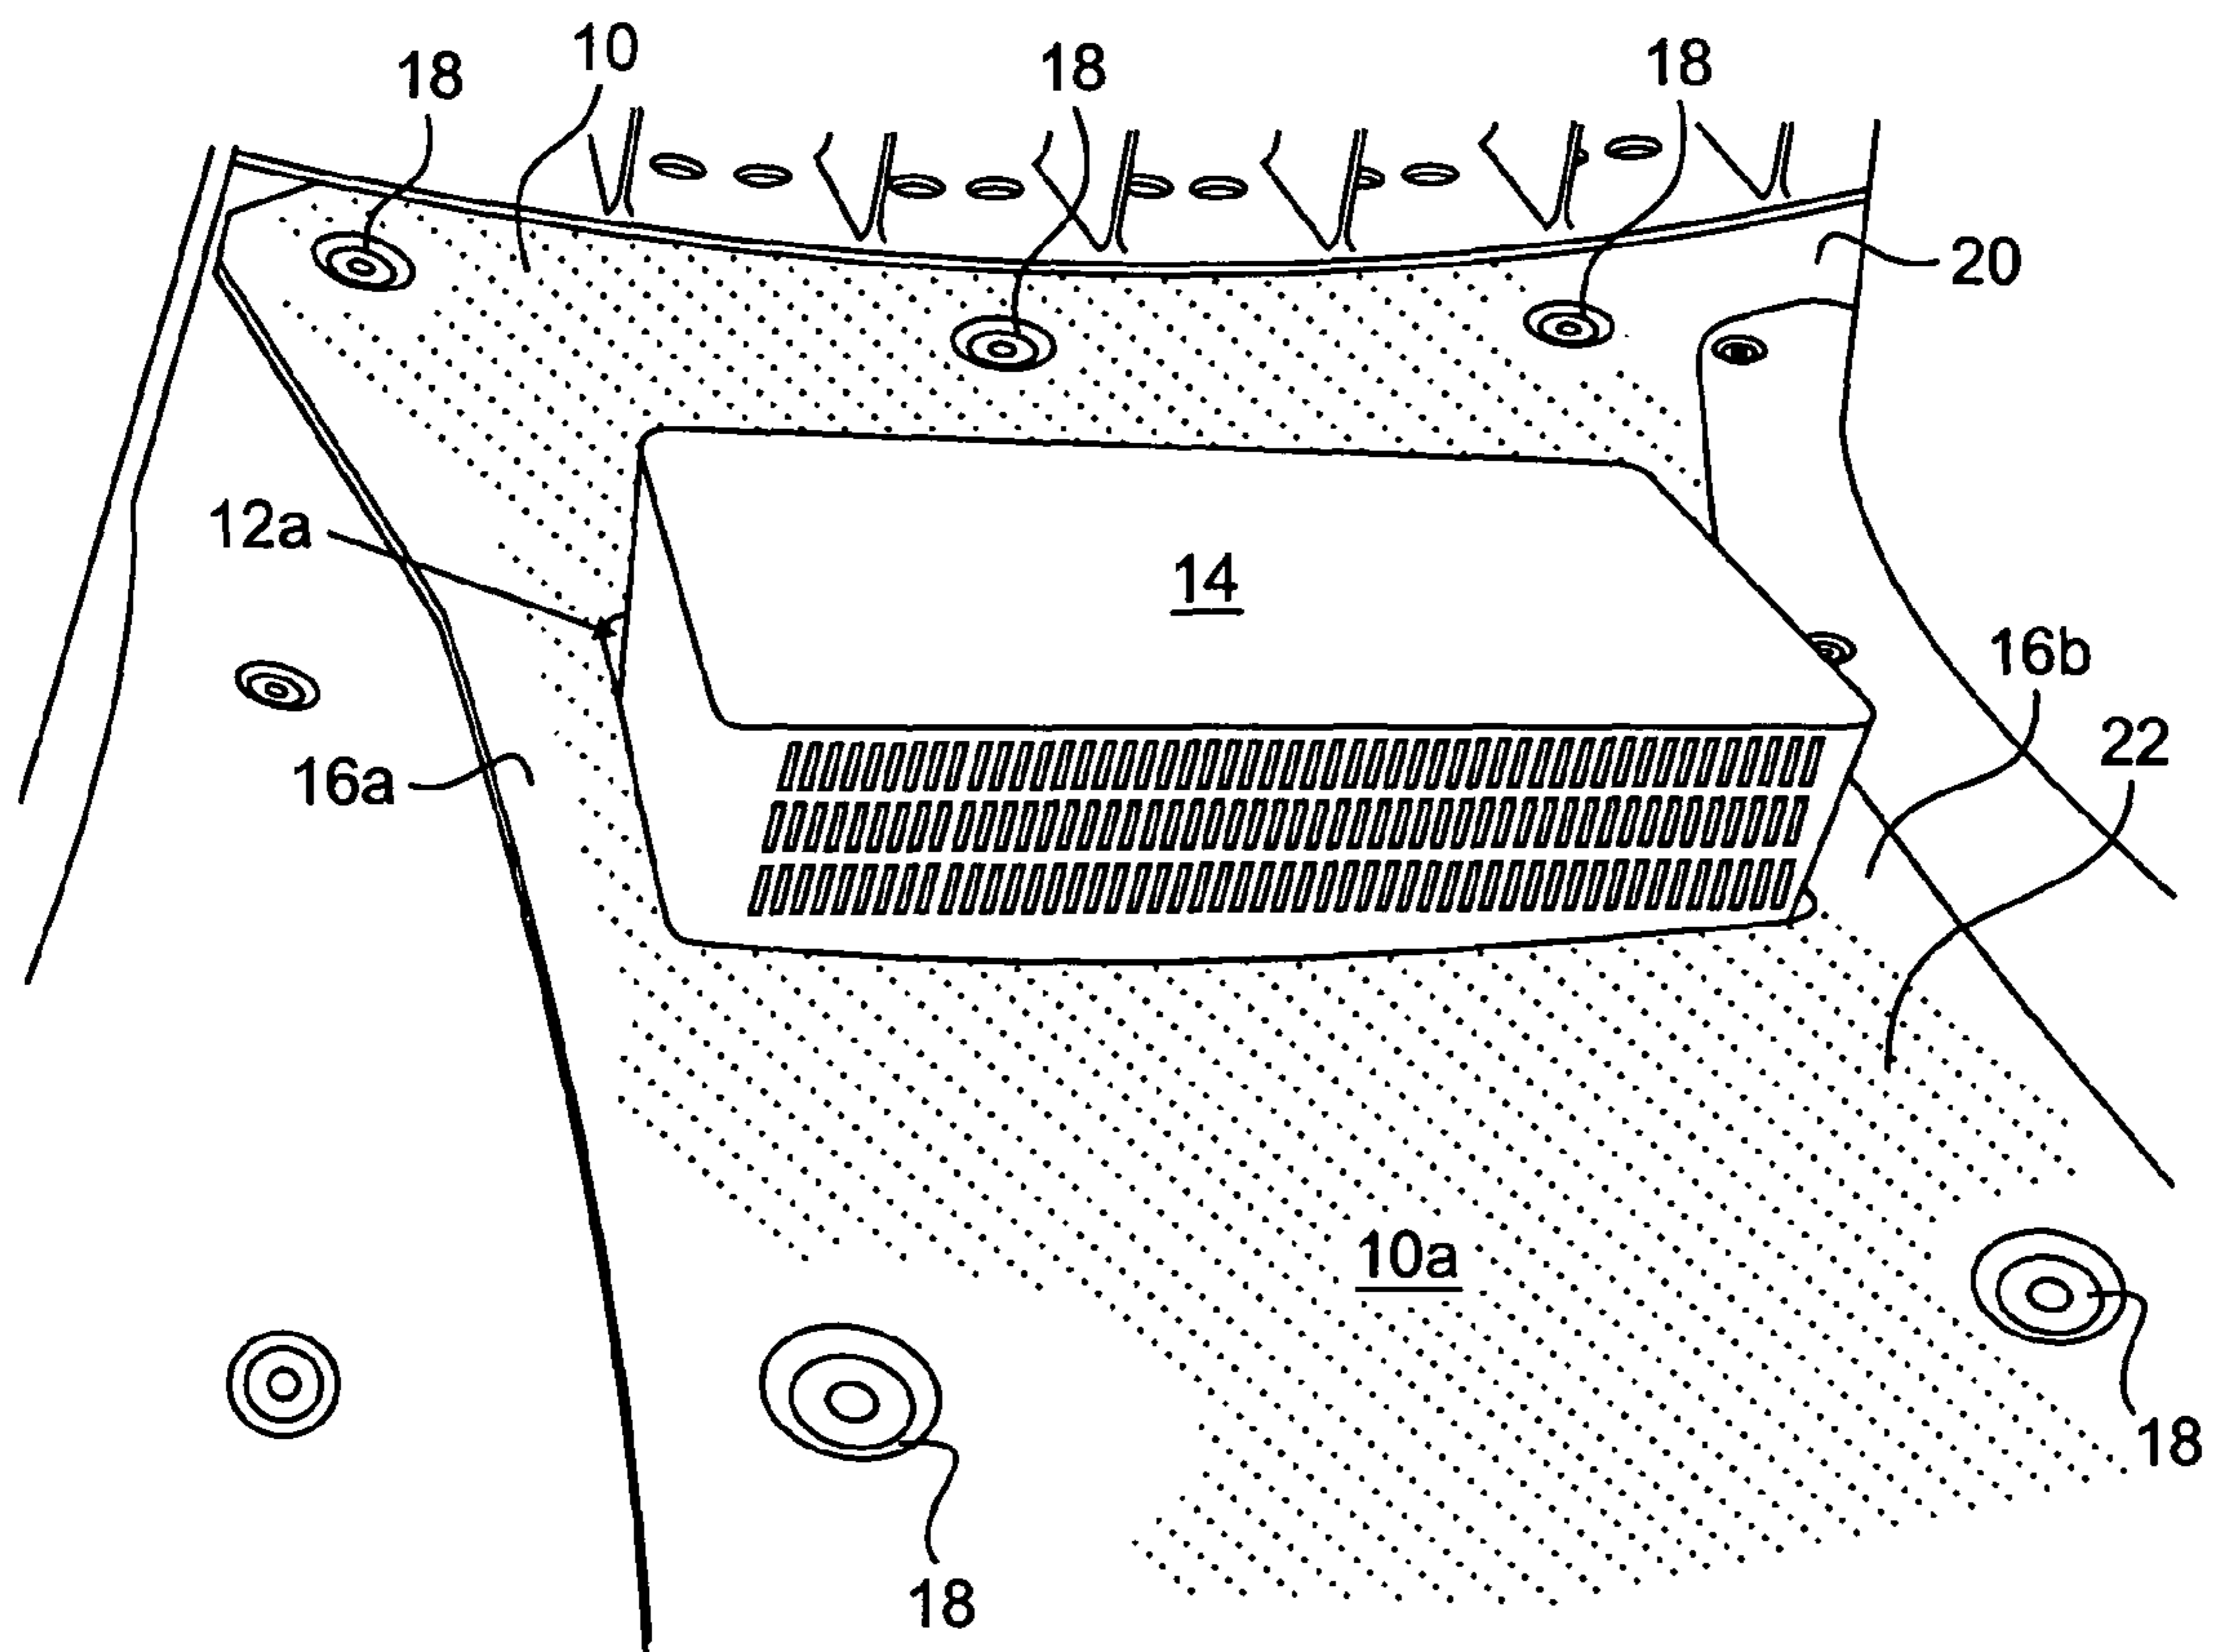
FIG. 1 is a perspective view of an acoustic liner of a gas turbine engine having a large cut-out or aperture for receiving an air-oil cooler.

FIG. 1 is a perspective view of acoustic liner 10 which includes an acoustic side 10a (also known as an airflow side)

and a non-acoustic side 10b (shown in FIG. 2). Acoustic liner 10 is typically a composite. In an exemplary embodiment, acoustic liner 10 may include an aluminum core, and acoustic side 10a may include a perforated skin, which may commonly be formed from fiberglass. Acoustic liner 10 includes aperture 12, which is a large cut-out configured to receive air-oil cooler 14. In a gas turbine engine, acoustic liner 10 is typically one of a plurality of acoustic liners or panels that are inserted between the struts of the intermediate case (not shown) and bolted to an inner or outer case (also not shown). (These component cases are part of an intermediate case assembly.) The other acoustic liners used in conjunction with acoustic liner 10, however, do not usually include aperture 12 since typically only a single air-oil cooler is used in the intermediate case assembly.

Due to the large size of aperture 12, side portions 16a and 16b of liner 10, which are located on each side of aperture 12, are thin and structurally weakened by aperture 12. As such, acoustic liner 10 may be prone to cracking in portions 16a and 16b. Typically, cracking occurs similarly or uniformly across portions 16a and 16b. As shown in FIG. 1, acoustic liner 10 includes a plurality of bolt holes 18 at both top portion 20 of liner 10 and bottom portion 22 of liner 10. Bolt holes 18 are used to secure liner 10 to the inner or outer case. However, if a crack forms in side portions 16a and 16b, such that liner 10 is essentially in two pieces, liner 10 may not remain static. In that case, bending moments of liner 10 may result in cracking of the inner or outer case to which liner 10 is attached. To avoid damage to the case, it may be necessary to repair or replace a cracked acoustic liner. Because it is costly to replace liner 10, it is preferable to repair liner 10. A repair process is described herein in which the repaired acoustic liner is structurally stronger, as compared to the original design of liner 10.

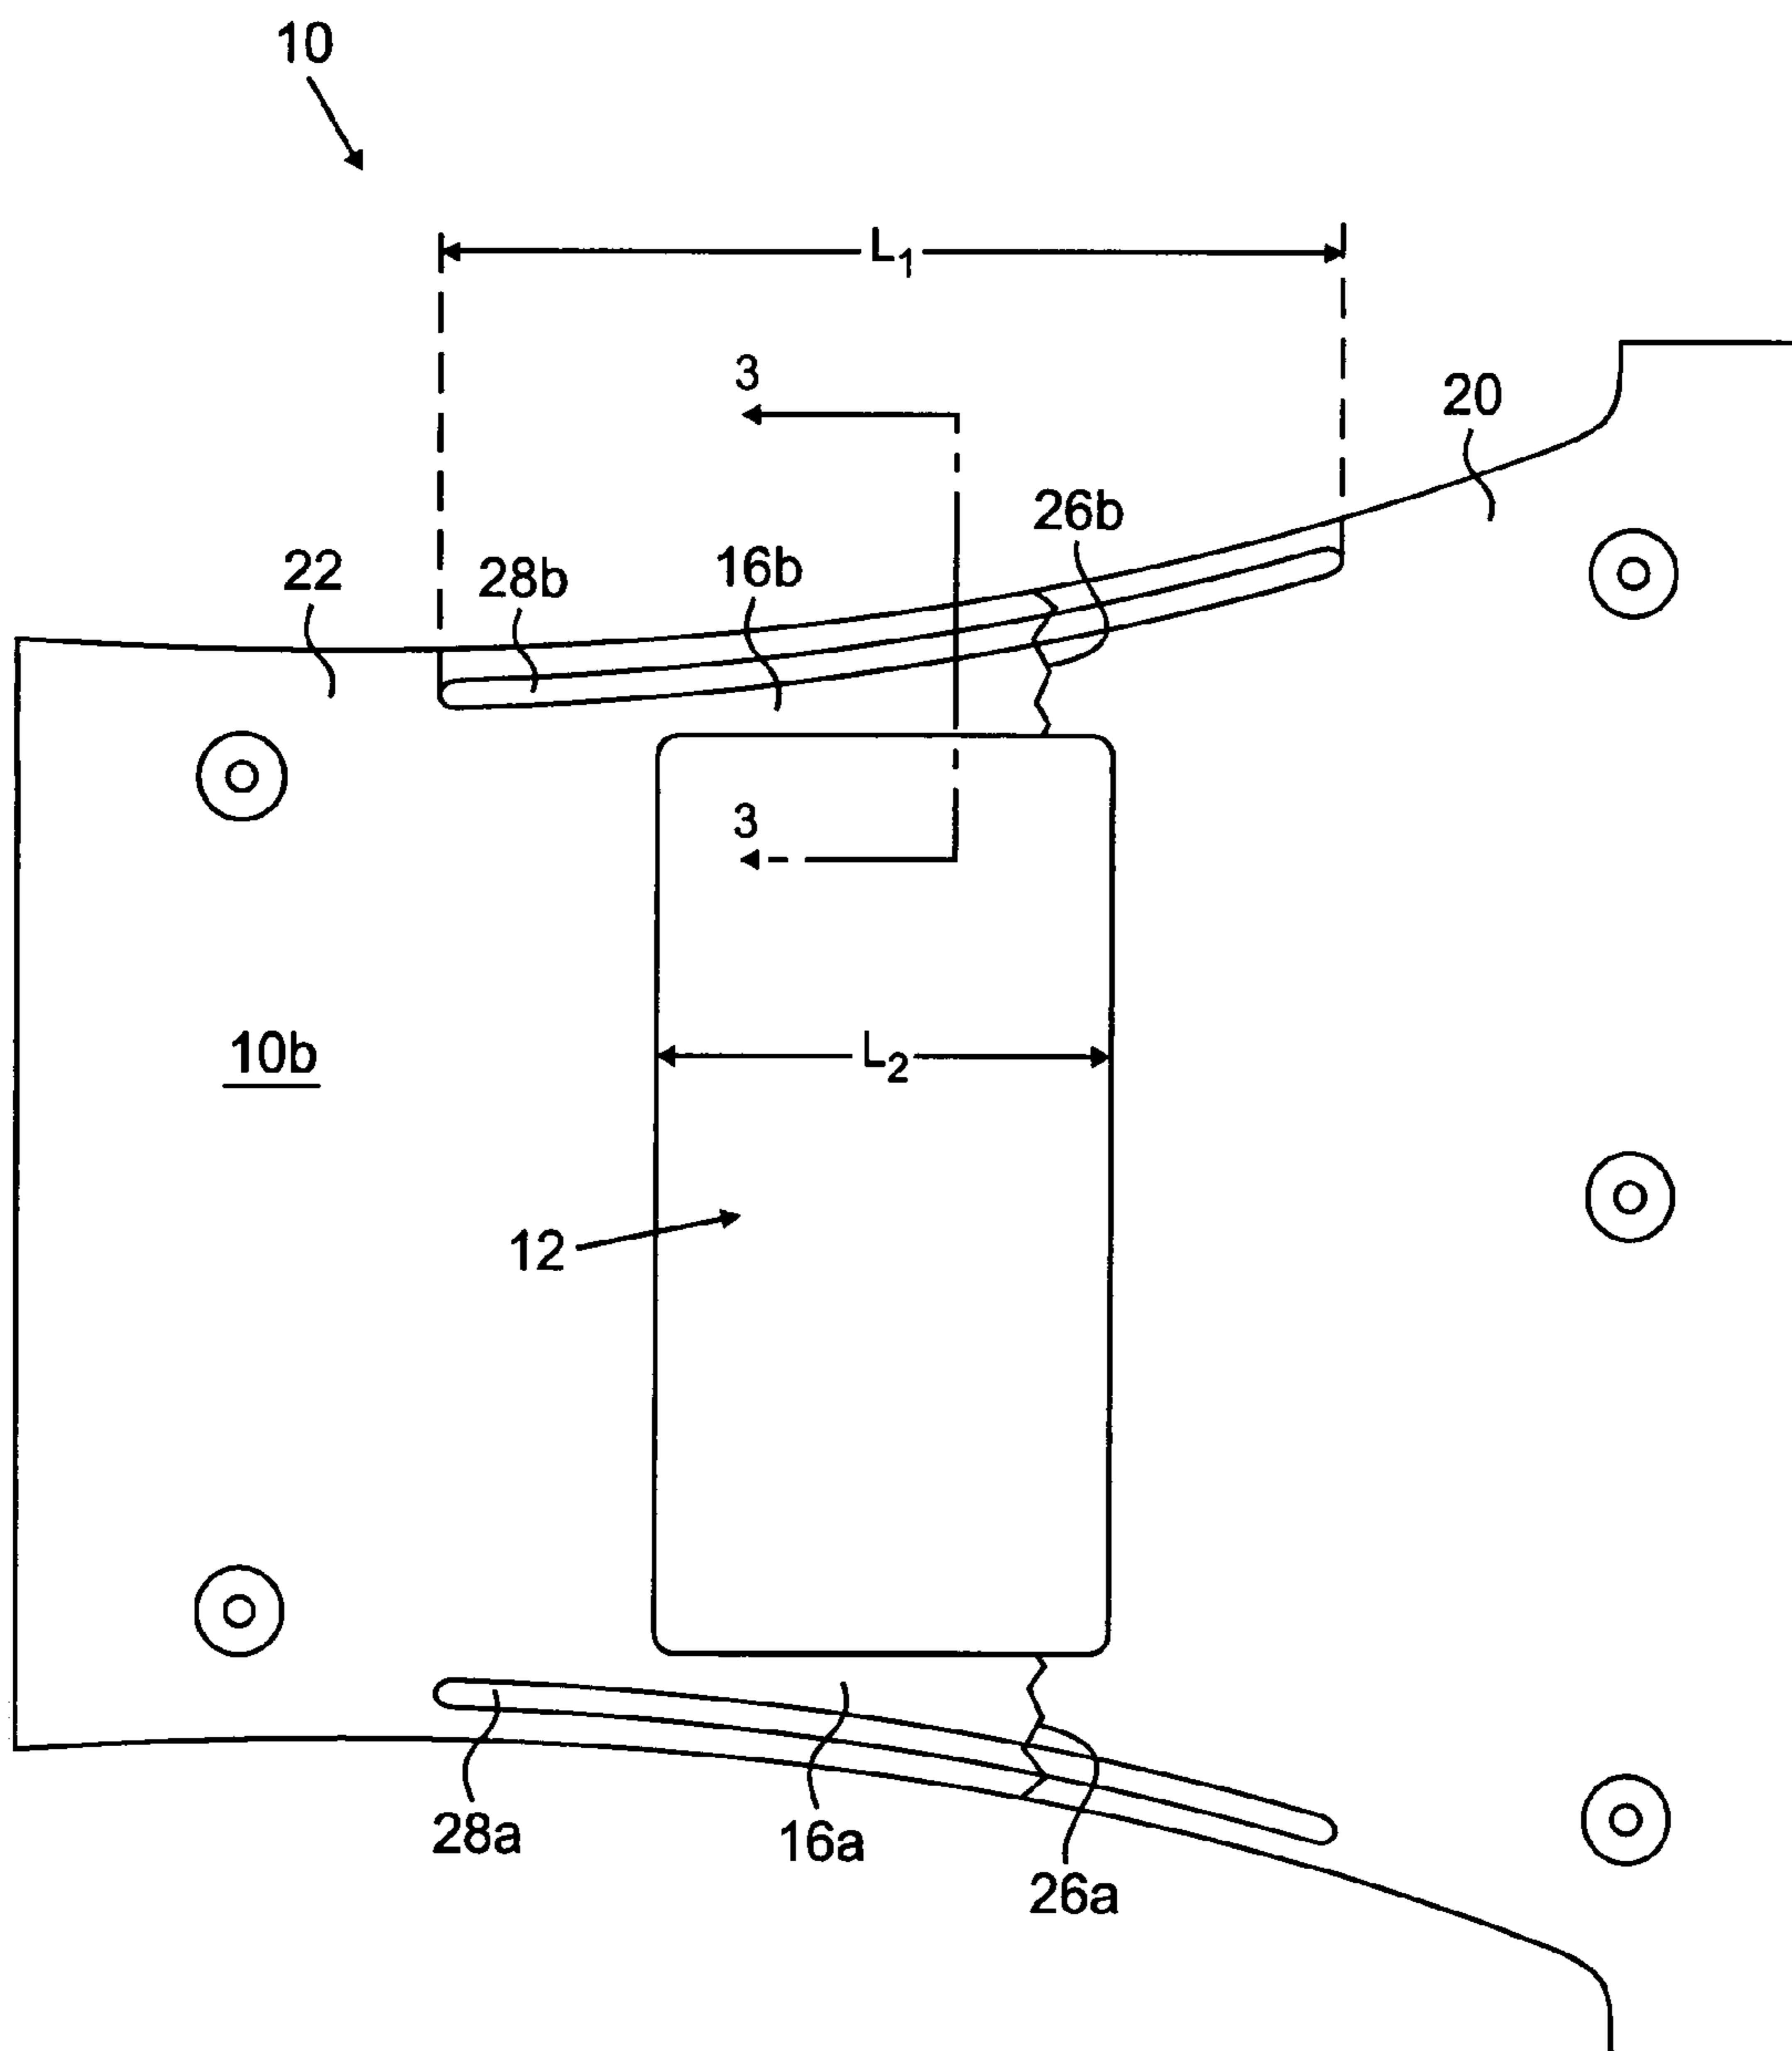
FIG. 2 is a back-view of the acoustic liner of FIG. 1 showing a first step in a repair process when a crack forms in the acoustic liner.

FIG. 2 is a back-view of acoustic liner 10 of FIG. 1, which may be referred to as non-acoustic side 10b of liner 10. (Air-oil cooler 14 has been removed for clarity.) In contrast to acoustic side 10a, non-acoustic side 10b is typically not perforated, but side 10b may still commonly include a fiberglass skin. As shown in FIG. 2, side portions 16a and 16b of liner 10 include cracks 26a and 26b.

Slots 28a and 28b may then be formed in any number of ways, including, but not limited to, routing or milling. As detailed below in reference to FIG. 3, slots 28a and 28b are formed by removing a portion of the skin of non-acoustic side 10b and the aluminum core. The perforated skin of acoustic side 10a is not removed from slots 28a and 28b. After slots 28a and 28b are formed, liner 10 is removed from the tool and cleaned to remove any debris residing in or around slots 28a and 28b.

As shown in FIG. 2, a length  $L_1$  of slots 28a and 28b is greater than a length  $L_2$  of aperture 12, in order to adequately reinforce side portions 16a and 16b. The dimensions for length  $L_1$  and a width of slots 28a and 28b may vary.

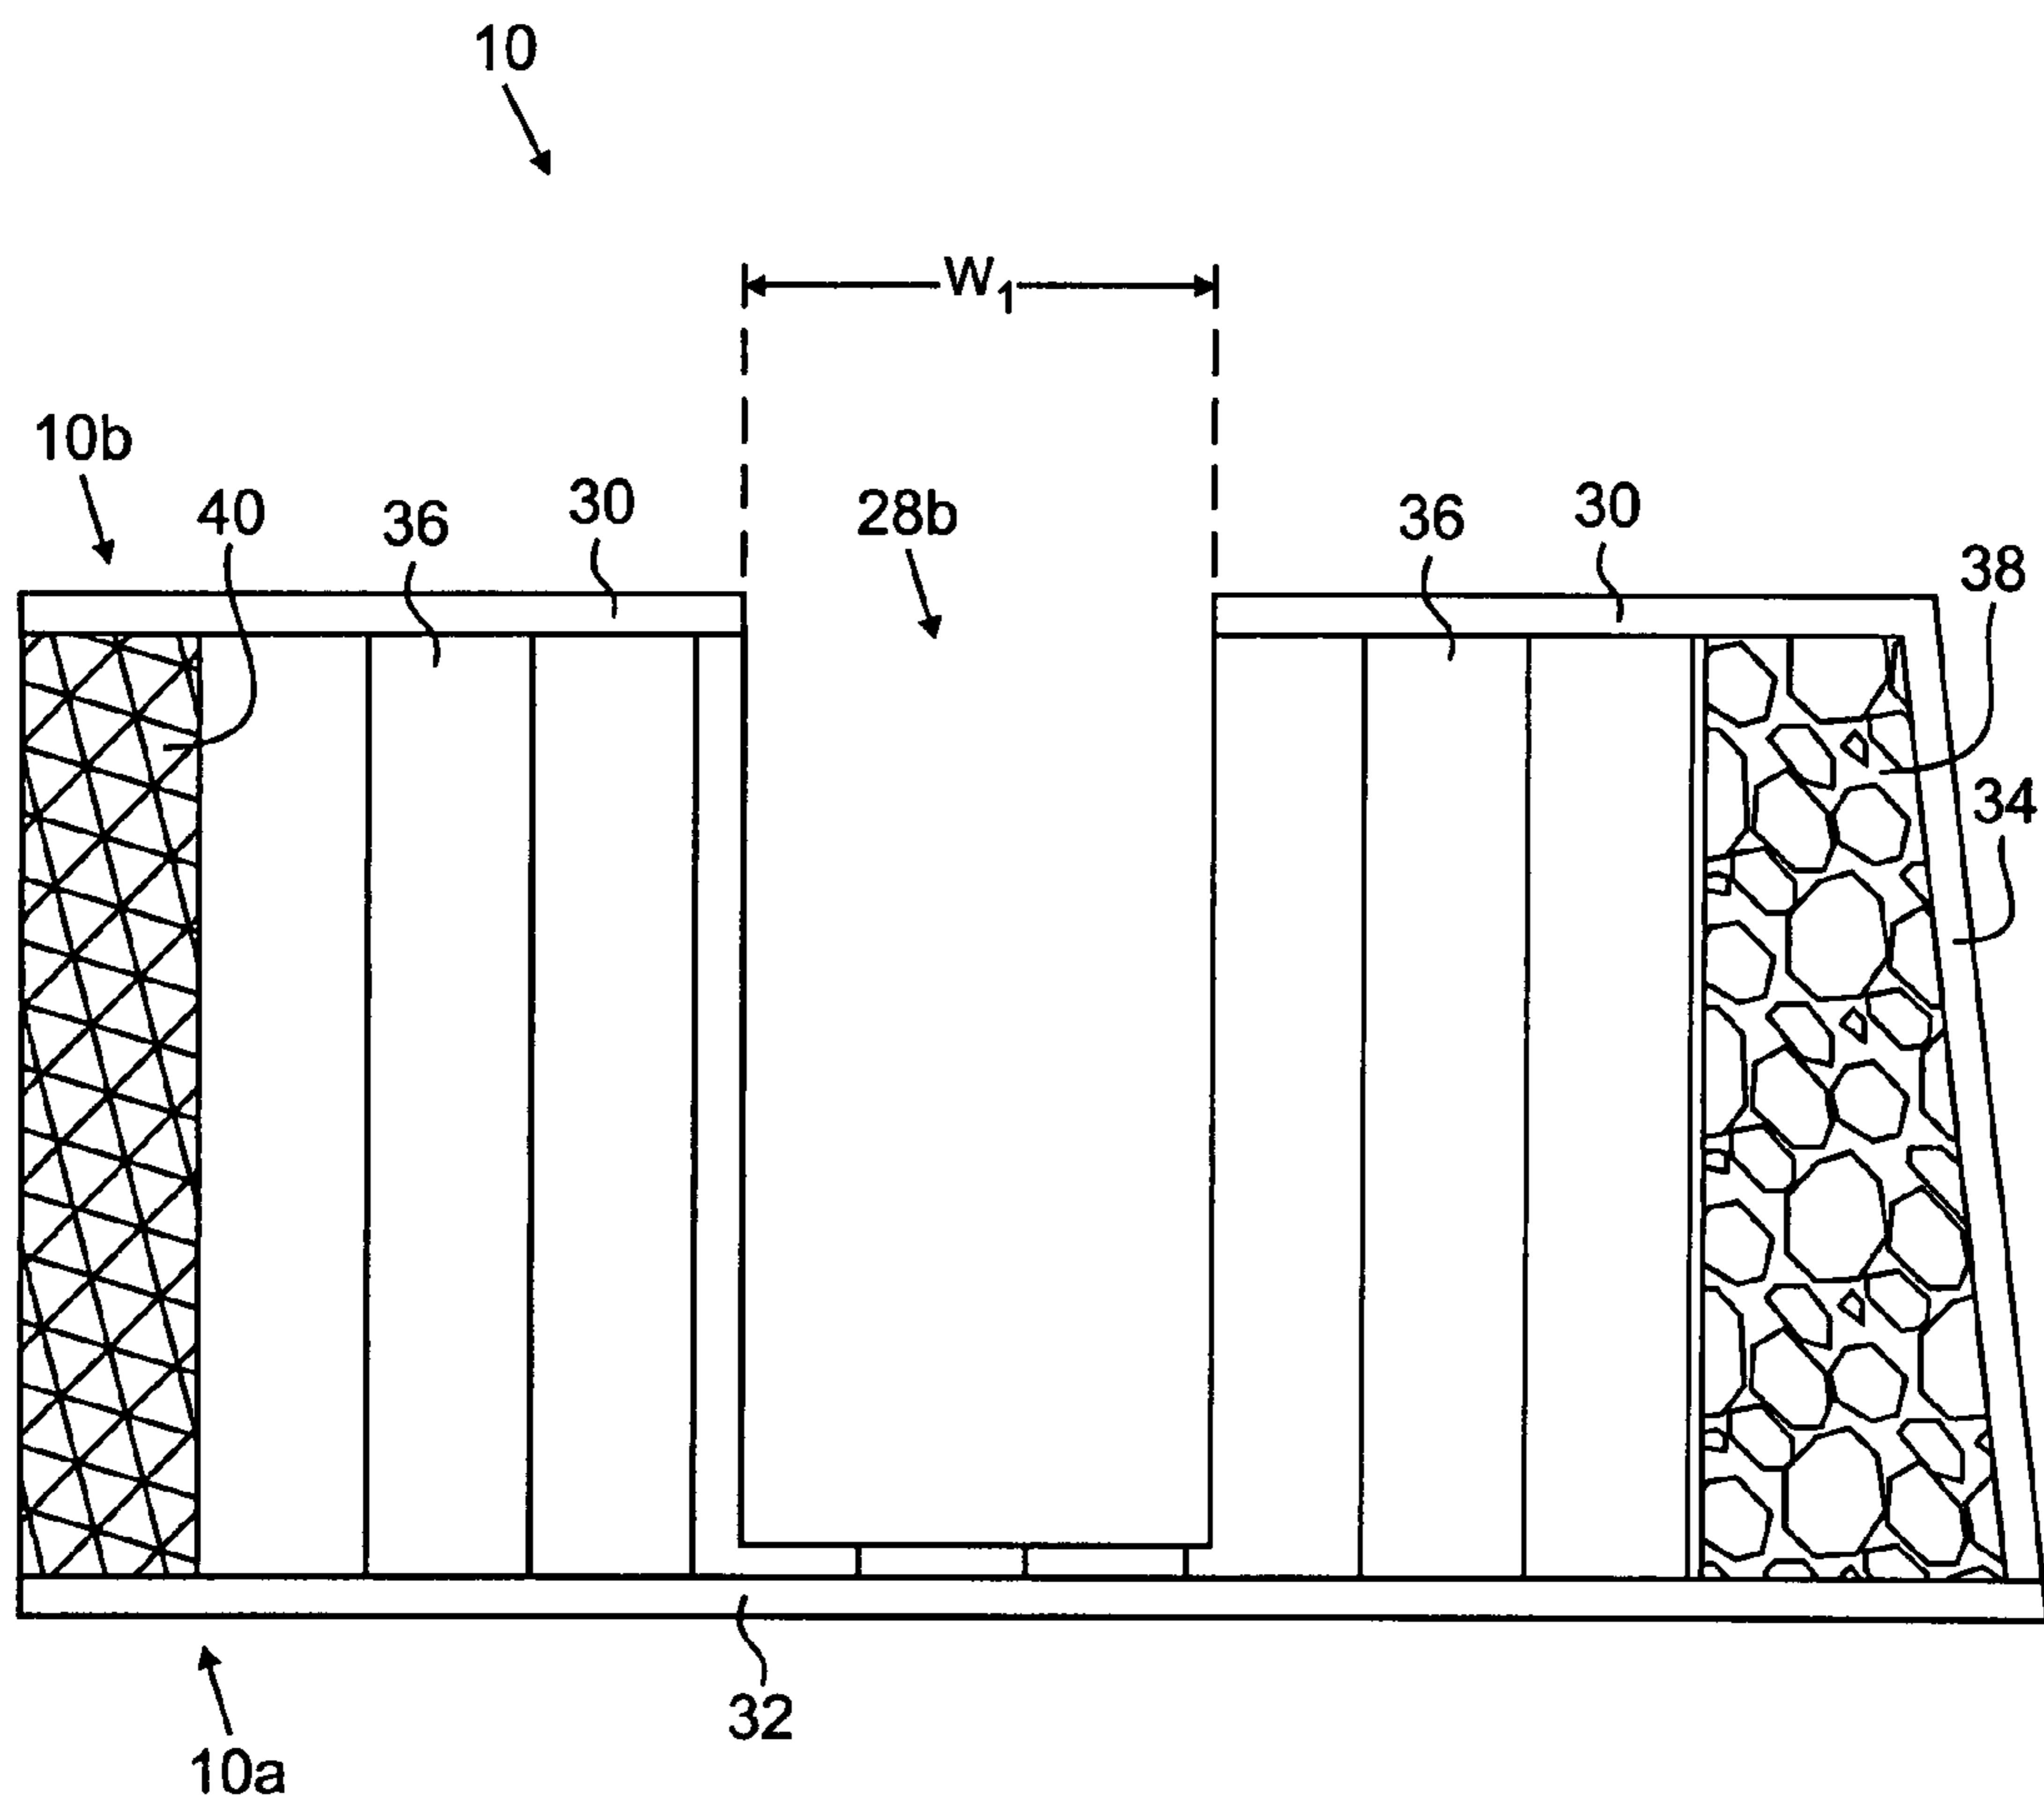
FIG. 3 is a cross-sectional view of a portion of the acoustic liner of FIG. 2 illustrating a slot formed in the acoustic liner (a first step in the repair) for receiving a stiffener.

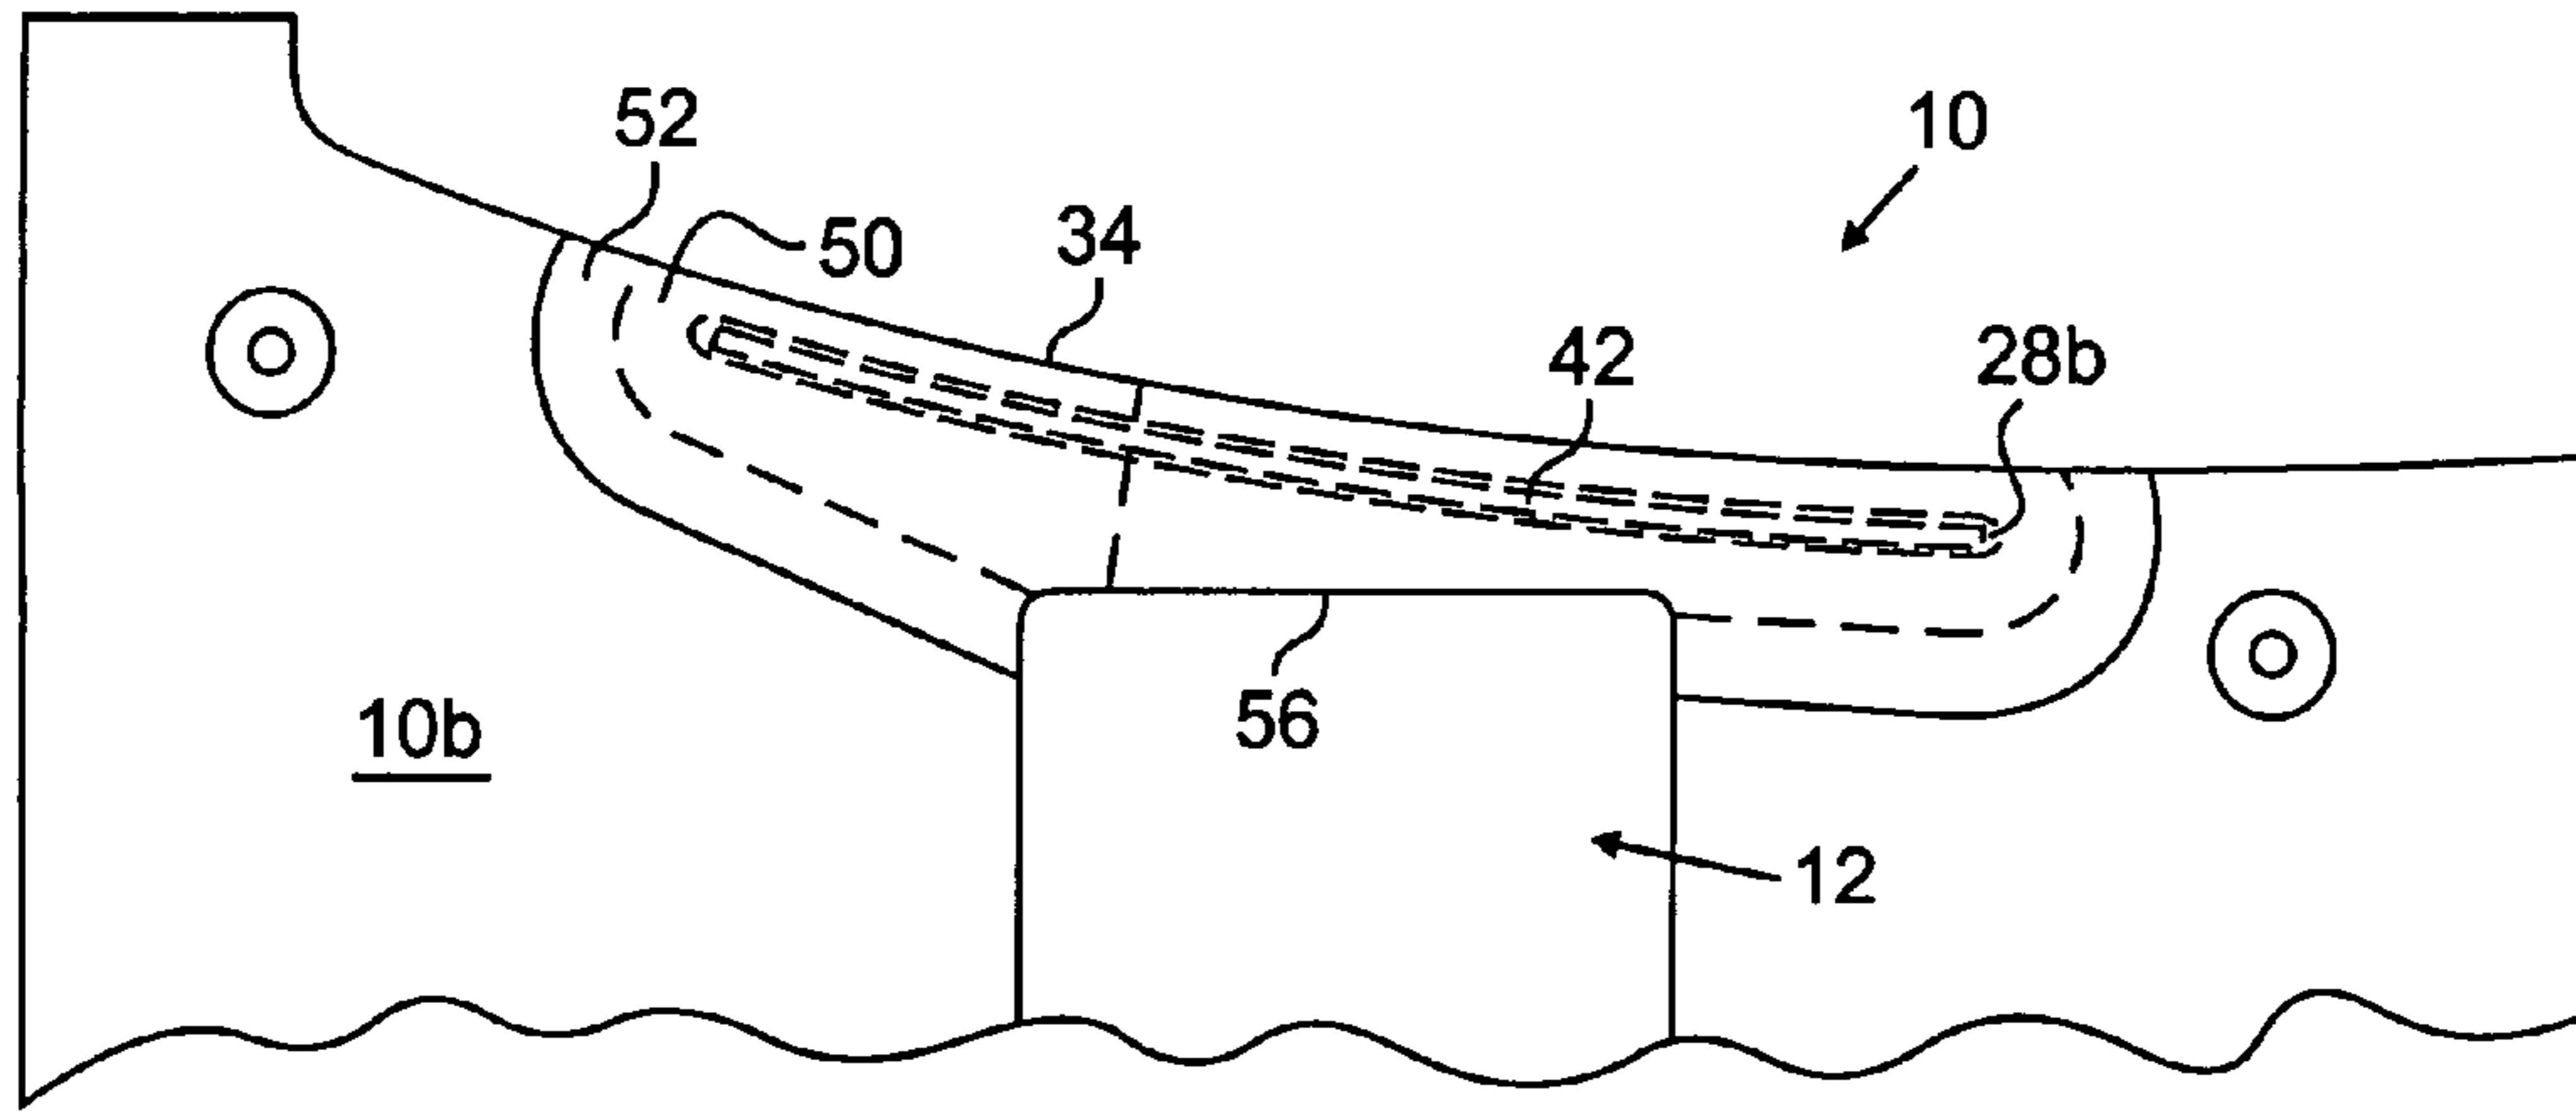
FIG. 7 is a back-view of the acoustic liner following the repair steps illustrated in FIGS. 4-6.

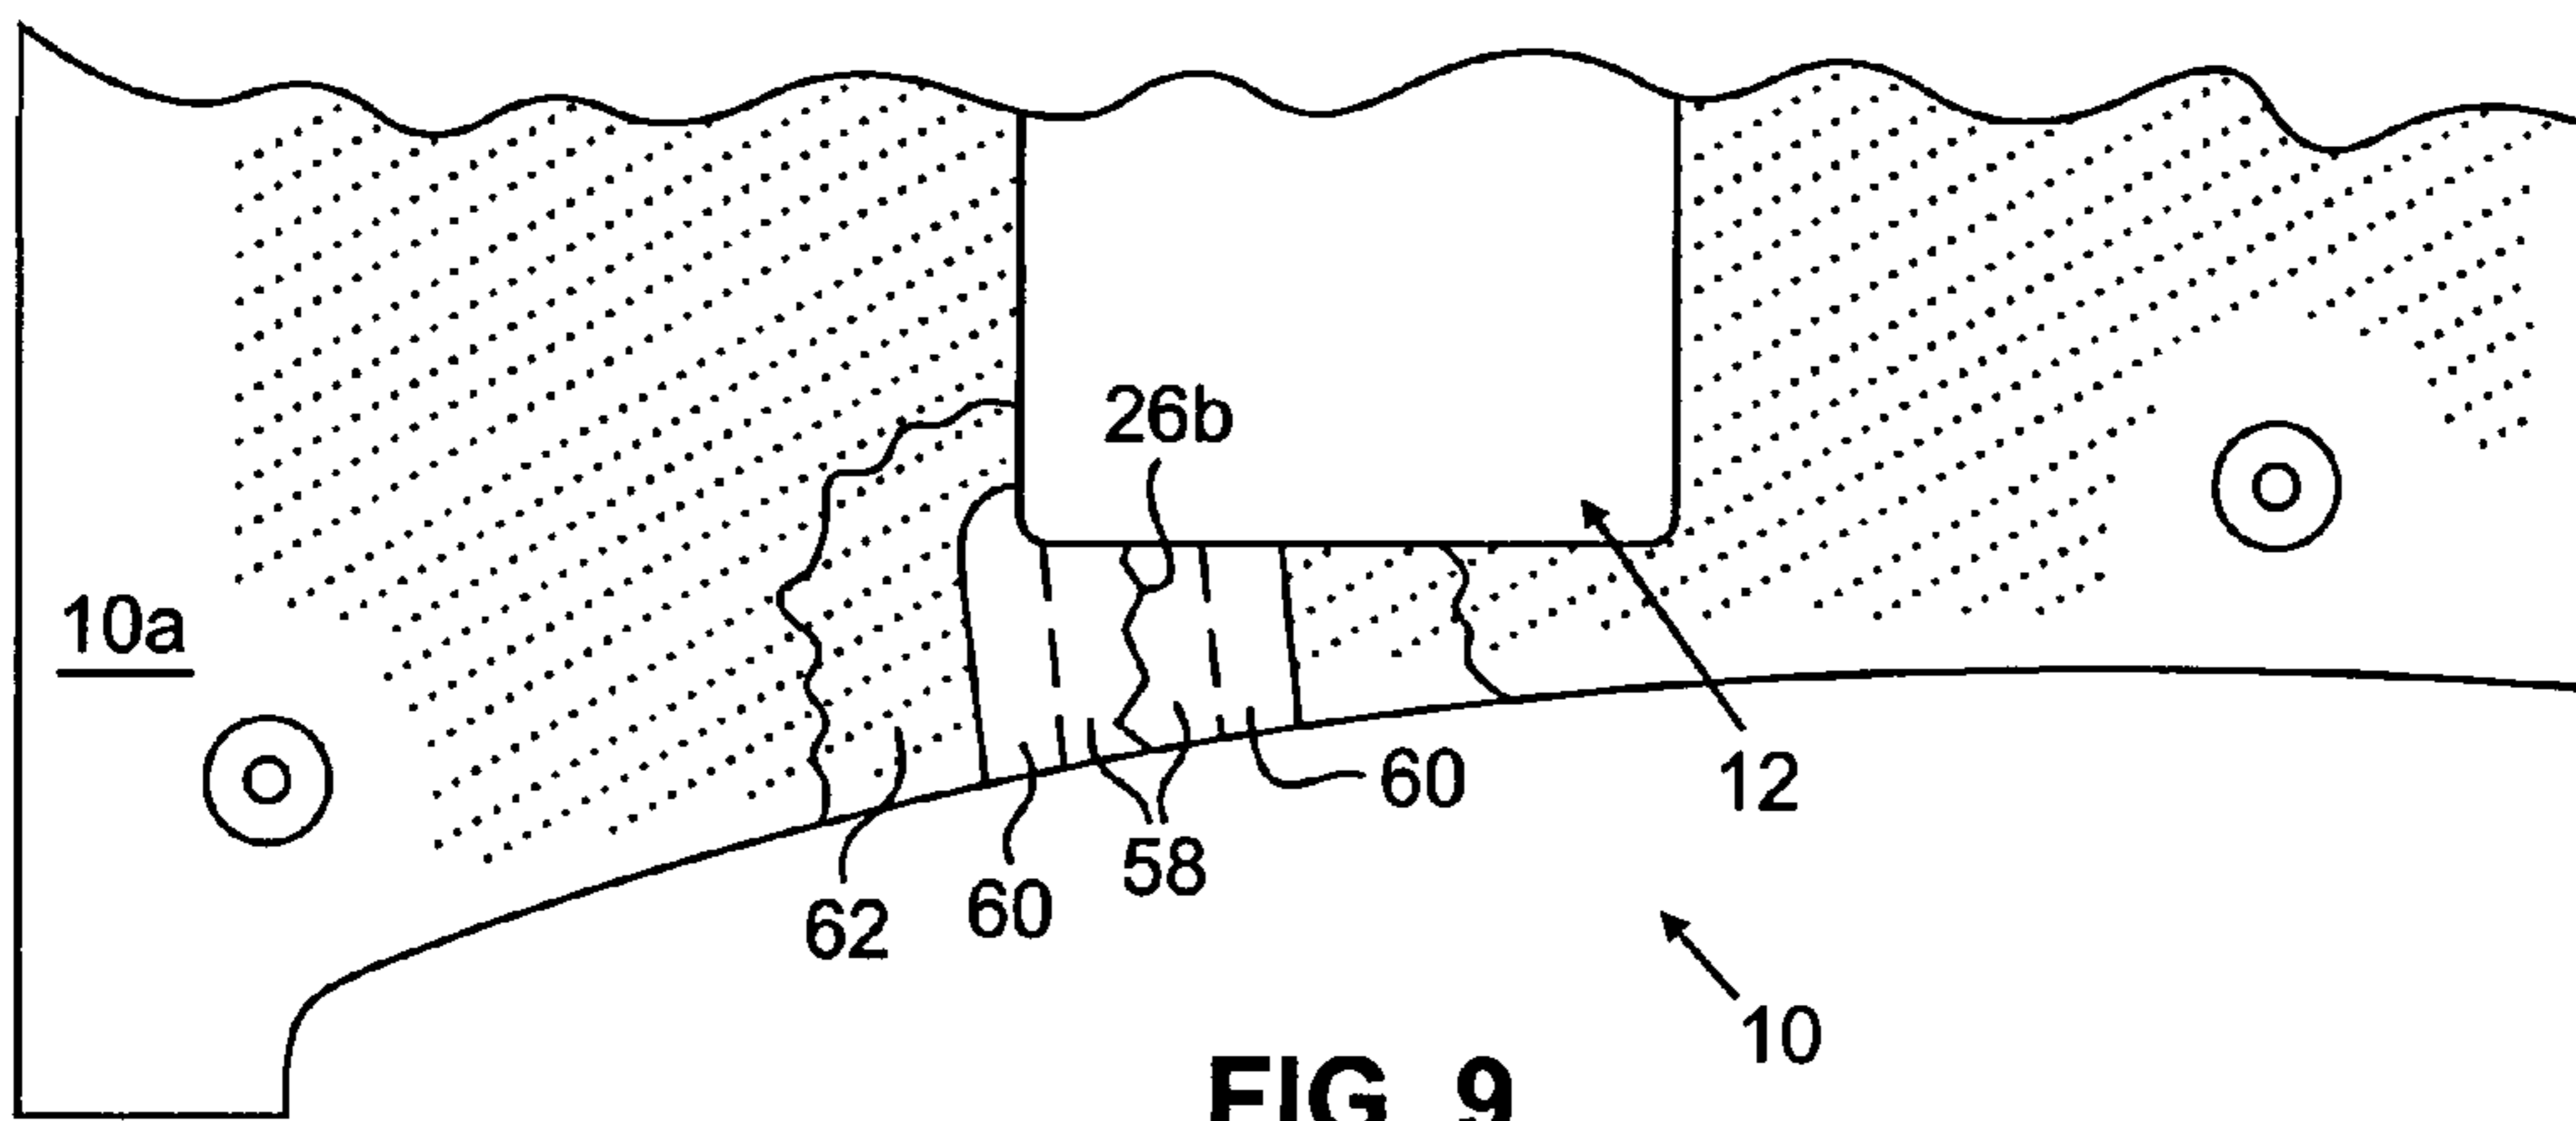
FIG. 9 is a front-view of the acoustic liner following the step illustrated in FIG. 8.

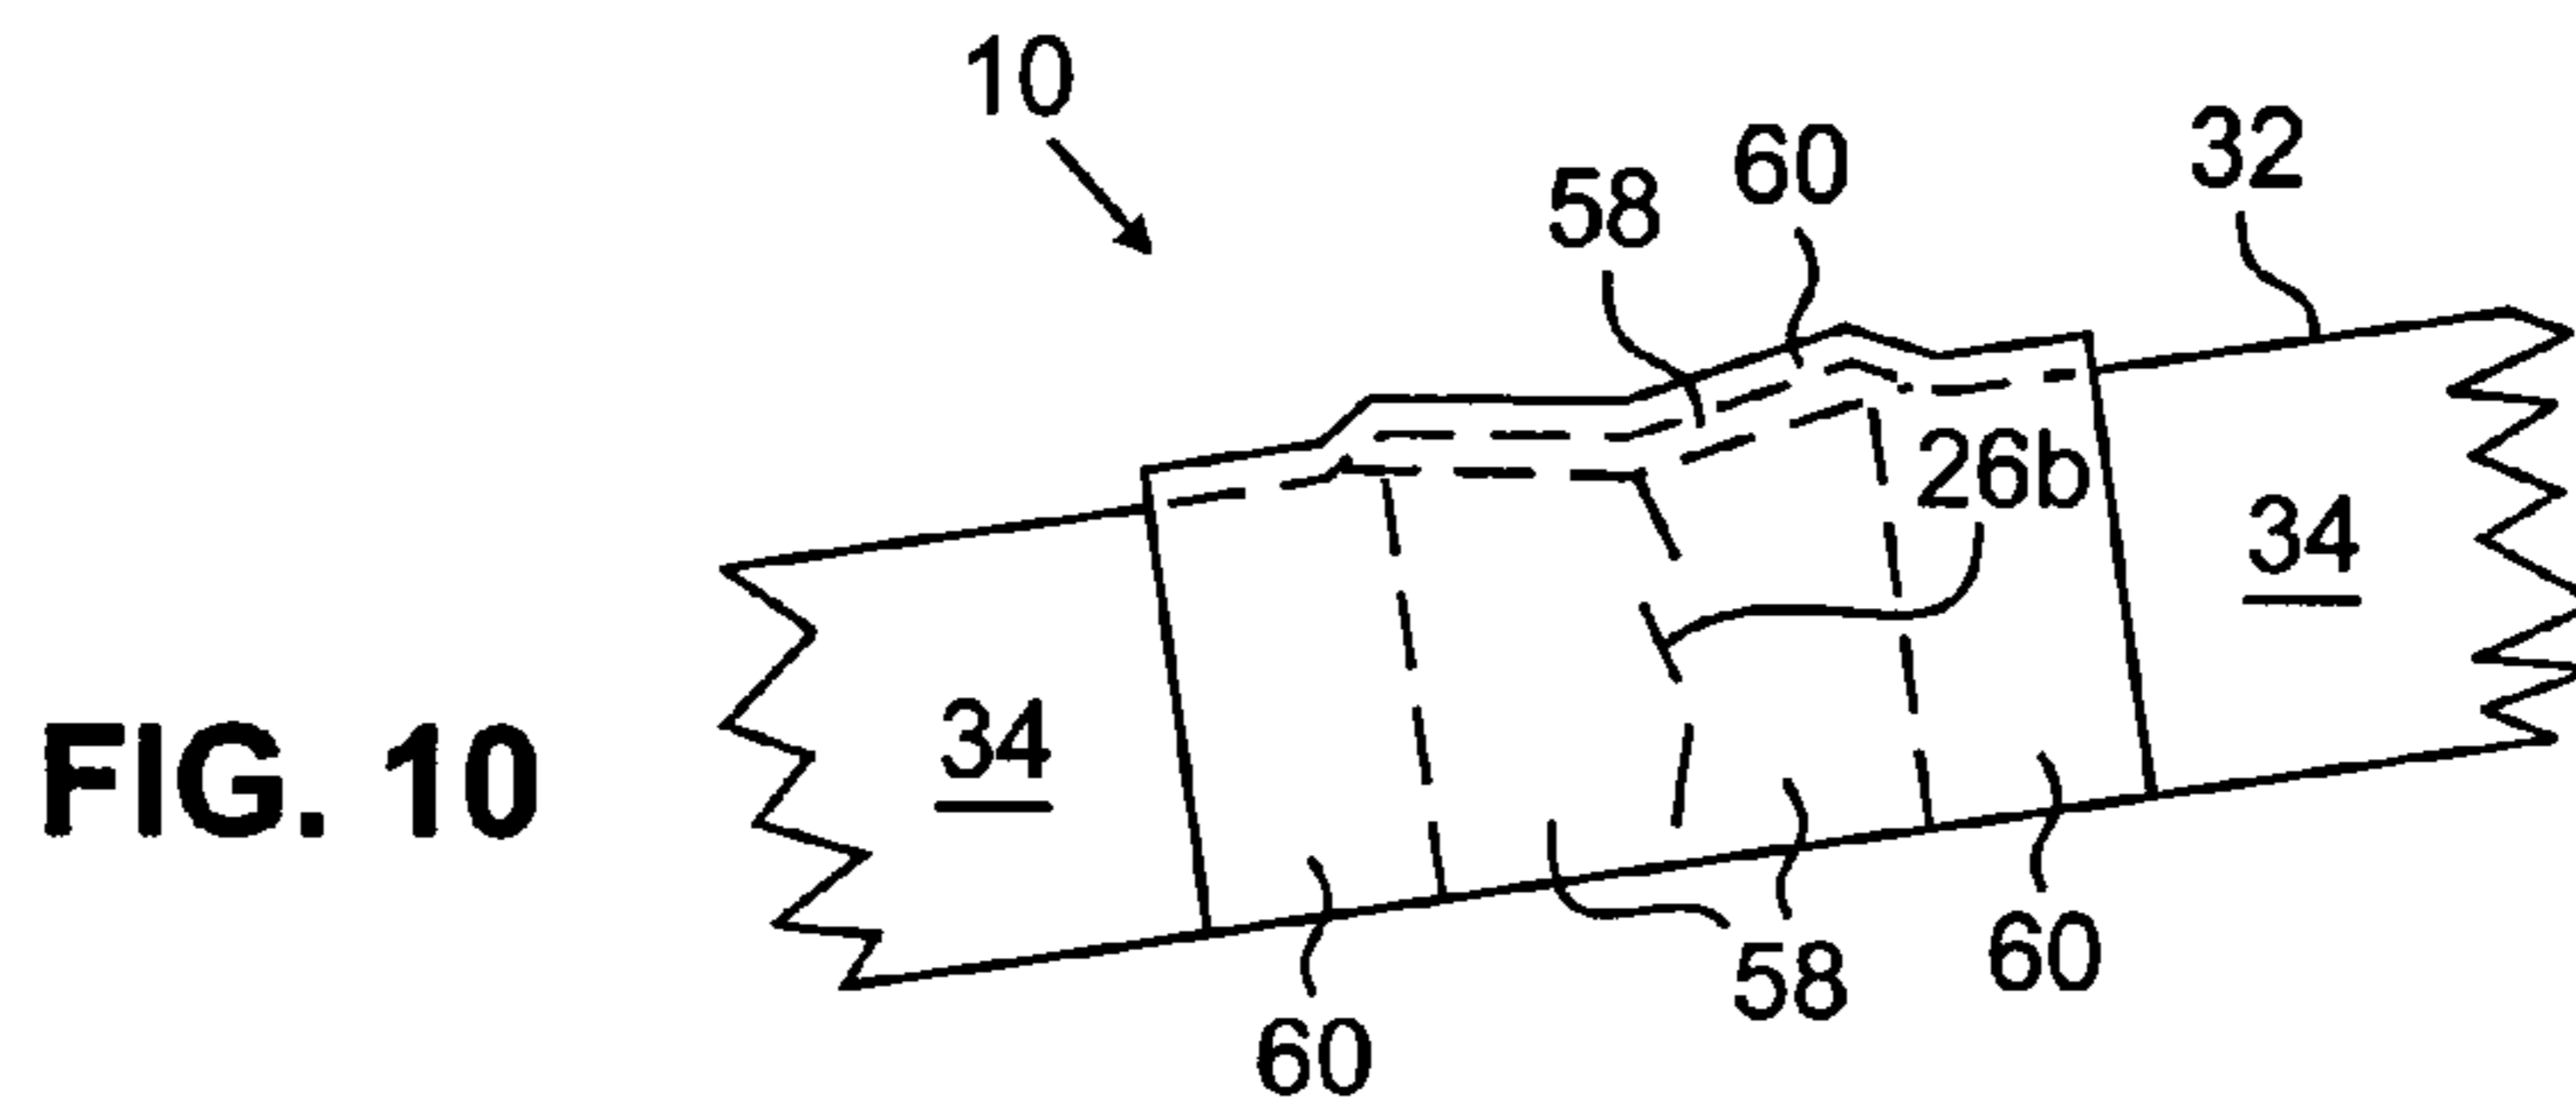
FIG. 10 is a side-view of a portion of the acoustic liner of FIG. 9.
