(54) **USING A STIFFENER TO REPAIR A PART FOR AN AIRCRAFT ENGINE**

A method of repairing a part, which has a first side, a second side opposite of the first side, and an aperture that makes the part susceptible to cracking, includes the steps of forming a slot in the first side of the part near the aperture, inserting a stiffener into the slot, and attaching at least one repair ply onto the first side of the part to cover the stiffener.

## USING A STIFFENER TO REPAIR A PART FOR AN AIRCRAFT ENGINE

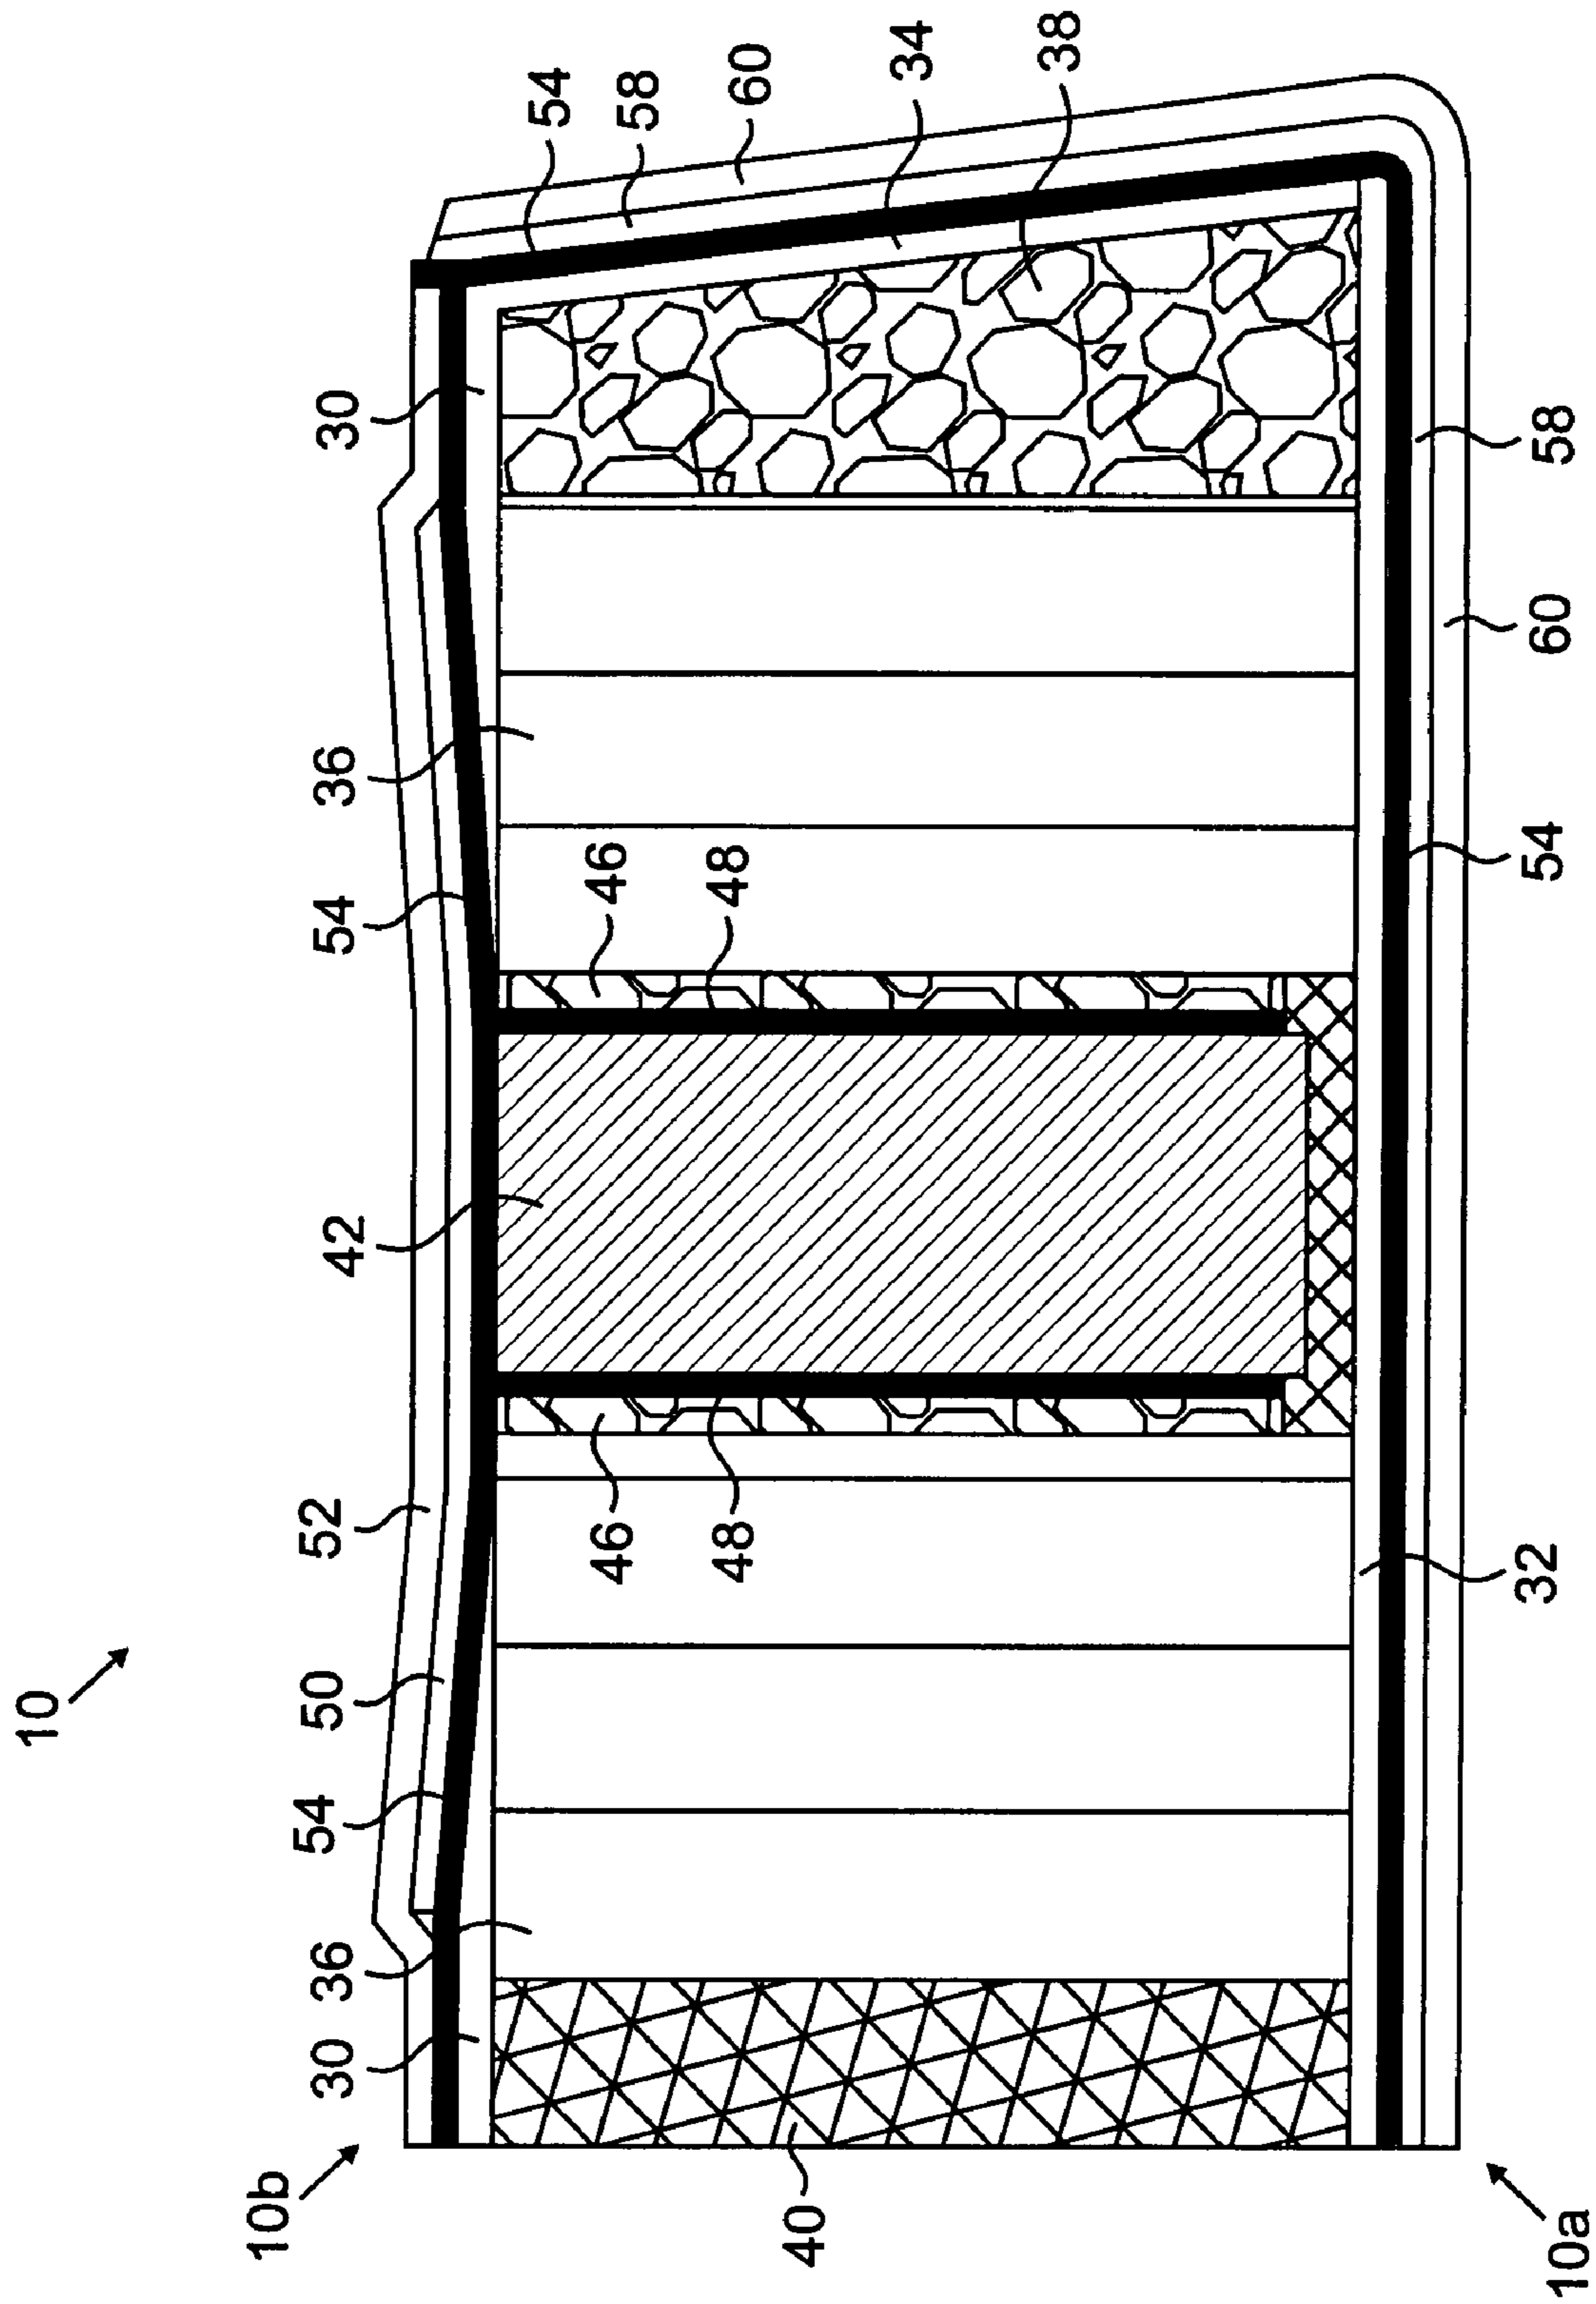
FIG. 8 is a cross-sectional view of the portion of the acoustic liner shown in FIGS. 2 and 4-6 illustrating a final step in the repair process.

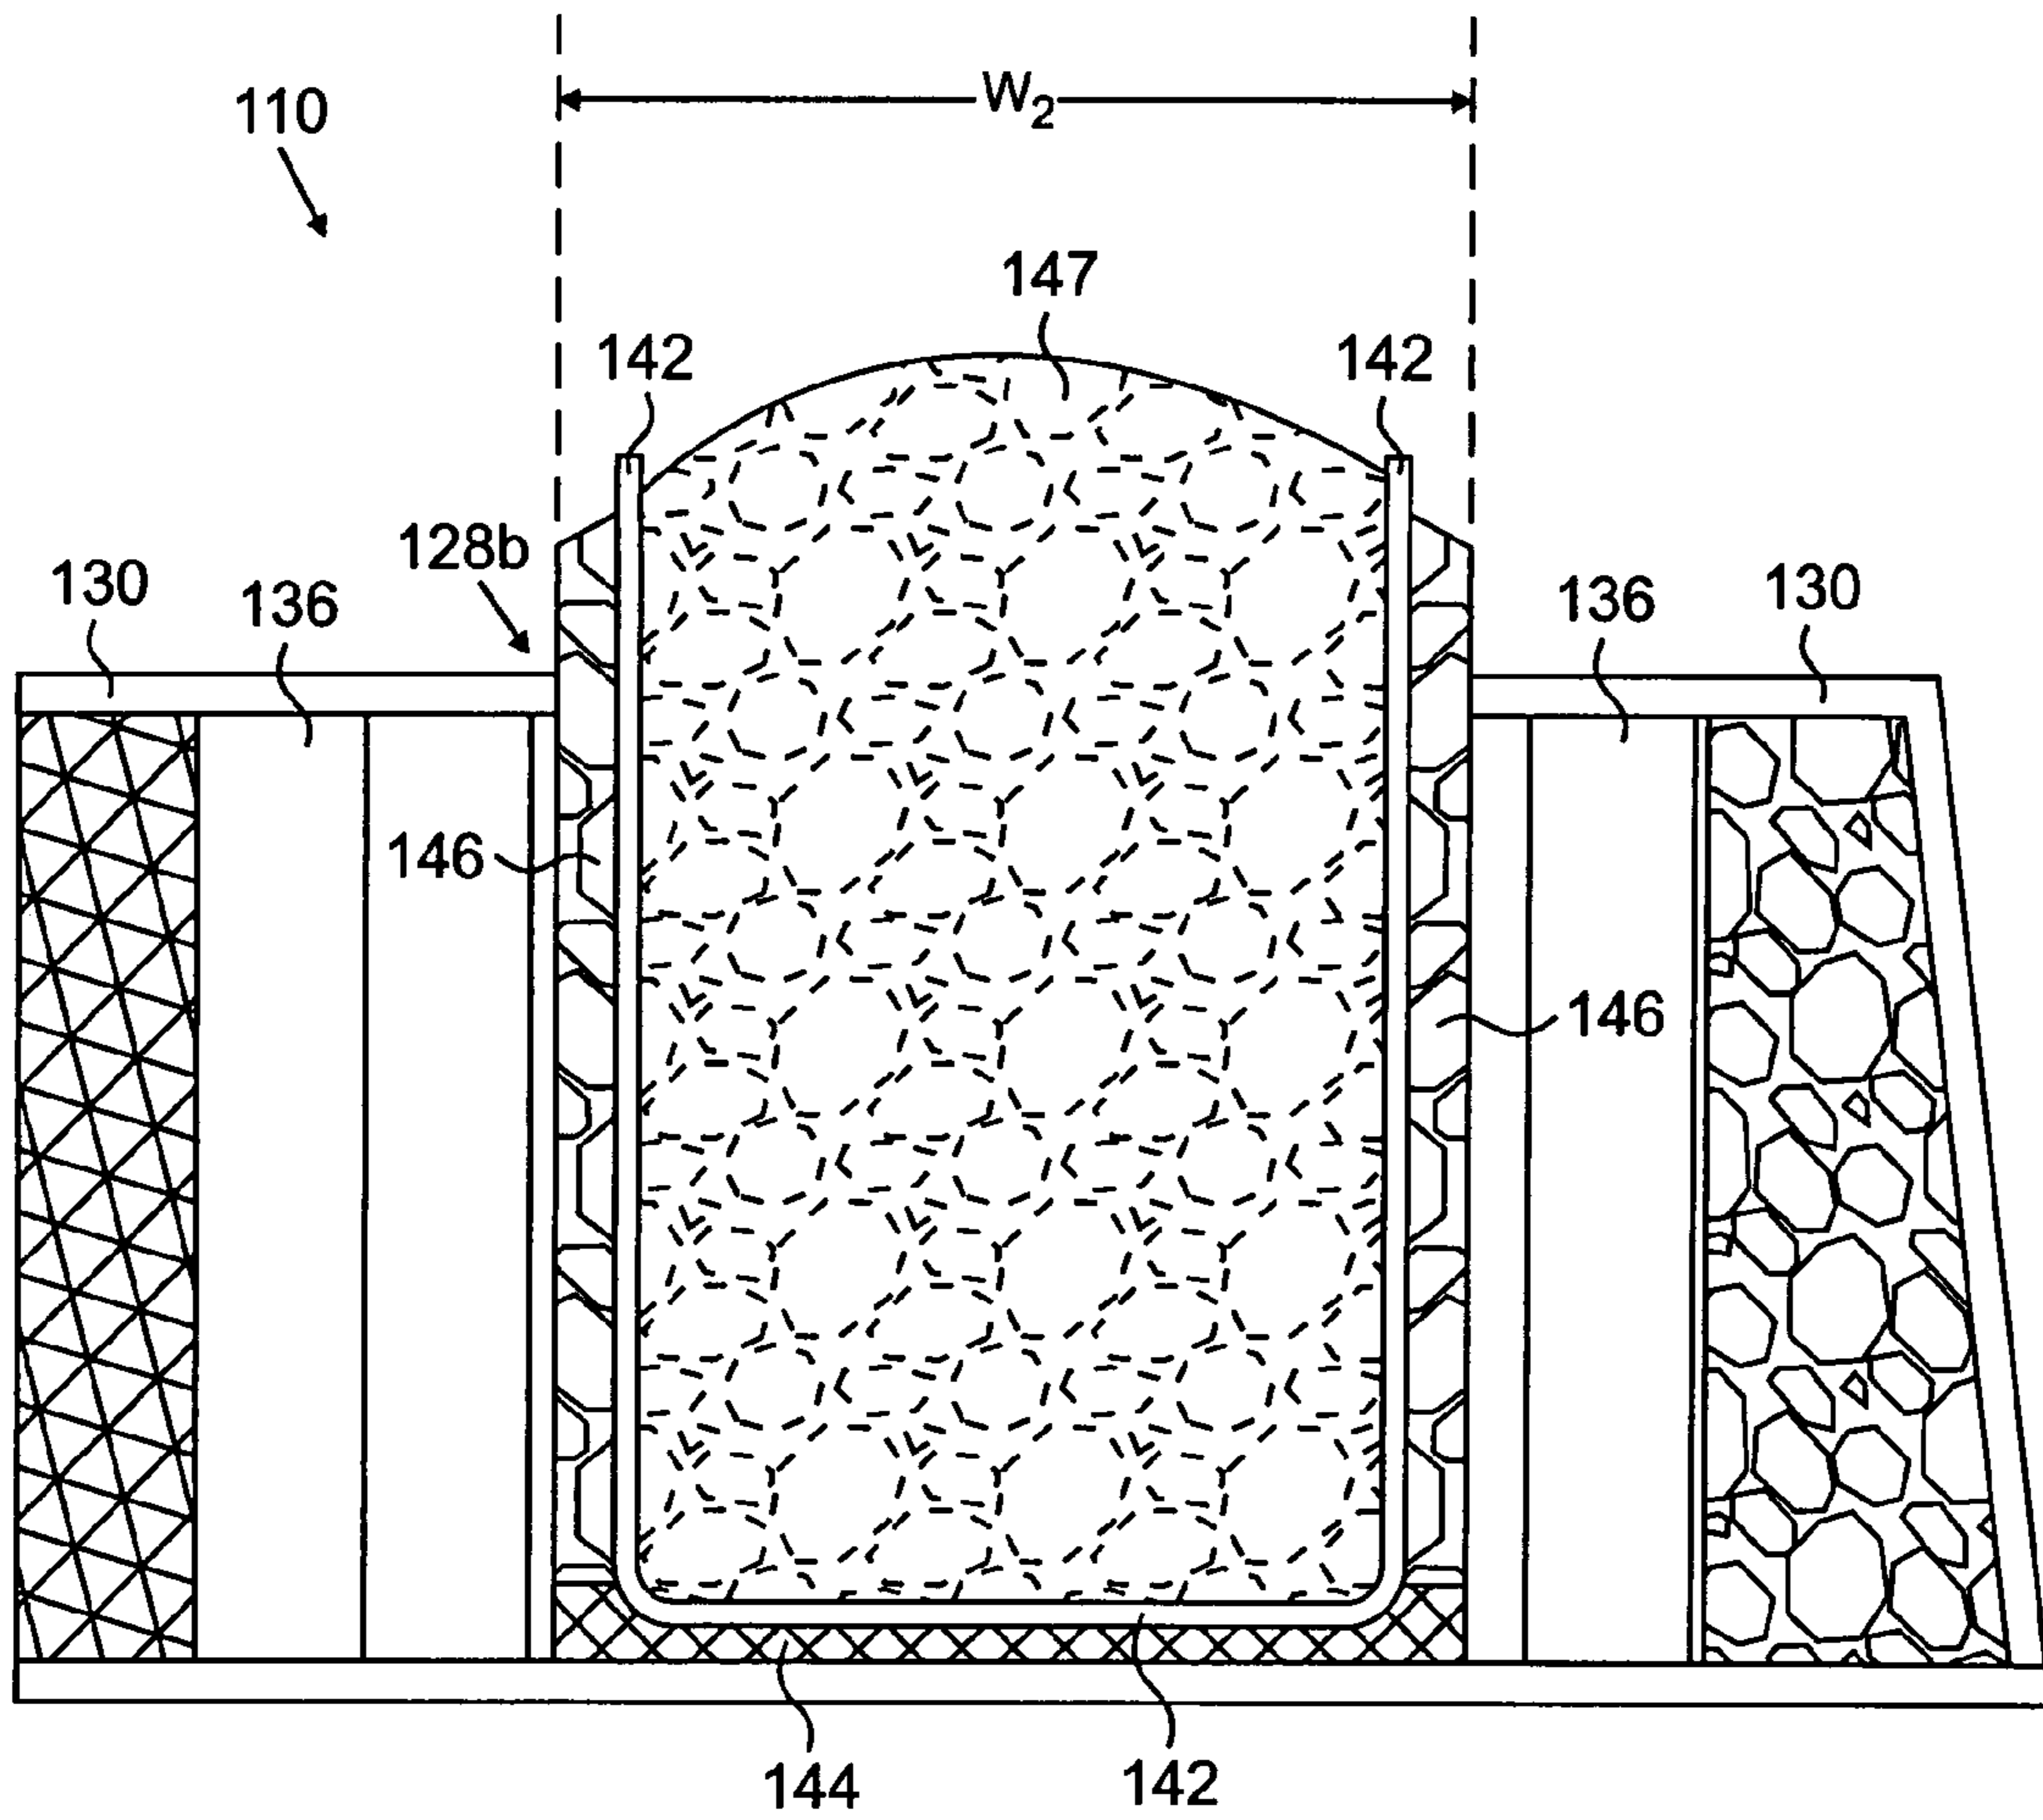
FIG. 11 is a cross-sectional view illustrating another embodiment of the present invention.
