US008220150B2

(54) **SPLIT VANE CLUSTER REPAIR METHOD**

SPLIT VANE CLUSTER REPAIR METHOD

The present invention relates to a method for repairing vanes for gas turbine engines, and more particularly to a method suitable for repairing high pressure turbine (HPT) nozzle segments for gas turbine engines.

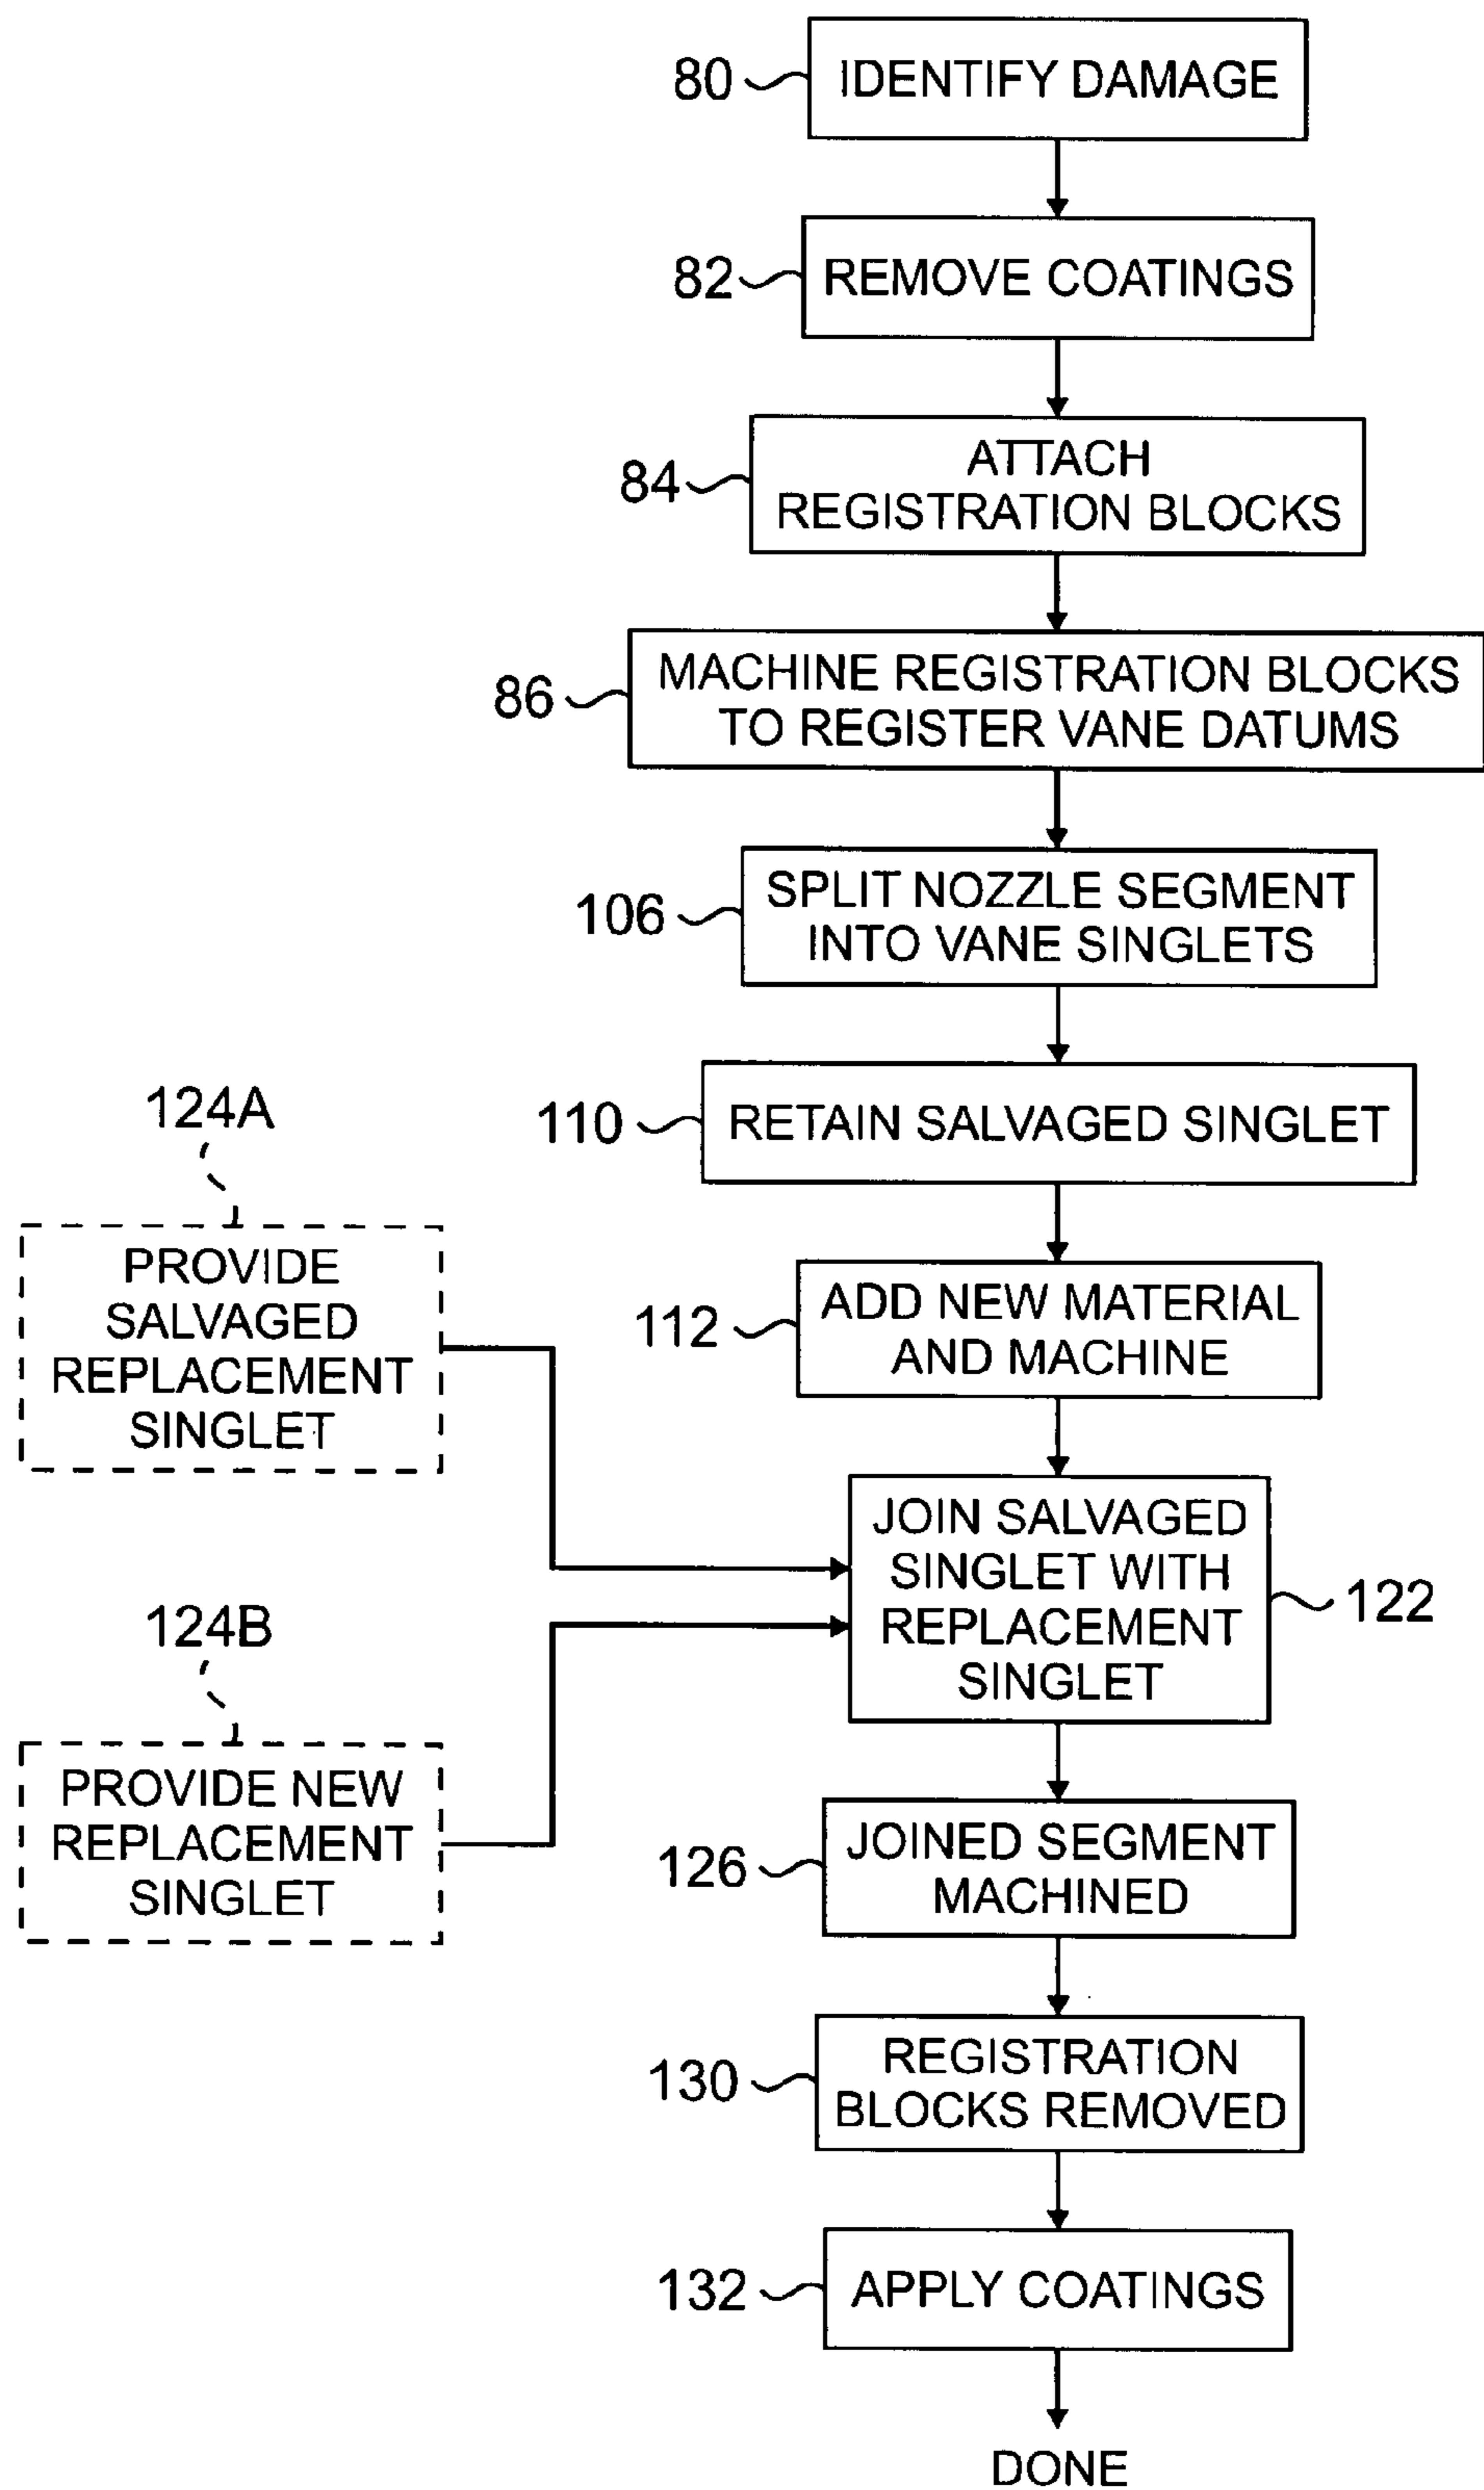
FIG. 1 is a flow chart of a repair method according to the present invention.

In use, HPT nozzle segments can become damaged due to corrosion, wear, or other factors. FIG. 1 is a flow chart of a method for repairing an HPT nozzle segment. Steps in the repair process shown in FIG. 1 are explained in detail below with reference to FIGS. 2-5. A first step of the process illustrated in FIG. 1 involves identifying damage to the HPT nozzle segment (step 80), which can include the identification of repairable damage and non-repairable damage. Damage identification (step 80) also includes identifying at least one half of the segment that is salvageable, that is, a half of the segment that can be reused either with or without repair. In order for a component to be considered repairable, the component or a portion thereof must generally have damage that falls within repairable limits for intended repair processes

Turning again to the flow chart of FIG. 1, the next step in the repair process is to split the nozzle segment 88 into two parts (step 106). The nozzle segment 88 is cut apart approximately in half, to form two "singlets" (or airfoil segments), which are structures having a single airfoil 108 located between portions of the outer and inner platforms 96 and 98. The nozzle segment 88 can be cut apart using wire electrical discharge machining (EDM), or other suitable processes. The nozzle segment 88 is often manufactured as two casting singlets that are brazed together. When the nozzle segment 88 is cut apart during step 106 of the repair process, the cut is generally made at or near the original braze location joining the original cast singlets. In FIG. 2, a cut location 108 for splitting the vane segment 88 into two singlets is shown at or near an original braze location of the nozzle segment 88. Typically the cut is made at the location 108, which divides the nozzle segment 88 into two substantially equal halves or singlets, although in alternative embodiments of the present repair method a cut could be made at a different location. The

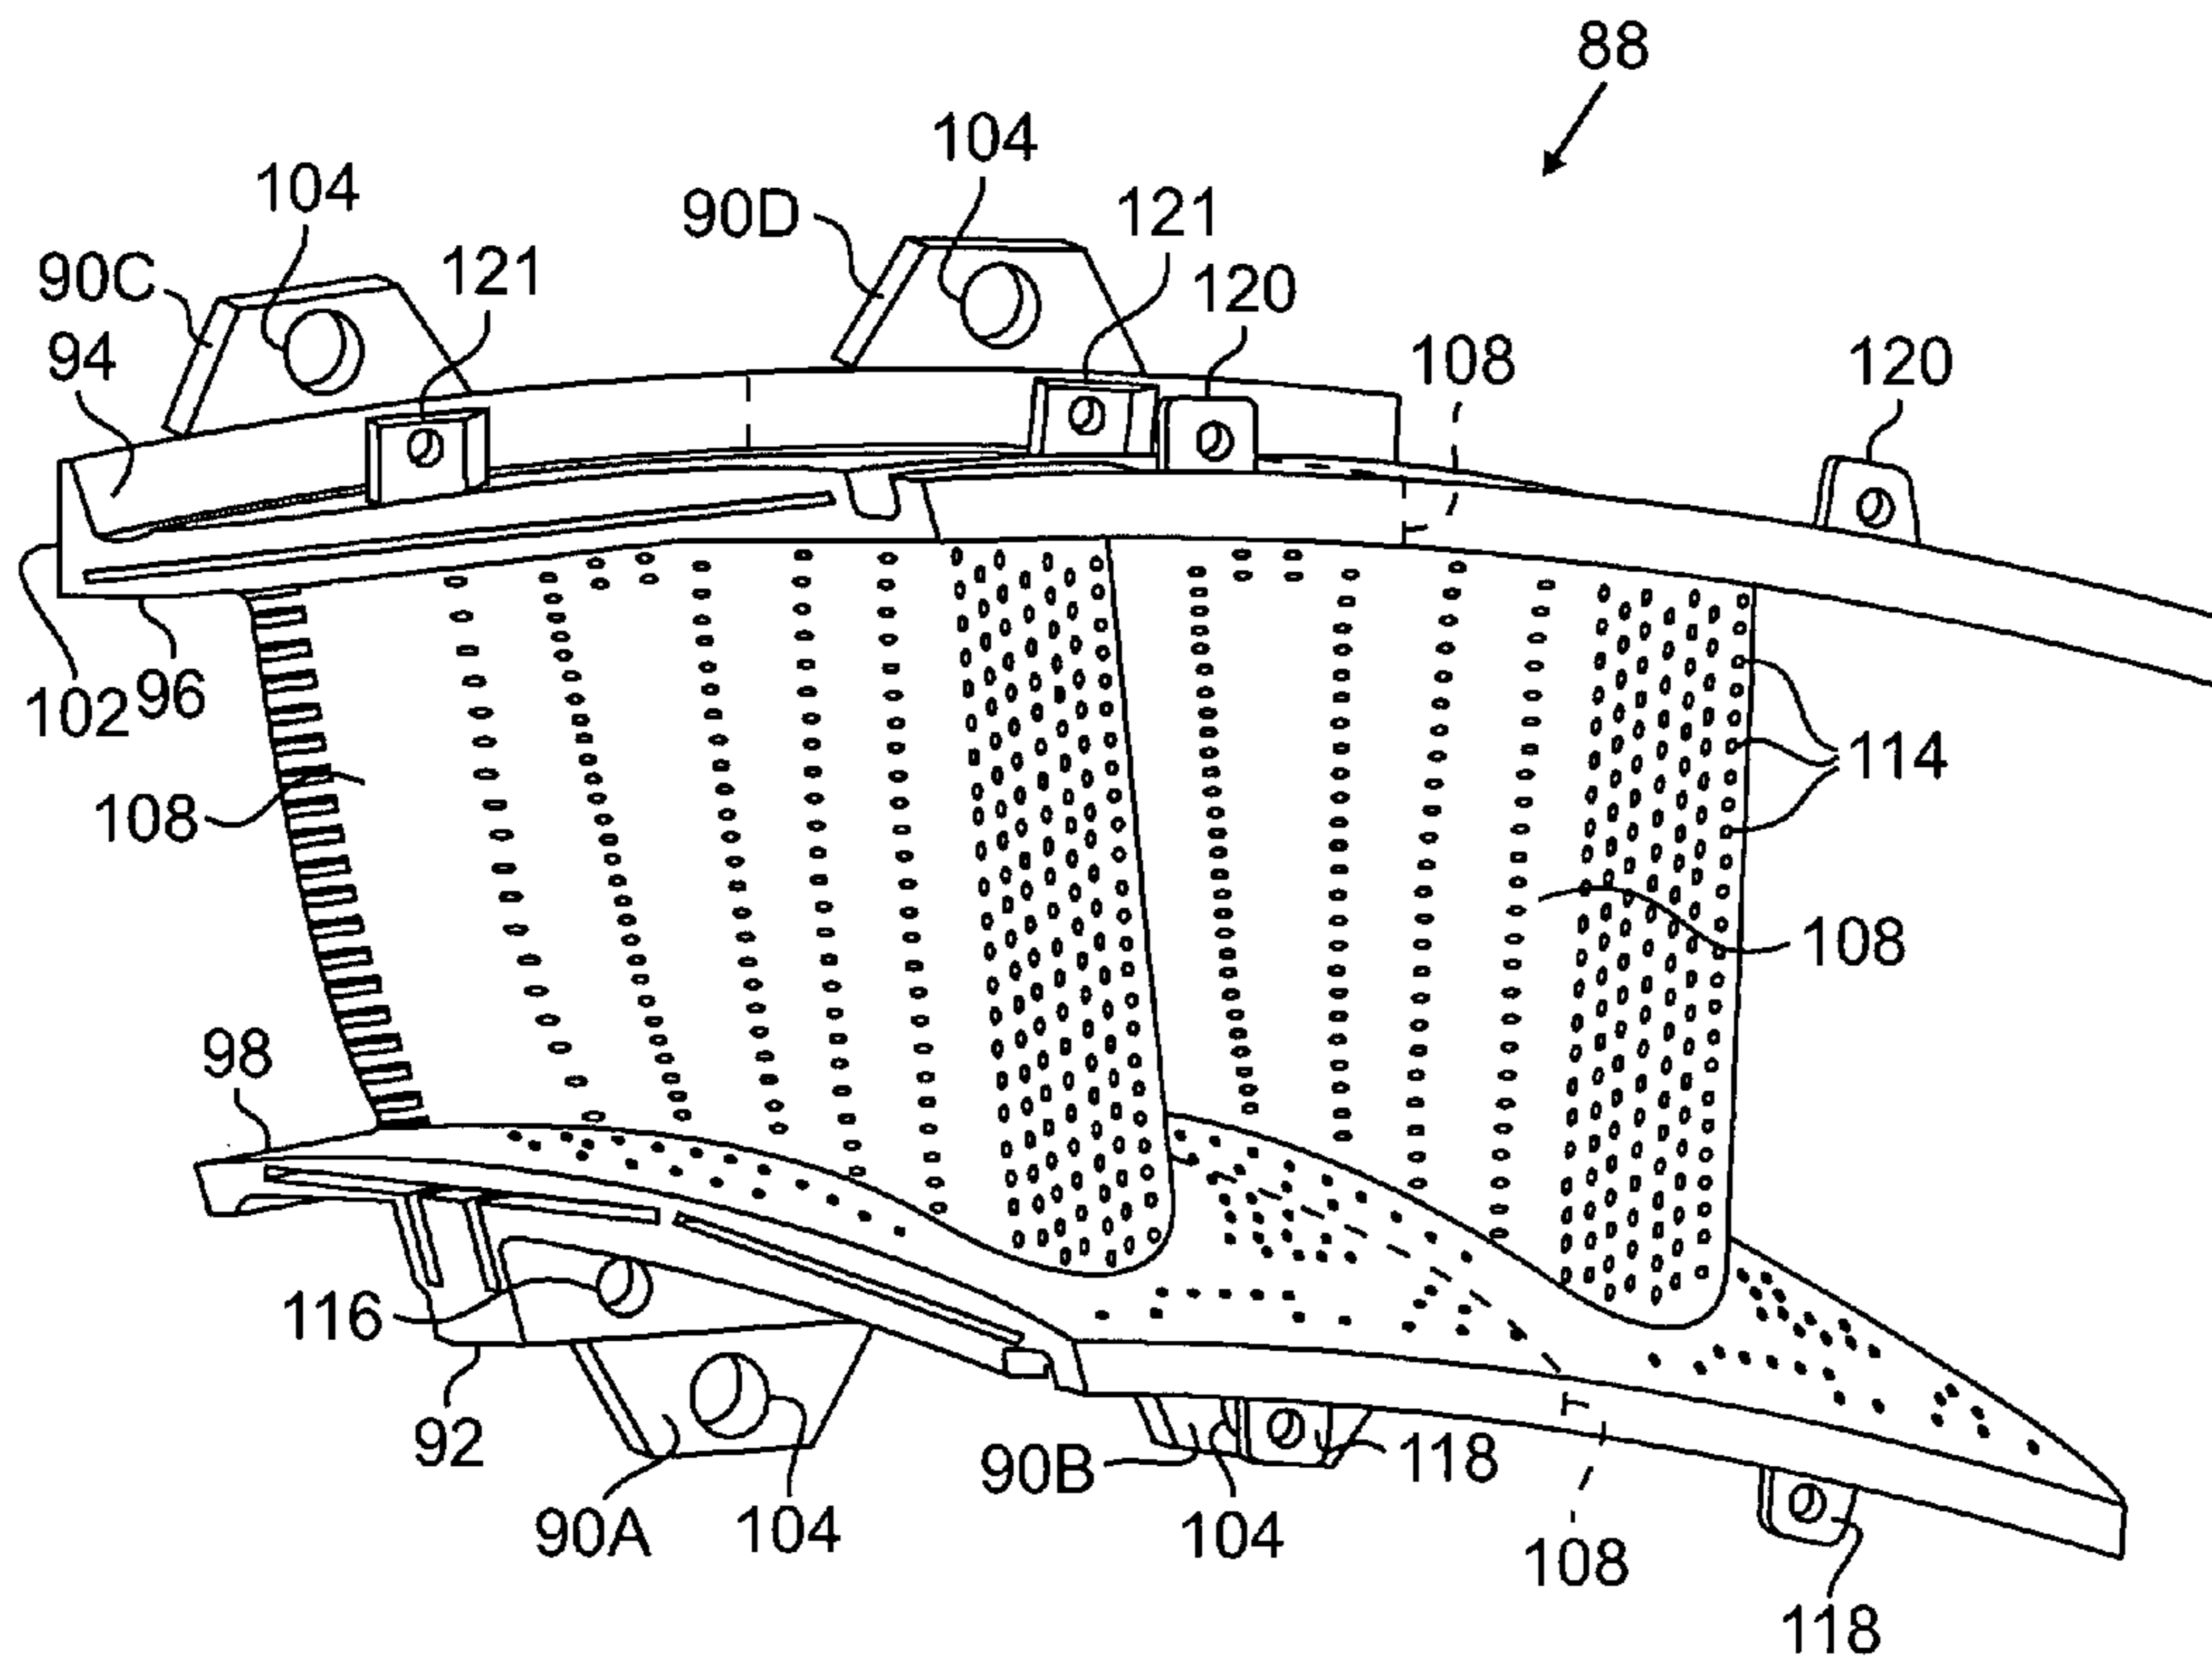
FIG. 2 is a perspective view of the HPT nozzle segment having registration blocks attached thereto.

Registration blocks are then attached to the nozzle segment (step 84), which can be accomplished by welding, brazing or other firm attachment processes. Once the registration blocks are attached, they are machined to register vane datums in a desired number of dimensions (step 86). Steps 84 and 86 of the repair process can be better understood with reference to FIG. 2, which is a perspective view of a HPT nozzle segment 88 having machined registration blocks 90A-90D (collectively 90) attached thereto. The registration blocks 90A-90D are each generally trapezoidal-shaped, and are made of a metal such as steel. In the illustrated embodiment, the registration blocks 90A and 90B are attached to an inner side of an inner flange 92 of the nozzle segment 88 and the registration blocks 90C and 90D are attached to an outer side of an outer flange 94, such that the registration blocks 90 are supported by outer and inner platforms 96 and 98 of the nozzle segment 88.

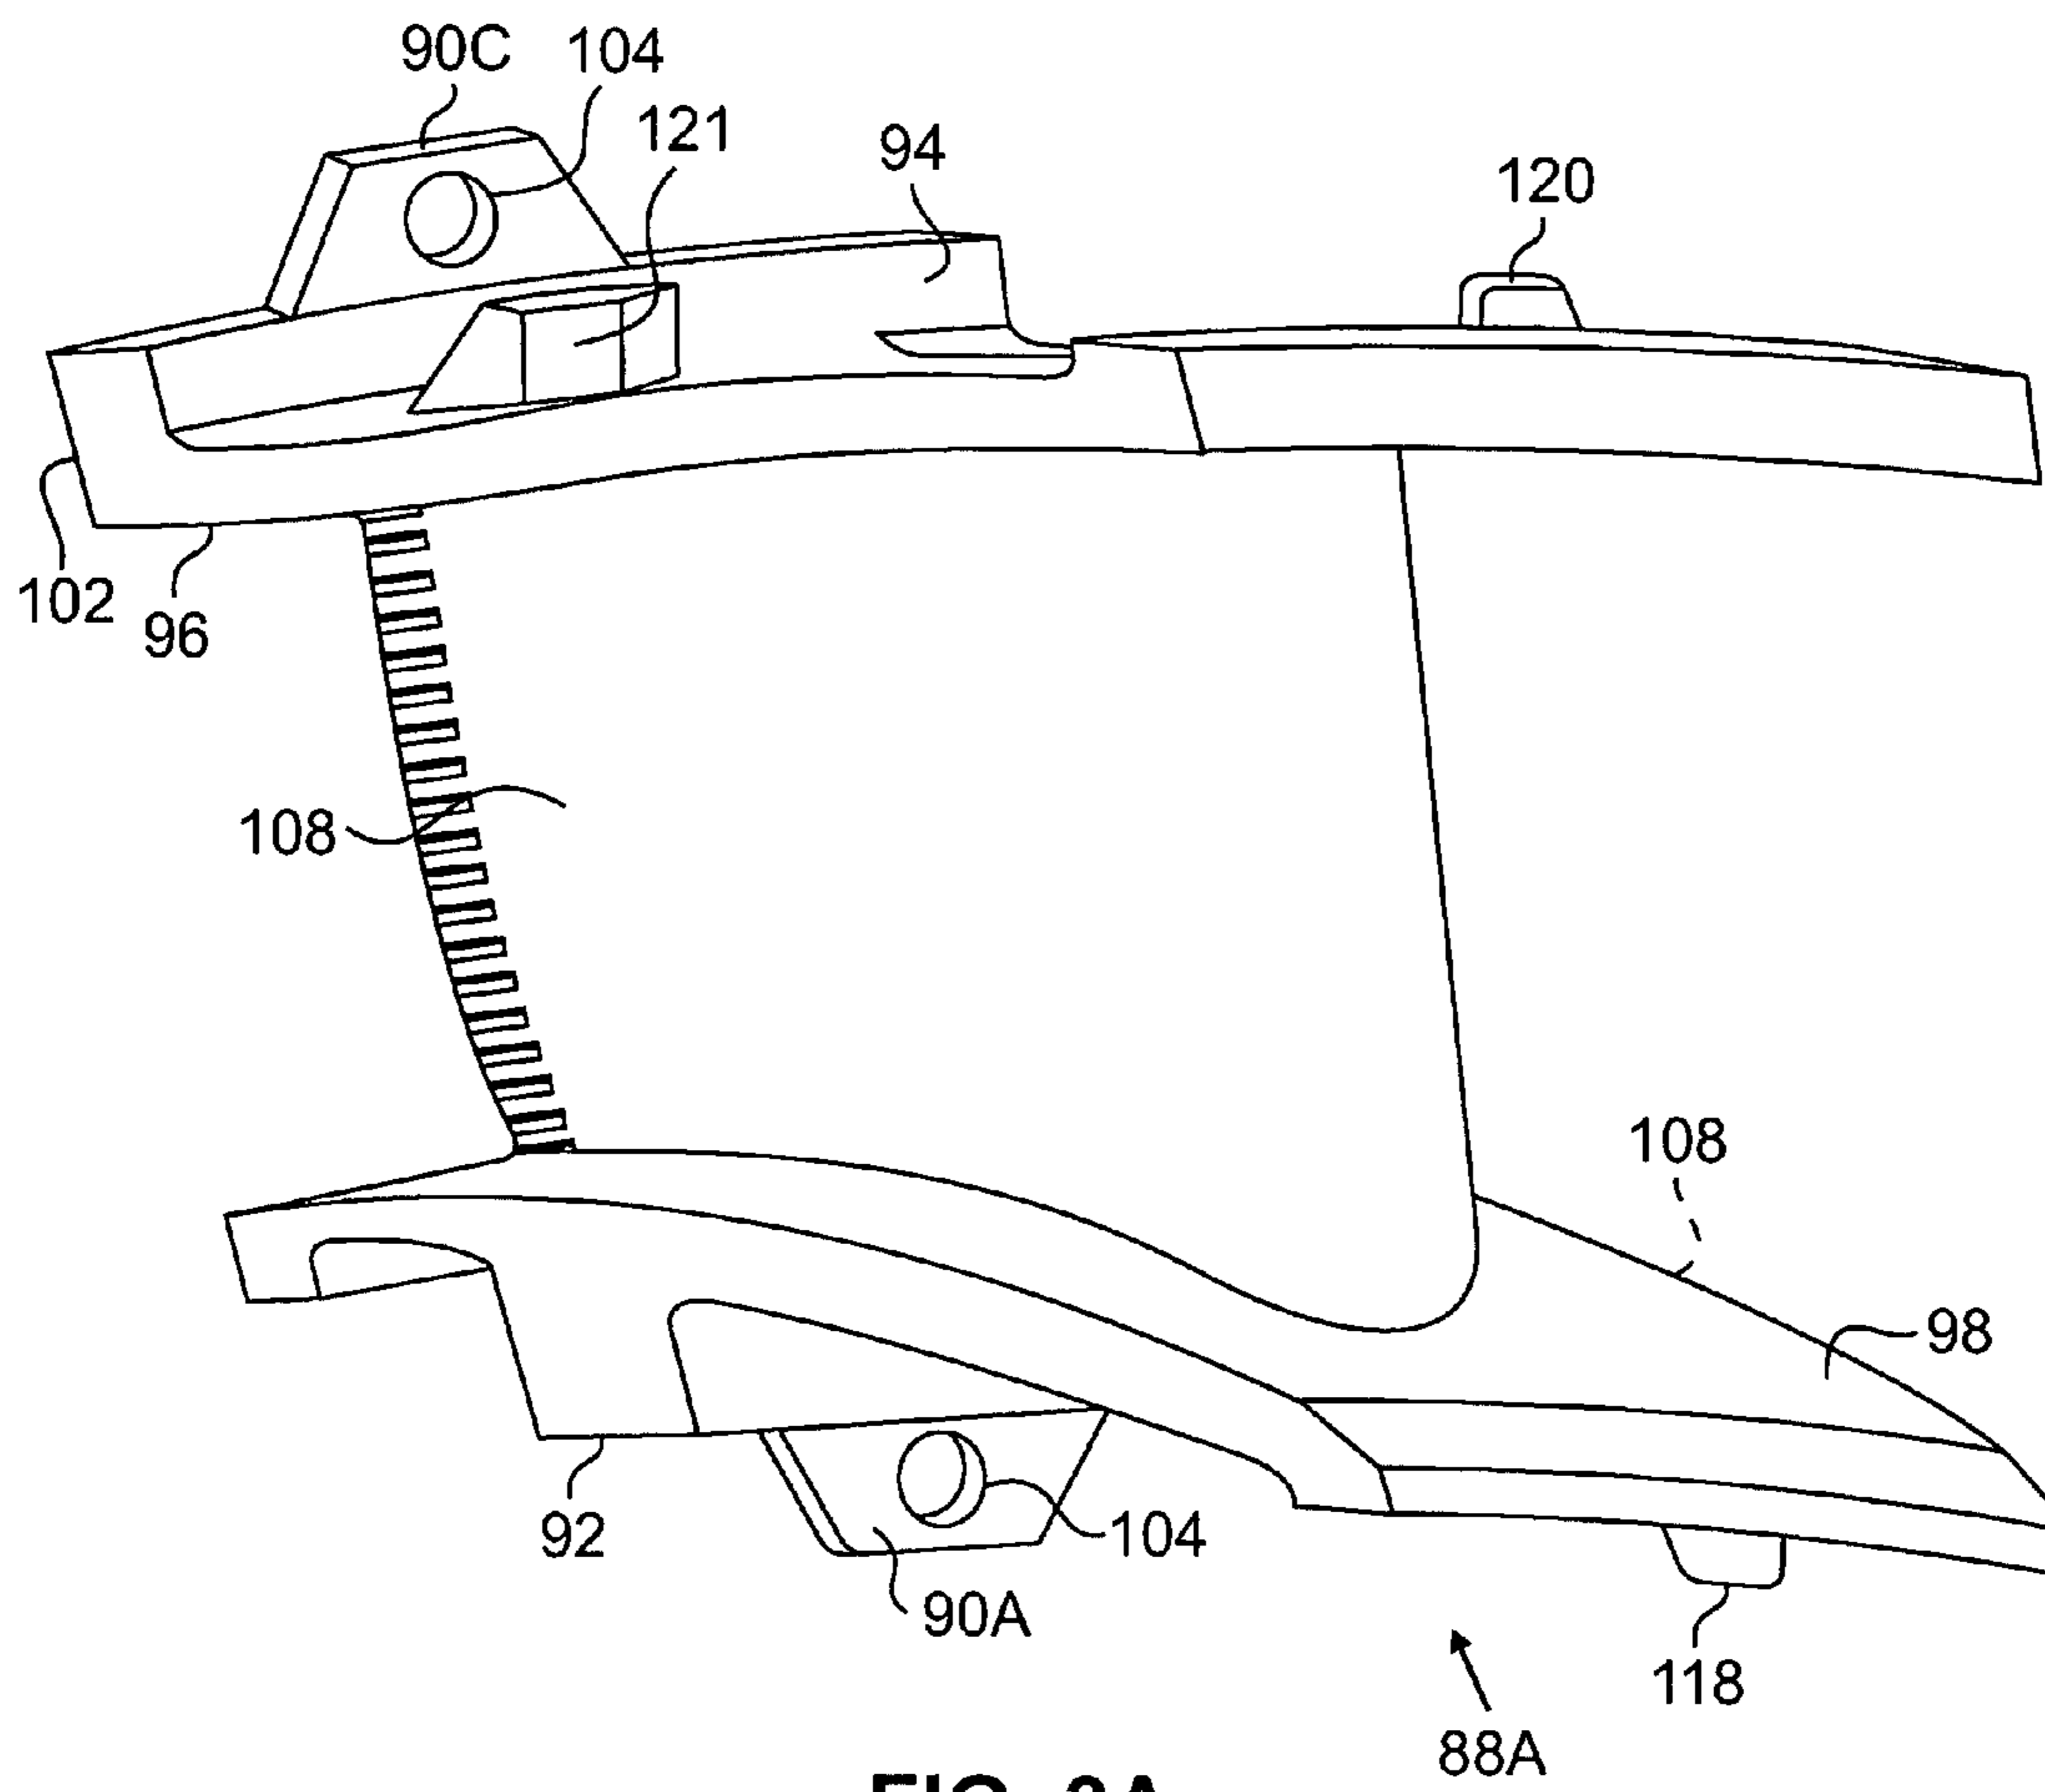
FIG. 3A is a perspective view of a salvaged vane singlet cut from the original HPT nozzle segment and having material added.

FIG. 3A is a perspective view of a salvaged vane singlet 88A that has been cut from the original HPT nozzle segment 88 shown in FIG. 2. The salvaged singlet 88A as shown in FIG. 3A has had new material added subsequent to being cut from the nozzle segment 88. For example, the cooling openings 114 have been filled in, material has been added at the perimeters of both the outer and inner platforms 96 and 98, and material has been added where machining was performed at the cut location 108. As noted above, the areas where new material is added for a particular repair will vary as desired.

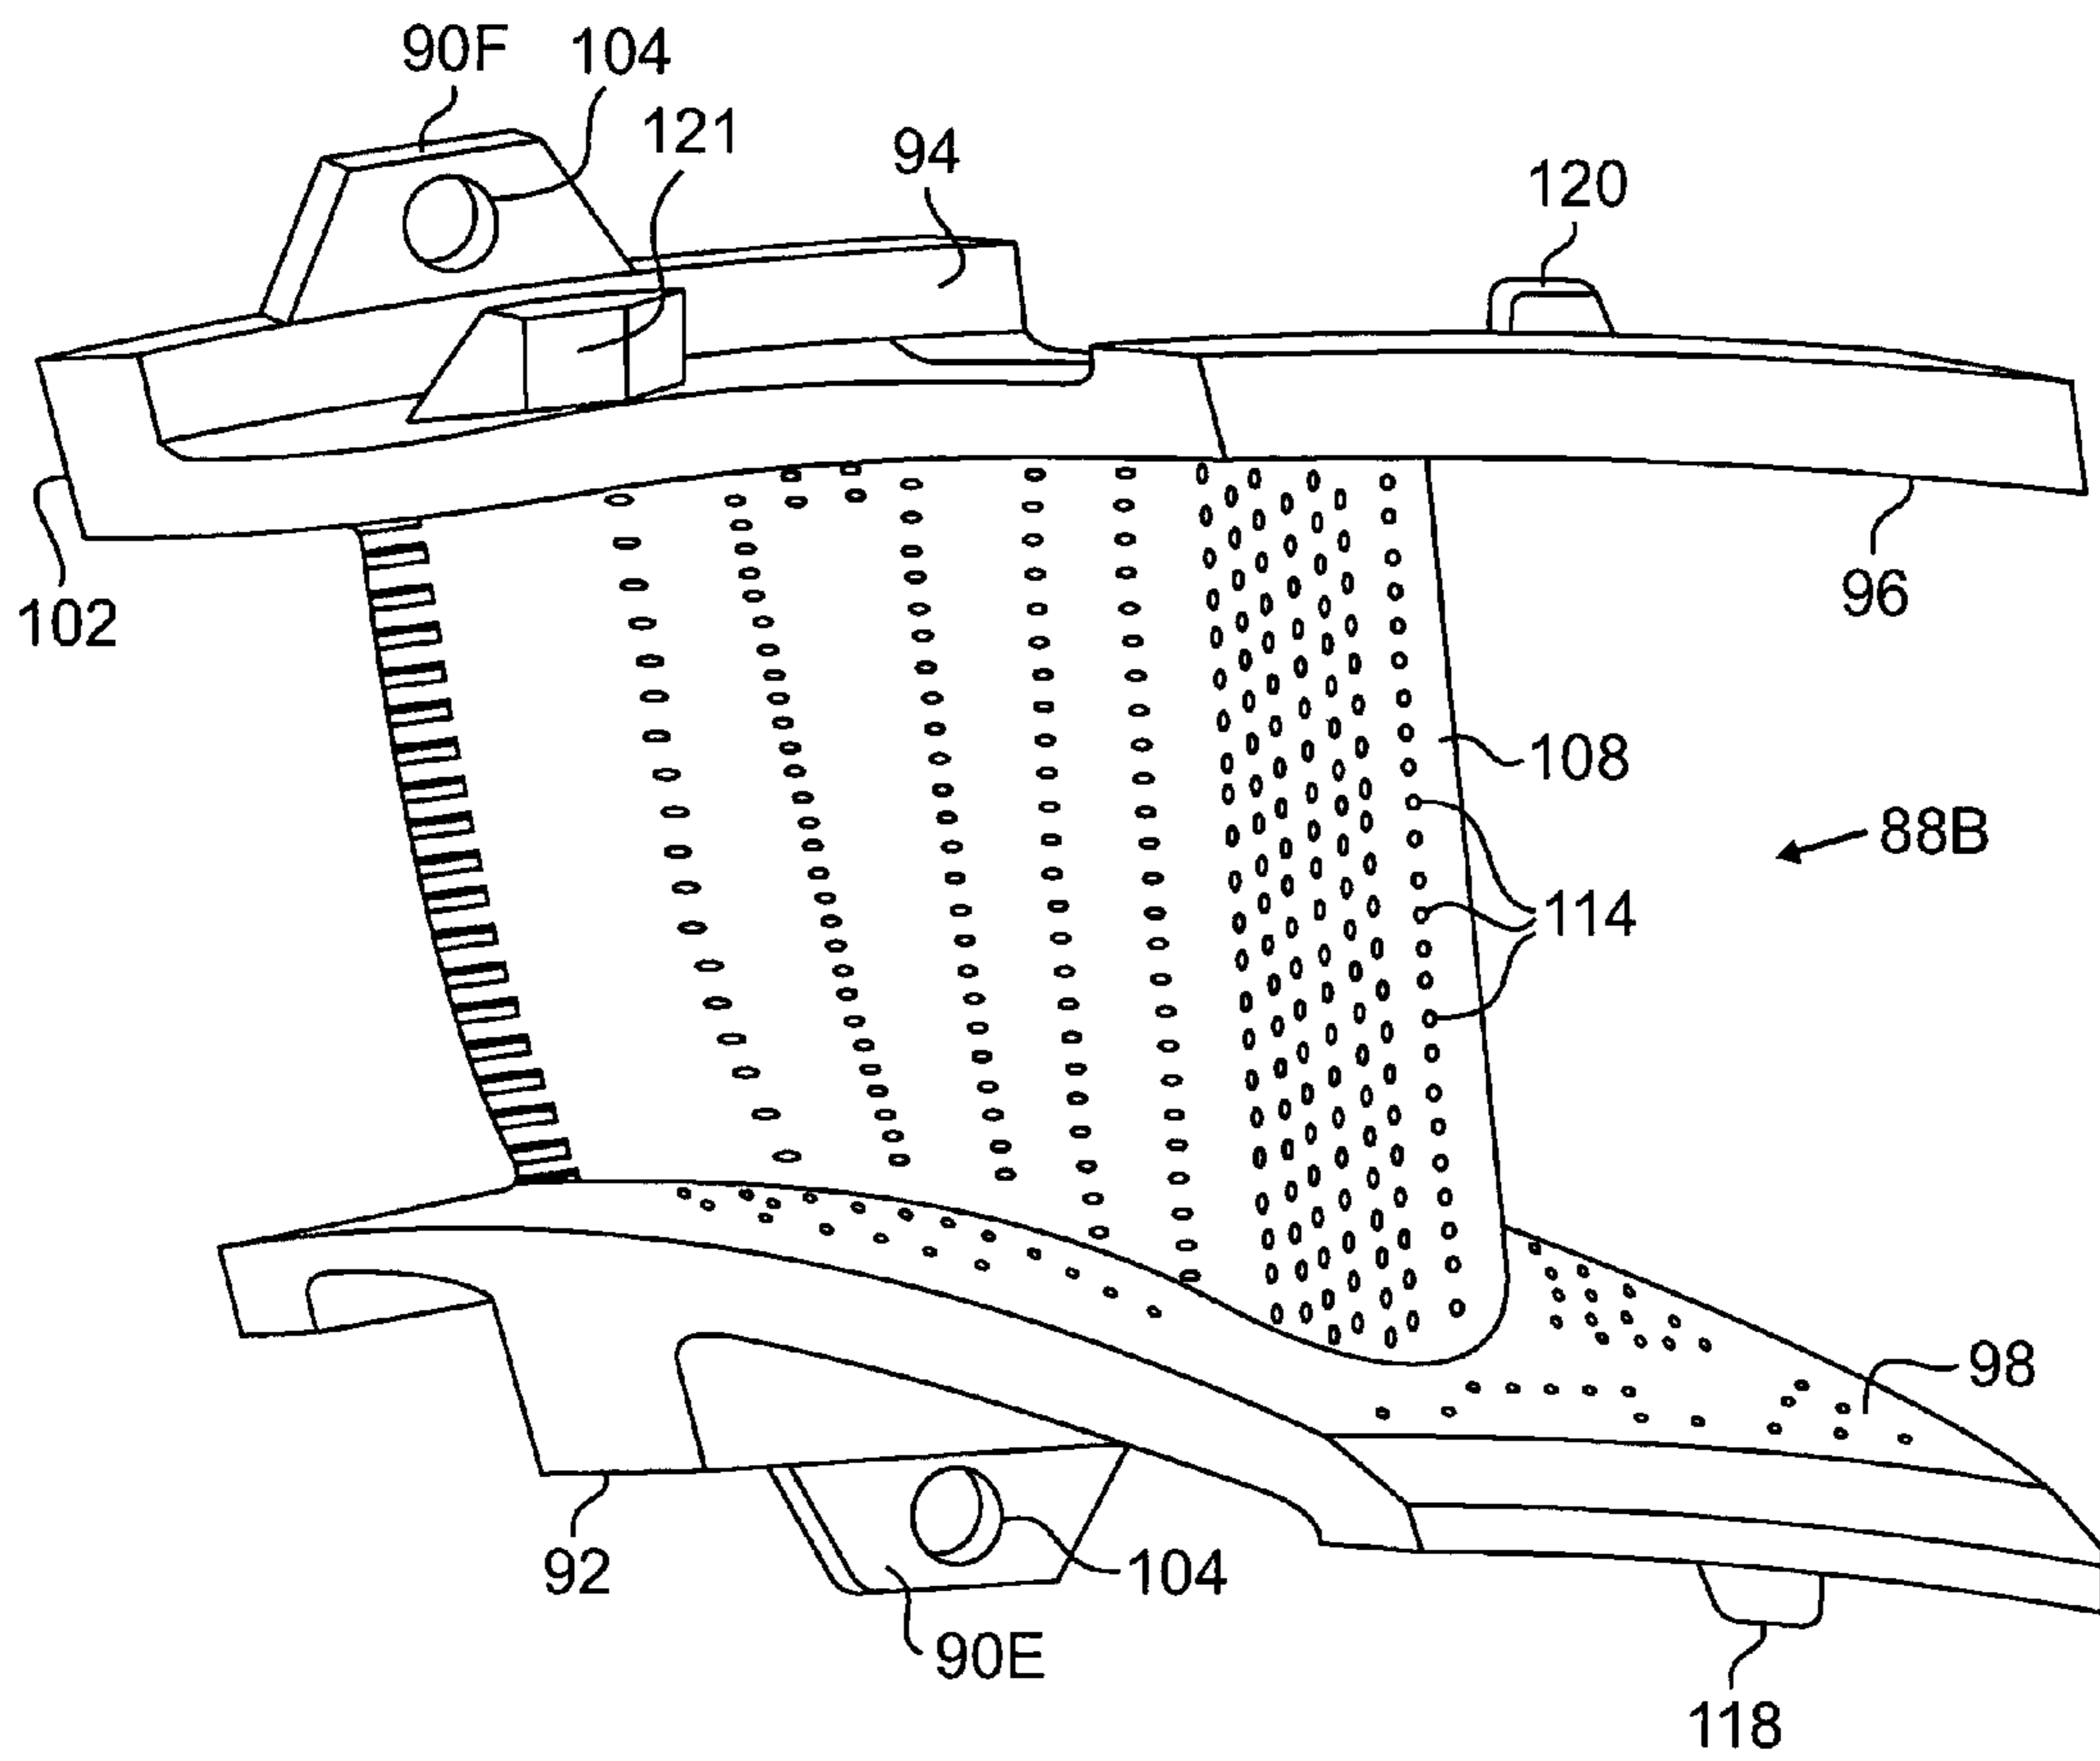
FIG. 3B is a perspective view of a newly manufactured replacement vane singlet.

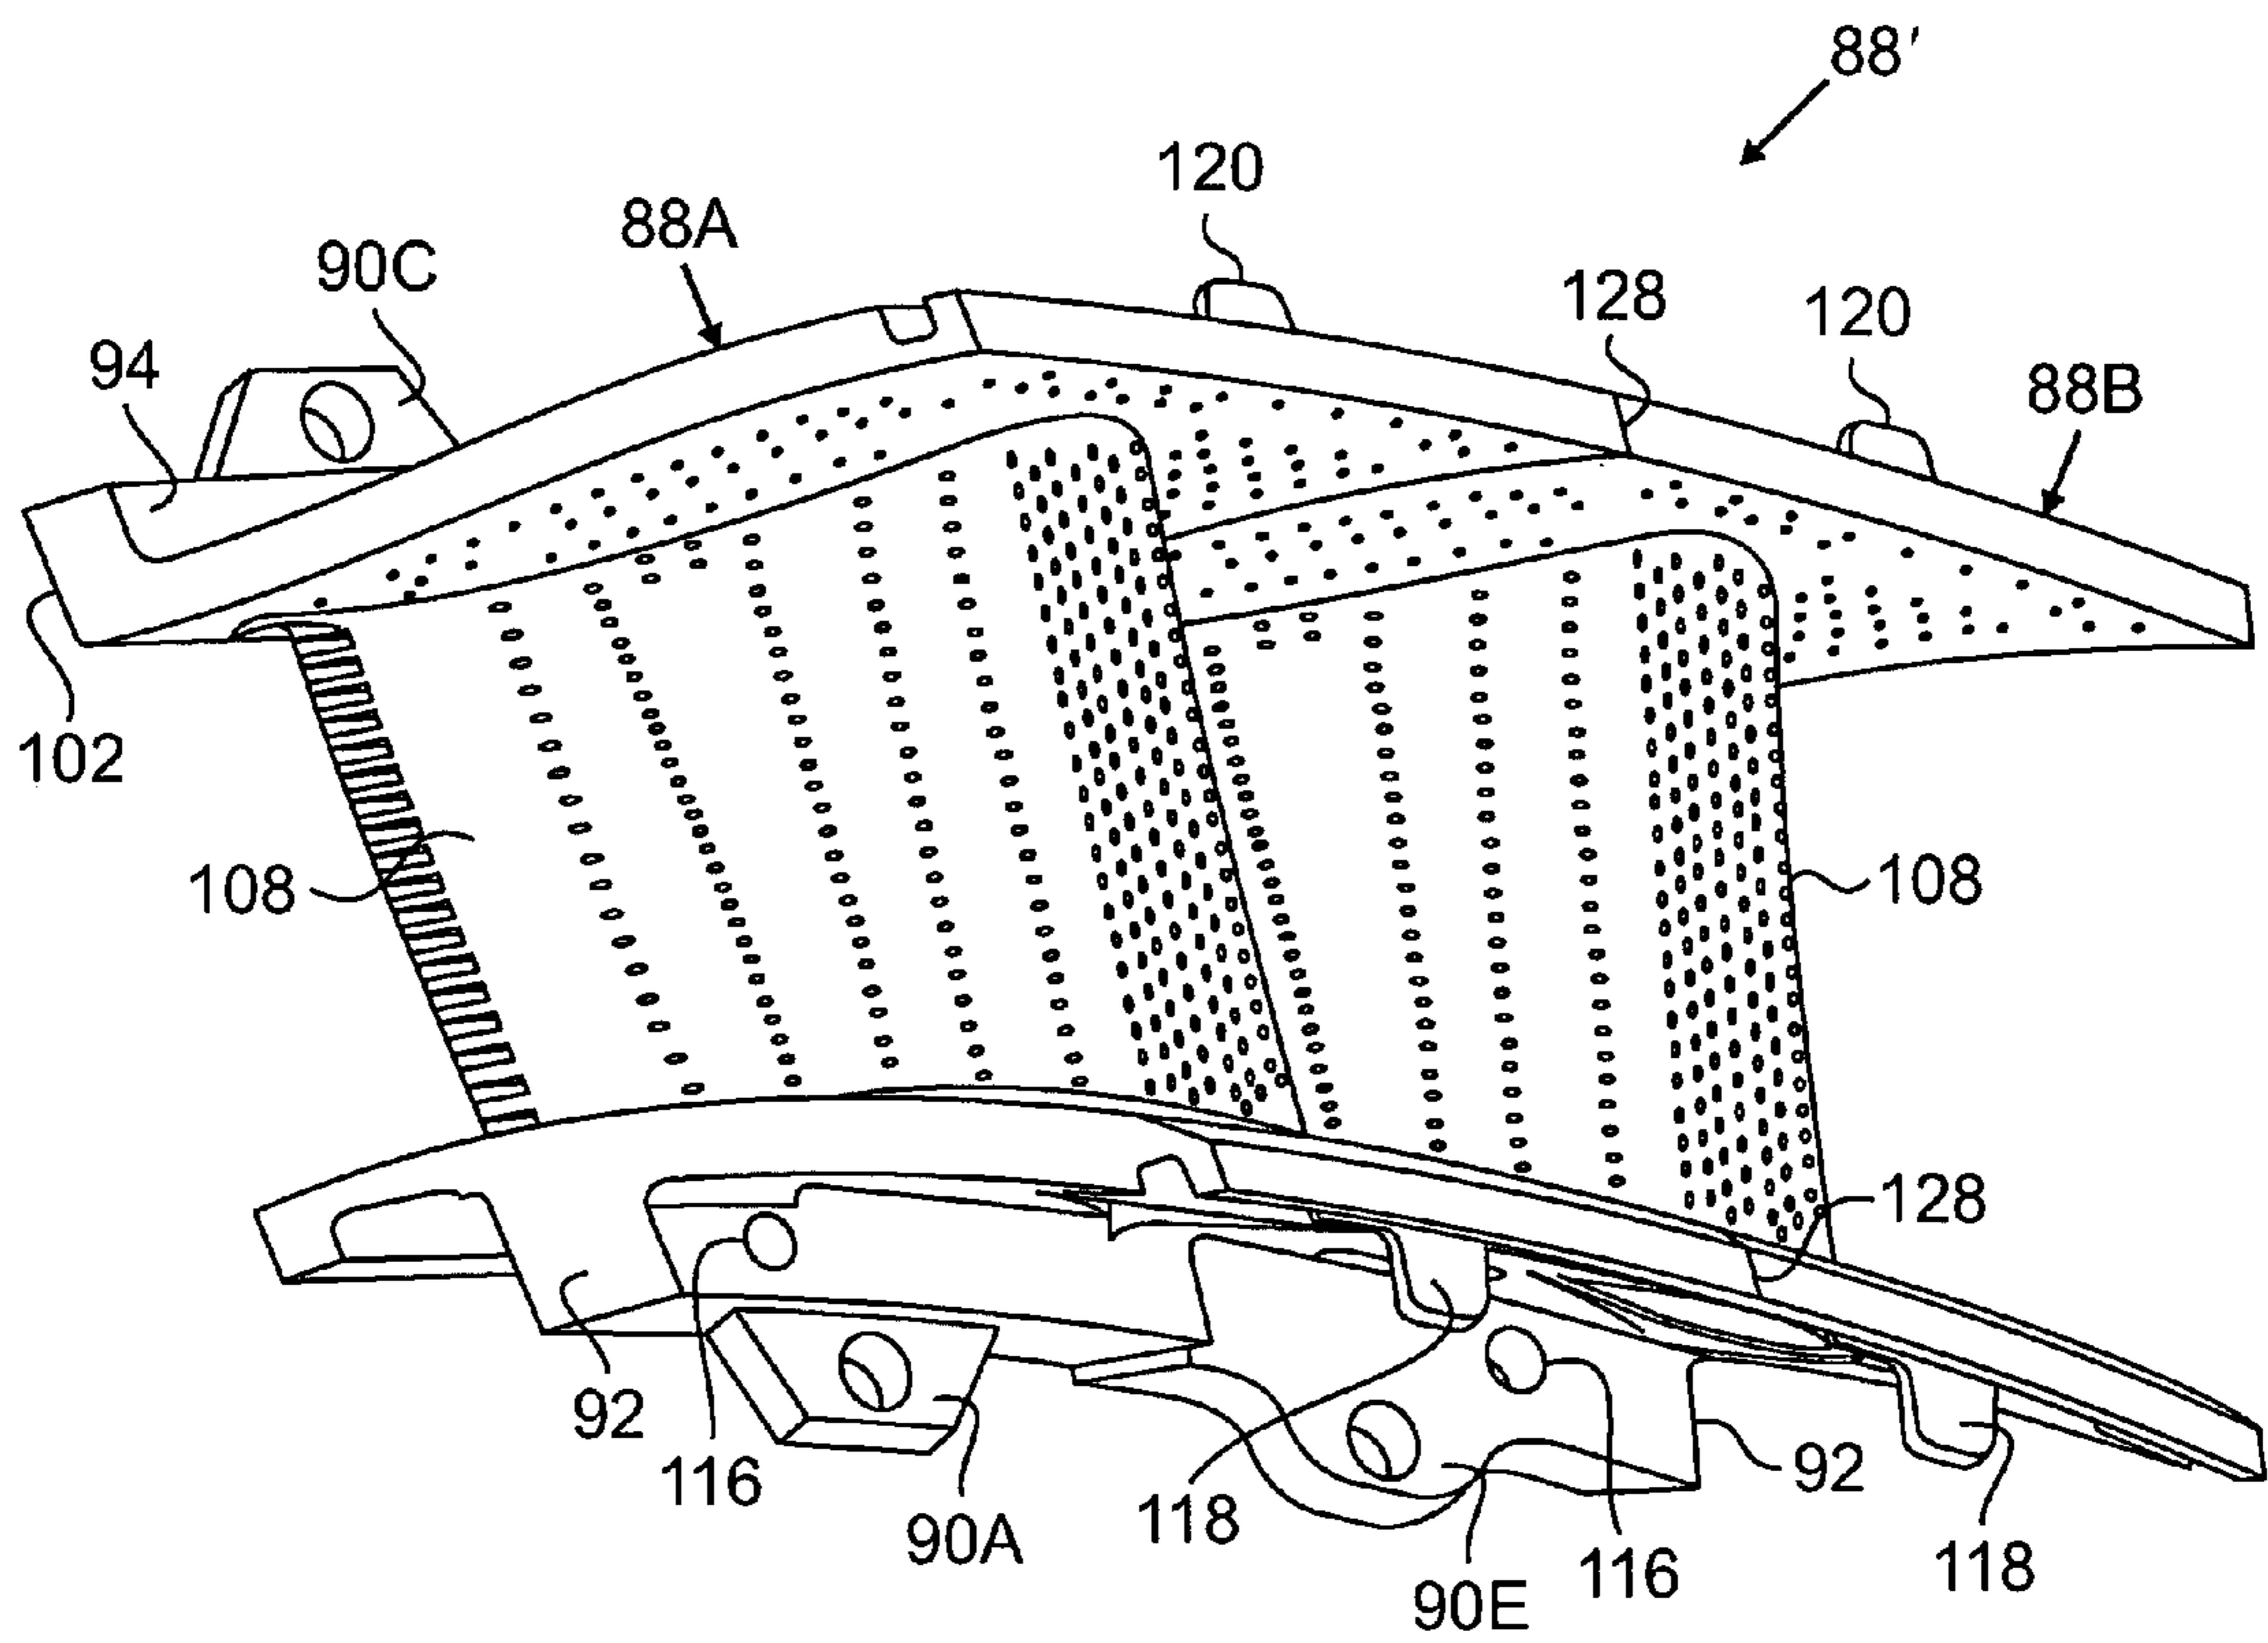
FIG. 4 is a perspective view of the salvaged vane singlet of FIG. 3A and the newly manufactured replacement vane singlet of FIG. 3B joined together.
