US008220150B2

(54) **SPLIT VANE CLUSTER REPAIR METHOD**

SPLIT VANE CLUSTER REPAIR METHOD

The present invention relates to a method for repairing vanes for gas turbine engines, and more particularly to a method suitable for repairing high pressure turbine (HPT) nozzle segments for gas turbine engines.

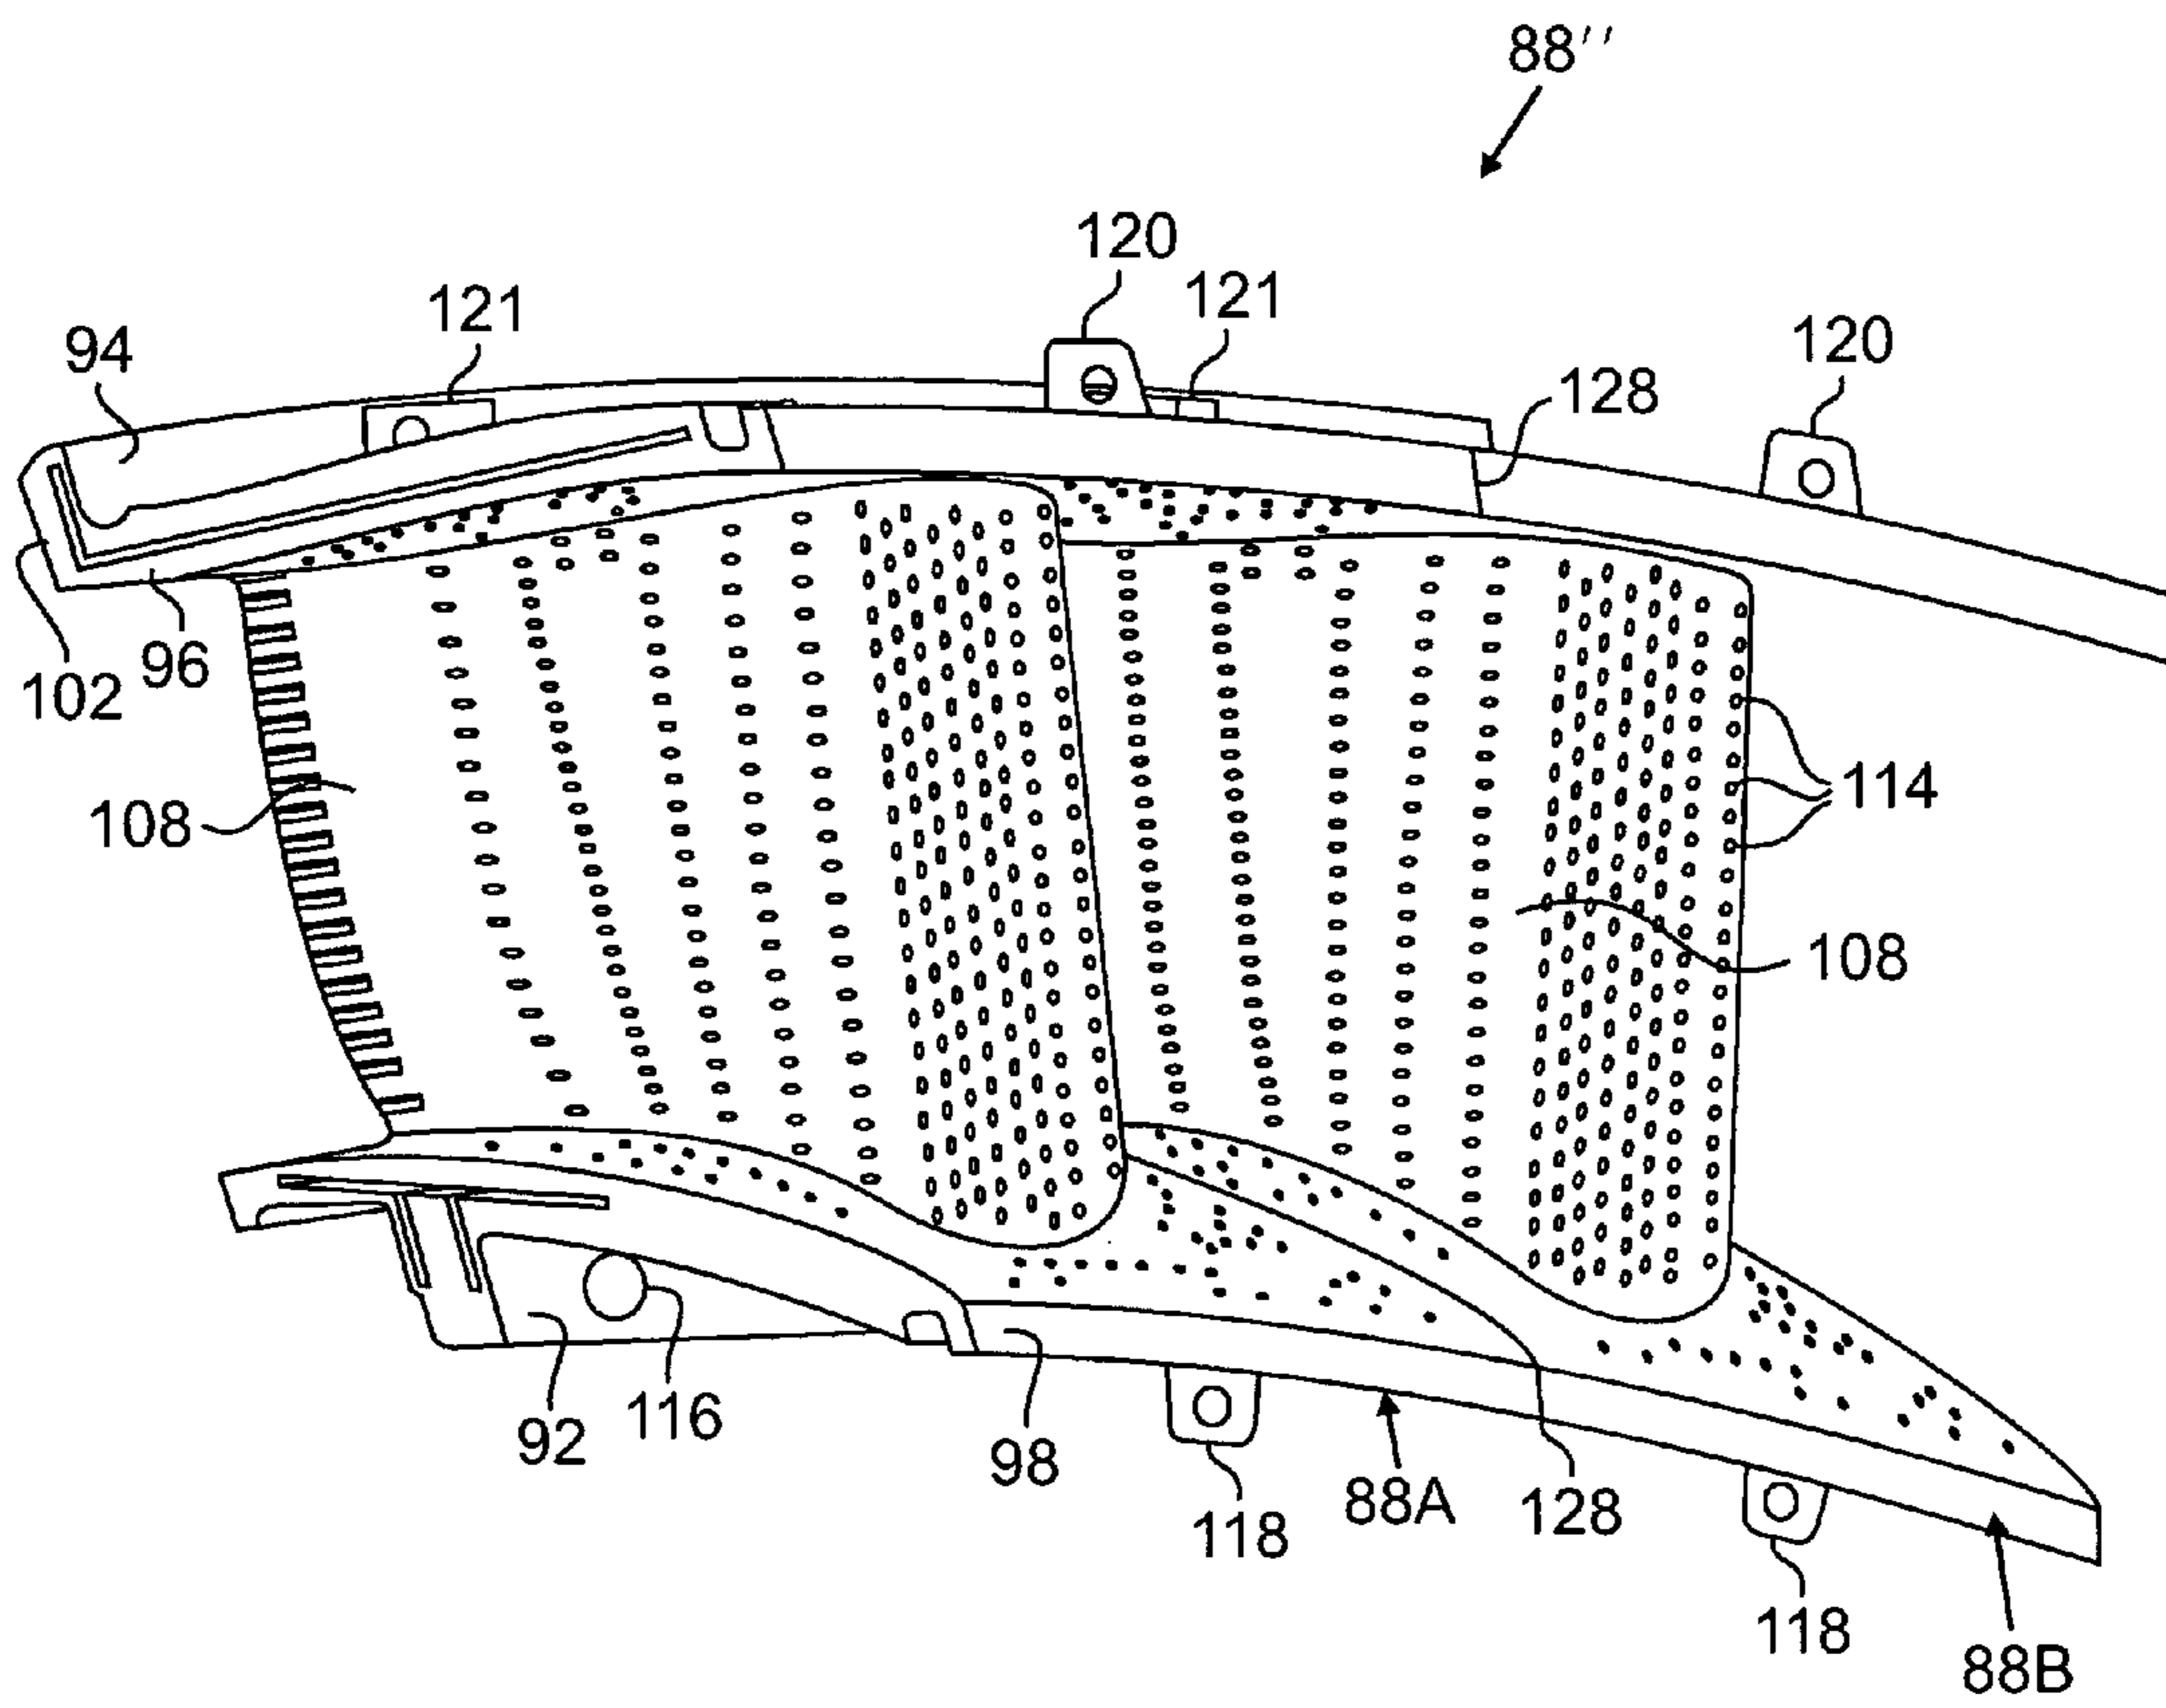
FIG. 5 is a perspective view of a repaired HPT nozzle segment.
