US008230569B2

(54) **REPAIR OF CASE FLANGE WITH BOLT HOLES**

## REPAIR OF CASE FLANGE WITH BOLT HOLES

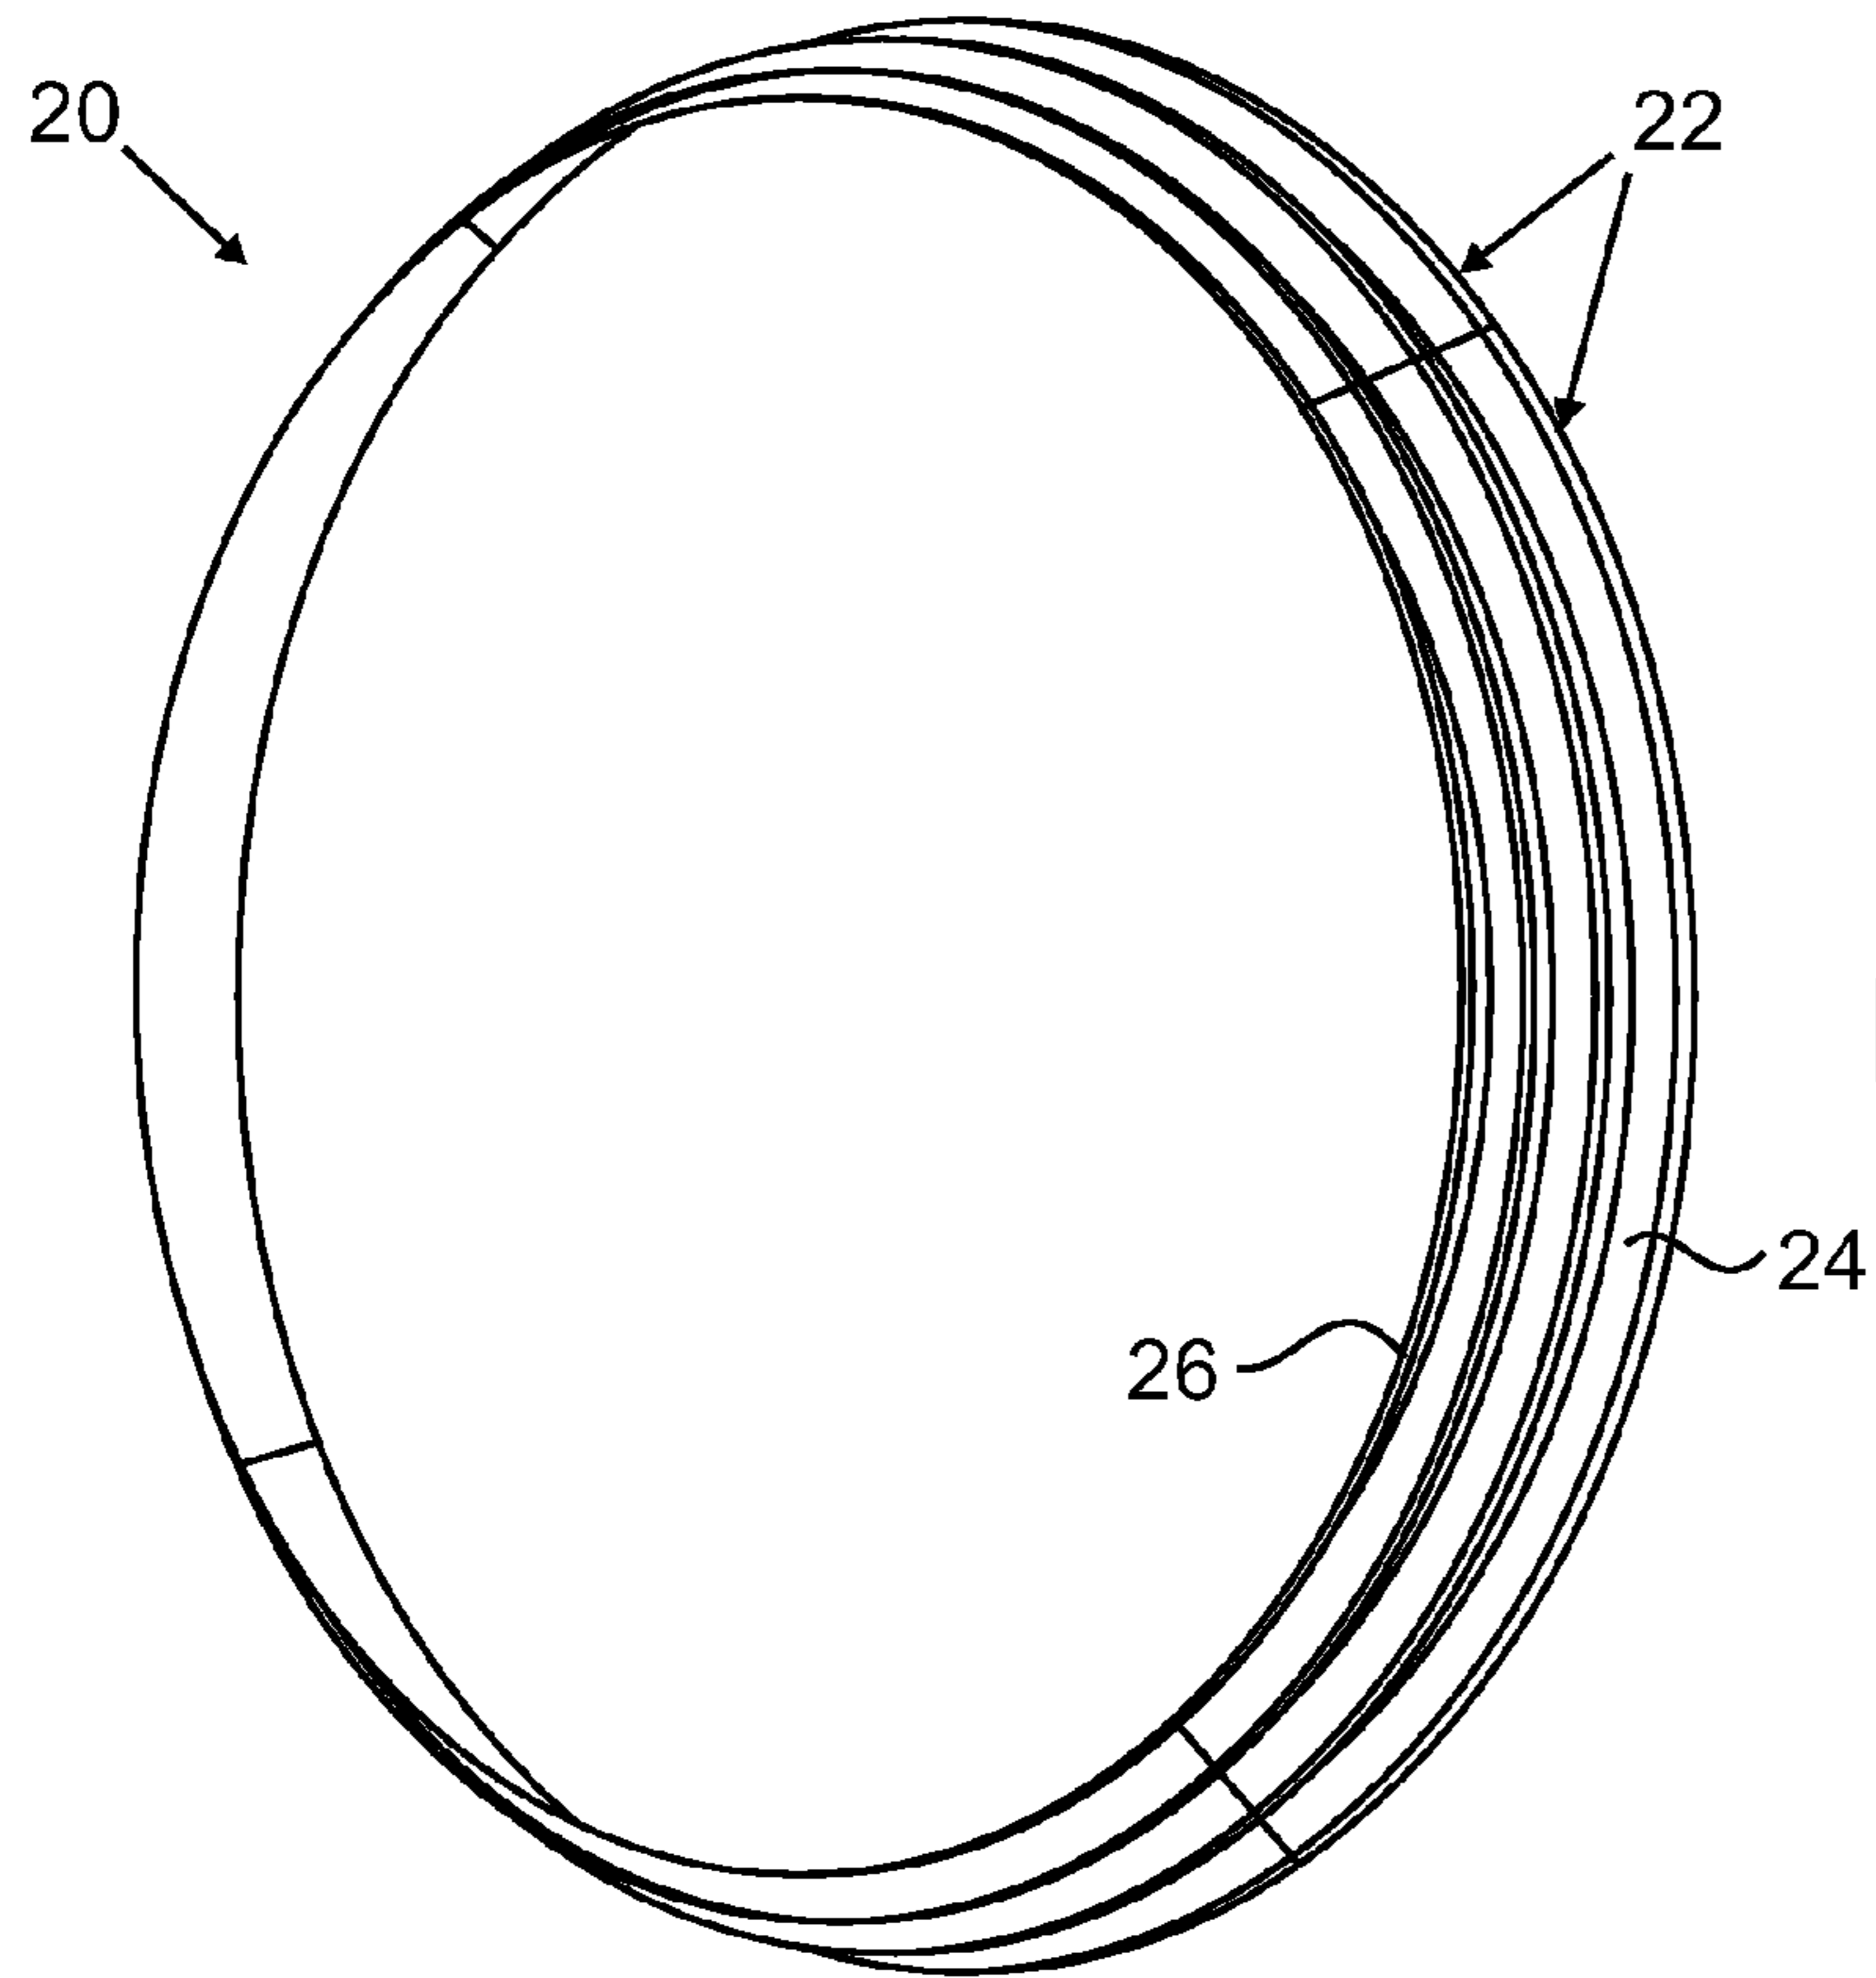
**FIG. 1**

FIG. 1 is a perspective view of a case assembly 20 for a gas turbine engine (not shown). The case assembly 20 is formed from a plurality of case segments 22 assembled together in a generally annular shape, each including a wall 24 and a flange 26. Each case segment 22 can be made of a metallic material.

FIG. 1 is a perspective view of a case assembly for a gas turbine engine.

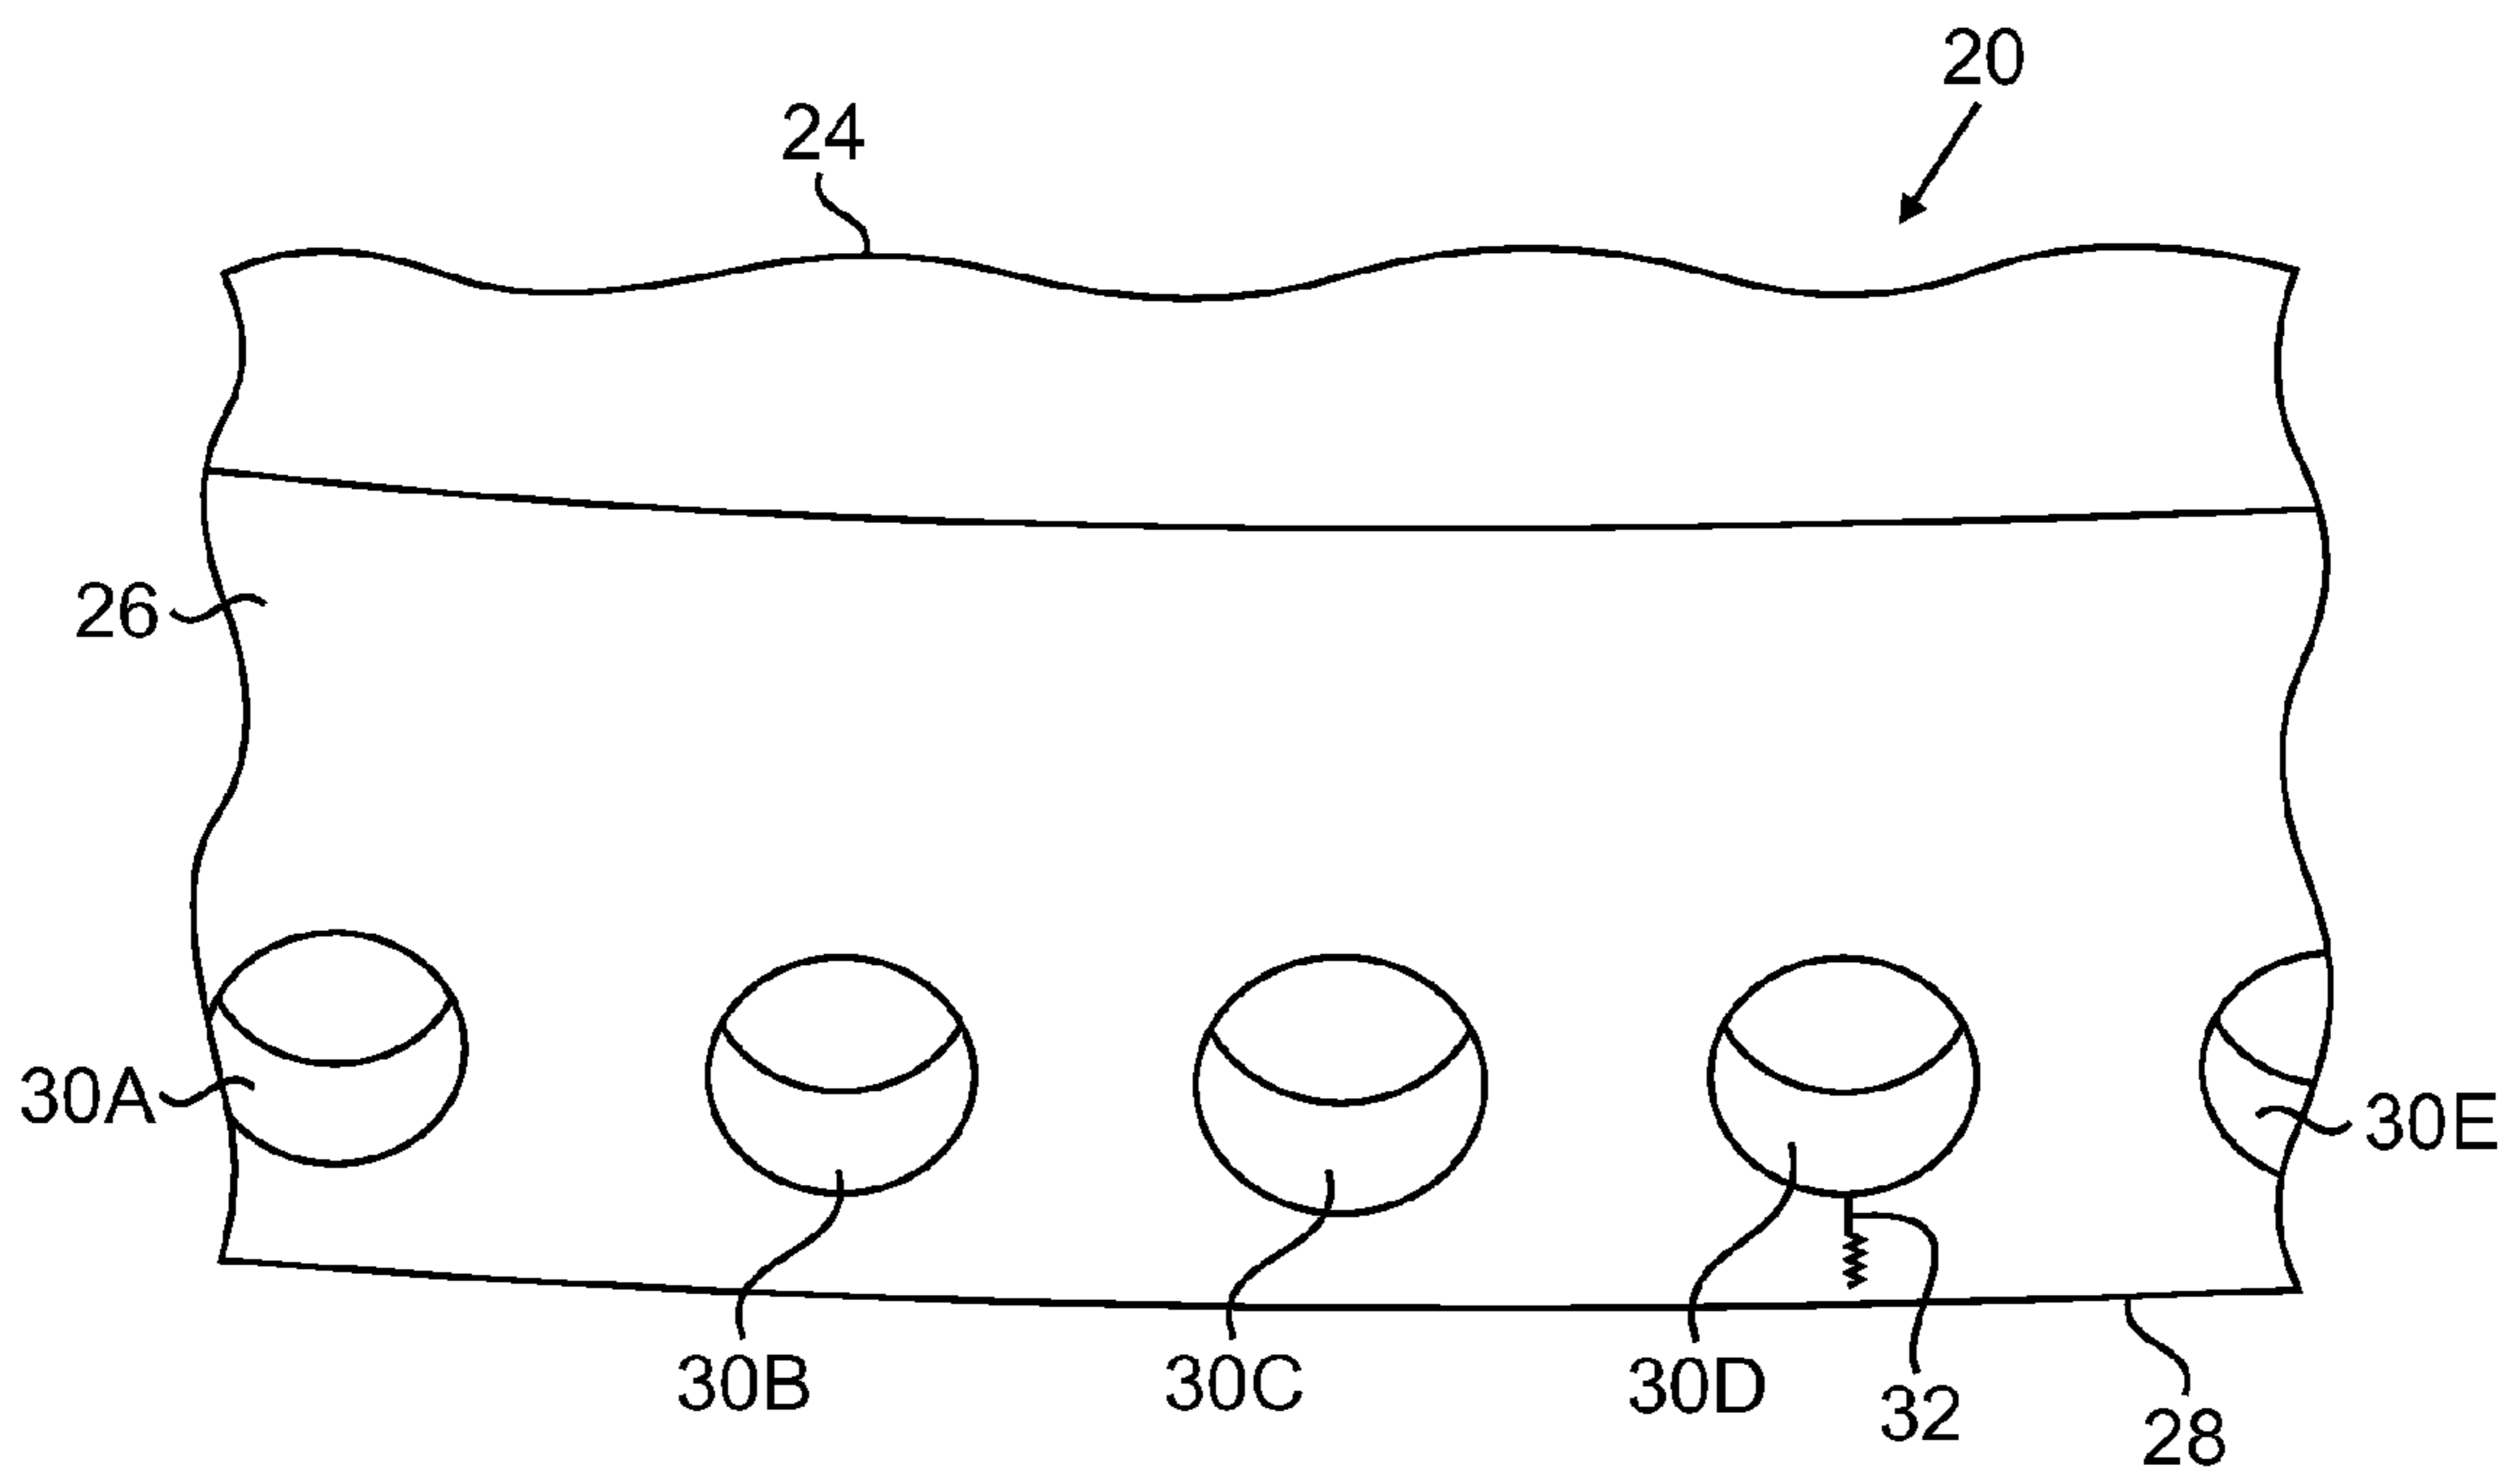
**FIG. 2**

FIG. 2 is a perspective view of a portion of the case assembly 20 prior to repair. The flange 26 has an outer edge 28 (e.g., an outer diameter edge) and a plurality of circumferentially spaced bolt holes 30 defined therein (bolt holes 30A-30E are shown, and are collectively referred to by reference number

30). The bolt holes 30 allow the flange 26 to be mechanically connected to other components in the engine. During use, the flange 26 and the bolt holes 30 can become worn or damaged. For example, as illustrated in FIG. 2, the bolt hole 30C is undesirably enlarged and an outbound crack 32 extends from the bolt hole 30D toward the outer edge 28. These forms of wear and damage are merely exemplary, and it should be understood that the method (see FIG. 7) applies to other types of flange wear and damage as well.

FIG. 2 is a perspective view of a portion of the case assembly prior to repair.

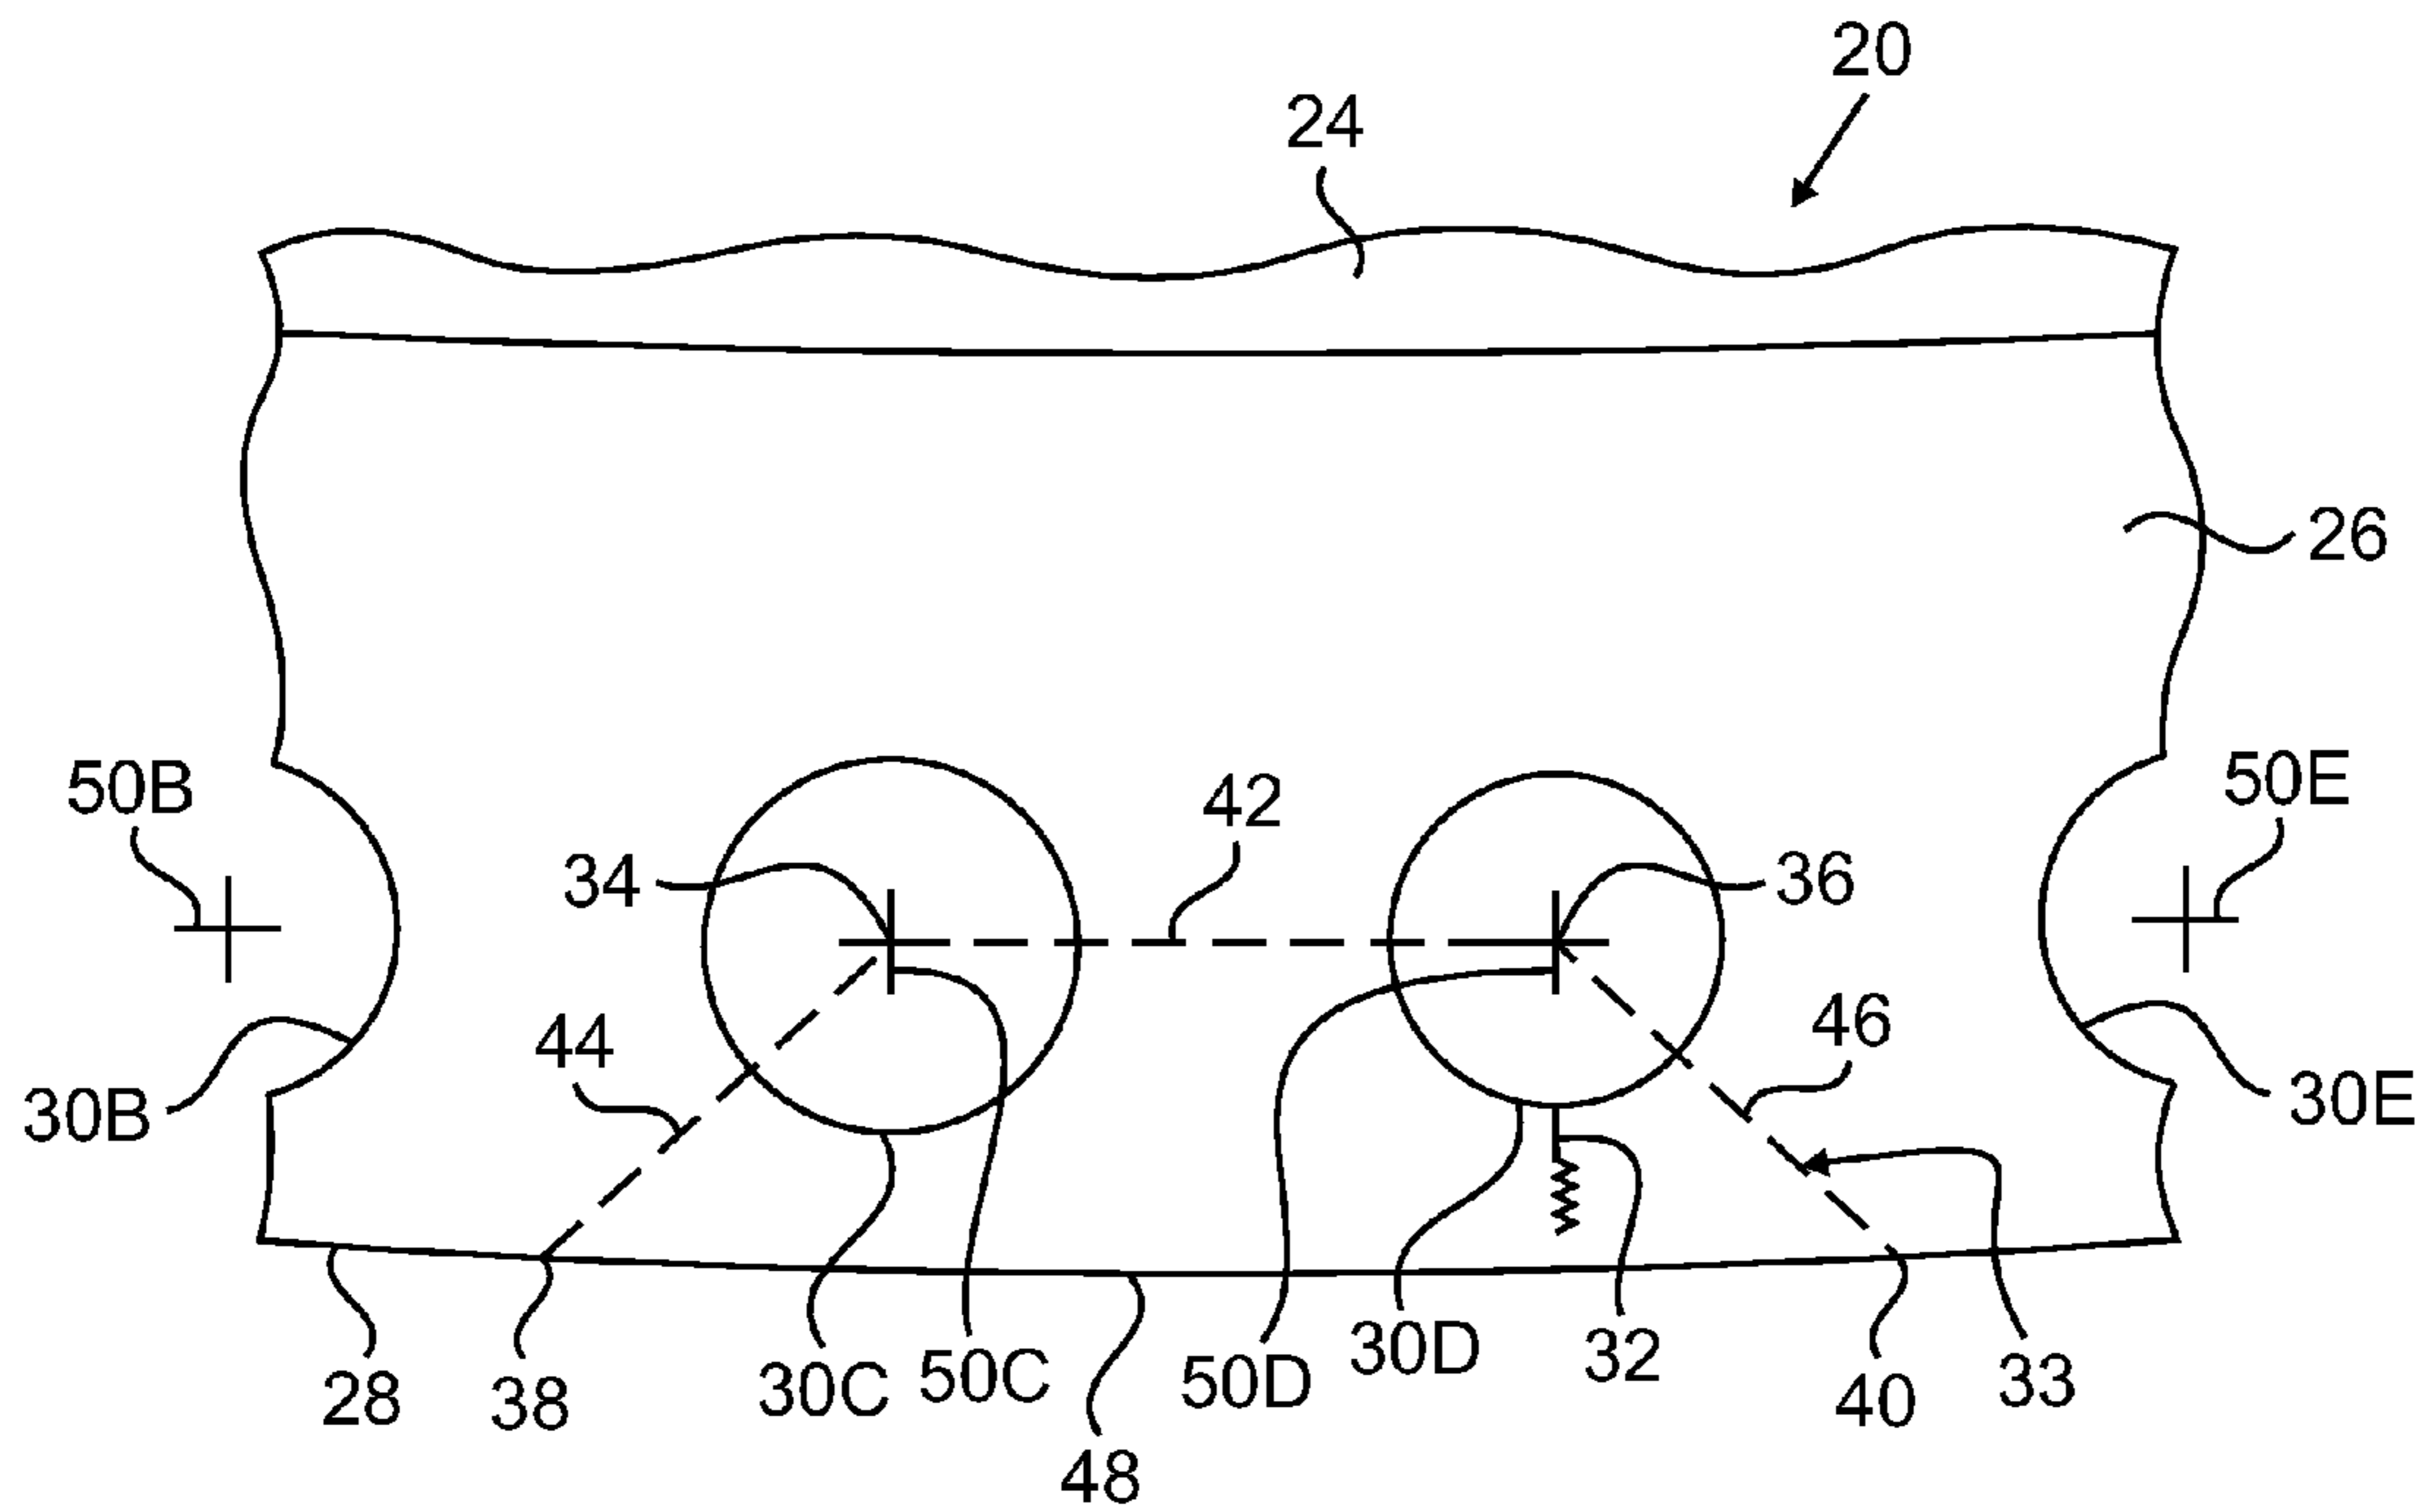
FIG. 3

FIGS. 3 and 4 are front views of a portion of the case assembly 20 during a repair. As shown in FIG. 3, a pattern 33 is defined relative to the flange 26. In the illustrated embodiment the pattern 33 is substantially trapezoidal in shape, and is bounded by first, second, third and fourth corner points 34, 36, 38 and 40, respectively. A first perimeter portion 42 is defined between the first and second corner points 34 and 36. A second perimeter portion 44 is defined between the first and third corner points 34 and 38, and a third perimeter portion 46 is defined between the second and fourth corner points 36 and 40. A fourth perimeter portion 48 is defined between the third and fourth corner points 38 and 40. Obtuse included angles are defined at both the first and second corner points 34 and 36. Furthermore, the first and second corner points 34 and 36 are substantially aligned with the center axes 50C and 50D of the bolt holes 30C and 30D, respectively. Acute included angles are defined at both the third and fourth corner points 38 and 40, which are both defined along the outer edge 28 of the flange 26, and can be substantially radially aligned with midpoints between circumferentially adjacent bolt holes 30. In other words, the third corner point 38 can be located approximately midway between the center axes 50B and 50C of the circumferentially adjacent bolt holes 30B and 30C, respectively, and the fourth corner point 40 can be located approximately midway between the center axes 50D and 50E of the bolt holes 30D and 30E, respectively. The first, second and third perimeter portions 42, 44 and 46 of the pattern 33 can each be substantially linear, and the fourth perimeter portion 48 can be arcuate to align with the outer edge 28 of the flange 26.

FIGS. 3 and 4 are front views of a portion of the case assembly during repair.

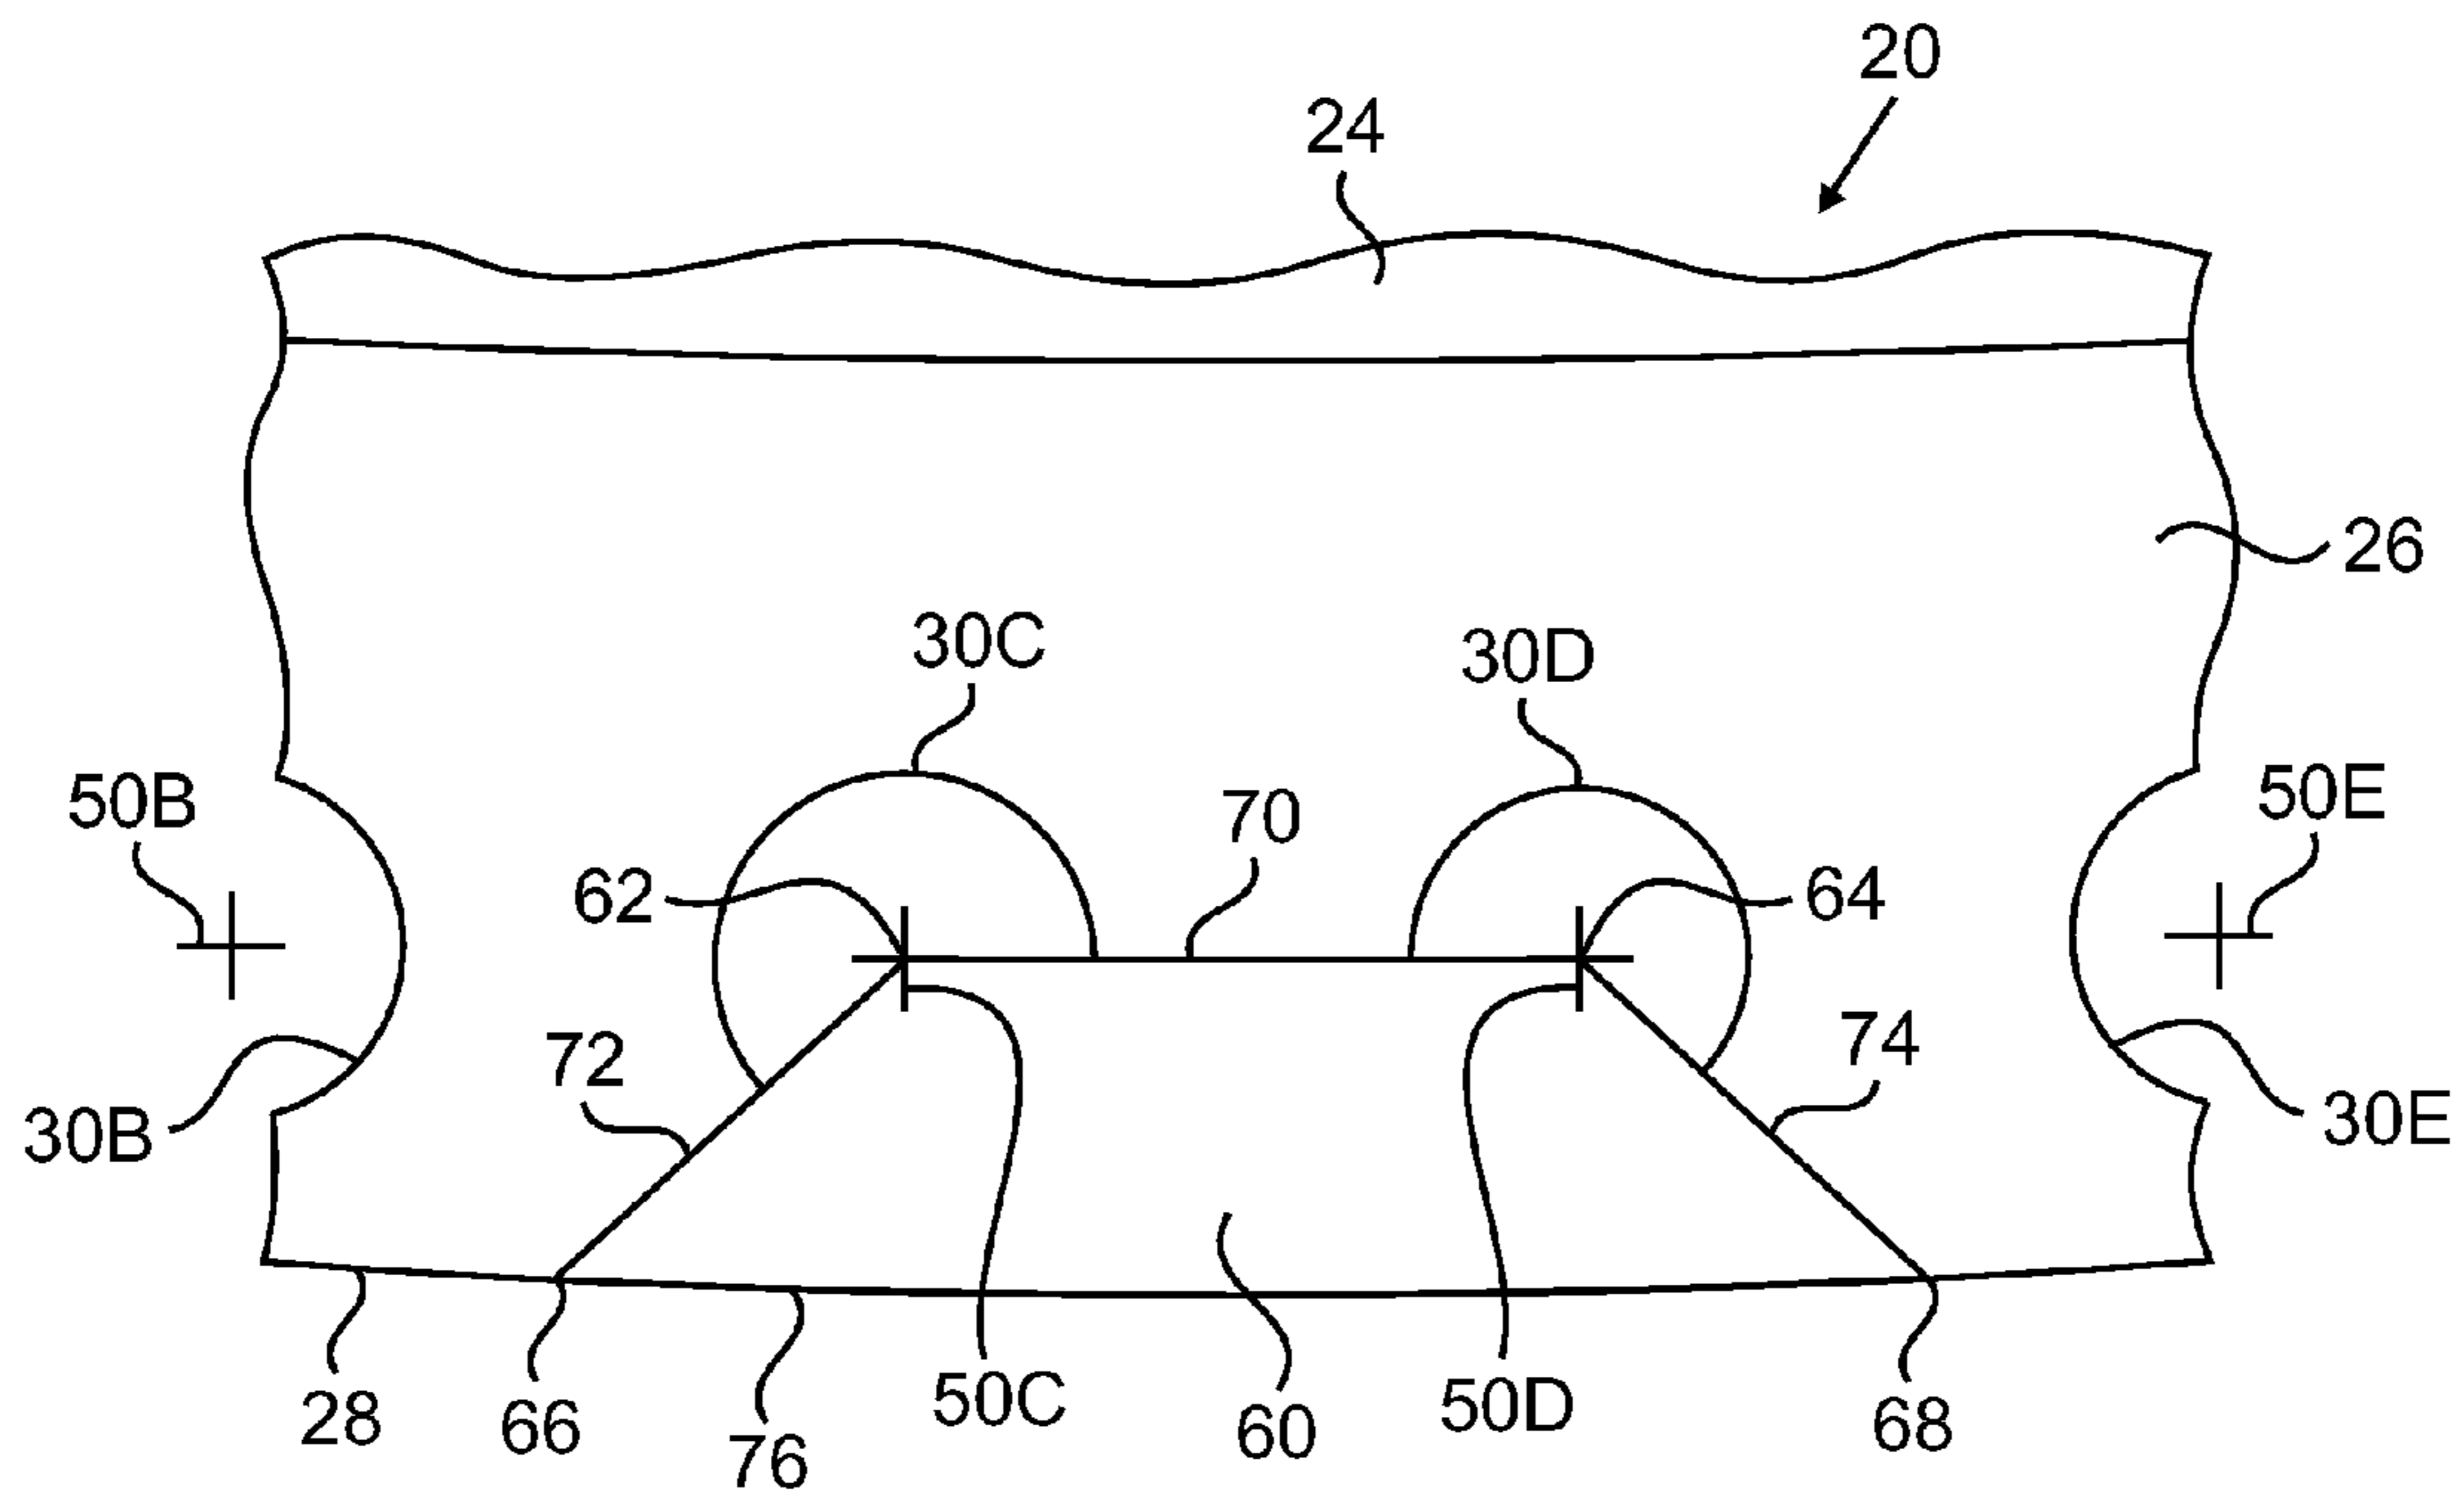
FIG. 4

A replacement detail 60 is created (e.g., through forming, stamping, machining, or any other suitable process or processes) to replace the parent material of the flange 26 removed within the pattern 33. The replacement detail 60 can be made of the parent material of the flange 26, or alternatively a different material from the parent material. The replacement detail 60 can be a generally trapezoidal shaped wedge, and more particularly, can have a shape substantially the same as that of the pattern 33 from which parent material was removed from the flange 26. As shown in FIG. 4, the replacement detail 60 is defined by first, second, third and fourth corner projections 62, 64, 66 and 68, respectively. A first perimeter portion 70 is defined between the first and second corner projections 62 and 64. A second perimeter portion 72 is defined between the first and third corner projections 62 and 66, and a third perimeter portion 74 is defined between the second and fourth corner projections 64 and 68. A fourth perimeter portion 76 is defined between the third and fourth corner projections 66 and 68. Obtuse included angles are defined at both the first and second corners 62 and 64. Acute

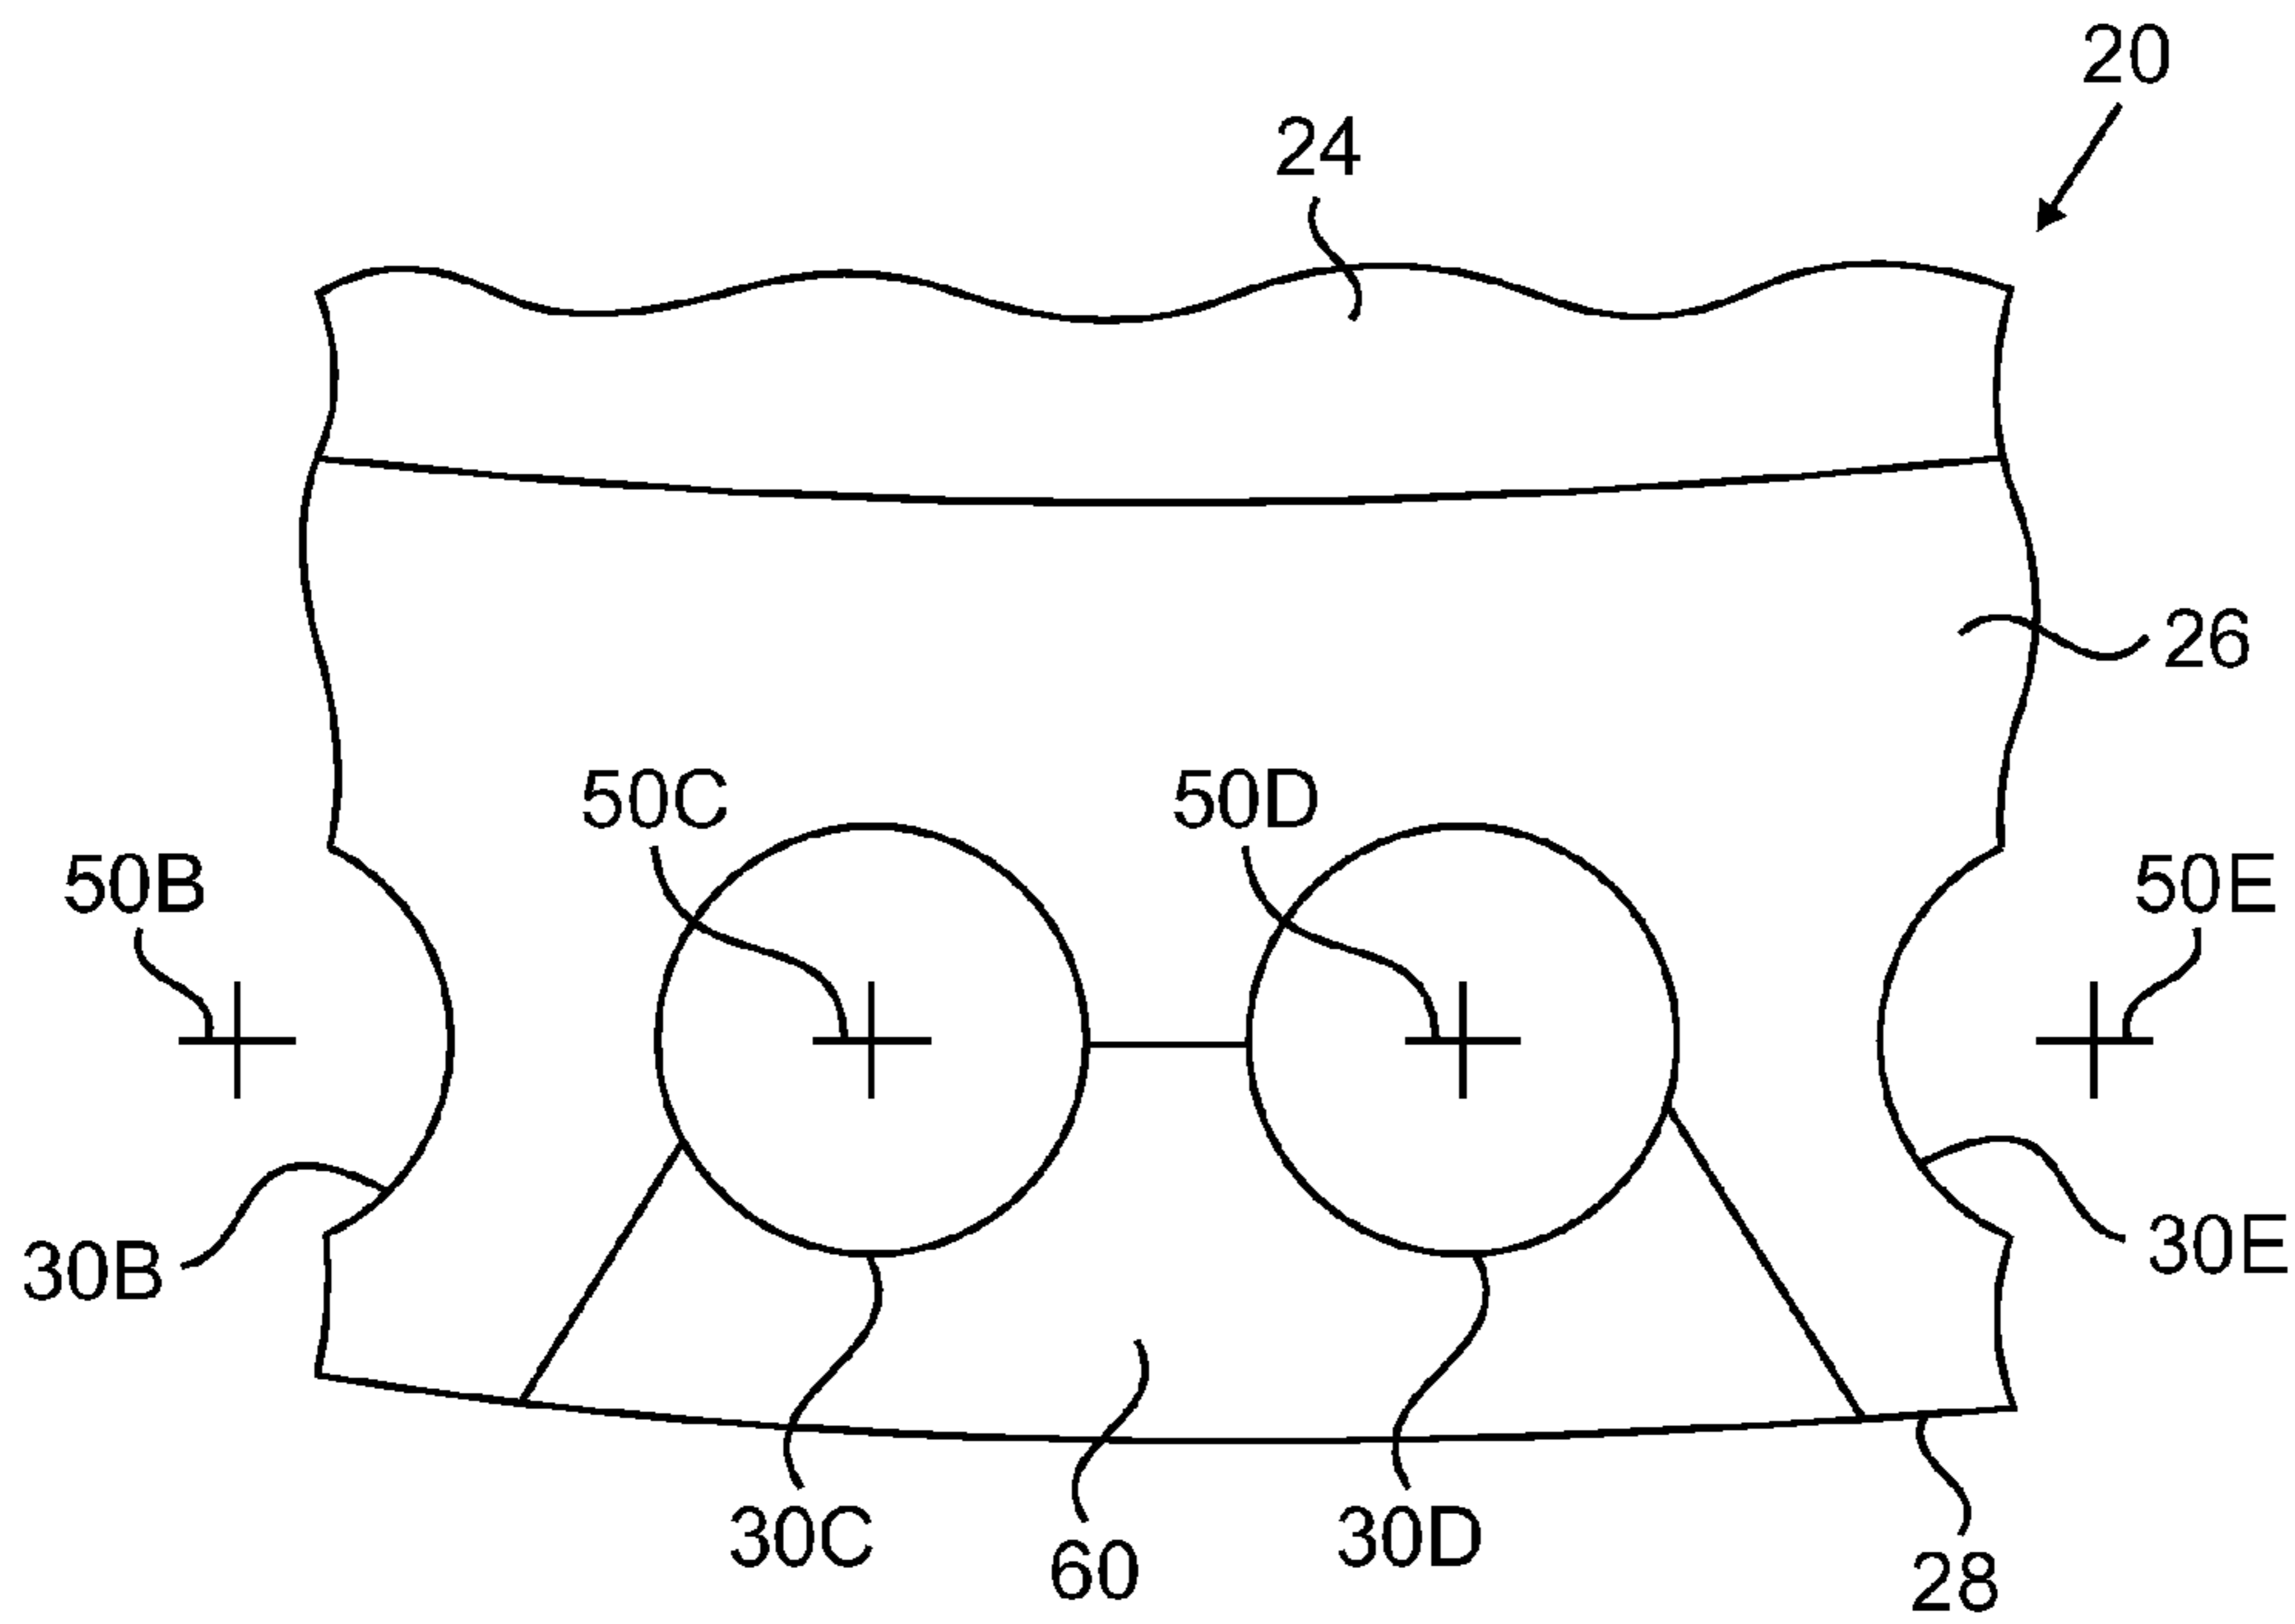
**FIG. 5**

FIG. 5 is a front view of a portion of the case assembly after repair.
