US008230569B2

(54) **REPAIR OF CASE FLANGE WITH BOLT HOLES**

## REPAIR OF CASE FLANGE WITH BOLT HOLES

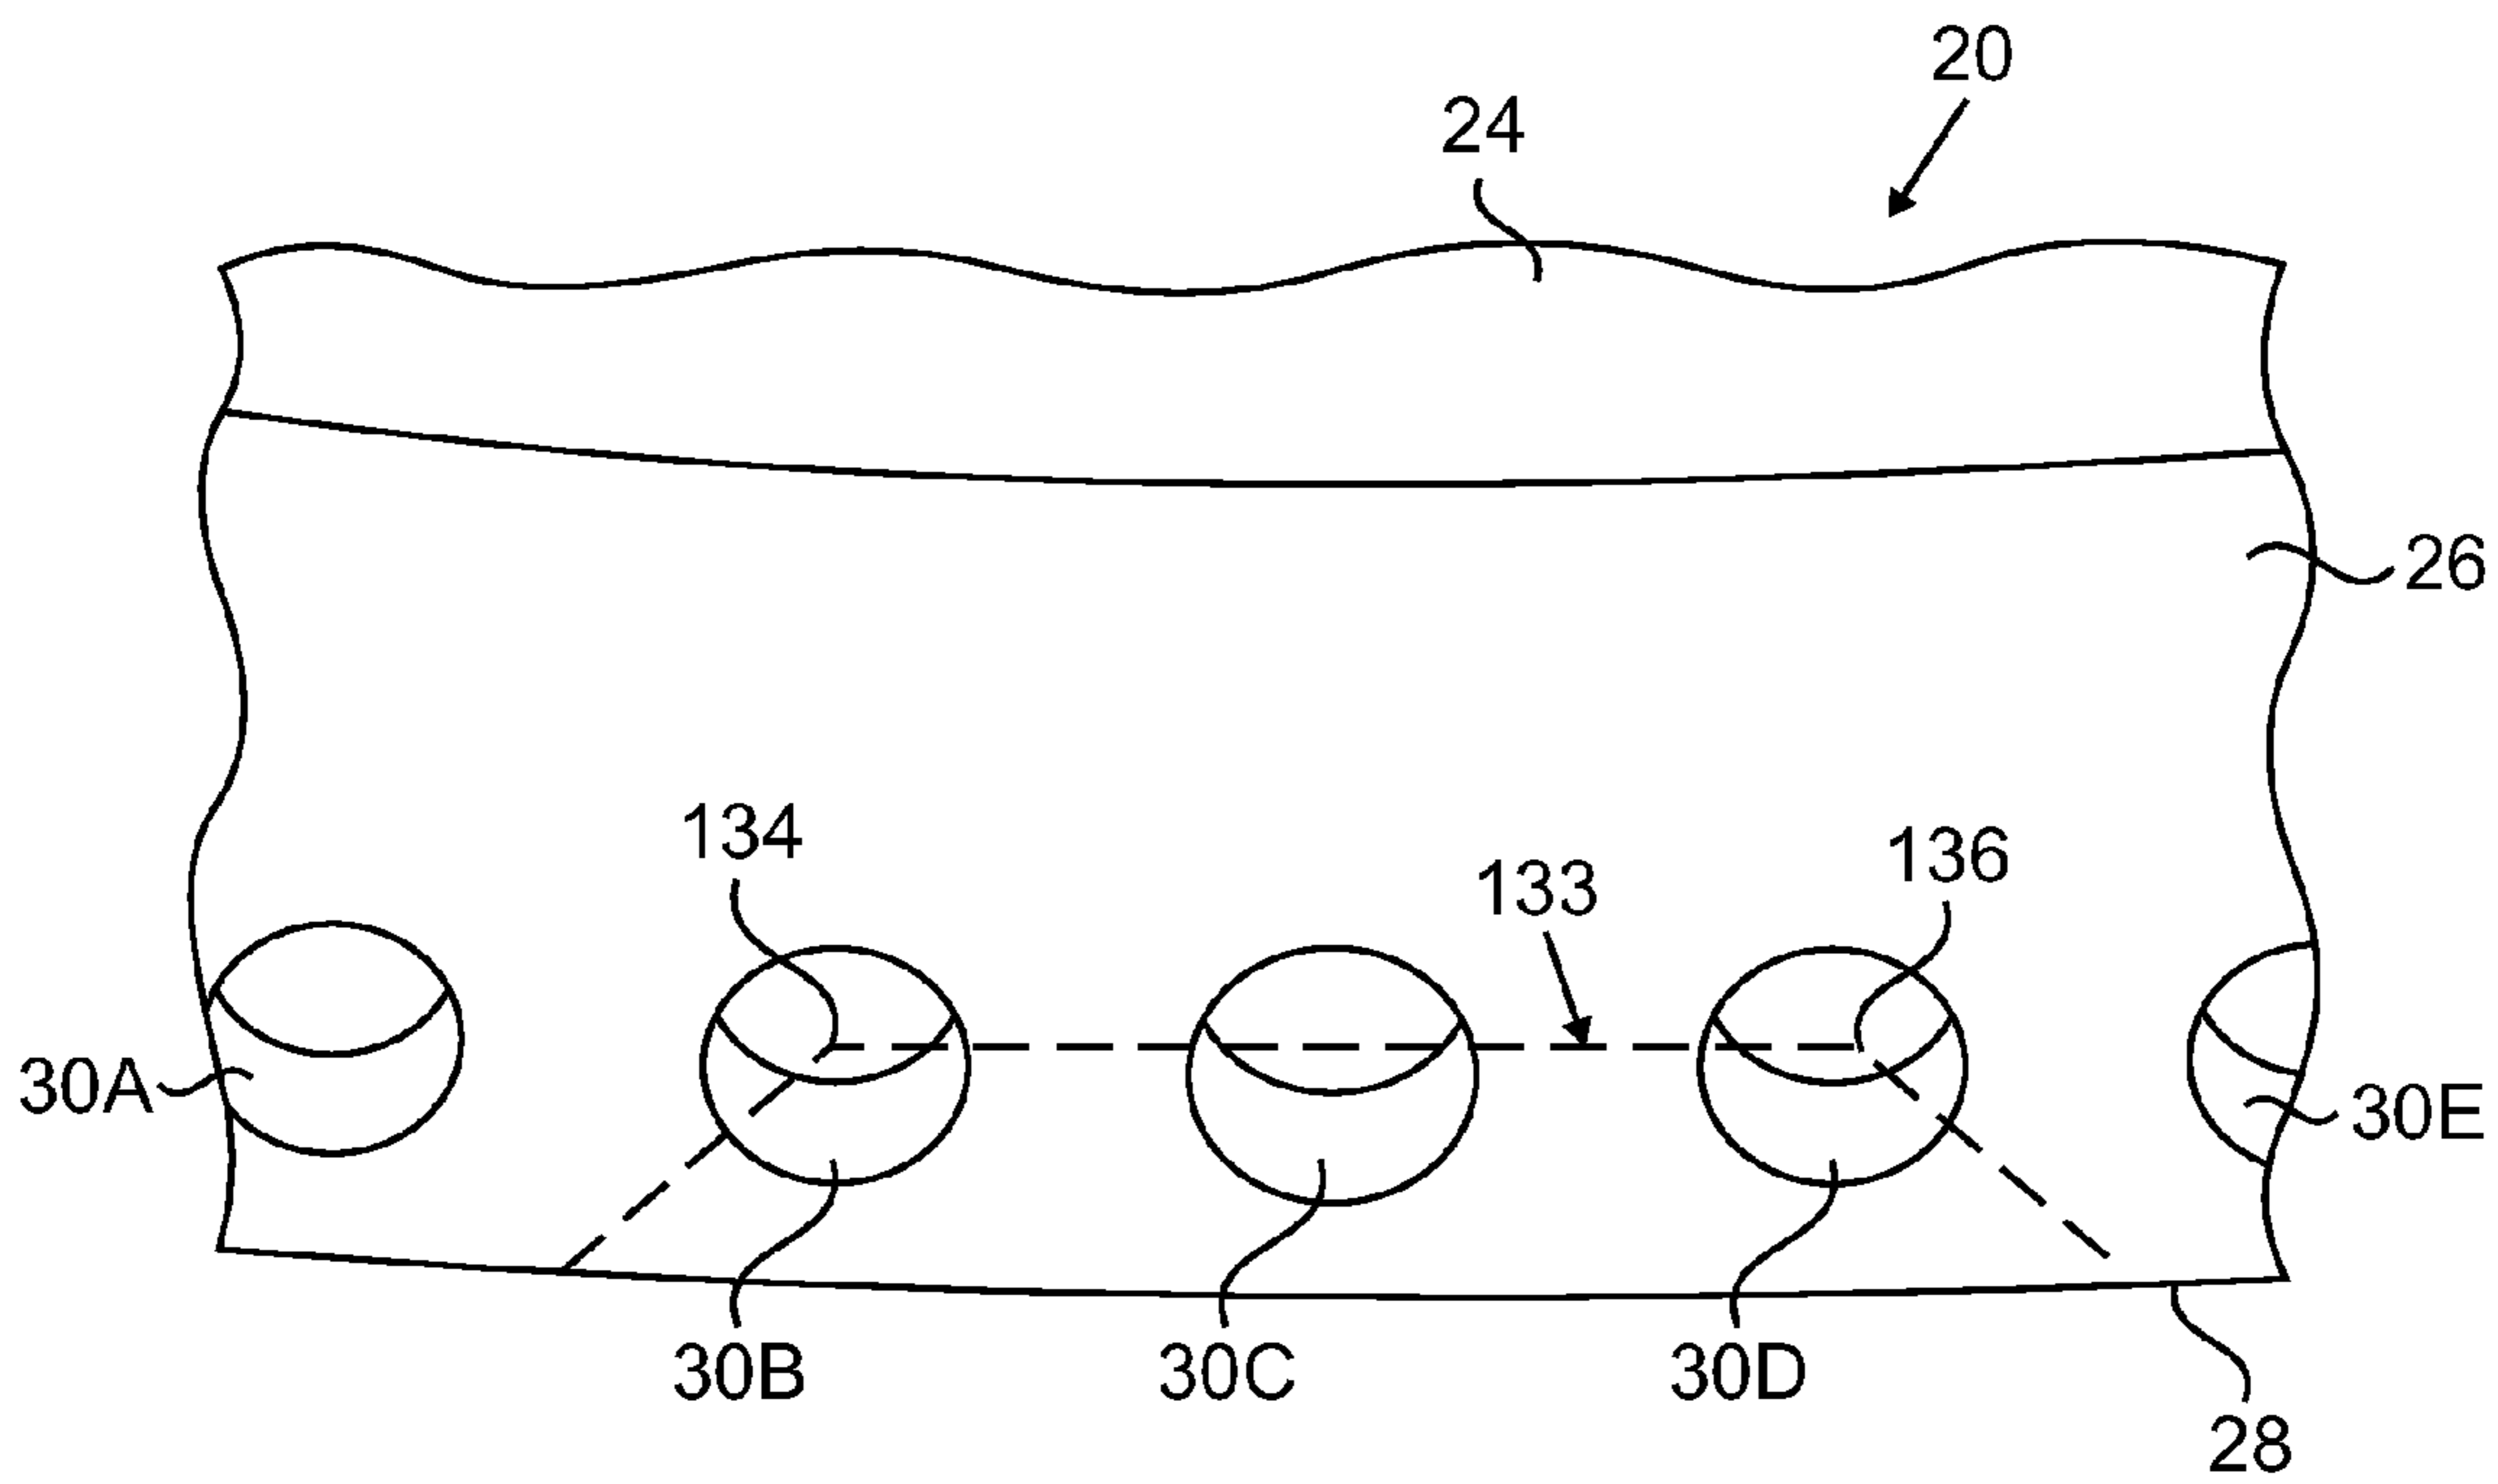
**FIG. 6**

FIG. 6 is a front view of a portion of the case assembly during an alternative repair process.
