## REPLACEMENT OF PART OF ENGINE CASE WITH DISSIMILAR MATERIAL

This disclosure relates to methods for repairing engine components and the repaired components produced by such methods.

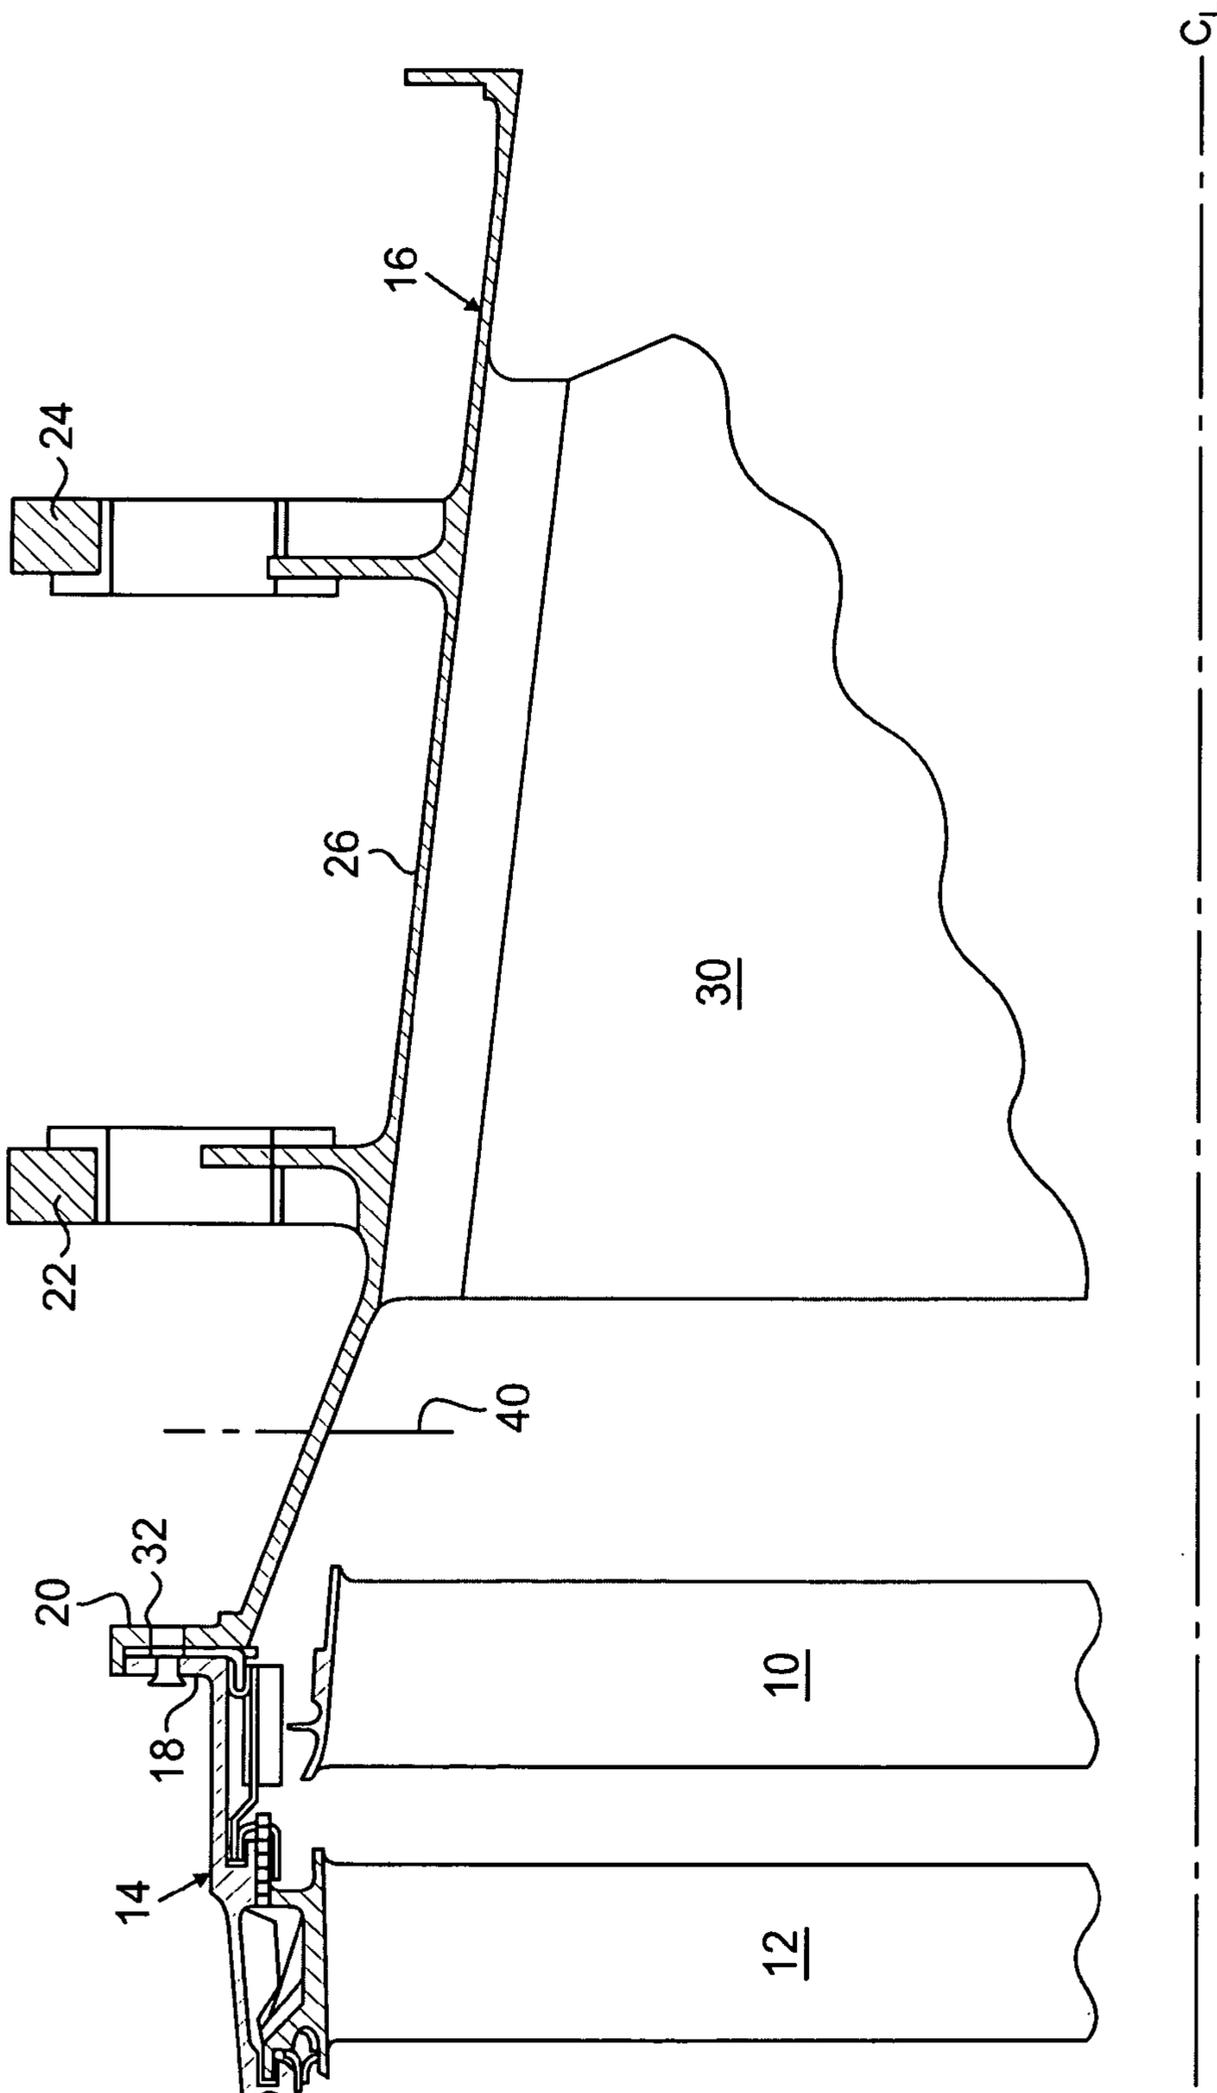
FIG. 1 is a cross-sectional view of a portion of a gas turbine engine.

FIG. 1 is a cross-sectional view of a portion of a gas turbine engine, including a low-pressure turbine (LPT) blade 10, a LPT vane 12, a LPT case 14, and a turbine exhaust case (TEC) segment 16, all arranged relative to an engine centerline CL. FIG. 2 is an isometric view of the TEC segment 16. The LPT case 14 includes a flange 18, which is located at an aft portion of the LPT case 14 near the aftmost LPT blade 10. The LPT case 14 can be made of a metallic material, for instance, a superalloy such as a nickel-based superalloy consistent with Aerospace Materials Specification (AMS) 5666 specifications (e.g., Inconel® 625).

The TEC segment 16 includes flanges 20, 22 and 24 extending from an outer diameter (OD) wall 26, an inner diameter (ID) wall 28, and at least one vane 30 extending between the OD and ID walls 26 and 28. The flange 20 is located at a forward portion of the TEC 16, and is configured to be mechanically connected at a bolt hole 32 to the flange 18 of the LPT case 14 with a bolt or other suitable fastener. As shown in FIG. 2, support structures 34 can extend from the ID wall 28, to facilitate mounting the TEC segment 16 in the engine. A plurality of TEC segments 16 can be assembled together to form a generally annular TEC assembly about the engine centerline CL, with a generally annular exhaust flow-

During repair, a cut plane 40 on the TEC segment 16 is determined (see FIG. 1). The flange 20 is removed from the rest of the TEC segment 16 at the cut plane 40, using a suitable machining process for example. The cut plane 40 is generally located at a relatively low-stress area of the TEC segment 16. In one embodiment, the cut plane 40 is located such that the material removed includes the entire flange 20 as well as an approximately 3.81-5.08 cm (1.5-2 inch) portion of the OD wall 26. A replacement detail is created (or otherwise provided) to replace the removed material, and is welded to parent material of the TEC segment 16 at the location of the cut plane 40.

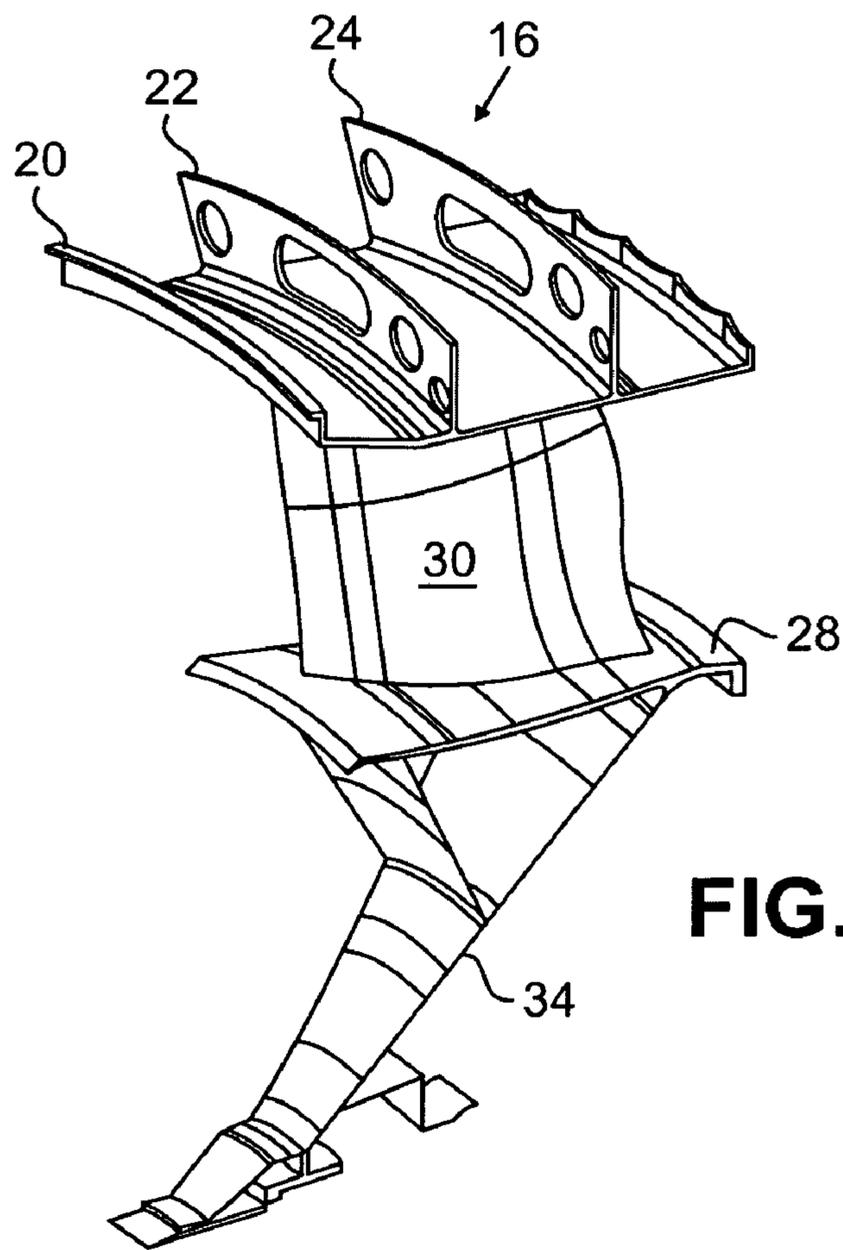
**FIG. 2**

FIG. 2 is an isometric view of a turbine exhaust case segment of the gas turbine engine.

path defined between the OD and ID walls 26 and 28 and the vanes 30 in a cascade configuration, in manner well known in the art. The TEC segment 16 can be made of a metallic material, for instance, a stainless steel such as a martensitic stainless steel consistent with AMS 5616 specifications (e.g., Greek Ascoloy™). It should be noted that the general configuration and operation of gas turbine engines is well known, and therefore is not discussed in detail here.

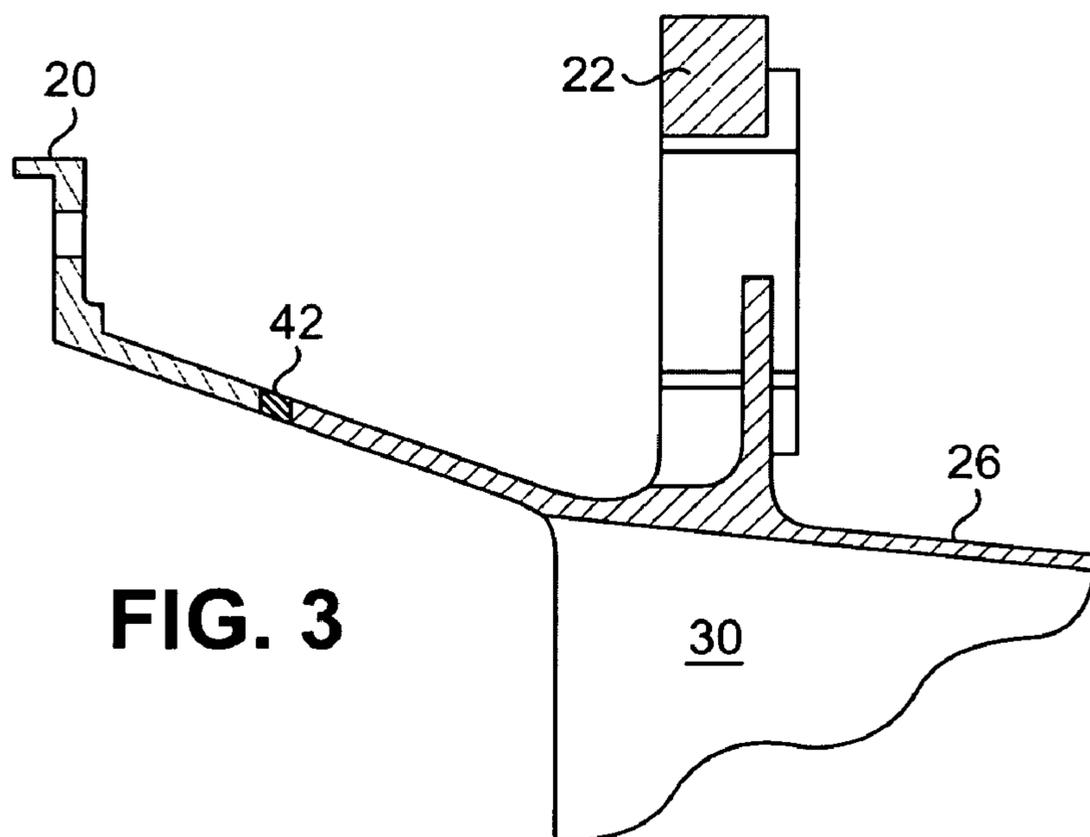
**FIG. 3**

FIG. 3 is a cross-sectional view of a repaired portion of the turbine exhaust case segment.

FIG. 3 is a cross-sectional view of a repaired portion of the TEC segment 16. A replacement detail 20' is welded to the parent material of the TEC case 16 along the OD wall 26. A weld joint 42 is formed at a location that corresponds to the location of the cut plane 40 (see FIG. 1). Electron beam welding or other suitable techniques can be used to form the weld joint 42. The replacement detail 20' can have a shape that is substantially identical to the removed material of the TEC segment 16, and can be made of a different material than the parent material of the TEC segment 16. The replacement detail 20' can be made of the same material as the LPT case 14, or a material have substantially the same coefficient of thermal expansion as the material of the LPT case 14. For example, the replacement detail 20' can be made of an Inconel® 625 alloy while the parent material of the TEC segment 16 can be made of a Greek Ascoloy™ alloy. By making the replacement detail 20' of a dissimilar material from the parent material of the TEC segment 16, contact between the LPT case 14 and the TEC segment 16 can occur between materials with substantially the same coefficient of thermal expansion. In that way, creep at the connection between the LPT case 14 and the repaired TEC segment 16 can be reduced, which can help reduce rework, turnaround time (TAT), costs, future part damage, and engine time off-wing.

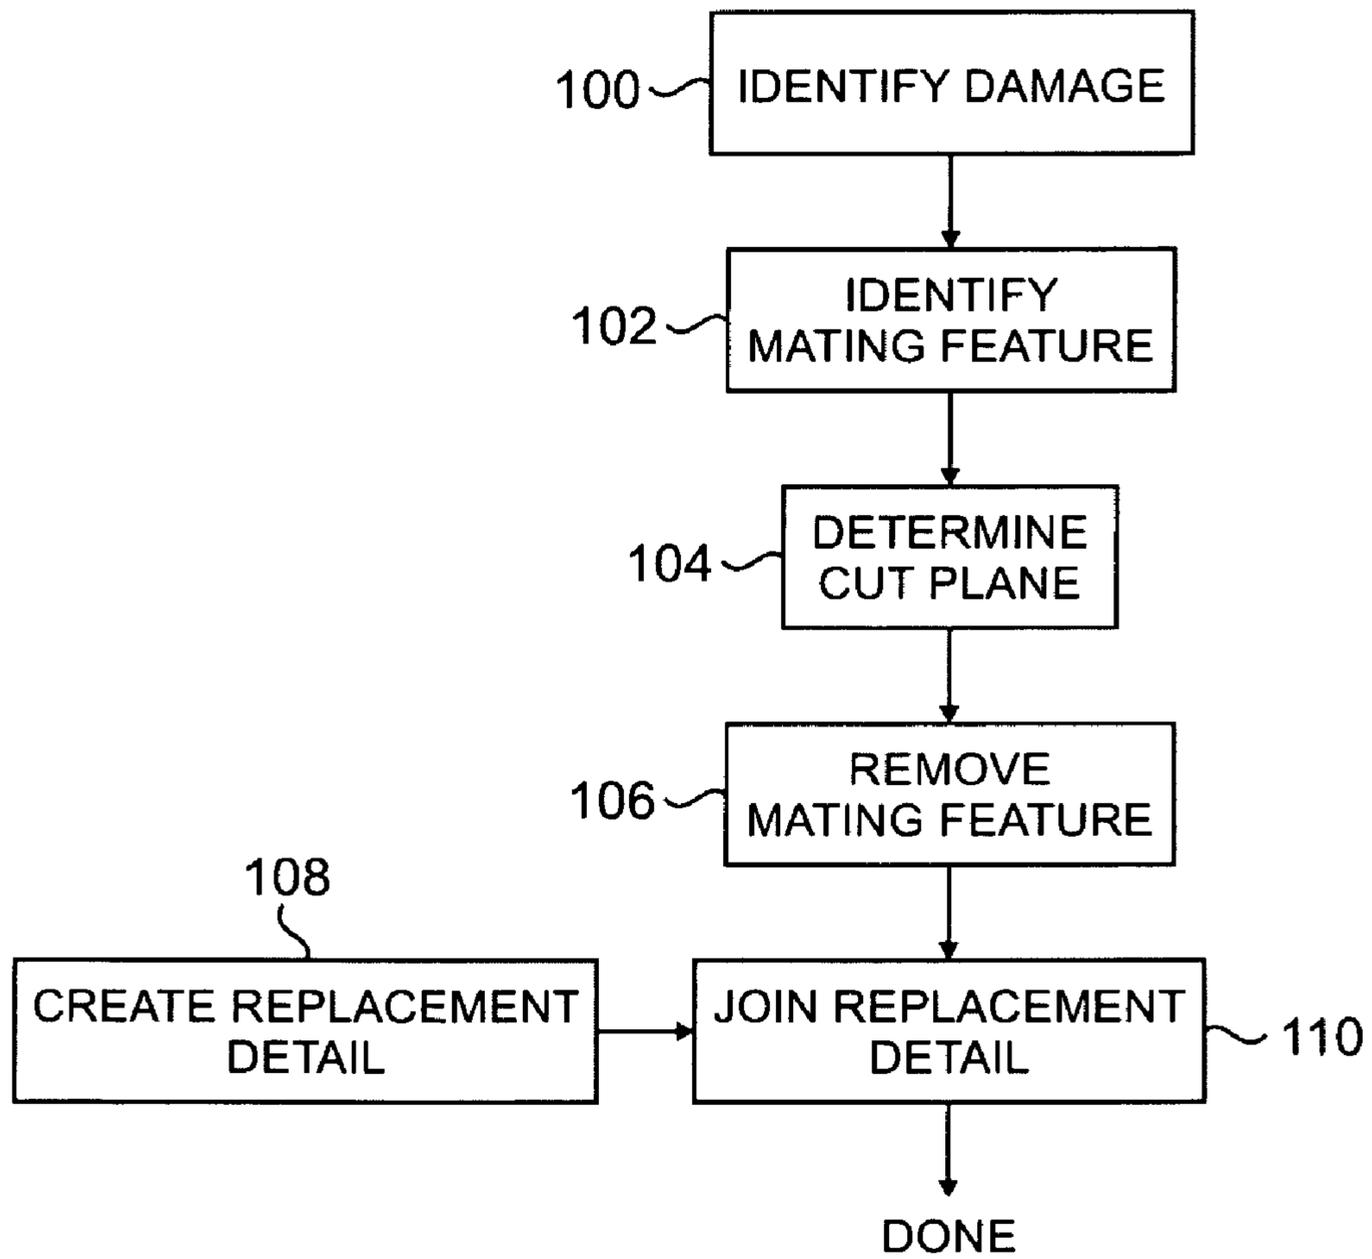
FIG. 4 is a flow chart of a repair method.

FIG. 4 is a flow chart of one embodiment of a repair. After a part has been removed from an engine for service, a first step is to identify damage to the part (step 100). Damage can include creep, bolt hole elongation, flange bending, cracks, etc. Next, a mating feature of the part is identified (step 102). The mating feature can include a flange or other structure that connects to another part in the engine. A cut plane is then determined (step 104). A portion of the part including the mating feature is removed from another portion of the part at the cut plane (step 106). A replacement detail is created (or otherwise provided) of a replacement material having a dif-

During use, the TEC segment 16 can become warped or damaged, for example, due to thermal conditions and low-cycle fatigue (LCF). Moreover, creep can occur at the flange 20 of the TEC segment 16. Creep can be particularly problematic because the LPT case 14 and the TEC segment 16 can be made of different materials (e.g., Inconel® 625 and Greek Ascoloy™, respectively) with different coefficients of thermal expansion, which can cause undesirable elongation of the bolt hole 32 and bending of the flange 20. Wear or damage to the TEC segment 16 can be repaired according to the disclosed method (see FIG. 4).
