(10) **Patent No.:** **US 8,257,039 B2**  
(45) **Date of Patent:** **Sep. 4, 2012**

(54) **GAS TURBINE ENGINE CASE WITH REPLACED FLANGE AND METHOD OF REPAIRING THE SAME USING COLD METAL TRANSFER**

A method of repairing an engine case for a gas turbine engine includes the steps of identifying a damaged flange on an engine case, removing the damaged flange down to a surface of the engine case to receive a replacement flange. The replacement flange is placed on the surface, and welded to the surface utilizing cold metal transfer.

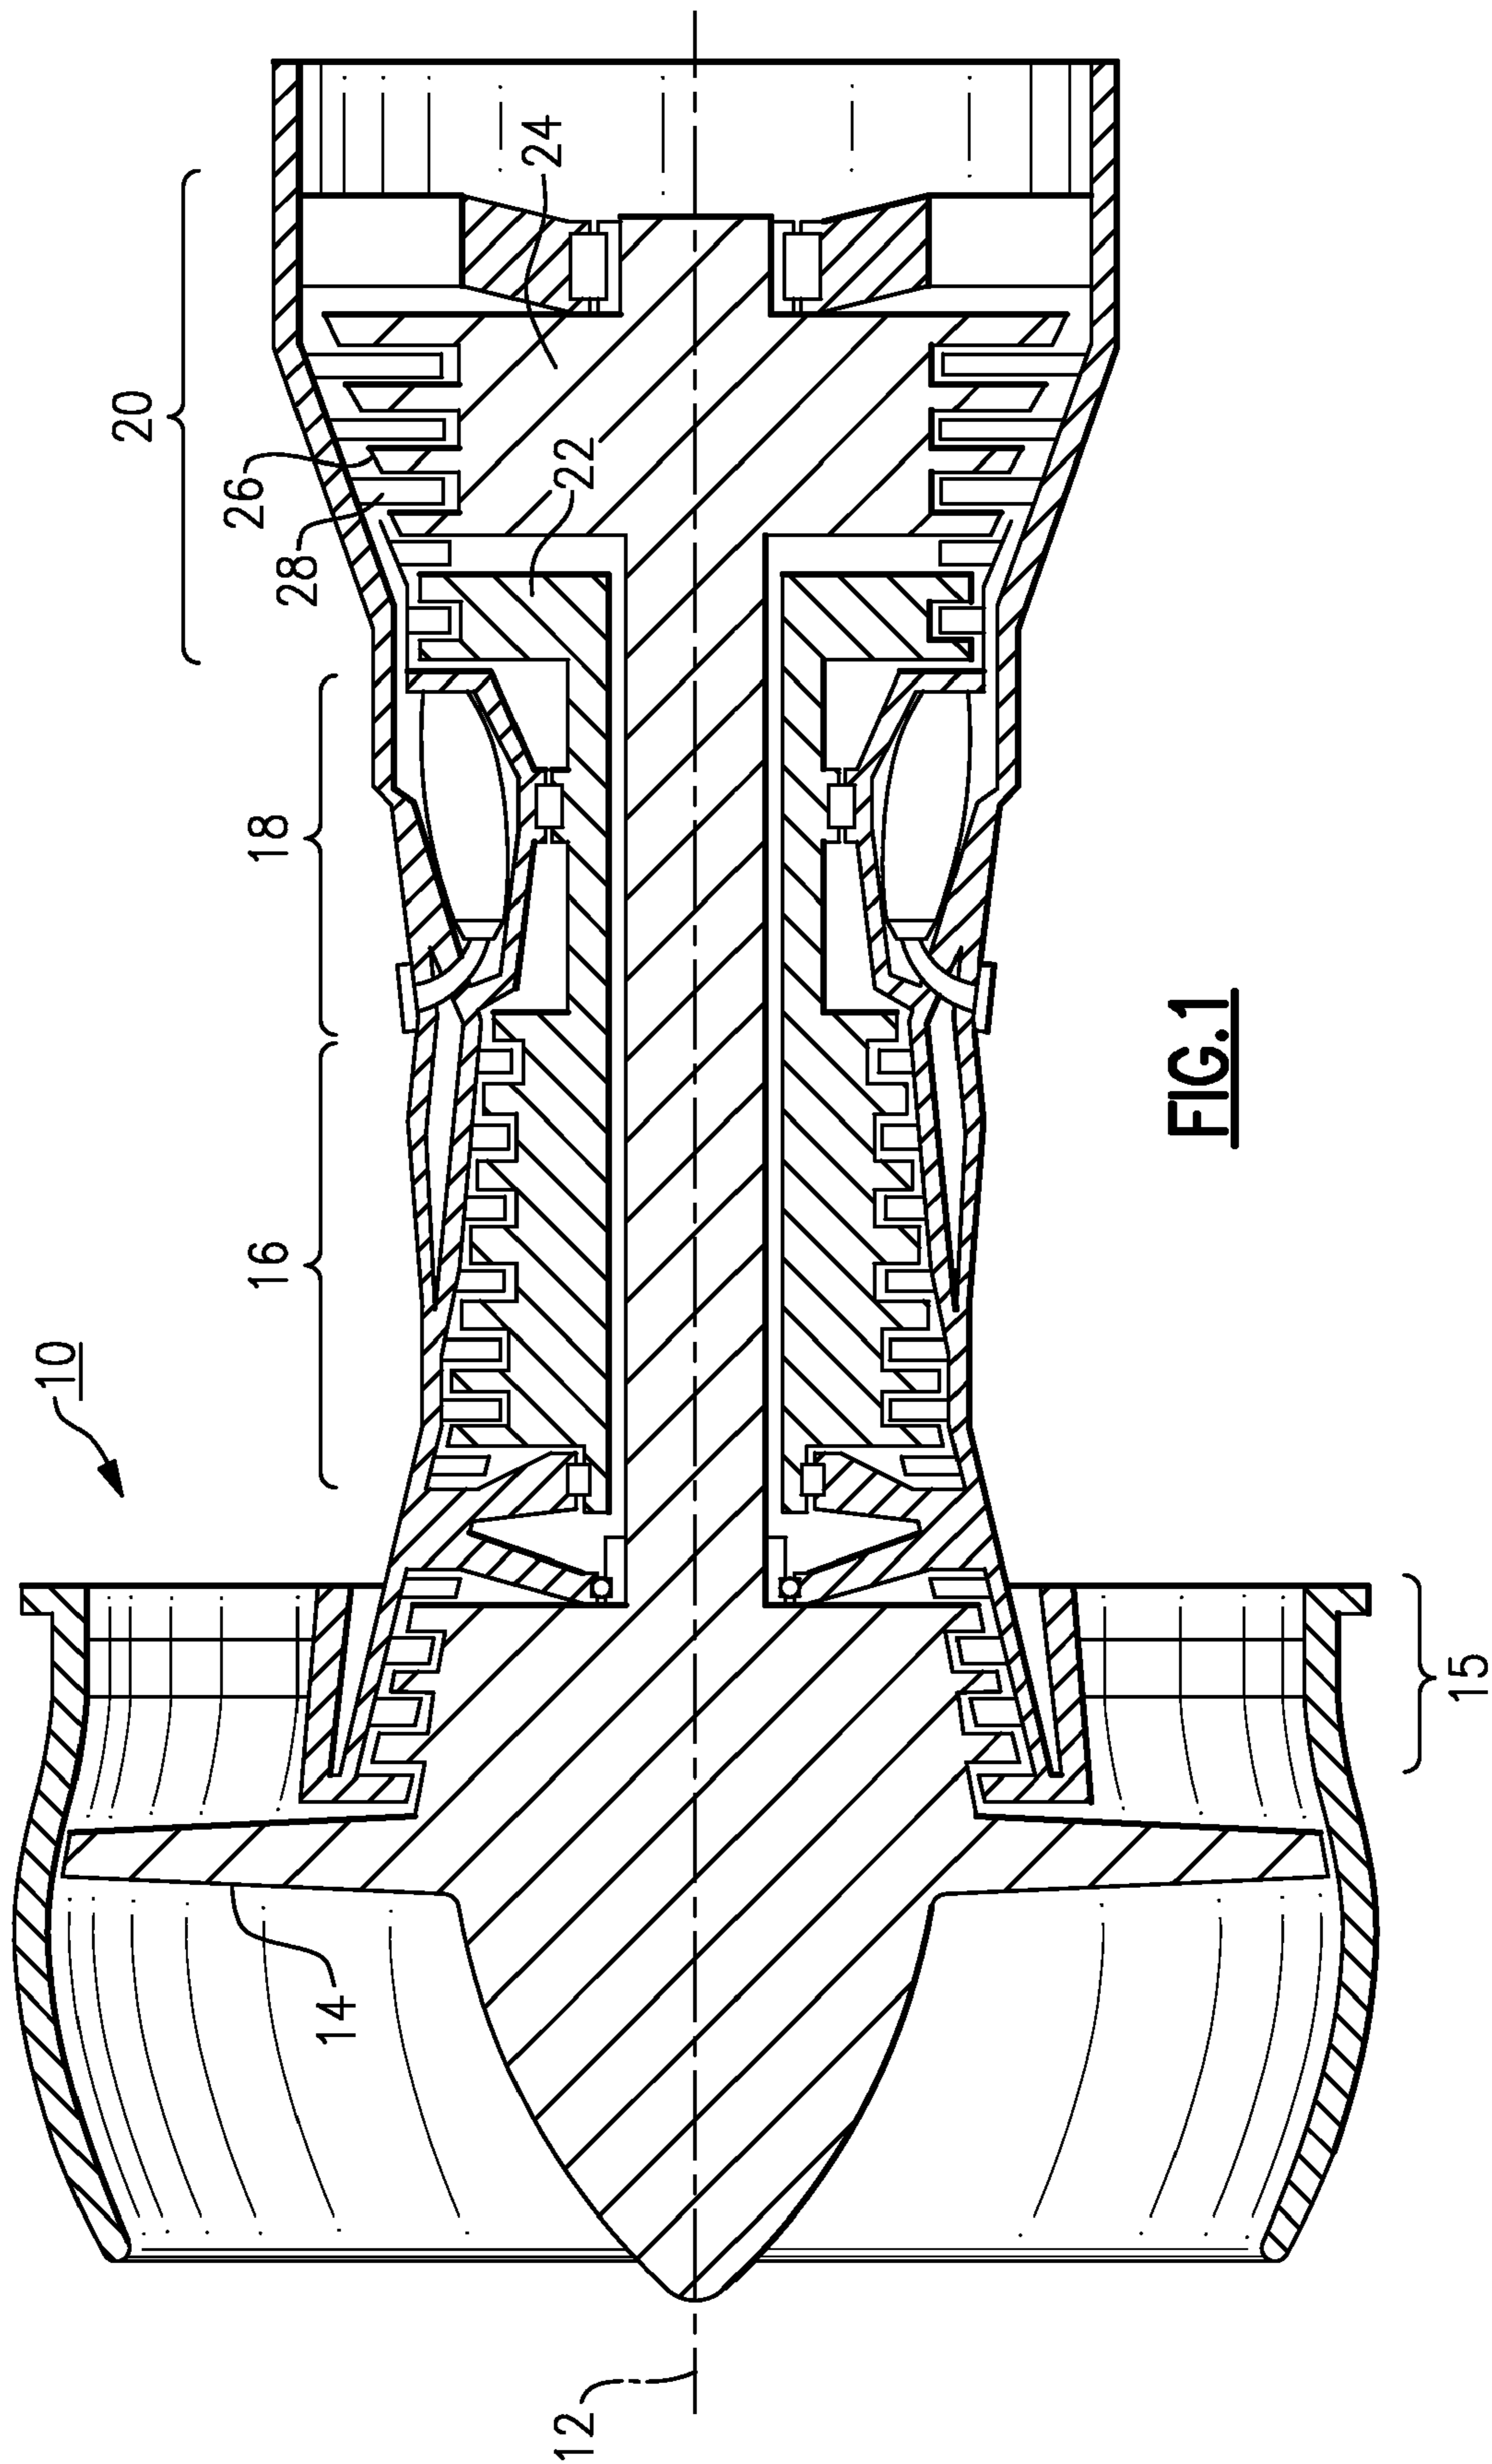
**FIG.2A**

FIG. 1 is a schematic view of a gas turbine engine.  
FIG. 2A is a flow chart of an exemplary repair method.

FIG. 2A is a flow chart of a method of repairing a worn engine case **40** such as is shown in FIG. 2B. The initial step **100** is to removed the case **40** from the engine **10**, for example, during a repair or overhaul shop visit. The case **40** is cleaned and inspected at step **102** for repair requirements. For example, as shown in FIG. 2B, a number of worn or damaged areas **44** may exist on a flange **42** of the engine case **40**. These areas **44** may be identified for repair prior to the engine case **40** being reinstalled on the engine **10**.

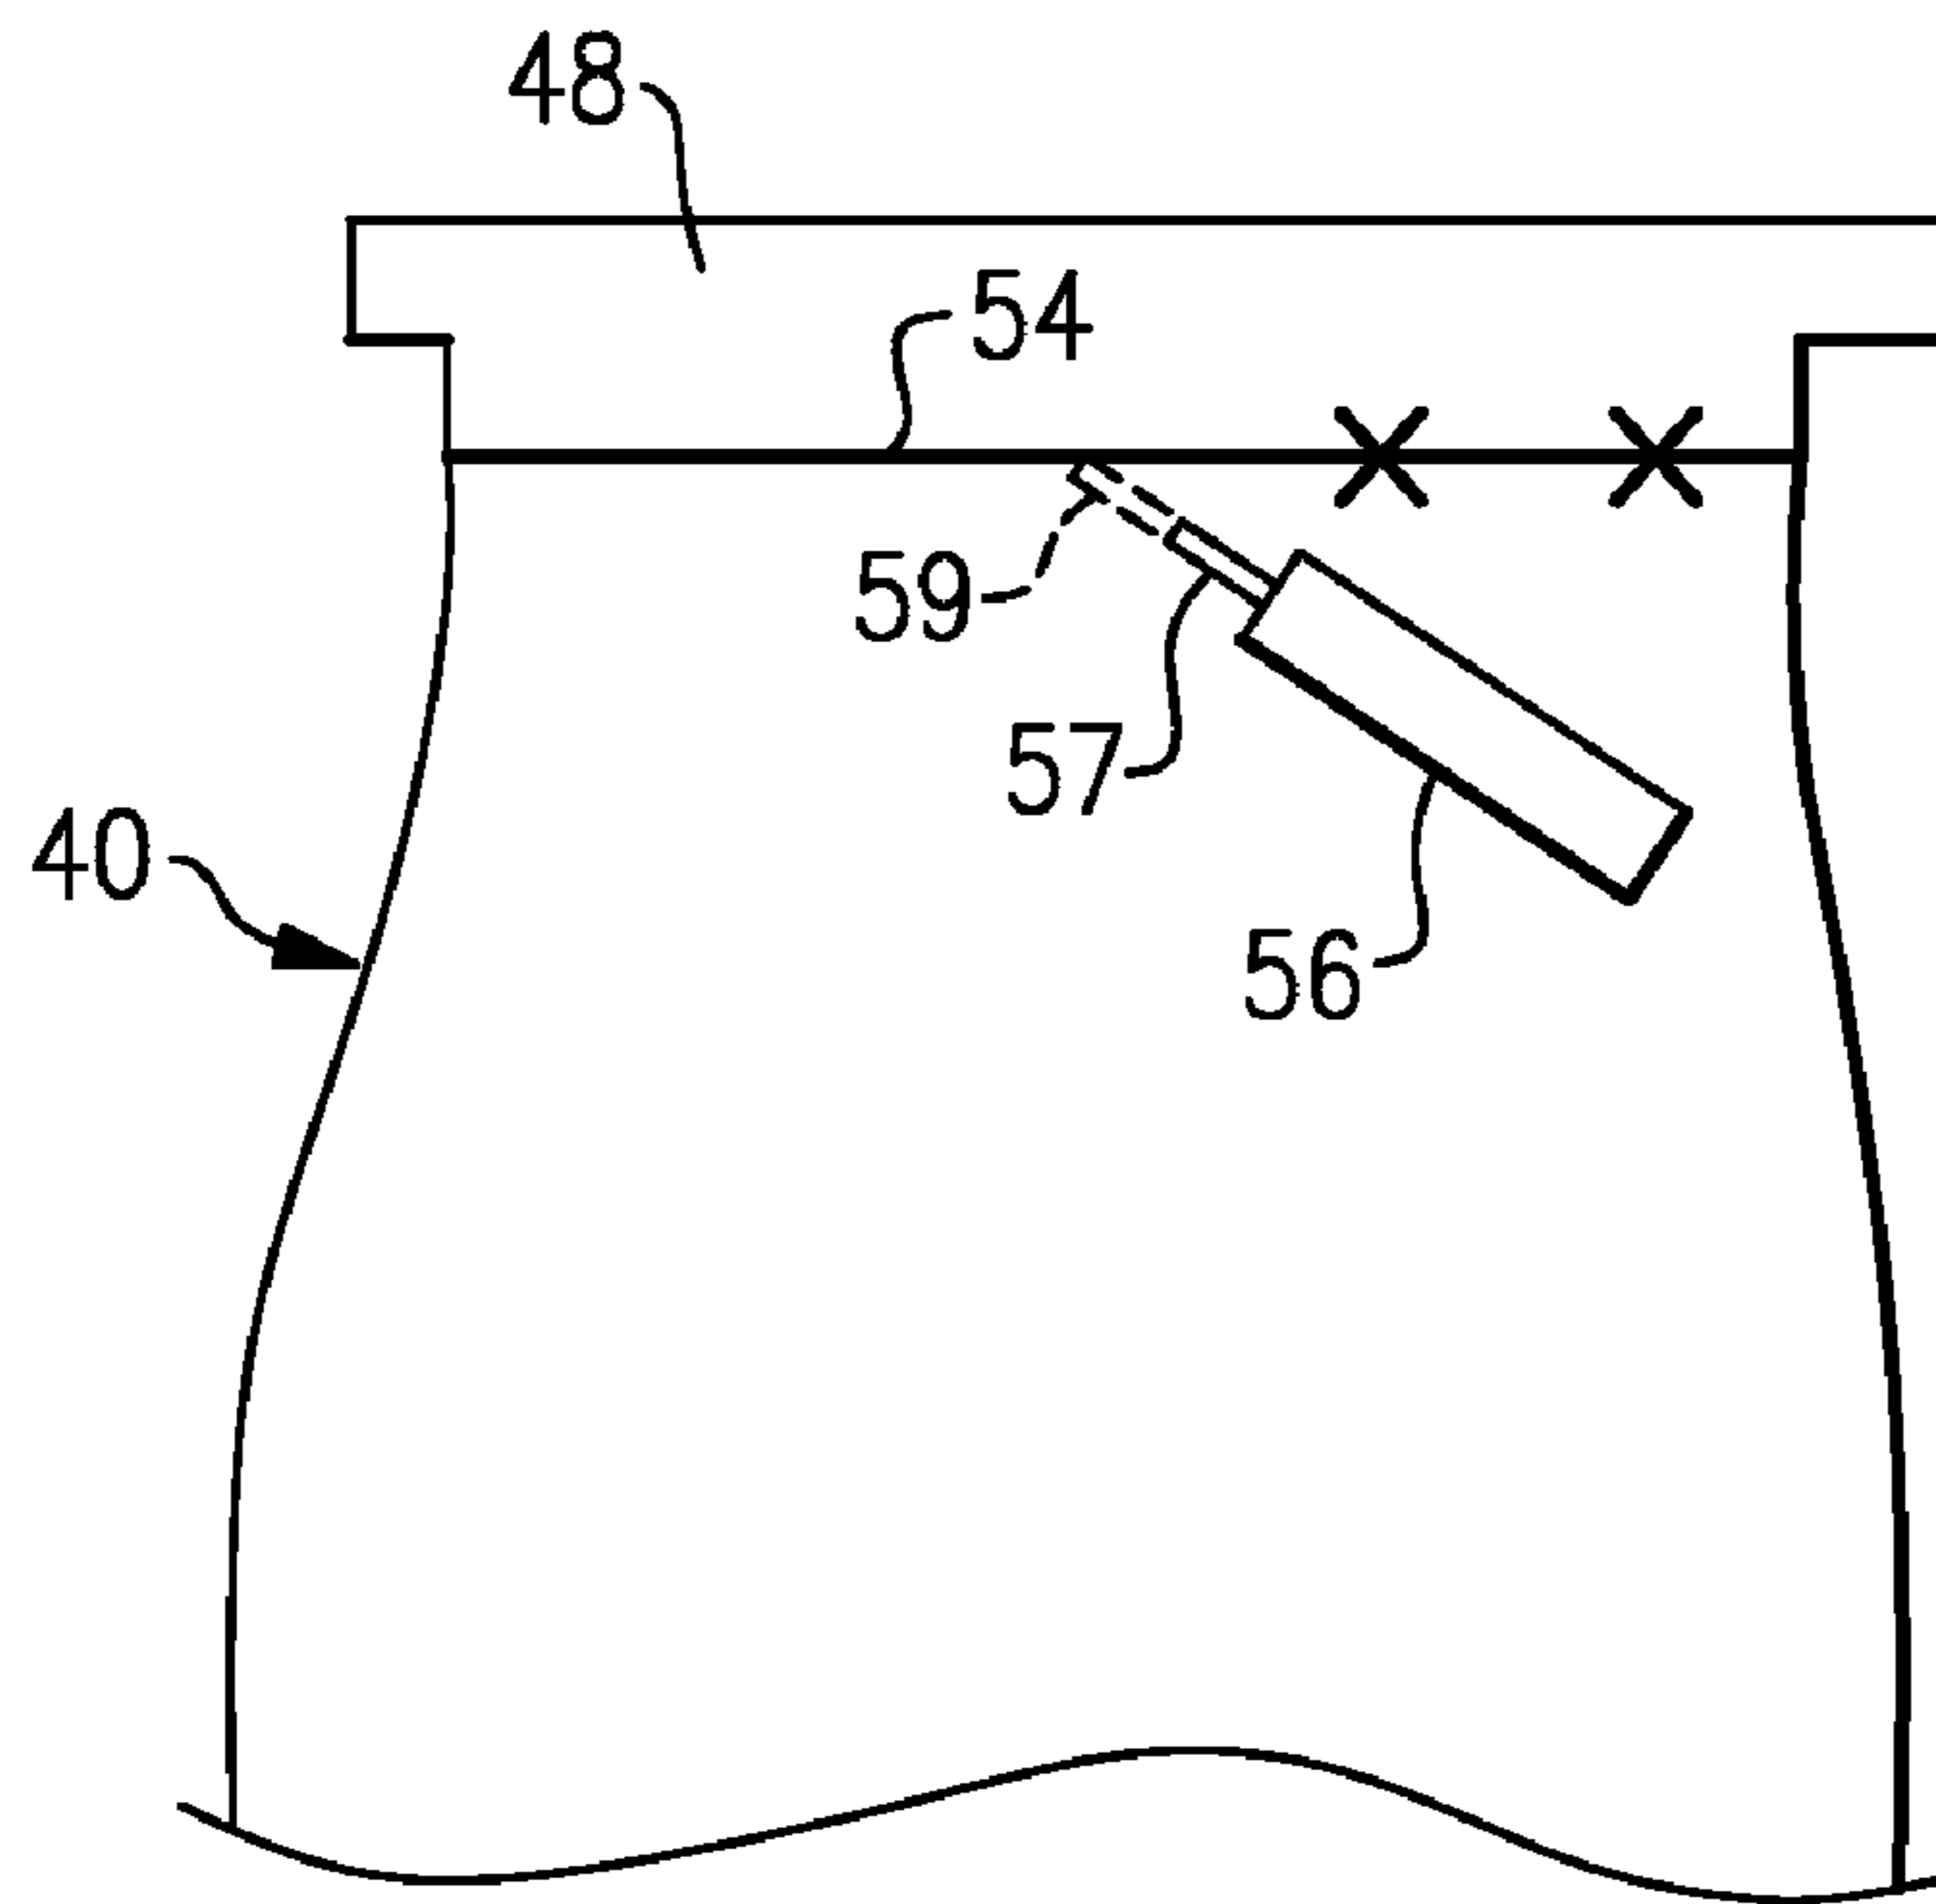
**FIG.3E**

FIG. 3E shows a final step in the repair process.
