(54) **CONTROL OF CASE WALL GROWTH DURING REPAIR AND METHOD**

A method for repairing a gas turbine engine component includes identifying a distorted feature located in a first portion of the component, identifying a second portion of the component that behaves as at least one of a heat sink or a stiffener, removing the second portion of the component from the first portion, cold working the first portion of the component to repair the distorted feature, heat treating the first portion of the component, and metallurgically joining the first portion of the component to the second portion of the component.

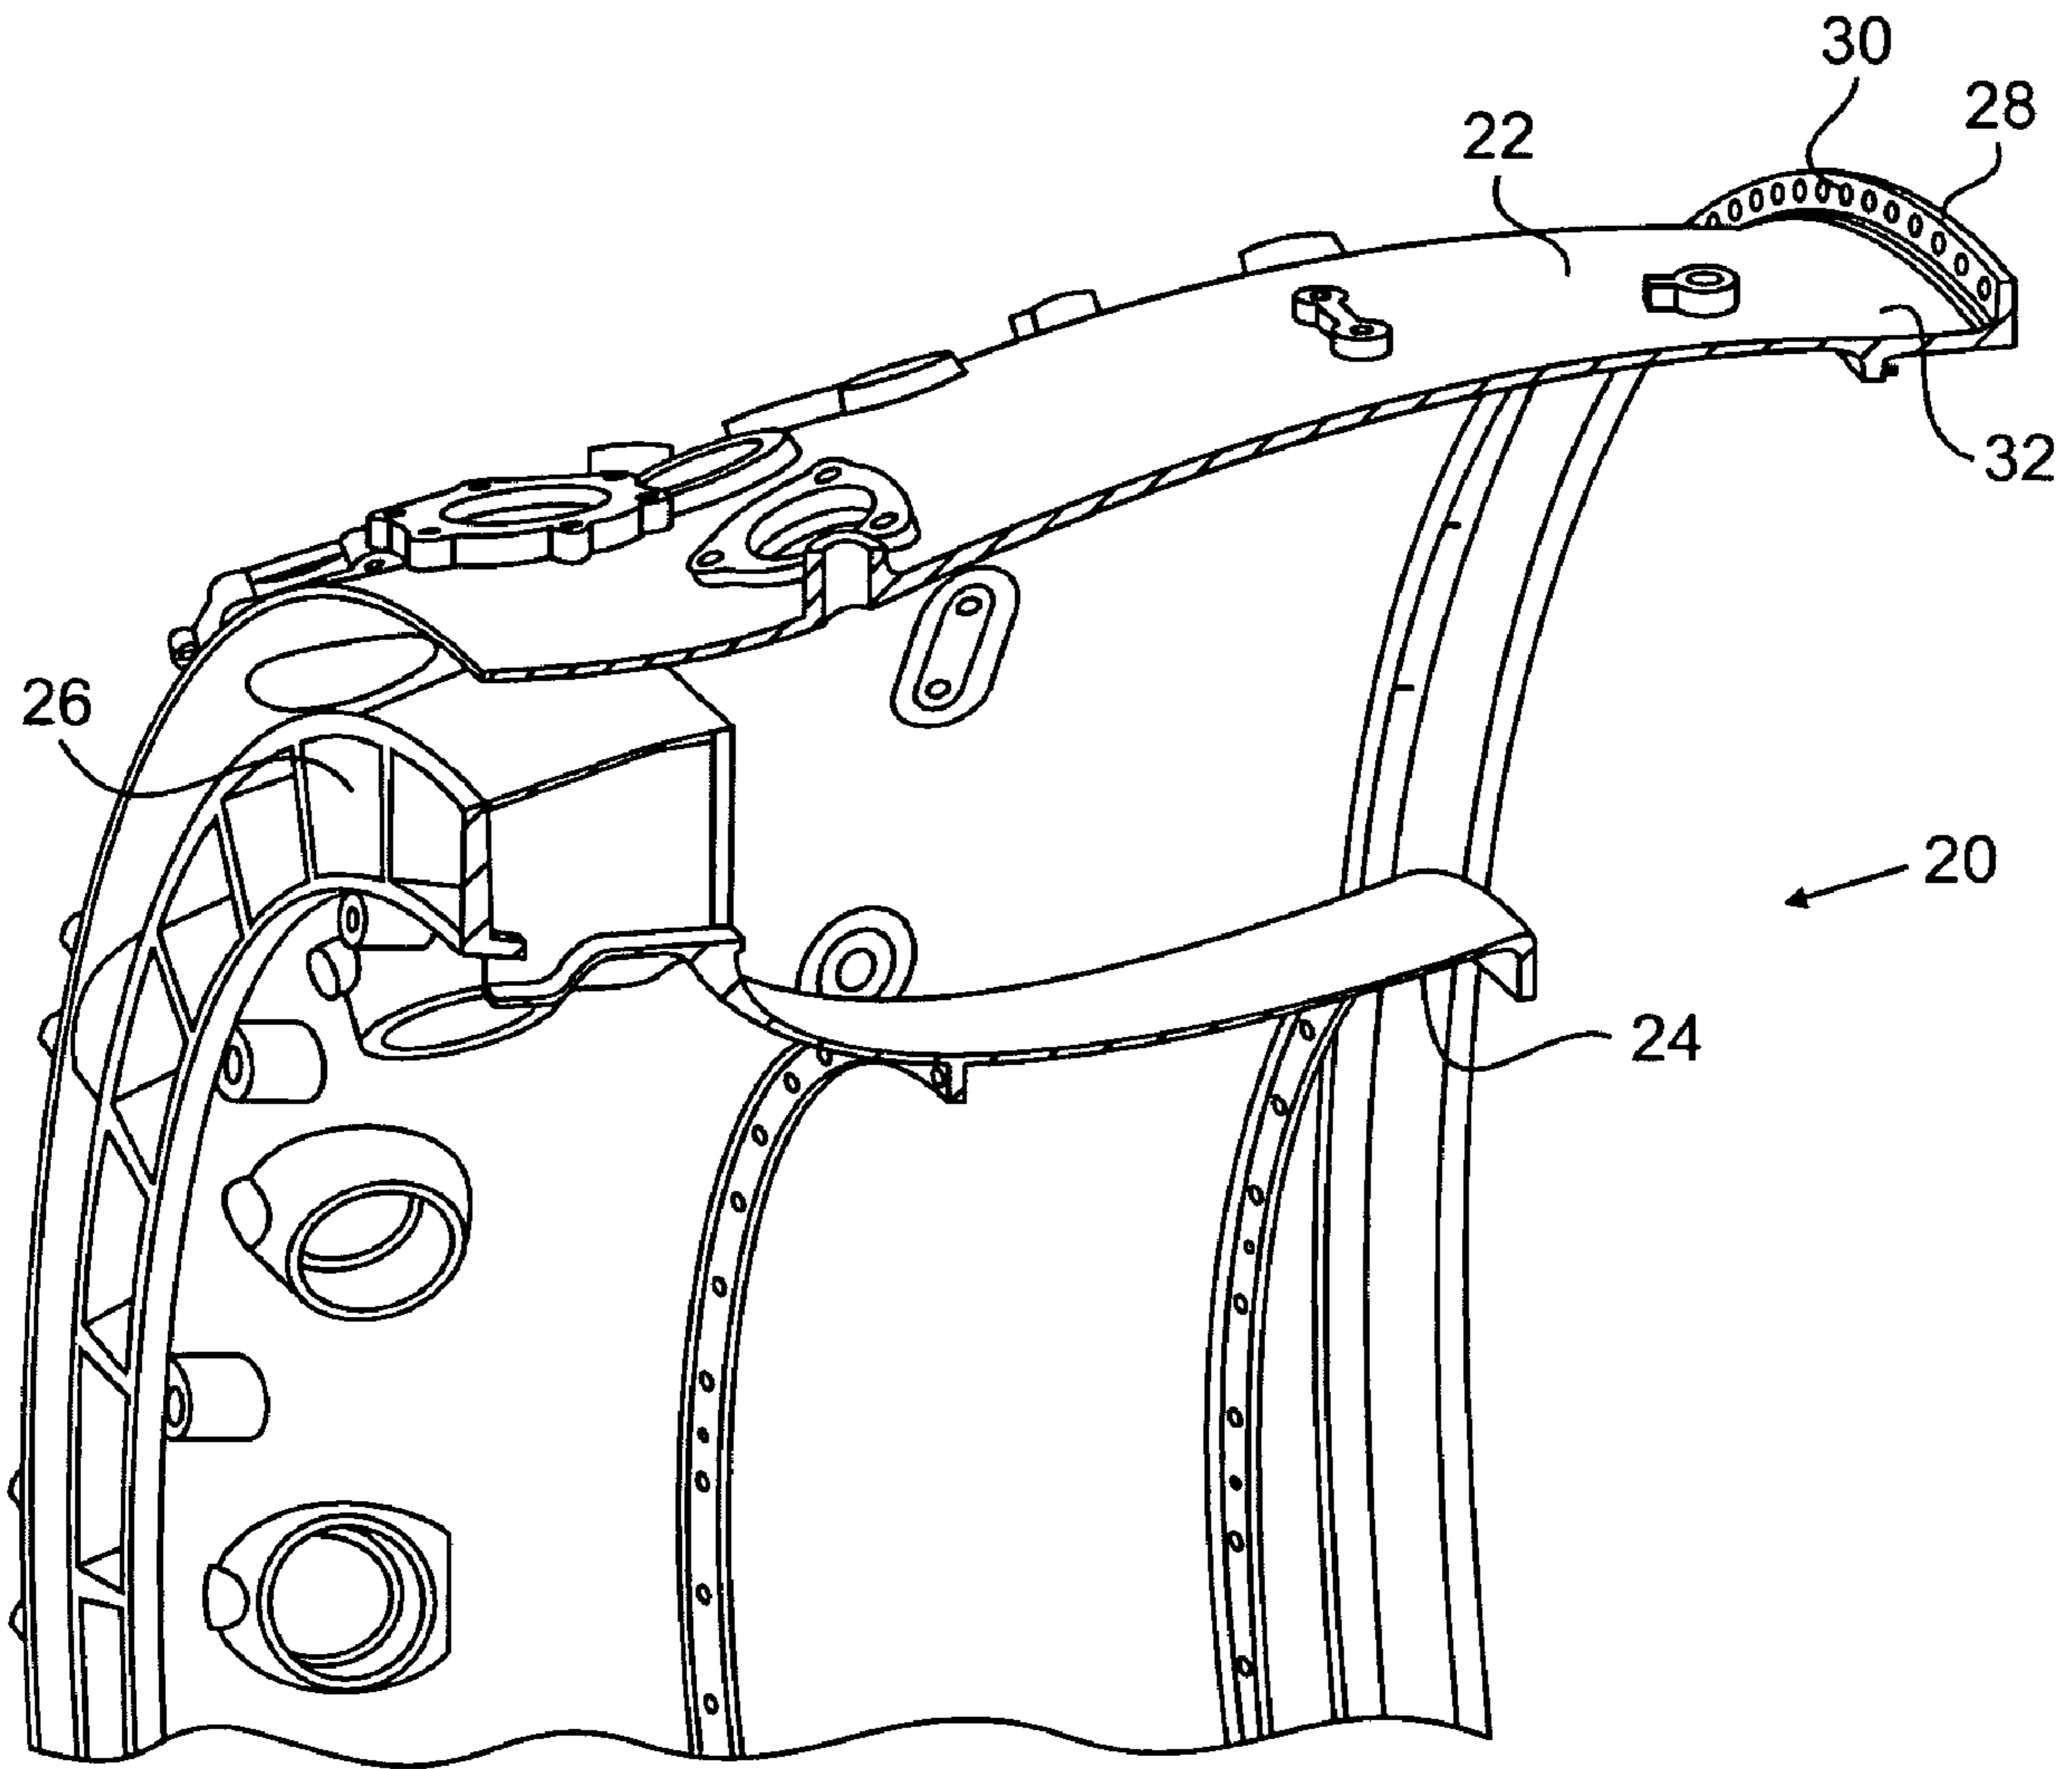
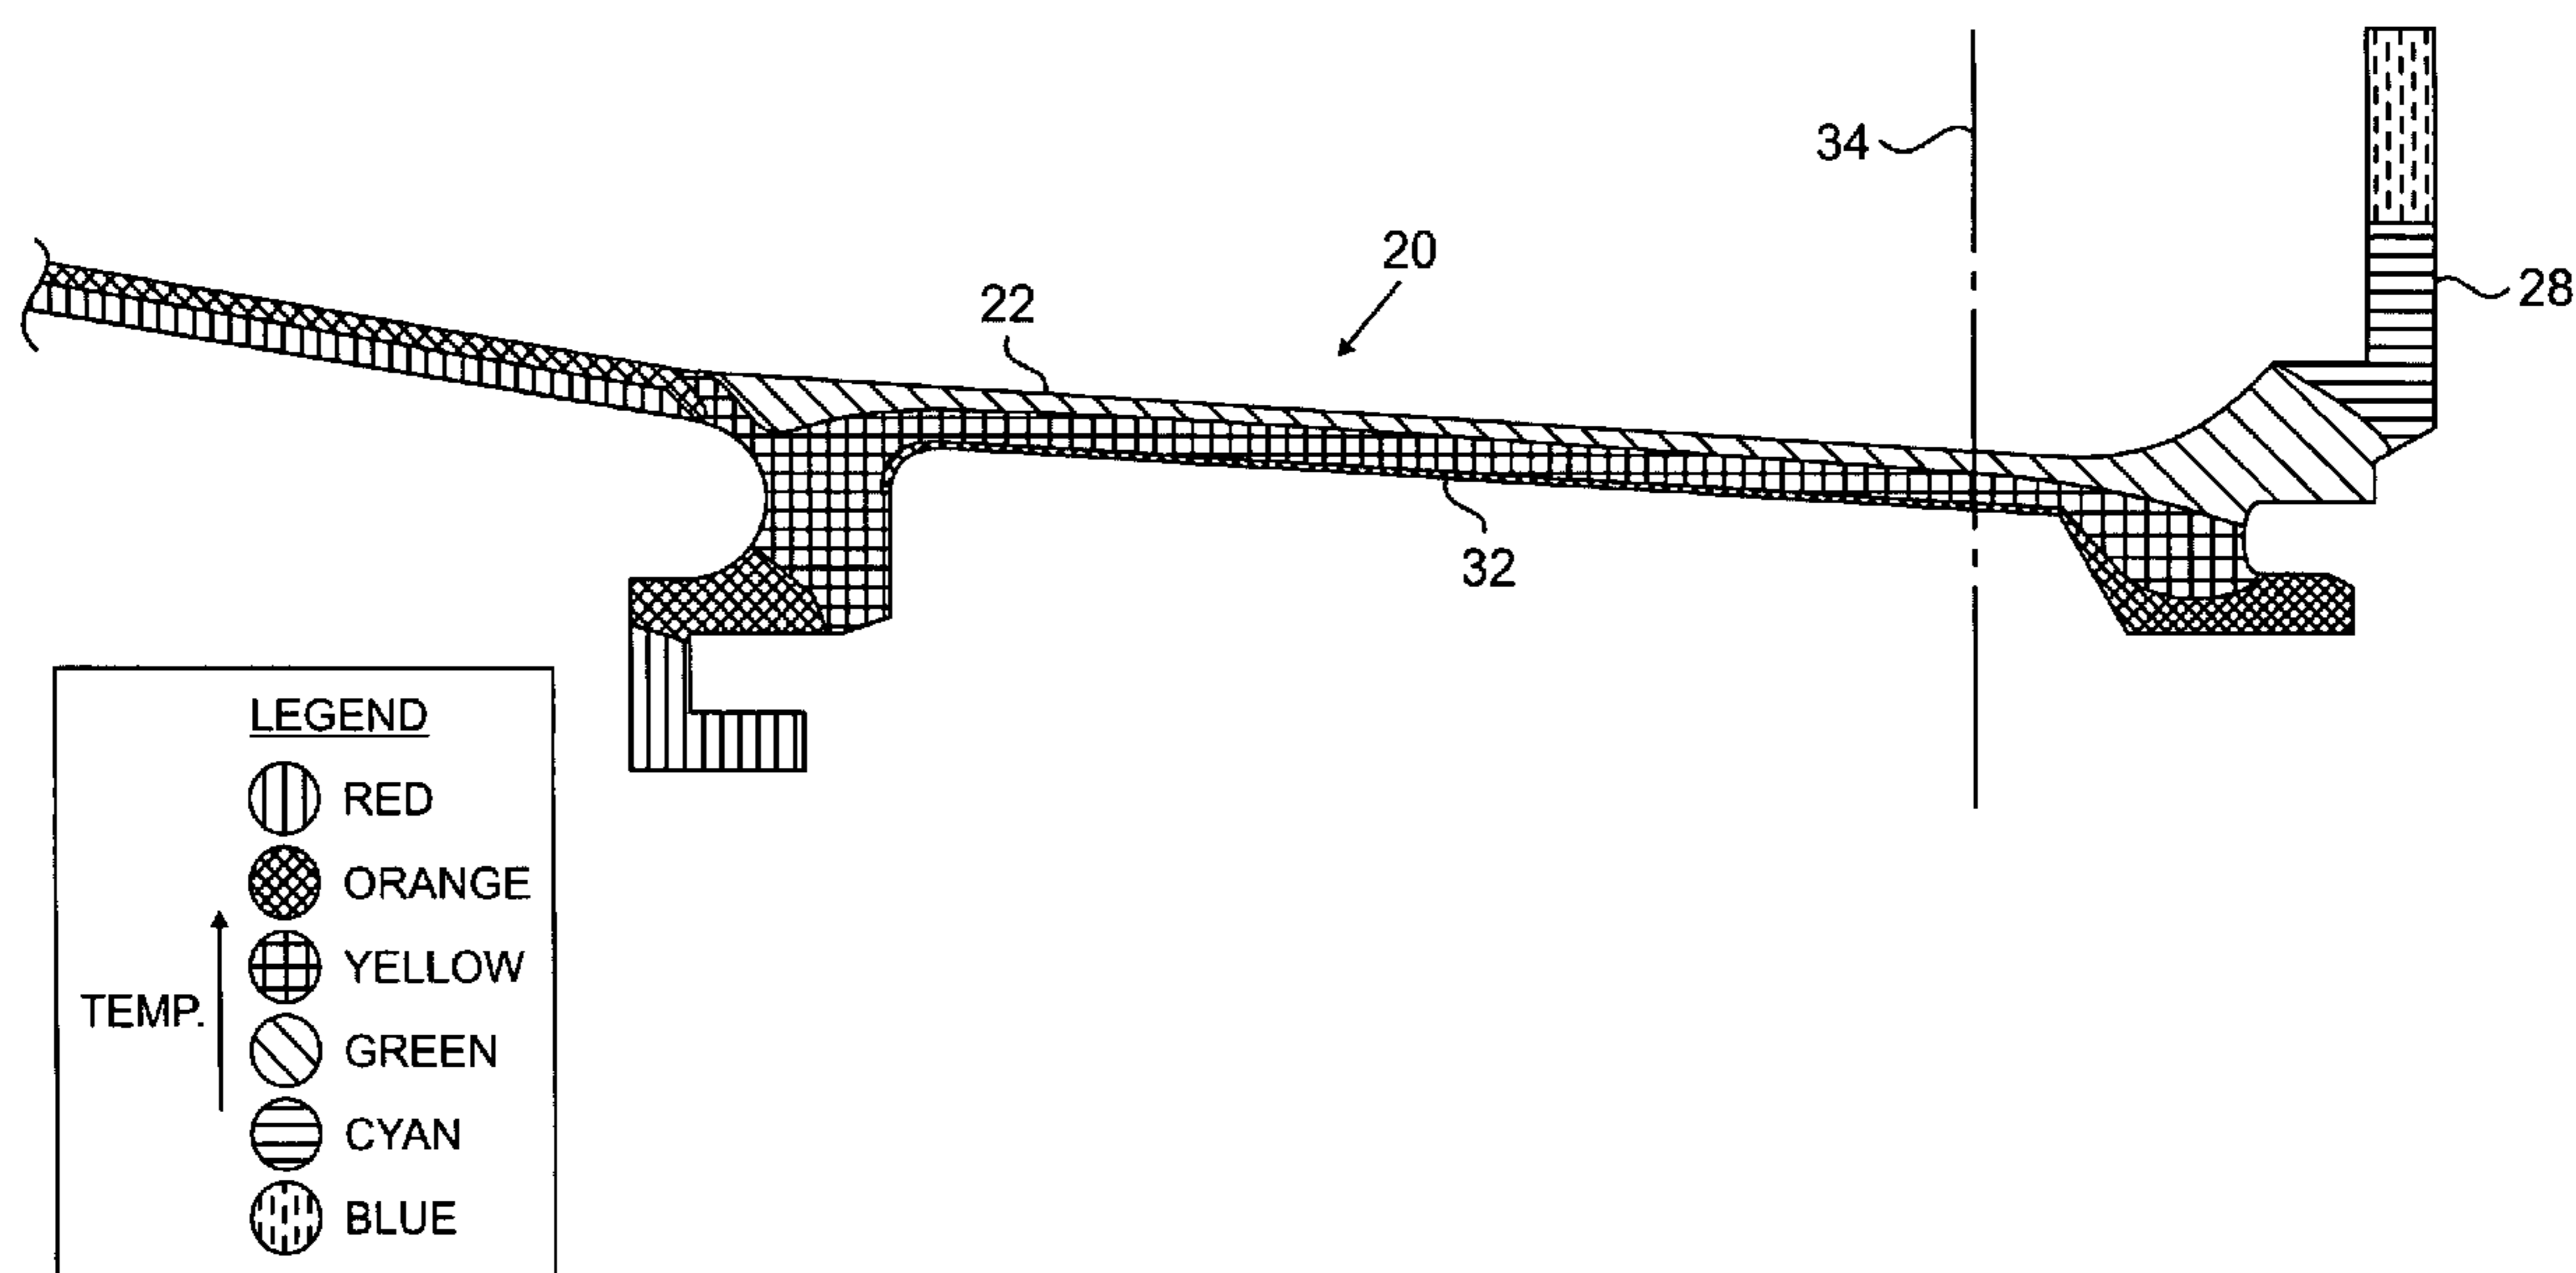
FIG. 1 is a cross-sectional perspective view of a diffuser case for a gas turbine engine.

FIG. 1 is a cross-sectional perspective view of a diffuser case **20** for a gas turbine engine. As is well-known in the art, the diffuser case **20** is typically located aft of a compressor section of the engine and has a cross-sectional flow area in the direction that increases in a downstream direction in order to decrease velocity and increase static pressure of fluid passing therethrough, which helps prepare the fluid for mixing with fuel for combustion. The general configuration and operation of gas turbine engines is well known in the art, and therefore is not discussed in detail here.

As shown in FIG. 1, the diffuser case **20** includes an outer wall **22**, an inner wall **24**, a plurality of vanes **26** located at a forward end of the case **20**, and an aft flange **28** extending from the outer wall **22**. A plurality of circumferentially spaced bolt holes **30** are formed in the aft flange **28**, which enable the diffuser case **20** to be mechanically connected to other components of an engine. Undesirable distorted features, such as a bulge **32**, can develop in the outer wall **22** (or other locations) during use and necessitate replacement or repair of the diffuser case **20**.

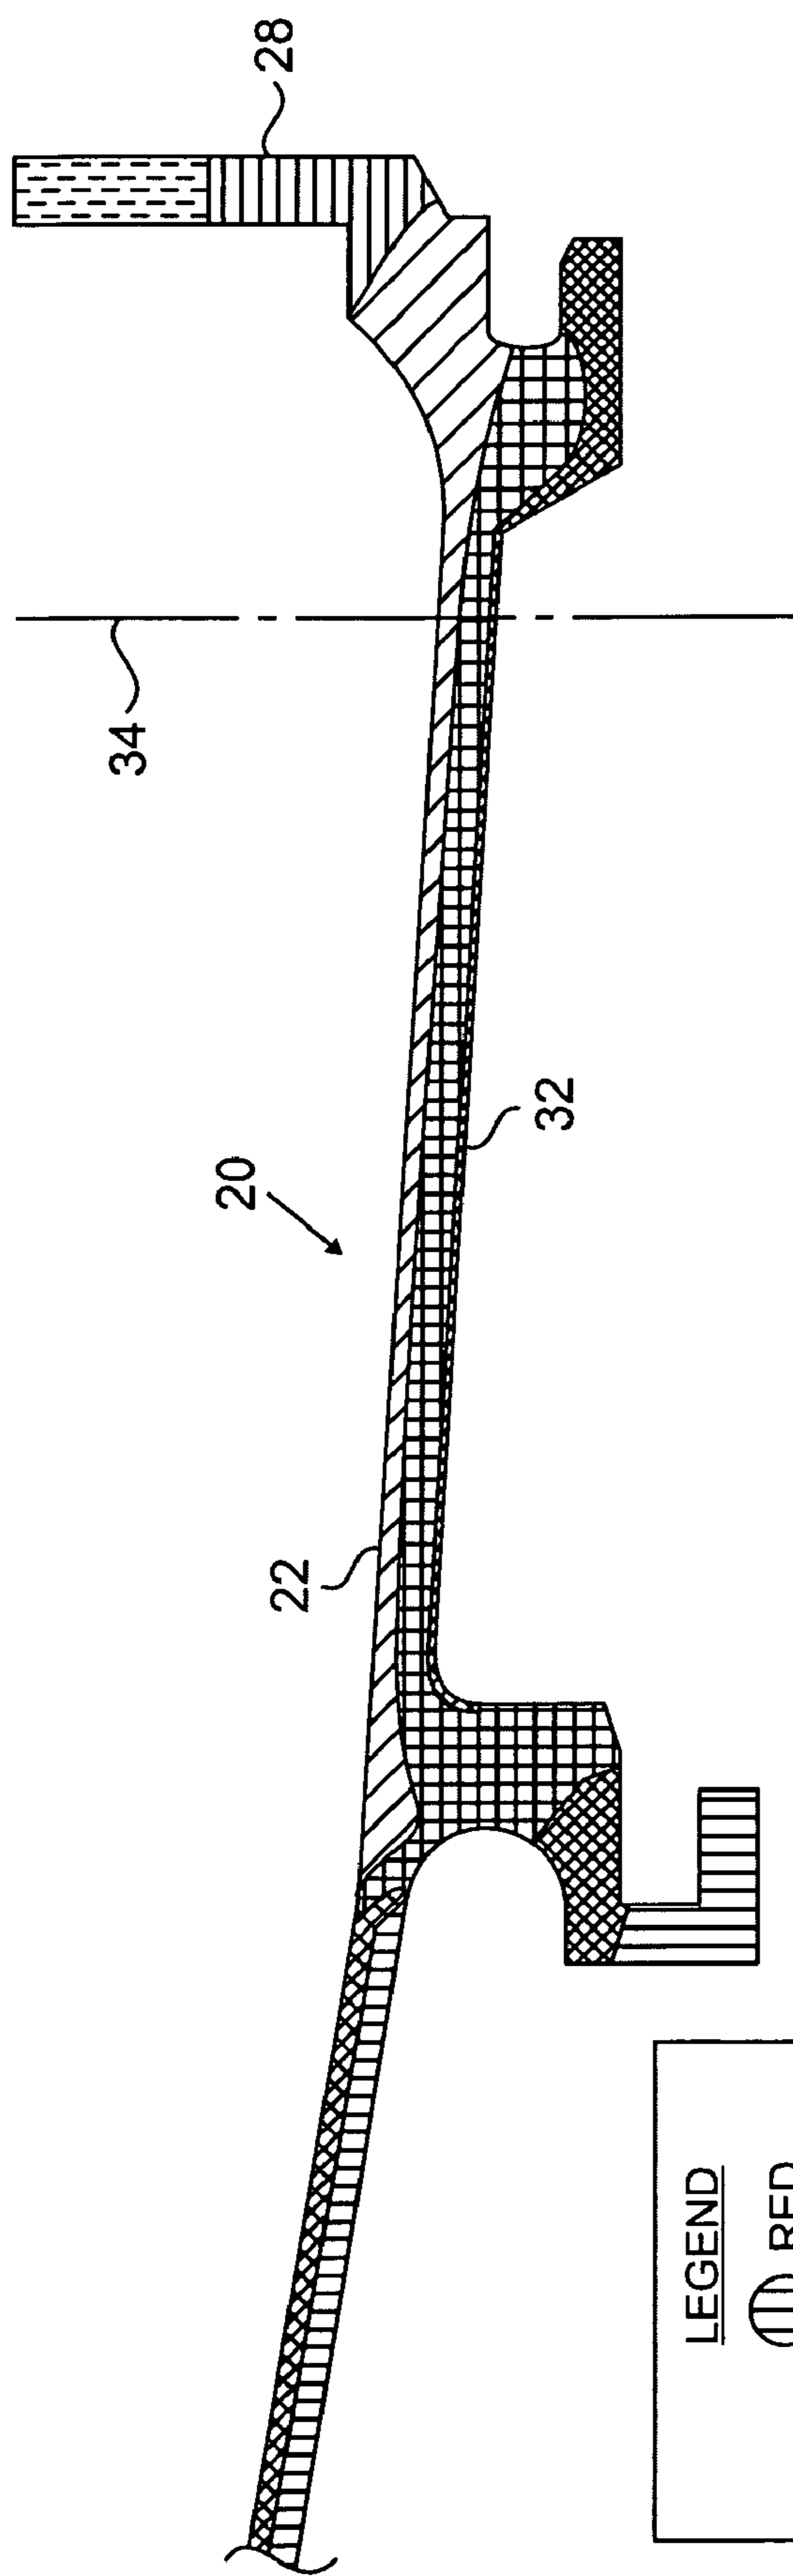
FIG. 2 is cross-sectional view of an outer diameter wall portion of the diffuser case, shaded to show temperature gradients.

FIG. 2 is cross-sectional view of a portion of the outer wall **22** of the diffuser case **20**. The portion of the diffuser case **20** shown in FIG. 2 is shaded to show temperature gradients in red, orange, yellow, green, cyan, and blue, where red represents the highest temperature, blue represents the lower temperature and the remaining colors designate intermediate temperatures (with magnitudes that vary between those of red and blue in the order listed). The shaded temperature gradients represent heat affected zones in the diffuser case **20** in response to applied heat, such as heat produced during a heat treatment process. Red areas tend to experience greater thermal expansion (or growth), while blue areas tend to experience lesser or the least thermal expansion. Portions of the diffuser case **20** that experience the least thermal expansion in response to applied heat tend to act like heat sinks. Heat sinks tend to deflect less than other portions of the diffuser case **20** when heat is applied, which can induce distortion in the diffuser case **20** during a repair heat treatment. Structures that are configured as relatively large concentrations of materials or configured with certain geometric properties, can also behave as stiffeners, which may restrict growth and movement of other heat affected zones during heat treatment. In the illustrated embodiment, the aft flange **28** tends to act as both a heat sink and a stiffener in the diffuser case **20**.

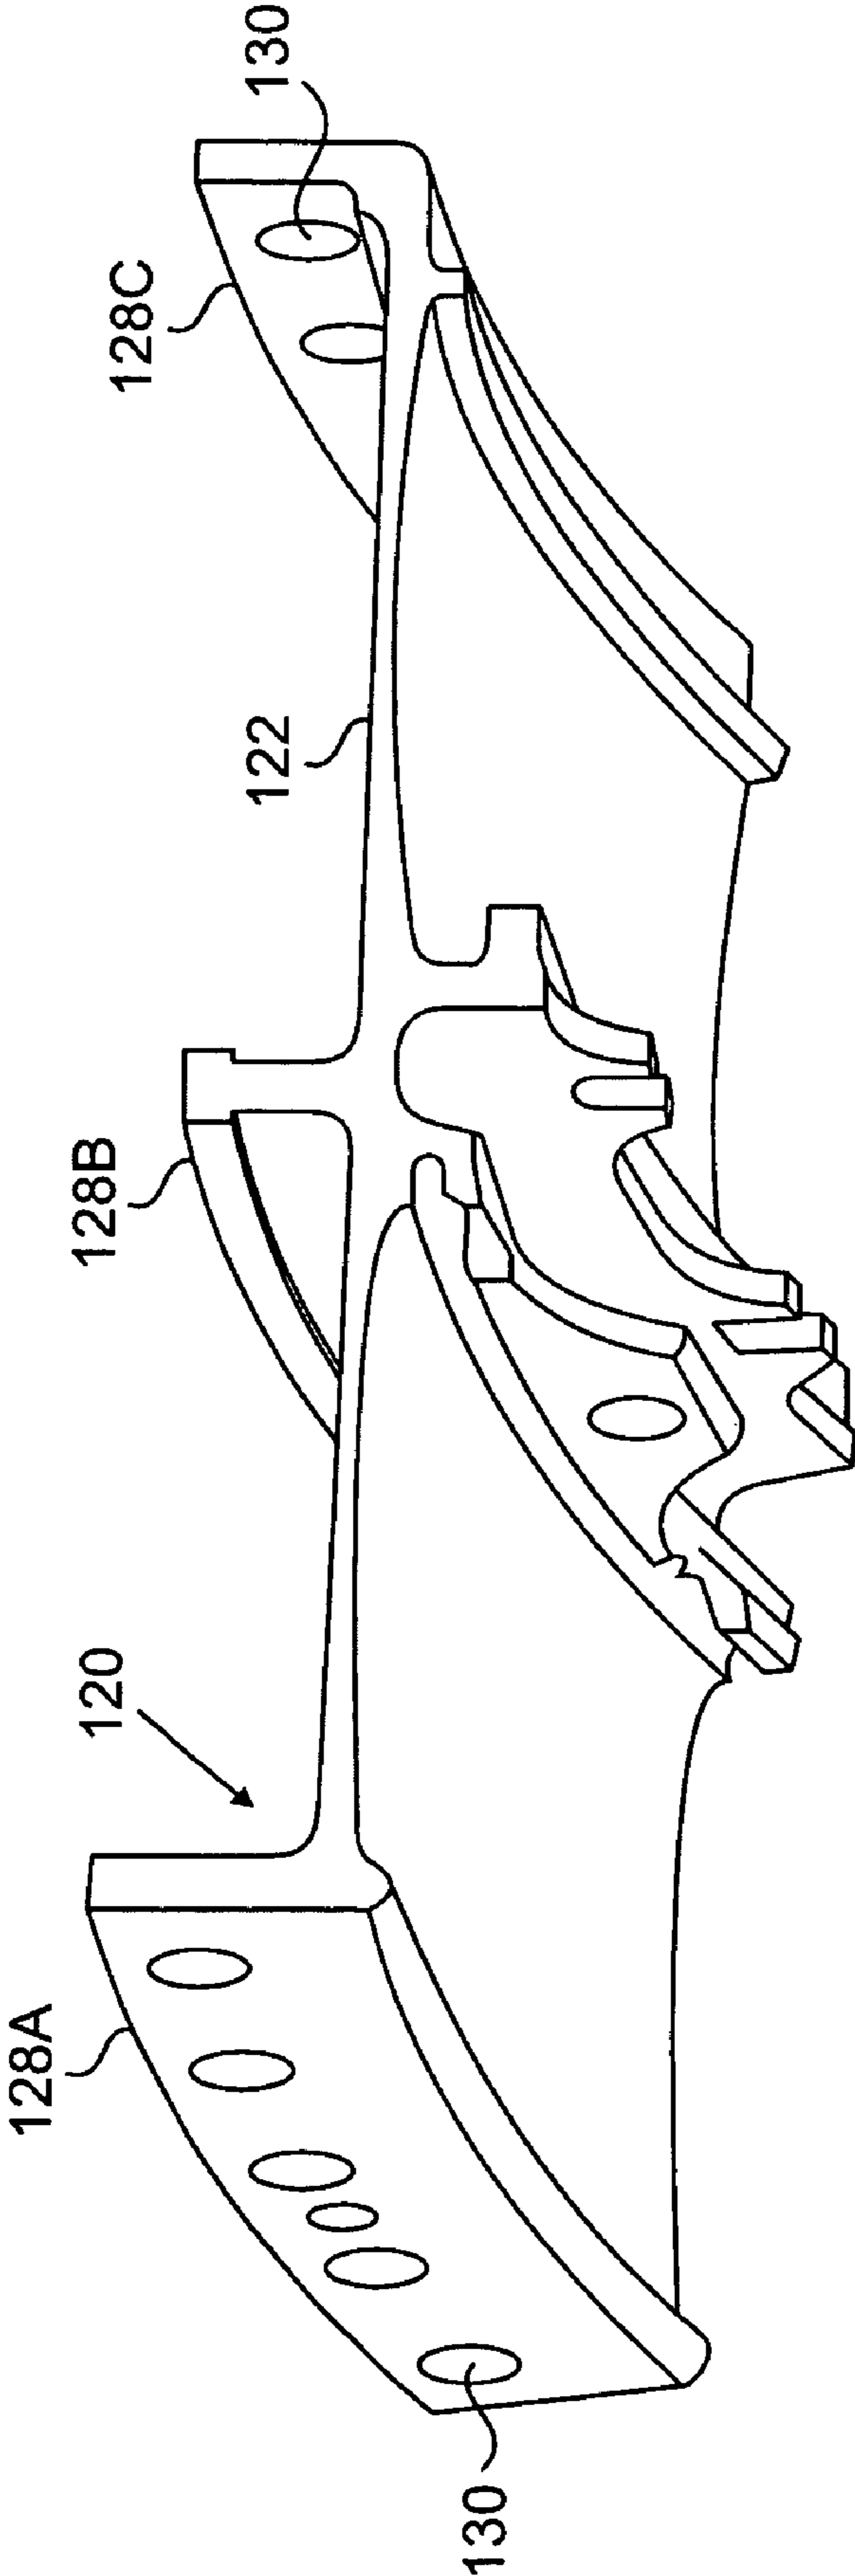
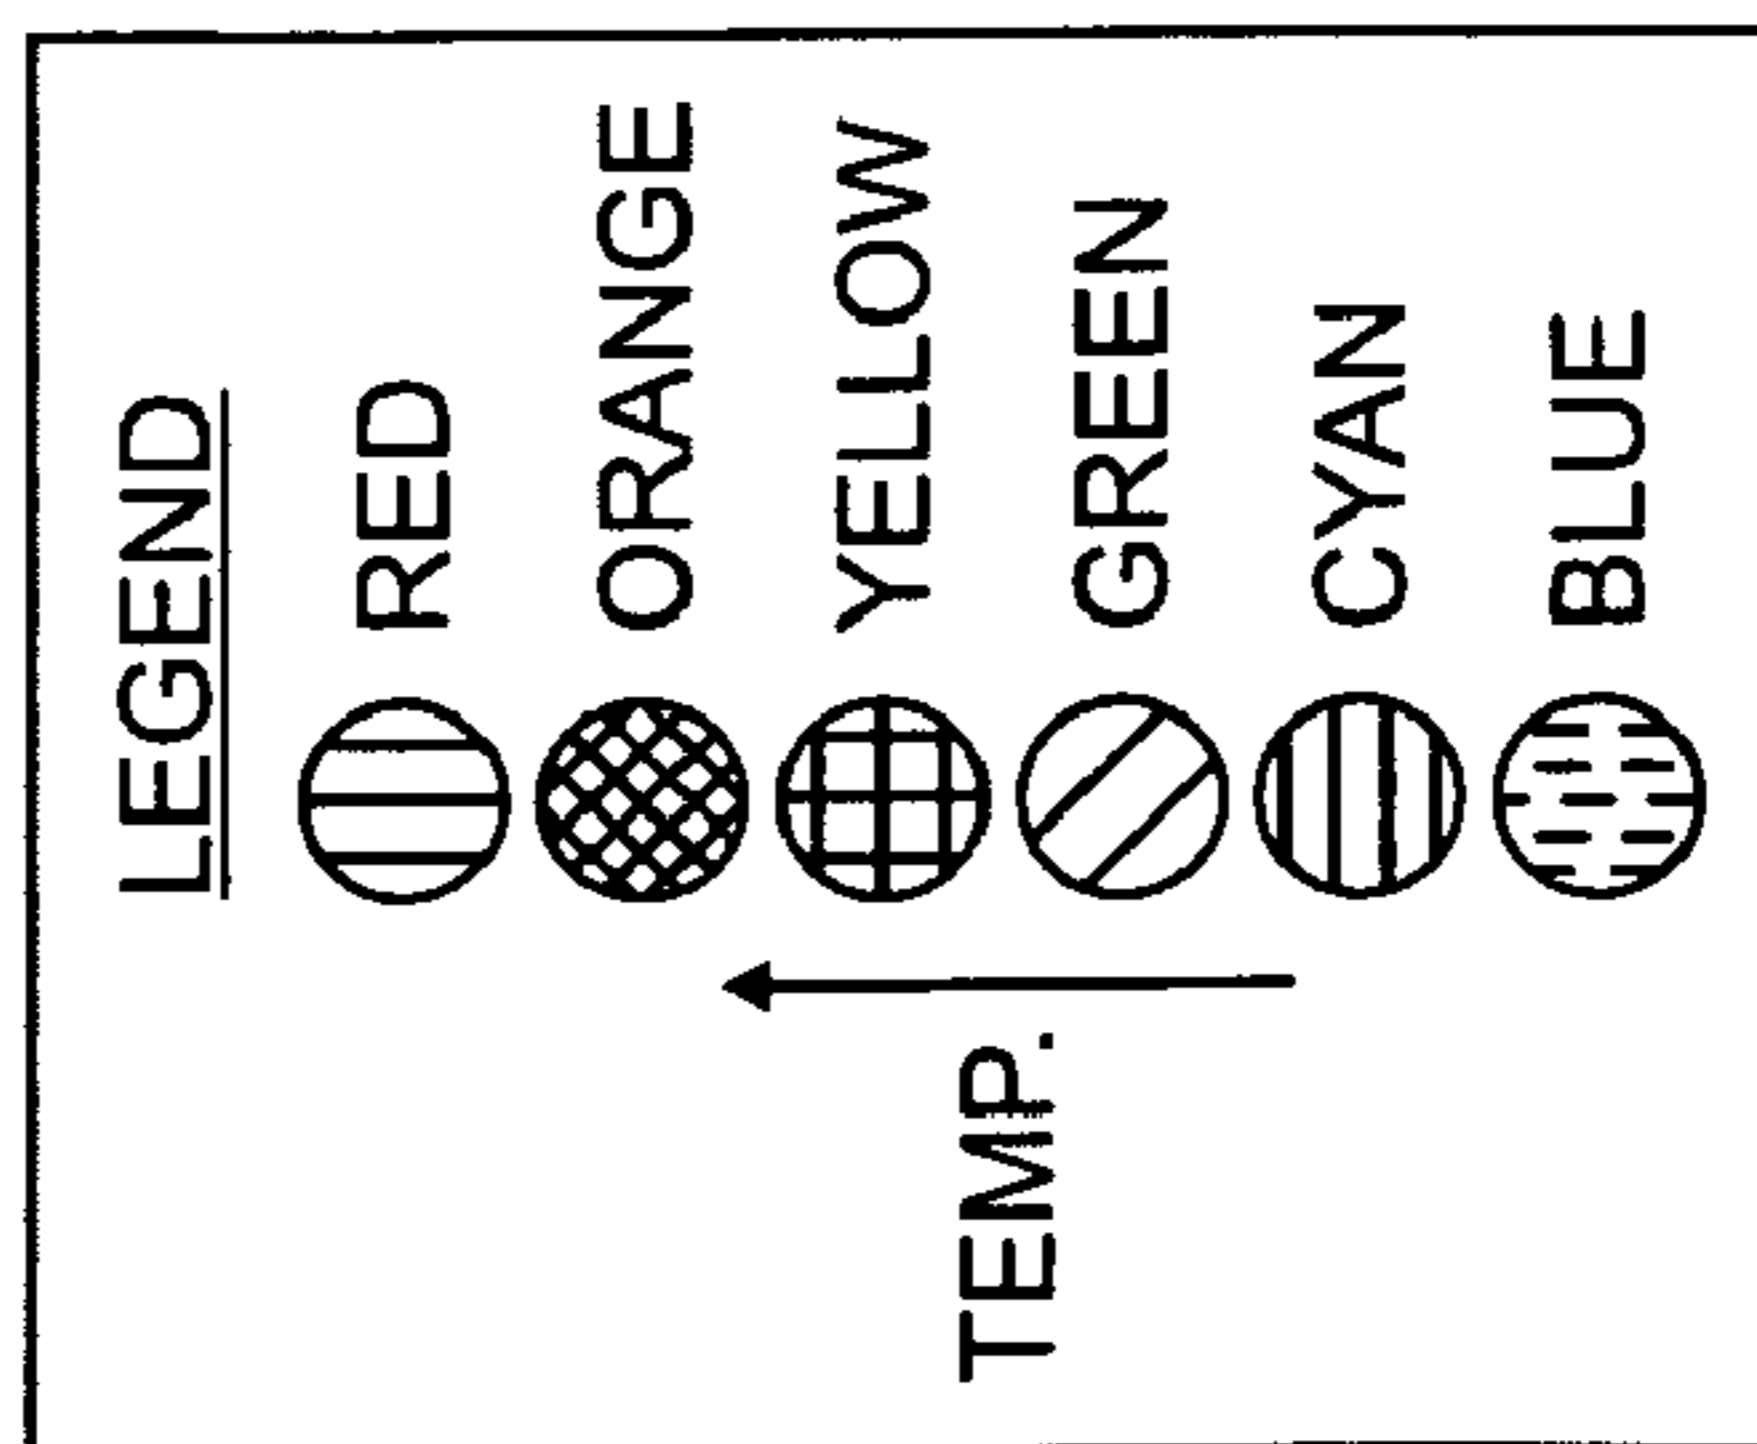
FIG. 3 is a perspective view of an outer case segment for a gas turbine engine.

The repair process of this disclosure can be performed on other engine components. FIG. 3 is a perspective view of an outer case segment **120** for case assembly of a gas turbine engine. The case segment **120** is configured to be connected to a plurality of additional case segments in order to form an annular case assembly, in a manner well known in the art. The case segment **120** includes an outer case wall **122**, and forward, middle and aft flanges **128A**, **128B** and **128C**, respectively. Bolt holes **130** are formed in both the forward and aft flanges **128A** and **128C**. The forward, middle and aft flanges **128A**, **128B** and **128C**, which each act as both stiffeners and heat sinks, can all be removed from the outer case wall **122** prior to performing cold work and heat treatment on the case

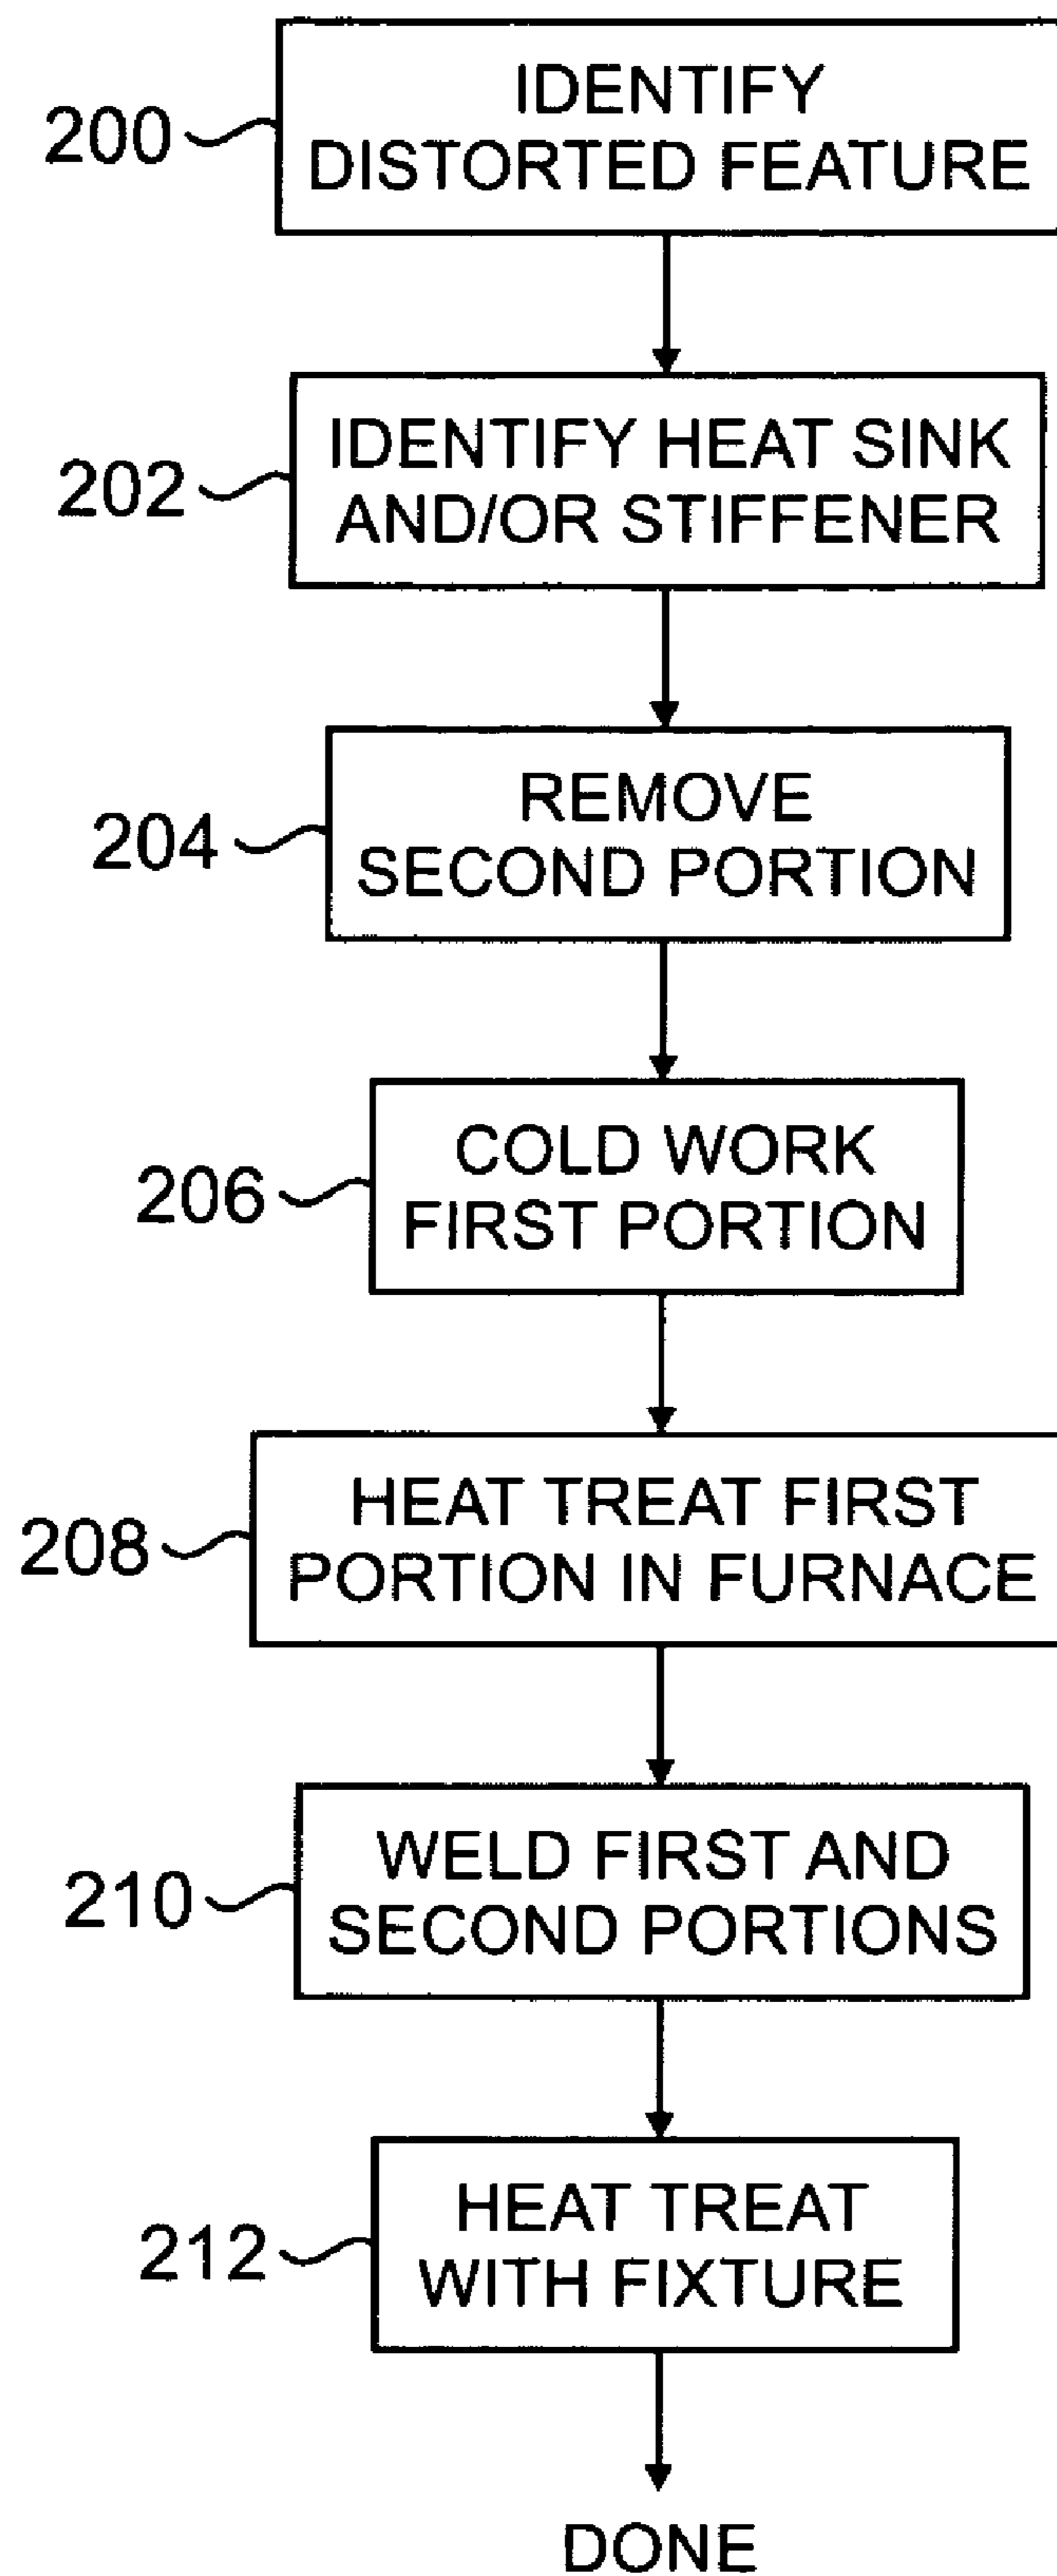
FIG. 4 is a flow chart of a repair method.
