(54) **CONTROL OF CASE WALL GROWTH DURING REPAIR AND METHOD**

A method for repairing a gas turbine engine component includes identifying a distorted feature located in a first portion of the component, identifying a second portion of the component that behaves as at least one of a heat sink or a stiffener, removing the second portion of the component from the first portion, cold working the first portion of the component to repair the distorted feature, heat treating the first portion of the component, and metallurgically joining the first portion of the component to the second portion of the component.

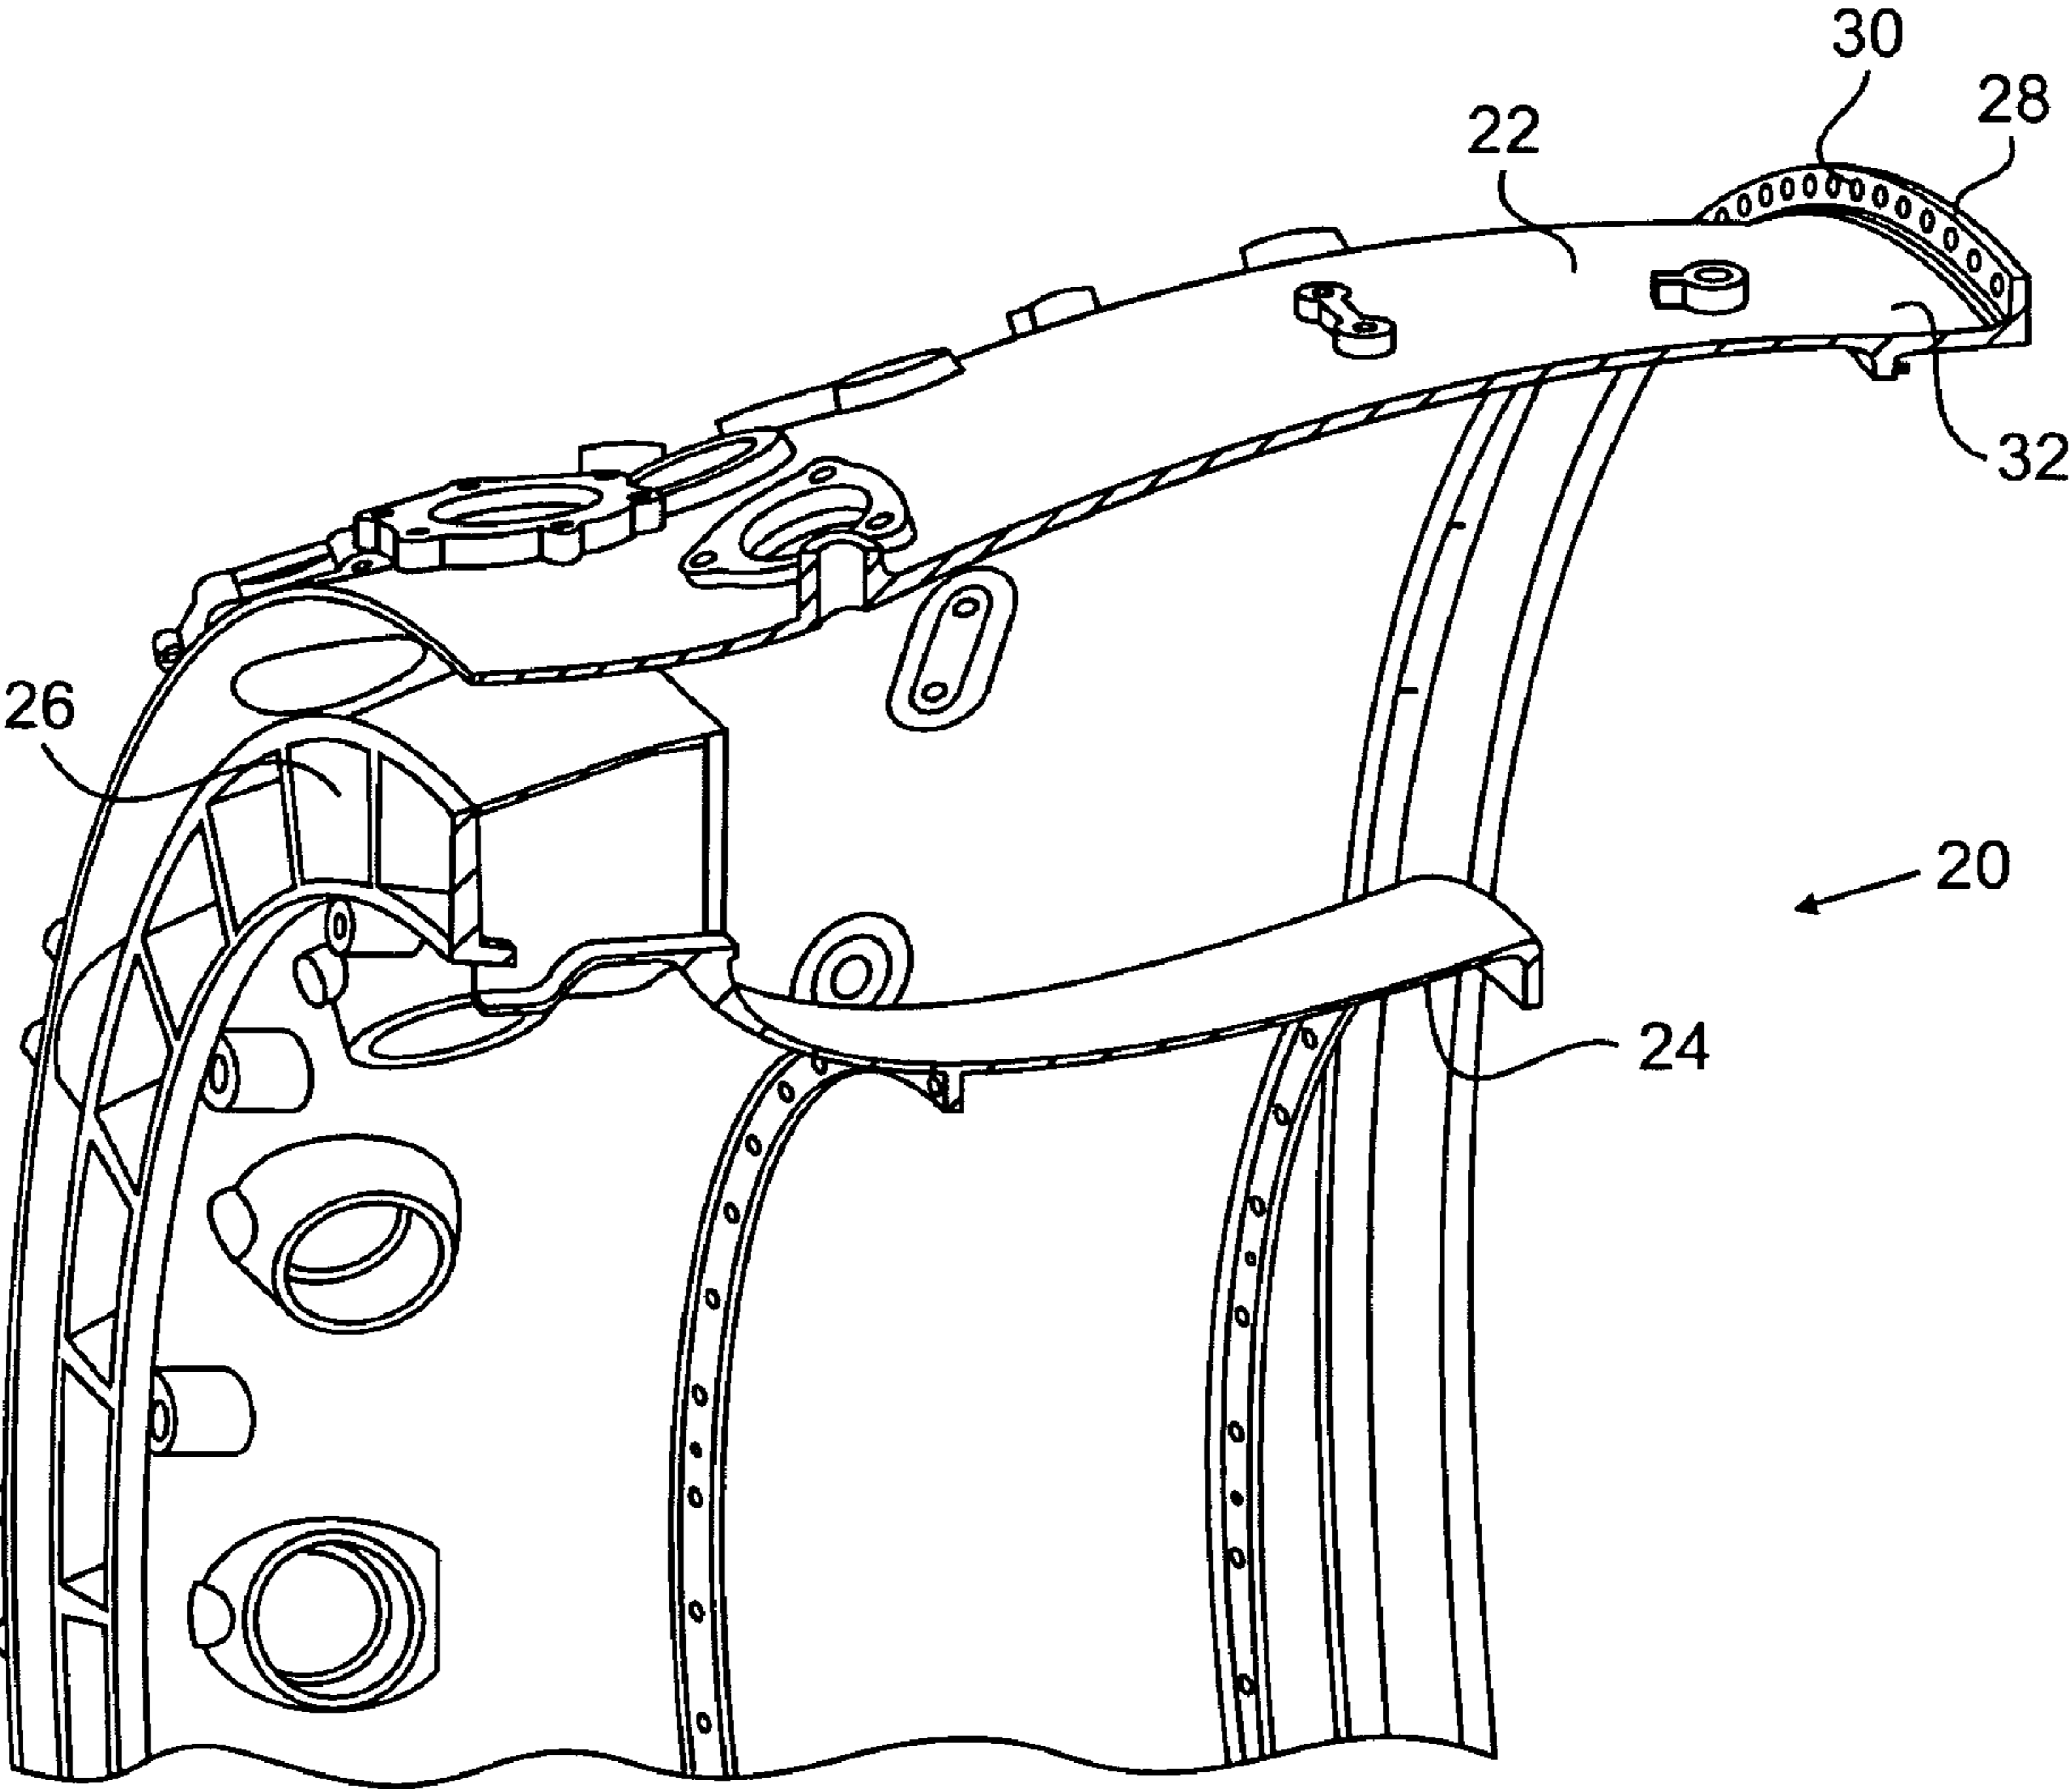
FIG. 1 is a cross-sectional perspective view of a diffuser case for a gas turbine engine.

FIG. 1 is a cross-sectional perspective view of a diffuser case **20** for a gas turbine engine. As is well-known in the art, the diffuser case **20** is typically located aft of a compressor section of the engine and has a cross-sectional flow area in the direction that increases in a downstream direction in order to decrease velocity and increase static pressure of fluid passing therethrough, which helps prepare the fluid for mixing with fuel for combustion. The general configuration and operation of gas turbine engines is well known in the art, and therefore is not discussed in detail here.

As shown in FIG. 1, the diffuser case **20** includes an outer wall **22**, an inner wall **24**, a plurality of vanes **26** located at a forward end of the case **20**, and an aft flange **28** extending from the outer wall **22**. A plurality of circumferentially spaced bolt holes **30** are formed in the aft flange **28**, which enable the diffuser case **20** to be mechanically connected to other components of an engine. Undesirable distorted features, such as a bulge **32**, can develop in the outer wall **22** (or other locations) during use and necessitate replacement or repair of the diffuser case **20**.

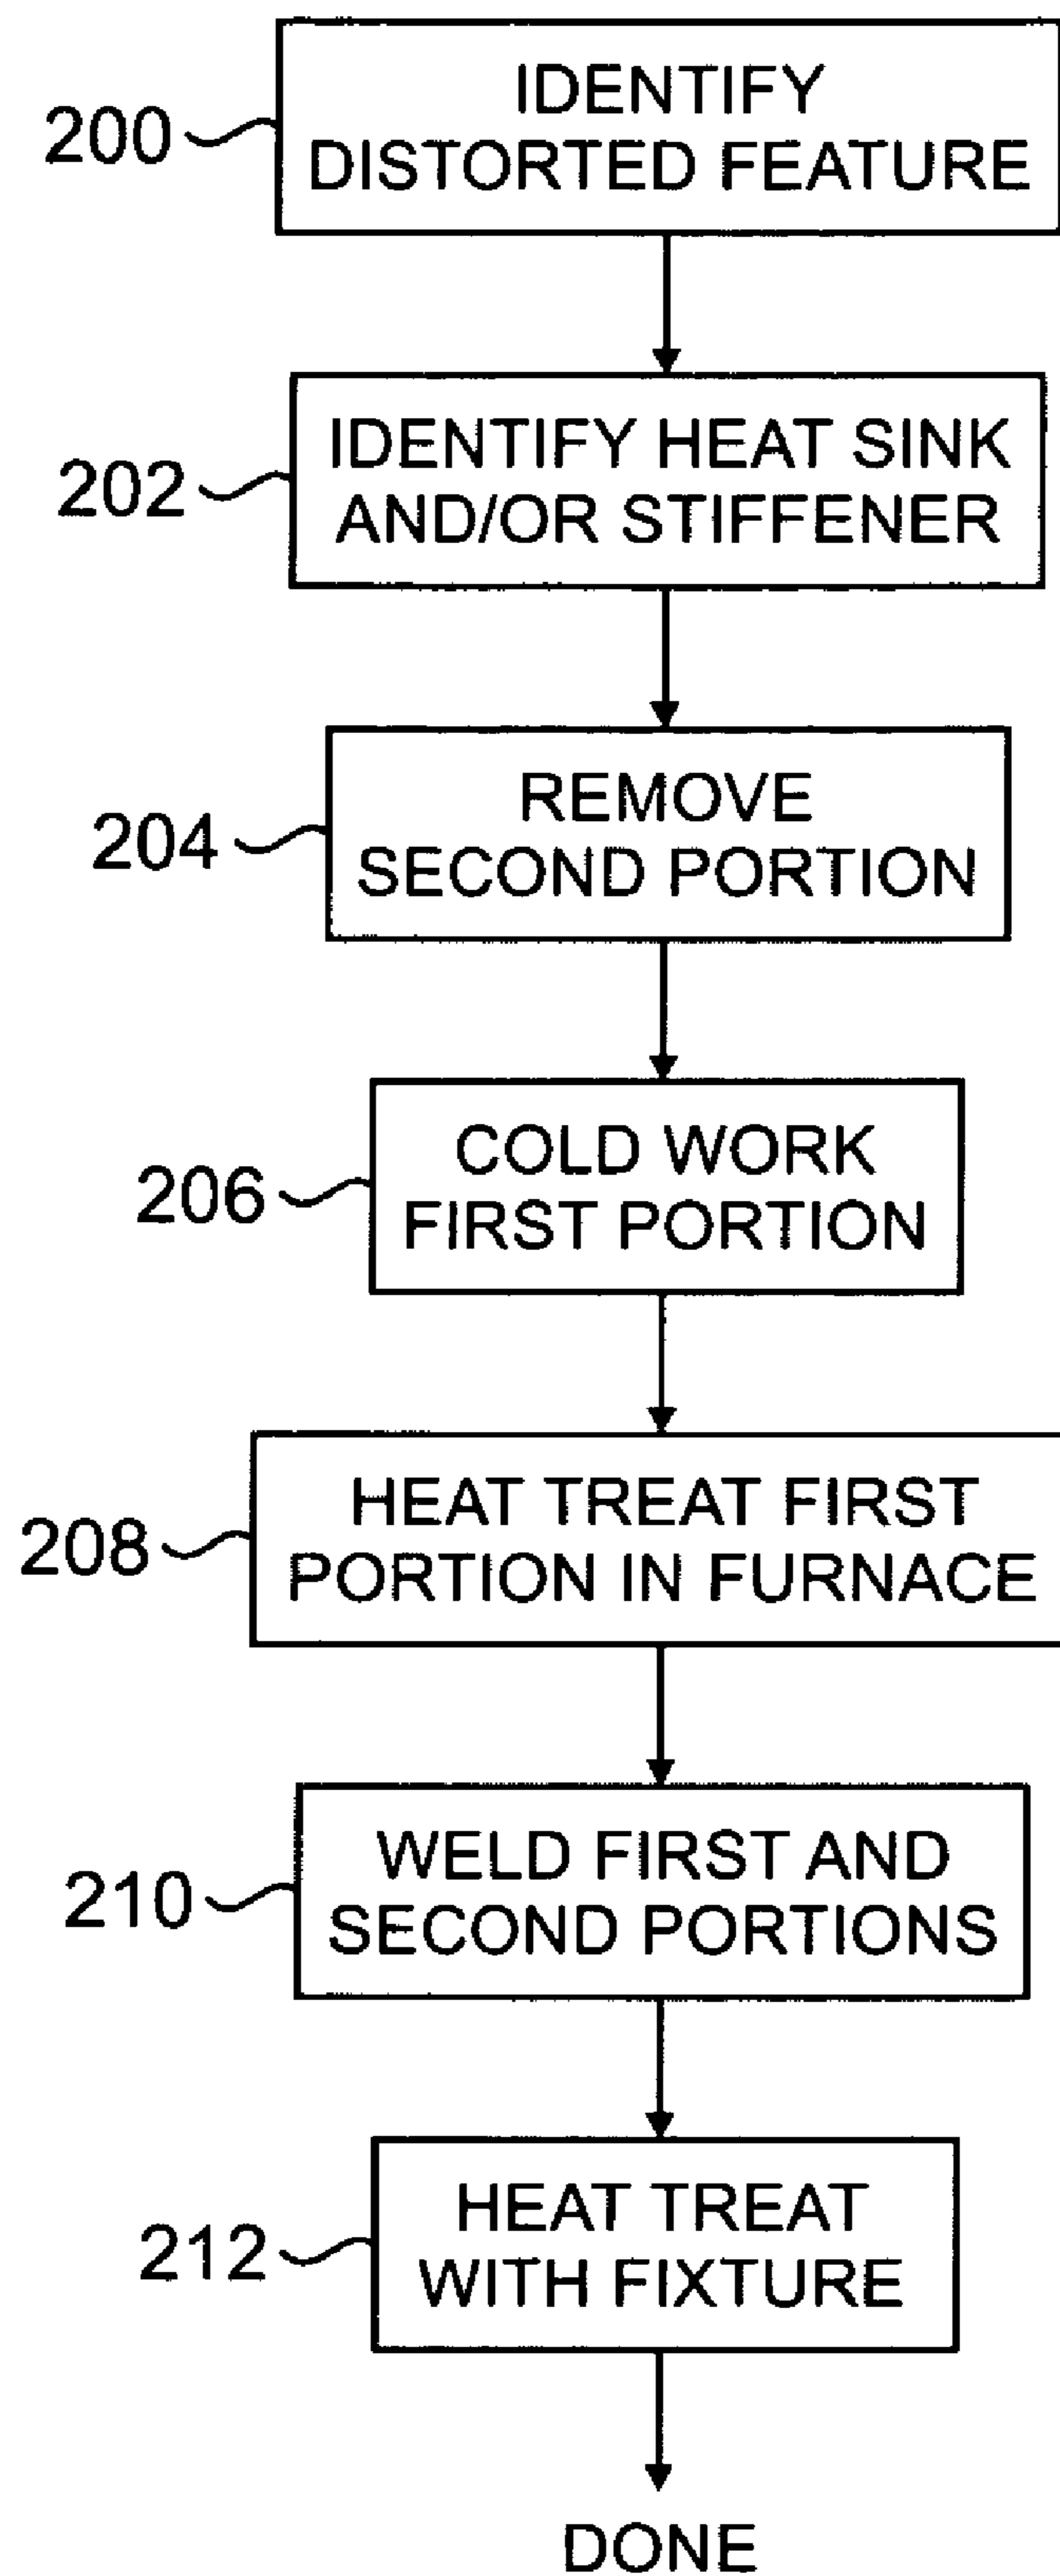
FIG. 4 is a flow chart of a repair method.
