(54) **METHOD FOR REPAIRING A GUIDE VANE SEGMENT**

(73) Assignee: **MTU Aero Engines GmbH**, Munich (DE)

A method for repairing a guide vane segment of a gas turbine, the guide vane segment including at least two guide vanes as well as an inner and an outer shroud. At least one guide vane is irreparably damaged and is separated from the guide vane segment while the guide vane segment is completed by joining at least one replacement vane. If the one irreparable guide vane is located in one half of the segment outside the circumferential center of the guide vane segment, or if the several irreparable guide vanes are located in the same half of the segment, the matching number of guide vanes to be separated from the segment and replacement vanes to be joined to the segment are determined first. The determined number of replacement vanes are then joined to the guide vane segment. The same number of guide vanes, including the at least one irreparable guide vane, are finally separated from the guide vane segment.

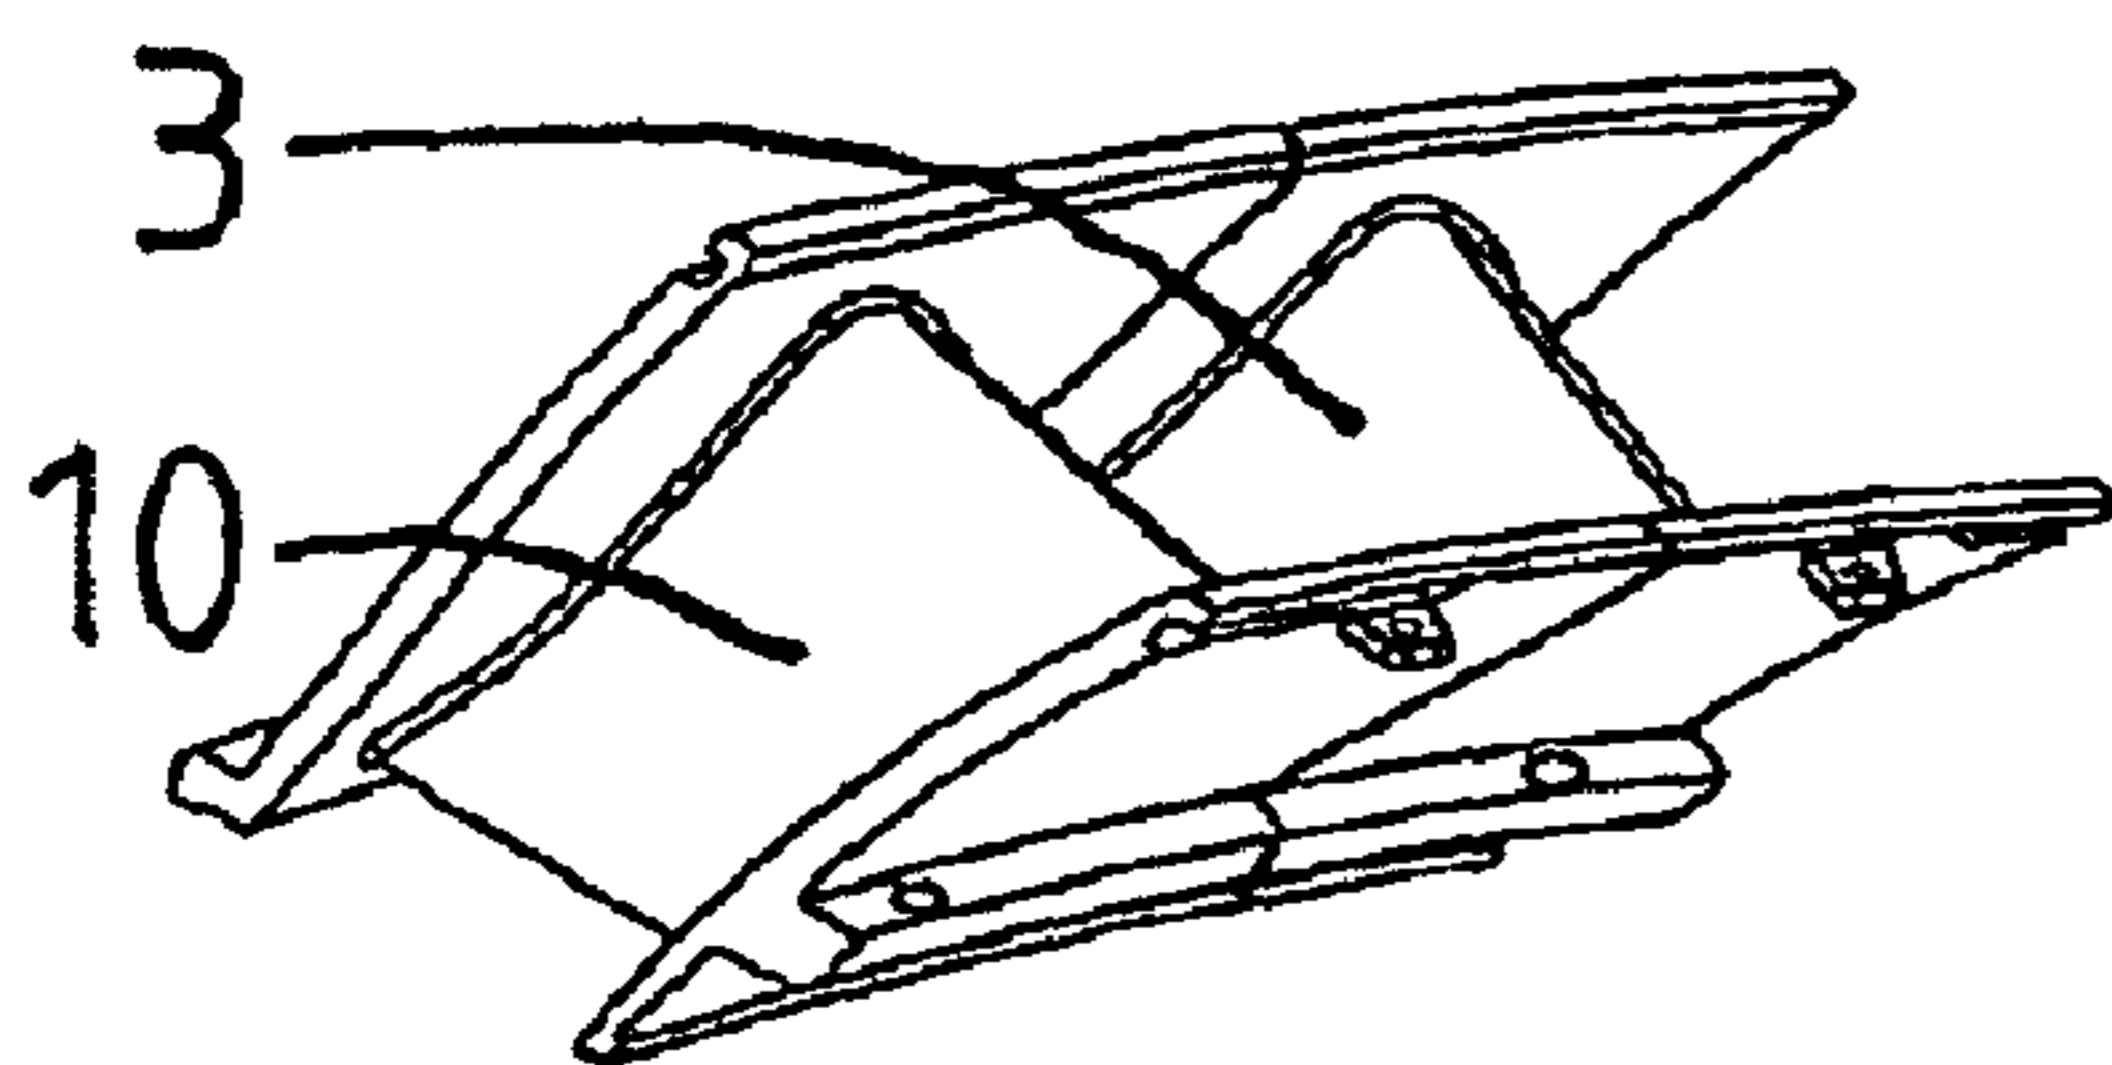
Fig.4

FIG. 4 shows a comparable view after the separation of the damaged guide vane from the guide vane segment,

Finally, FIG. 4 shows the restored guide vanes segment having the nominal number of vanes and the intended geometry, such that—after separation of guide vane 4—replacement vane 10 and guide vane 3 are still present. The state of each of the remaining vanes may be undamaged, repaired, or at least repairable. Possible repair methods for vanes and
