(54) **METHOD FOR REPAIRING A GUIDE VANE SEGMENT**

(73) Assignee: **MTU Aero Engines GmbH**, Munich (DE)

A method for repairing a guide vane segment of a gas turbine, the guide vane segment including at least two guide vanes as well as an inner and an outer shroud. At least one guide vane is irreparably damaged and is separated from the guide vane segment while the guide vane segment is completed by joining at least one replacement vane. If the one irreparable guide vane is located in one half of the segment outside the circumferential center of the guide vane segment, or if the several irreparable guide vanes are located in the same half of the segment, the matching number of guide vanes to be separated from the segment and replacement vanes to be joined to the segment are determined first. The determined number of replacement vanes are then joined to the guide vane segment. The same number of guide vanes, including the at least one irreparable guide vane, are finally separated from the guide vane segment.

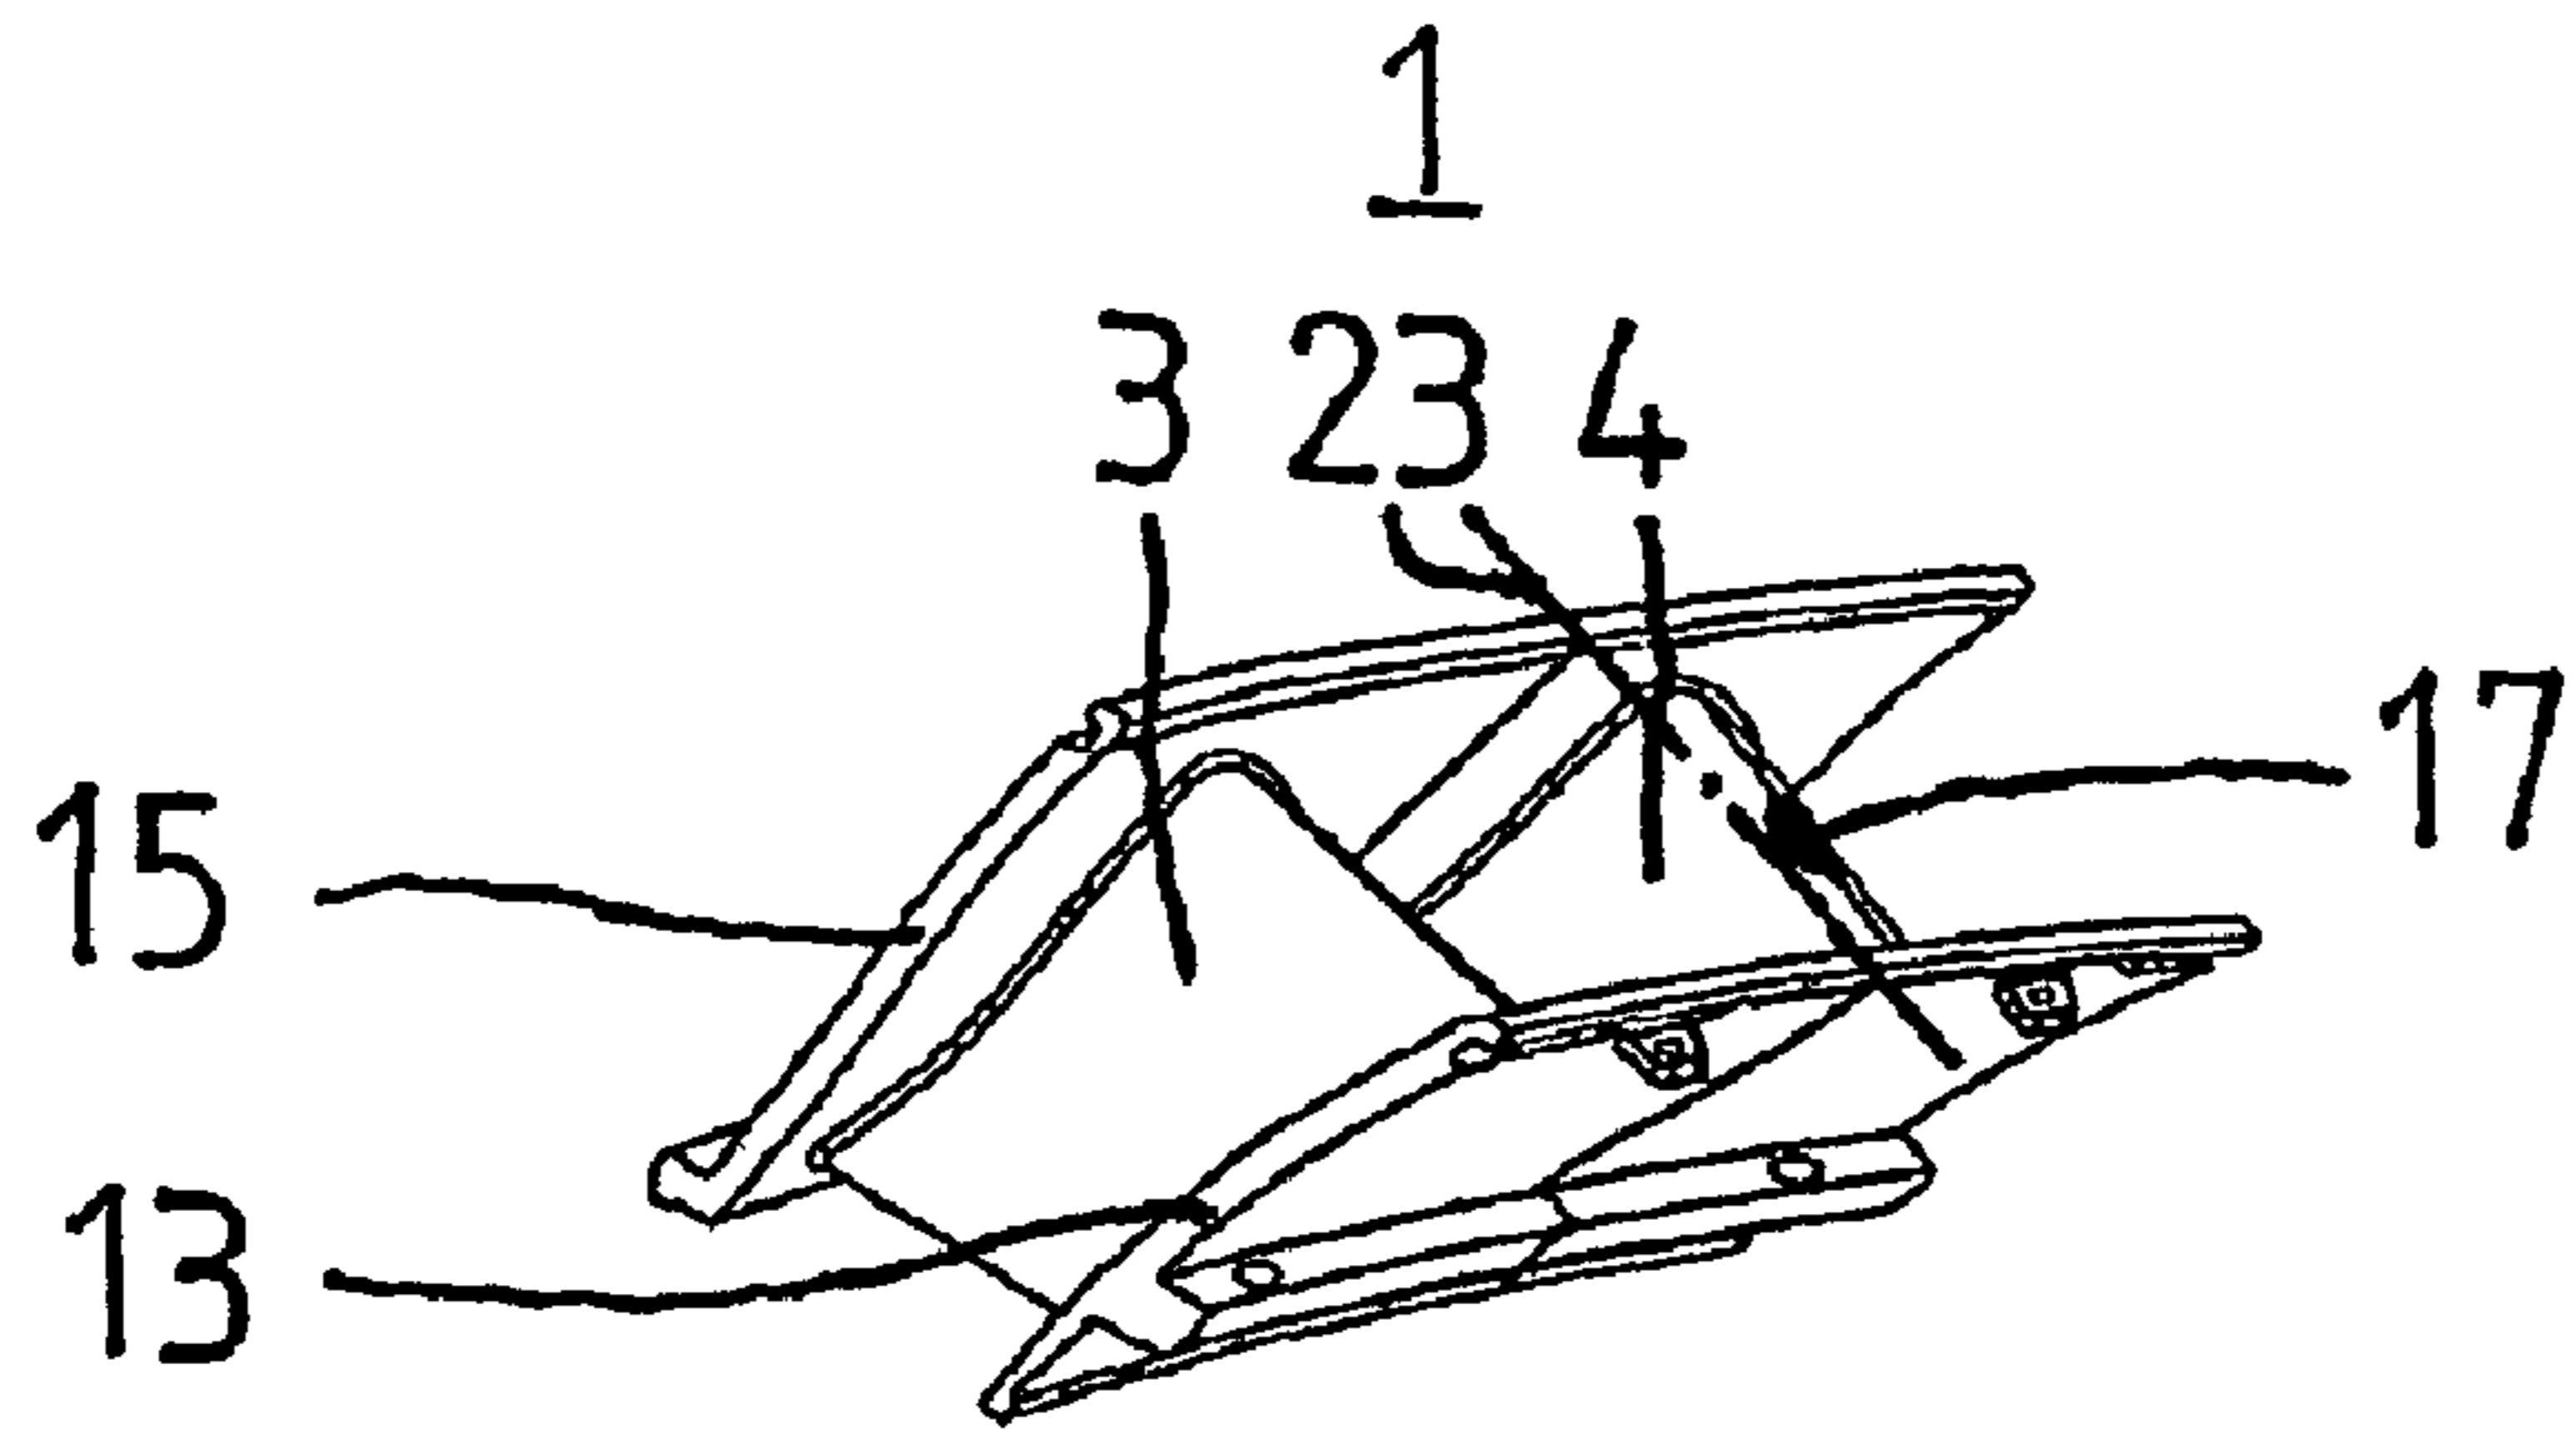
Fig. 1

FIG. 1 shows a perspective view of a guide vane segment having two guide vanes, of which one is irreparably damaged,

FIG. 1 shows a guide vane segment 1 having a minimum number of vanes, i.e. two guide vanes 3 and 4. Such an arrangement is also called a twin guide vane. One of the two guide vanes, here at position 4, has irreparable damage 17, e.g. in the form of a breakage in the area of its leading edge. The expression "irreparable" here is not to be understood in an absolute sense, but rather in the sense that it would no longer make sense economically to repair the vane. As a rule, such damages result during operation of the component, but they may also be already present as a result of manufacturing, or may be "pre-programmed," e.g. in the form of insufficient wall thickness, insufficient coating, a defect in joining, etc. Guide vanes 3, 4 are connected to one another via a radially inner shroud 13 and via a radially outer shroud 15. This makes it possible e.g. to cast the entire guide vane segment 1 in one piece or to produce it powder-metallurgically. However, individual vanes manufactured by casting, forging, machining, or powder metallurgy may also be materially bonded to a segment, e.g. by soldering or welding.

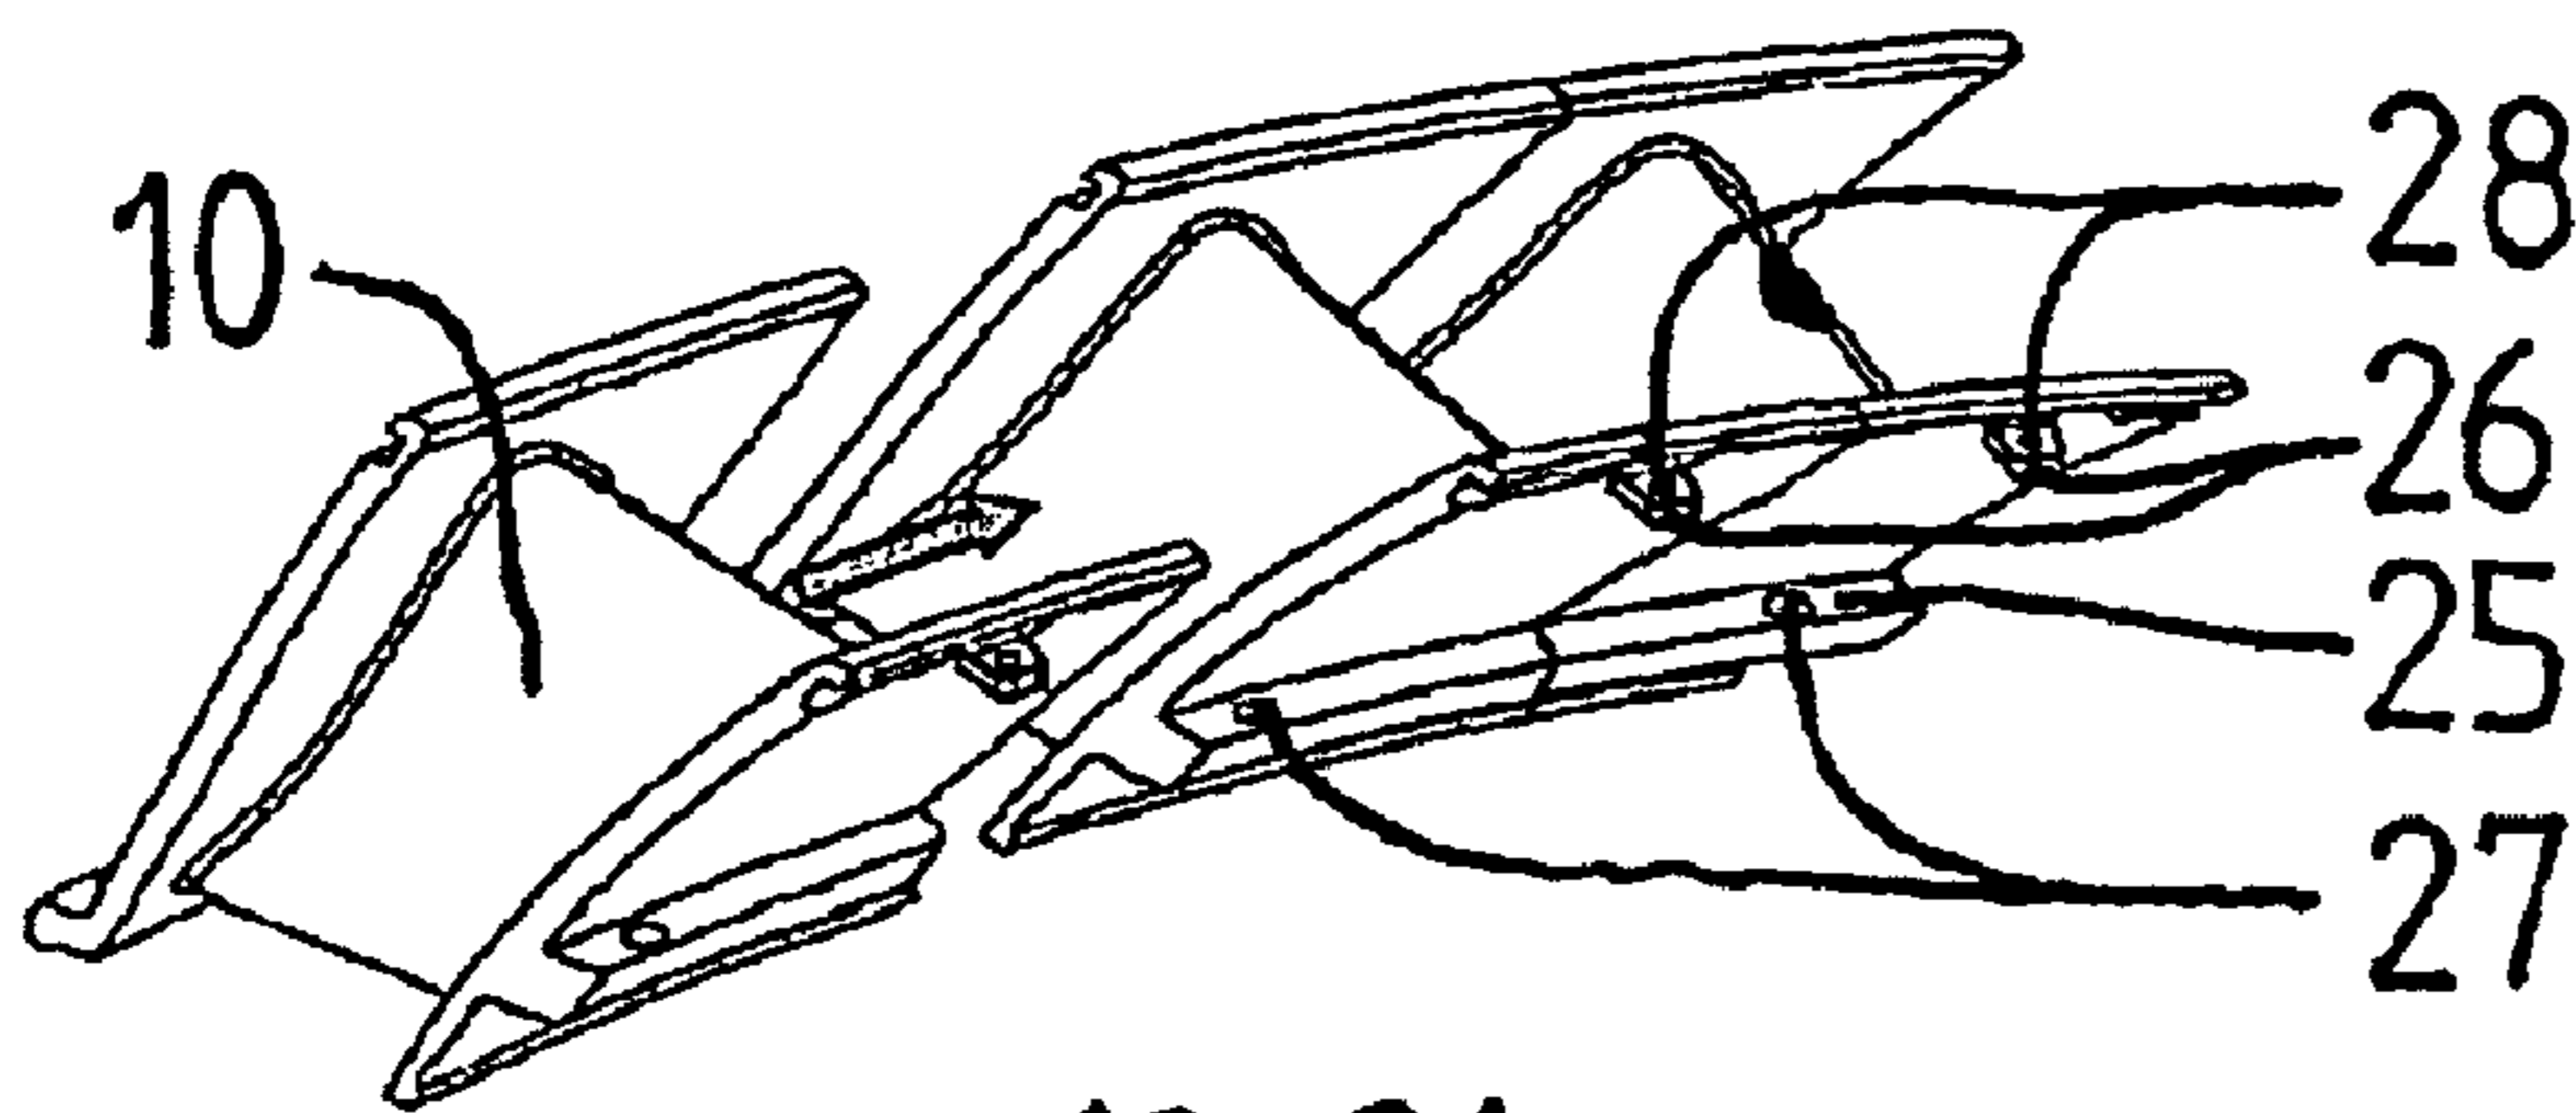
Fig. 2

FIG. 2 shows a comparable view including a replacement vane that is to be joined to the guide vane segment,

In addition to damaged guide vane segment 1, FIG. 2 shows a replacement vane 10 that is to be joined thereto. Because at the time of joining guide vane segment 1 is still complete, it has a sufficient number of reliable reference points, here in the form of bores 27 and 28 on a flange 25 and on tongues 26 on inner shroud 13. With the aid of these reference points, replacement vane 10 can be positioned with sufficient precision and stability before and during joining.

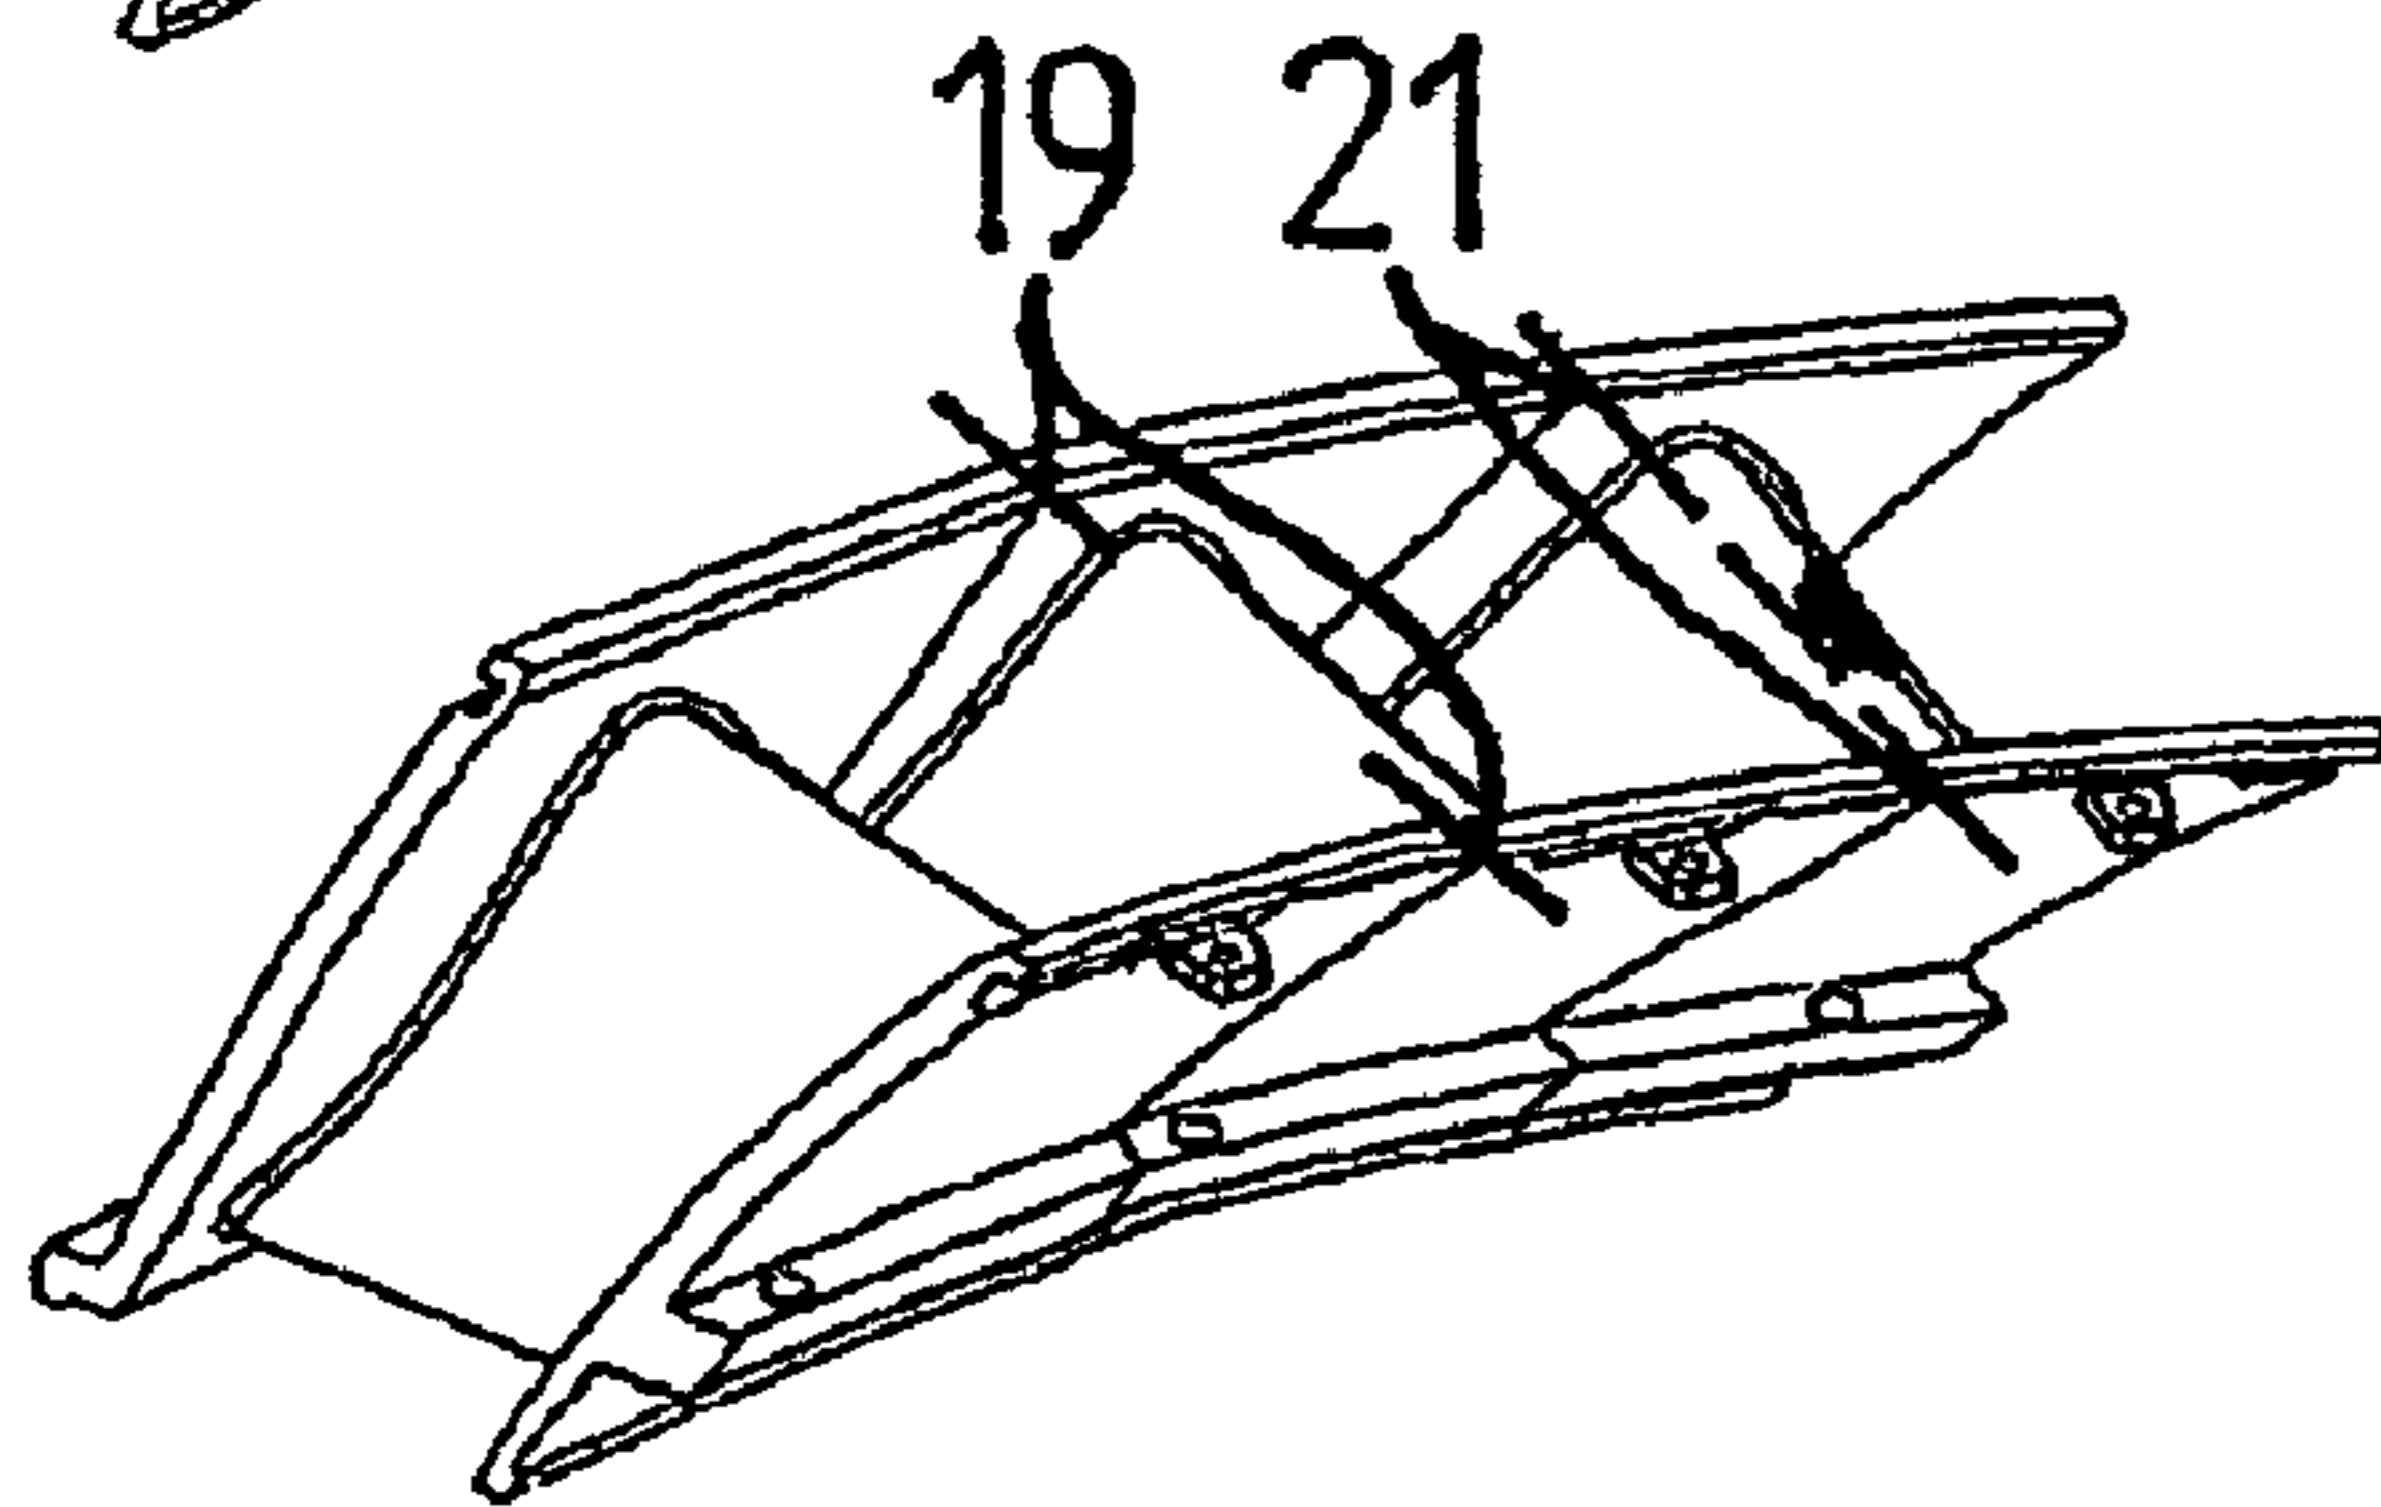
Fig. 3

FIG. 3 shows a comparable view after the joining of the replacement vane,

FIG. 3 shows the state after joining, in which guide vane segment 1 has one vane too many, because damaged guide vane 4 has not yet been separated. Join point 19, located between replacement vane 10 and remaining guide vane 3, is marked at the entry side on shrouds 13, 15 by two short lines. Point of separation 21 between guide vane 3 and damaged guide vane 4 on shrouds 13, 15 is indicated at the entry side by a broken line.

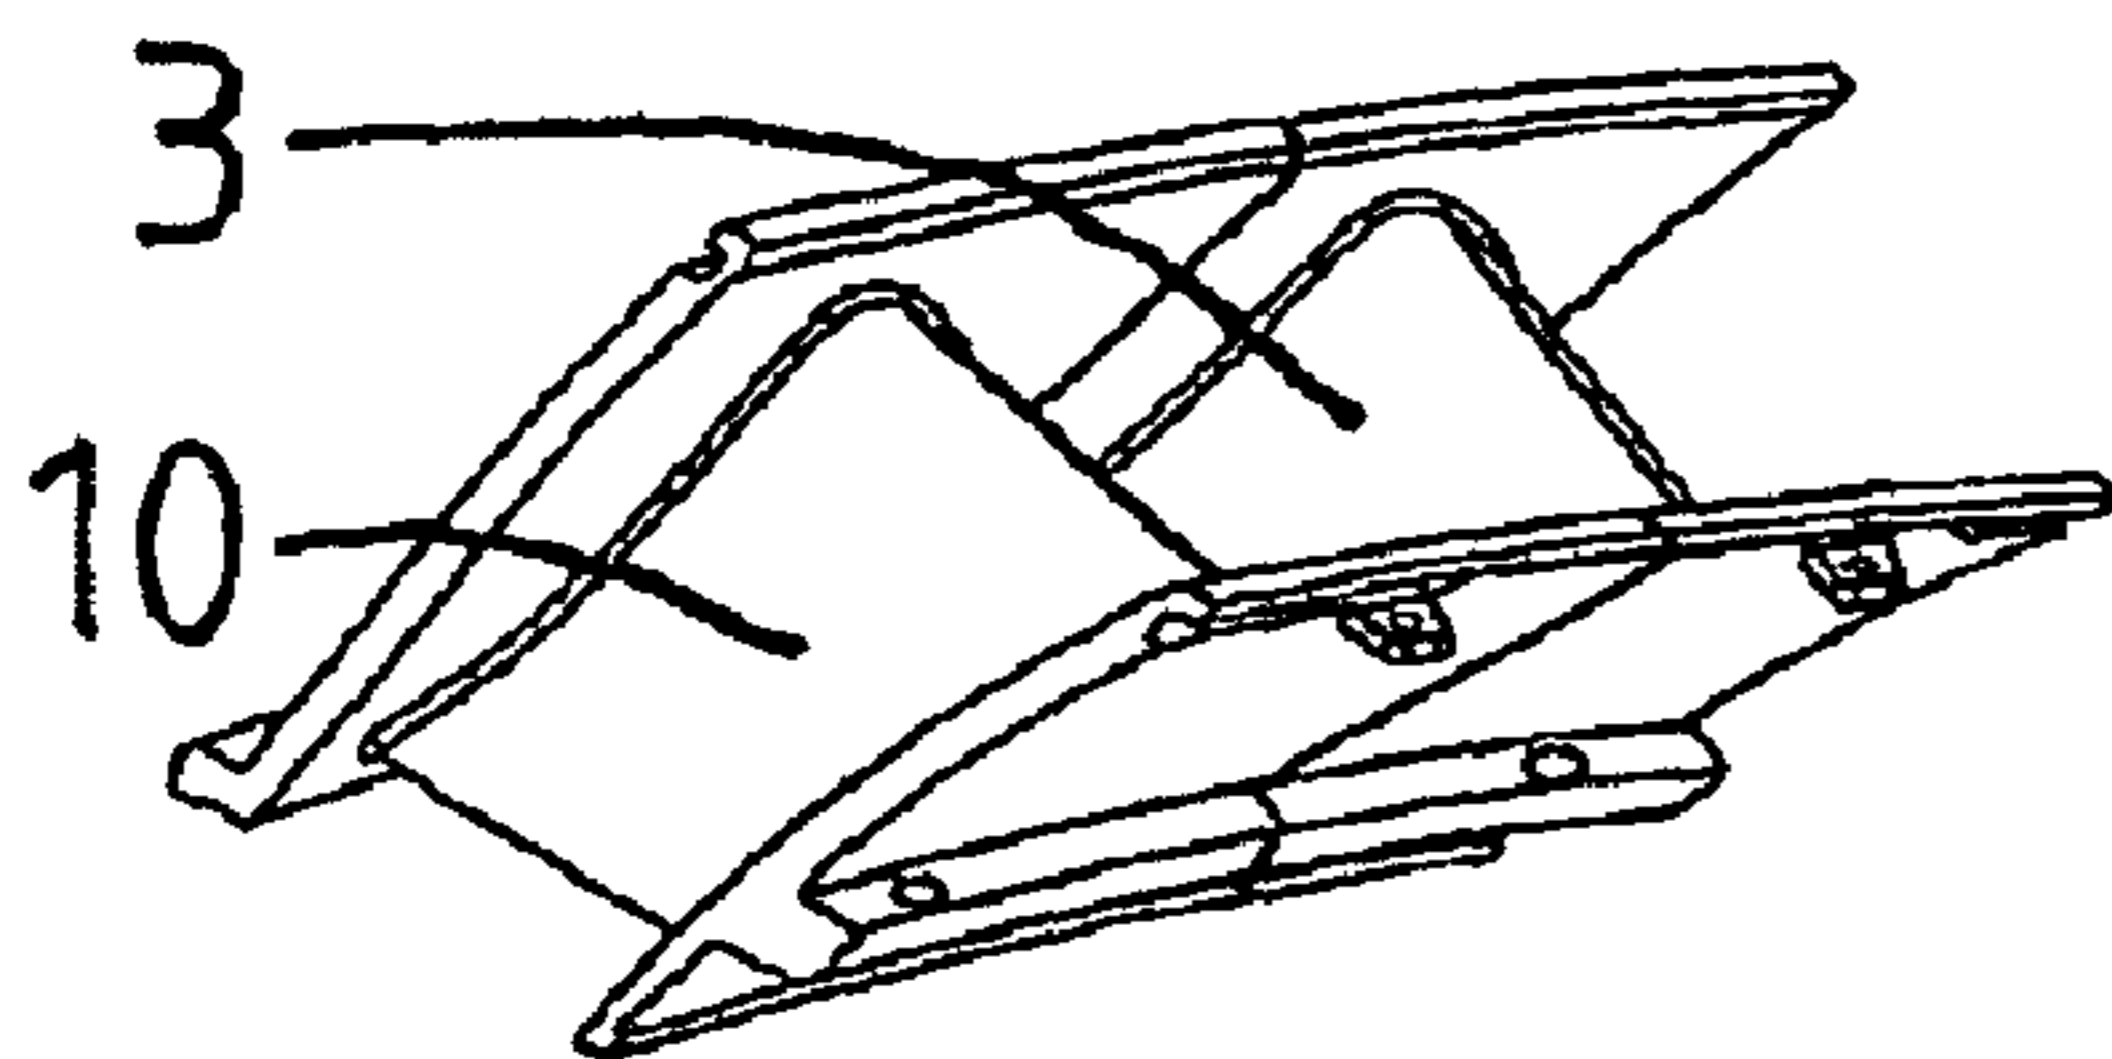
Fig. 4

FIG. 4 shows a comparable view after the separation of the damaged guide vane from the guide vane segment,

Finally, FIG. 4 shows the restored guide vanes segment having the nominal number of vanes and the intended geometry, such that—after separation of guide vane 4—replacement vane 10 and guide vane 3 are still present. The state of each of the remaining vanes may be undamaged, repaired, or at least repairable. Possible repair methods for vanes and

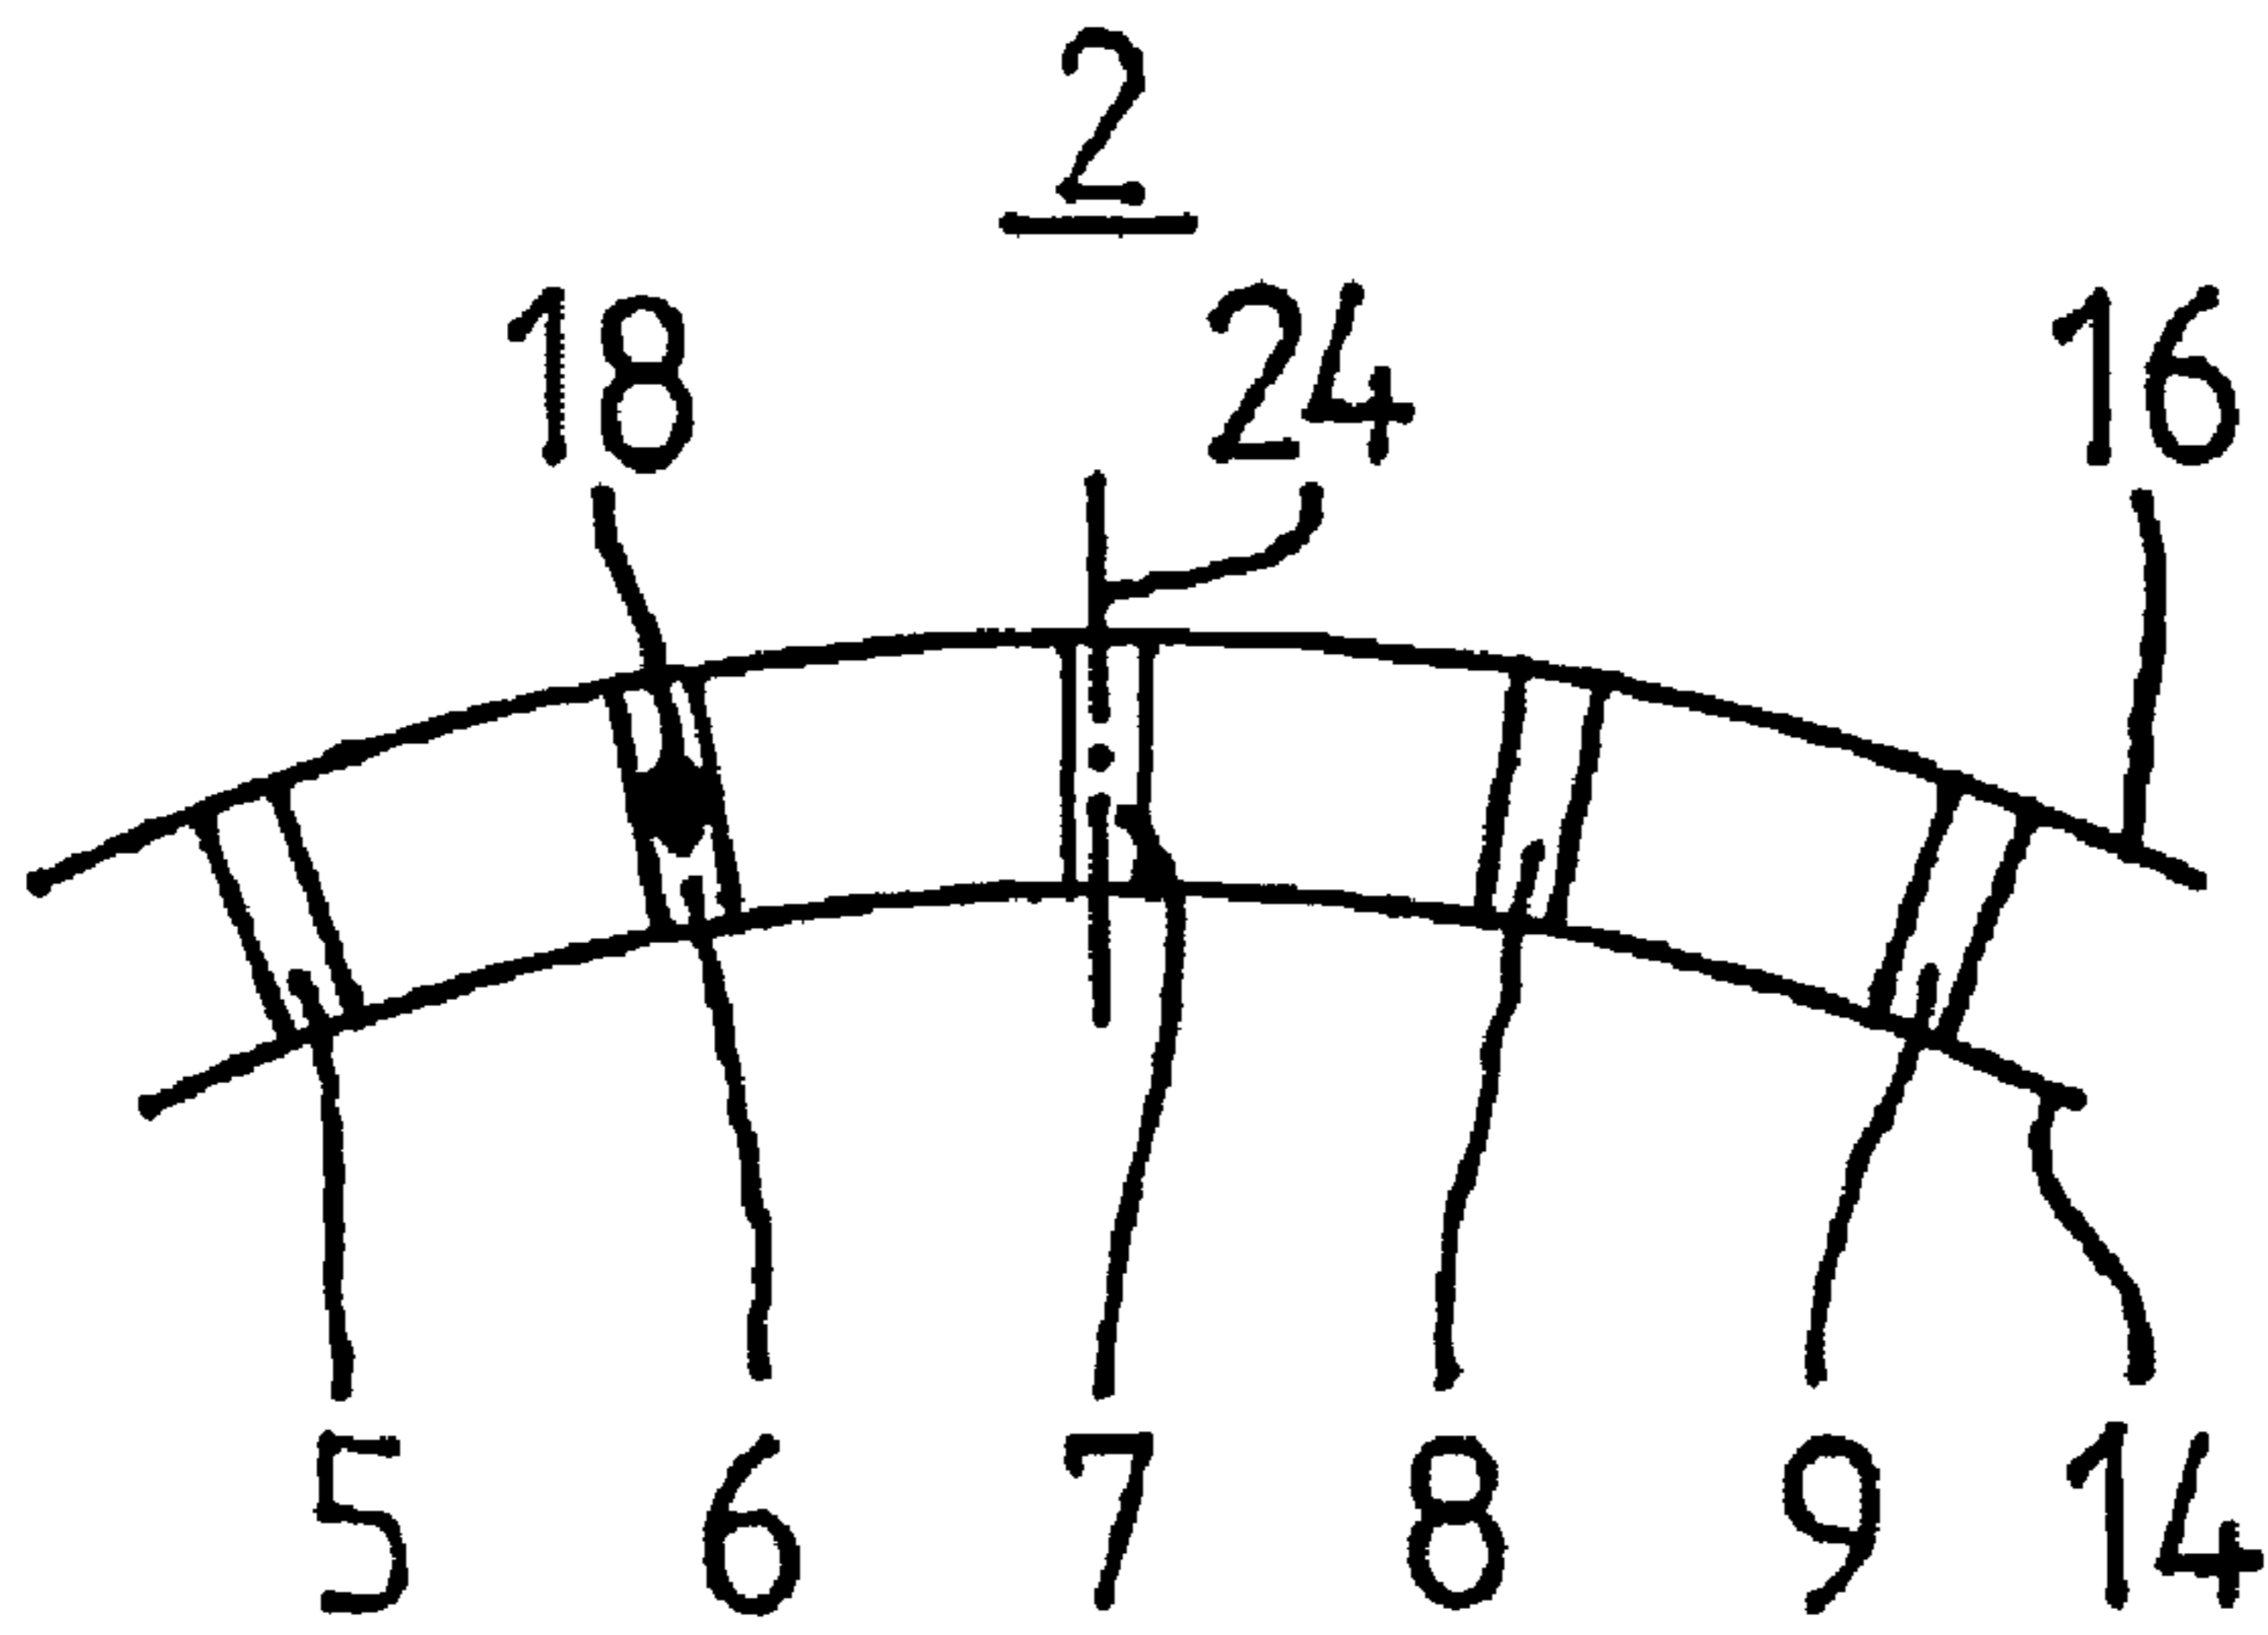
Fig. 5

FIG. 5 shows an axial view of a guide vane segment having five guide vanes, of which one is irreparably damaged, and

FIG. 5 shows, in highly schematized form, a guide vane segment 2 having five guide vanes 5 to 9, a radially inner shroud 14 and a radially outer shroud 16. Circumferential center 24 is indicated by a vertical dash-dot line, and corresponds at least approximately to the position of center, third guide vane 7. Second guide vane 6 (counted from the left segment end) has an irreparable damage 18 and must therefore be replaced. Because guide vane 6 is situated outside circumferential center 24, in the left segment half, and neither center guide vane 7 nor one or both guide vanes 8, 9 in the right segment half are irreparably damaged, the conditions are met for repair according to the present invention. The vane positions are now counted, beginning with damaged guide vane 6, until the left segment end is reached. In the present case this comes to two positions, namely the positions of guide vanes 6 and 5. Thus, according to the present invention, as the next step two replacement vanes 11, 12 are joined to the oppositely situated, right guide vane end, so that guide vane segment 2 temporarily has seven vanes.

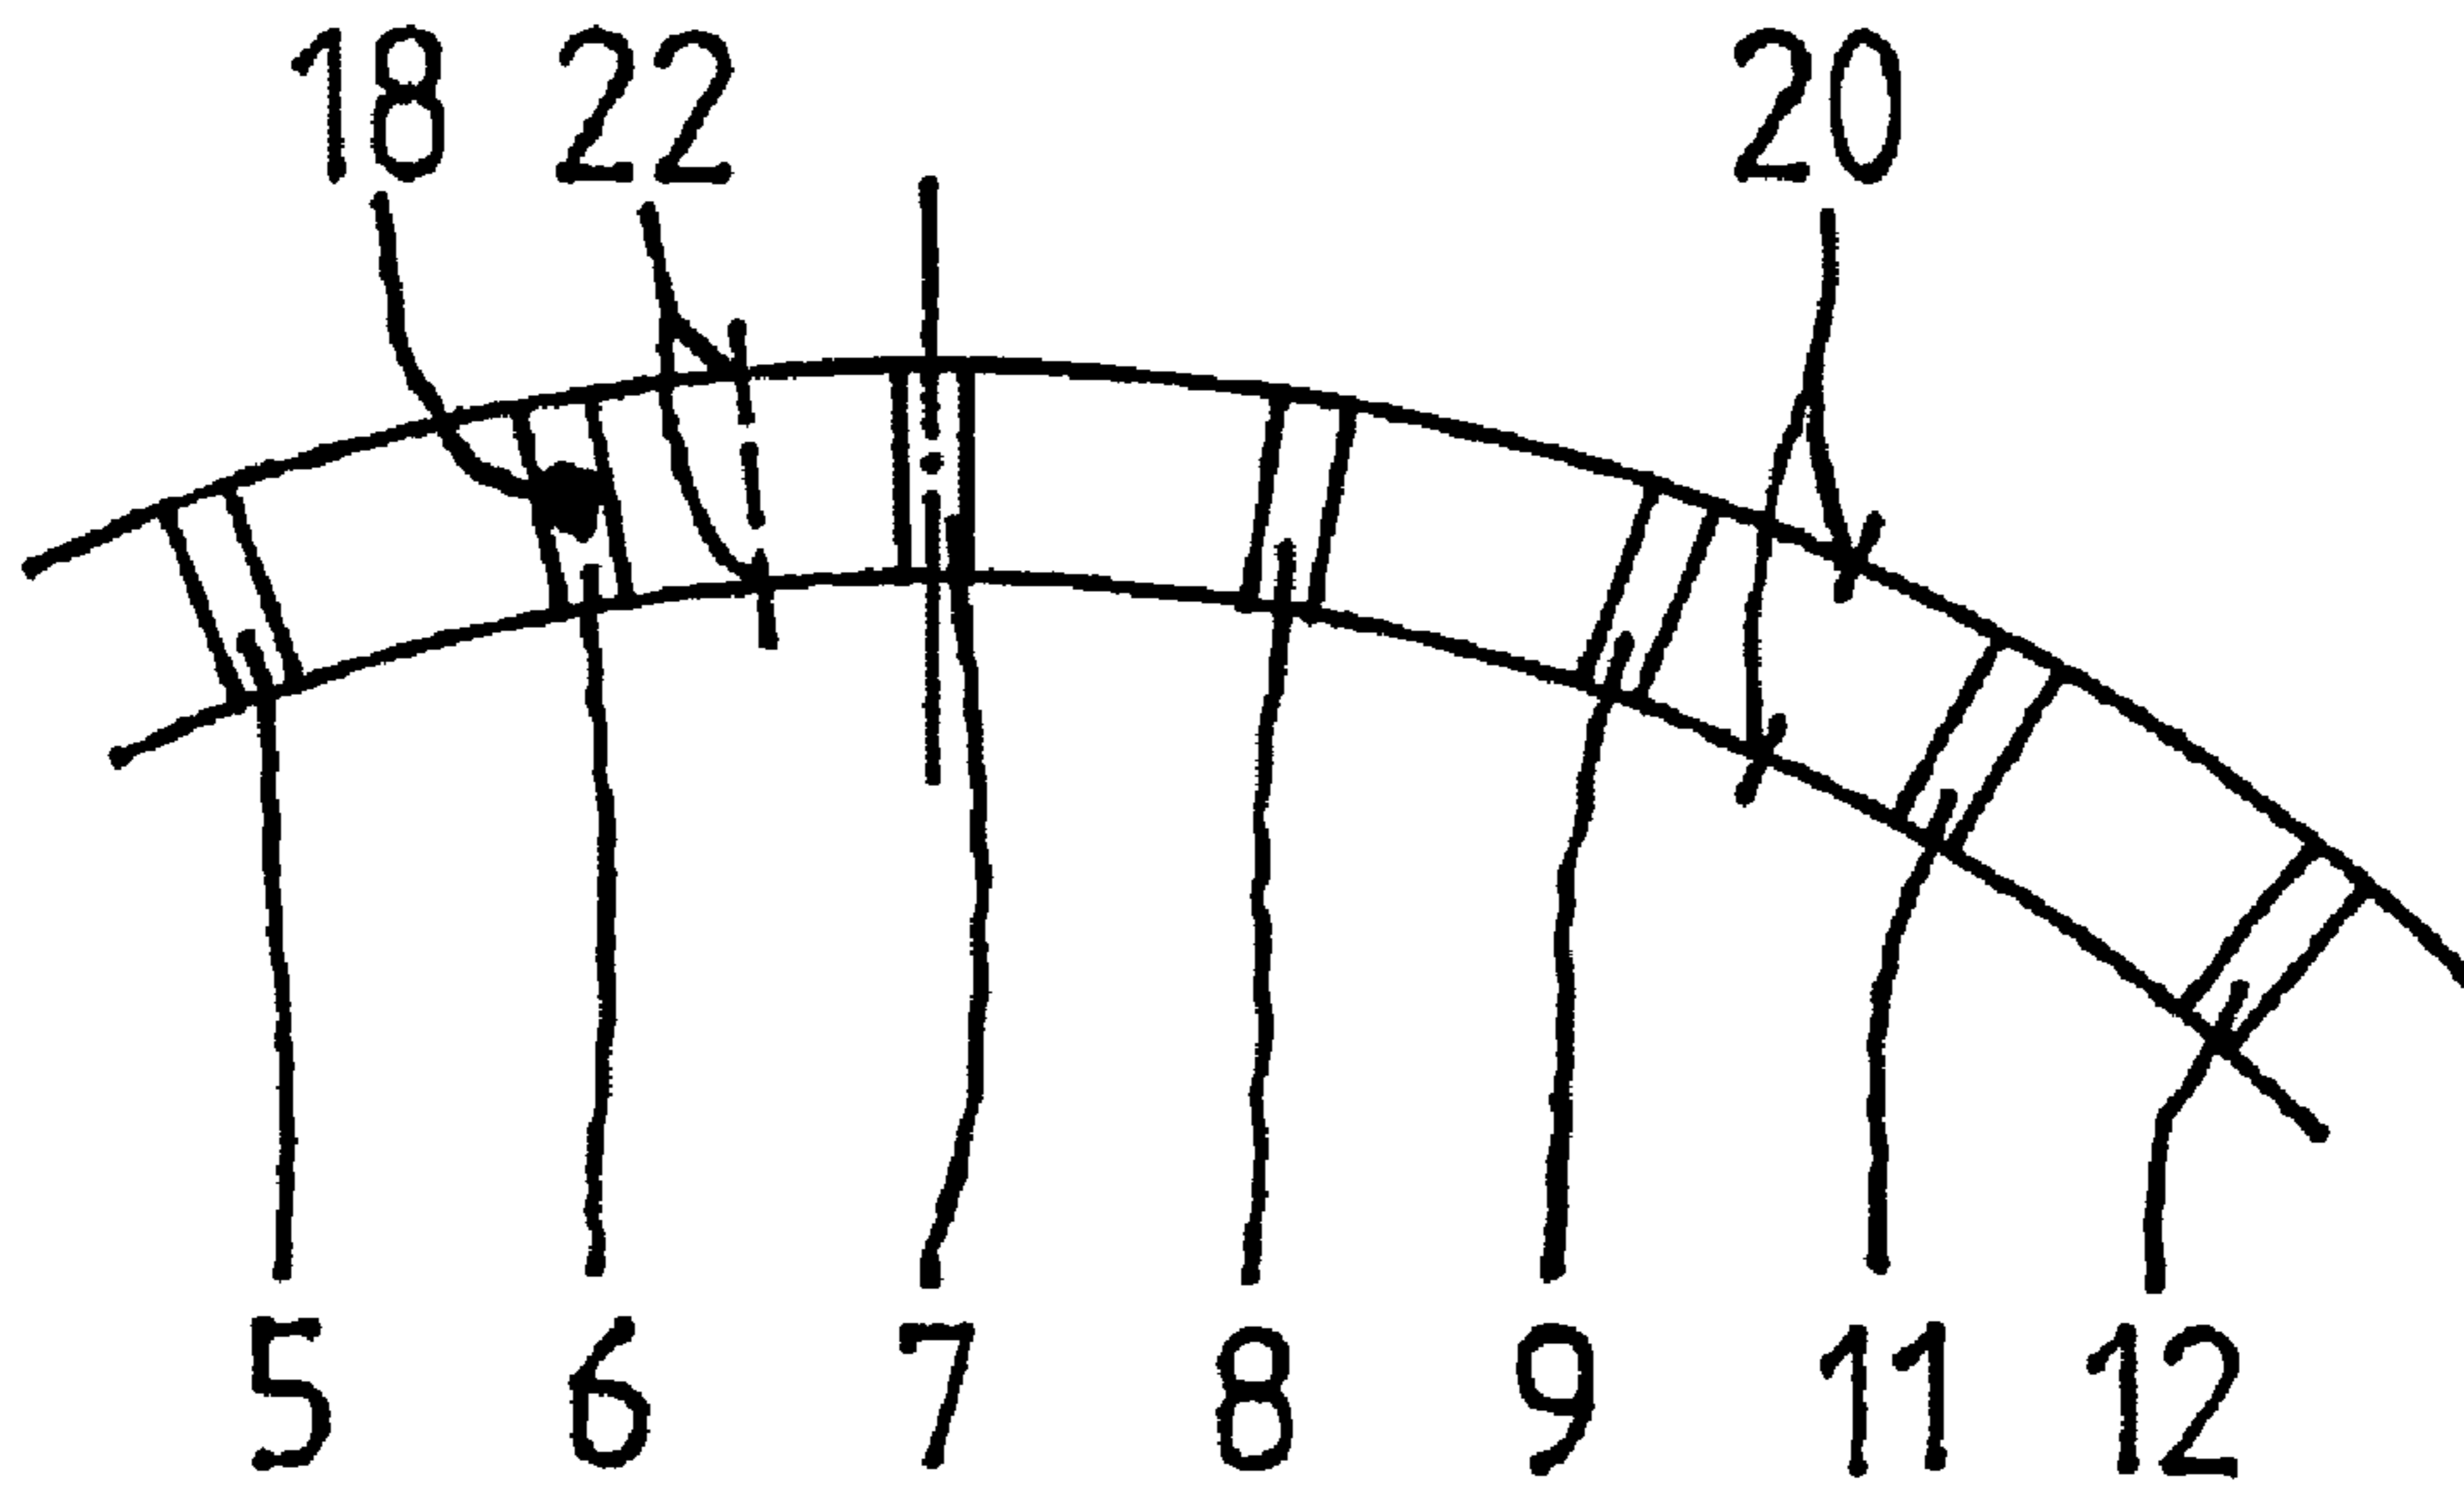
Fig. 6

FIG. 6 shows a comparable view after the joining of two replacement vanes to the guide vane segment.
