(54) **REPAIR SYSTEM AND METHOD**

Disclosed herein is a repair apparatus and method for pipe and fittings. In one form, the method relates to utilizing fabric-like material which is intermixed with an adhesive. In one form, the adhesive is a two-part adhesive which hardens to a semi-rigid state to avoid stress fractures through repeated expansion and contraction due to physical movement or temperature variation in the pipe and/or fittings. In one form the method and apparatus are particularly useful in thermoplastic pipes. In other forms, the method is particularly useful in metal pipes and fittings, or in non-pipe structures.

This disclosure relates to the field of methods to repair or strengthen pipe, pipe fittings, and related structures. In one form, the disclosure relates to repairing of thermoplastic pipe and thermoplastic fittings.

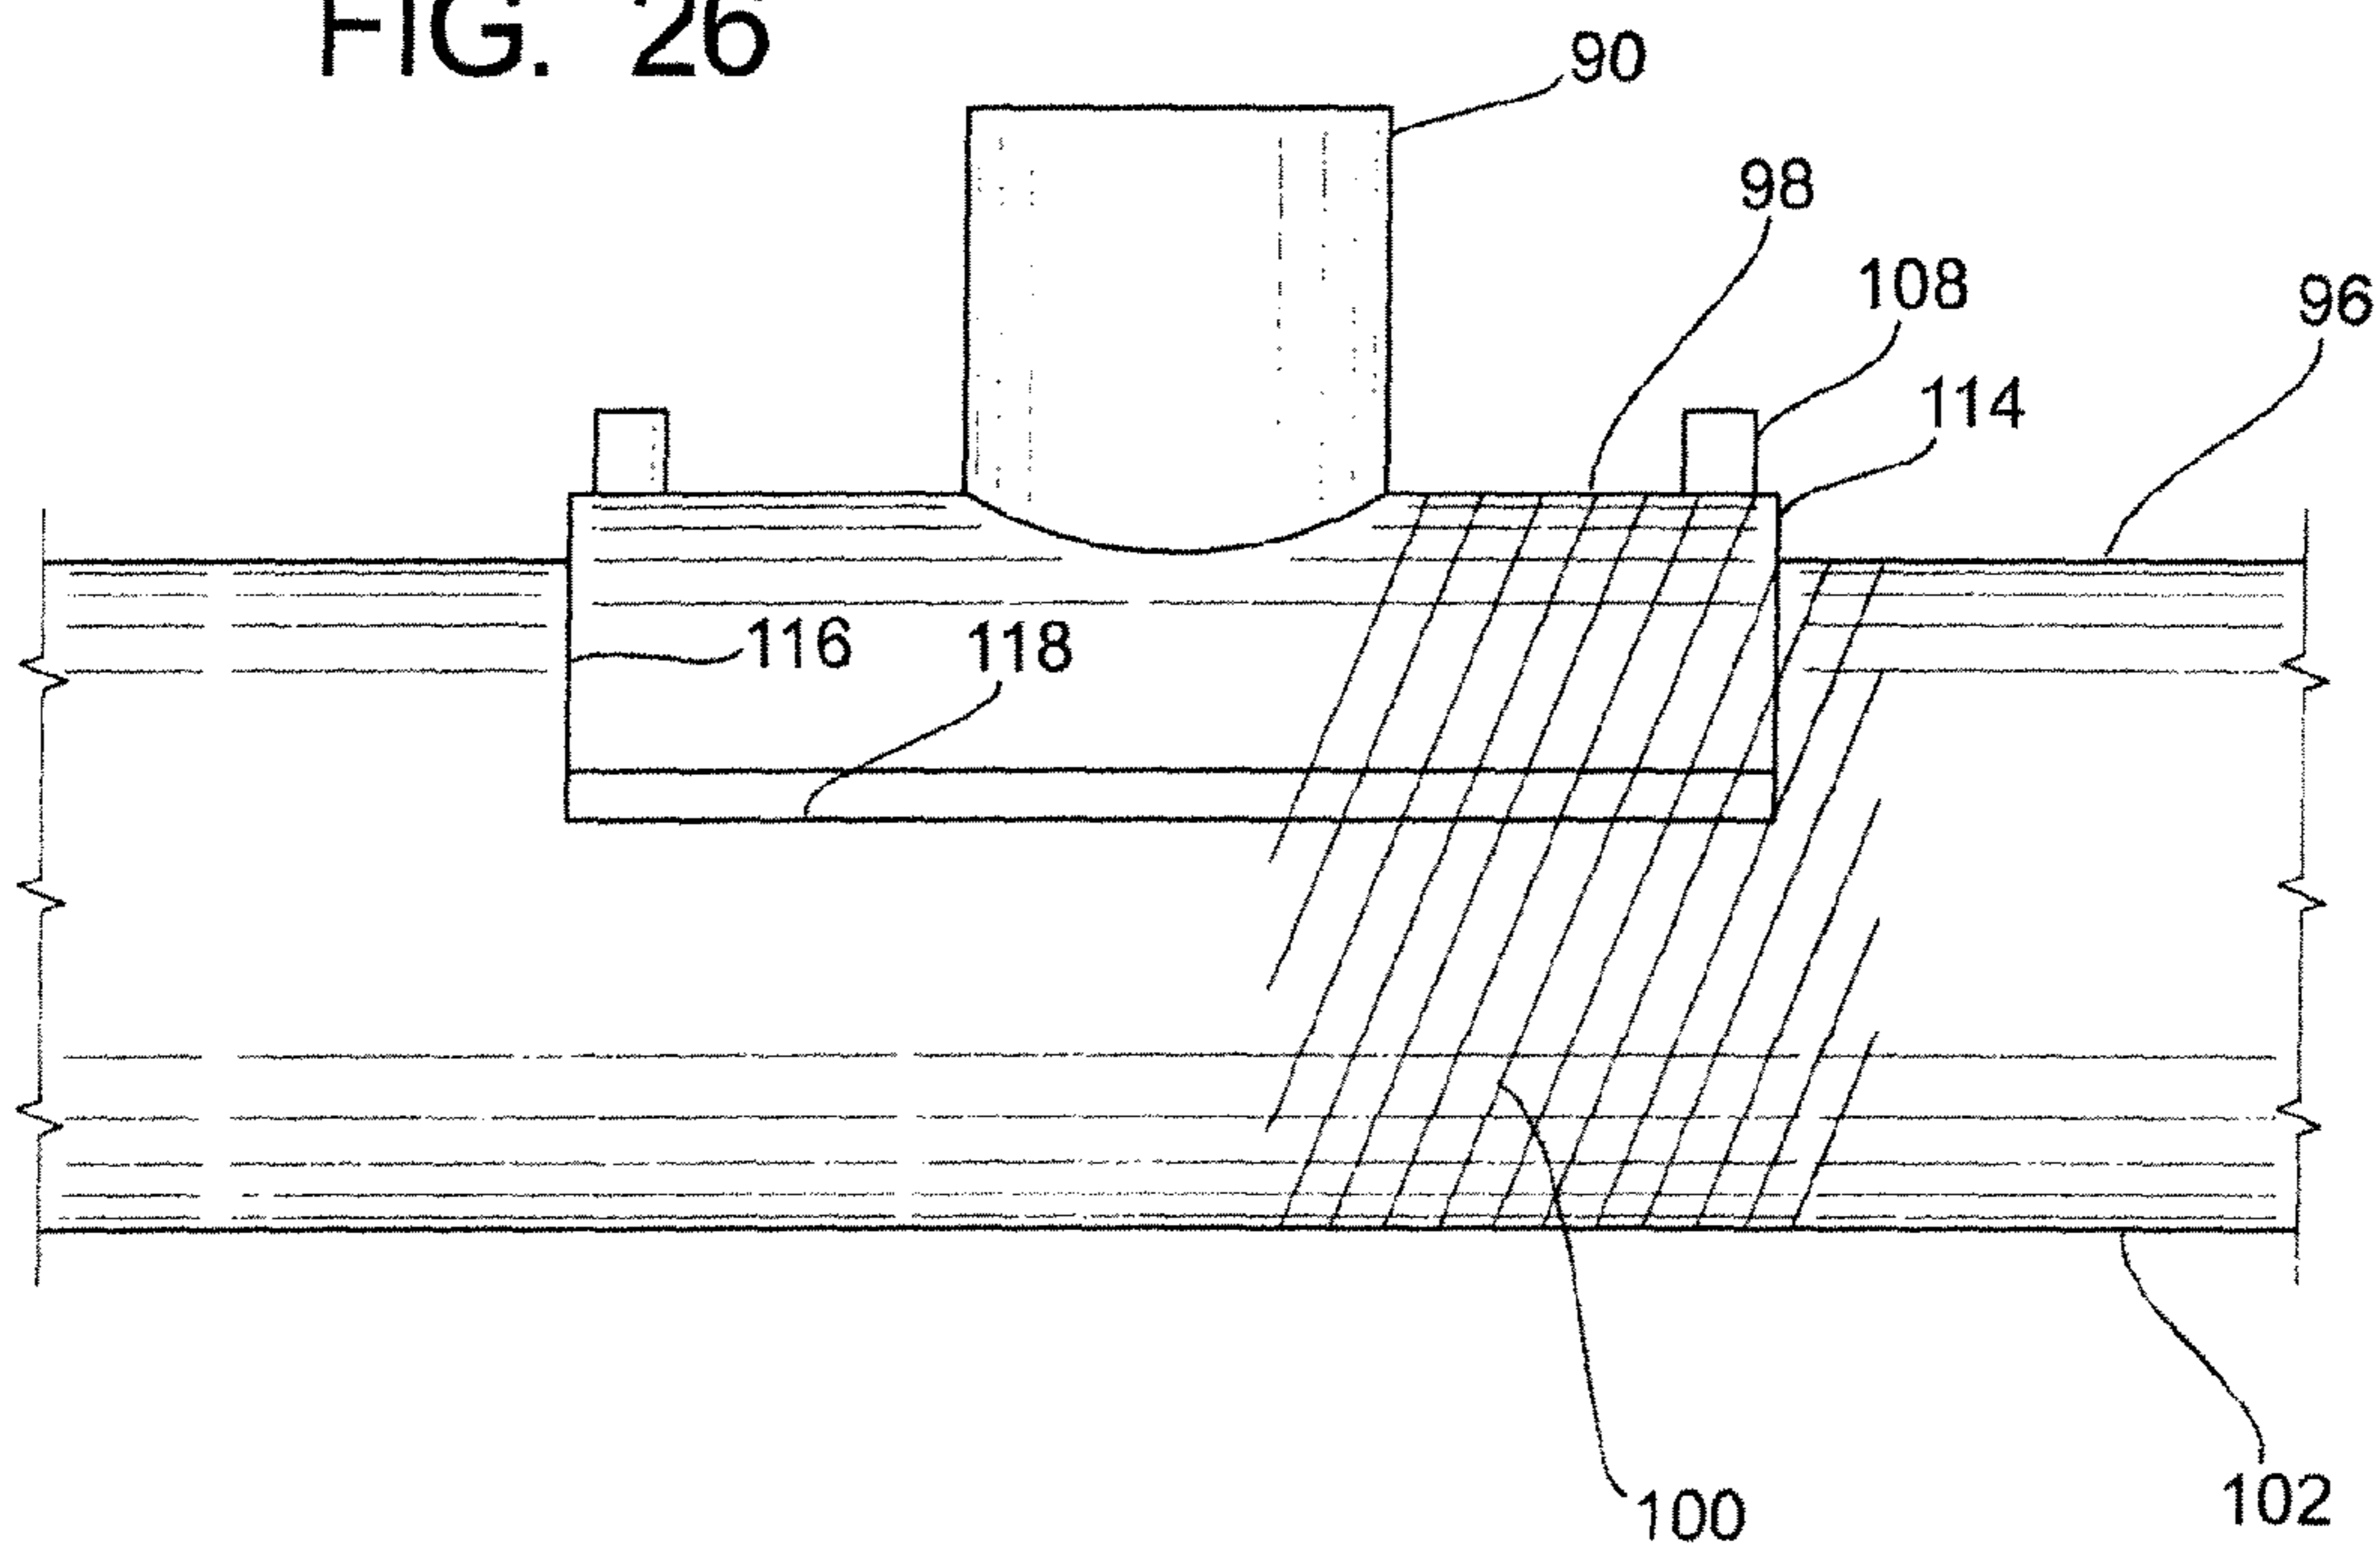
FIG. 27 is a side cutaway view of a section of pipe and a fitting in the process of being repaired using the disclosed method in one form.

To accomplish a repair 92 to a compromised fitting 94, coupled to a thermoplastic distribution pipe 96 in one form, as shown in FIG. 27, the compromised fitting 94 must first be identified and accessed. It may be desired to substantially reduce or eliminate fluid pressure within the distribution pipe 96. The compromised fitting 94 and surrounding areas are again cleaned of debris and other contaminants. As the surface of these fittings and thermoplastic pipe is often substantially smooth (which may not allow for a firm adhesive bond), an abraded surface 100 shown in FIG. 26 may be formed on the repair area to enhance the adhesive bond. For example, the person(s) conducting the repair could utilize a coarse grit sandpaper (in one range 20-220 grit) to "rough up" the surface of the saddle 98, and a portion of the distribution pipe 96. For example, the abraded surface 100 could extend 1/2" or more on all sides of the fitting 90 around the compromised area. The abraded surface 100 could extend from the edge of the fitting 90 up to the distance equal to the diameter of the distribution pipe 96 or more. The abraded surface 100 may extend around the diameter of the outer surface 102 of the distribution pipe 96. Once again contaminants should be removed following abrasion. Once the surface 102 is sufficiently abraded, the abraded surface 100 may be heated, such as by a propane or acetylene torch or heat gun. The abraded surface 100 may be heated up to 100°, 180° or more, as long as the melting point of the pipe and/or fitting is not reached. A roll perforator, as previously explained, can then be utilized. Looking to FIG. 27, these devices can be "rolled" around the surface substantially defined by the abrasion or cleaning step and provide a number of piercings, which do not extend through the interior wall 104 of the distribution pipe 96 or the saddle 98. These piercings further provide a good adhesive surface upon the distribution pipe 96 for the adhesive and other materials.

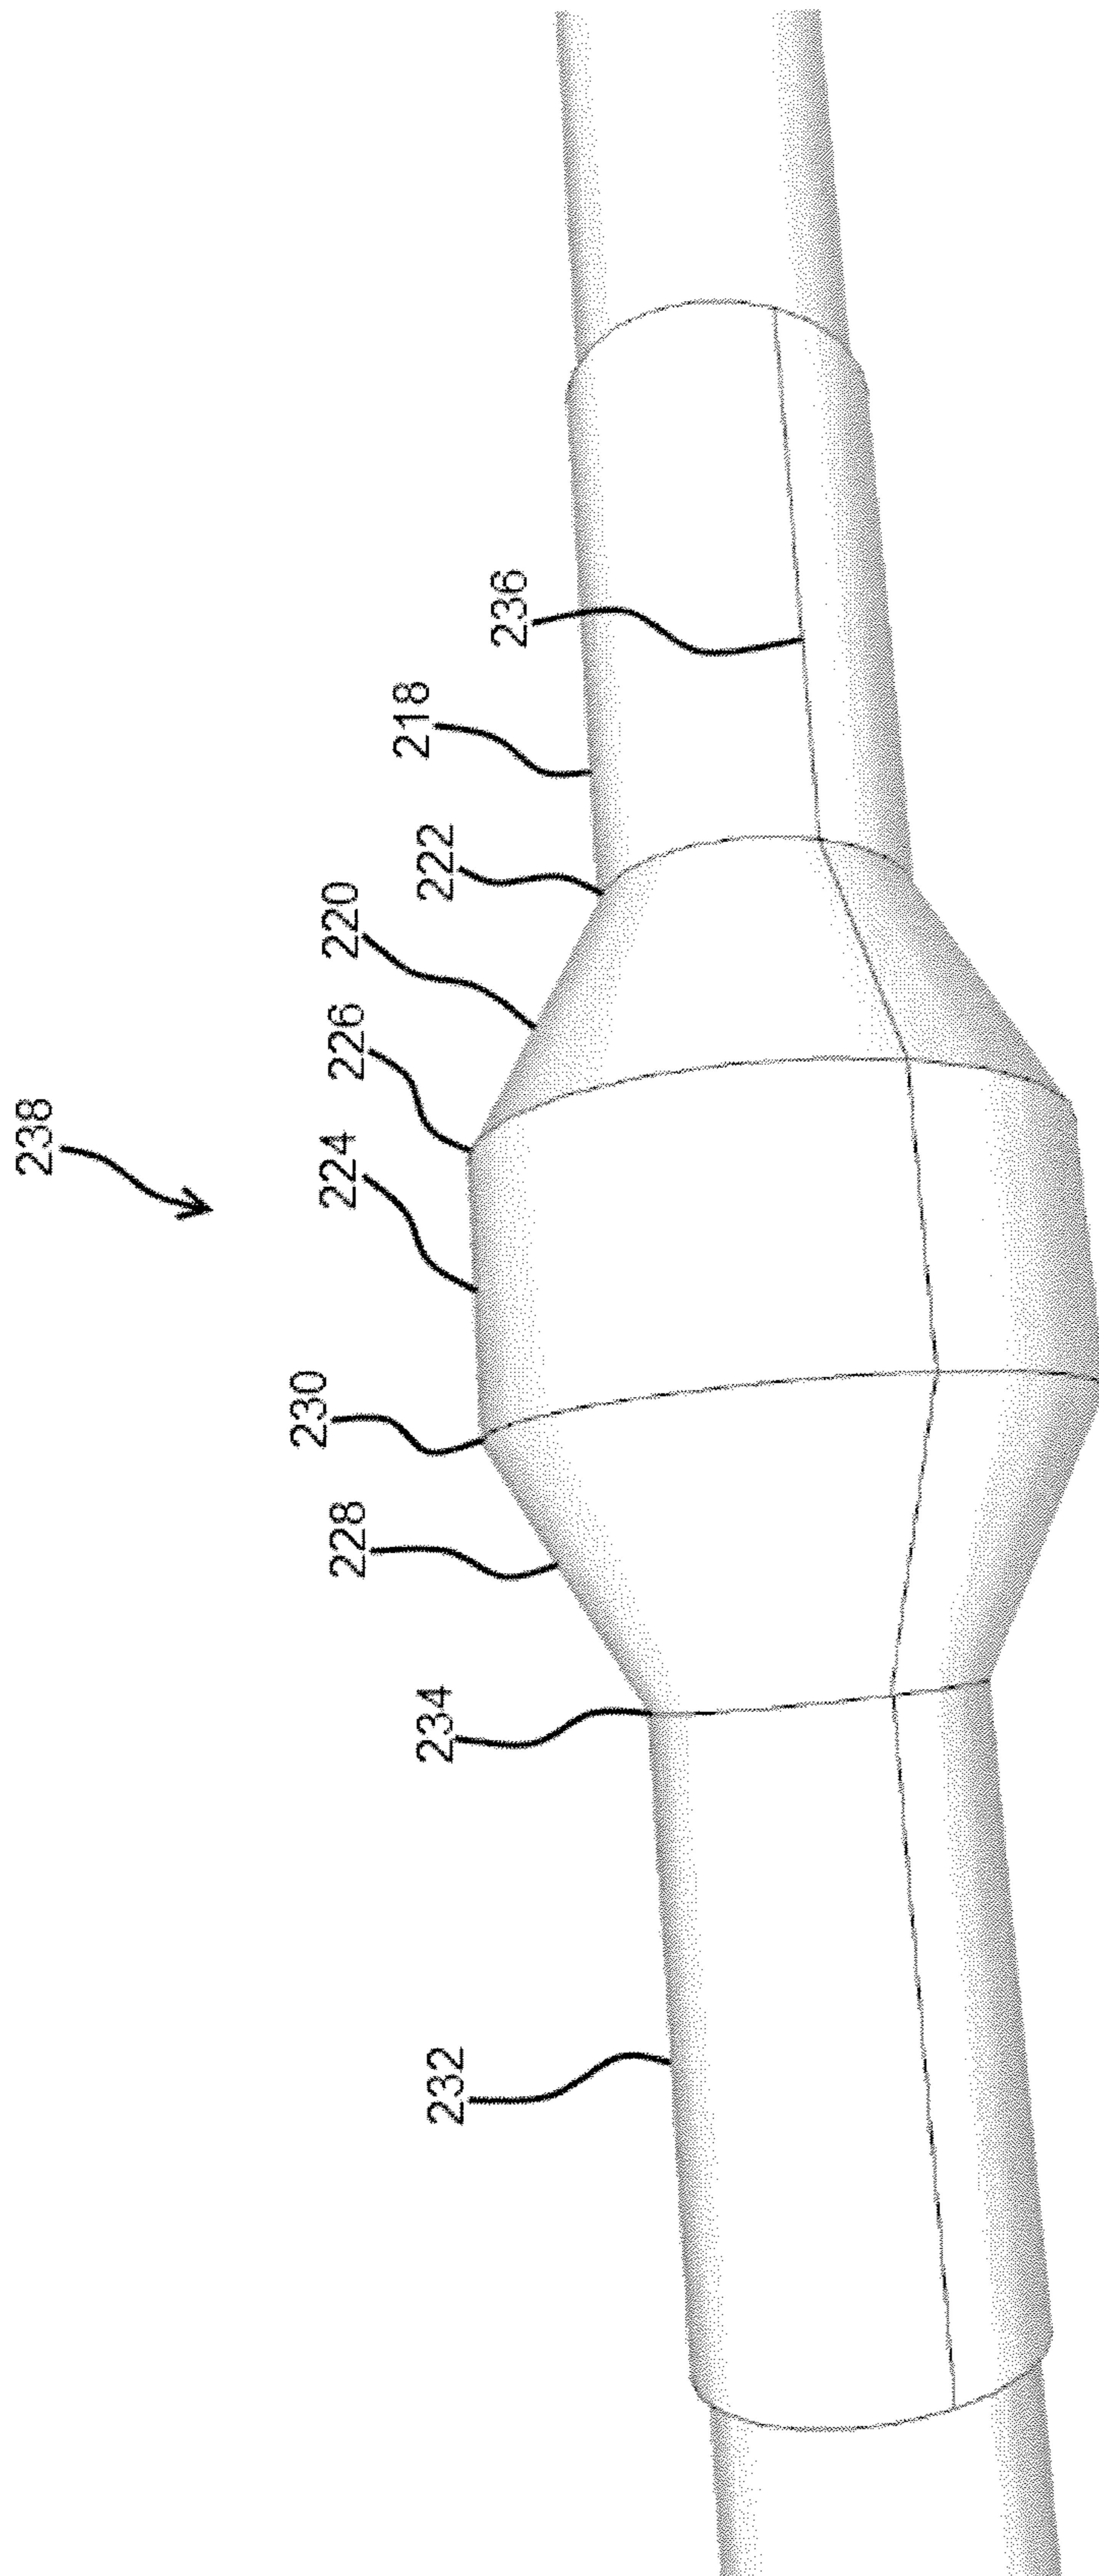
FIG. 40 is a side view of another method of repairing a compromised section of pipe.

FIG. 41 is a cross sectional view of the embodiment of FIG. 40.
