US008424571B2

(54) **REPAIR SYSTEM AND METHOD**
(76) Inventor: **Carl M. Brooks**, Caldwell, ID (US)
(*) Notice: Subject to any disclaimer, the term of this patent is extended or adjusted under 35 U.S.C. 154(b) by 51 days.
This patent is subject to a terminal disclaimer.

(57) **ABSTRACT**
Disclosed herein is a repair apparatus and method for pipe and fittings. In one form, the method relates to utilizing fabric-like material which is intermixed with an adhesive. In one form, the adhesive is a two-part adhesive which hardens to a semi-rigid state to avoid stress fractures through repeated expansion and contraction due to physical movement or temperature variation in the pipe and/or fittings. In one form the method and apparatus are particularly useful in thermoplastic pipes. In other forms, the method is particularly useful in metal pipes and fittings, or in non-pipe structures.

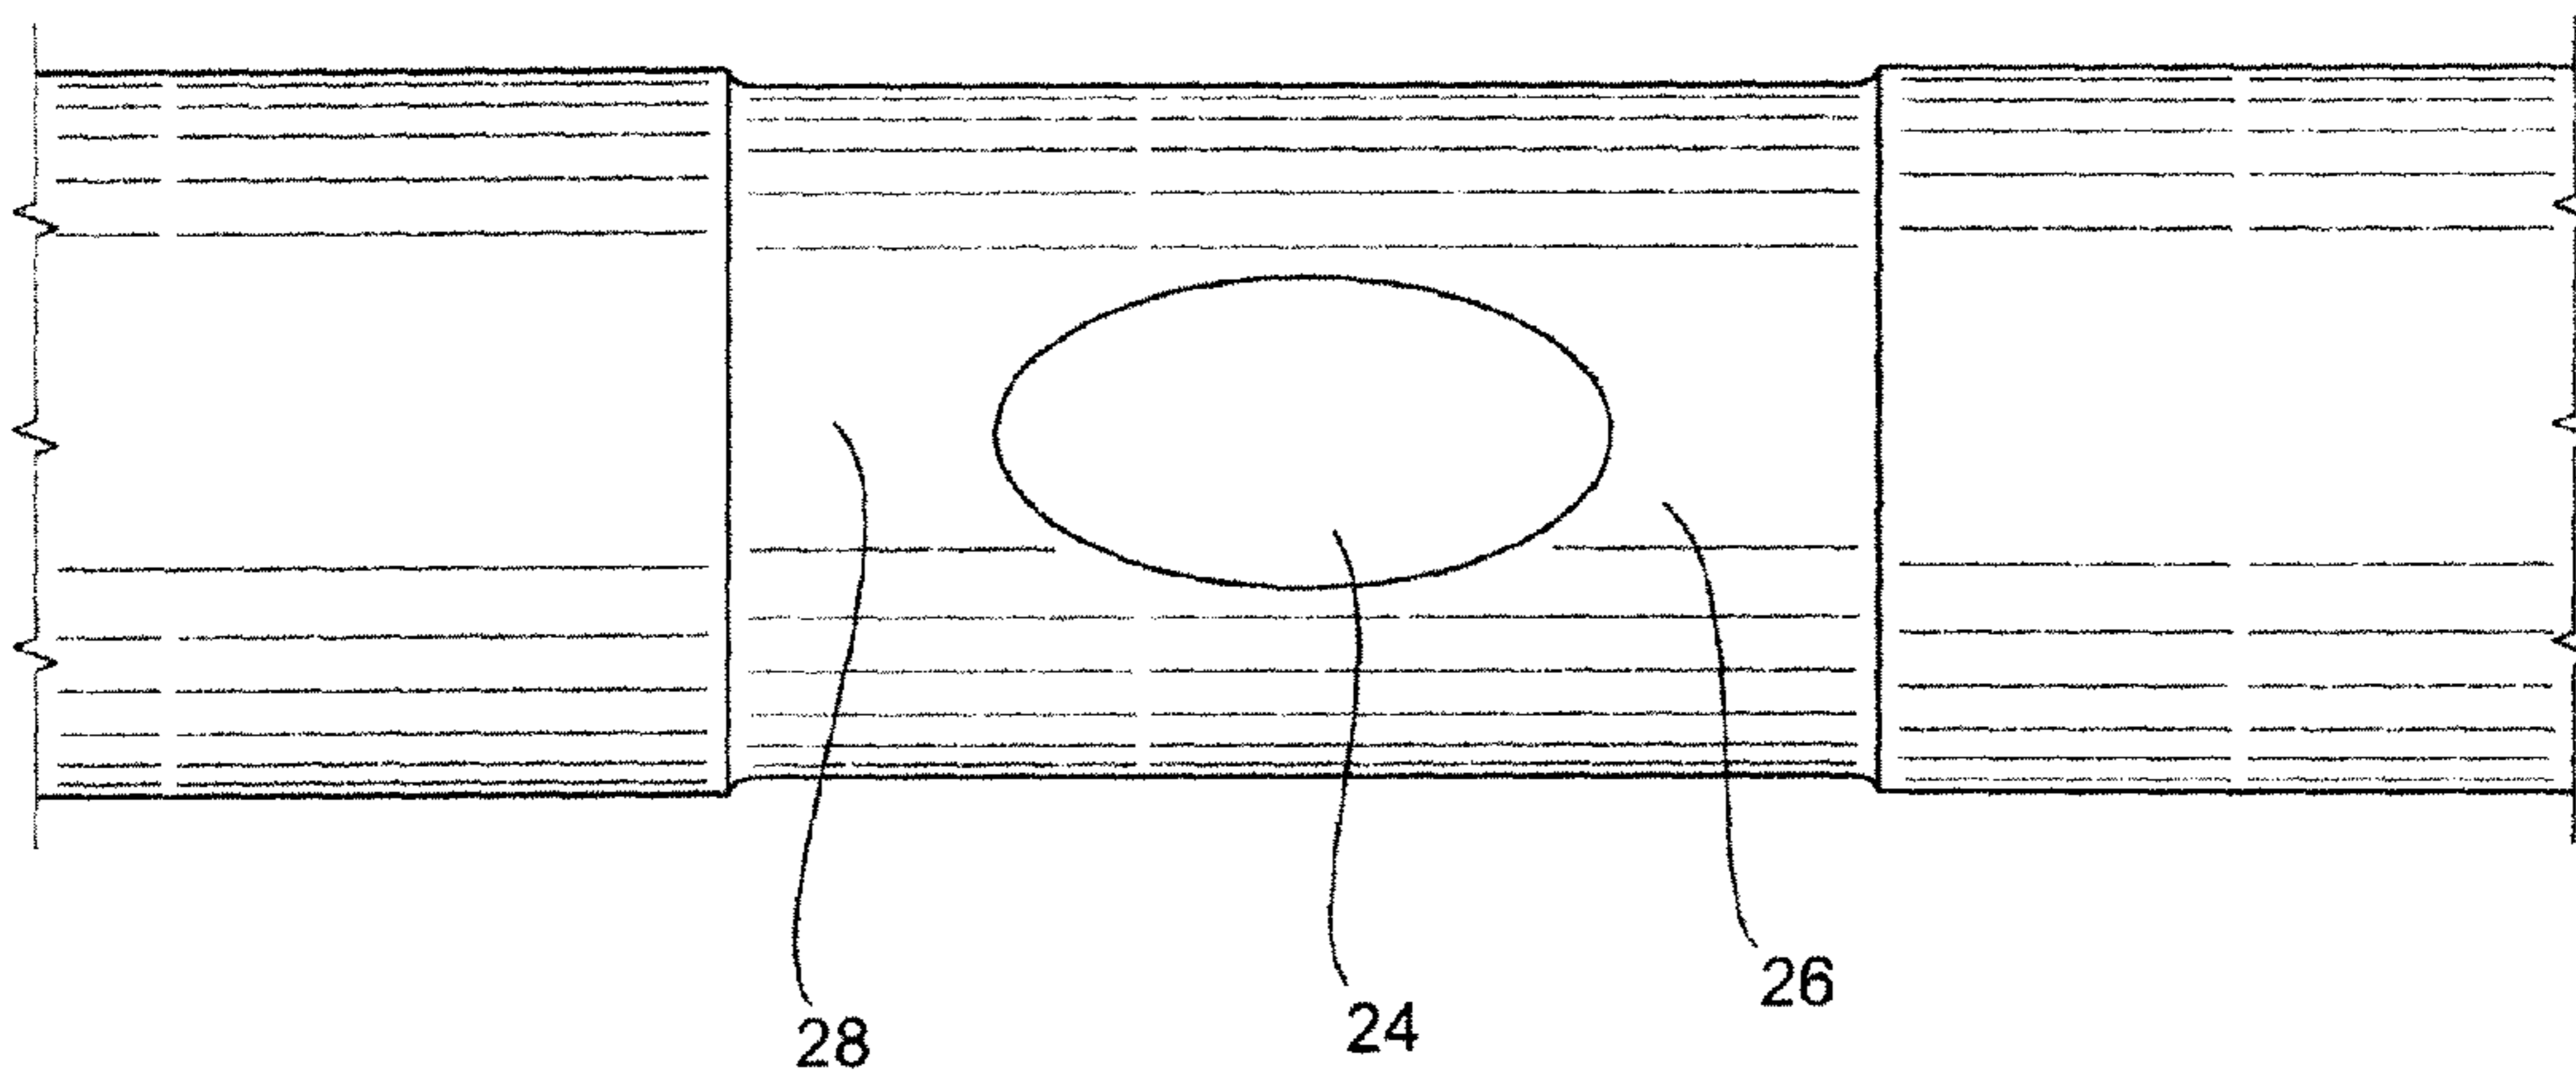
FIG. 4

Looking to FIG. 4, once the compromised portion **24** and overlap portion **28** are sufficiently abraded, the pipe adjacent to the compromised portion **24** may be heated such as by a propane or acetylene torch or heat gun. The pipe could be heated up to 100°, 180° or more as long as the melting point of the pipe **22** is not reached.

24. The abraded surface **26** could in one form extend from the edge of the compromised portion **24** up to the distance equal to the diameter of the pipe **22** or more. The abraded surface **26** may extend circumferentially **16** around the diameter of the outer surface **30** of the pipe **22** as shown in FIG. 4. Once again, contaminants left over from the abrasion process should be removed prior to continuing.

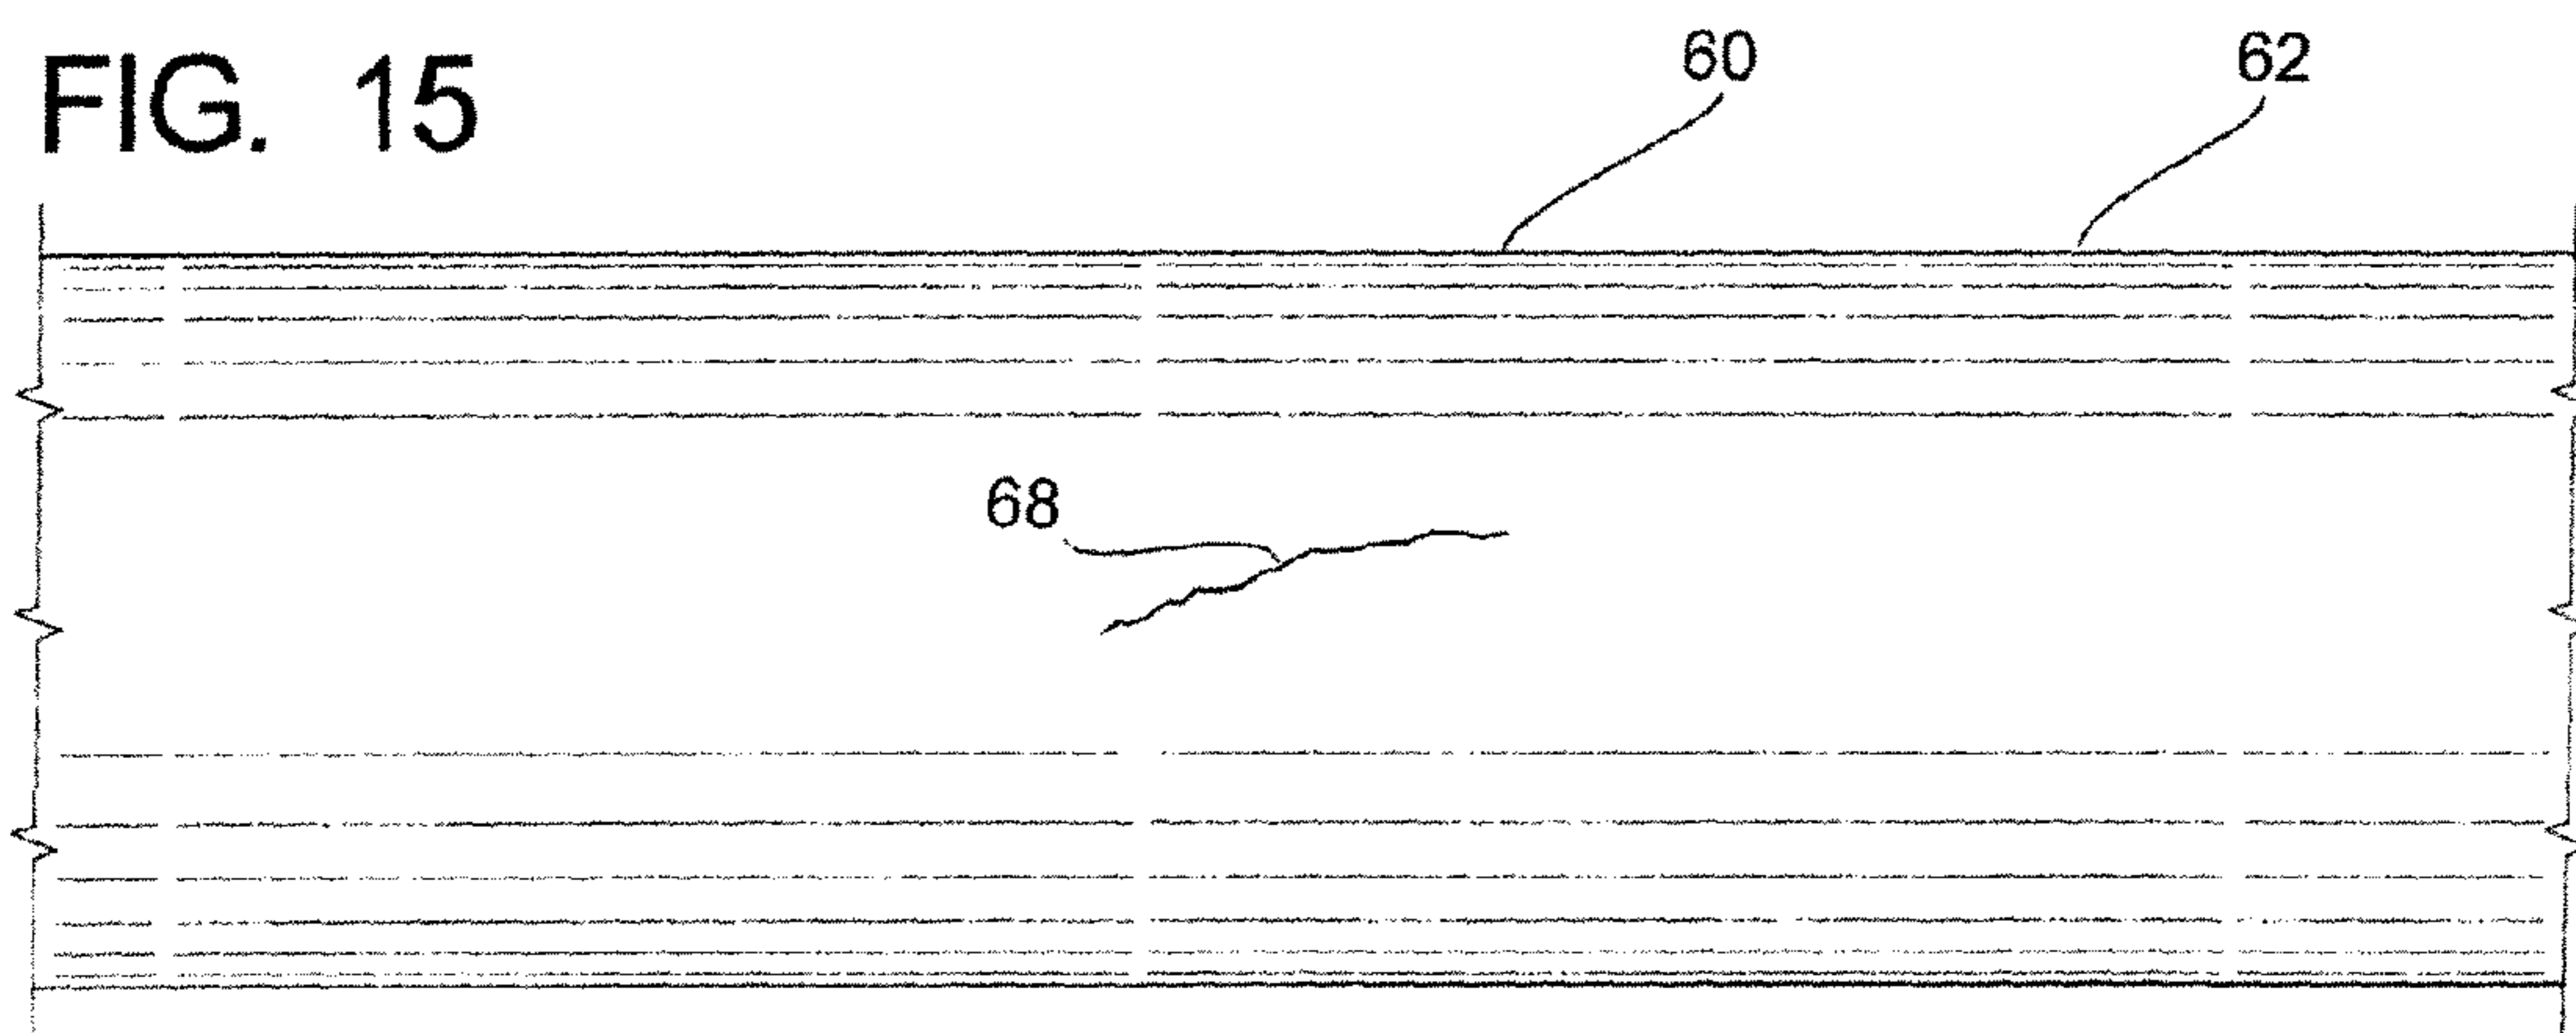
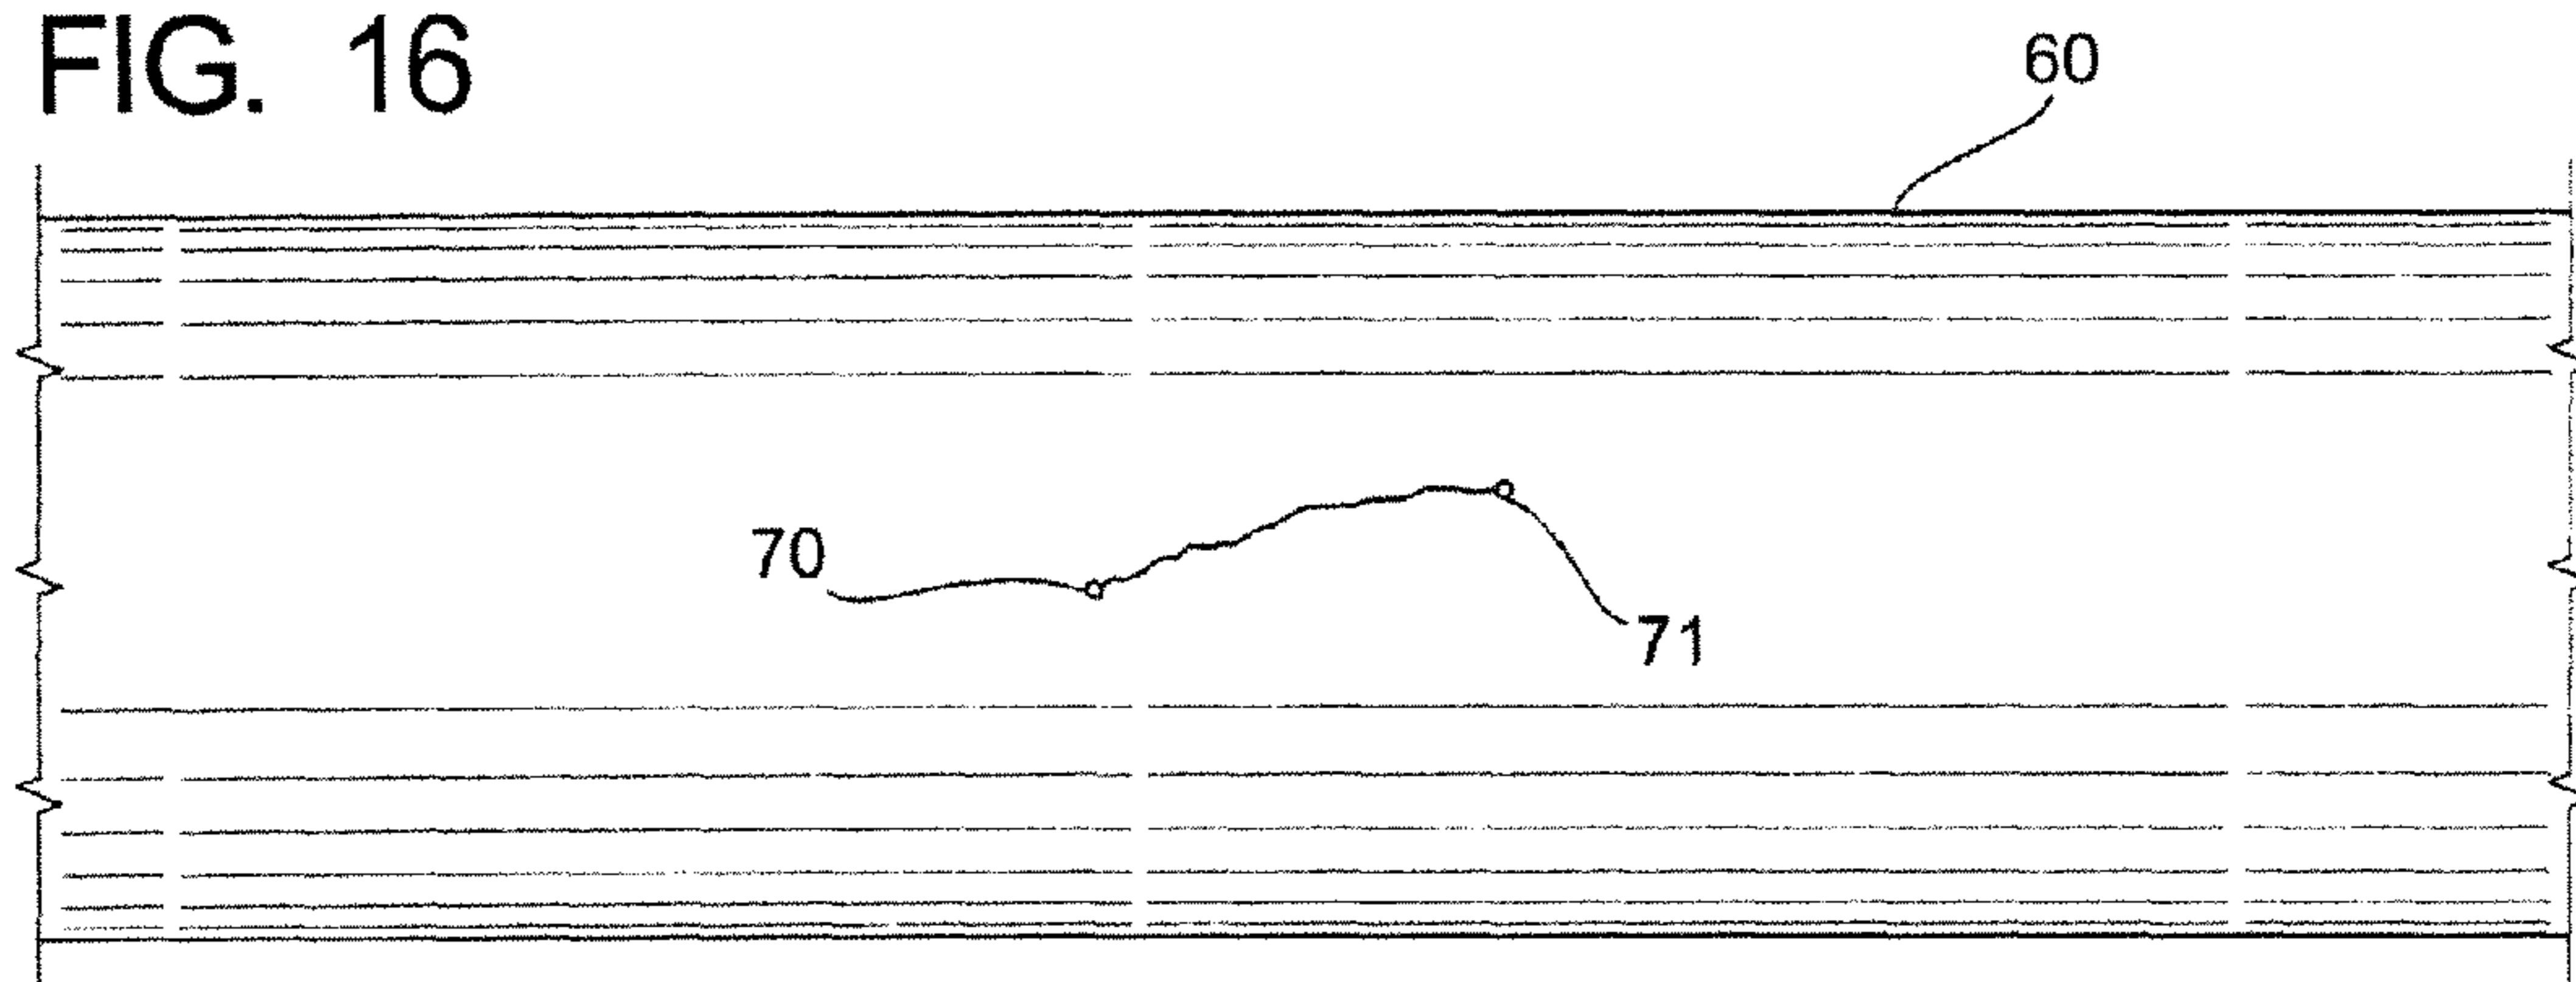
FIGS. 16 and 17 are plan views of a compromised structure in the process of being repaired using the disclosed method in one form.

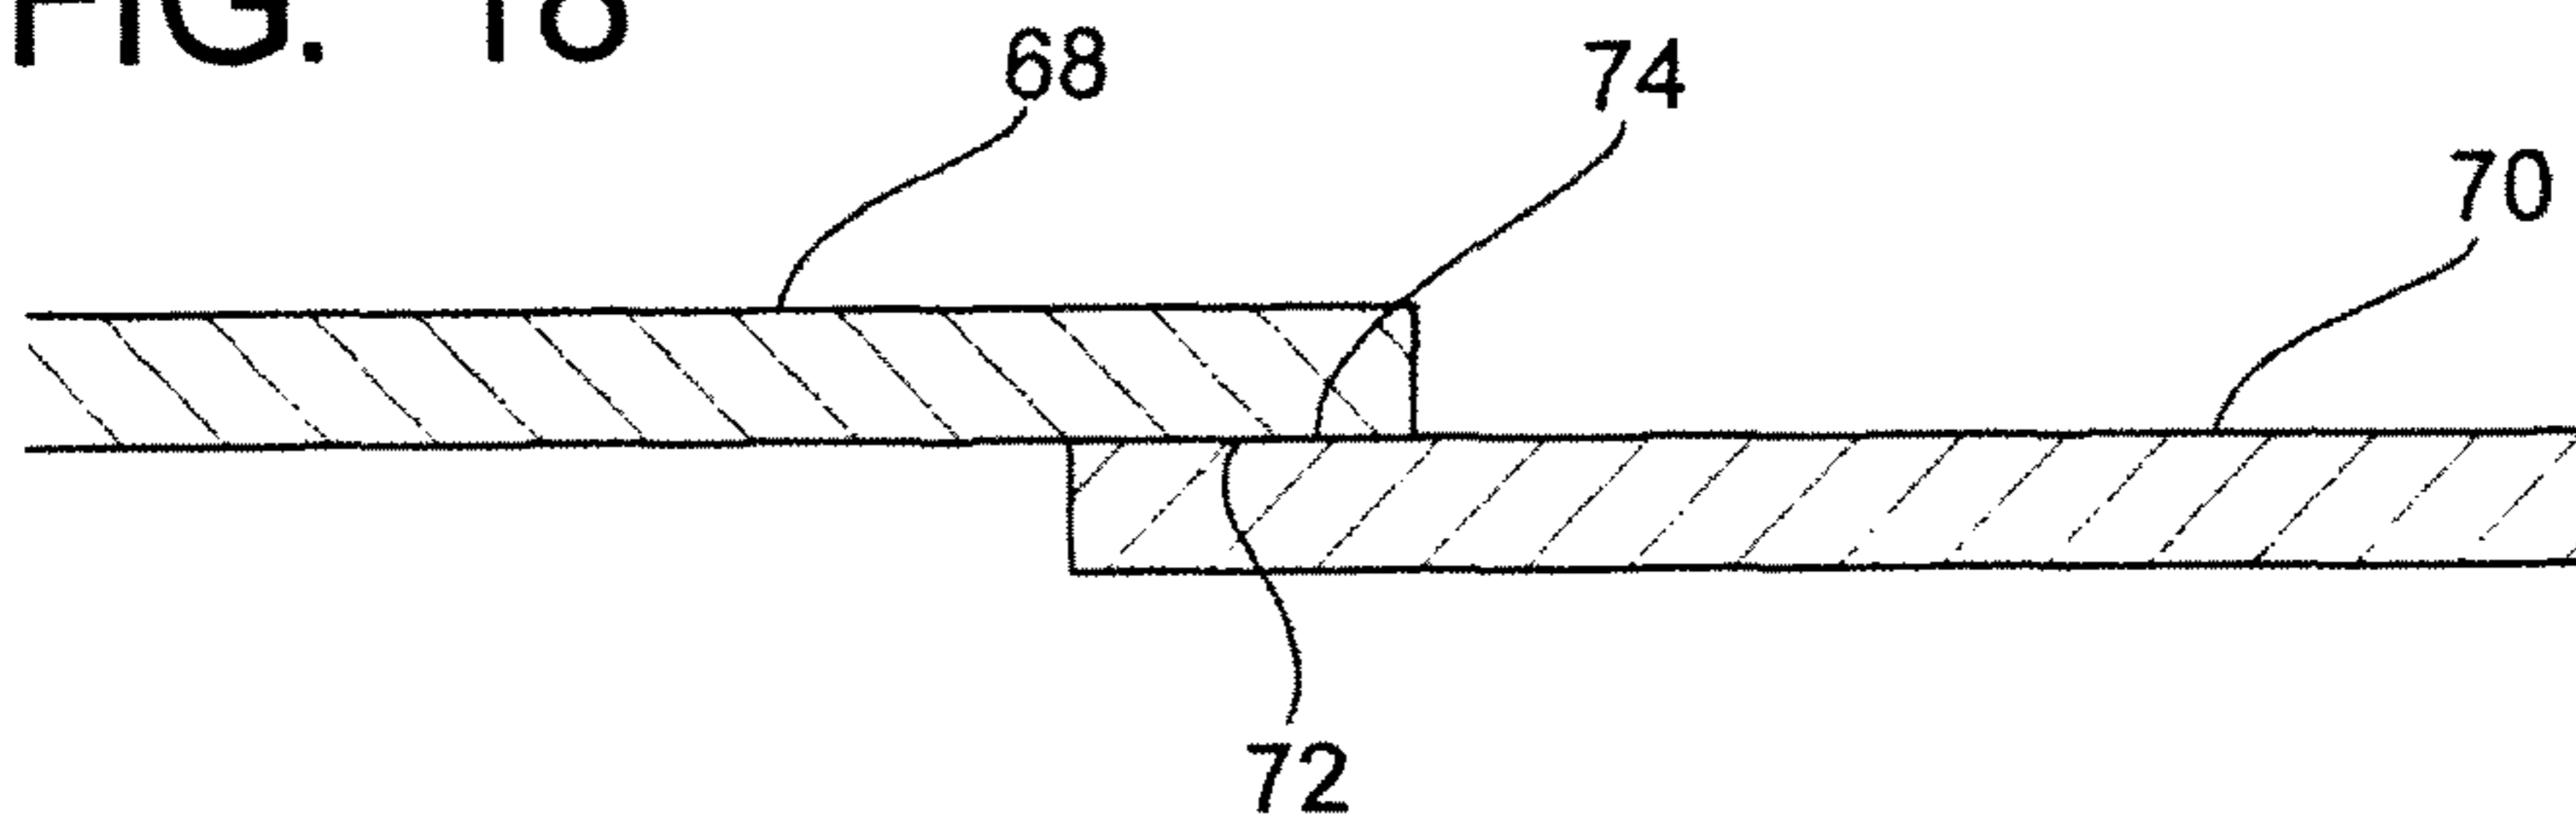
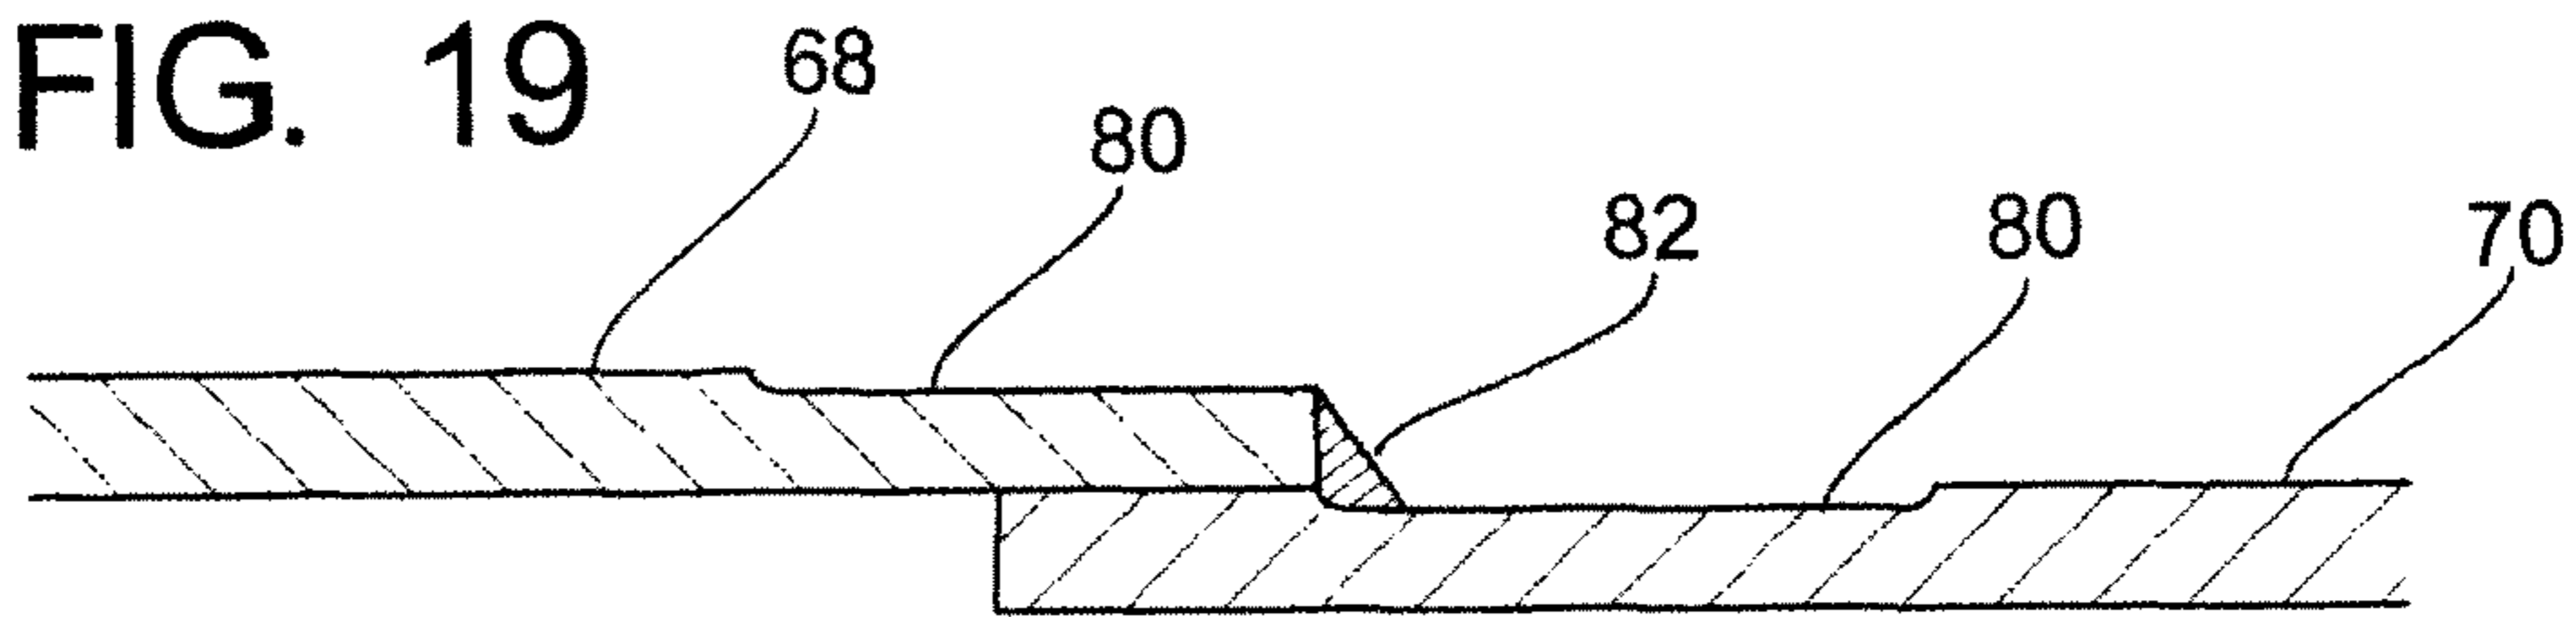
FIGS. 18 through 20 are side cutaway views of a structure in the process of being repaired using the disclosed method in one form.

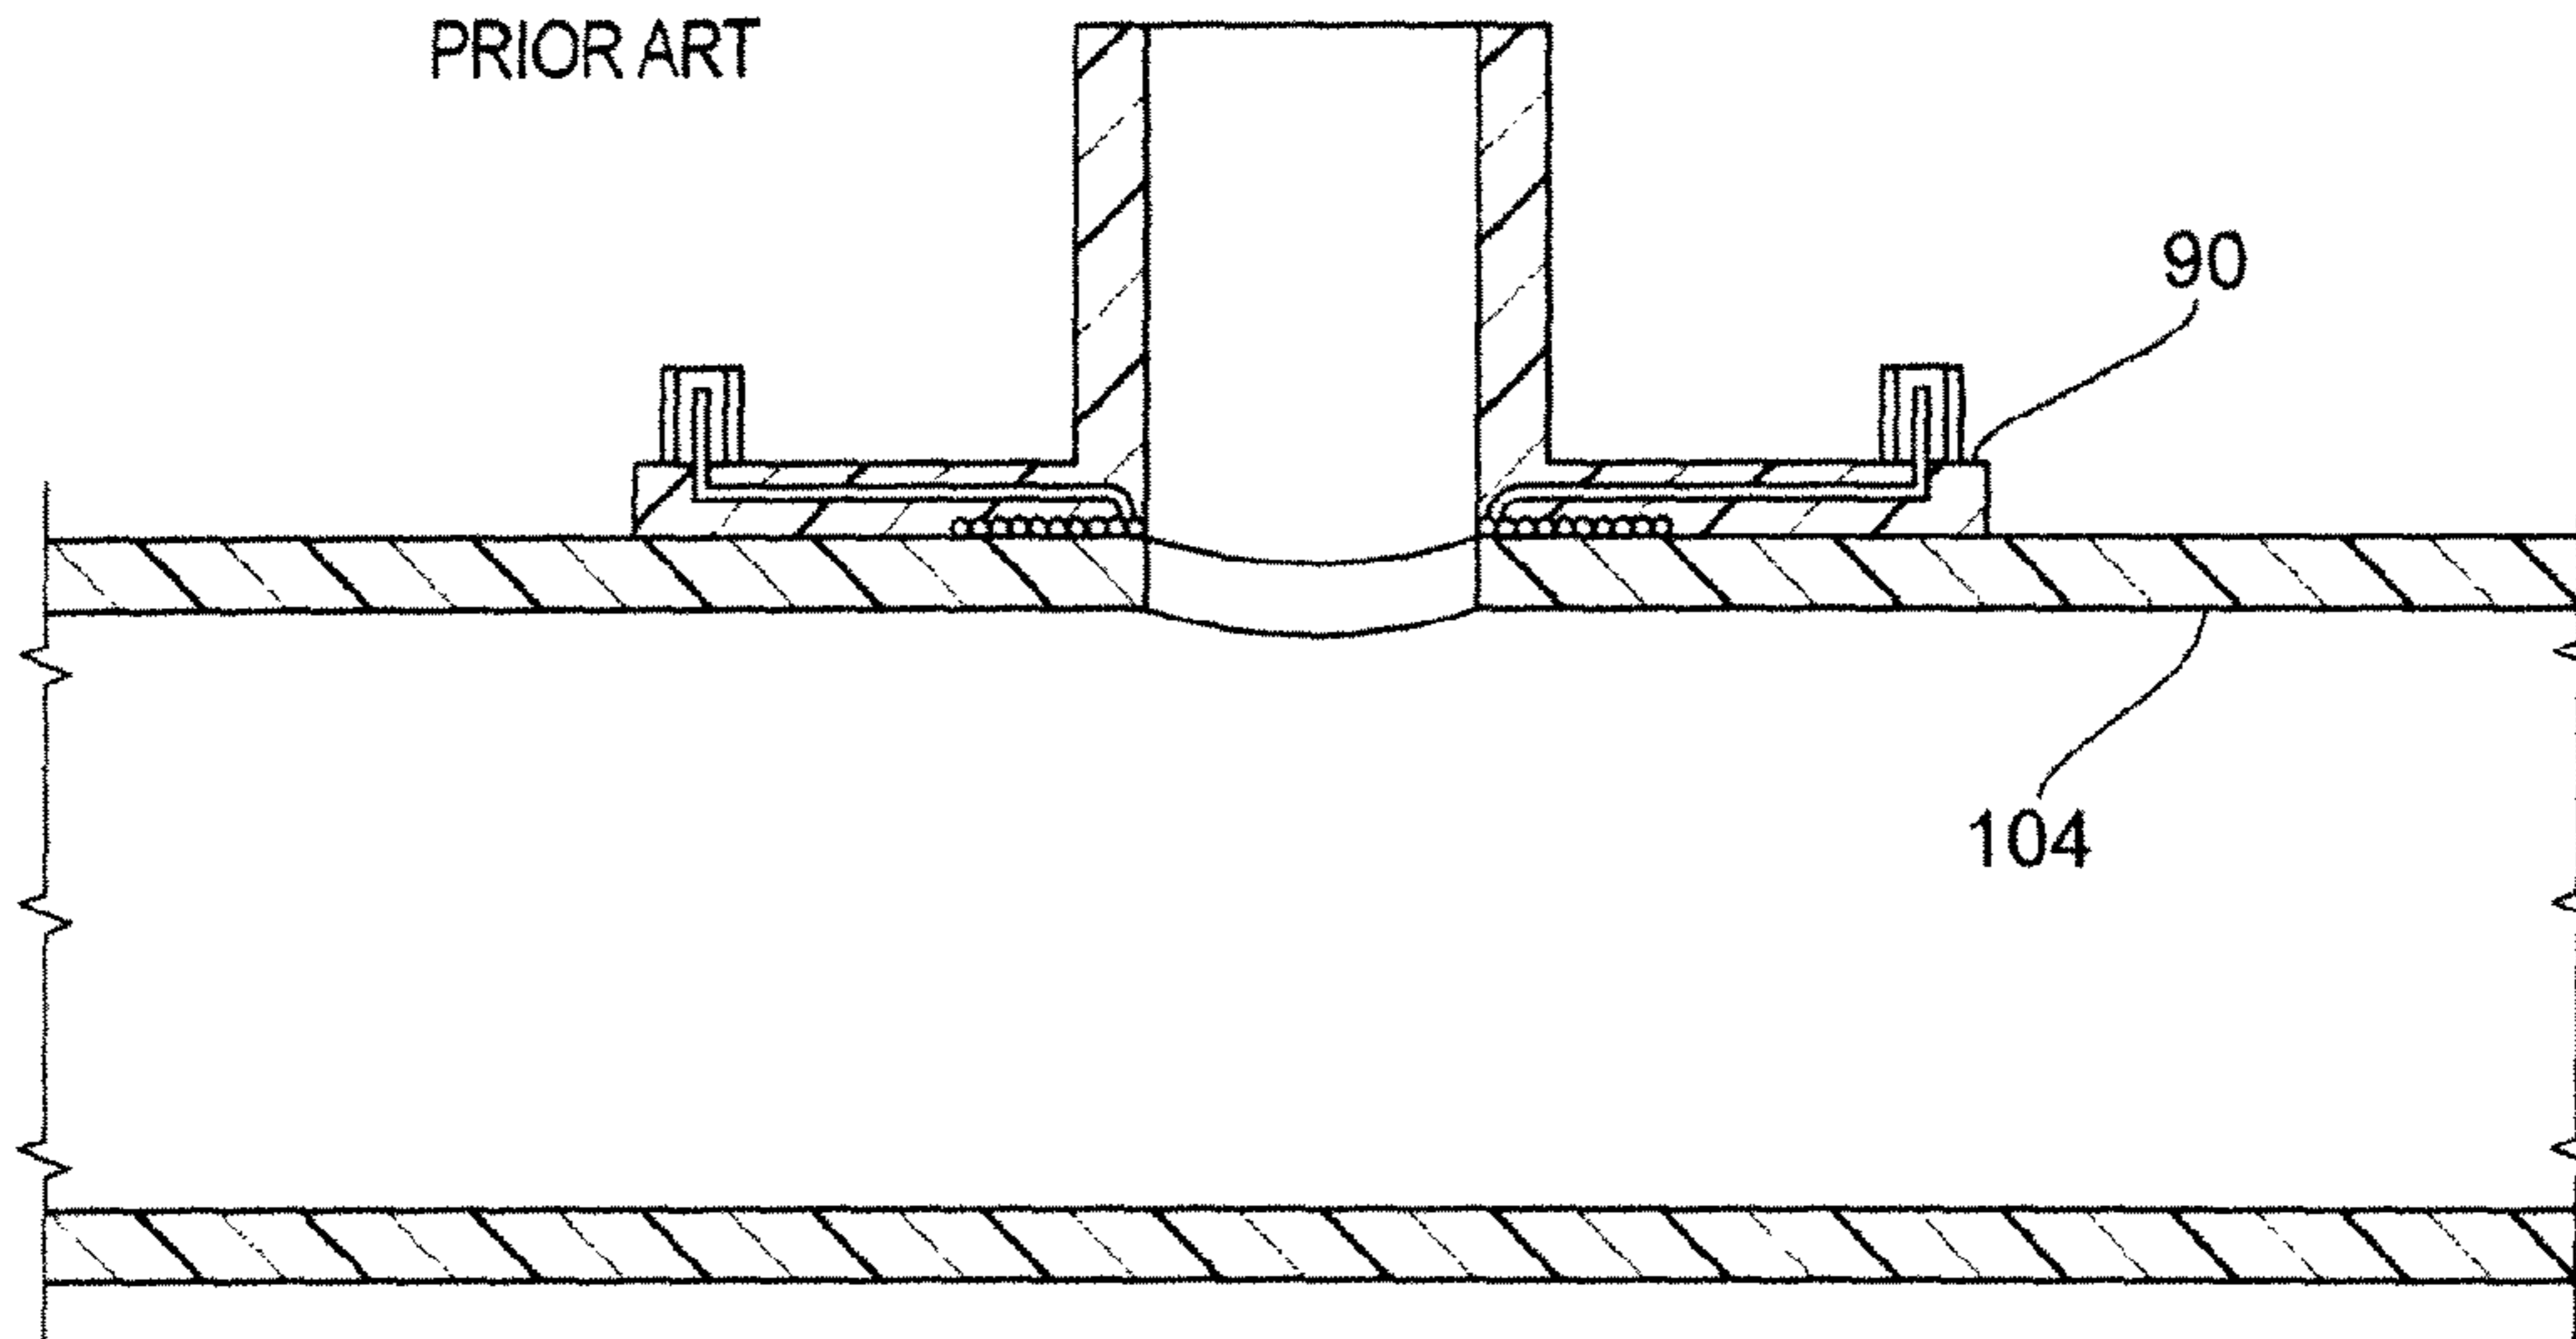
FIG. 26 is a side view of a thermocouple saddle fitting positioned upon a pipe structure.

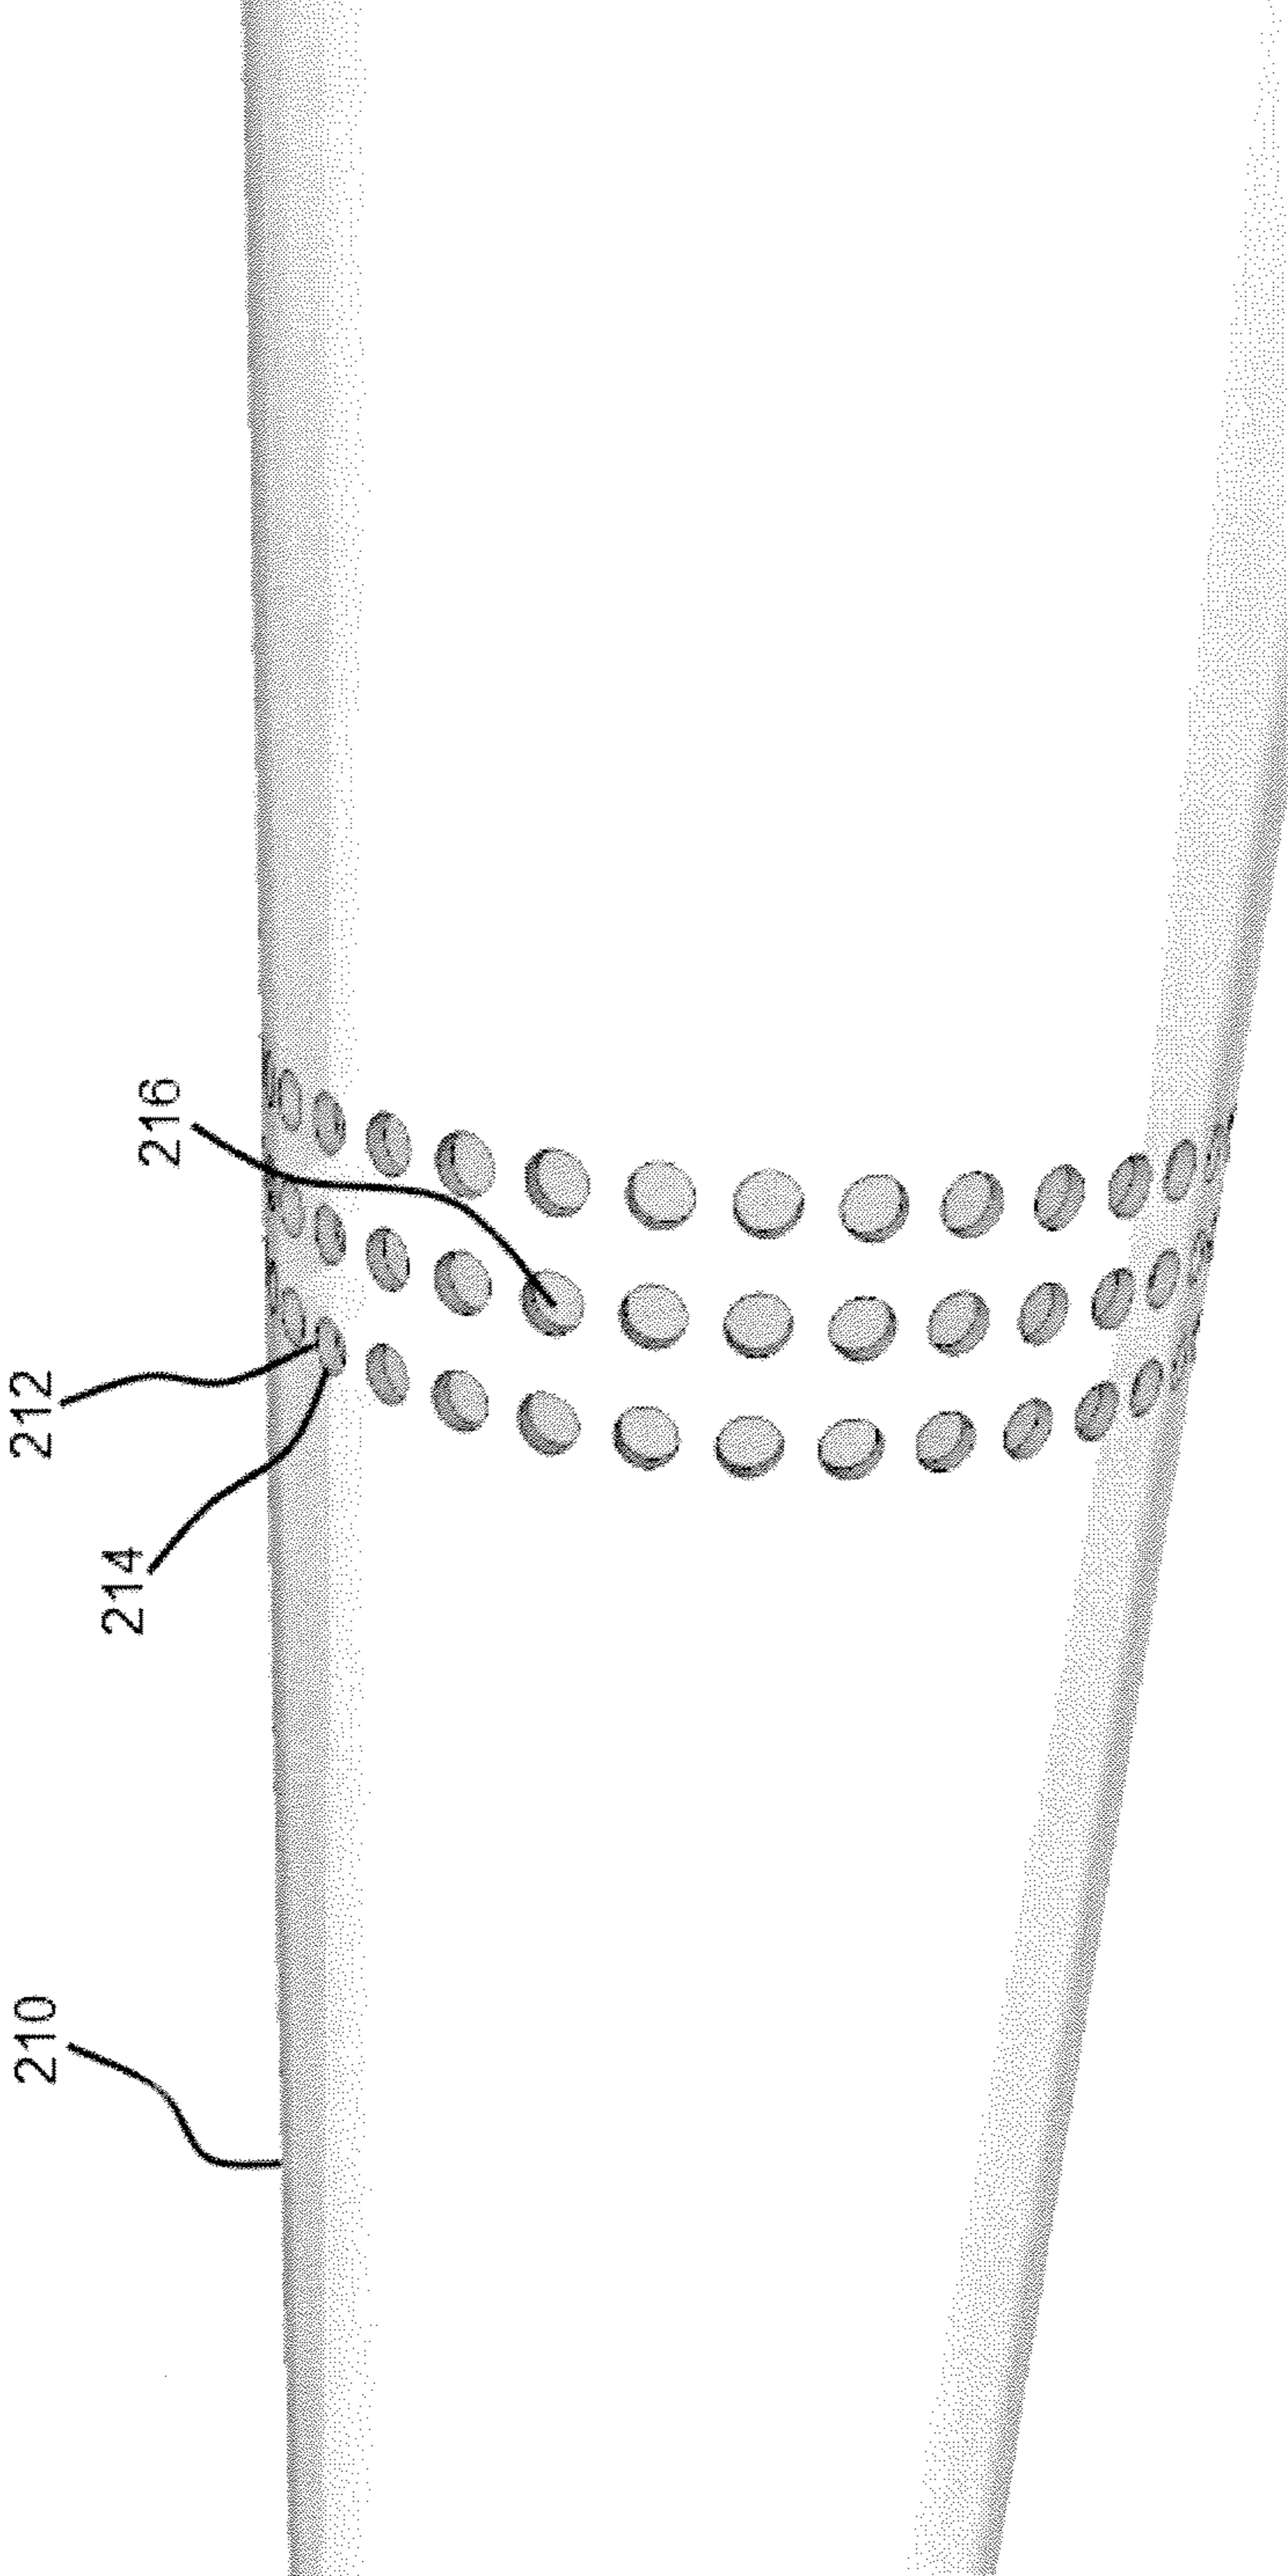
FIG. 39 is an isometric view of a surface drilled to accept an adhesive layer.

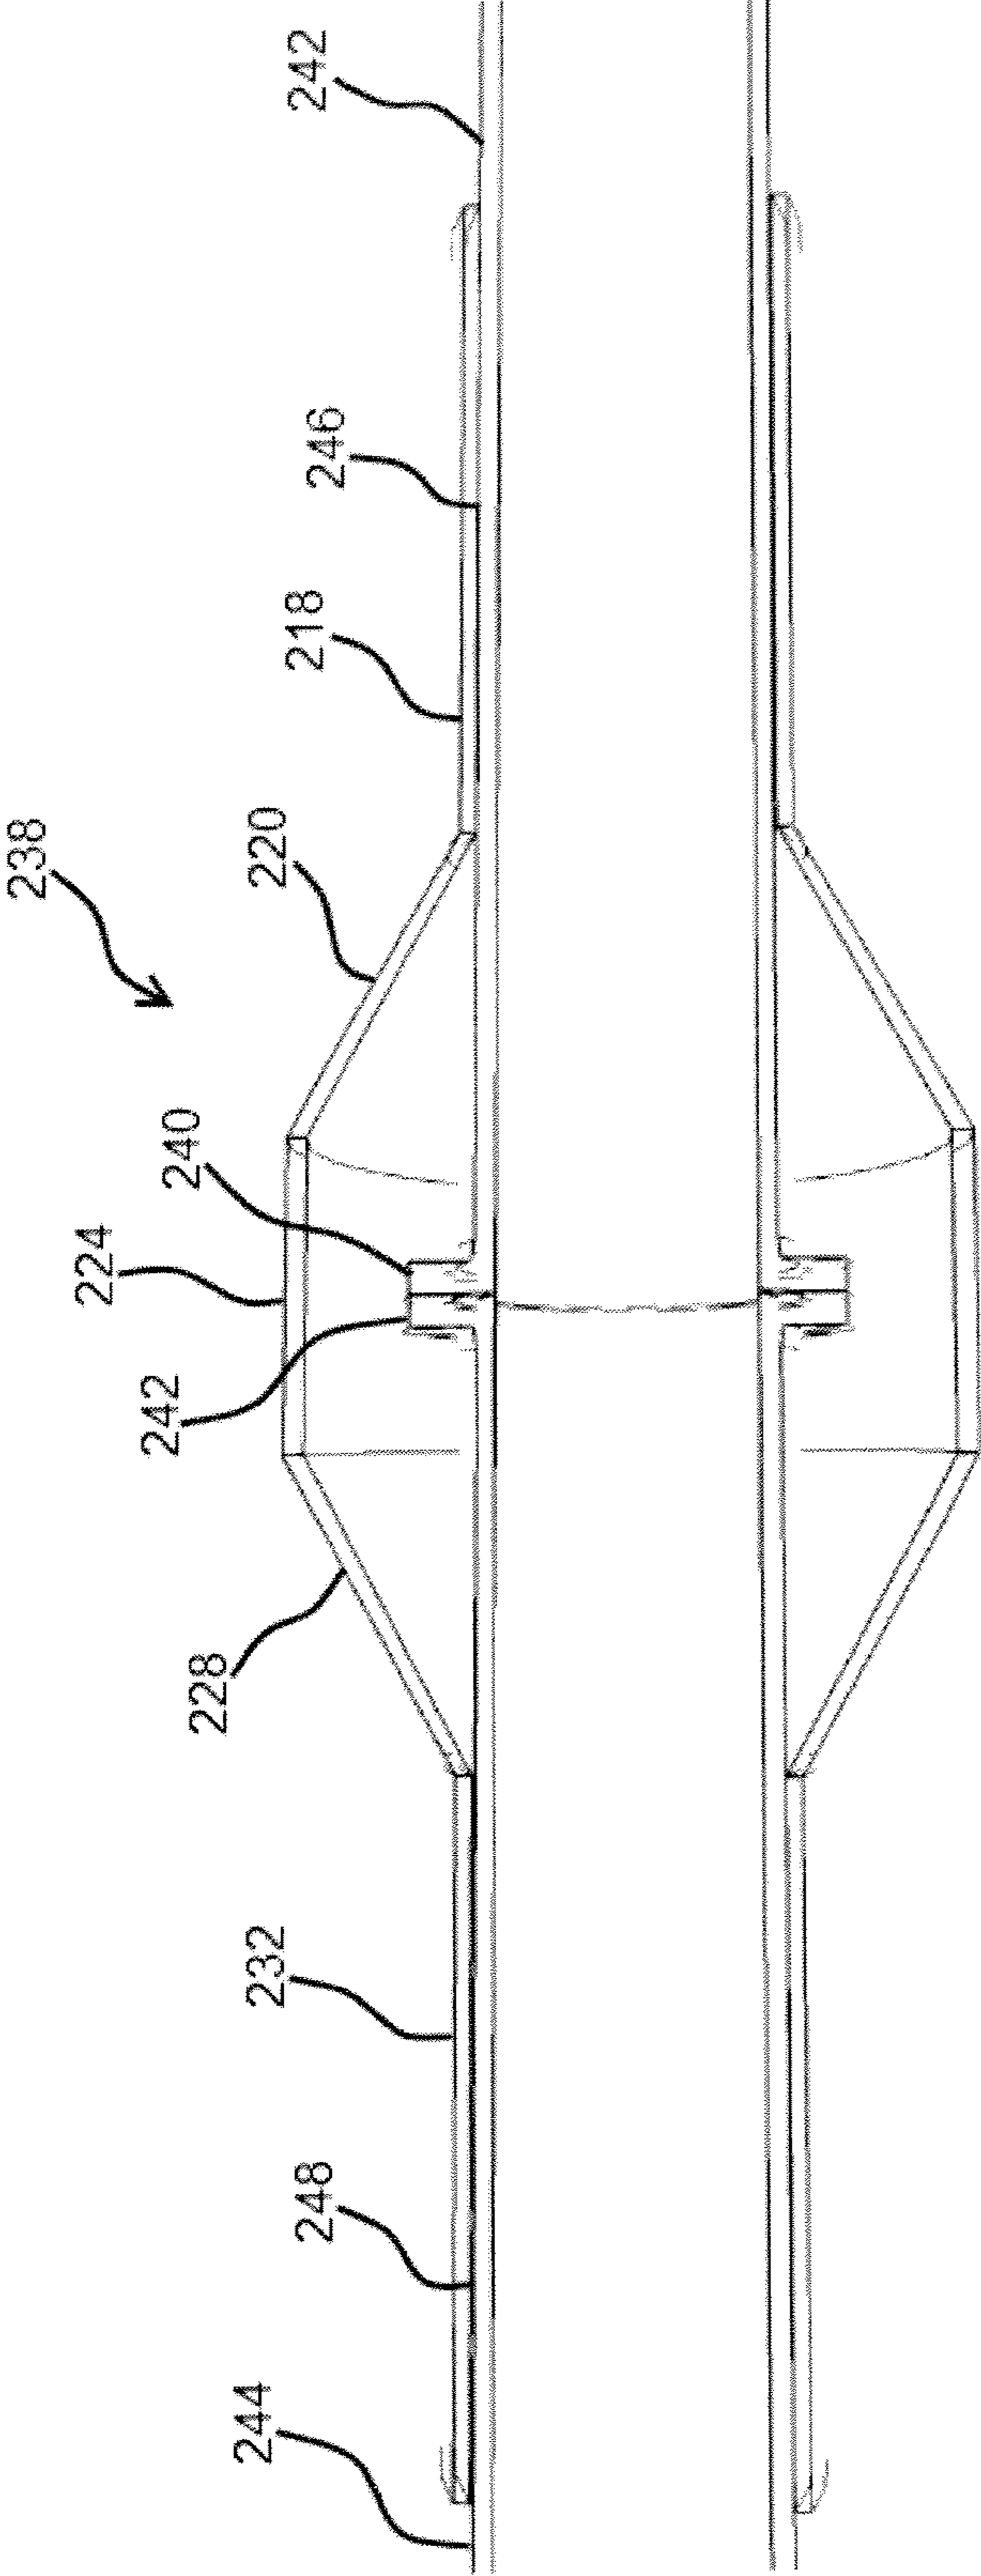
FIG. 41 is a cross sectional view of the embodiment of FIG. 40.

Looking to FIG. 41, it can be seen how the covering assembly in one form 238 fits over a first flange 240 and second flange 242. Of course, the covering assembly 238 can be utilized over pipe without any fitting, or may be utilized with fittings other than flanges. As with the above embodiment, the first rigid sleeve 218 and second rigid sleeve 232 are attached to the pipes 242 and 244, respectively, by way of an adhesive layer 246 and 248, respectively. This follows in accordance with the above embodiments.
