(12) **United States Patent**
Stadtlander

- (54) **BOND AND STITCH REPAIR FOR DELAMINATED COMPOSITE**
- (75) Inventor: **Daniel M. Stadtlander**, West Hartford, CT (US)
- (73) Assignee: **United Technologies Corporation**, Hartford, CT (US)
- (*) Notice: Subject to any disclaimer, the term of this patent is extended or adjusted under 35 U.S.C. 154(b) by 0 days.

A method of repairing delaminated plies of a composite includes drilling a plurality of holes in the plies, stitching one or more tows into the plurality of holes, and tensioning the tows. The holes are disposed across an area of the plies that is delaminated. The method introduces a resin into the area of the plies that is delaminated and cures the resin. Curing of the composite can be performed prior to the stitching and the tensioning of the one or more tows and can be performed by the tensioning of the one or more tows. Optionally, one or more additional plies can be applied to the repaired area and/or a portion of the one or more tows that extends above a surface the plies can be removed.

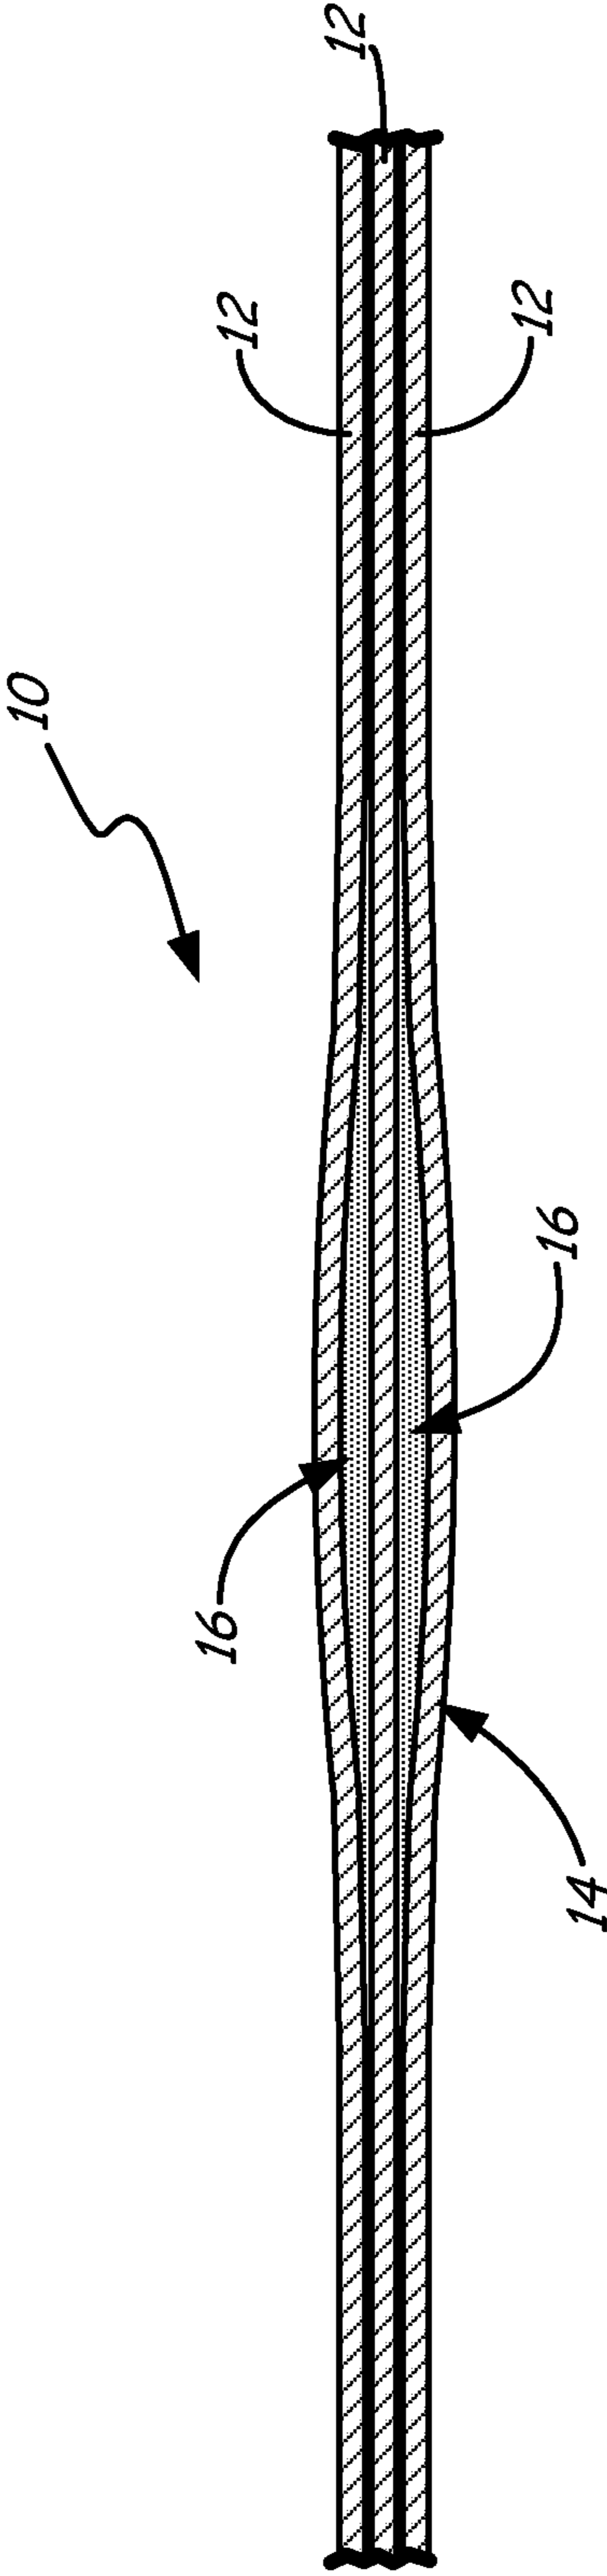
FIG. 1 is a cross-sectional view of a composite with plies that have a delaminated area.

FIG. 1 shows a sectional view of a composite **10** with a plurality of laminated plies **12** that have a delaminated area **14**. The composite **10** is potentially applicable to a wide range of industries including the aerospace industry, and can be used for rotor components of gas turbine engines.

A core or additional plies of composite **10** are not illustrated in FIG. 1 and may have been removed due to delaminated area **14** leaving only plies **12**. In the embodiment shown in FIG. 1, plies **12** comprise a lightweight material used in the aerospace industry such as Kevlar®, carbon fiber, fiberglass, basalt, and/or ceramic fiber. A resin (not numbered) is cured to form a matrix and bond the plies together. Non-exhaustive examples of resins that are stable in the harsh aerospace environment include epoxy, polyimide, bismaleimide (BMI) and cyanate ester. The material of the plies **12** and resin are selected, in part, based on stability in the operating environment where the composite **10** is to be located.

Ply **12** have become delaminated due to loads, defects, and other environmental factors that result from cyclic stresses, impact, elevated temperatures, and other phenomena. The loads are transferred from one layer to the next by shear through the resin or interfacing ply **12**. The interlaminar shear forces, which transfer loads from one ply to the next ply, have in the embodiment shown in FIG. 1, initiated delamination of the composite structure. Thus, delaminated area **14** has developed with one or more cavities **16** disposed between plies **12**.

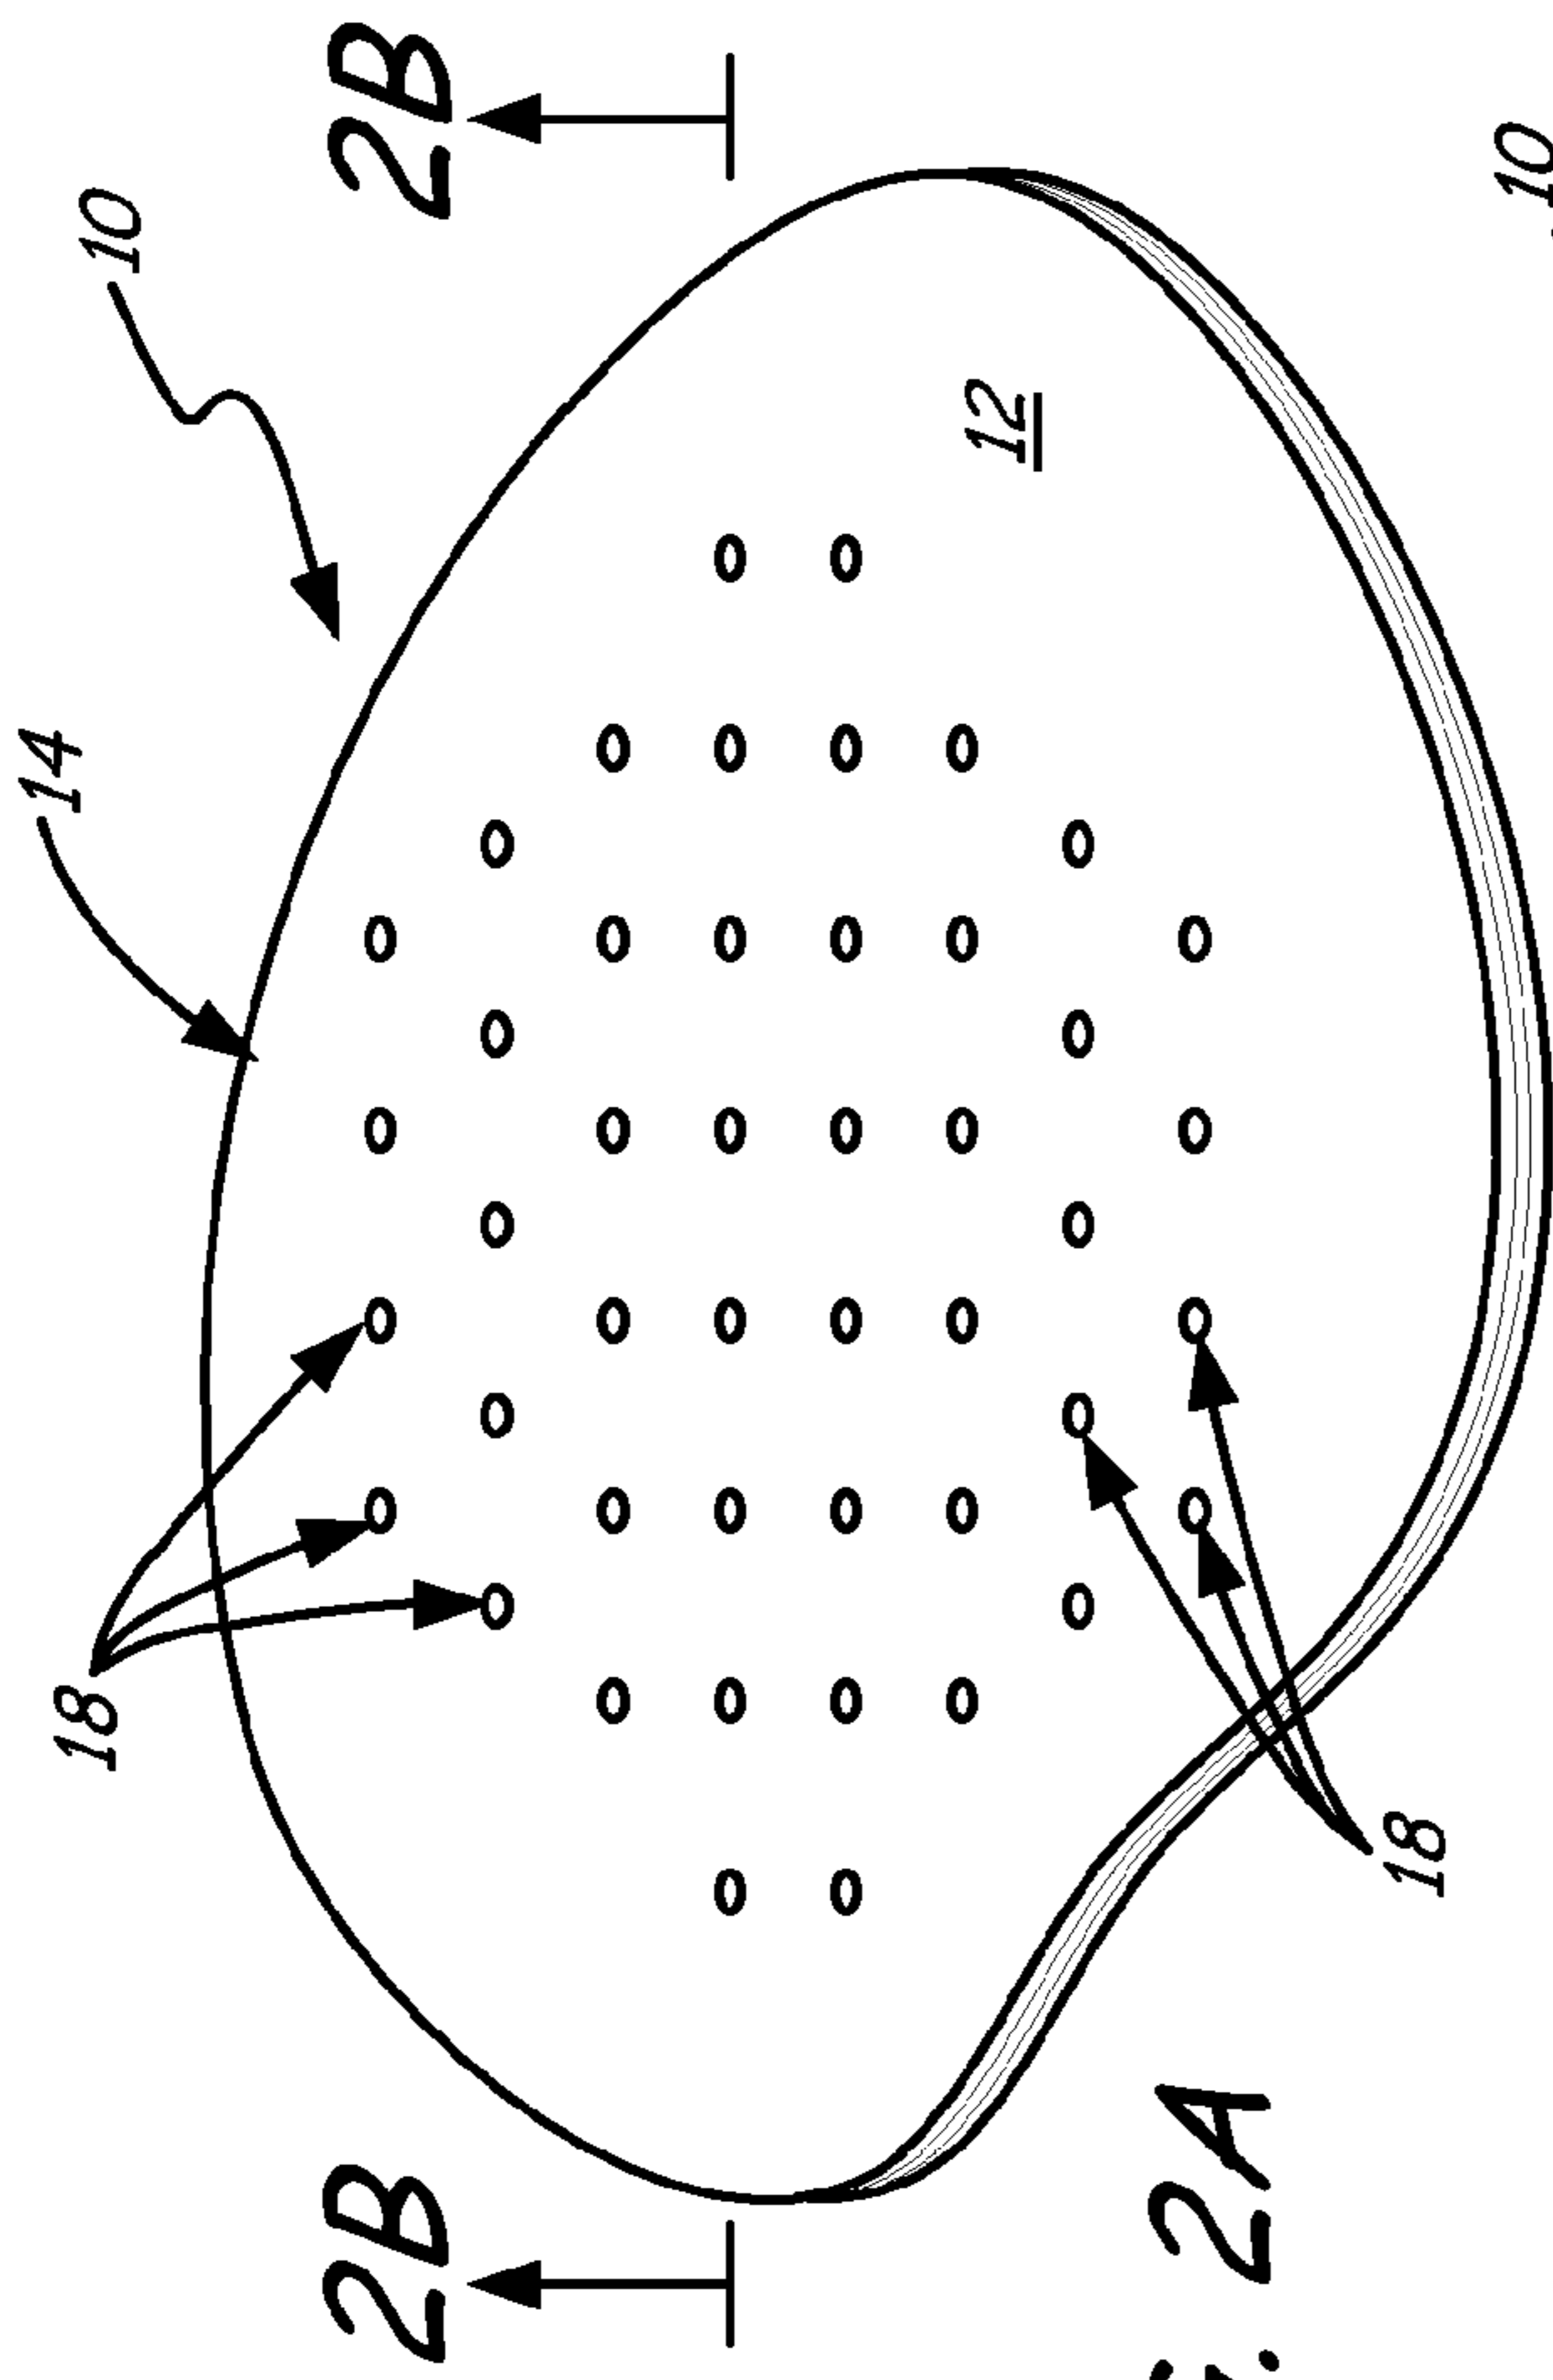
FIG. 2A is a top view of a composite with a plurality of holes drilled in the delaminated area of the composite.

FIG. 2A is a top view of composite **10** with a plurality of holes **18** drilled in delaminated area **14** (generally delimited by dashed lines) of composite **10**. FIG. 2B is a cross-sectional view of composite **10** through delaminated area **14**.

Holes **18** are disposed across delaminated area **14** at spaced intervals. In the embodiment shown in FIG. 2A, holes **18** are disposed at intervals across substantially all of delaminated area **14** and a portion of composite **10** that is not delaminated. The extent of the area which the holes **18** cover, and the size and spacing of the holes **18** are determined by a structural analysis. In such an analysis, the combined tensile and shear strength of delaminated area **14** and composite **10** are determined including any degradation that results from drilling holes **18**. The combined tensile and shear strength of the tow and resin disposed in holes **18** in delaminated area **14** (a process that will be discussed subsequently) should exceed the combined tensile and shear strength values required for composite **10**. The structural analysis would also determine the static and fatigue capability of composite **10** after repair including the retention of properties after environmental exposure.

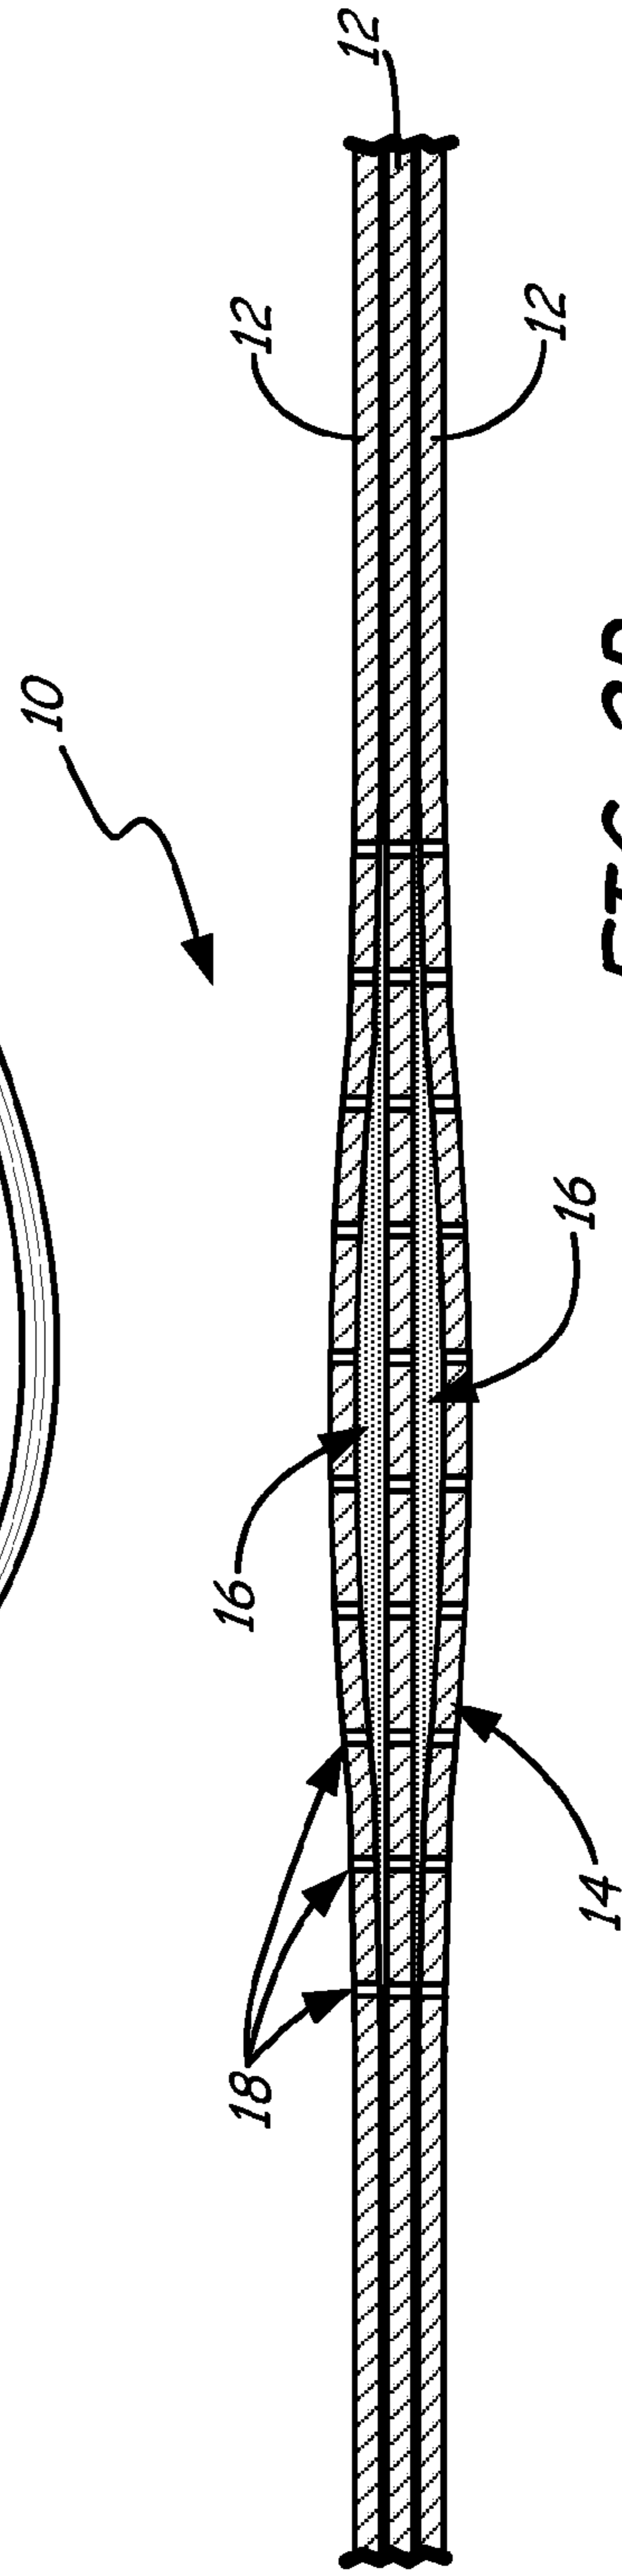
FIG. 2B is a cross-sectional view of the composite through the delaminated area.

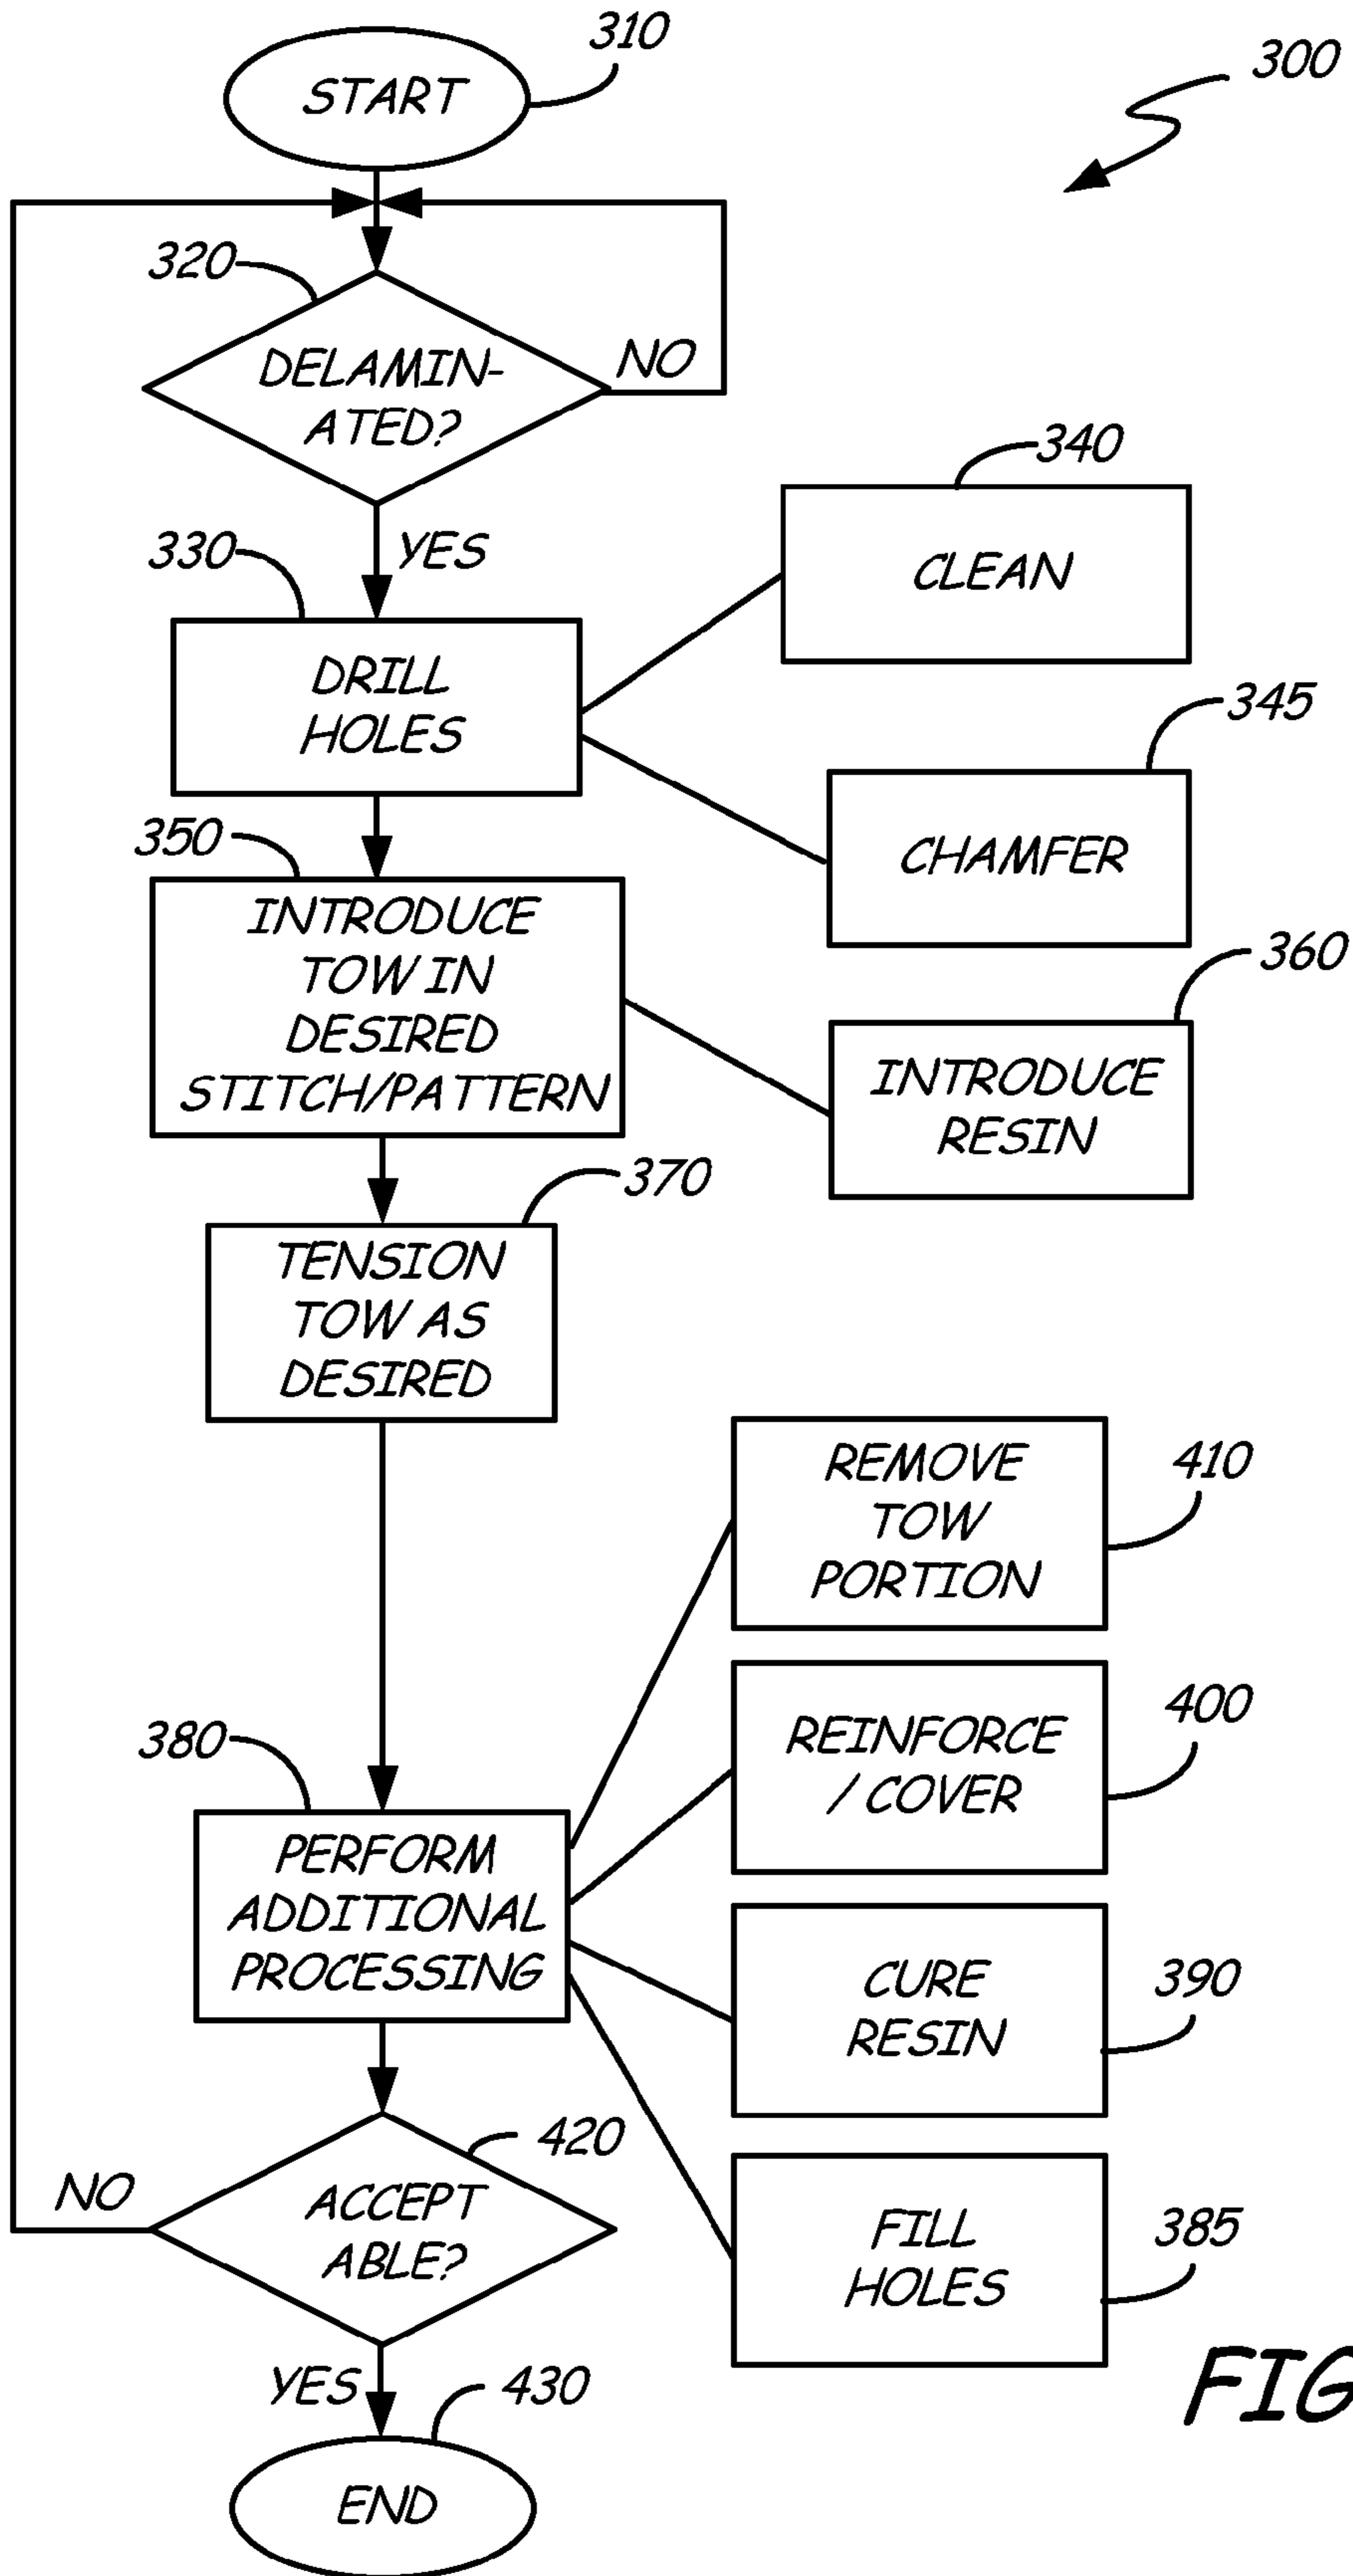
FIG. 4 is a flow diagram of a second method of repairing the composite with the delaminated area.

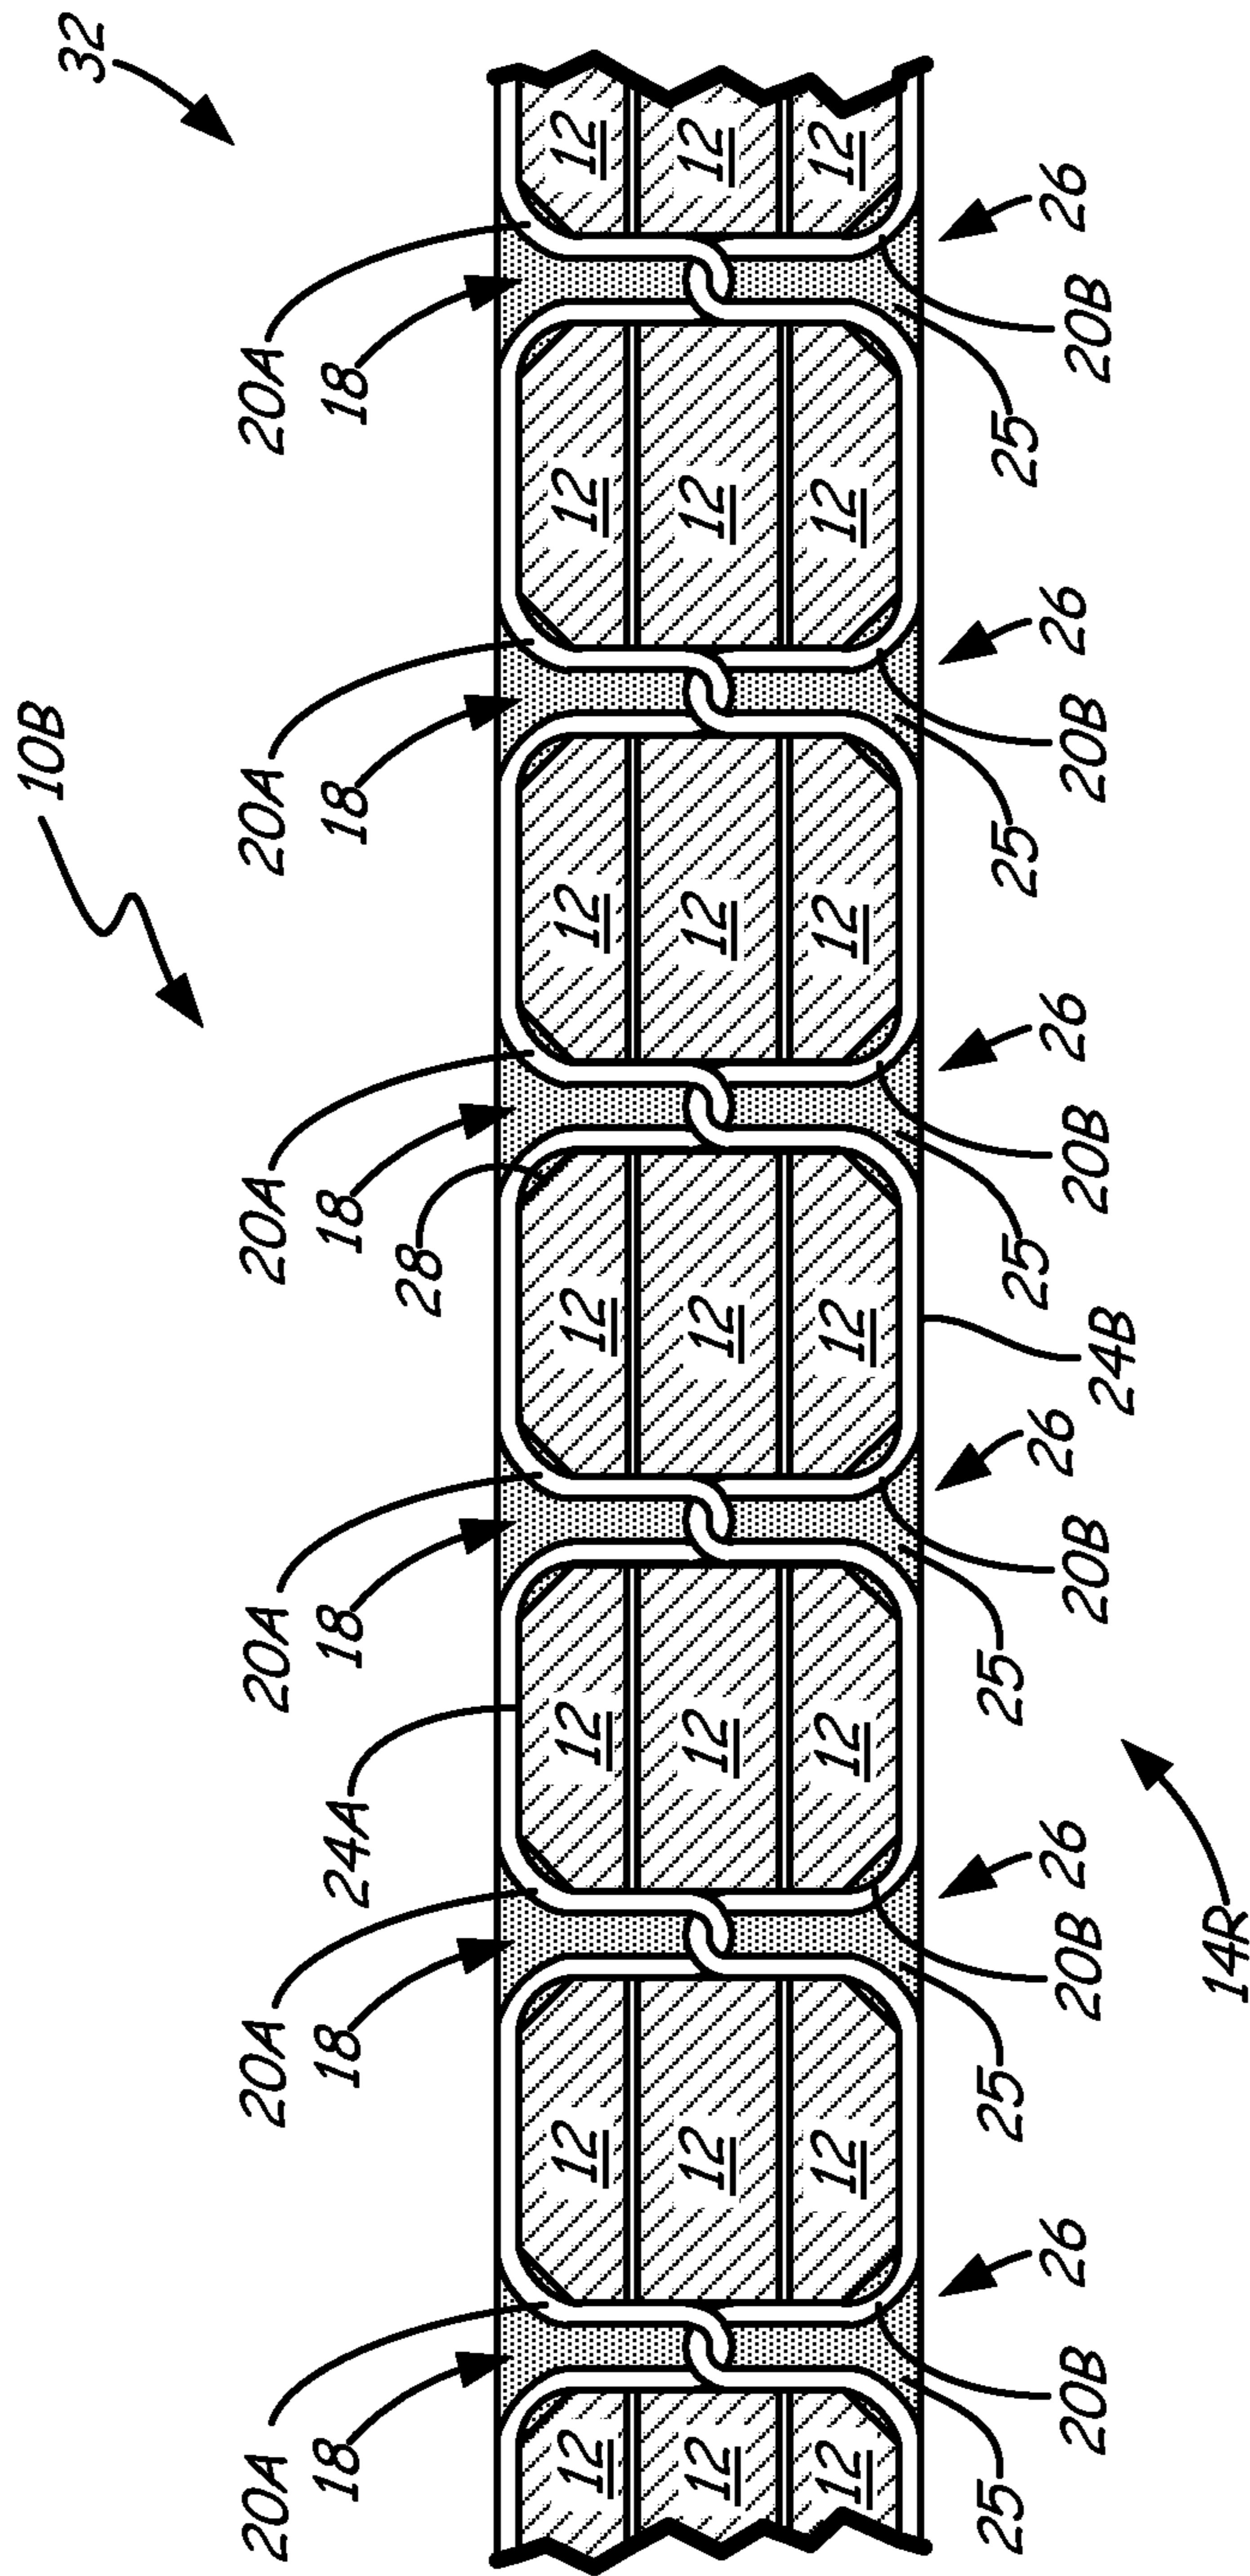
FIG. 5B is a cross-sectional view of another embodiment of the repaired composite with tows stitched into the plurality of holes in a lock stitch manner.

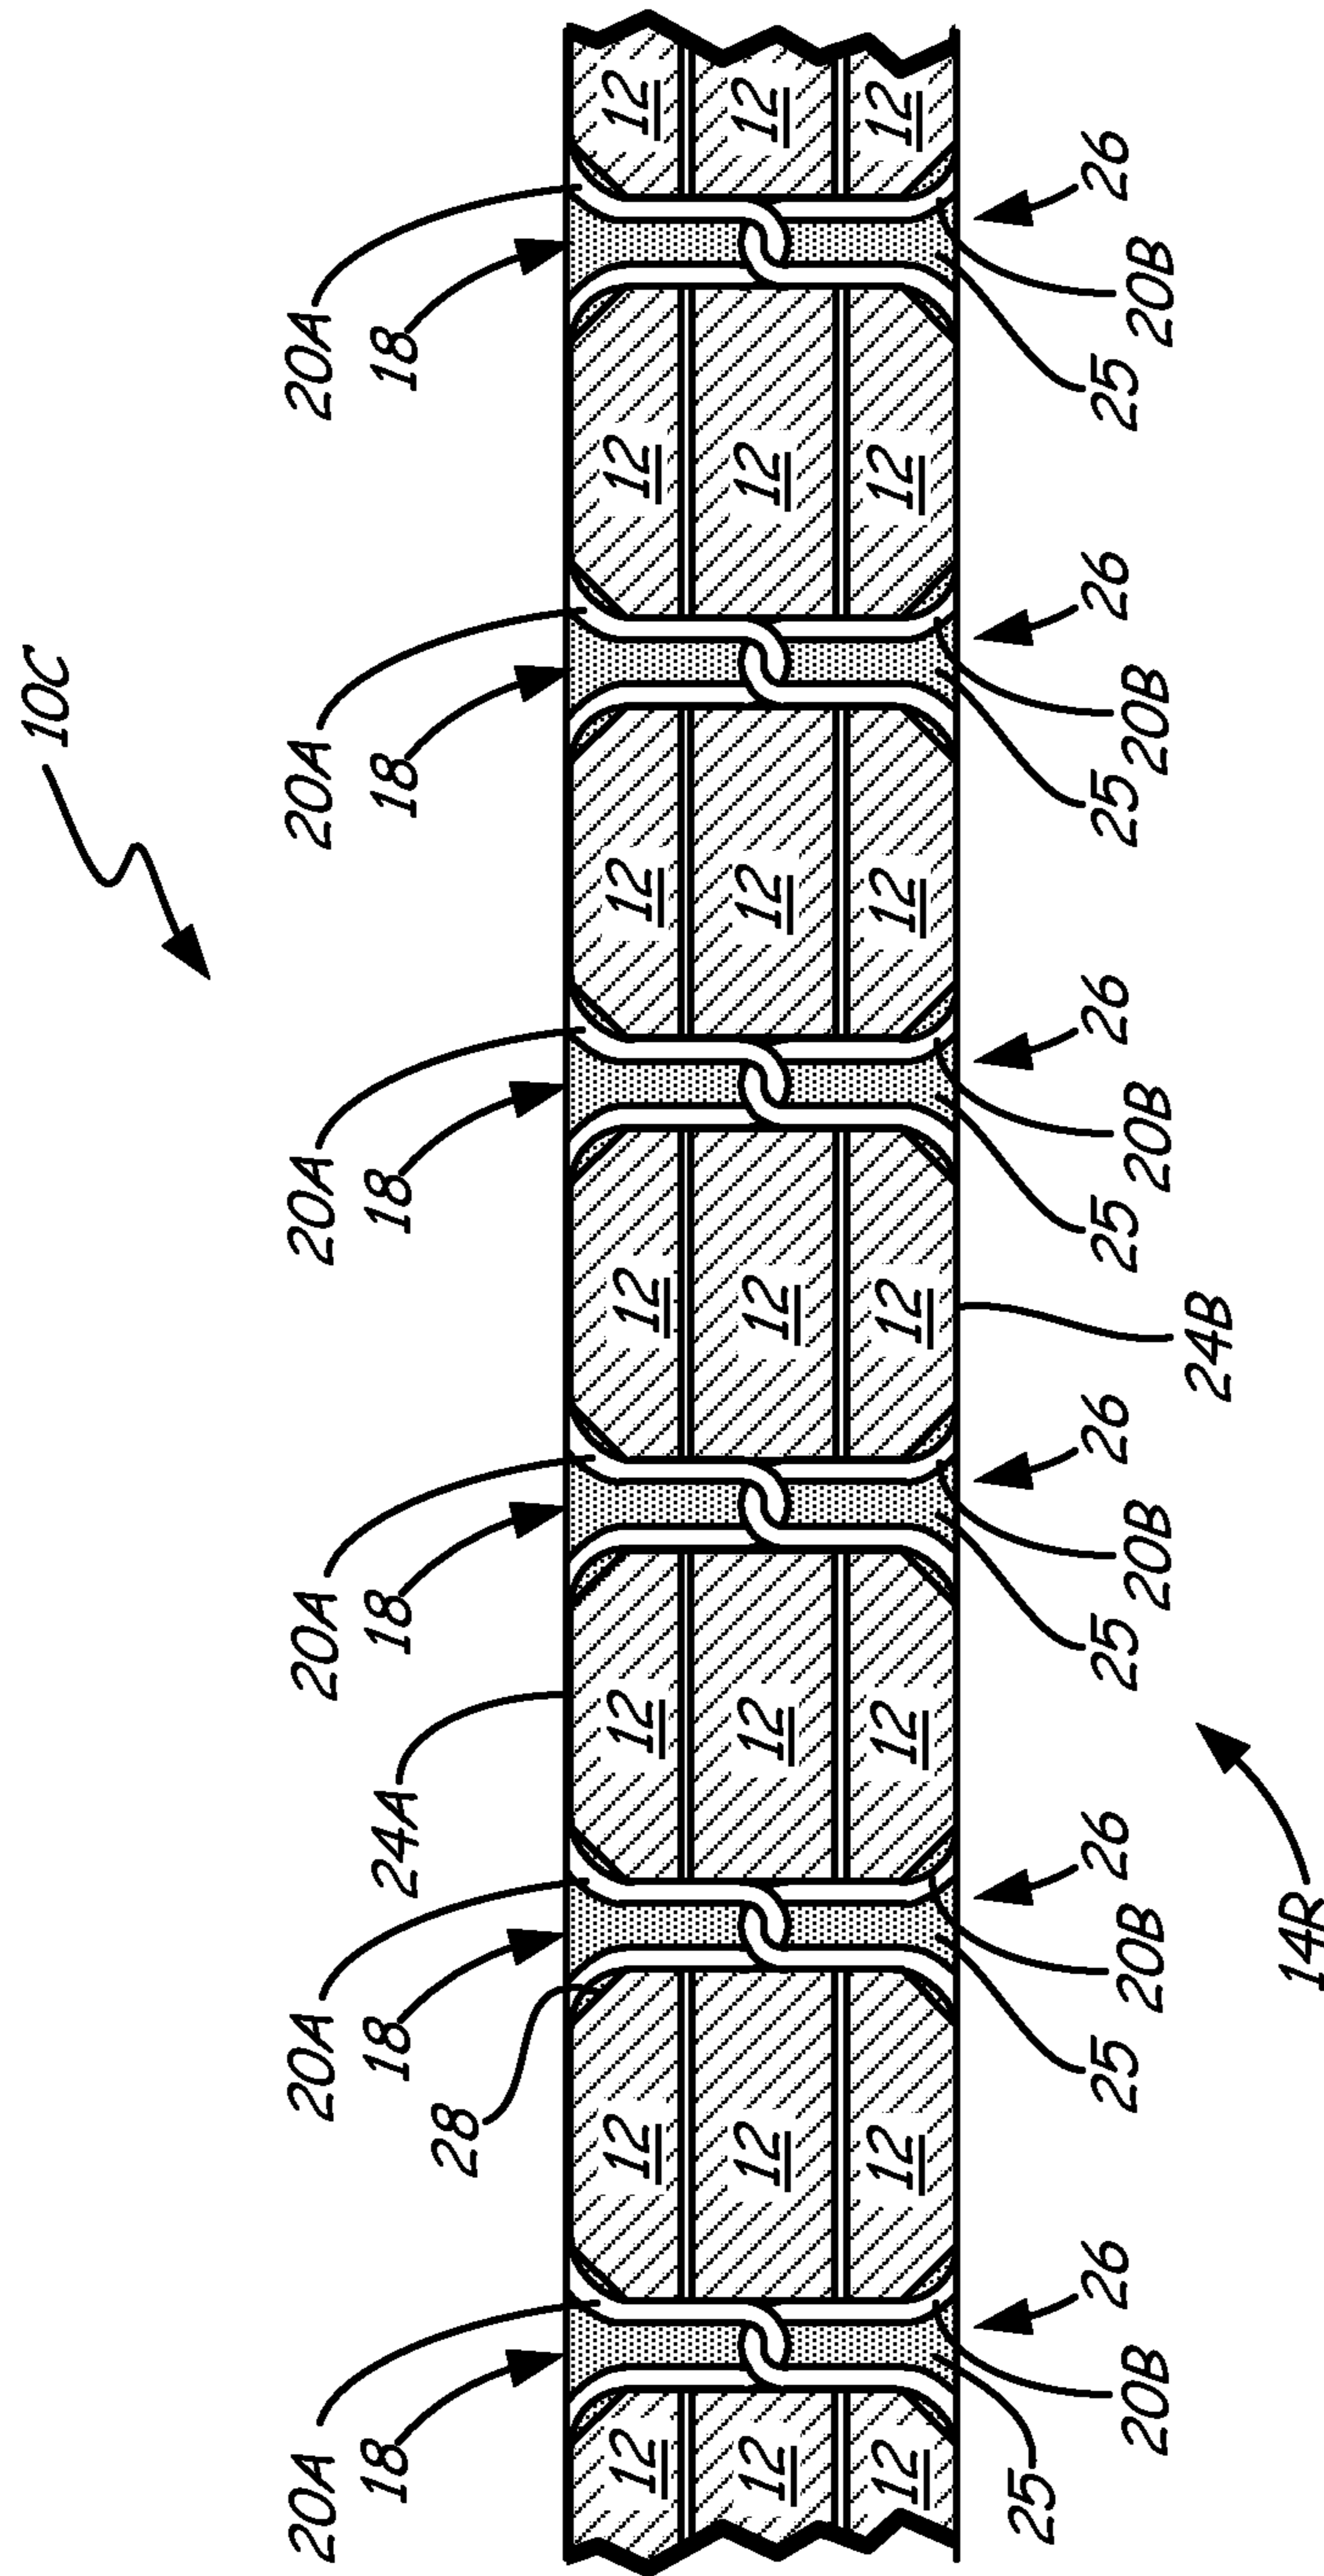
FIG. 5C is a cross-sectional view of yet another embodiment of the repaired composite with the tows removed flush to first and second surfaces of the composite.
