(12) **United States Patent**
Huang et al.

(54) **OVER-ERASE VERIFICATION AND REPAIR METHODS FOR FLASH MEMORY**

OVER-ERASE VERIFICATION AND REPAIR METHODS FOR FLASH MEMORY

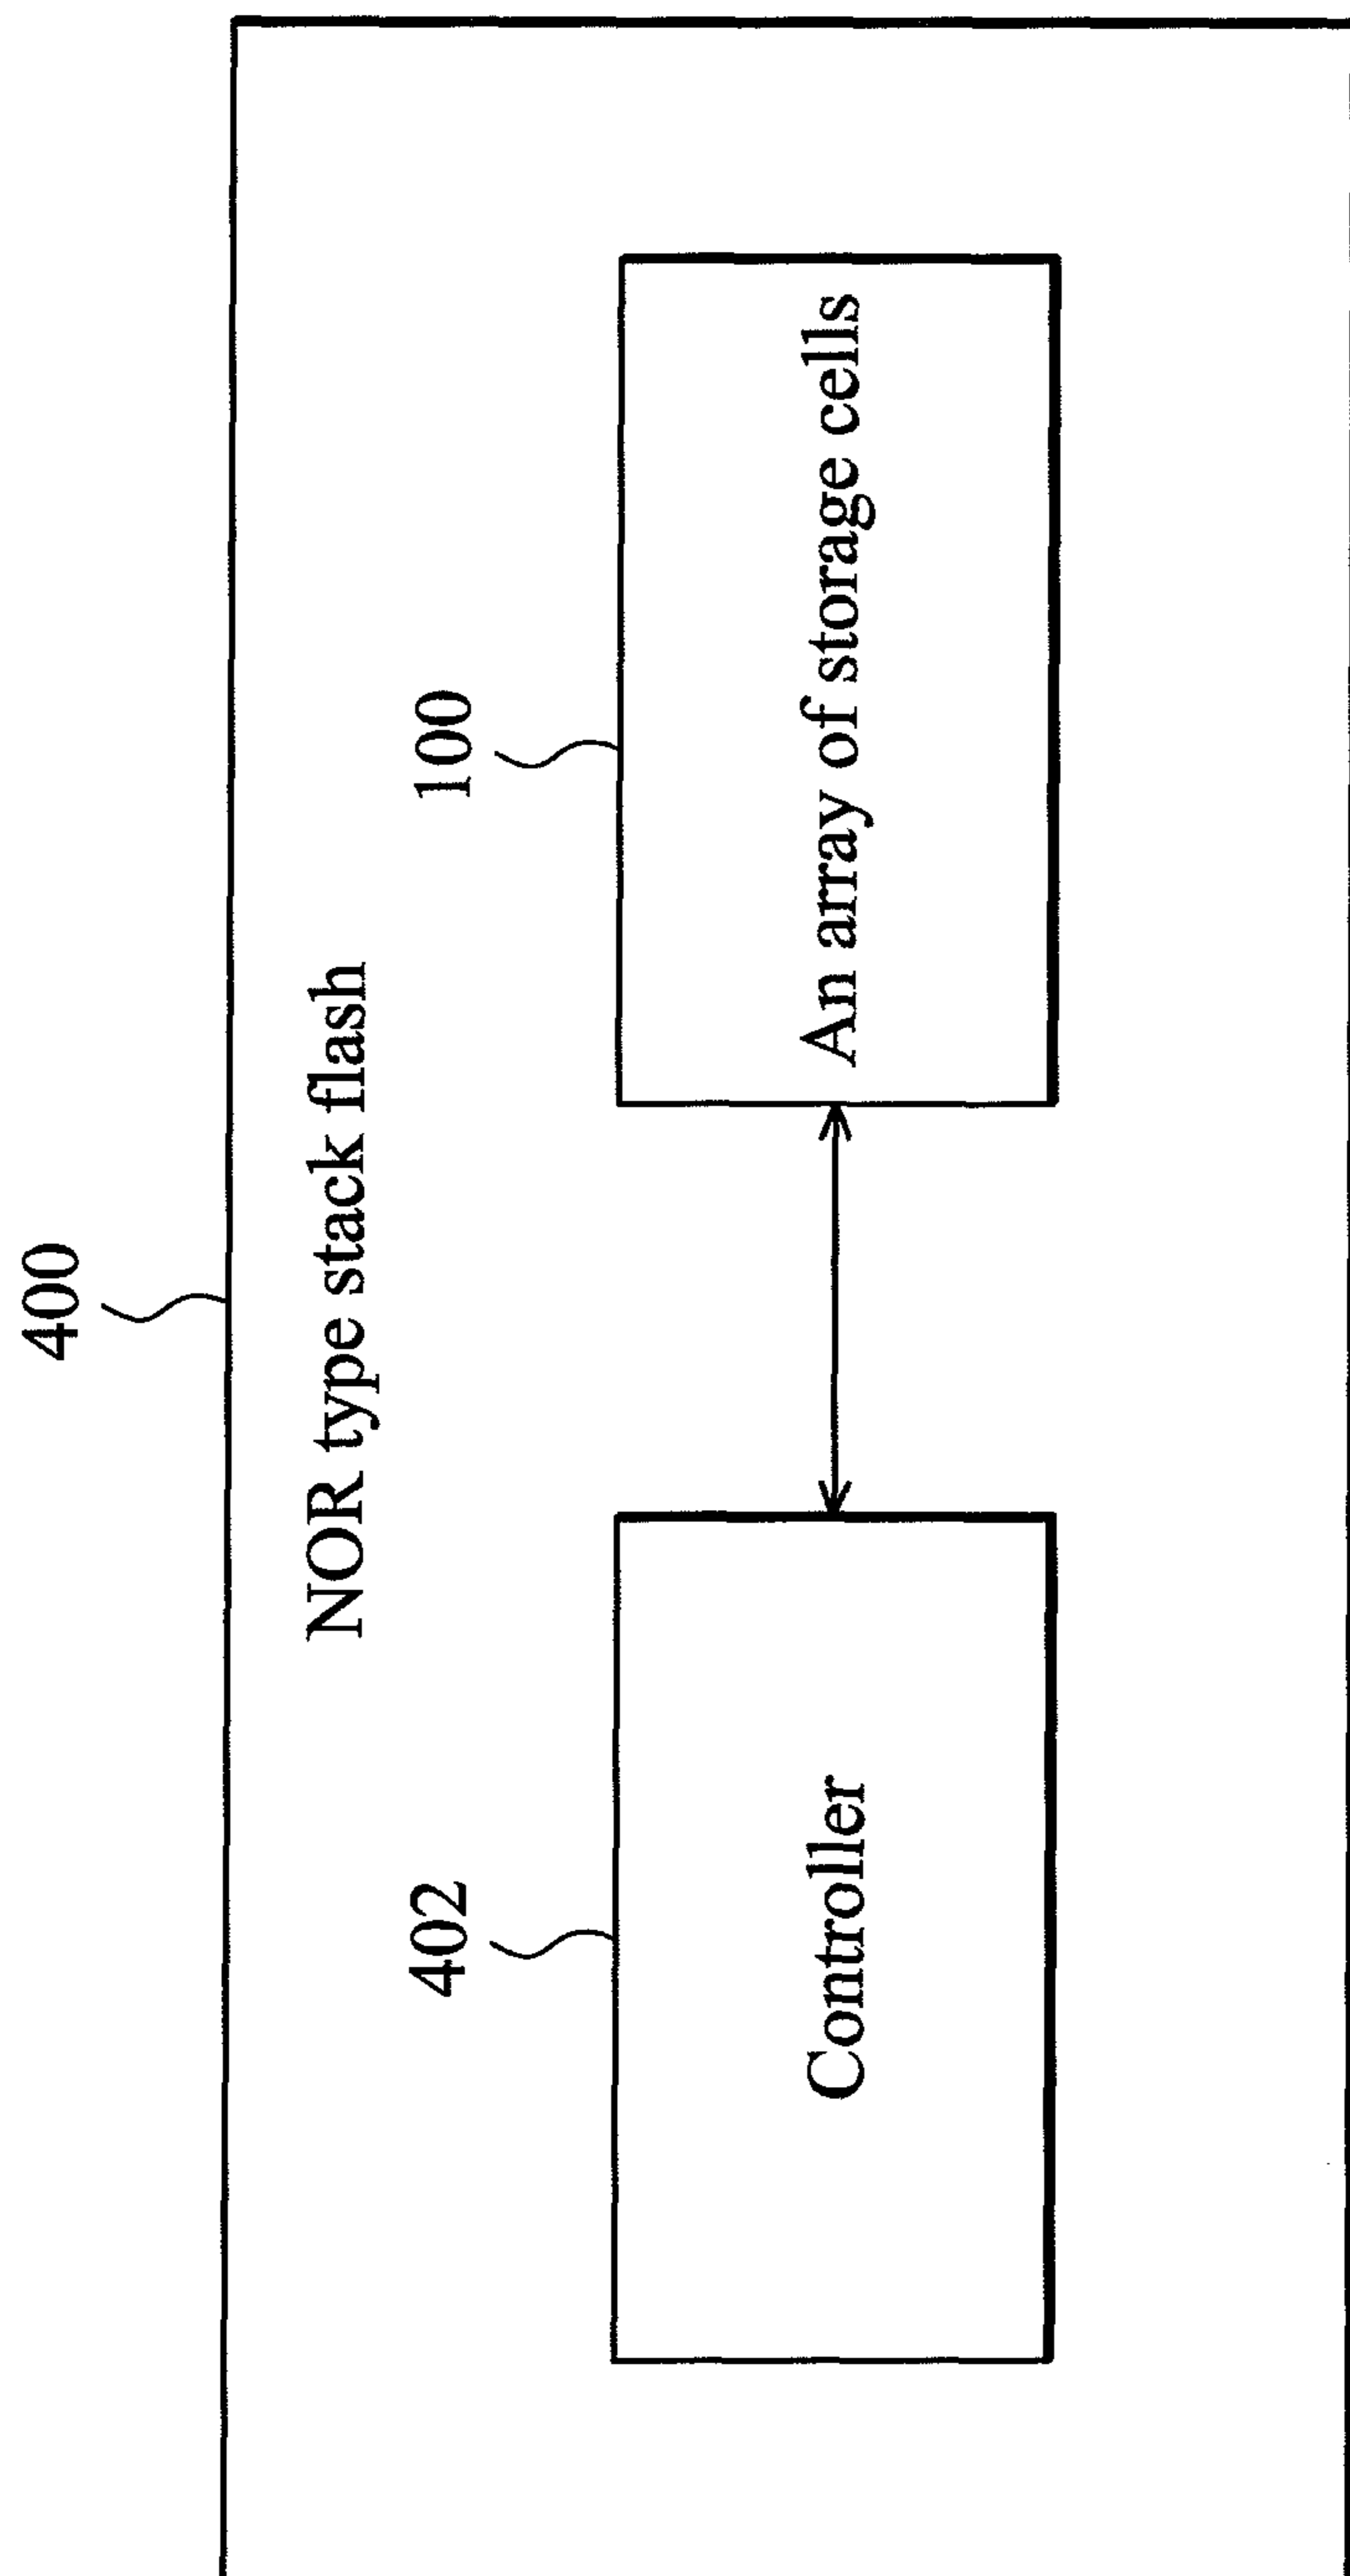
FIG. 4 is a block diagram depicting an exemplary embodiment of an NOR type stack flash.

FIG. 4 is a block diagram depicting an NOR type stack flash in accordance with an exemplary embodiment of the invention. The NOR type stack flash 400 comprises at least one sector (such as the array 100 of storage cells shown in FIG. 1) and a controller 402. The controller 402 may implement the aforementioned over-erase verification and repair methods, to perform an over-erased column verification test on the columns of the array 100, and to perform an over-erased column repair process on the columns which do not pass the over-erased column verification test, and to perform the over-erased bit verification test on the bits of the columns which still do not pass the over-erased column verification test after the over-erased column repair process, and to perform the over-erased bit repair process on the bits which do not pass the over-erased bit verification test.
