(54) **METHOD FOR DETECTING DEFECT IN MATERIAL AND SYSTEM FOR THE METHOD**

(73) Assignee: **Nippon Steel & Sumitomo Metal Corporation**, Tokyo (JP)

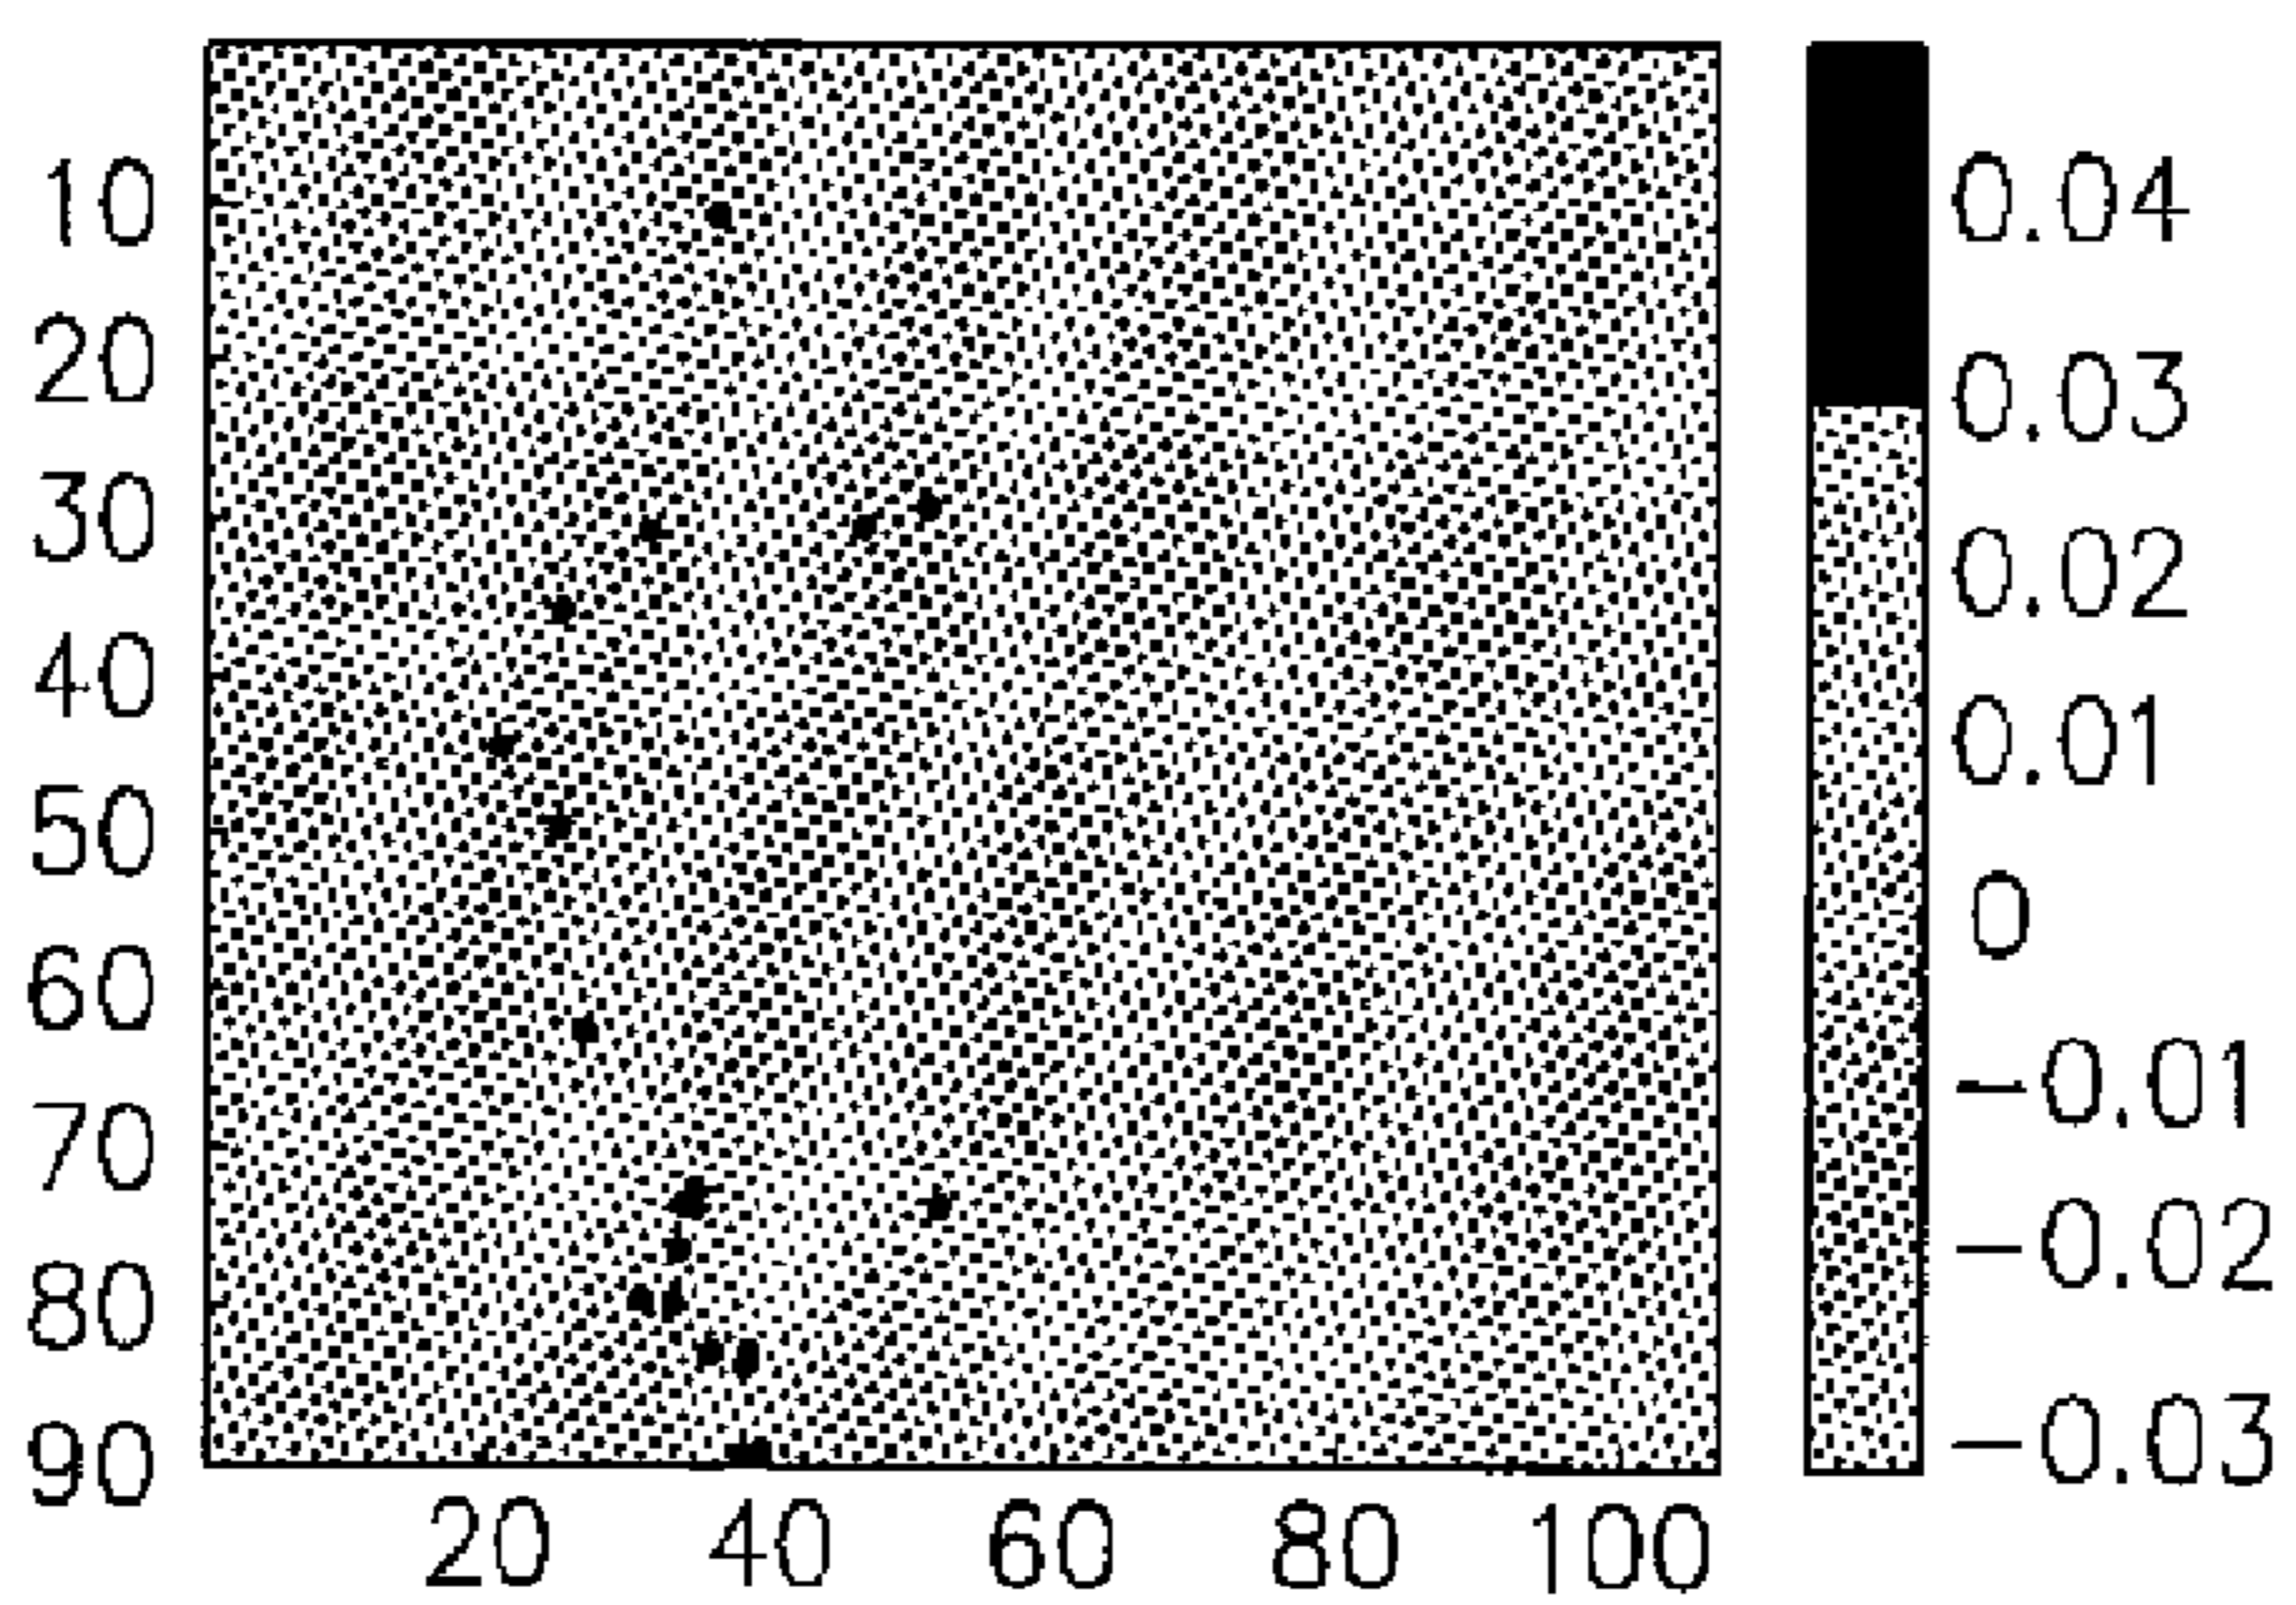
FIGS. 2A, 2B and 2C are schematic diagrams to illustrate an example of the image data processing performed in the image processing part of the detecting device.

An image processing part **302** in the detecting device **3** is for processing the thermal image data input into the inputting part **301** in accordance with a predetermined image data processing procedure. FIGS. 2A, 2B and 2C are schematic diagrams to illustrate an example of the image data processing performed in the image processing part **302** of the detecting device **3**. FIG. 2A shows thermal image data input into the inputting part **301**. FIG. 2B shows Laplacian-processed thermal image data where the temperature is converted into Laplacian value. FIG. 2C shows a binarized image of the thermal image data of Laplacian value. Laplacian processing is performed in order to reduce a disturbance in the thermal image data (FIG. 2A) provided by temperature irregularity, and also to detect the heat balance taking place at the surface and surface layer of the steel sheet **100** as described later. A surface layer is defined as a part very close to the surface of the material and experientially about one fourth of the thickness region from the surface can be regarded as the surface layer in the case of a 1-2 mm thick steel sheet.

Since the absolute value of Laplacian $\Delta_{xy}T$ at the position of the defect **101** is detected larger in the inspection area S, it can be said that Laplacian processing can provide the image where the defect **101** is extracted (see the black colored portion in FIG. 2C). Also the type of the defect **101** can be determined based on whether the value of Laplacian $\Delta_{xy}T$ is positive or negative.

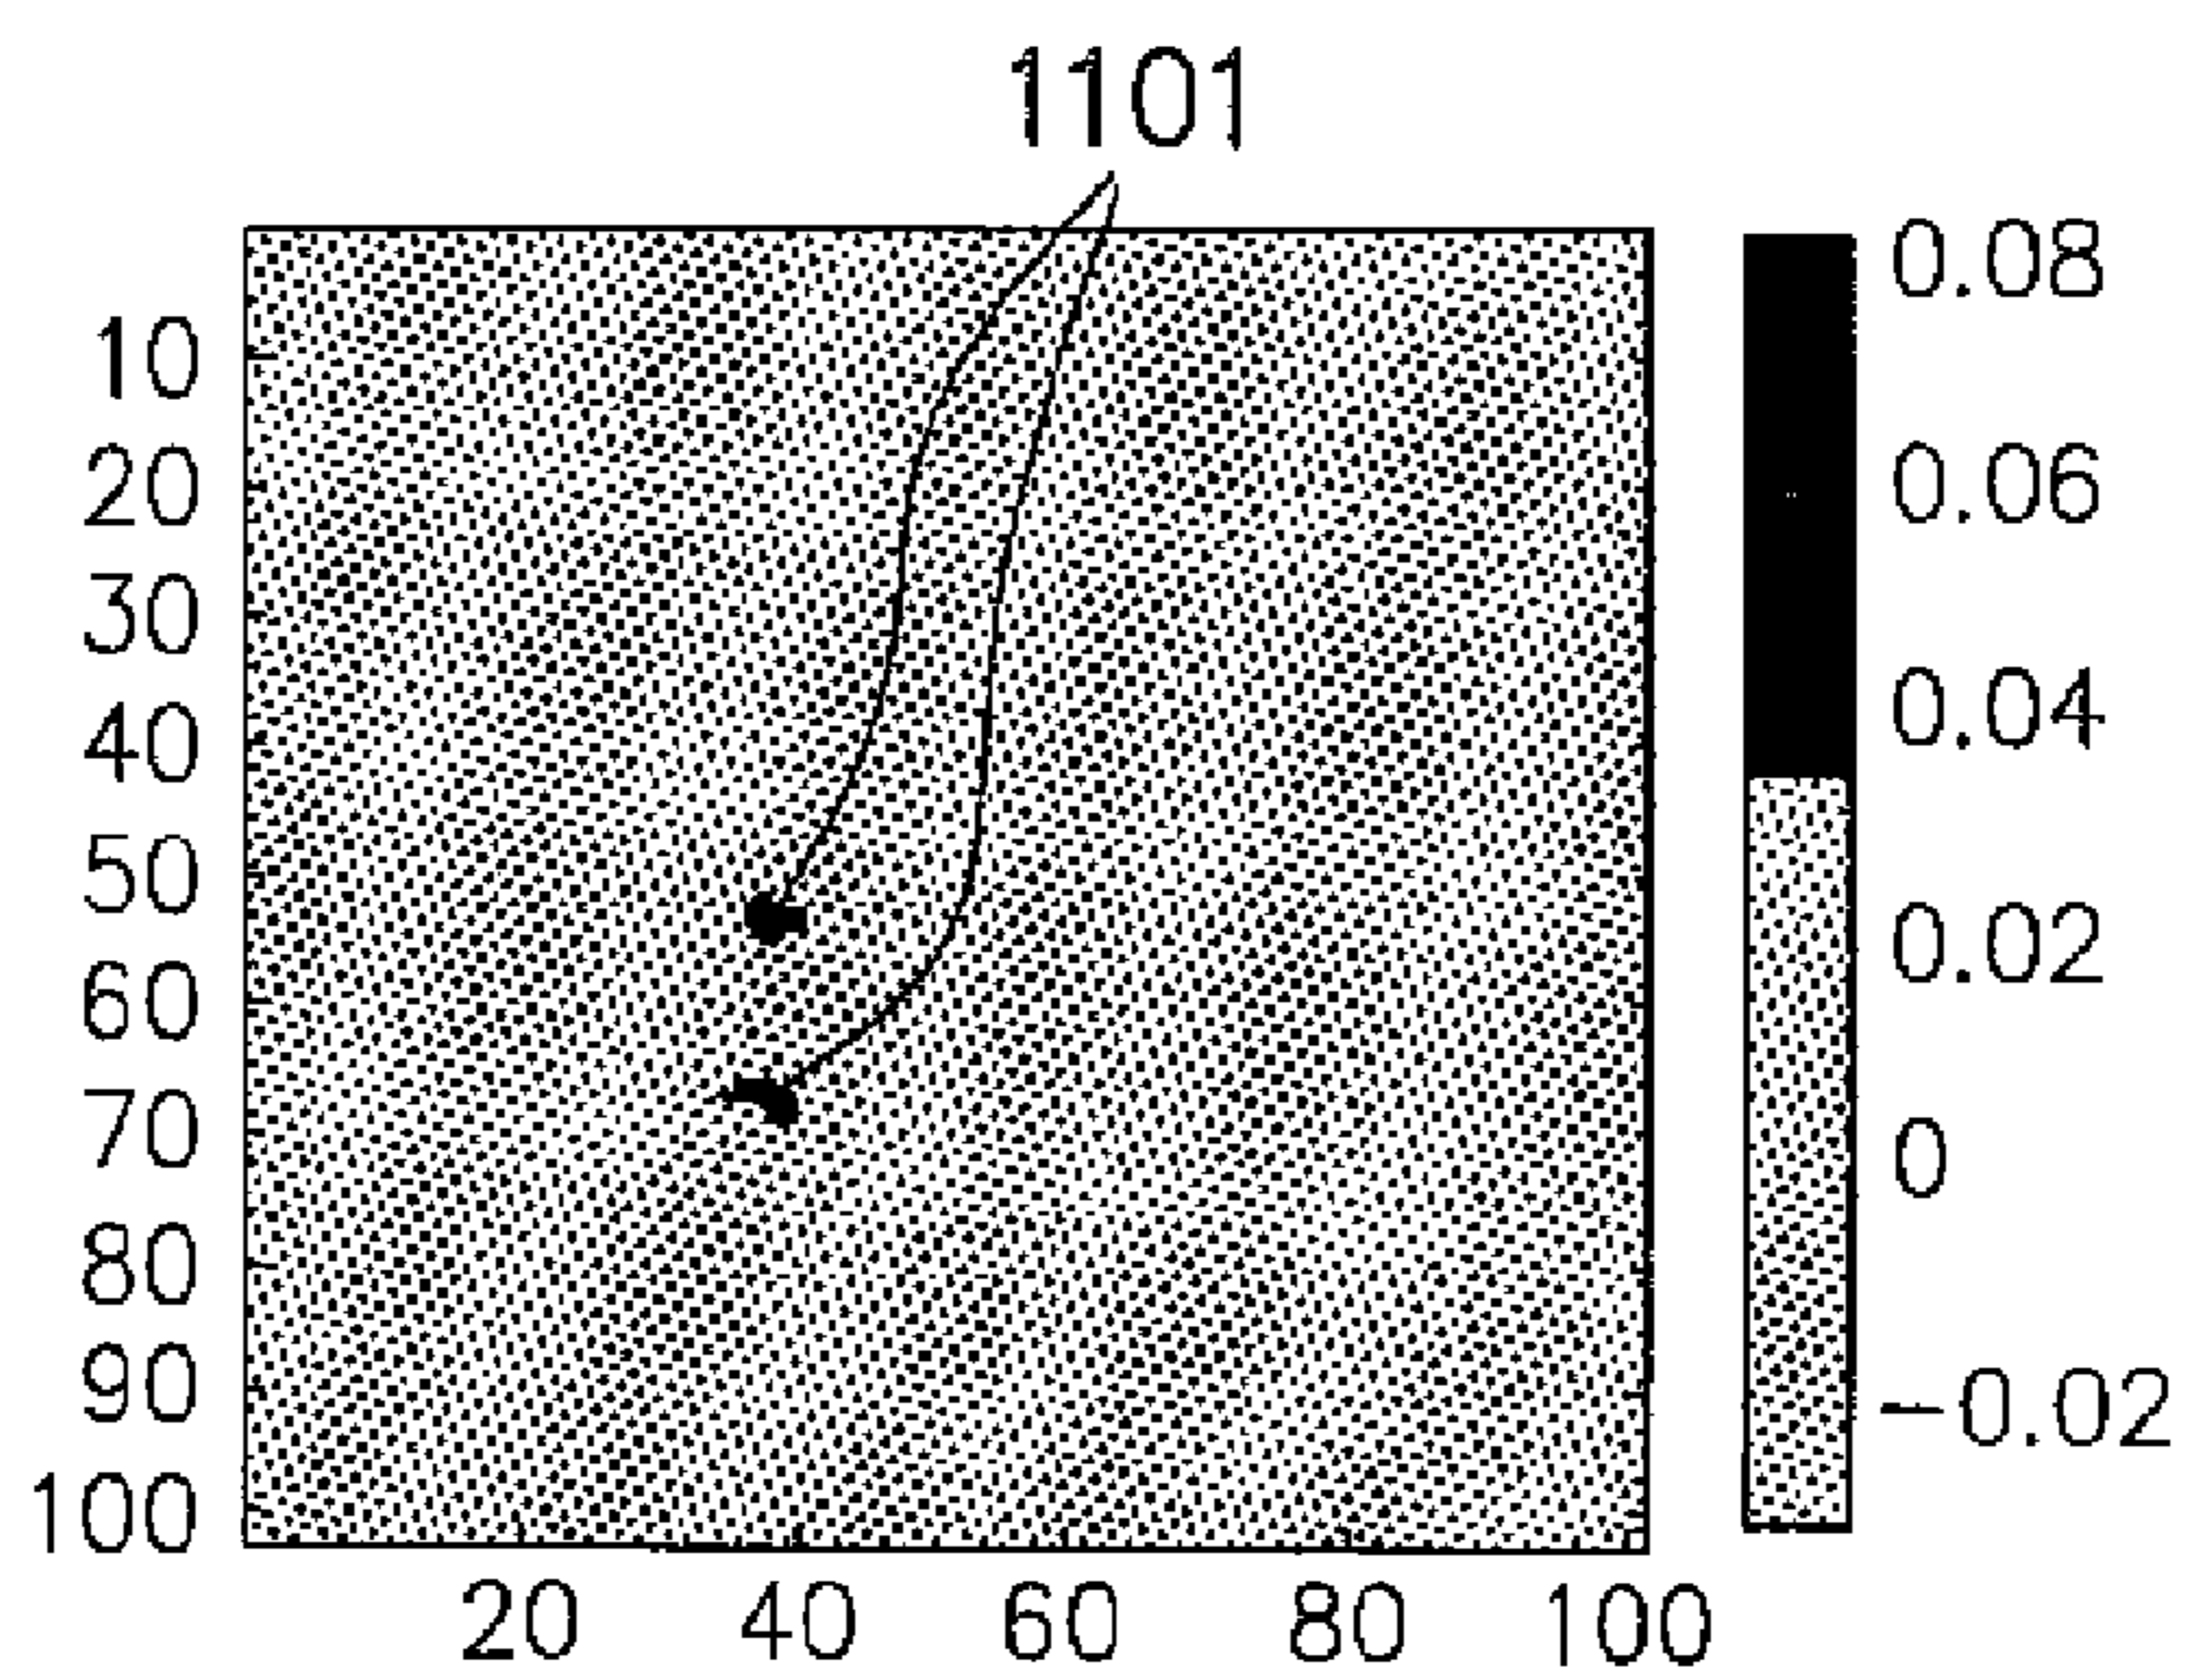
FIGS. 11A, 11B and 11C are an example of an image showing detecting a defect in the cooling down process, wherein the defect is a foreign material or a void located in the surface layer of the steel sheet.

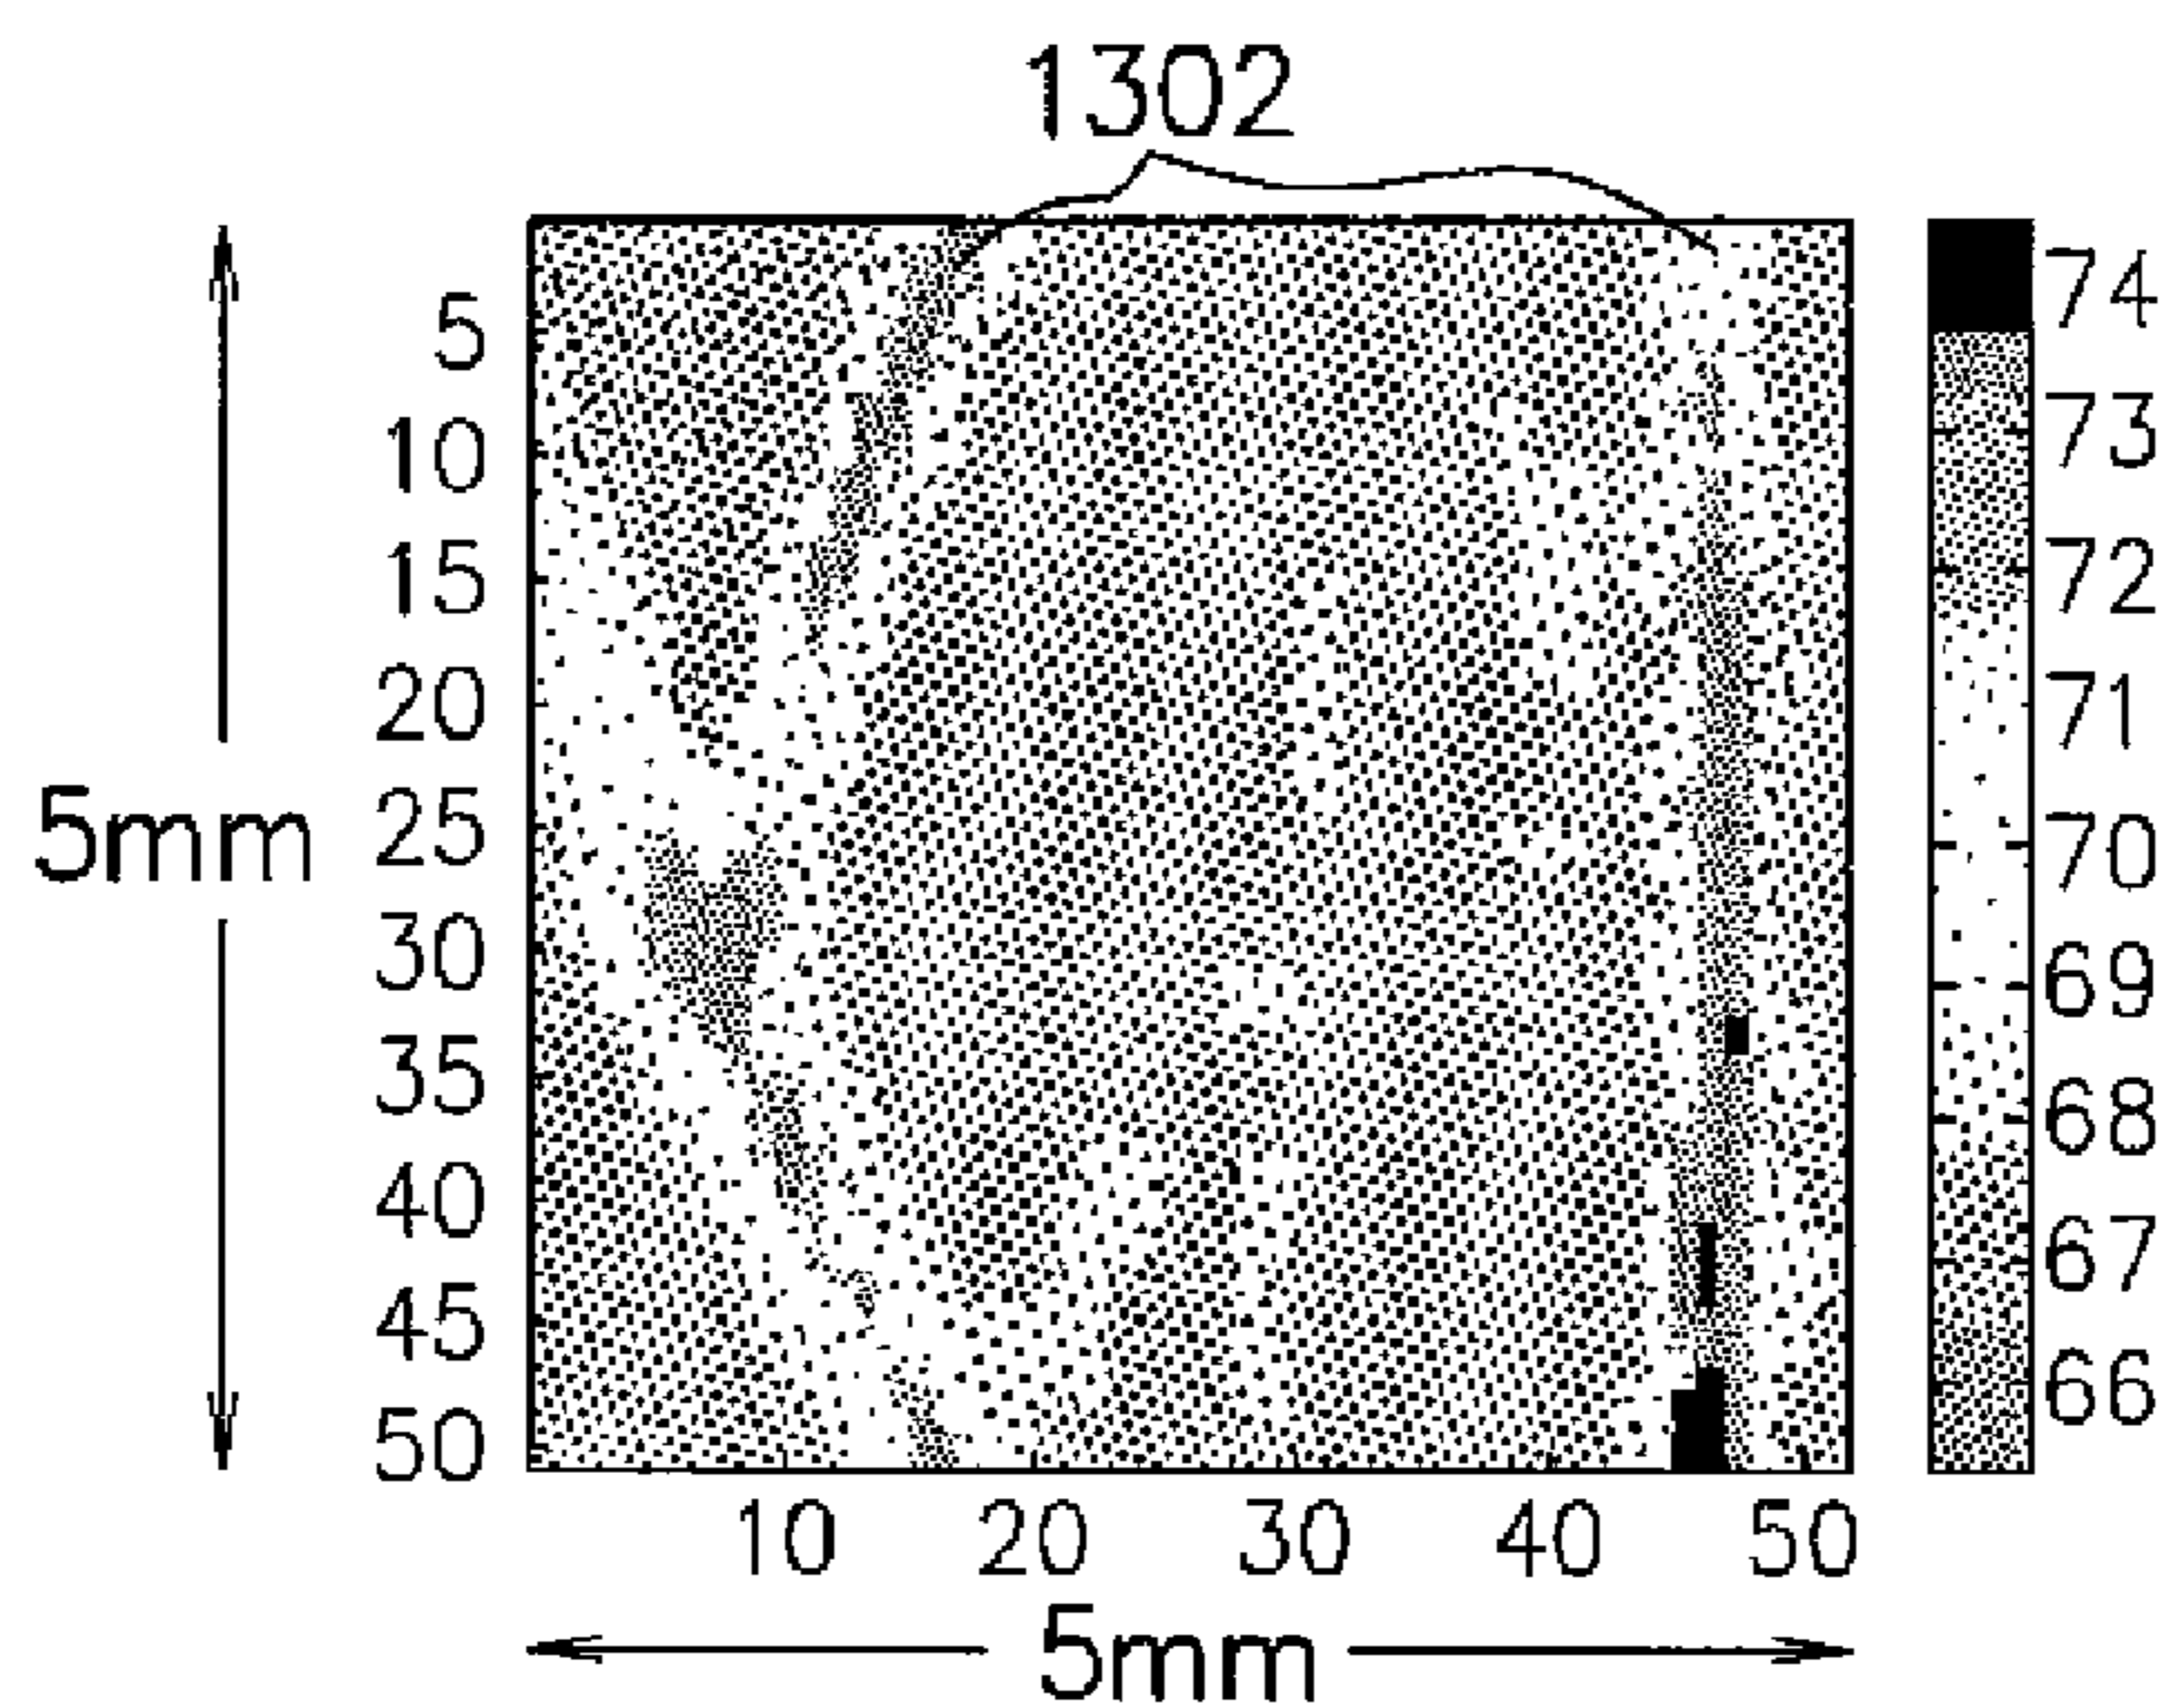
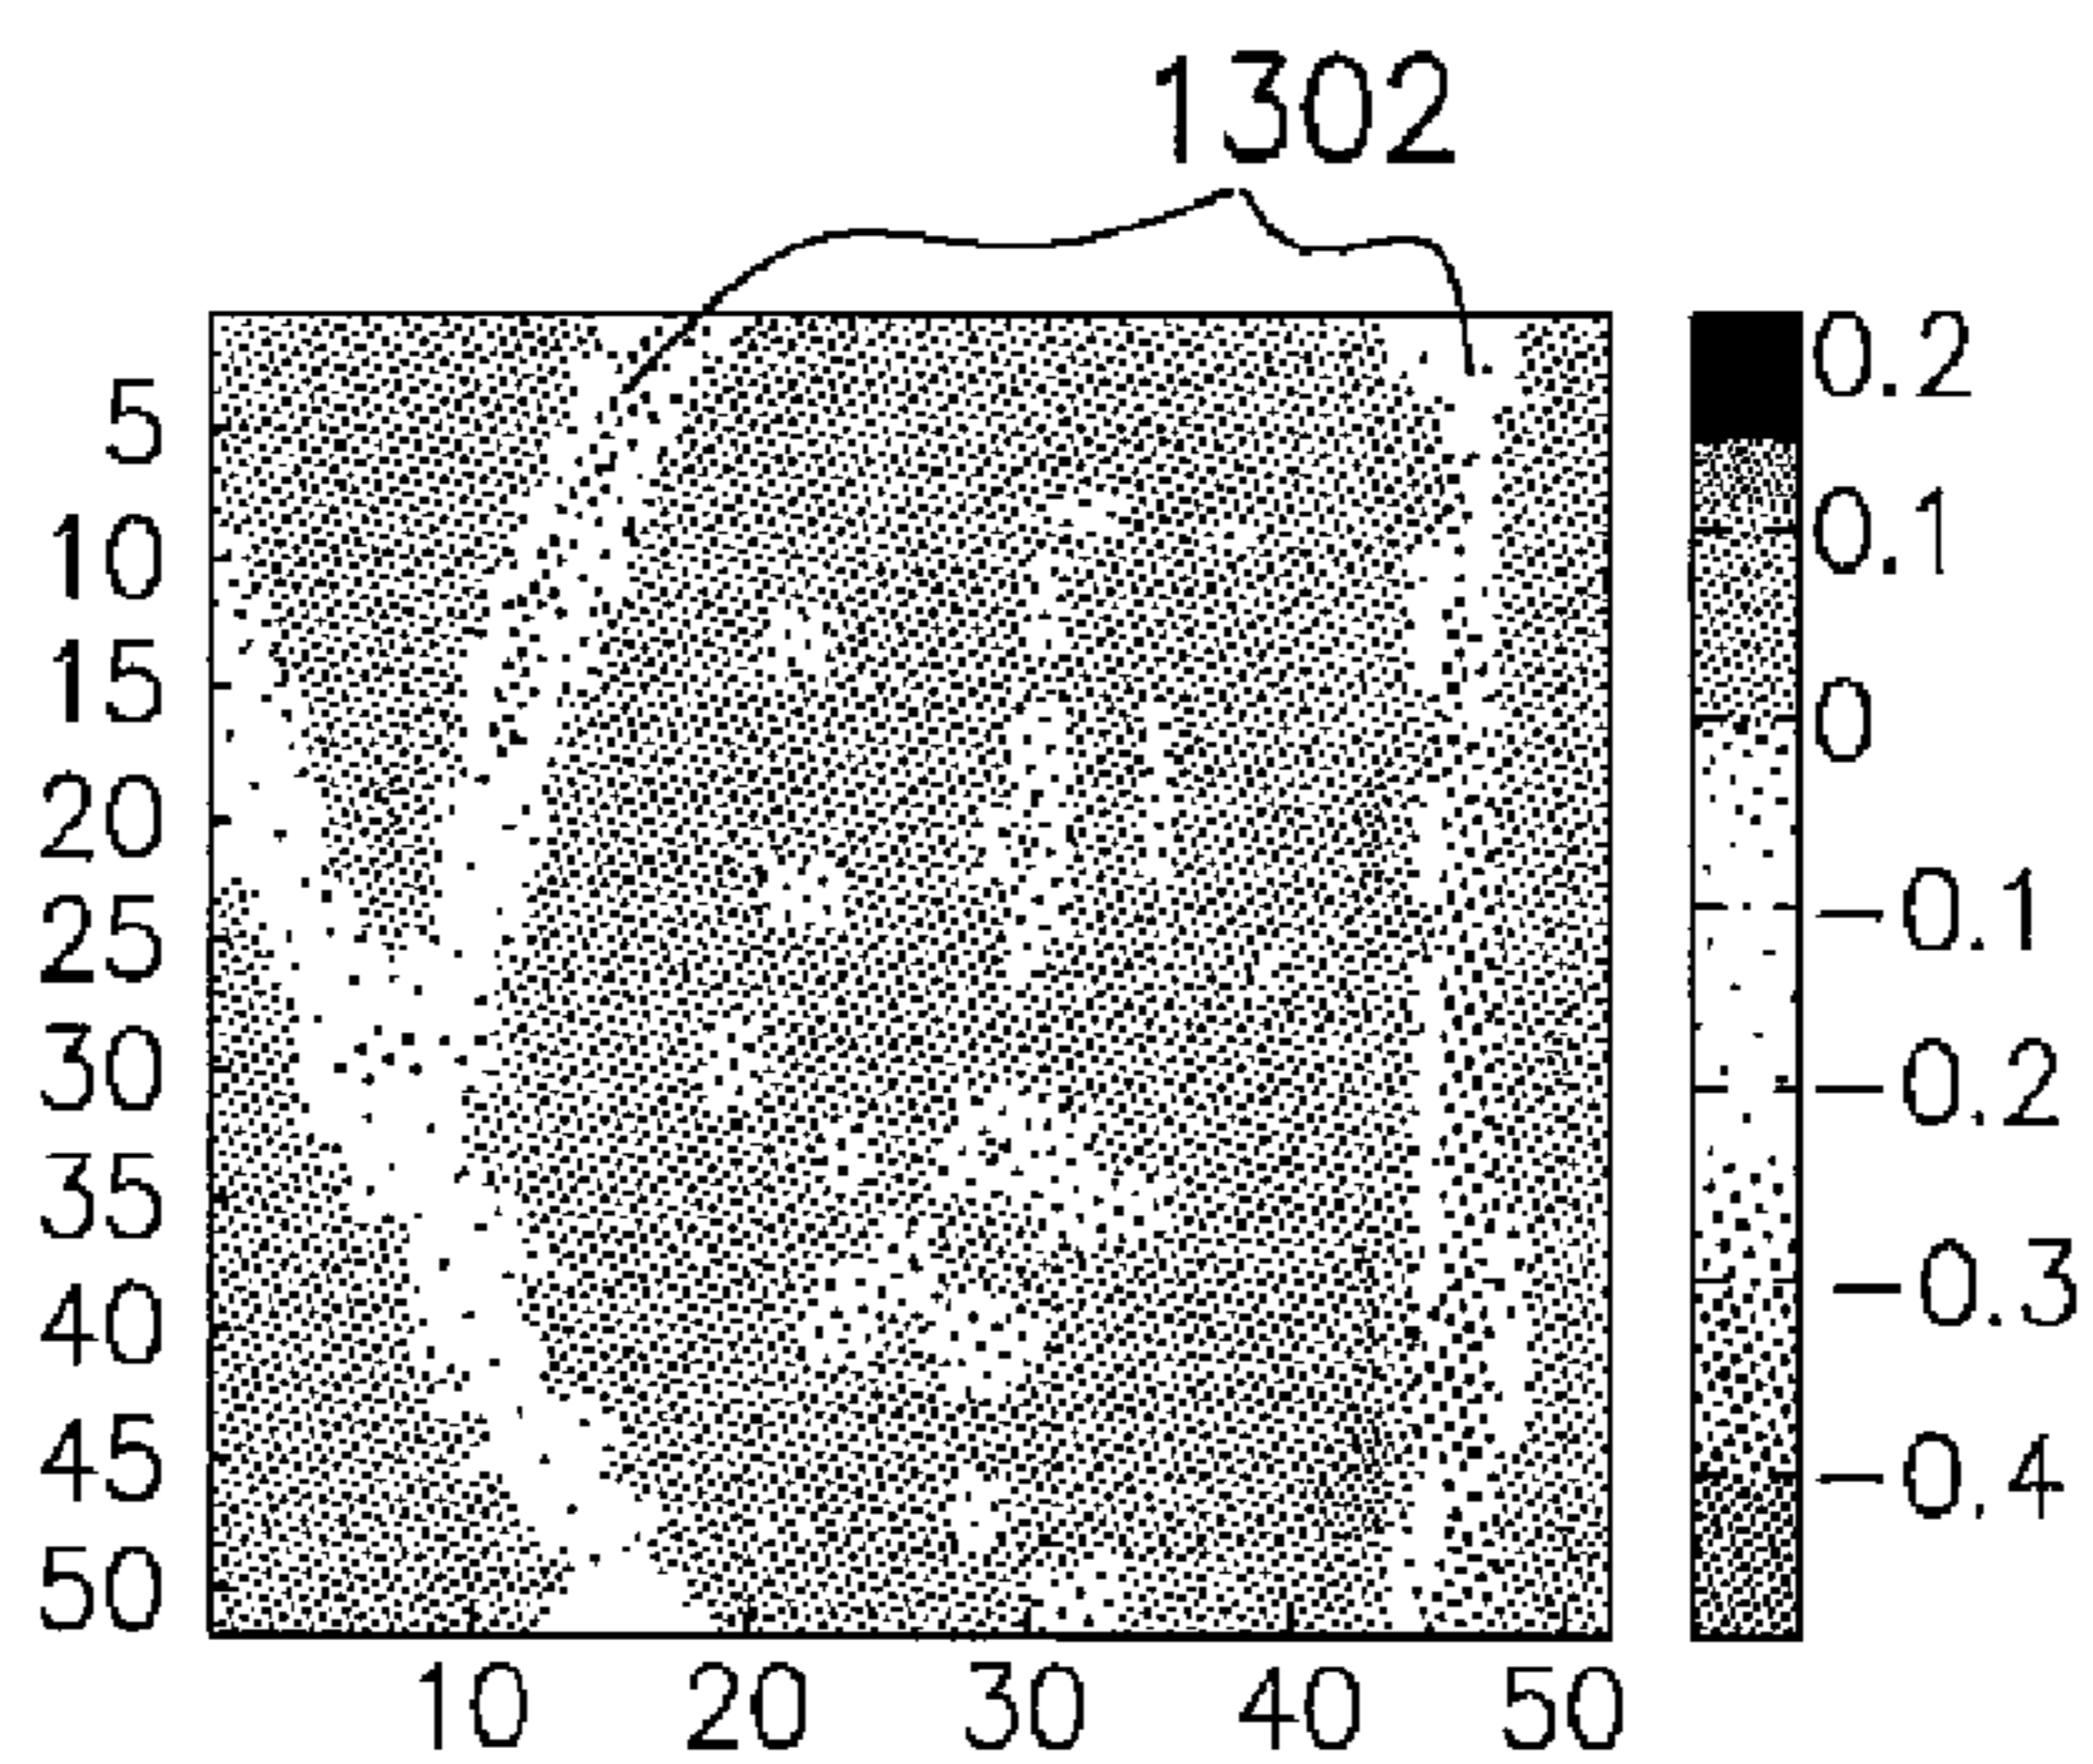
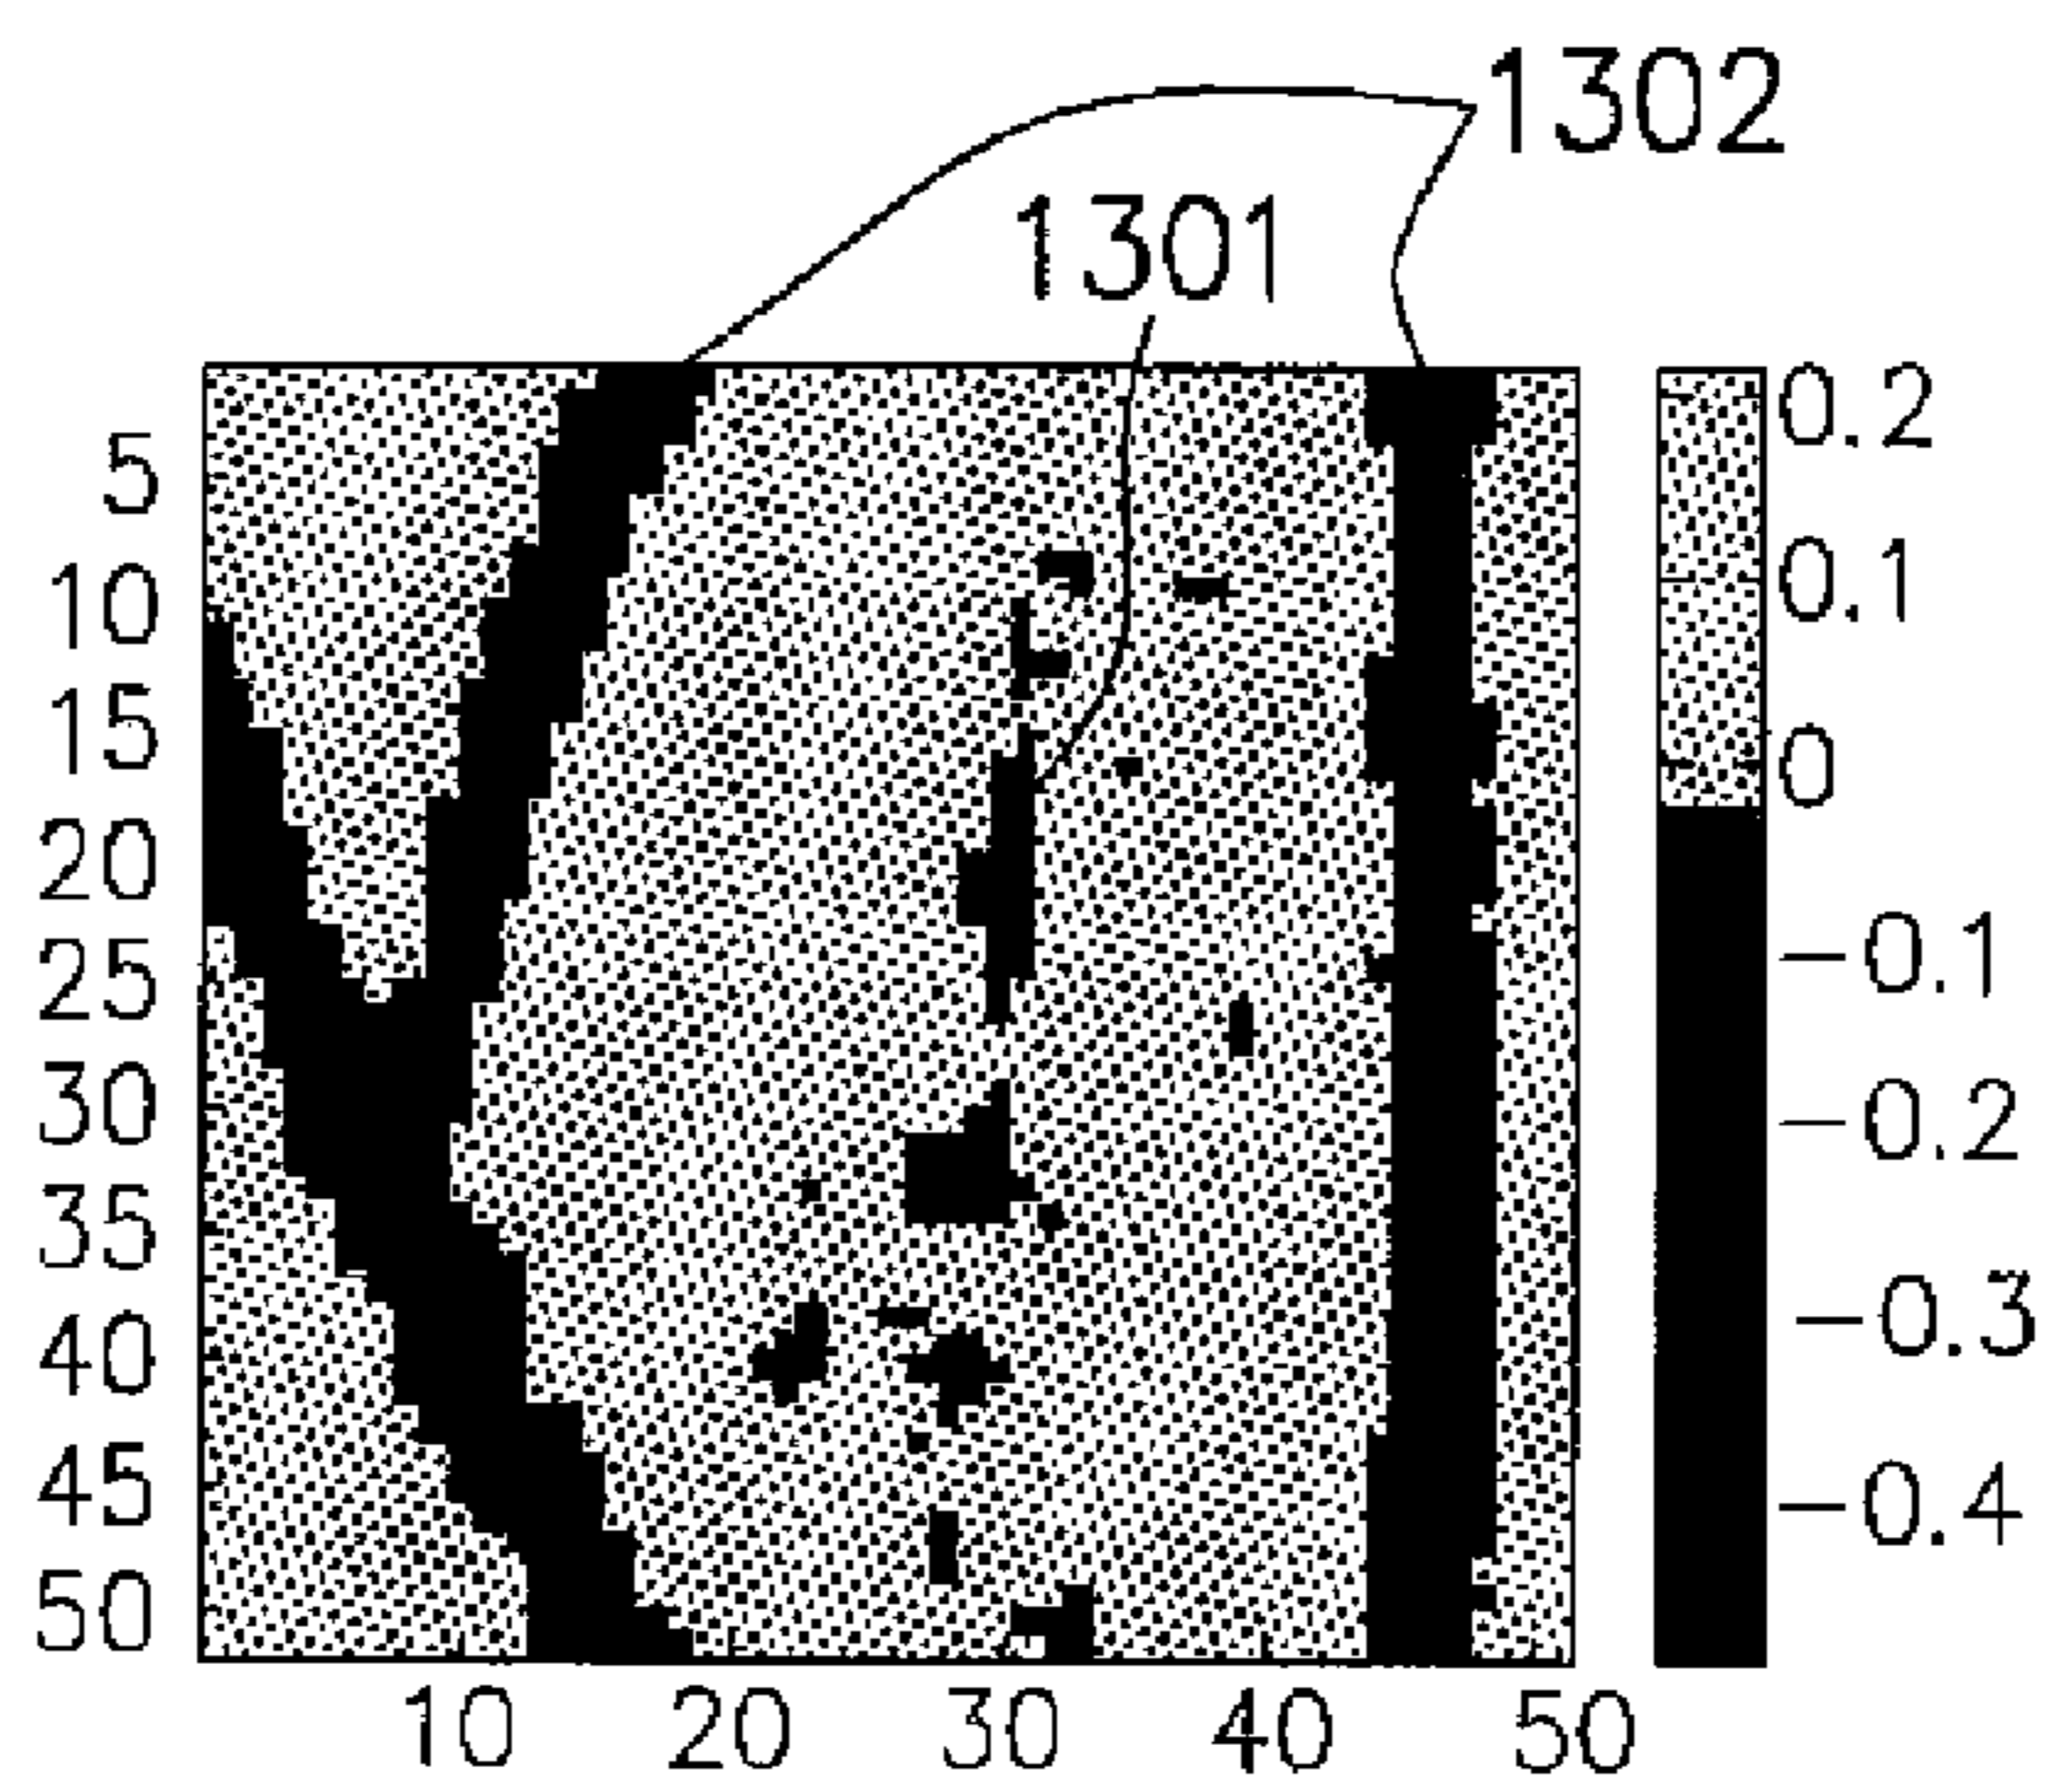
FIGS. 13A, 13B and 13C are an example of an image showing detecting a defect in the cooling down process, wherein the defect is a minute sharp dent located on the surface of the steel sheet.
