(54) **METHOD FOR DETECTING DEFECT IN MATERIAL AND SYSTEM FOR THE METHOD**

(73) Assignee: **Nippon Steel & Sumitomo Metal Corporation**, Tokyo (JP)

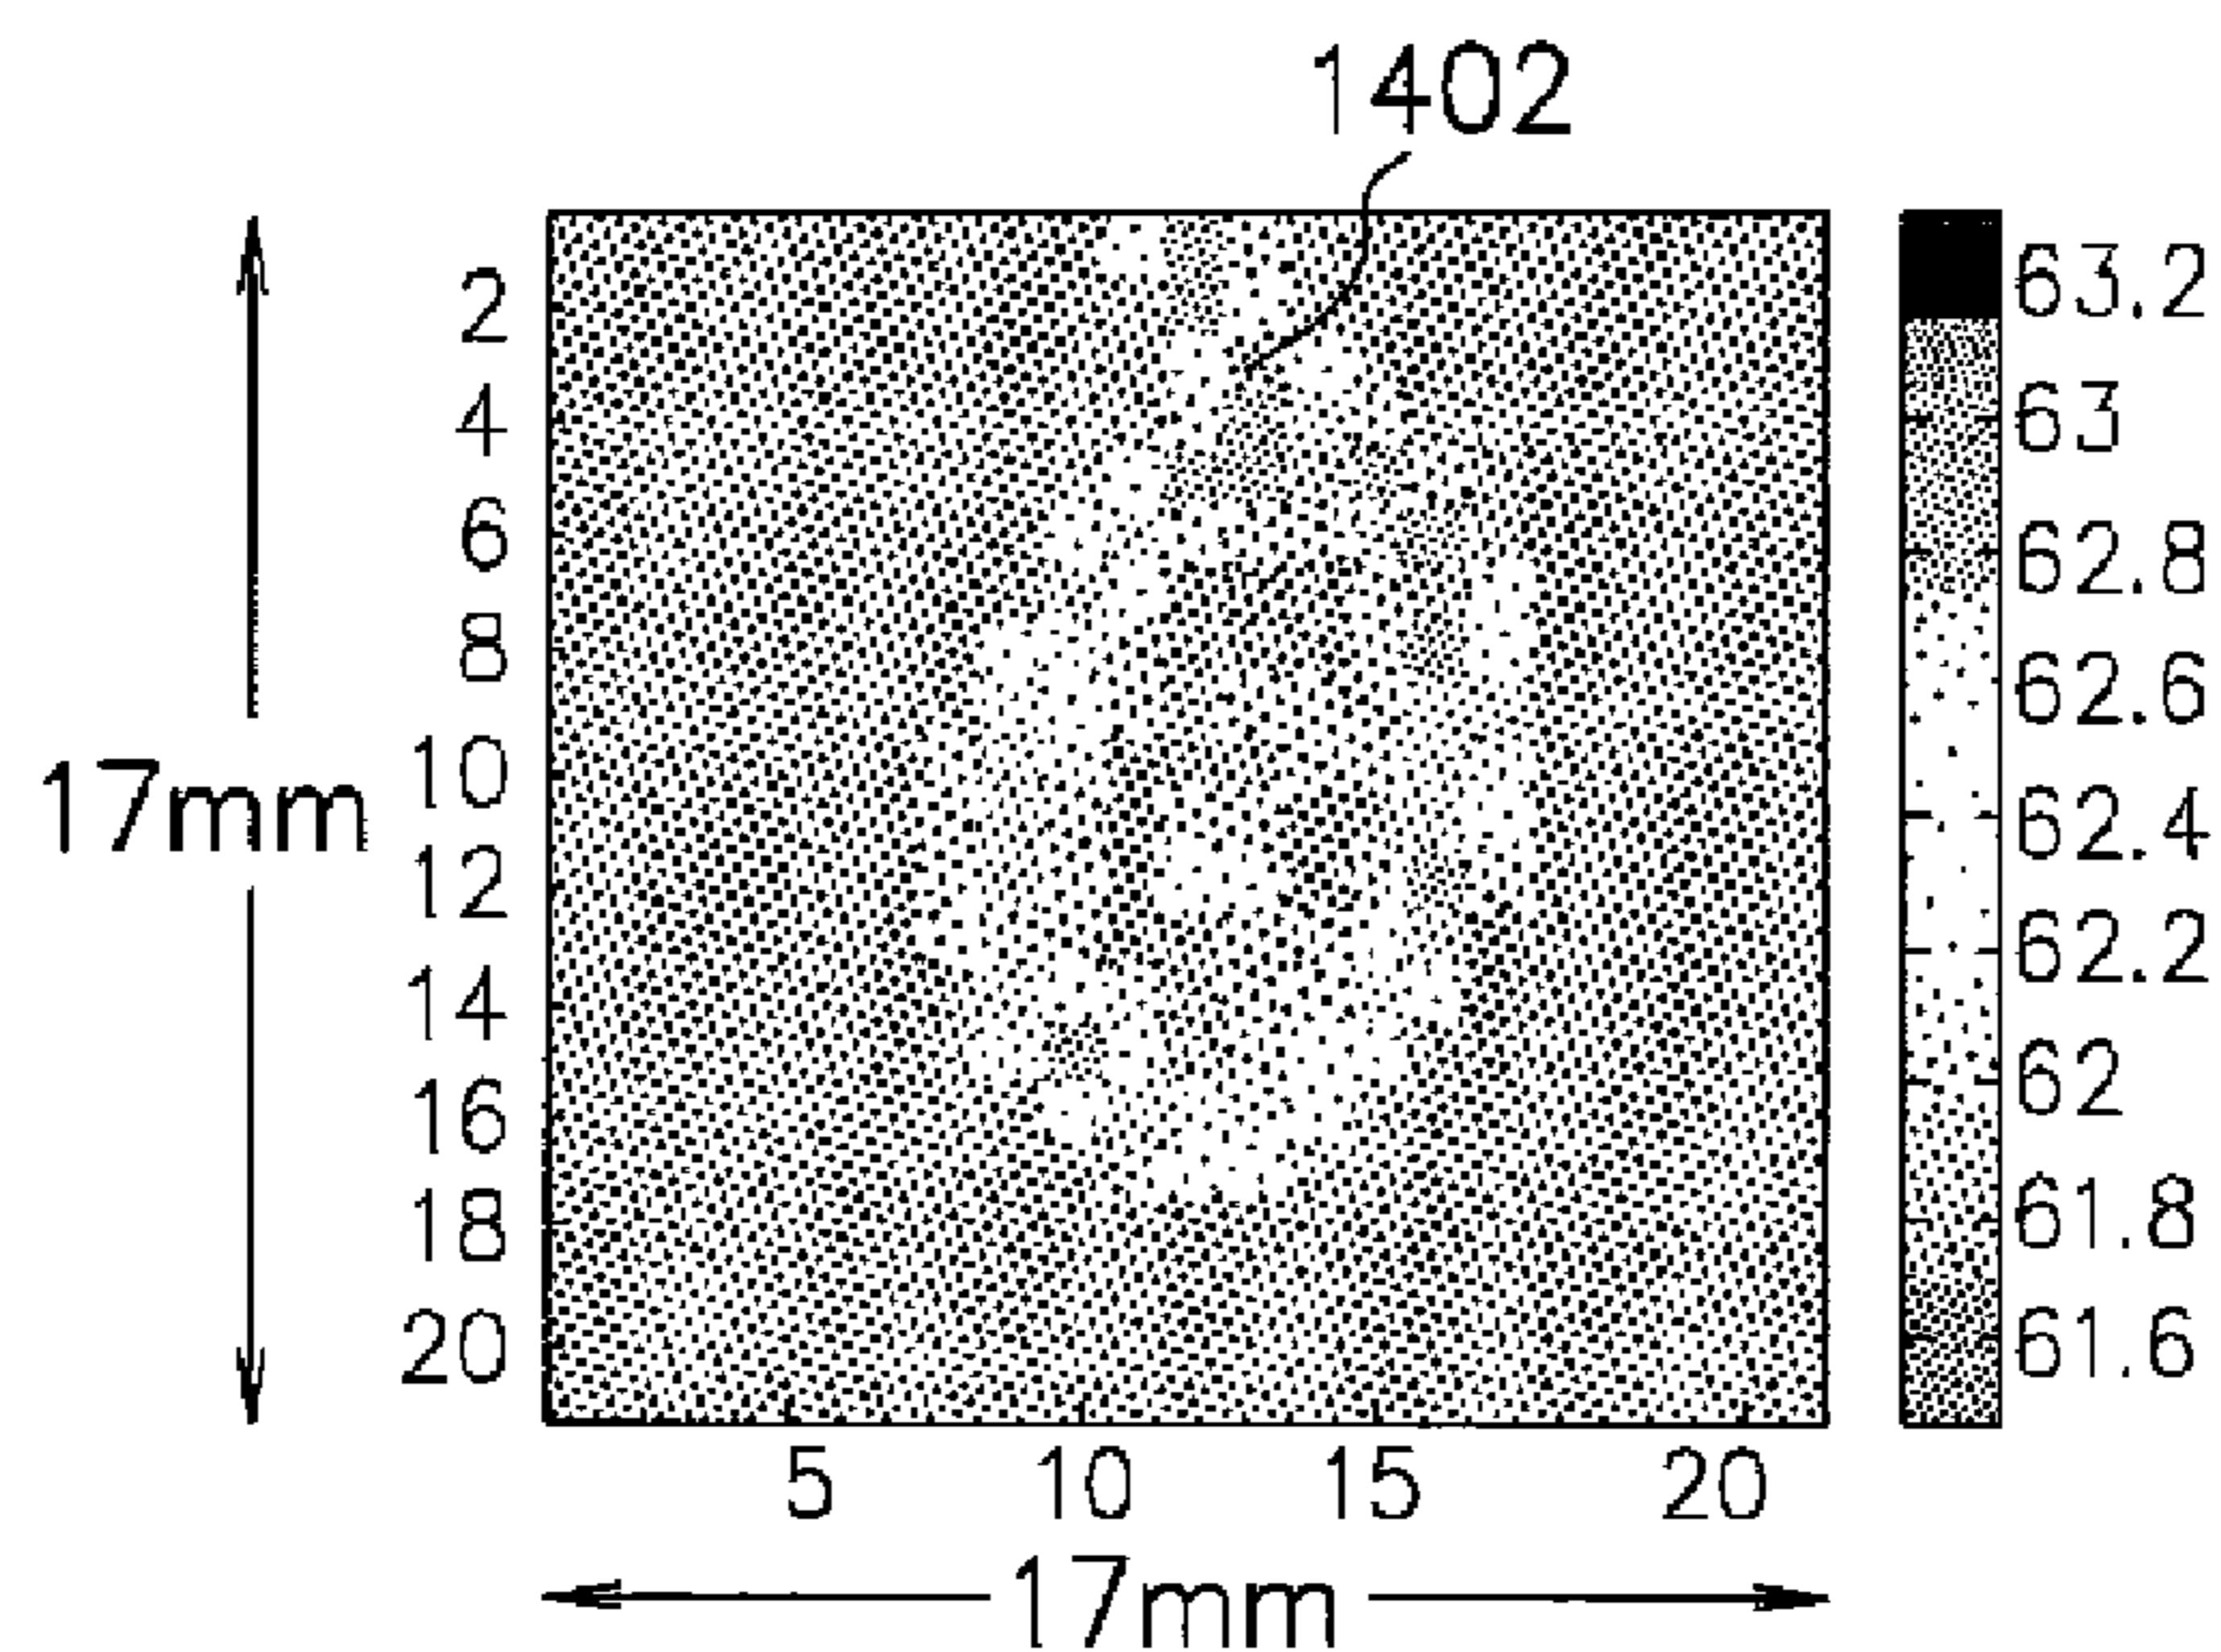
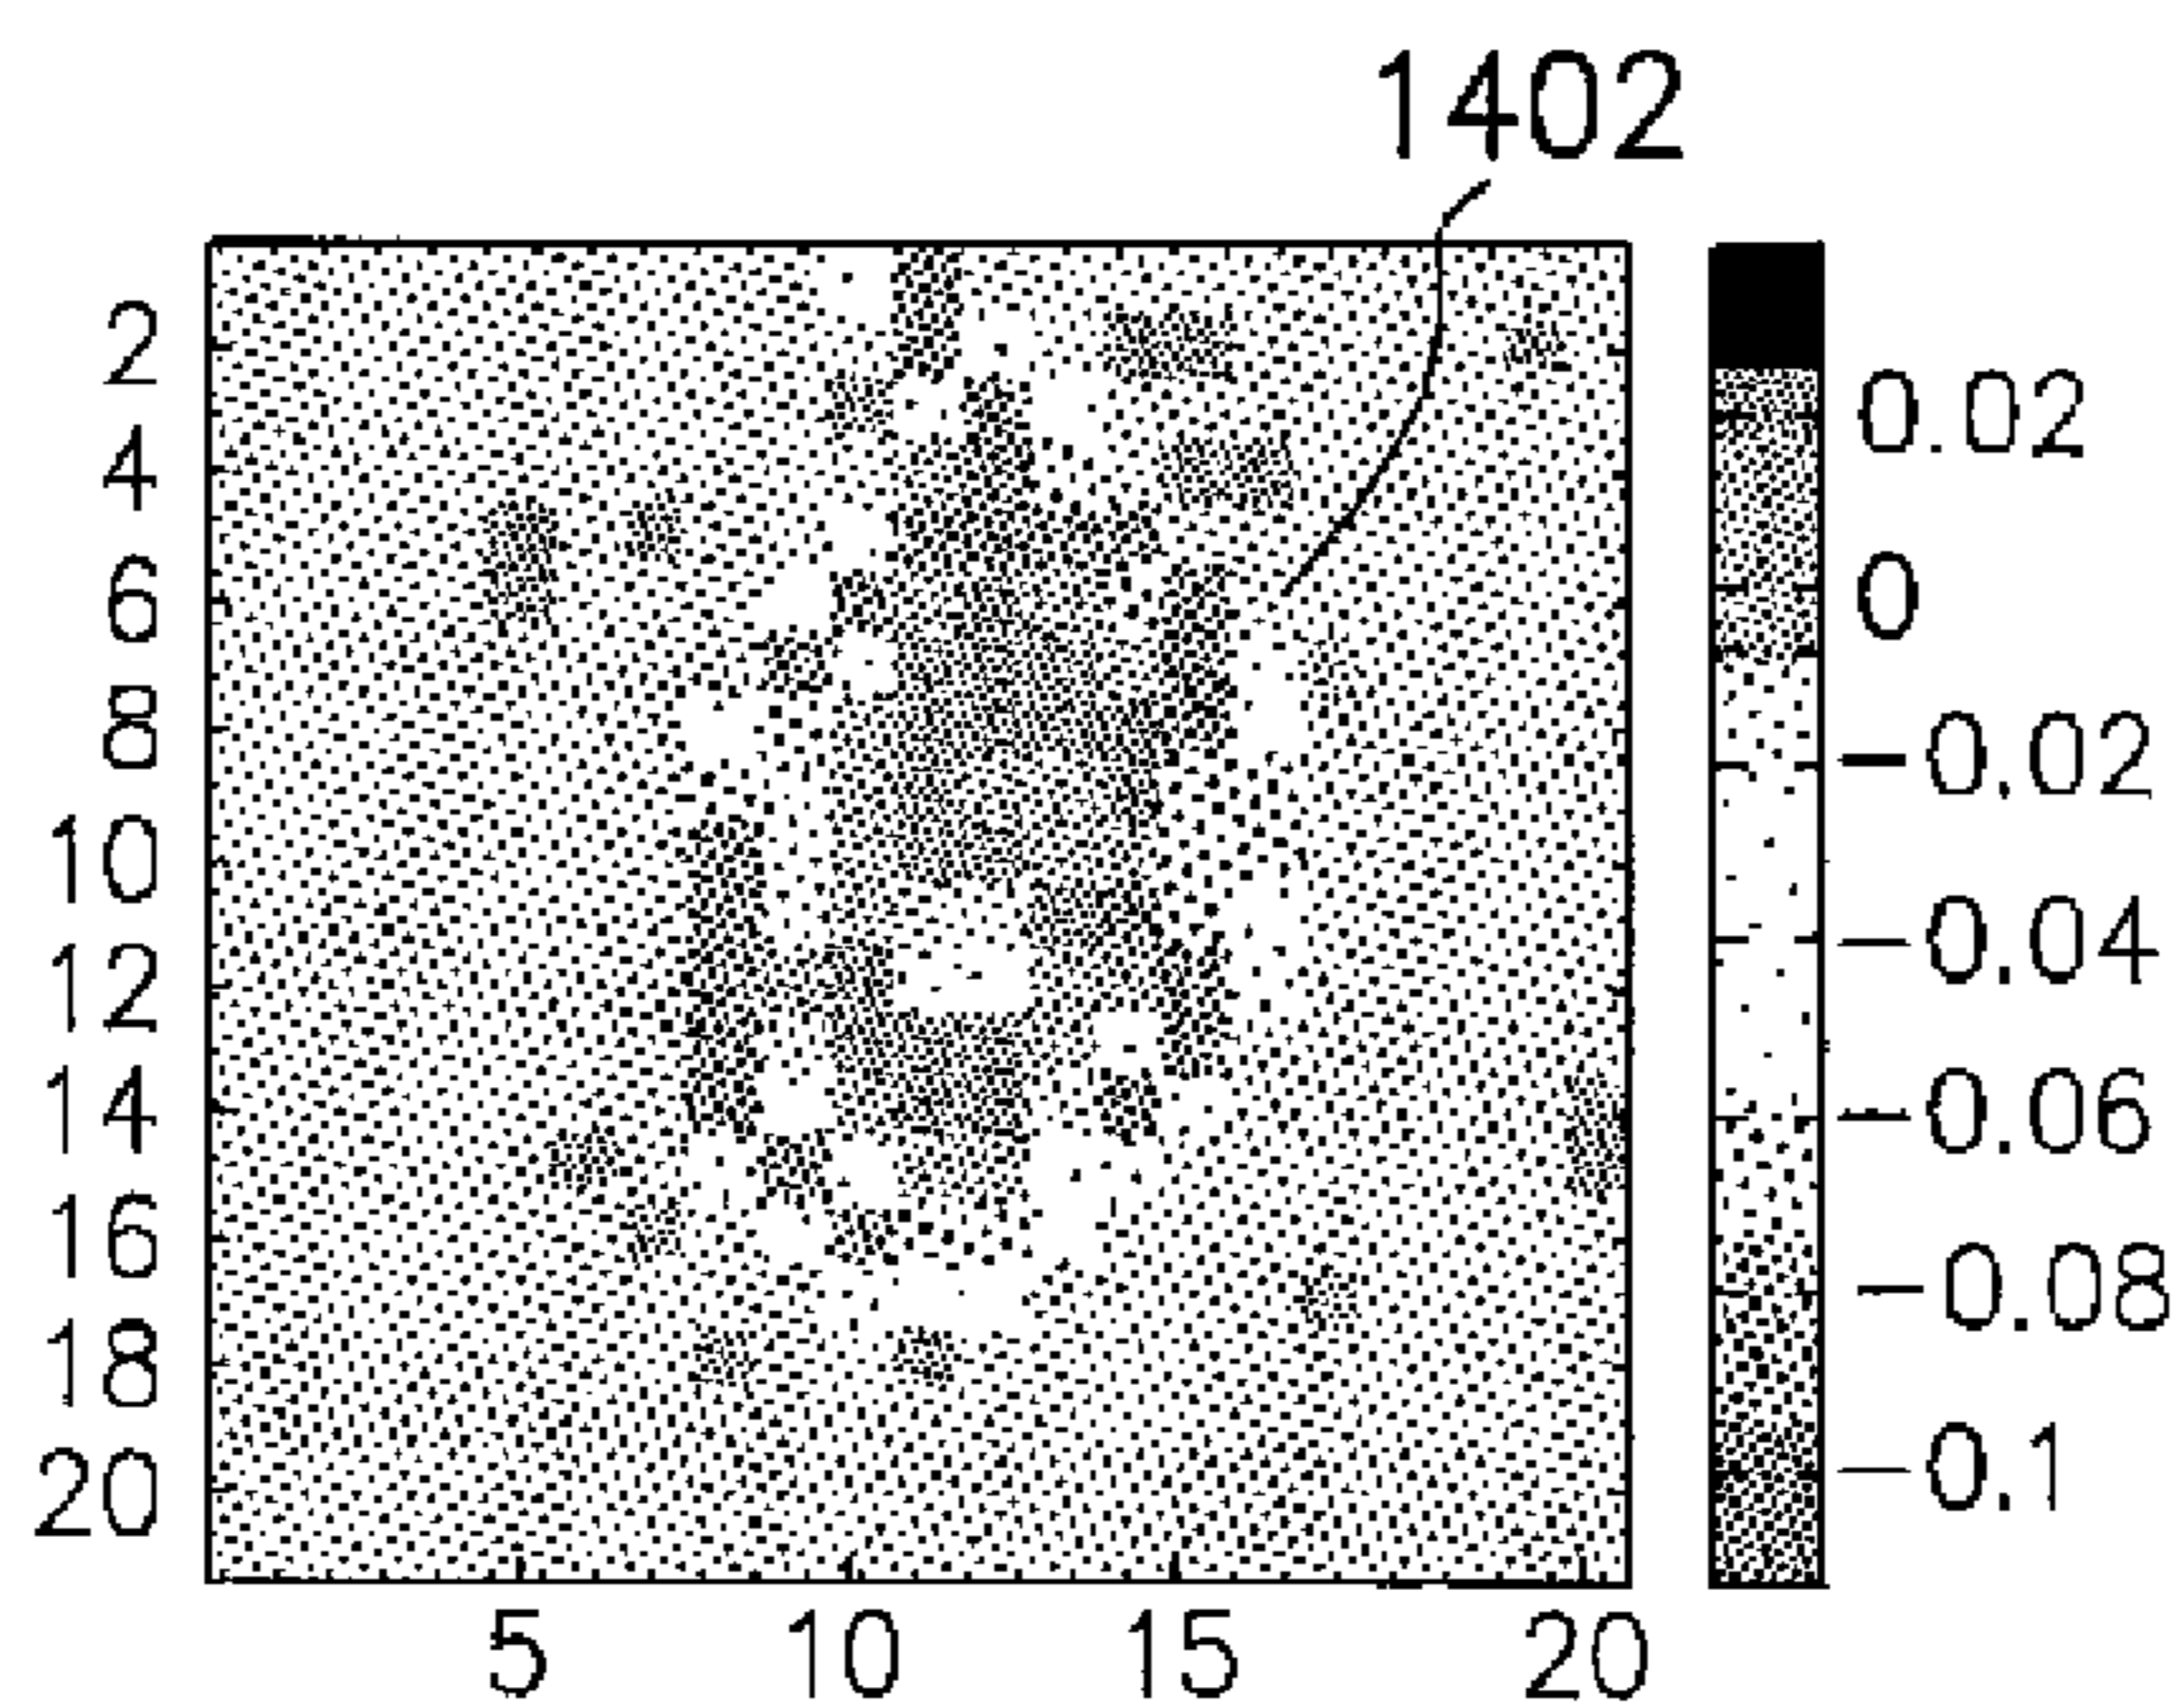
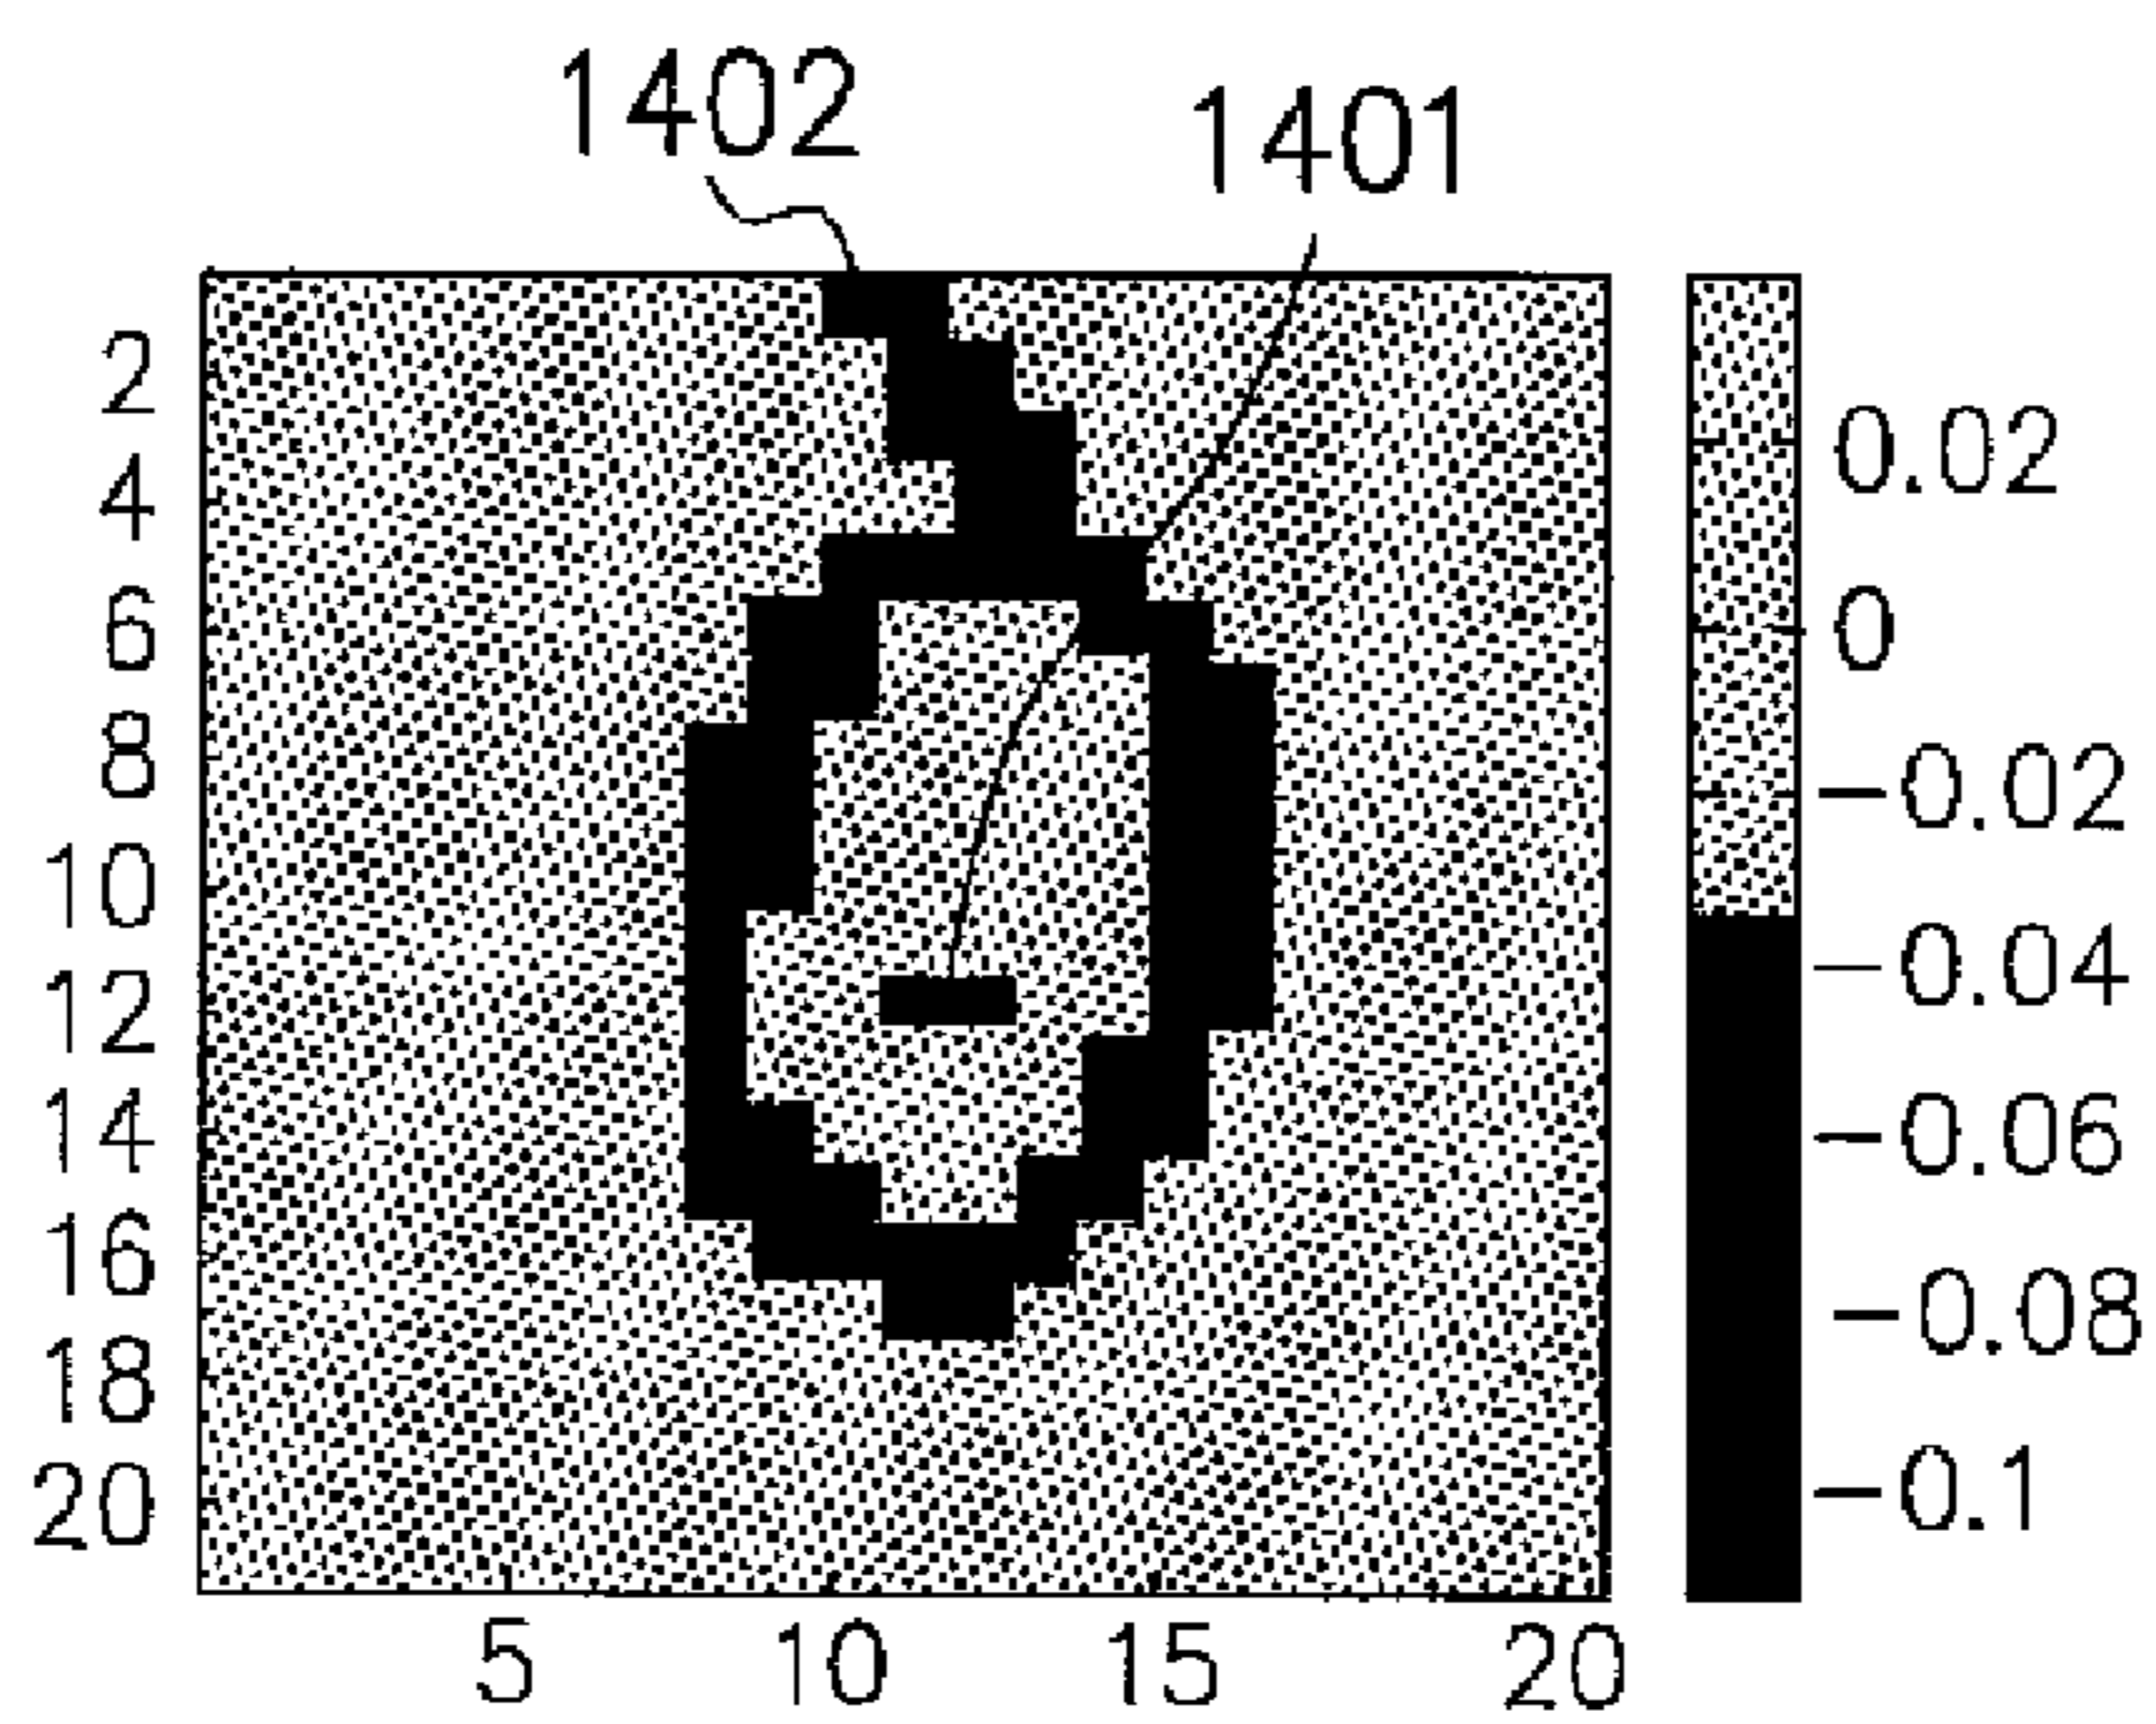
FIGS. 14A, 14B and 14C are an example of an image showing detecting a defect in the cooling down process, wherein the defect is a foreign material attached on the surface of the steel sheet.
