US008506159B2

(54) **METHOD FOR DETECTING DEFECT IN MATERIAL AND SYSTEM FOR THE METHOD**

(73) Assignee: **Nippon Steel & Sumitomo Metal Corporation**, Tokyo (JP)

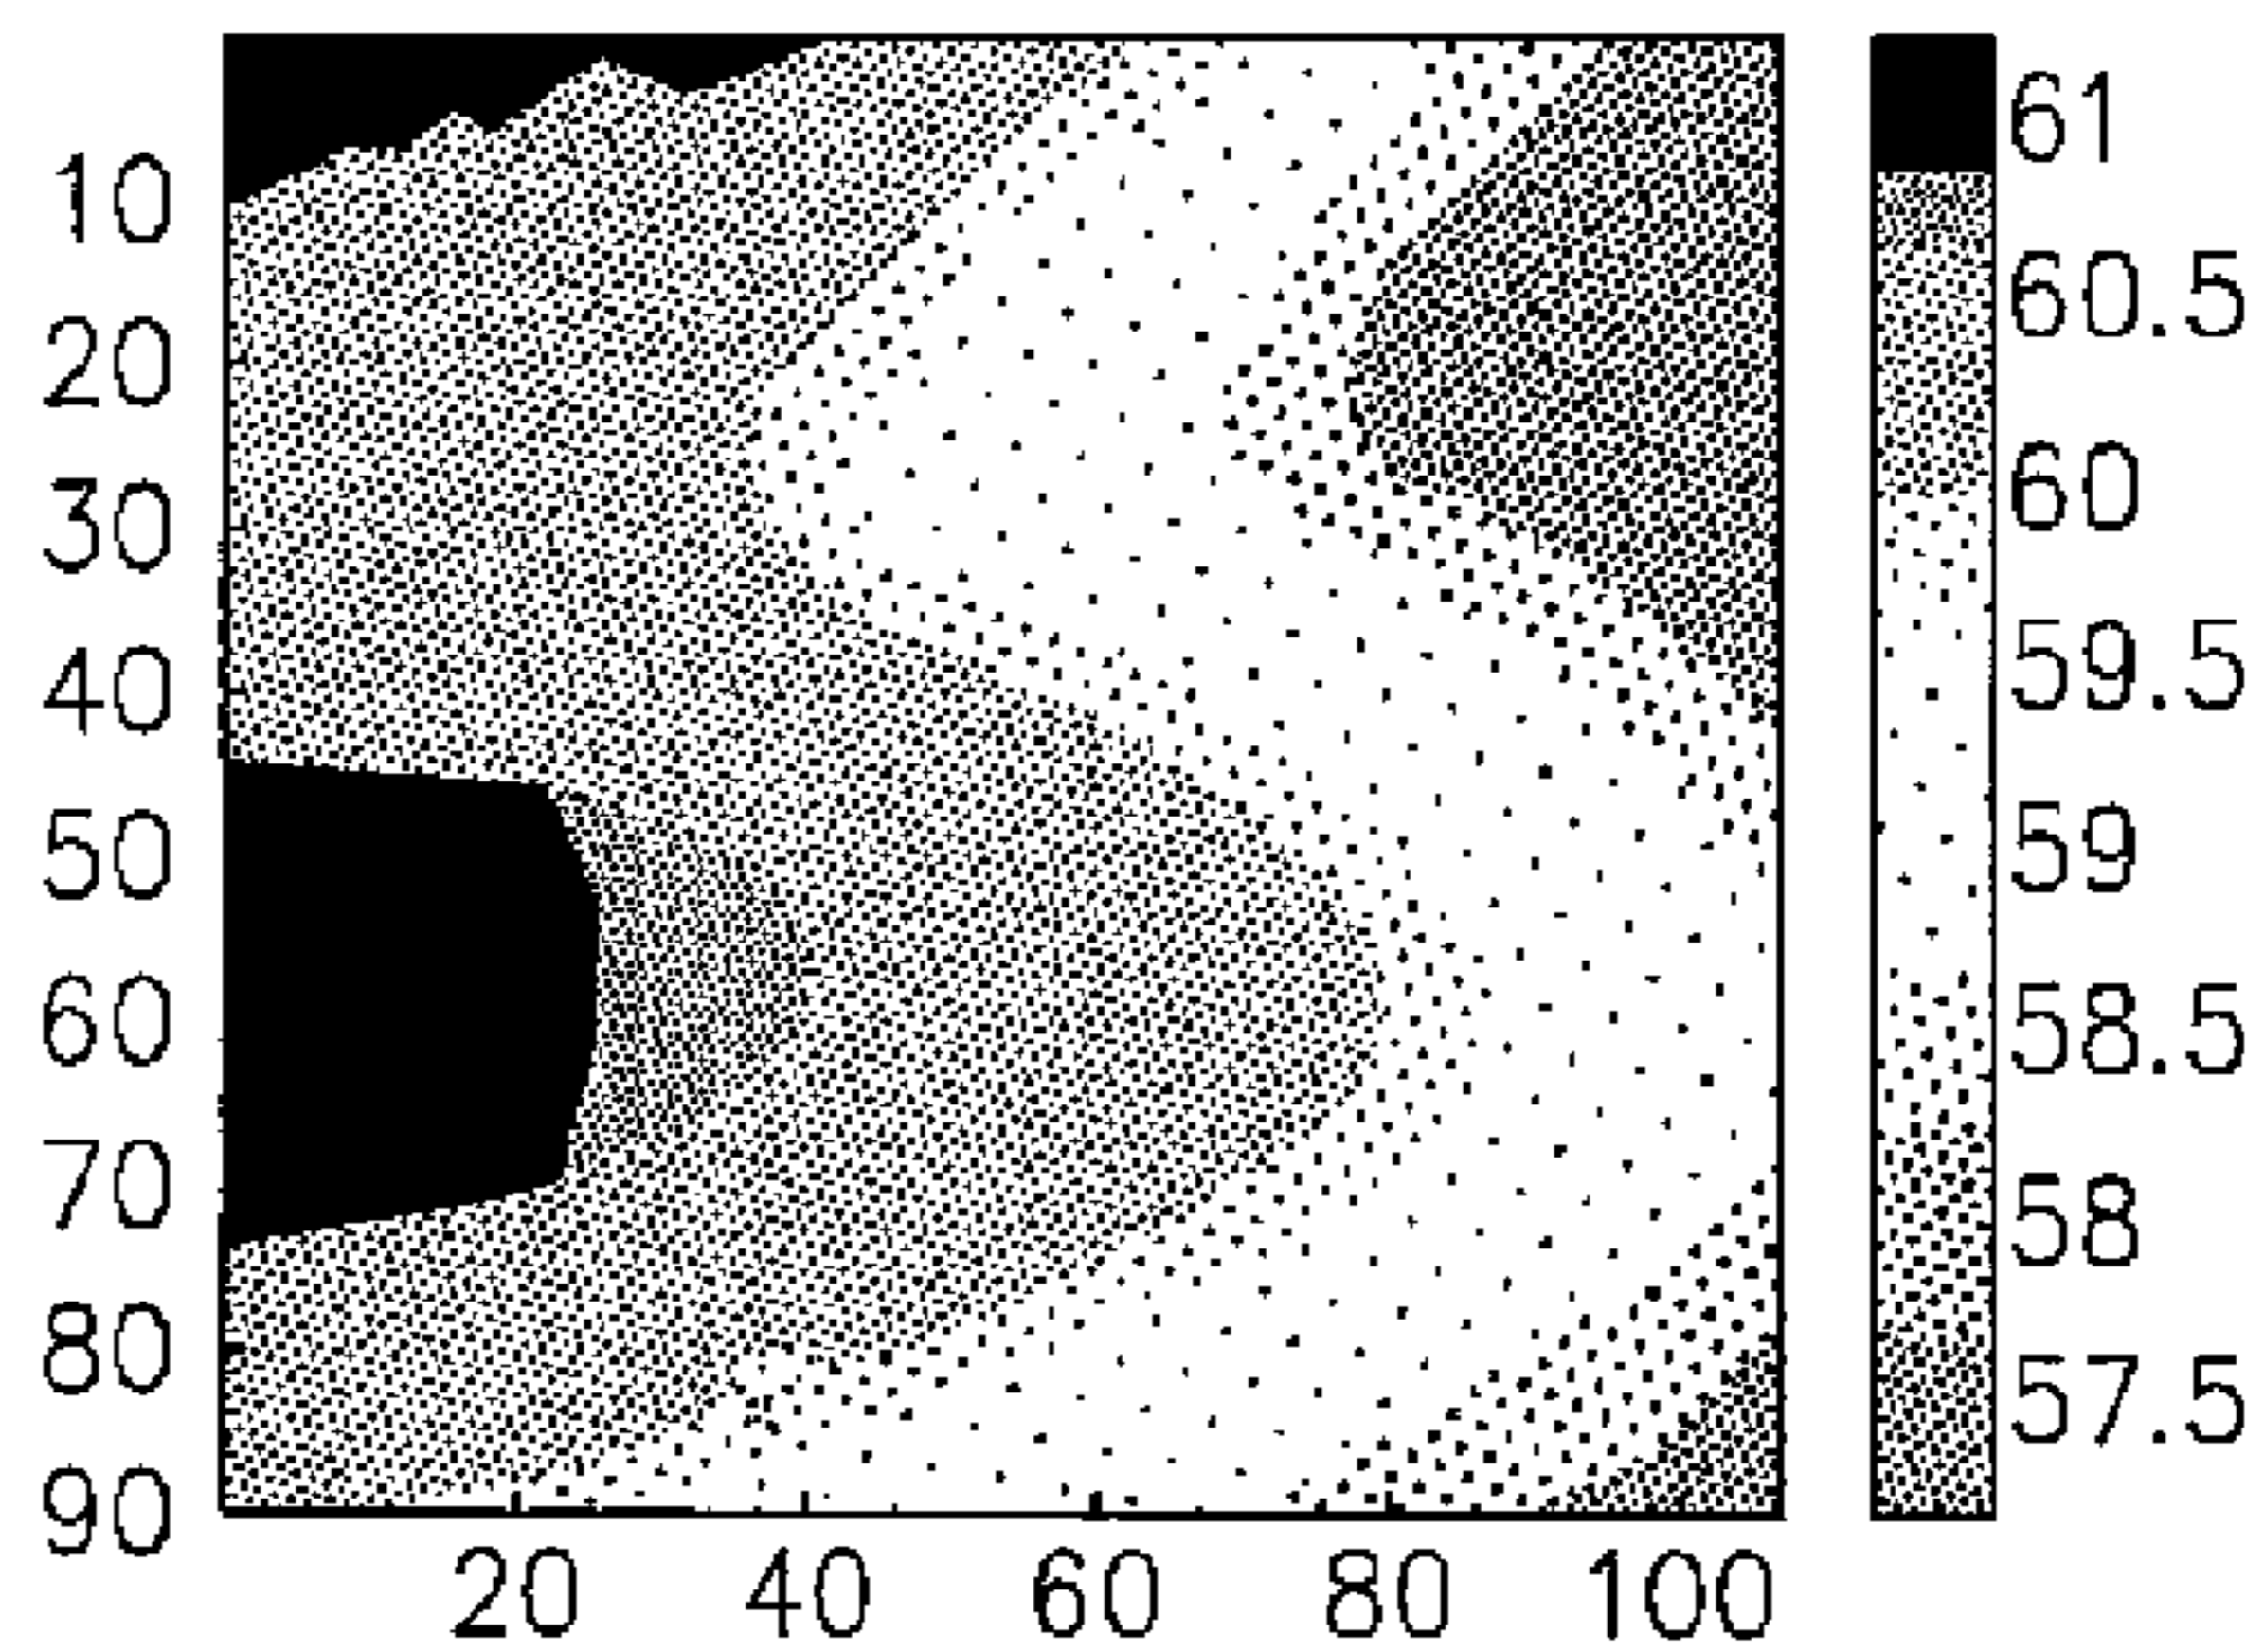
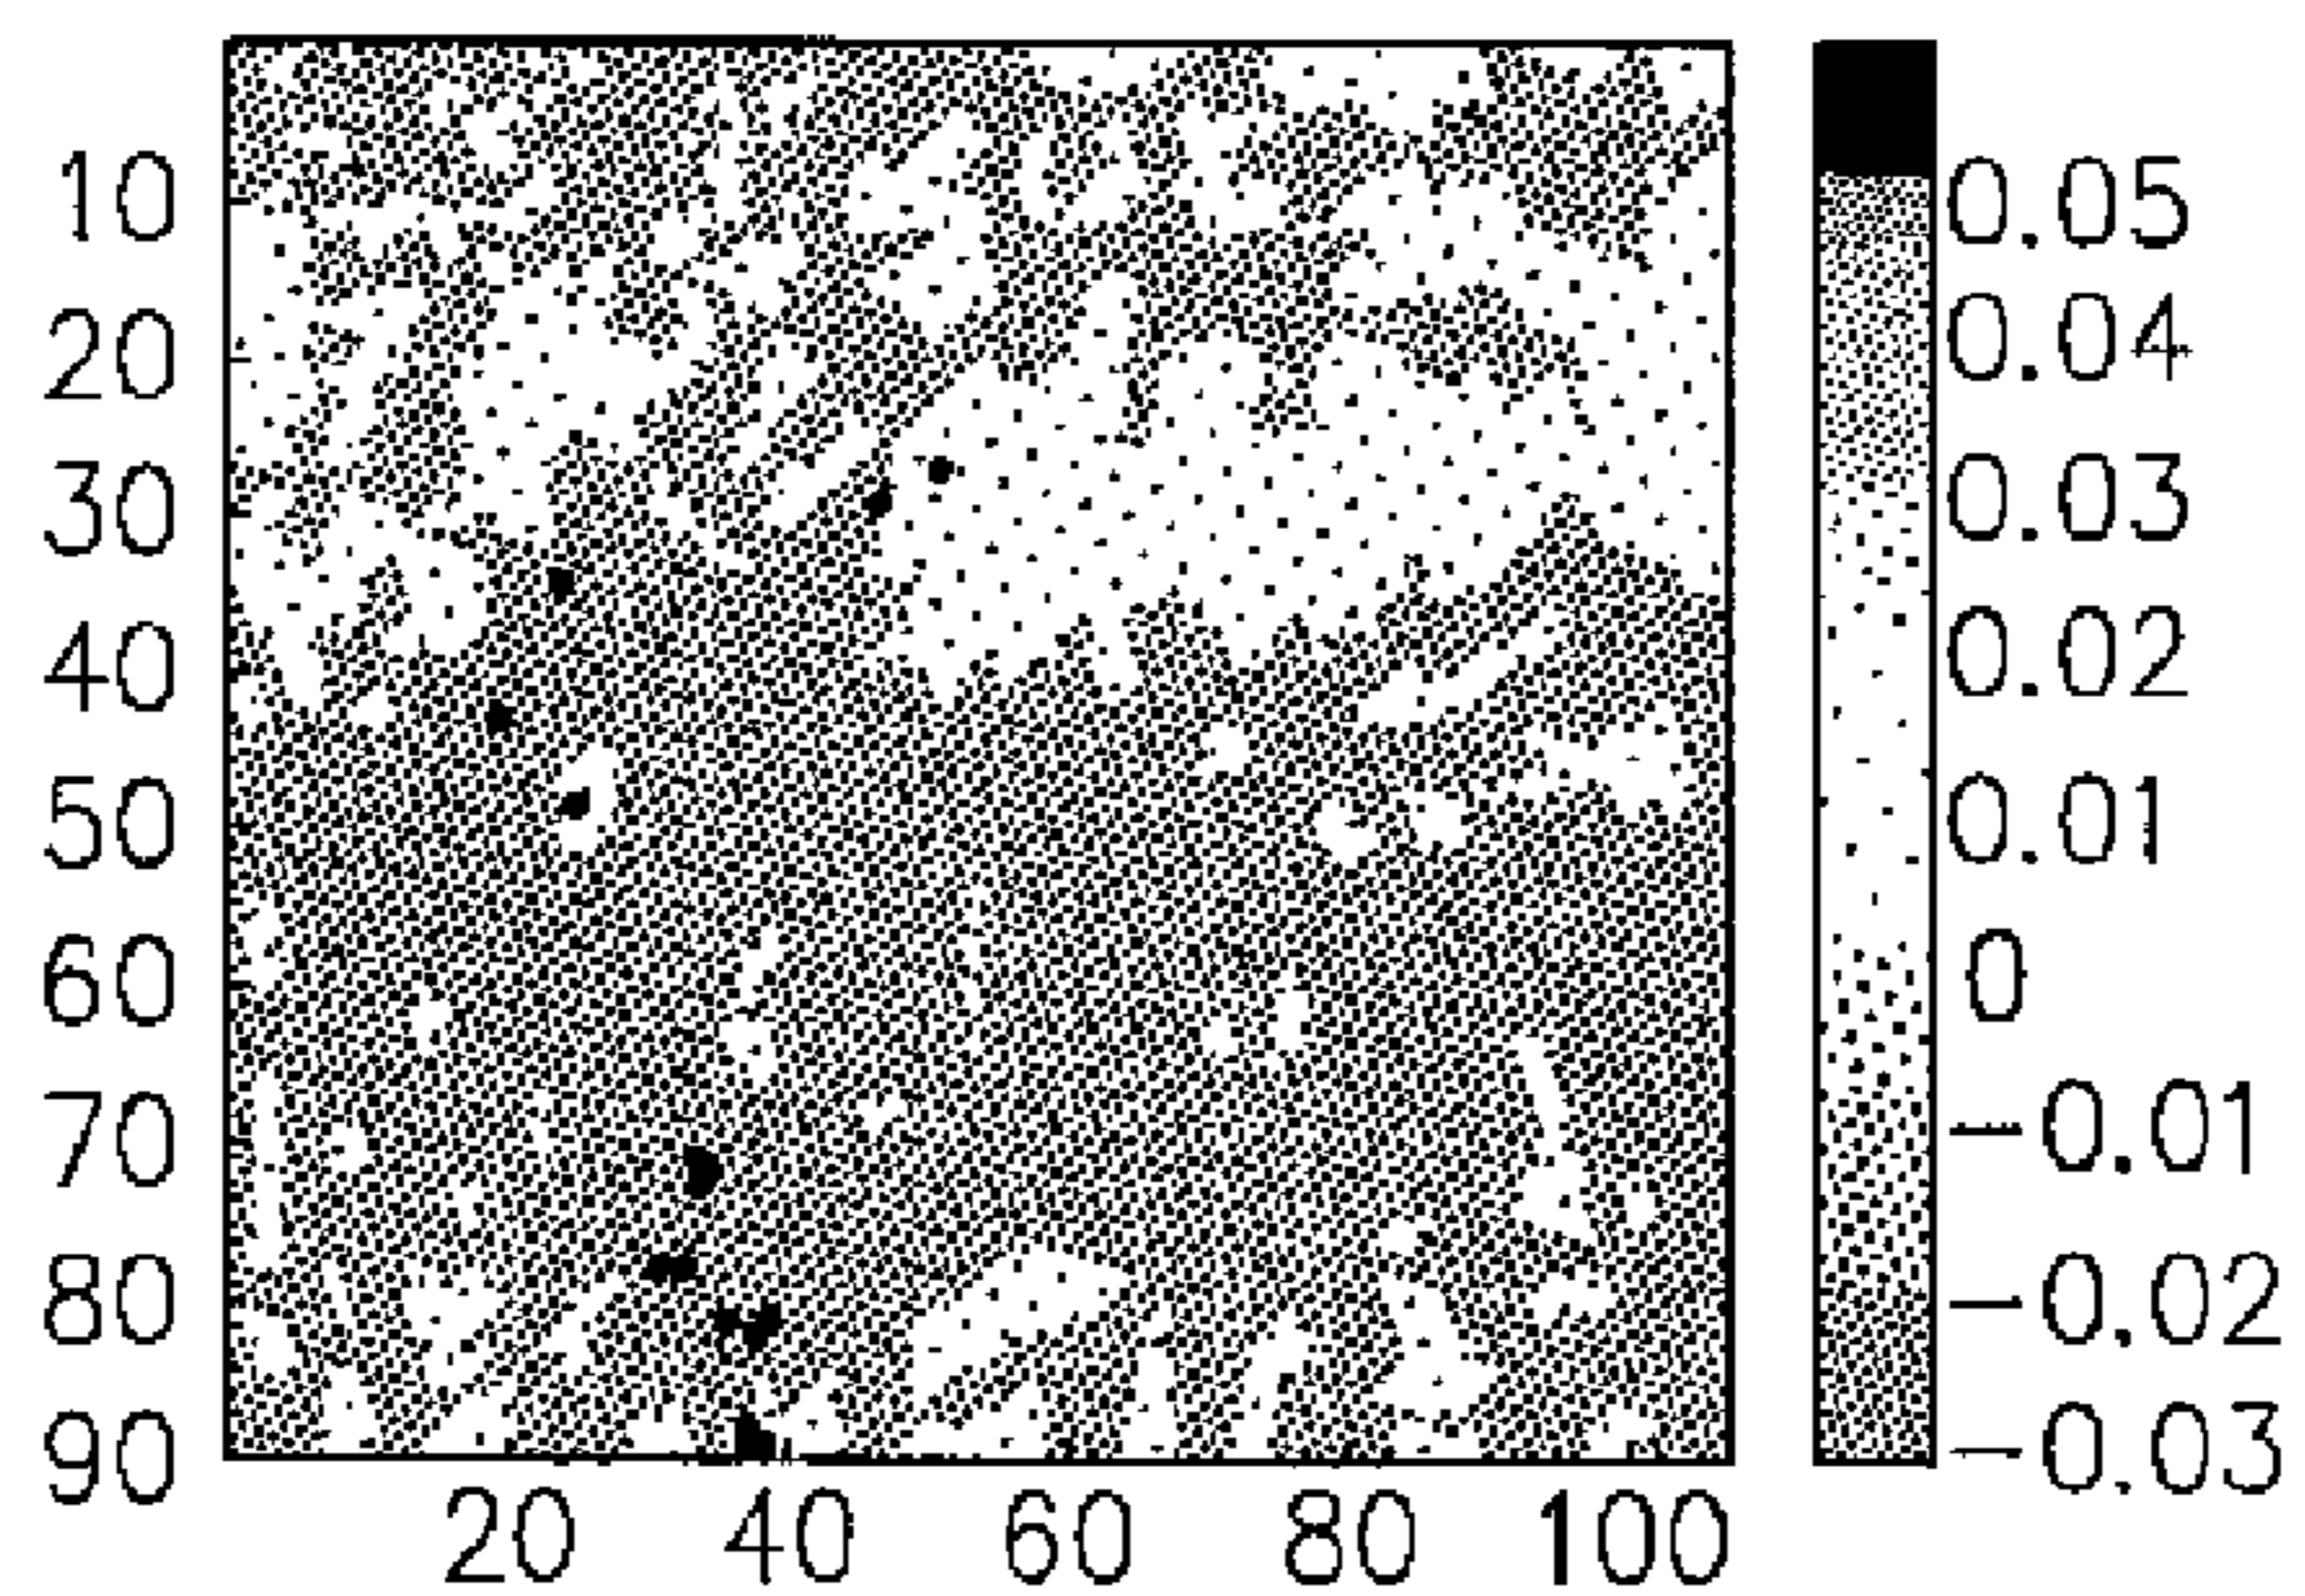
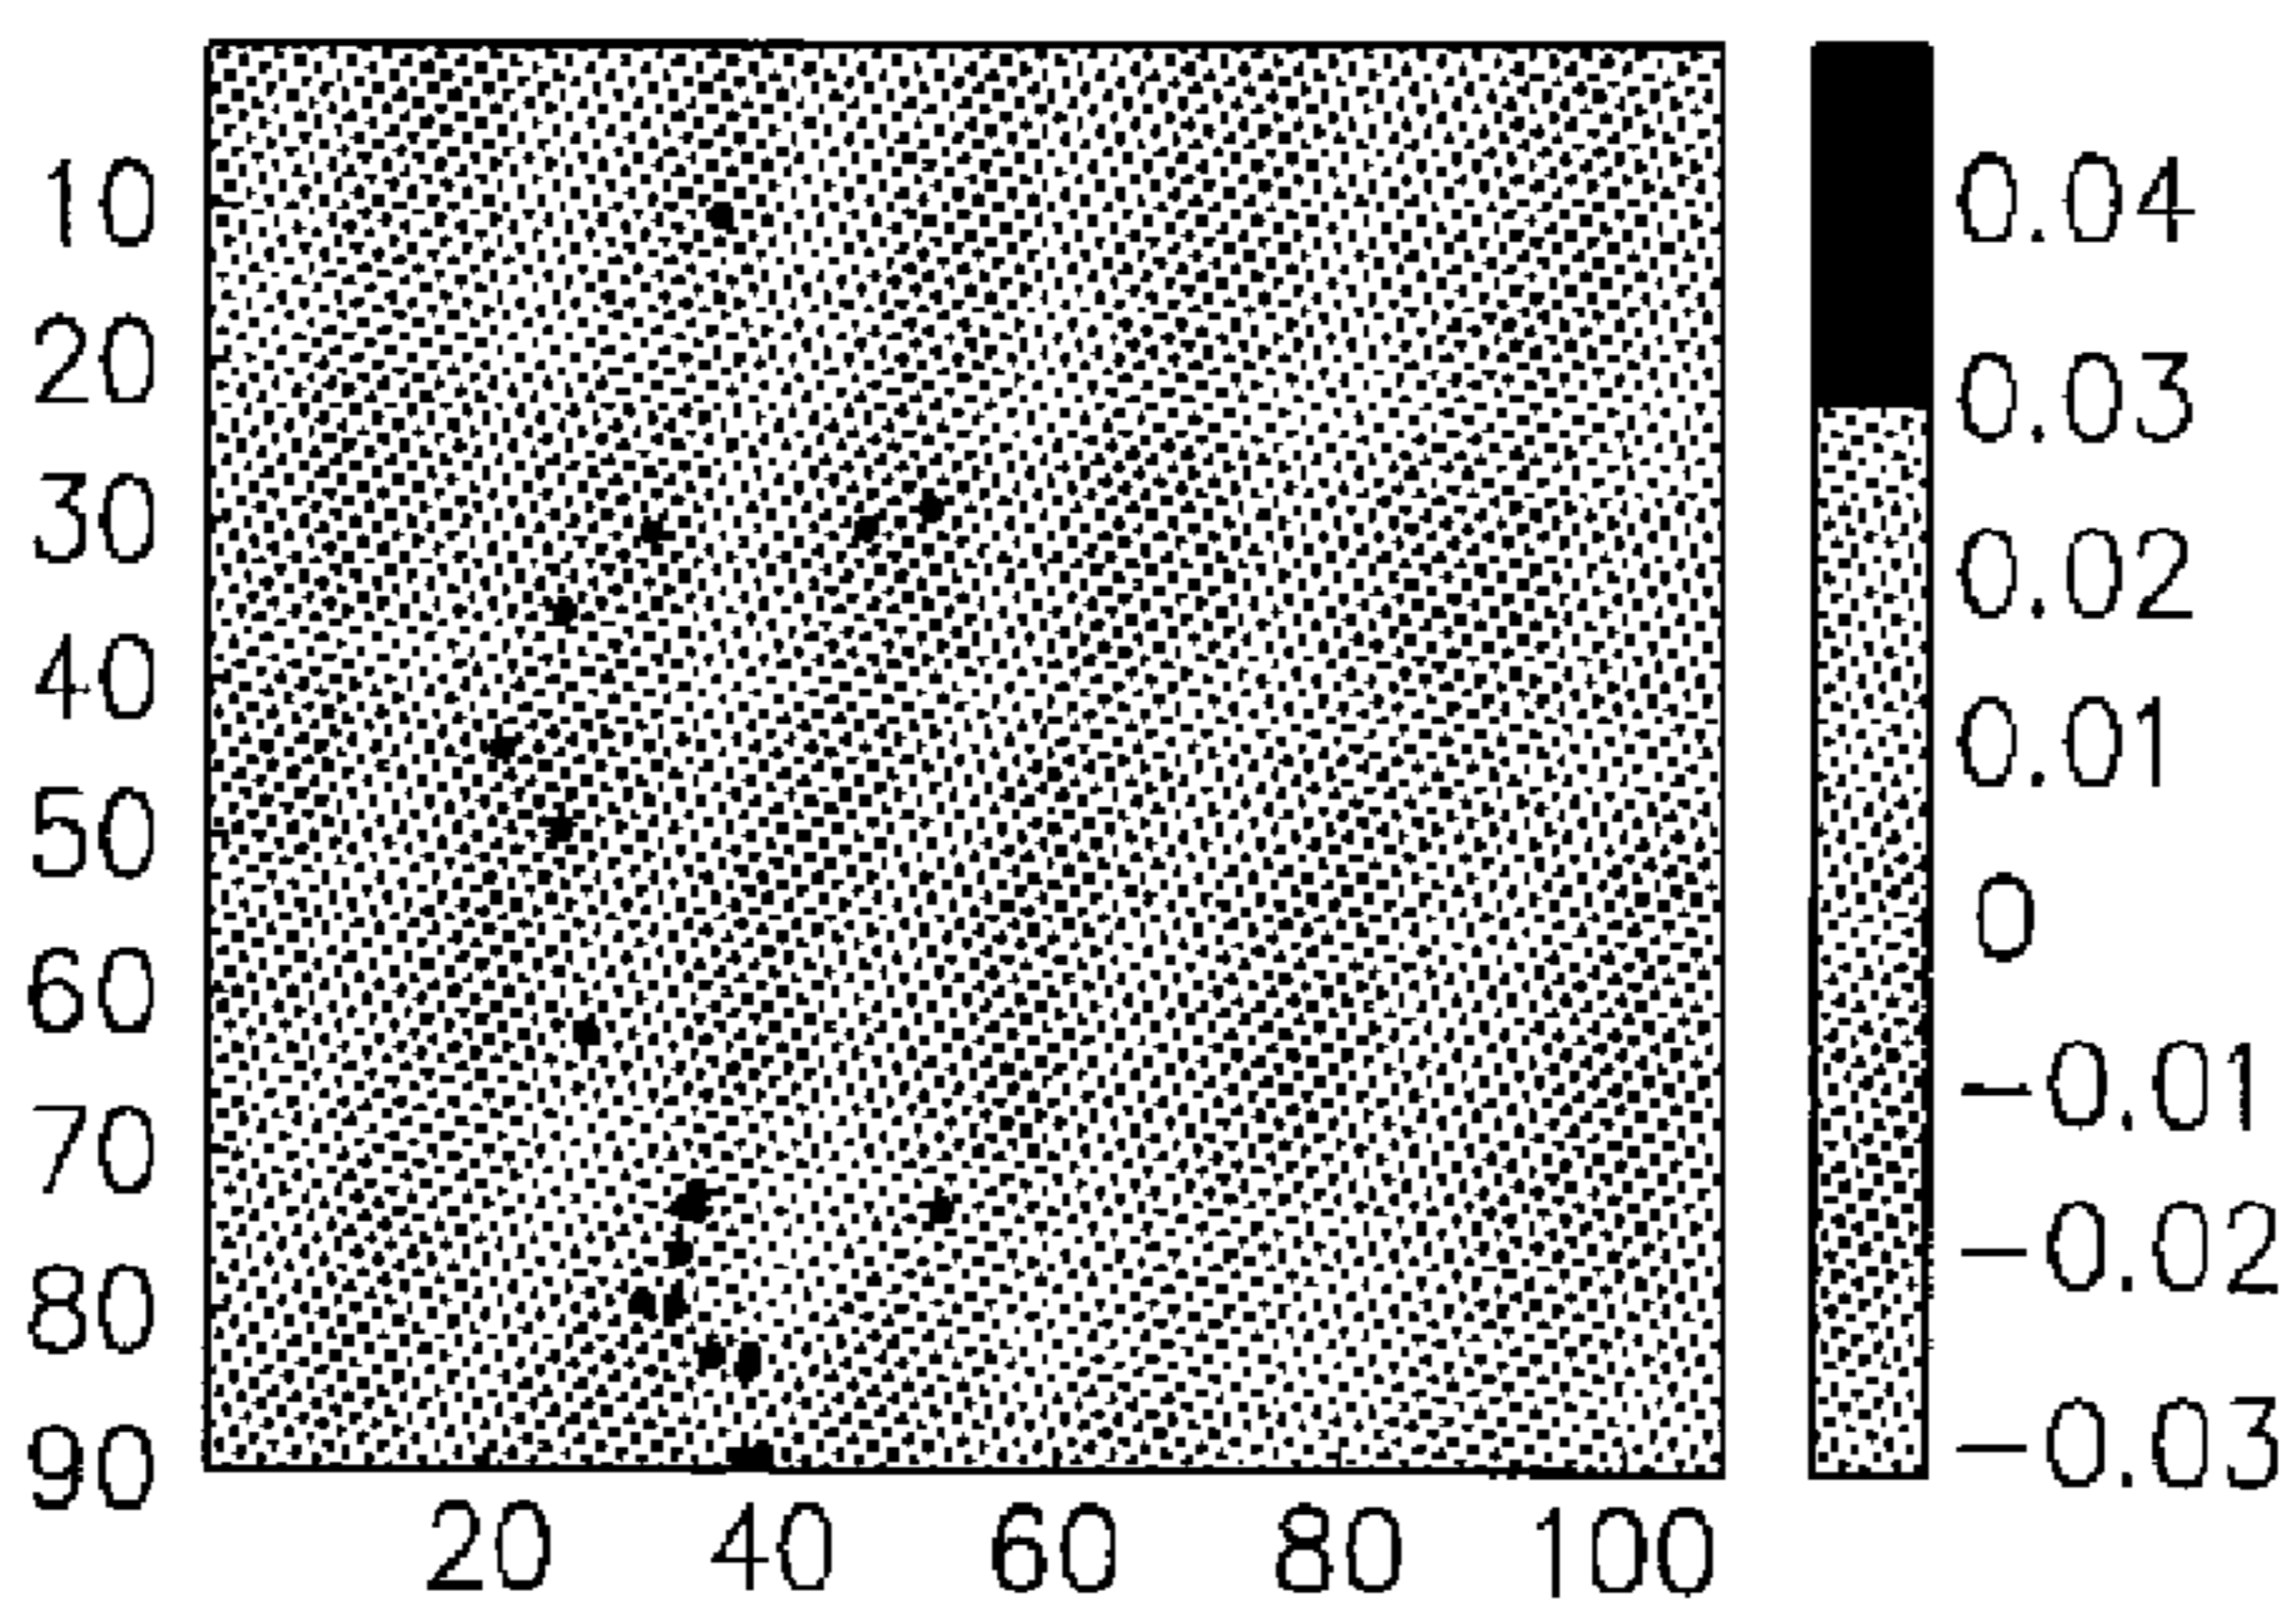
FIGS. 2A, 2B and 2C are schematic diagrams to illustrate an example of the image data processing performed in the image processing part of the detecting device.

An image processing part **302** in the detecting device **3** is for processing the thermal image data input into the inputting part **301** in accordance with a predetermined image data processing procedure. FIGS. 2A, 2B and 2C are schematic diagrams to illustrate an example of the image data processing performed in the image processing part **302** of the detecting device **3**. FIG. 2A shows thermal image data input into the inputting part **301**. FIG. 2B shows Laplacian-processed thermal image data where the temperature is converted into Laplacian value. FIG. 2C shows a binarized image of the thermal image data of Laplacian value. Laplacian processing is performed in order to reduce a disturbance in the thermal image data (FIG. 2A) provided by temperature irregularity, and also to detect the heat balance taking place at the surface and surface layer of the steel sheet **100** as described later. A surface layer is defined as a part very close to the surface of the material and experientially about one fourth of the thickness region from the surface can be regarded as the surface layer in the case of a 1-2 mm thick steel sheet.

Since the absolute value of Laplacian  $\Delta_{xy}T$  at the position of the defect **101** is detected larger in the inspection area S, it can be said that Laplacian processing can provide the image where the defect **101** is extracted (see the black colored portion in FIG. 2C). Also the type of the defect **101** can be determined based on whether the value of Laplacian  $\Delta_{xy}T$  is positive or negative.

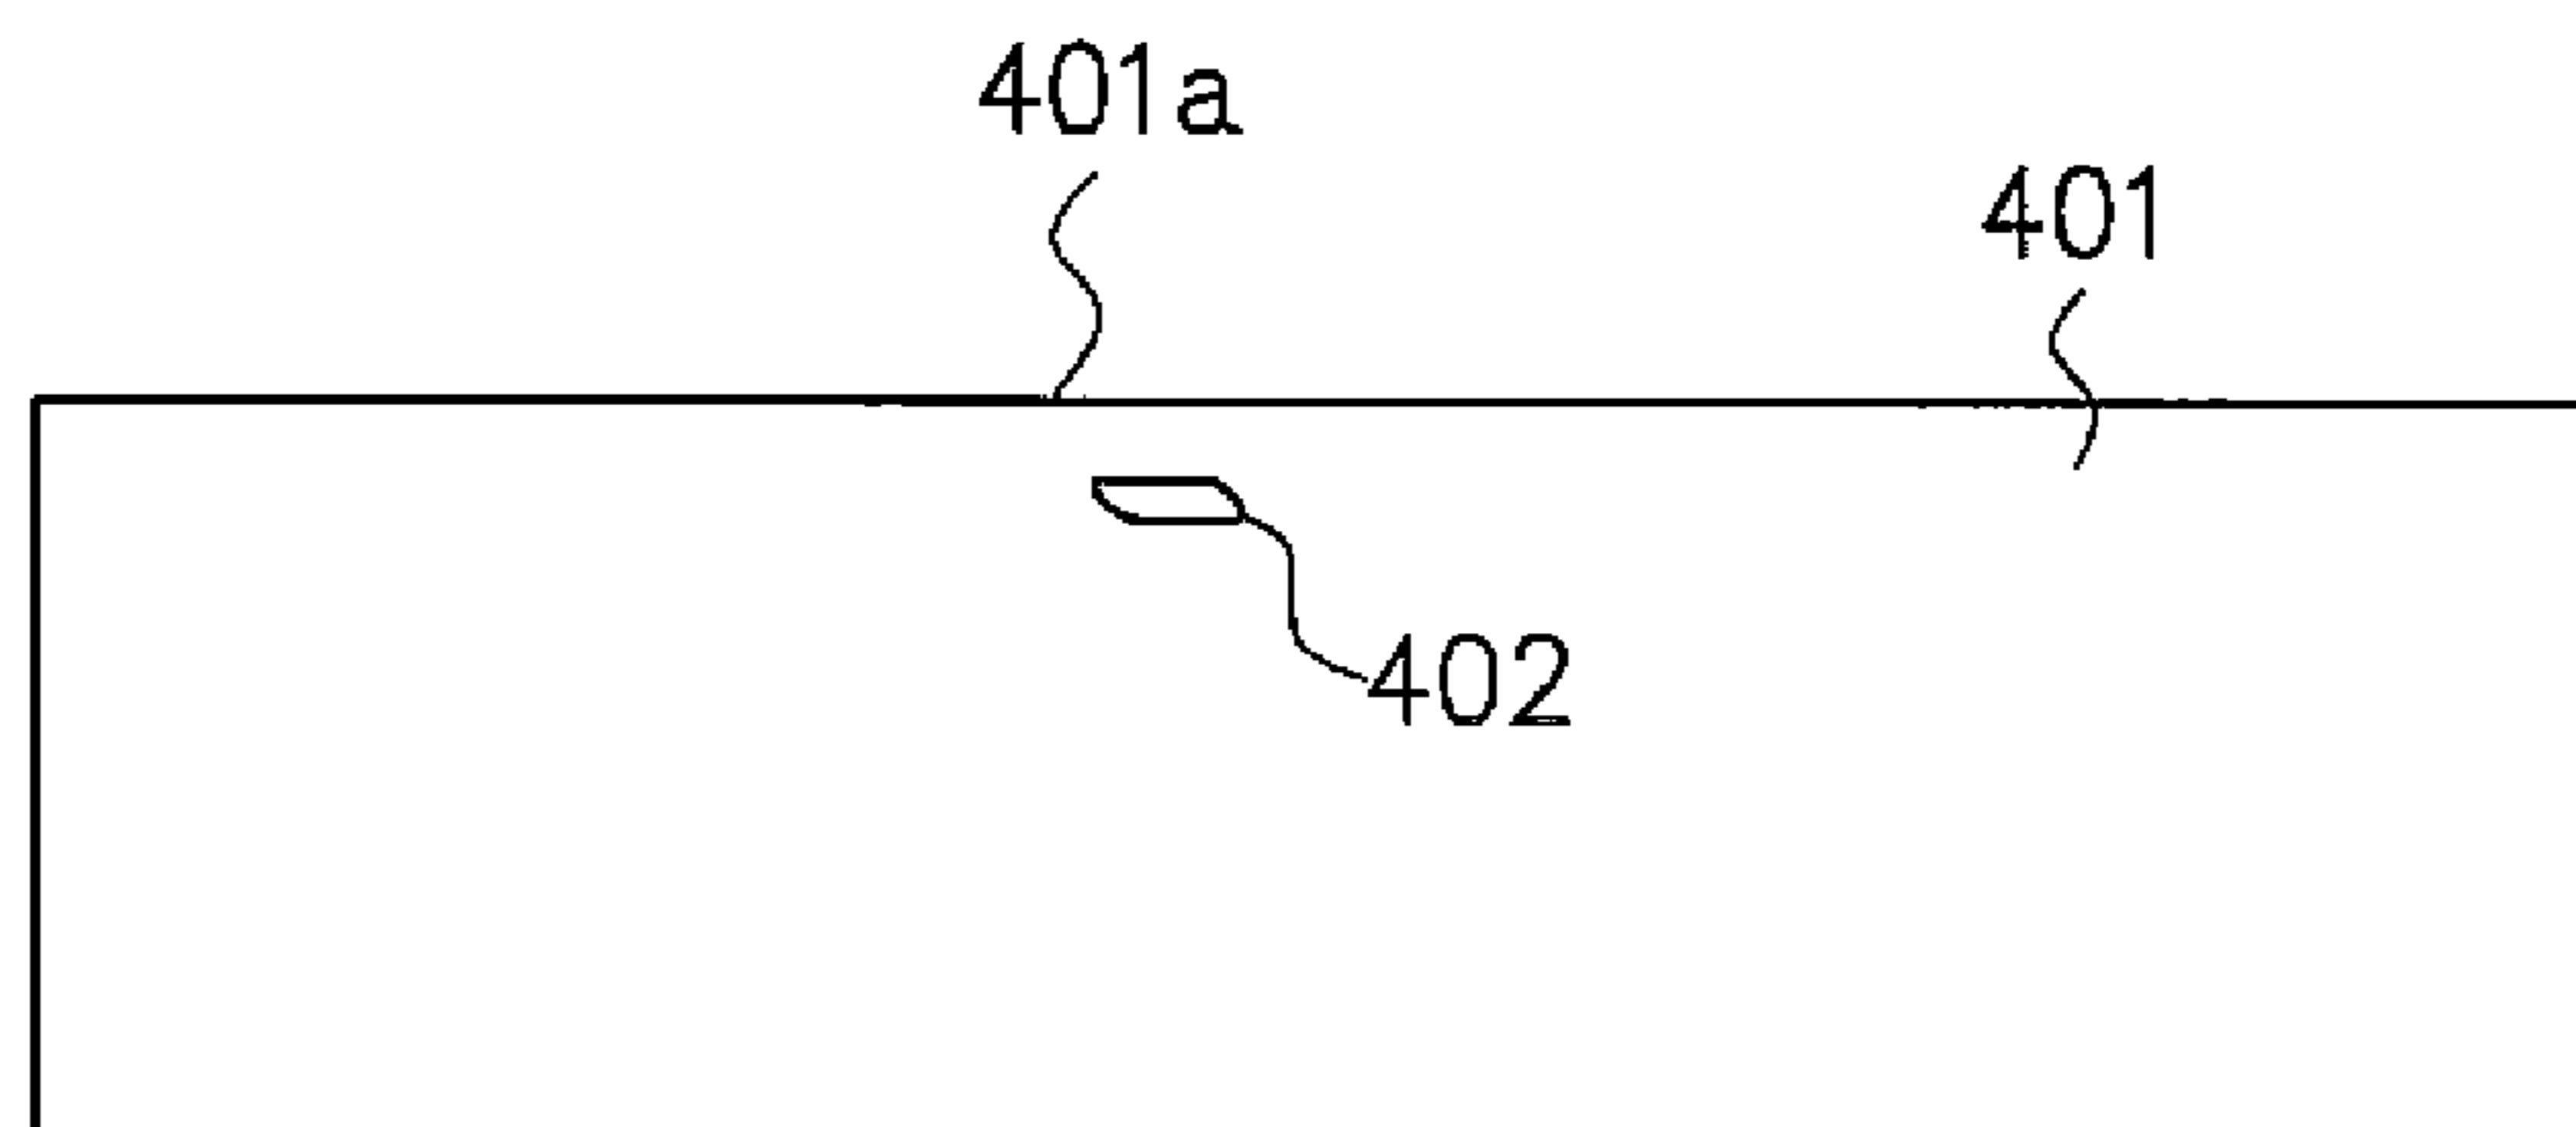
FIG. 4 is an explanatory diagram for explaining a nondestructive inspection using an infrared thermography camera.

An infrared thermography camera can be used to detect an inside defect **402** (e.g., captured foreign material or formation of void) located inside the object-to-be-inspected **401** as shown in FIG. 4. As thermal conductivity of the object-to-be-inspected **401** and that of the defect **402** are generally different, the amount of heat radiation from the surface at the position of the object-to-be-inspected **401** is different from that of the defect **402**. Consequently, the defect **402** inside the object-to-be-inspected **401** can be detected by measuring a distribution of the heat radiation amount with time over the surface of the object-to-be-inspected **401**.

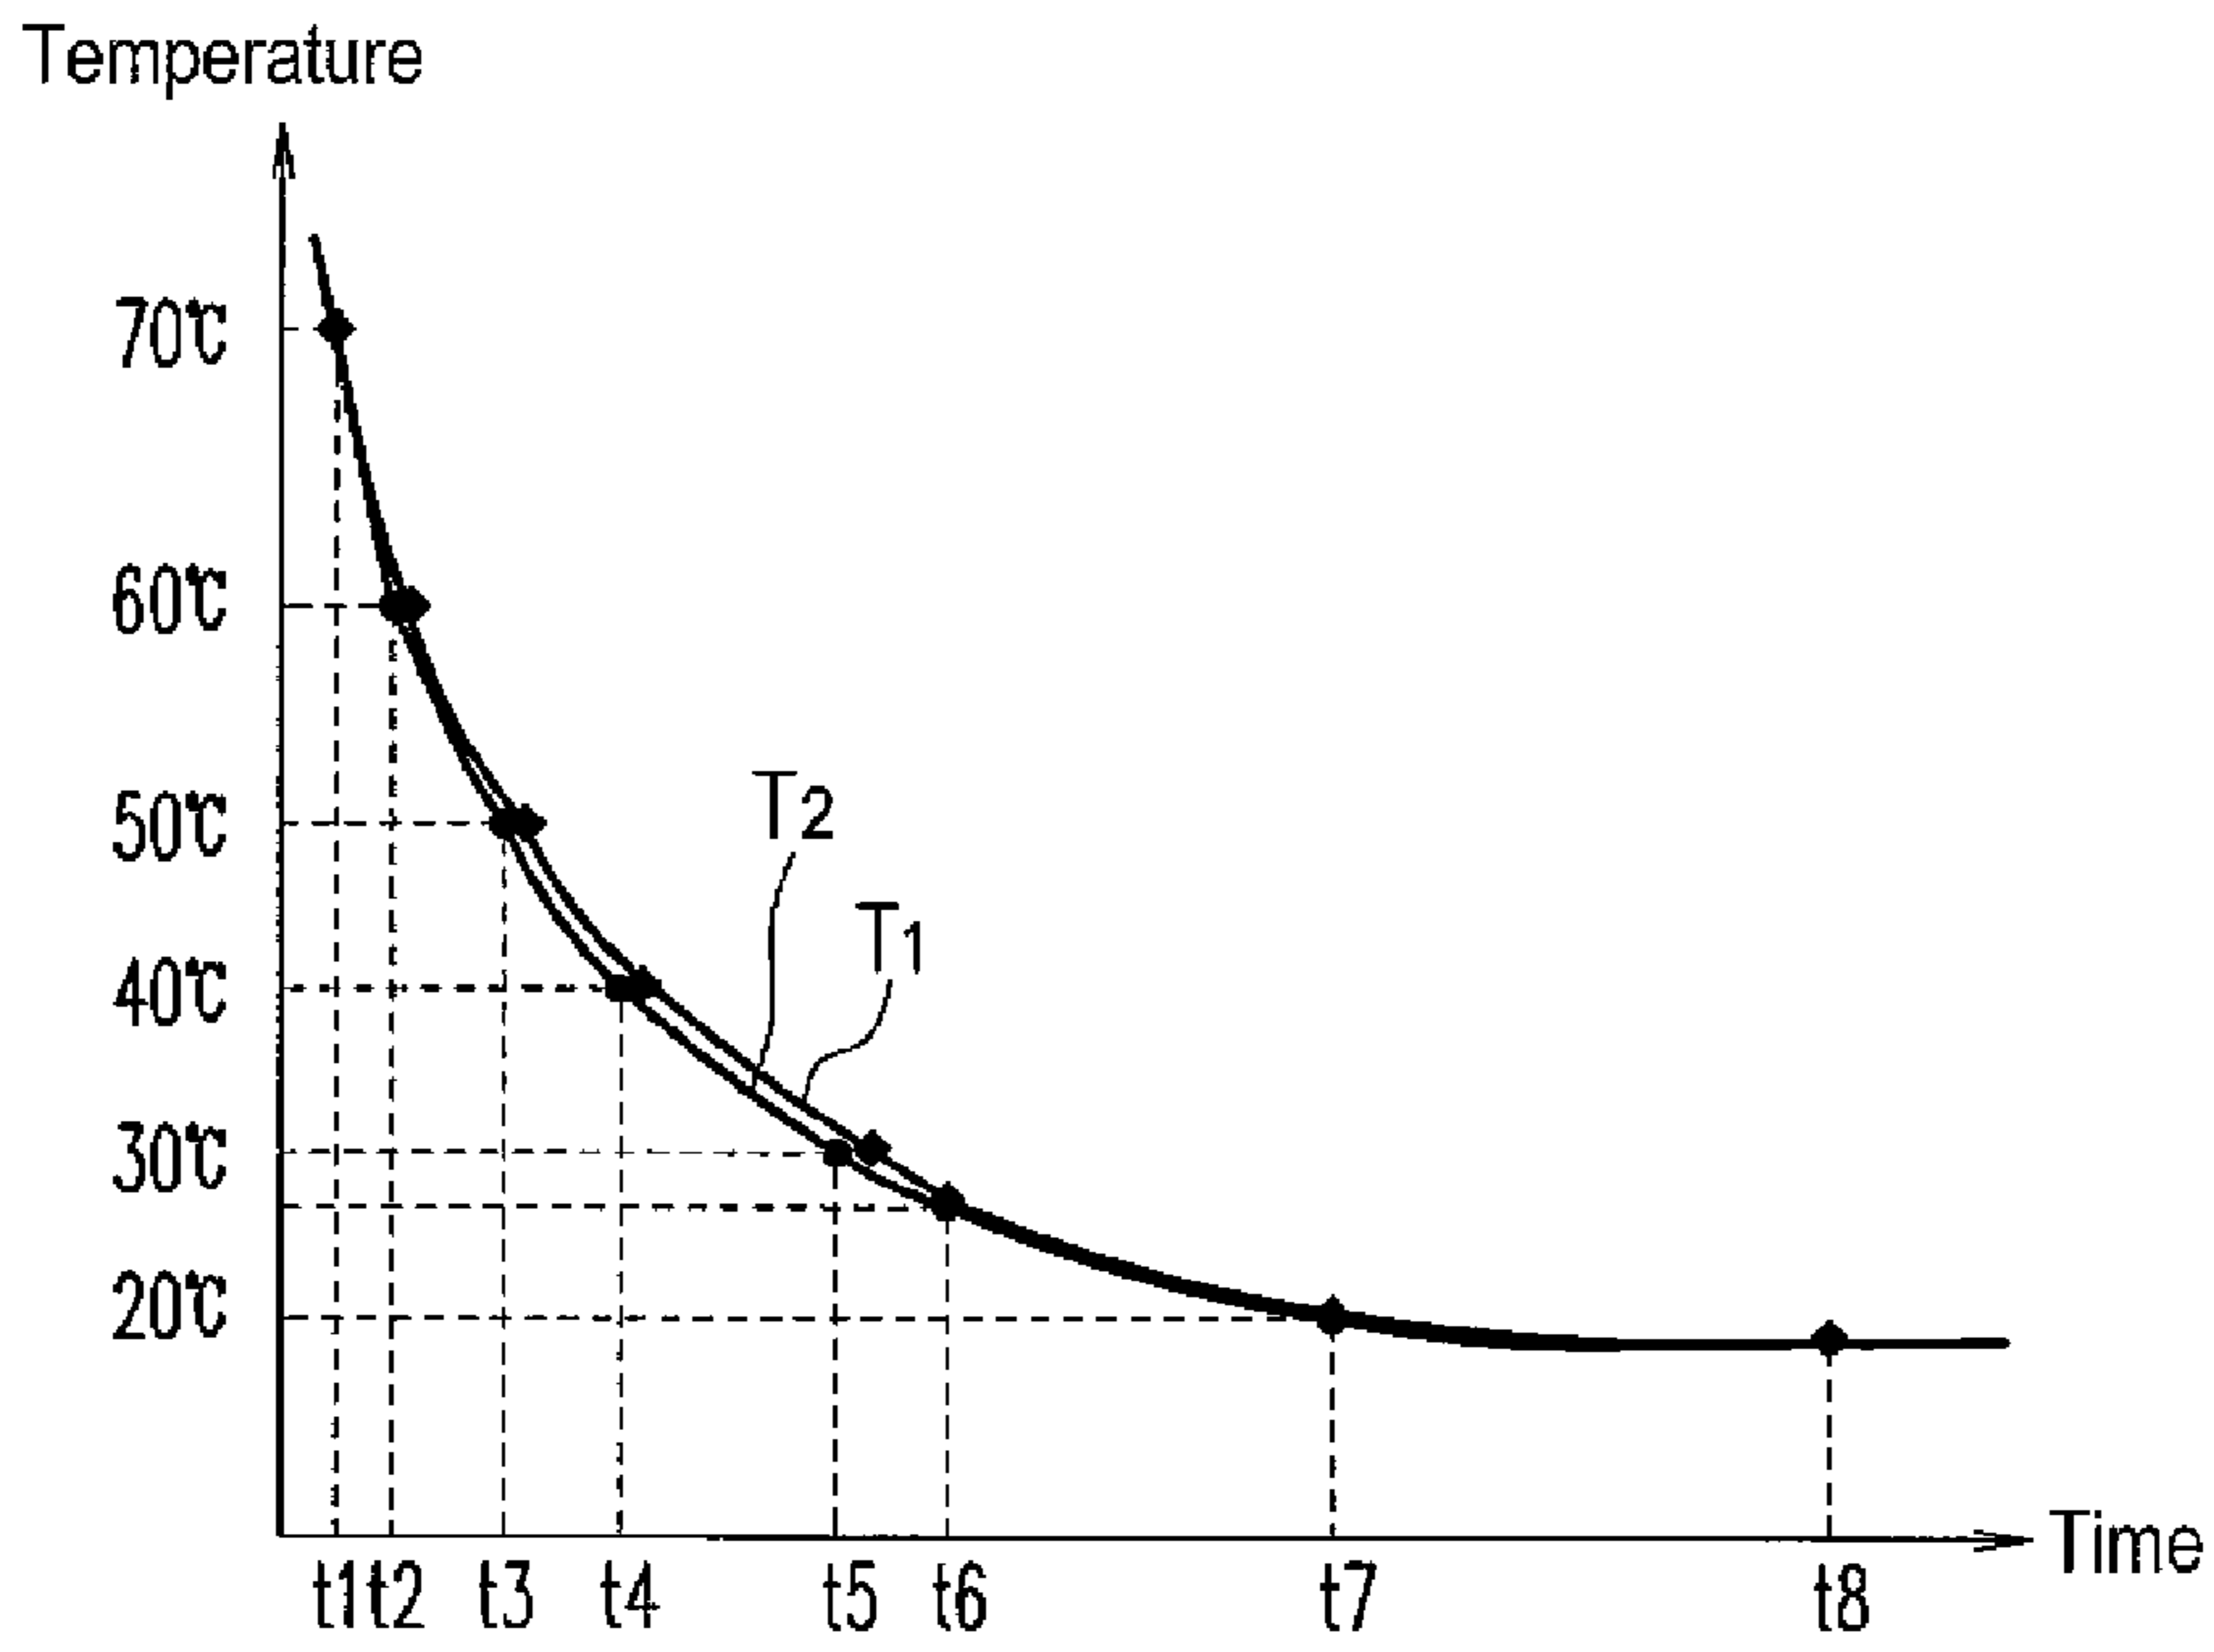
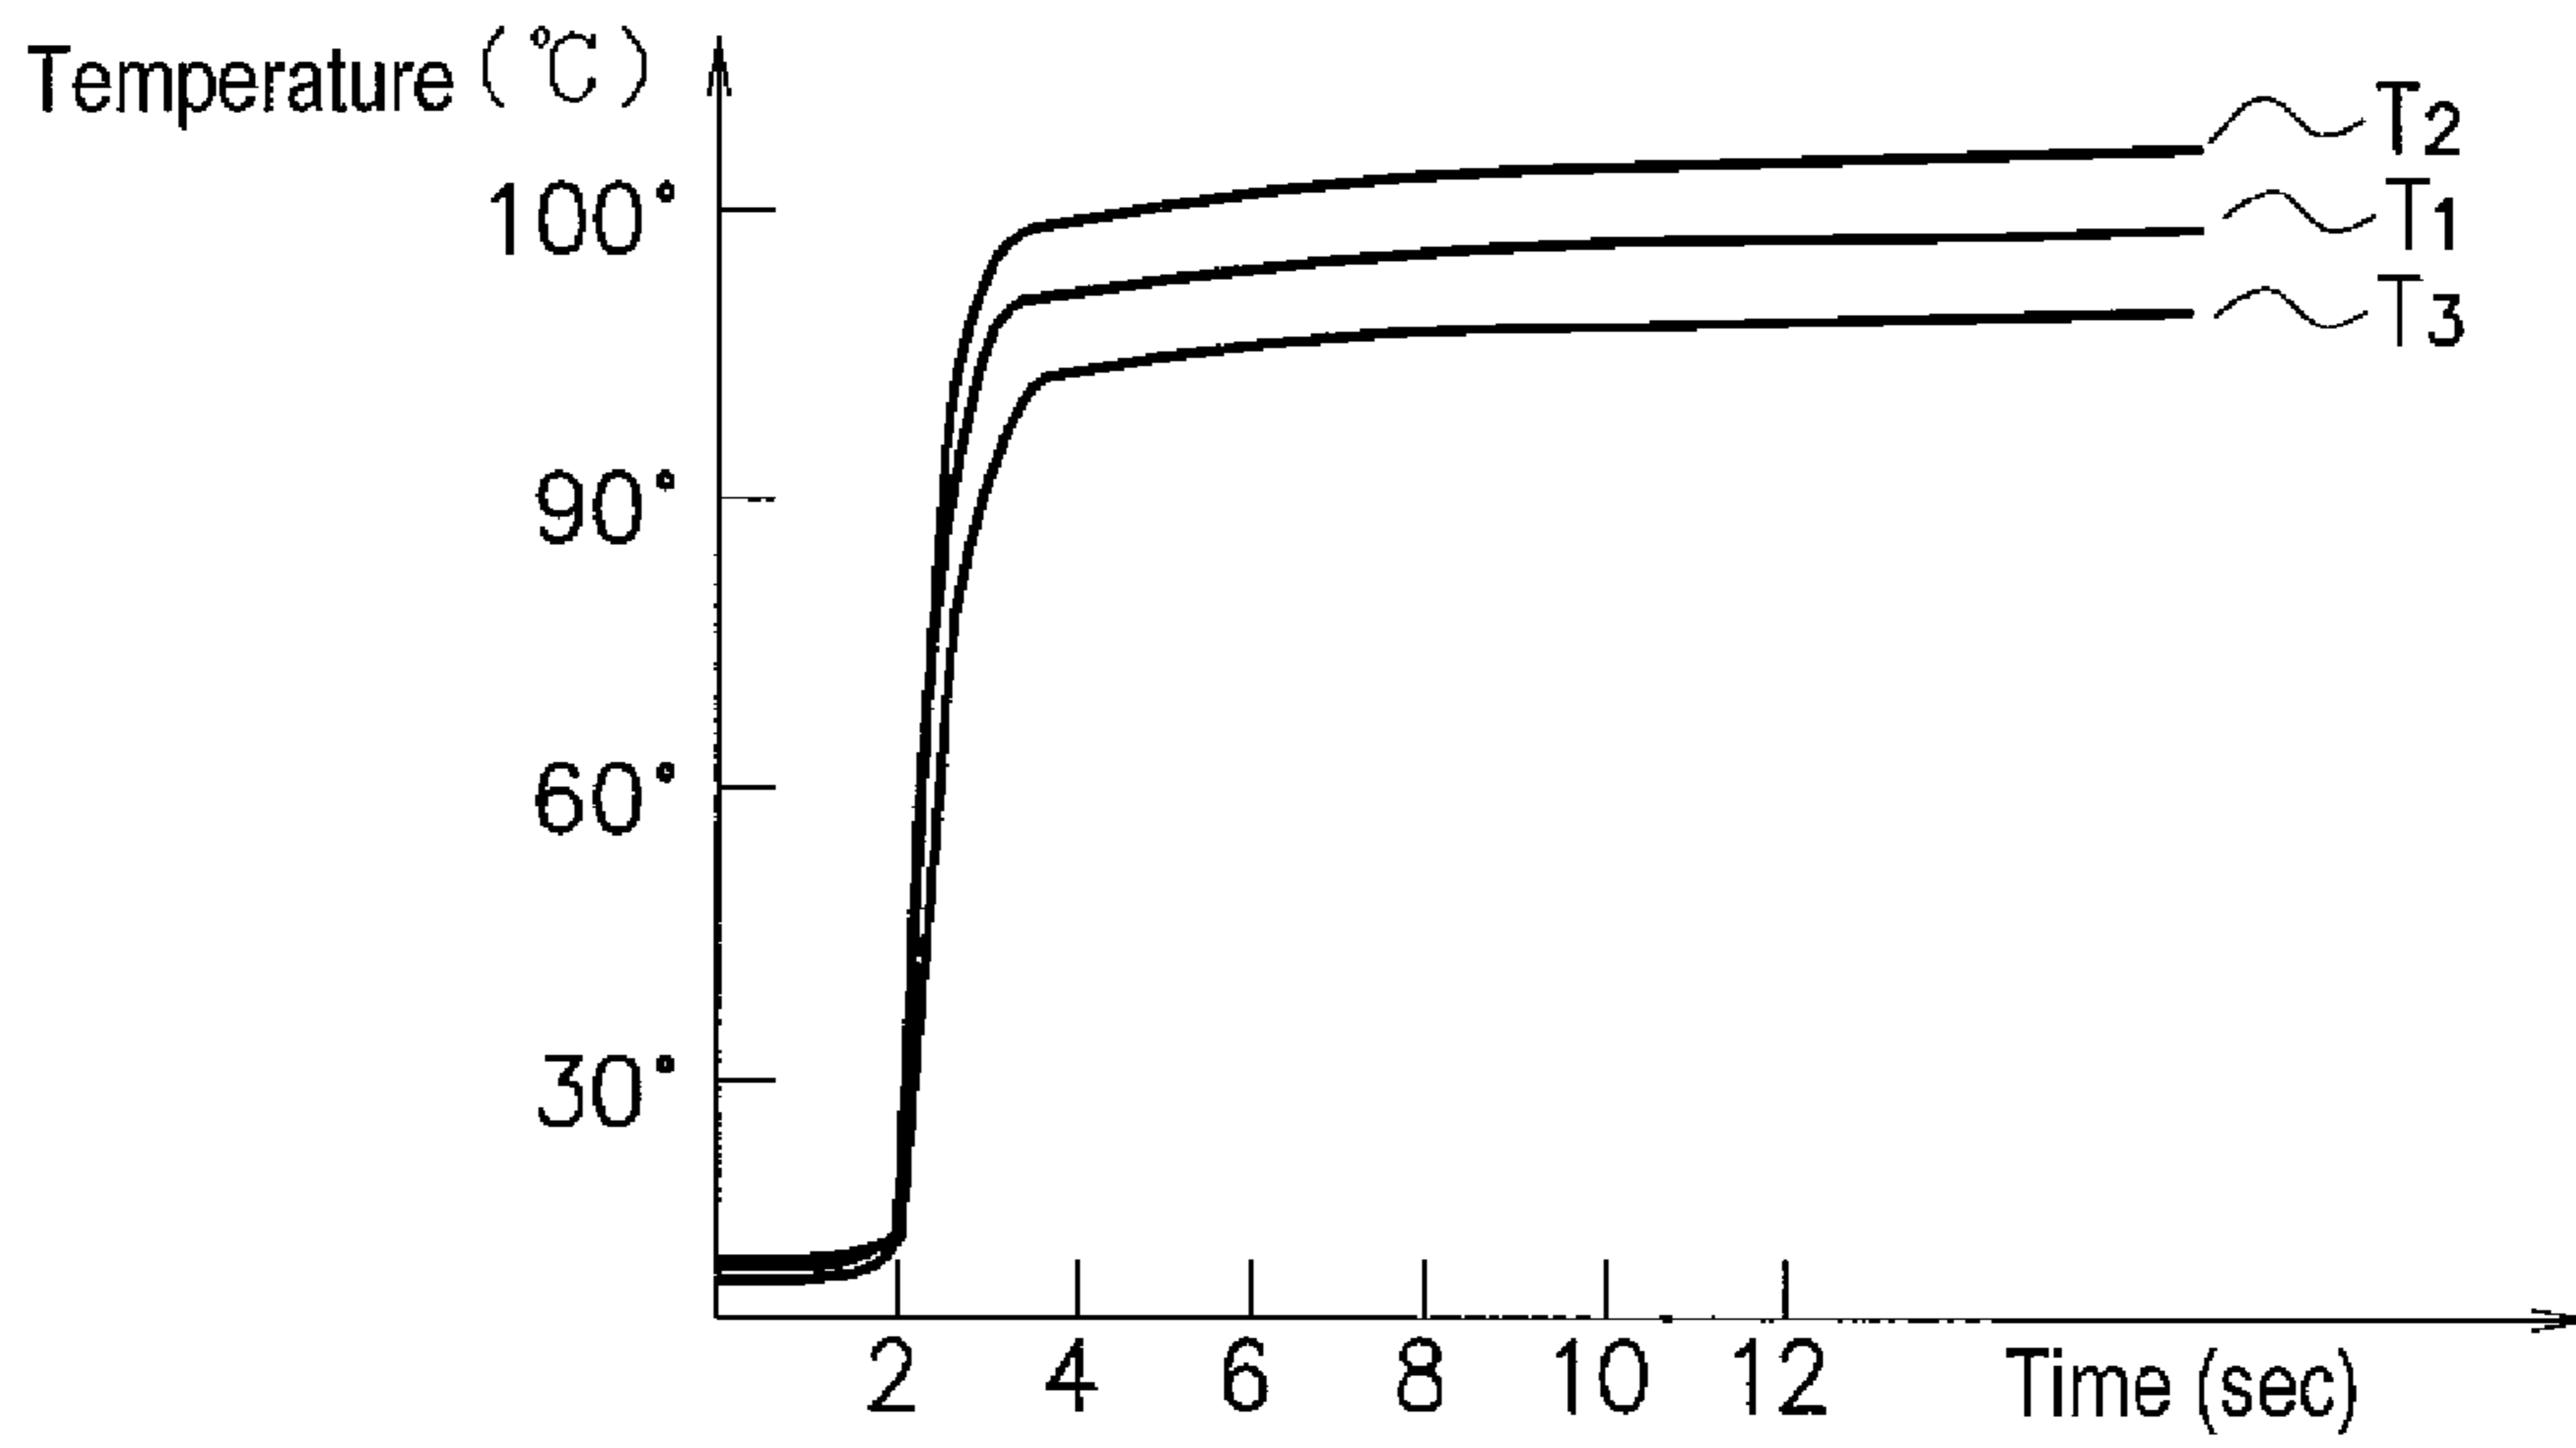
FIGS. 6A/6B are a graph showing temperature characteristics curves representing surface temperature based on thermal image data in a cooling-down/being-heated-up process obtained by an infrared thermography camera.
