US008506159B2

(54) **METHOD FOR DETECTING DEFECT IN MATERIAL AND SYSTEM FOR THE METHOD**

(73) Assignee: **Nippon Steel & Sumitomo Metal Corporation**, Tokyo (JP)

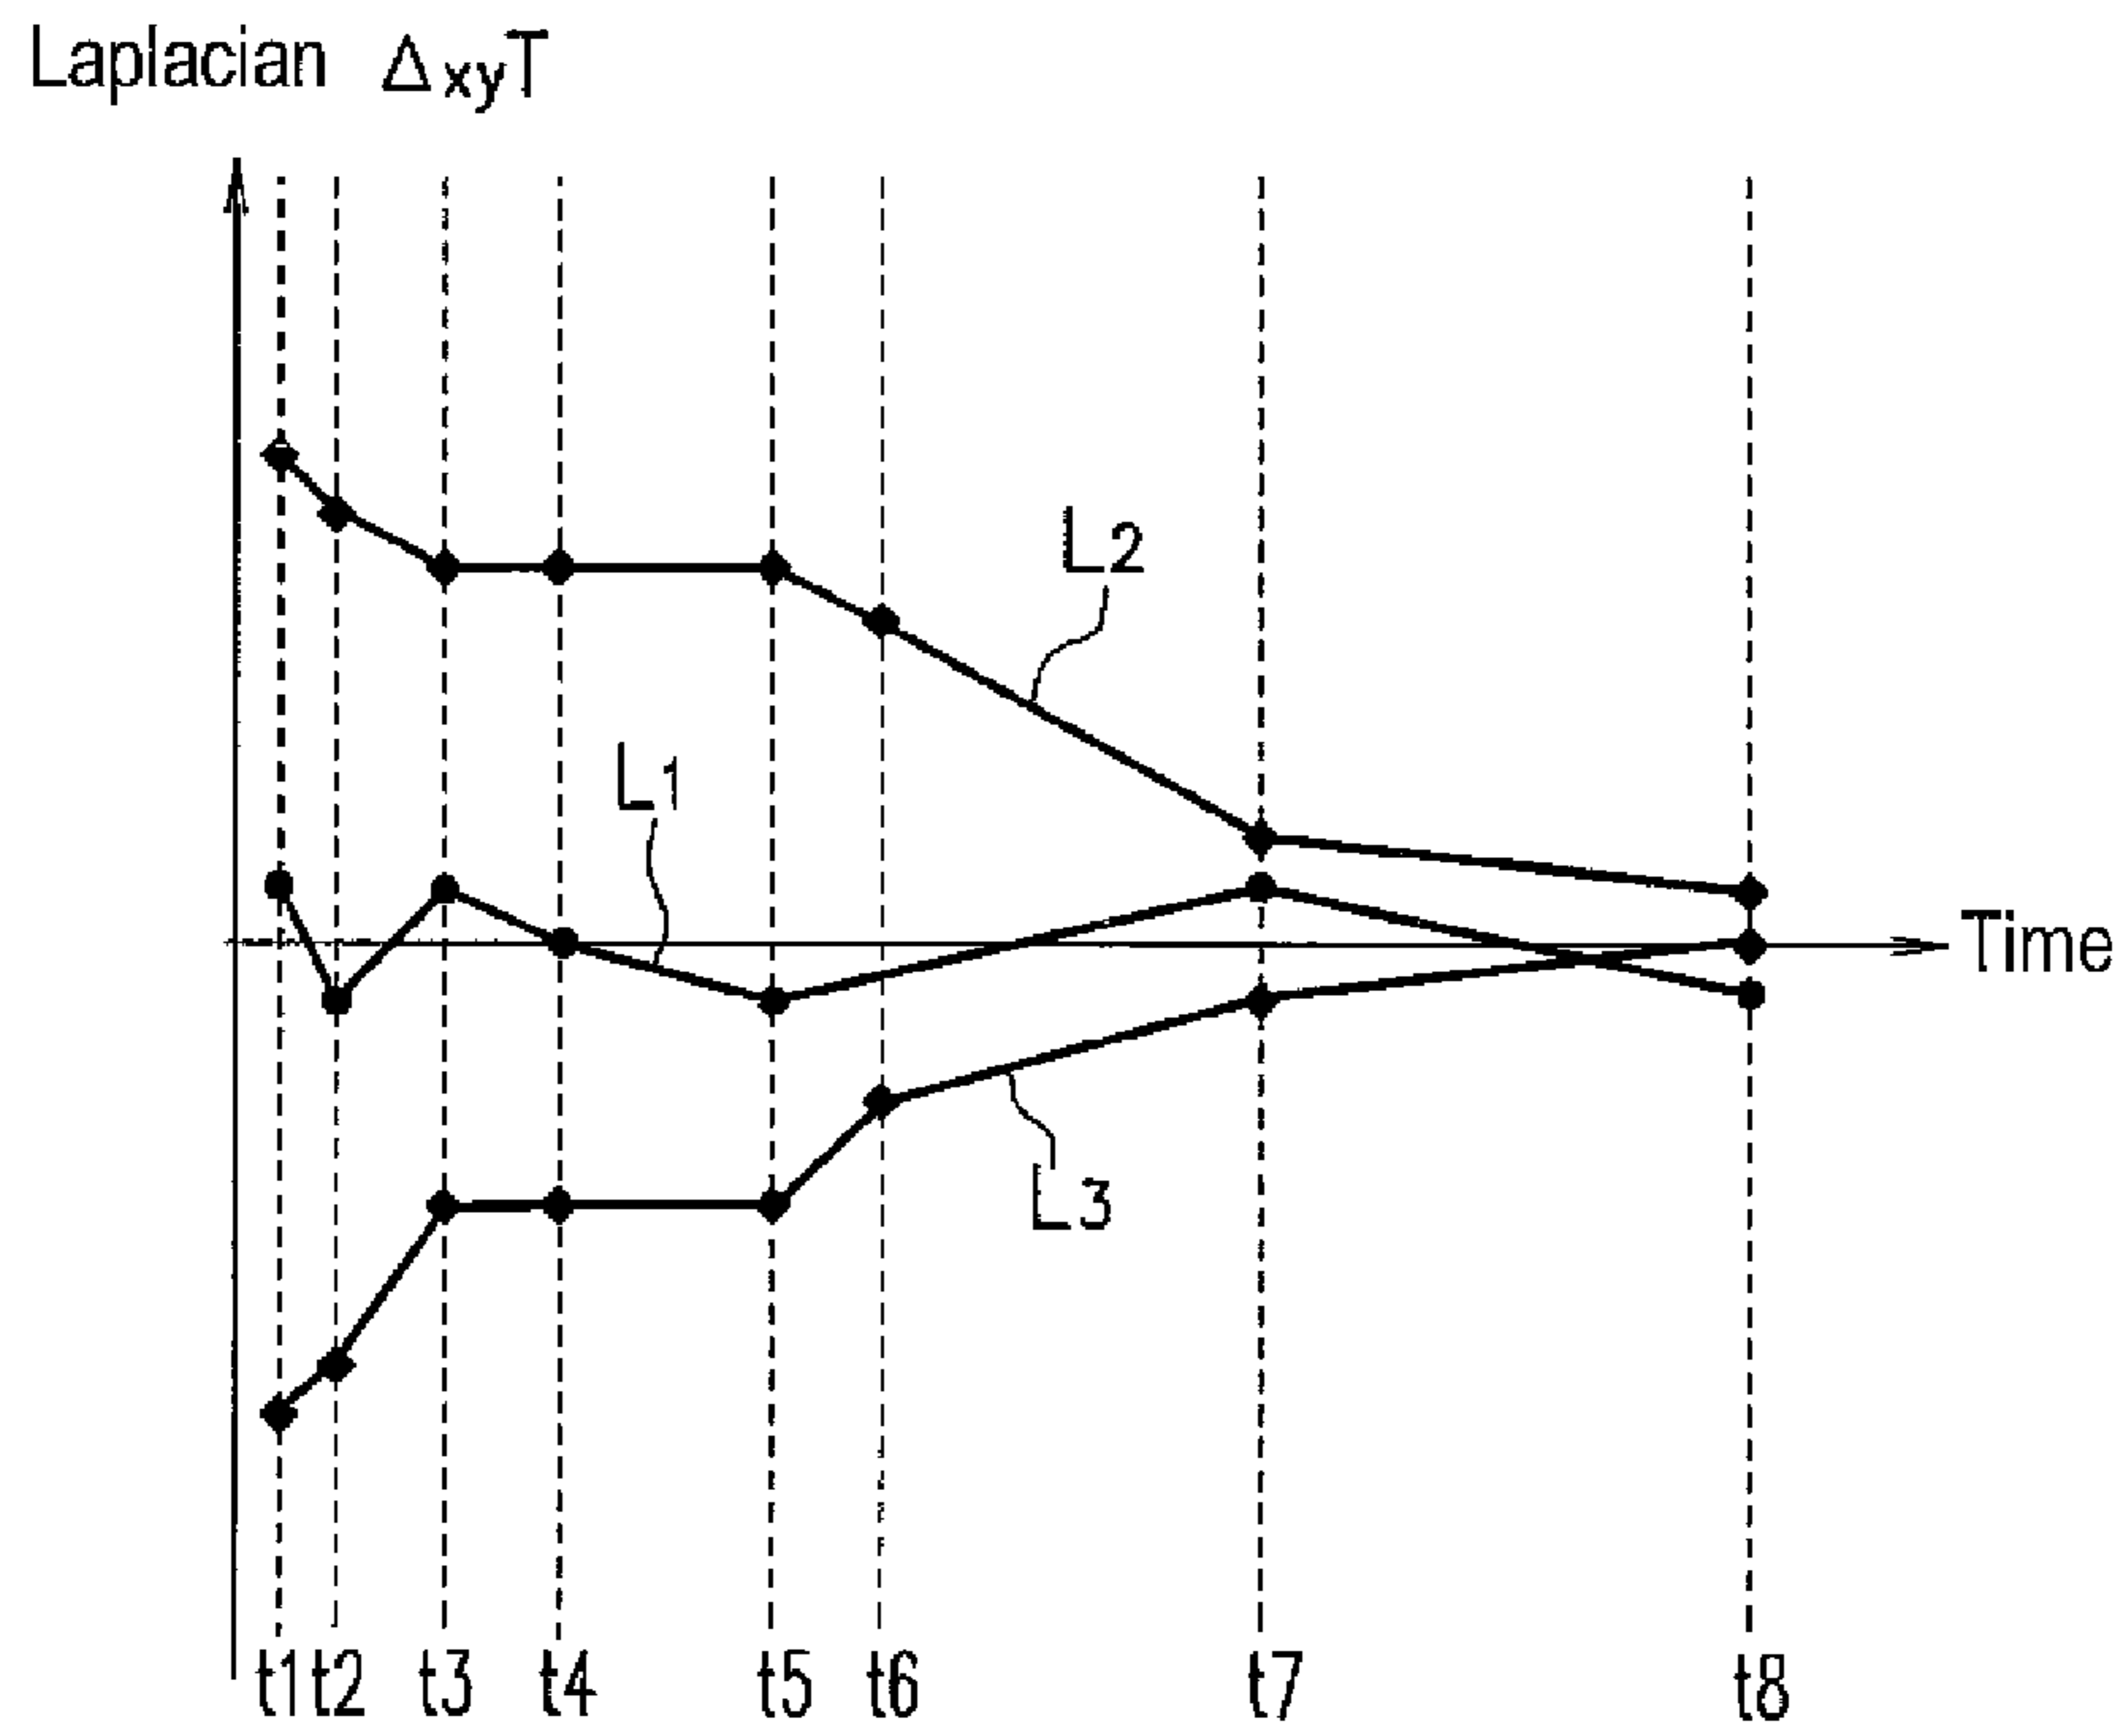
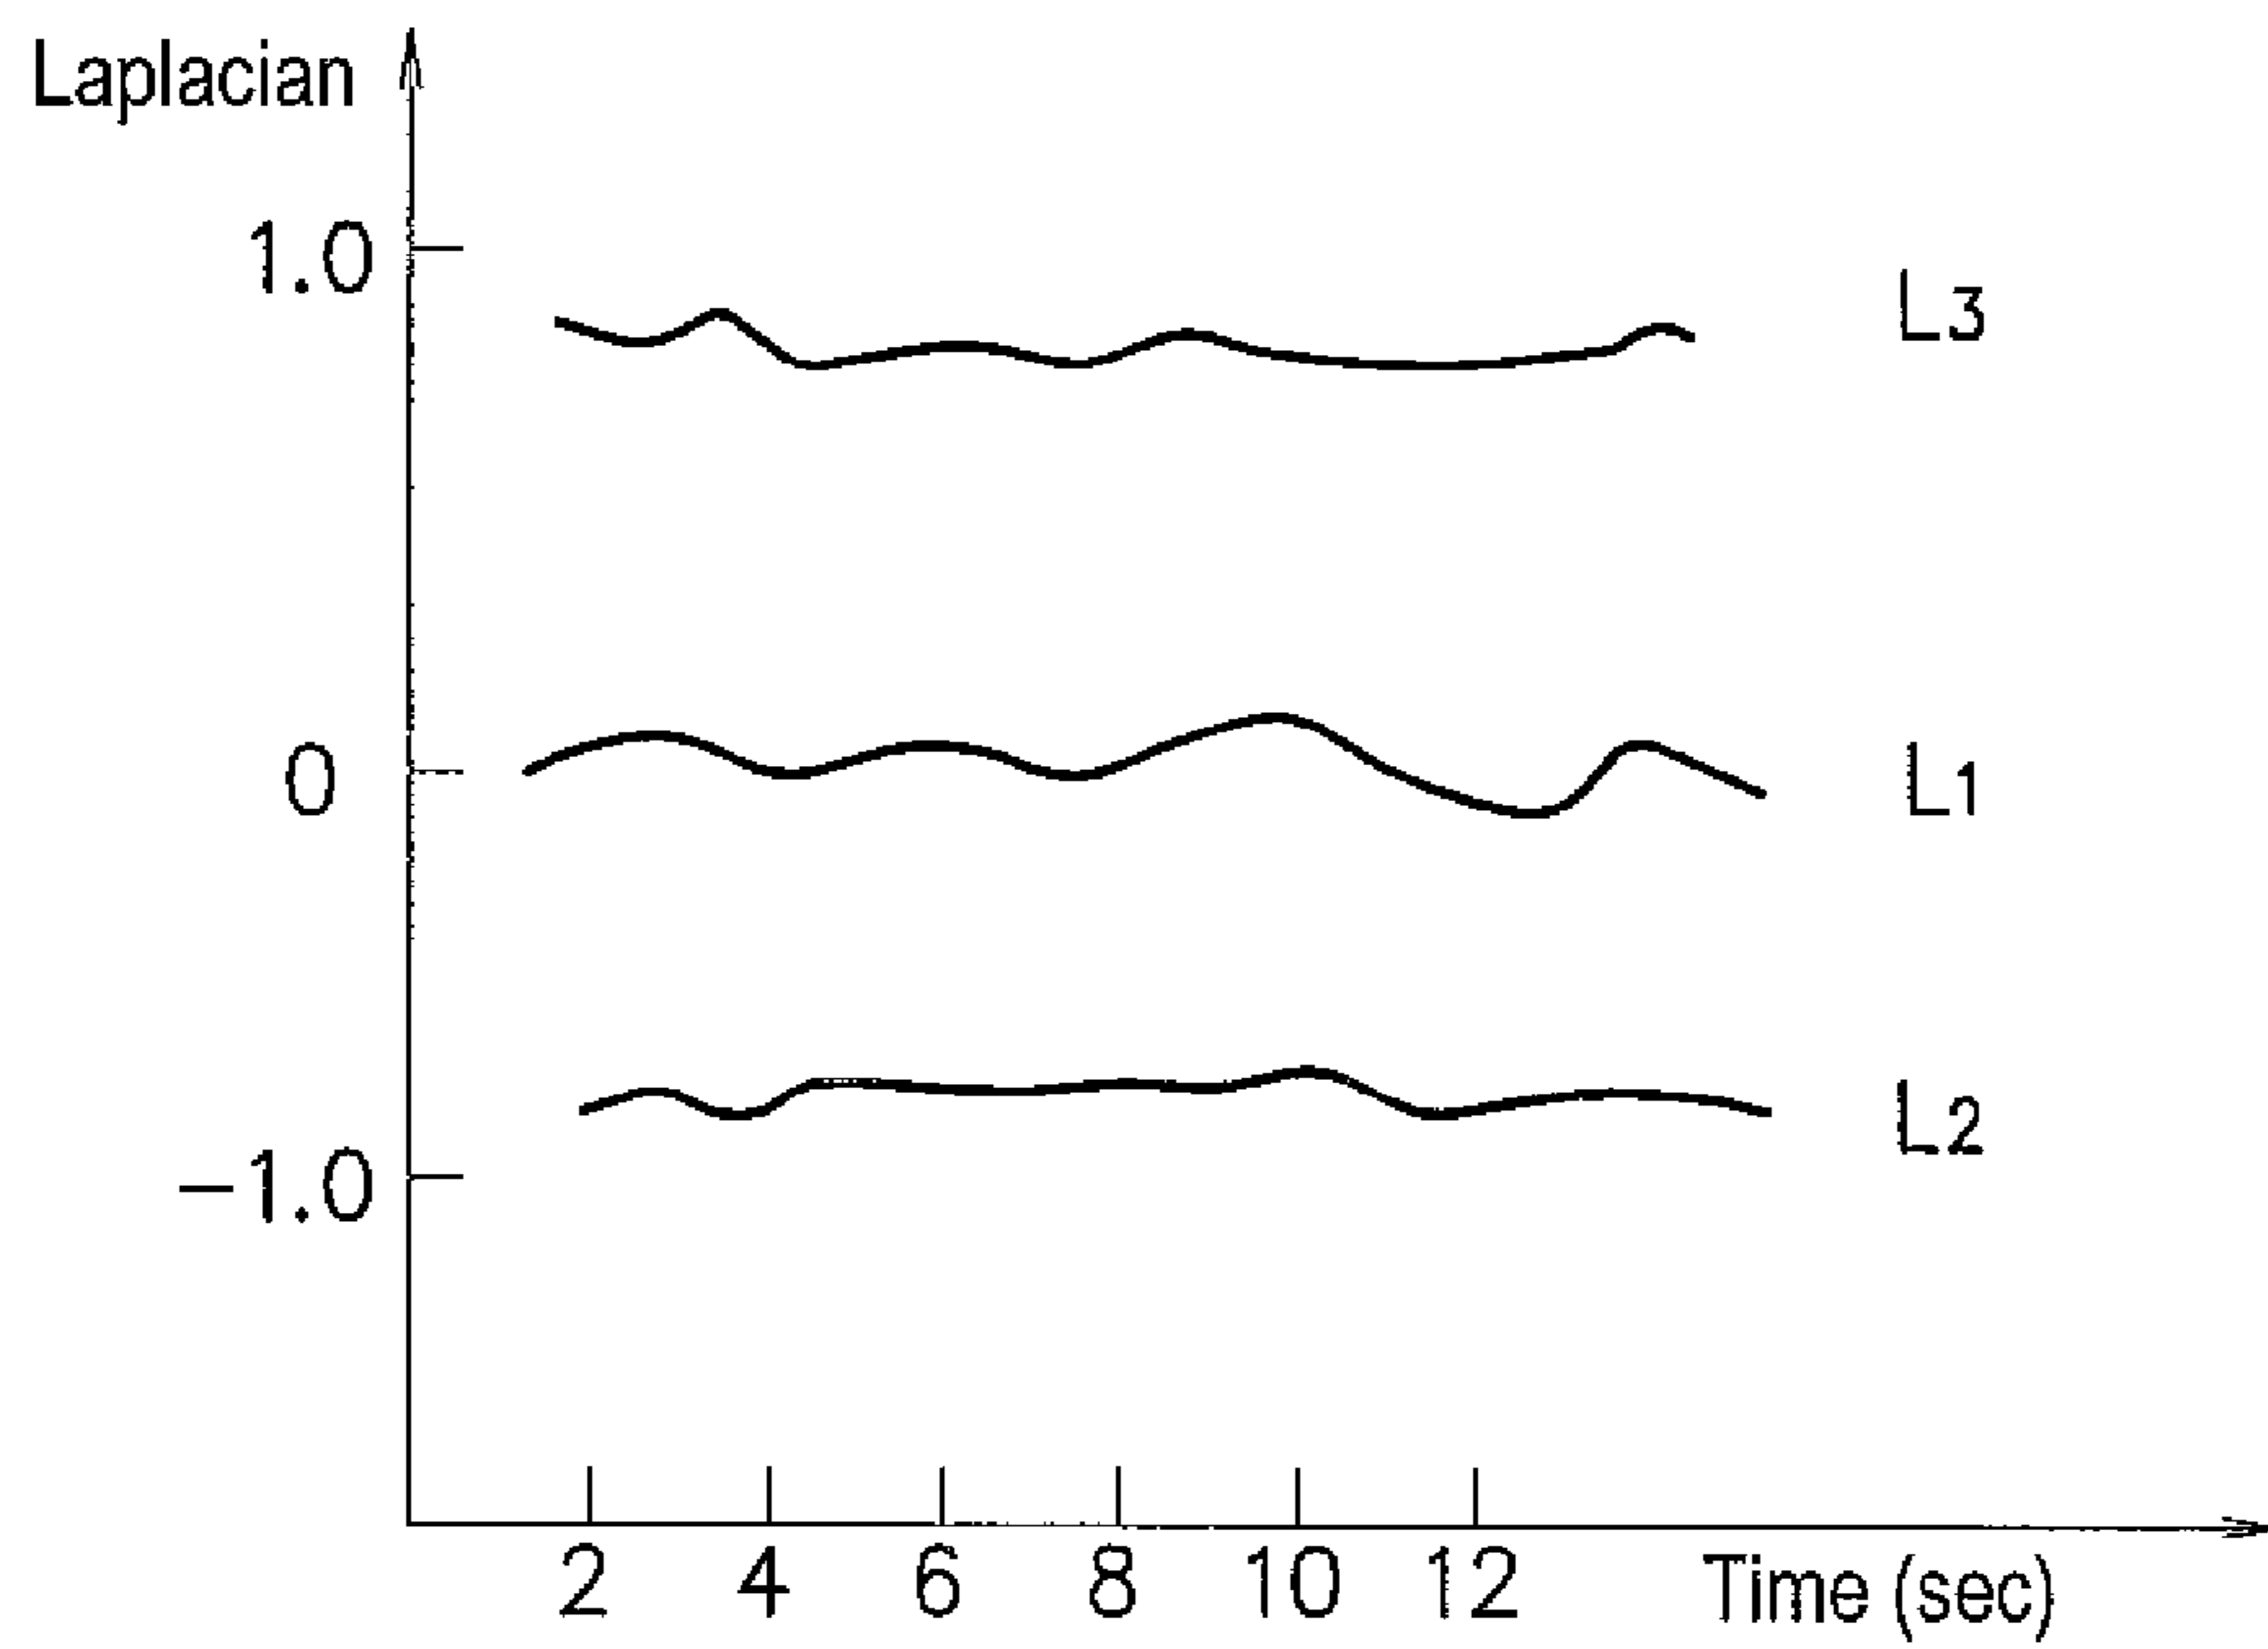
FIGS. 7A/7B are a graph showing Laplacian corresponding to temperature characteristics curves of FIGS. 6A/6B.

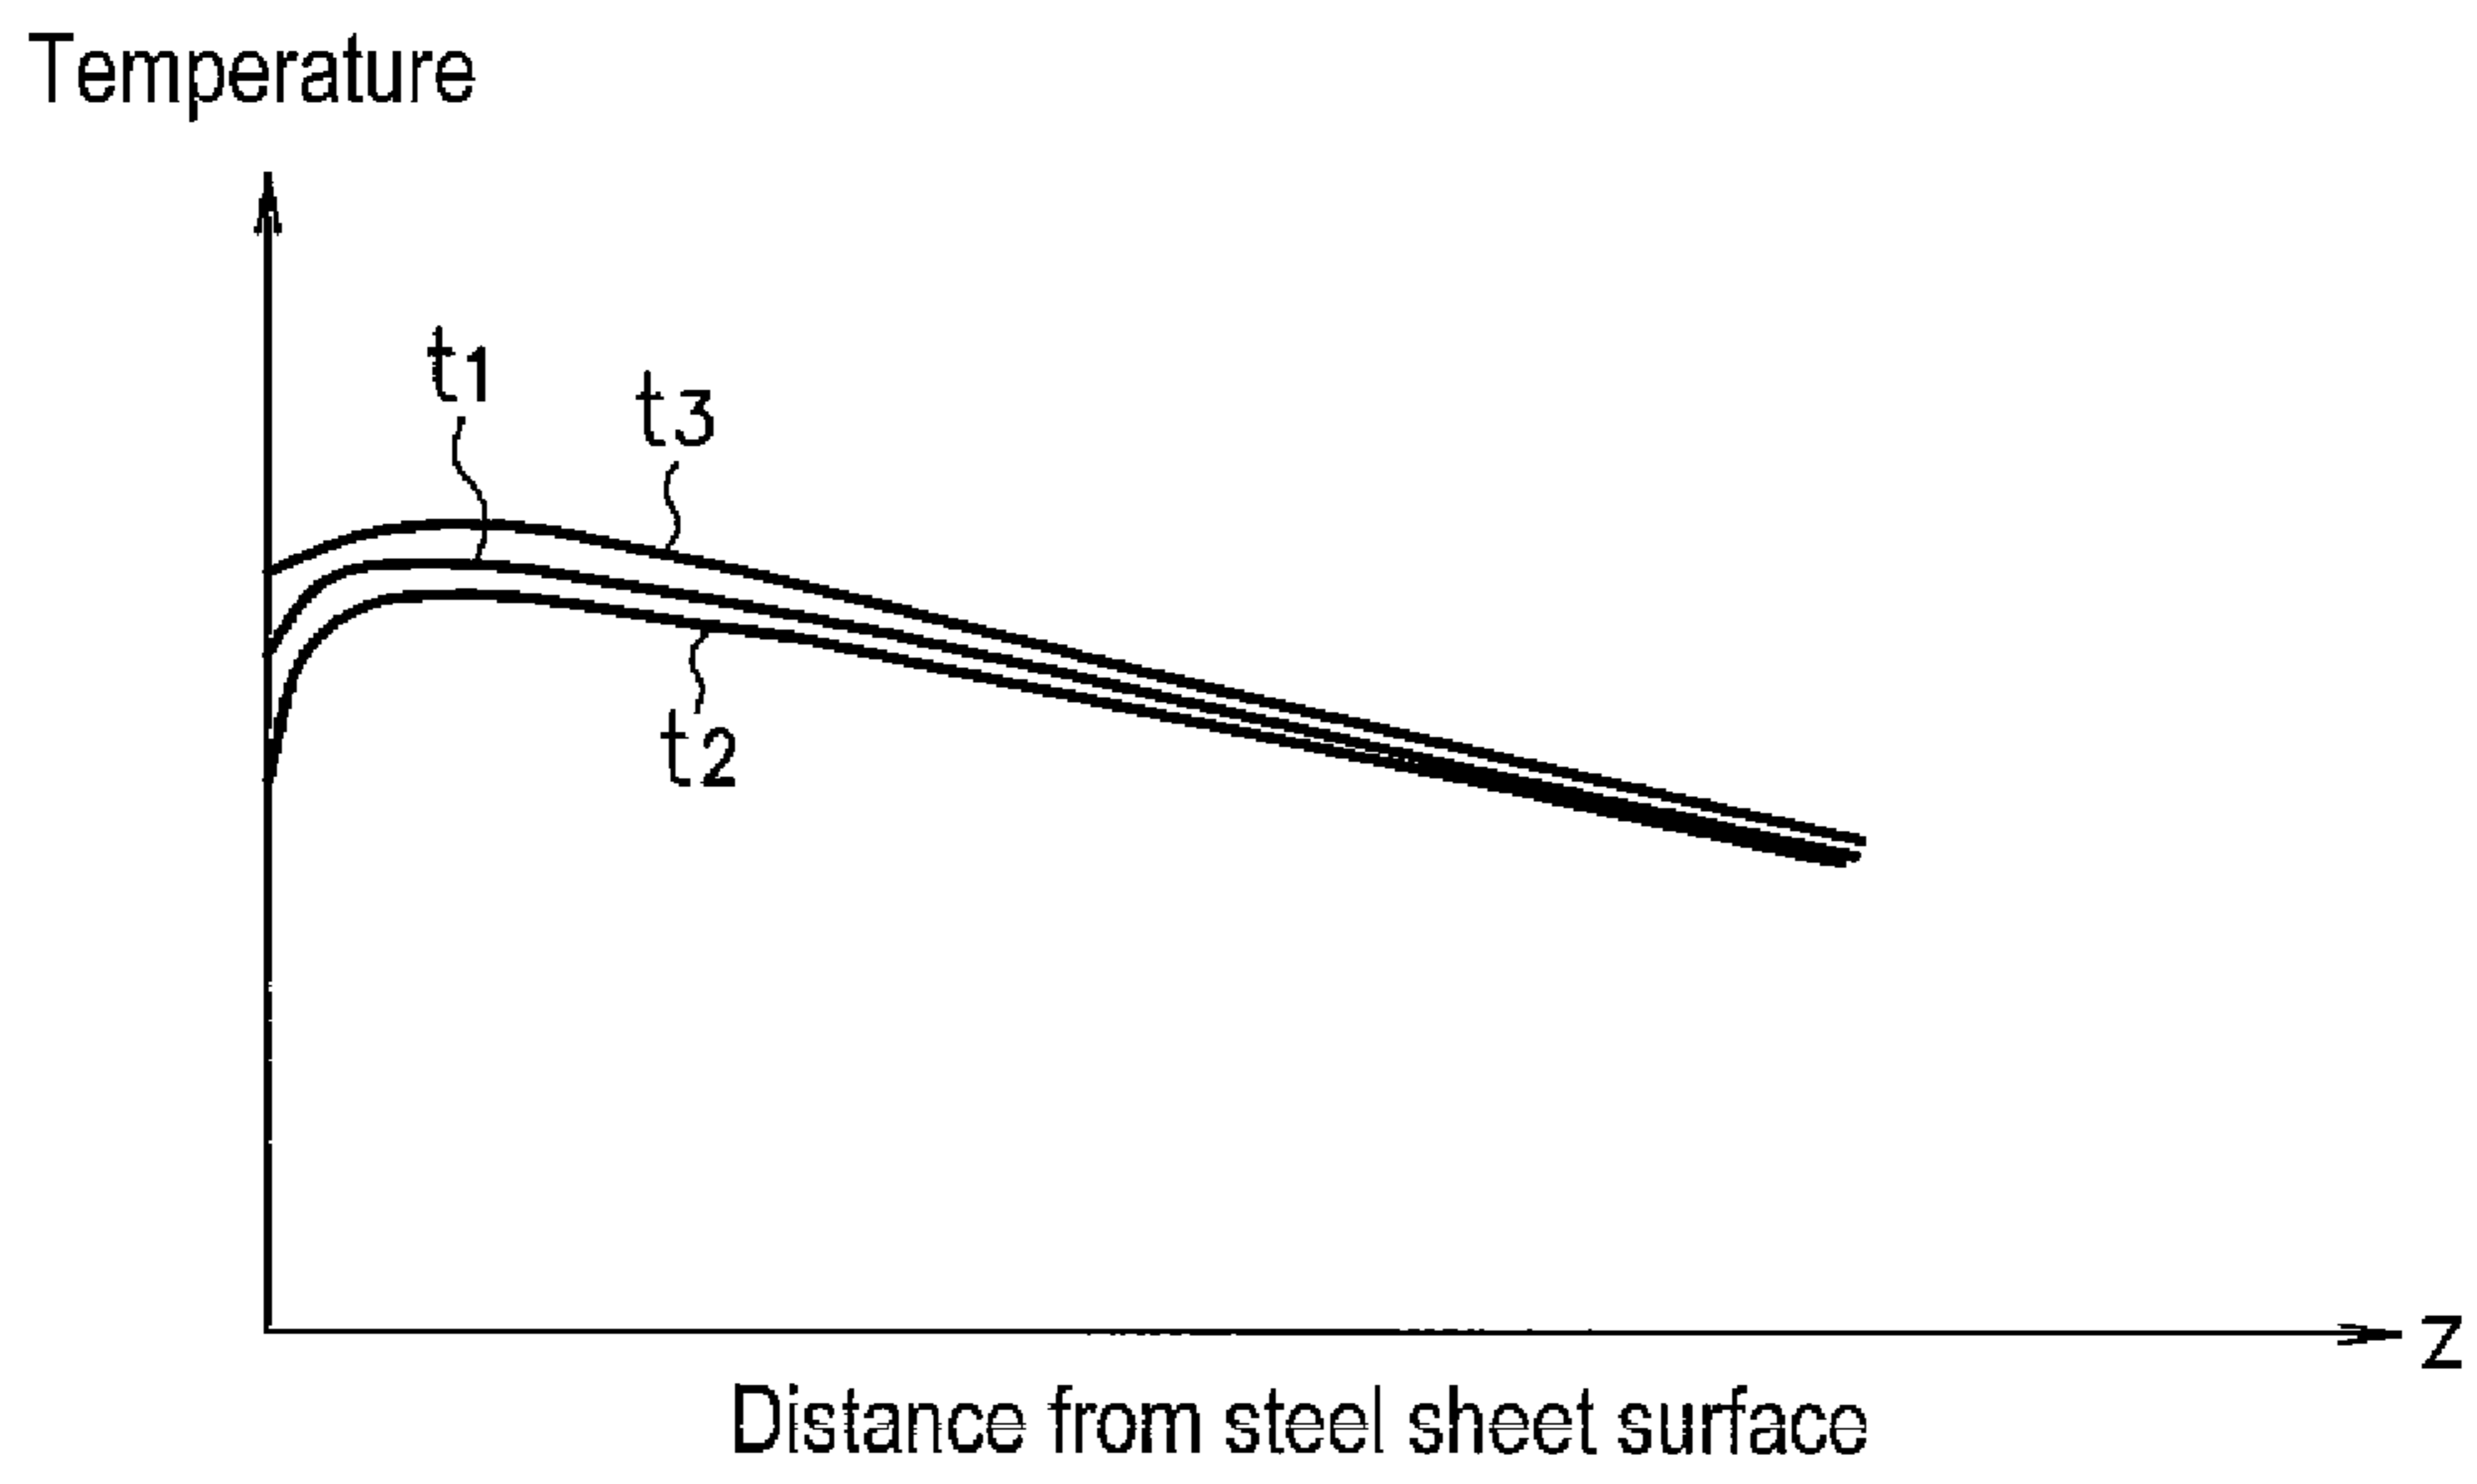
FIG.8

FIG. 8 is a graph showing temperature distribution curves in the surface layer.

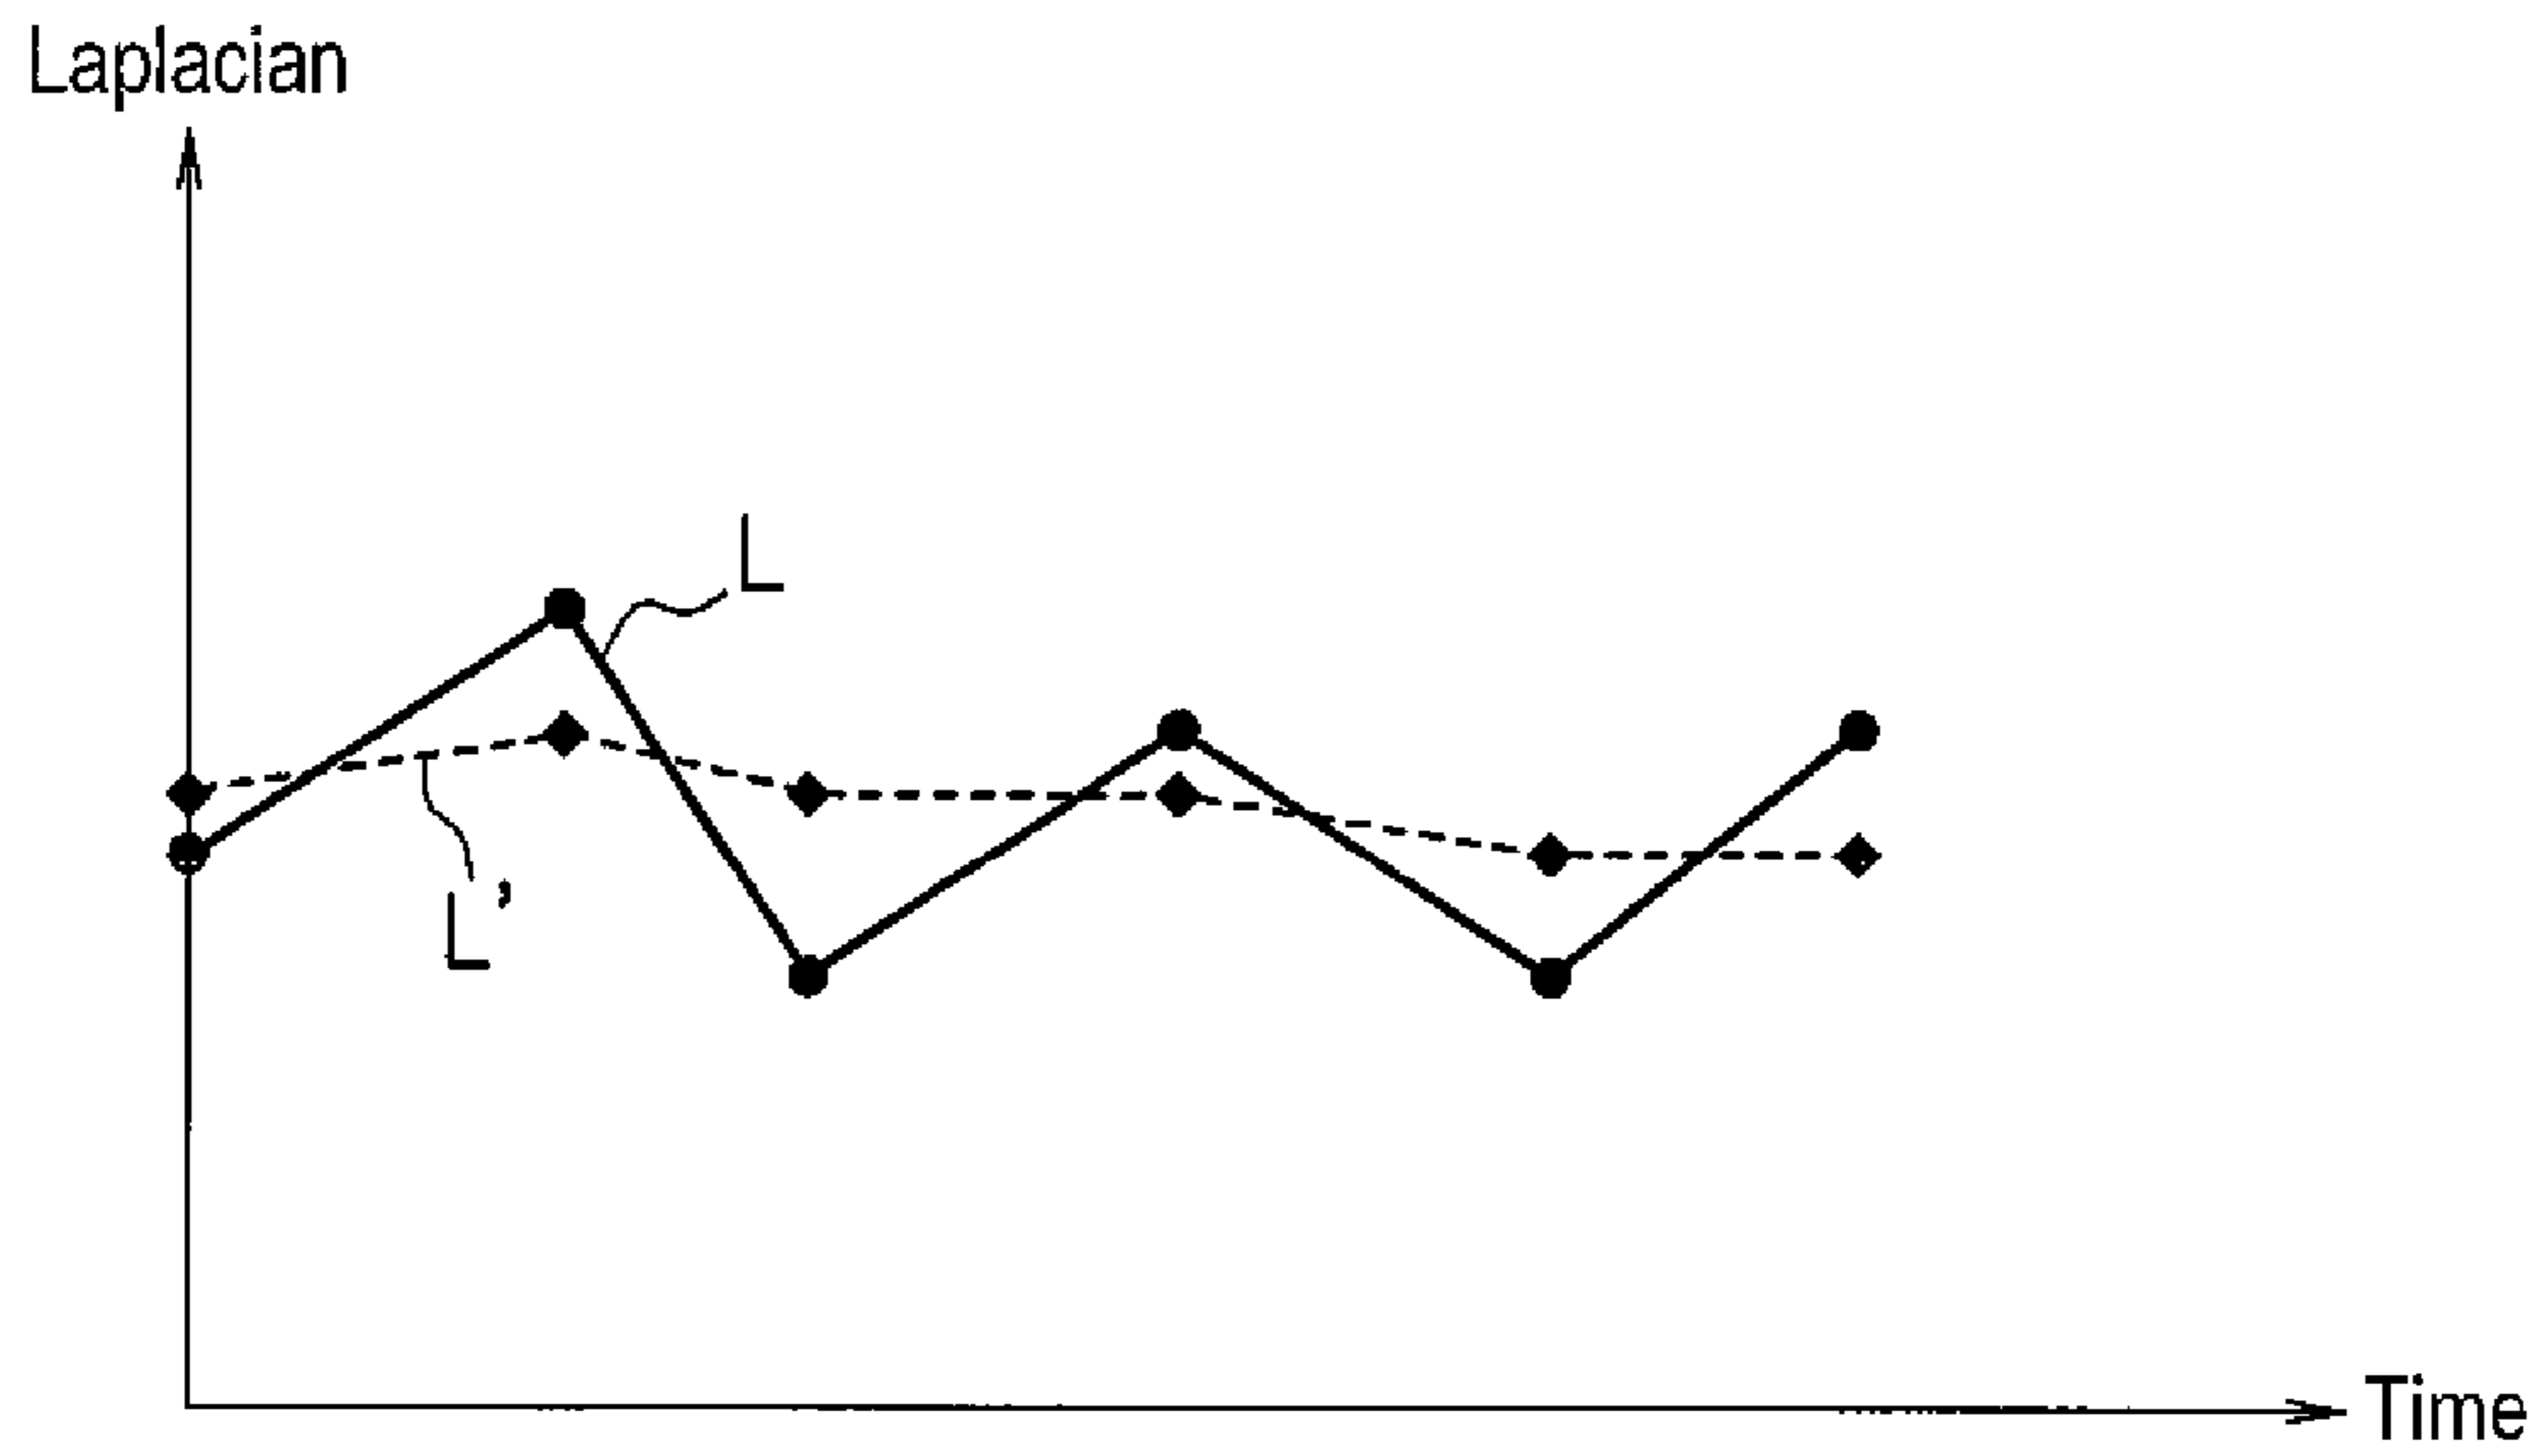
FIG.9

FIG. 9 is a graph showing an effect by Gaussian filtering with respect to thermal image data.
