US008506159B2

(54) **METHOD FOR DETECTING DEFECT IN MATERIAL AND SYSTEM FOR THE METHOD**

(73) Assignee: **Nippon Steel & Sumitomo Metal Corporation**, Tokyo (JP)

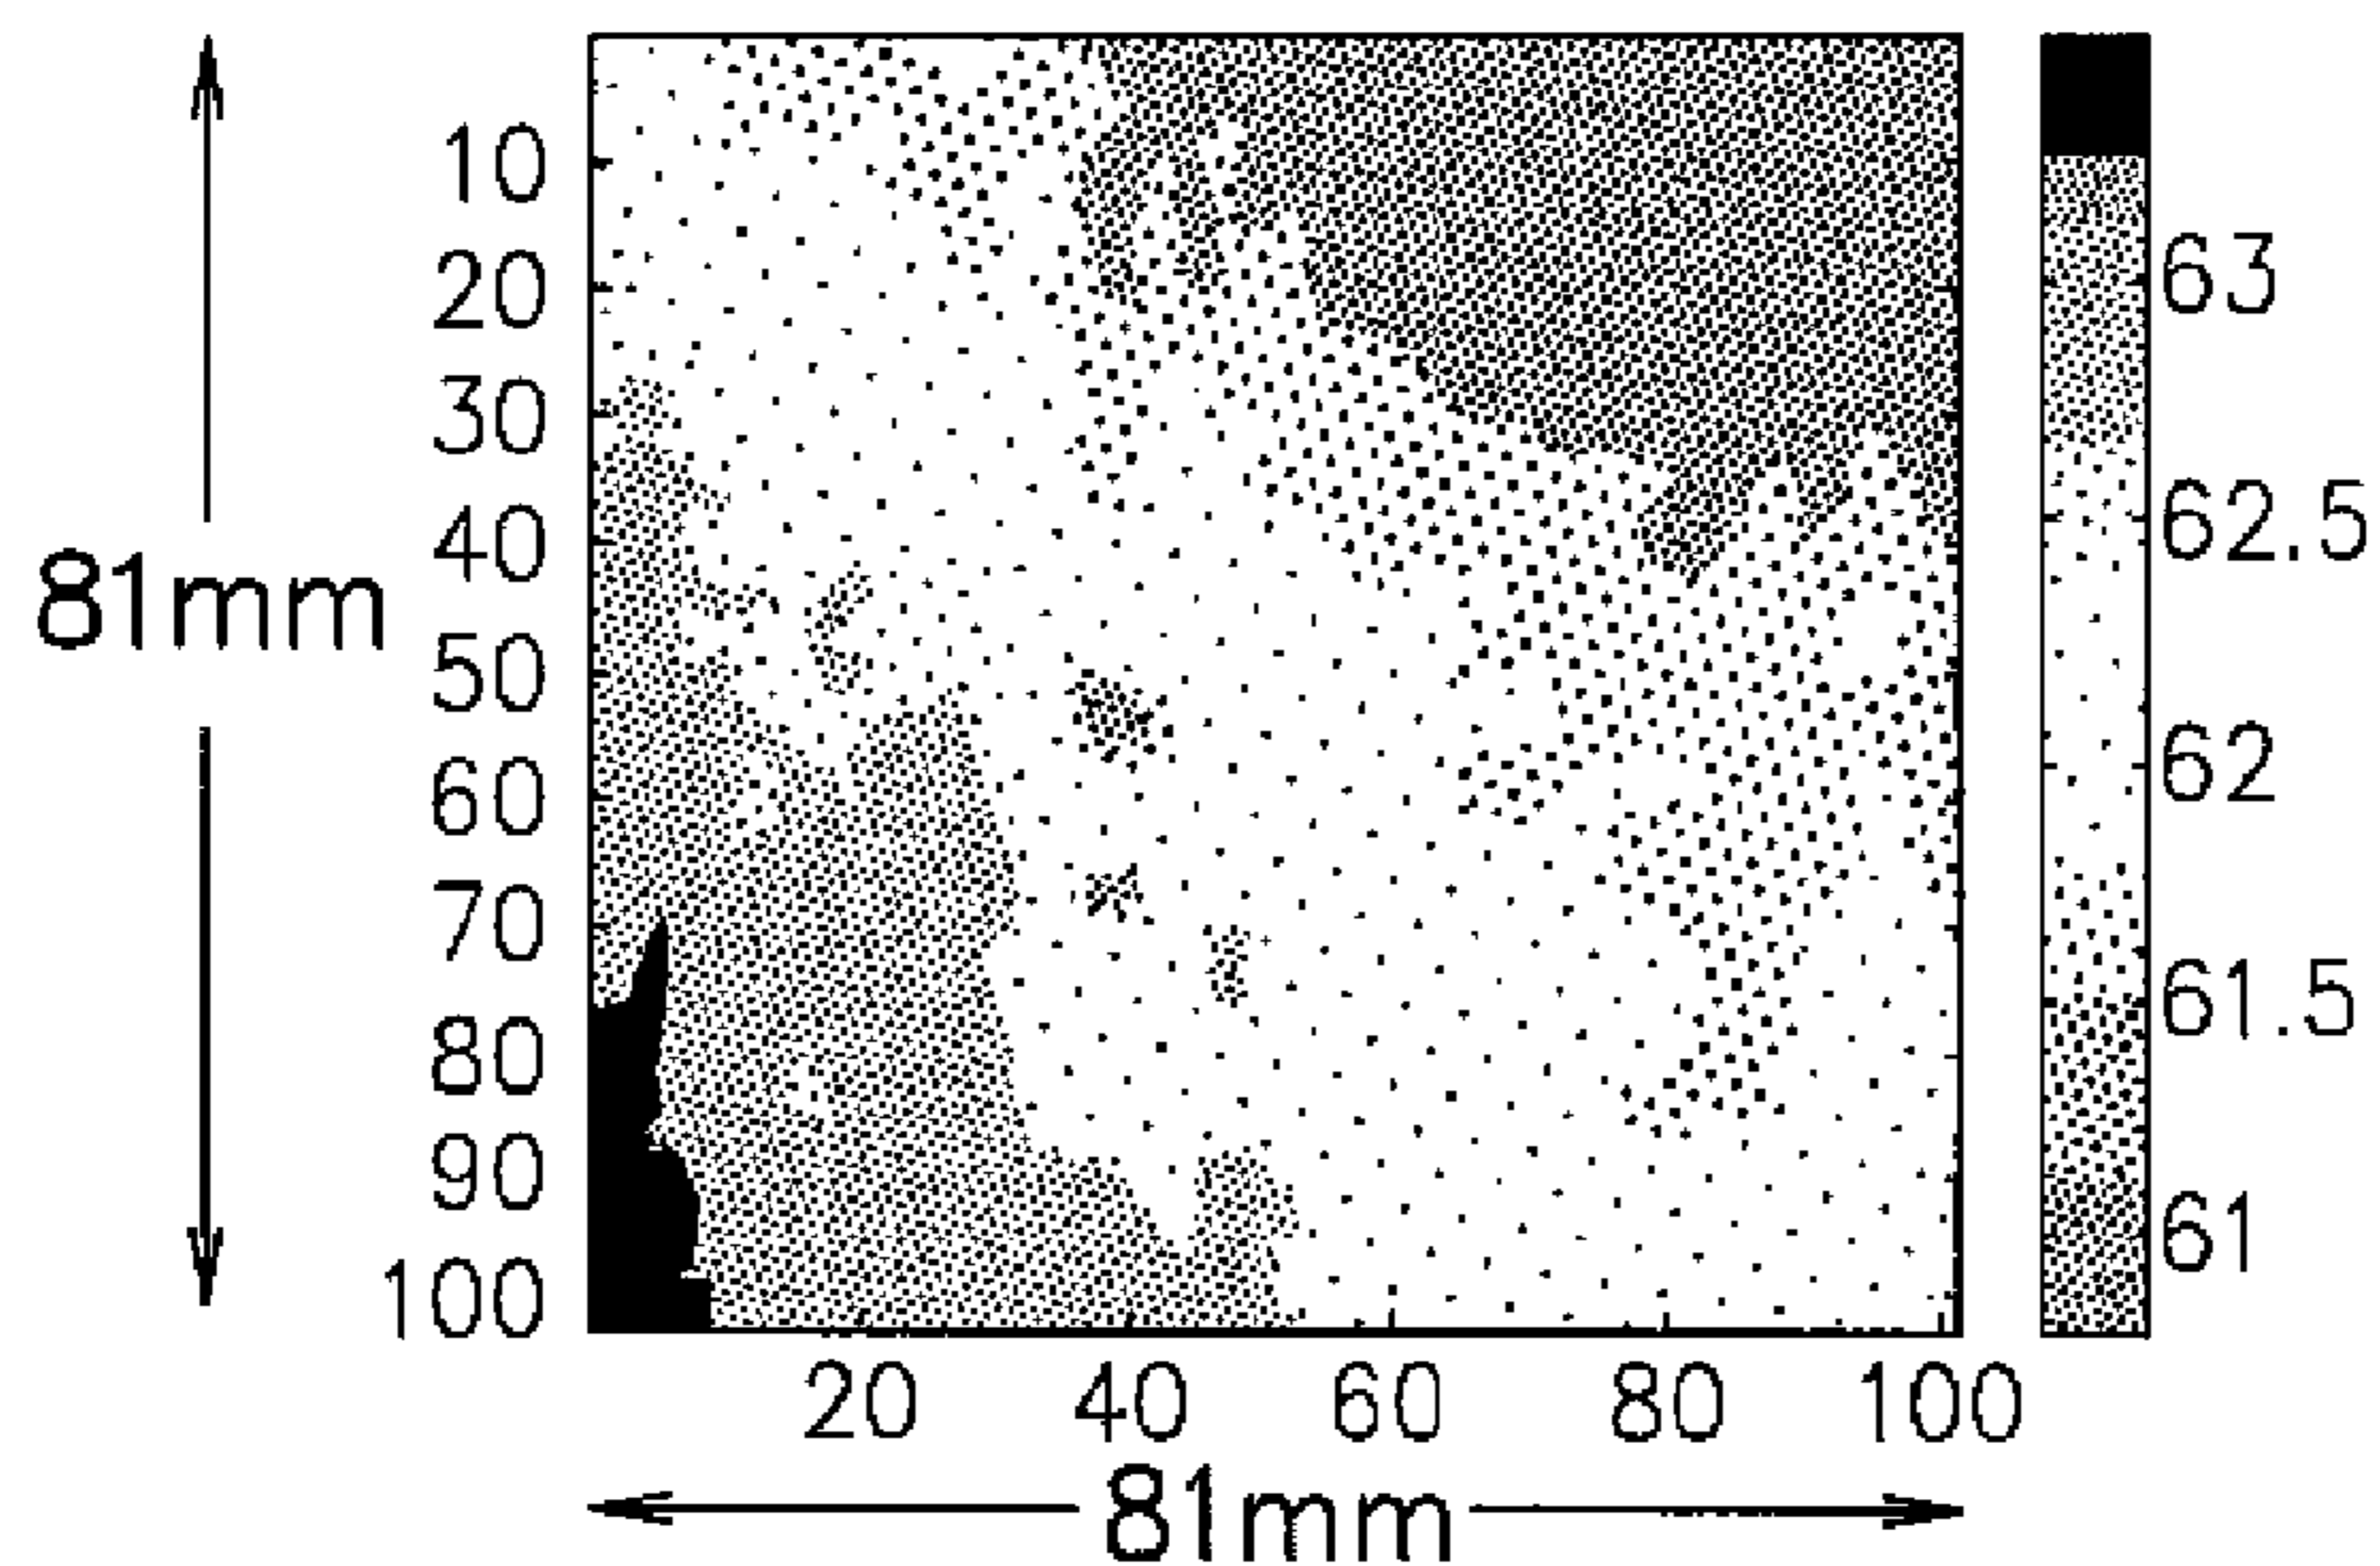
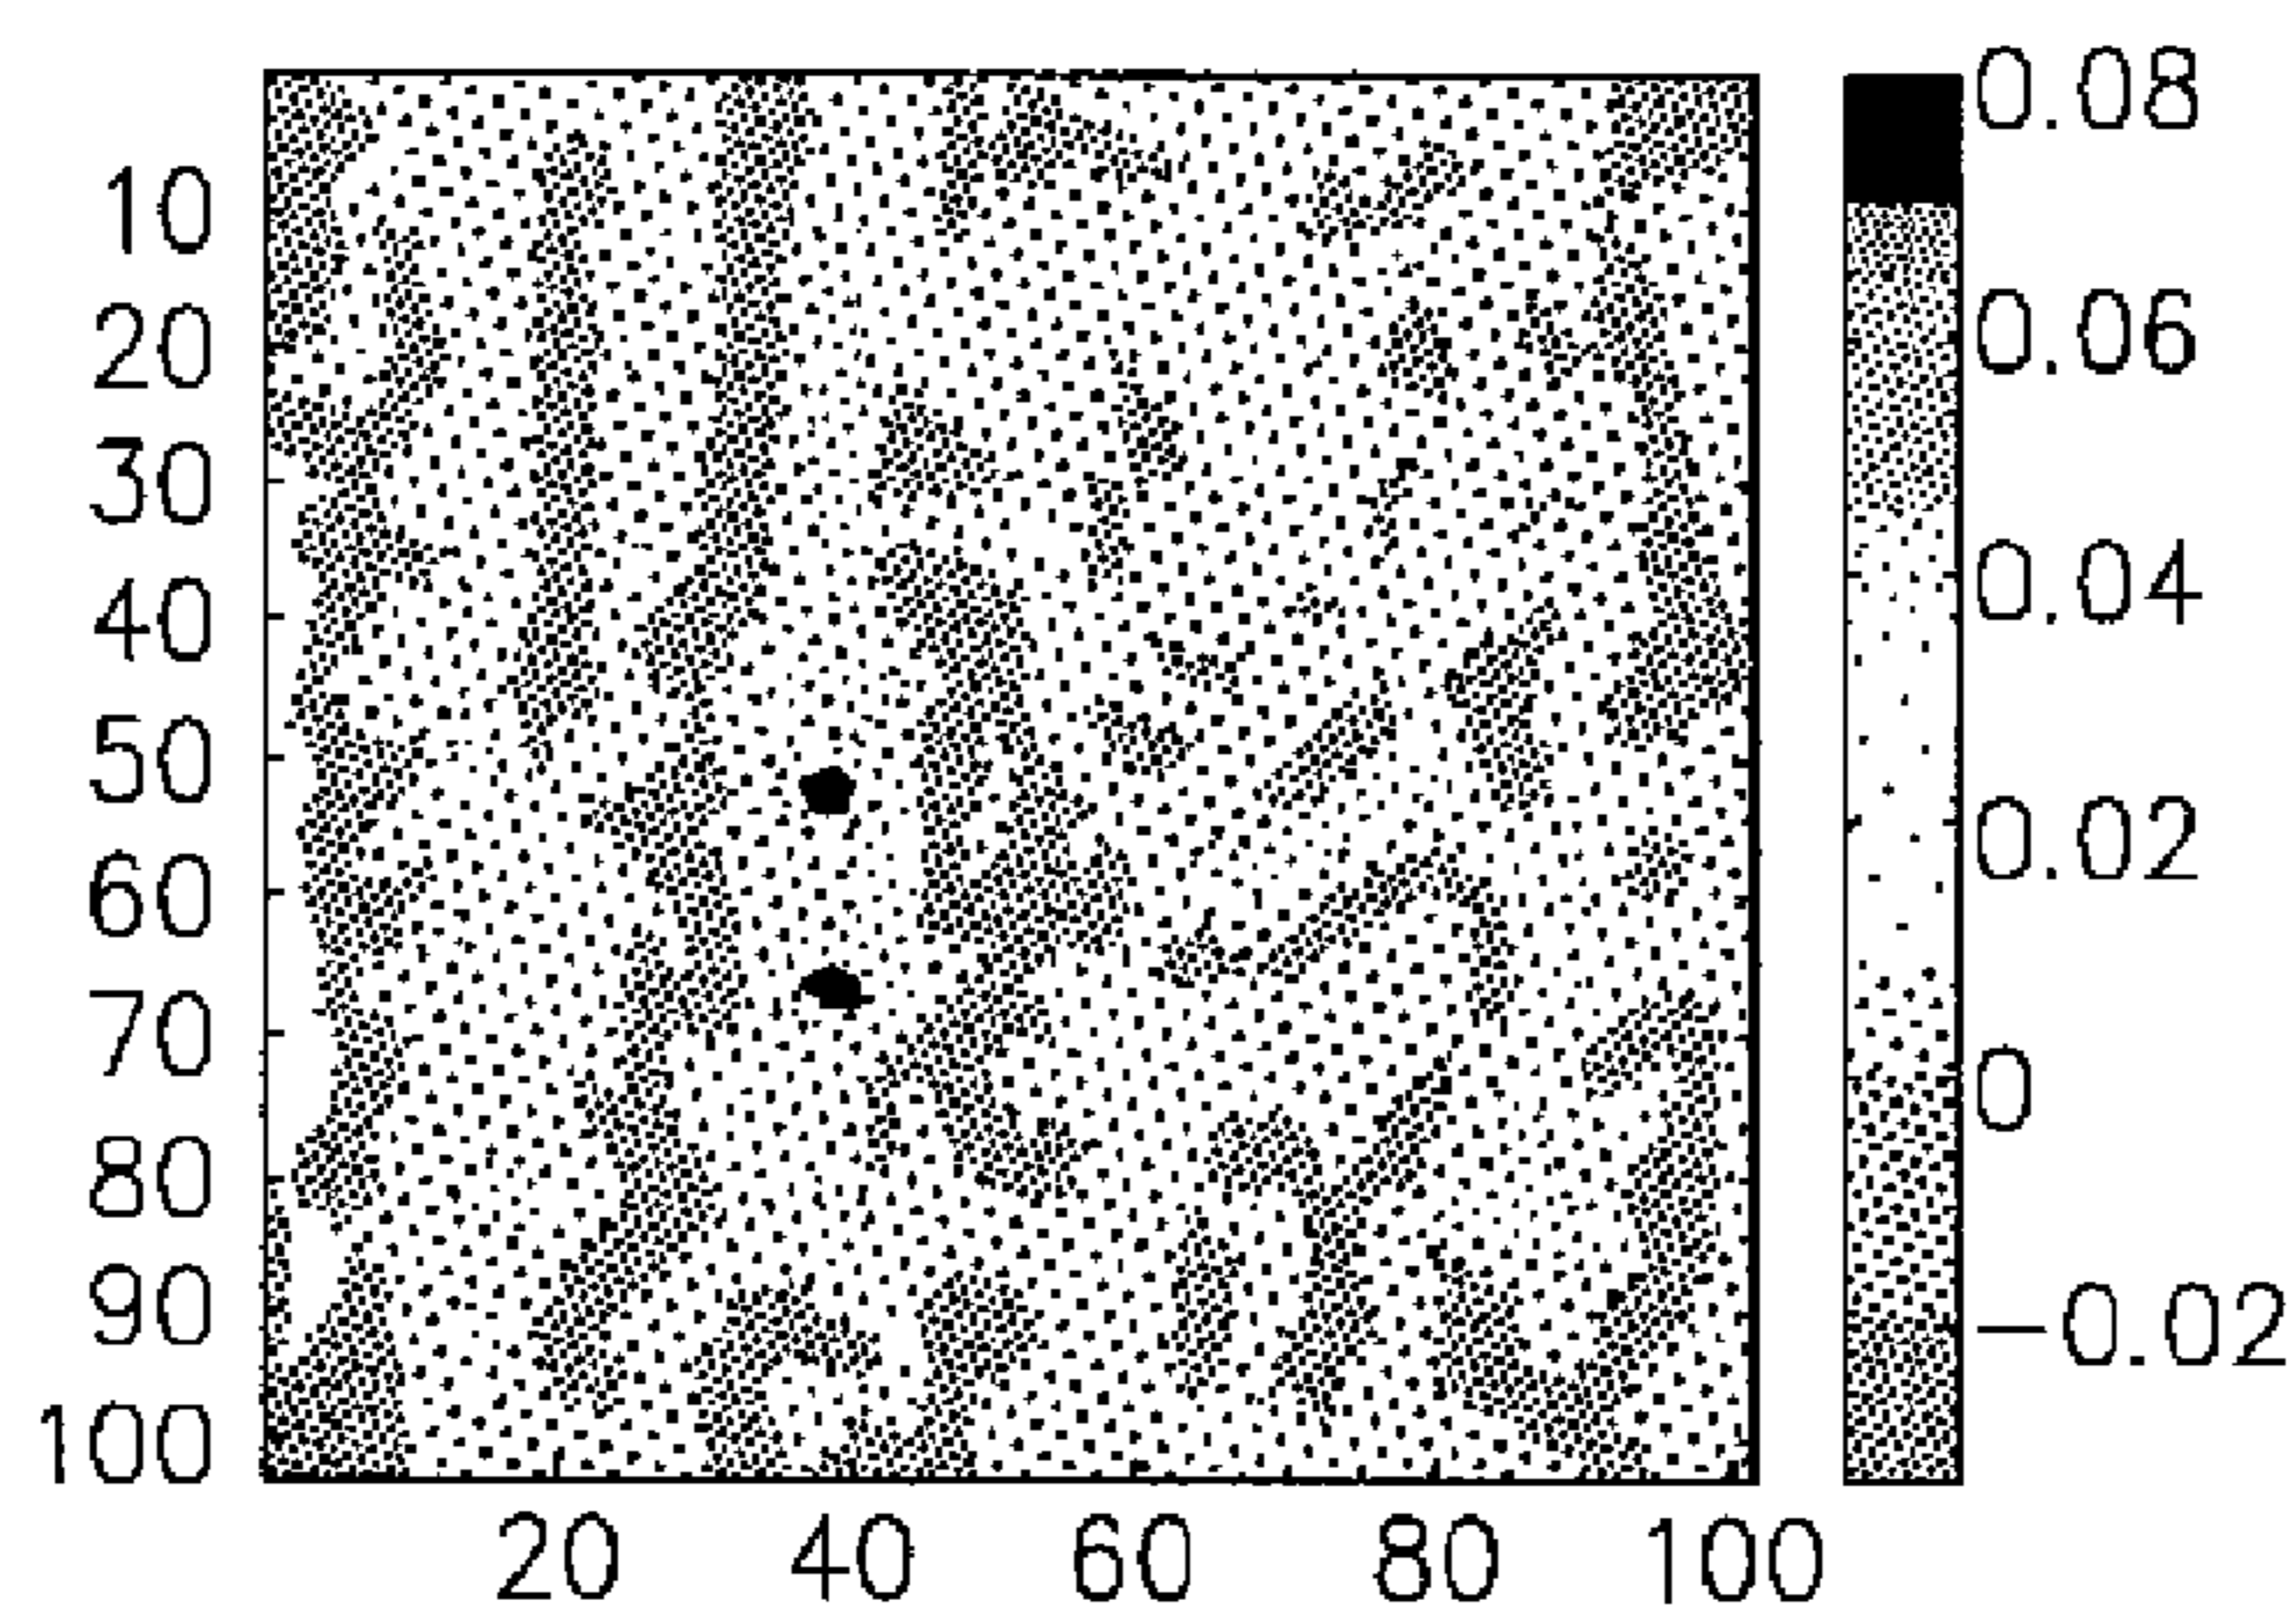
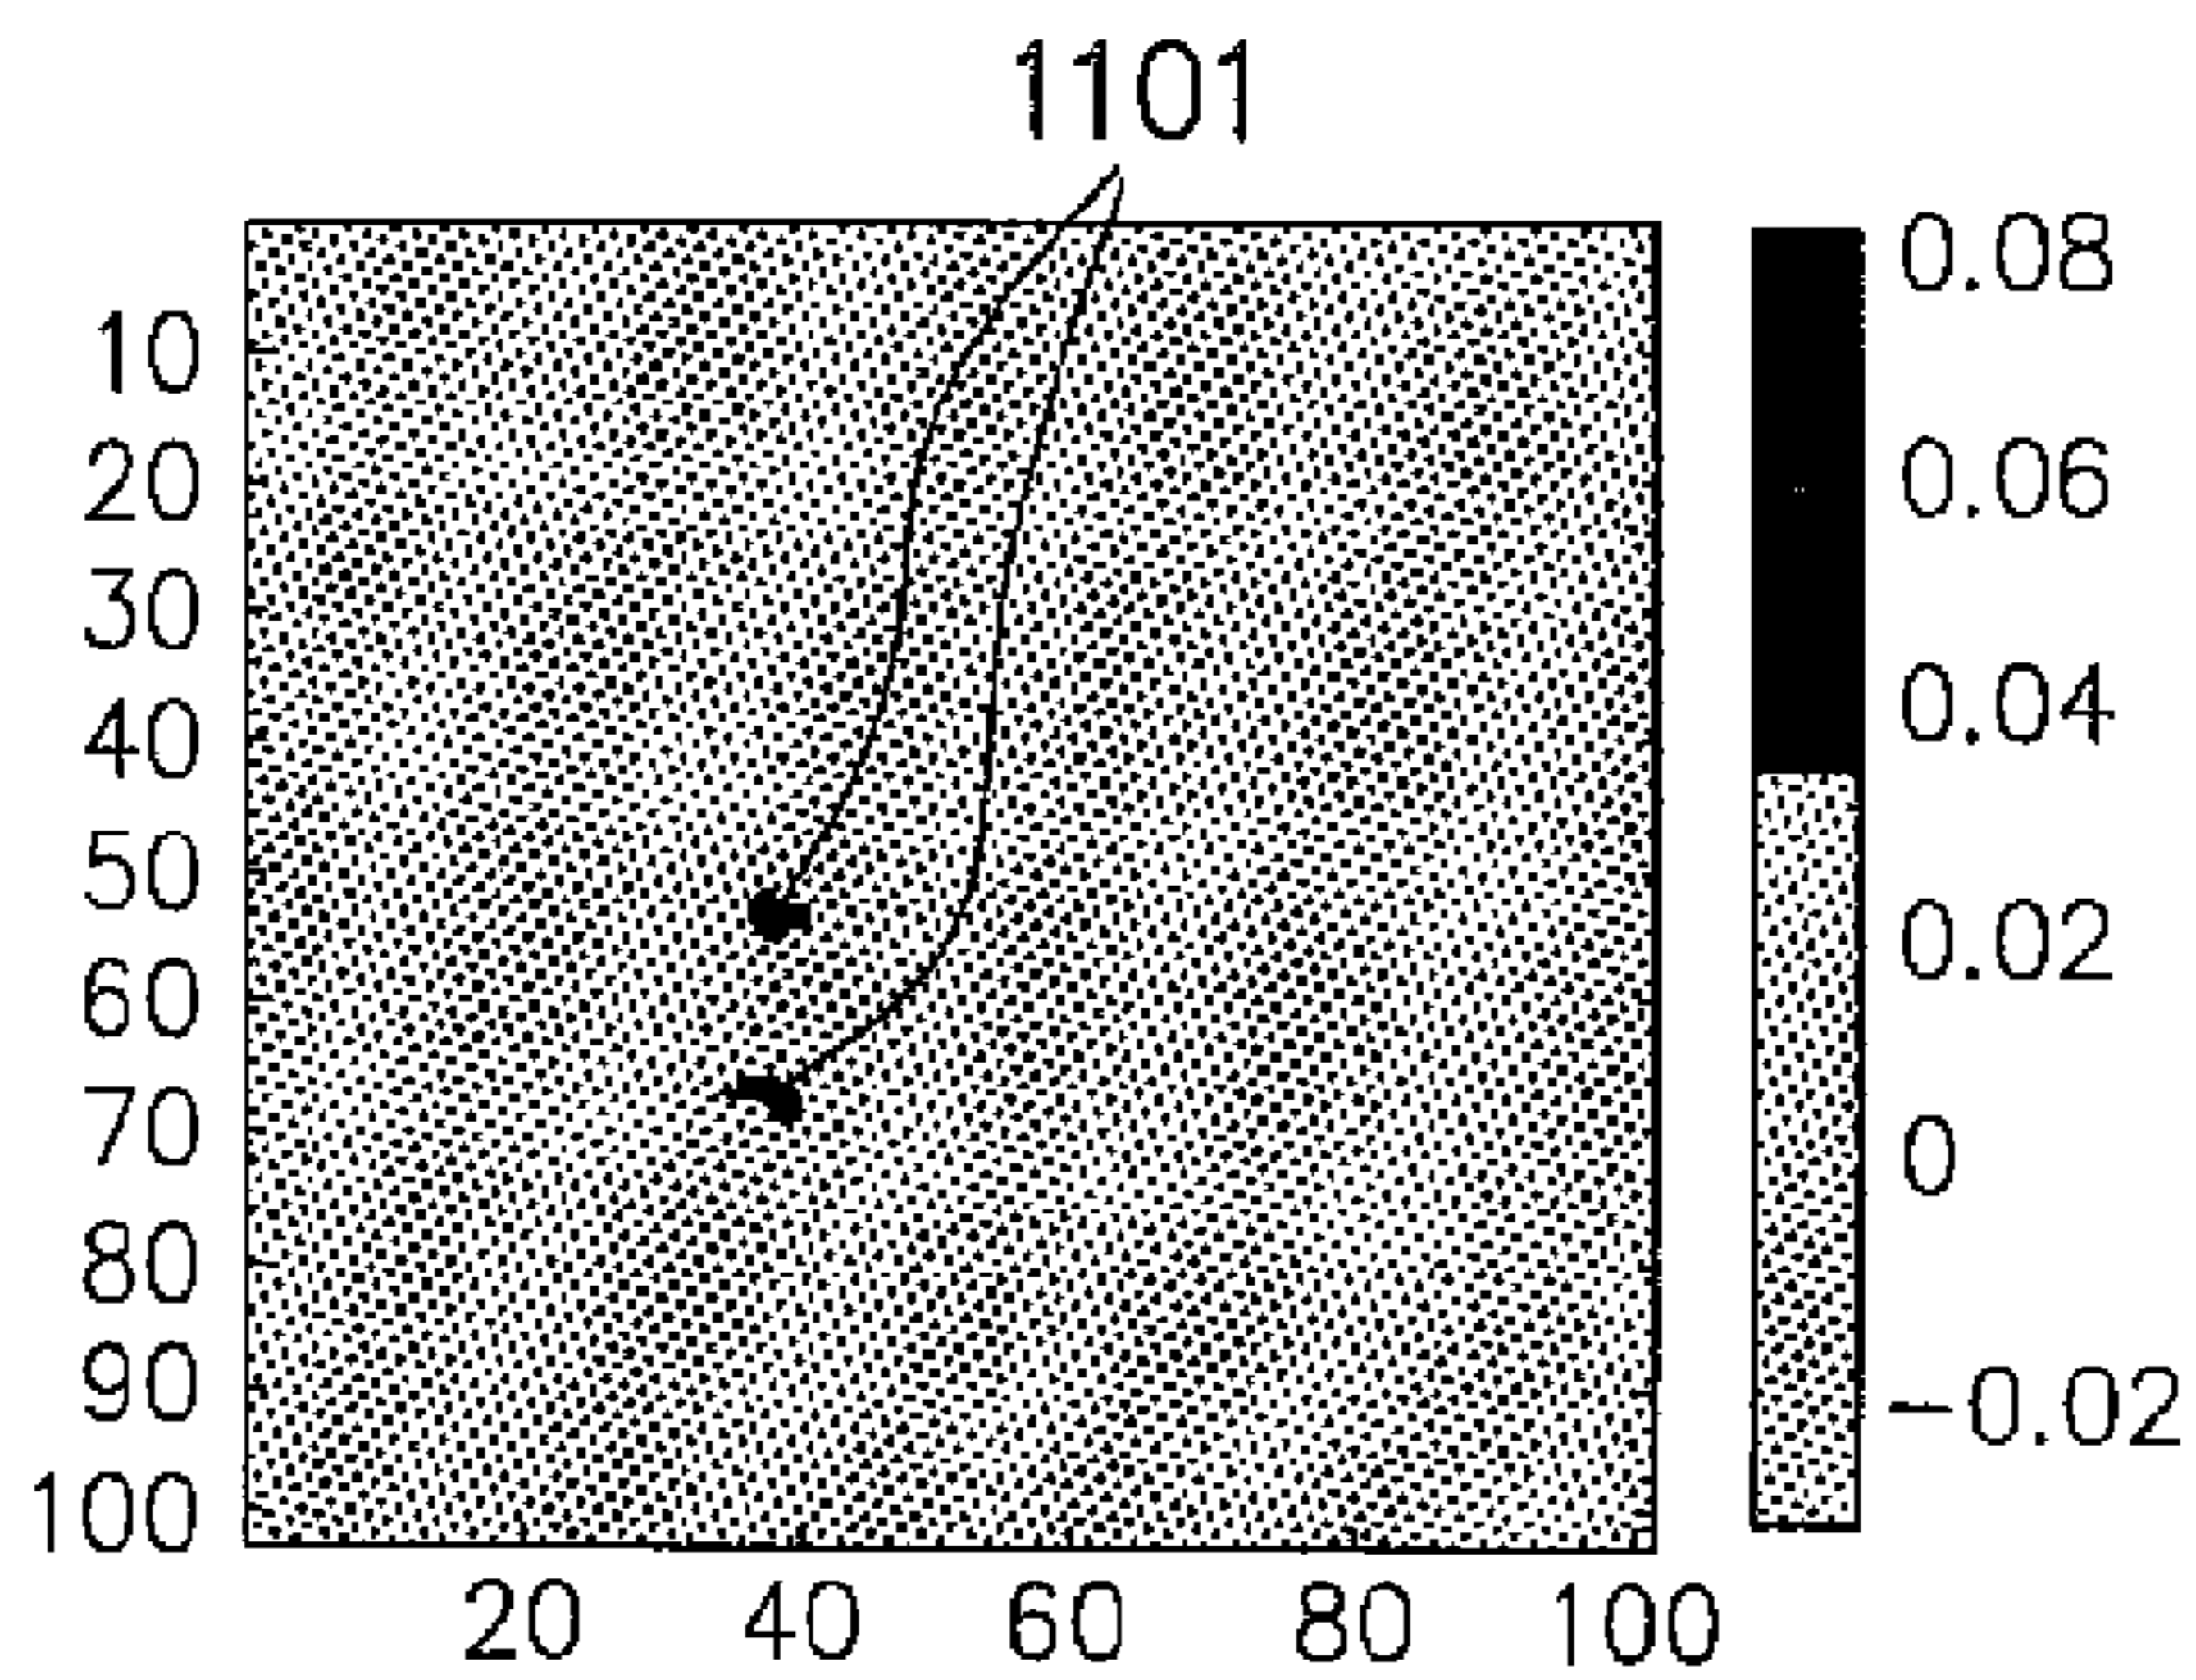
FIGS. 11A, 11B and 11C are an example of an image showing detecting a defect in the cooling down process, wherein the defect is a foreign material or a void located in the surface layer of the steel sheet.

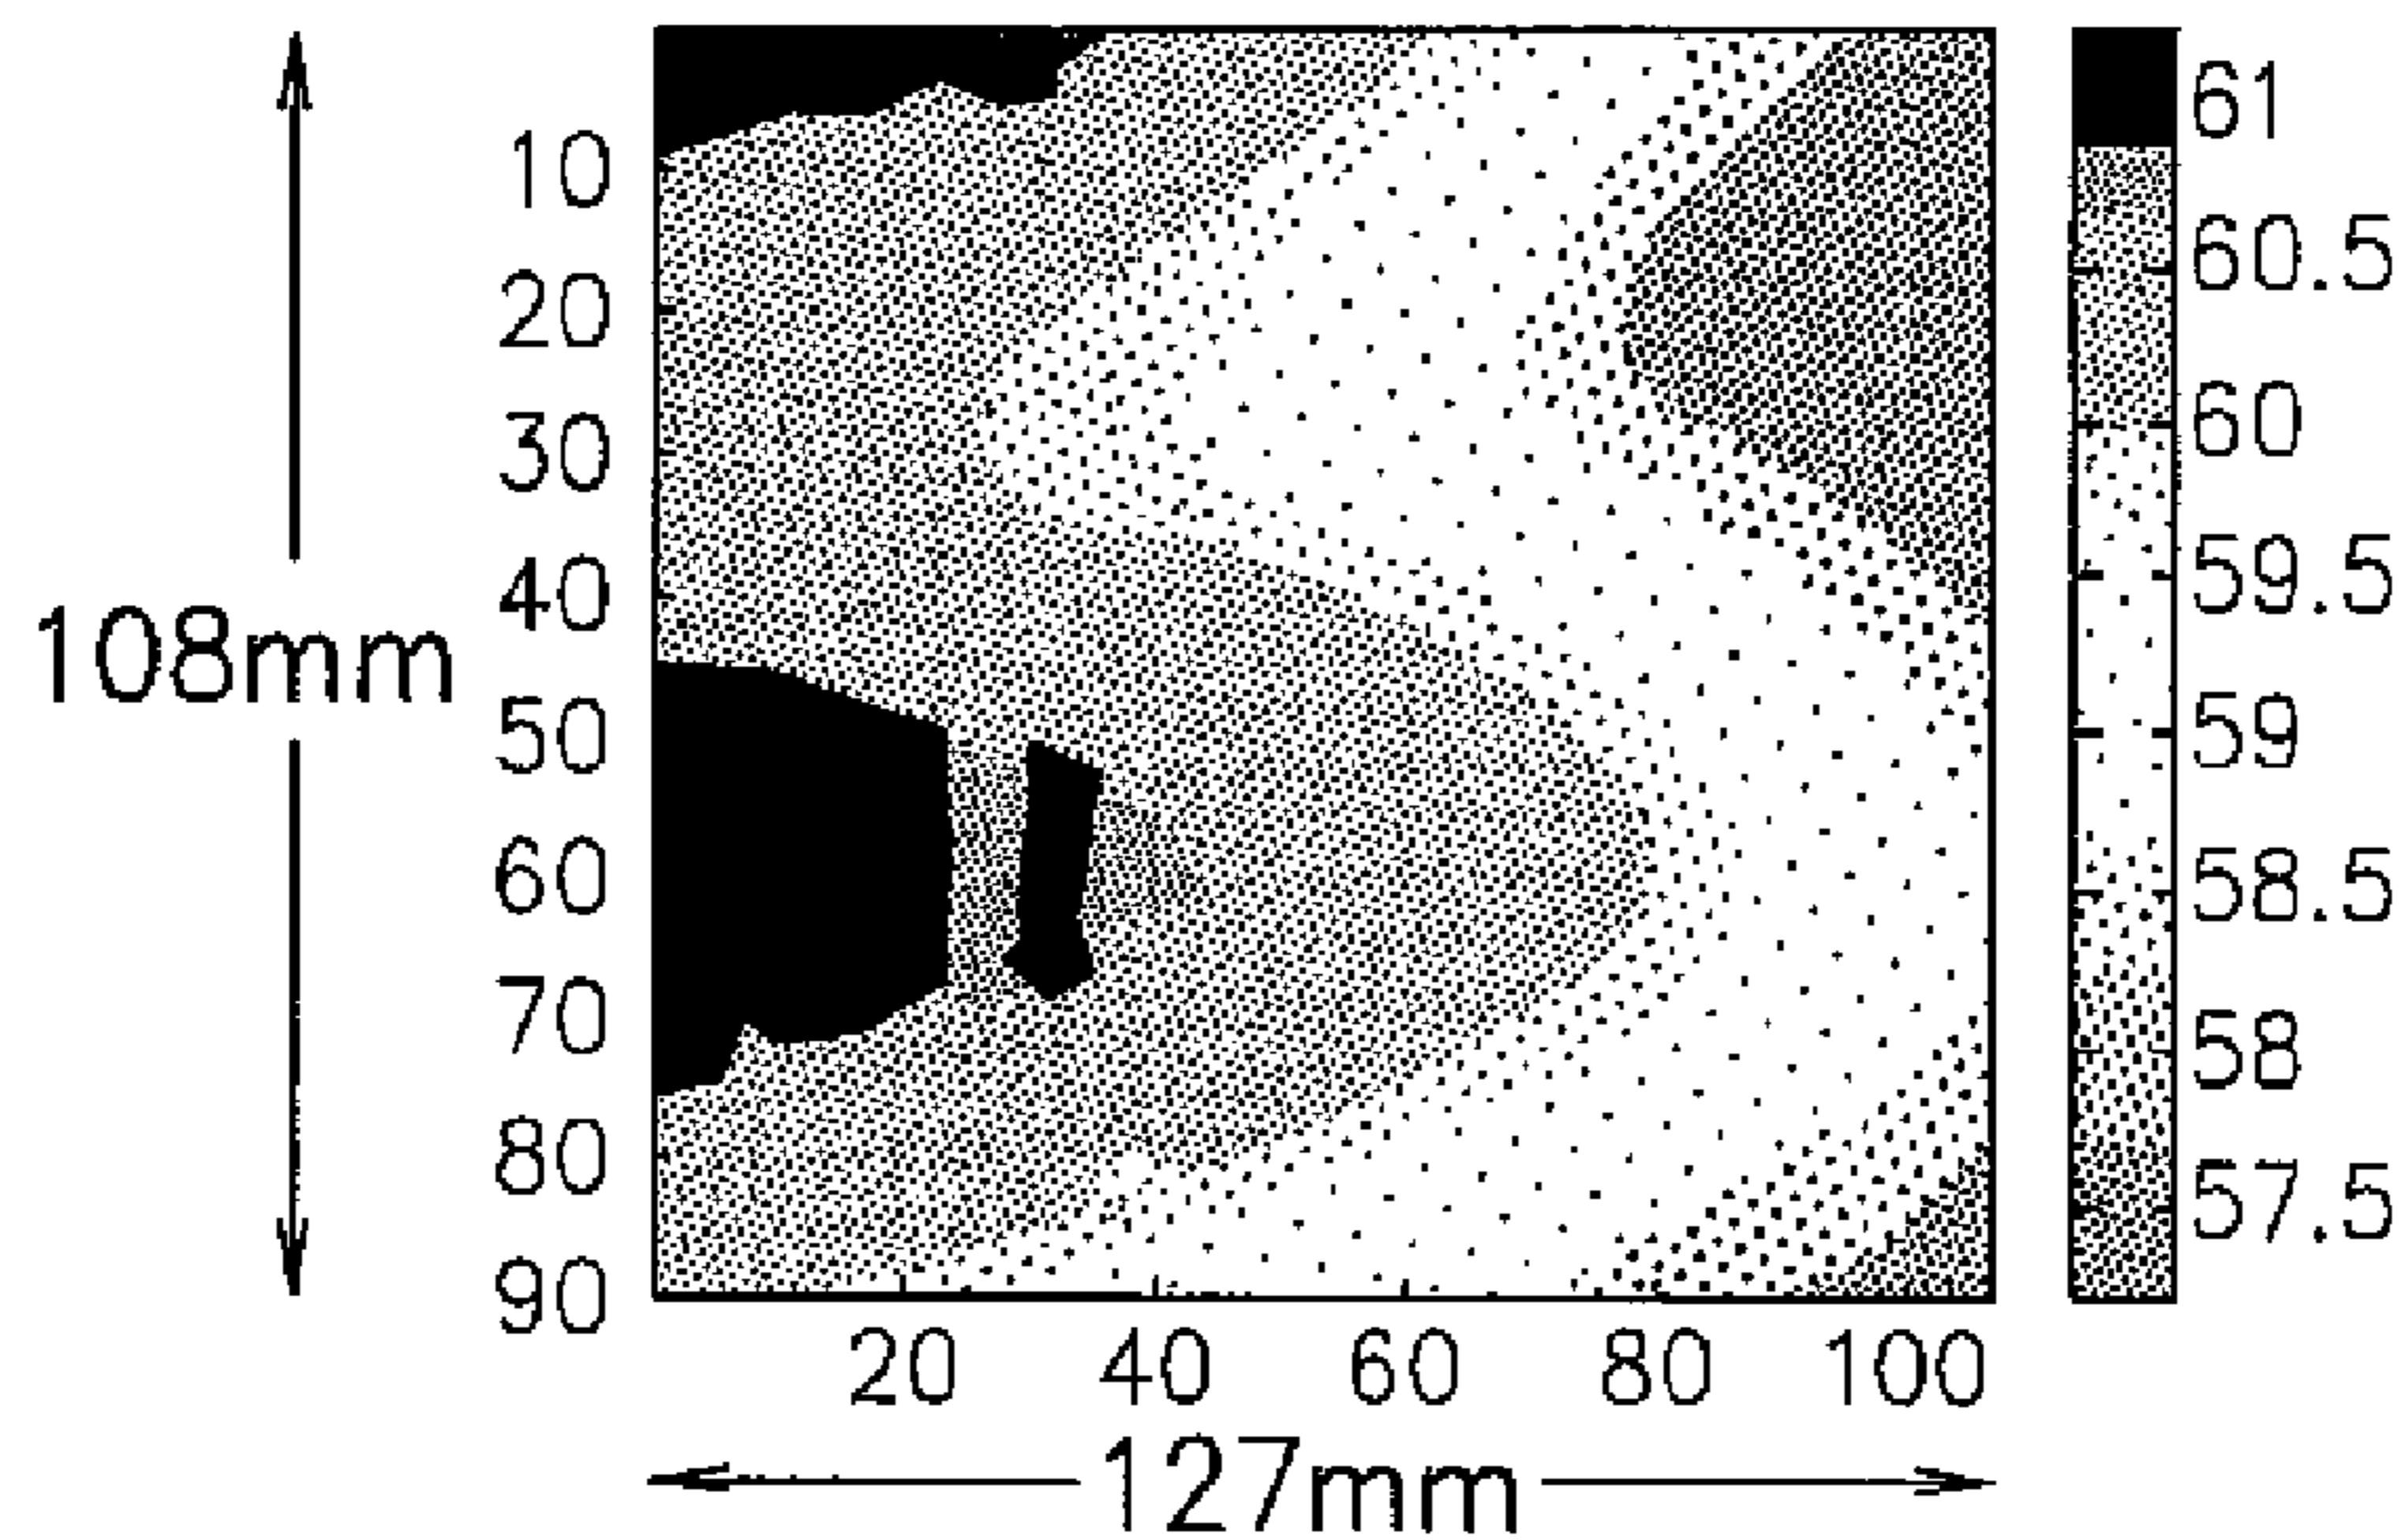
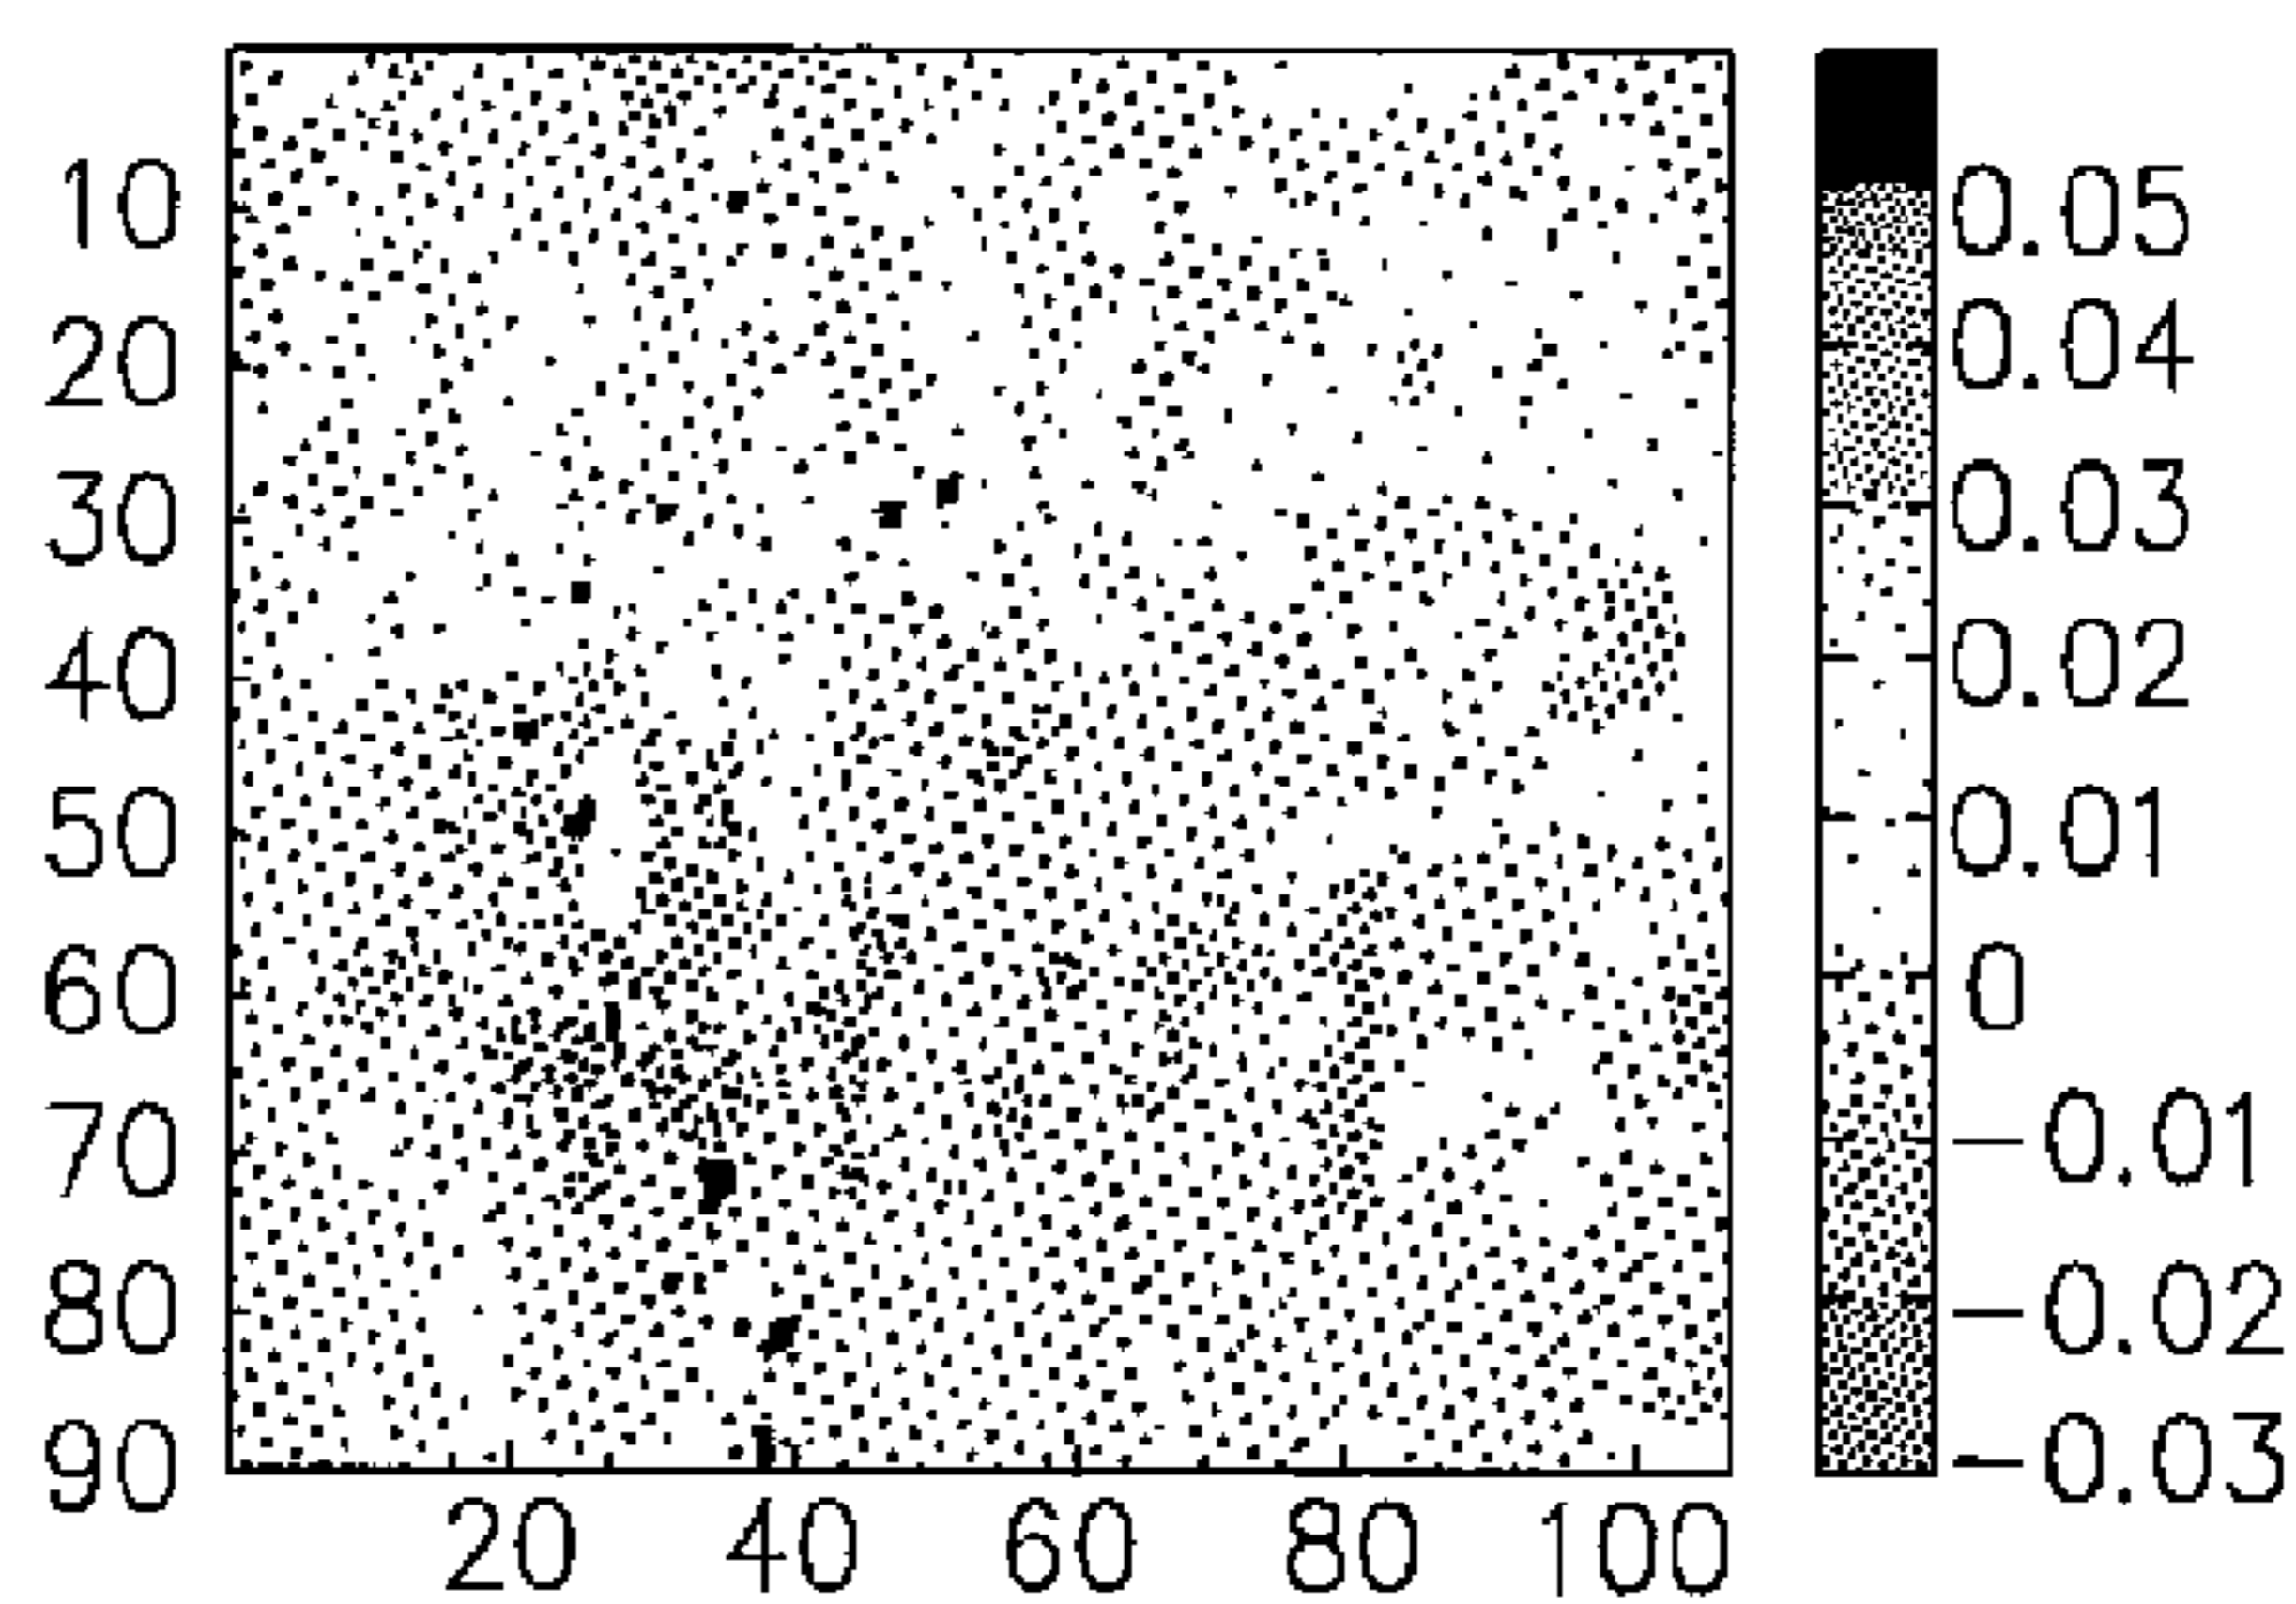
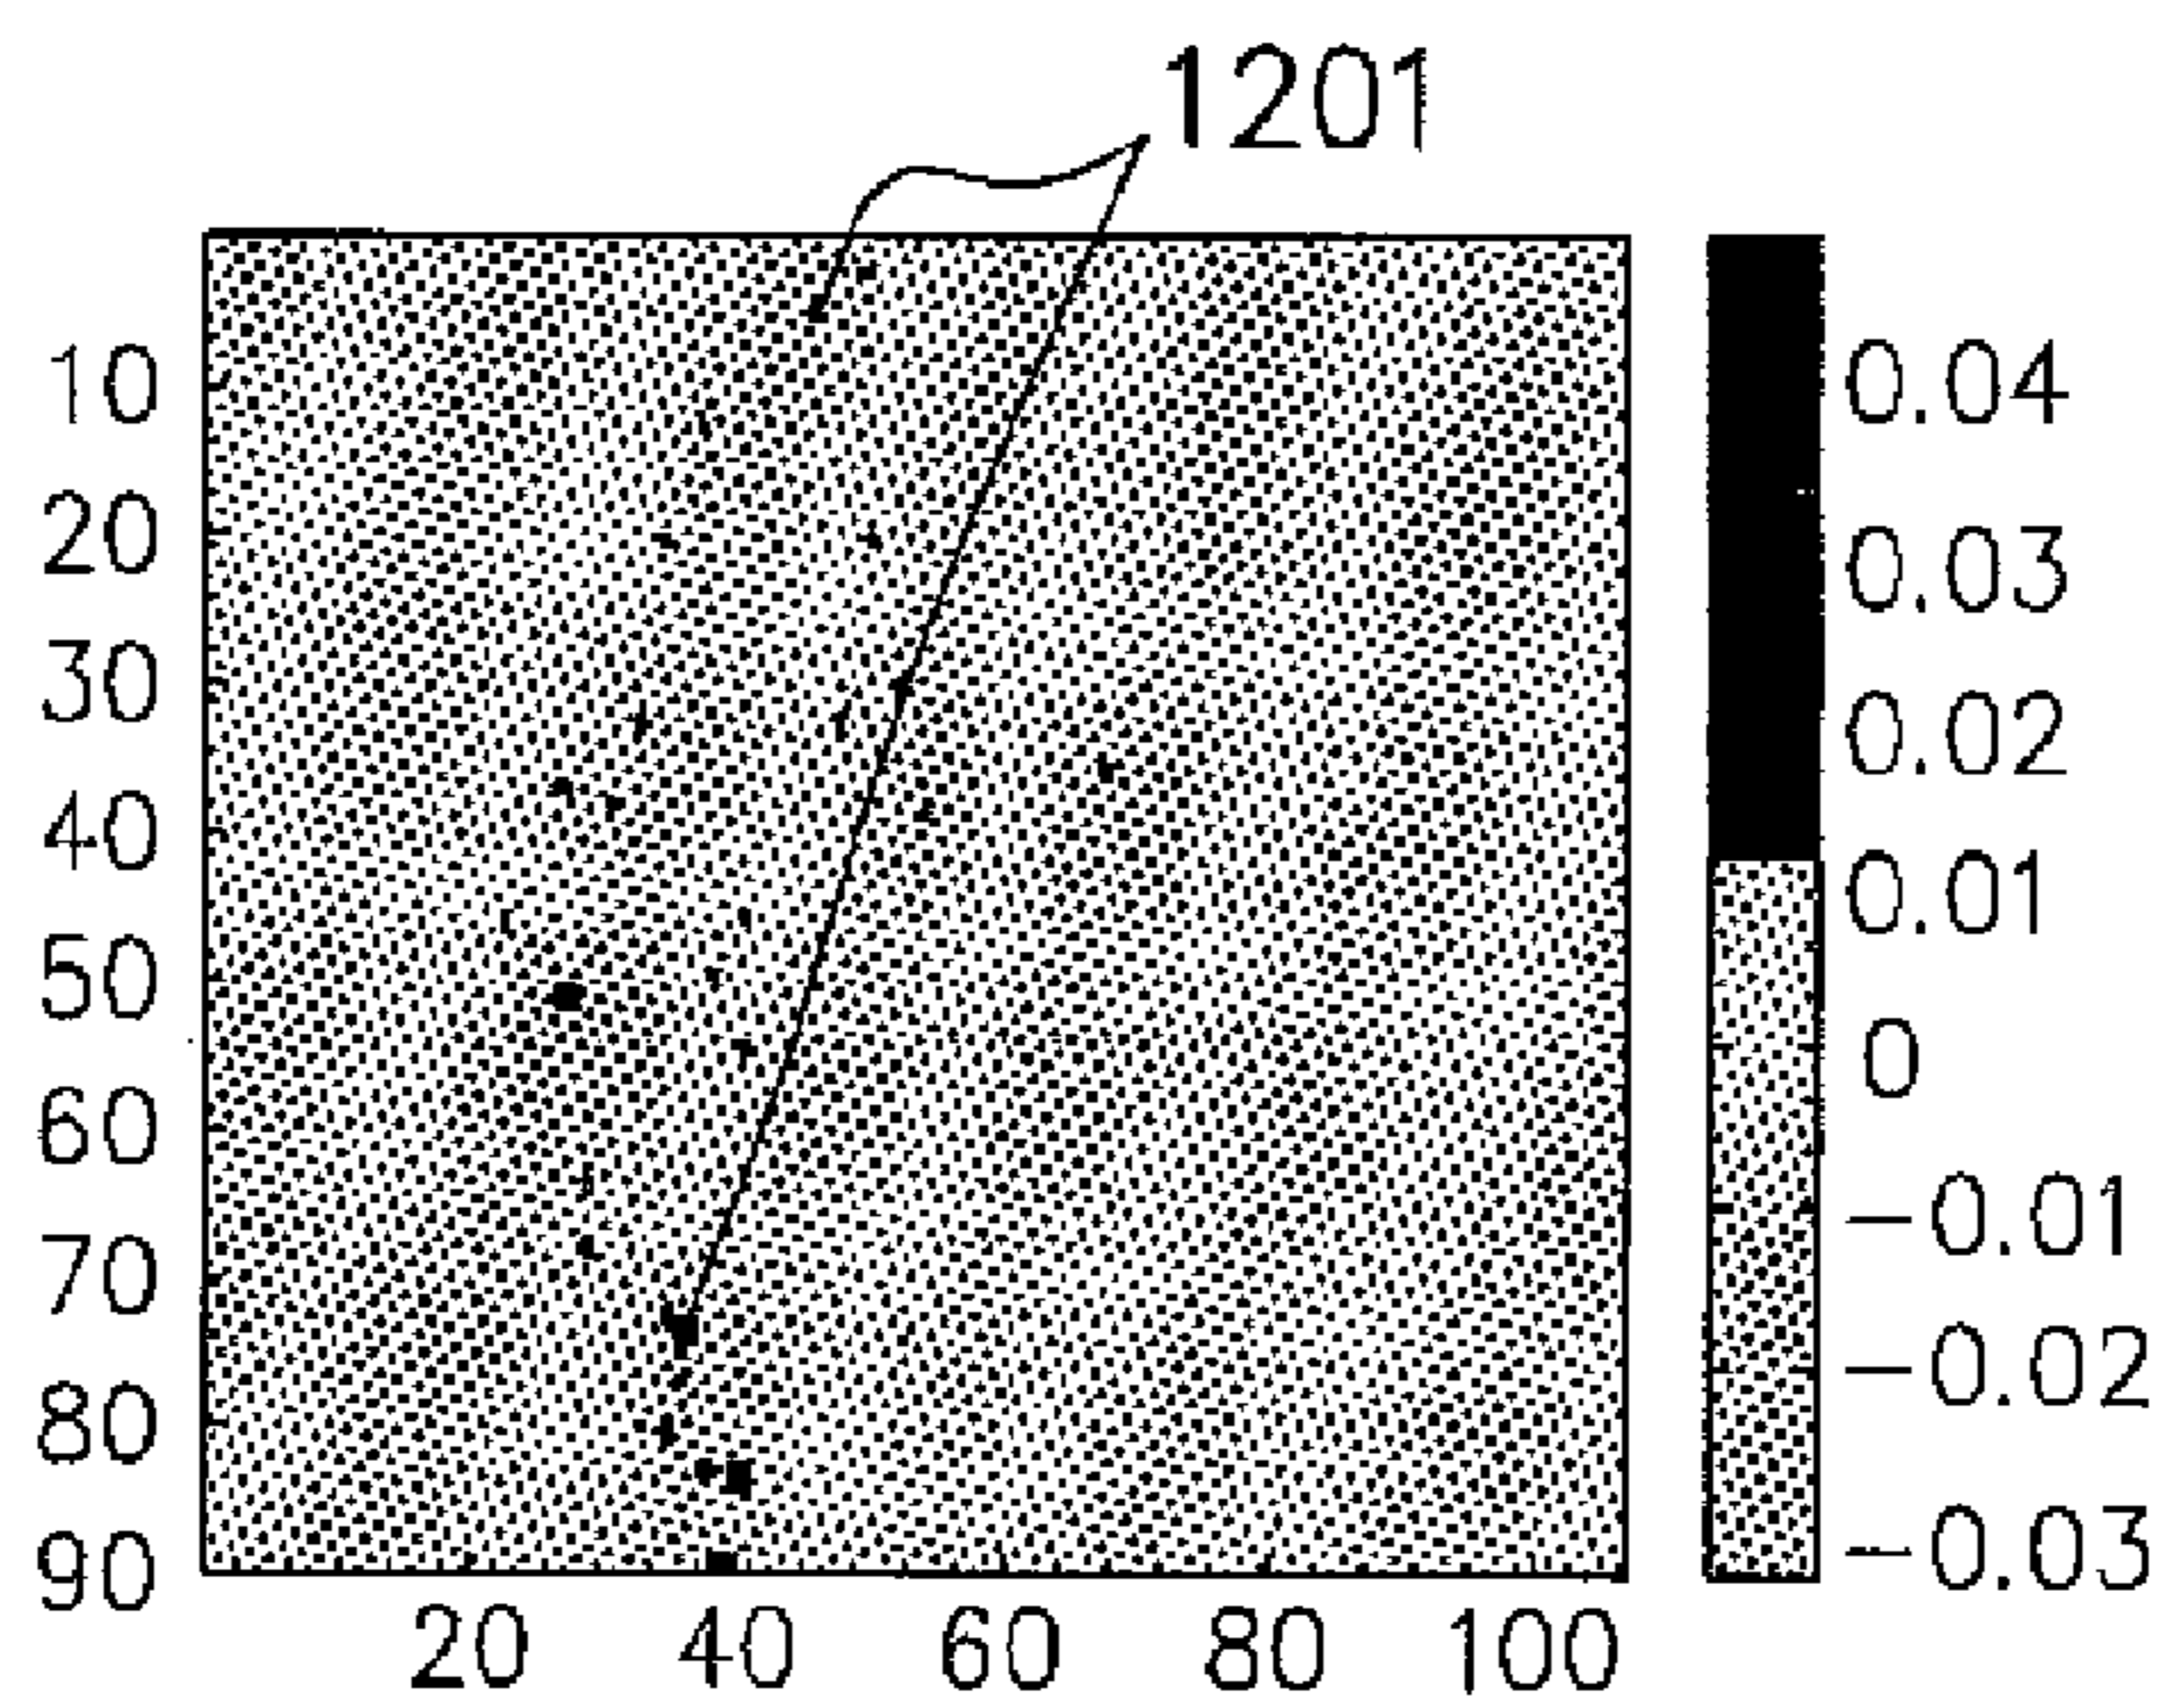
FIGS. 12A, 12B and 12C are an example of an image showing detecting a defect in the cooling down process, wherein the defect is a minute raised convex portion located on the surface of the steel sheet.
