US008506159B2

(54) **METHOD FOR DETECTING DEFECT IN MATERIAL AND SYSTEM FOR THE METHOD**

(73) Assignee: **Nippon Steel & Sumitomo Metal Corporation**, Tokyo (JP)

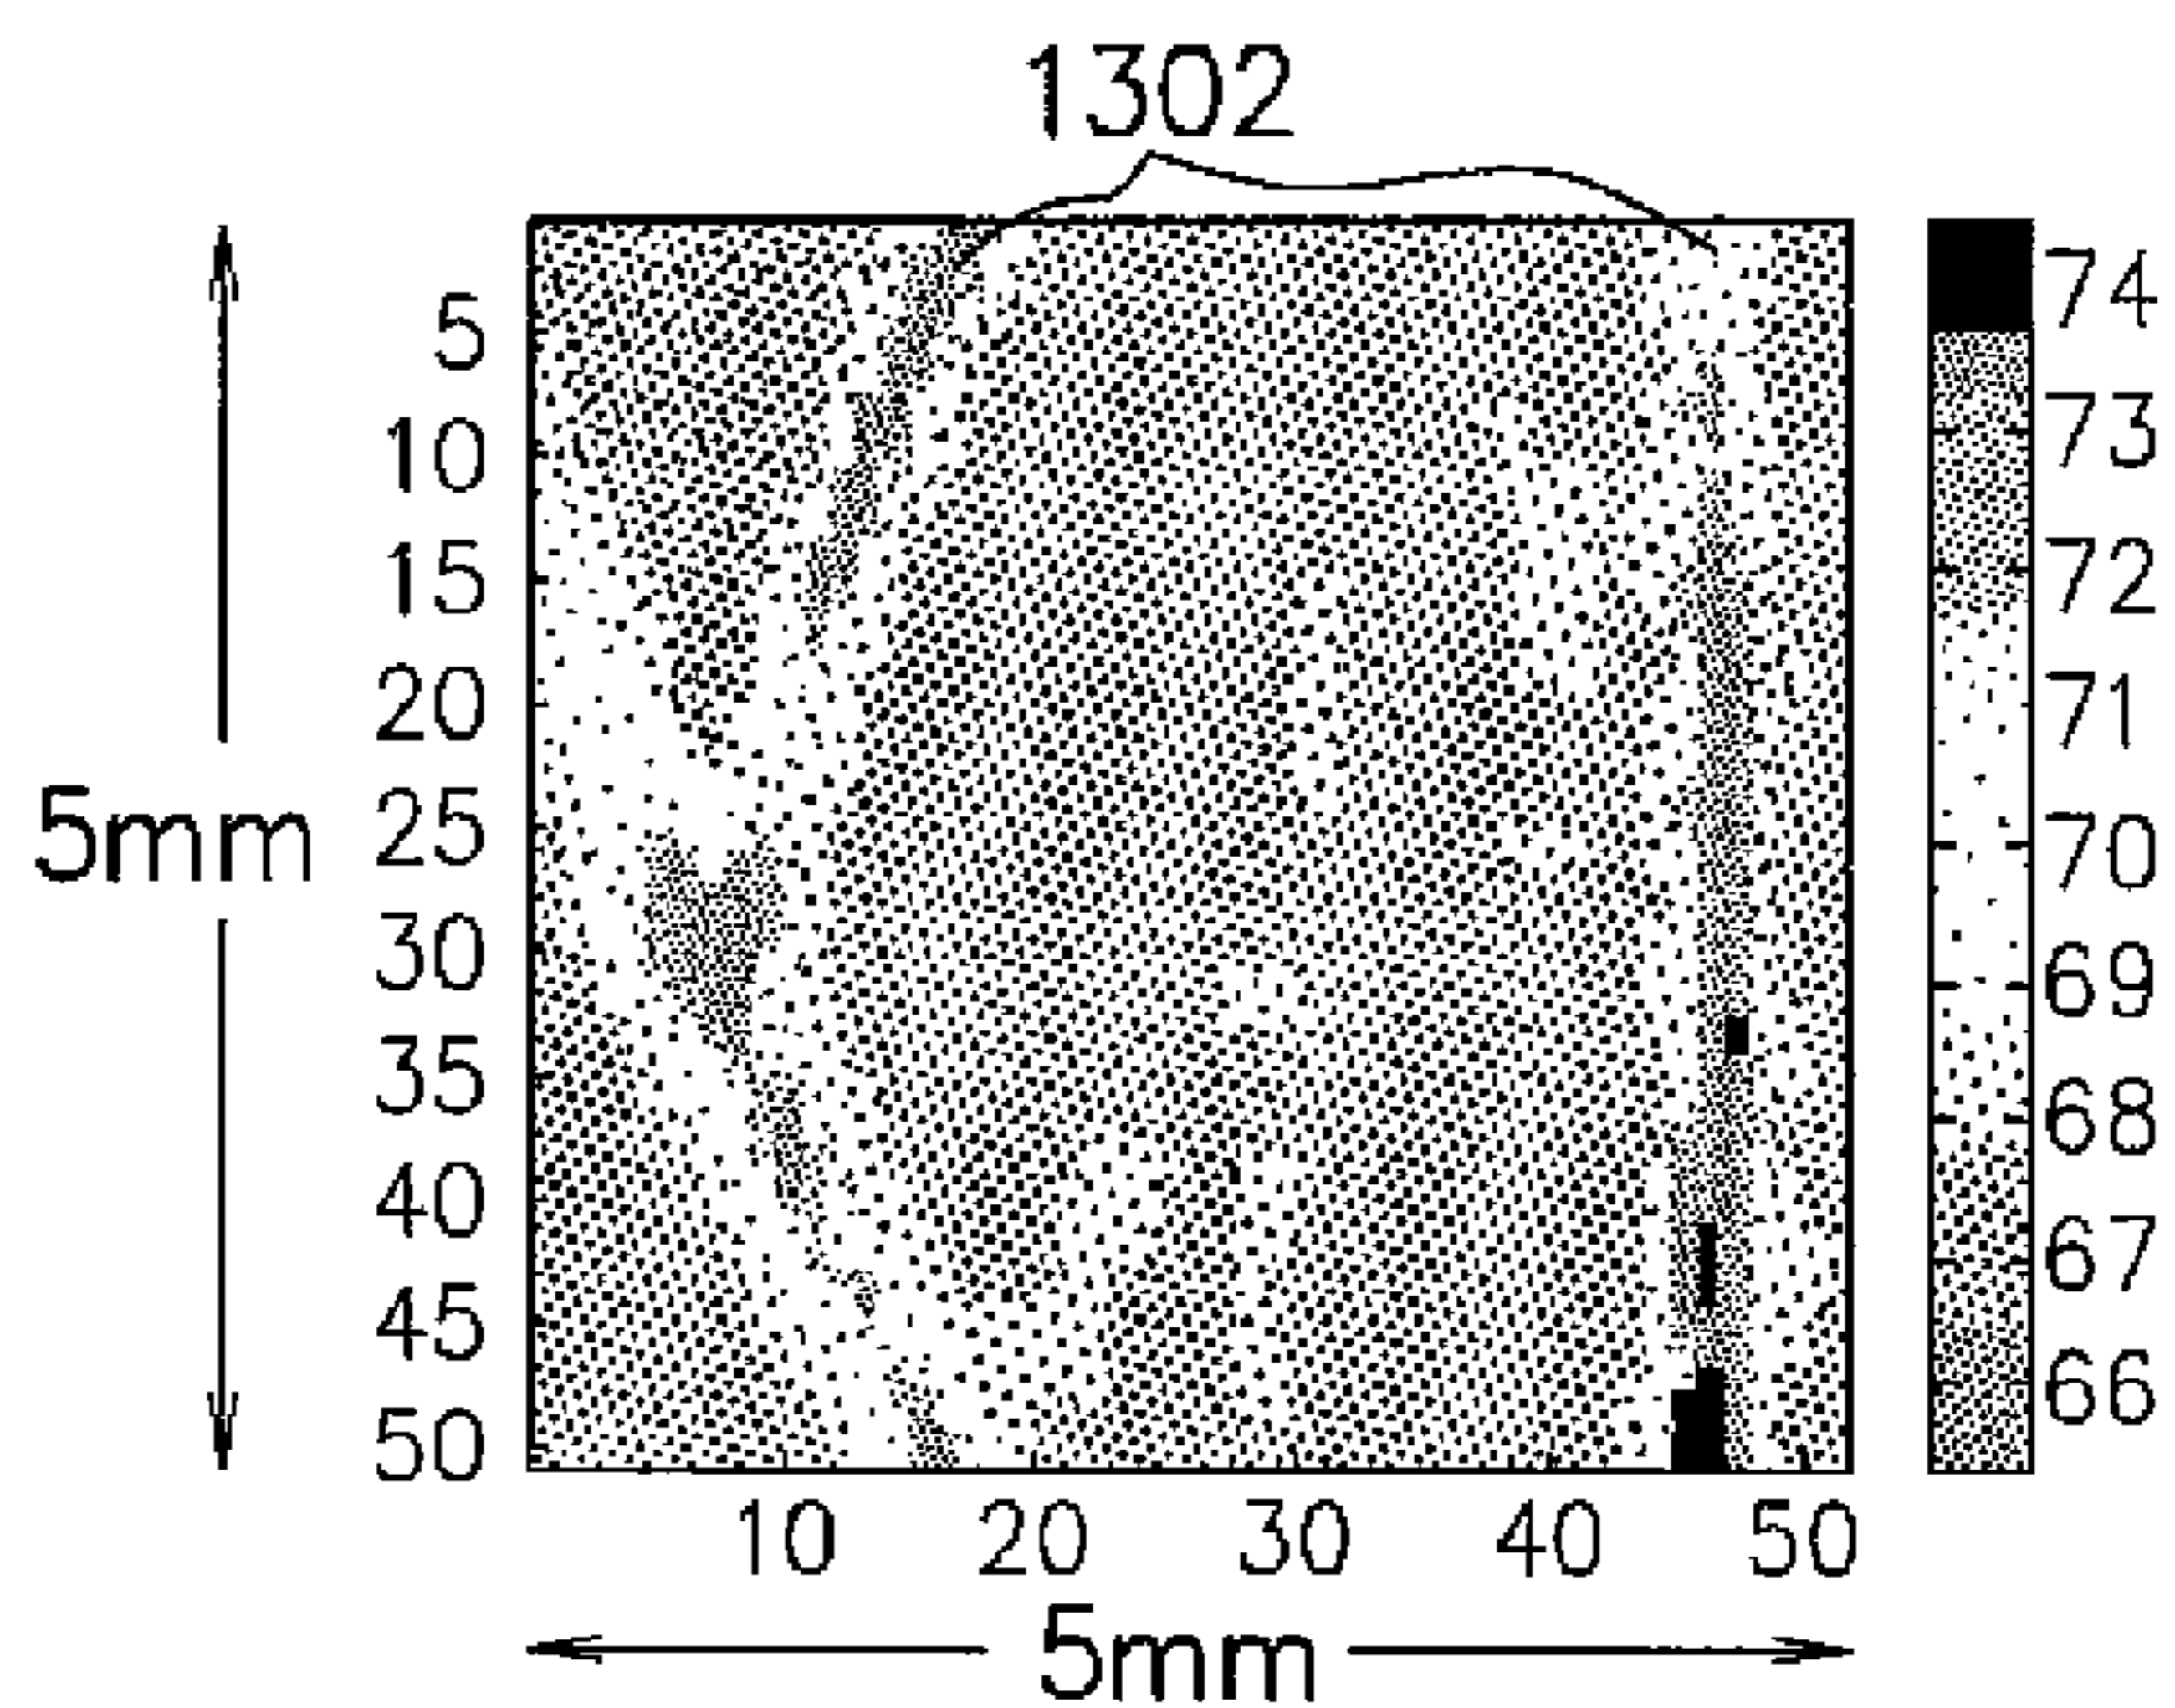
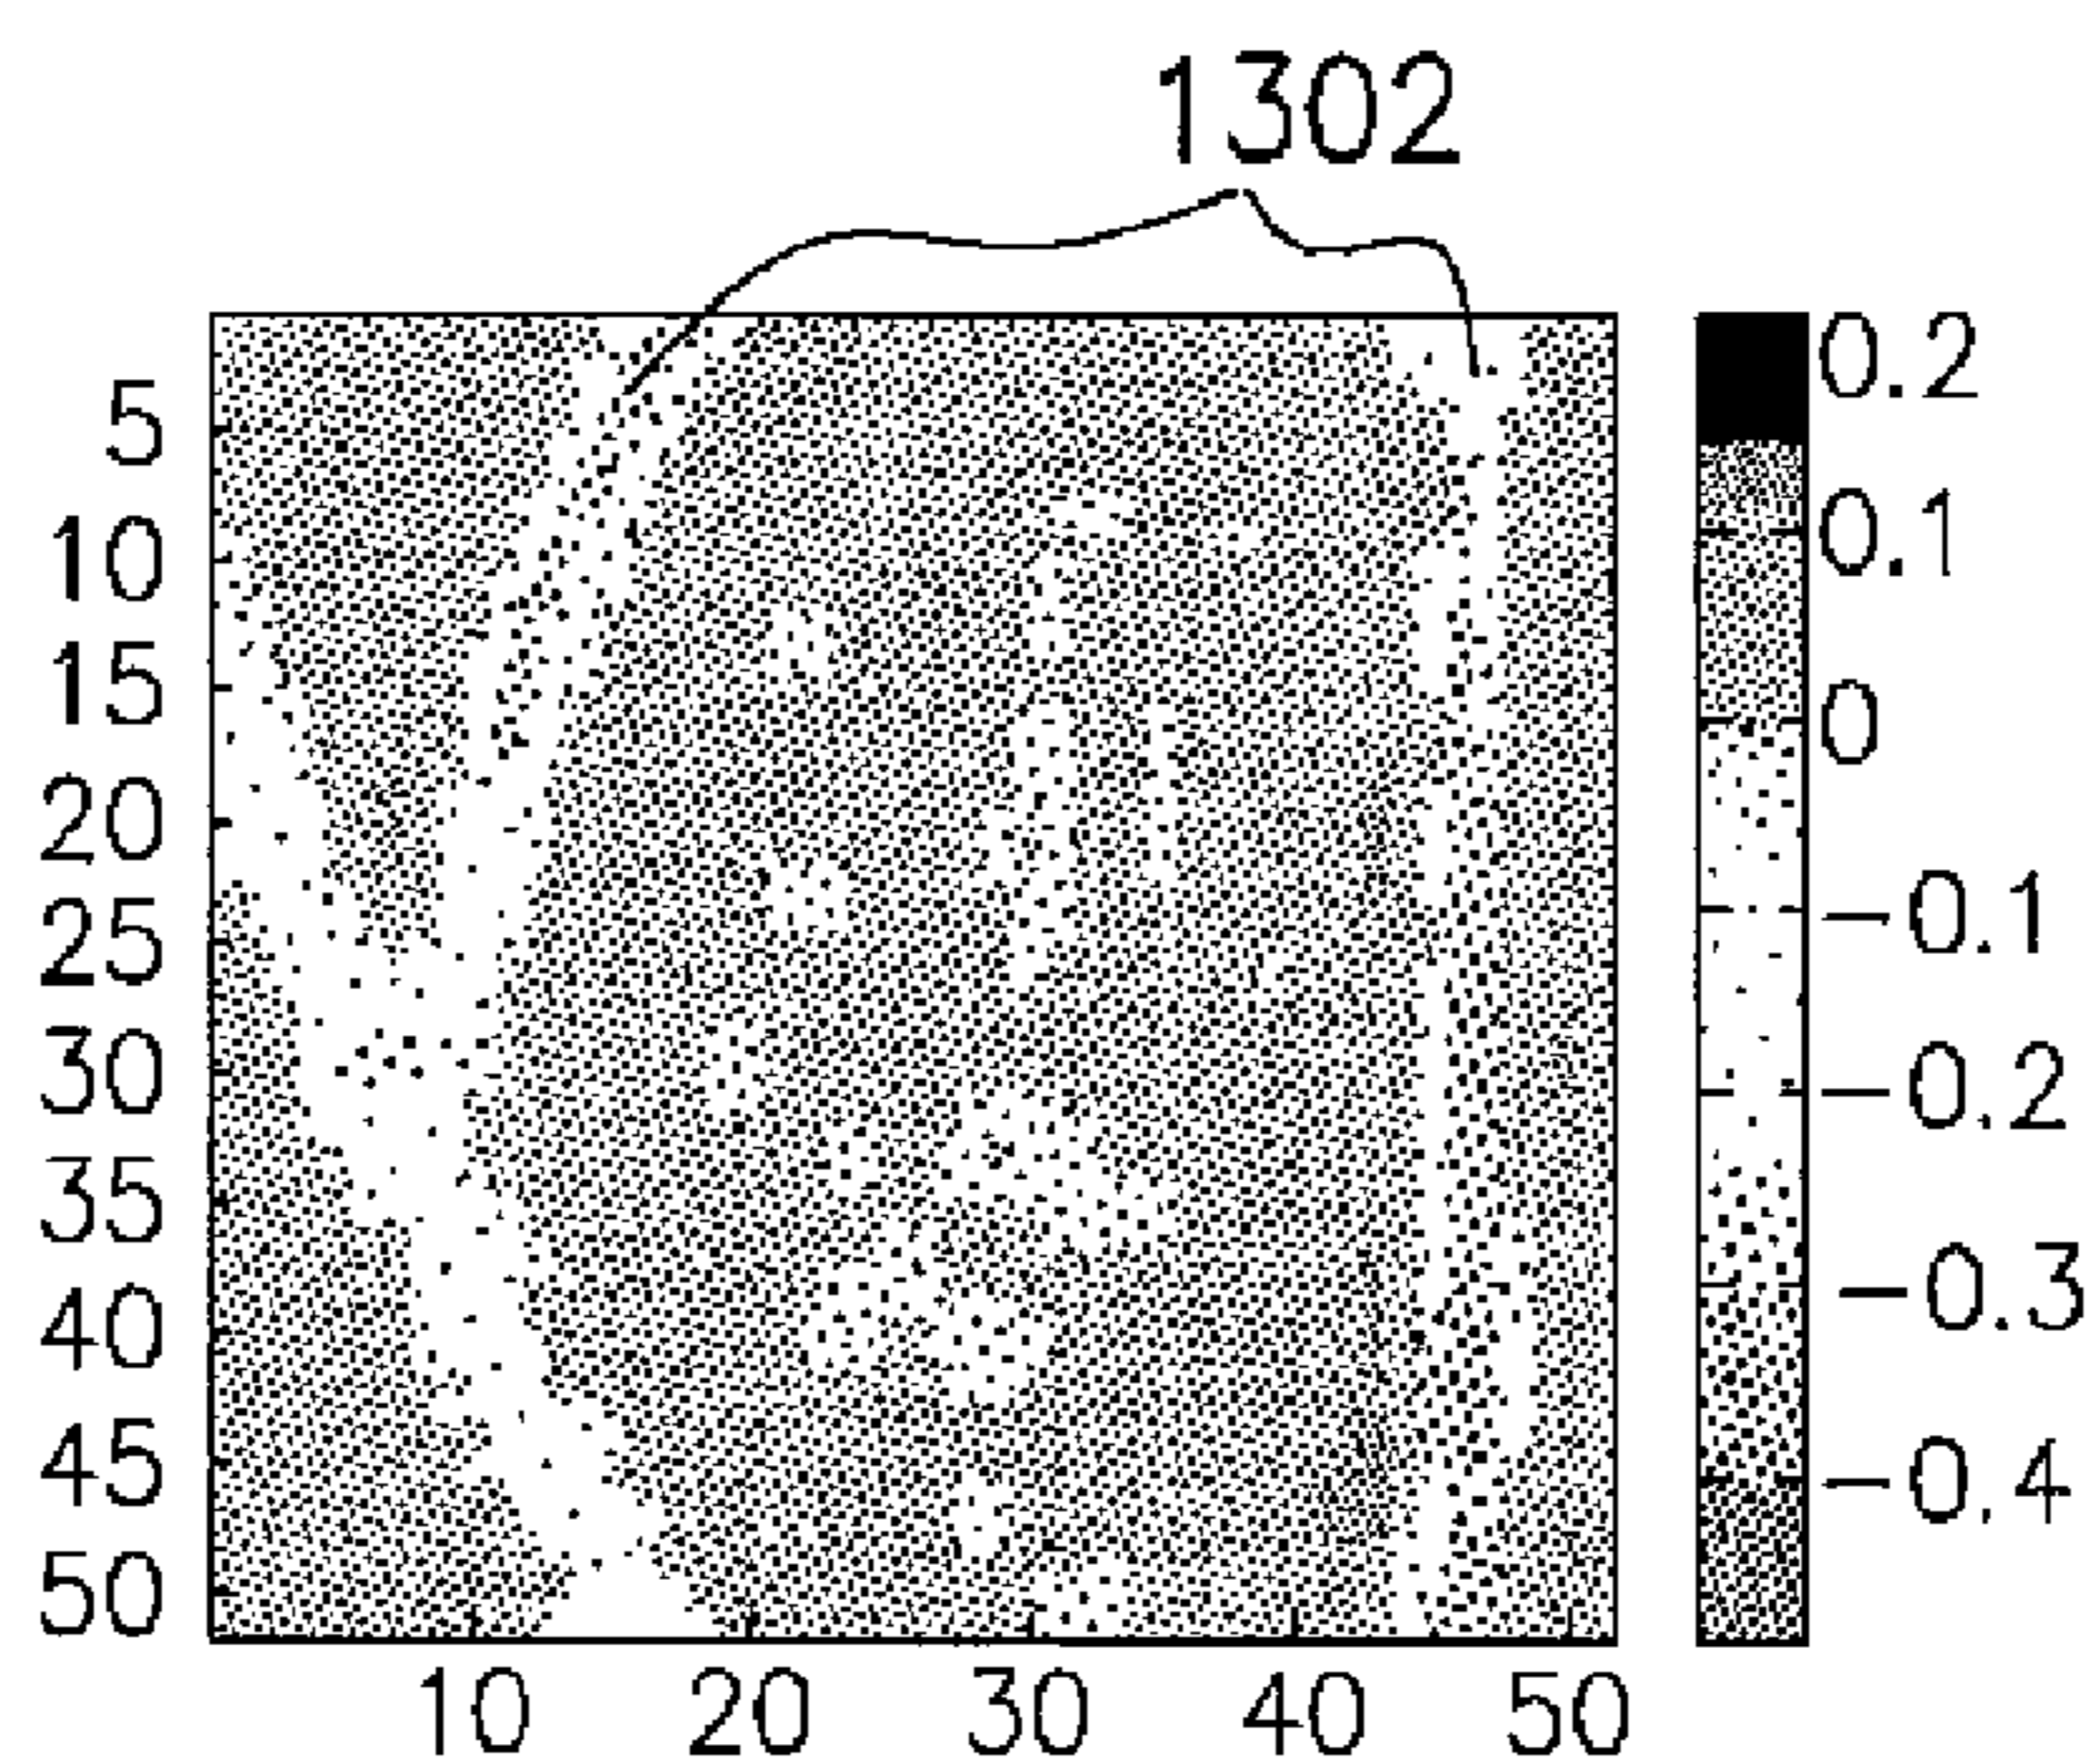
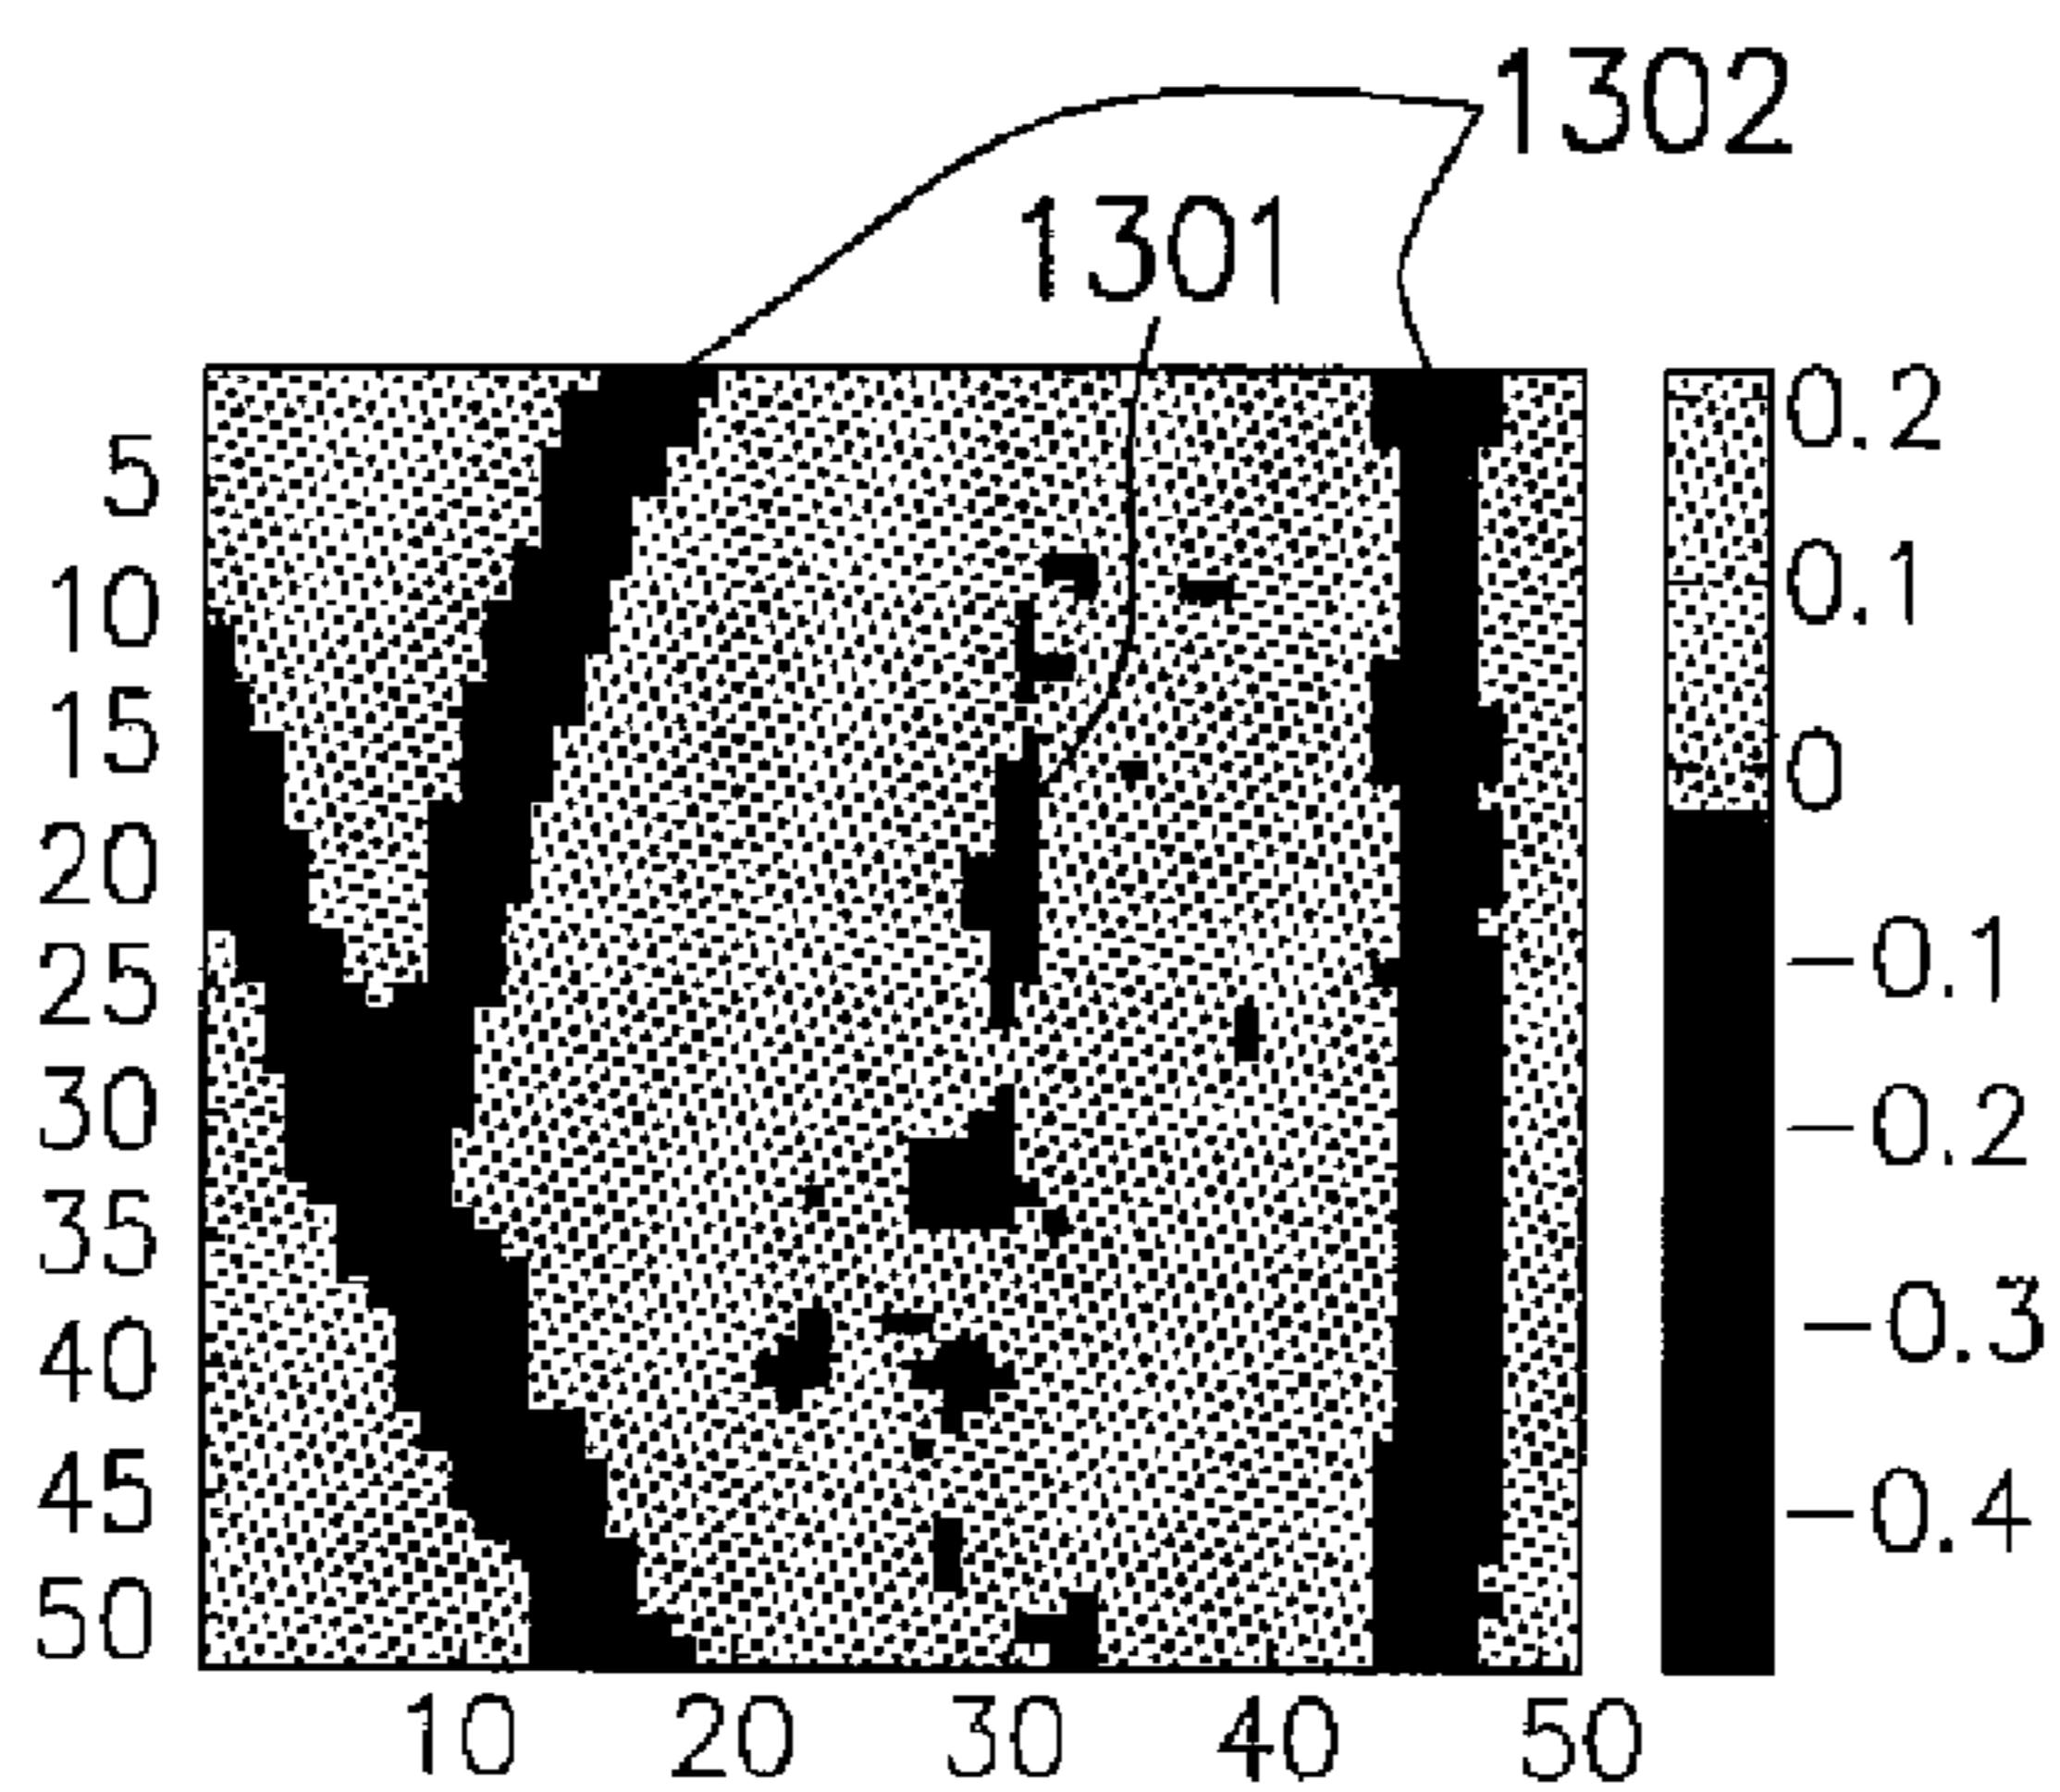
FIGS. 13A, 13B and 13C are an example of an image showing detecting a defect in the cooling down process, wherein the defect is a minute sharp dent located on the surface of the steel sheet.

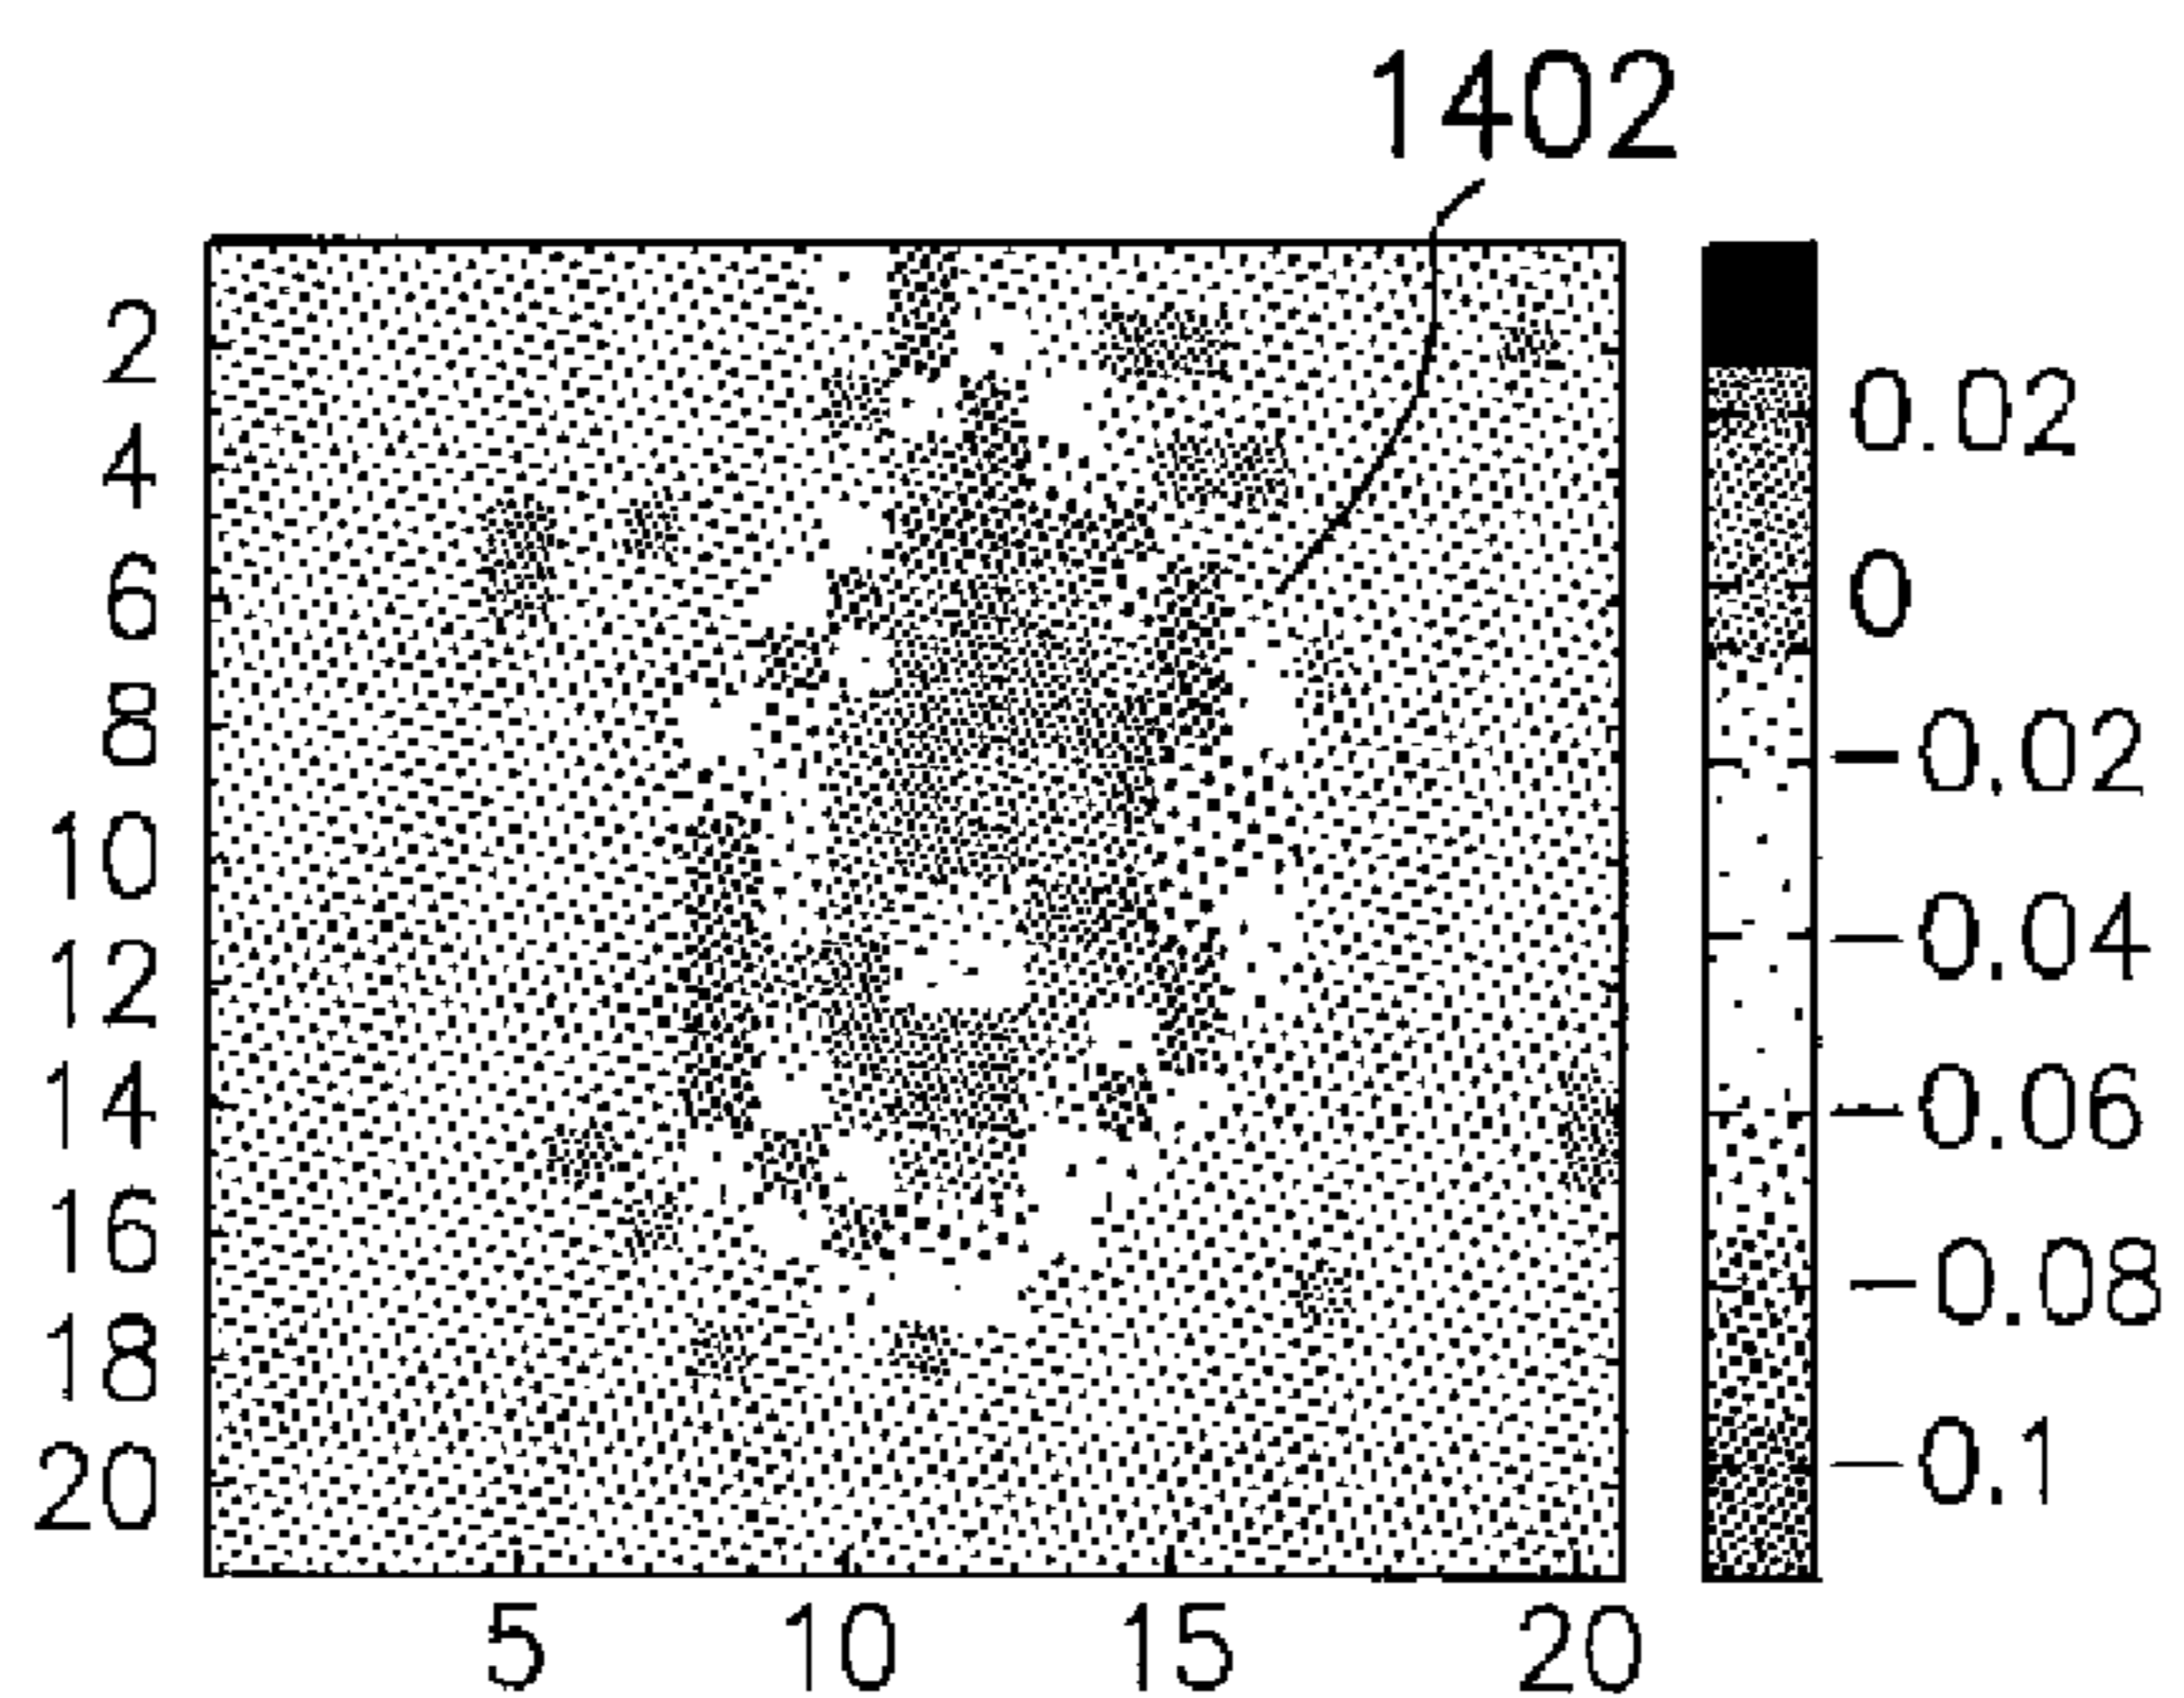
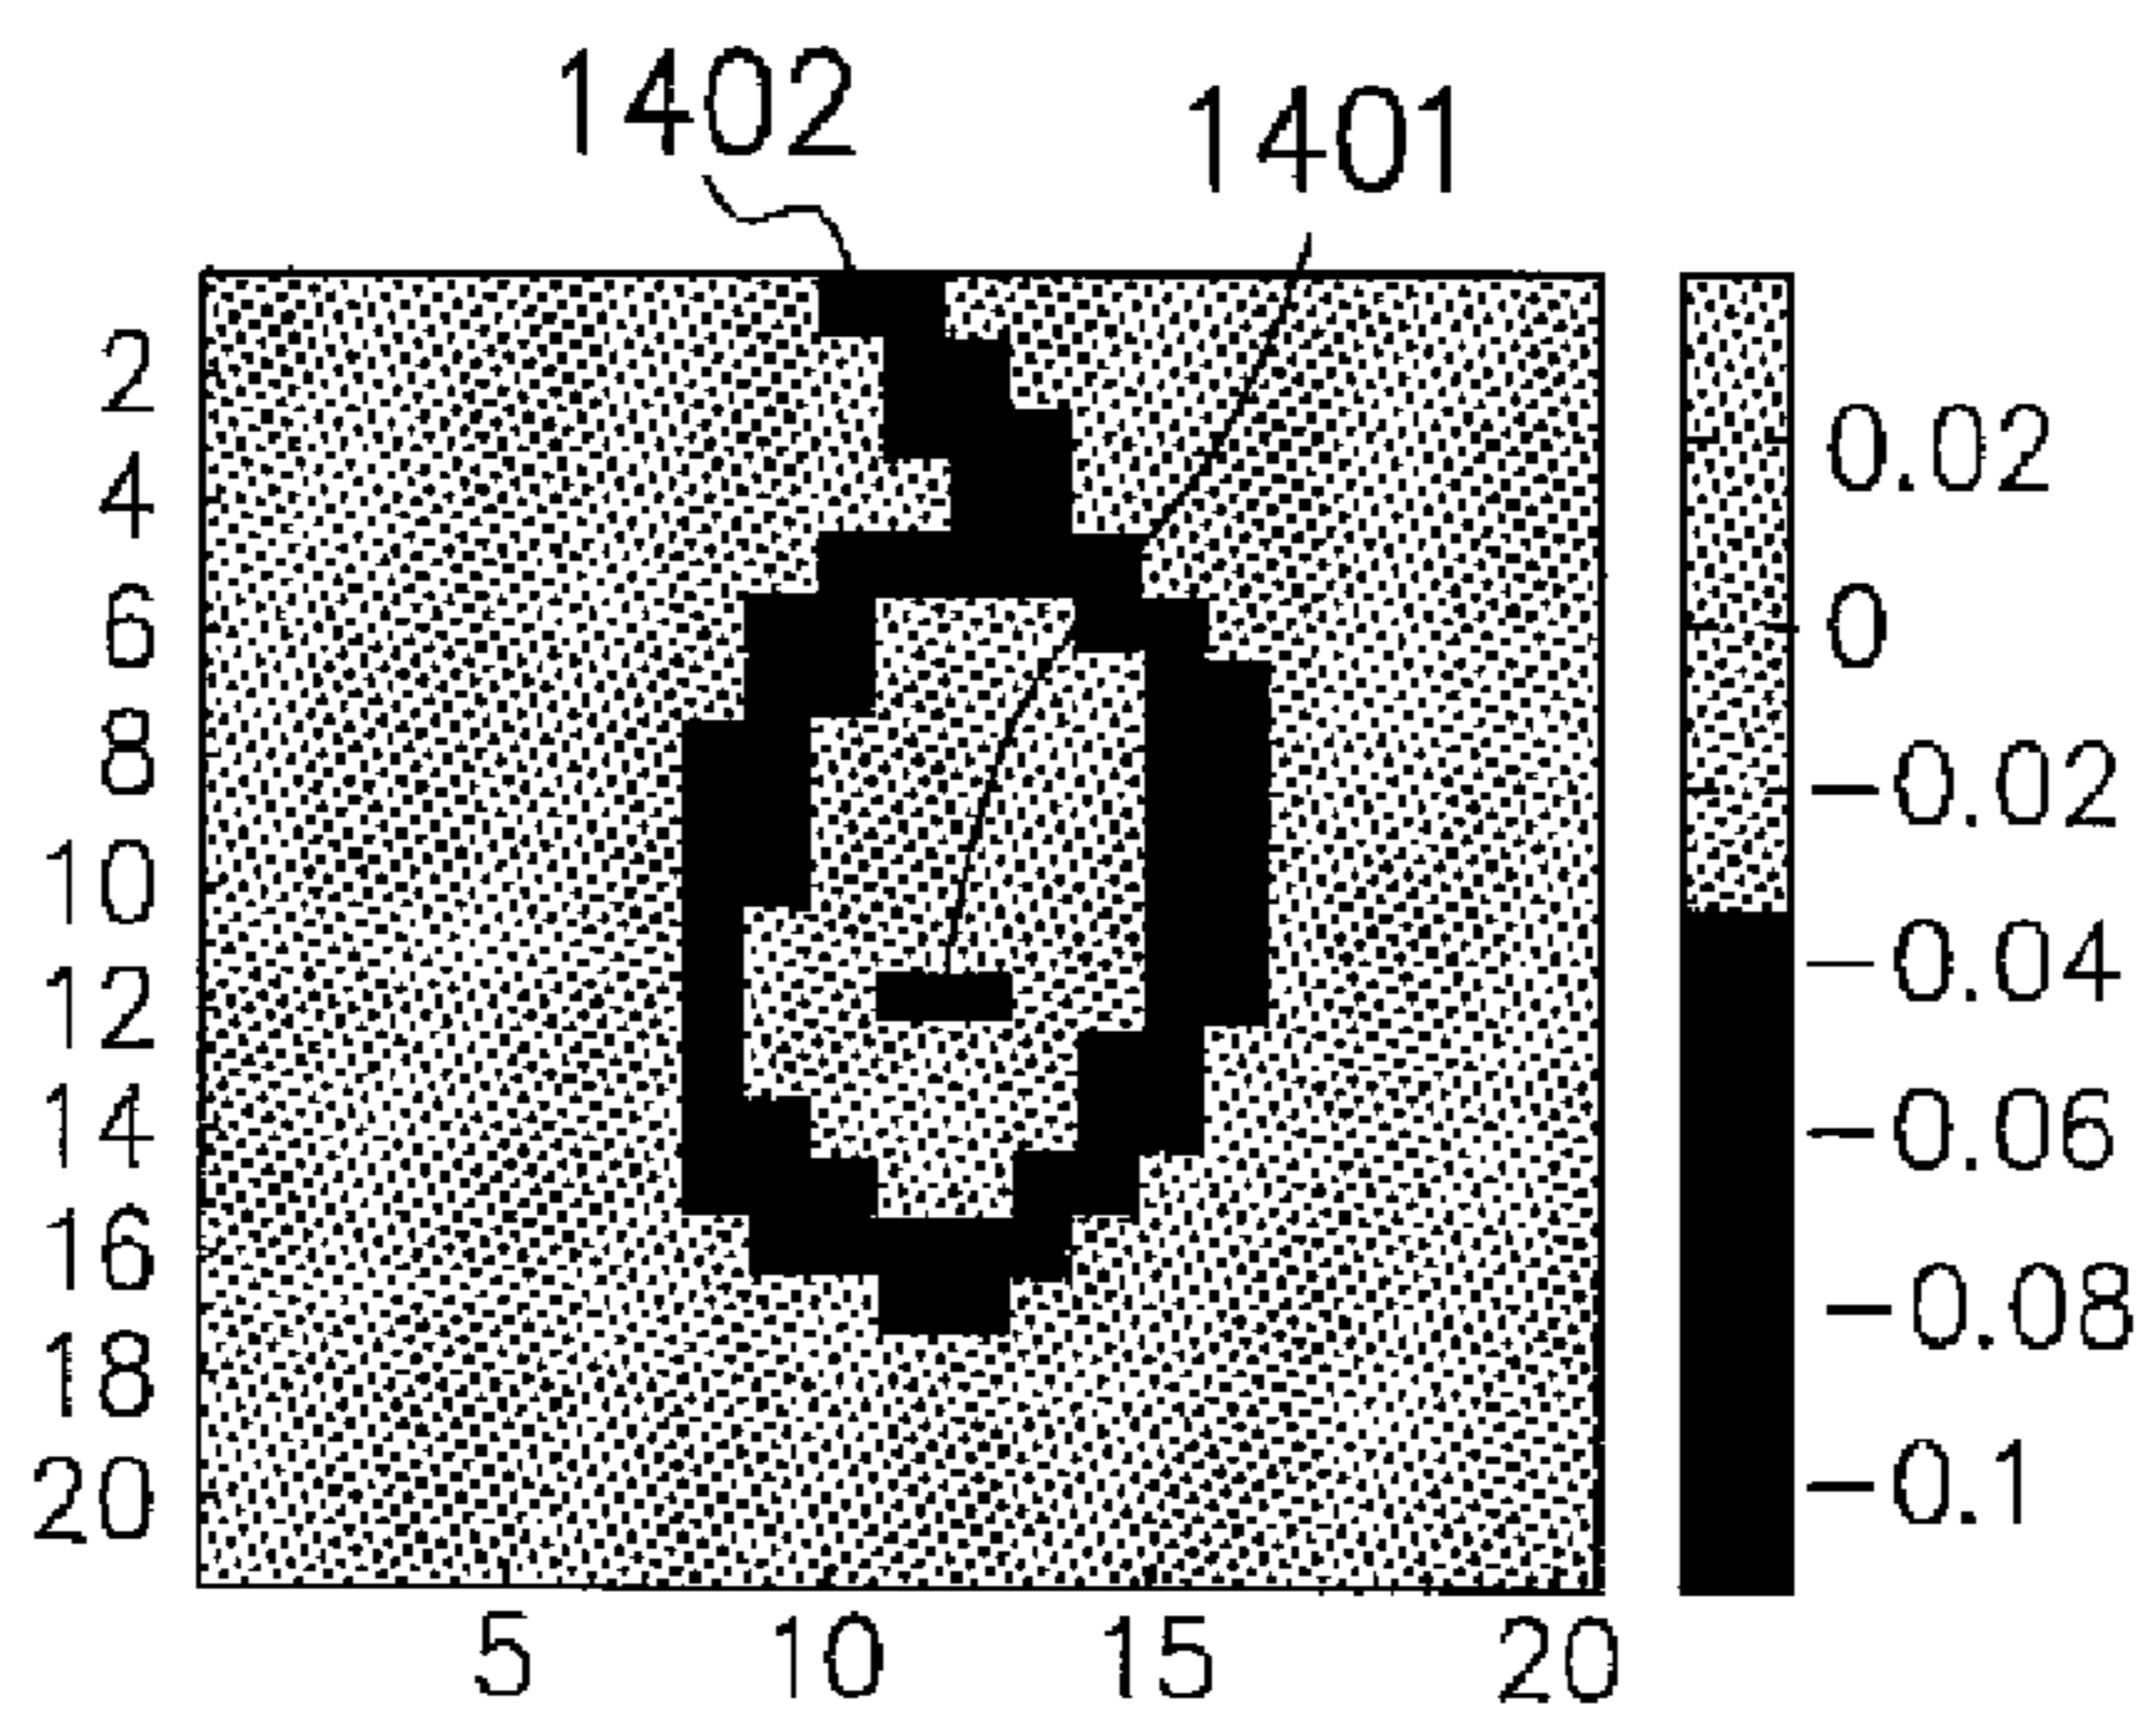
FIGS. 14A, 14B and 14C are an example of an image showing detecting a defect in the cooling down process, wherein the defect is a foreign material attached on the surface of the steel sheet.
