US008506159B2

(54) **METHOD FOR DETECTING DEFECT IN MATERIAL AND SYSTEM FOR THE METHOD**

(73) Assignee: **Nippon Steel & Sumitomo Metal Corporation**, Tokyo (JP)

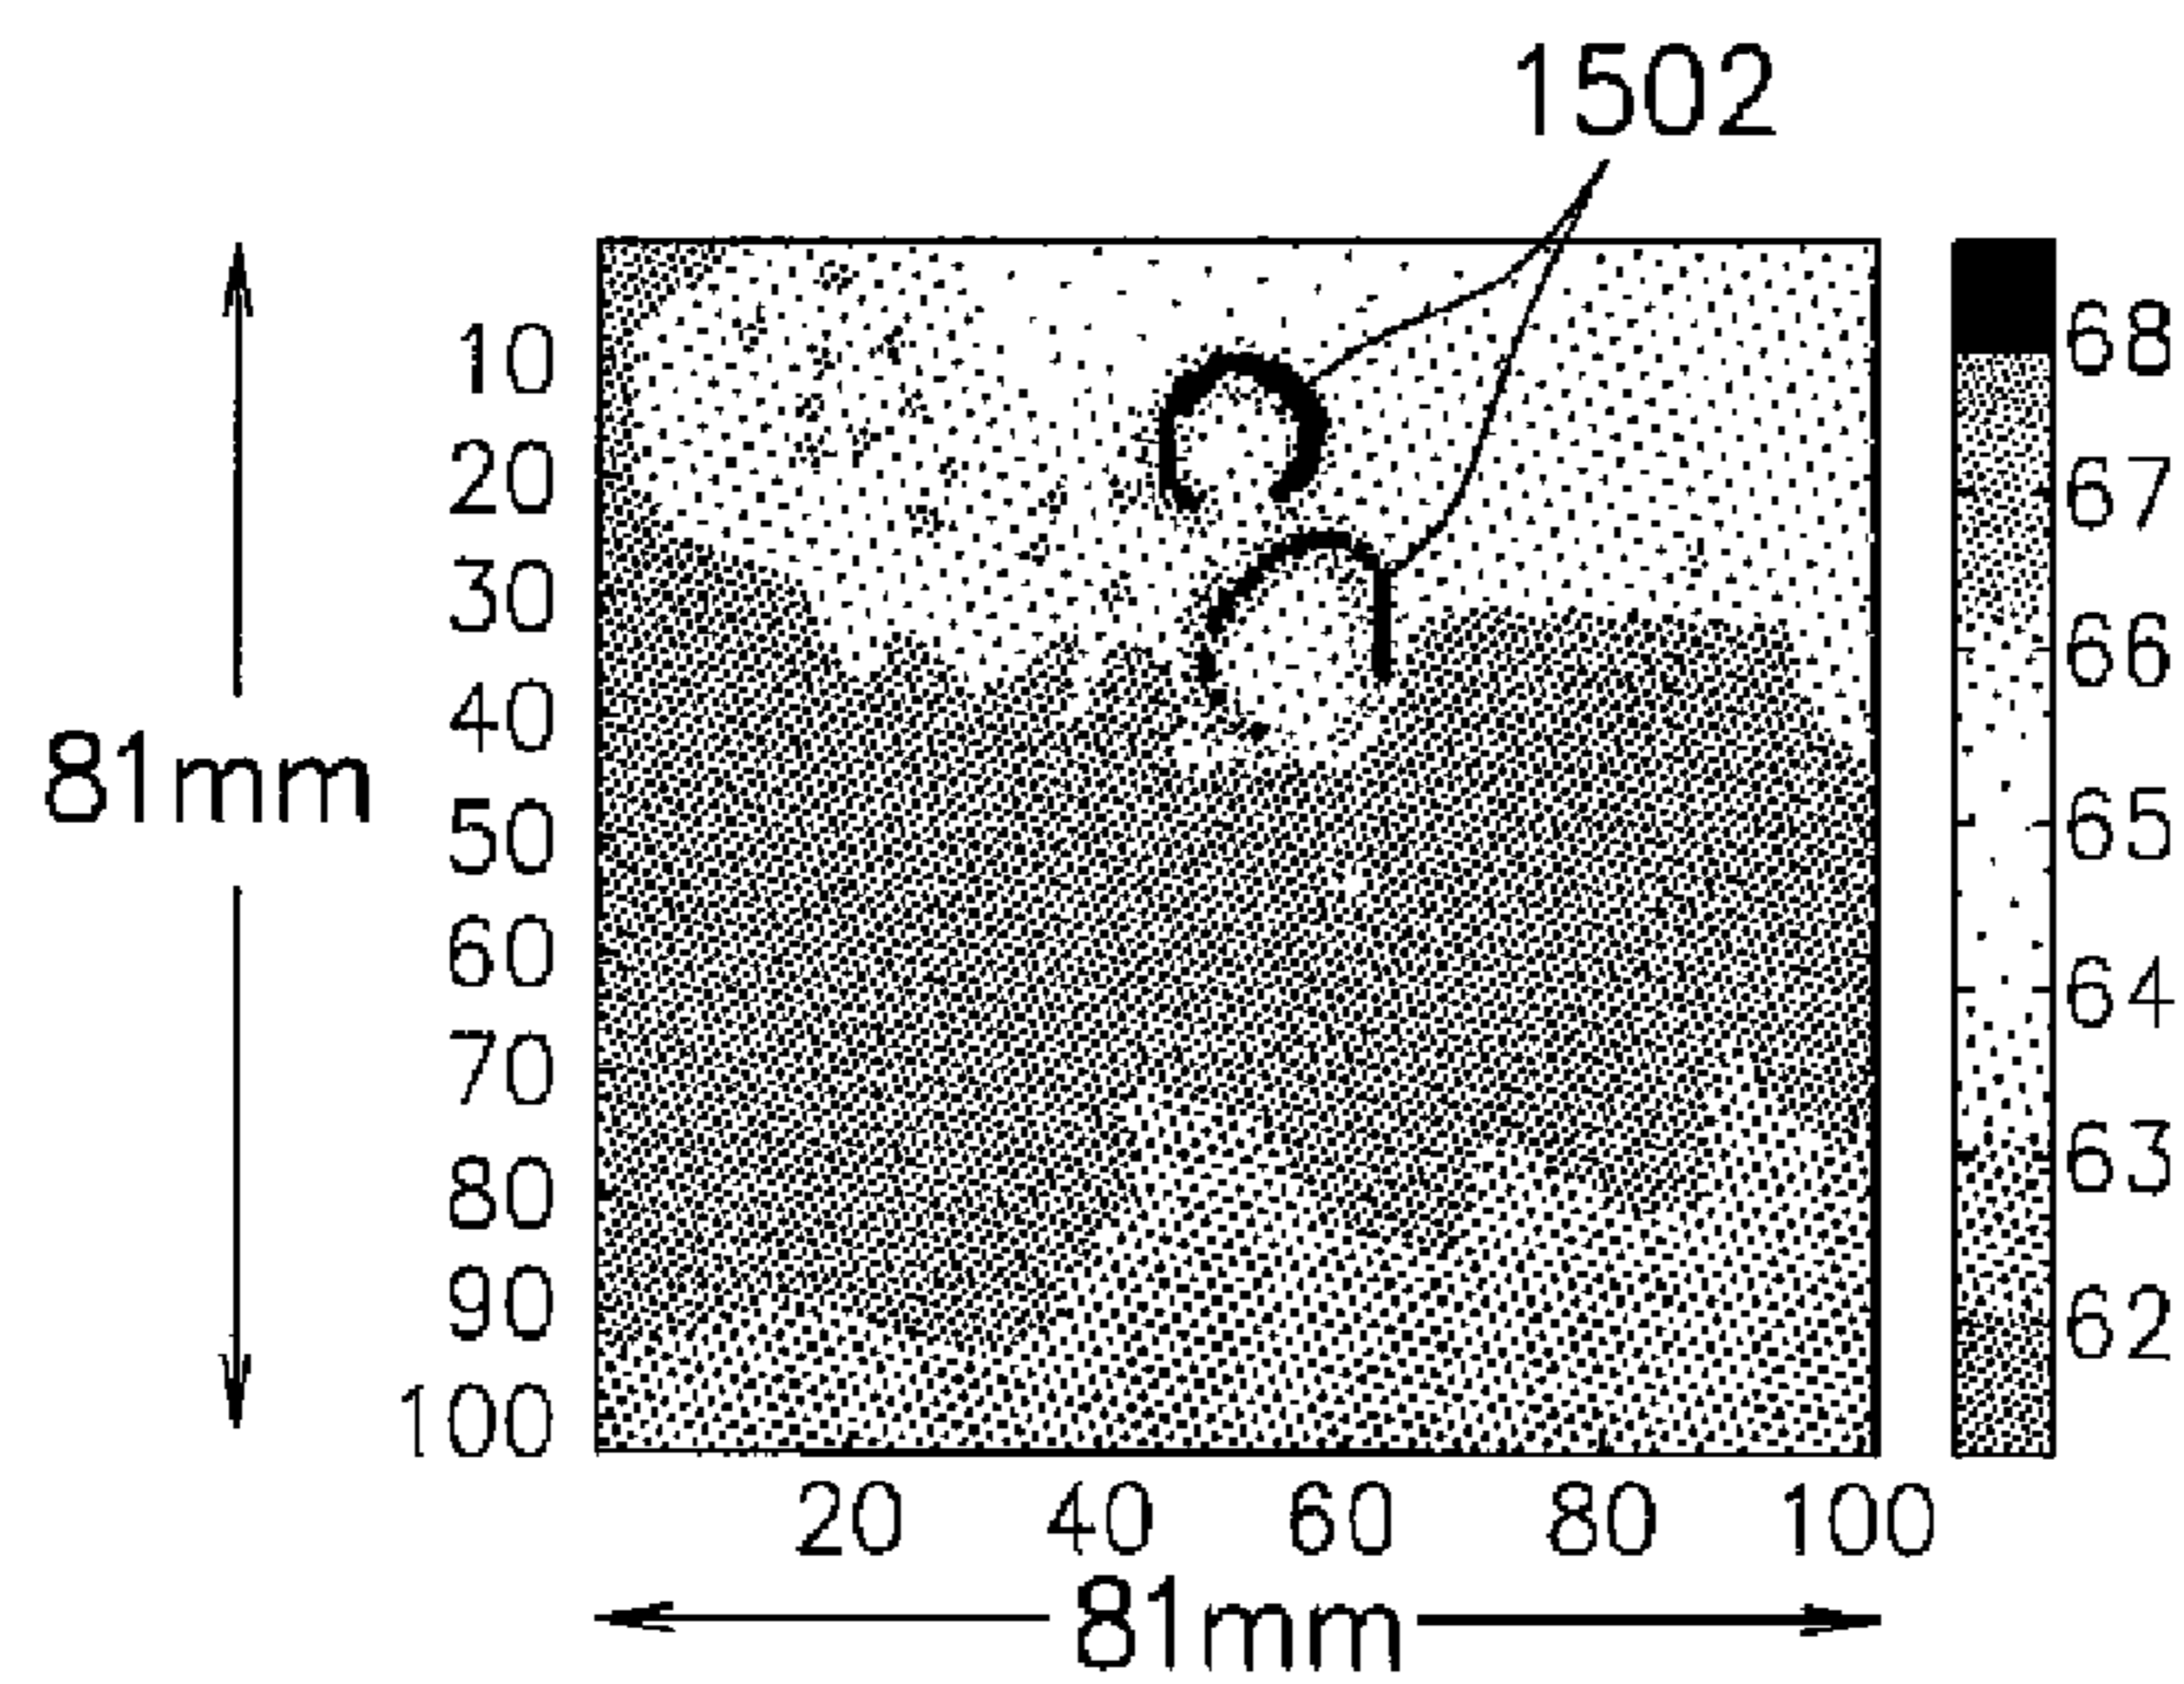
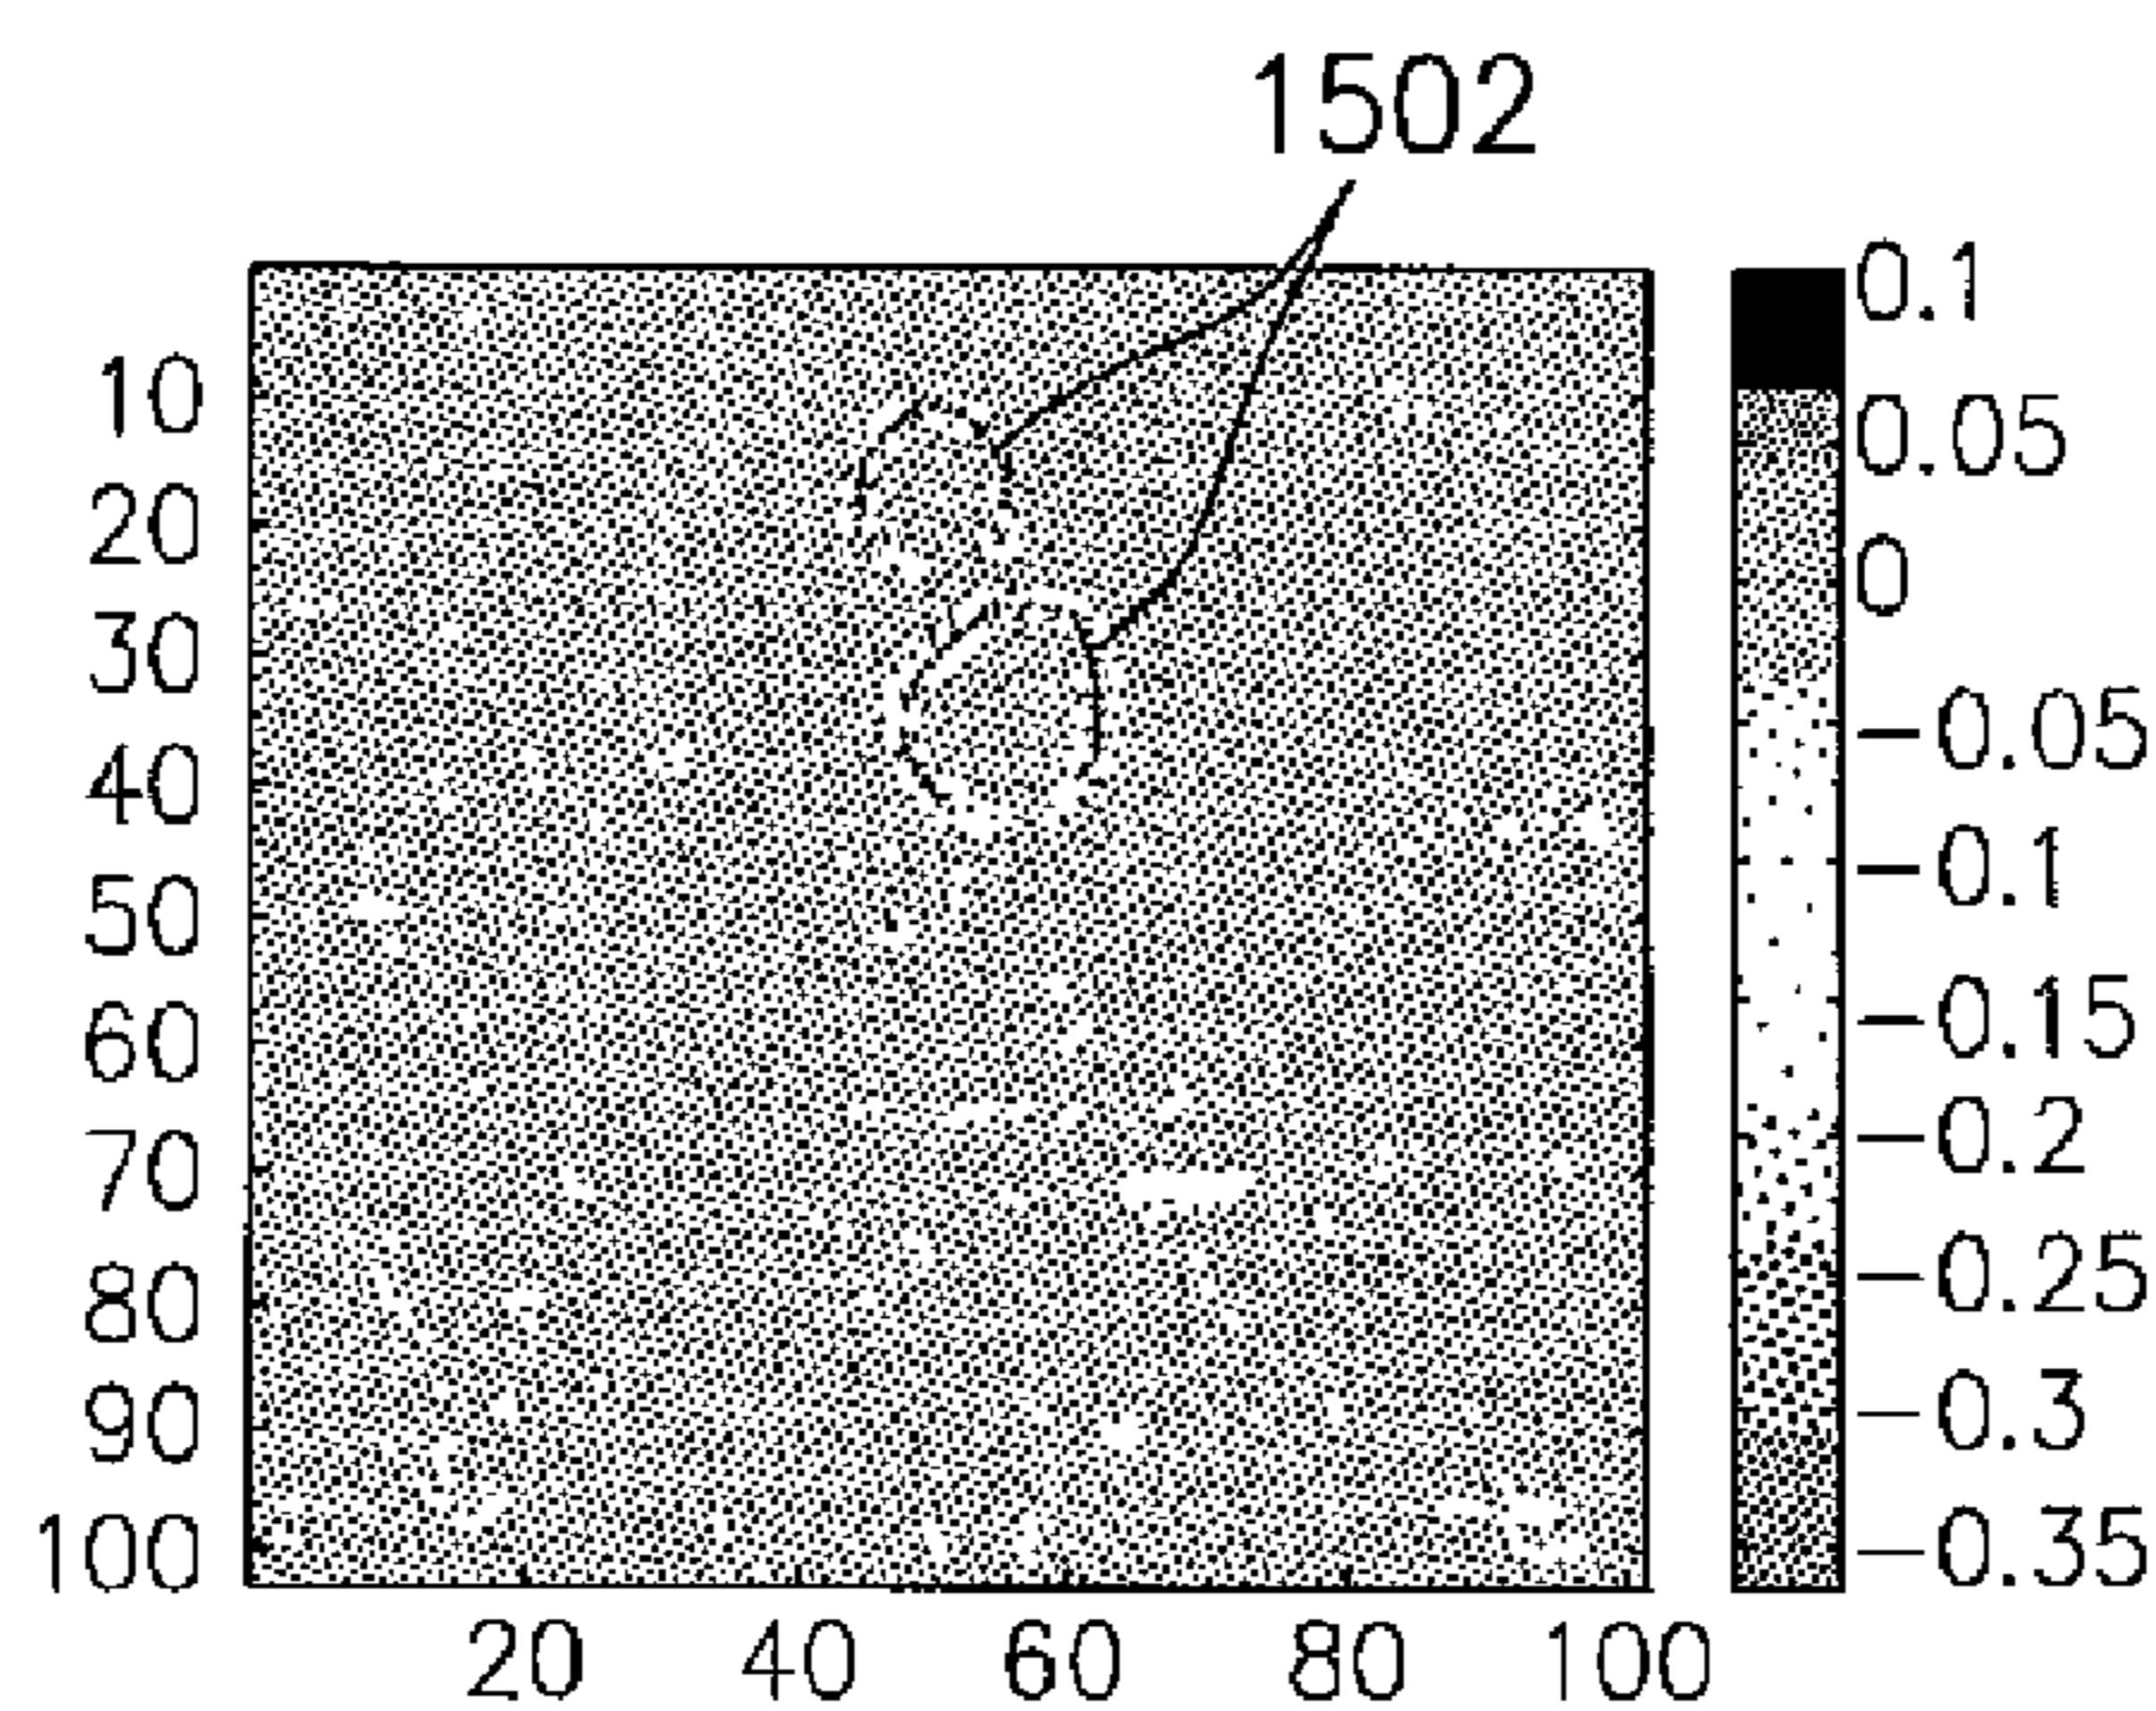
FIGS. 15A, 15B and 15C are an example of an image showing detecting a defect in the cooling down process, wherein the defect is a foreign material in the surface layer of a resin fuel tank for an automobile.

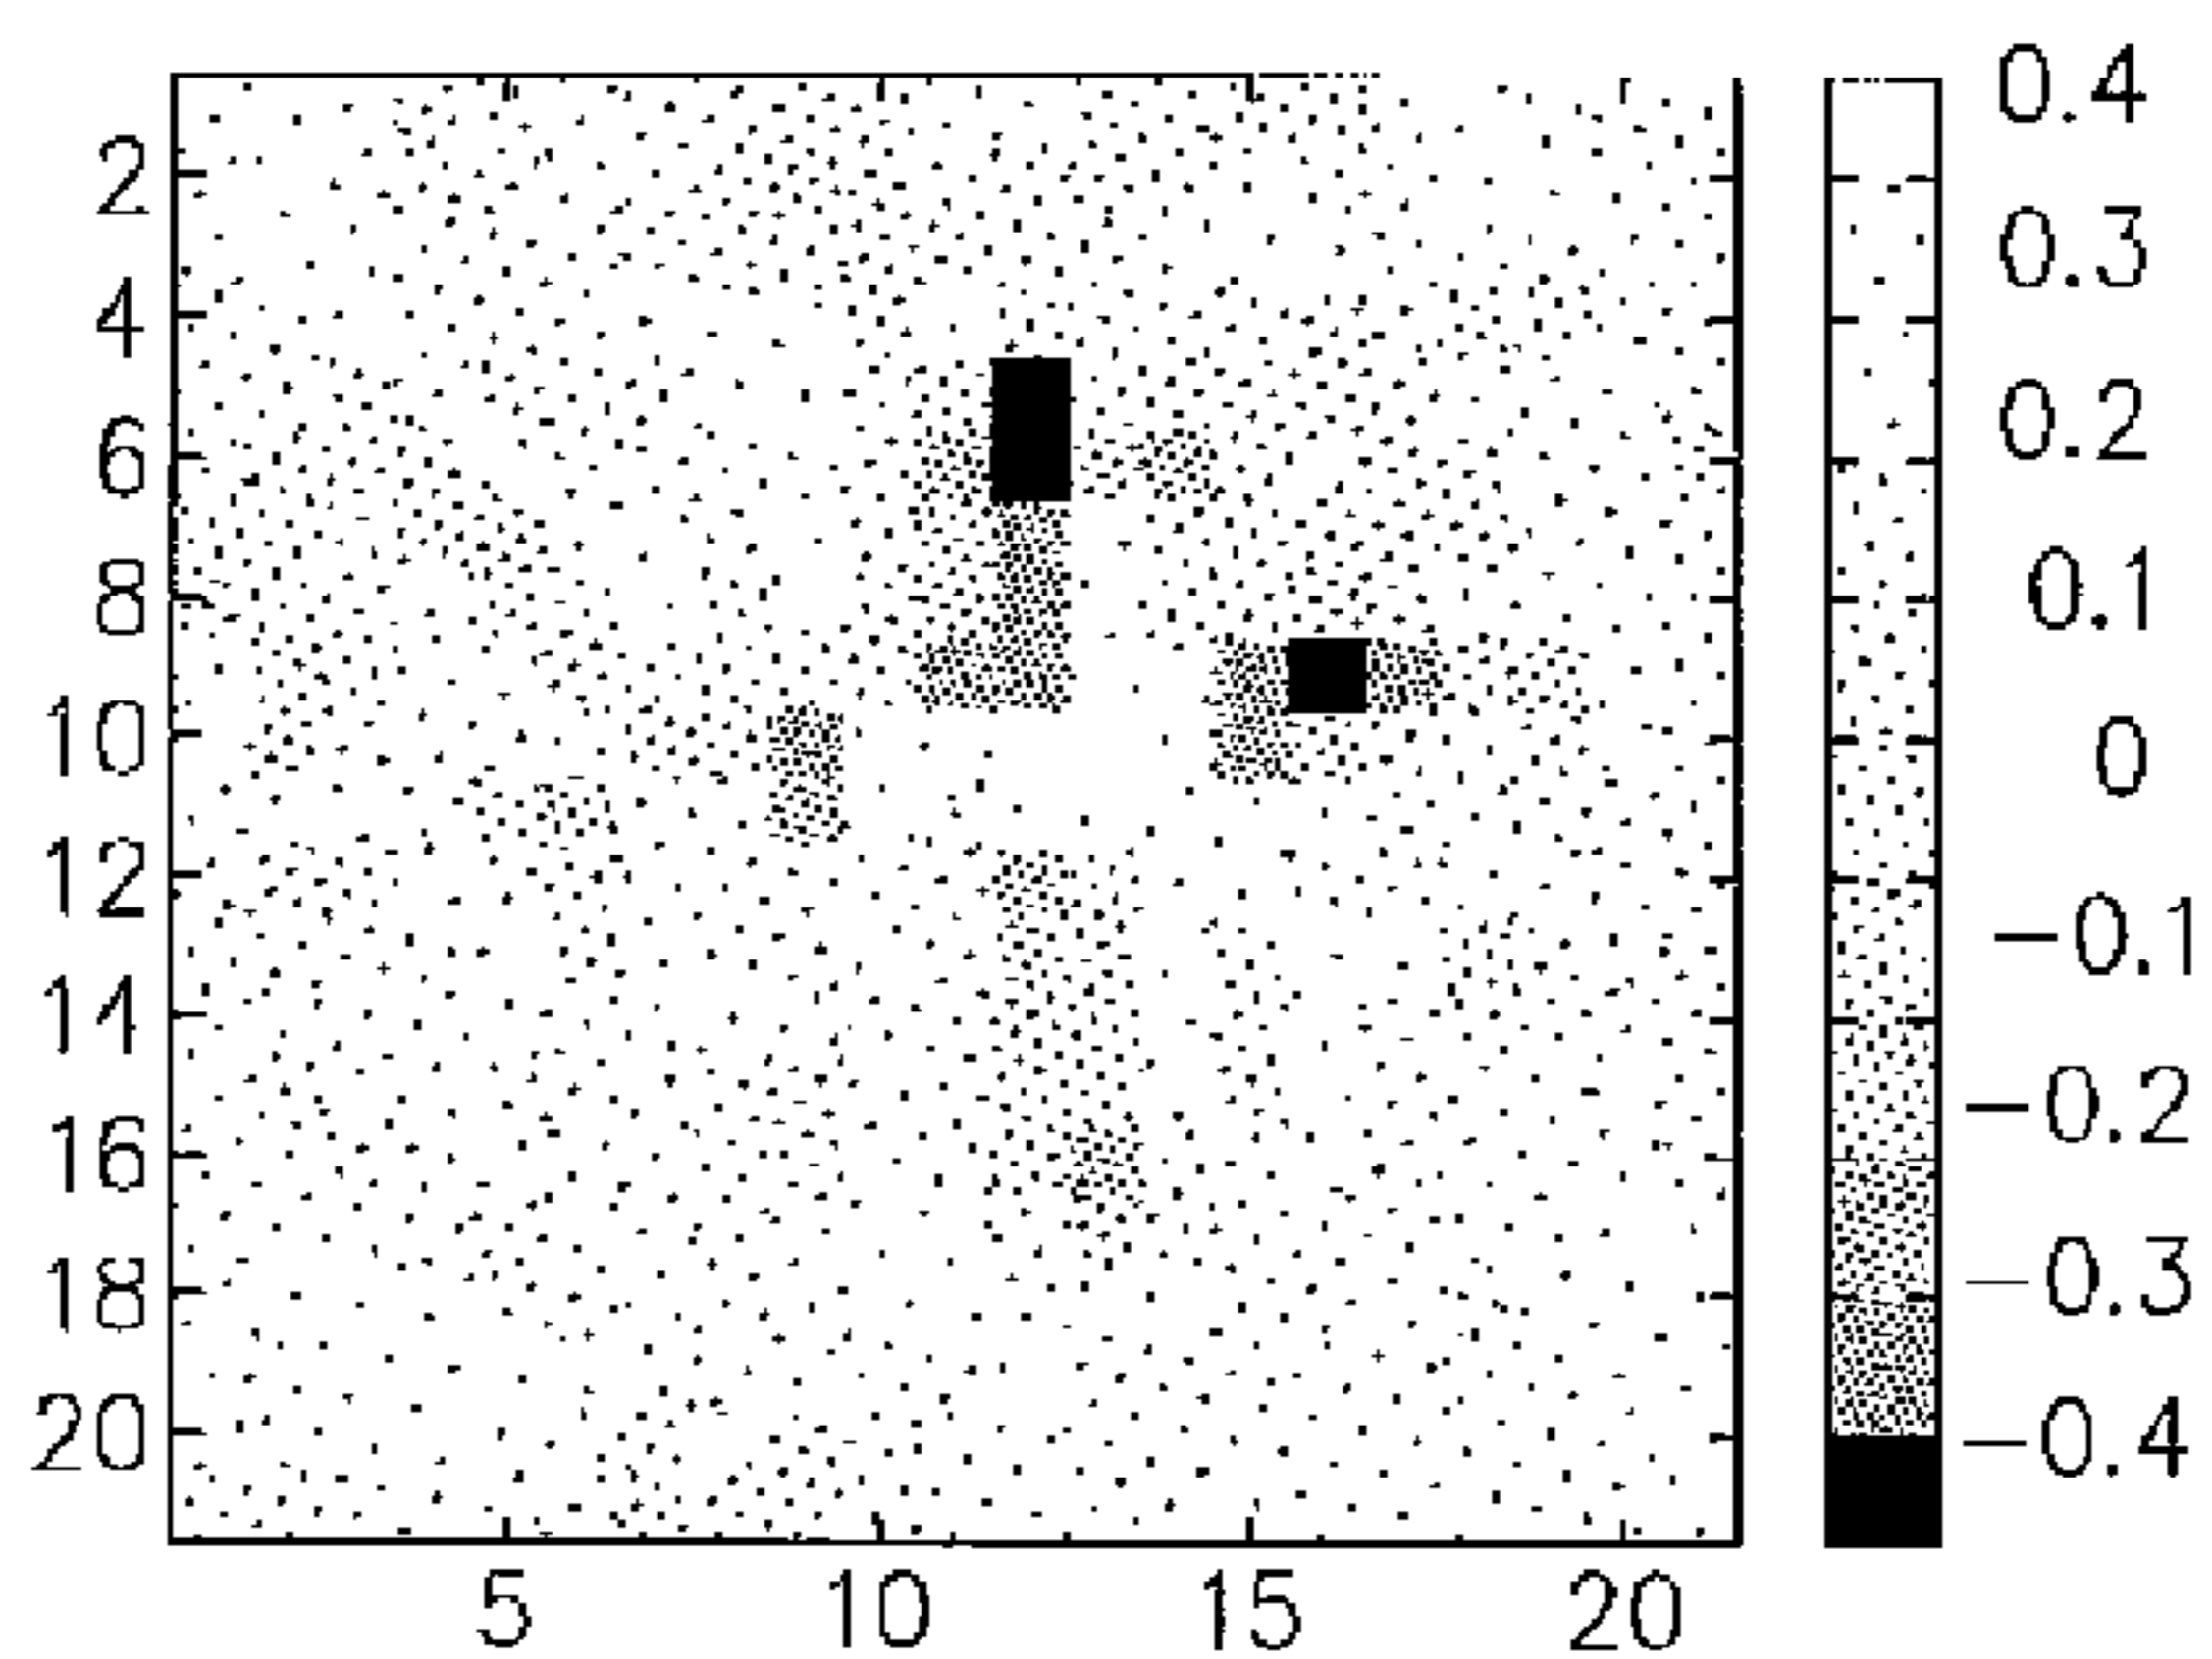
FIG.17A

FIGS. 17A, 17B and 17C are an example of an image showing detecting a defect in the heating process, wherein the defect is a minute sharp dent located on the surface of the steel sheet.

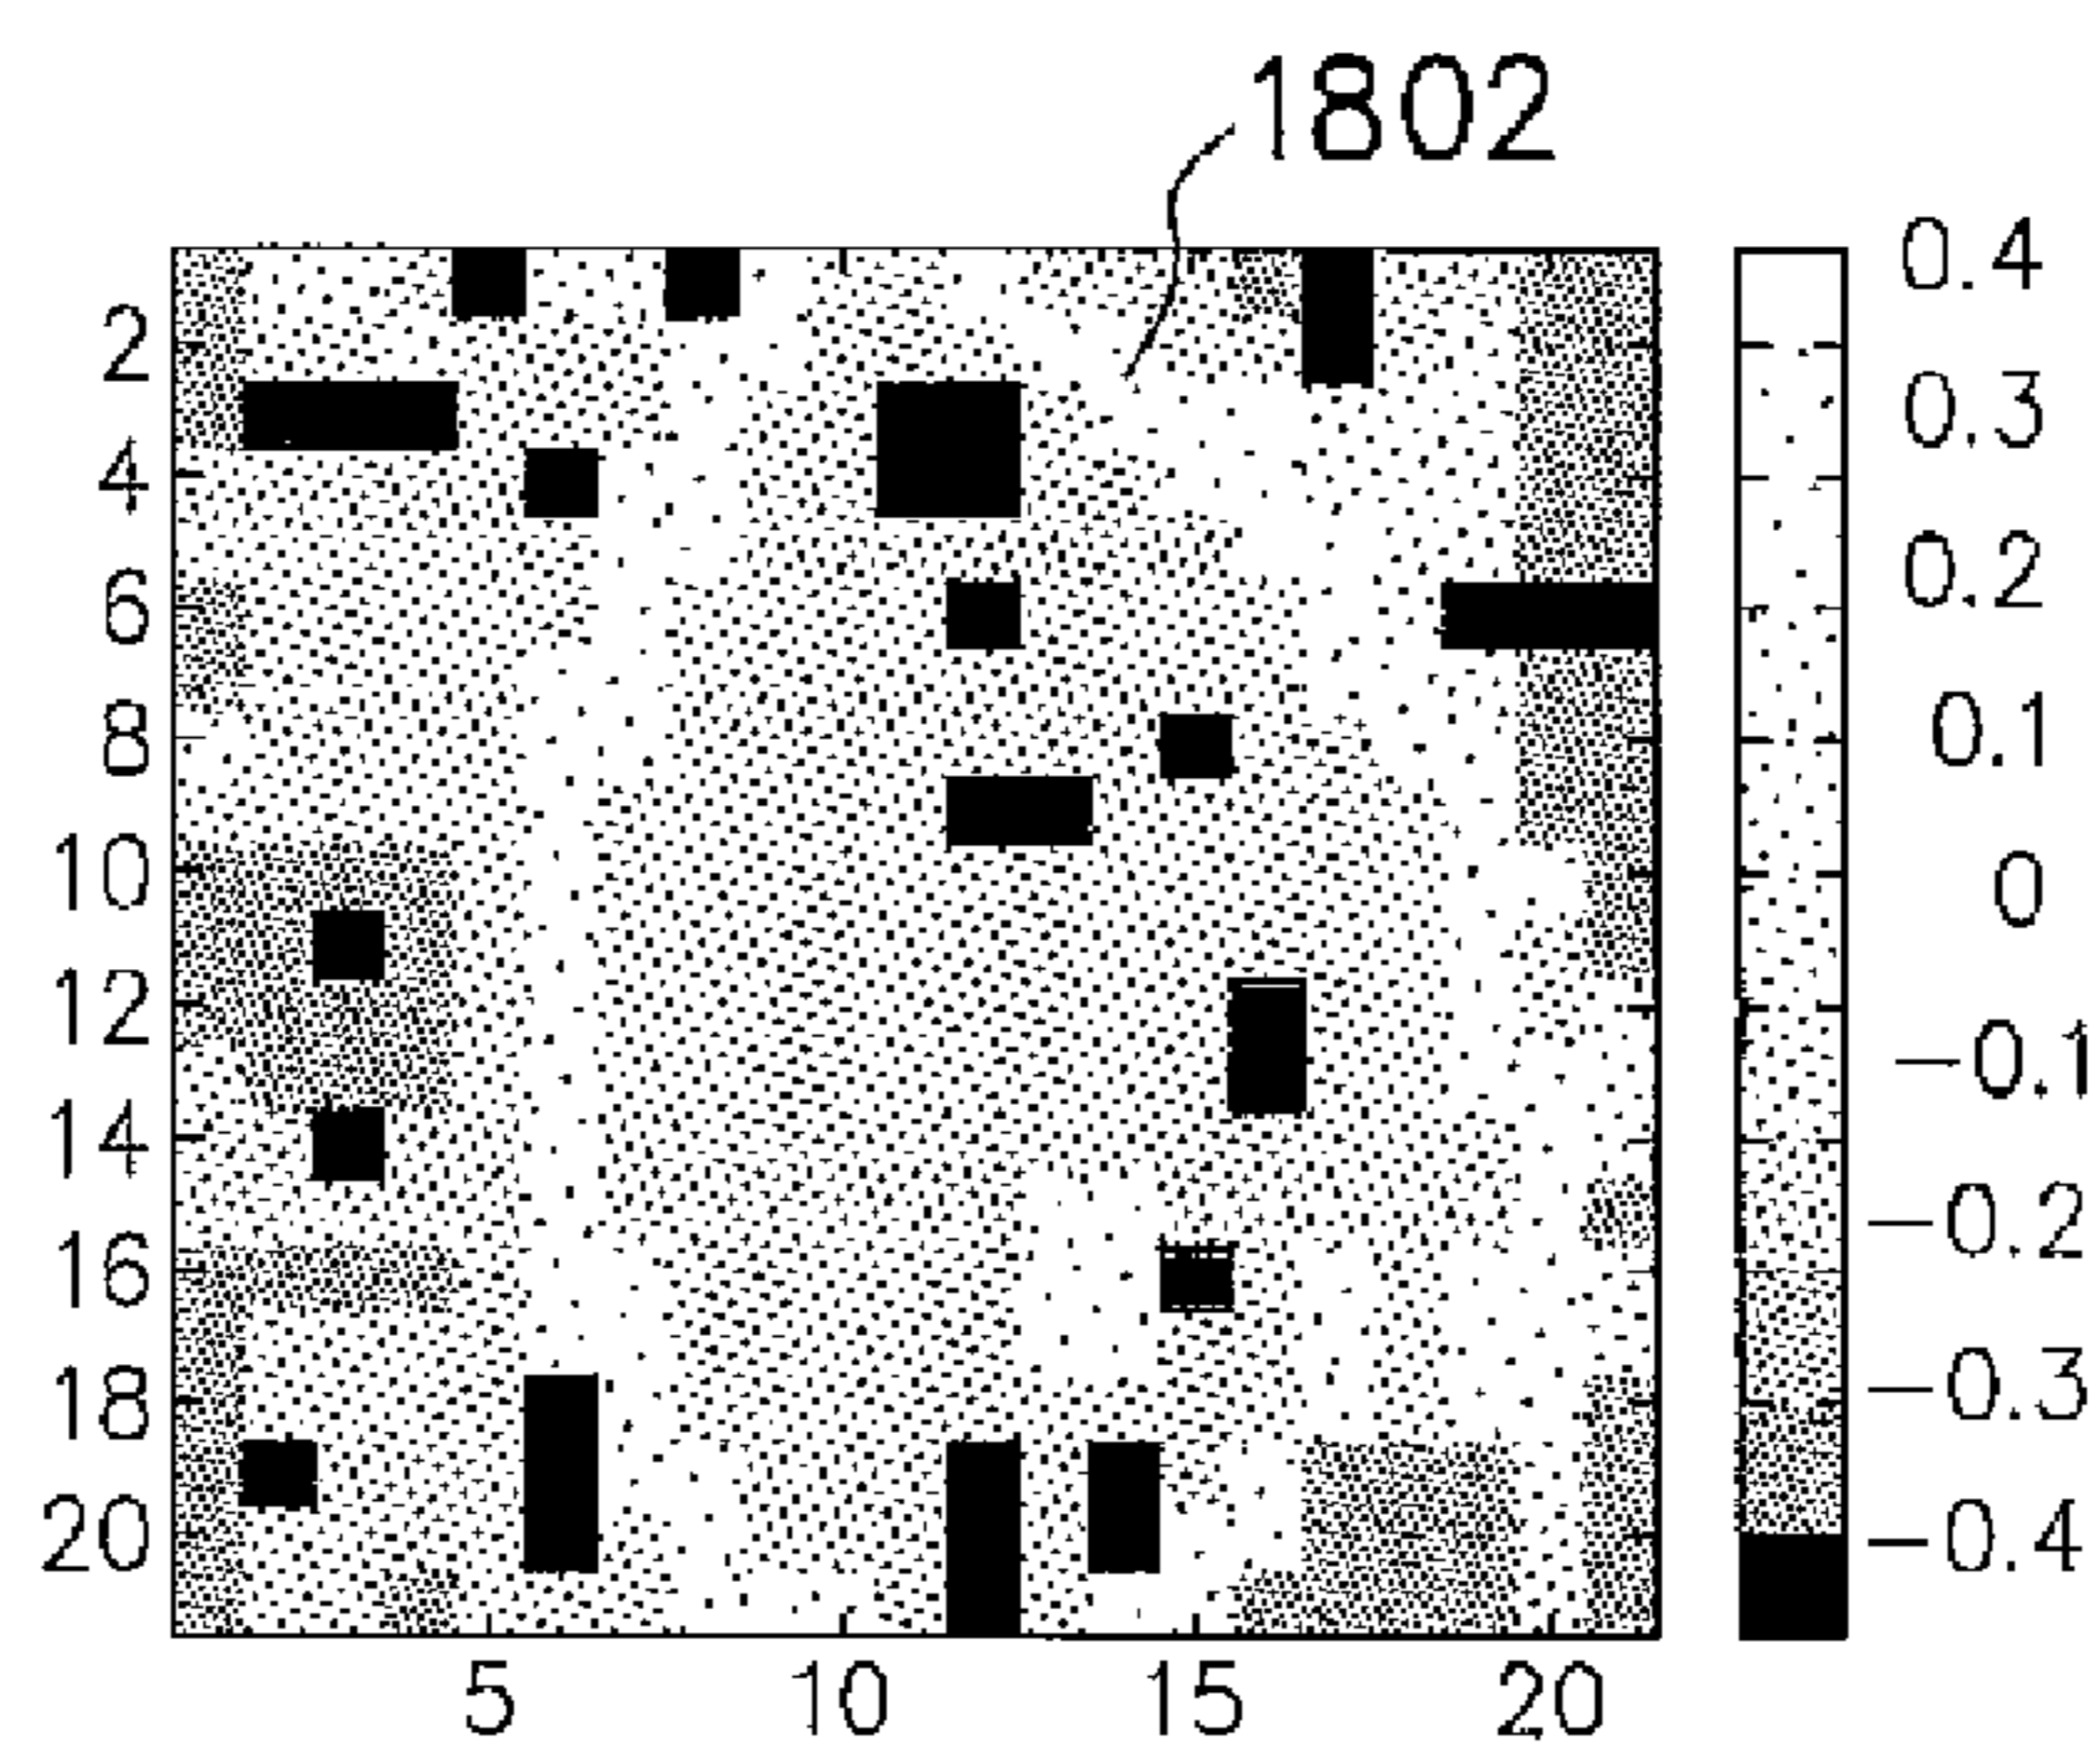
FIG. 18A

FIGS. 18A, 18B and 18C are an example of an image showing detecting a defect in the heating process, wherein the defect is a foreign material attached on the surface of the steel sheet.
