(54) **METHOD FOR REPAIRING A GAS TURBINE ENGINE COMPONENT**

A method of repairing a stator assembly of a gas turbine engine includes removing a worn surface of the stator assembly to provide a revealed area, and securing additional material to the stator assembly utilizing gas metal arc welding.

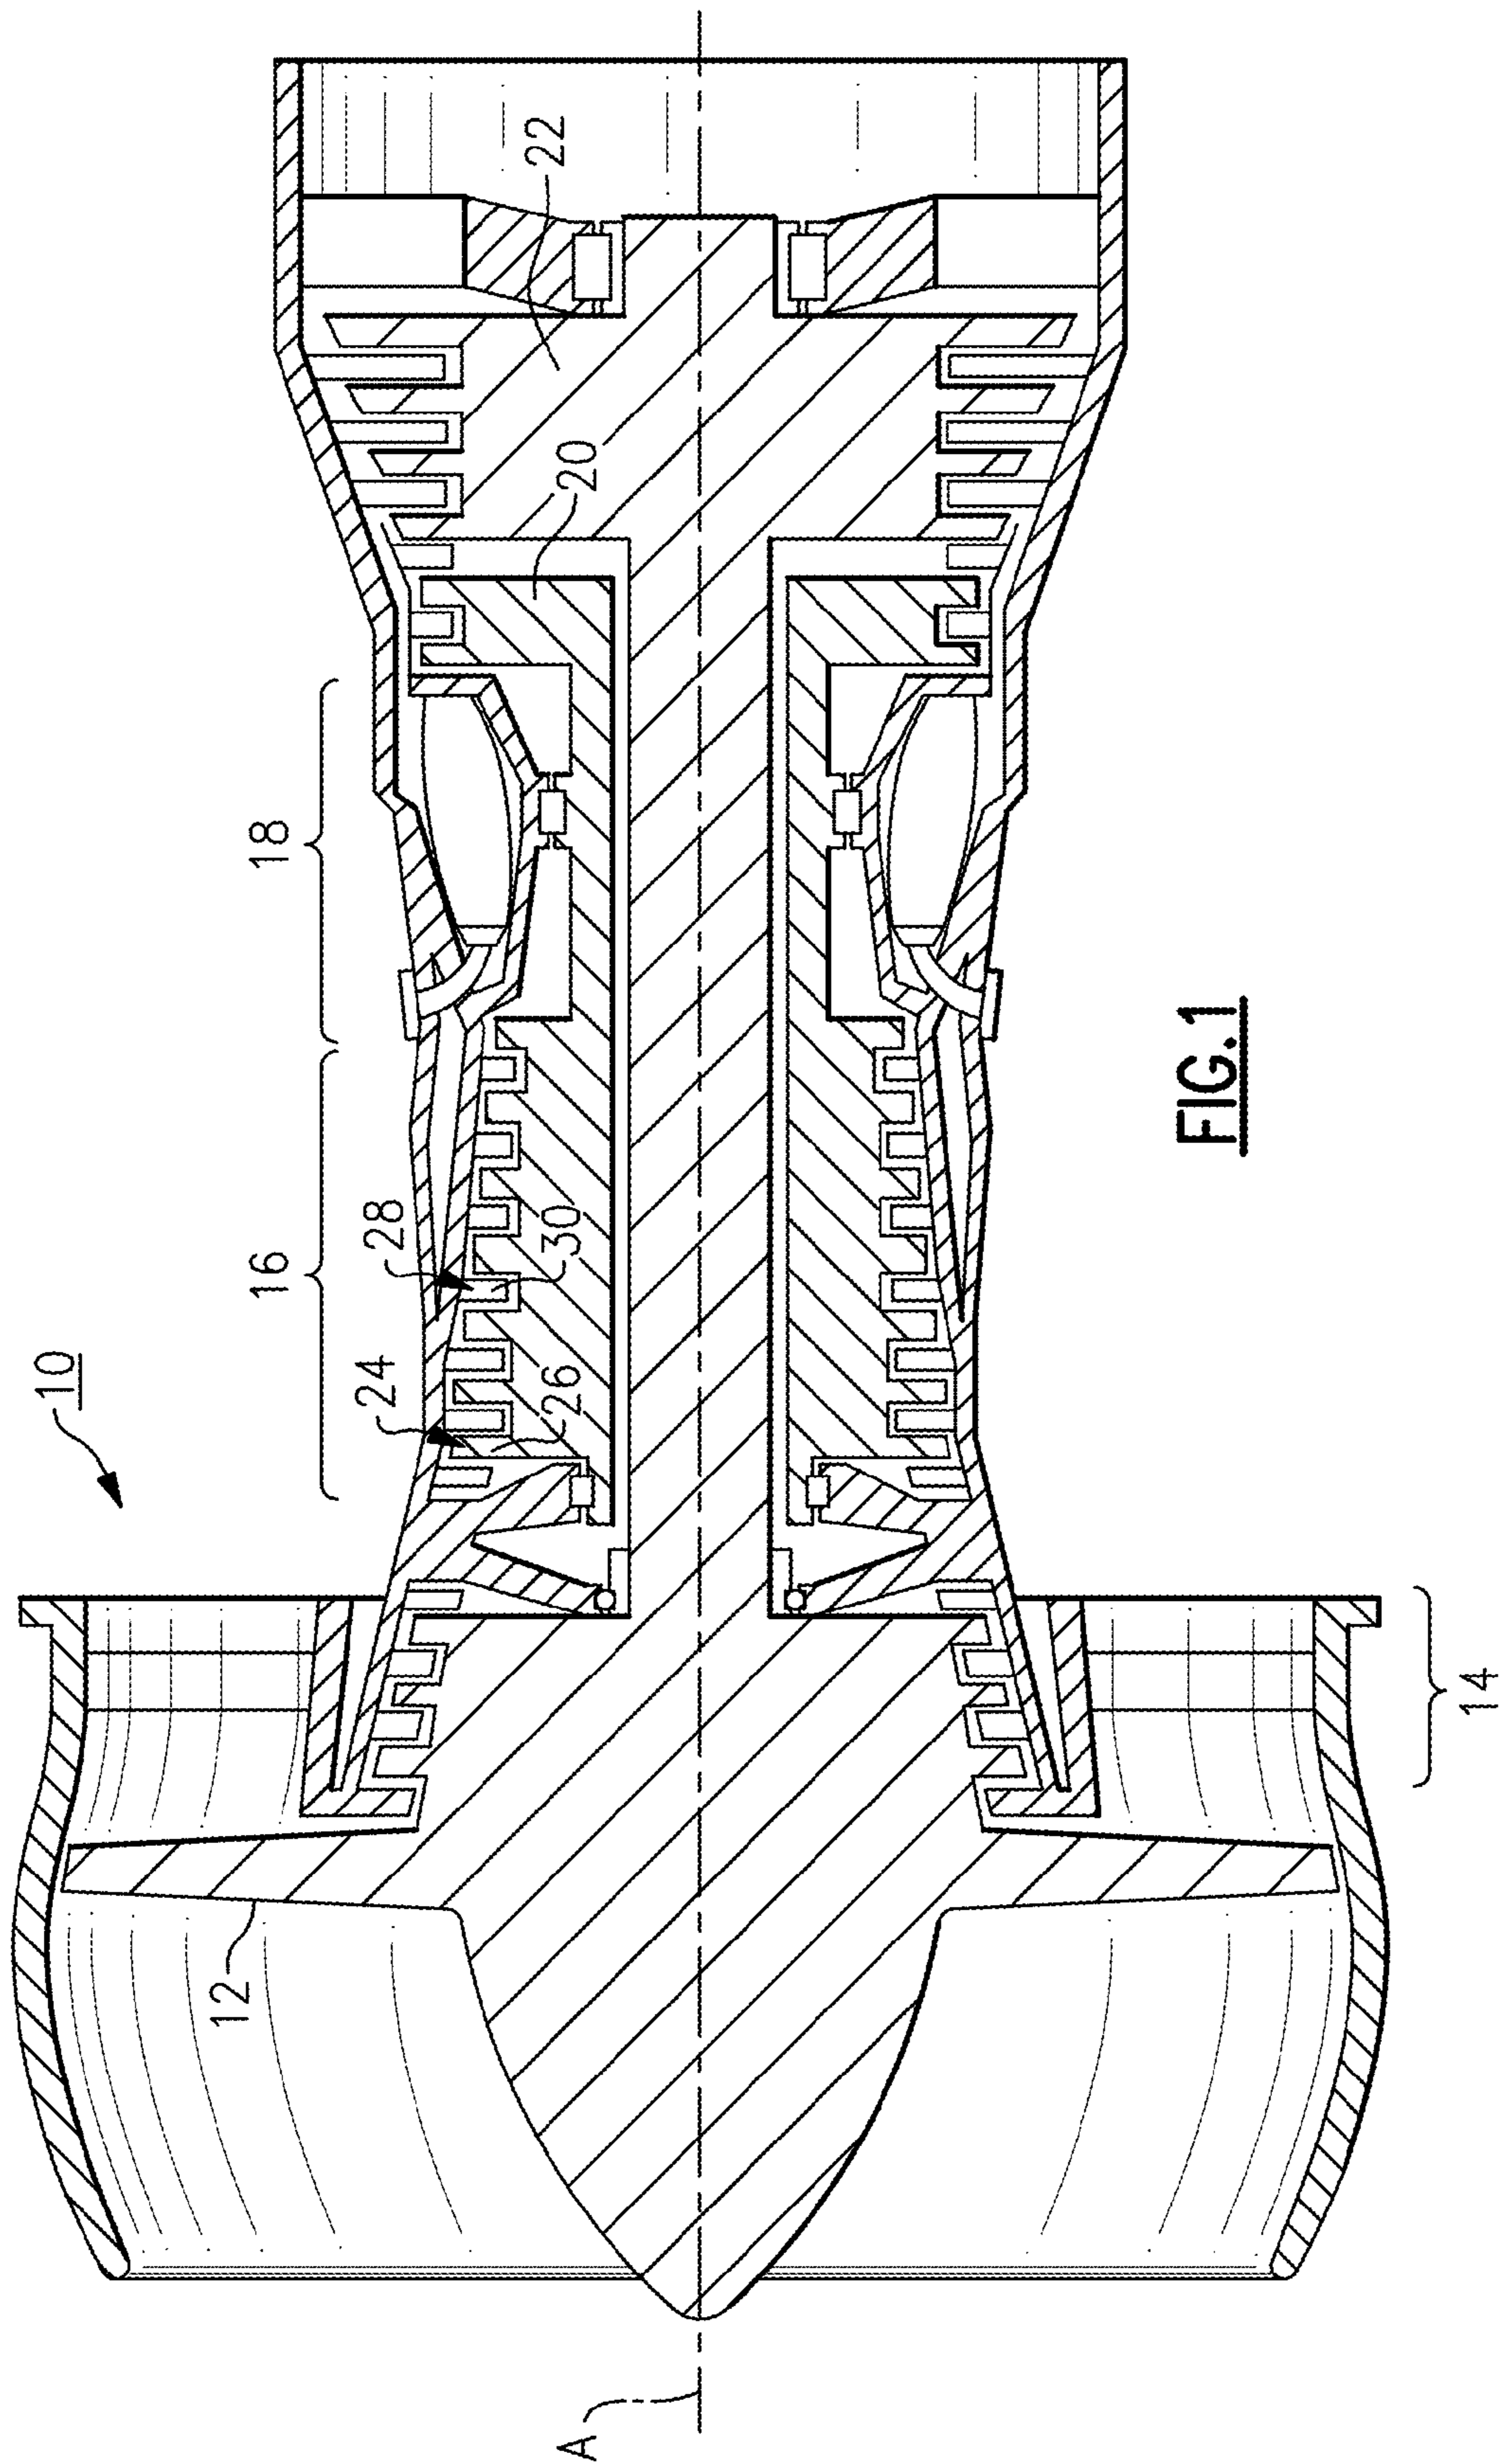
FIG. 1 is a schematic view of an example gas turbine engine;

FIG. 1 schematically illustrates an example gas turbine engine 10 that is circumferentially disposed about an engine centerline axis A. The gas turbine engine 10 includes (in serial flow communication) a fan section 12, a low pressure compressor 14, a high pressure compressor 16, a combustor section 18, a high pressure turbine 20, and a low pressure turbine 22. During operation, airflow is drawn into the gas turbine engine 10 by the fan section 12, and is pressurized in the low pressure compressor 14 and the high pressure compressor 16. Fuel is mixed with the pressurized air and combusted within the combustor section 18. The combustion gases are discharged through the high pressure turbine 20 and the low pressure turbine 22, which extract energy from the combustion gases for powering the compressor sections 14, 16 and the fan section 12.

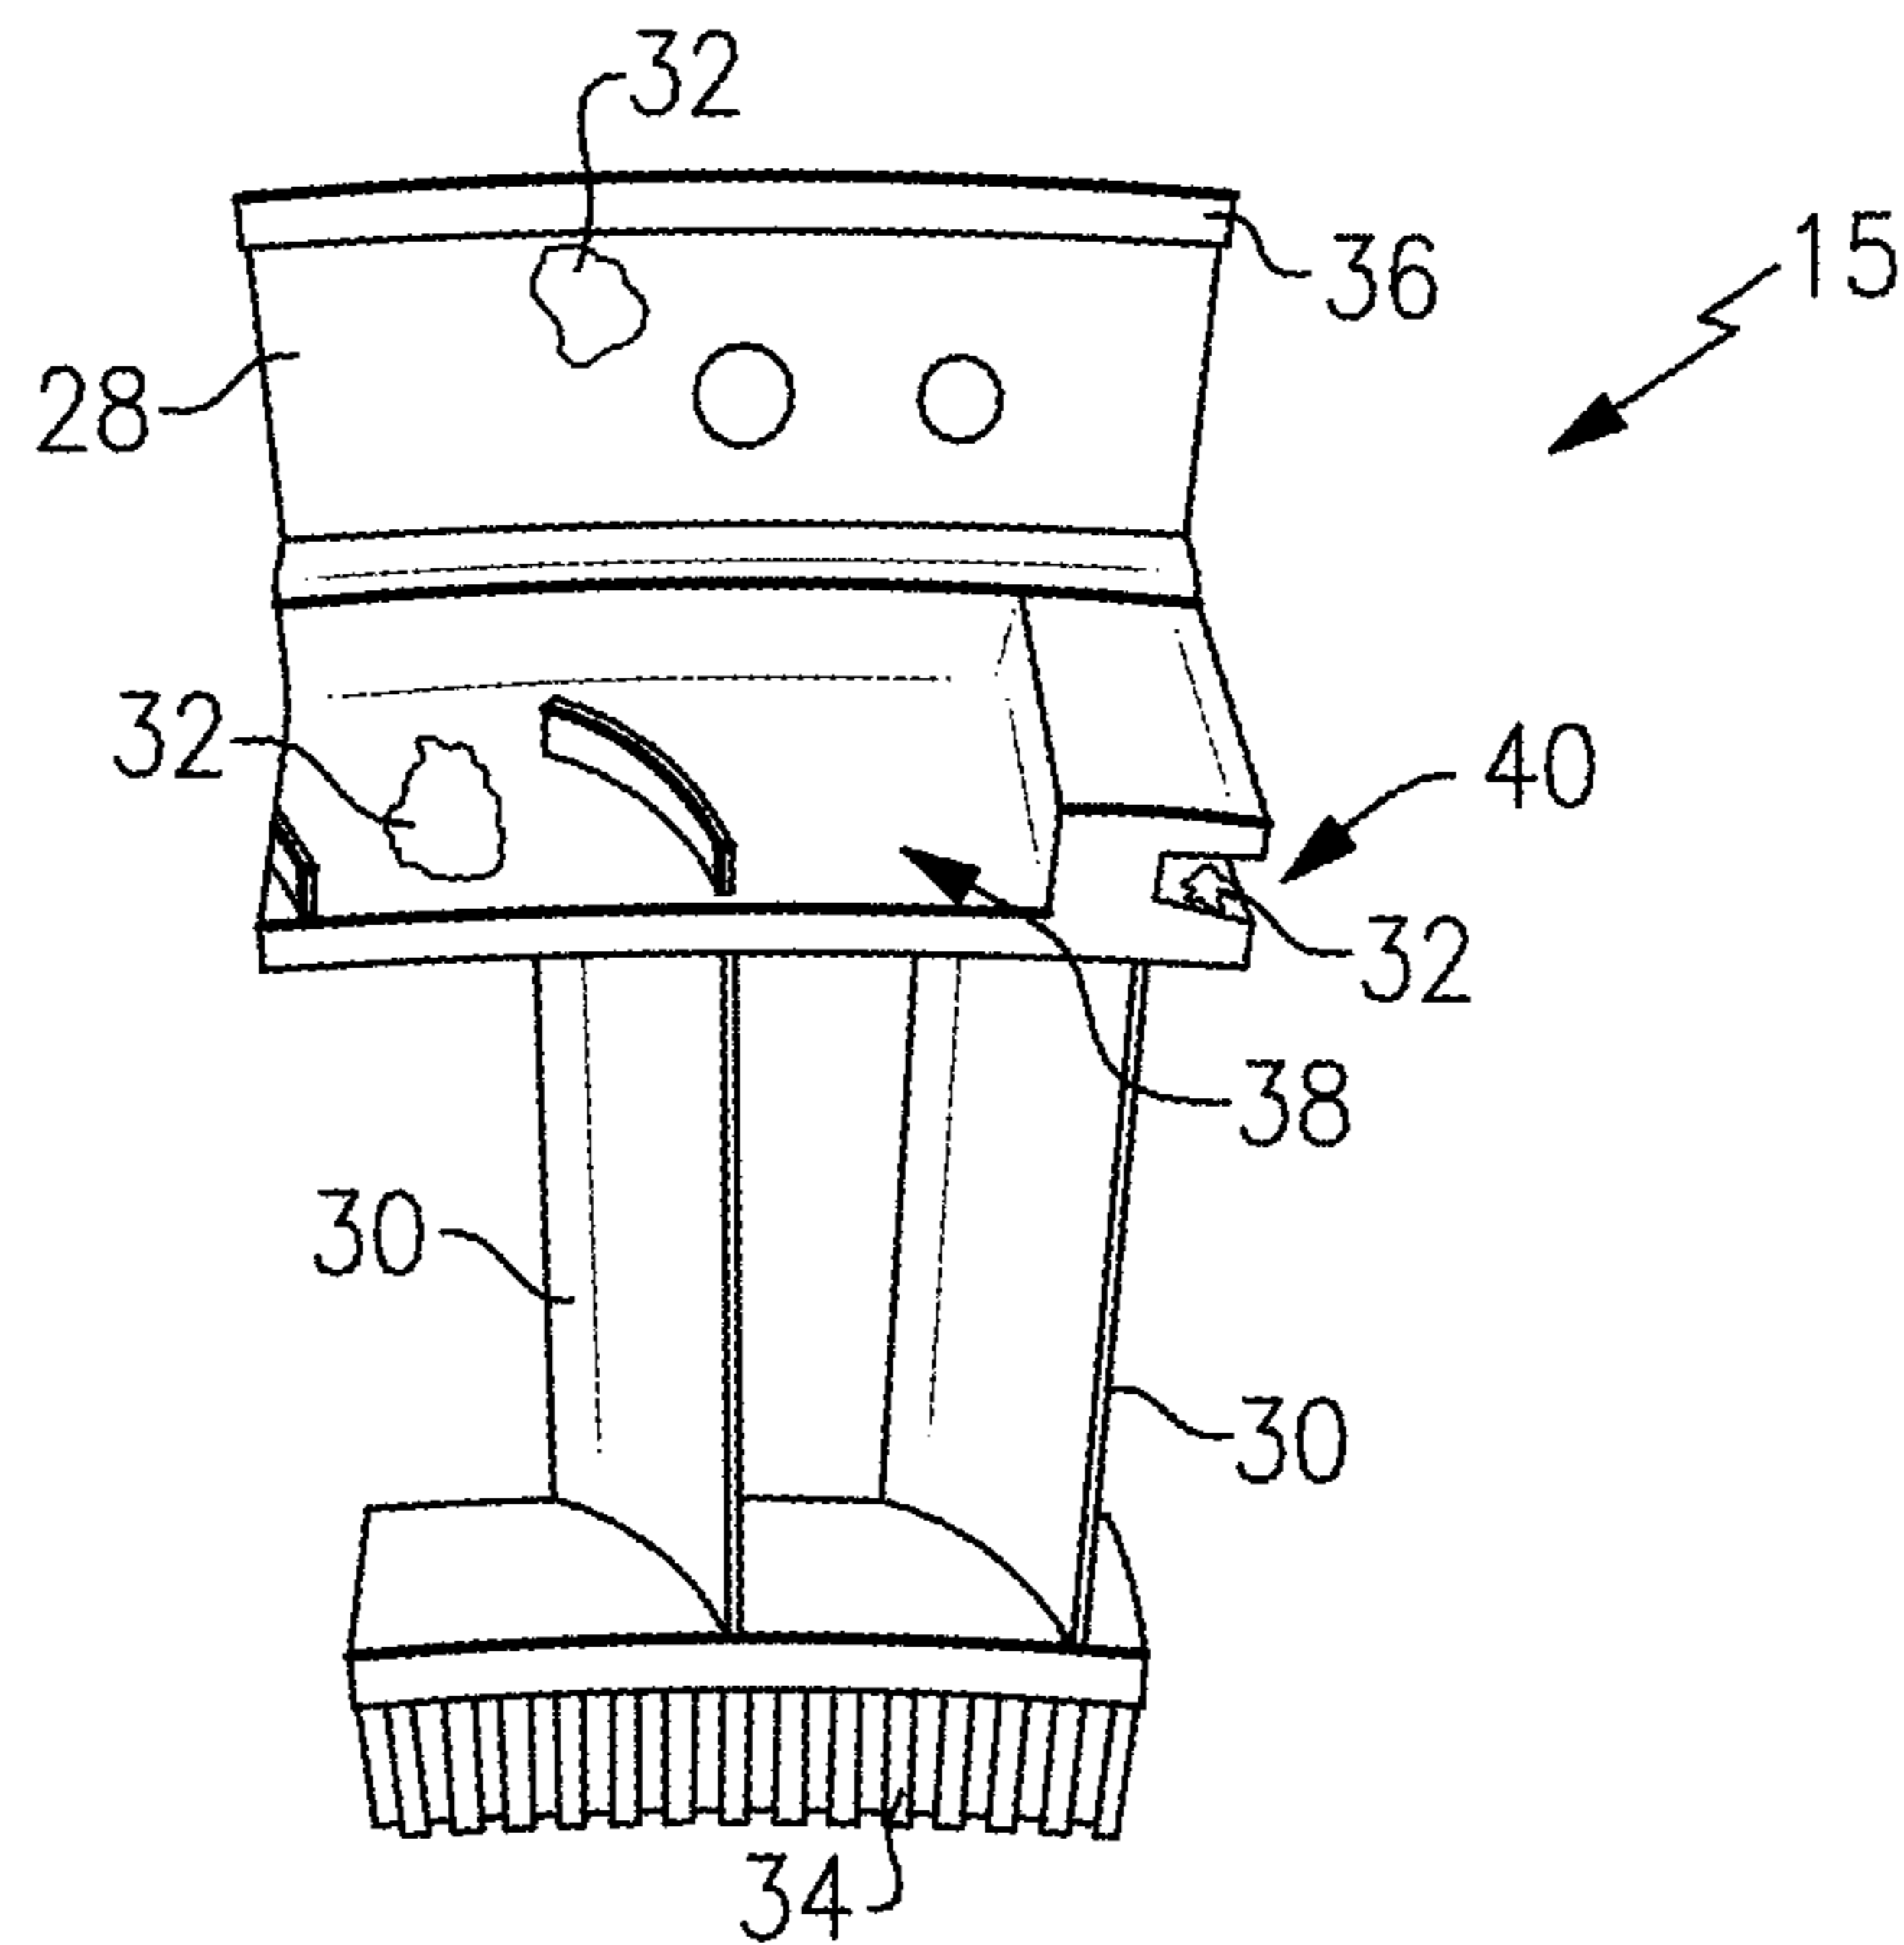
FIG. 2 illustrates a gas turbine engine component including a worn surface;

FIG. 2 illustrates an example gas turbine engine component 15 having at least one worn surface 32. In this example, the gas turbine engine component 15 is a stator assembly 28 of the high pressure compressor 16. The stator assembly 28 includes a plurality of vanes 30 that extend between a radially inward honeycomb 34 and a radially outward flange 36. The flange 36 includes an outer diameter surface 38 and a plurality of featherseal slots 40 (one shown in FIG. 2).

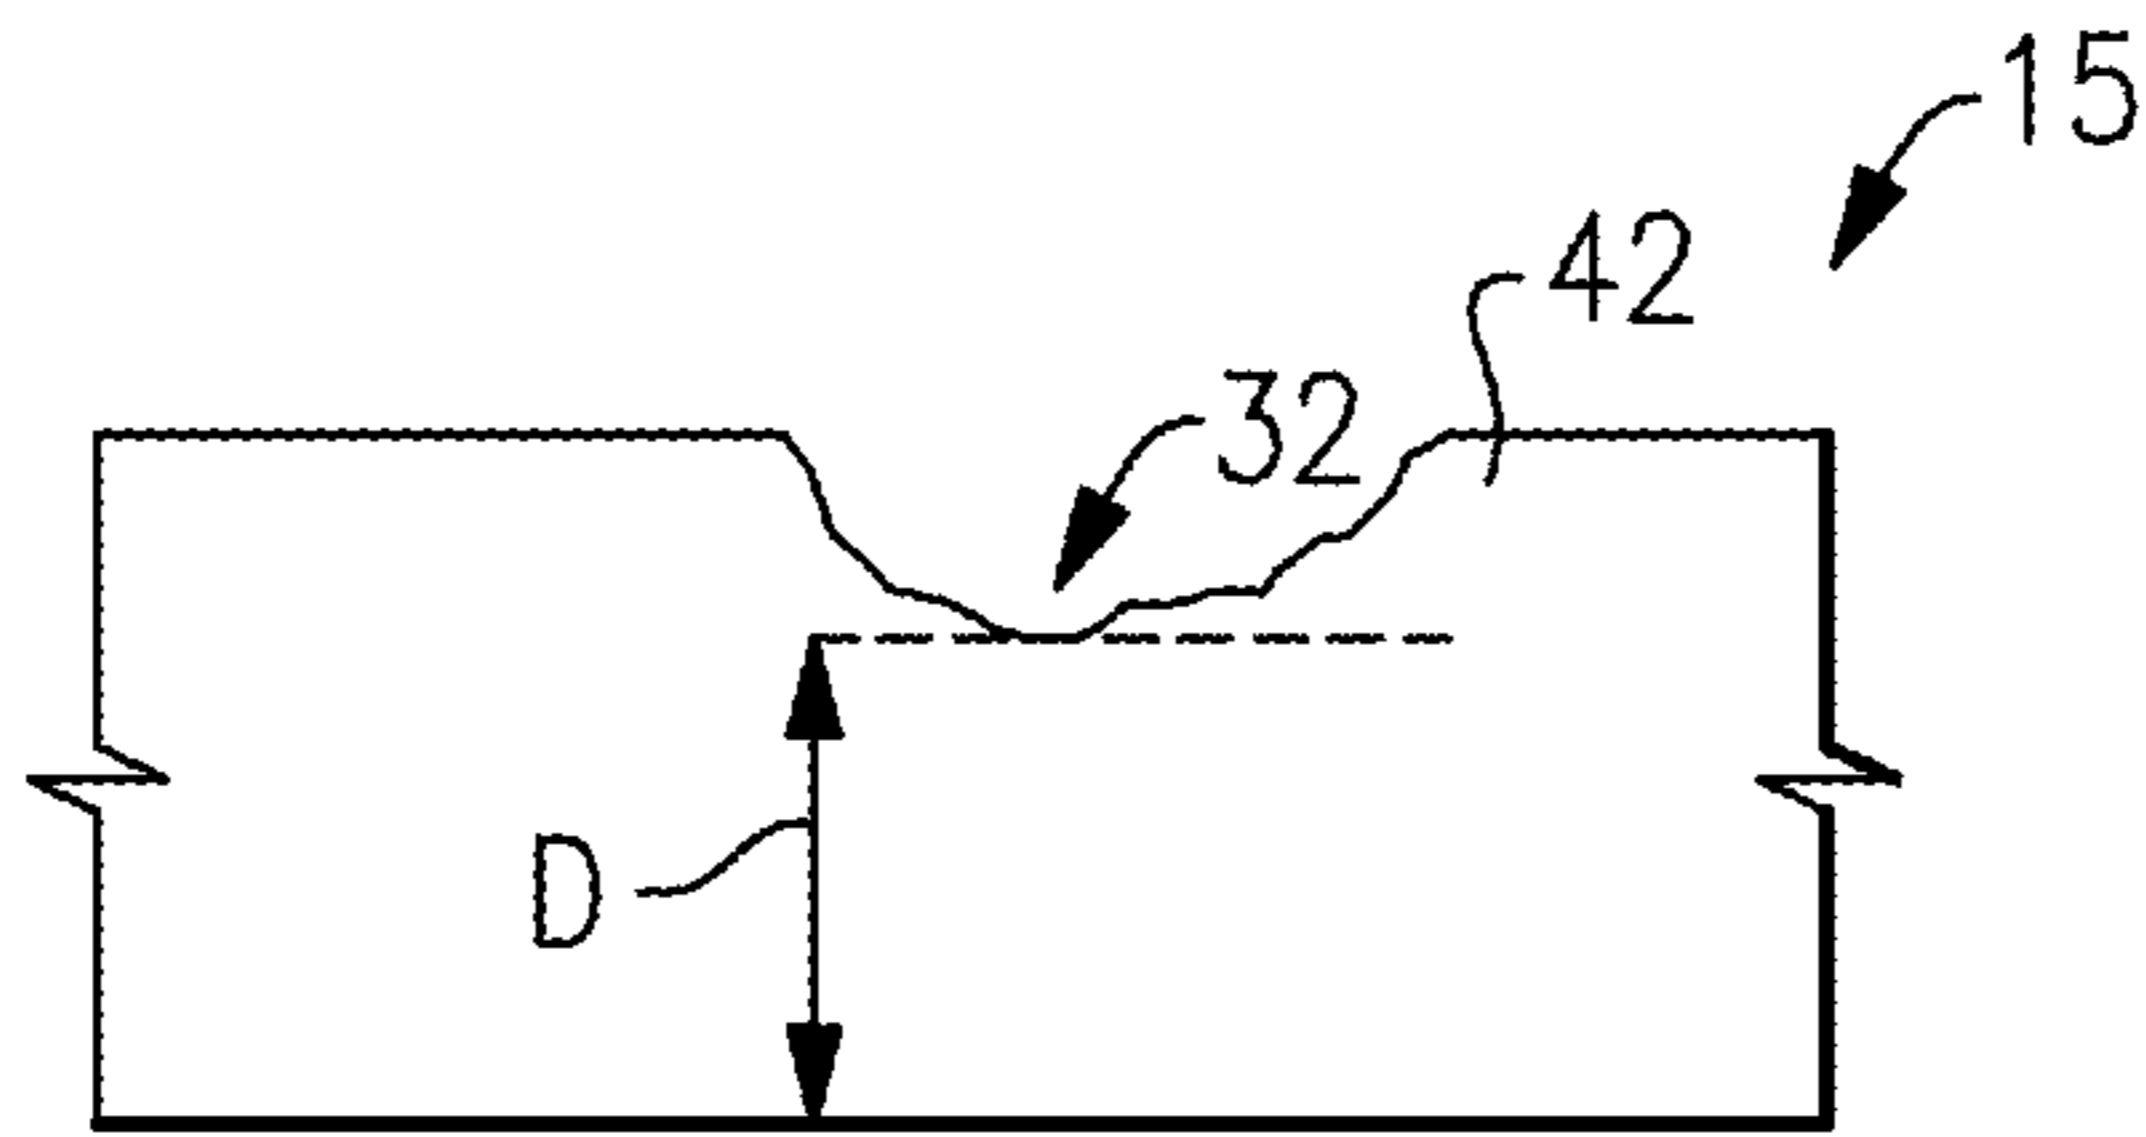
FIG. 4A shows an initial step in an example repair process;

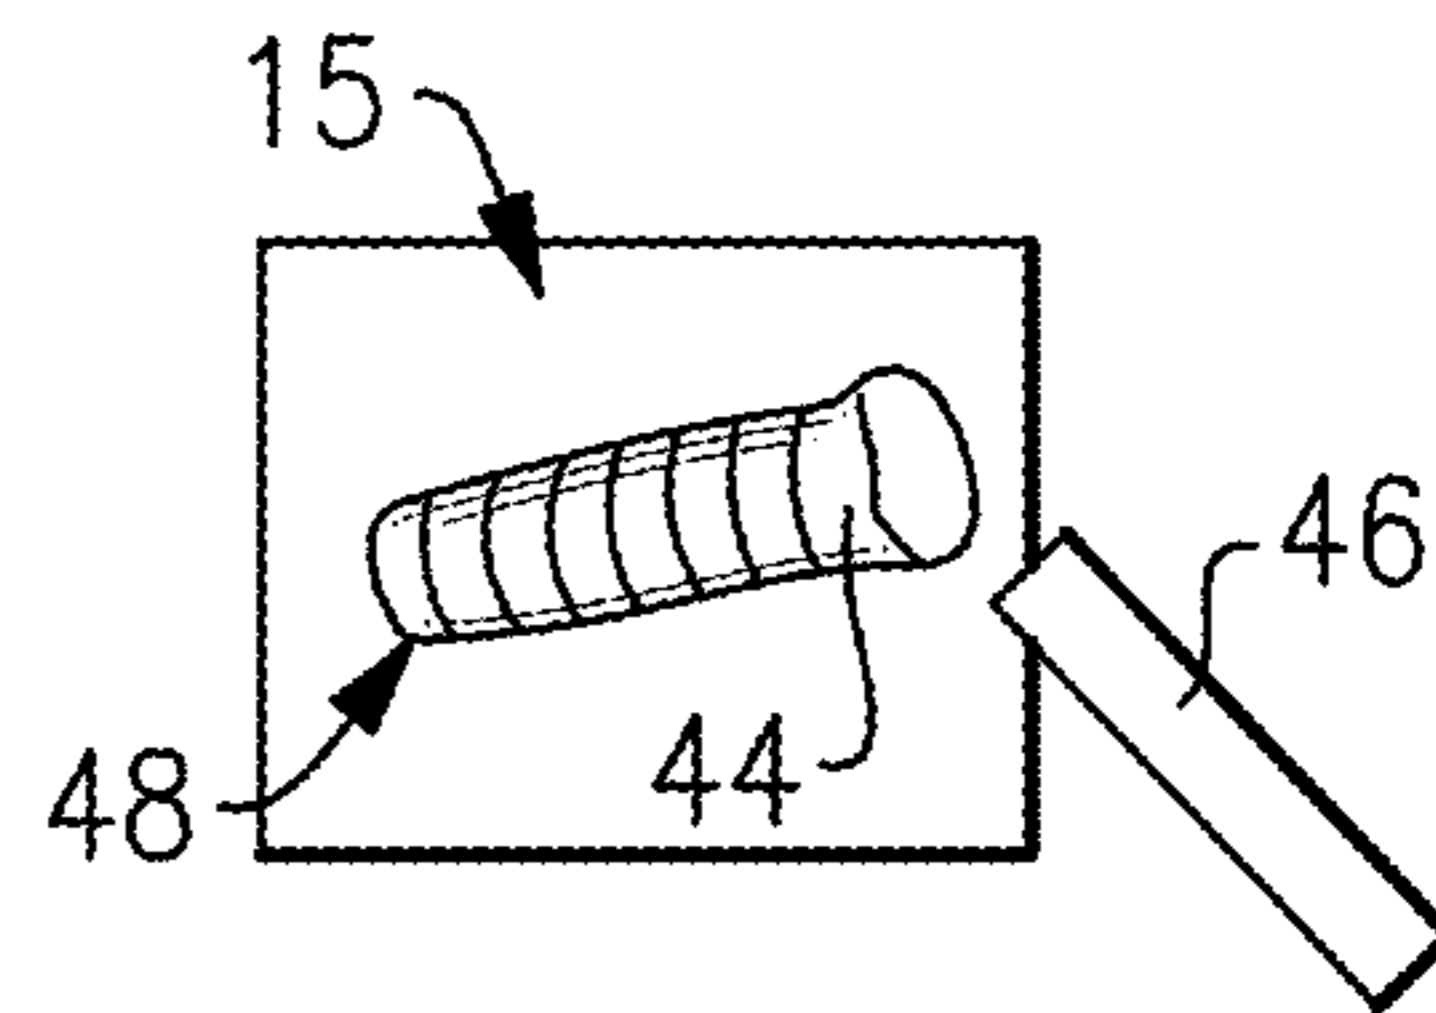
FIG. 4B shows a subsequent step of the repair process; and

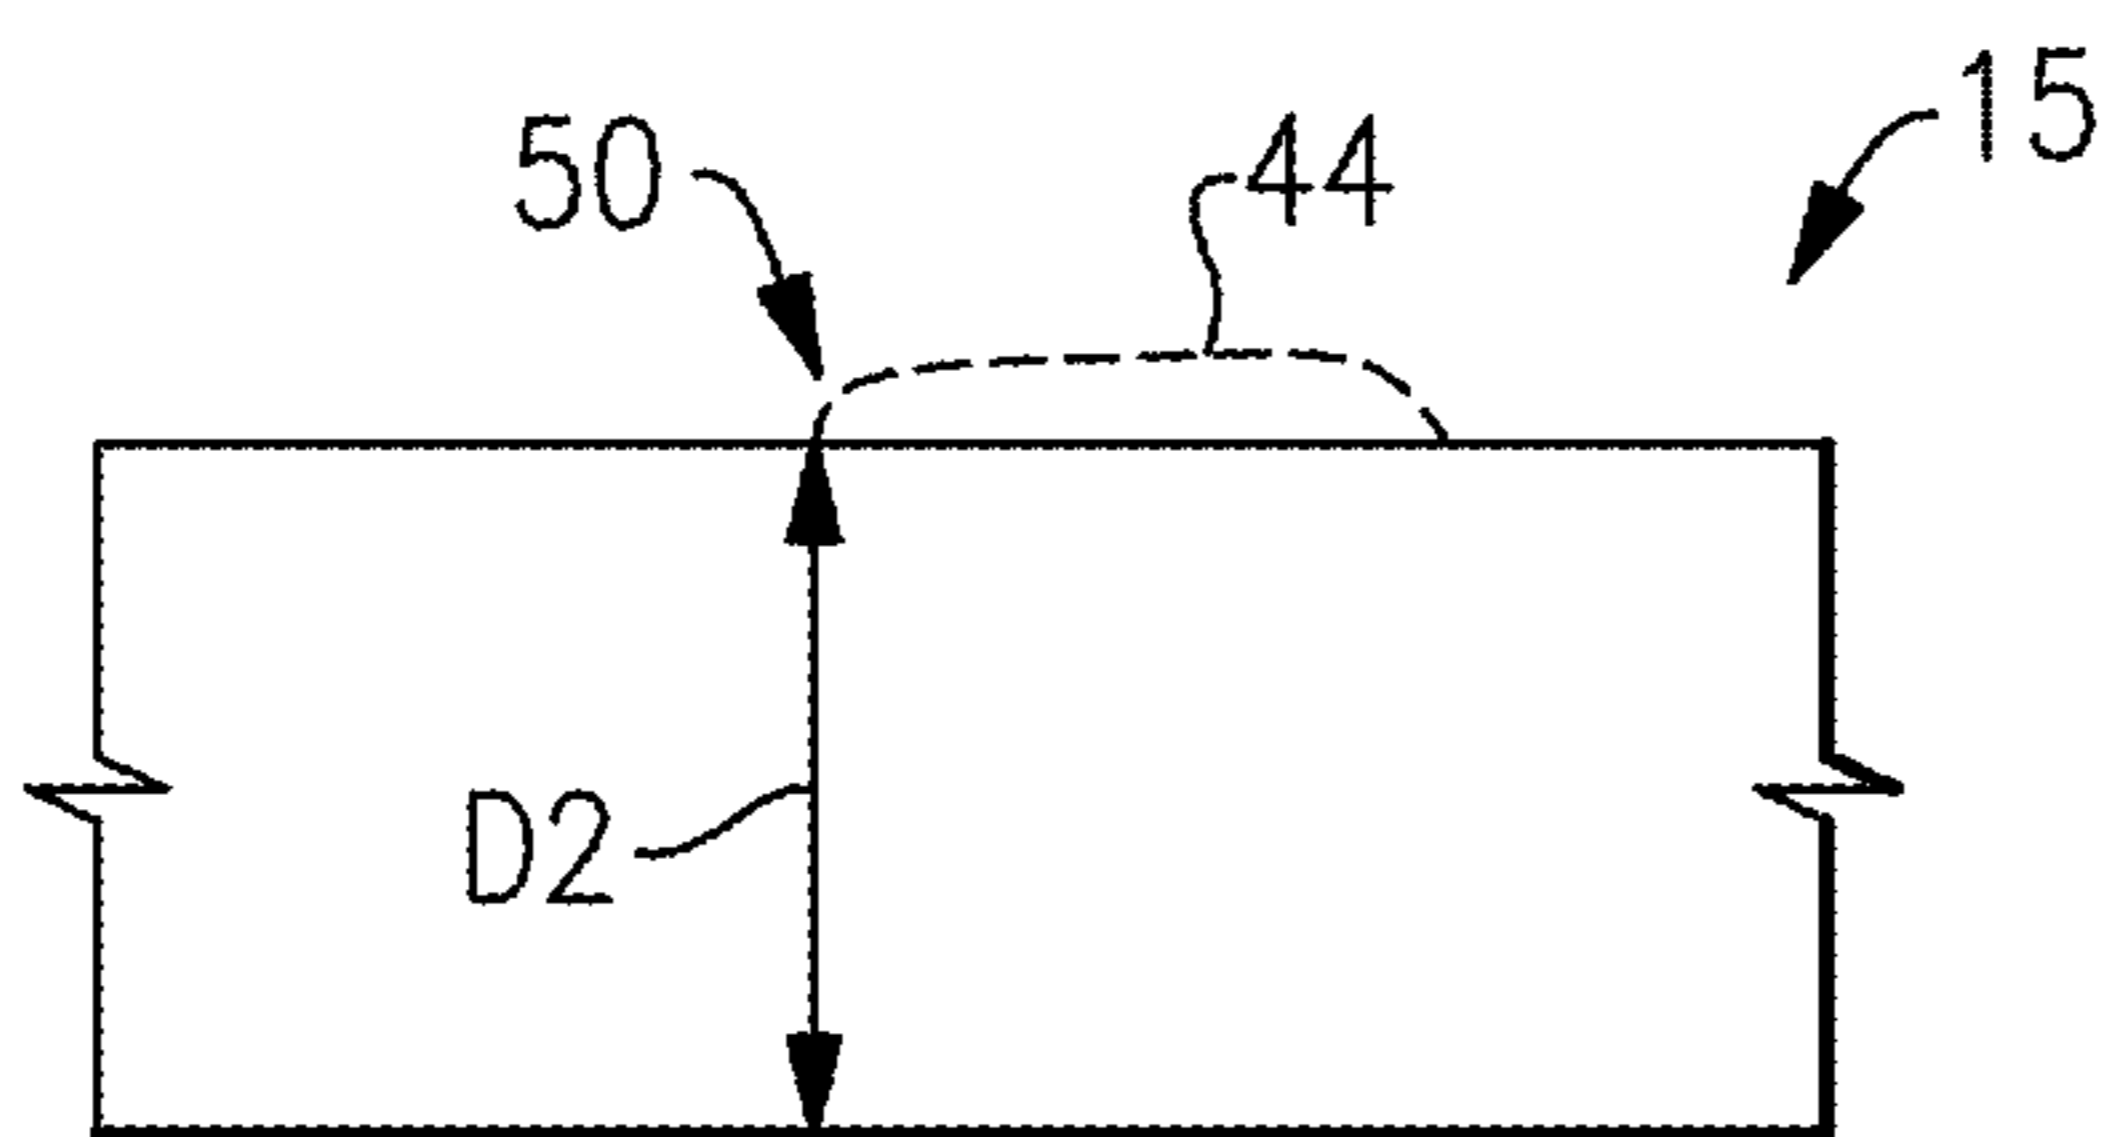
FIG. 4C illustrates yet another step in the repair process.
