US008544173B2

(54) **TURBINE NOZZLE BIFORM REPAIR**

(73) Assignee: **General Electric Company**, Schenectady, NY (US)

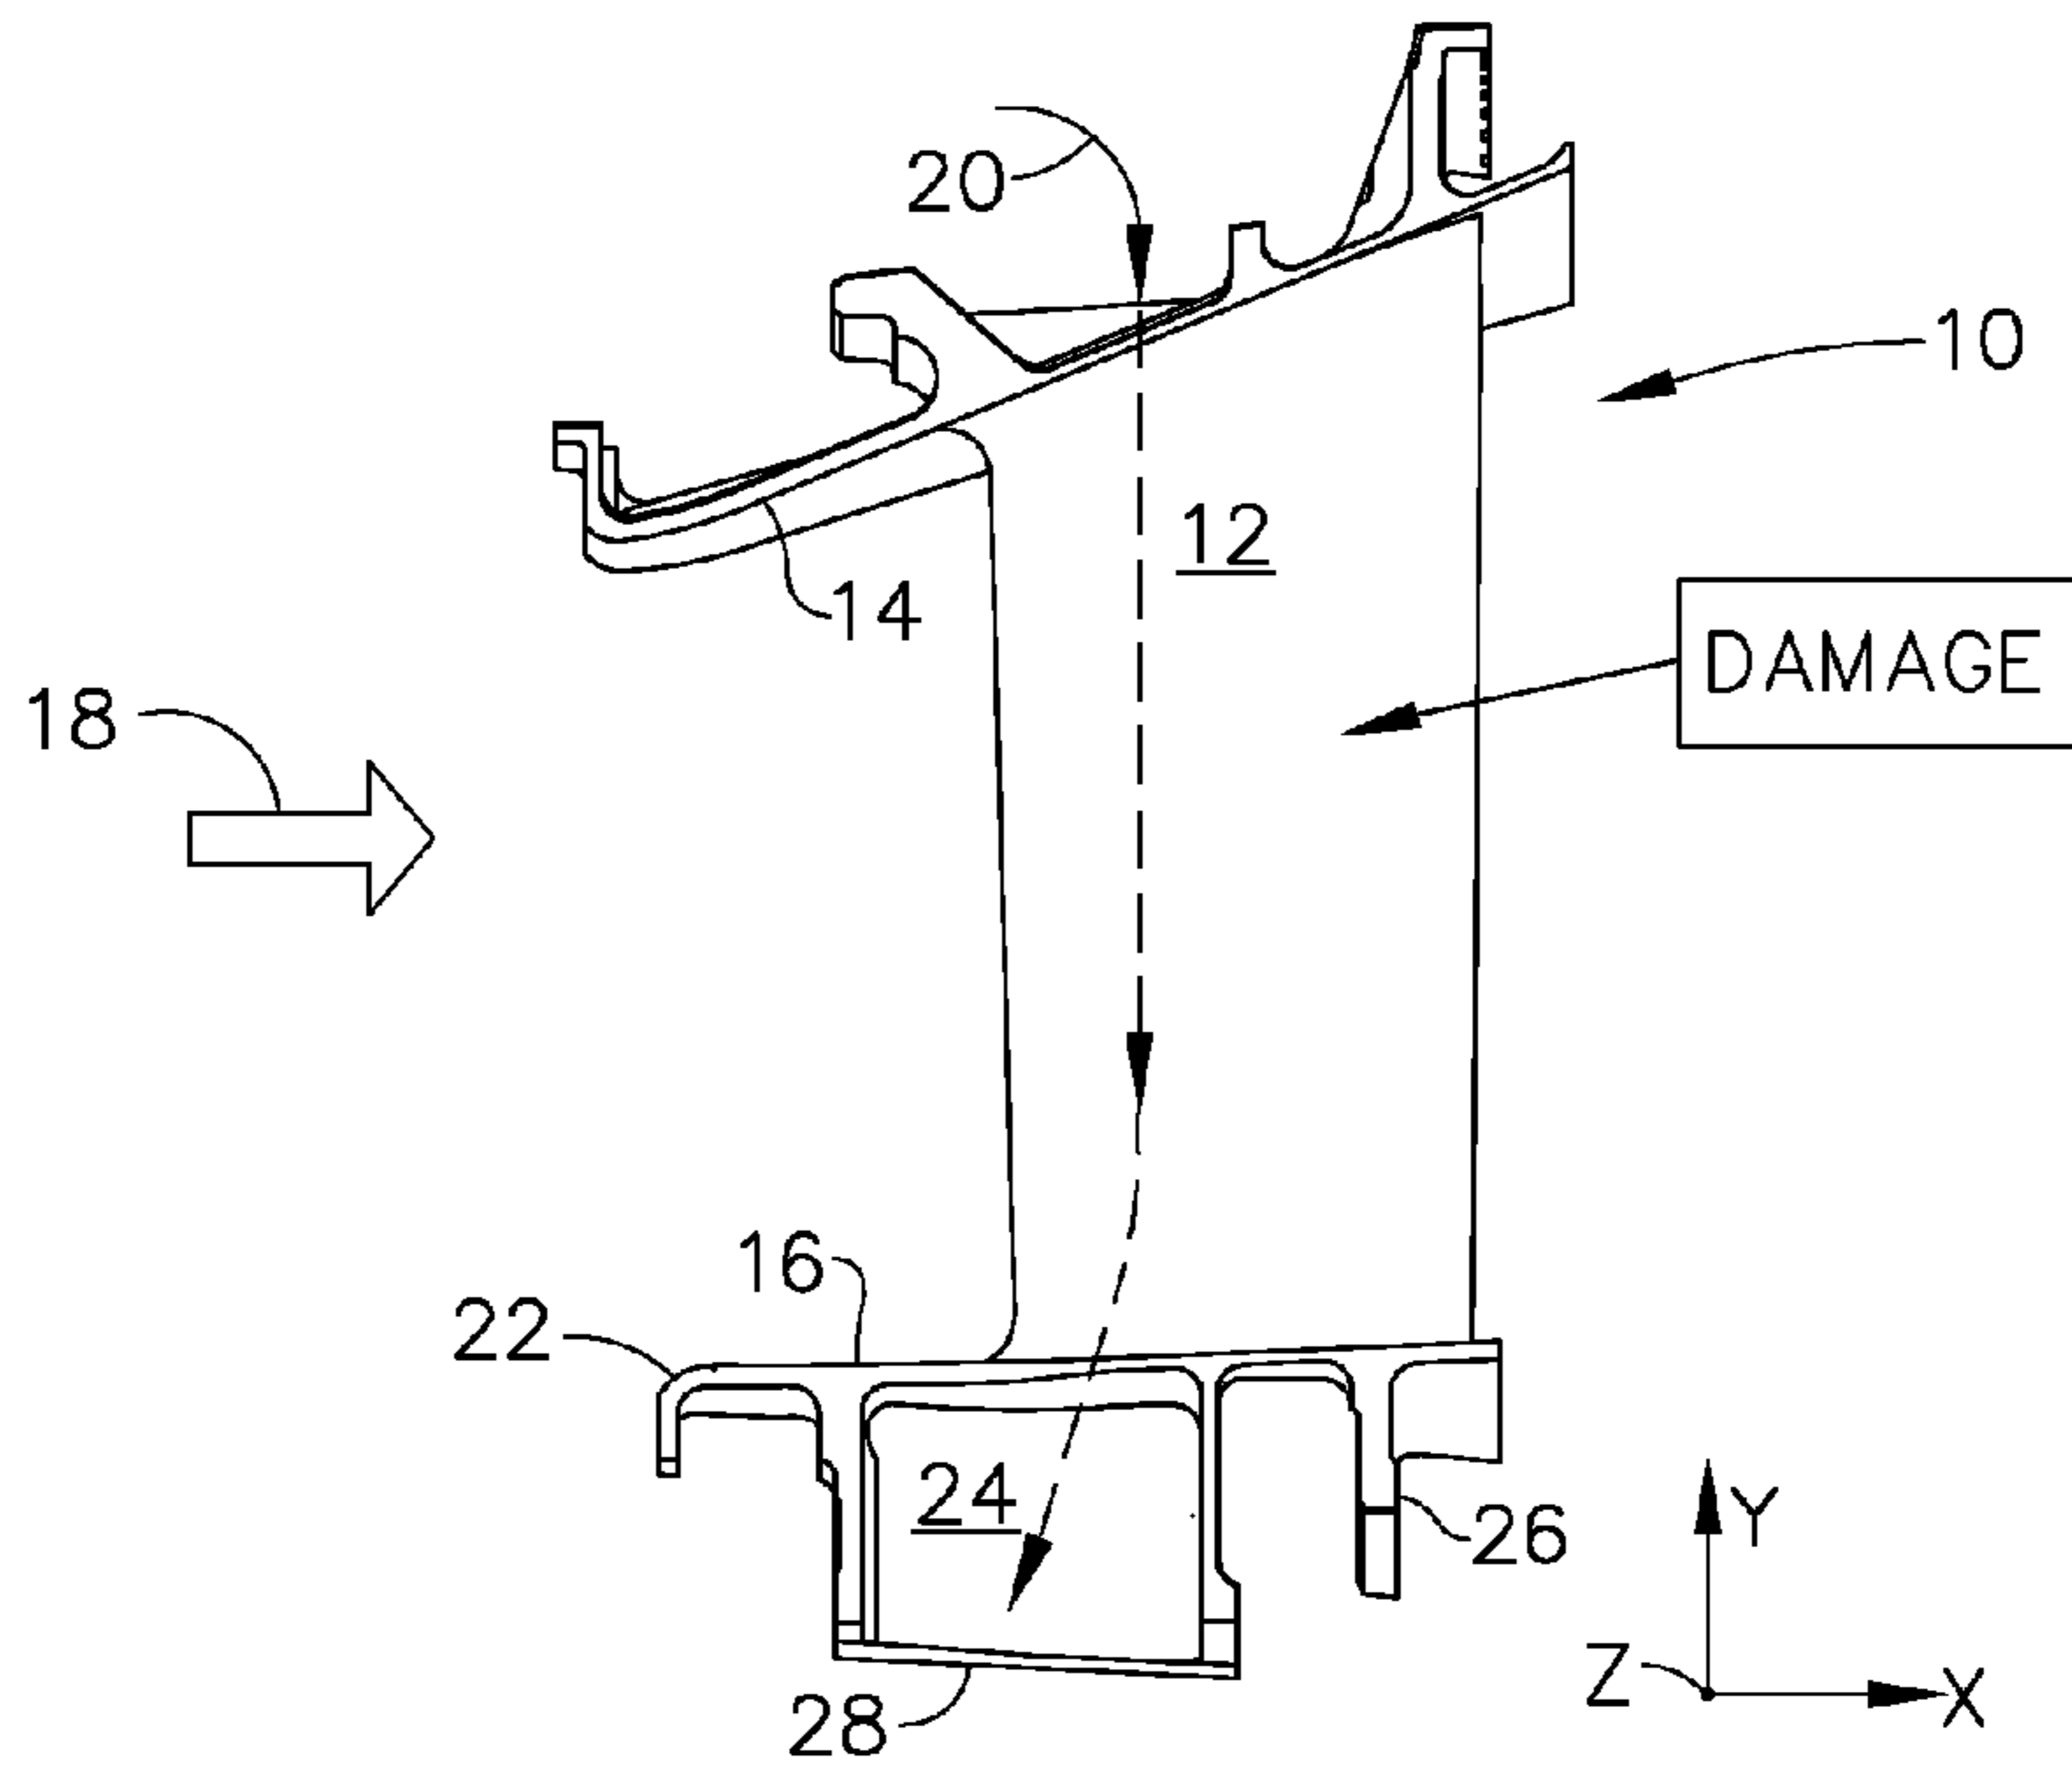
FIG. 1 is an axial view of an exemplary turbine nozzle configured for the first stage of a low pressure turbine.

Illustrated in axial elevational view in FIG. 1 is an exemplary first stage turbine nozzle **10** for a low pressure turbine in a gas turbine, or turbofan, engine. The nozzle **10** is axisymmetrical about a longitudinal or axial centerline axis and is an annular assembly of discrete nozzle segments.

In the exemplary embodiment illustrated in FIG. 1, the forward end of the inner band **16** includes a bullnose lip **22**, and extending radially inwardly from the underside of the inner band is a plenum box **24** and a radial flange **26** spaced axially aft therefrom.

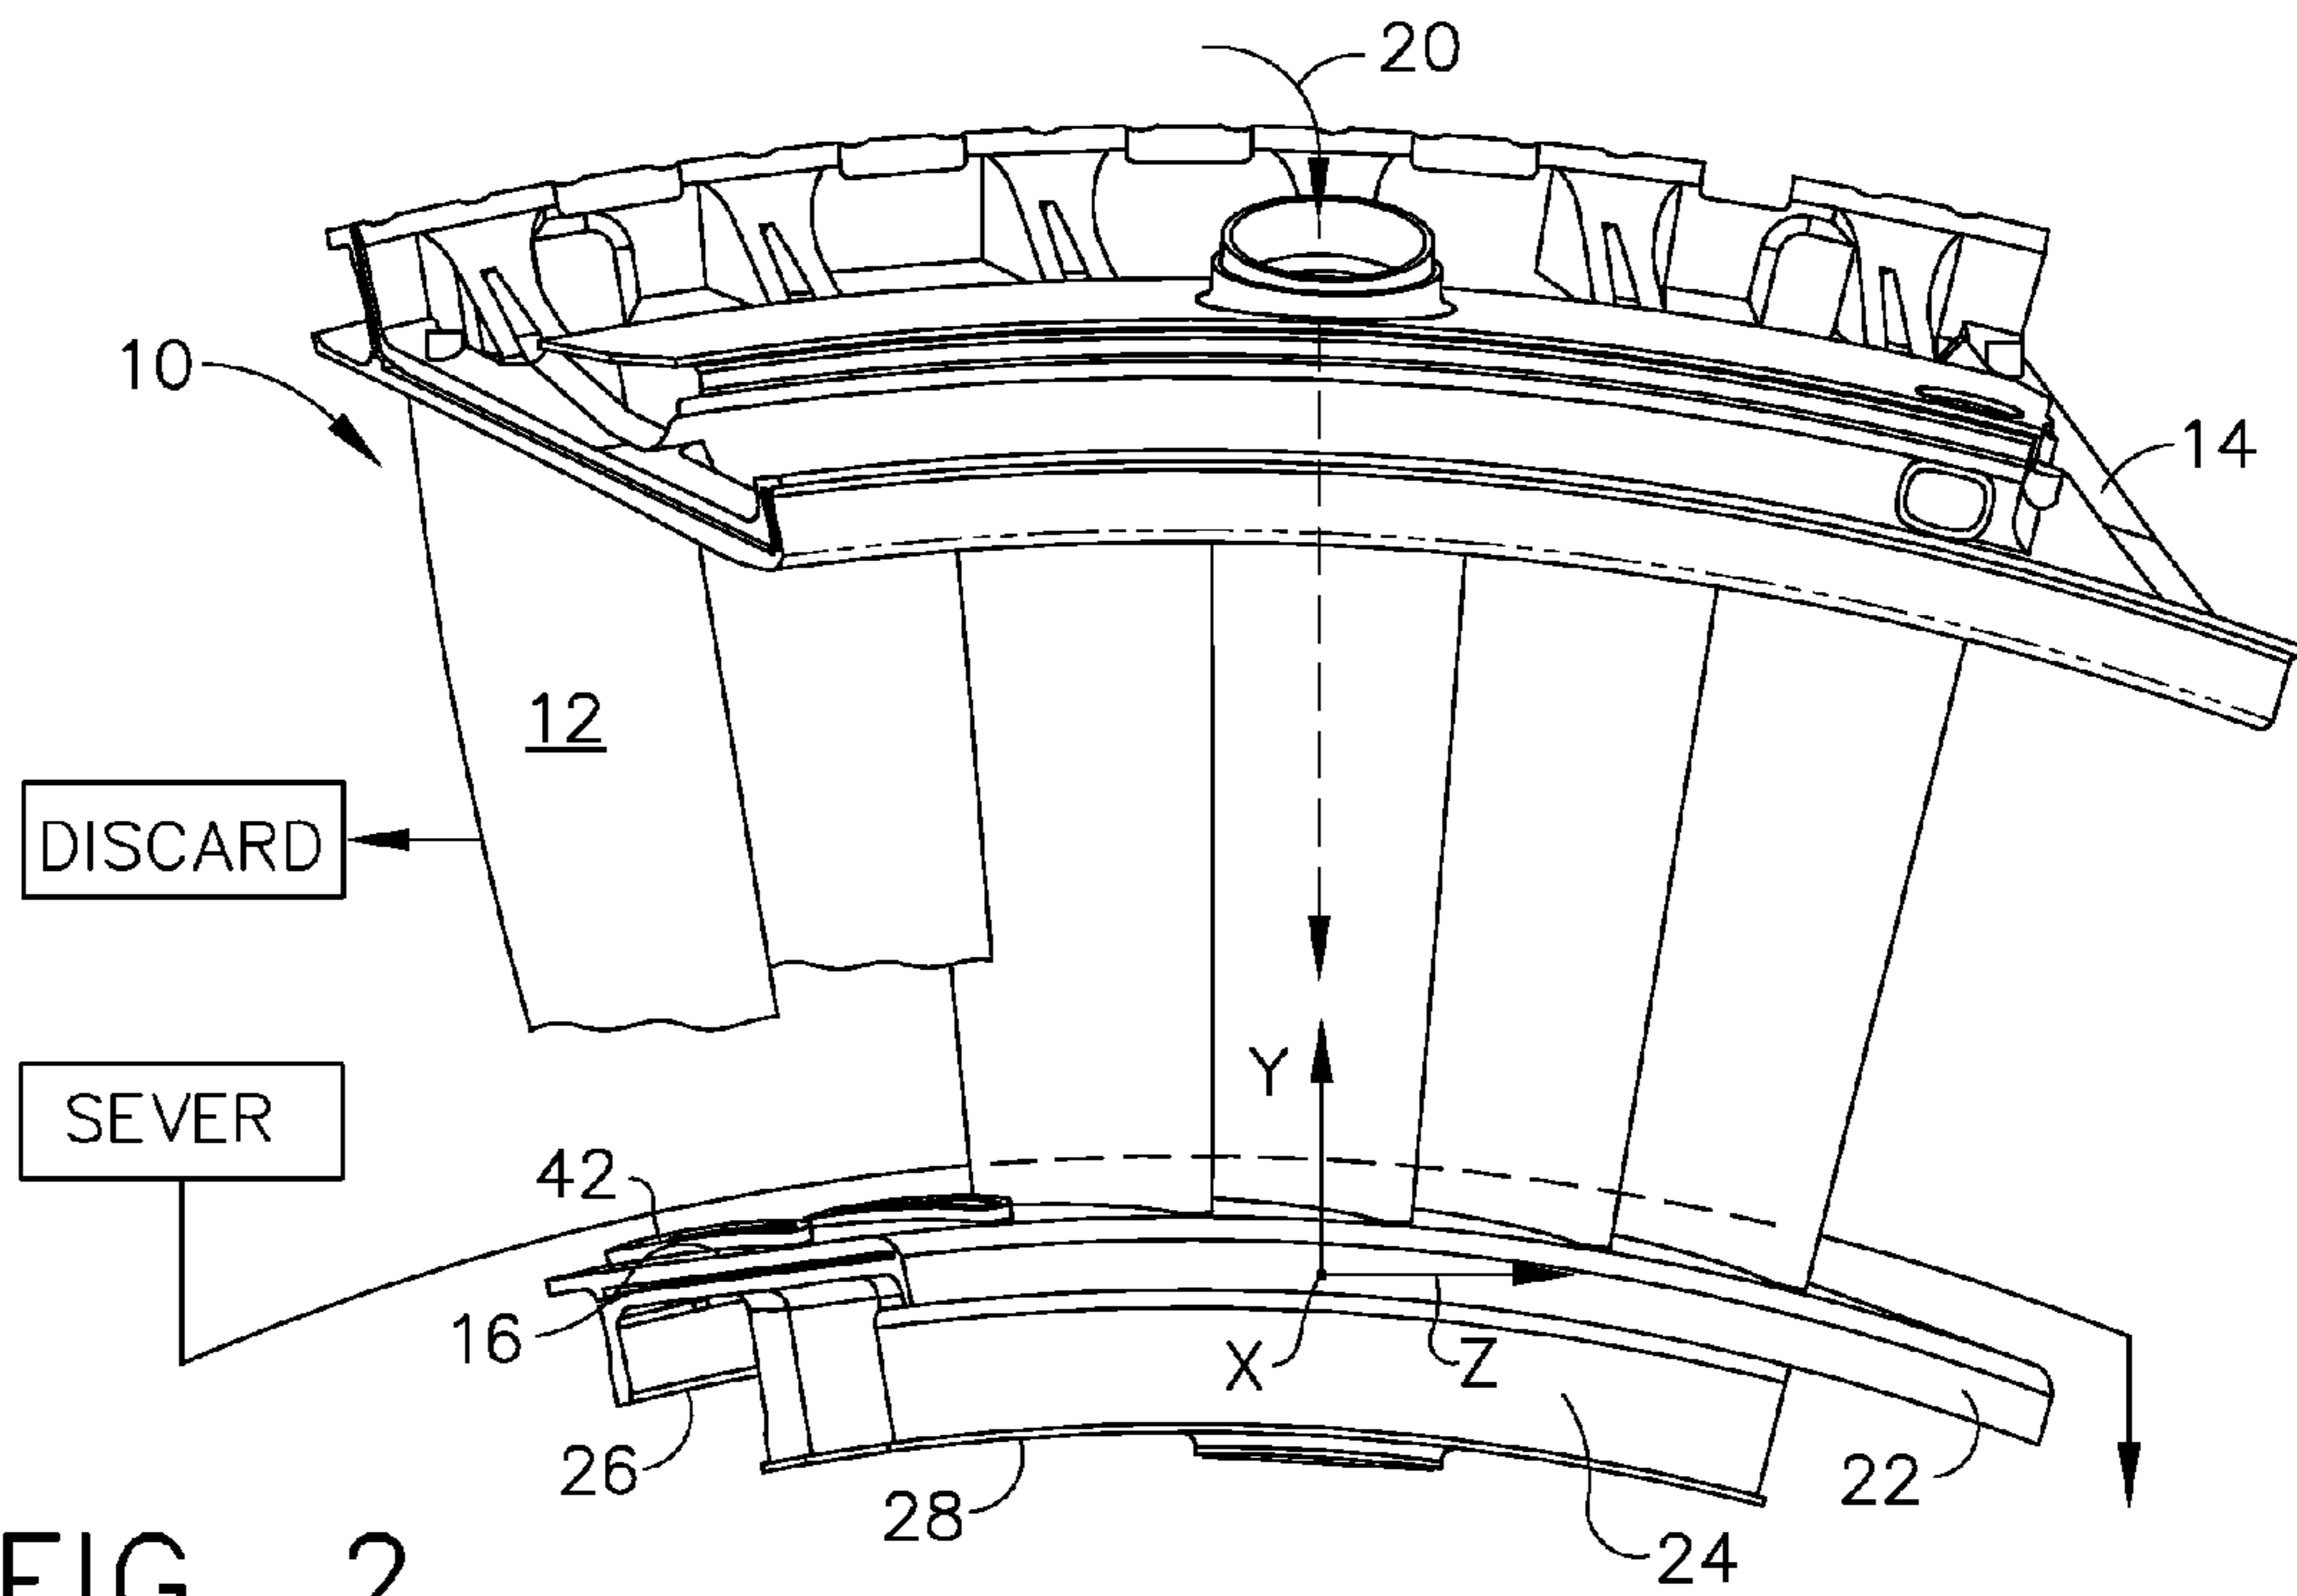
FIG. 2 is an isometric view of an exemplary nozzle segment requiring repair.

As additionally shown in FIG. 2, the plenum box **24** extends circumferentially over the arcuate extent or length of the nozzle segment, and is suitably covered by a sheet-metal cover **28**. The exemplary cooling circuit extends radially through the hollow vanes are **12**, with the cooling air being supplied through the outer band and discharged into the plenum box **24** below the inner band during operation.

As initially shown in FIG. 2, the original inner band **16** is suitably cut or severed from the original nozzle vanes **12** and the attached original outer band **14** in the original turbine nozzle **10** after prolonged use thereof in the gas turbine engine.

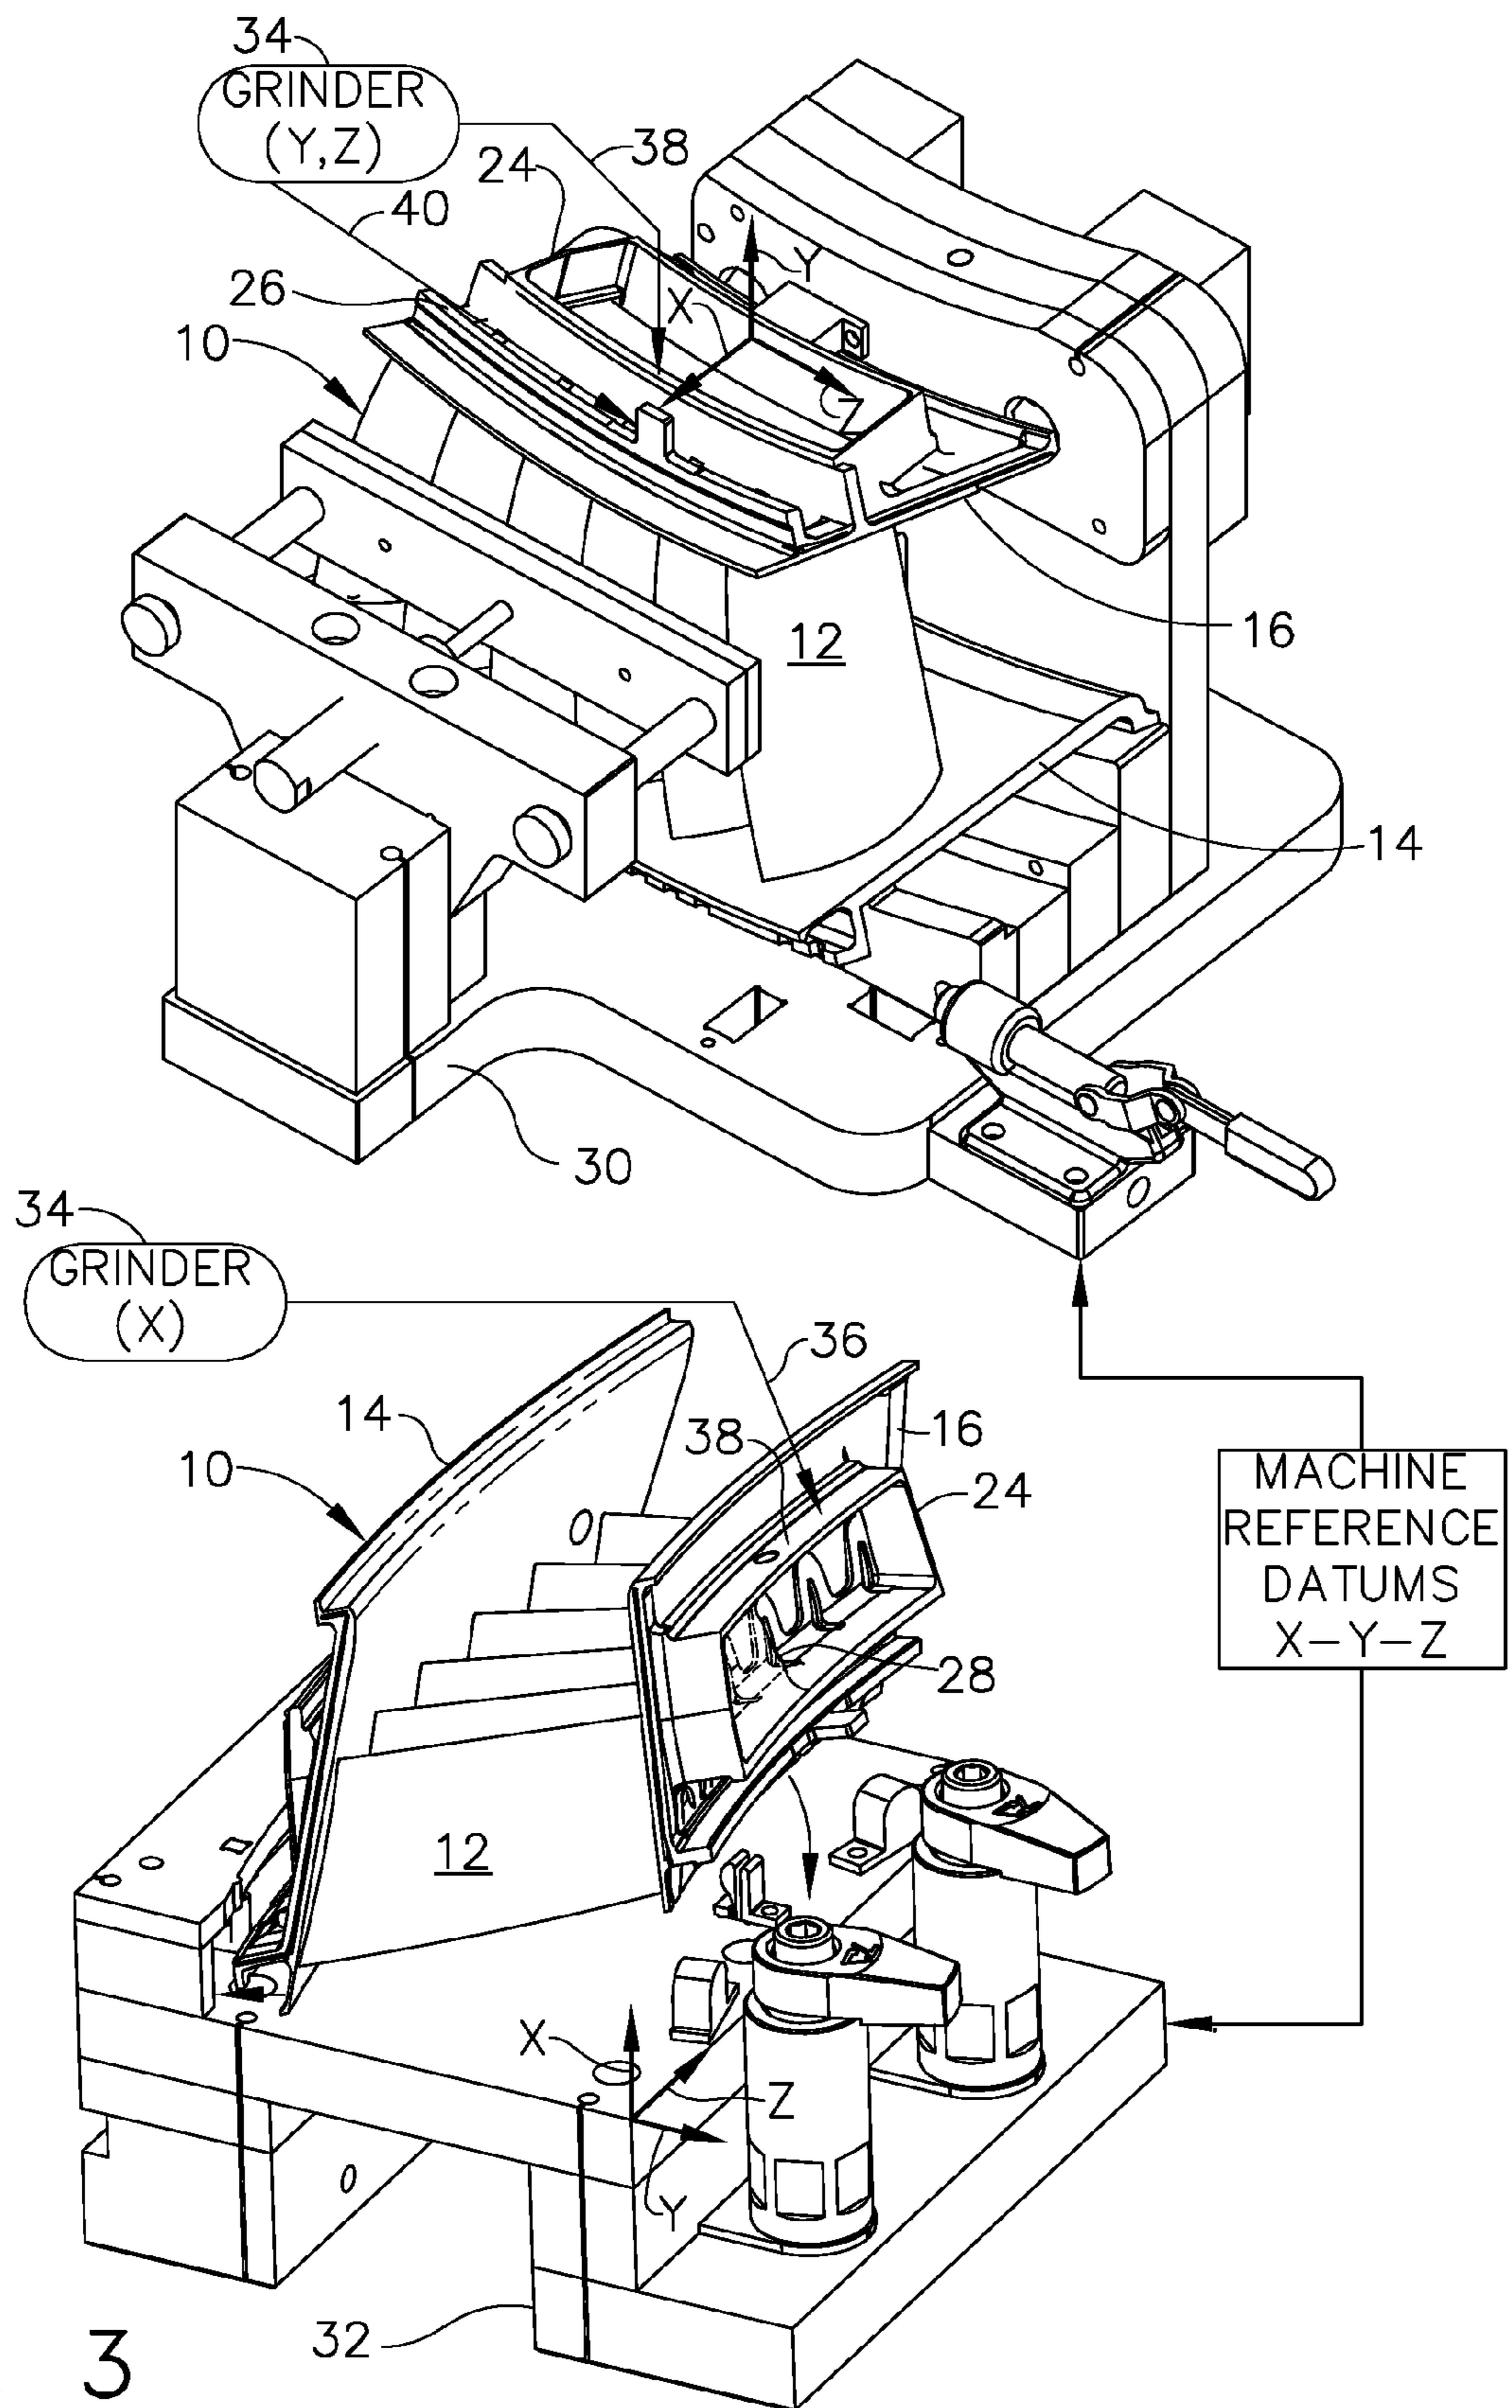
FIG. 3 is a flowchart illustrating initial repair features of the original nozzle segment.

FIG. 3 illustrates preliminary procedures for initially preparing the used turbine nozzle **10** for undergoing repair.

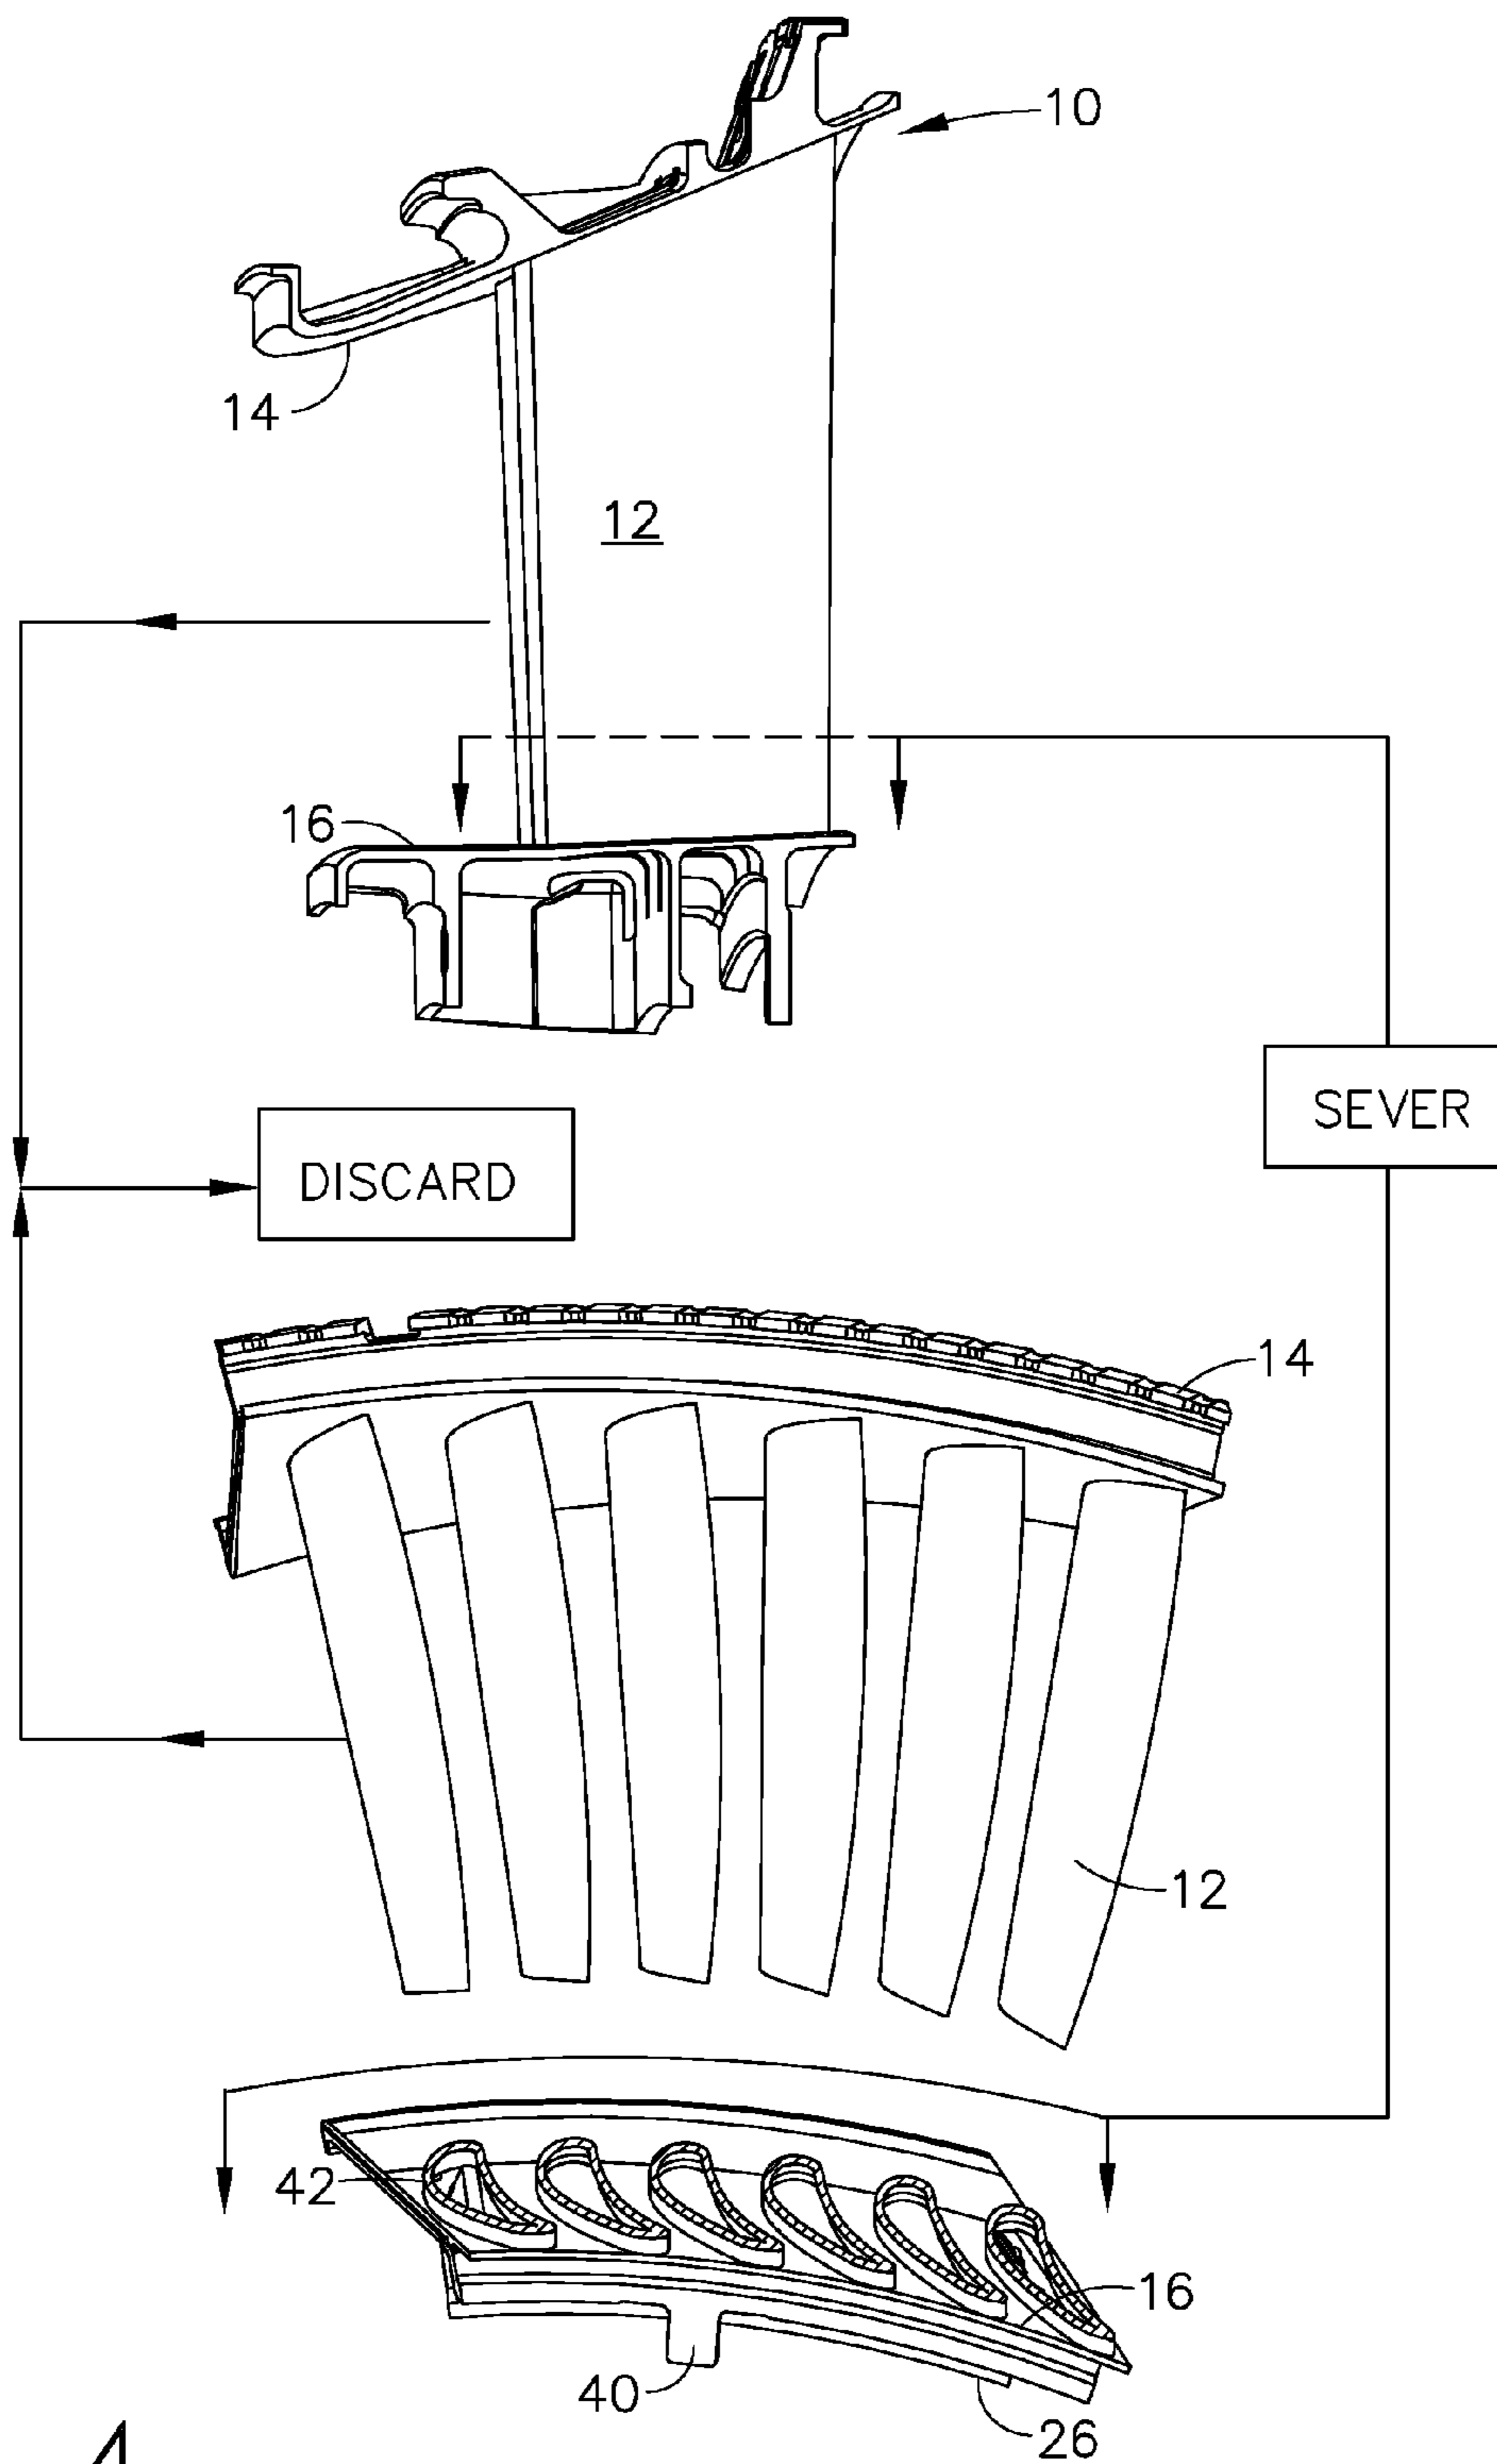
FIG. 4 is a flowchart illustrating removal of the original inner band from the nozzle segment.

As shown in FIG. 4, the inner band **16** is suitably severed or liberated from the original vanes **12** by using any conventional cutting machine that need not require precision and can leave behind rough cut vane stubs **42** top the inboard flow surface of the inner band **16**. The vanes can be cut as close as practical to their junctions with the inner band, in the fillet region therebetween, to minimize size of the remaining stubs.

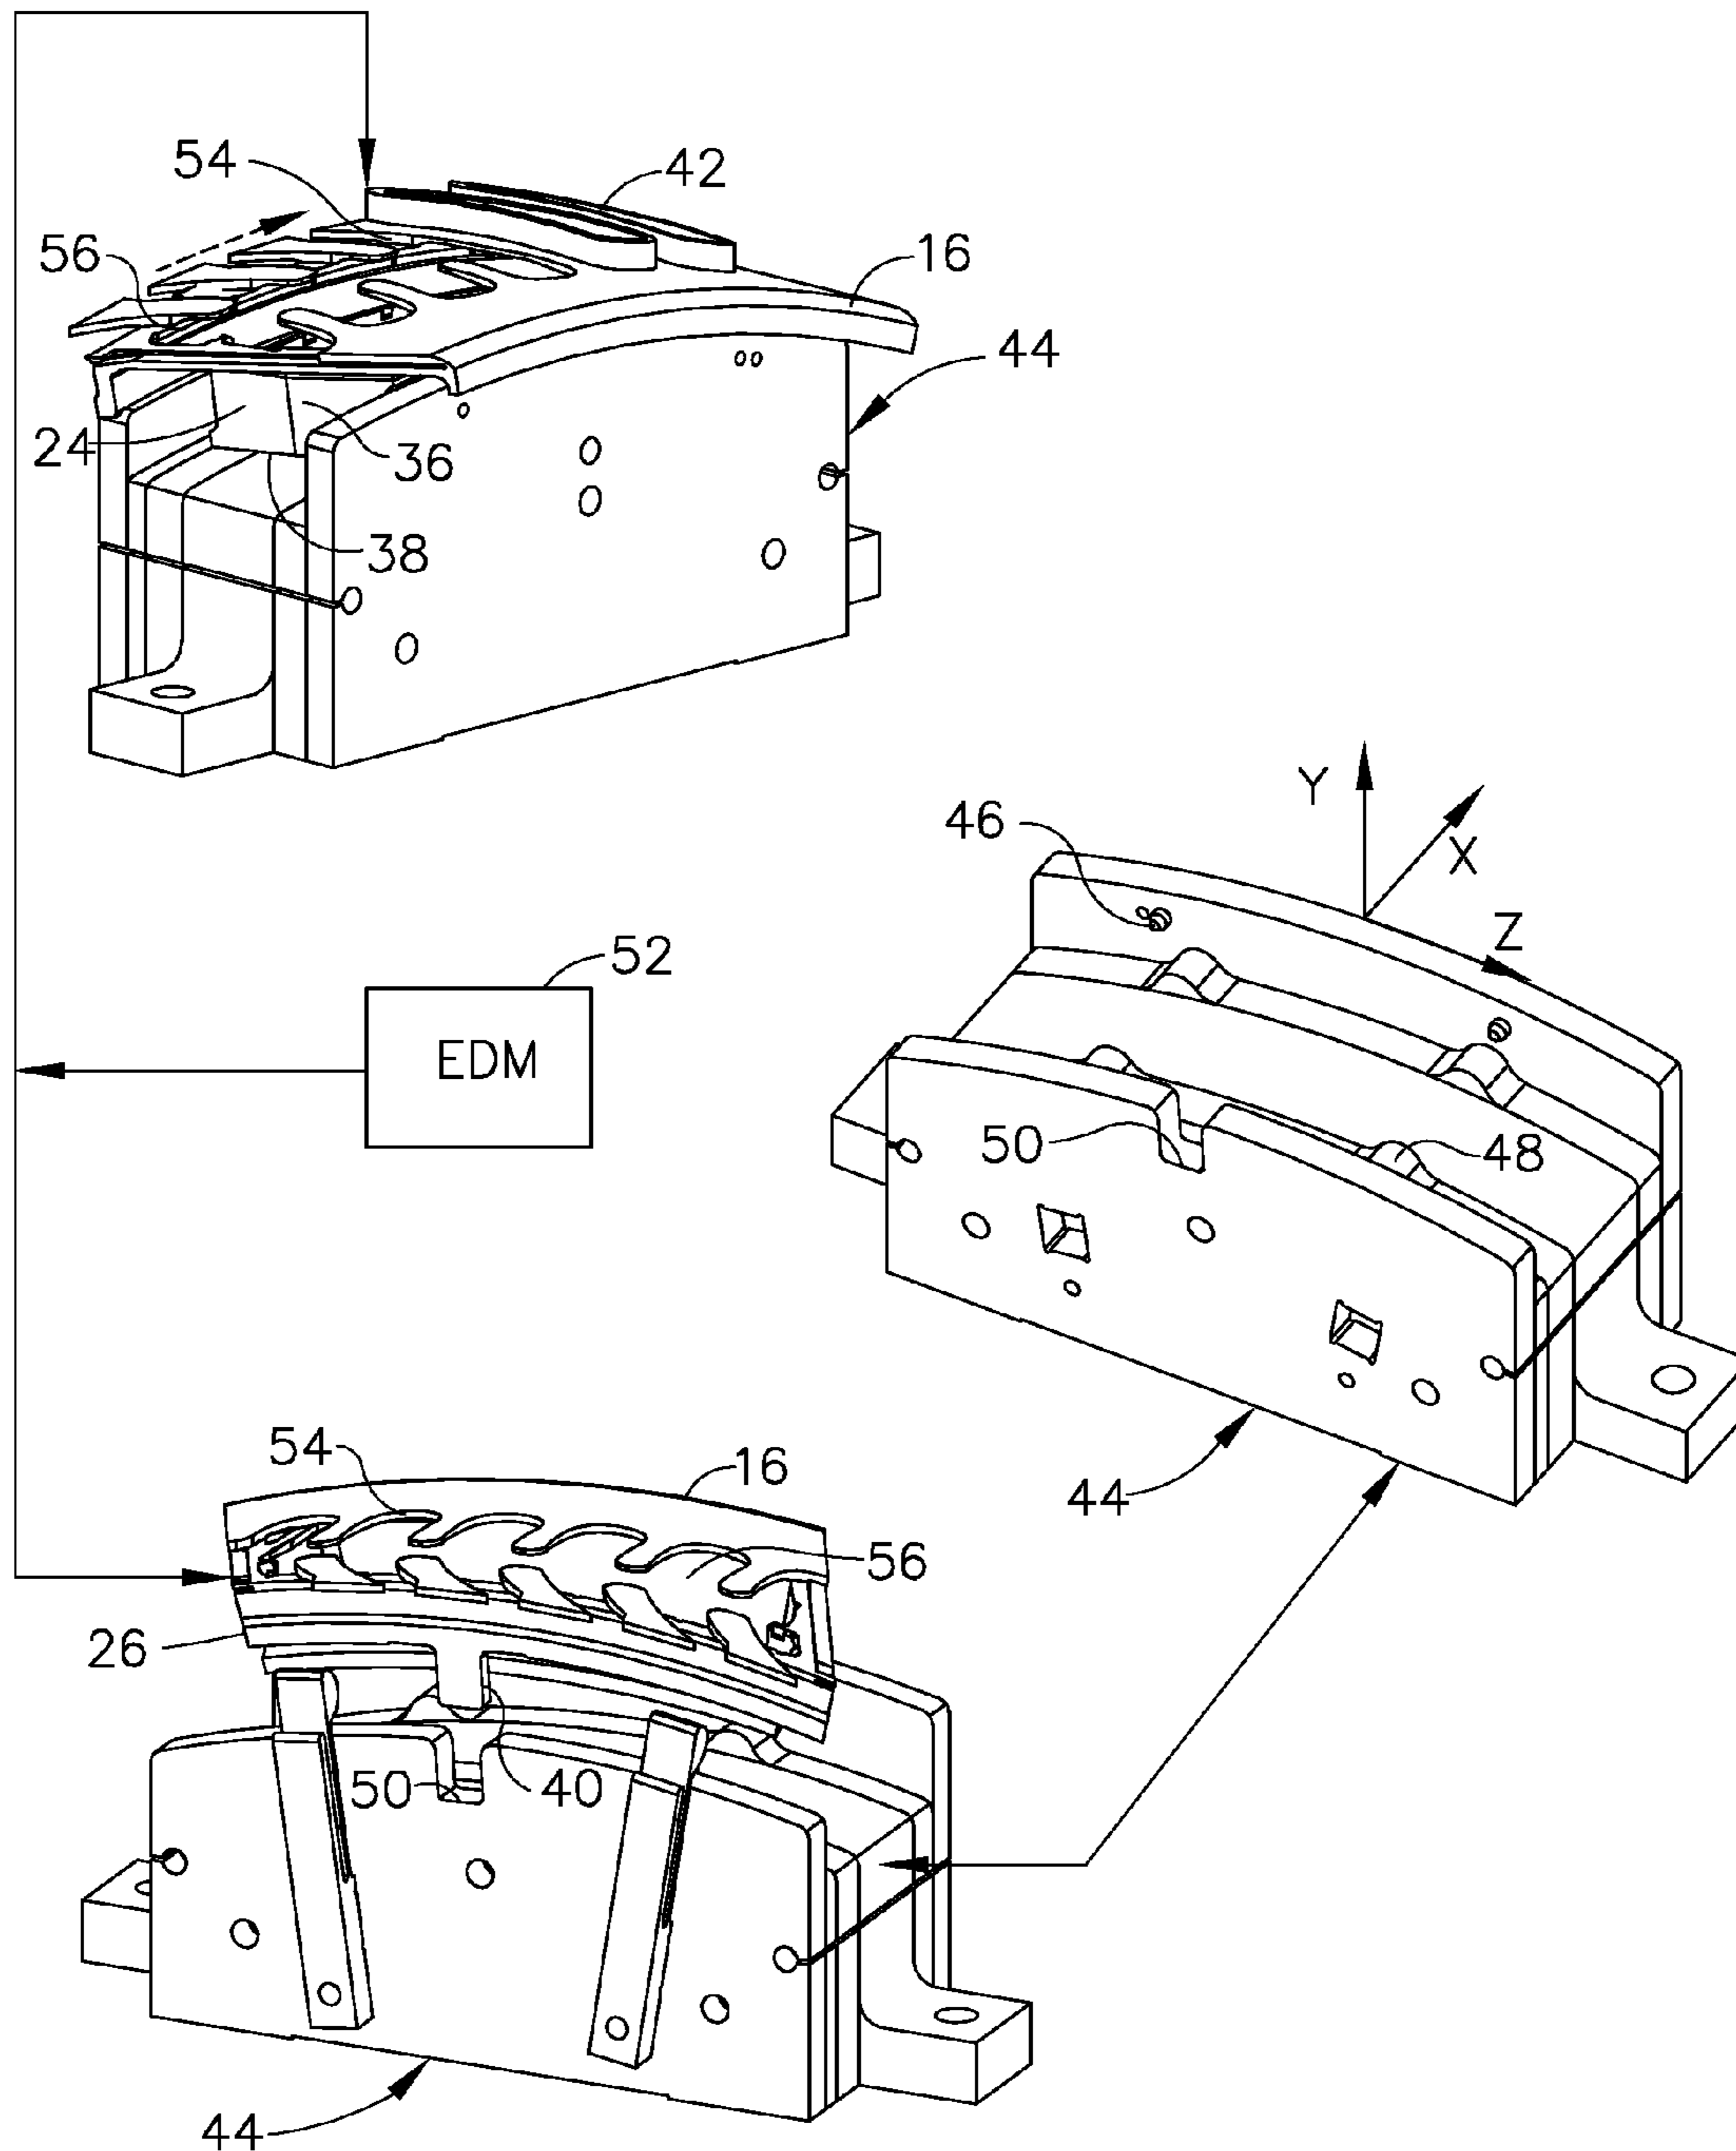
FIG. 5 is a flowchart illustrating machining of the removed inner band in the repair process.

As shown in FIG. 5, the severed inner band **16** may then be mounted in a third tool or fixture **44** specifically configured therefor.

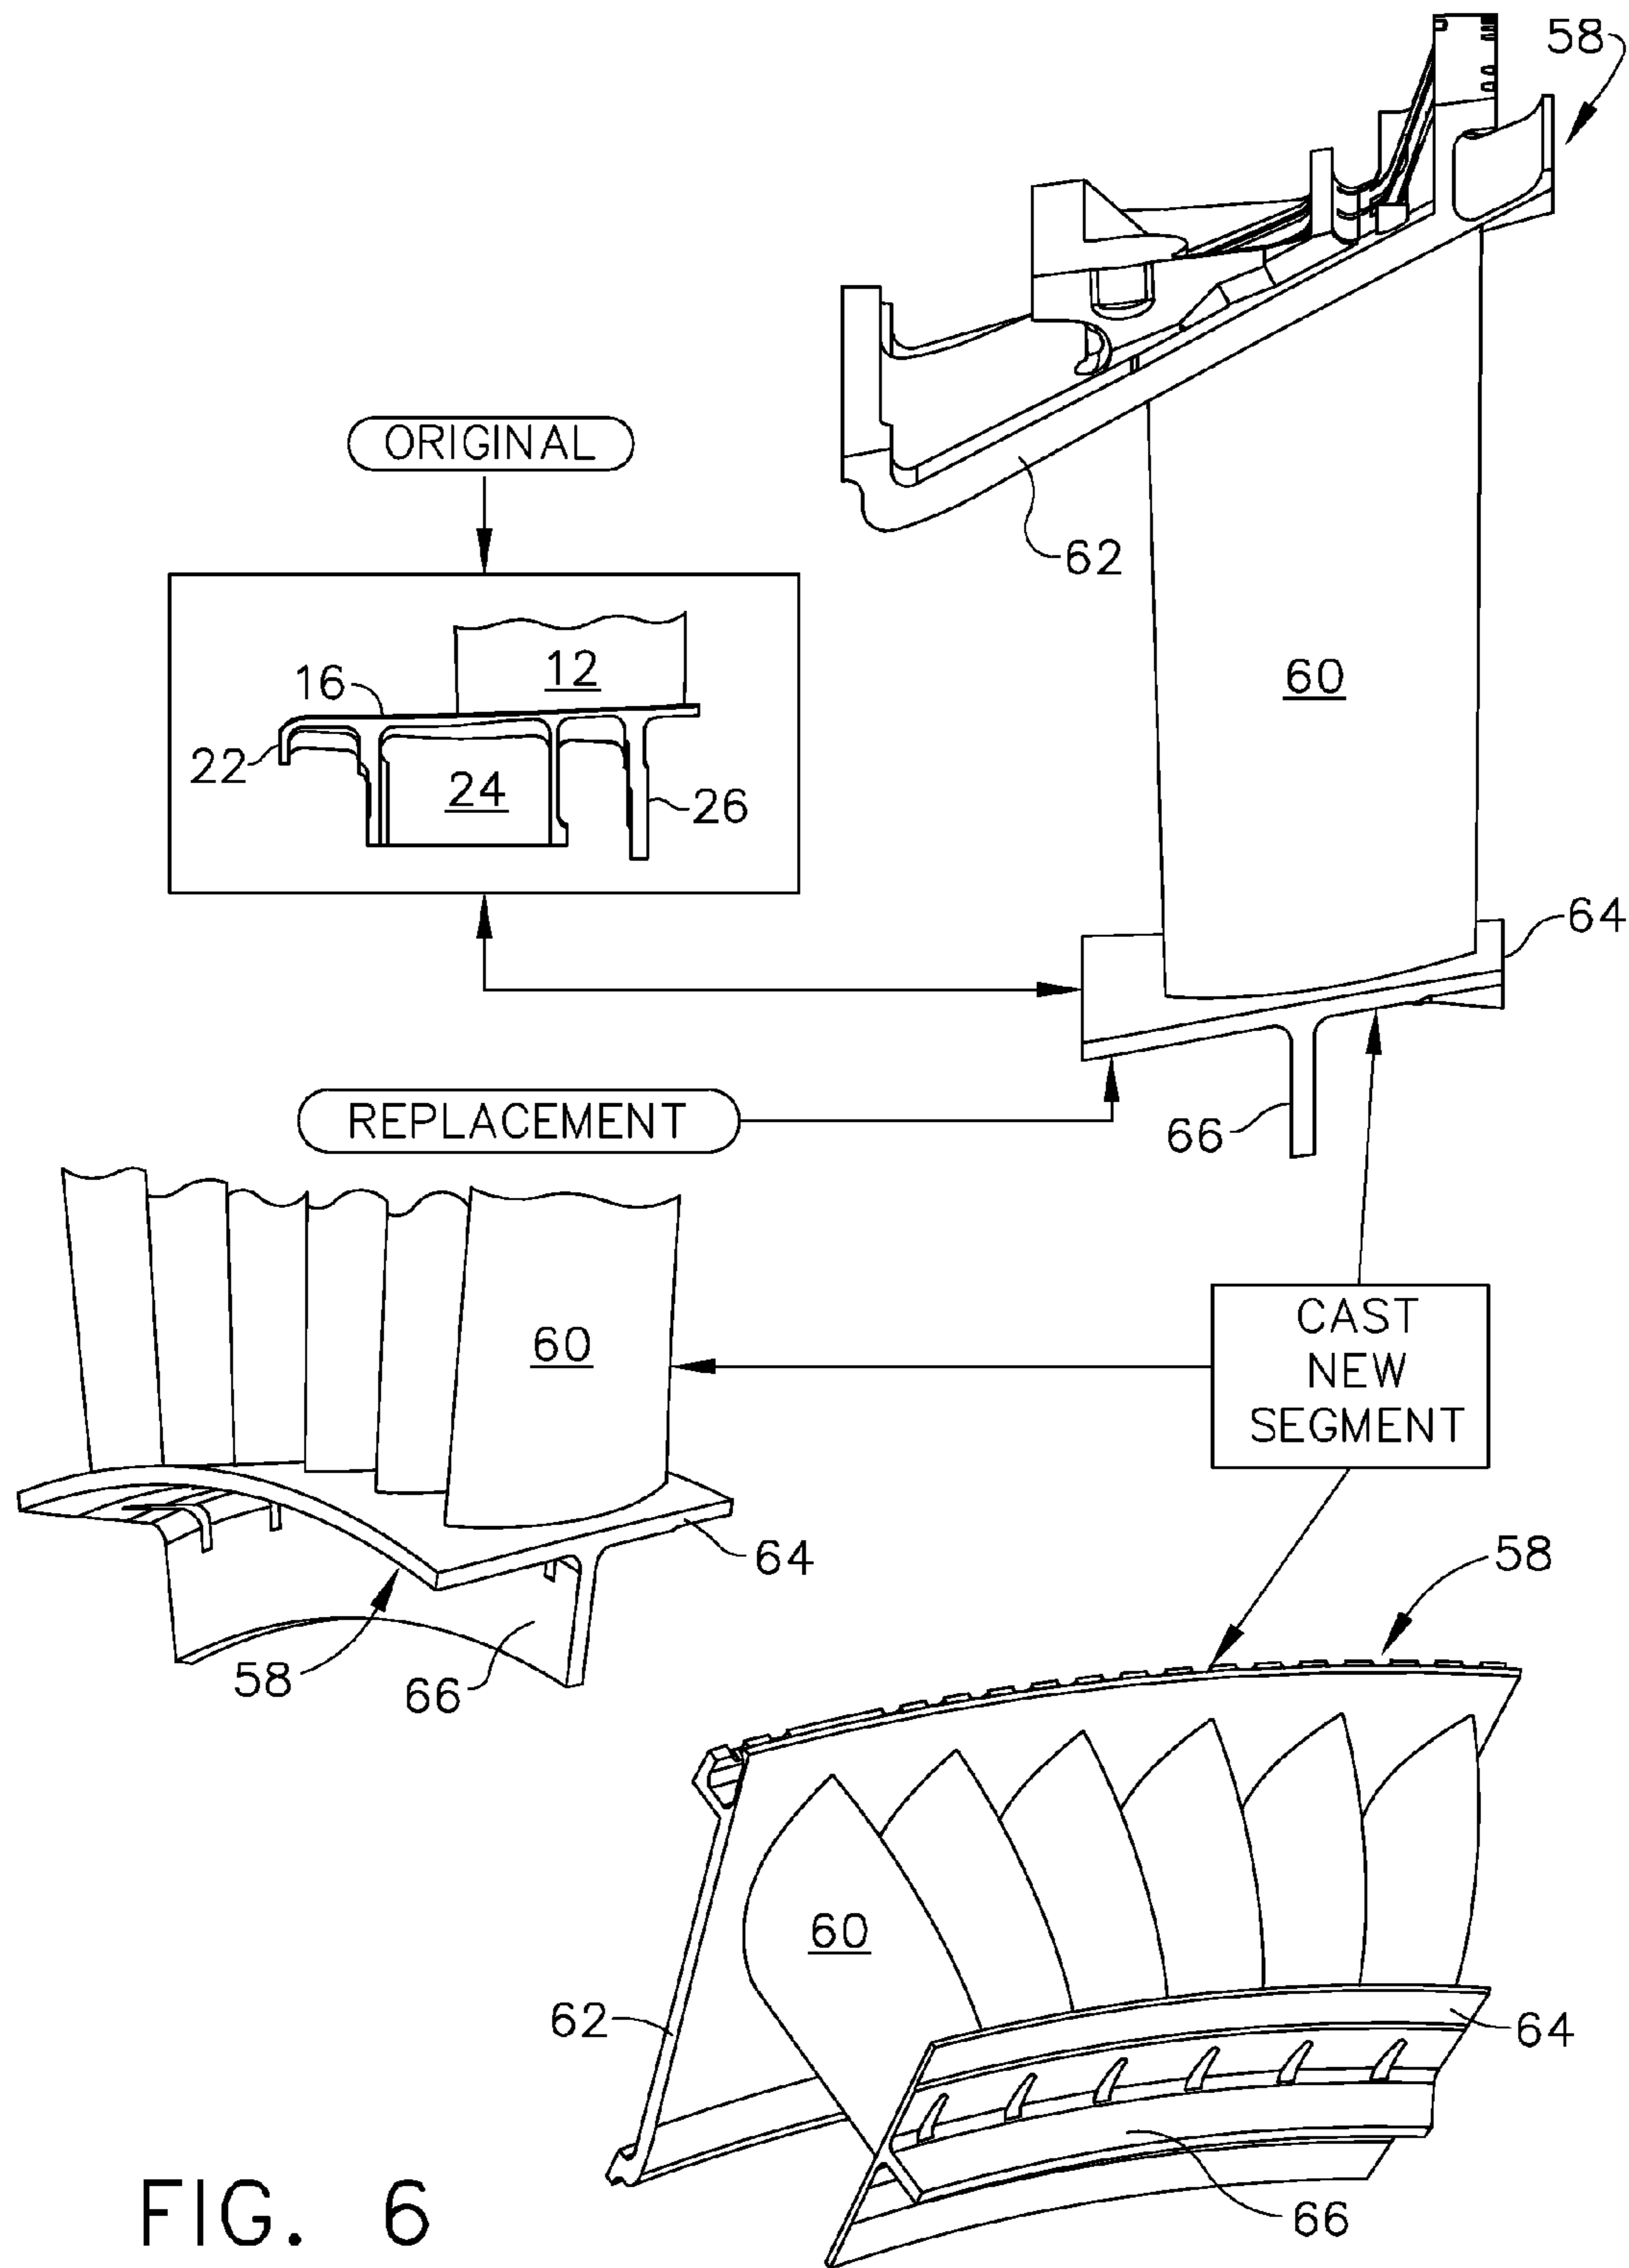
FIG. 6 is a flowchart illustrating casting of a replacement turbine nozzle segment including replacement nozzle vanes and outer band, and a special radially inner web.
