US008544173B2

(54) **TURBINE NOZZLE BIFORM REPAIR**

(73) Assignee: **General Electric Company**, Schenectady, NY (US)

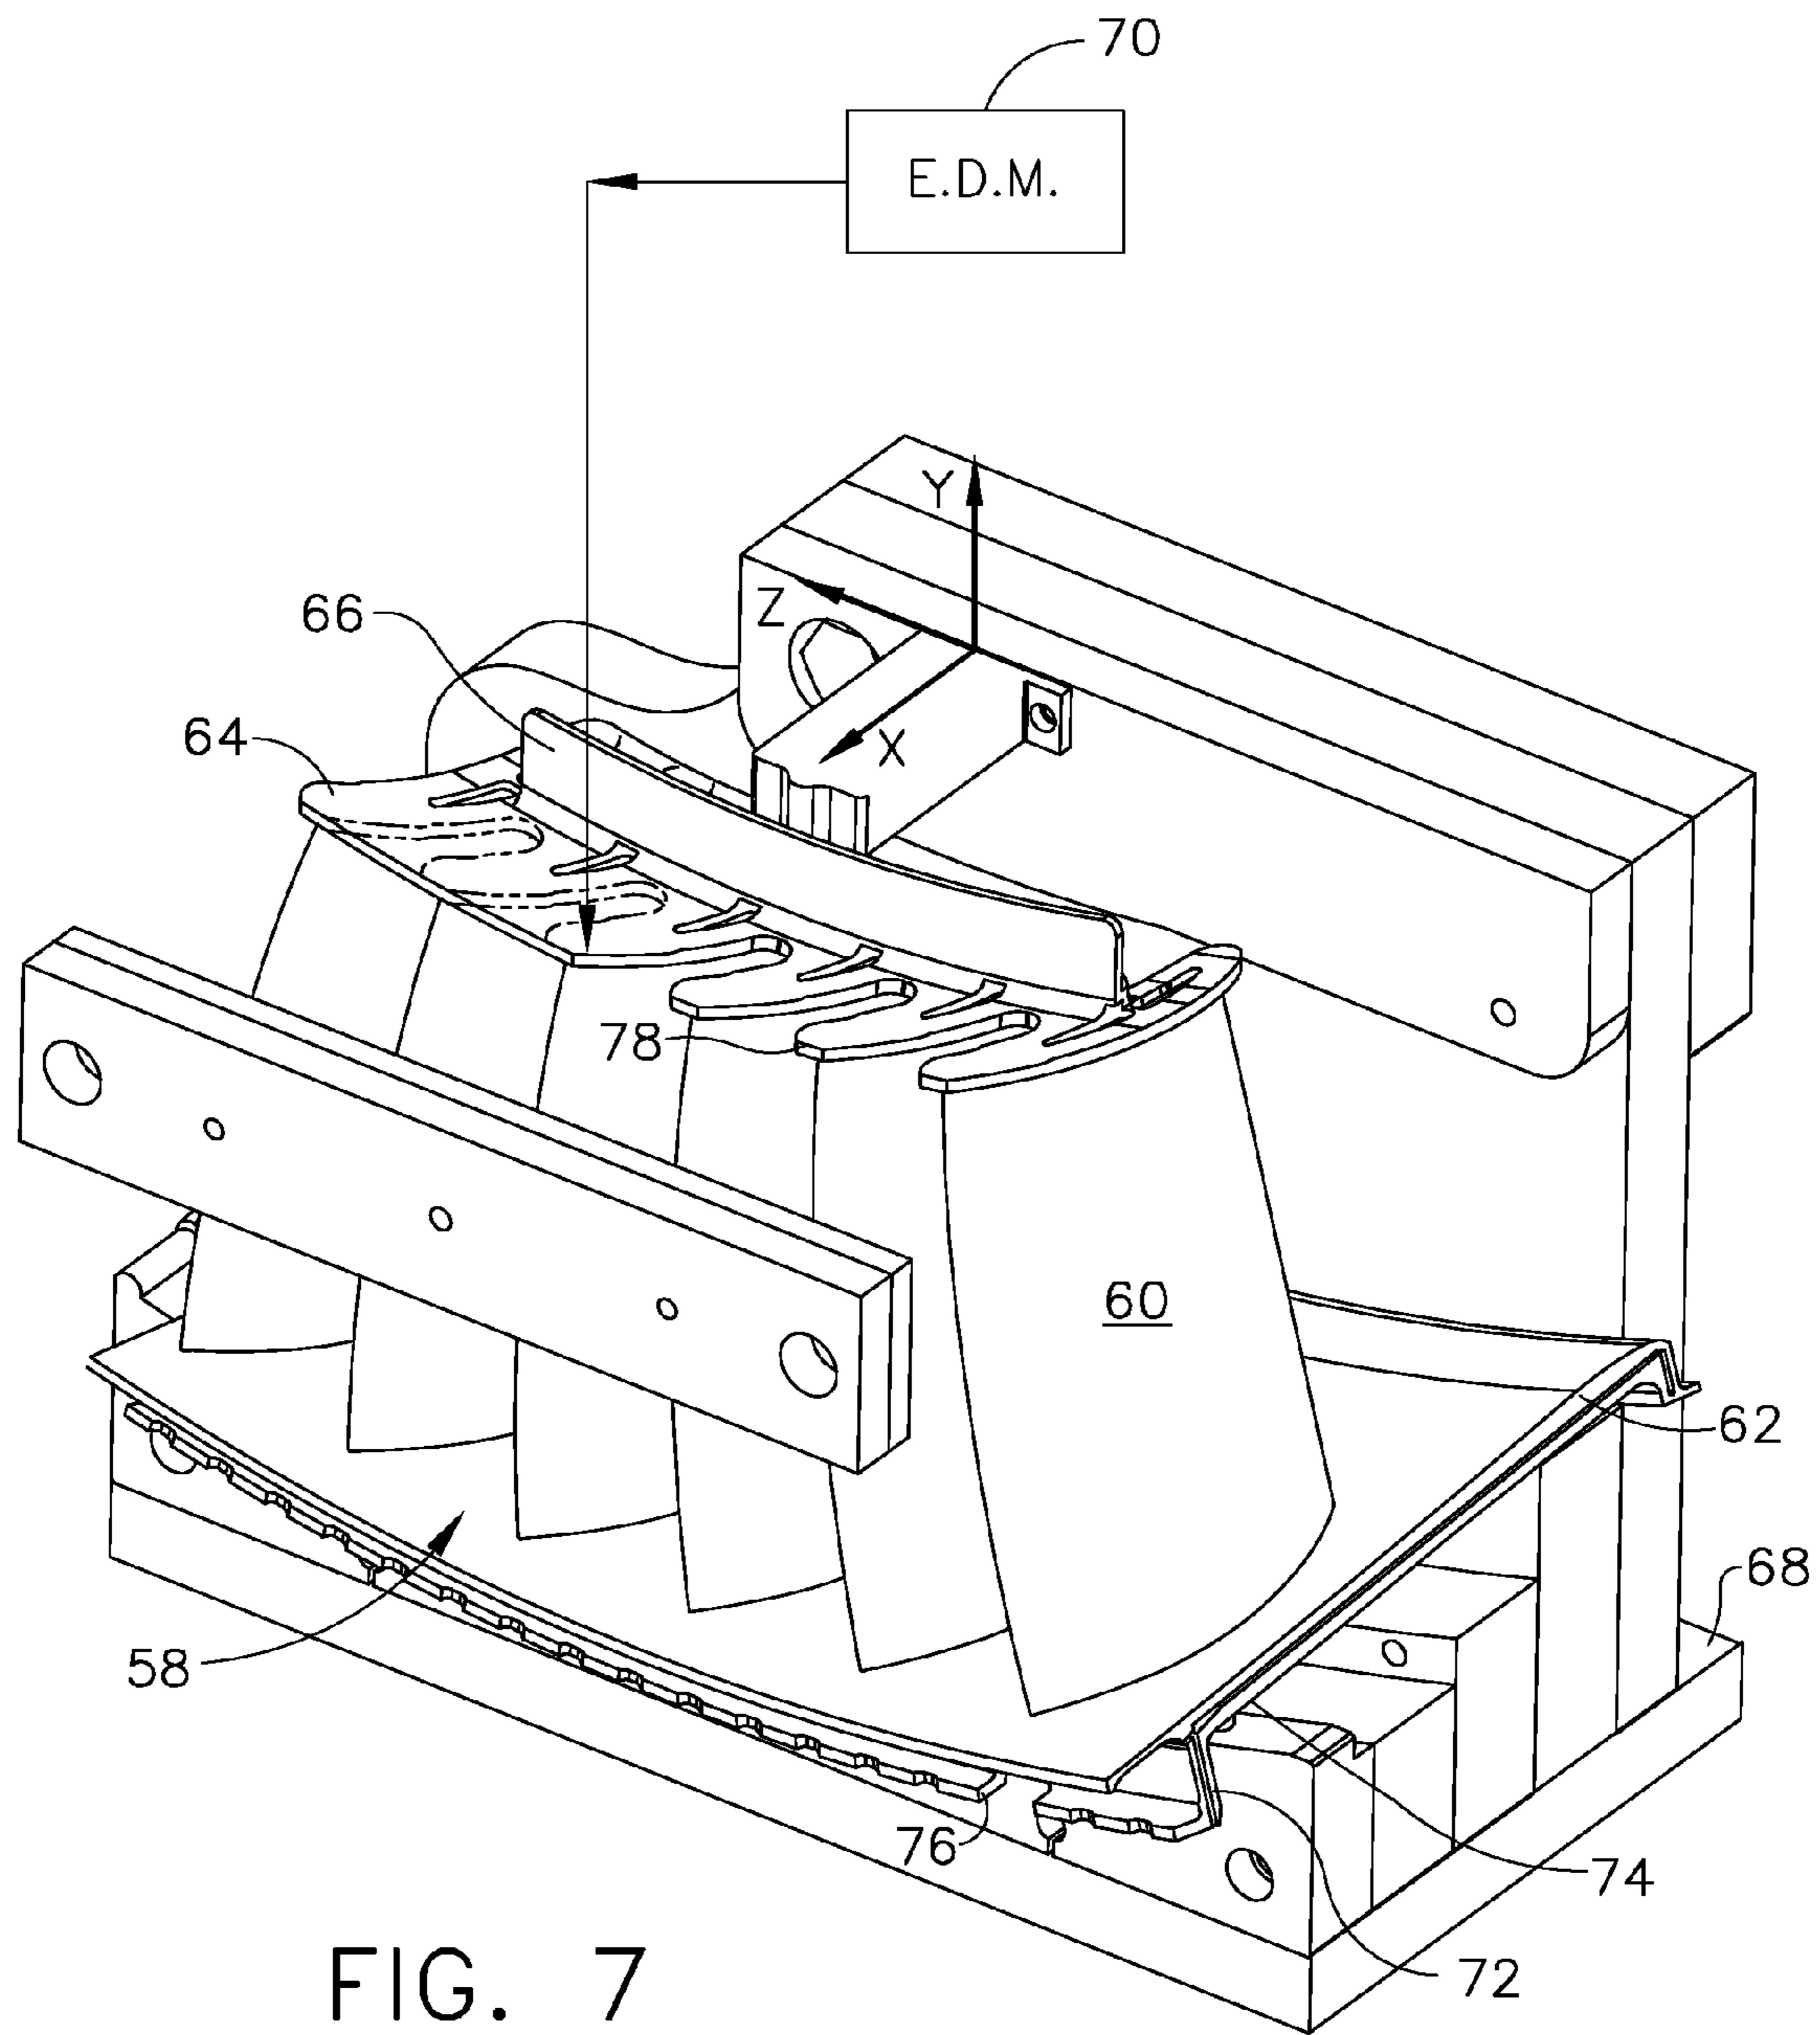
FIG. 7 is a flowchart illustrating machining of the special inner web.

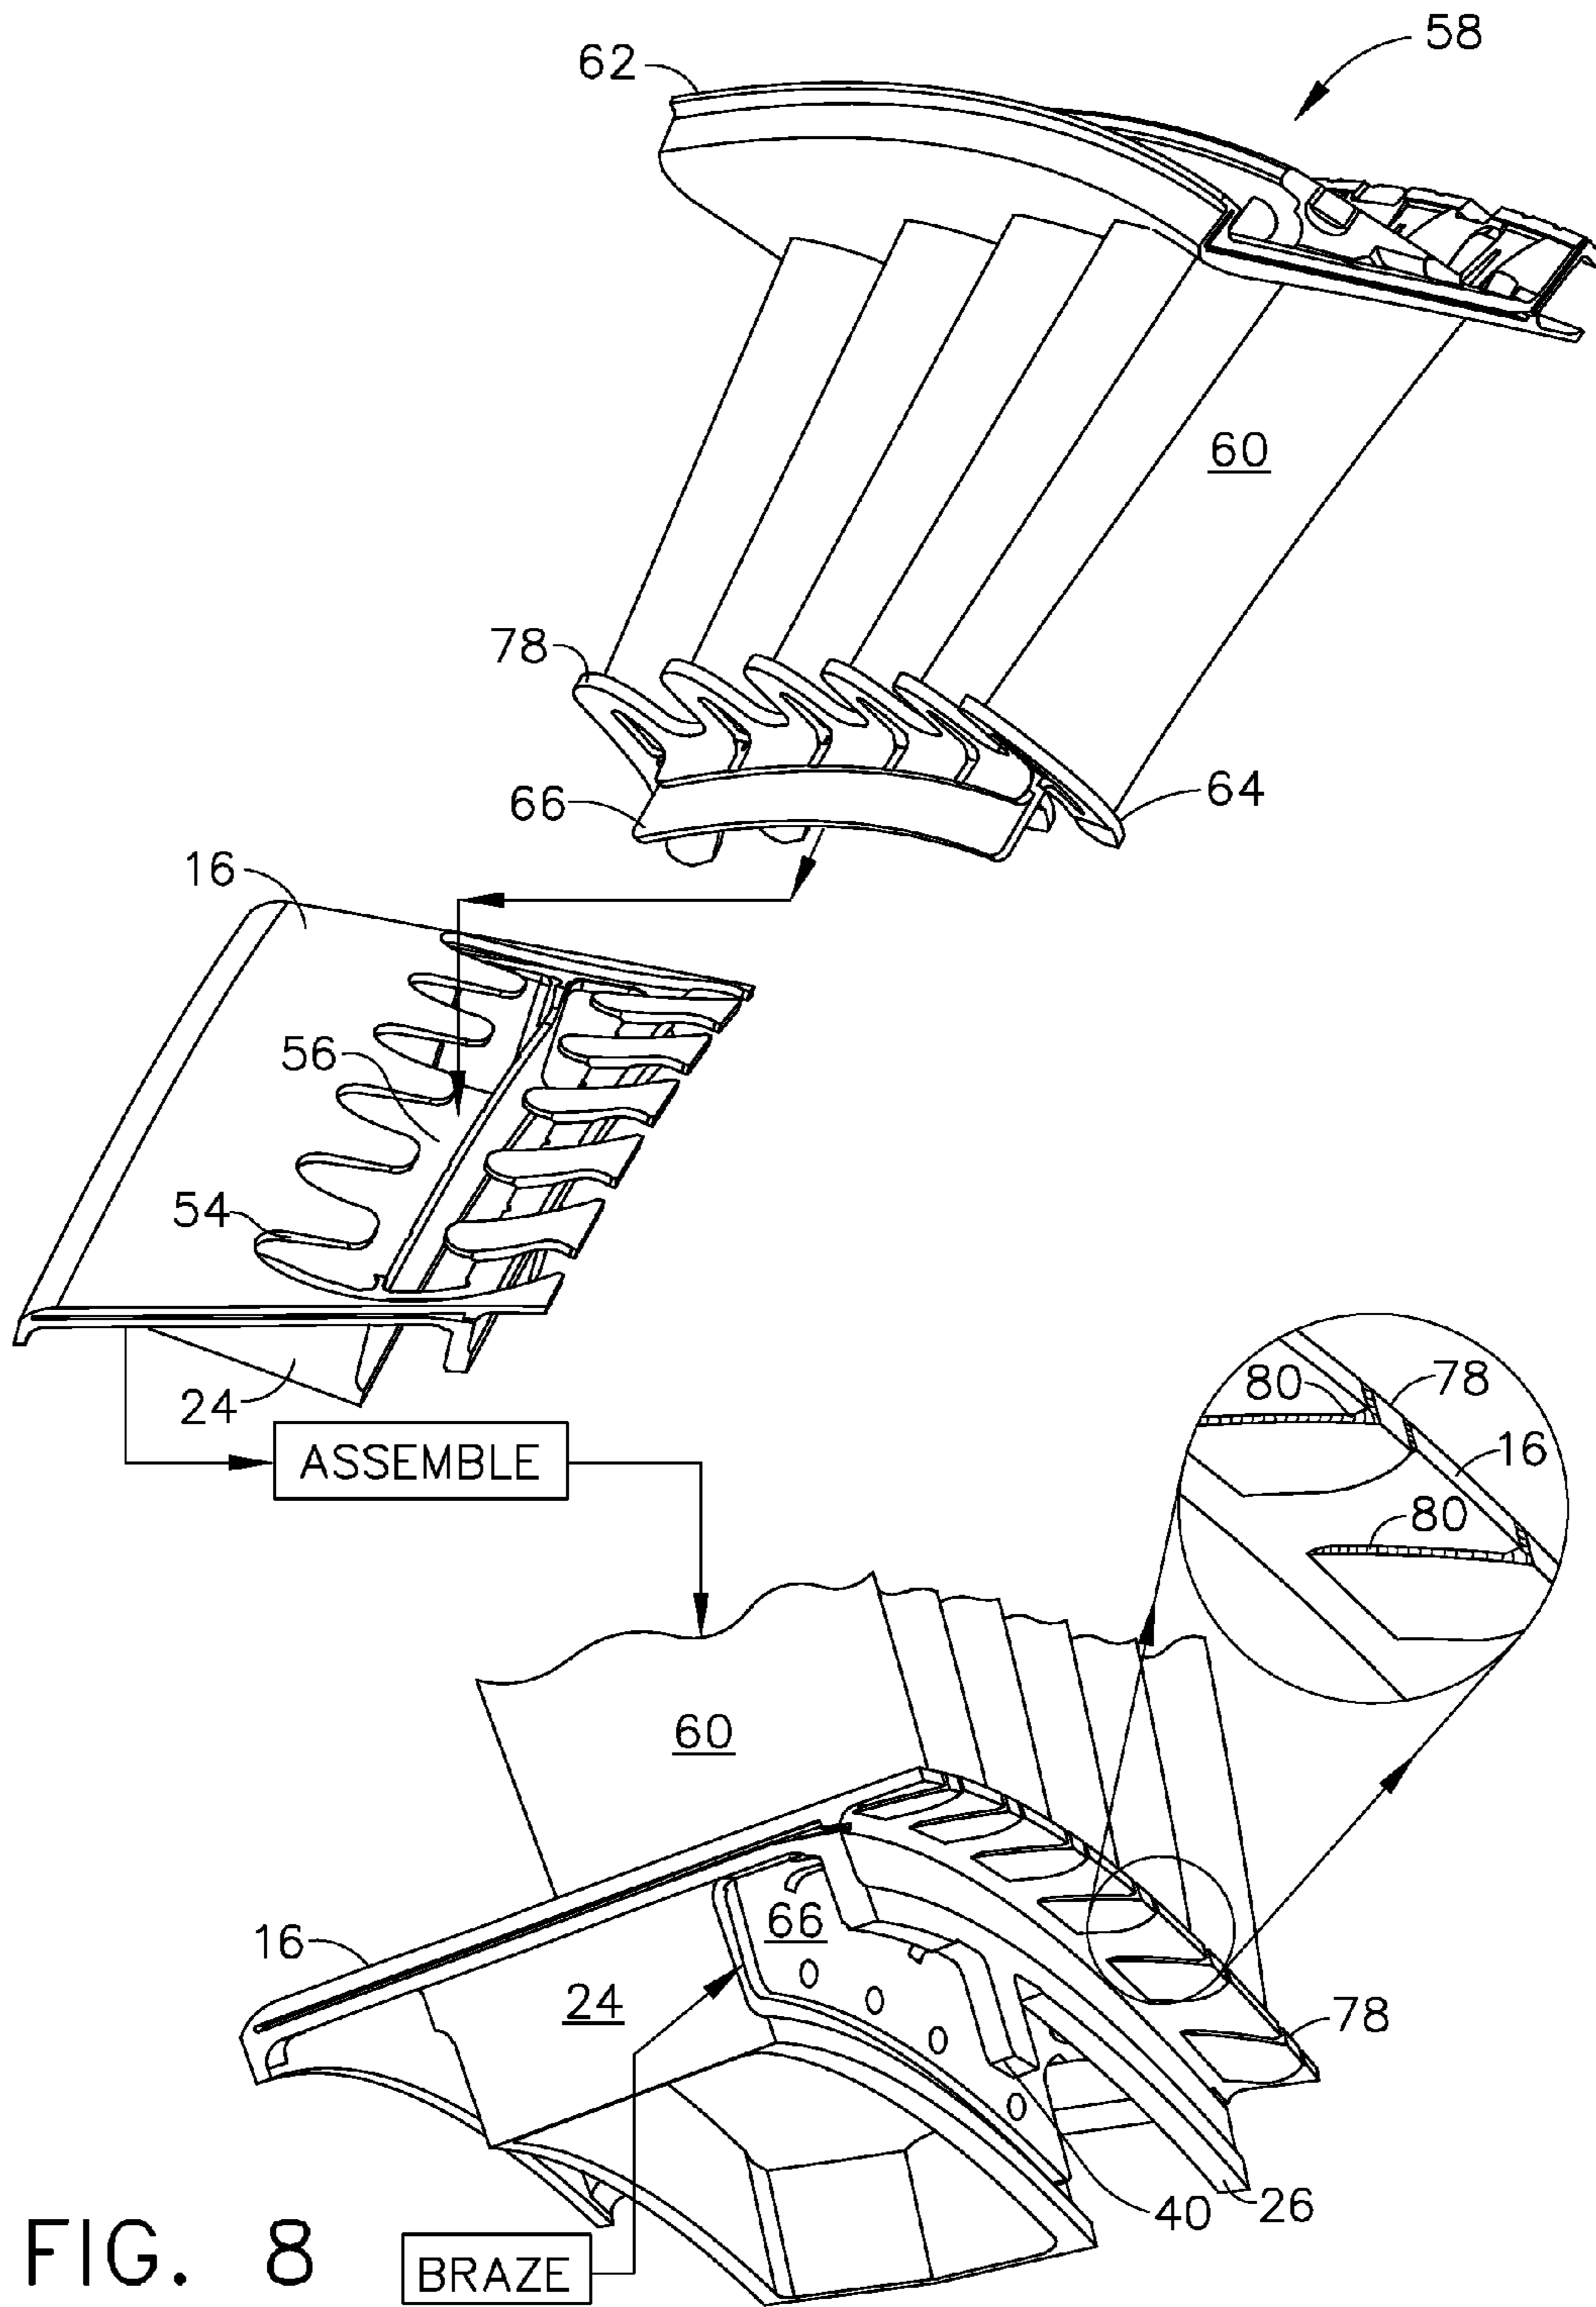
FIG. 8 is a flowchart illustrating assembly of the replacement turbine nozzle with the machined original inner band.

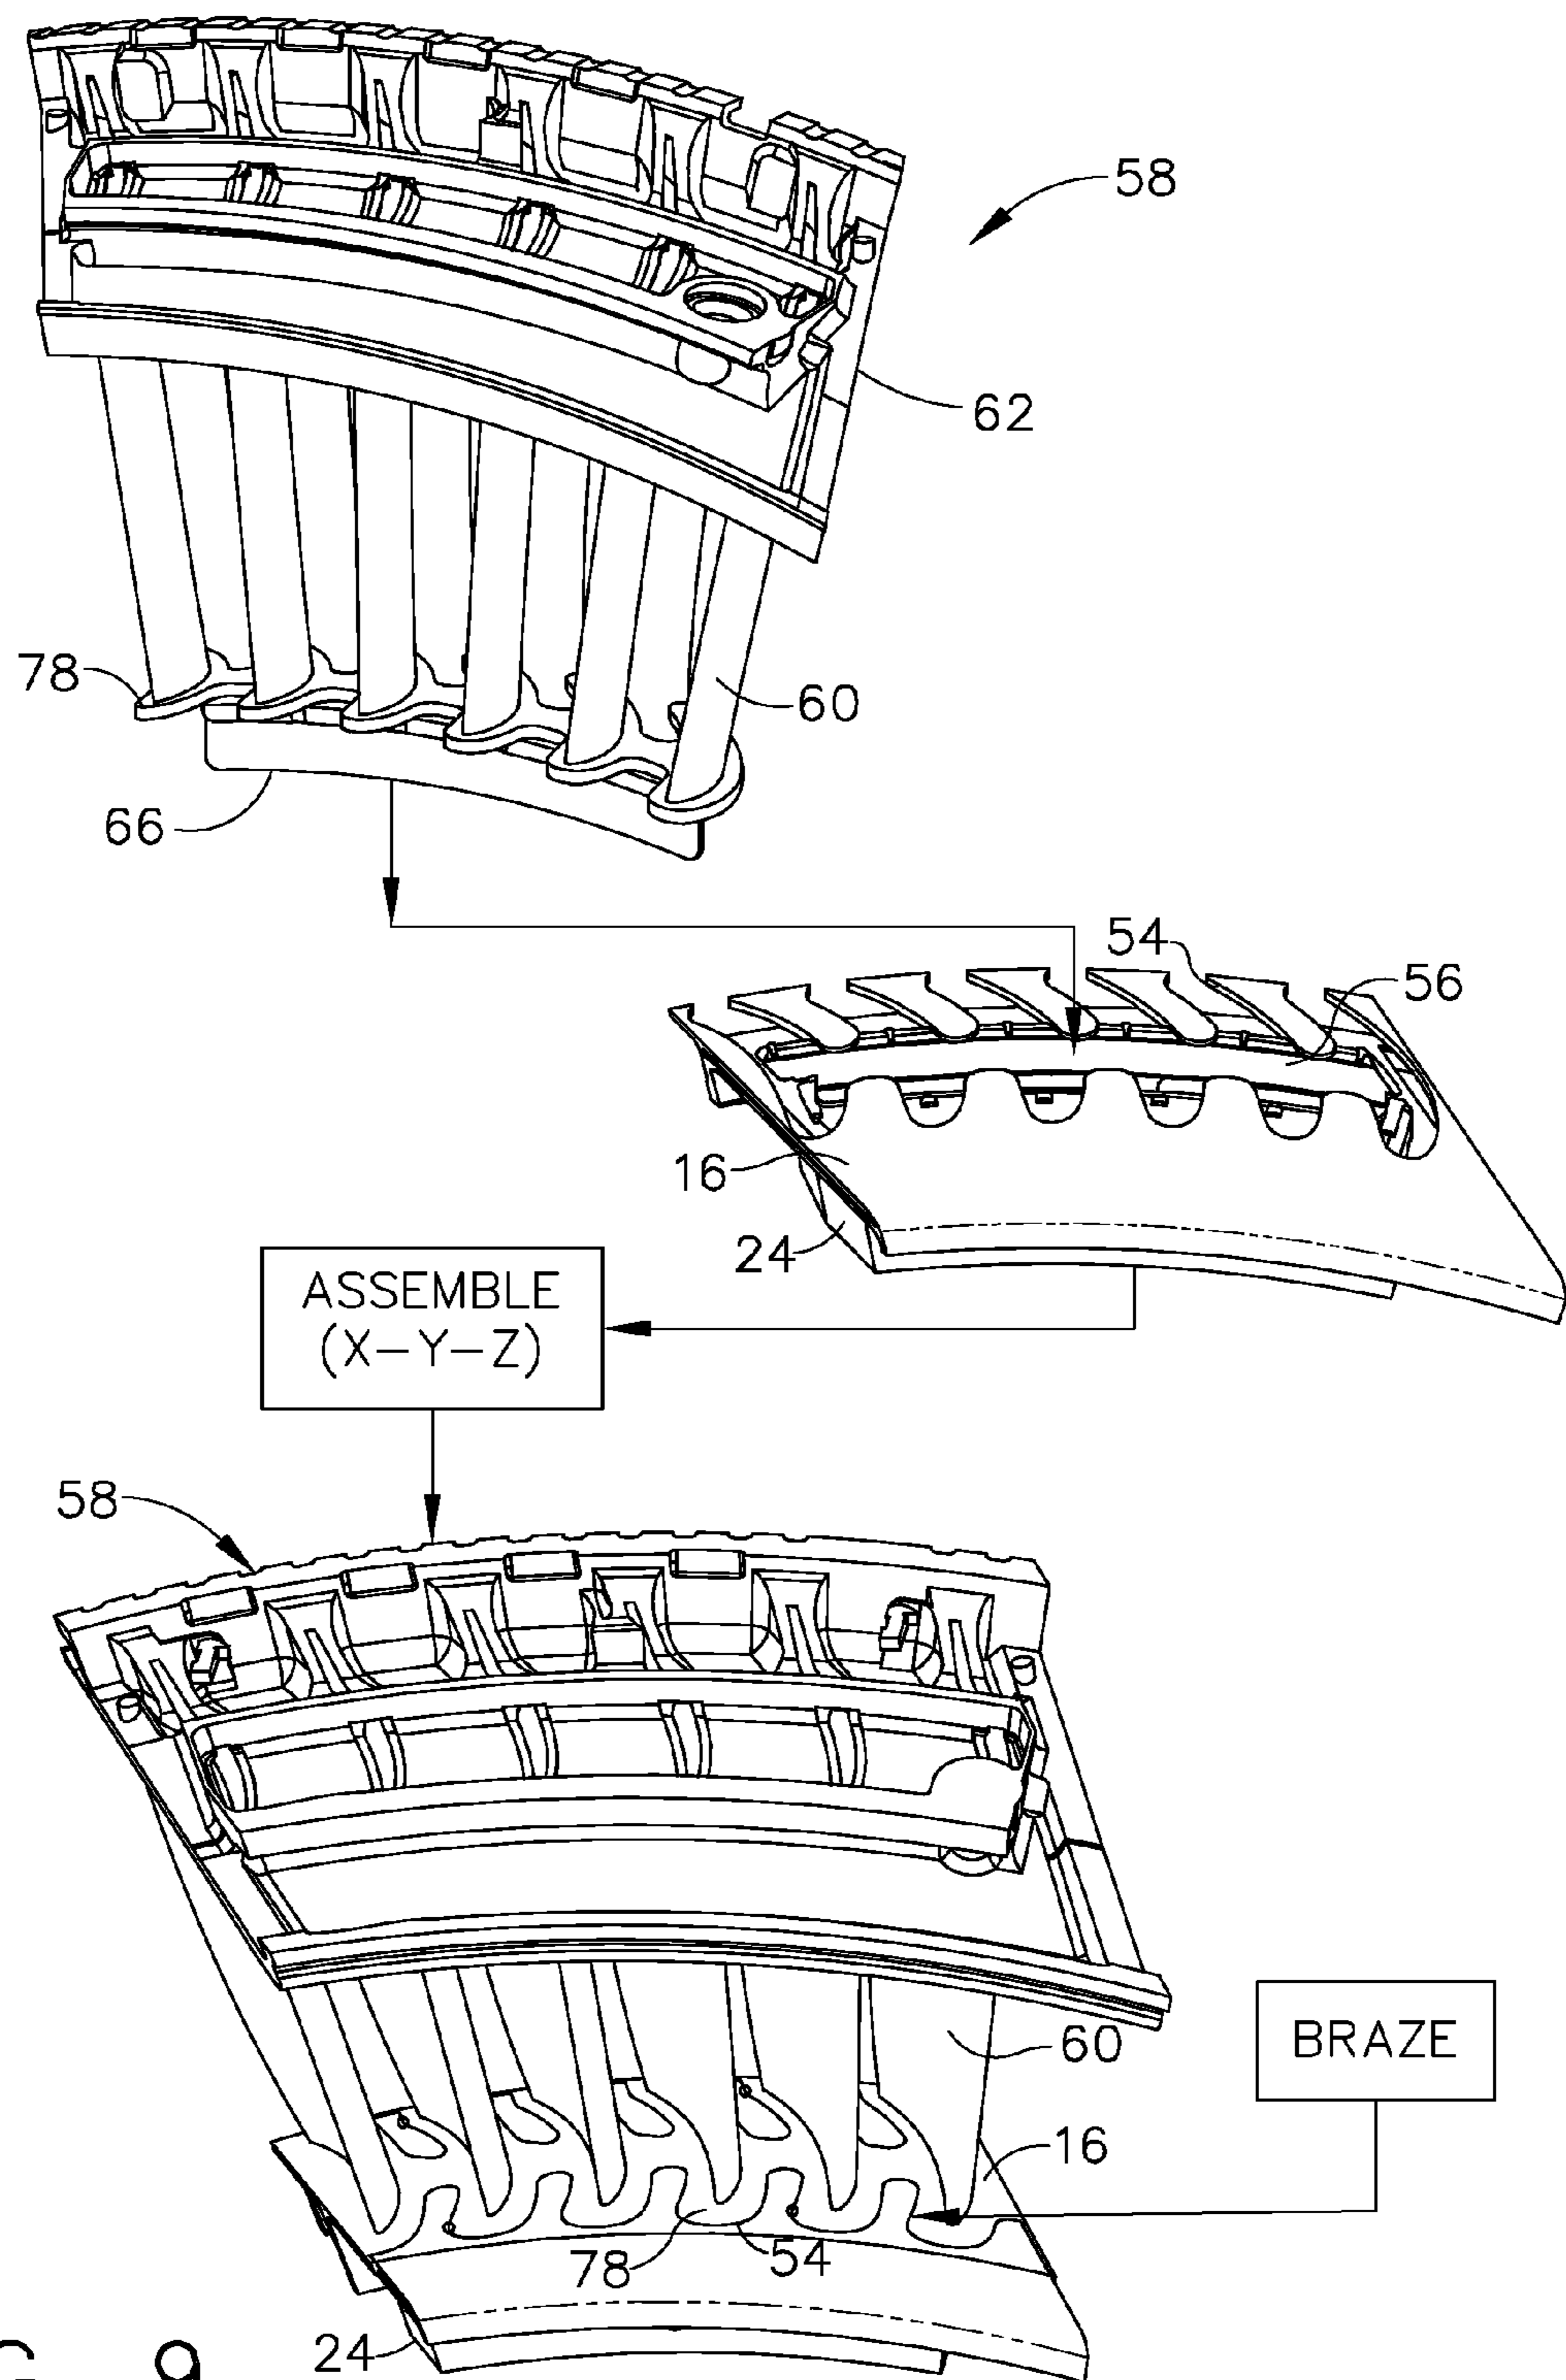
FIG. 9 is a flowchart, like FIG. 8, illustrating assembly and bonding together of the replacement turbine nozzle and repaired inner band.
